Building and Timber Pest Inspection Report

Inspection Date: Wed, 18 Mar 2026

Property Address: 15 Ballybunnion Terrace, Glenmore Park
NSW 2745

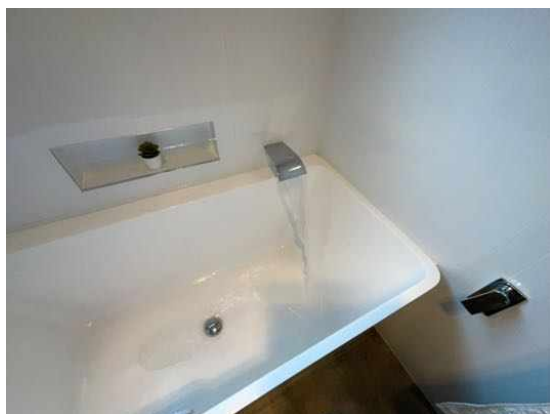
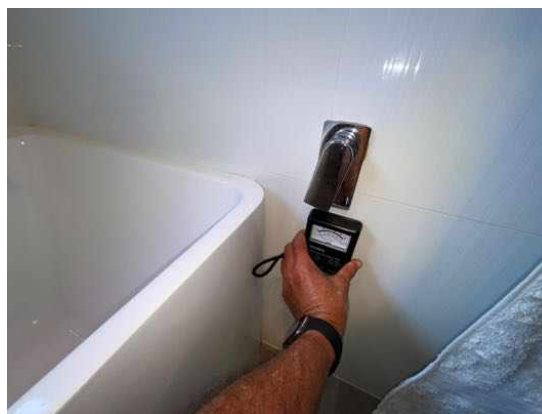
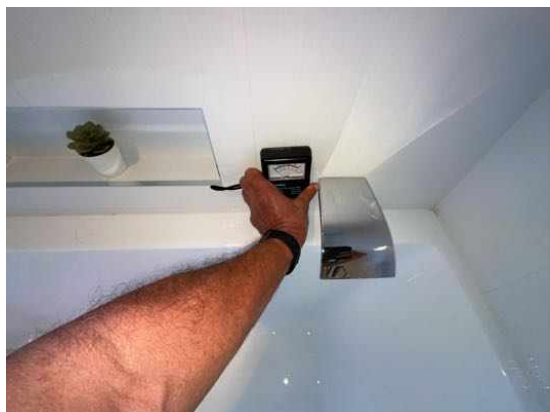
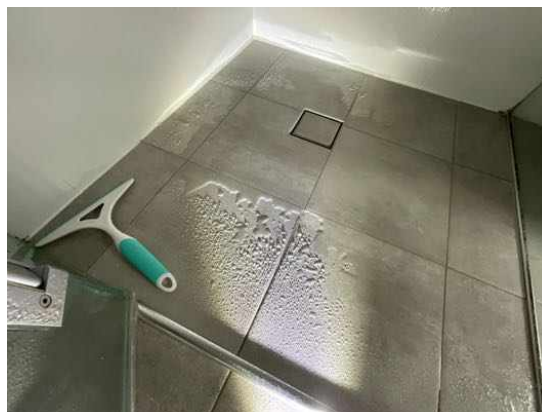
Building: Main Building
 Location: Ensuite
 Finding: Wet Areas - Bathroom(s) - Overall Condition & Recommendations.
 Information: Overall Condition & Recommendations

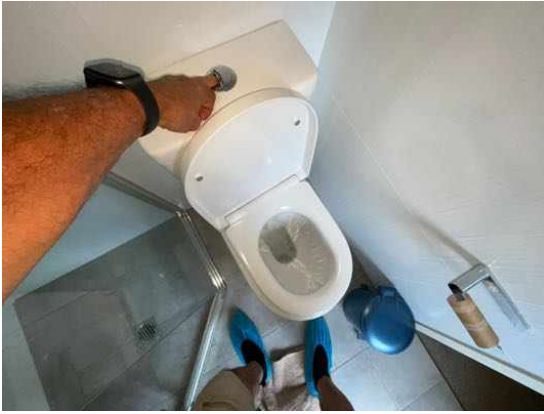
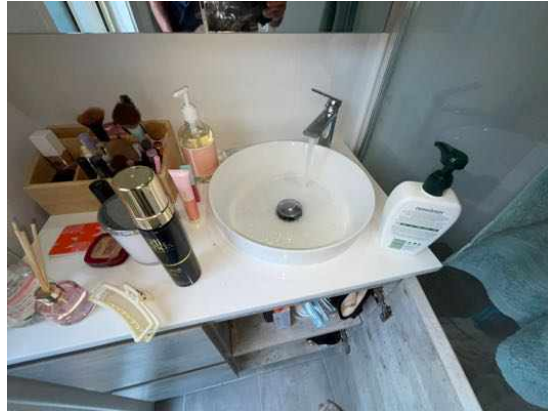
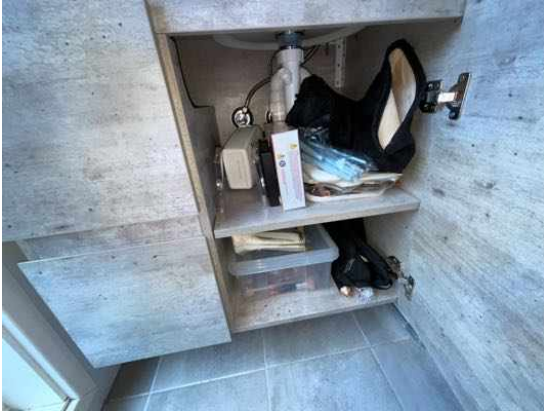
Building: Main Building
Location: Toilet (WC)
Finding: Overall Condition: Toilet.
Information: TOILET ASSESSMENT
