Building and Timber Pest Inspection Report VR

Inspection Date: Fri, 9 Jan 2026

Property Address: 20 Glen Frew St, Kenmore QLD 4069,
Australia

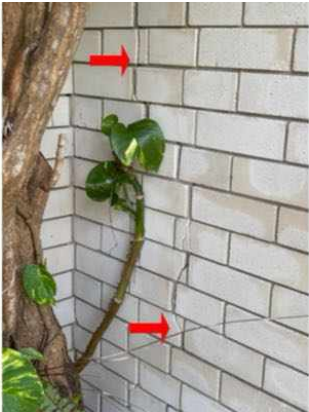
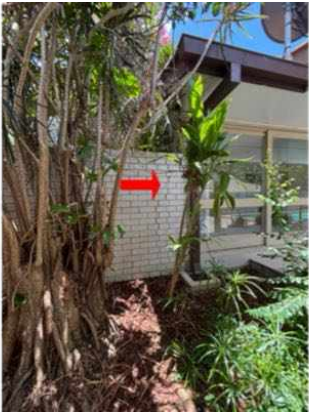
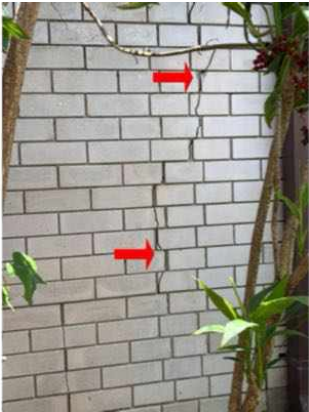
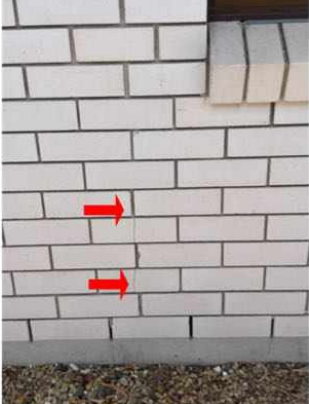
Building:	Main Building
Location:	All External Areas
Finding:	Brickwork - Step cracking
Information:	At the time of the inspection, it was noted that there was step cracking to the brickwork on the left hand side of the carport area and on in sections of the brickwork on the left hand side of the dwelling. The client should monitor this area for any change to the step cracking.

Step cracking, which is similar to other forms of cracking, has a variety of possible causes. However, the most common is the subsidence of adjacent footings.

Step cracking is a relatively common defect, and is most likely to occur adjacent to windows, doors and other openings. Mortar failure in the gaps between affected bricks indicates the stresses and tensions affecting the wall.

Where step cracking is extensive or severe, the client is advised to consult a structural engineer. Minor step cracking can be used as a warning sign to address factors causing stress to the wall, which can include the effect of surrounding trees, water leaks, soil erosion, or even the presence of reactive soils in the surrounding area.

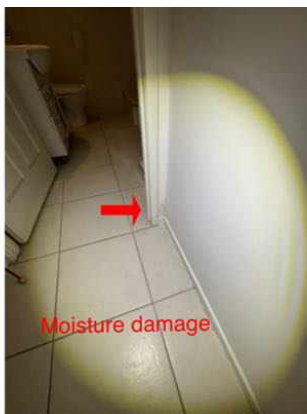
Finding 3.02

Moisture in wall cavities creates a conducive environment for termite activity and can cause undetected damage to the associated building materials.

A bathroom specialist, such as The Grout Guys, should be engaged to assess the family bathroom shower and provide a solution to rectify this issue. This should be done as a matter of urgency.
