Building and Timber Pest Inspection Report

Inspection Date: Tue, 17 Feb 2026

Property Address: 147 The Trongate, GRANVILLE, NSW, 2142, Australia

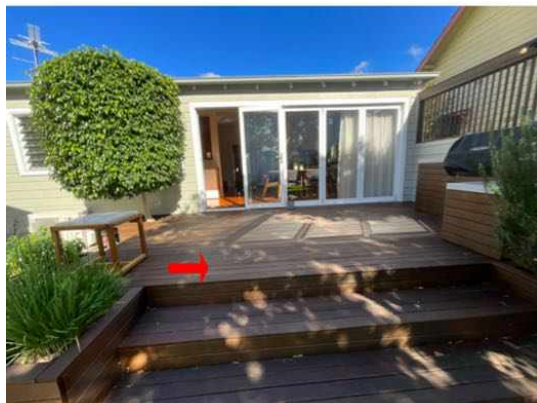
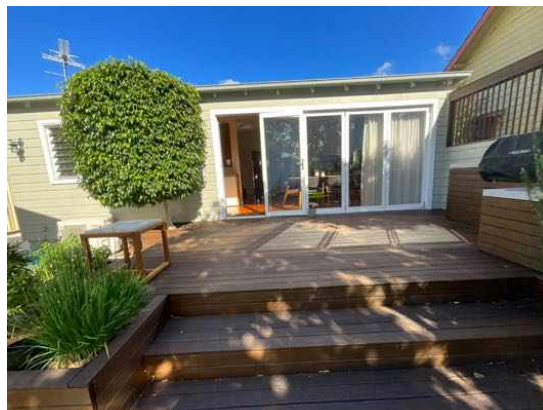
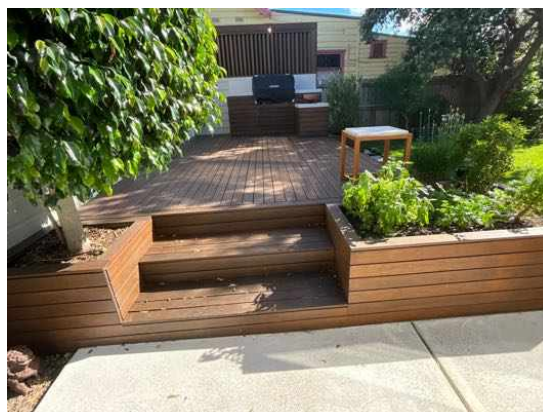
External timber structures are also constantly exposed to weather deteriorates in an exhilarate manner, ongoing assessments are required.

It is highly recommended that a structural engineer further, assess the external timber balcony or a deck to inform the client of its load capacity.

Regular maintenance inspections by competent practitioners is needed.

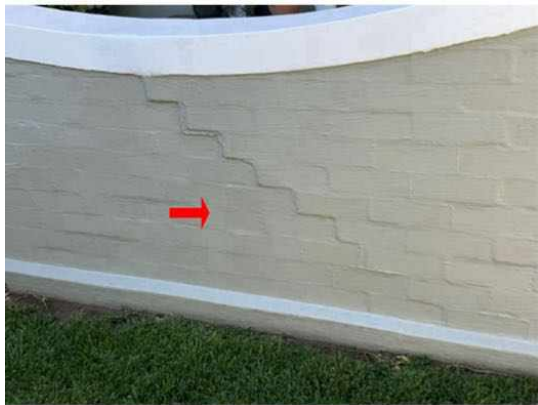
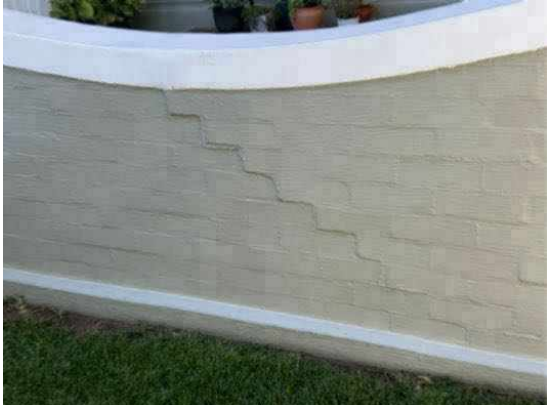
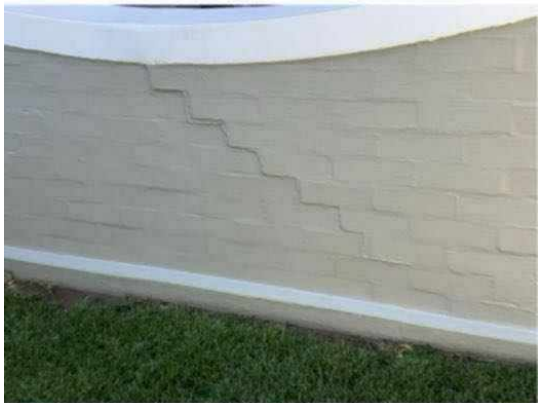
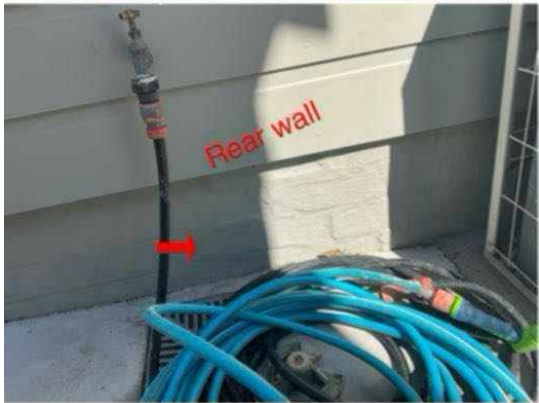
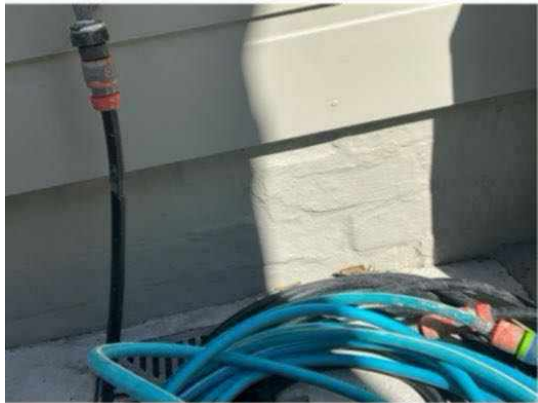
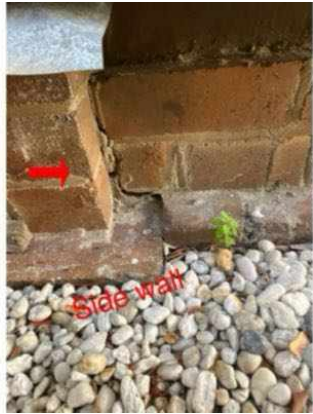
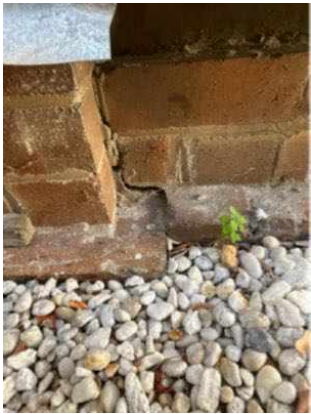
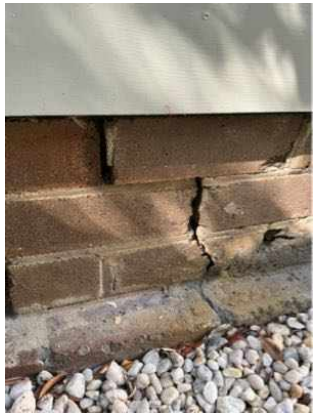
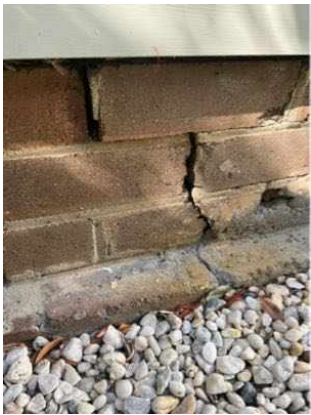
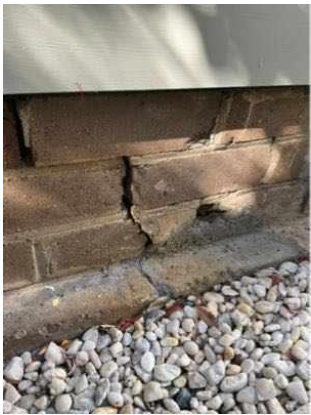
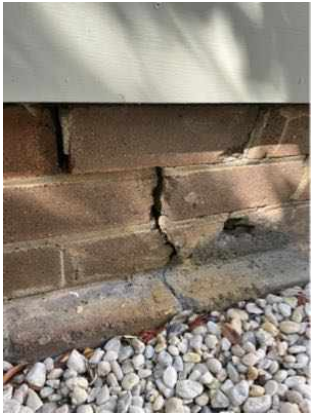
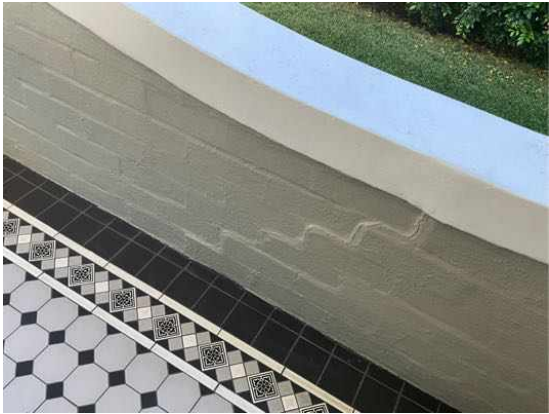
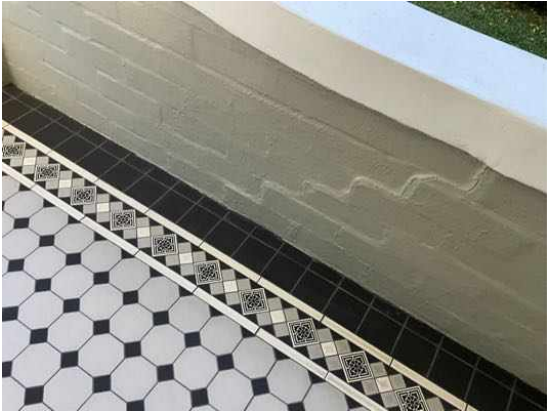
Finding 2.01

Building: Main Building
Location: All Areas
Finding: Brickwork - Cracking [Repair required]
Information: Major cracking was identified to the brickwork in this area. Cracks of this type are likely to have been caused by movement of building elements, but may also have a structural cause that is more significant. A crack of this size may be repaired by extensive filling.

A qualified bricklayer should be contacted immediately to estimate and perform repair and restoration works. Consultation with a structural engineer may be required where structural instability is found to be the underlying cause of the cracking.

Always contact a building inspector should cracks widen, lengthen, or become more numerous.

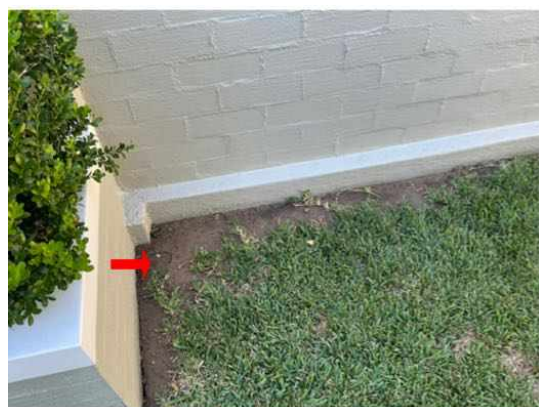
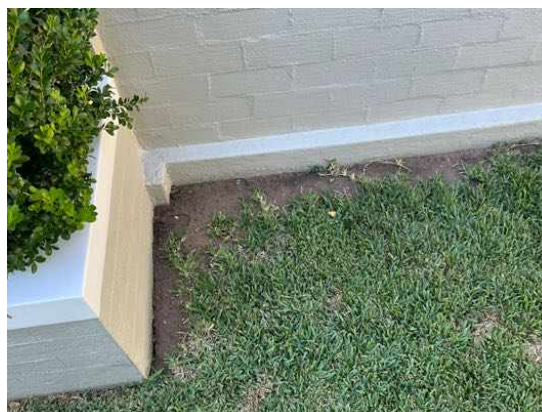
Finding 3.01

Building: Main Building
 Location: All Areas
 Finding: Perimeter - Insufficient Fall
 Information: The perimeter ground levels were found to have an inadequate slope away from the adjoining building structure, creating potential for water pooling in this area.

Perimeter is required to fall from the building by a minimum of 25mm in the first metre and bare ground should fall away from the house by 50mm in the first meter. This standard ensures that excessive moisture does not pool around the base of building structures, which creates potential for water and structural damage, as well as making the area susceptible to termite and timber pest activity.

Where ground levels do not have adequate fall, a licensed paving contractor should be appointed to install or remove and re-level pavement.

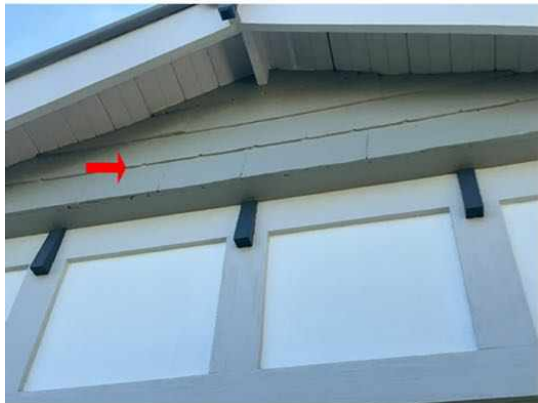
Finding 3.02

Finding: Timber - exposed to weather
Information: External timbers that are frequently exposed to harsh weather conditions require adequate protection in order to maintain their condition. Where timbers have not been painted or treated adequately, general deterioration is likely to occur at an accelerated rate.

If left unattended, replacement of these timbers is likely to be necessary in the short-term future. Adequate treatment of these timbers is required as soon as possible by a painting contractor or general handyman.

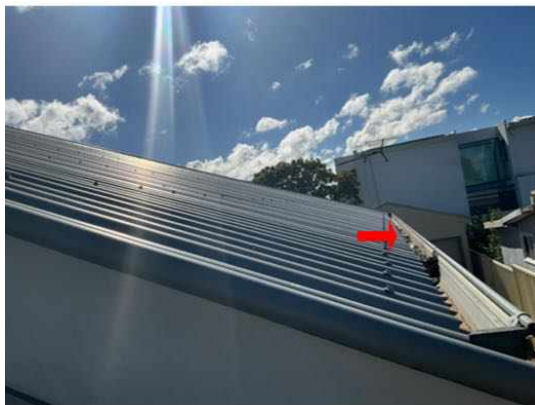
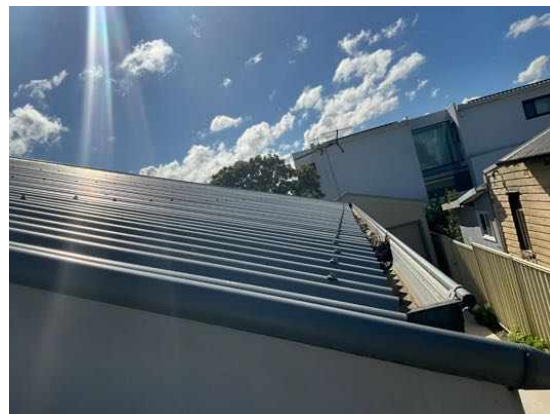
Finding 3.03

Information: The roof gutter system was observed to be blocked with organic debris and moss growth, as evident in the provided images.

- Water ingress into the eaves or walls,
- Timber rot or deterioration of fascia and soffits,
- Accelerated moss and algae growth, promoting further blockages,
- Potential foundation issues if water pools near the base of the structure.

A licensed roofing contractor or qualified gutter cleaning service should be engaged to remove the debris and inspect the system for any further issues.

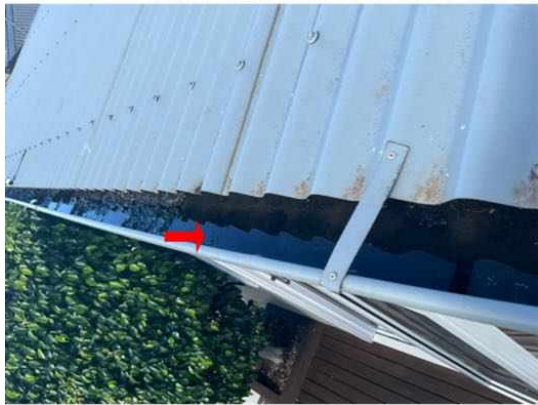
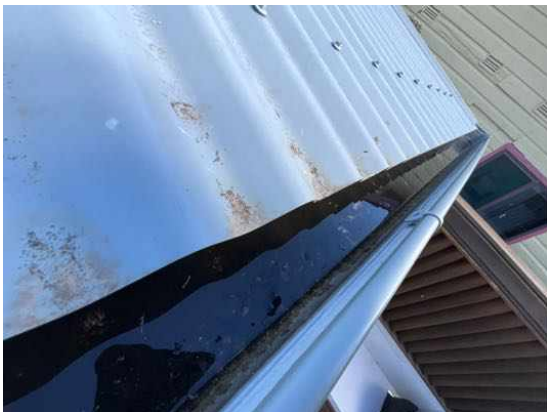
Finding 3.04

Building:	Main Building
Location:	All Areas
Finding:	Gutters - Water pooling
Information:	Water was found to be pooling in sections of the roof guttering. This is generally a secondary defect caused by blocked or partially blocked gutters. Such blockages and subsequent water pooling are likely to lead to rust and water damage to associated structures if left unattended.

Any areas of guttering that shows evidence of water pooling should be checked for partial or full blockages and any secondary damage that may have occurred as a result. Depending on the extent of the damage, building elements may require repair and/or replacement to ensure adequate roof drainage and function of exterior plumbing system.

A roofing plumber should be appointed as soon as possible to rectify this issue. It is highly advised that all gutters be maintained on a frequent basis to ensure the condition of roof plumbing.

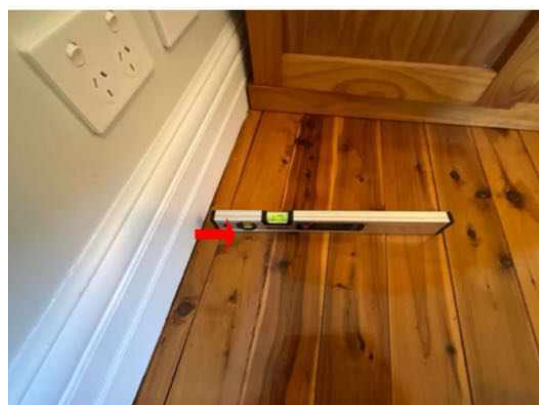
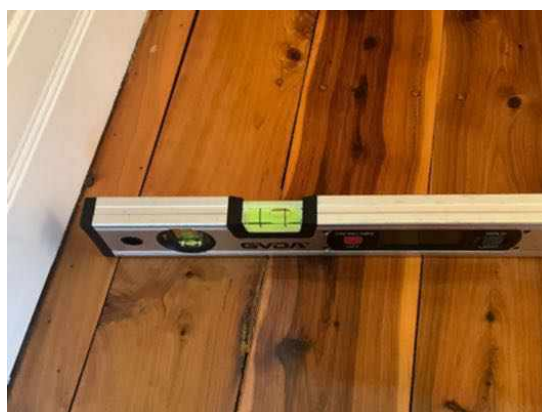
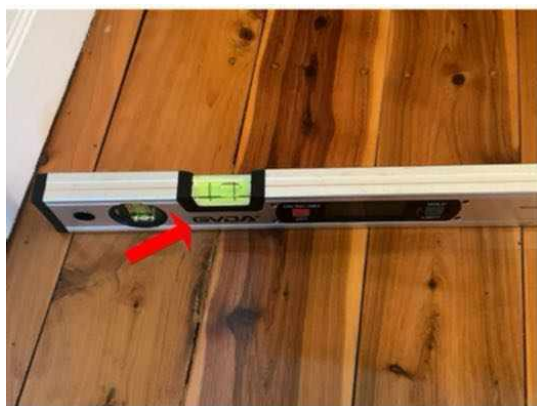
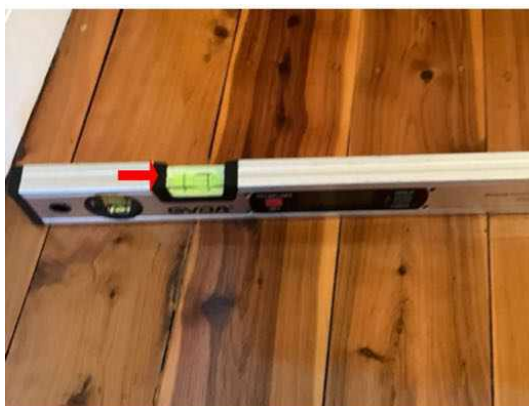
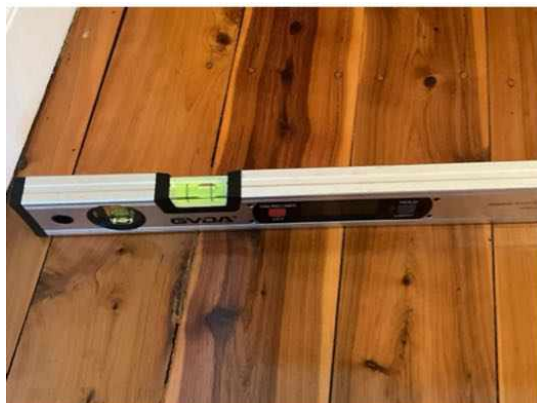
Finding 3.05

Information: The internal flooring within the inspected area was observed to be out of level and uneven underfoot. Variations in floor levels can indicate structural movement, which may be associated with foundation settlement, reactive soil movement, or deterioration and/or subsidence of supporting subfloor stumps and bearers.

Given the nature of this defect, a further invasive inspection of the subfloor area is strongly recommended to assess the condition of stumps, bearers, joists, and footings. Access limitations during a visual, non-invasive inspection may prevent full assessment of structural elements.

Repairs, if required, would typically involve re-levelling and/or re-stumping works and should be carried out by a suitably qualified and registered builder experienced in structural rectification works. In some cases, structural engineer assessment may also be required to determine the extent and cause of movement prior to rectification.

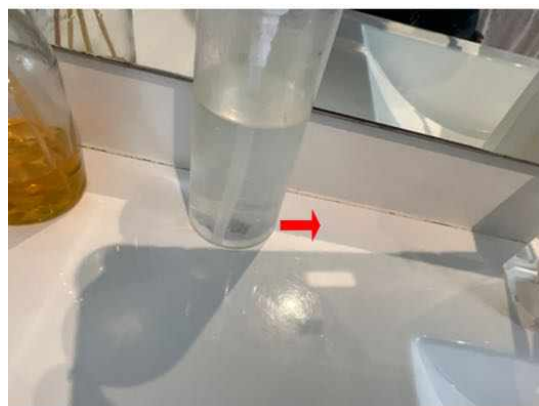
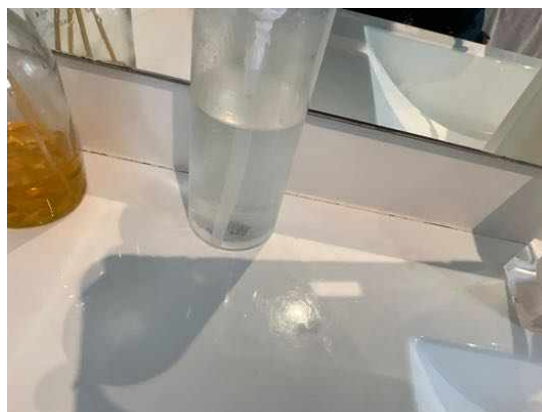
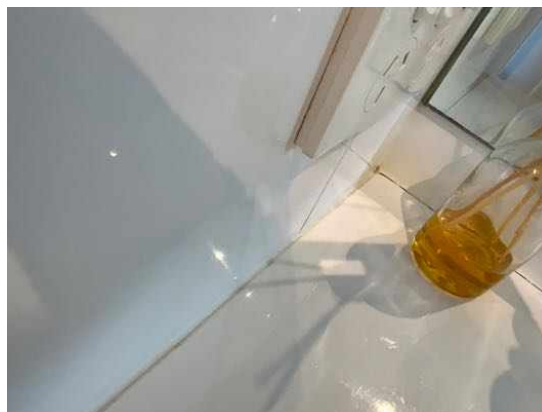
Finding 3.06

Information: The silicone seal around the basin has deteriorated, with visible gaps and discolouration noted along the edges.

Water penetration through the deteriorated seal may cause damage to surrounding surfaces, promote mould growth, and lead to deterioration of adjacent materials.

A licensed plumber or qualified handyman should remove the old sealant and reapply a sanitary-grade silicone to ensure watertight protection.

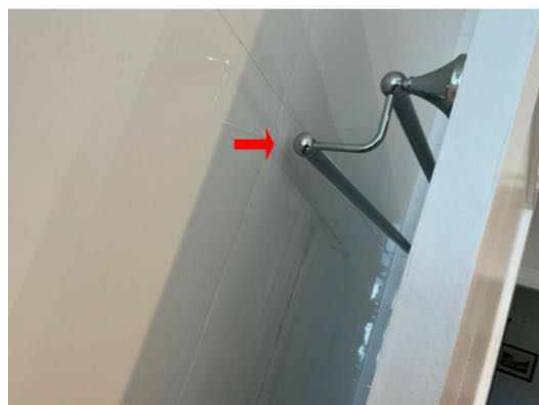
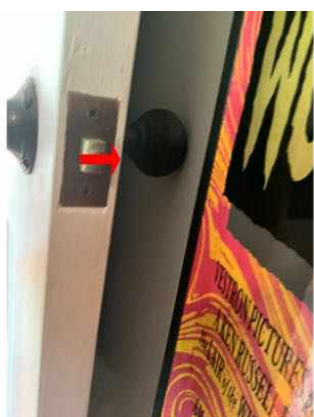
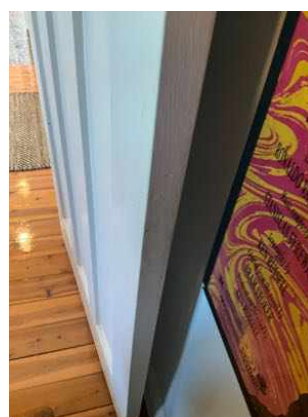
Finding 3.07

Building:	Main Building
Location:	All Areas
Finding:	Missing Door Stopper
Information:	The door lacks a stopper, which is essential to prevent the door from swinging too far and potentially damaging the wall or the door handle. The absence of a door stopper increases the likelihood of impact damage to both the door and surrounding surfaces over time.

- **Damage Risk:** Moderate risk of damage to the door handle, wall, or door itself from repeated impacts when the door is opened forcefully or by a gust of wind.
- **Wear and Tear Risk:** Increased wear on door hardware and hinges due to the potential for abrupt stops without a dedicated stopper.

This issue is a minor defect but should be addressed to prevent potential damage and

maintain the integrity of the door and surrounding areas.

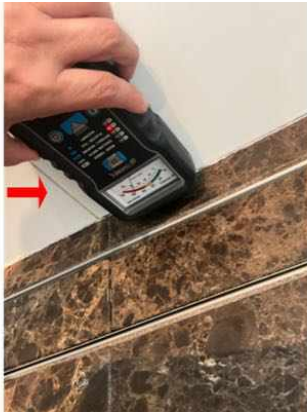
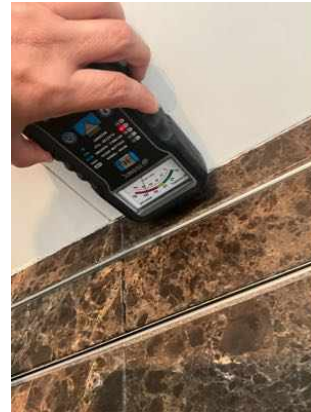
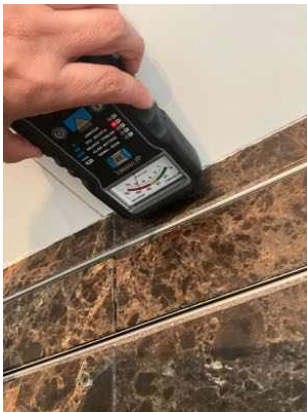
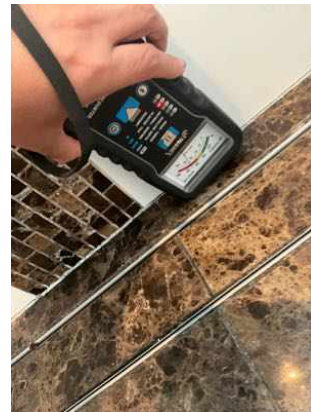
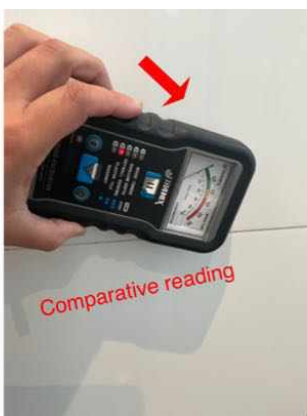
Information: Damp is evident to the lower 300mm of wall to the shower alcove. This defect is quite common, and is suspected to have been caused by moisture permeating through the grouting in this area, which shows evidence of deterioration. Leaking pipes within the adjoining wall is also a possible cause.

Damp (or structural damp) refers to the presence of unwanted moisture in the structure of a building, either as the result of intrusion from outside, or condensation from within the structure. In the shower area, internal water leaks or other sources of excessive moisture are generally the cause of damp.

Unmanaged damp in the shower recess is likely to facilitate the formation and development of mould and fungi growth, decaying associated building materials and compromising their structural integrity. It is important to address damp conditions, as the World Health Organisation notes that excess moisture leads - on almost all indoor materials - to growth of microbes such as moulds, fungi and bacteria, which subsequently emit spores and other matter into the indoor air. Exposure to these

Consultation with a qualified plumber or bathroom specialist is advised immediately to identify the cause of damp and to perform remedial works as required. Where excessive mould growth is present, further inspection by a specialist environmental health inspector should also be considered.

Always ensure that sealant and grout is in good condition to prevent any moisture issues occurring in the future.

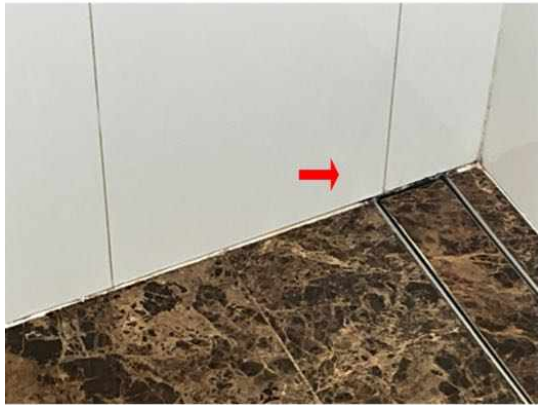
Finding 3.09

Building: Main Building
Location: Bathroom
Finding: Sealant and grouting - Missing or damaged
Information: It was noted on inspection that sealant or grout is degraded to the tiled shower alcove and or other areas of the bathroom.

Different materials and floor areas move at different rates, generally causing cracking to grout or sealant at this point. A flexible sealant is required to allow for expected expansion and contraction, while keeping the joint water tight and protective of all associated building materials.

There appears to be excessive mould to the sealant and grout which will likely require scraping out and replacement.

Flexible and mould resistant materials should be applied to affected areas to prevent any subsequent water damage that is likely to occur. Regular maintenance and replacement of damage or missing or damaged sealant and grout is highly recommended to the wet areas, as this is a regular wear and tear defect. Sealant and grouting in areas that come into regular contact with water should be maintained for the long term care of your property.

A sealant specialist or tiling contractor should be appointed to complete these works as soon as possible

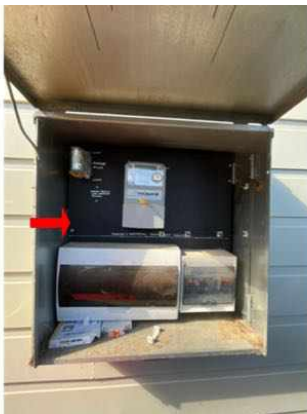
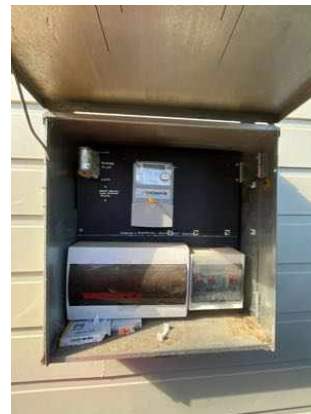
Building: Main Building
Location: Exterior walls - left side
Finding: No Evidence of Termite Management System - Durable notice / Legible Sticker
Information: The application of a pre & post-construction chemical termite barrier is highly recommended for all properties. Such barriers are highly effective in preventing termite attack on any timber building elements throughout the property.

A durable notice was not placed in the switchboard unit to indicate current termite barriers is legible at the time of inspection.

Client must seek further information from the vendor or real estate agent if the conditions of termite management systems were maintained.

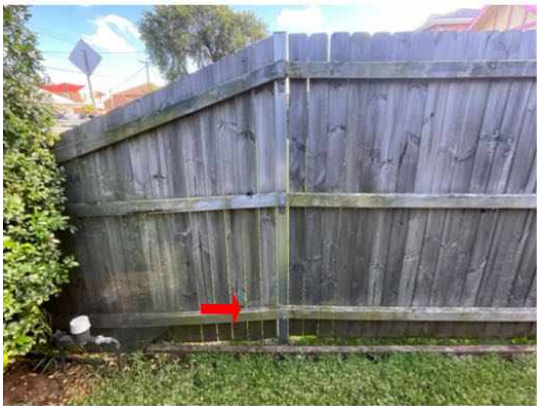
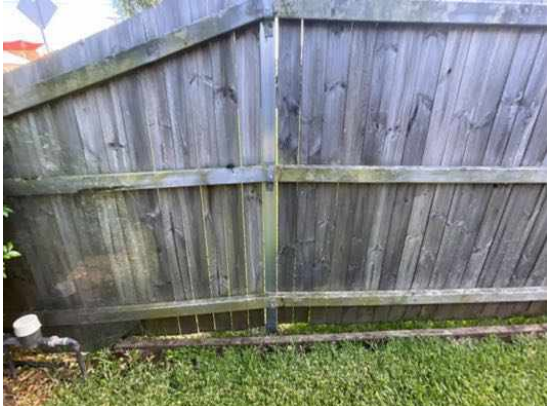
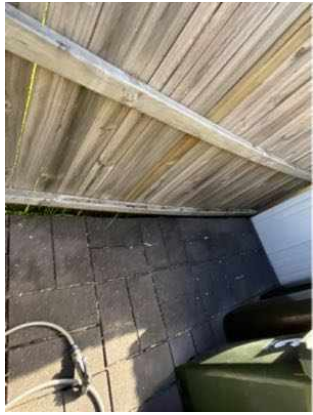
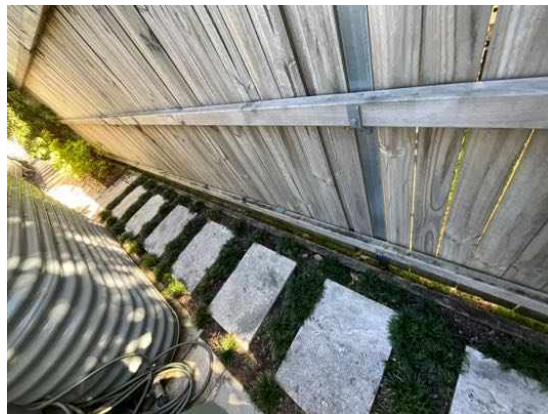
Finding 6.03

Building: Main Building
 Location: All Areas
 Finding: Timber on ground / conducive conditions to termite damage
 Information: Timber on the ground is indeed conducive to termite damage. Termites are known to thrive in moist environments, and wood in contact with soil or moisture is more susceptible to infestation.

To prevent this, it's important to keep timber elevated and away from direct ground contact. Regular inspections and proper termite control measures are also essential to protect your wooden structures from termite damage.

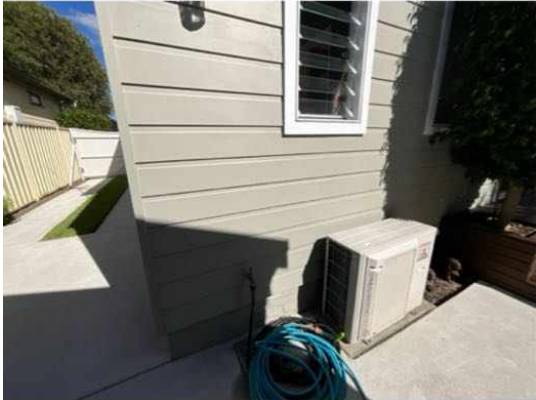
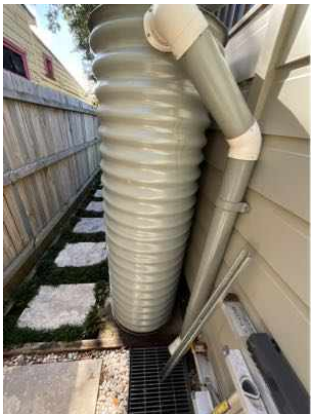
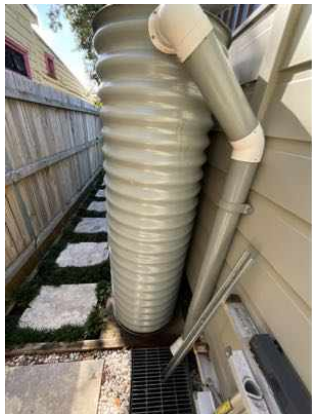
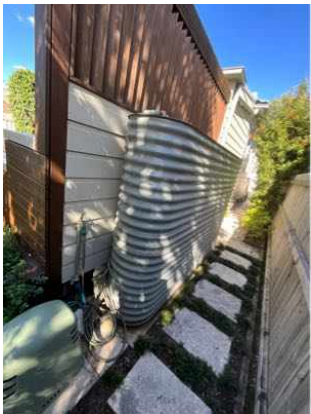
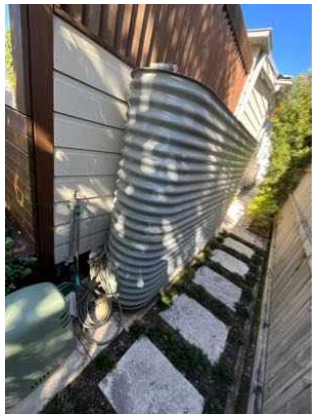
Finding 6.04

Building:	Main Building
Location:	All Areas
Finding:	Bridging or Obstruction Conducive environment for Termites
Information:	Bridging of termite barriers occurs when termites bridge (usually by building a mud tunnel) a termite barrier or inspection inspection zone or where termites have a passage, allowing them to bridge the barrier.

Where bridging has occurred full inspection is prevented and termites may enter a property in a concealed or undetected manner.

Recommended moving obstructions away from the external walls for further and future inspections.

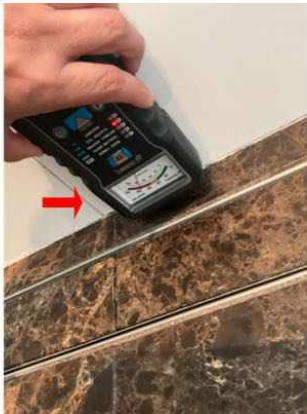
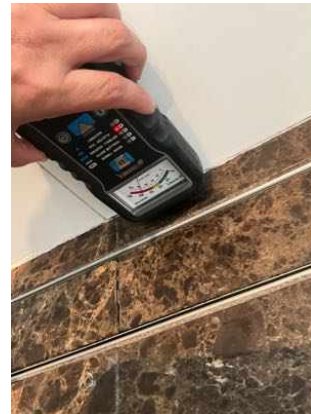
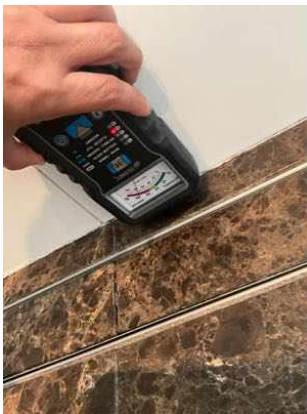
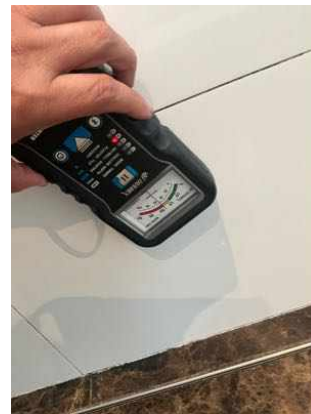
Building: Main Building
Location: Bathroom
Finding: Excessive moisture - Conducive to Timber pest
Information: Excessive moisture can attract termites and produce conditions that promote fungal

growth and wood decay.

Excessive moisture is generally caused by deteriorated inadequate or missing roof drainage leaking plumbing pipes or fixtures poorly plumbed HWS overflows or condenser units and poor site drainage.

If mould growth has been found there may be environmental biological or health issues involved. In these cases an appropriately qualified inspector should also be contacted.

Prior to any remedial works being performed a qualified plumber should be appointed to further inspect the property and to identify the cause of the excessive moisture. Works to remove affected building elements may then be necessary and should be performed by an appropriate tradesperson.

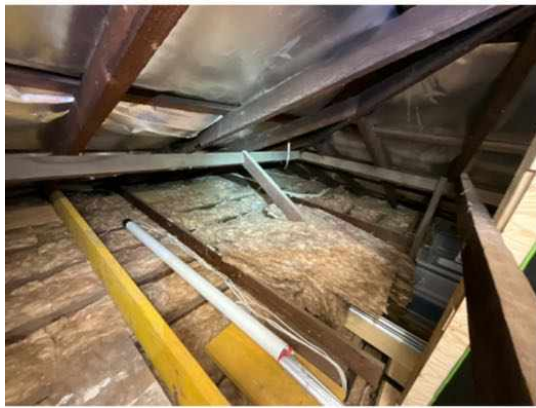
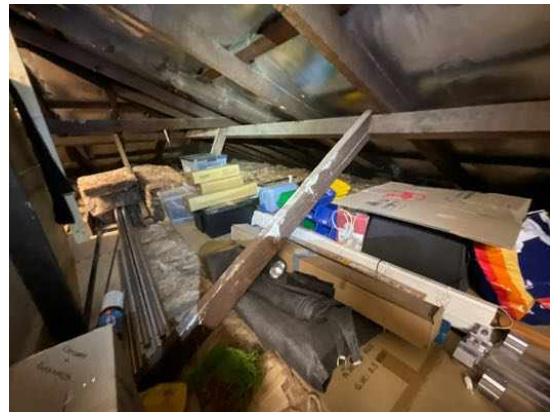
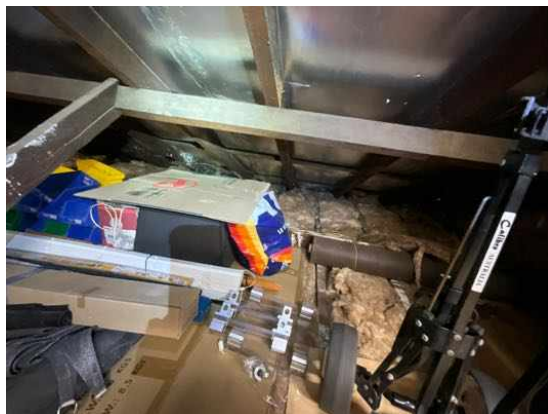
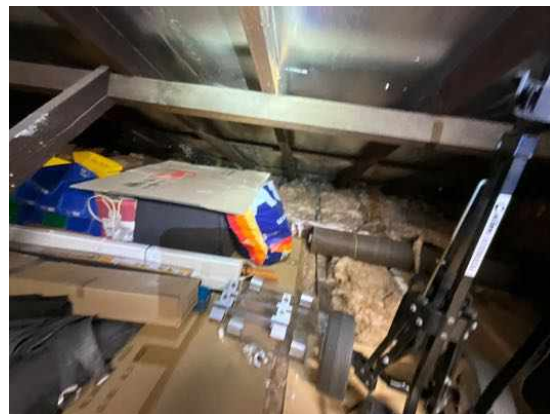
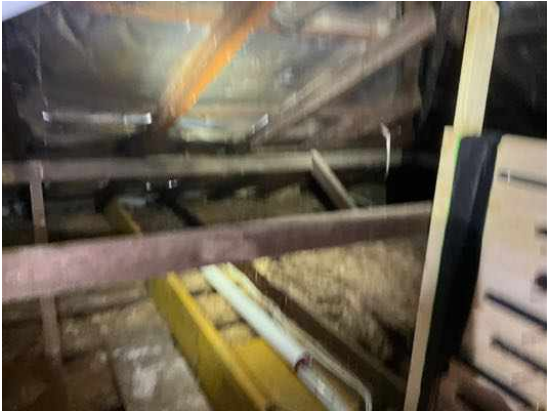
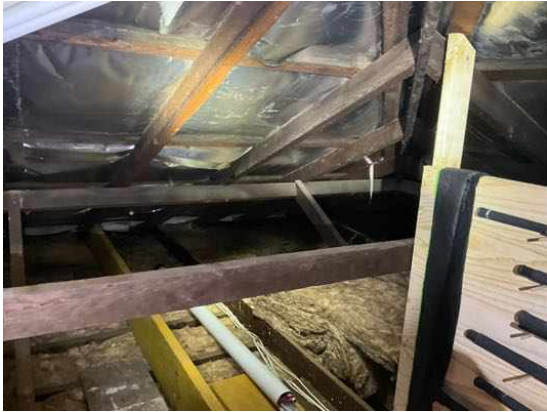
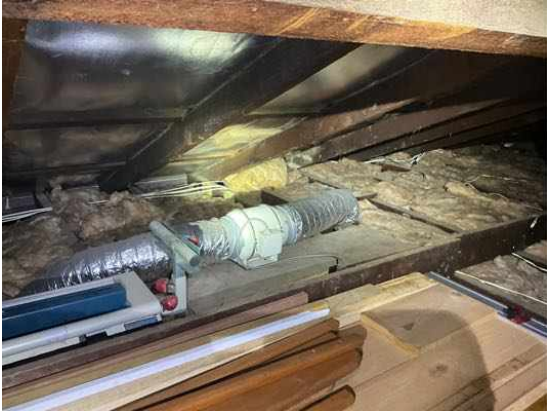
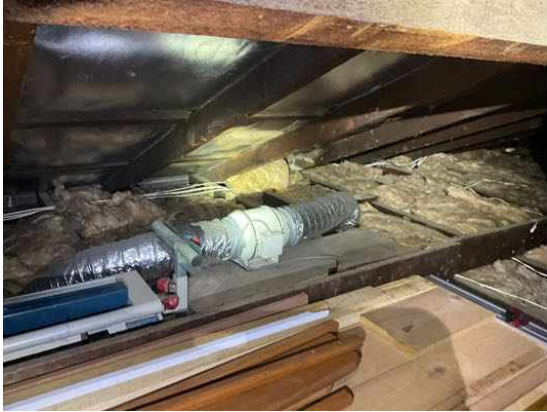
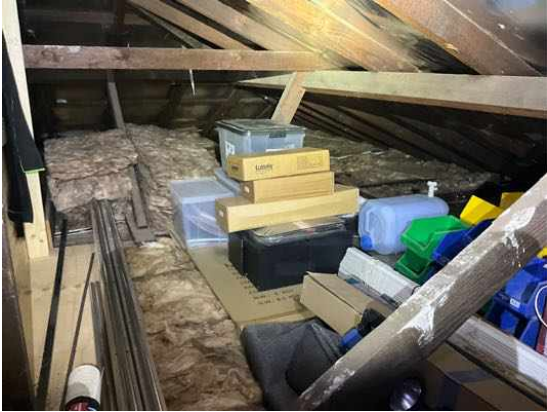
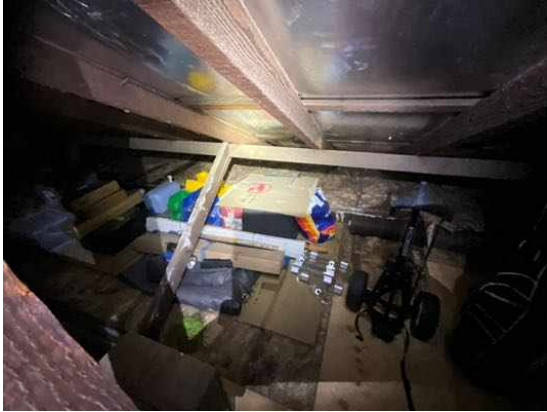
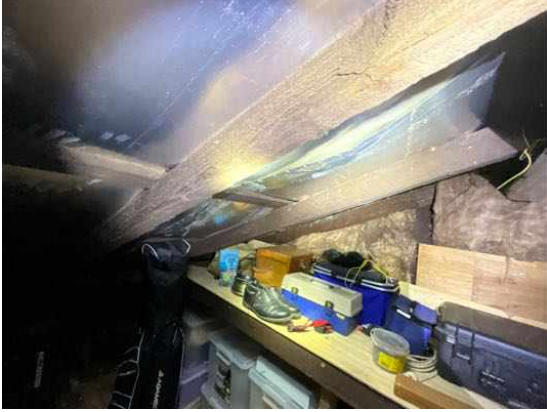
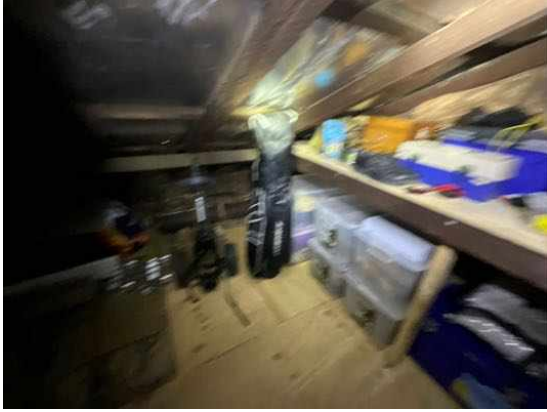
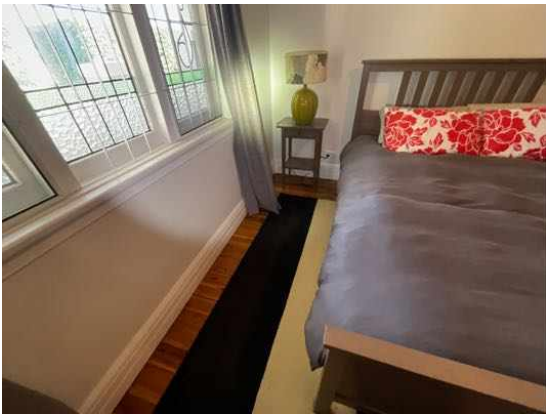
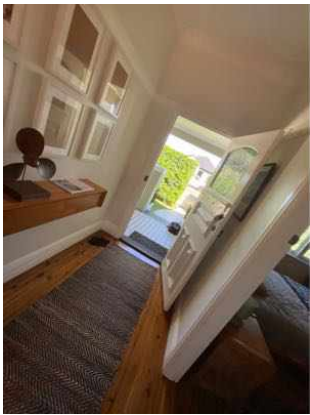
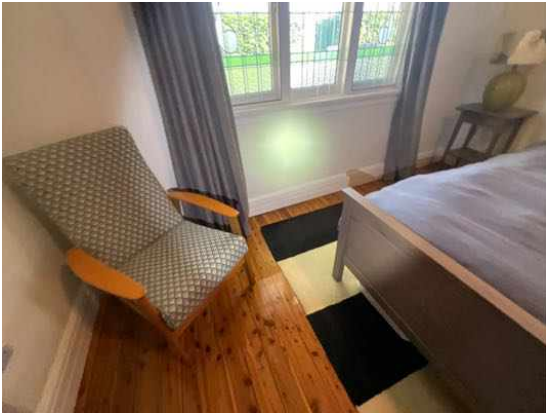
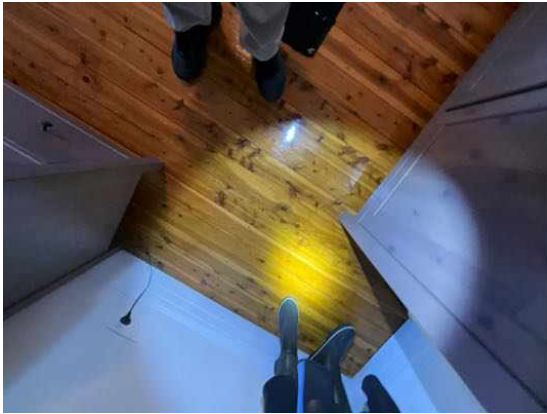
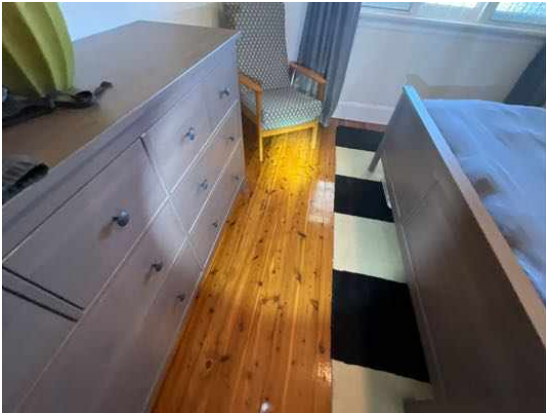
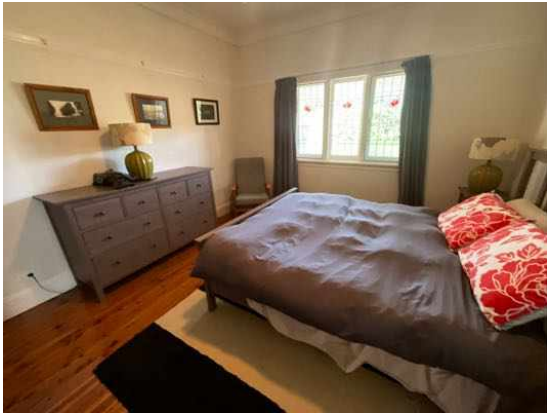
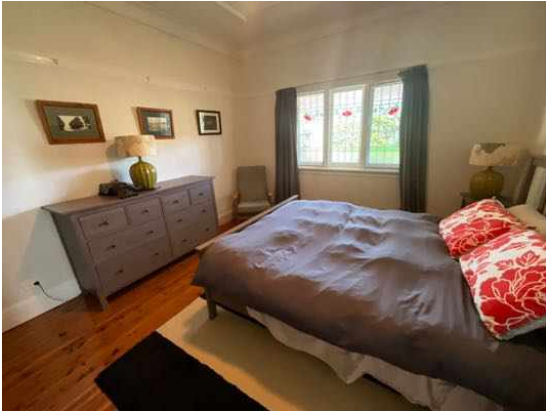
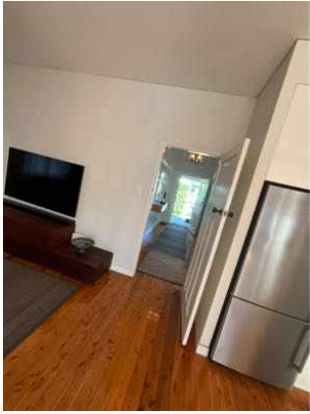
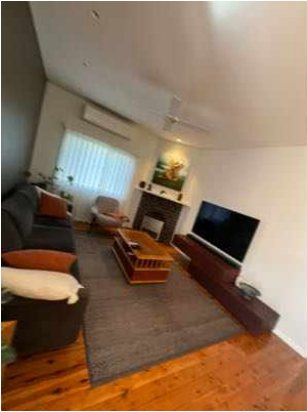
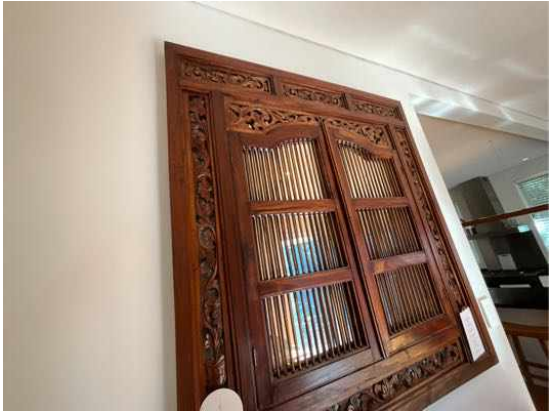
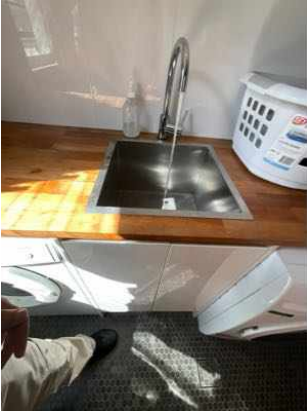
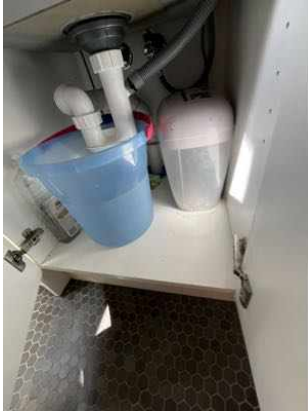
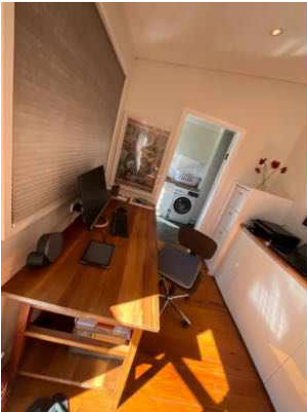
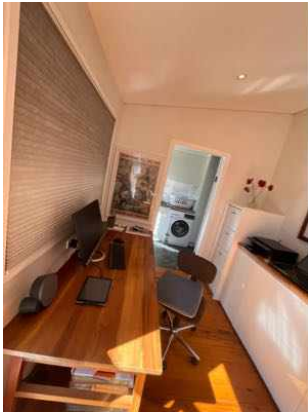
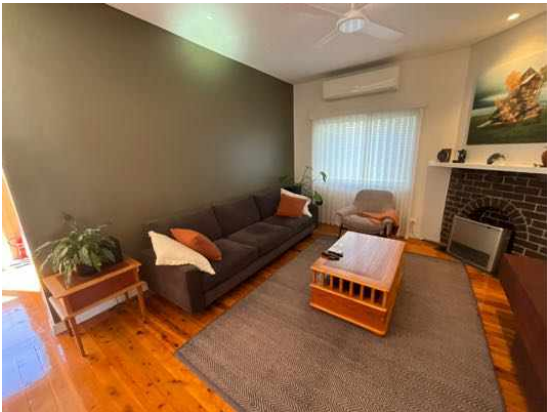
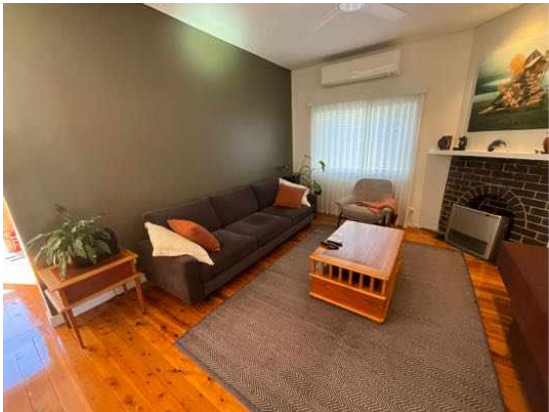
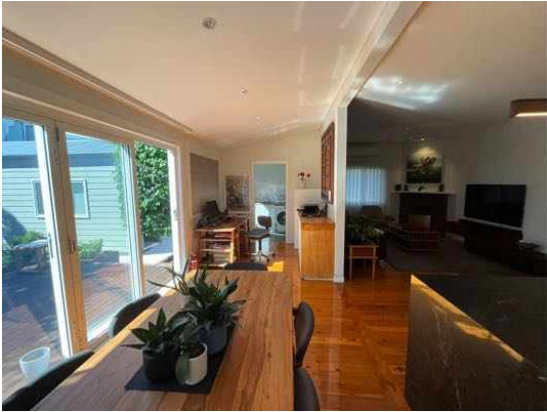
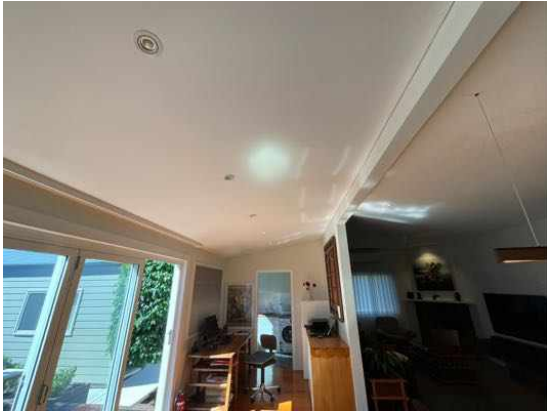
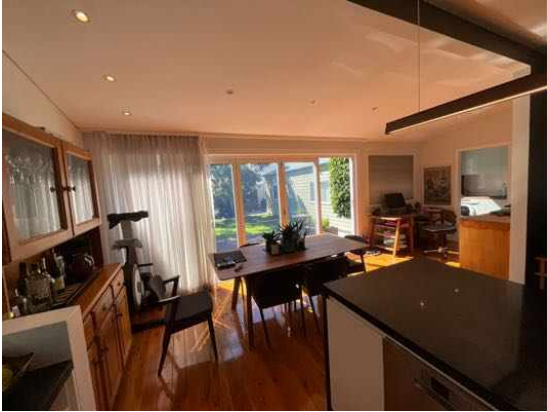
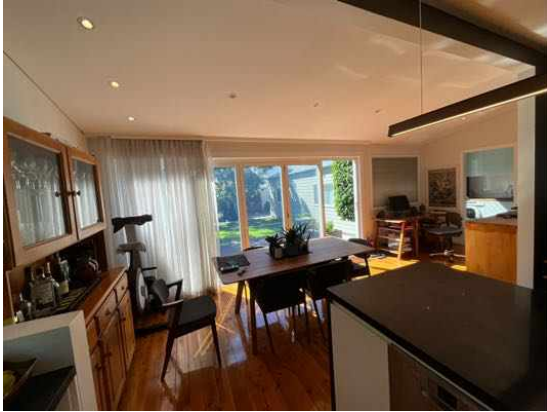
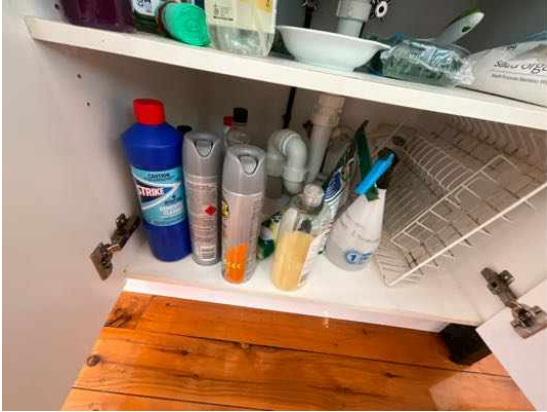
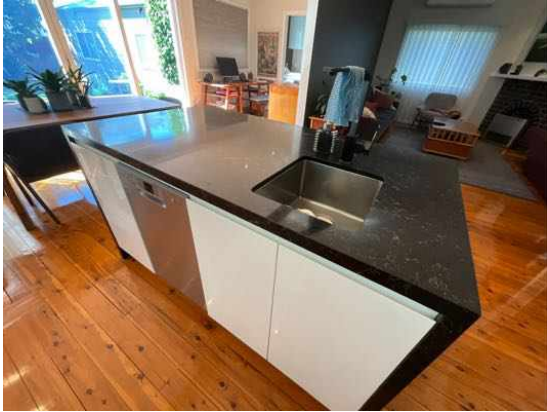
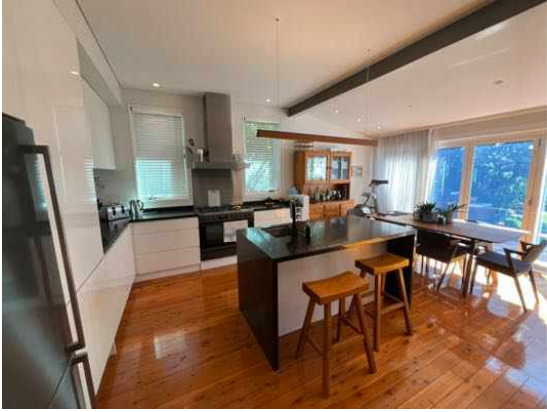
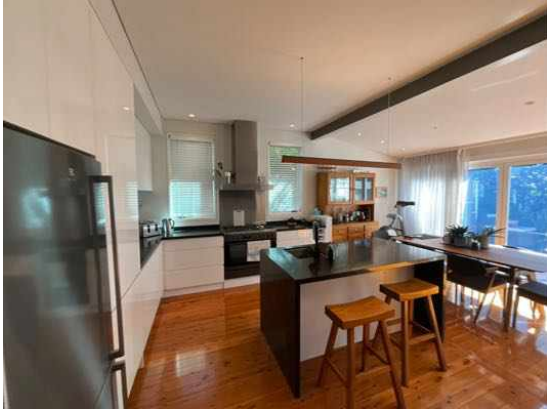
Finding: Additional Photos - Obstructions and Limitations

Information: These photographs are an indication of the obstructions and limitations which impeded full inspection of the property at the time of inspection. These obstructions can hide an array of defects and should be removed to allow full inspection to be carried out. A re-inspection is recommended once the areas are made accessible.
