Building and Timber Pest Inspection Report

Inspection Date: Tue, 17 Feb 2026

Property Address: 147 The Trongate, GRANVILLE, NSW, 2142, Australia

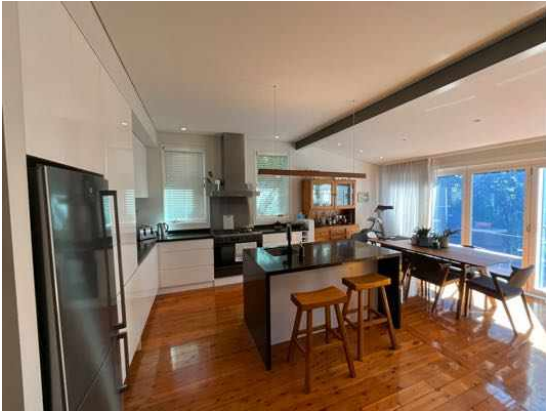
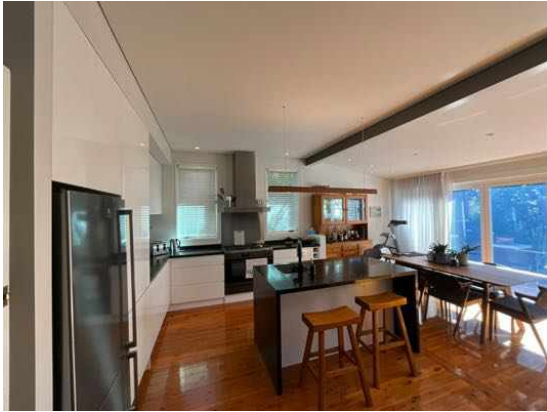
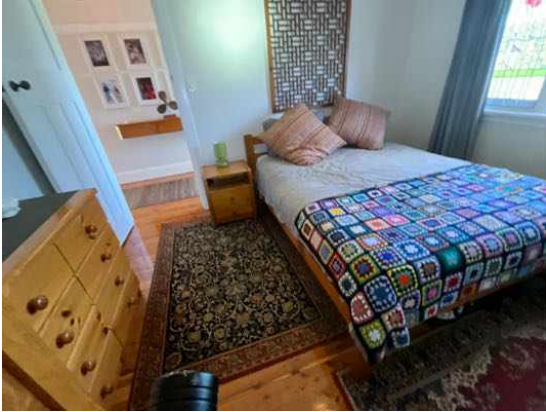
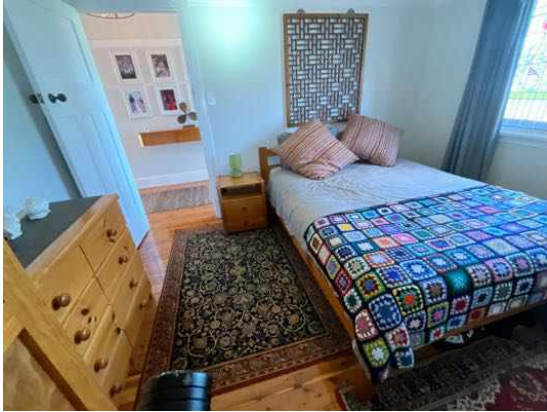
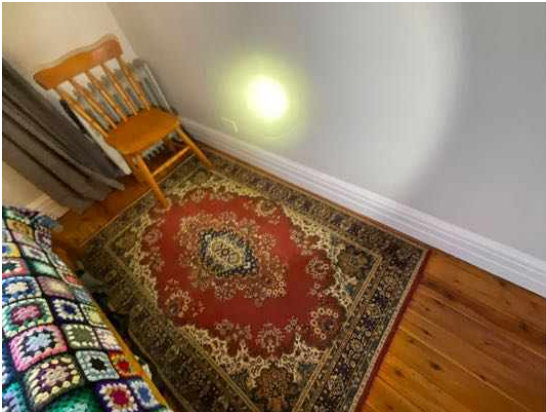
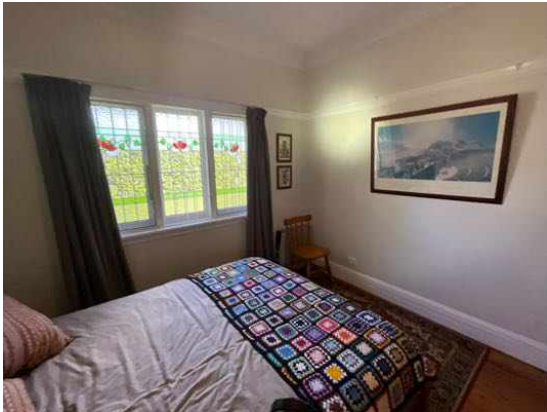
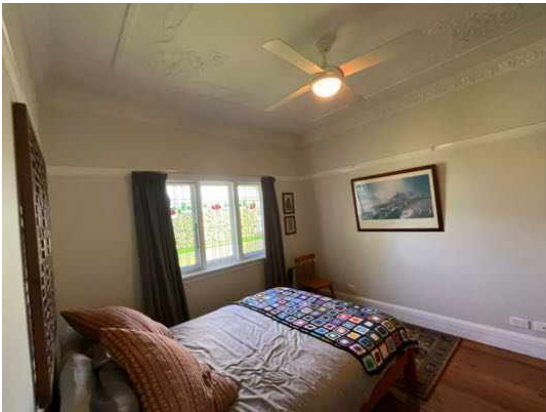
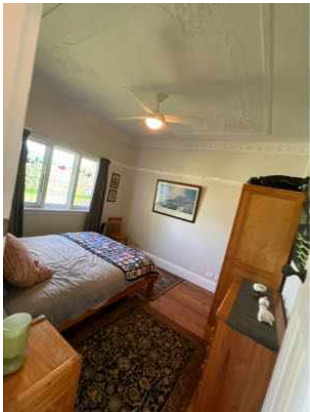
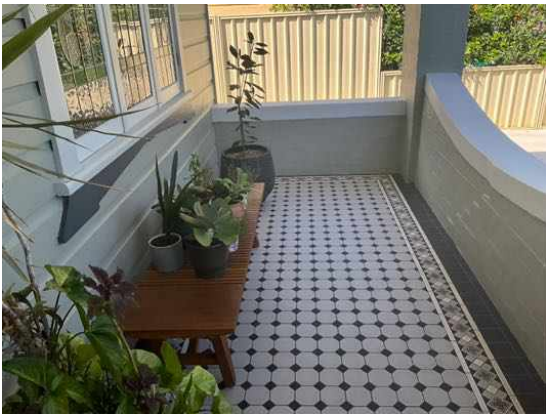
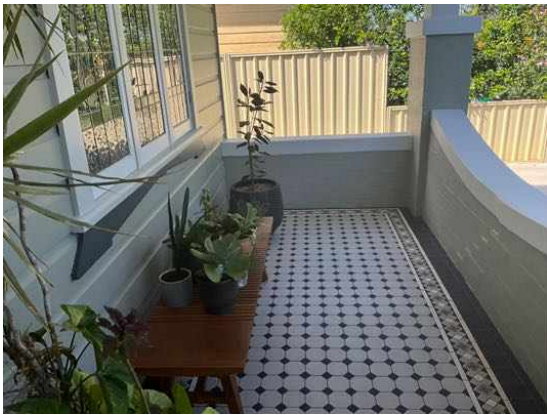
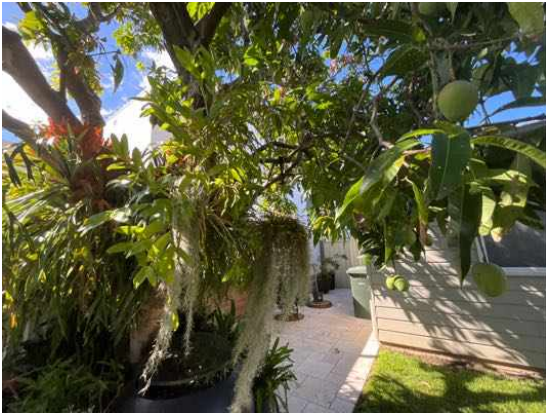
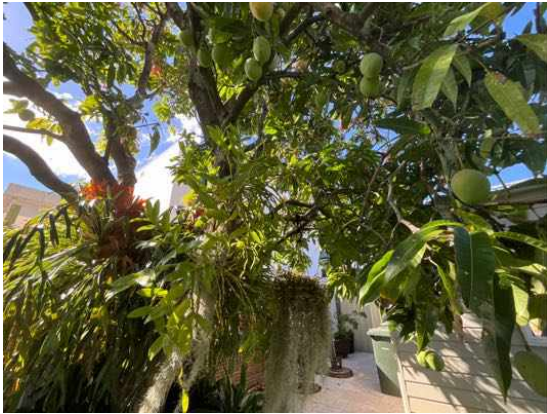
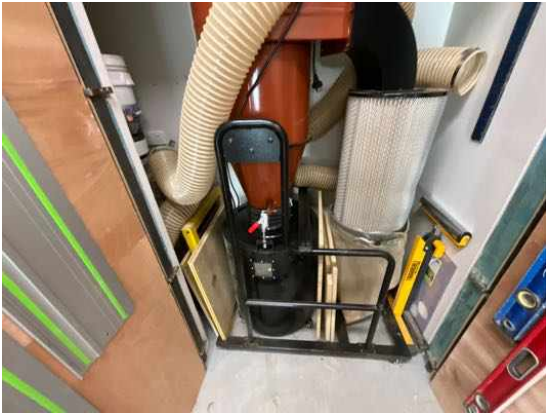
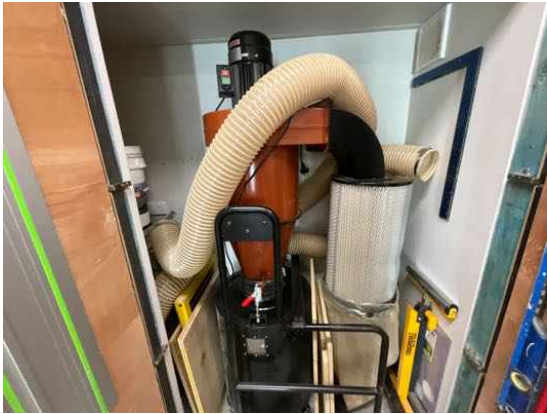
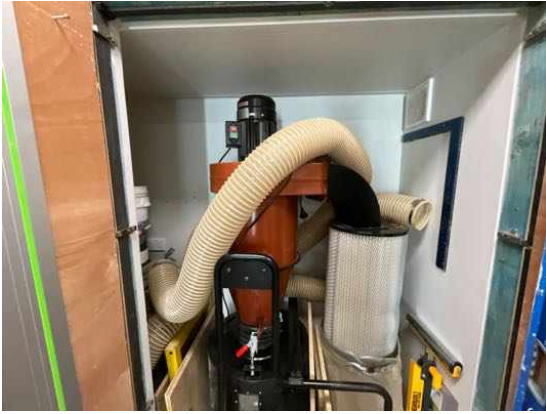
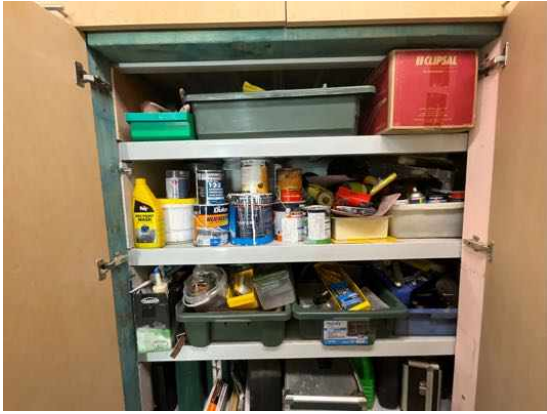
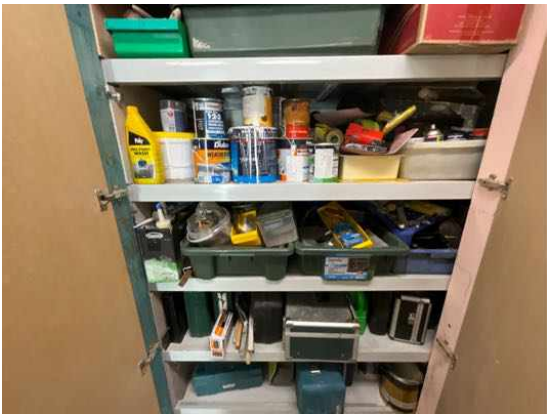
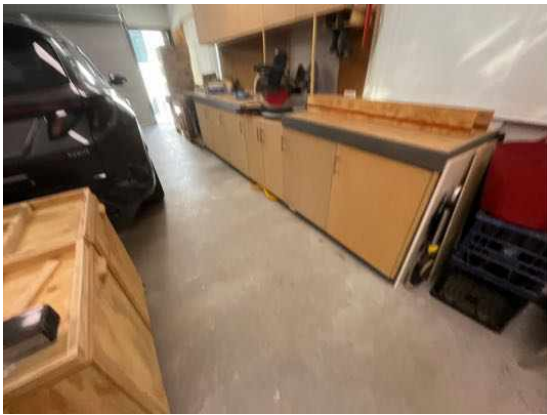
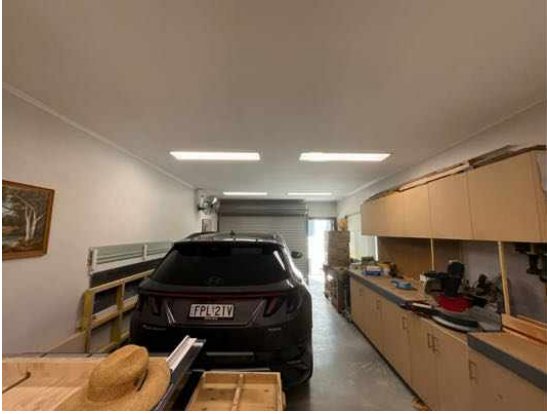
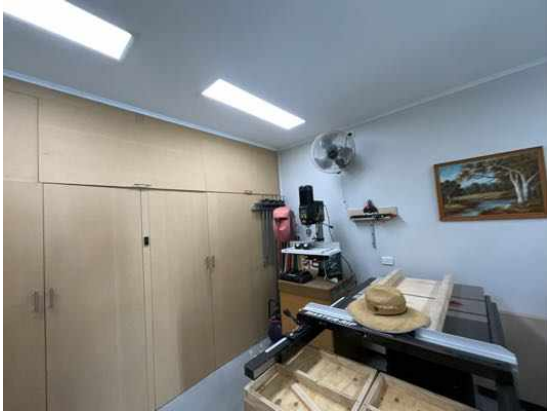
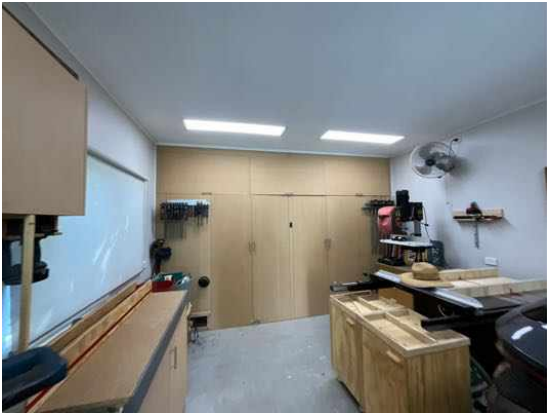
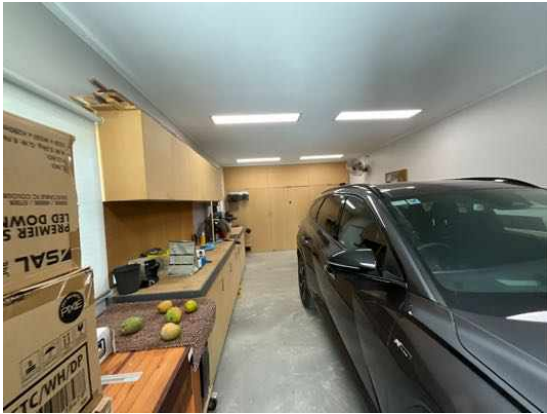
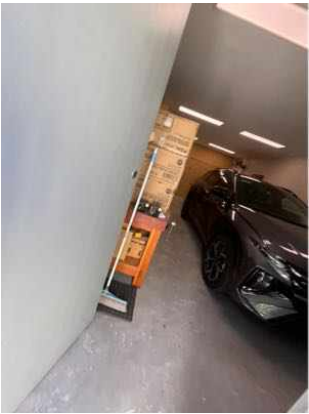
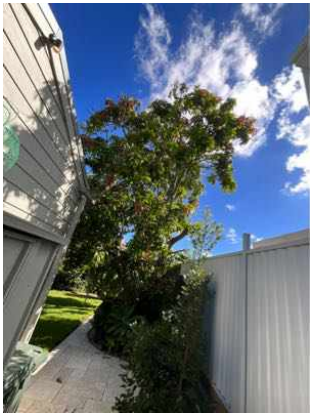
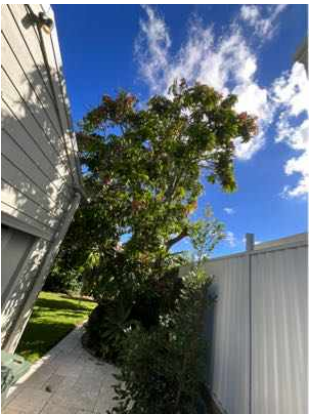
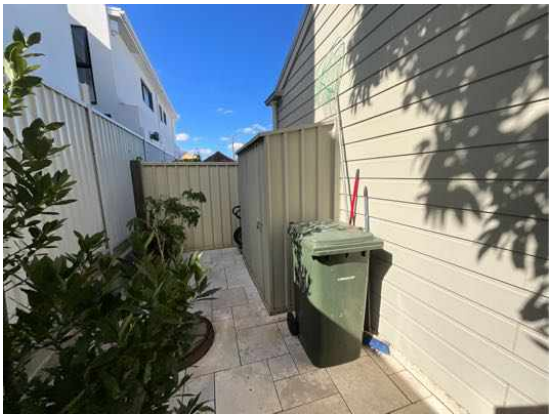
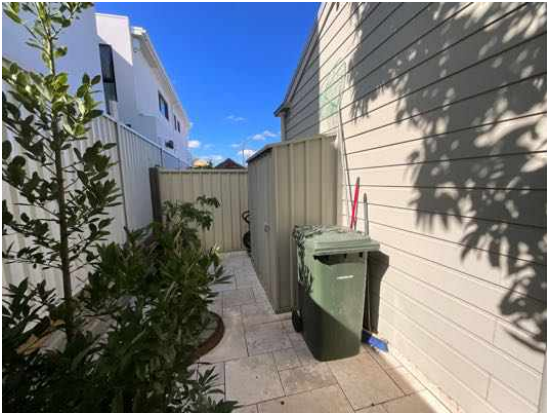
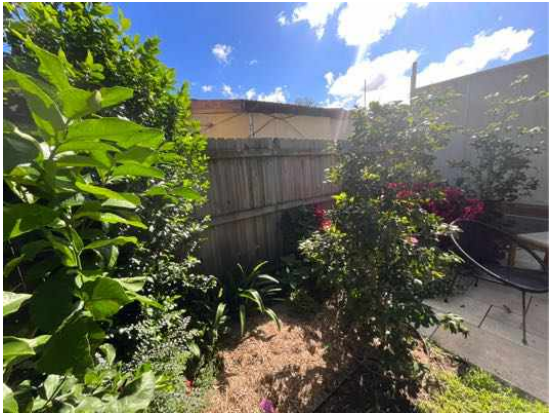
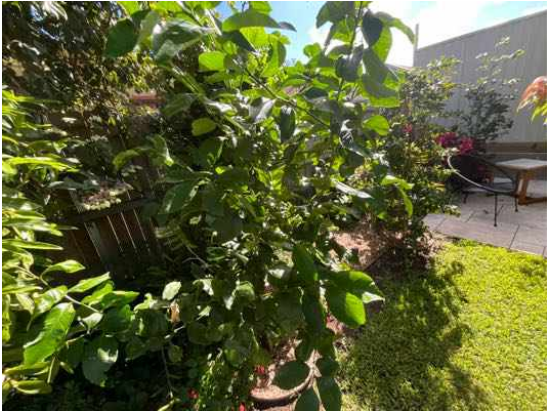
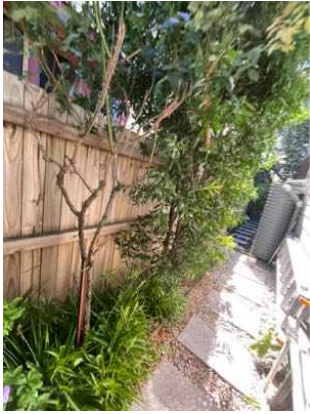
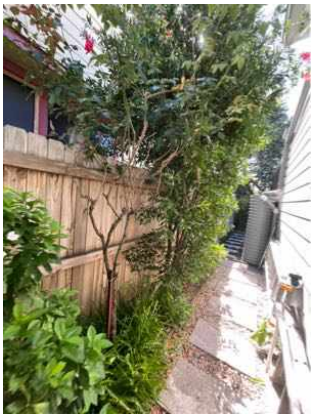
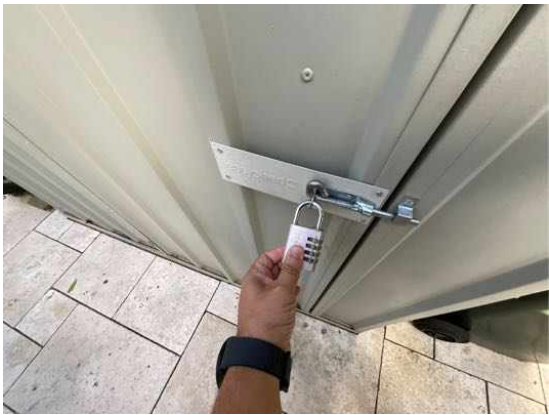
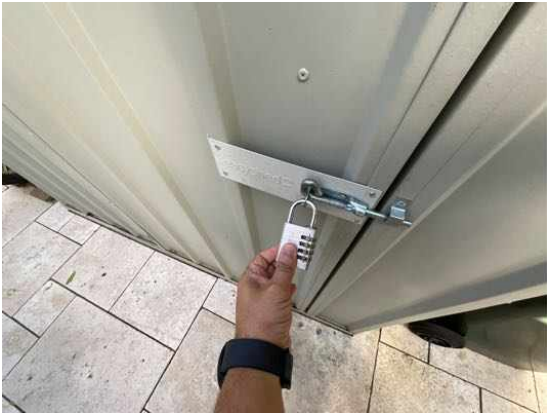
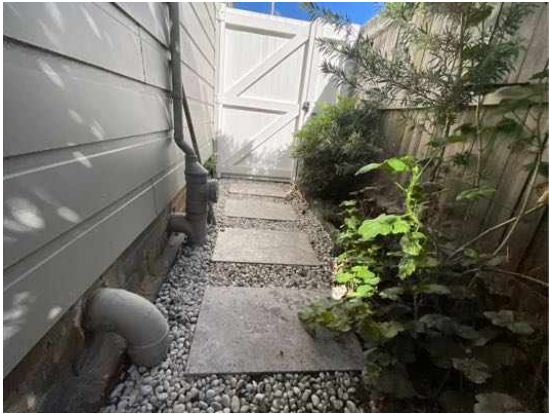
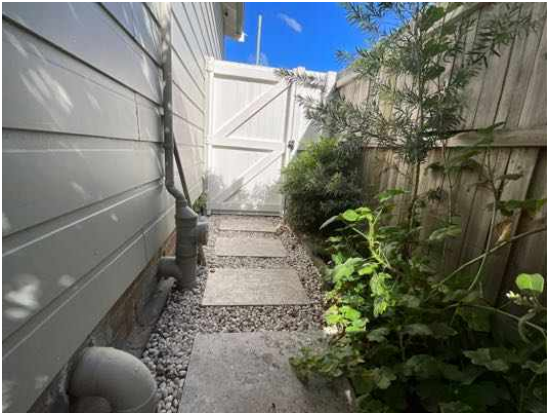
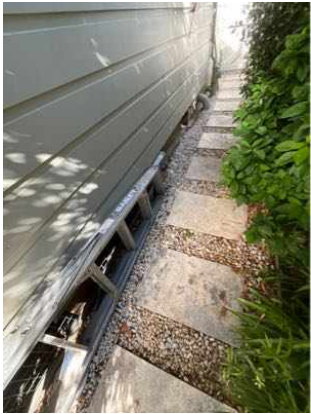
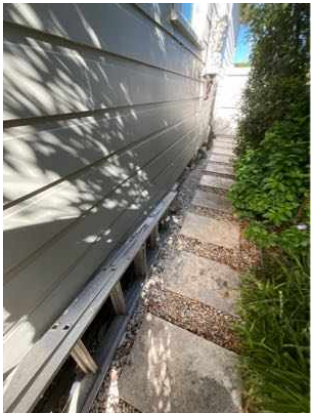
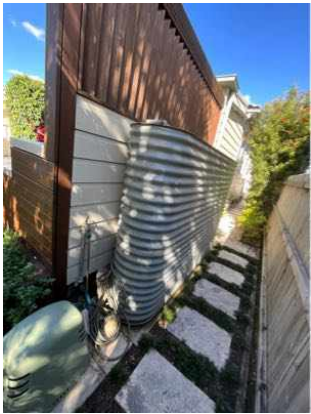
Information: These photographs are an indication of the obstructions and limitations which impeded full inspection of the property at the time of inspection. These obstructions can hide an array of defects and should be removed to allow full inspection to be carried out. A re-inspection is recommended once the areas are made accessible.

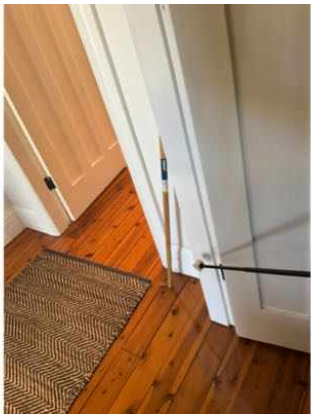
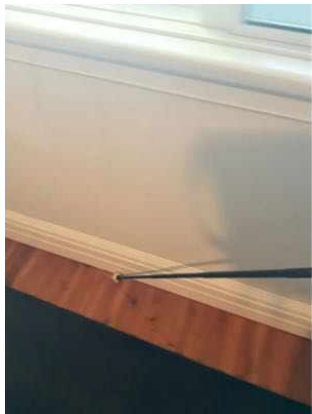
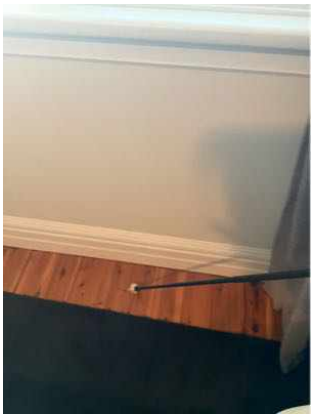
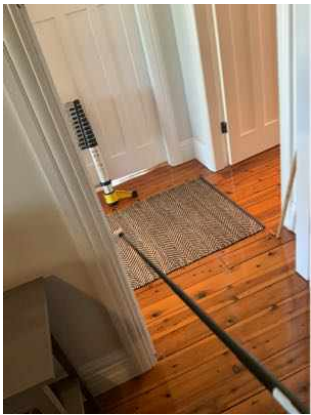
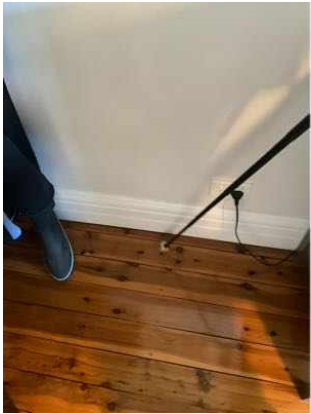
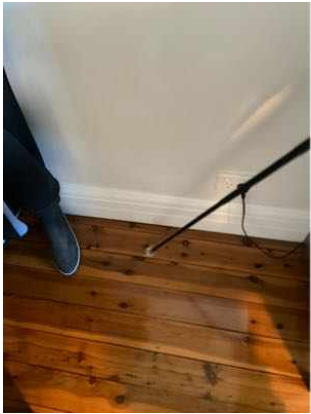
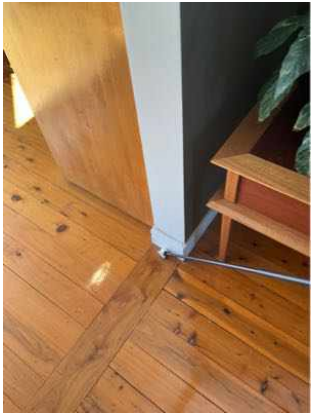
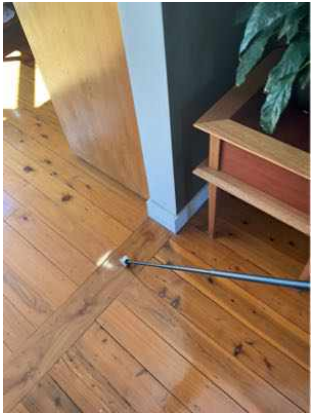
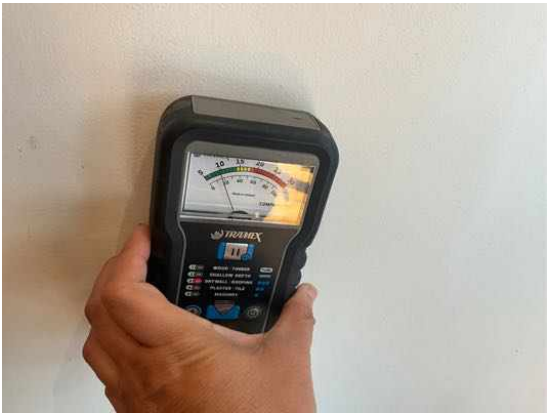
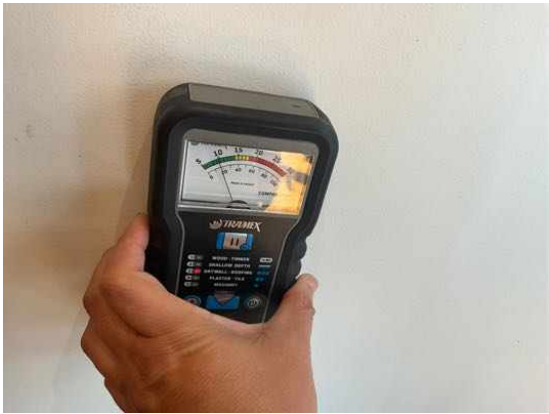
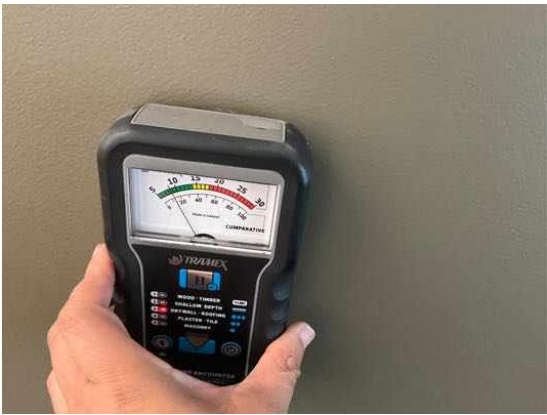
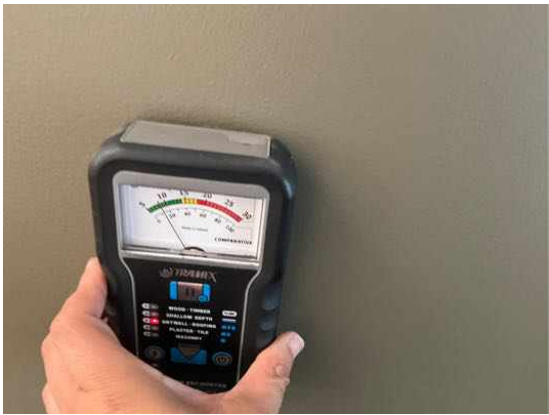
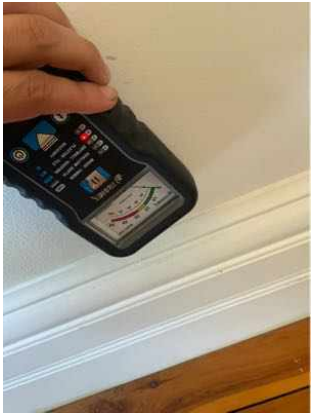
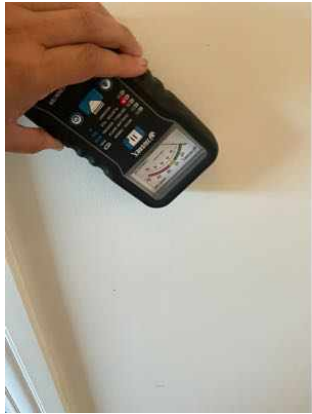
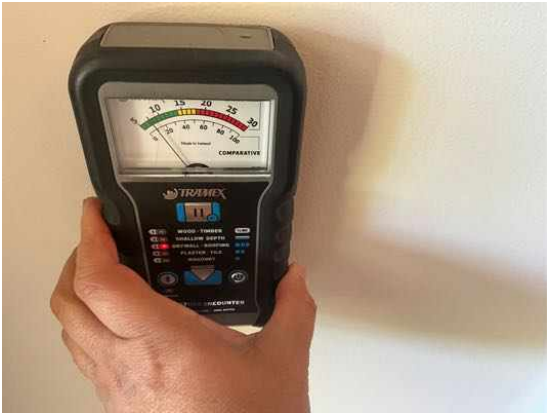
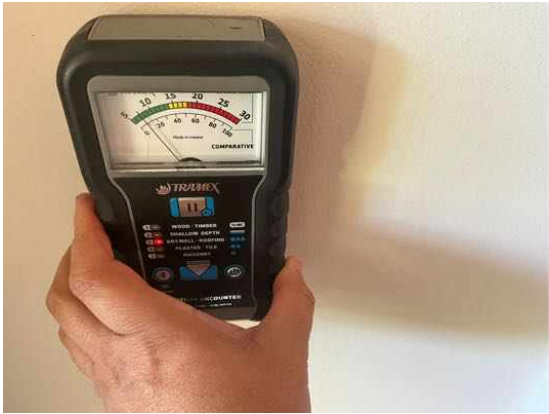
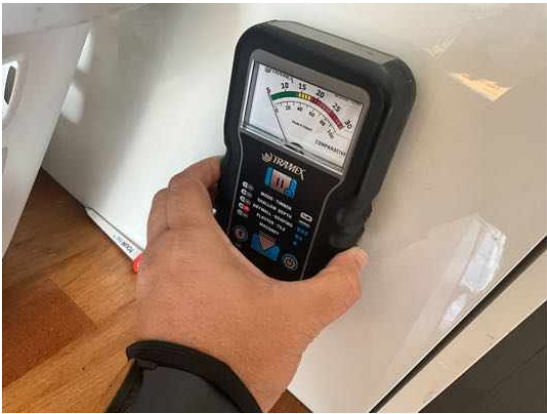
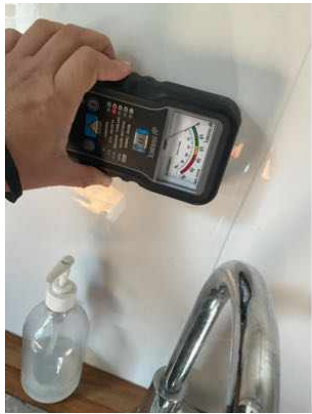
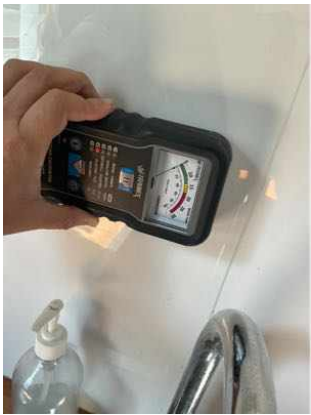
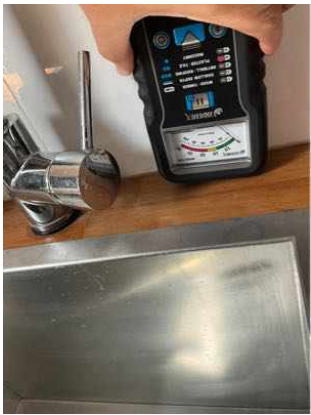
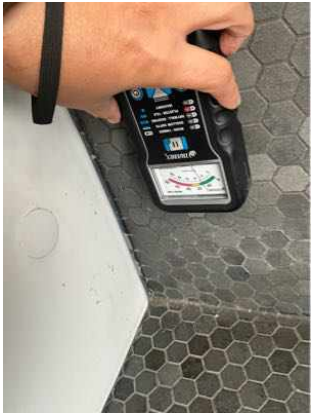
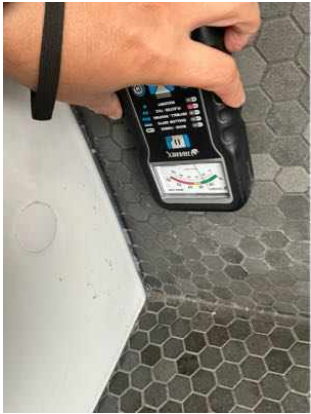
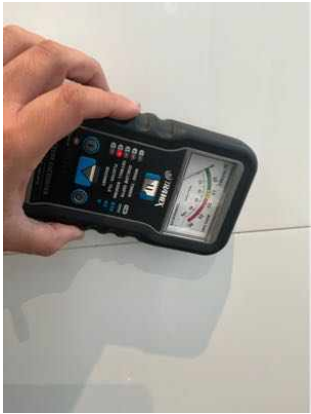
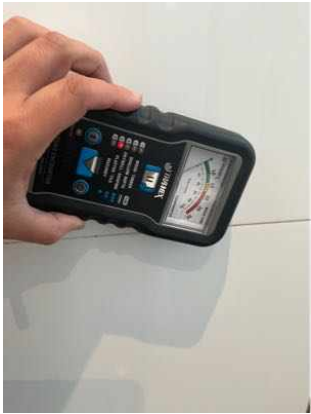
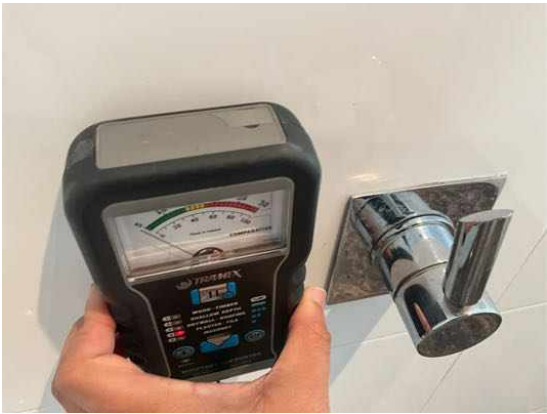
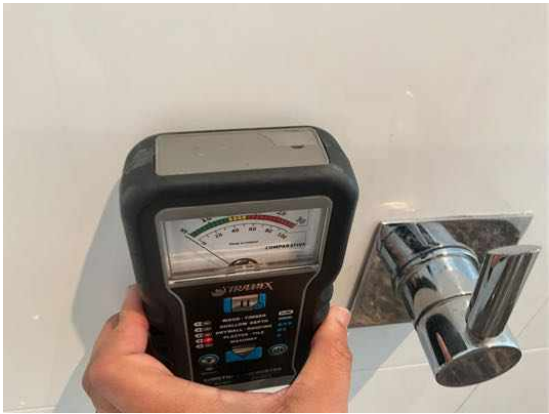
Building: Main Building
Location: All Areas
Finding: Additional Photos
Information: Additional photos are provided for your general reference
