Building and Timber Pest Inspection Report

Inspection Date: Wed, 25 Feb 2026

Property Address: 2/2 Geraldton Dr, Varsity Lakes QLD 4227,
Australia

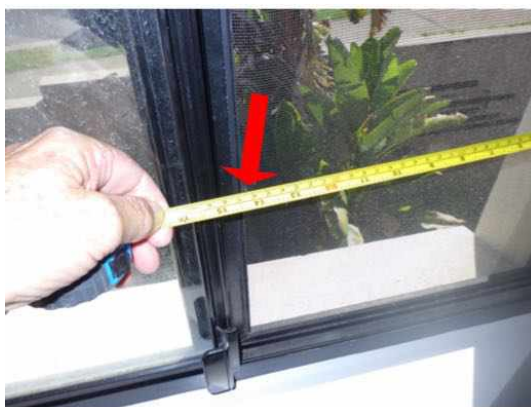
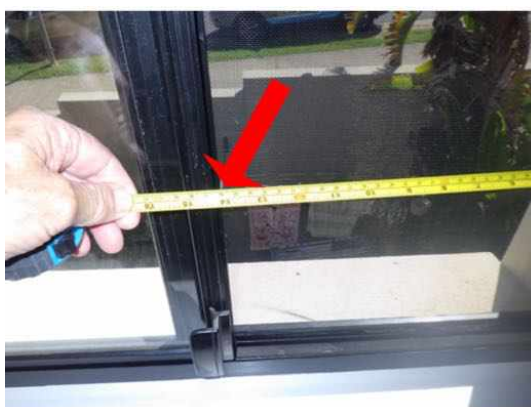
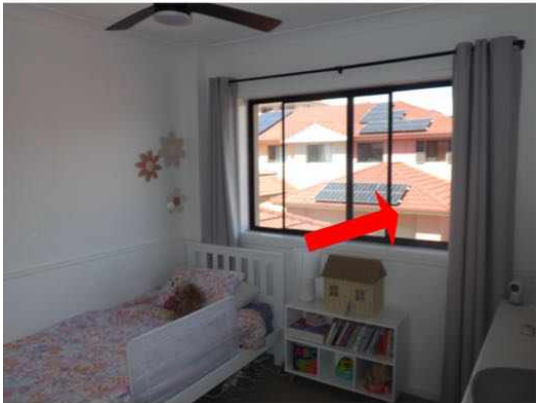
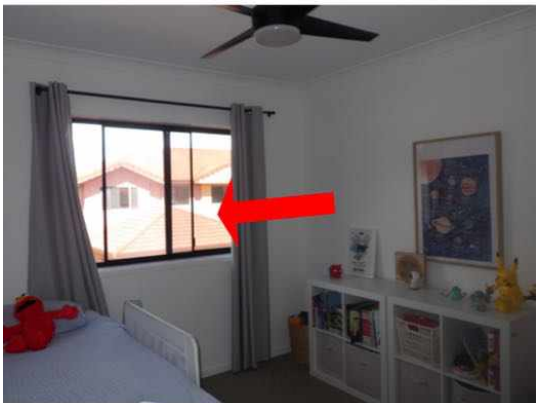
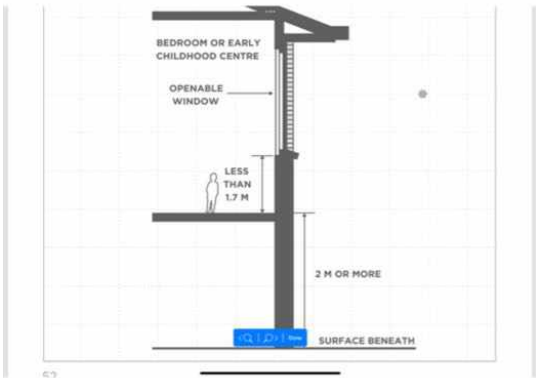
Building: Main Building
Location: Bedrooms > Existing
Finding: Window safety
Information: It was noted that the windows of the upper level bedrooms are less than 1.7m from the floor and have a fall greater than 2m on the exterior from the sill and as such are required to only open upto 125mm or have security grills fitted.

This is noted as a safety concern and this regulation may not have been in place at the time of construction.

Windows are defective if they do not comply with provision 3.9.2.5 of Volume 2 of the BCA that requires that a window opening must have protection if the floor below the window in a bedroom is 2 m or more above the ground surface beneath.

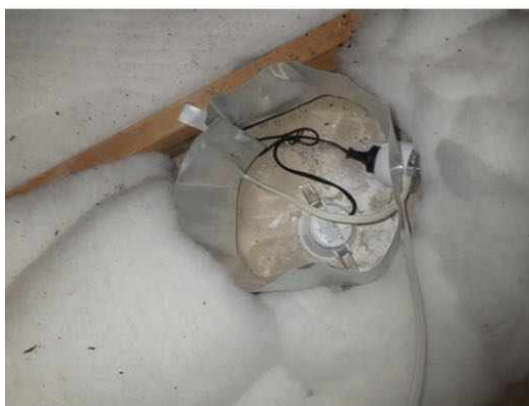
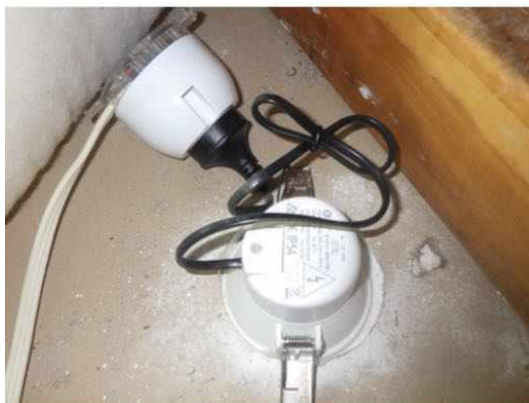
Building: Main Building
Location: Attic > Existing
Finding: Insulation - Covering downlights
Information: At the time of inspection it was suspected sections of insulation in the roof void may be covering down light fittings. While the down lights appear to be sealed LED style lights the presence of this insulation can create a potential fire hazard.

Downlights with clear markings and supporting documentation showing the appropriate IC-F or IC ratings may be covered with insulation, but is still not recommended by the manufacturers.

Alternatively a general handyman could be engaged to provide a clear space of 50 - 100mm minimum around the installed downlight fittings.

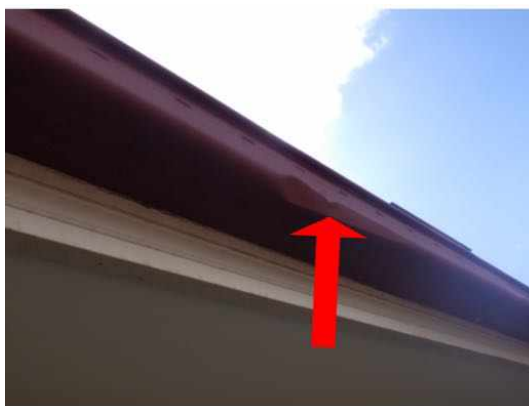
Building: Main Building
 Location: Roof Exterior > Front
 Finding: Gutters - damaged
 Information: At the time of inspection there was dent type damage to a section of the roof guttering to the front of the garage area. The dent or damage to the roof guttering appears to be the result of impact.

A roofing plumber or general handyman could be appointed to rectify this issue. It is highly advised that all gutters be maintained on a frequent basis to ensure the condition of roof plumbing.

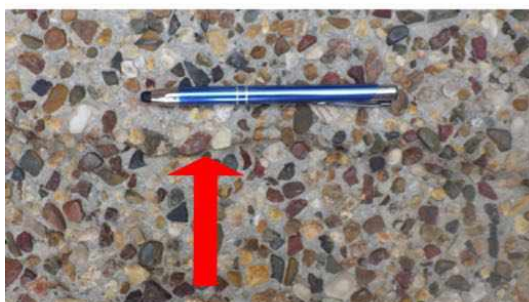
Finding 3.02

Building:	Main Building
Location:	Court Yard > Ground Level
Finding:	Cracking in concrete slab - Category 1
Information:	Cracking coded as Category 1 was identified in the footpaths concrete slab. A Category 1 crack is described as a fine but noticeable crack, with the slab at an otherwise reasonable level.

To be considered Category 1, the approximate width of the crack is less than 1.0mm, or a less than 10mm change in offset when a 3m straight edge is placed over the defect.

Category 1 cracks should be monitored for a period of 12 months. At the end of the monitoring period, identified cracks that are rated greater than Category 2 are considered defects, and require rectification.

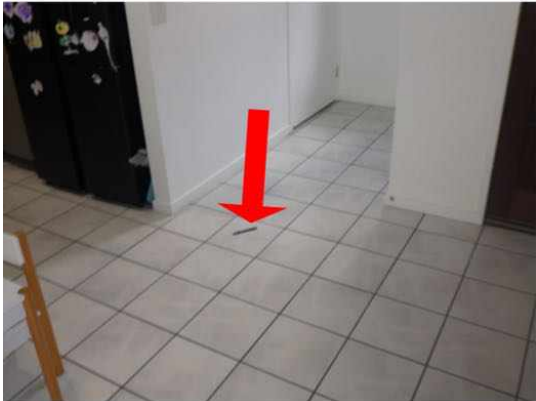
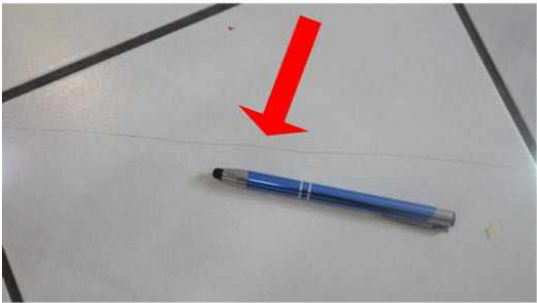
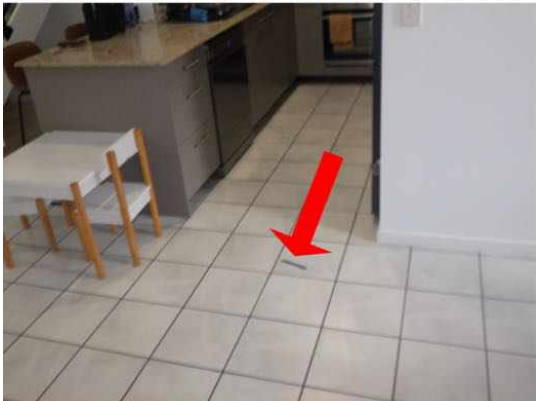
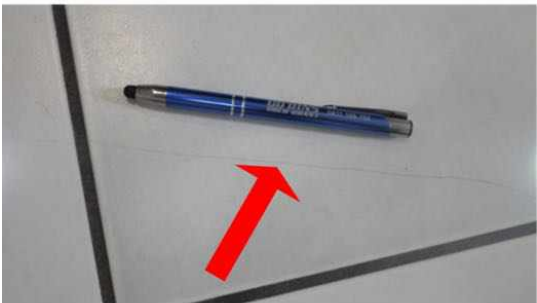
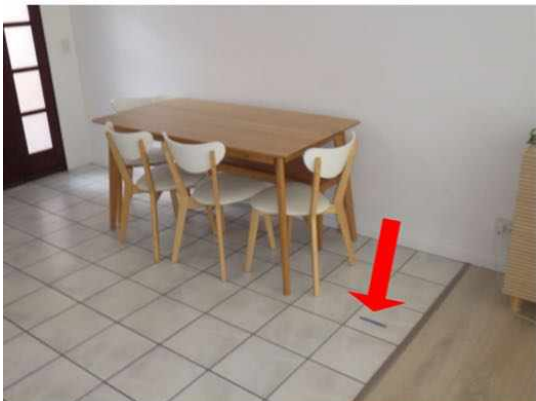
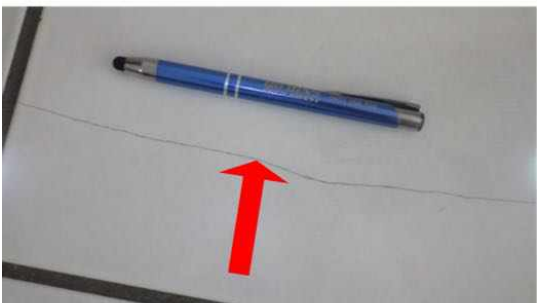
Finding 3.03

Building:	Main Building
Location:	Entry/Dining Room > Existing
Finding:	Tiles - Cracked
Information:	Cracked tiles to the entry/dining room area floor were identified at the time of

inspection (as per example photos). Such defects are generally caused by impact. Cracked or broken tiled areas may also be a direct result of poor workmanship during the construction process.

A tiling contractor could be appointed to perform repair works at the clients discretion.

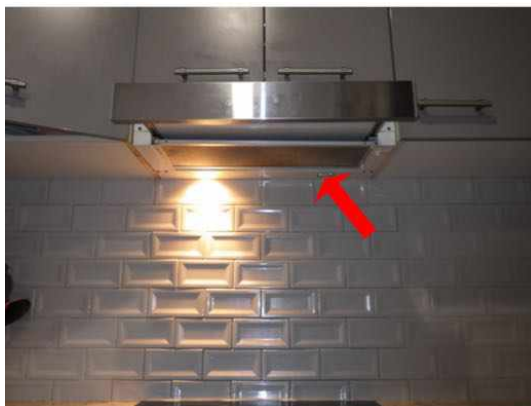
Finding 3.04

Building: Main Building
Location: Kitchen > Rear
Finding: Rangehood - Light
Information: The right side range hood light was not working at the time of inspection. It is advised

to replace the bulb first - if still not functioning, a licensed electrician could be appointed to repair or replace the range hood to restore it to a fully operational state.

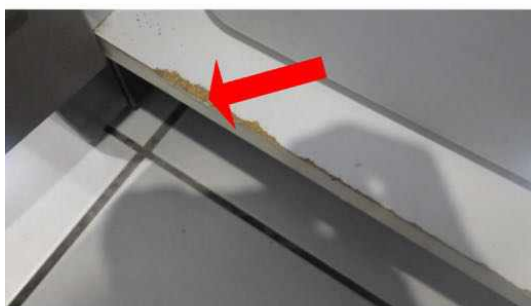
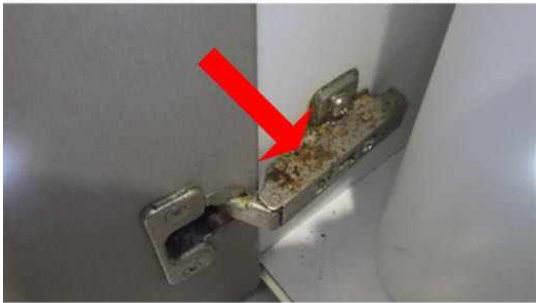
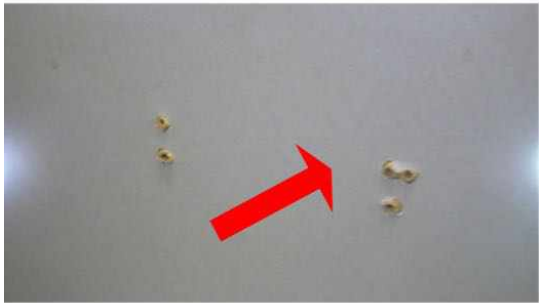
Finding 3.05

Building: Main Building
 Location: Kitchen > Centre Left
 Finding: Cabinetry - Deterioration
 Information: At the time of inspection the kitchen cabinetry showed signs of minor deterioration. The level of damage appears consistent with exposure to moisture or general wear and tear.

A qualified cabinet maker or general handyman could be engaged to undertake repair works at the clients discretion.

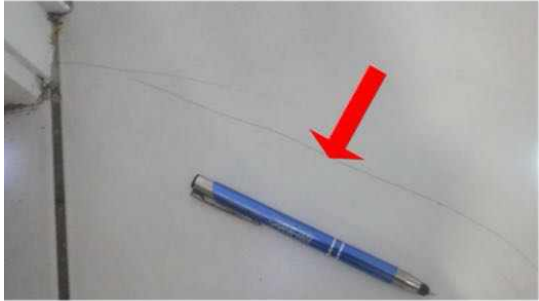
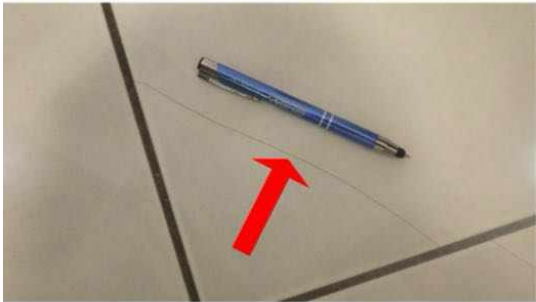
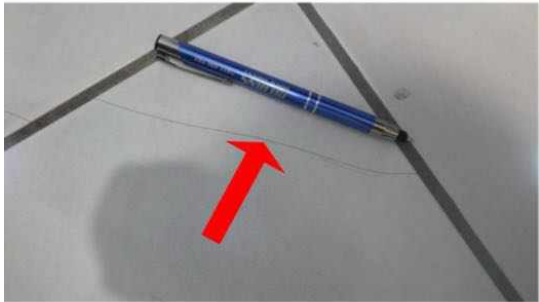
Finding 3.06

Building: Main Building
Location: Laundry > Existing
Finding: Tiles - Cracked
Information: Cracked tiles to the laundry floor area were identified at the time of inspection 9as per example photos). Such defects are generally caused by impact. Cracked or broken tiled areas may also be a direct result of poor workmanship during the construction process.

A tiling contractor could be appointed to perform repair works at the clients discretion.

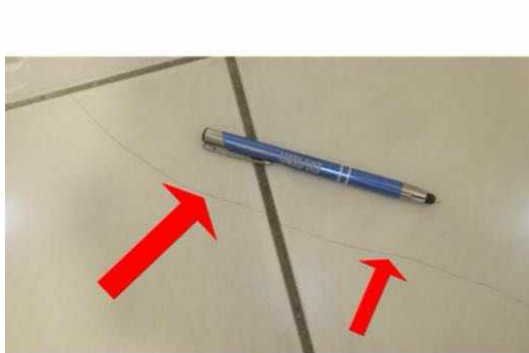
Finding 3.07

Building:	Main Building
Location:	Toilet (WC) > Front Left
Finding:	Tile - Cracked
Information:	Cracked tiles to the WC floor area were identified at the time of inspection. Such defects are generally caused by impact. Cracked or broken tiled areas may also be a direct result of poor workmanship during the construction process.

A tiling contractor could be appointed to perform repair works at the clients discretion.

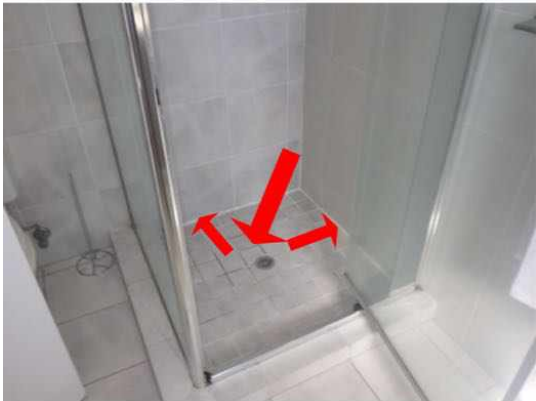
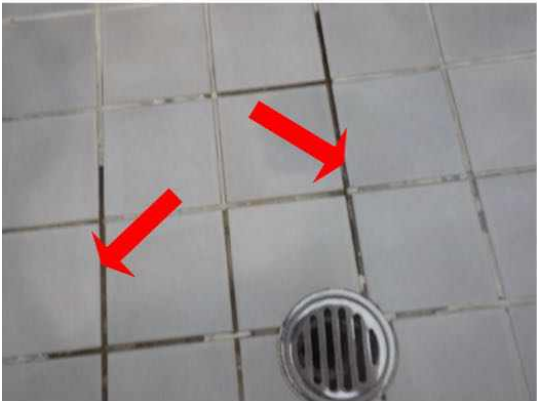
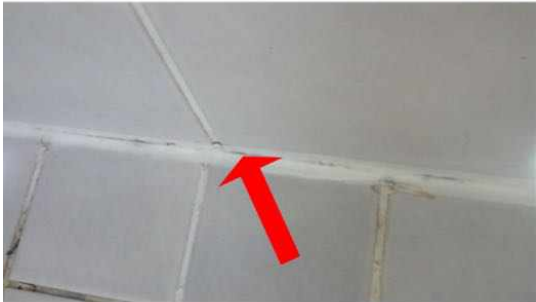
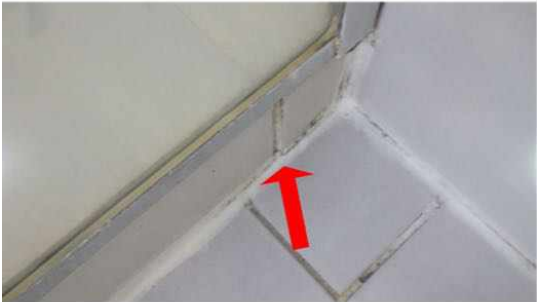
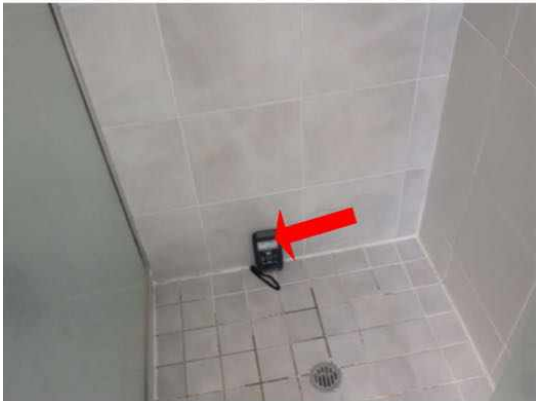
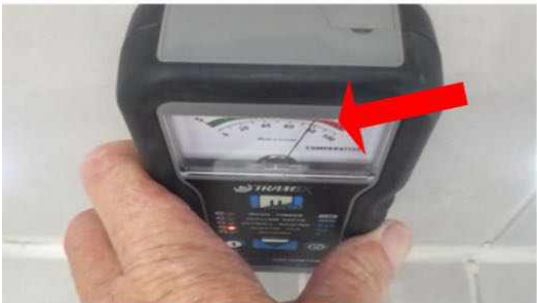
Finding 3.17

Building: Main Building
 Location: Ensuite > Rear Left
 Finding: Tiles - Sealant & Grout
 Information: Areas of missing grout and/or deteriorated sealant were evident to the floor and wall tiling in the ensuite shower cubicle at the time of inspection. As this area is frequently exposed to water, the missing grout and/or deteriorated sealant creates potential for possible water penetration into adjoining sections of walls or flooring.

If left unmanaged, any potential water penetration to these areas may lead to subsequent water damage, which is likely necessitate repair work to affected building elements. At the time of inspection elevated moisture level readings were observed to the lower area of the left side shower cubicle wall, but the elevated readings didn't transfer outside the shower cubicle or to the opposite sides of the wall in areas where moisture level readings could be obtained.

As noted in the report there is deteriorated sealant and grout to the ensuite area shower cubicle floor and wall tiles. It is highly recommended a licensed tiler or shower area specialist is engaged to further investigate and/or undertake repairs as required.

A tiling contractor or shower sealant specialist should be appointed to undertake repair work to ensure that no further water damage occurs. The re-application of silicone and grouting throughout remaining tile work is also advised, to further protect the area against water penetration.

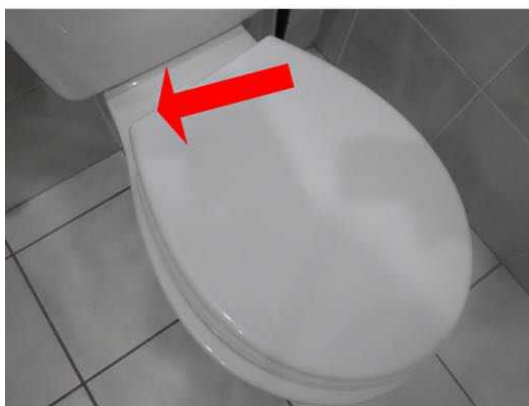
Finding 3.18

Building: Main Building
 Location: Bathroom > Front Right
 Finding: Toilet seat - Loose
 Information: The bathroom area toilet seat was found to be loose at the time of inspection. It is suspected that this defect has developed due to general wear and tear.

If left unmanaged, the toilet seat could deteriorate further, leading to destabilisation and the potential for water leaks to the toilet pan area.

It is recommended that the seat be repaired by a licensed plumbing or general handyman.

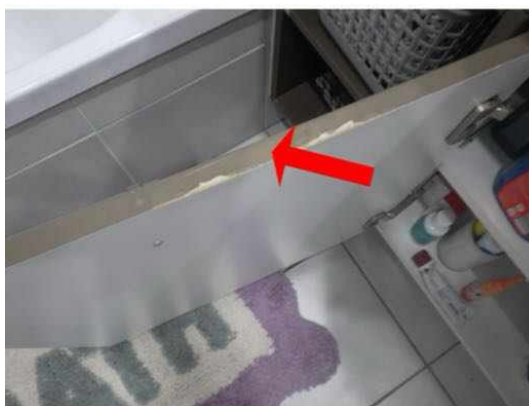
Finding 3.19

Building: Main Building
 Location: Bathroom > Centre
 Finding: Cabinetry - Deterioration
 Information: At the time of inspection the bathroom cabinetry showed signs of minor deterioration. The level of damage appears consistent with exposure to moisture or general wear and tear.

A qualified cabinet maker or general handyman could be engaged to undertake repair works at the clients discretion.

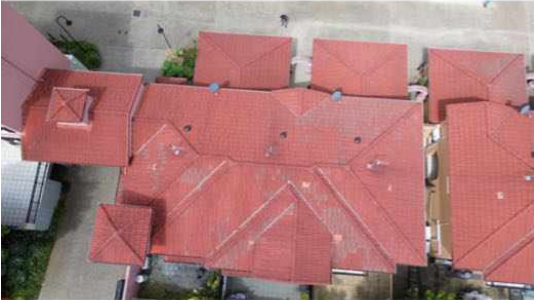
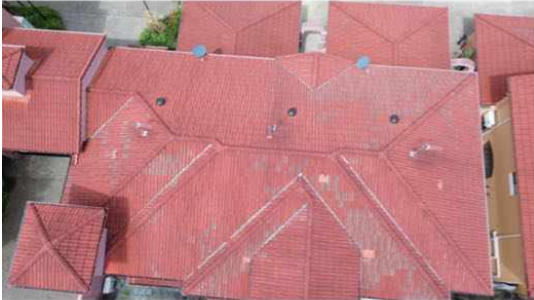
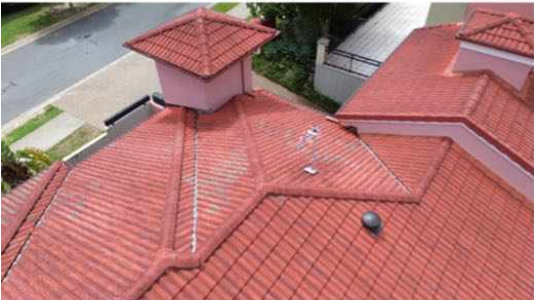
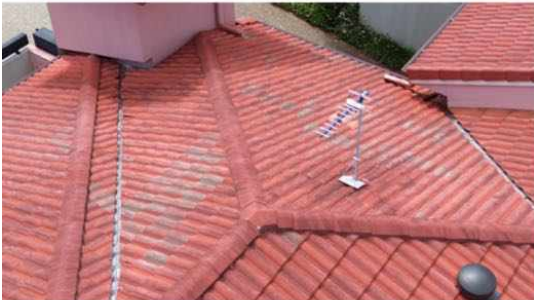
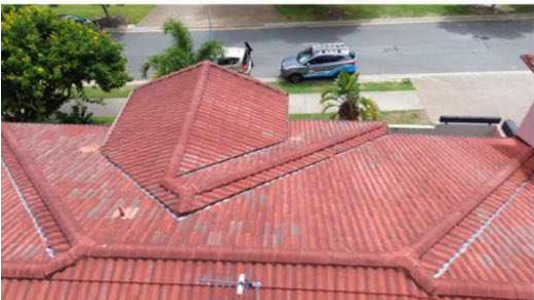
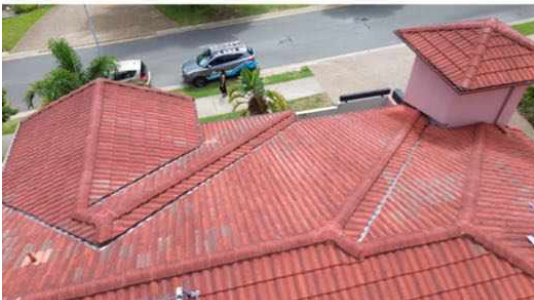
Finding 3.20

Building: Main Building
 Location: Roof Exterior > Existing
 Finding: Roof tiles - Weathered
 Information: Upon inspection of the exterior roofing photos (taken manually and with the DJI Mini 3 drone), the majority of roof tiles were considered to be in a fair condition. While weathering of the tiles is consistent with the age of the property, maintenance works may be required.

The client could consult a roofing contractor to gain advice on costs of any remedial works that may be required in the short to medium term. Remedial works are likely to increase the longevity of the exterior roofing structure.

NOTE - External roof area repairs or maintenance may be the responsibility of the buildings body corporate managers.

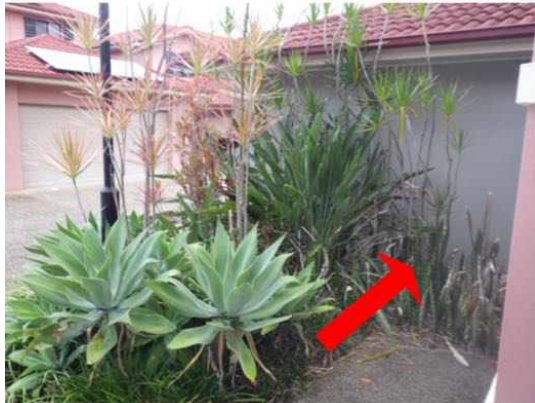
Finding 6.02

Building:	Main Building
Location:	Exterior walls - right side > Existing
Finding:	Vegetation
Information:	At the time of inspection there was vegetation growing over external wall areas on the right side of the building.

The vegetation over growing wall areas should be trimmed back clear of the external surfaces. The grass and other vegetation heights should be maintained around the perimeter of the building to allow for an inspection zone around the building exterior.

Frequent pest inspections are highly recommended in these areas.

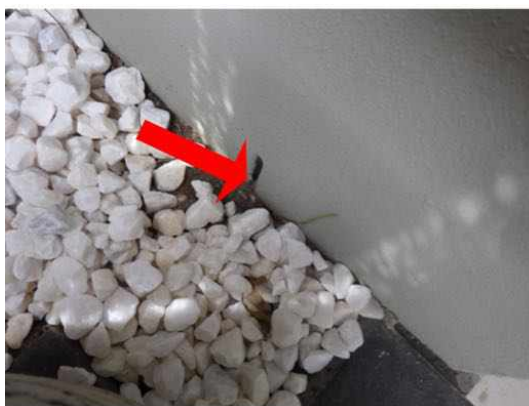
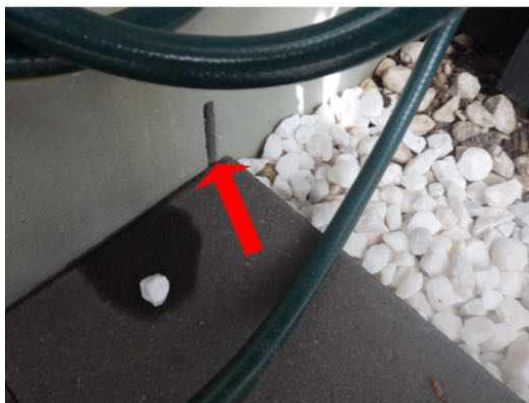
Finding 6.03

Building:	Main Building
Location:	Exterior walls - rear > Ground Level
Finding:	Weep holes exposure
Information:	It was noted at the time of inspection areas of the finished ground level at the rear of the property partly cover the brickwork weep holes.

Any areas where the weep holes are covered provide an opportunity for timber pest activity. An inspection zone of 50 - 75mm between the bottom of the brickwork weep holes and the finished ground surface is required. This inspection zone should be maintained in order to force termites into the open where they can be detected more readily during regular inspections.

It is highly advised the area be regularly monitored for timber termite pest activity.

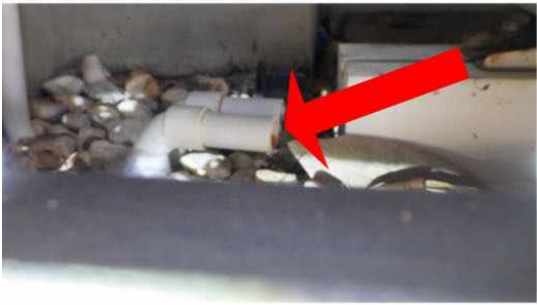
Finding 6.04

Building:	Main Building
Location:	Exterior walls - rear > Ground Level
Finding:	Overflow - Not plumbed for drainage
Information:	At the time of inspection it appeared the air conditioning unit overflow is not plumbed or connected to suitable drainage, which can result in the surrounding area becoming excessively damp. These damp conditions can lead to secondary defects such as rot, rust or corrosion of associated building elements, the formation of fungal decay, or even the creation of potential slip hazards. When coupled with poor site drainage, pooling of water may also attract termite activity to this area. It is highly recommended that a qualified plumber be appointed to install adequate drainage to the overflow. These works will ensure that the area remains dry and free of any secondary defects.

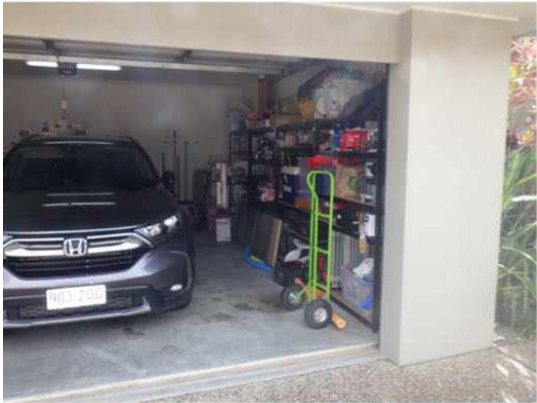
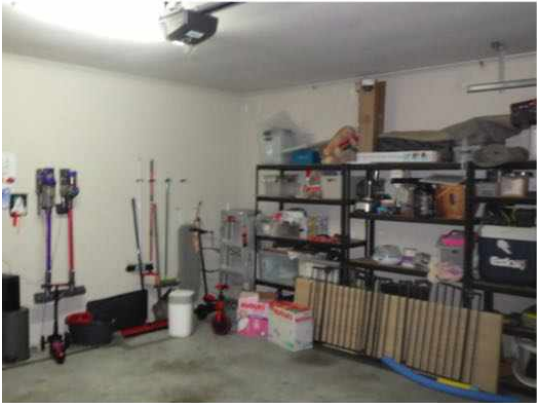
Finding 6.05

Building: Main Building
Location: Garage > Existing
Finding: Stored Items
Information: At the time of inspection there was furniture, personal and stored items against internal walls in areas of the garage area inspected.

These stored items severely limit full inspection of the area and may conceal timber termite pest and or vermin activity.

It is highly recommended the items are removed to allow for complete inspection of the area.

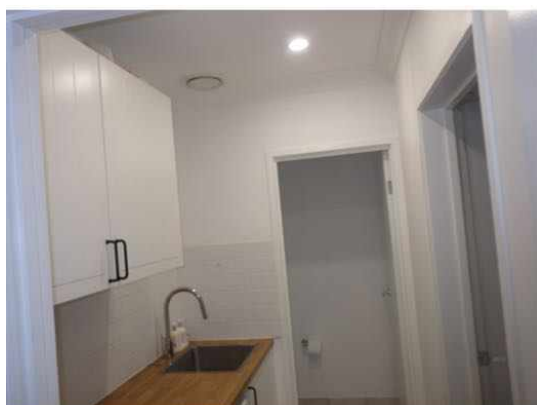
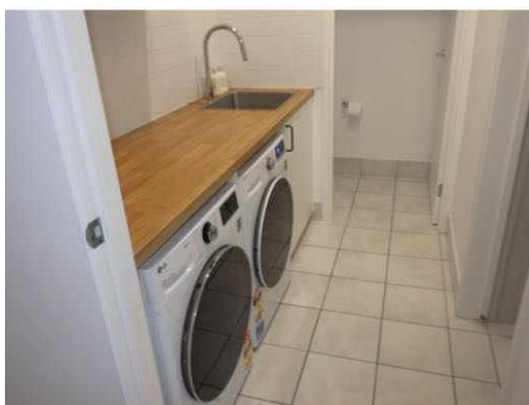
Building: Main Building
 Location: Laundry > Existing
 Finding: Additional Photos
 Information: Additional photos are provided for your general reference

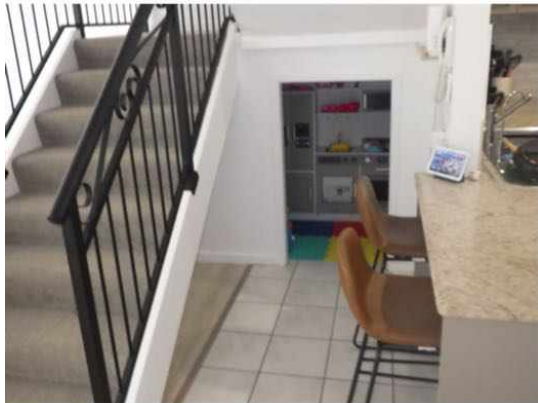
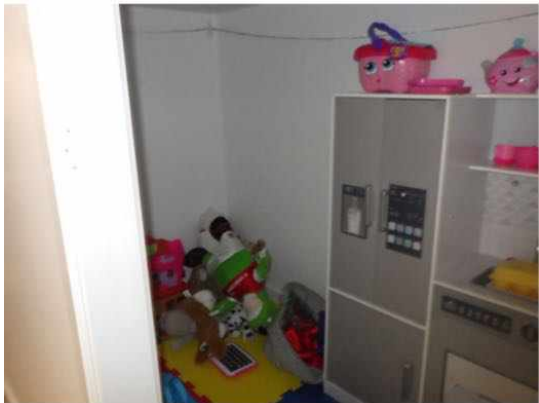
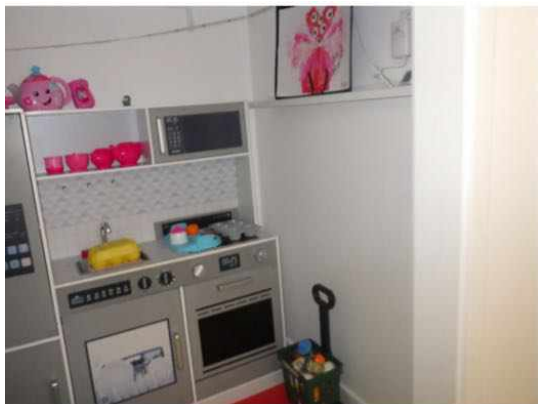
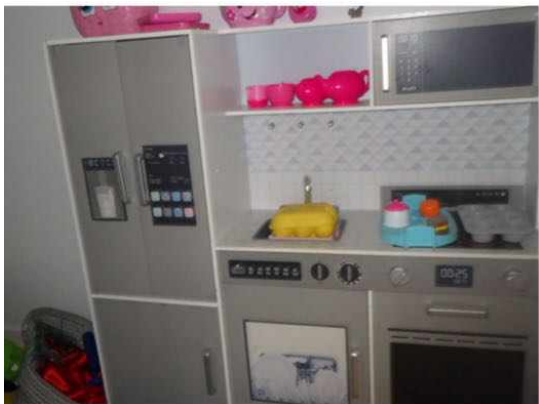
Building: Main Building
 Location: Under Stair Void or Storeroom > Existing

Finding: No obvious defect
Information: No obvious defects found at the time of inspection.

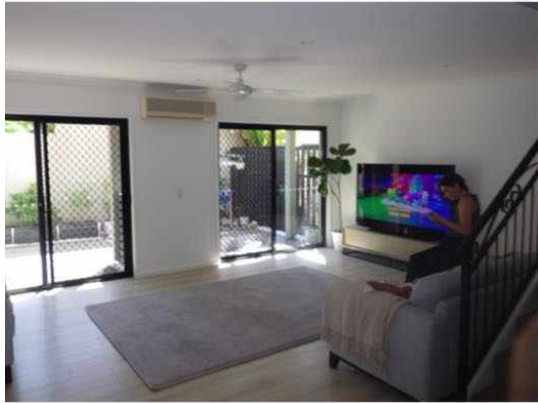
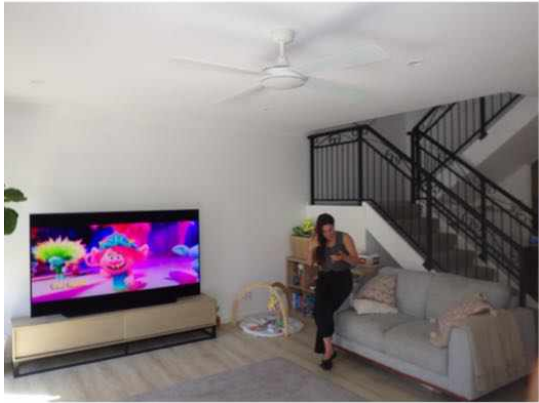
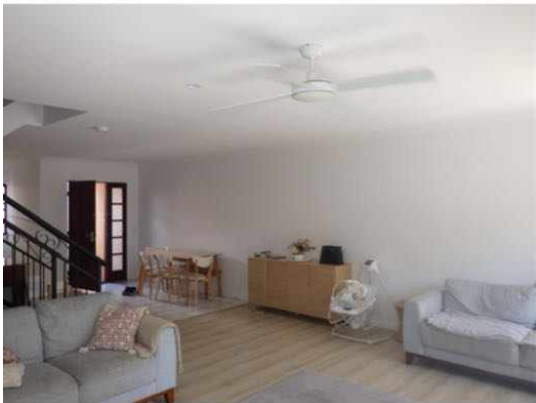
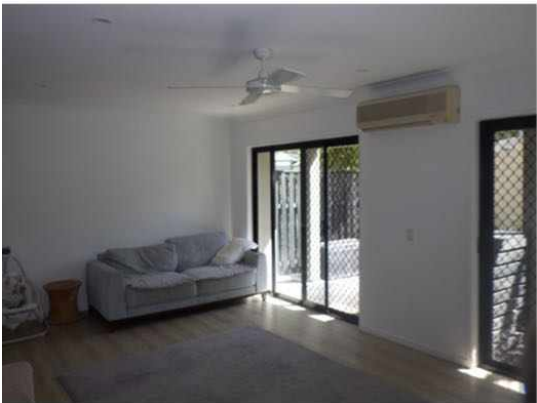
Building: Main Building
Location: Living Room > Existing
Finding: Additional Photos
Information: Additional photos are provided for your general reference

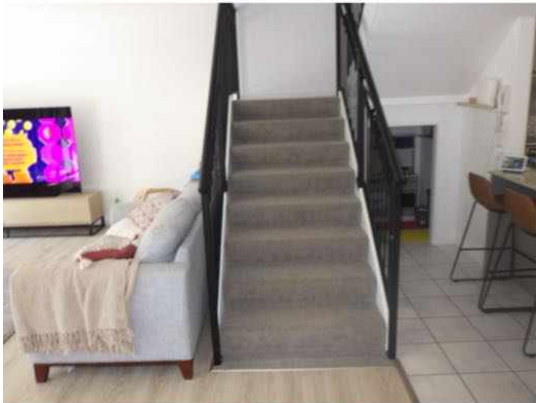
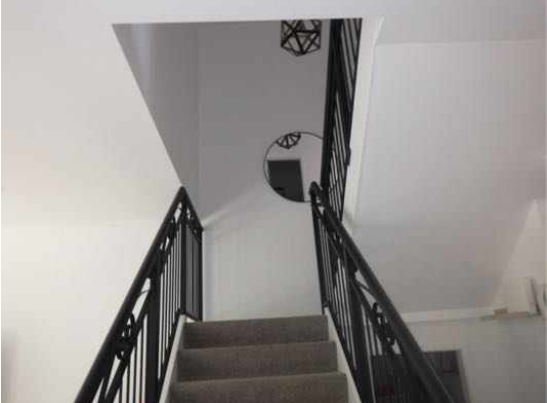
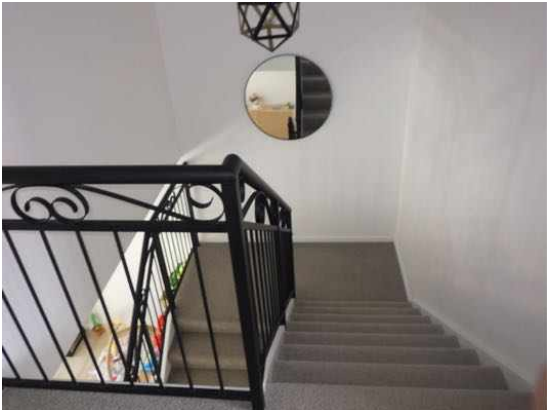
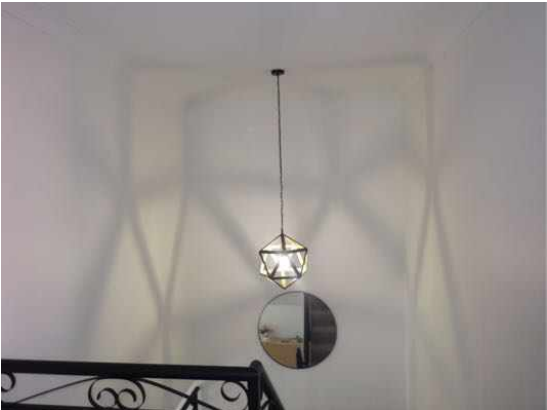
Building: Main Building
 Location: Stairs - Internal > Existing
 Finding: No obvious defect
 Information: No obvious defects found at the time of inspection.

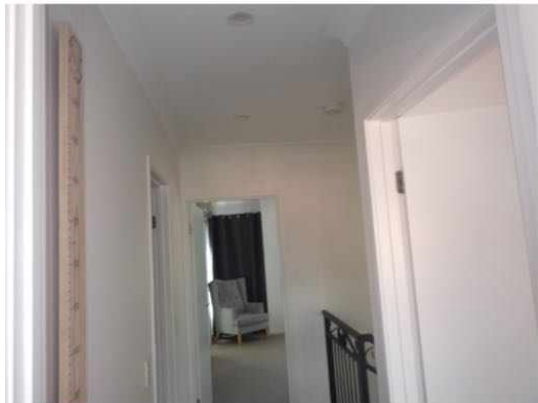
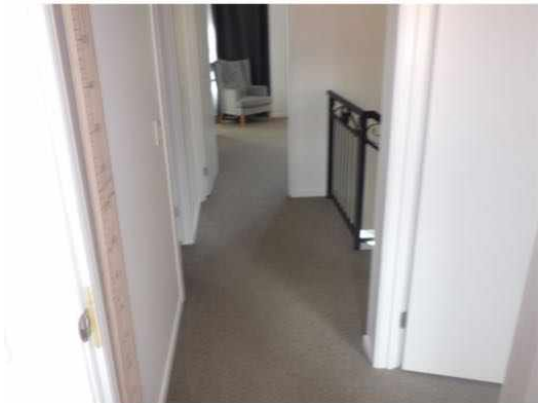
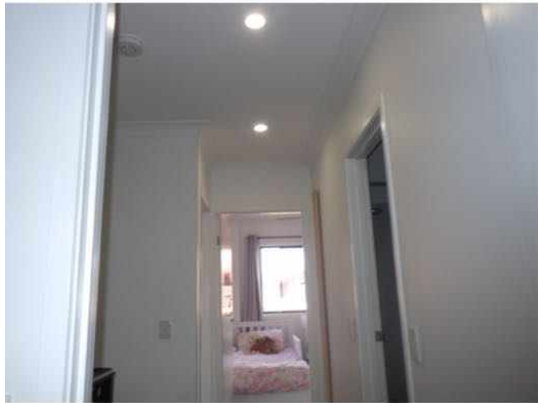
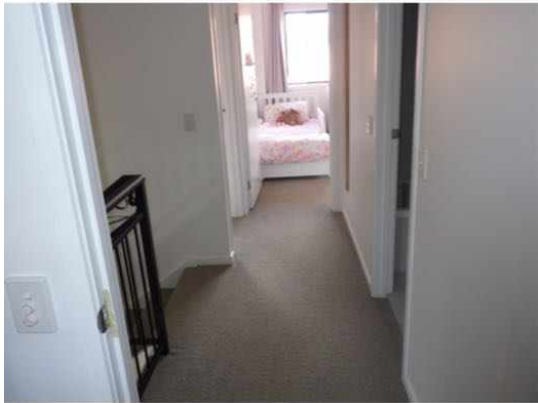
Building: Main Building
 Location: Stair Landing > Existing
 Finding: No obvious defect

Information: No obvious defects found at the time of inspection.

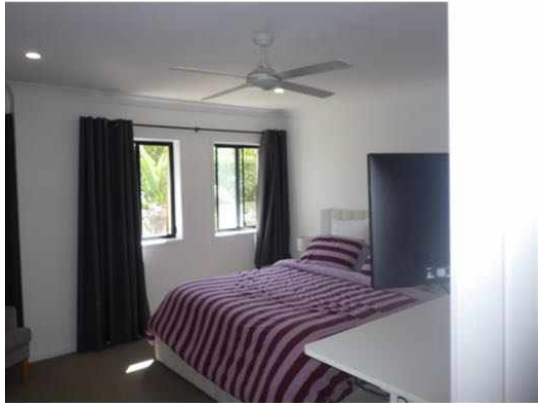
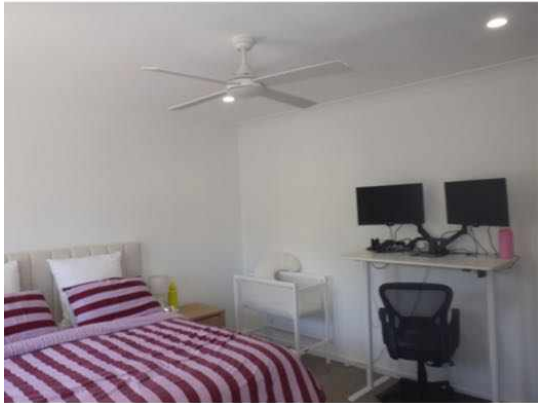
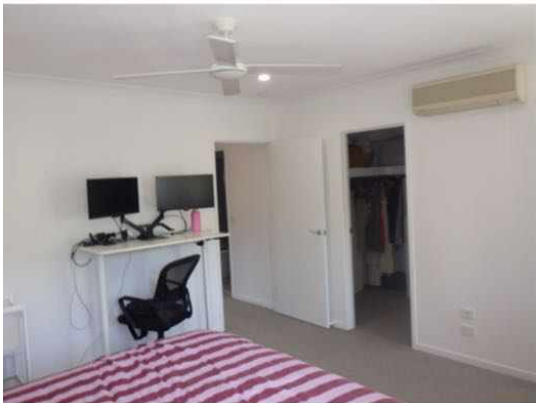
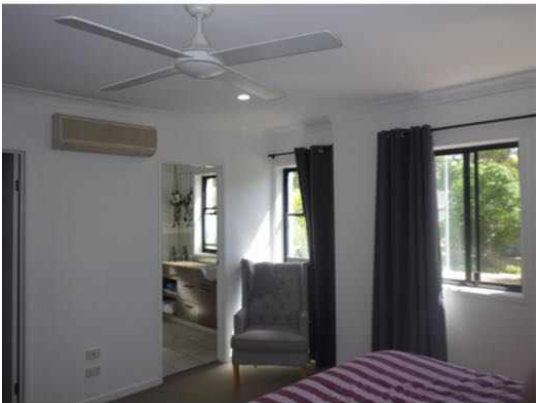
Building: Main Building
Location: Bedroom - Master > Existing
Finding: No obvious defect
Information: No obvious defects found at the time of inspection.

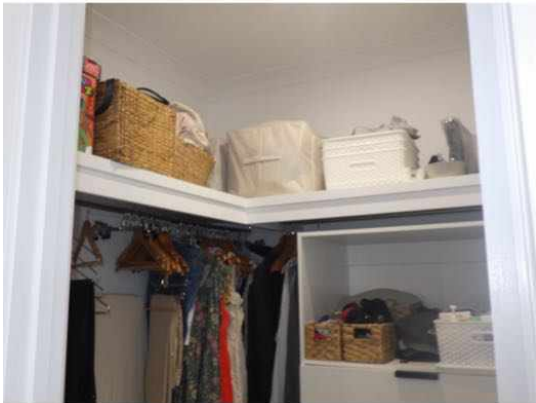
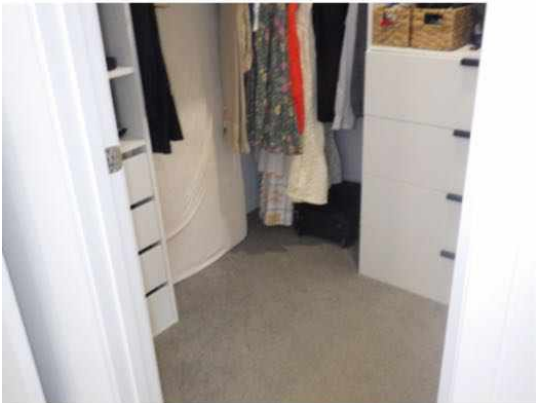
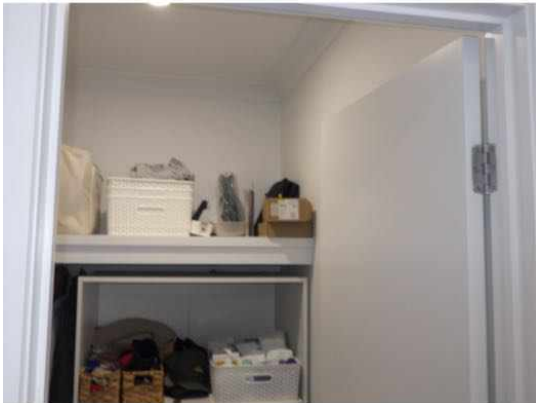
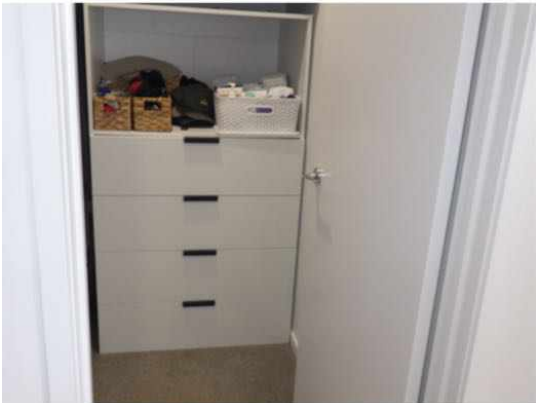
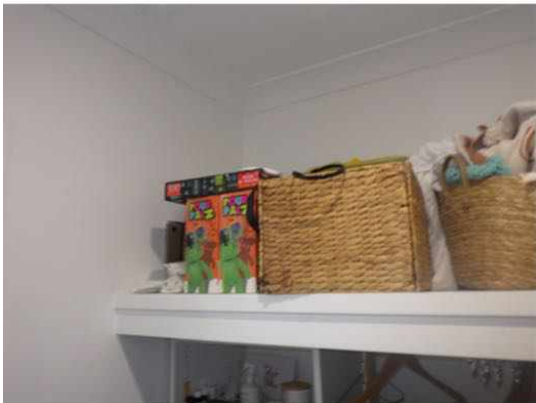
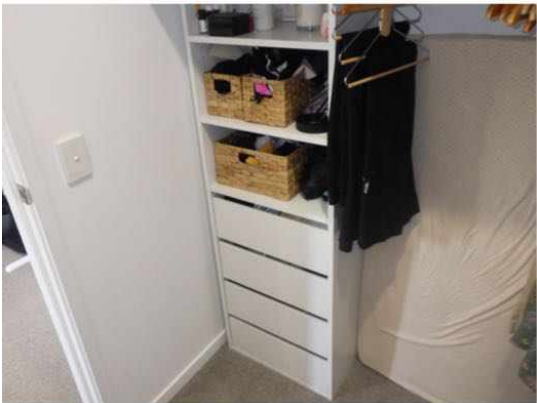
Building: Main Building
Location: Walk In Robe > Existing
Finding: No obvious defect
Information: No obvious defects found at the time of inspection.

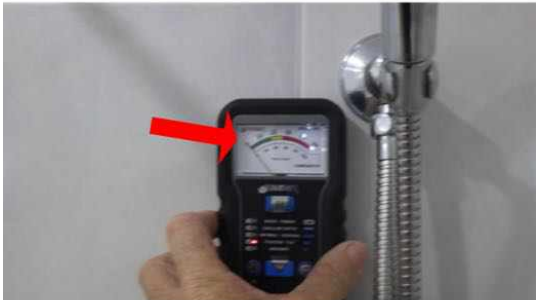
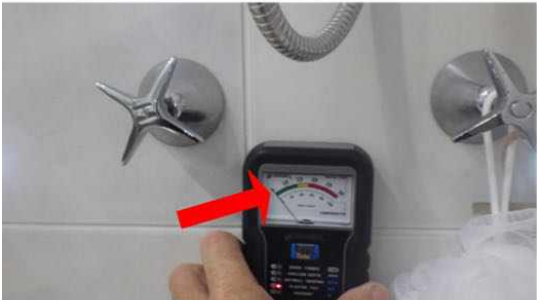
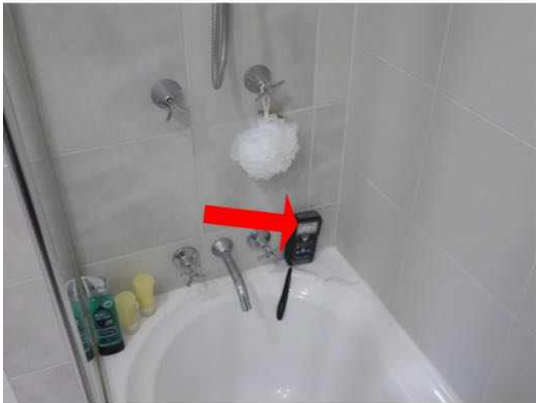
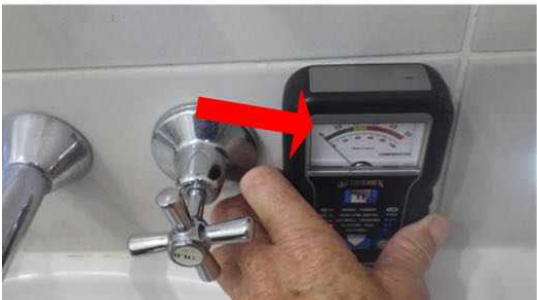
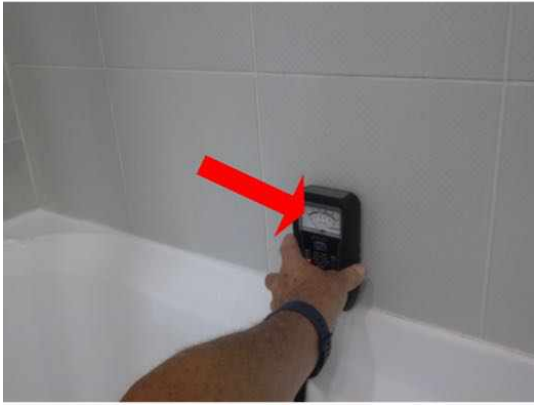
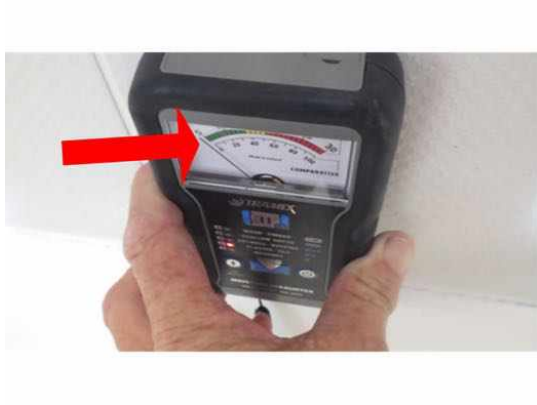
Building: Main Building
Location: Bathroom > Centre Left
Finding: Moisture Level Readings
Information: At the time of inspection the bathroom shower cubicle areas checked with the Tramex Moisture Meter returned low - normal moisture level readings.

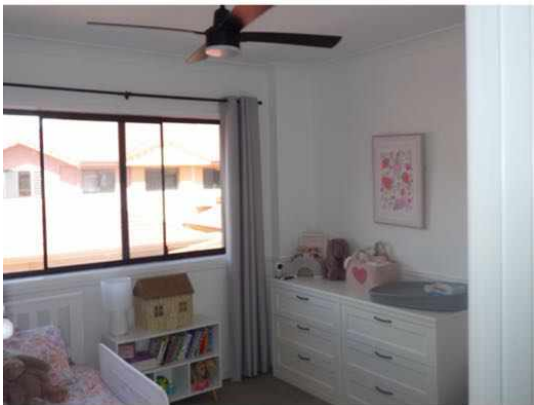
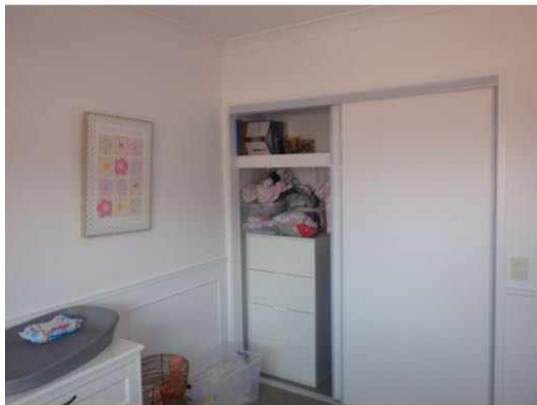
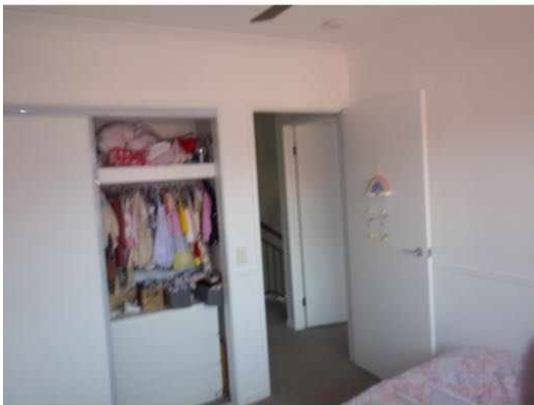
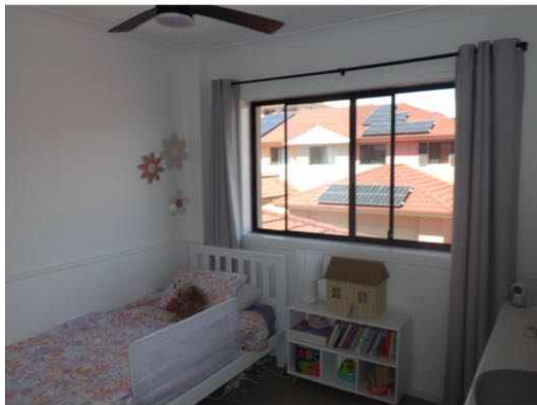
Building: Main Building
Location: Bedroom 2 > Existing
Finding: No obvious defect
Information: No obvious defects found at the time of inspection.

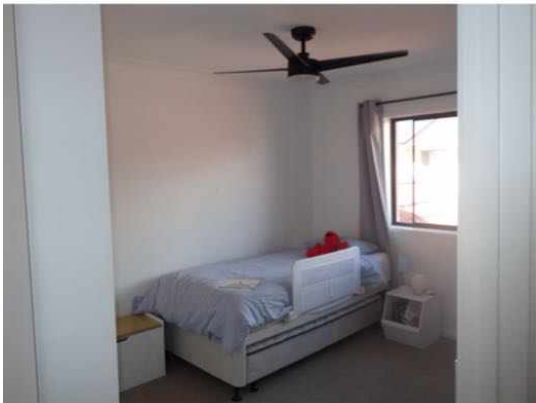
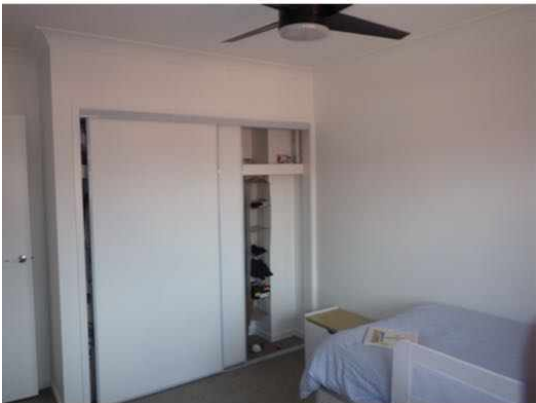
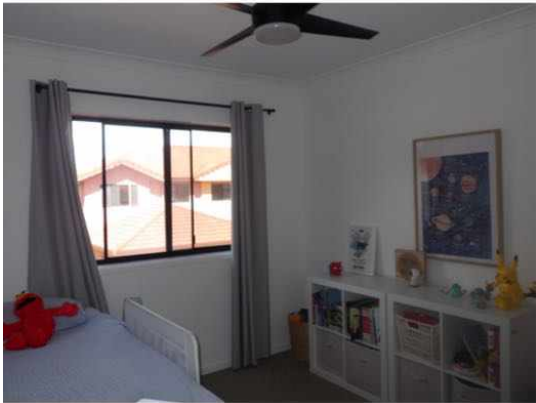
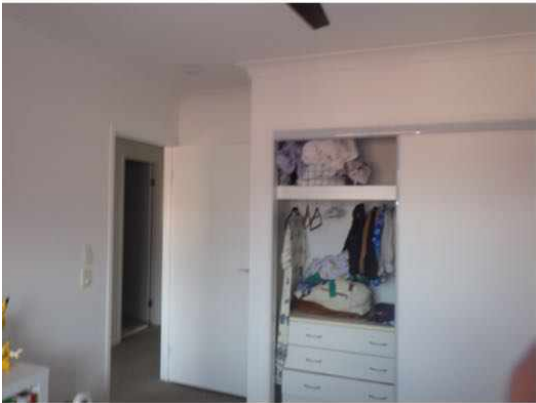
Building: Main Building
Location: Bedroom 3 > Existing
Finding: No obvious defect

Information: No obvious defects found at the time of inspection.

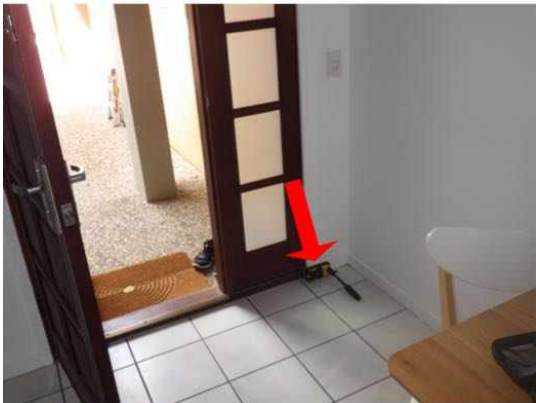
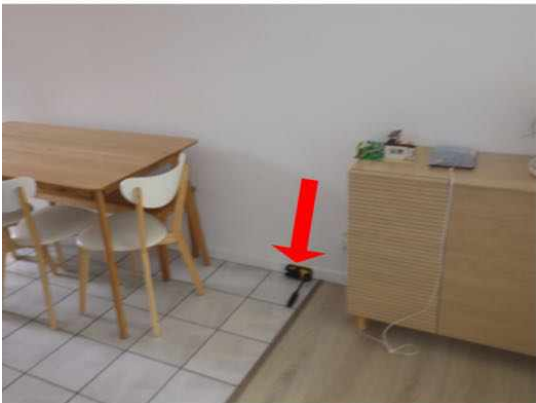
Building: Main Building
Location: Internal Areas > Existing
Finding: Termitracker
Information: The termitracker itracker was positioned randomly to internal wall, timber skirting and window frame areas checking for signs of termite activity.

No activity was recorded at the time of inspection.

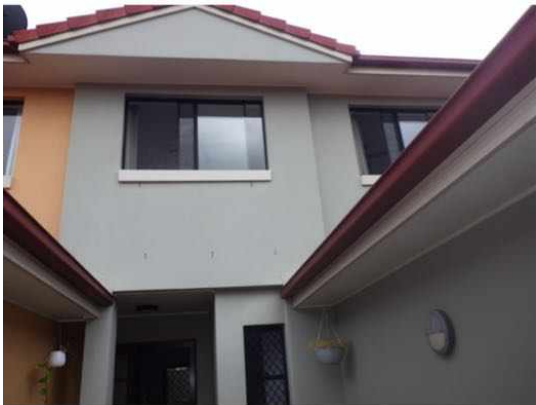
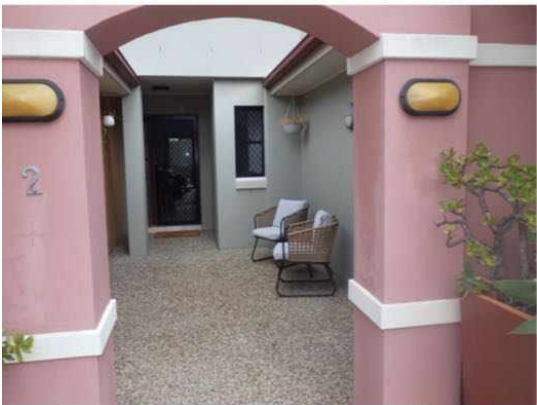
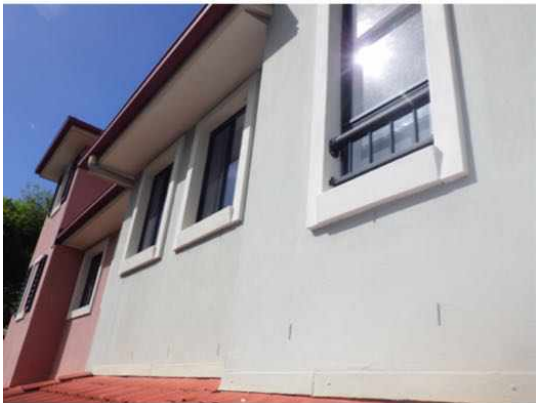
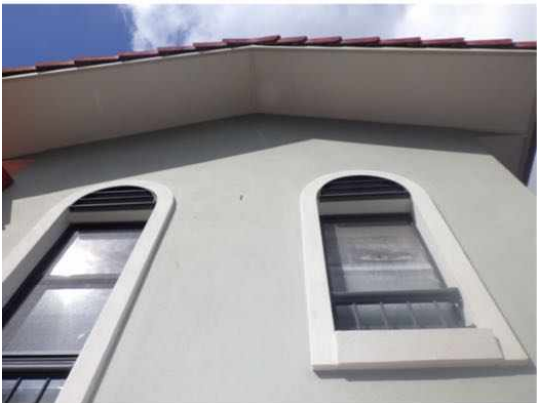
Building: Main Building
Location: External Areas > Existing
Finding: Additional Photos
Information: Additional photos are provided for your general reference
