Building and Timber Pest Inspection Report

Inspection Date: Wed, 8 Apr 2026

Property Address: 10/10 Stanbury Pl, Quakers Hill NSW 2763,
Australia

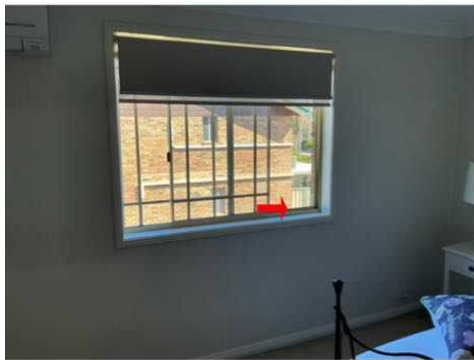
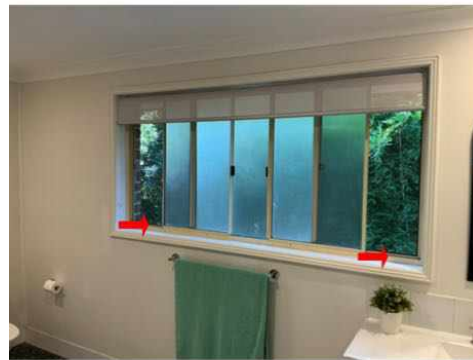
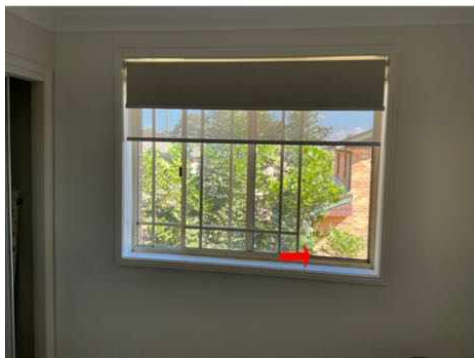
Building: Main Building
 Location: All Areas Upstairs
 Finding: Window Restrictors - Recommended
 Information: Upstairs windows did not have window restrictors installed. Although not a requirement at the time of construction, it is advisable to install window opening restrictors on all second storey windows with sill heights below 1.7 meter and potential fall of 2 meters or more.

If you live in a strata scheme, window safety devices must be installed on all applicable windows by 13 March 2018. Residents with safety devices installed can still fully open their windows but it's recommended that devices be engaged whenever children are present, to prevent falls.

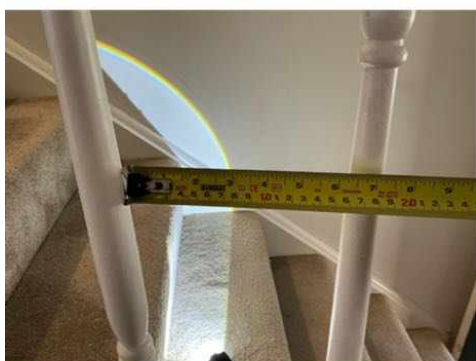
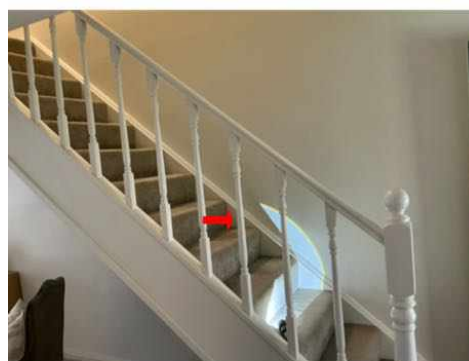
Finding 1.02

Building: Main Building
 Location: Stairs - Internal

Finding: Spacing Between Balusters - Non Complaint
Information: At the time of inspection, it was observed that the spacing between the balusters exceeds 125 mm. In accordance with the National Construction Code (NCC) 2022 Volume Two and referenced standards, any openings in a balustrade or barrier must be constructed to prevent a 125 mm sphere from passing through, in order to minimise the risk of falls or entrapment, particularly for young children.

The current baluster spacing does not comply with these safety requirements and may pose a fall or injury hazard. While this may have been acceptable at the time of original construction, it does not meet current Australian safety standards.

It is recommended that the balustrade be modified to reduce the openings between balusters to no greater than 125 mm, in accordance with current NCC requirements, to ensure occupant safety and compliance. Note - this may not have been a requirement when the house was built.

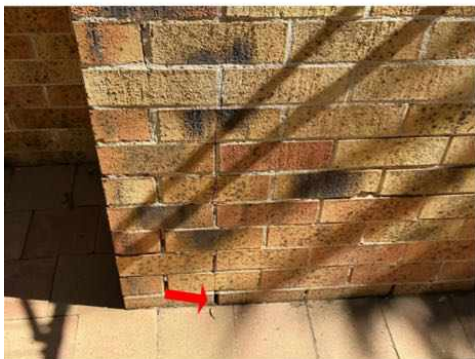
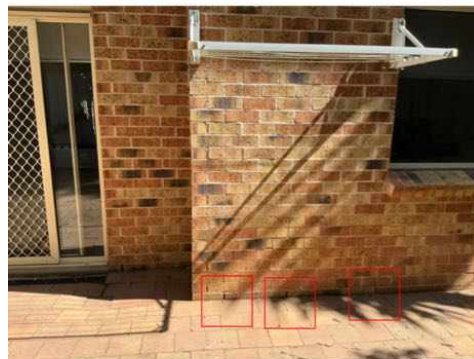
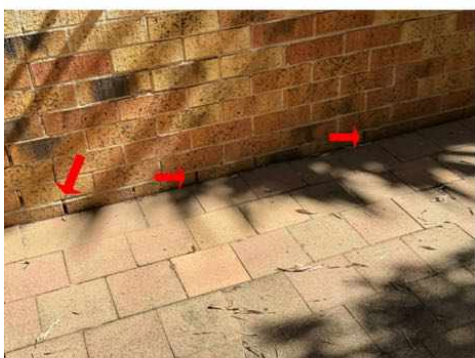
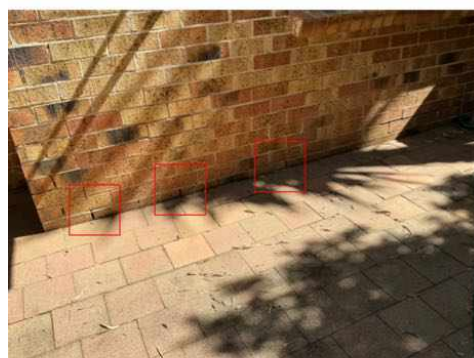
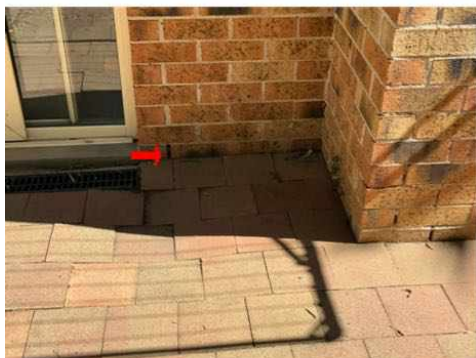
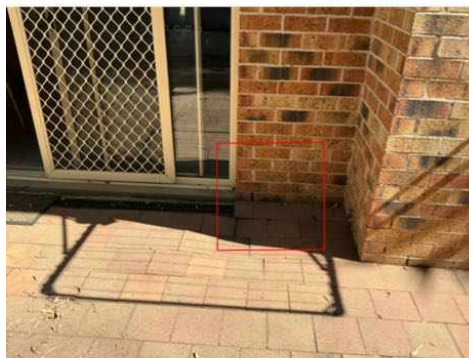
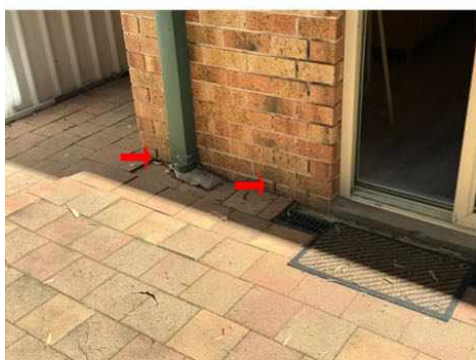
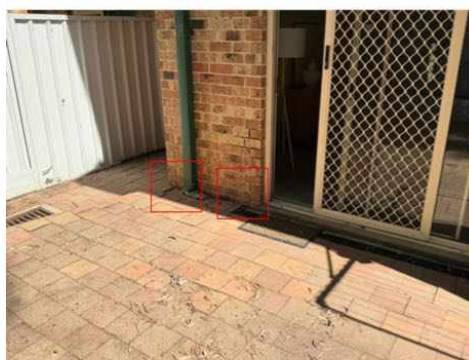
Finding 2.01

Building: Main Building
Location: Exterior walls - rear
Finding: Blocked Weep Holes and Inadequate Drainage
Information: At the time of inspection, the weep holes to the ground floor brickwork were noted to be blocked and/or partially obstructed by paving and debris. Weep holes are a critical component of brick veneer construction, designed to allow moisture that enters the wall cavity to safely drain out and to provide ventilation to prevent the buildup of dampness within the wall system.

Due to the current installation of pavers up against the wall, the weep holes are obstructed and not functioning as intended. Additionally, the paving was noted to be sloping towards the building, which is directing surface water towards the wall rather than away from it. This increases the risk of water entering the wall cavity, leading to

potential moisture ingress, internal dampness, and long-term deterioration of building elements.

Furthermore, the raised paving levels are bridging the termite management zone. This creates conducive conditions for termite activity, as it reduces the effectiveness of any existing termite barrier and allows concealed entry pathways into the structure. As a general requirement, a minimum of 75mm slab edge exposure should be visible to allow for proper inspection and to maintain the integrity of the termite barrier system.

The client is advised to engage a qualified landscaping or drainage specialist to rectify this issue. Remedial works should include removal and regrading of the affected pavers, installation of a continuous strip drain along the base of the wall from one end of the property to the other, and ensuring that surface water is directed away from the building. The paving should be reinstated at a lower level to maintain clear and unobstructed weep holes and achieve the required slab edge exposure.

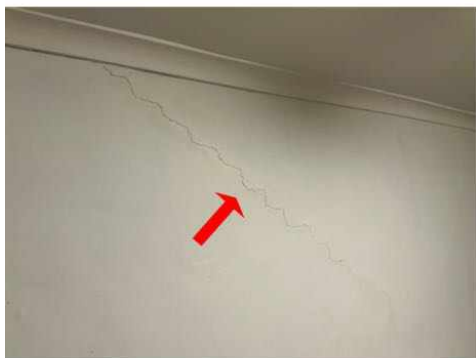
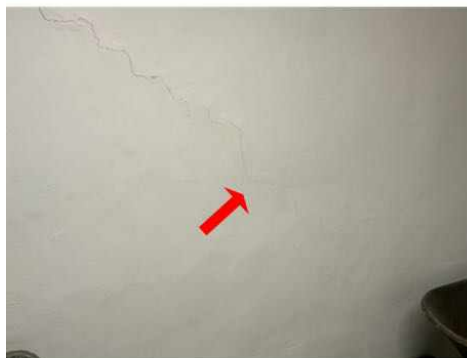
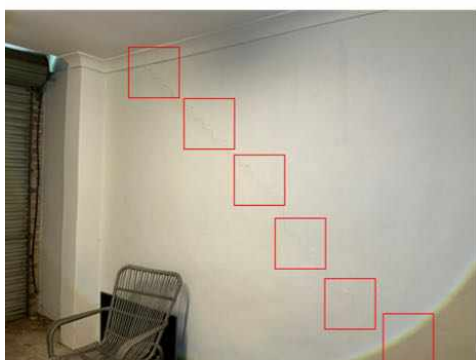
Finding 3.01

Building:	Main Building
Location:	Garage
Finding:	Cracking to Internal Wall – Monitor
Information:	At the time of inspection, a diagonal crack was noted to the internal wall surface. The crack appears to follow a stepped pattern through the plaster and is consistent with minor movement over time. Evidence suggests that this area has been previously repaired; however, the crack has reappeared.

For the time being, the client is advised to engage the services of a qualified plasterer or painter to repair the crack through appropriate patching and repainting to restore the appearance of the wall.

The client is also advised to monitor the area over the next 12 months for any signs of further movement, including widening, lengthening, or additional cracking. If the crack exceeds approximately 5mm in width or shows continued progression, further assessment may be required, and involvement of strata management and a builder is recommended to determine any underlying structural concerns.

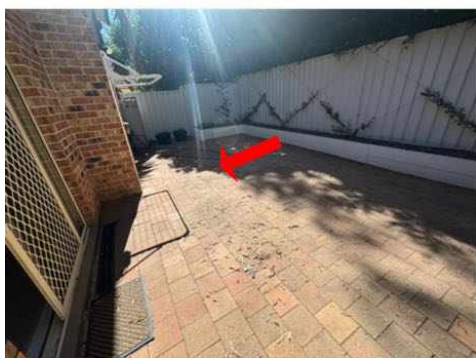
Finding 3.02

Building:	Main Building
Location:	Yard - Back
Finding:	Inadequate Site Drainage - Exterior Areas
Information:	At the time of inspection, inadequate site drainage was observed around the perimeter of the building, which can lead to water pooling and insufficient runoff management.

This condition may result in moisture being absorbed by the foundation or lower walls, potentially leading to rising damp, cracks in brickwork, erosion of the soil around the building, or structural issues over time. Water pooling can also create ideal conditions for mould growth, contribute to the deterioration of exterior materials, and act as conducive conditions for termite activity, as termites are attracted to areas with elevated and persistent moisture levels.

It is recommended that proper site drainage be installed, such as redirecting water flow away from the building or incorporating drainage systems, to prevent further damage and ensure the long-term stability of the structure.

To address the inadequate site drainage, a qualified landscaper or drainage specialist should be engaged to design and install appropriate drainage solutions, such as grading the ground away from the building or installing French drains, surface drains, or downspout extensions. If more complex issues are present, such as damage to the foundation or moisture entering the walls, a structural engineer may need to assess

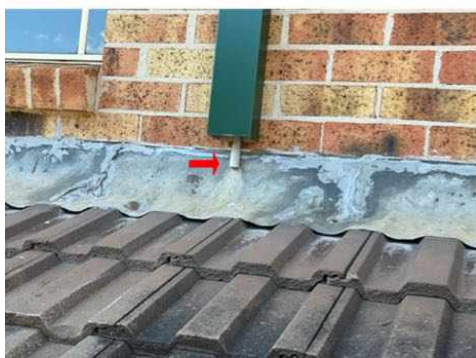
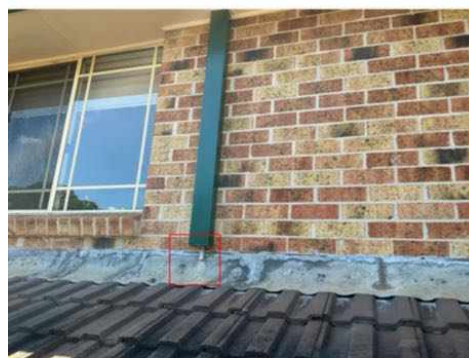
Finding 3.03

Building:	Main Building
Location:	Exterior walls - front
Finding:	Air conditioner - Disconnected overflow
Information:	The Air Conditioner (A/C) overflow was found to be disconnected from storm water drainage and is creating excessive moisture in the surrounding area.

Such leaking creates an environment which is conducive to an array of defects, including water damage to associated building elements and the attraction of termite or timber pest infestation.

It is highly recommended that a licensed plumber be appointed to connect the A/C overflow in order to prevent such an environment from being created.

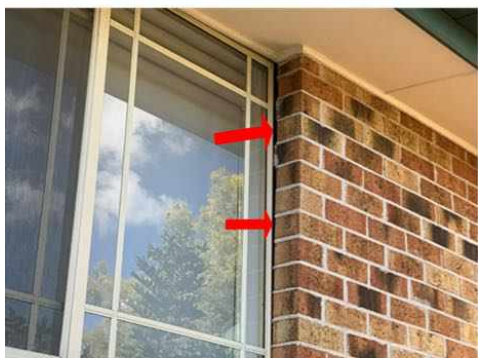
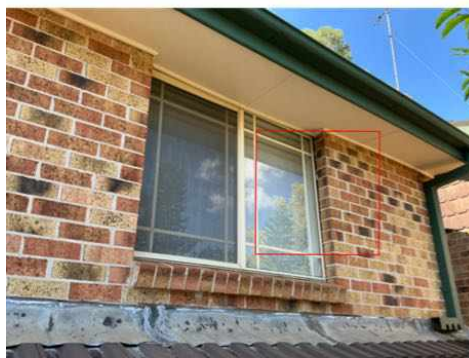
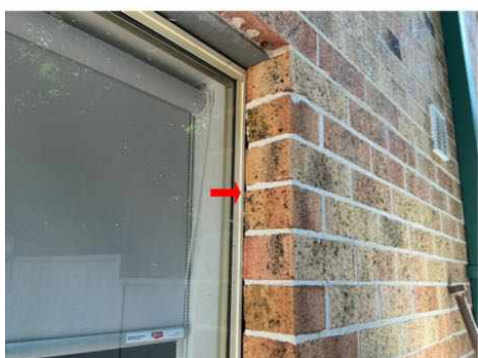
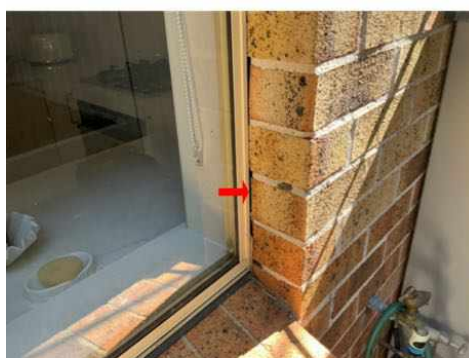
Finding 3.04

Building:	Main Building
Location:	Kitchen, Bedroom 3
Finding:	Gaps - Exterior Windows
Information:	Gaps were observed along the sides of the window frame at the time of inspection,

These unsealed gaps may compromise the weatherproofing and energy efficiency of the property, allowing drafts and moisture ingress that could result in higher energy costs due to heat loss and reduced insulation. Additionally, moisture entering through these gaps can cause water damage, mould growth, or deterioration of the surrounding building materials over time.

The gaps could be attributed to several potential causes. Structural movement or settling of the building, due to foundation shifts or soil subsidence, may have caused the window frame to separate from the surrounding brickwork. Improper installation is another possibility, where the window may have been incorrectly fitted or the materials used were not adequate, leading to misalignment over time. Alternatively, the gaps may be a result of shrinkage or degradation of the original sealant, which can occur due to exposure to weather elements.

It is recommended that these gaps be professionally sealed with a high-quality weatherproof sealant to restore proper insulation, prevent moisture ingress, and maintain the overall integrity of the window installation. Additionally, a sealant or window professional should be consulted to fix the issue.

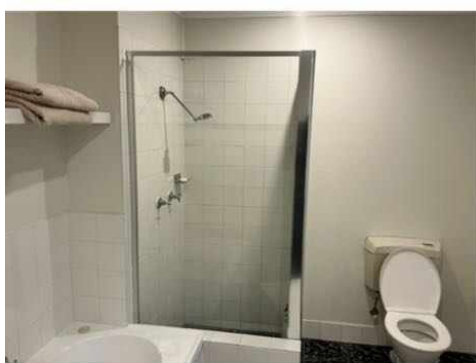
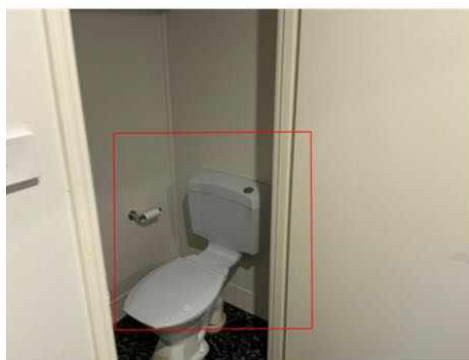
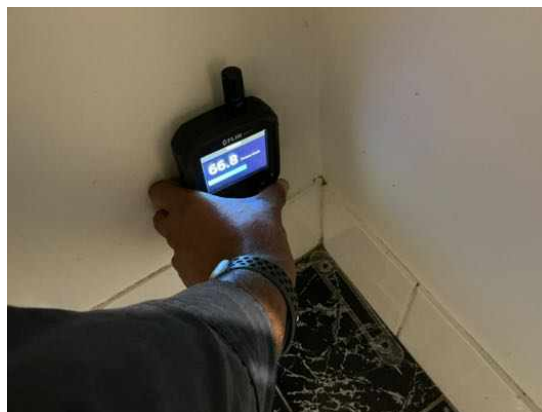
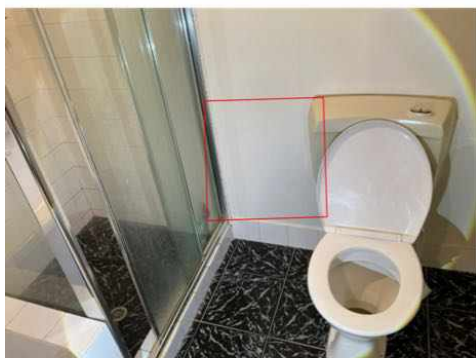
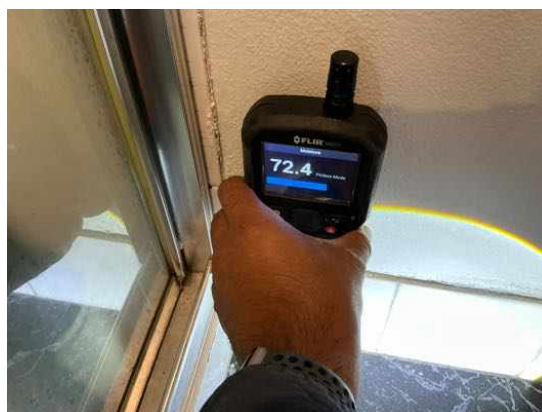
Finding 3.10

Building:	Main Building
Location:	Bathroom
Finding:	Shower Damp - Adjacent Bathroom (Monitoring)
Information:	At the time of inspection, elevated moisture levels were detected on the wall adjacent to the shower area. While no visible water damage or deterioration was noted, the presence of moisture suggests possible seepage or condensation associated with regular shower use.

At this stage, no immediate action is required. However, the area should be monitored over the next 12 months for any signs of deterioration such as staining, bubbling paint, or mould growth. It should be noted that moisture ingress of this nature does not generally resolve without intervention, and at some point remedial works are likely to be required. Should conditions worsen, the client is advised to engage services of a licensed plumber or waterproofing specialist to rectify the issue of moisture before this minor defect turns into major defect.

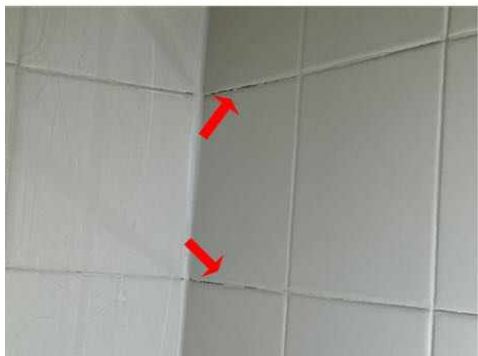
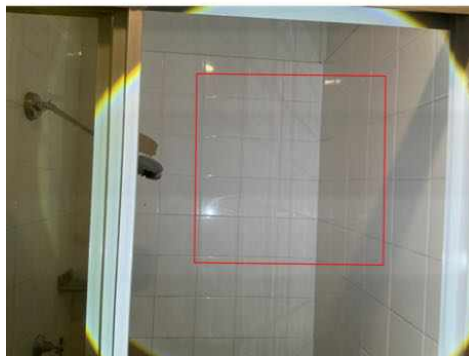
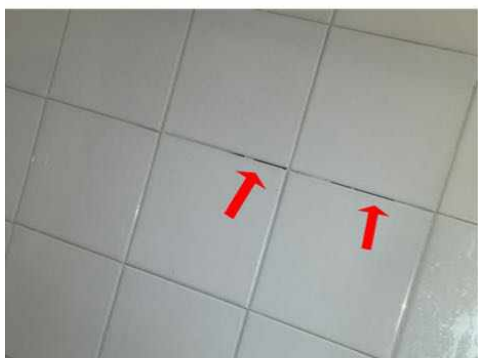
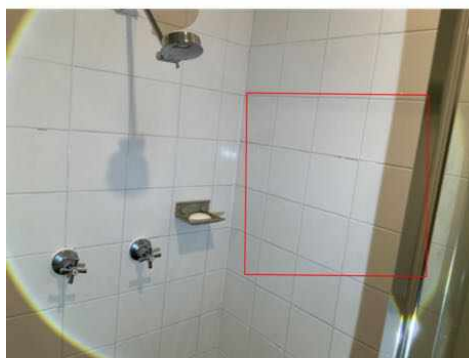
Finding 3.11

Building:	Main Building
Location:	Both Bathrooms
Finding:	Sealant/Grouting - Missing or Damaged
Information:	At the time of inspection, areas of missing and/or deteriorated sealant and grout were noted in this area. This condition can allow water to penetrate behind finishes, which may lead to moisture ingress, deterioration of waterproofing membranes, mould growth, and potential leaks into adjoining areas over time. If left unaddressed, this may result in costly repairs and hidden water damage.

It is recommended that a licensed plumber (or suitably qualified tradesperson experienced in wet area sealing) be engaged to assess the affected areas and

reinstate compliant waterproof sealant and grout as required, ensuring all junctions are properly sealed to prevent further water ingress.

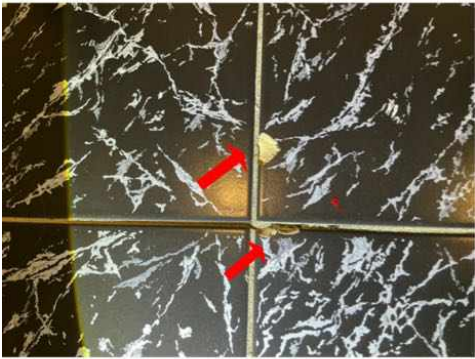
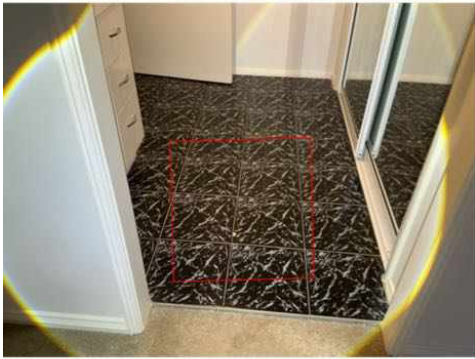
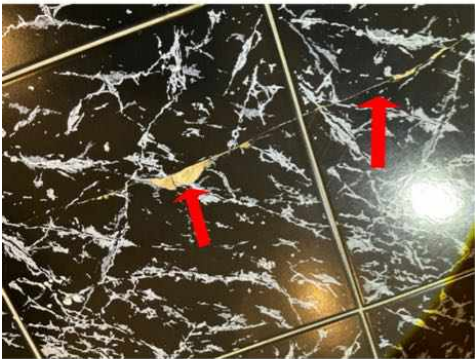
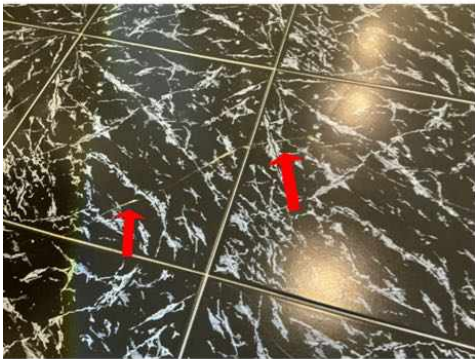
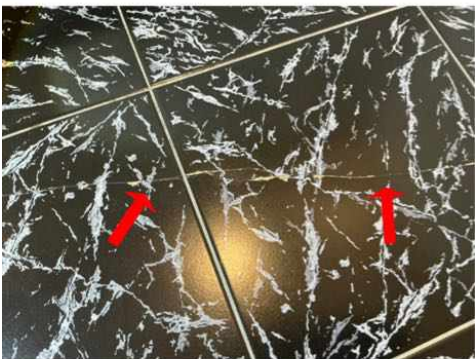
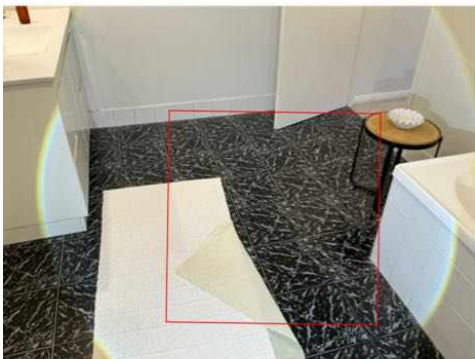
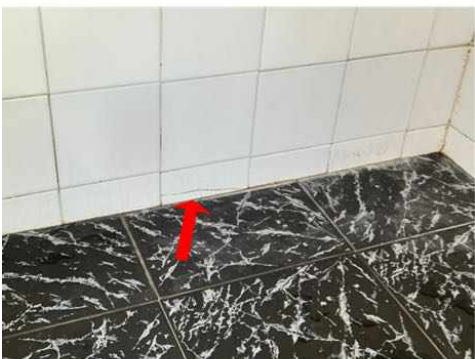
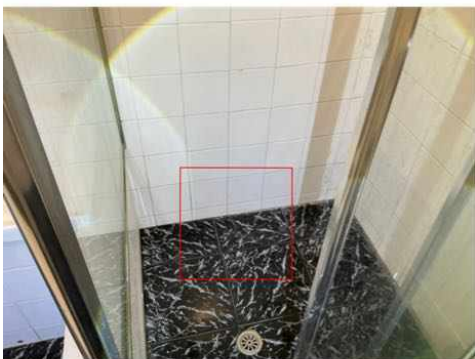
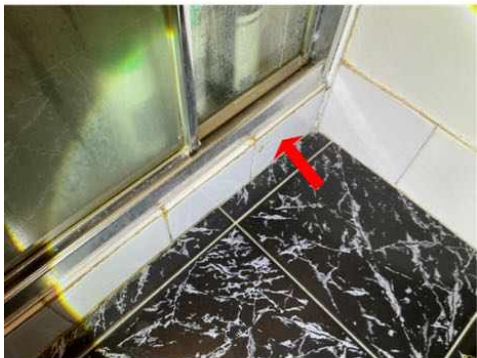
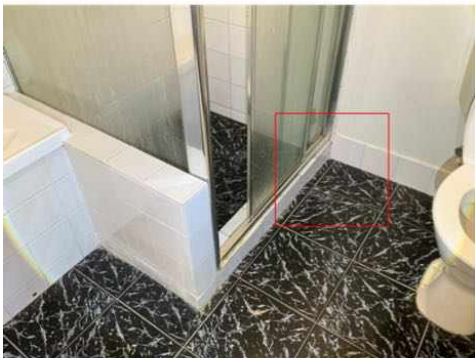
Finding 3.12

Finding: Tiles - Cracked and/or Damaged

Information: At the time of inspection, cracking in the tiles was evident in this area. It is suspected that this cracking has occurred as a result of minor settlement or material shrinkage.

While the cracking appears to be minor, this area may be exposed to water, allowing potential for water penetration into adjoining sections of walls or flooring. In wet areas particularly, cracked or compromised tiles can allow moisture to bypass the surface finish and place additional stress on the underlying waterproofing membrane. Over time, this may contribute to deterioration of the waterproofing system and shorten its effective service life.

While not considered a matter of urgency, replacement of cracked floor tiles is recommended at the client's discretion, particularly in wet areas to preserve the integrity and longevity of the waterproofing system. A licensed tiling contractor may be appointed to perform these works.

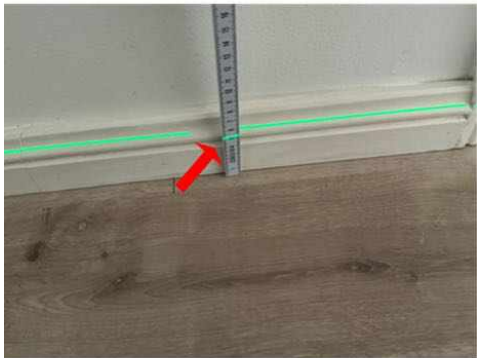
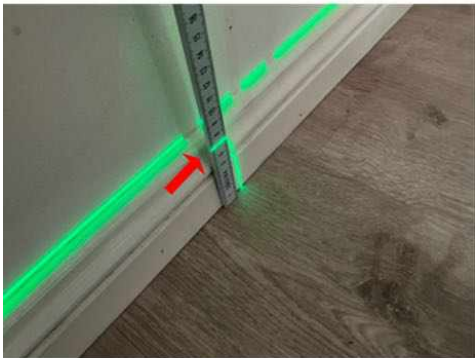
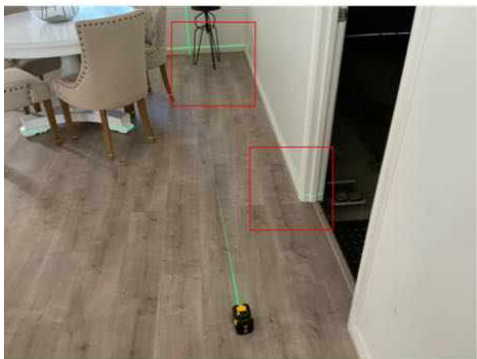
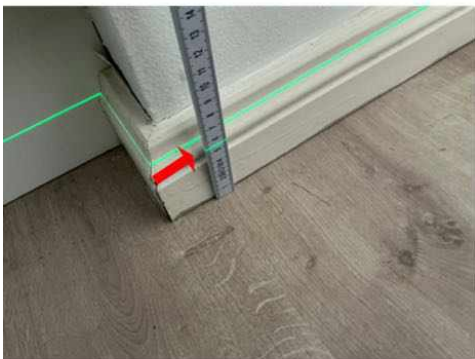
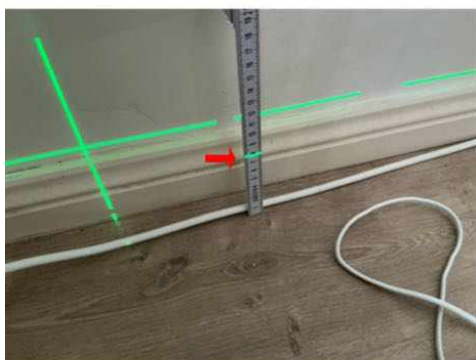
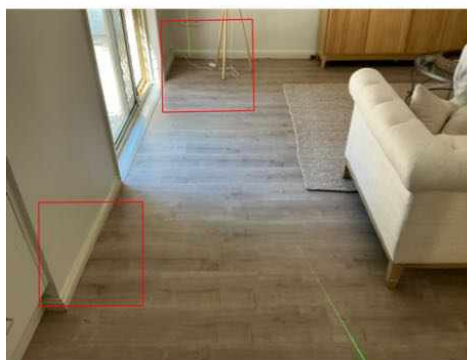
Finding 3.13

Finding: Flooring - Uneven (Monitoring)

Information: At the time of inspection, the floor was noted to be uneven. This may be due to general movement, moisture changes, or natural settling. Uneven flooring can create trip hazards, affect how furniture sits, and may lead to further deterioration over time. The area should be monitored, and if any cracking, shifting, or worsening unevenness is observed, a builder may be required to assess and carry out any necessary rectification works at the client's discretion.

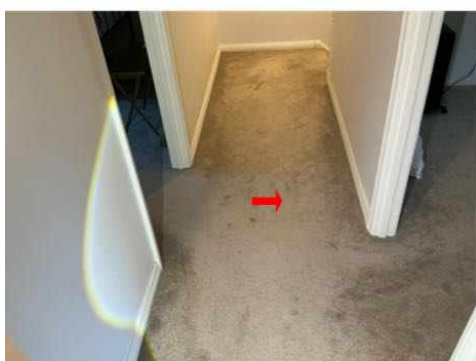
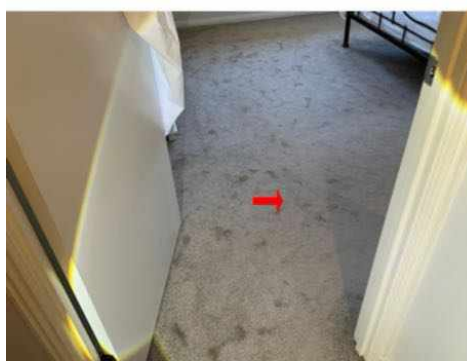
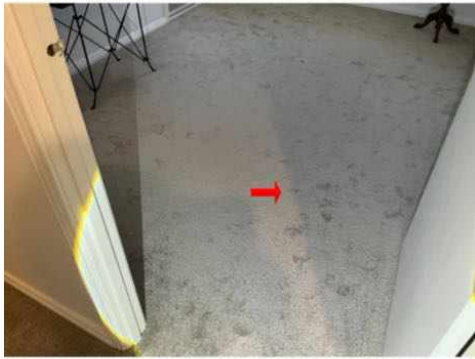
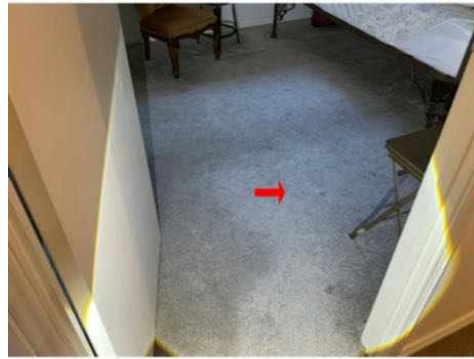
Finding 3.14

Information: At the time of inspection, bouncy flooring was noted at this area. Several factors could be contributing to this issue. One potential cause is insufficient structural support, such as undersized or improperly spaced floor joists, which may result in excessive flexing when weight is applied. Over time, this can lead to a bouncy or springy sensation underfoot. Another possibility is that the subfloor may not be securely fastened to the joists, causing movement between the layers of the floor system. Additionally, wear and tear on the structural components, such as floorboards or beams, could cause degradation or warping, further contributing to the issue.

It is recommended that a flooring specialist assess the condition of the floor. They may recommend reinforcing the joists, securing the subfloor, or addressing any structural shifts to ensure the safety and stability of the floor.

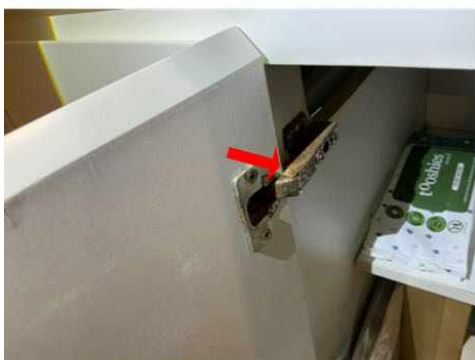
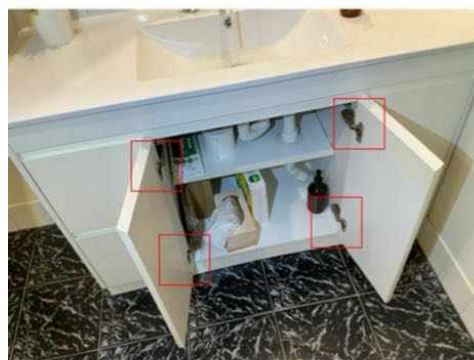
Finding 3.15

Building:	Main Building
Location:	Bathroom
Finding:	Building element - Rusted or corroded
Information:	This building element shows evidence of rusting and corrosion, which is likely to have developed as a result of excessive exposure to moisture and or inadequate coatings.

As surface rust provides no protection to the underlying iron, the deteriorating condition is likely to worsen if not addressed in the short-term future.

Where possible, the use of galvanized (treated) metals or aluminium coated metals aid in rust prevention, as does regular general maintenance. Rust formation can be controlled with coatings, such as paint, that isolate the iron from the environment.

Rusting and corrosion should be managed by ideally removing or limiting the affected surface from exposure to moisture. A registered builder may be appointed to replace any building elements that have been severely affected by rust or water damage.

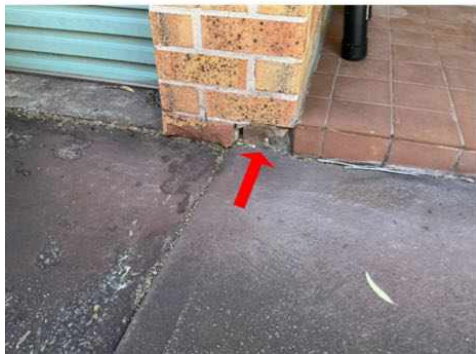
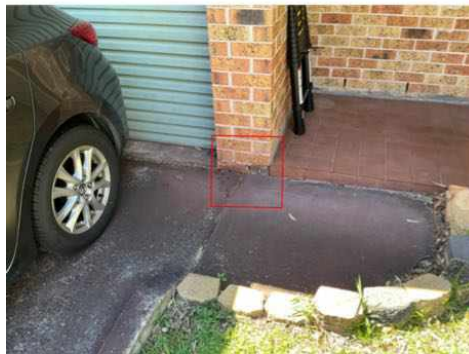
Finding 3.16

Building:	Main Building
Location:	Exterior walls - front
Finding:	Damaged Brickwork at Base

Information: At the time of inspection, a damaged brick was noted at the base of the wall.

The client is advised to replace the affected brick to restore the area. A bricklayer or handyman can be engaged to carry out the repair.

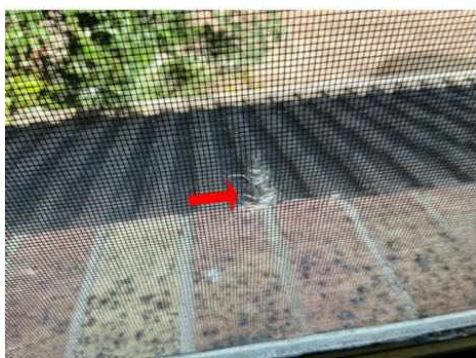
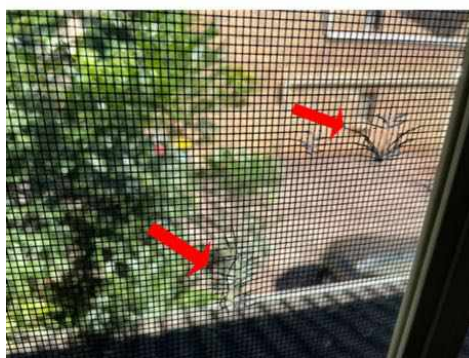
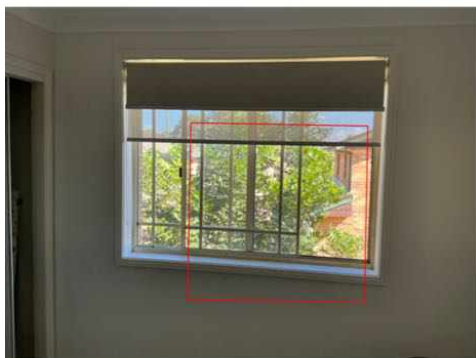
Finding 3.17

Finding: Fly Screen Damaged

Information: It was noted at the time of inspection, the fly screen was damaged.

Window fly screens can sustain damage due to a variety of reasons, including exposure to harsh weather conditions like storms or strong winds, accidental tears or punctures, wear and tear over time, pets scratching or clawing at the screens, poor installation leading to misalignment or weak attachment points, and the use of low-quality materials that may deteriorate faster. Regular maintenance and addressing these factors can help prevent or minimize damage to window fly screens.

A general handyman should be appointed to rectify the issue at owners discretion.

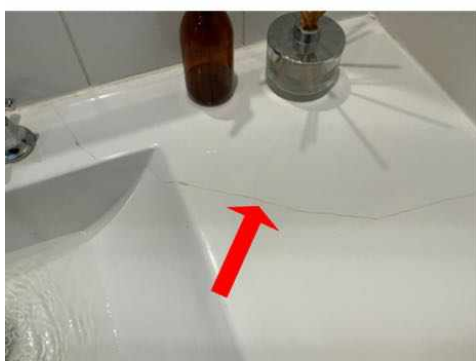
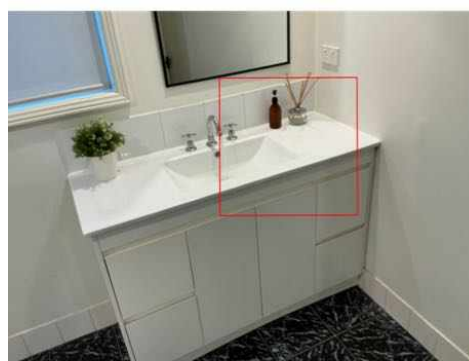
Finding 3.18

Finding: Sink - Cracked

Information: At the time of inspection, a visible crack was noted on the surface of the bathroom sink basin. While the crack appears minor, it may worsen over time due to regular use and moisture exposure. It is recommended to engage a licensed plumber to assess and replace the basin to prevent potential water damage to the underlying vanity unit and maintain the integrity of the bathroom fixture.

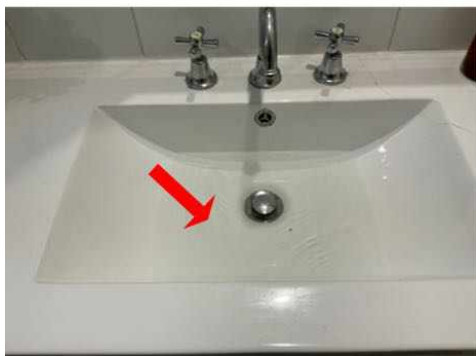
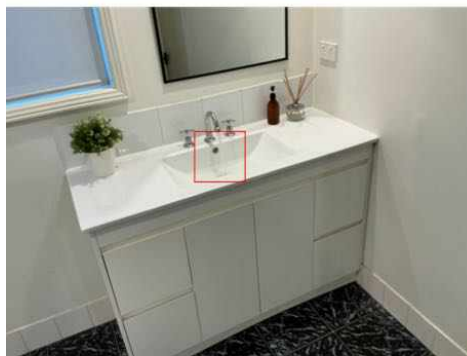
Blockages prevent building elements from operating as intended. If left unmanaged, a lack of general maintenance may lead to the development of more significant defects, such as water damage to surrounding building materials. It is advised that the blockage be removed as soon as possible.

If blockage remains, a licensed plumber should be appointed as soon as possible to perform any remedial works where required.

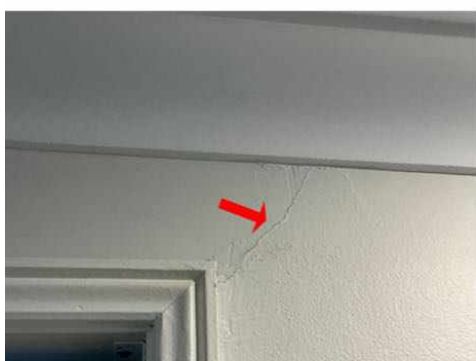
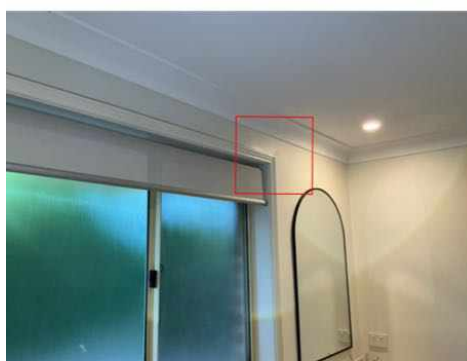
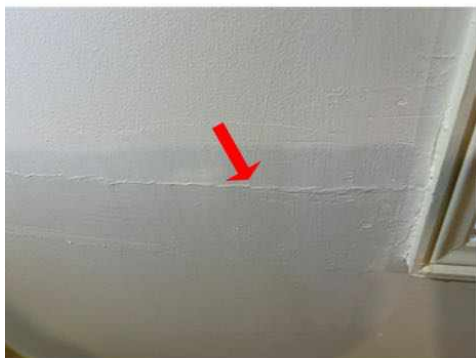
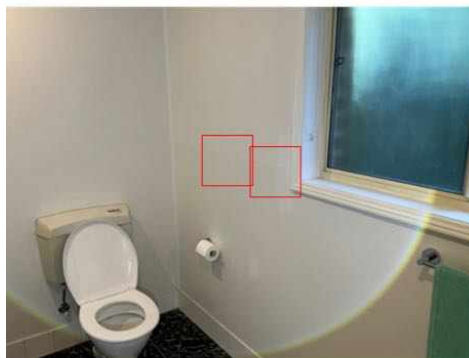
Finding 3.20

Finding: Cracking - Damage Category 1 - Fine (up to 1mm)

Information: Although fine cracks are quite noticeable, they are often only considered to be an appearance defect, and usually do not indicate any structural damage. Generally, the cause of a fine crack is indicative of a separation between building materials and finishes (e.g. paint, plaster, etc.) along joins.

Cracking of this nature can generally be repaired with minor sanding, filling and/or repainting. Such works should be performed by a qualified painter or a general handyman.

Monitoring of all cracking should be conducted frequently. Always contact a building inspector should cracks widen, lengthen, or become more numerous.

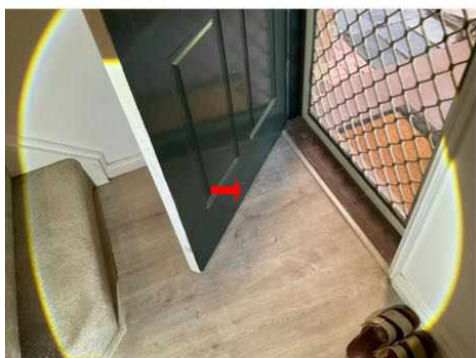
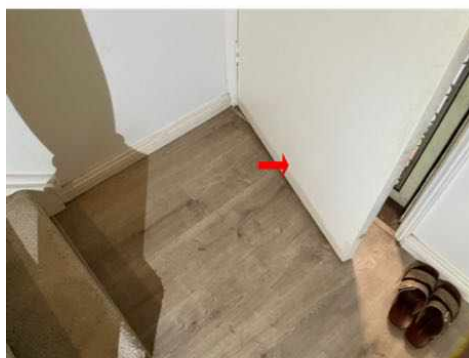
Finding 3.21

Building:	Main Building
Location:	Entry
Finding:	Door Weatherstrip - Missing
Information:	It was noted at the time of inspection, the door weatherstrip was missing.

The absence of a door weatherstrip could be due to wear and tear, improper installation, or deliberate removal. The implications include increased energy loss, reduced insulation, potential water leaks during rain, and a compromised seal, allowing drafts and noise to enter the space. Replacing the missing weatherstrip is advisable to maintain energy efficiency, weather protection, and overall comfort within the enclosed area.

A general handy man should be appointed to install the weatherstrip at owners discretion.

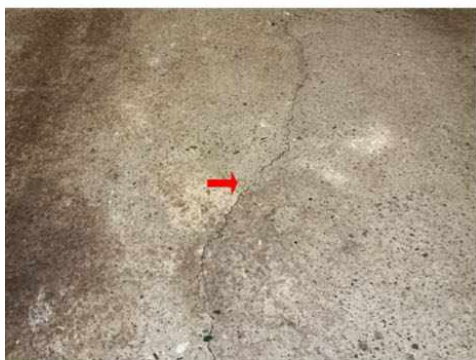
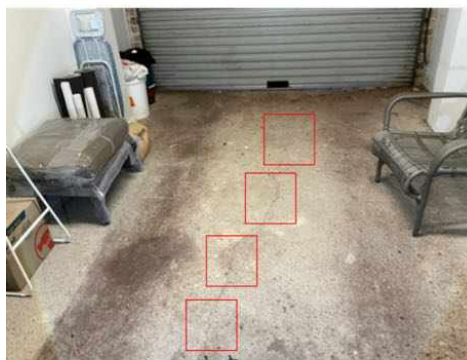
Finding 3.22

Building:	Main Building
Location:	Garage
Finding:	Crack in concrete slab - Category 2
Information:	A crack coded as Category 2 was identified in the slab. A Category 2 crack is

described as a distinct crack, with the slab being noticeably curved or changed in level.

To be considered Category 2, the approximate width of the crack is less than 2.0mm, or a change in offset of less than 15mm when a 3m straight edge is placed over the defect.

Category 2 cracks to slabs should be monitored for a period of 12 months. At the end of the monitoring period, cracks rated greater than Category 2 are considered defects that require rectification.

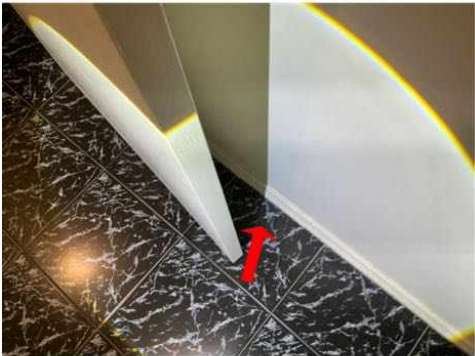
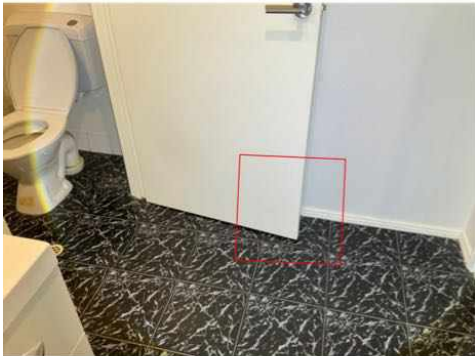
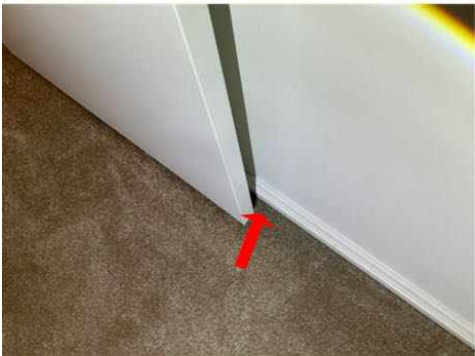
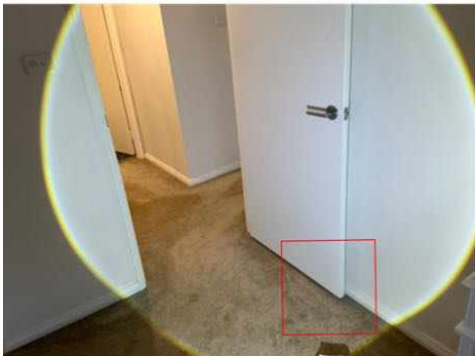
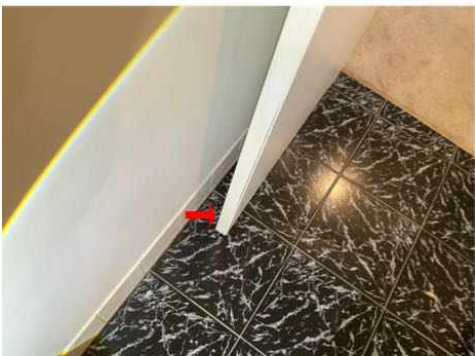
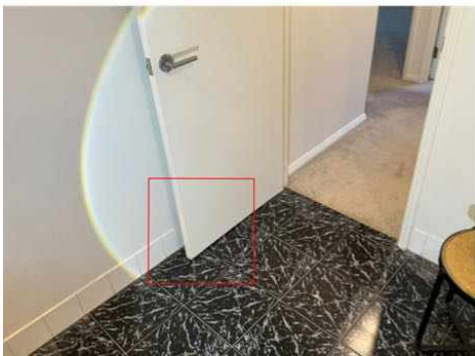
Finding 3.23

Building:	Main Building
Location:	All Areas
Finding:	Door Stopper(s) - Missing
Information:	At the time of inspection, it was noted that a door stopper was missing in this area.

The absence of a door stopper can lead to potential damage to the door, wall, or surrounding finishes, as the door may swing open too far and impact the wall or adjacent objects. Over time, this can cause dents, scuffs, or even structural damage to the wall or door. It is recommended that a door stopper be installed to prevent further damage and ensure the protection of both the door and the surrounding area.

The client is advised to engage services of a handyman to install the door stopper.

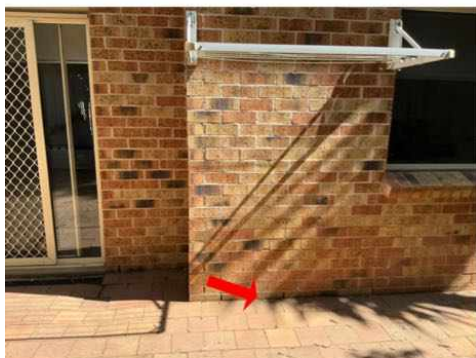
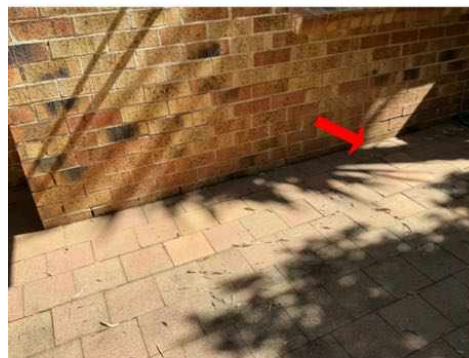
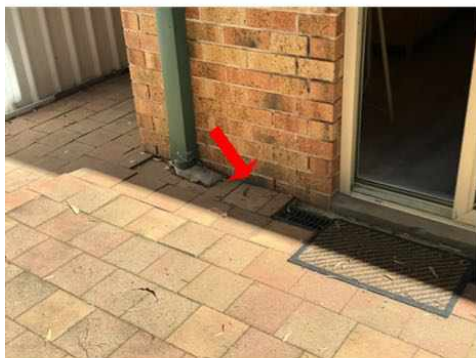
If the slab edge is not properly exposed there is a high risk of termite attack. Sometimes, in order to determine the type of slab, a suitably qualified person such as an architect or builder may be required to consult the construction plans.

Where the slab edge cannot be properly inspected, it is highly recommended that termite or timber pest inspections be carried out every 6-12 months to aid protection of the property against infestation.

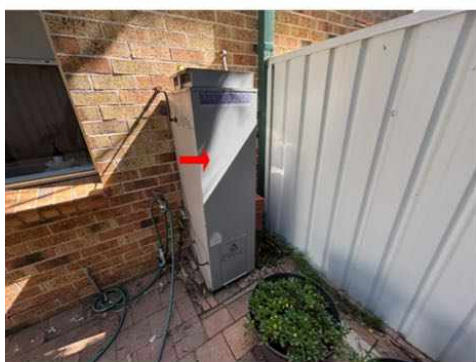
Finding 6.02

Building:	Main Building
Location:	Exterior walls - rear
Finding:	Bridging Appliances - Attachment to Buildings
Information:	Bridging occurs when items against a building provide a concealed entry point for termites into the building or by passing around a termite management system.

Where any part of an attachment to a building is not isolated and is not provided with a clear gap of not less than 25mm from the building, bridging occurs. Attachments to buildings such as hot water services, downpipes, verandahs, decks, steps, fences, service conduits and the like provide the opportunity for concealed entry.

Building attachments of this nature need to be frequently inspected for termite activity by a qualified inspector.

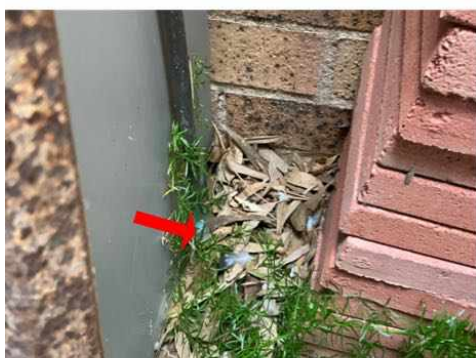
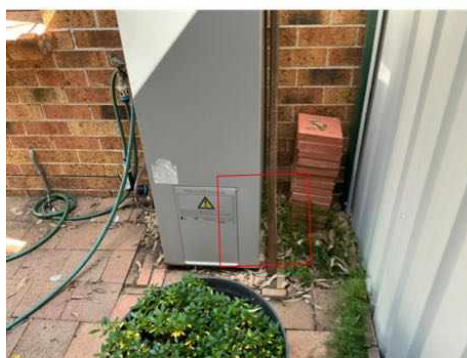
Finding 6.03

Building:	Main Building
Location:	Exterior walls - rear
Finding:	Overflow Disconnected - HWS/AC/Gas - Conducive Conditions to Termites
Information:	The overflow to this service was found to be disconnected from stormwater drainage and is creating excessive moisture in the surrounding area.

Such leaking creates an environment that is conducive to an array of defects, including water damage to associated building elements and the attraction of termite or timber pest infestation. These damp conditions can lead to secondary defects such as rot, rust, or corrosion of associated building elements, the formation of fungal decay, or even the creation of potential slip hazards. When coupled with poor site drainage, pooling of water may also attract termite activity to this area.

It is highly recommended that a licensed plumber be appointed to connect the overflow in order to prevent such an environment from being created. These minor works should be carried out as soon as possible.

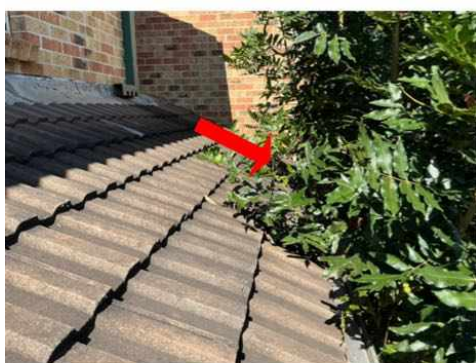
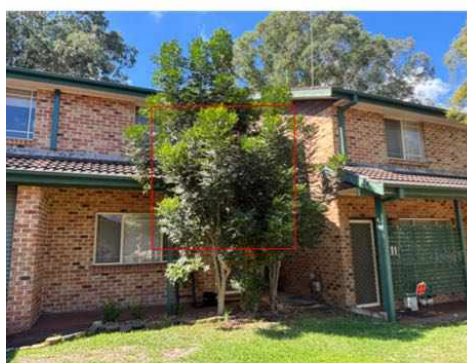
Building:	Main Building
Location:	Yard - Front
Finding:	Overhanging Trees/Branches/Roots
Information:	Overhanging trees and exposed roots were noted near the property, which pose potential risks to the structure and surrounding areas.

The overhanging branches can cause damage to the roof, gutters, or walls, particularly during storms or high winds. Additionally, the roots may pose a threat to the foundation by causing ground movement, leading to cracks or uneven settling over time. The accumulation of leaves and debris in gutters and drainage systems can also lead to blockages, contributing to water overflow and potential water damage.

It is recommended that a qualified arborist be engaged to prune back the overhanging branches and assess any potential risks posed by the tree roots to prevent further damage to the property. It is advised to get this fixed as soon as possible. Regular maintenance should be carried out to ensure the trees are managed effectively and the property remains safe.

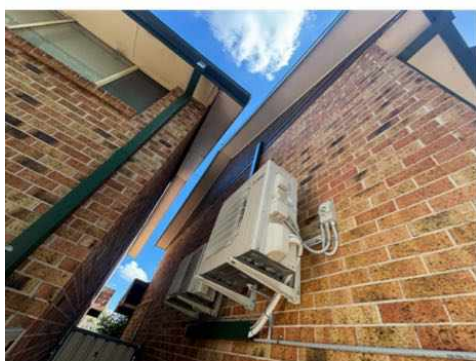
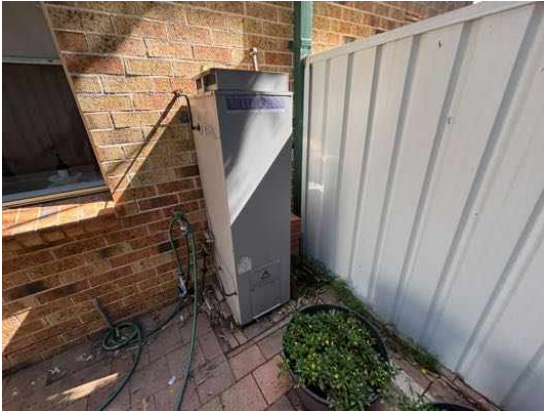
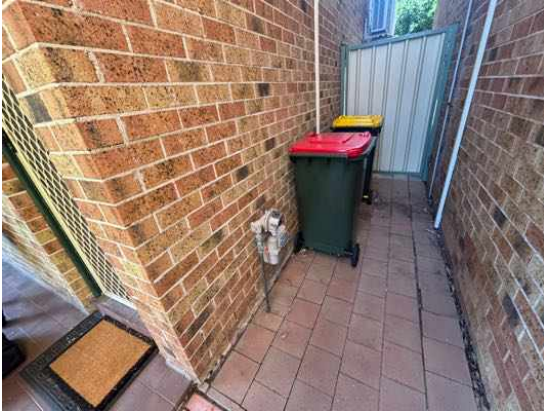
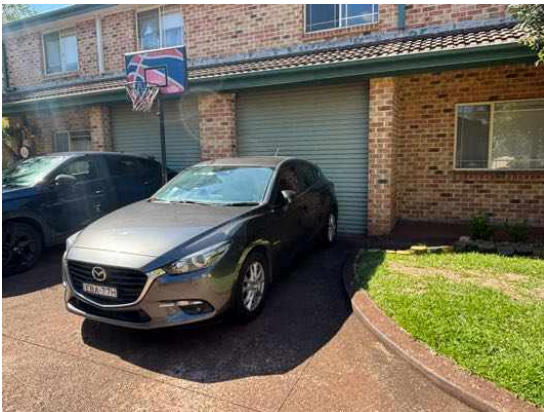
Building: Main Building
Location: All External Areas
Finding: Obstructions and Limitations - External Areas
Information: The attached photographs provide a visual representation of the obstructions and limitations that impeded a full inspection of the external areas of the property at the time of assessment. These obstructions, which may include vegetation, stored items, debris, or other physical barriers, can obscure potential defects and prevent a thorough evaluation of the property's condition. Obstructions of this nature can conceal a wide range of issues, such as structural damage, water ingress, pest infestations, or deteriorating building materials, which may not be visible during the initial inspection.

It is essential that these obstructions be cleared to allow for a comprehensive inspection of the external areas. Removing these barriers will enable a more accurate assessment of the property's condition and allow any hidden defects to be identified and addressed promptly. Failure to do so could result in undetected issues worsening over time, potentially leading to more costly repairs in the future.

Therefore, it is strongly recommended that the obstructions be removed and a re-inspection be scheduled once the affected areas are made fully accessible. This will ensure a complete evaluation of the property's exterior and provide the client with a clear understanding of any potential issues that may have been concealed during the initial inspection.
