Building and Timber Pest Inspection Report

Inspection Date: Wed, 8 Apr 2026

Property Address: 10/10 Stanbury Pl, Quakers Hill NSW 2763,
Australia

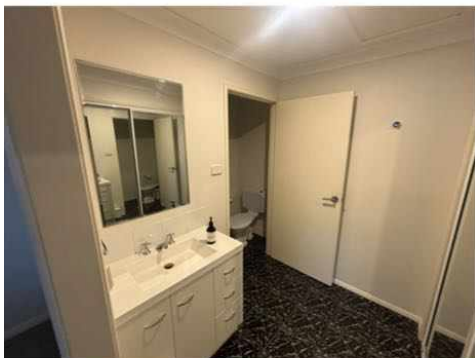
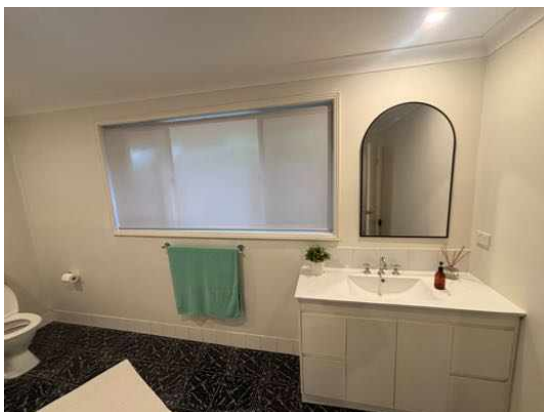
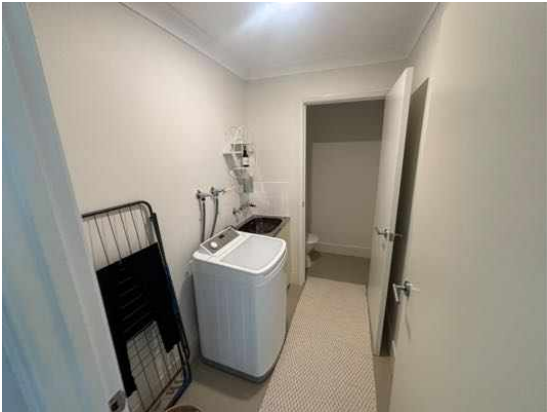
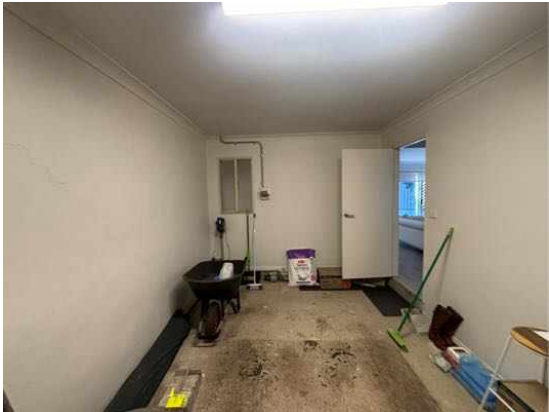
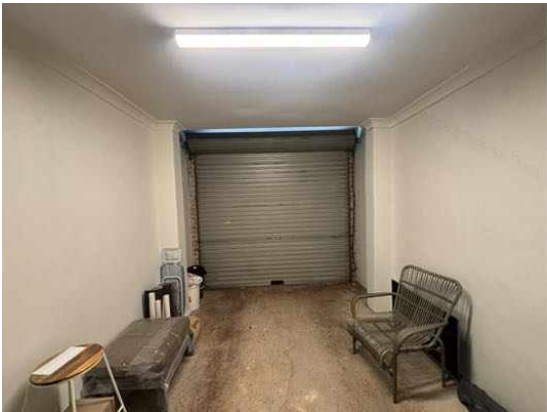
Building:	Main Building
Location:	All Internal Areas
Finding:	Obstructions and Limitations - Internal Areas
Information:	The accompanying photographs provide clear evidence of the obstructions and limitations that restricted a comprehensive inspection of the internal areas of the property at the time of assessment. These obstructions, which may include furniture, personal belongings, stored items, or structural elements such as wall coverings and built-ins, significantly hindered the ability to thoroughly evaluate these areas. It is important to note that such obstructions can potentially conceal a wide array of defects, ranging from hidden structural damage, water leaks, pest infestations, or

electrical issues, to deteriorating materials that may not be visible during the initial inspection.

The presence of these impediments means that critical areas of the property were not accessible, and therefore, any underlying defects that may affect the integrity and safety of the property could remain undetected. These hidden defects, if left unaddressed, could worsen over time and may result in costly repairs or pose potential safety hazards to the occupants.

It is highly recommended that all obstructions be cleared to facilitate a complete and thorough inspection of the internal areas. Once the obstructions have been removed and full access is available, a re-inspection should be carried out to ensure that any previously concealed issues can be properly identified and rectified. This follow-up inspection will provide a more accurate assessment of the property's internal condition and help the client make informed decisions about any necessary repairs or maintenance.

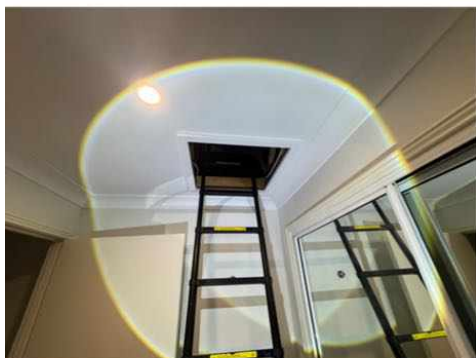
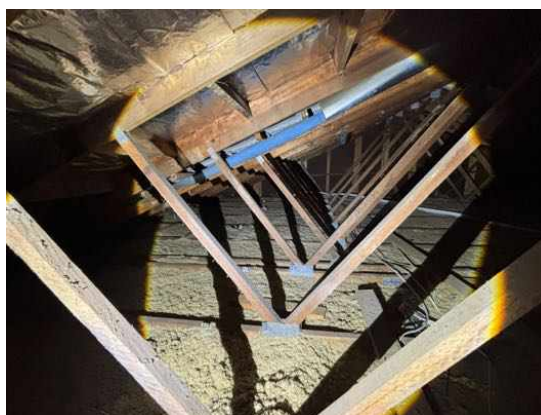
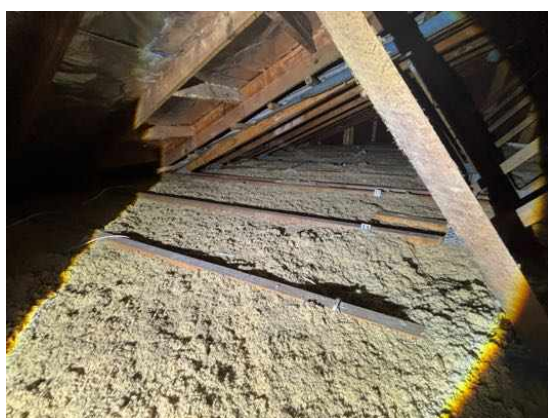
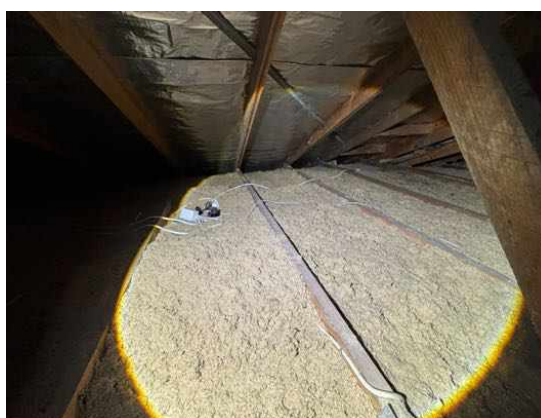
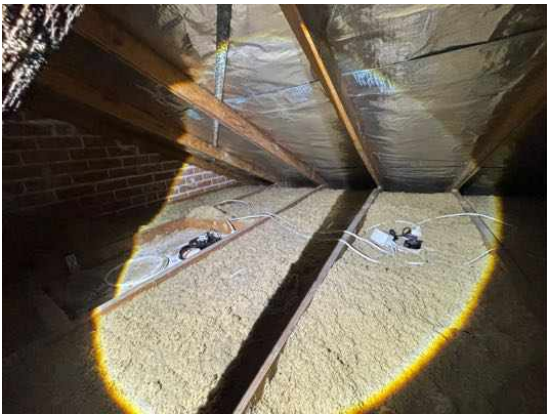
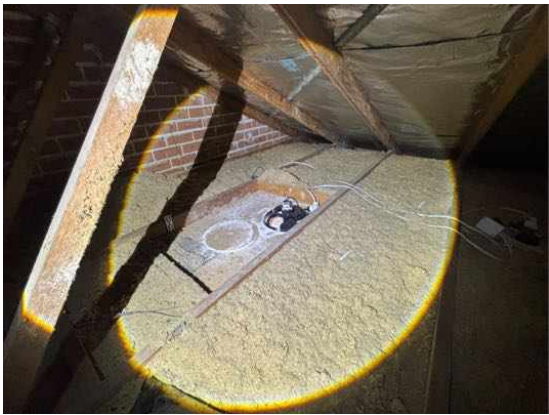
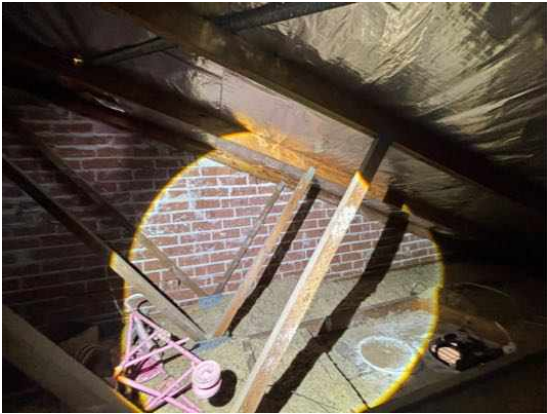
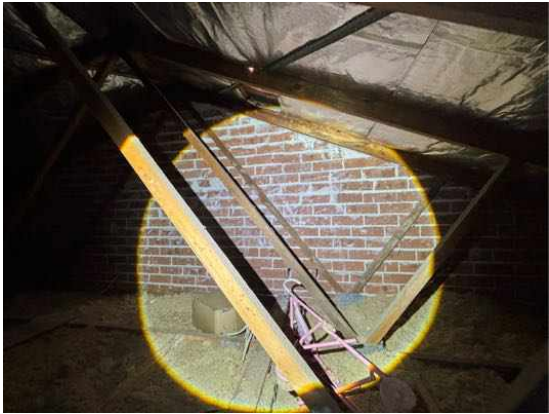
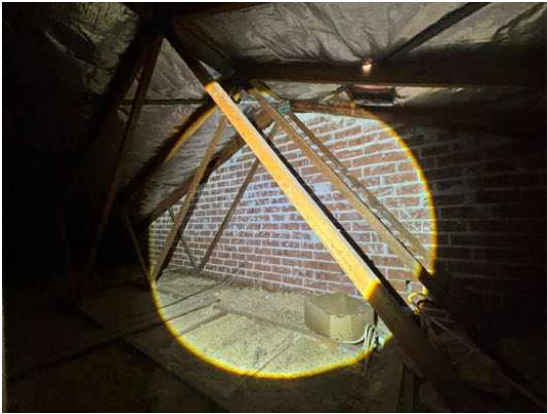
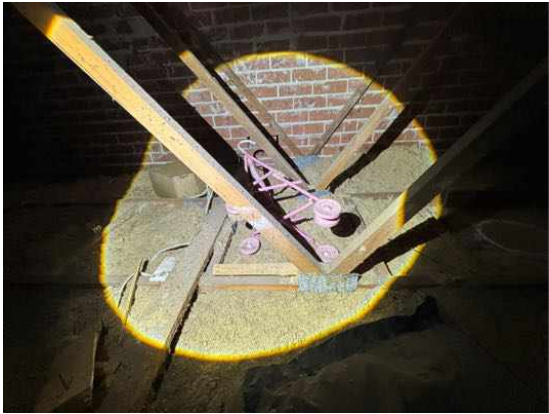
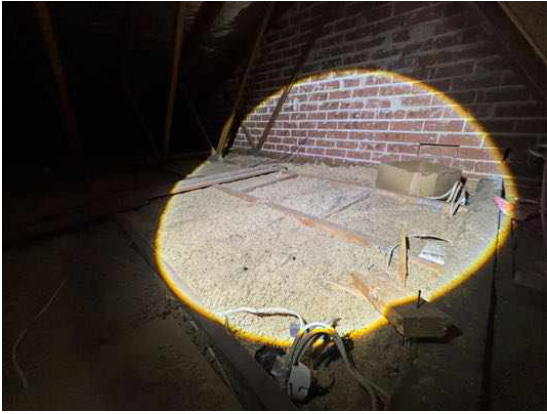
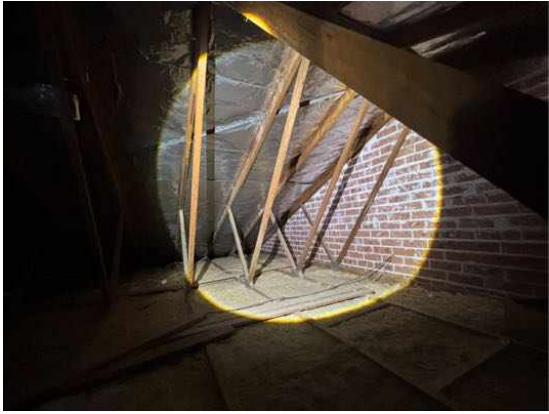
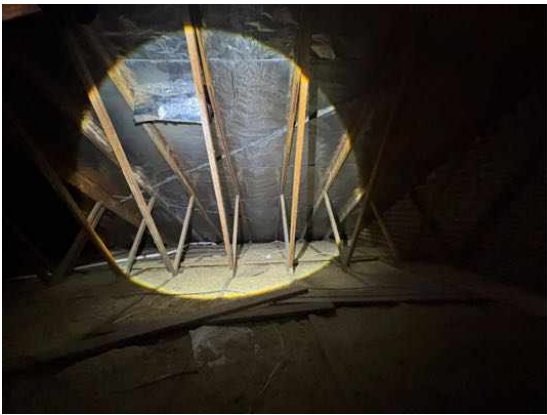
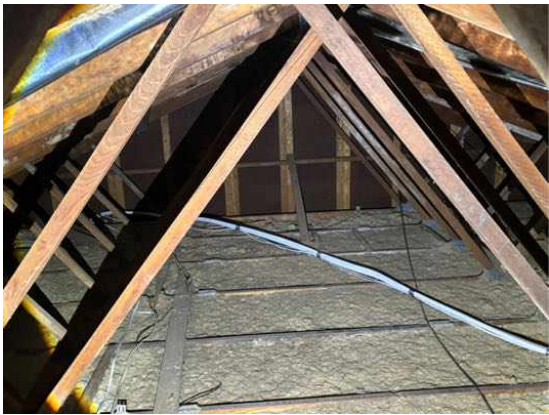
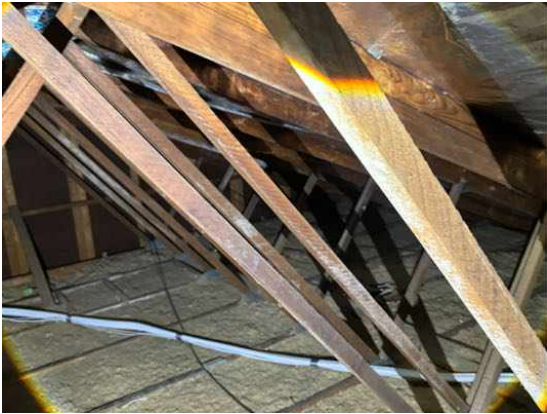
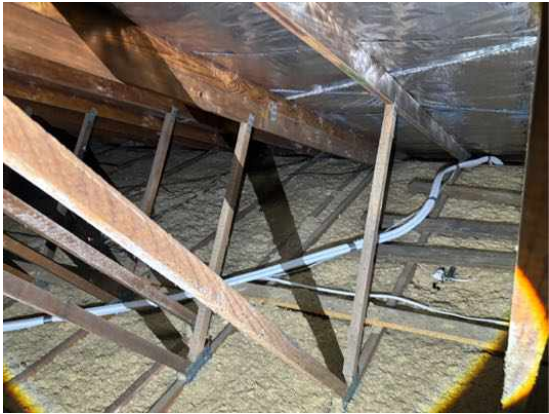
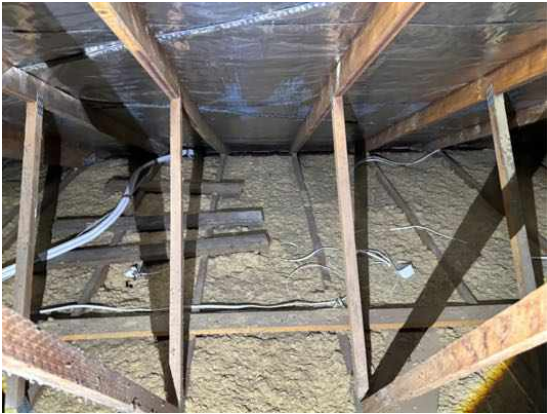
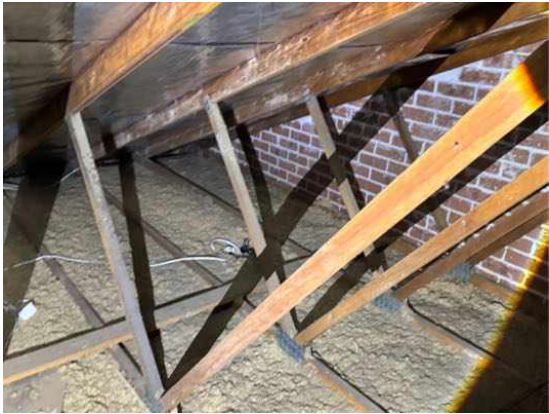
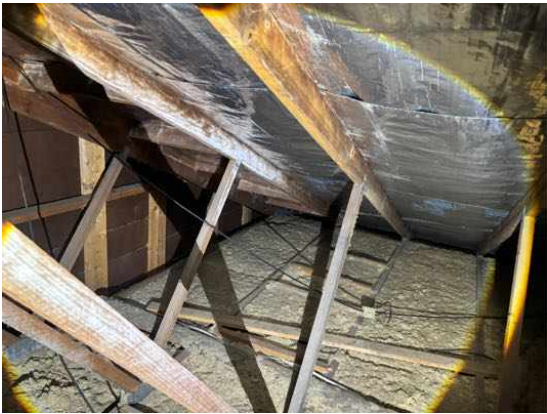
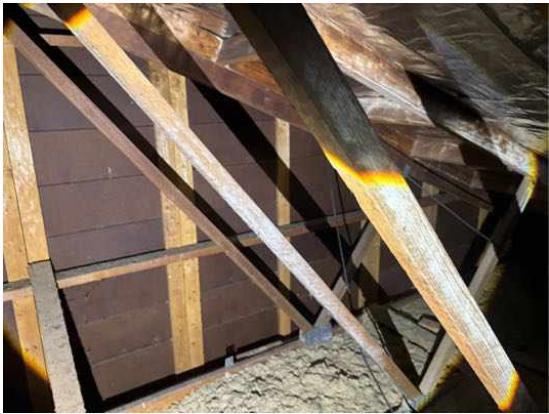
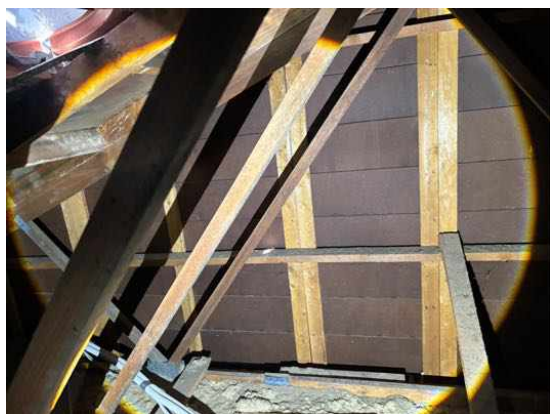
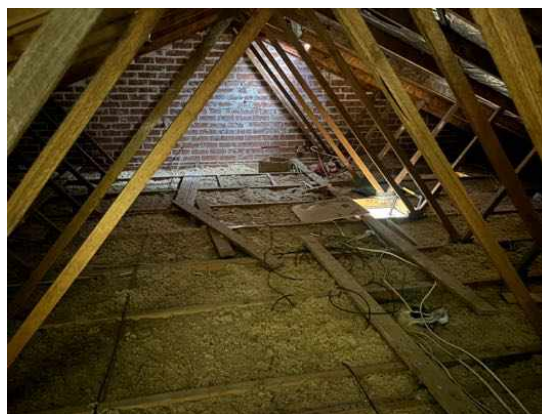
Building: Main Building
Location: Roof Void
Finding: Obstructions, Limitations, and General Roof Space Condition
Information: The photographs provided document both the general condition and the obstructions and limitations that were present in the roof cavity of the main building at the time of inspection. These obstructions—such as insulation materials, stored items, structural elements, or electrical wiring—restricted safe and adequate access to key areas within the roof space. As a result, a comprehensive inspection of all components could not be completed.

Obstructions of this nature may conceal a variety of potential defects, including damaged framing, compromised insulation, evidence of moisture ingress, pest activity, or electrical hazards. While no major issues were observed in the visible areas, the presence of these limitations means that some defects may remain undetected.

It is recommended that these barriers be removed or repositioned to facilitate full and safe access to the roof space. Once clear, a follow-up inspection should be conducted to allow for a thorough assessment of all concealed areas. This will help ensure that the condition of the roof cavity is accurately evaluated and any hidden issues are appropriately identified and addressed.

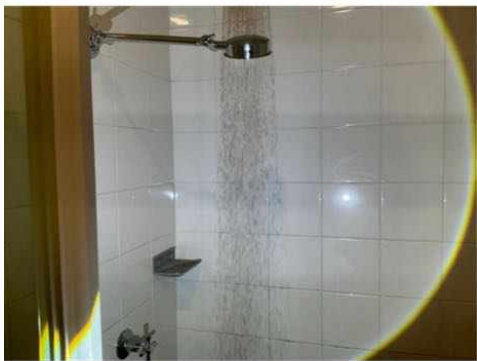
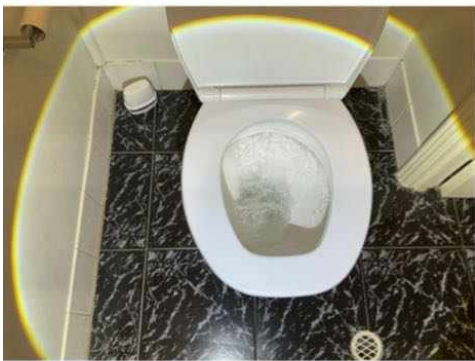
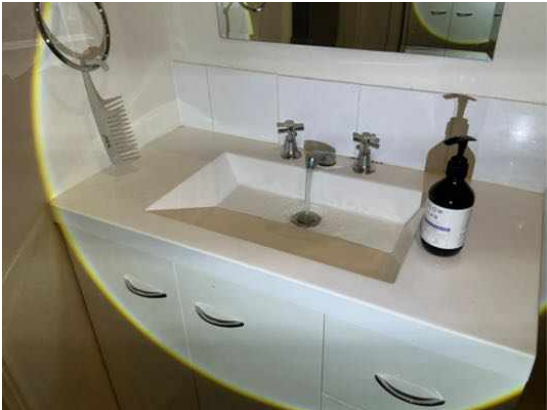
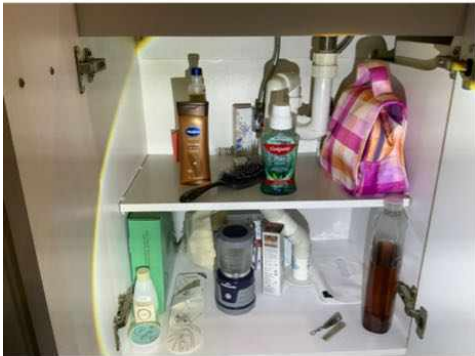
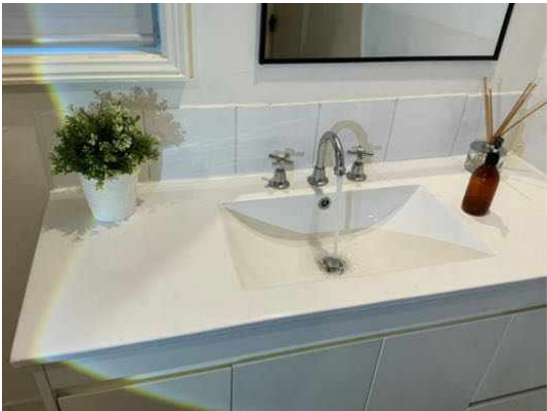
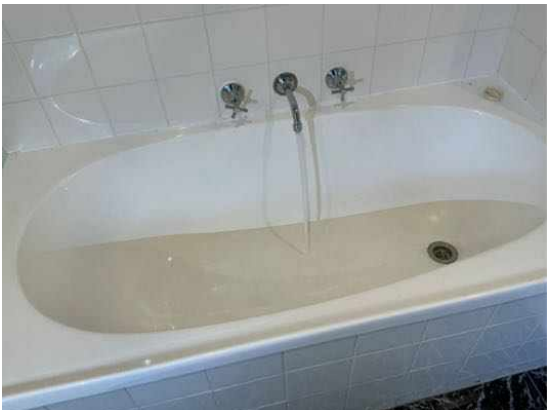
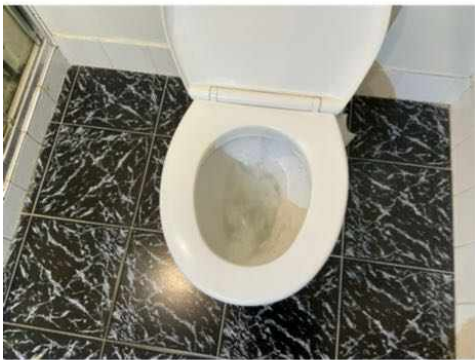
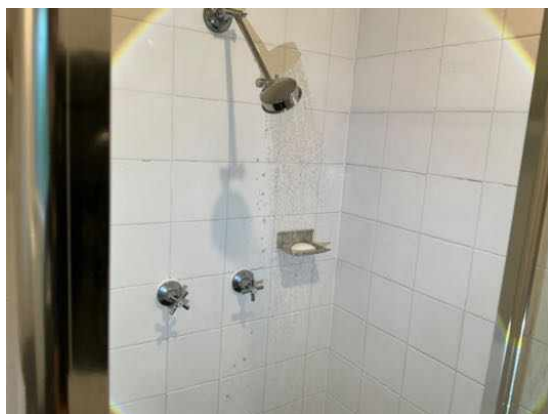
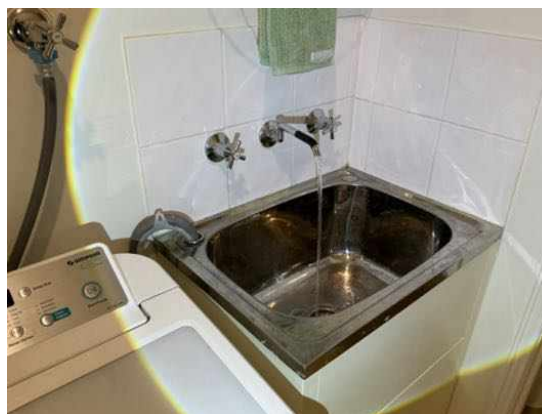
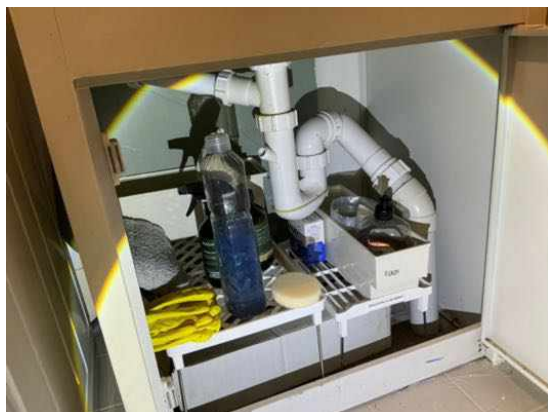
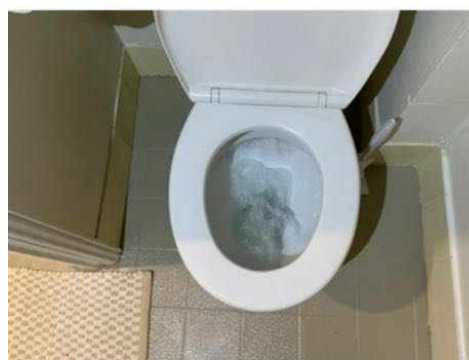
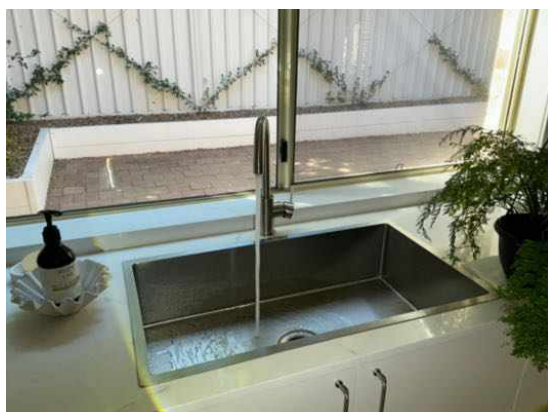
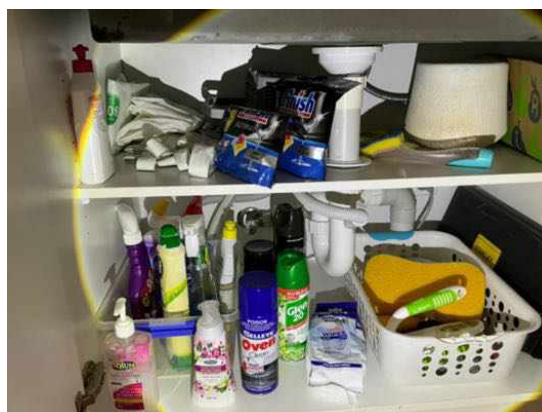
Building:	Main Building
Location:	All Areas
Finding:	FYI - Taps, Drainage & Toilets Tested and Cabinetry Obstructions
Information:	During the inspection, all accessible taps, drainage systems, and toilets were tested for water flow and drainage efficiency, and checked for any visible signs of leakage. At the time of the inspection, no issues were noted in these areas. Unless highlighted in a separate defect statement, no immediate remedial work appears necessary. Supporting images may be found in the additional photos section for reference.

It is important to note that while a visual inspection of cupboards and cabinetry beneath sinks and vanities was undertaken, stored personal items and fixtures presented obstructions that limited full visibility of the internal areas. As per standard inspection practices, inspectors are not permitted to move or disturb personal belongings during the inspection process. Therefore, only visible and accessible sections were inspected, and concealed water damage or plumbing defects may not have been detected.

Given this, a re-inspection is recommended after all obstructions have been cleared to allow for a comprehensive assessment of these areas. Regular maintenance and monitoring of plumbing and drainage systems is also advised to ensure ongoing functionality and early detection of potential issues.

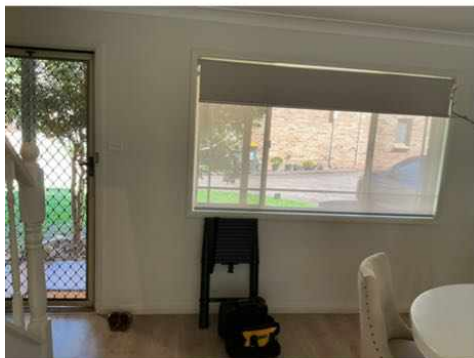
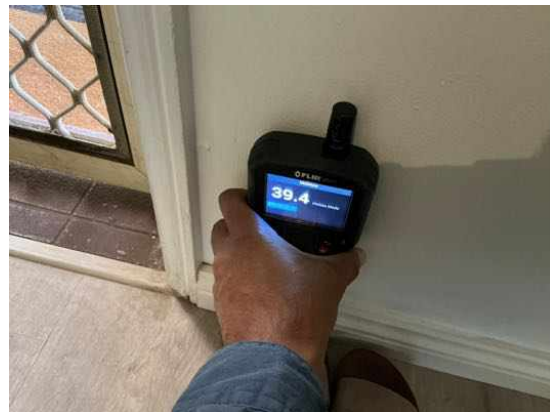
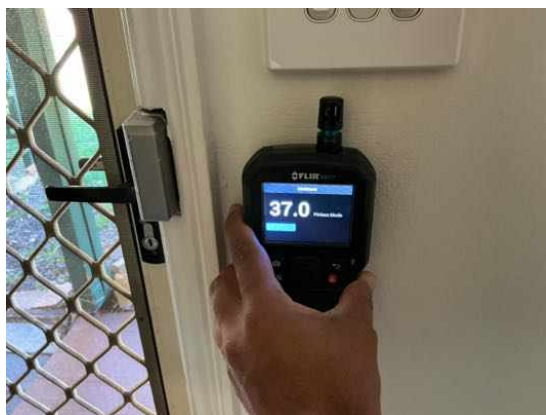
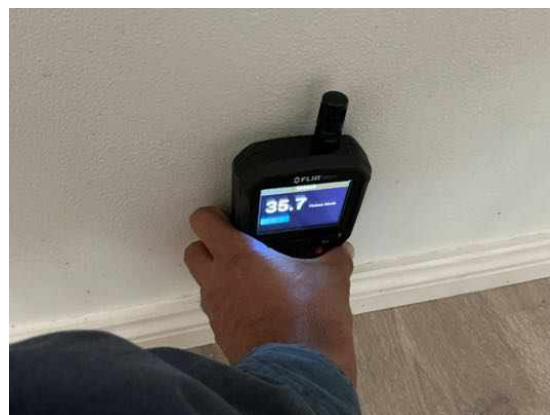
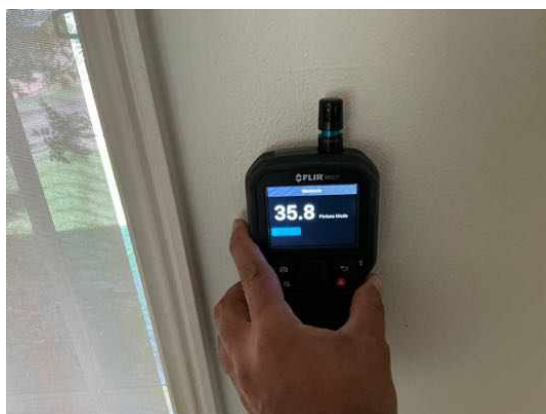
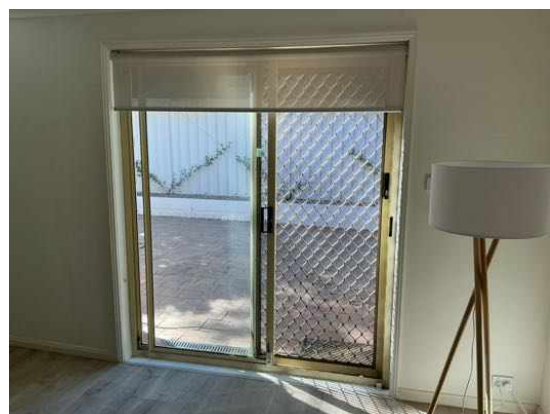
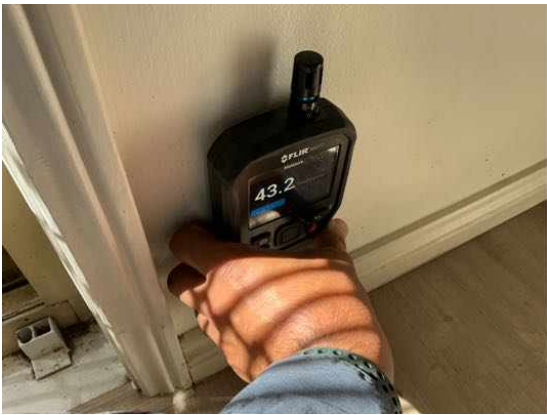
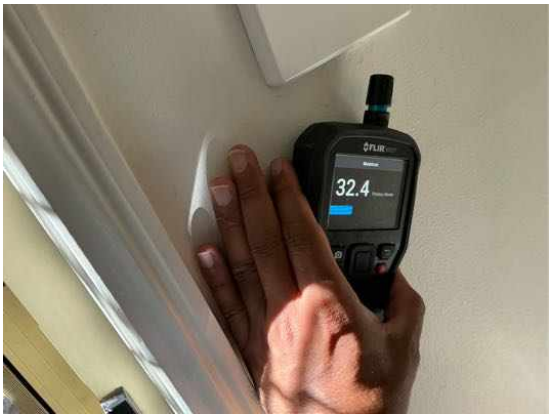
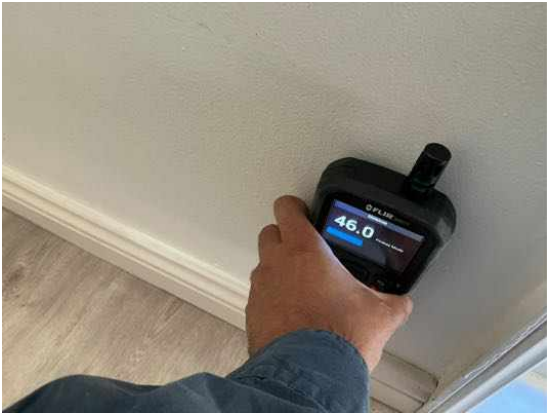
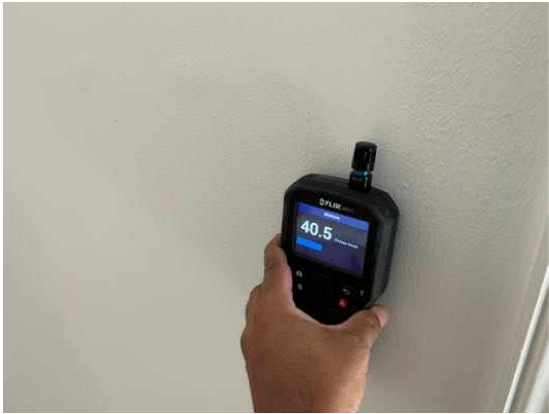
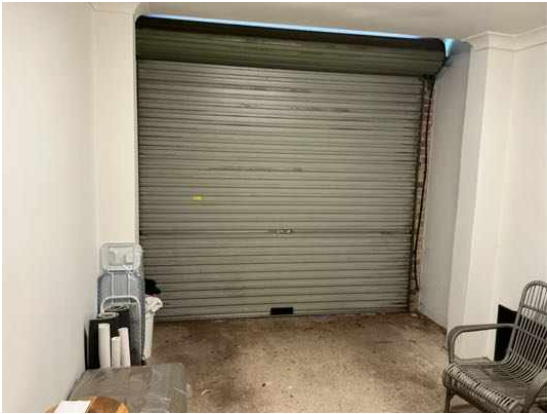
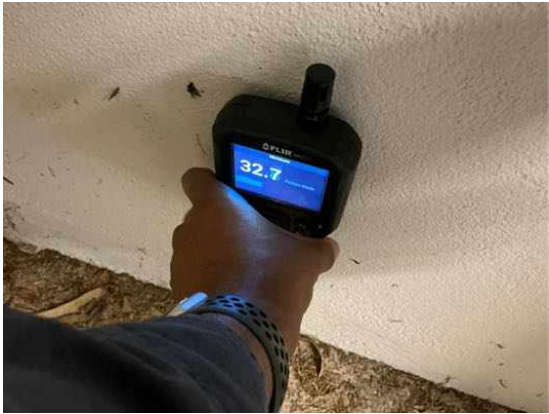
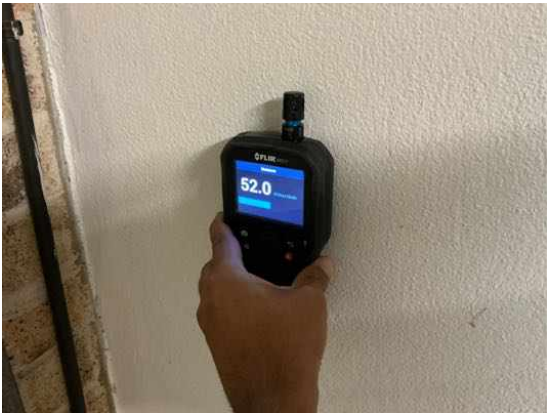
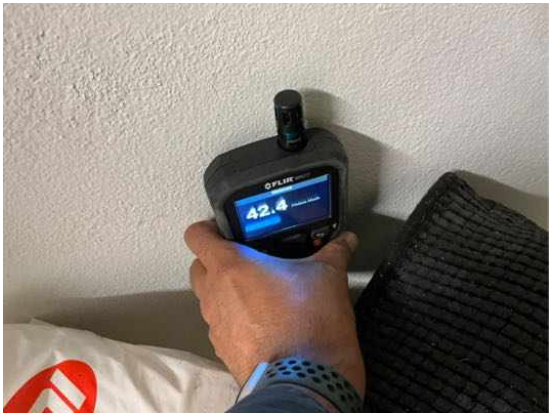
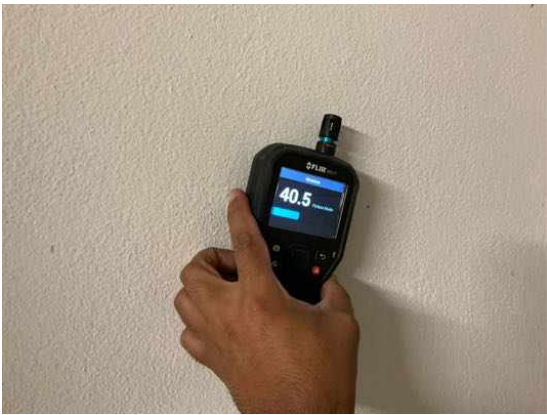
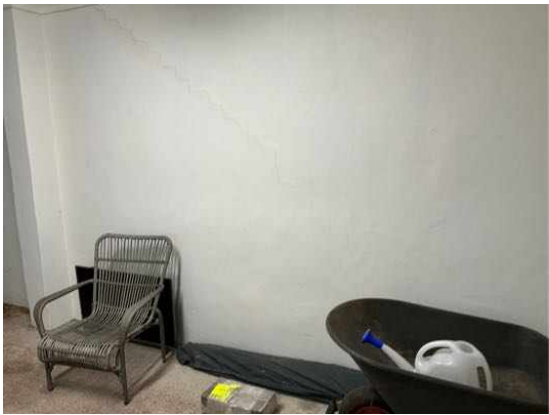
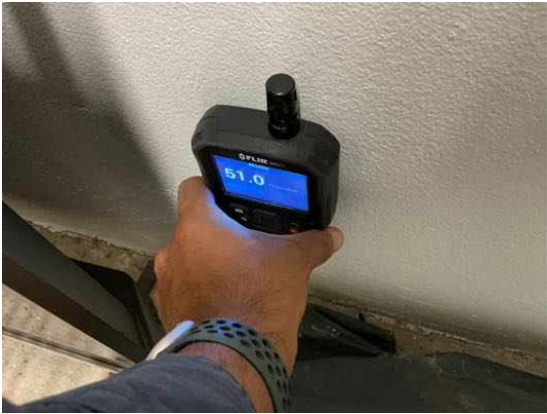
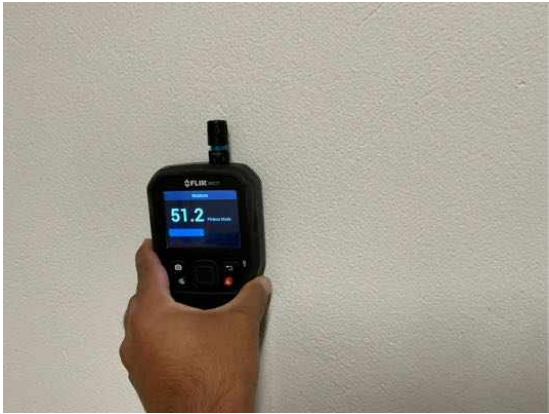
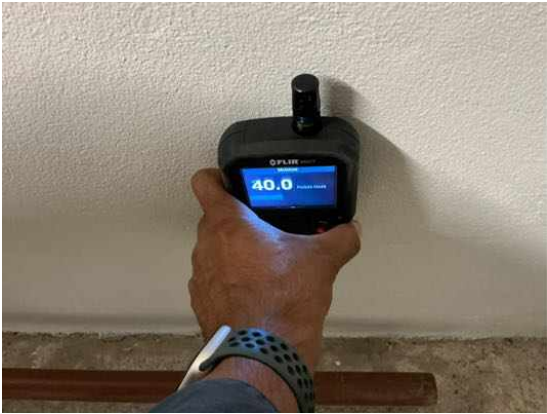
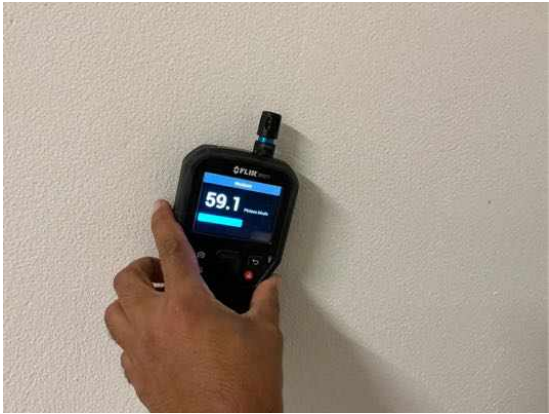
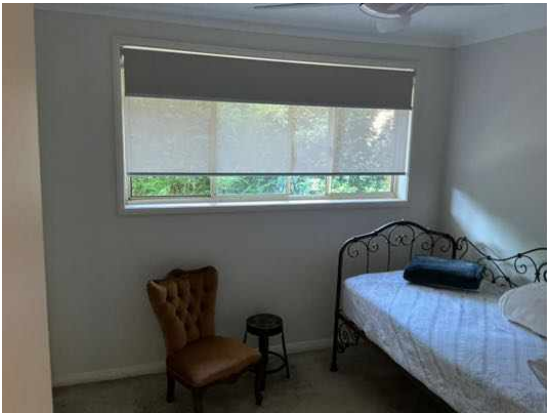
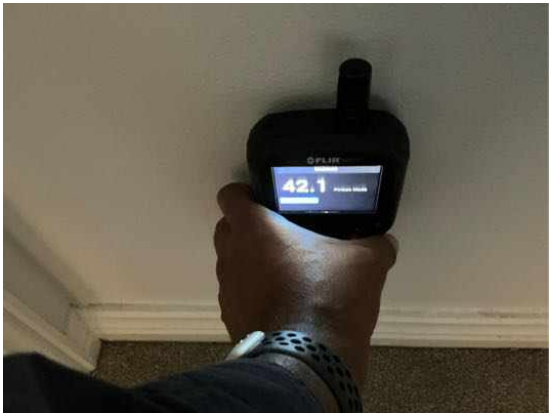
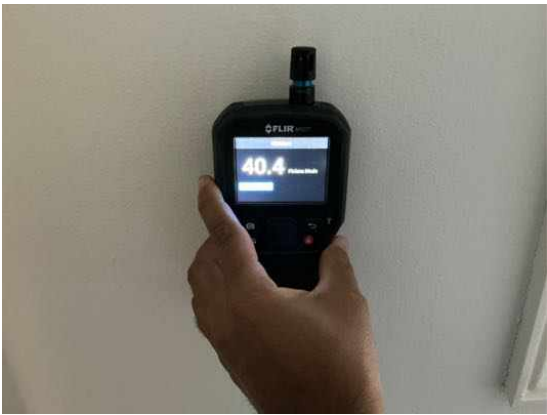
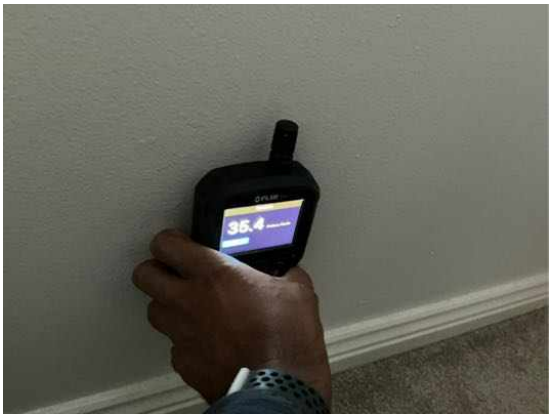
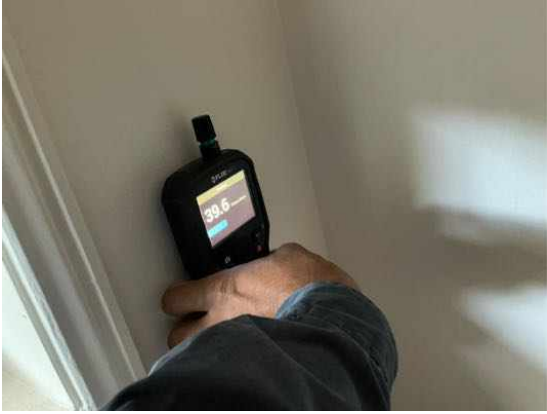
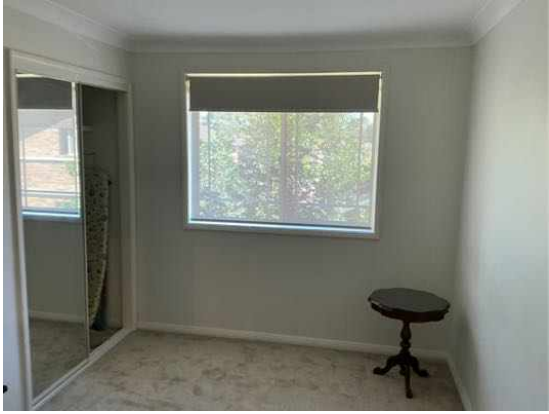
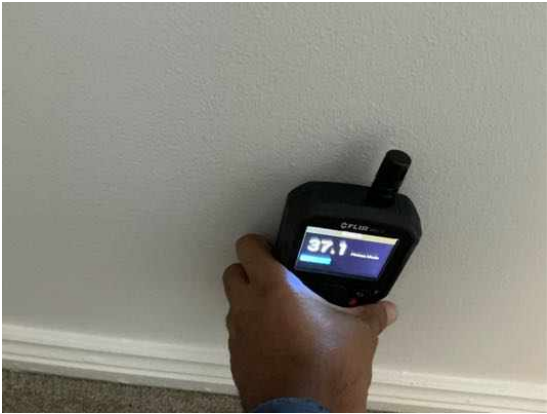
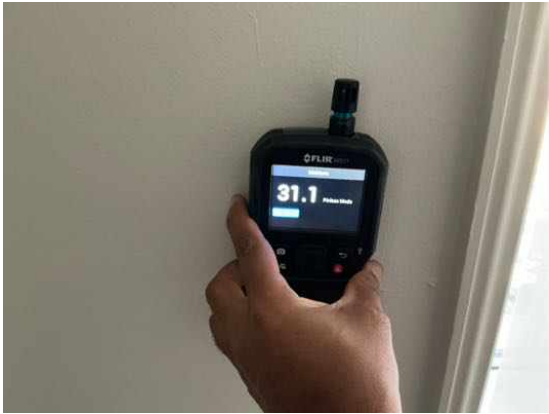
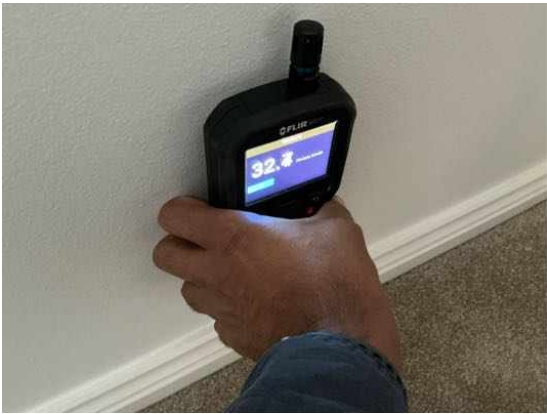
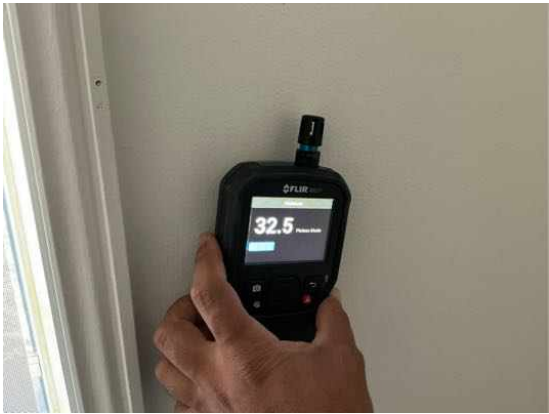
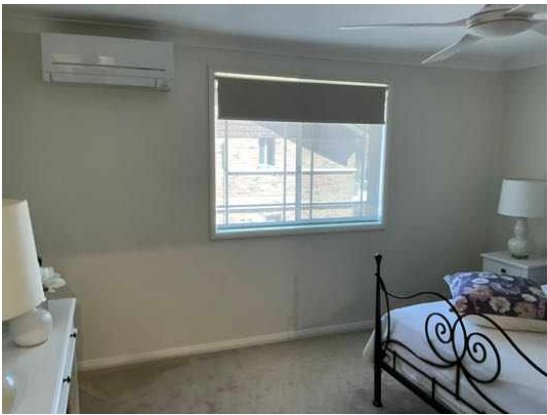
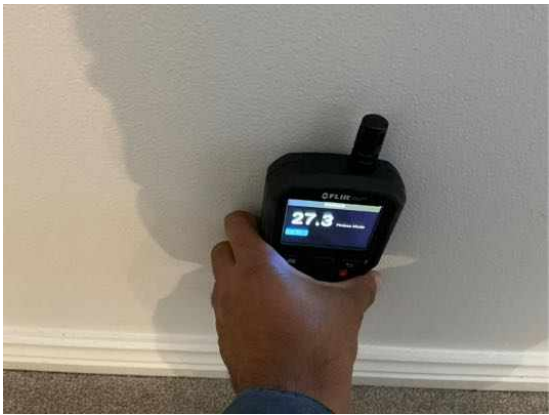
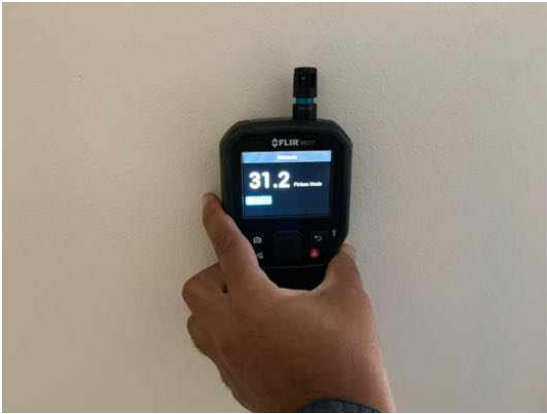
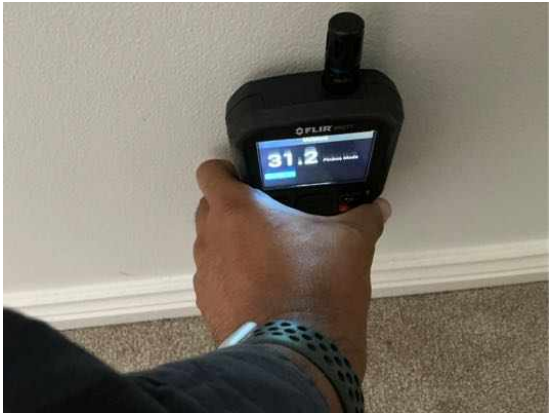
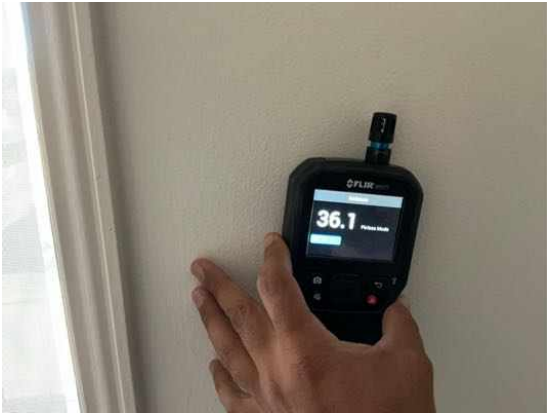
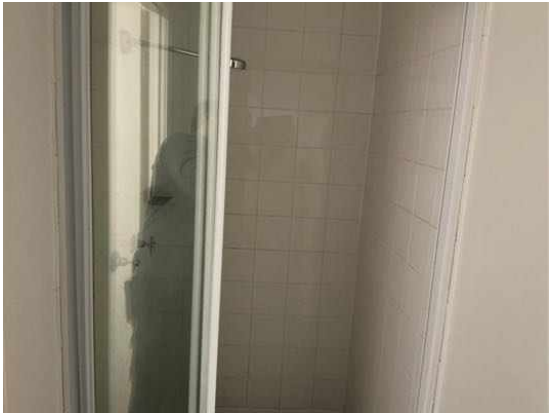
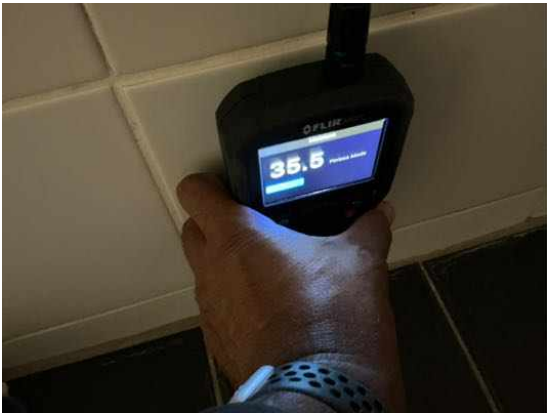
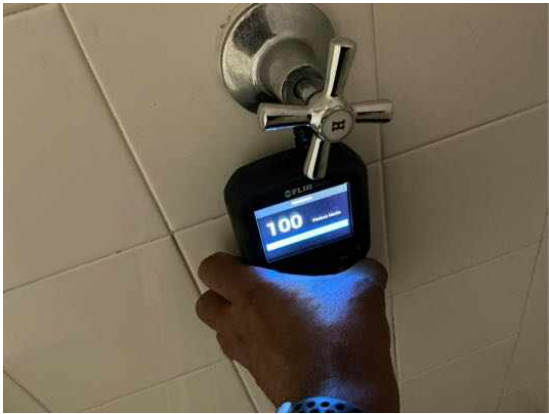
Building:	Main Building
Location:	All Areas
Finding:	Additional Photos - Moisture Meter Readings
Information:	Additional moisture meter reading photos have been provided for the property to offer further clarity on areas tested during the inspection. These photos are intended to give a visual reference for the specific locations where moisture levels were measured. These readings were taken at the time of the inspection to assess any potential moisture-related issues within the property. Any defects related to moisture that were identified during the inspection have been separately mentioned in the defect statements within the report.

It is important for the client to understand that moisture levels can fluctuate over time due to various factors, including changes in weather, humidity, and environmental conditions. While the readings reflect the property's moisture levels during the inspection, they may not represent future conditions, and increased moisture could lead to issues such as dampness, mould growth, or deterioration of building materials if left unmonitored.

For further clarification or additional information regarding the moisture readings, the client is encouraged to contact the building inspector directly. Regular monitoring of moisture-prone areas is recommended to ensure any emerging concerns are addressed promptly, particularly during wetter seasons or in high-humidity conditions.
