Building and Timber Pest Inspection Report

Inspection Date: Wed, 8 Apr 2026

Property Address: 10/10 Stanbury Pl, Quakers Hill NSW 2763,
Australia

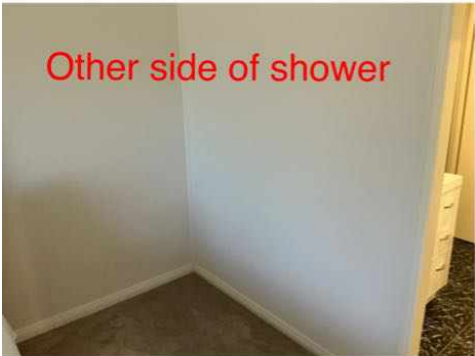
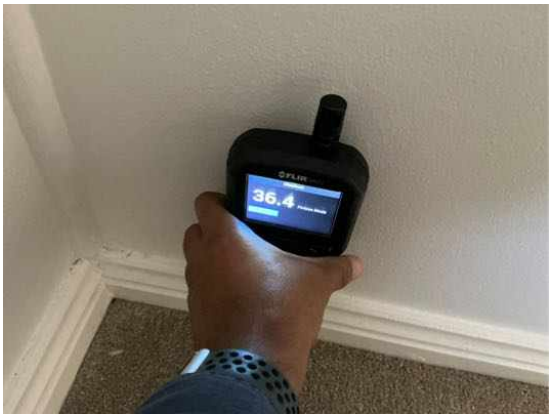
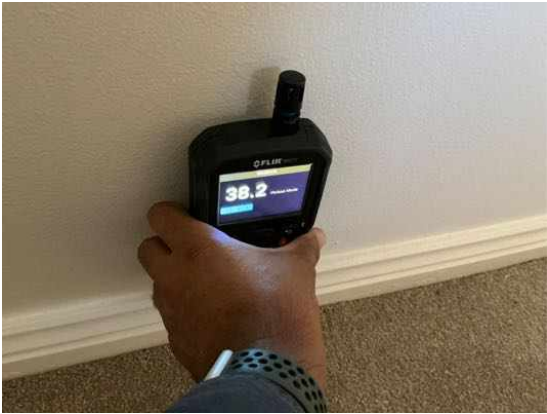
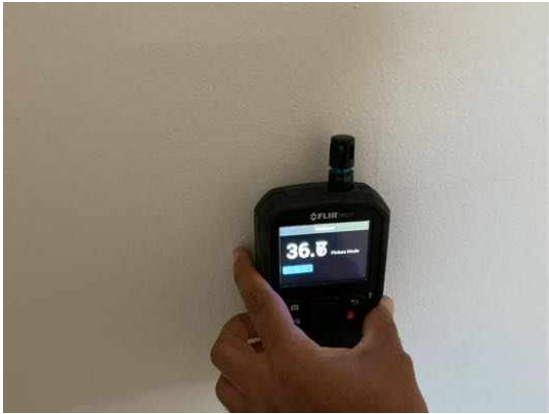
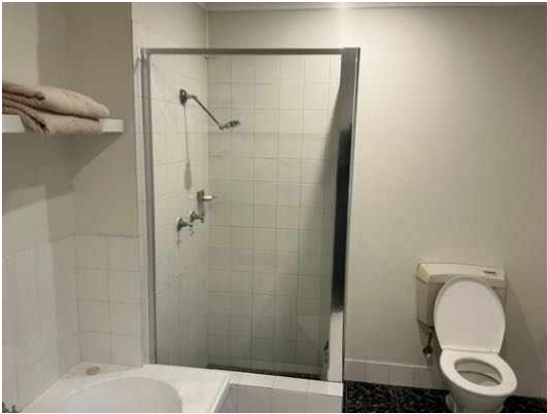
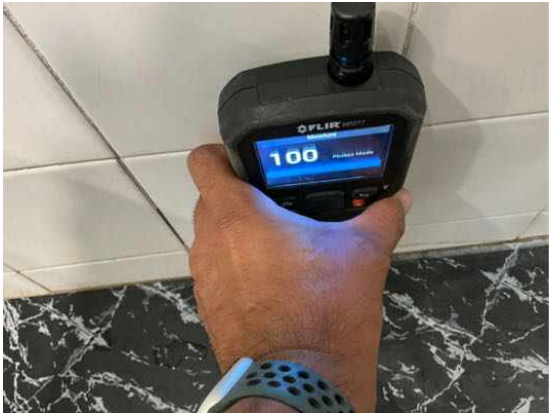
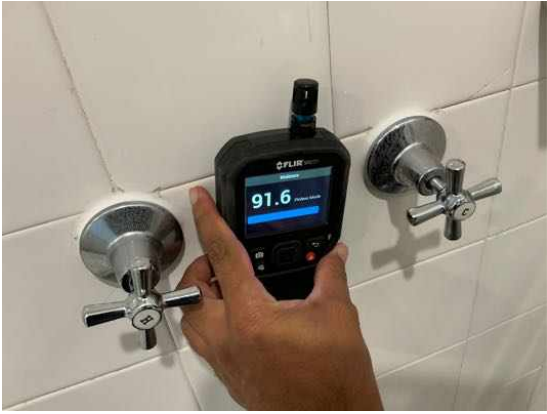
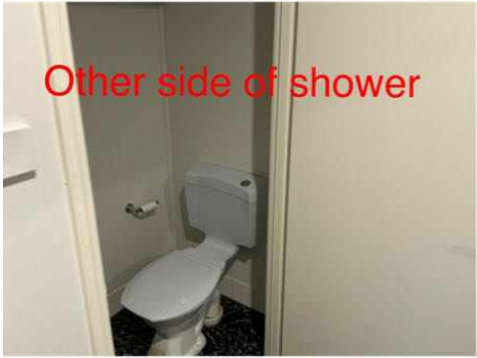
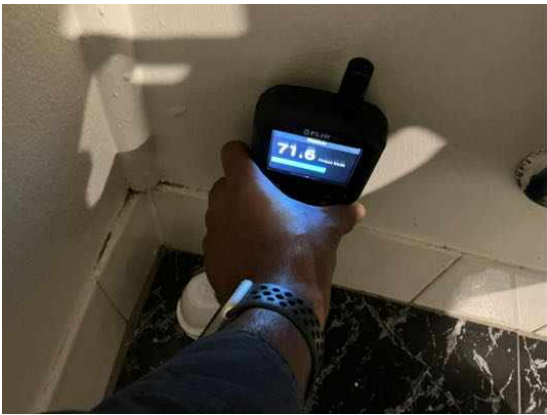
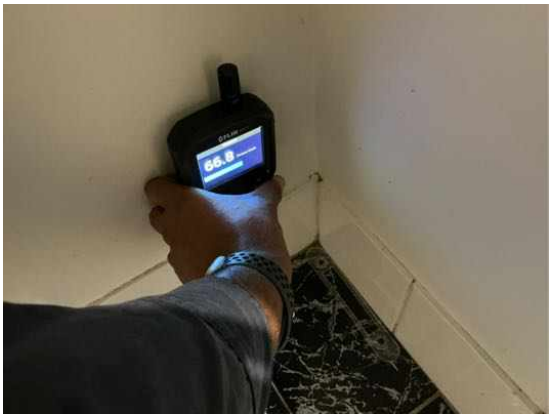
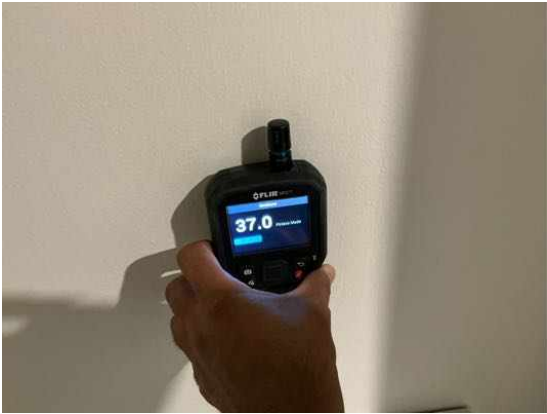
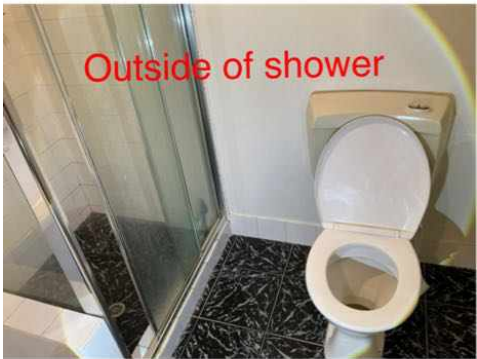
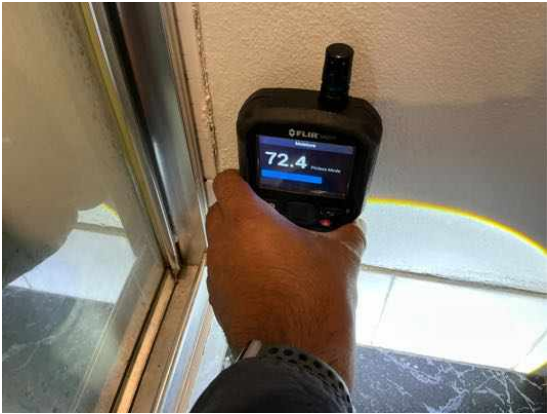
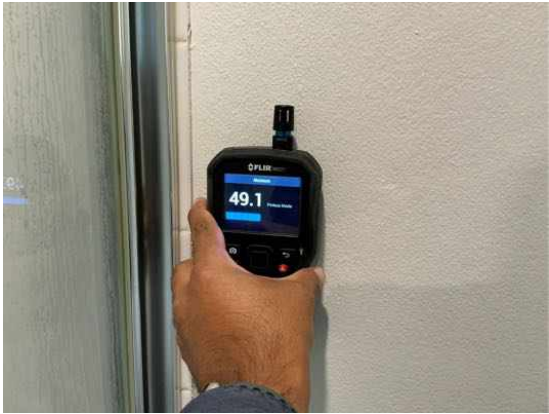
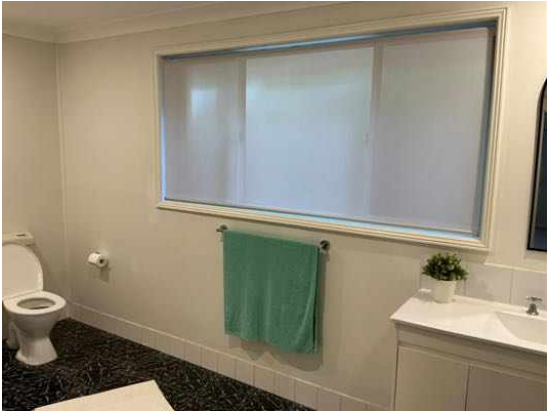
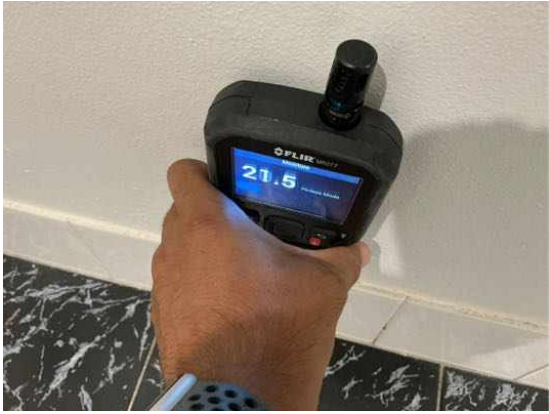
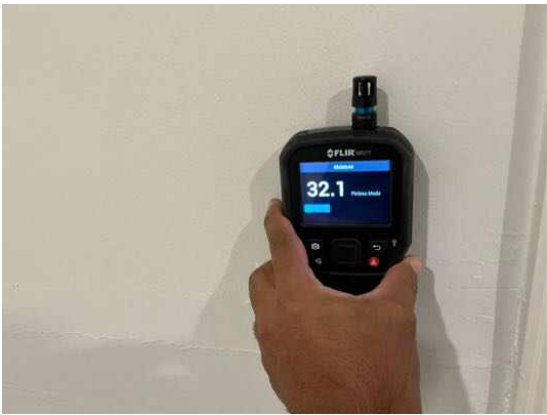
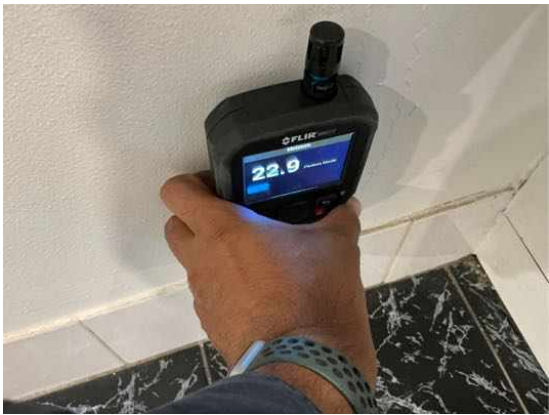
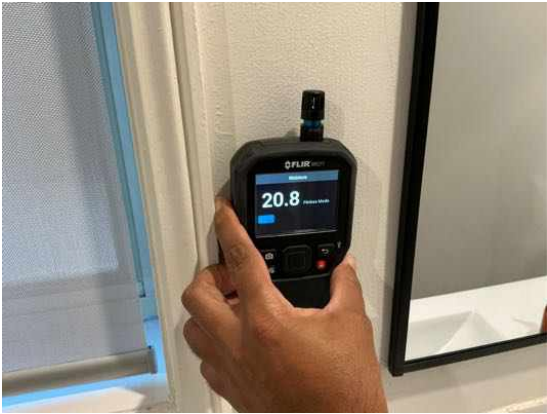
Building:	Main Building
Location:	All Areas
Finding:	Additional Photos - Moisture Meter Readings
Information:	Additional moisture meter reading photos have been provided for the property to offer further clarity on areas tested during the inspection. These photos are intended to give a visual reference for the specific locations where moisture levels were measured. These readings were taken at the time of the inspection to assess any potential moisture-related issues within the property. Any defects related to moisture that were identified during the inspection have been separately mentioned in the defect statements within the report.

It is important for the client to understand that moisture levels can fluctuate over time due to various factors, including changes in weather, humidity, and environmental conditions. While the readings reflect the property's moisture levels during the inspection, they may not represent future conditions, and increased moisture could lead to issues such as dampness, mould growth, or deterioration of building materials if left unmonitored.

For further clarification or additional information regarding the moisture readings, the client is encouraged to contact the building inspector directly. Regular monitoring of moisture-prone areas is recommended to ensure any emerging concerns are addressed promptly, particularly during wetter seasons or in high-humidity conditions.

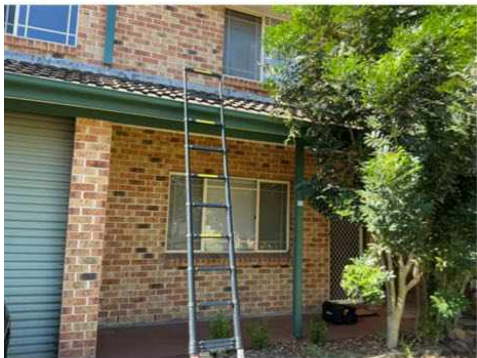
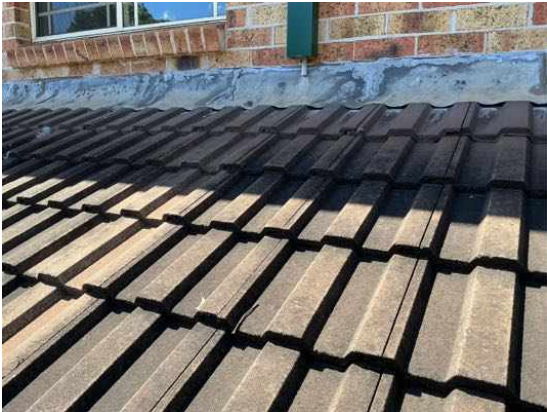
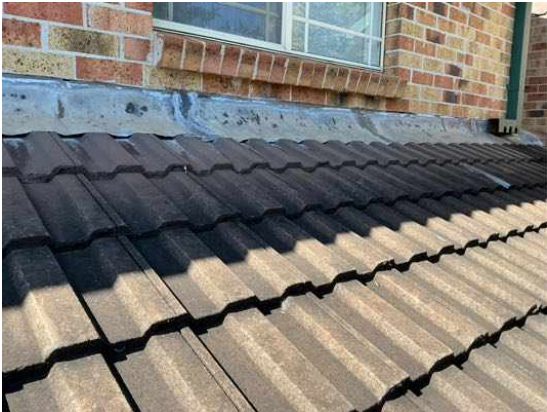
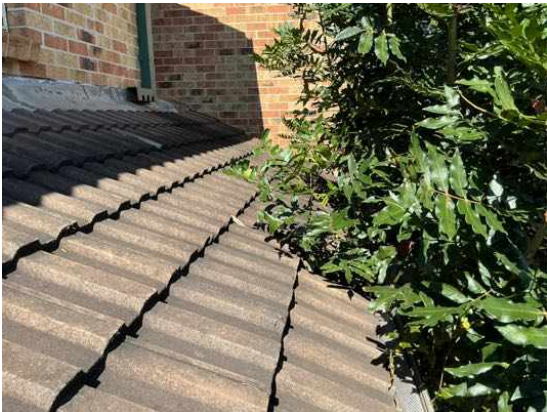
Building: Main Building
Location: Roof Exterior
Finding: Additional Roof Photos

Information: As part of the information provided, please note that the attached roof photos represent the condition of the roof at the time of inspection. These photos are for visual reference only and do not constitute a detailed roofing assessment. Any defects or issues identified with the roof are mentioned separately in the defect statements. It is strongly recommended that the client engage a qualified roofer to conduct a thorough inspection of the roof, ensuring that any potential issues, such as leaks, structural integrity, or wear and tear, are properly identified and addressed.

Additionally, the condition of the roof may change over time due to weather, natural wear, or other unforeseen factors. Regular maintenance and inspections by a licensed professional are advised to ensure the roof remains in good condition and to avoid costly repairs in the future. The information provided in these photos should be considered a snapshot of the roof's condition during the time of inspection and not a guarantee of its future performance.

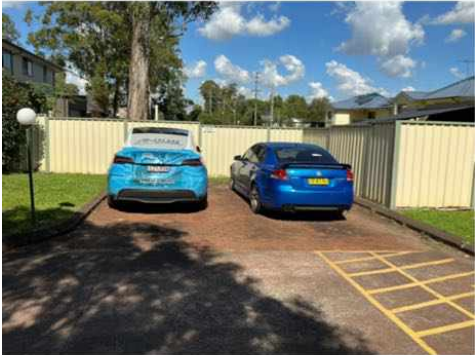
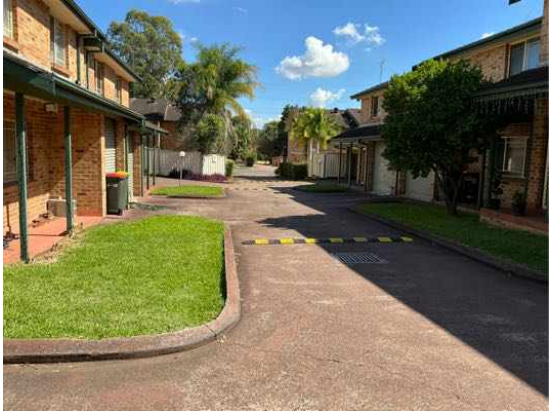
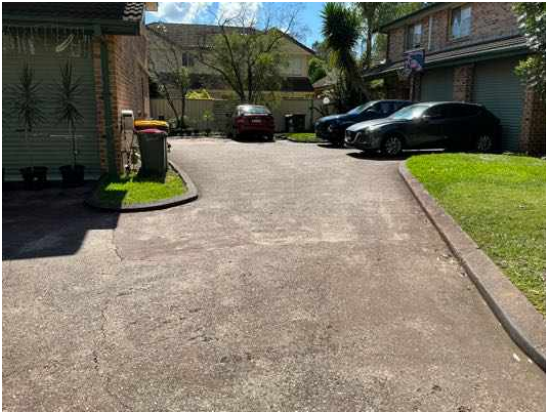
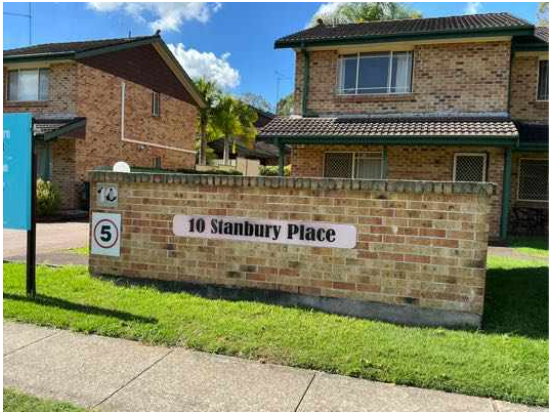
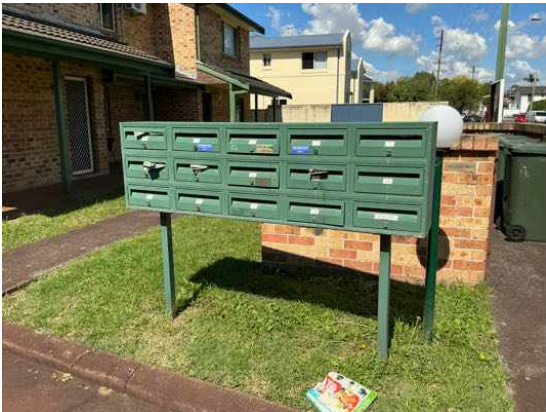
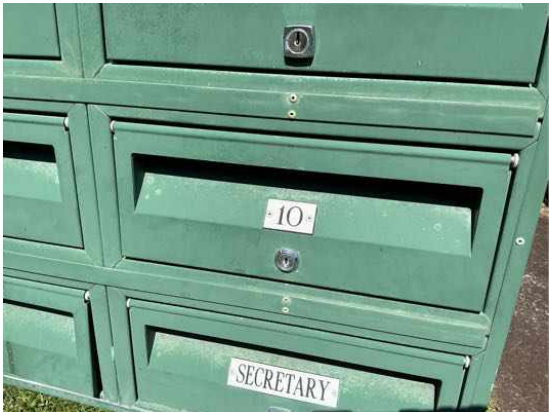
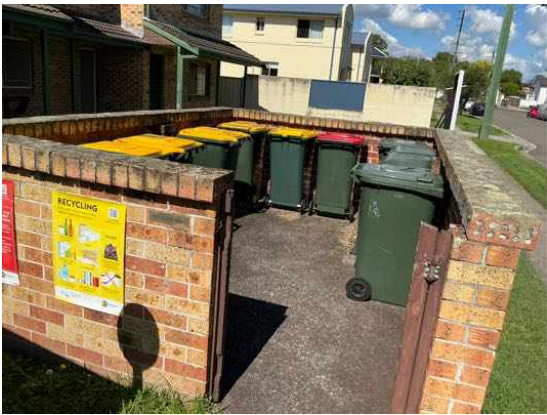
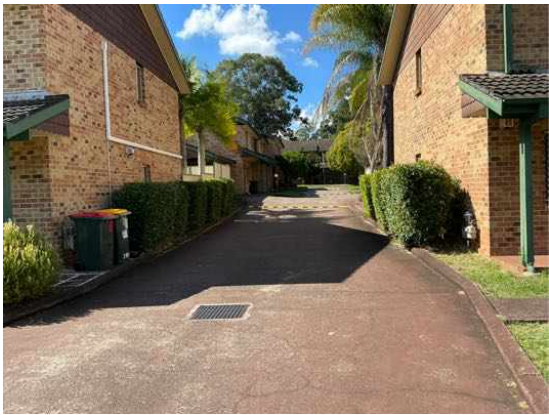
Building:	Main Building
Location:	All Areas
Finding:	Additional Photos of Common Areas
Information:	Additional photos have been provided for your general reference. These images serve as visual documentation of the current condition of the common areas within the

building complex at the time of inspection. It is recommended that the client consult with strata management regarding any necessary repairs or maintenance required throughout the complex. These photographs are intended to illustrate the present state of the common areas and should be used as a basis for discussing and prioritizing any needed remedial works with the relevant parties.

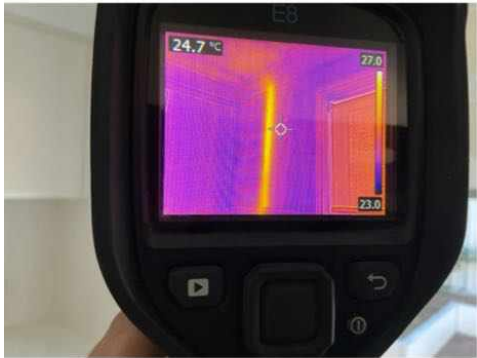
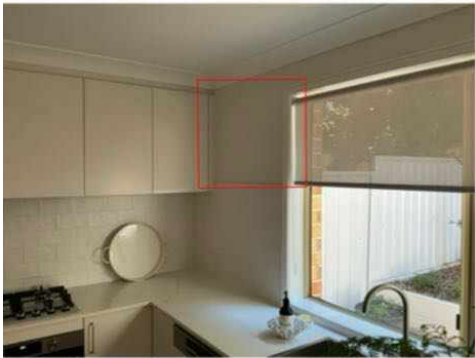
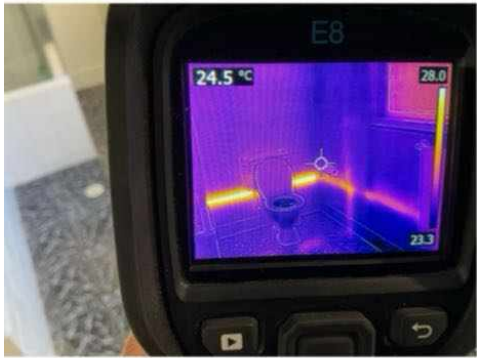
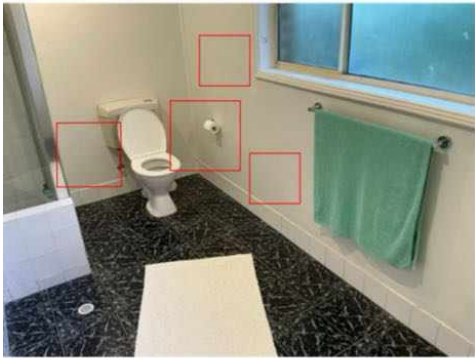
Building: Main Building
 Location: Kitchen, Upstairs Bathroom
 Finding: FYI – Hot Water Pipe Located Within Wall
 Information: At the time of inspection, a thermal camera was used and temperature variations were noted within sections of the wall, consistent with the presence of active hot water pipework concealed behind the surface.

This is provided for your information only. The client is advised to avoid drilling, nailing, or installing any fixtures in these areas, as this may result in damage to the concealed plumbing and potential water leaks.
