Building and Timber Pest Inspection Report

Inspection Date: Fri, 6 Feb 2026

Property Address: 43/10 Dural St, Hornsby NSW 2077,
Australia

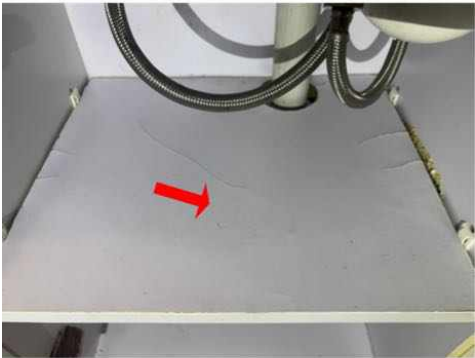
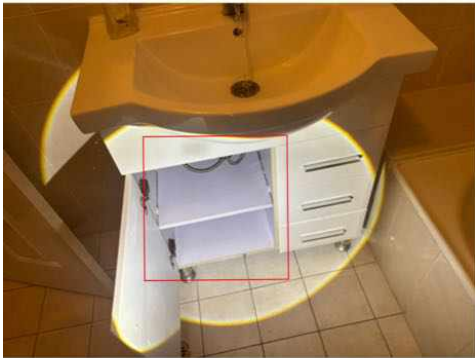
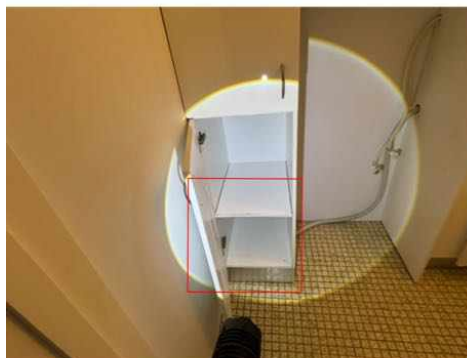
Finding 3.02

Building: Main Building
Location: Bathroom, Laundry
Finding: Cabinetry - Water Damage
Information: At the time of inspection, water-damaged cabinetry was observed, indicating previous or ongoing exposure to moisture. The affected sections show swelling, discolouration, and material deterioration, which may reduce the cabinetry’s structural integrity and appearance over time. It is recommended that the client engage a cabinet maker to repair or replace the damaged sections and inspect for any underlying leaks or moisture sources to prevent recurrence.

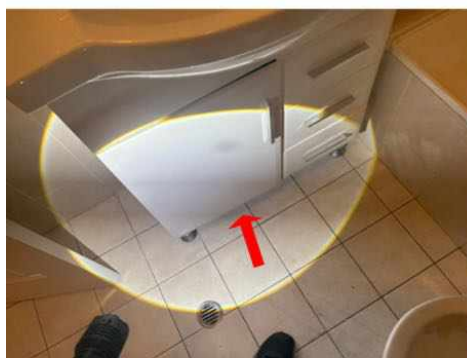
Finding 3.03

Finding: Sealant/Grouting - Missing or Damaged

Information: At the time of inspection, areas of missing and/or deteriorated sealant and grout were noted in this area. This condition can allow water to penetrate behind finishes, which may lead to moisture ingress, deterioration of waterproofing membranes, mould growth, and potential leaks into adjoining areas over time. If left unaddressed, this may result in costly repairs and hidden water damage.

It is recommended that a licensed plumber (or suitably qualified tradesperson experienced in wet area sealing) be engaged to assess the affected areas and reinstate compliant waterproof sealant and grout as required, ensuring all junctions are properly sealed to prevent further water ingress.

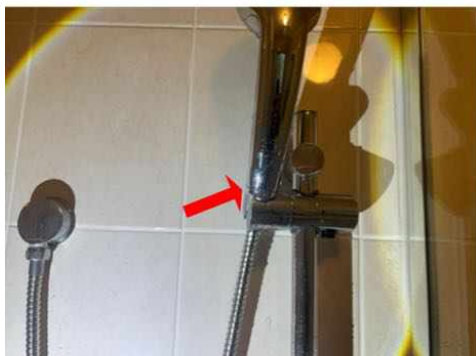
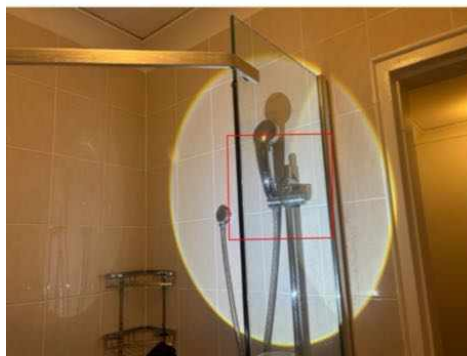
Finding 3.04

Finding: Shower Head - Leaking

Information: Showerhead was found to be leaking at the time of inspection. This is a common defect.

A leaking shower head could be due to issues like a worn-out washer, a loose connection, a damaged O-ring, or mineral deposits blocking the flow. Inspecting and replacing any damaged components or tightening connections might help resolve the leakage.

A qualified plumber should be engaged to rectify the situation as soon as possible.

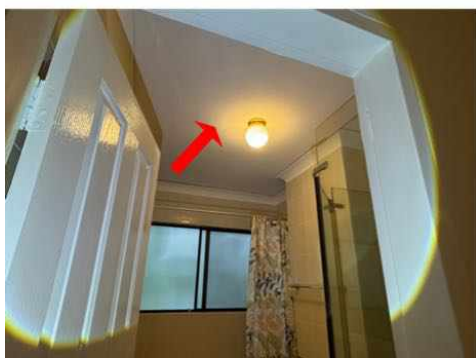
Finding 3.05

Building:	Main Building
Location:	Bathroom
Finding:	Exhaust Fan Missing - Bathroom
Information:	At the time of inspection, an exhaust fan was found to be missing in the bathroom.

Adequate ventilation is essential in wet areas to prevent moisture build-up, which can lead to mould growth, dampness, and potential damage to fixtures and finishes.

It is recommended that a licensed electrician be engaged to install a compliant exhaust fan to improve air circulation and maintain healthy indoor air quality.

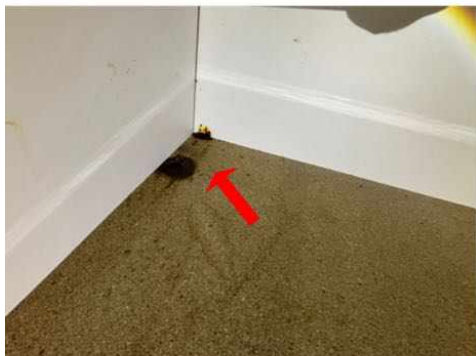
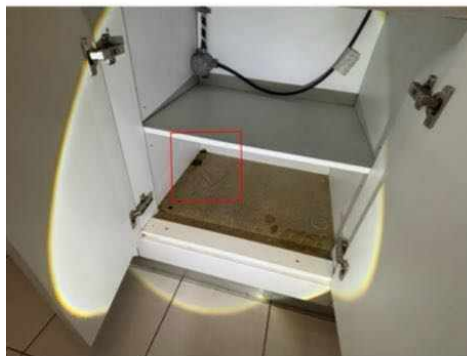
Finding 3.06

Location: Kitchen
 Finding: Kitchen Cabinets - Wear & Tear
 Information: At the time of inspection, wear and tear was noted to the internal surfaces of the kitchen cabinets, including staining, scuffing, and deterioration to the cabinet base panels.

If the client is seeking an improved finish or to prevent further deterioration, a cabinet maker or handyman can be engaged to repair, reseal, or replace the affected cabinet base panels as necessary.

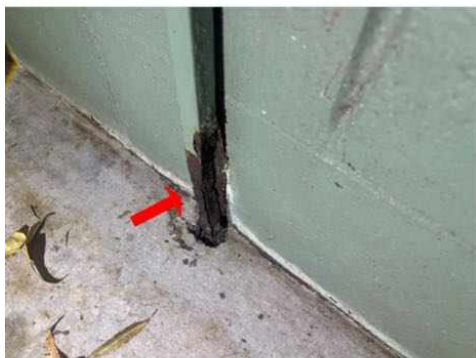
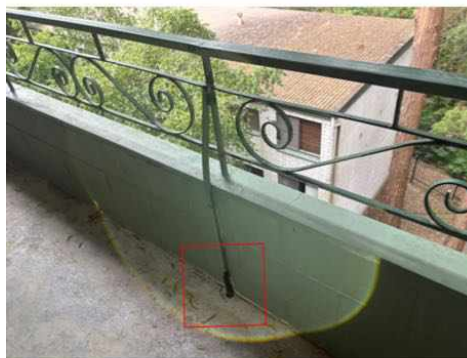
Finding 3.07

Building: Main Building
 Location: Balcony
 Finding: Building element - Rusted or corroded
 Information: This building element shows evidence of rusting and corrosion, which is likely to have developed as a result of excessive exposure to moisture and or inadequate coatings.

As surface rust provides no protection to the underlying iron, the deteriorating condition is likely to worsen if not addressed in the short-term future.

Where possible, the use of galvanized (treated) metals or aluminium coated metals aid in rust prevention, as does regular general maintenance. Rust formation can be controlled with coatings, such as paint, that isolate the iron from the environment.

Rusting and corrosion should be managed by ideally removing or limiting the affected surface from exposure to moisture. A registered builder may be appointed to replace any building elements that have been severely affected by rust or water damage.

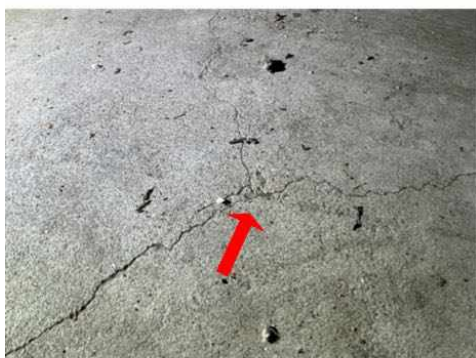
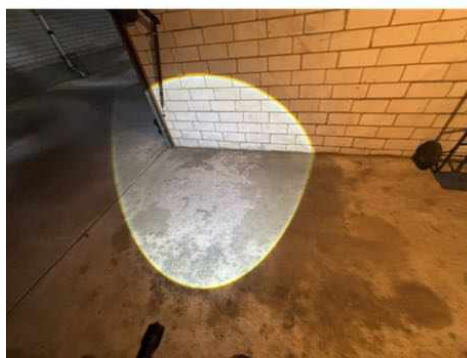
Finding 3.08

Building: Main Building
 Location: Garage
 Finding: Crack in concrete slab - Category 1
 Information: A crack coded as Category 1 was identified in the slab. A Category 1 crack is described as a fine but noticeable crack, with the slab at an otherwise reasonable level.

To be considered Category 1, the approximate width of the crack is less than 1.0mm, or a less than 10mm change in offset when a 3m straight edge is placed over the defect.

Category 1 cracks should be monitored for a period of 12 months. At the end of the monitoring period, identified cracks that are rated greater than Category 2 are considered defects, and require rectification.

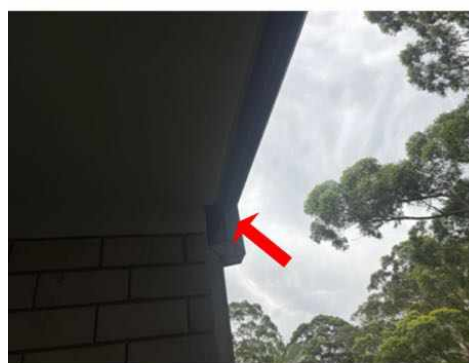
Finding 3.09

Building: Main Building
 Location: Balcony
 Finding: Downpipe(s)/Gutter(s) - Corroded/Rusted
 Information: At the time of inspection, sections of the gutters and downpipes were observed to be

rusted and showing signs of corrosion. This deterioration is likely the result of prolonged exposure to moisture, debris build-up, and standing water, which can prevent proper drainage and accelerate metal decay. Over time, corrosion can lead to leaks, restricted water flow, and eventual failure of the stormwater drainage system, potentially allowing water to overflow and impact the building structure.

As gutters and downpipes typically form part of the common property, it is recommended that the client consult with the strata manager or owners corporation to confirm responsibility and arrange for inspection, repair, or replacement of the affected sections by an appropriately licensed contractor. Ongoing maintenance, including regular cleaning and ensuring adequate fall, is also advised to reduce the risk of further corrosion.

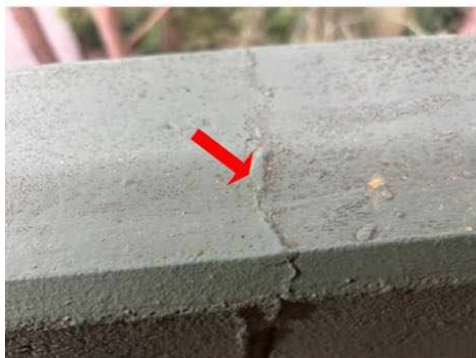
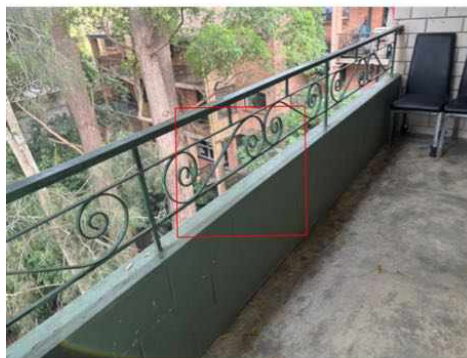
Finding 3.10

Building:	Main Building
Location:	Balcony
Finding:	Minor Cracking - Balcony
Information:	At the time of inspection, minor hairline cracking was observed to sections of the balcony surfaces. These cracks appear consistent with age-related movement and normal wear and tear and are not considered unusual for this type of construction. No signs of significant structural movement or active deterioration were evident at the time of inspection.

It is recommended that the client monitor the affected areas for any increase in cracking, widening, or associated signs such as water ingress or spalling. If further cracking or deterioration is observed in the future, the matter should be reported to the strata manager or owners corporation for assessment and appropriate action, as balconies generally form part of the common property. At this stage, no further action is required.

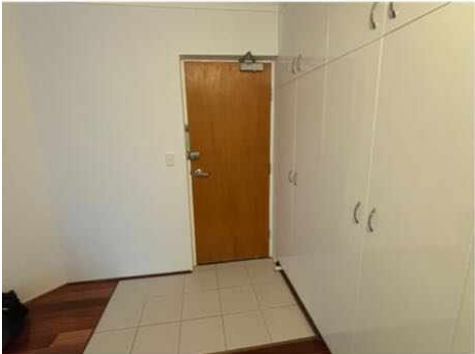
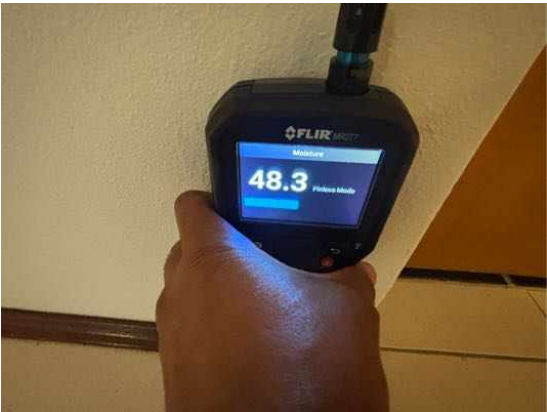
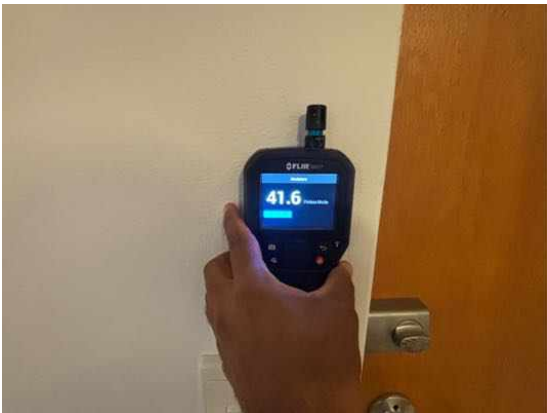
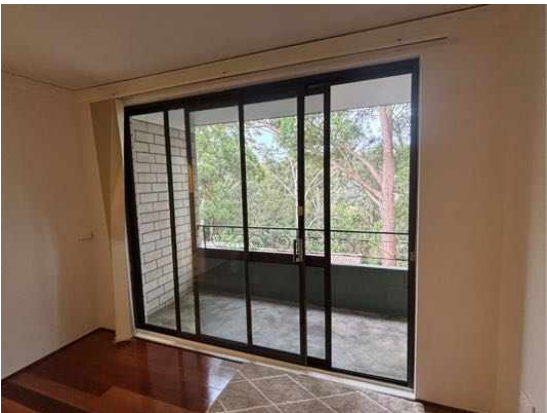
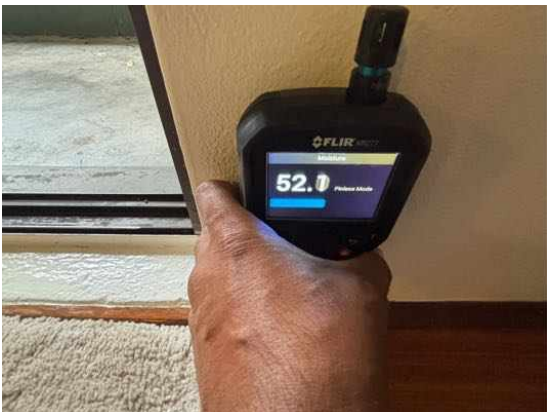
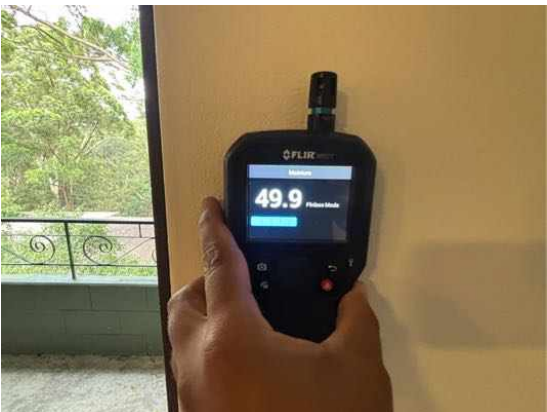
Building:	Main Building
Location:	All Areas
Finding:	Additional Photos - Moisture Meter Readings
Information:	<p>Additional moisture meter reading photos have been provided for the property to offer further clarity on areas tested during the inspection. These photos are intended to give a visual reference for the specific locations where moisture levels were measured.</p> <p>These readings were taken at the time of the inspection to assess any potential moisture-related issues within the property. Any defects related to moisture that were identified during the inspection have been separately mentioned in the defect statements within the report.</p>

For further clarification or additional information regarding the moisture readings, the client is encouraged to contact the building inspector directly. Regular monitoring of moisture-prone areas is recommended to ensure any emerging concerns are addressed promptly, particularly during wetter seasons or in high-humidity conditions.

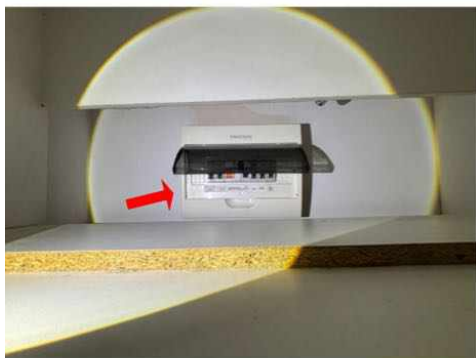
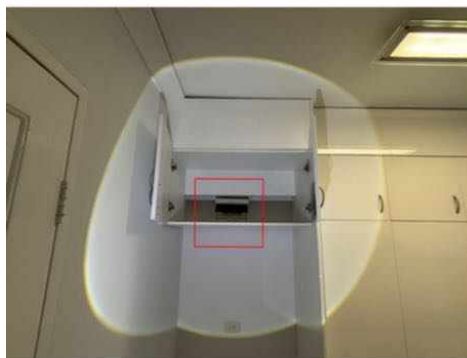
Finding: Electrical Meter Box

Information: Electrical meter box is located in kitchen cabinets

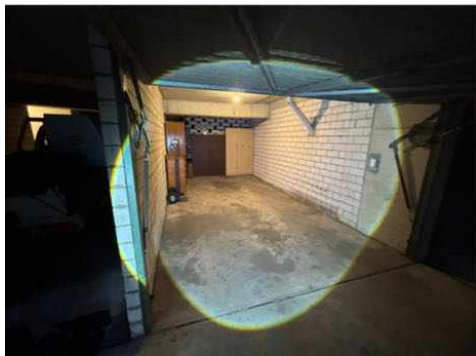
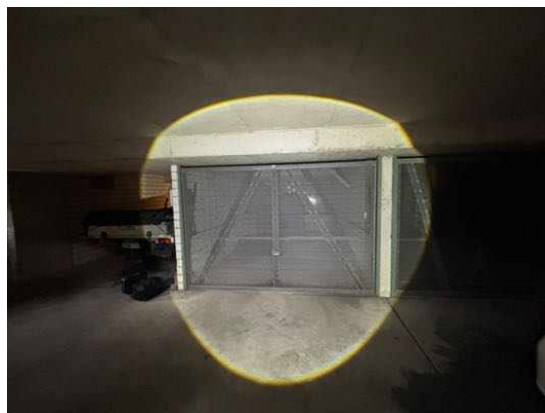
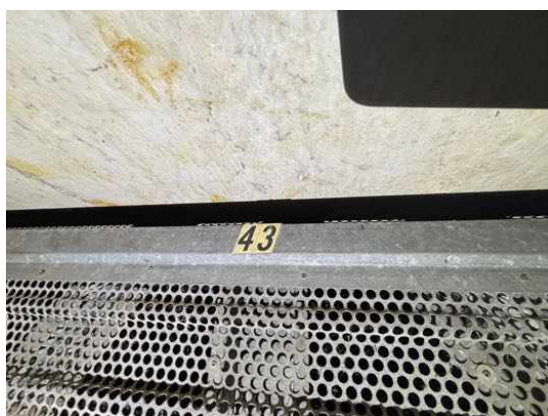
Information: The accompanying photos are provided for your general reference, showcasing the current condition of the car parking spots and storage rooms as observed at the time of inspection. It is important to note that these images are meant to serve as a visual snapshot of the property's features at the time of the assessment. However, the client is strongly advised to confirm all allocations, such as car parking spots, storage rooms, and any associated rights or access, within the terms of the contract. Verifying

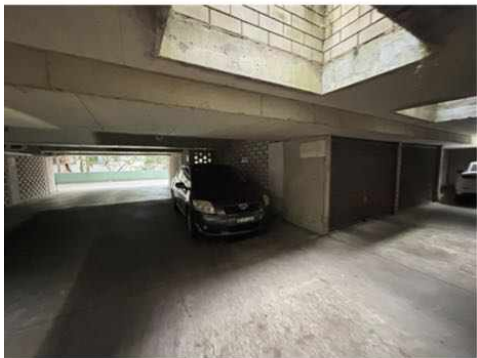
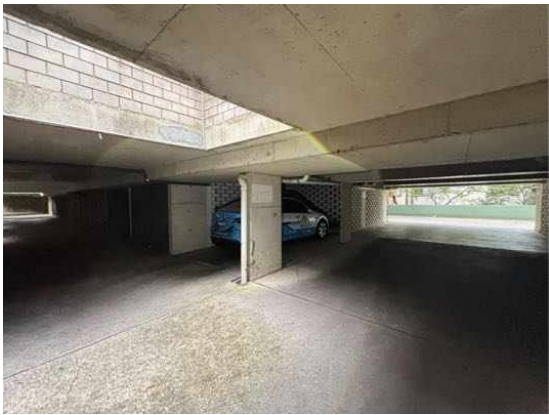
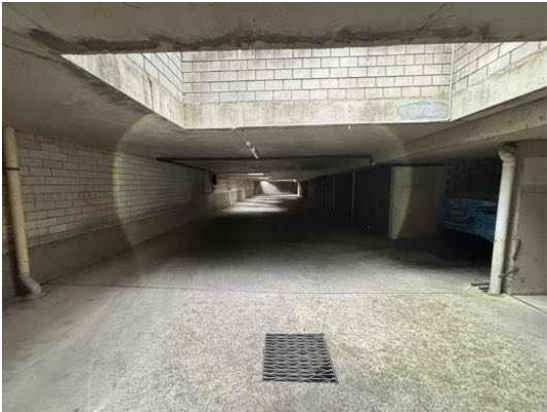
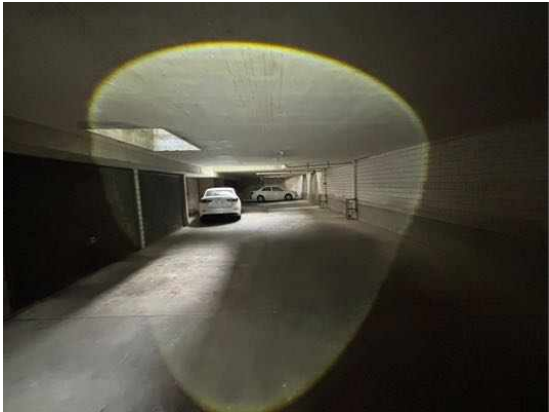
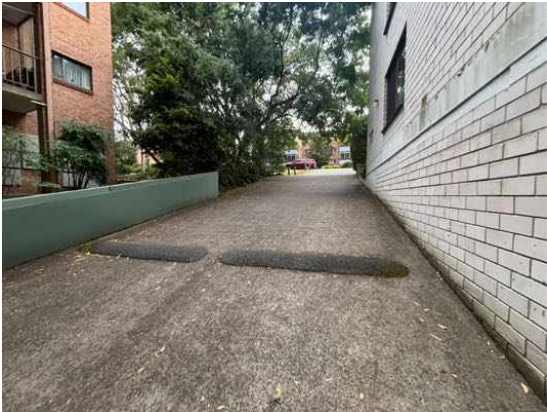
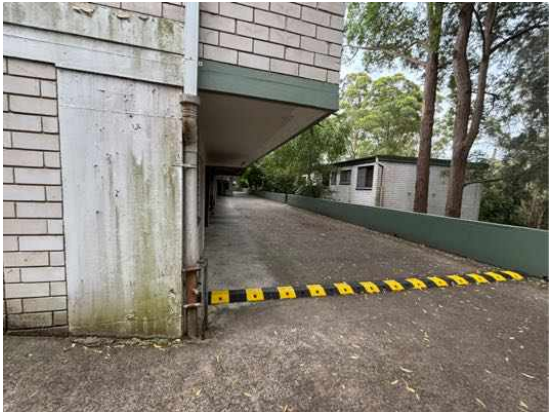
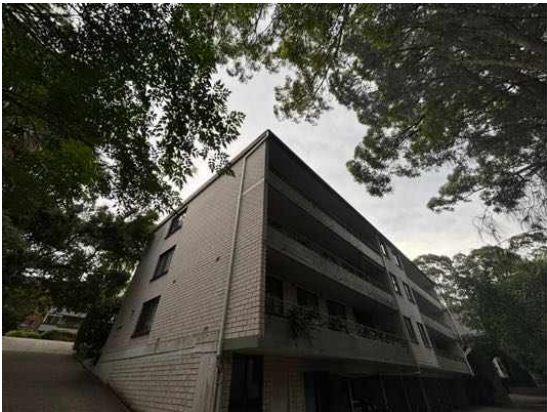
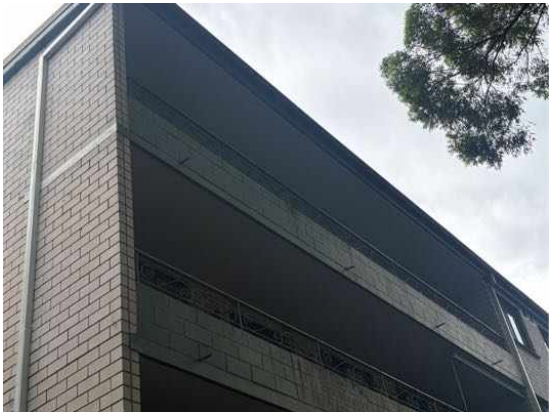
Building:	Main Building
Location:	All Areas
Finding:	Additional Photos of Common Areas
Information:	Additional photos have been provided for your general reference. These images serve as visual documentation of the current condition of the common areas within the building complex at the time of inspection. It is recommended that the client consult with strata management regarding any necessary repairs or maintenance required throughout the complex. These photographs are intended to illustrate the present state of the common areas and should be used as a basis for discussing and prioritizing any needed remedial works with the relevant parties.
