# Building and Timber Pest Inspection Report

Inspection Date: Fri, 27 Feb 2026

Property Address: 14 Harrington St, Altona VIC 3018, Australia

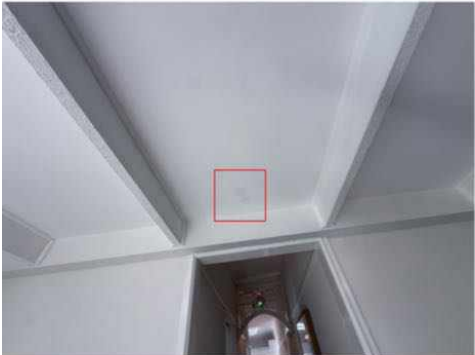
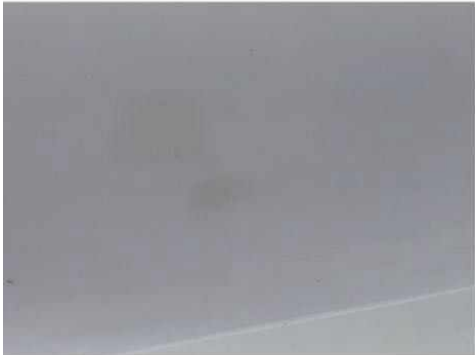
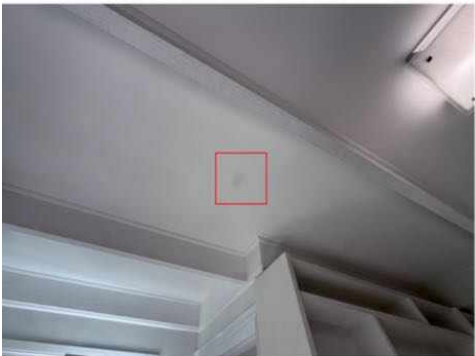
#### Finding 2.01

Building:	Main Building
Location:	Lounge Room
Finding:	Ceiling - Water stained
Information:	Water staining to ceiling linings in this area was evident at the time of inspection. At least 3-4 water stains were present in the lounge.

Water staining indicates that surfaces have been exposed to excessive moisture over time. The minerals and other elements in the water lead to staining, which may graduate to corrosion and deterioration if left unmanaged.

While mostly an appearance defect, water staining can be indicative of more serious defects, which may be currently concealed by interior ceilings. Externally the roof exterior has excessive vegetation/ debris covering the roof (cleanup is highly recommended)

Where water staining is active, a licensed roof plumber must be consulted to identify the cause of the staining and to provide advice on any reparation works that may be required. Replacement of any damaged structures is advised.

Conversely, where water staining is old and inactive, affected building materials may be repaired, repainted or replaced at client discretion.

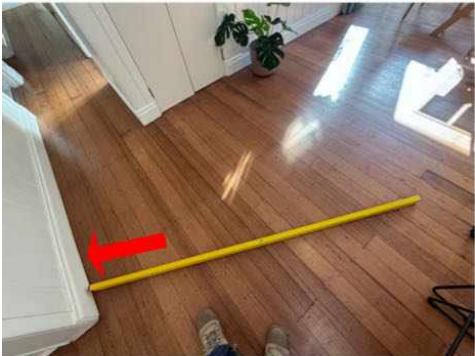
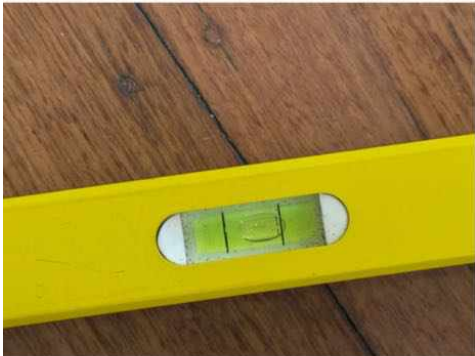
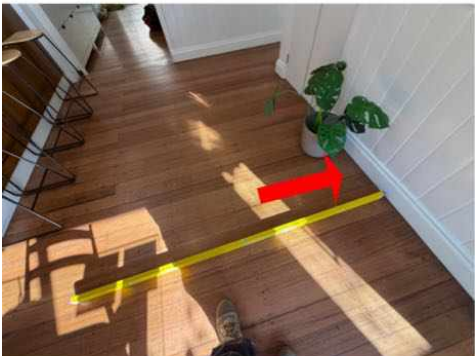
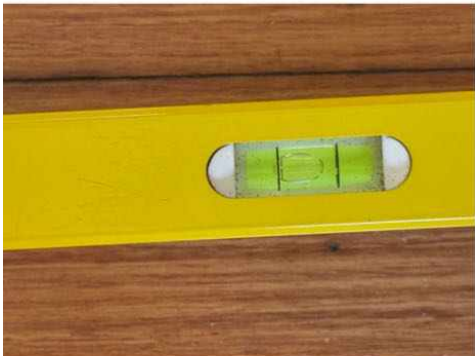
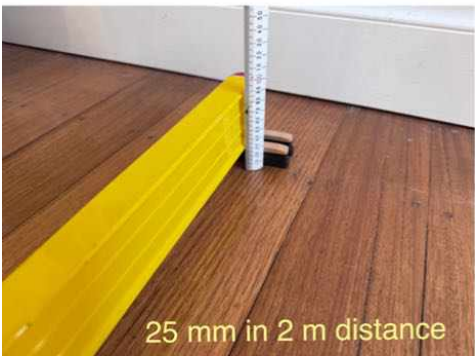
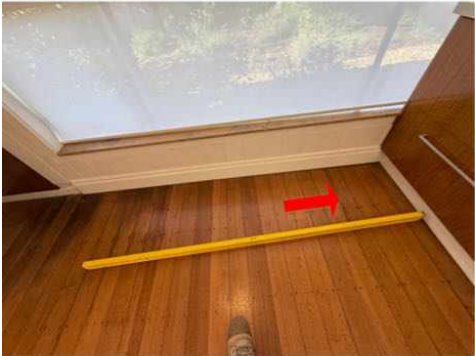
### Finding 3.01

Building:	Main Building
Location:	Some Internal Areas
Finding:	Subsidence- moderately significant
Information:	It is suspected that the subfloor structure might have been affected by movement of the foundations, often referred to as sinking or subsidence.

General subsidence is usually initiated by changes in soil moisture content. The most critical factor is identifying the specific causes, and identifying if this is a recurring or ongoing problem, or one that has been resolved by previous works in the past.

Subsidence can have complex and varying causes, which will influence the required remedial works. If secondary defects like door binding, cracks around the cornices, or gaps between walls & flooring are evident (some are evident) . It will be advised to begin by consulting a structural engineer to determine the required scope of works. This generally includes some form of underpinning, as well as addressing the underlying cause.

A Registered Builder specialising in re-stumping would then generally carry out works as advised by an Engineer.

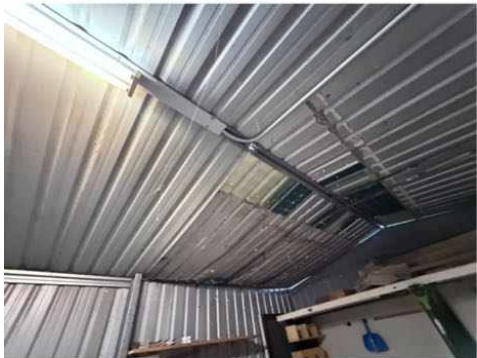
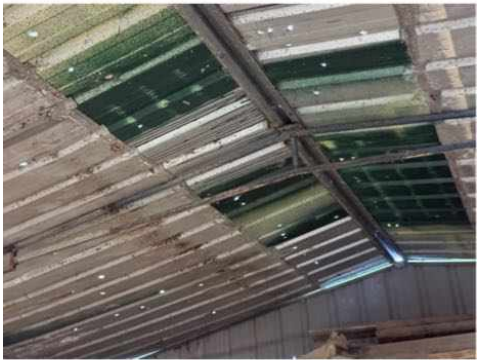
Building:	Main Building
Location:	Yard - shed
Finding:	Shed Roof (small holes)
Information:	The metal roof sheeting to the shed is in fair to poor condition, with visible holes at a few locations. Evidence of basic sealant/caulking has been noted; however, such temporary sealing methods are prone to deterioration over time due to UV exposure and thermal movement. These gaps may allow moisture ingress during wind-driven rain events, and the current sealing cannot be relied upon as a long-term waterproofing solution.

While no active major leak was observed at the time of inspection, preventative maintenance is recommended. Consider proper mechanical rectification (e.g., refastening, replacement of damaged sheets, installation of appropriate flashing or closures) rather than relying solely on surface caulking to maintain weatherproofing

integrity.

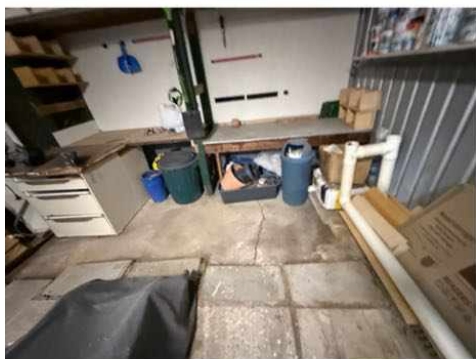
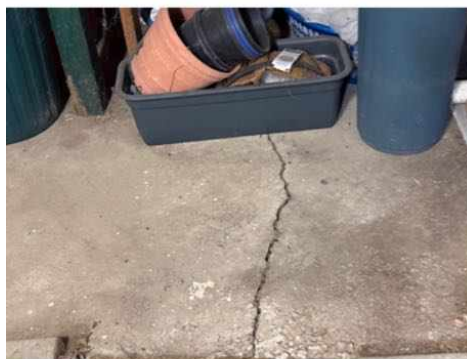
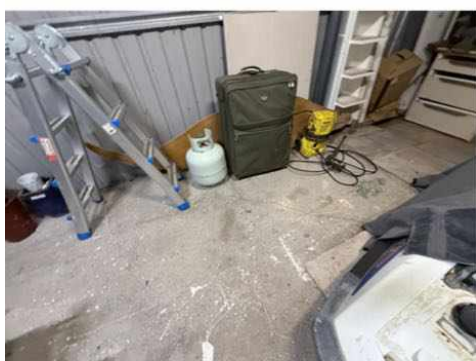
**Finding 3.04**

Building: Main Building  
Location: Yard - shed  
Finding: Crack in concrete slab - Category 2  
Information: A crack coded as Category 2 was identified in the slab. A Category 2 crack is described as a distinct crack, with the slab being noticeably curved or changed in level.

To be considered Category 2, the approximate width of the crack is less than 2.0mm,

or a change in offset of less than 15mm when a 3m straight edge is placed over the defect.

Category 2 cracks to slabs should be monitored for a period of 12 months. At the end of the monitoring period, cracks rated greater than Category 2 are considered defects that require rectification.

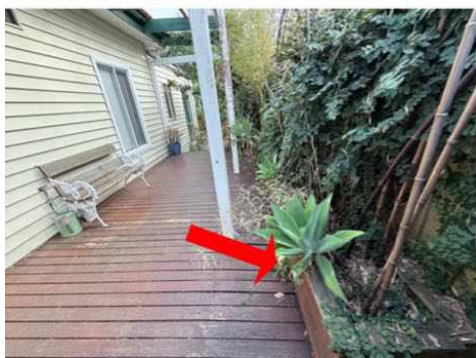
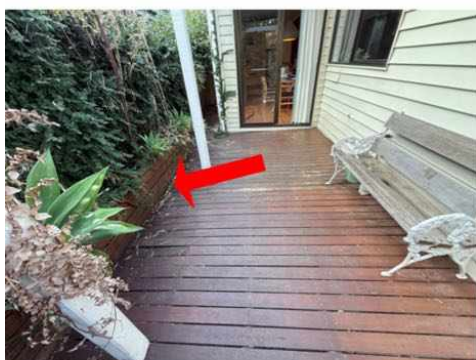
### Finding 3.05

Building:	Main Building
Location:	Yard - Side
Finding:	Localised Deck Subsidence Adjacent to Planter Box (moderately significant)
Information:	The timber decking adjacent to the raised planter box exhibits signs of localised deflection, with sections appearing to slope downward and sit lower than surrounding boards. Given the proximity to dense vegetation and soil-filled planter beds, prolonged moisture exposure is likely. This condition increases the risk of concealed timber decay to decking boards, joists, or bearers beneath the affected area.

While no immediate structural failure was observed at the time of inspection, continued moisture retention from irrigation, soil contact, and restricted ventilation may accelerate deterioration. If left unattended, this may lead to progressive rot and potential load-bearing reduction.

It is recommended that the planter interface be further investigated by lifting selected

boards to assess the condition of the substructure. Any decayed members should be replaced, and improvements to drainage, moisture separation (e.g., barrier or flashing), and ventilation should be implemented to prevent recurrence.

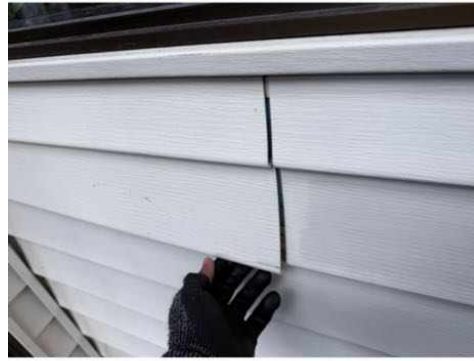
### Finding 3.06

Building:	Main Building
Location:	Exterior walls - right side
Finding:	Loose Lightweight Cladding Panel
Information:	A section of the lightweight external cladding beneath the window was found to be loose and not securely fixed to the substrate. The affected board demonstrates movement when lightly pressed, indicating inadequate fixing or possible fastener failure. While no immediate water ingress was observed at the time of inspection, loose cladding can allow moisture penetration, wind-driven rain entry, and potential pest access if left unaddressed.

It is recommended that the panel be refixed and securely fastened in accordance with manufacturer installation requirements to prevent future deterioration or damage.

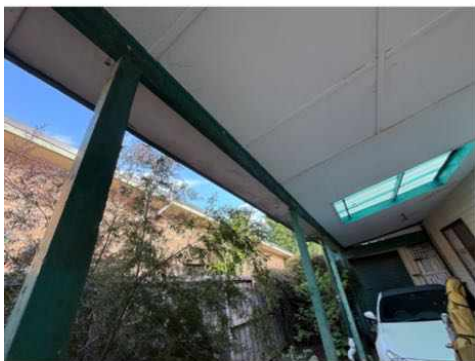
### Finding 3.07

Building:	Main Building
Location:	Carport
Finding:	Eaves- Water stained.
Information:	Water stain to eaves was evident at the time of inspection. This type of defect is generally consistent with older properties, where the eave sheeting has worn over time.

Eaves are important in preventing water ingress to associated walls by promoting adequate water run-off from roofing structures. Their secondary function is to prevent shelter to adjoining structures from excessive moisture and hence prevent water damage to these areas.

Eaves which are water stained might get damaged over time & hence will be susceptible to the attraction of excessive moisture, and are therefore will be considered non-functional. This defect also detracts from the overall appearance and condition of the roofing structure and any associated structures.

A roofing plumbing or a building maintenance provider is recommended to perform rectification works if eaves starts sagging.

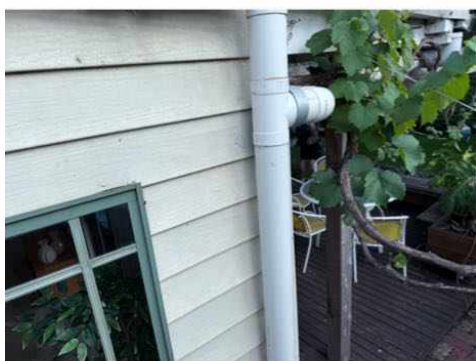
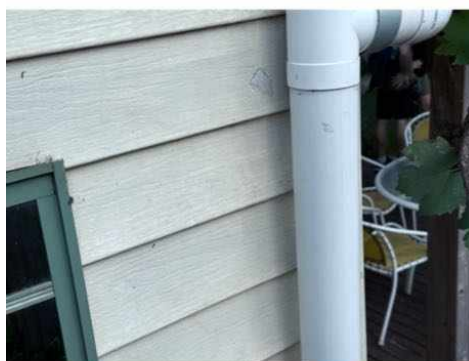
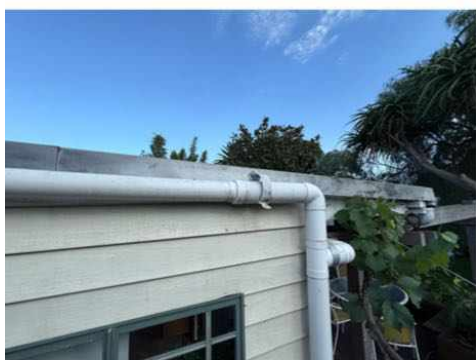
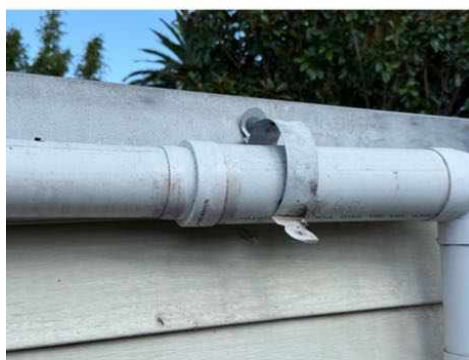
Building: Main Building  
 Location: Exterior walls - right side  
 Finding: Pipework - Not clipped off adequately  
 Information: Plumbing pipes in this area have not been correctly clipped off (secured) to the adjoining structure. Where pipes have not been clipped off, they are more susceptible to impact damage and moisture damage, particularly if they are in direct contact with the ground.

A qualified plumber should be appointed immediately to provide adequate clipping for the plumbing pipes. Failure to do so may necessitate repair works to affected plumbing pipes, which may be a costly exercise.

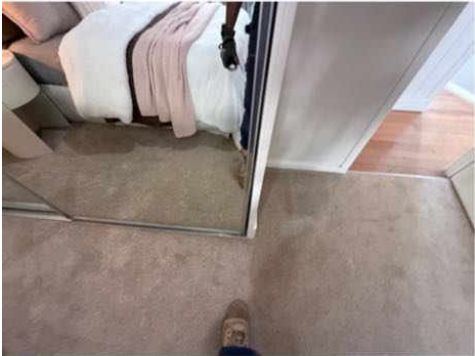
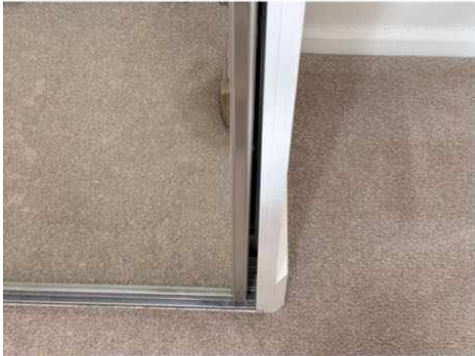
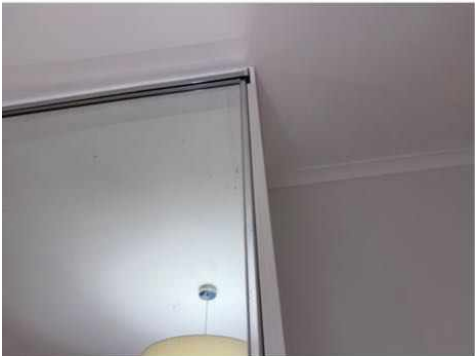
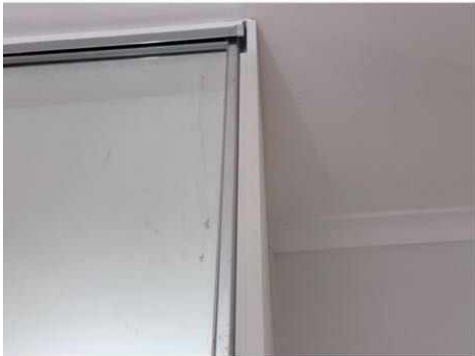
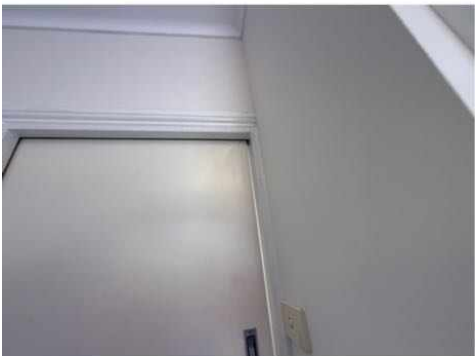
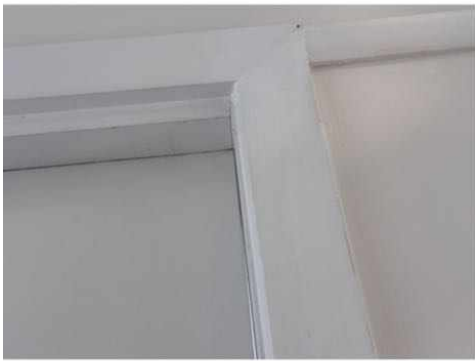
### Finding 3.09

Building: Main Building  
 Location: All Internal Areas  
 Finding: Doors Misaligned on closing.  
 Information: It is observed that some of the Doors are not aligned and / or have inconsistent gaps between the doors. Its a result of substandard workmanship & sometimes ground movements.

A carpenter can be hired at clients discretion to rectify the issue.

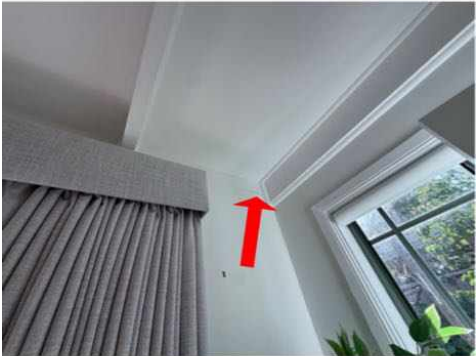
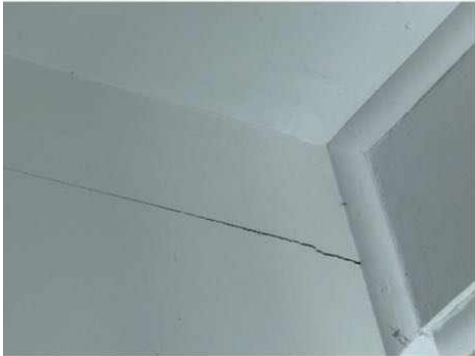
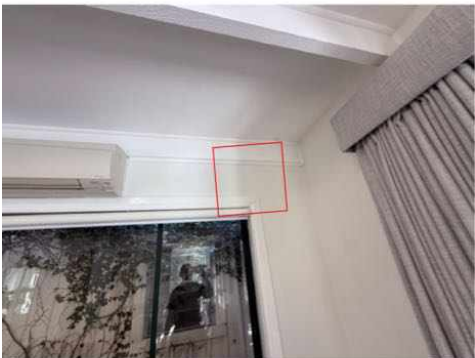
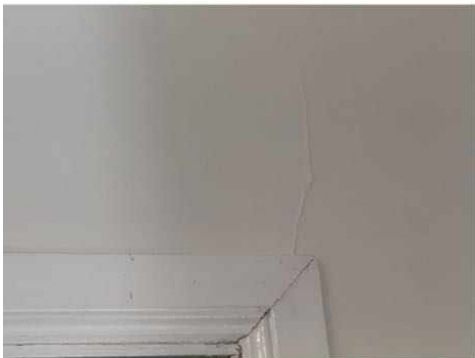
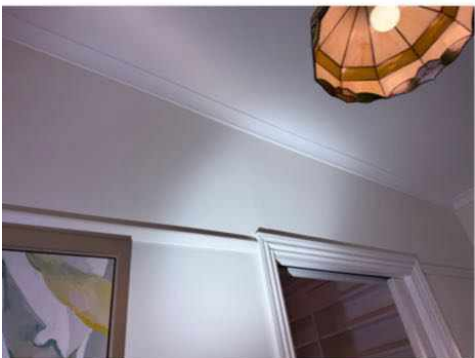
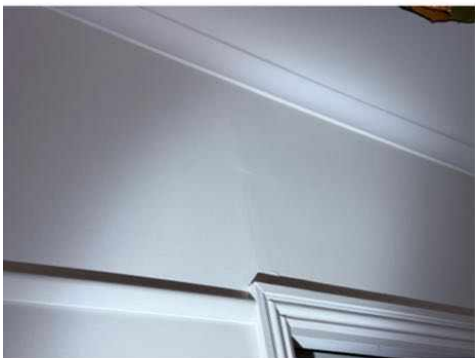
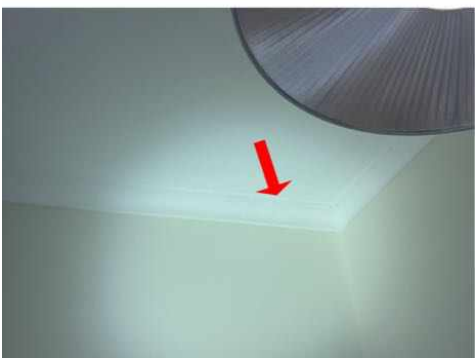
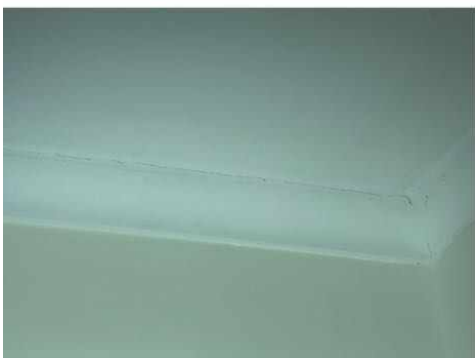
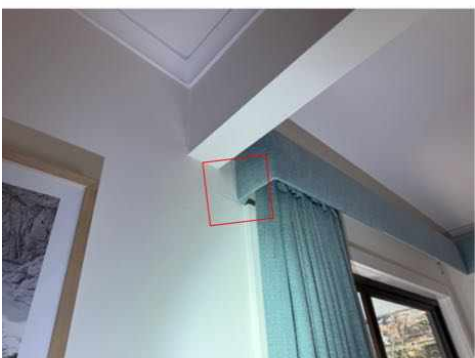
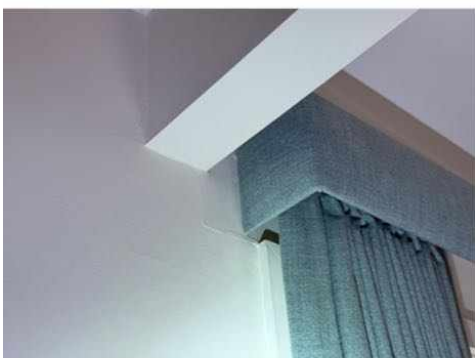
**Finding 3.10**

Building: Main Building  
Location: All Internal Areas  
Finding: Cracking - Damage Category 1 - Fine (up to 1mm)  
Information: Although fine cracks are quite noticeable, they are often only considered to be an appearance defect, and usually do not indicate any structural damage. Generally, the cause of a fine crack is indicative of a separation between building materials and finishes (e.g. paint, plaster, etc.) along joins.

Cracking of this nature can generally be repaired with minor sanding, filling and/or repainting. Such works should be performed by a qualified painter or a general handyman.

Monitoring of all cracking should be conducted frequently. Always contact a building inspector should cracks widen, lengthen, or become more numerous.

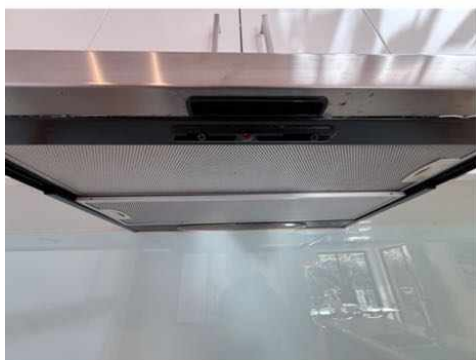
Finding 3.11

Building:	Main Building
Location:	Kitchen
Finding:	Rangehood - Light not working
Information:	While the range hood appears to be working at a satisfactory level, the light to the appliance was not working at the time of inspection.

A licensed electrician should be appointed to replace the light on the range hood to restore it to a fully operational state.

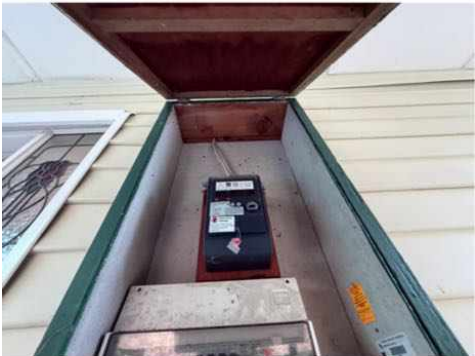
Building:	Main Building
Location:	Meter Box
Finding:	Termite Management System - no evidence of a chemical installation
Information:	The application of a post-construction chemical termite barrier is highly recommended for all properties, particularly if live termite activity has been found on the site previously. Such barriers are highly effective in preventing termite attack on any timber building elements throughout the property.

A durable notice should be placed in the switchboard unit to indicate current termite barriers. At the time of inspection, it appeared as though no termite management system has been installed, with no evidence to suggest preventative works taking place.

The client may consider gaining further advice from a pest controller as to the costs and procedures involved with this application. It is recommended that obtaining such advice be a short-term priority.

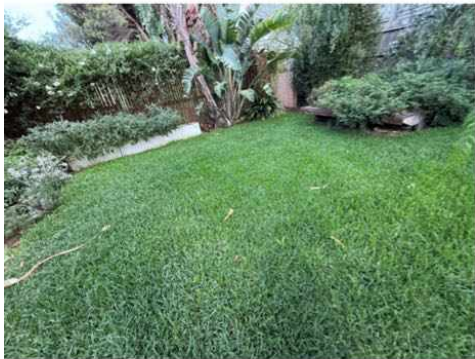
**Finding 6.02**

Building: Main Building  
Location: All External Areas  
Finding: Garden Bed/ Mulch - Conditions Conducive to Termites  
Information: Mulch were found around the property. These areas can include untreated timber, and with a combination of moisture from watering hosing can make conditions conducive to termite activity and termite ingress.

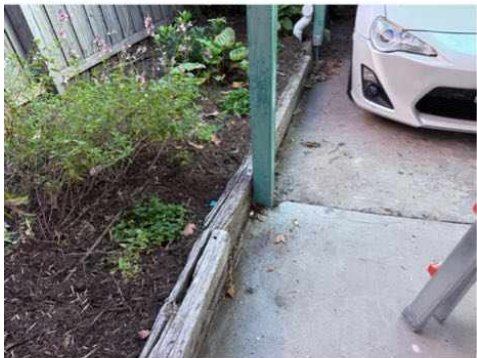
### Finding 6.03

Building:	Main Building
Location:	All External Areas
Finding:	In ground contact
Information:	Any timbers in direct ground contact provide opportunity for concealed termite entry and are likely to be subject to premature rot and decay as the soil retains moisture or damp conditions against the timbers.

Remove untreated timber that is in direct contact with external grounds. Consider replacement with more durable materials i.e. treated timber or non timber elements. Frequent pest inspections are advised to readily identify any termite activity in these areas.

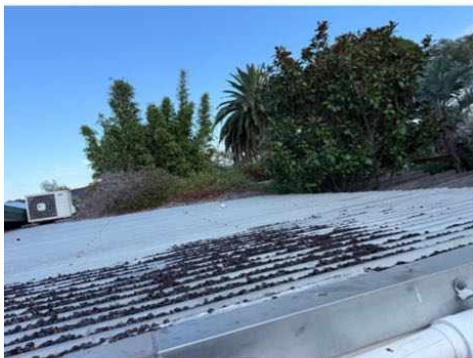
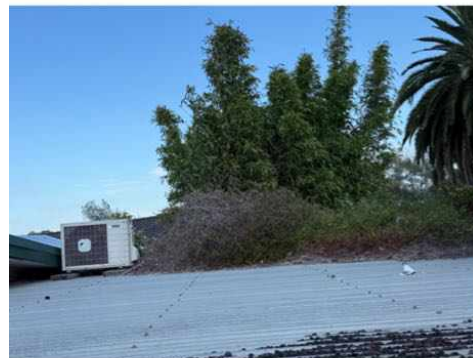
### Finding 6.04

Blocked or partially blocked gutters can lead to high levels of moisture in the affected areas (eg: entry porch). Such moisture will not only cause rust and decay of the associated building materials, but can also provide conditions that are conducive to termite and timber pest activity. Blocked part of the gutters should therefore be cleaned immediately to ensure dry conditions are maintained.

It is advised that gutters should be maintained regularly by the homeowner & a general handyman should be appointed as a matter of urgency to clean the gutters.

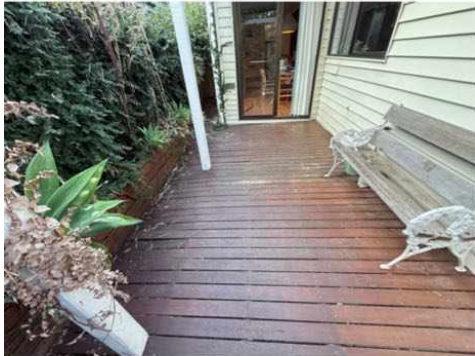
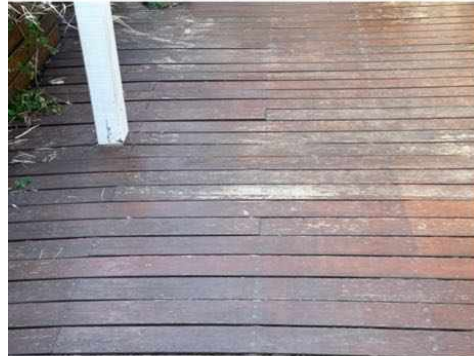
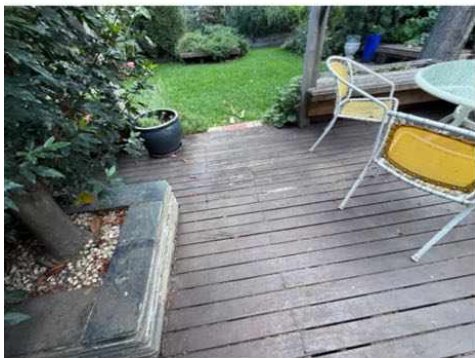
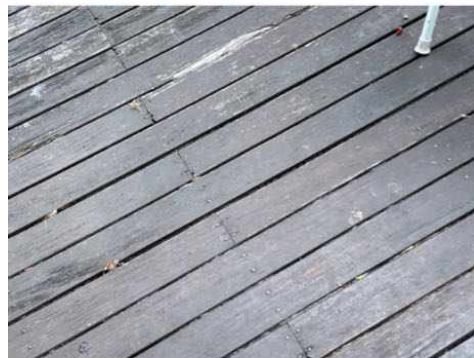
### Finding 6.05

Finding: Timber deck- High conducive condition.  
 Information: We are unable to inspect under the timber deck if its in close proximity to the ground.

Where we are unable to inspect timber structures, decks and subfloor areas the risk of undetected termite activity is rated as extremely High.

We strongly recommend the purchaser prioritise a termite treatment by a Licensed Pest Controller to protect and maintain the asset as it is a timber structure.

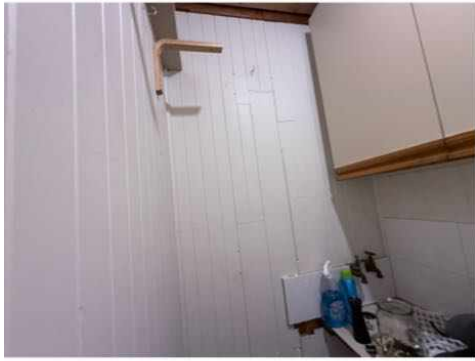
### Finding 6.06

Building: Main Building  
 Location: All Areas  
 Finding: Timber cladding- conducive condition  
 Information: Timber cladding can also be vulnerable to attack from termites, which can cause significant damage if not taken care of early on. Concealed entry is high possibility.

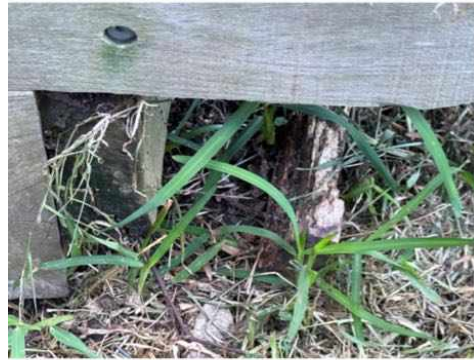
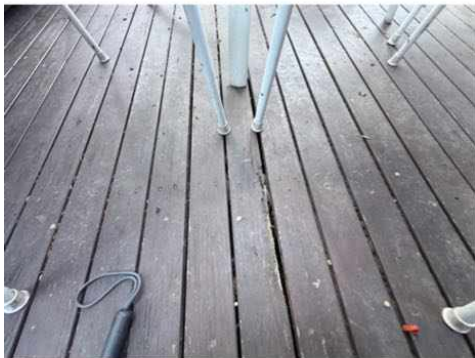
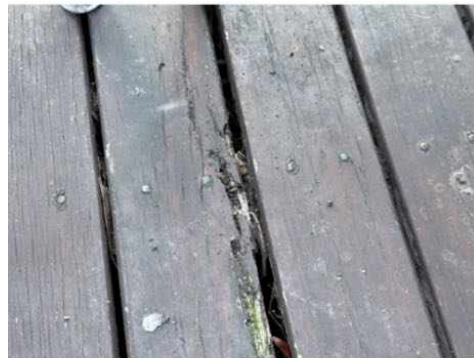
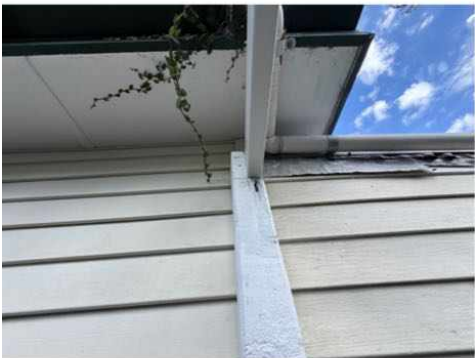
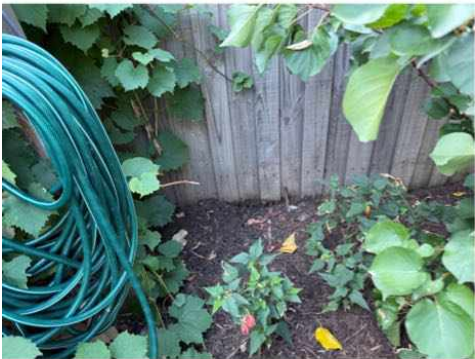
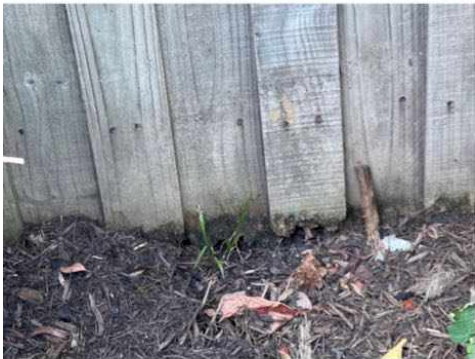
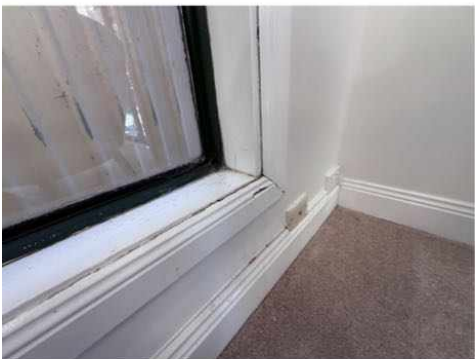
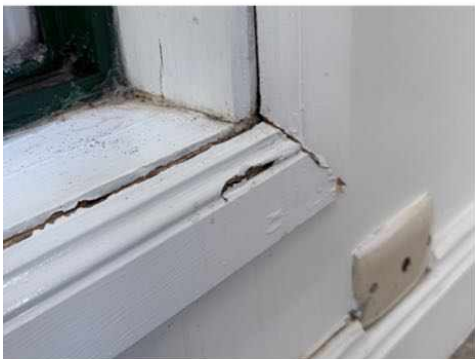
### Finding 7.01

Finding: Wood rot

Information: These building elements shows evidence of wood rot. Wood rot, also known as Fungal Decay, occurs when timbers and other cellulose building materials are exposed to damp conditions on an ongoing basis. This could be the result of exposure to weathering over a prolonged period of time, or the attraction of excessive moisture

Wood rot is often associated with general damp problems and is evidenced by a 'musty' smell or mould and mildew occurring on surfaces. If left unmanaged, damp conditions can lead to further health problems and the decay of timbers will continue.

Early intervention and regular maintenance, particularly of exterior timbers, will prolong the useful life of these building elements. Prior to any works being performed, the cause of the moisture that has created the visible wood rot should be identified and addressed in a suitable manner. Replacement of affected timbers may then be a necessary step in protecting surrounding building elements from such deterioration.

A qualified plumber may be appointed to assess the cause of excessive moisture and to provide advice on any remedial works as required. A qualified carpenter or registered builder may also be required to replace affected building materials.

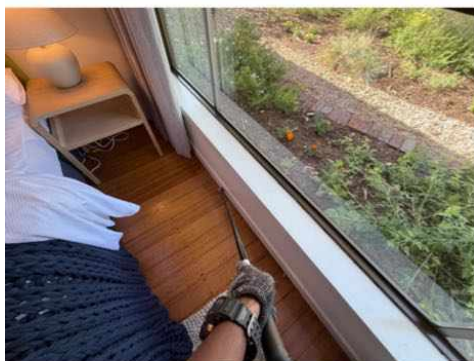
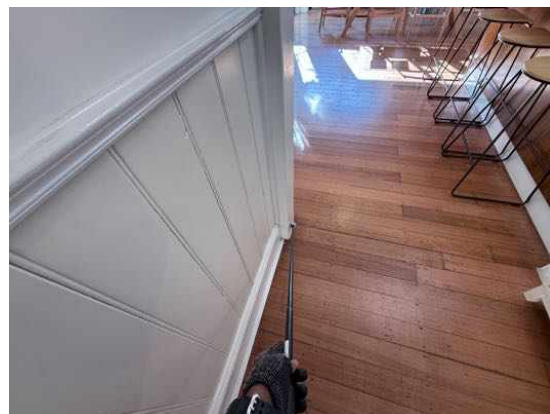
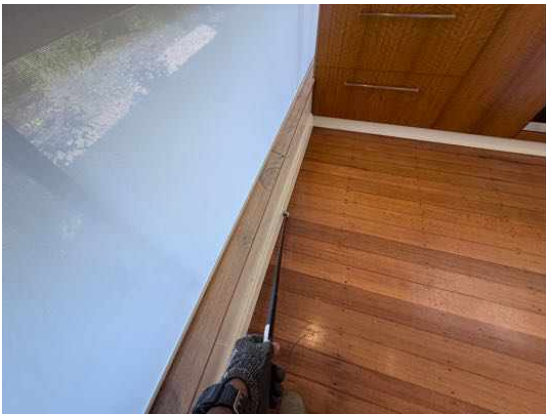
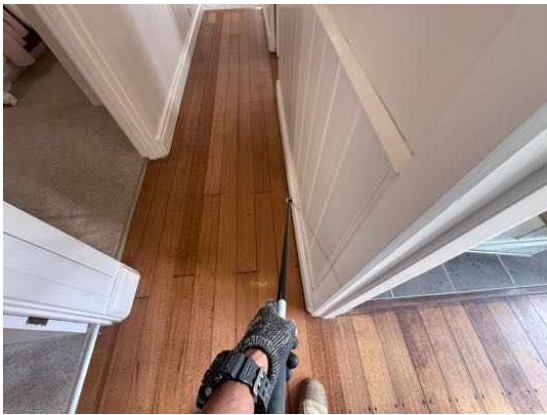
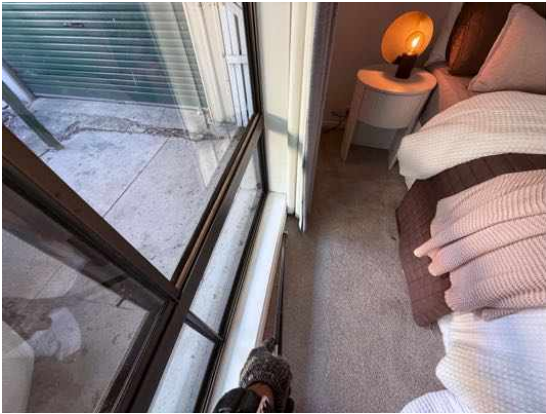
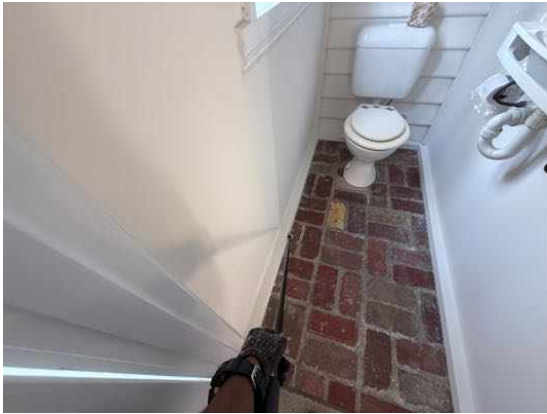
#### Noted Item

Building: Main Building  
Location: All Areas  
Finding: Termite Techniques  
Information: All areas of the dwelling are checked with particular attention paid to wet areas which were closely assessed to check for excessive levels of moisture and temperature anomalies.

No evidence of termite activity was found inside the house at the time of the inspection.

In an attempt to identify the presence of hidden timber pest activity, a variety of techniques are adopted to identify irregularities including, a moisture meter reading of susceptible areas, sounding of timber elements using a device called a "donga" visual assessment of materials affected by moisture or signs of deformity, trails and bridging constructed by termites, irregular and regular shaped holes in timber elements indicating pest destruction.

Termite activity generates high temperatures and moisture and if this irregularity is found it can be grounds for further investigation.

Wall paneling, wallpaper, carpet and fixed cabinetry can obscure termite activity.

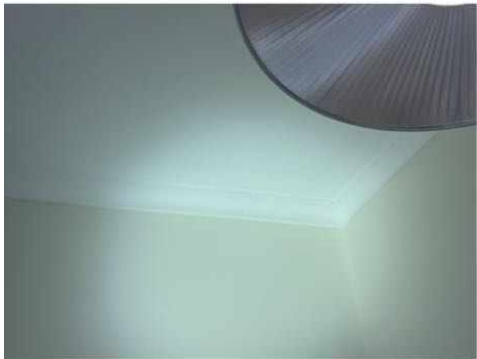
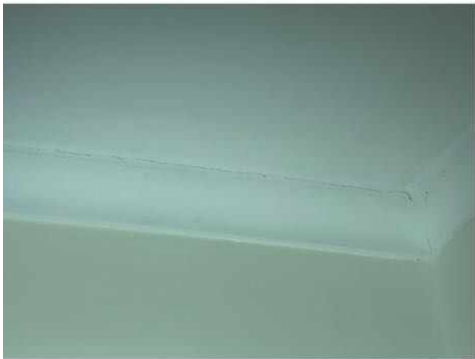
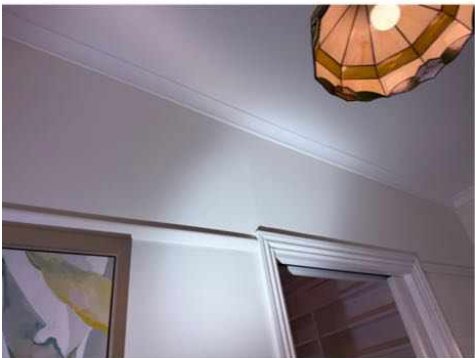
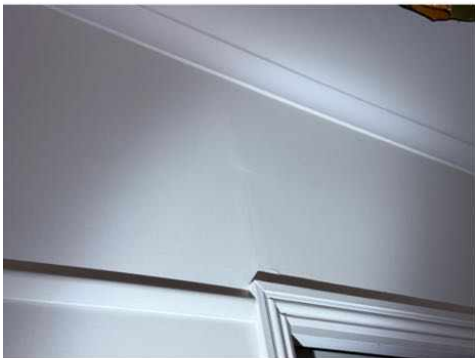
**Noted Item**

Building: Main Building  
Location: All Areas  
Finding: Evidence of recent renovations.  
Information: Whenever a property is refurbished, majority of the defects if present could get obscured beneath the revamped work. The same can be said for this property as well. Some fine cracks are filled over, walls have been painted etc. It is difficult to pinpoint on any particular defects present below such layers.

Once the property is occupied, all areas should be monitored for a period of 12-24 months to lookout for any arising defects. If staining or cracking is noticed extensively in that period, always consult your building inspector.

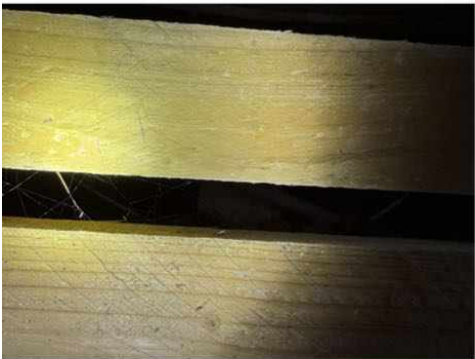
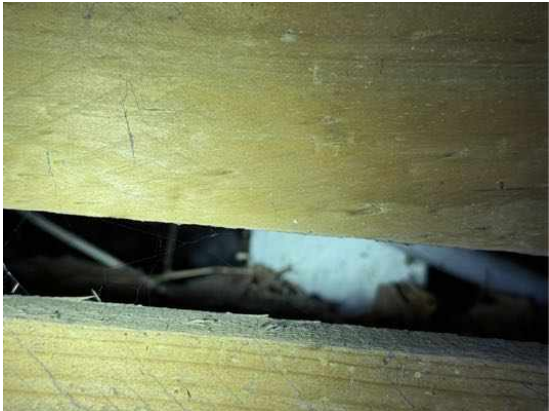
**Noted Item**

Building: Main Building  
Location: All Areas  
Finding: Additional photos & Obstruction/Limitations.  
Information: Additional photos for general documentation. May have some minor maintenance items not listed in the defects section.

Furthermore, some photographs are an indication of the obstructions and limitations which impeded full inspection of the property at the time of inspection. These obstructions can hide an array of defects and should be removed to allow full inspection to be carried out. A re-inspection is recommended once the areas are made accessible.
