# Building and Timber Pest Inspection Report

Inspection Date: Fri, 27 Feb 2026

Property Address: 14 Harrington St, Altona VIC 3018, Australia

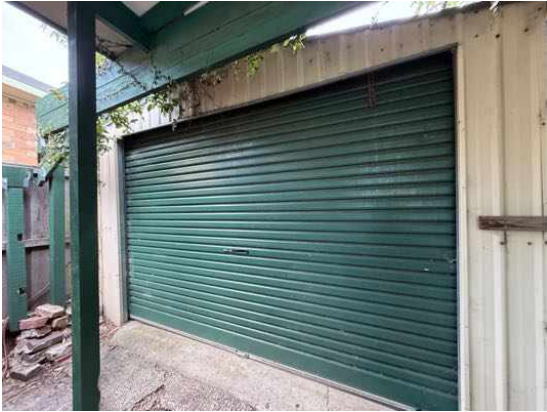
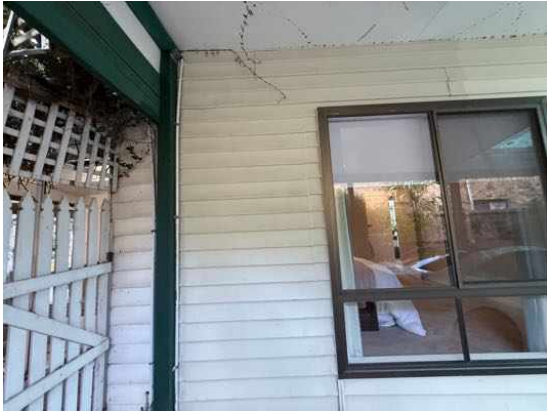
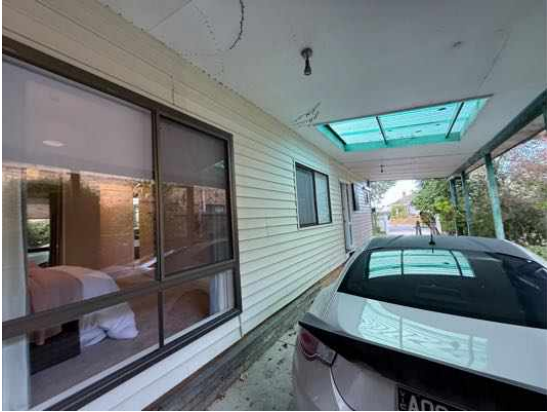
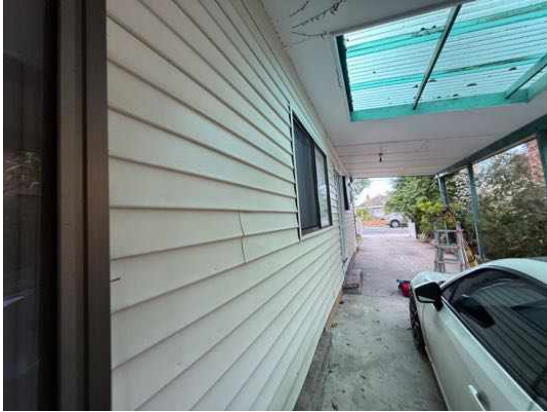
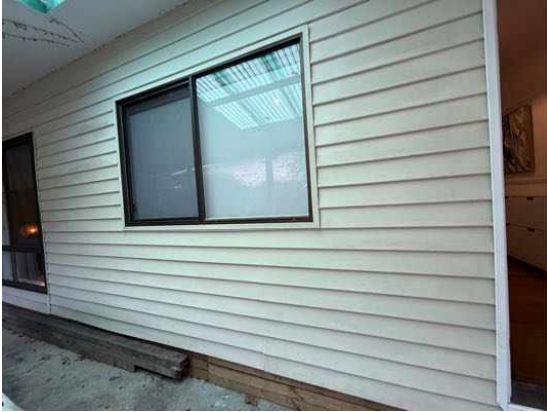
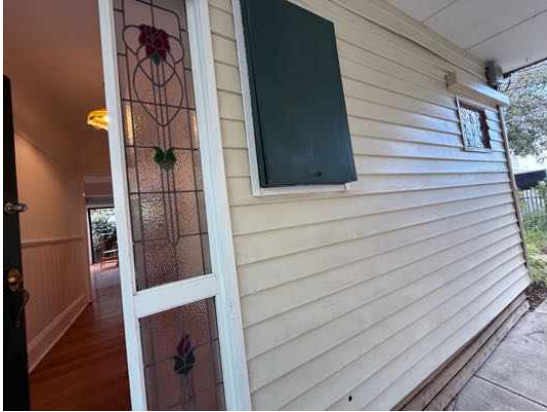
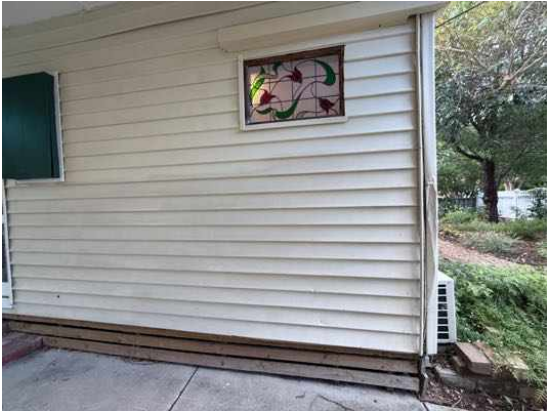
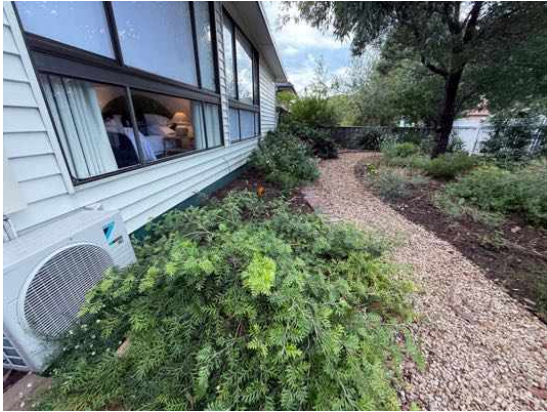
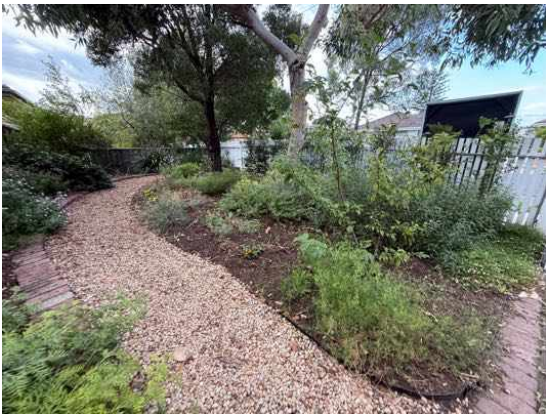
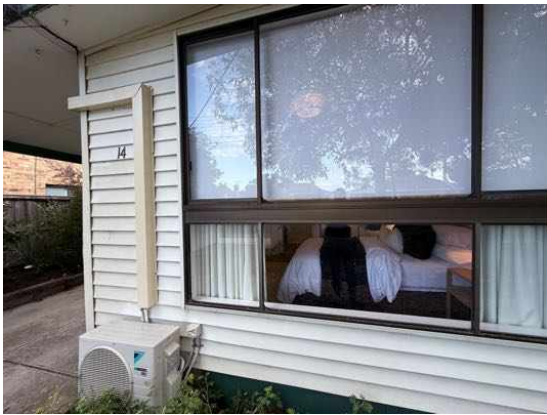
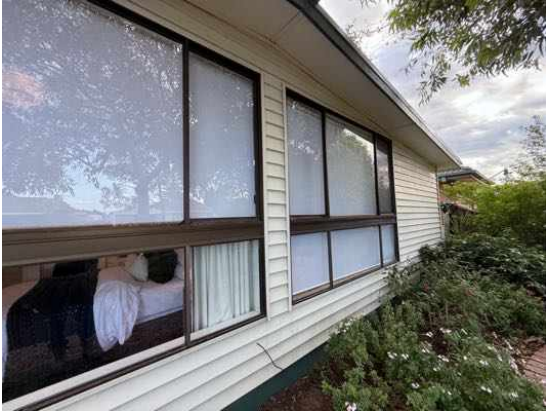
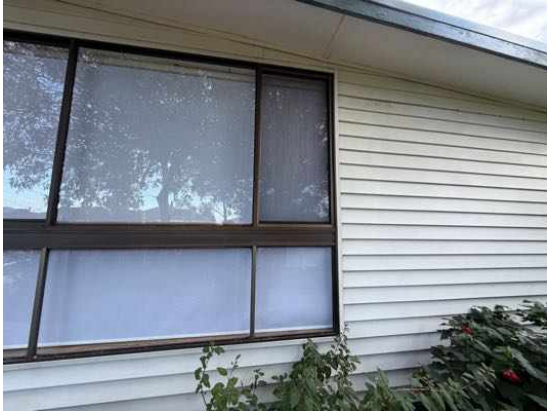
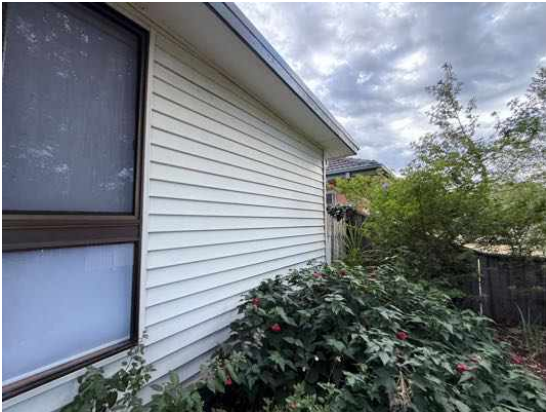
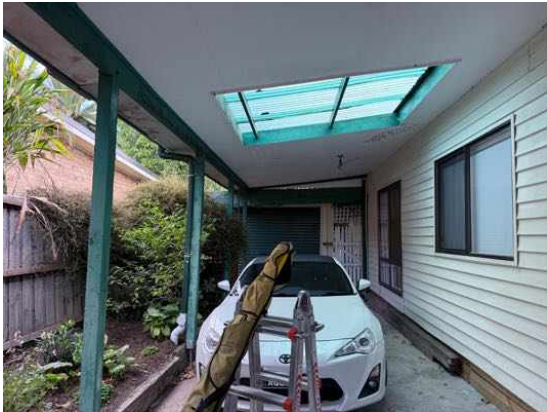
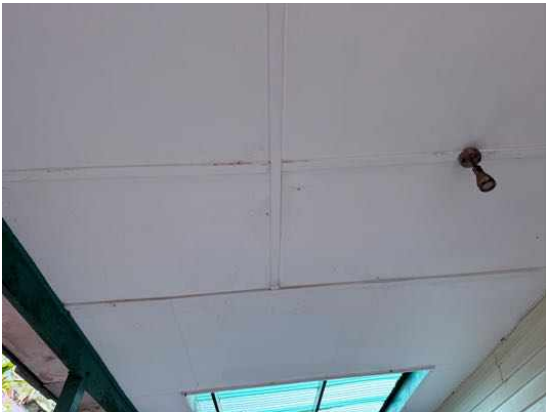
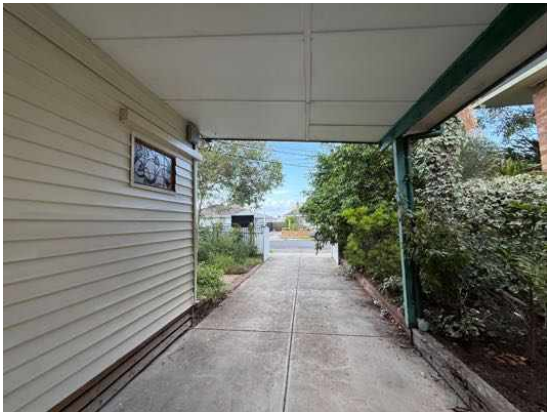
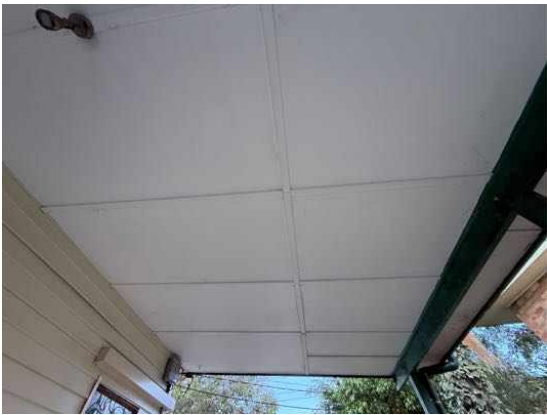
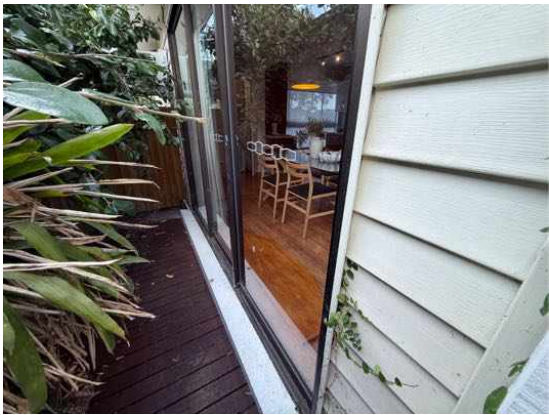
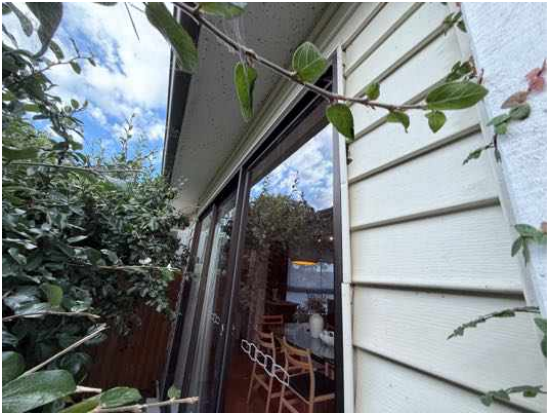
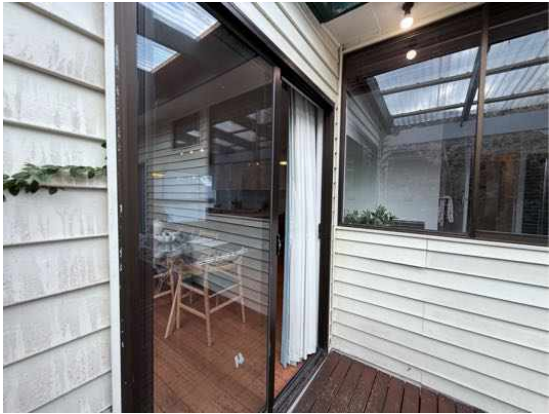
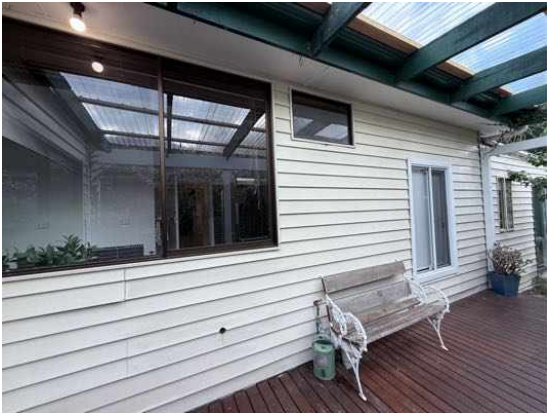
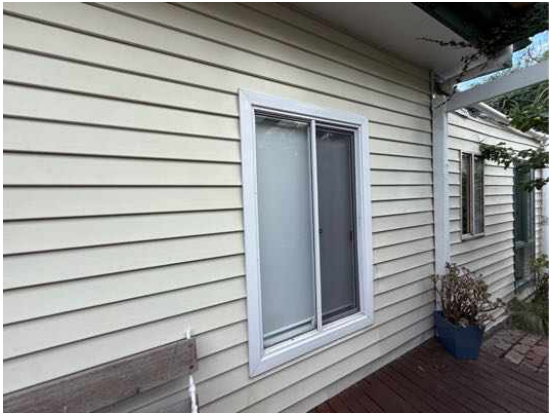
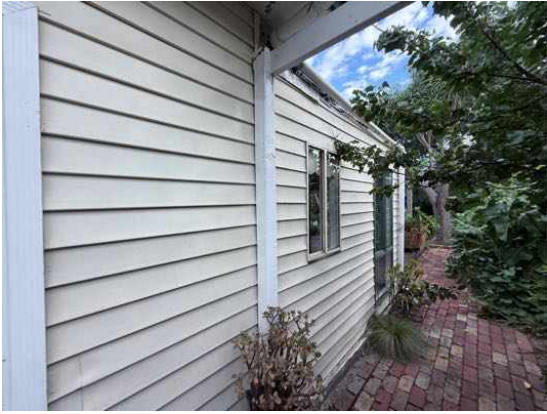
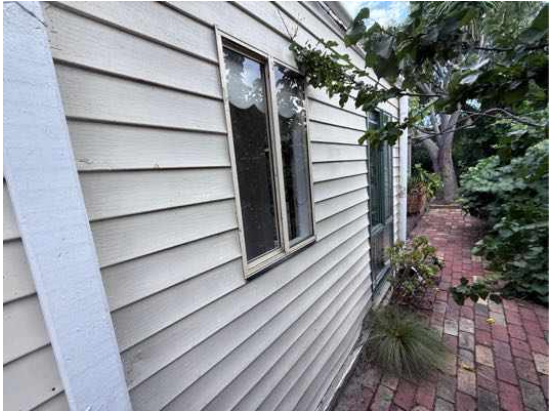
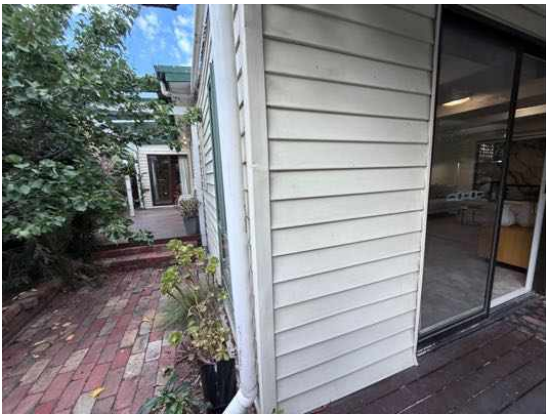
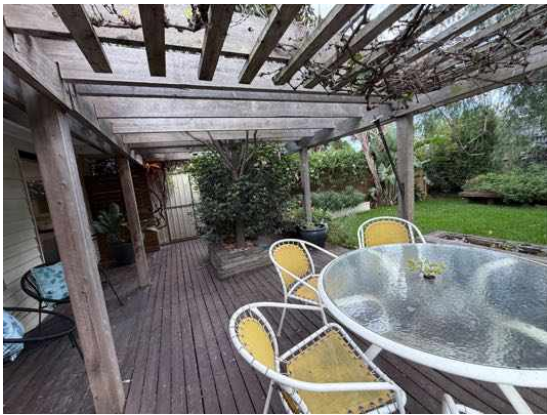
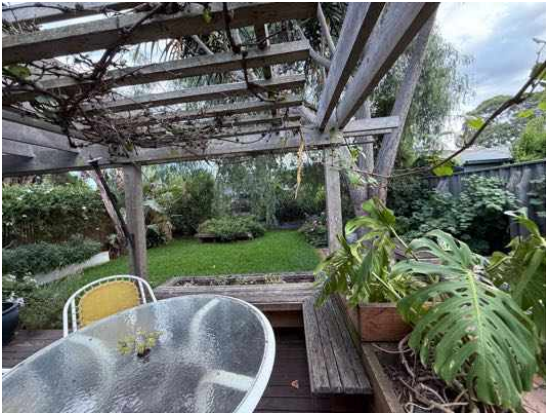
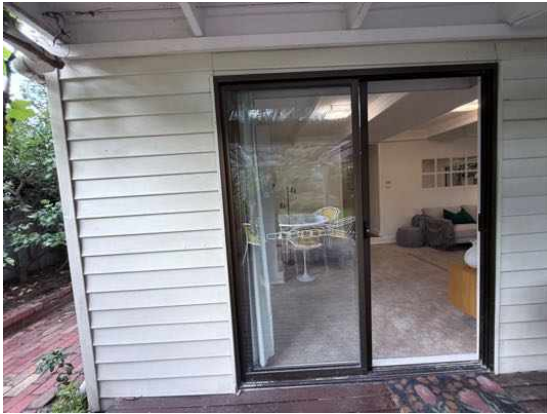
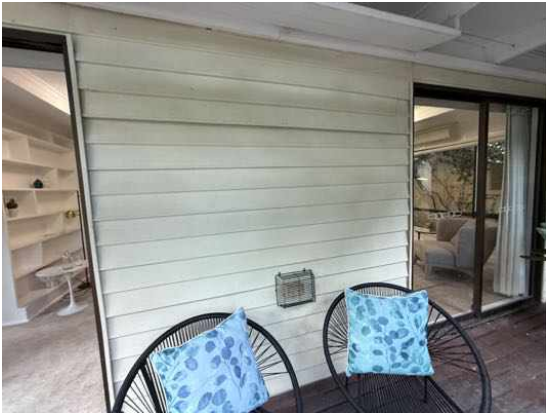
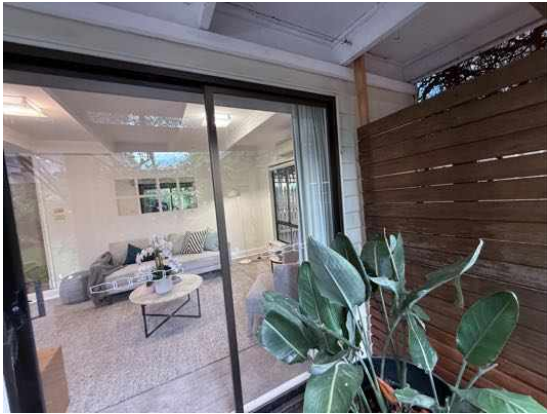
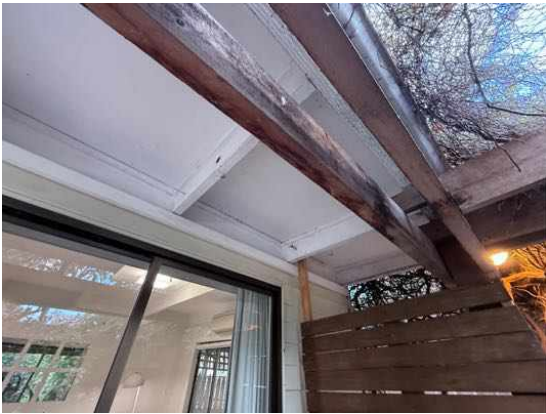
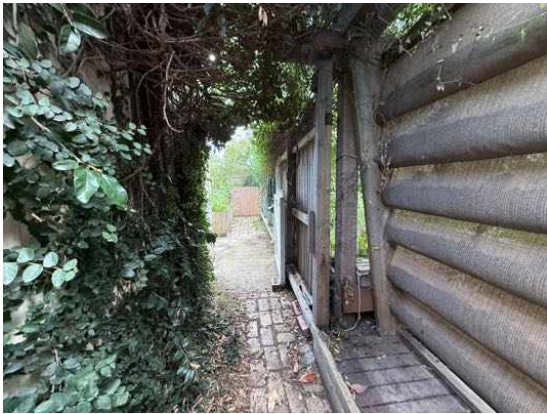
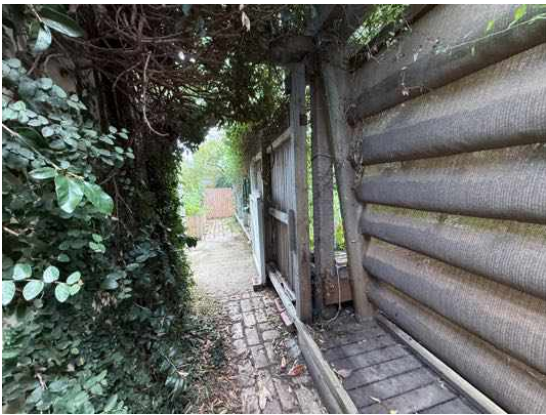
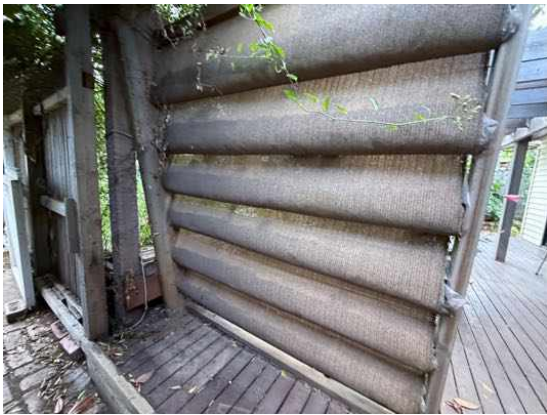
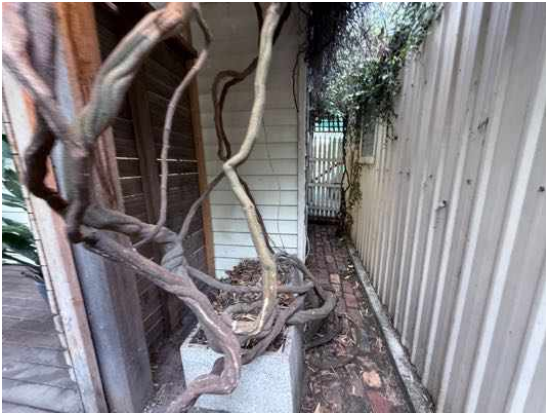
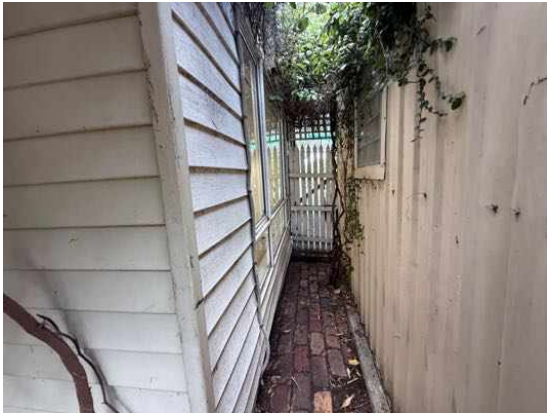
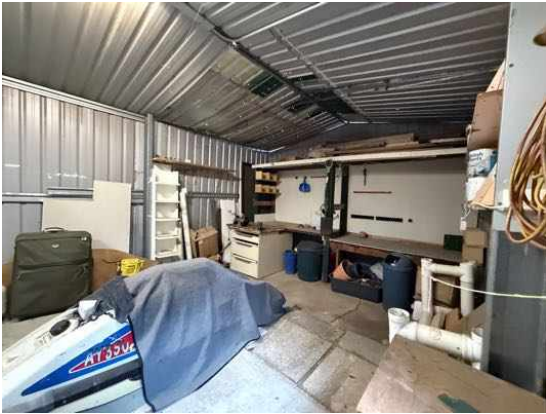
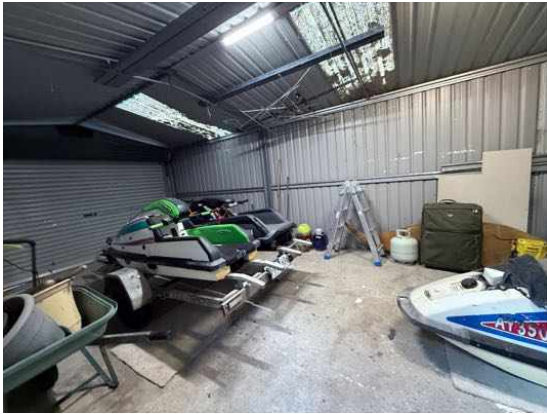
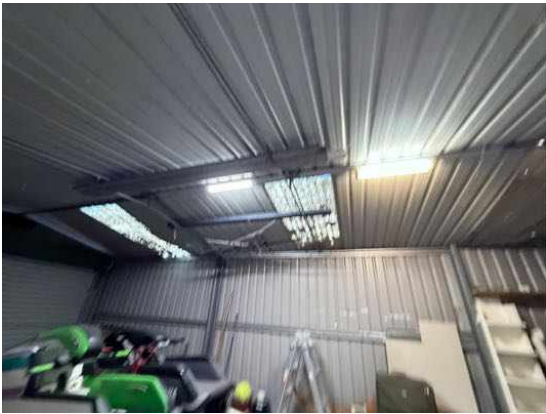
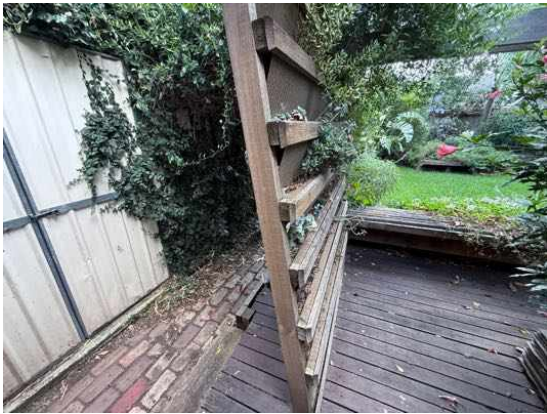
Building: Main Building  
Location: All Areas  
Finding: Additional photos & Obstruction/Limitations.  
Information: Additional photos for general documentation. May have some minor maintenance items not listed in the defects section.

Furthermore, some photographs are an indication of the obstructions and limitations which impeded full inspection of the property at the time of inspection. These obstructions can hide an array of defects and should be removed to allow full inspection to be carried out. A re-inspection is recommended once the areas are made accessible.
