BEFORE YOU BUY
BEFORE YOU BUILD

Building Inspection Report

Inspection Date: Thu, 9 Apr 2026

Property Address: 5/20 Pennant Hills Rd, NORTH

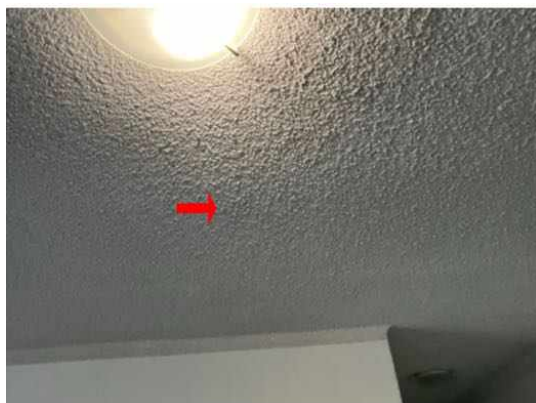
Defects 1.01

Building:	Main Building
Location:	All Areas
Finding:	Asbestos - Suspected ACM Identified on Site
Information:	Reporting on Asbestos is outside the Scope of this Report. This suspected defect is highlighted as a caution only. We suspect, based on our experience in the building industry, that there is a higher risk of the identified building element containing asbestos.

As Asbestos Reporting is outside the scope of this report, we advise that you consider a separate Asbestos Inspection and Condition Audit, which can include the taking of samples for definitive confirmation of the presence of Asbestos.

In the interim, the client is advised to act with caution, especially when considering any damage to building materials general wear and tear renovations extensions demolition and general maintenance activities due to the suspected presence of Asbestos.

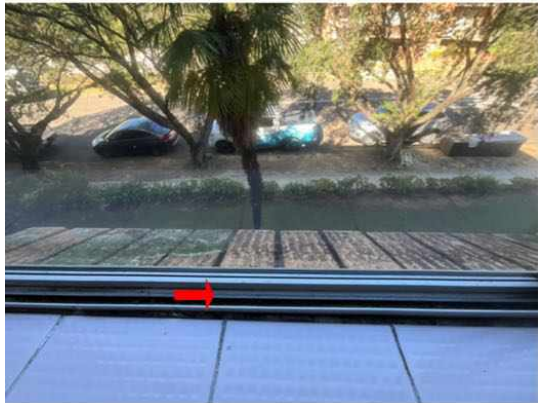
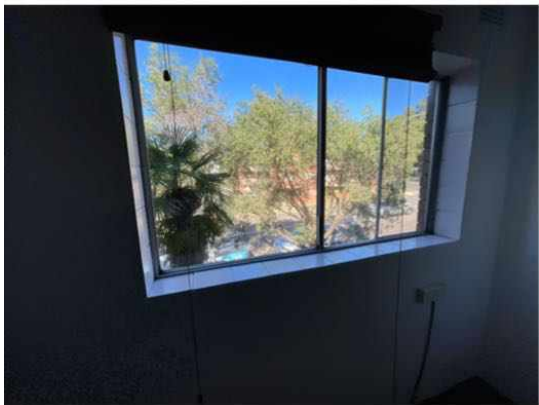
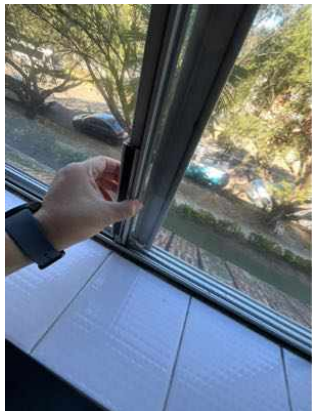
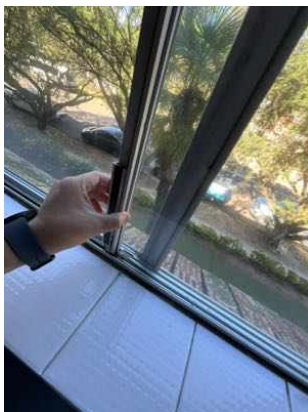
Defects 1.02

Building: Main Building
Location: All Areas
Finding: Window child lock missing
Information: The window in question lacks a child lock mechanism, which poses a potential safety risk to young occupants in the premises. As per Australian Standards windows accessible to children should be equipped with appropriate child safety locks to prevent accidental opening, reducing the risk of falls and ensuring compliance with safety regulations.

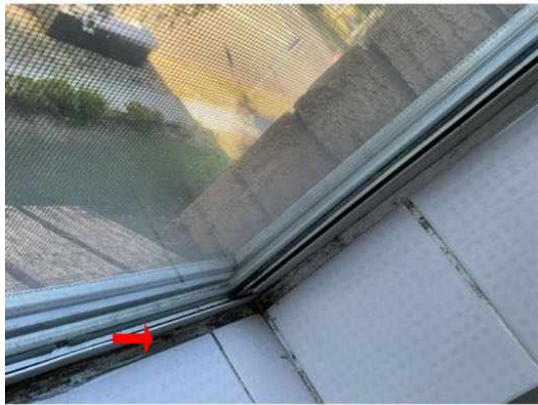
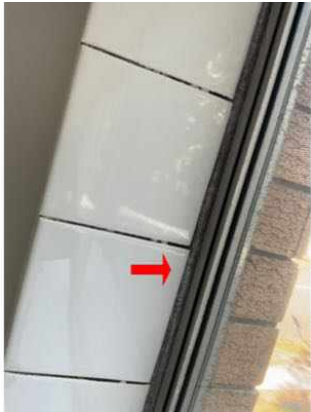
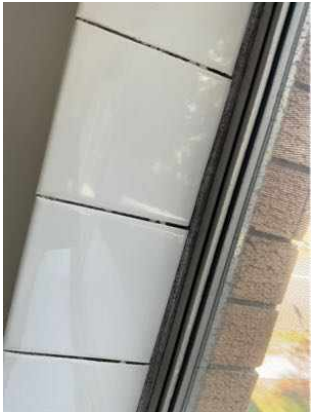
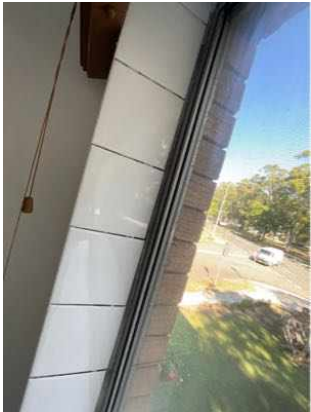
Defects 1.03

Building:	Main Building
Location:	Bedroom
Finding:	Mould - Present
Information:	Mold growth is present throughout the property, primarily due to inadequate ventilation. Poor airflow and moisture accumulation within the house have created ideal conditions for mold to thrive.

- ****Health Hazards****: Mold growth can pose serious health risks to occupants, particularly those with allergies, asthma, or other respiratory conditions. Prolonged exposure to mold spores can cause respiratory issues, skin irritation, and other allergic reactions.
- ****Structural Damage****: Mold can degrade building materials over time, leading to rot and weakening of the structural components such as timber, drywall, and insulation, which can result in costly repairs.
- ****Decreased Property Value****: The presence of mold can significantly reduce the value of the property, as it indicates underlying moisture and ventilation issues that need addressing.

A licensed mold remediation specialist should be engaged to remove the mold and treat affected areas. In addition, a ventilation expert or builder should assess and improve the house's ventilation system, possibly installing exhaust fans, vents, or mechanical ventilation systems to ensure adequate airflow and prevent future mold growth.

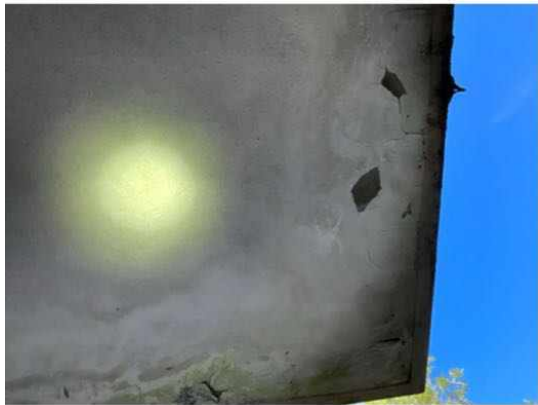
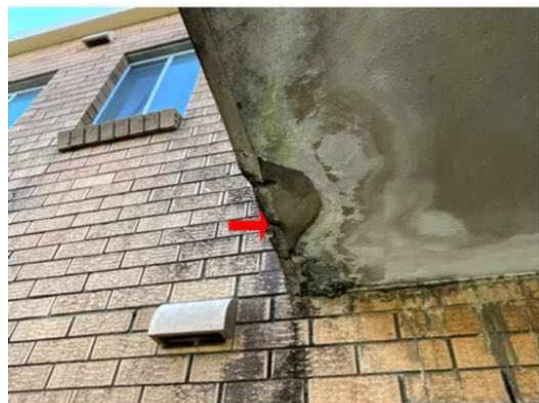
Defects 2.01

Building: Main Building
Location: Balcony
Finding: Water damage
Information: The area has sustained water damage resulting in potential structural issues. This damage compromises both the aesthetic and functional aspects.

1 **Plumber:** If the water damage is due to plumbing issues, a plumber can fix leaks and ensure there are no further water-related problems.

2 **General Contractor:** If the damage is extensive and affects the surrounding area, a general contractor can coordinate the repair work, including any related structural or cosmetic repairs.

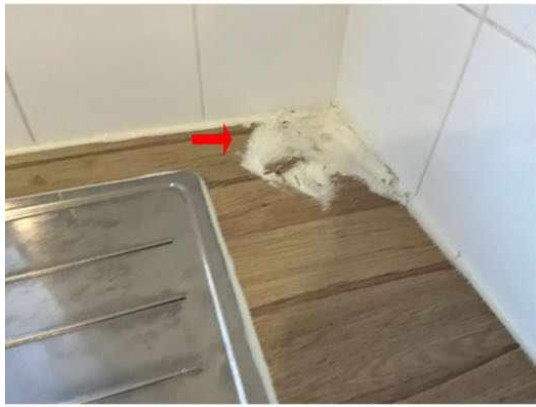
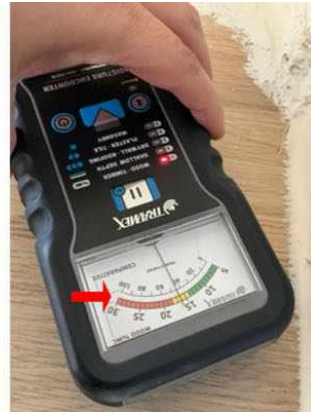
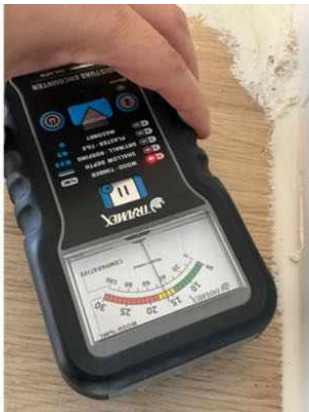
Defects 2.02

Building:	Main Building
Location:	Kitchen
Finding:	Water damage
Information:	The area has sustained water damage resulting in potential structural issues. This damage compromises both the aesthetic and functional aspects.

1 **Plumber:** If the water damage is due to plumbing issues, a plumber can fix leaks and ensure there are no further water-related problems.

2 **General Contractor:** If the damage is extensive and affects the surrounding area, a general contractor can coordinate the repair work, including any related structural or cosmetic repairs.

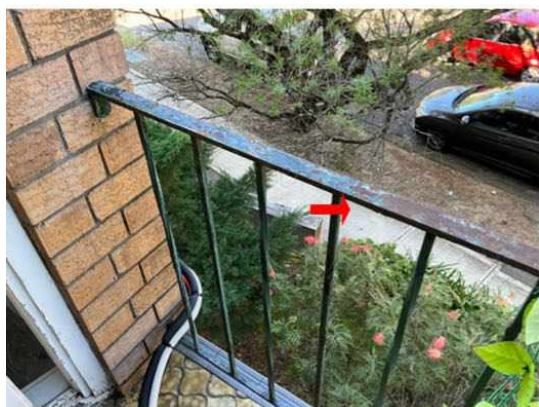
Defects 3.01

Building:	Main Building
Location:	Balcony
Finding:	Building element - Rusted or corroded
Information:	This building element shows evidence of rusting and corrosion, which is likely to have developed as a result of excessive exposure to moisture and or inadequate coatings.

As surface rust provides no protection to the underlying iron, the deteriorating

condition is likely to worsen if not addressed in the short-term future.

Where possible, the use of galvanized (treated) metals or aluminium coated metals aid in rust prevention, as does regular general maintenance. Rust formation can be controlled with coatings, such as paint, that isolate the iron from the environment.

Rusting and corrosion should be managed by ideally removing or limiting the affected surface from exposure to moisture. A registered builder may be appointed to replace any building elements that have been severely affected by rust or water damage.

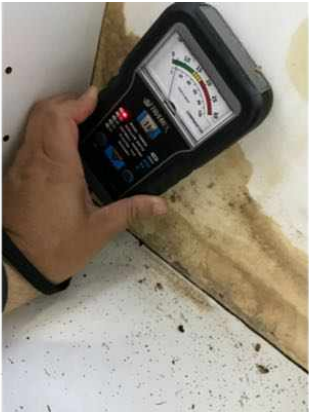
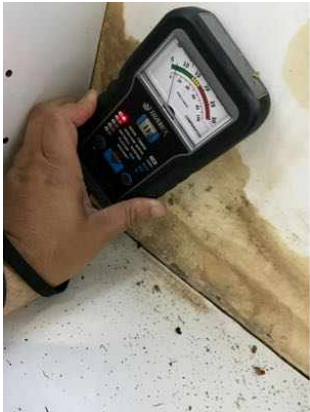
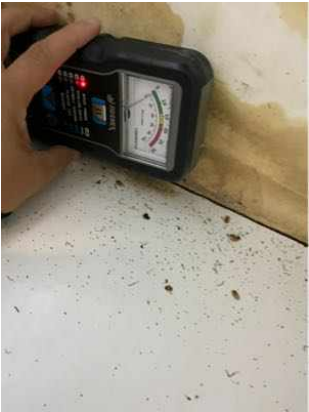
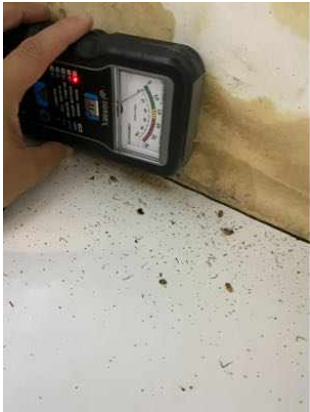
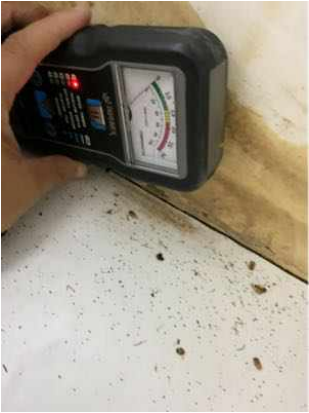
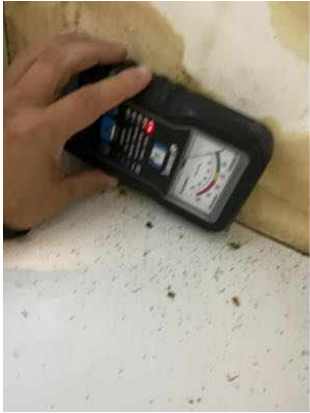
Defects 3.04

Building:	Main Building
Location:	Kitchen
Finding:	Water damage / Vanity
Information:	"The vanity in the shower area has sustained water damage, resulting in swelling and discoloration of the wood, as well as potential structural issues. This damage compromises both the aesthetic and functional aspects of the vanity."

1. **Carpenter or Woodworker:** They can assess and repair the damage to the vanity, potentially replacing any irreparable parts.
2. **Plumber:** If the water damage is due to plumbing issues, a plumber can fix leaks and ensure there are no further water-related problems.
3. **General Contractor:** If the damage is extensive and affects the surrounding area, a general contractor can coordinate the repair work, including both the vanity and any related structural or cosmetic repairs.

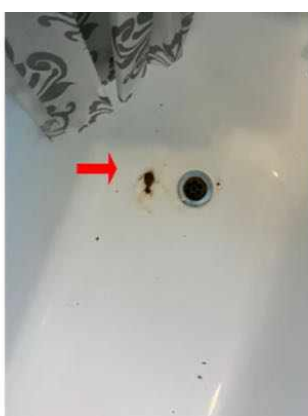
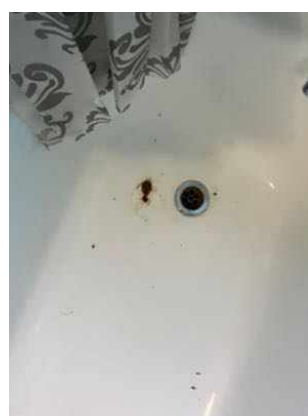
Defects 3.05

Building: Main Building
Location: Bathroom
Finding: Bathtub Stains
Information: This staining is indicative of long-term water exposure, possibly due to slow drainage, water quality issues, or the deterioration of materials in the bath.

- **Aesthetic Damage:** The stains detract from the visual appeal of the bathroom and may affect its overall cleanliness perception.
- **Material Degradation:** The source of the stains, such as rust or hard water, may eventually contribute to the deterioration of the bathtub's surface, leading to further damage if not addressed.
- **Plumbing Issues:** If the staining is caused by slow drainage or leaks, this may indicate a more significant issue with the plumbing that could worsen over time.

- **Professional Cleaner:** A professional cleaner specializing in bathroom or surface restoration can attempt to remove the stains using appropriate cleaning agents.
- **Plumber:** If the staining is caused by slow drainage, a plumber should inspect the drainage system for blockages or leaks.
- **Bath Refinishing Specialist:** If the staining is severe or has caused damage to the surface, a refinishing specialist can repair or recoat the bathtub.

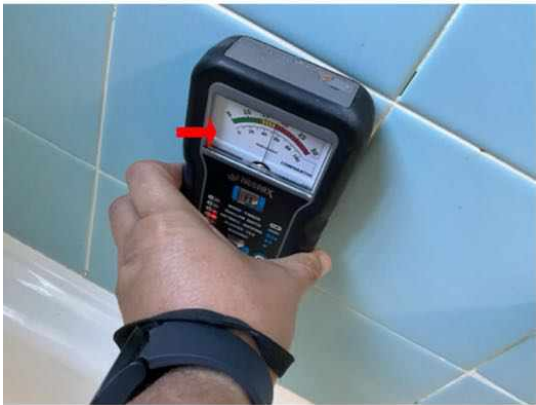
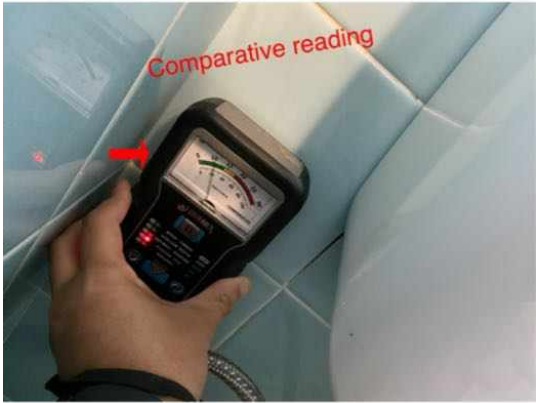
Defects 3.06

Finding: Evidence of excessive moisture was present at the time of inspection
Information: Excessive moisture is present behind the bathroom tiles, indicating a potential water leakage issue within the wall.

The prolonged presence of moisture can lead to mold growth, deteriorate the structure, and create an environment conducive to health hazards. Additionally, it may compromise the adhesive holding the tiles, leading to their detachment.

A licensed plumber or a qualified contractor specializing in water damage remediation should investigate the source of the moisture, fix any leaks, and address the damage. Additionally, replacing affected tiles and ensuring proper waterproofing are crucial to preventing future issues.

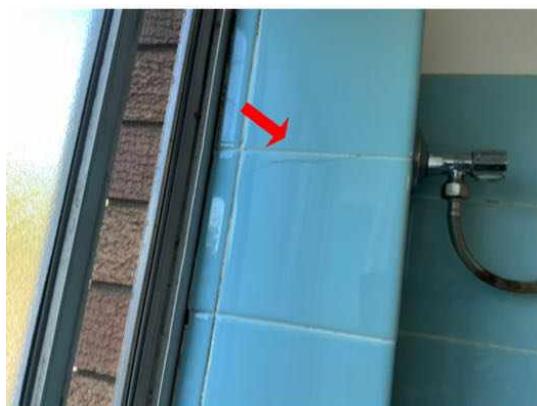
Defects 3.08

Building:	Main Building
Location:	Bathroom
Finding:	Tiles - Cracked or damaged
Information:	Cracking was evident to the tiling in this area at the time of inspection. While the cracking appears to be minor, this area is frequently exposed to water, allowing potential for water penetration into adjoining sections of walls or flooring.

If left unmanaged, water penetration to these areas may lead to subsequent water damage, which is likely necessitate repair work to affected building elements.

A tiling contractor should be appointed to ensure that no further water damage occurs. The re-application of silicone and grouting throughout remaining tile work is also advised, to further protect the area against water penetration.

Where water penetration has led to water damage, appointment of a relevant tradesperson may be required to repair damaged building elements.

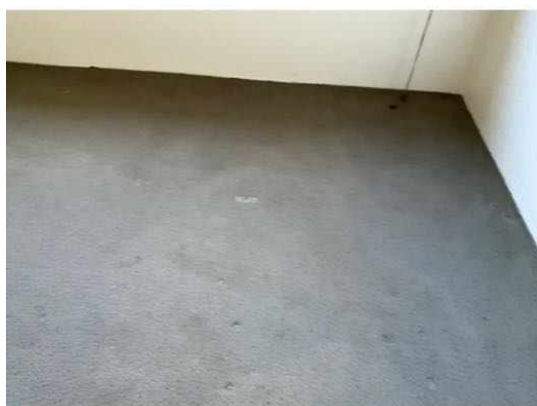
Defects 3.09

Building:	Main Building
Location:	All Areas
Finding:	carpet exhibits visible signs of aging
Information:	Carpets are exhibiting visible signs of aging, including fraying edges, faded colors, and flattened fibers, diminishing their aesthetic appeal and functional quality.

The risk associated with aging carpets includes diminished appearance, decreased comfort, potential tripping hazards due to frayed edges, and a negative impact on indoor air quality if fibers begin to degrade and release particles into the air.

Professional carpet cleaning and restoration services can address issues such as deep cleaning to rejuvenate colors, repairing frayed edges, and restoring fibers. Additionally, replacing the carpets entirely may be necessary in severe cases of aging or damage beyond repair.

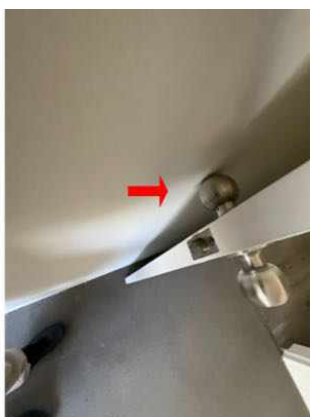
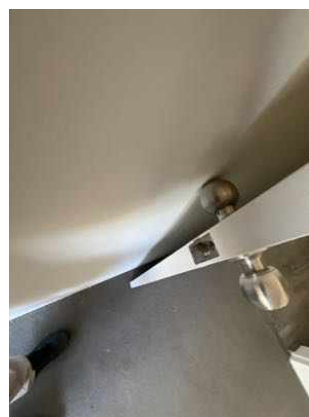
Defects 3.10

Building:	Main Building
Location:	All Areas
Finding:	Missing Door Stopper
Information:	The door lacks a stopper, which is essential to prevent the door from swinging too far and potentially damaging the wall or the door handle. The absence of a door stopper increases the likelihood of impact damage to both the door and surrounding surfaces over time.

- **Damage Risk:** Moderate risk of damage to the door handle, wall, or door itself from repeated impacts when the door is opened forcefully or by a gust of wind.
- **Wear and Tear Risk:** Increased wear on door hardware and hinges due to the potential for abrupt stops without a dedicated stopper.

This issue is a minor defect but should be addressed to prevent potential damage and

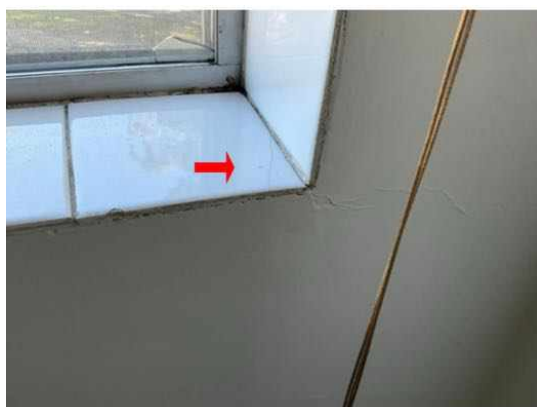
Defects 3.11

Building: Main Building
 Location: Bedroom 2
 Finding: Tile Damaged
 Information: A tile is visibly damaged, showing a chipped/broken section on the surface.

The damaged tile presents a trip hazard, may lead to cuts if stepped on barefoot, and can allow moisture ingress into the substrate, which may cause further deterioration or loosening of adjacent tiles. It also affects the overall appearance of the floor.

A licensed tiler should be engaged to remove the damaged tile and install a matching replacement. If spare tiles are unavailable, additional remedial work may be required to blend the repair with surrounding finishes.

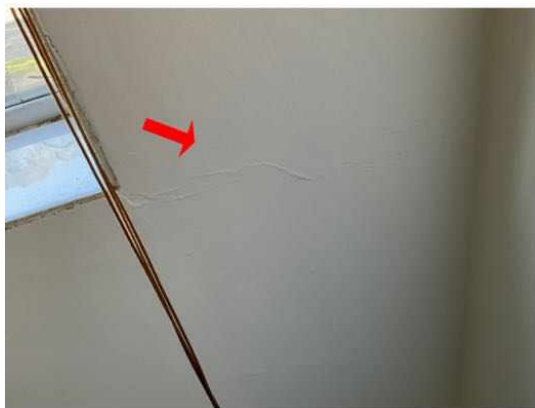
Defects 3.12

Finding: Brickwork - Cracking [Fine]

Information: Although fine cracks are quite noticeable, they are often only considered to be an appearance defect and usually do not indicate any structural damage. Generally, the cause of a fine crack is indicative of a separation between brickwork and mortar throughout the structure, but single bricks may also show cracks of this nature.

Cracking of this nature can generally be repaired with minor filling and should be conducted by a qualified bricklayer.

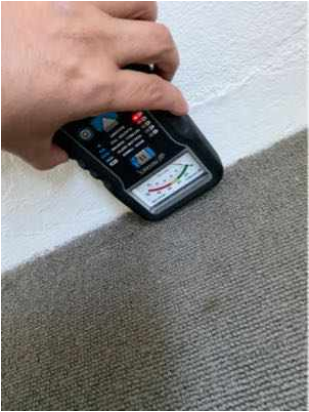
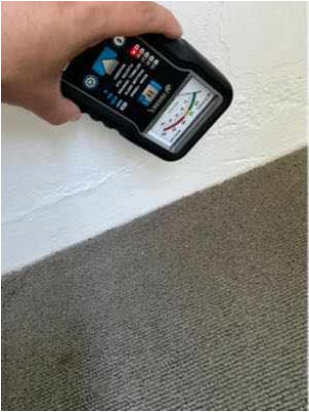
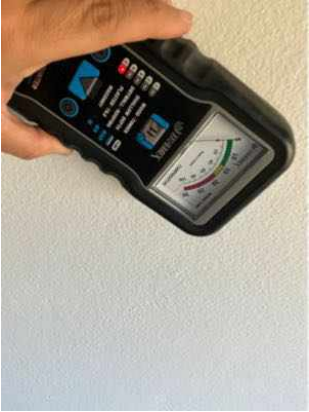
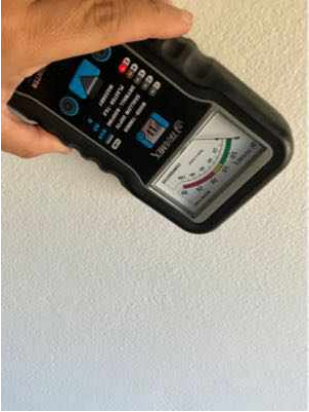
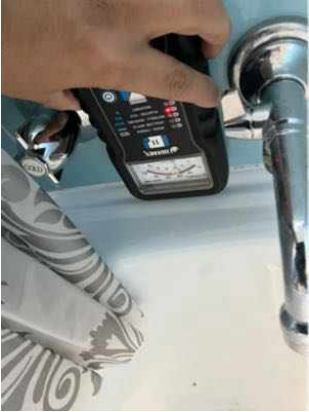
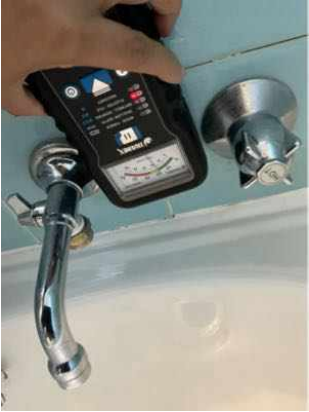
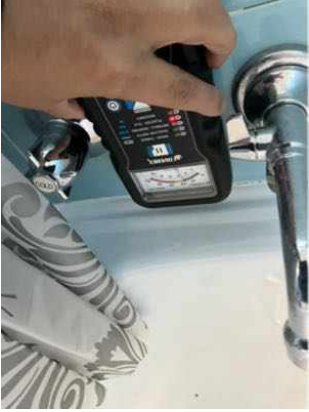
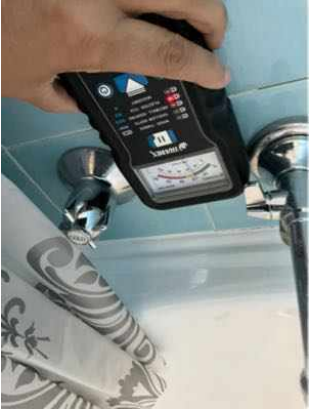
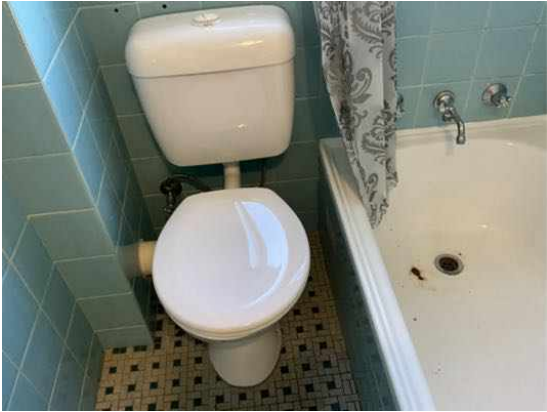
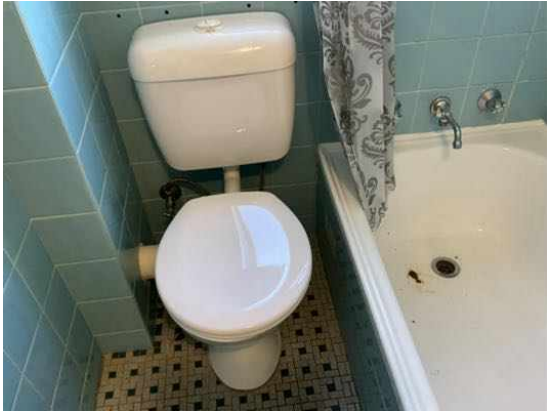
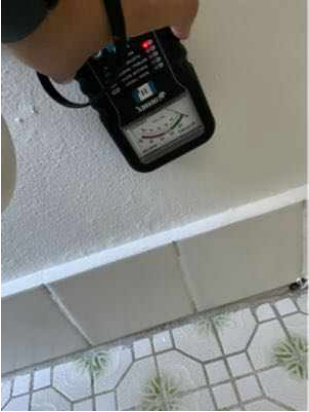
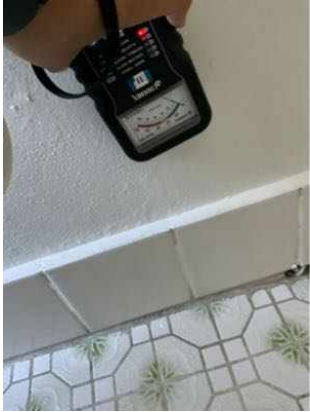
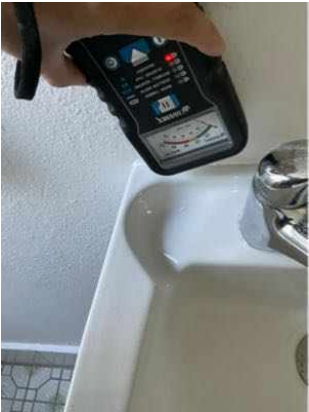
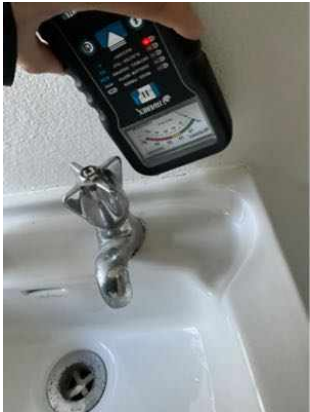
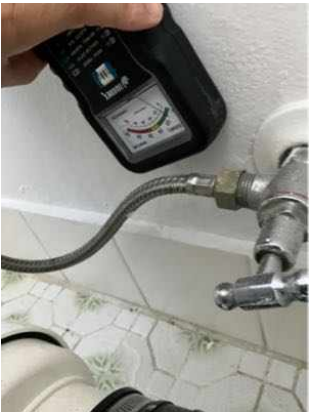
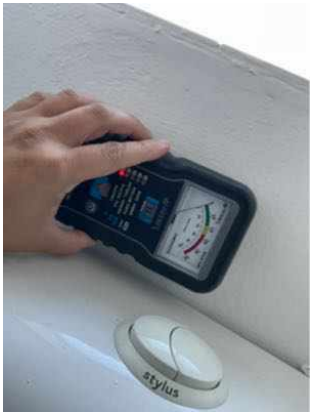
Building: Main Building
Location: All Areas
Finding: Additional Photos
Information: Additional photos are provided for your general reference

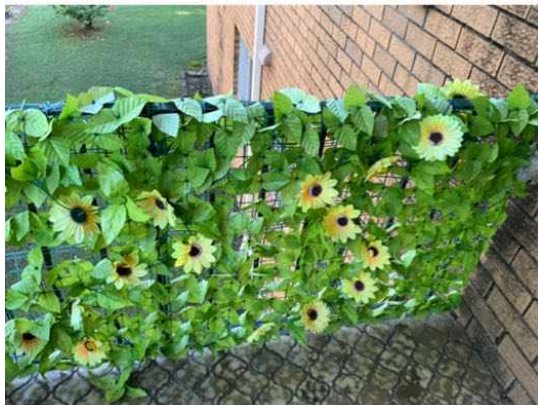
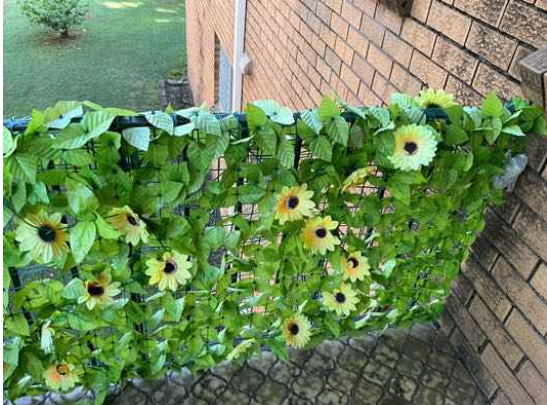
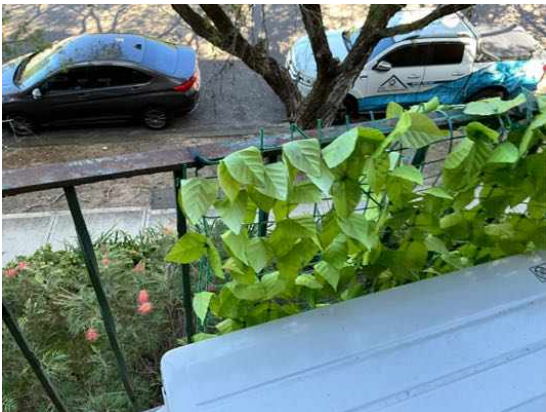
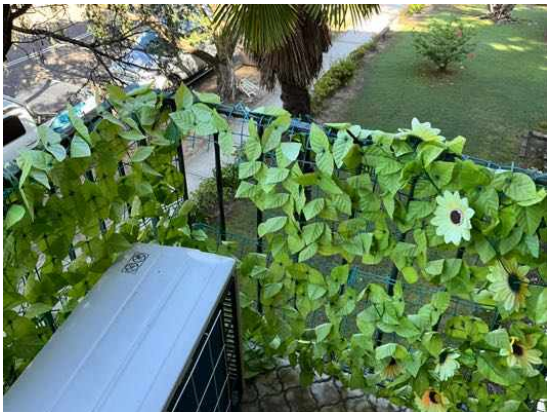
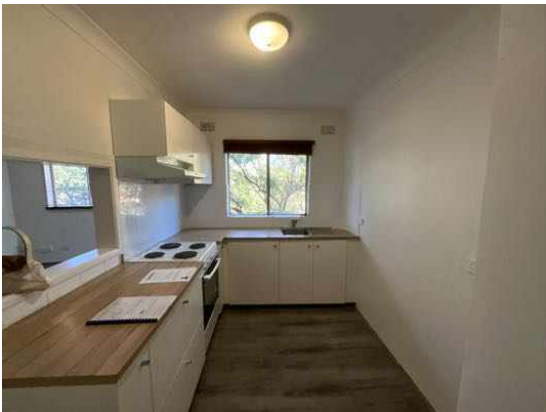
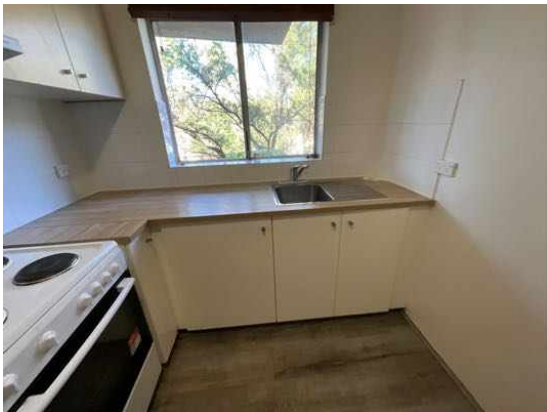
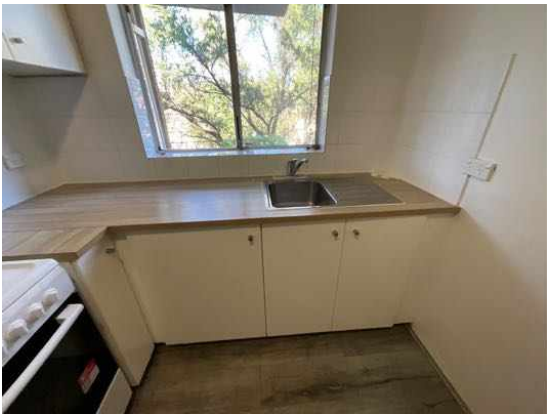
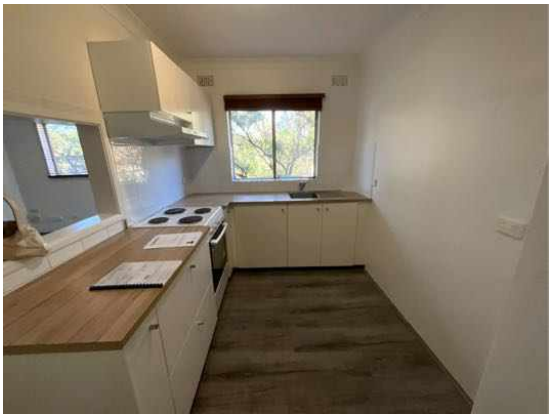
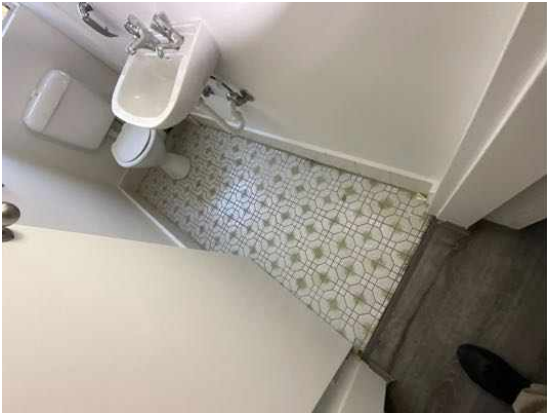
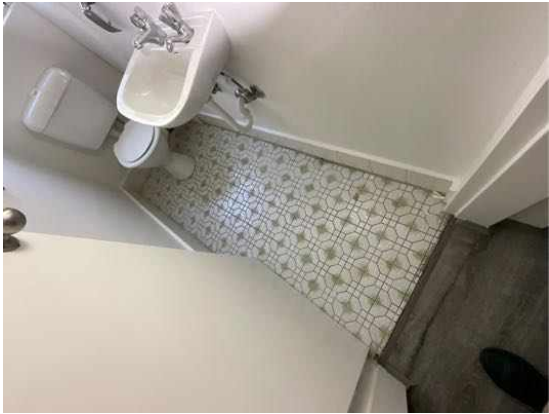
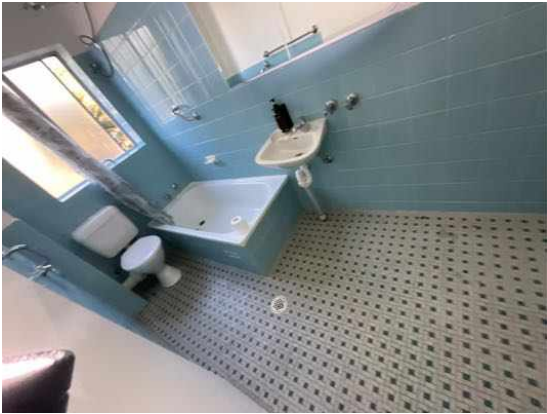
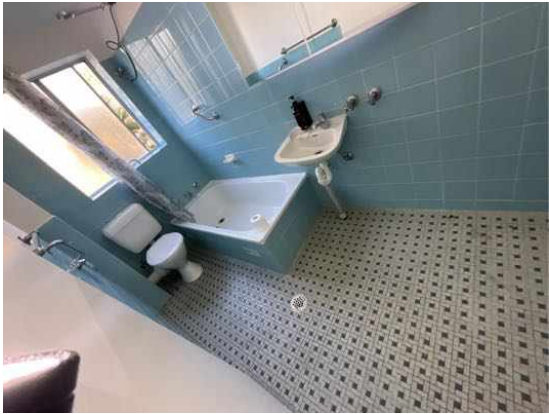
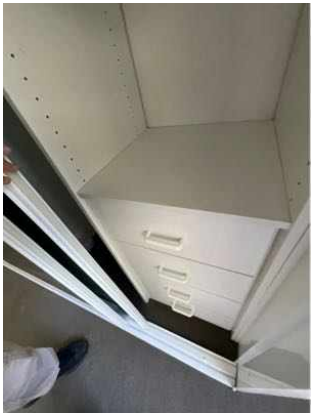
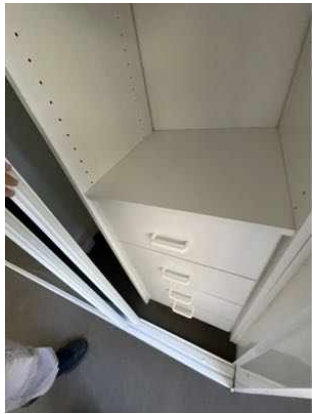
Building: Main Building
Location: All Areas
Finding: Additional Photos - Obstructions and Limitations
Information: These photographs are an indication of the obstructions and limitations which impeded full inspection of the property at the time of inspection. These obstructions can hide an array of defects and should be removed to allow full inspection to be carried out. A re-inspection is recommended once the areas are made accessible.
