Building Inspection Report

Inspection Date: Tue, 13 Jan 2026

Property Address: Unit 205, 24 Crimea St, St Kilda Vic 3182

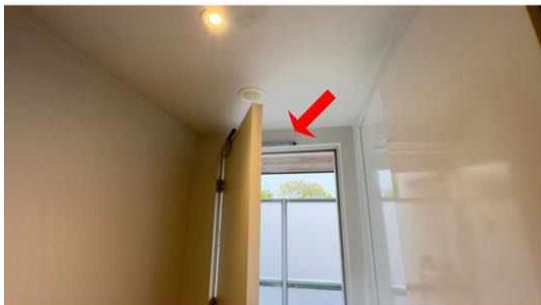
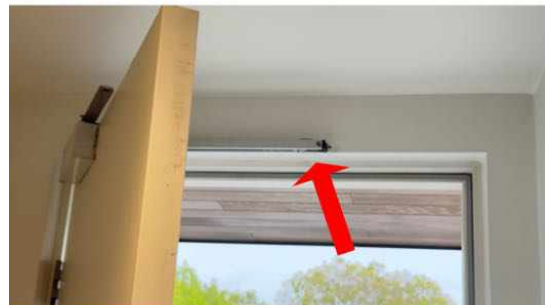
Defects 1.01

Building: Main Building
Location: Entry
Finding: Doors - Fire Door Closer Not Connected (Safety Hazard)
Information: The fire-rated door was observed to have a door closer installed but not connected or operational at the time of inspection. A non-functional door closer prevents the fire door from self-closing as required, which compromises the fire separation, smoke control, and overall fire safety performance of the building.

This condition is likely due to incomplete installation, disconnection during maintenance works, or general neglect.

The fire-rated entry door was observed to have a door closer installed but not connected or operational at the time of inspection. A non-functional door closer prevents the fire door from self-closing as required, which compromises the fire separation, smoke control, and overall fire safety performance of the building.

A suitably qualified door hardware contractor or fire services technician should be engaged immediately to reconnect, adjust, or replace the door closer and confirm the fire door is fully operational and compliant with relevant fire safety regulations and Australian Standards. Prompt rectification is required as this represents a safety hazard.

A suitably qualified door hardware contractor or fire services technician should be engaged immediately to reconnect, adjust, or replace the door closer and confirm the fire door is fully operational and compliant with relevant fire safety regulations and Australian Standards.

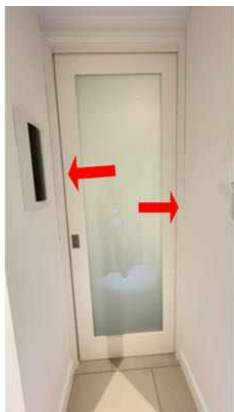
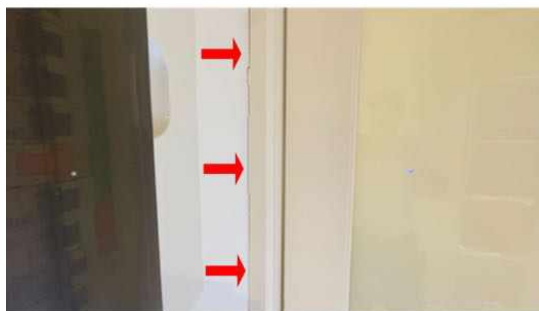
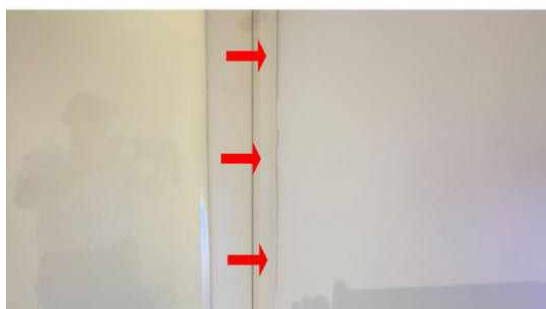
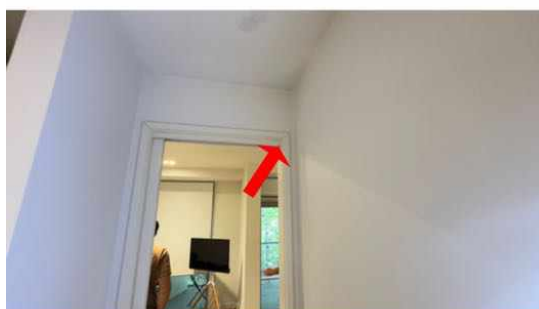
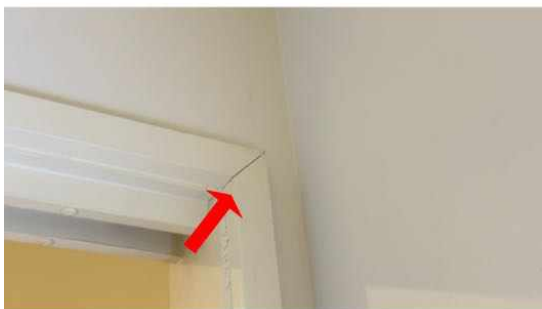
Defects 3.01

Information: Minor movement was noted in the architraves and skirting boards in this area, with small gaps at joints, slight separations from adjoining surfaces, and minor cracking in paint and sealant. This movement appears superficial and is generally related to normal timber behaviour or minor building settlement.

Common causes include seasonal timber shrinkage or expansion, slight building settlement, historic moisture or thermal movement, or insufficient fixing during installation. While largely cosmetic, these gaps and cracks can affect the appearance of finishes. If left unaddressed, minor deterioration may continue over time.

When practical, a qualified painter should be engaged to fill and repaint affected areas, to restore a neat finish.

Ongoing monitoring is advised, especially after seasonal changes. If movement worsens, a structural engineer should be consulted immediately to assess and recommend any necessary repairs.

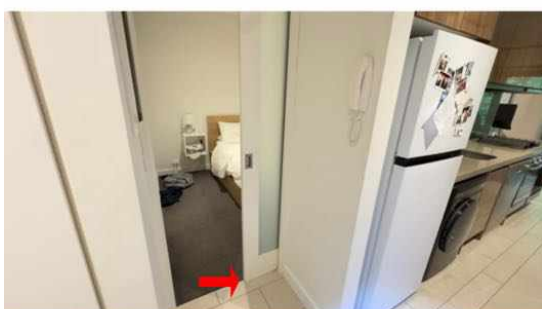
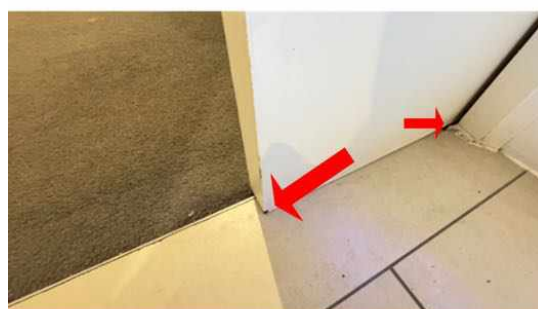
Defects 3.02

Building: Main Building
 Location: Bedroom - Master >
 Finding: Doors - Binding Sliding Doors
 Information: The sliding door in this area is binding and does not operate smoothly. This can affect the functionality of the door, making it difficult to open and close, and may cause wear or damage to the door and track over time.

Possible causes include misalignment of the door within its frame, worn or damaged rollers, or inadequate installation.

A qualified carpenter or door specialist should be engaged immediately to inspect the door, clear any obstructions, adjust the alignment, or repair/replace components as required to ensure smooth and safe operation.

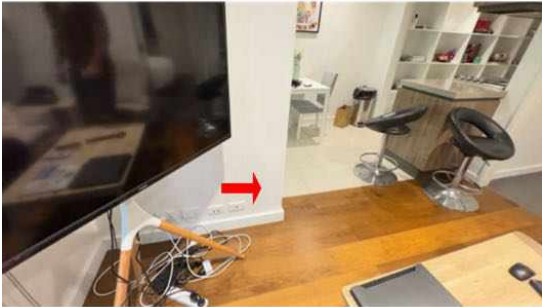
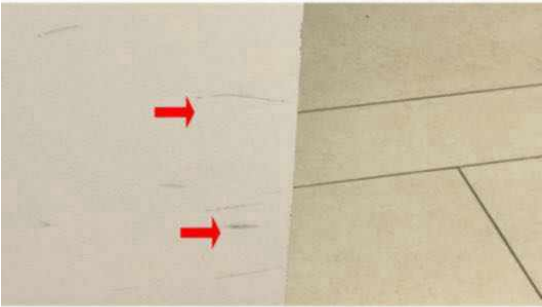
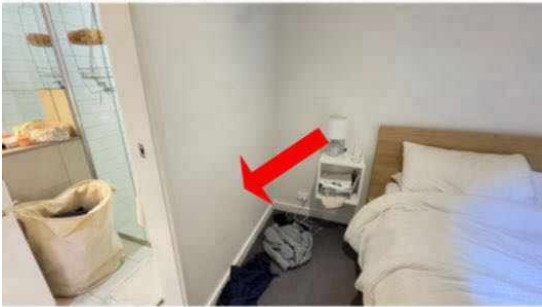
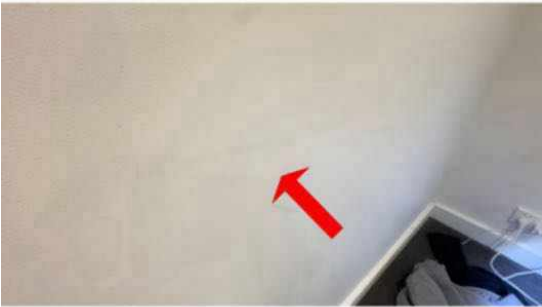
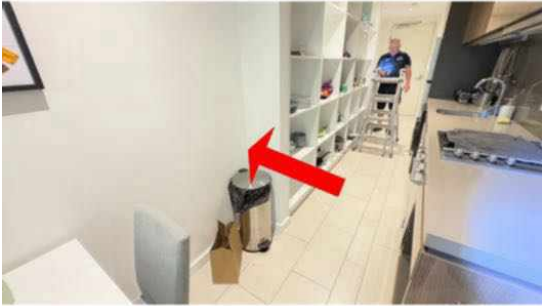
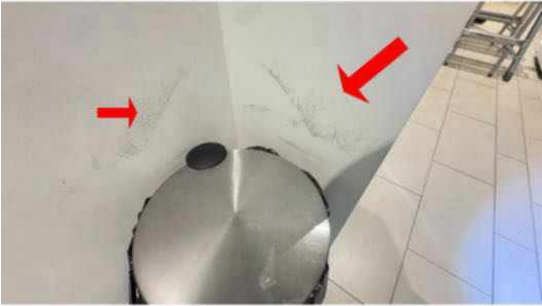
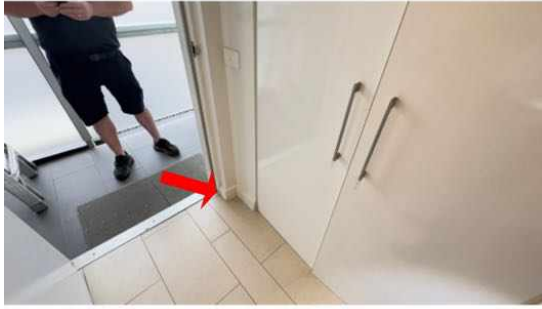
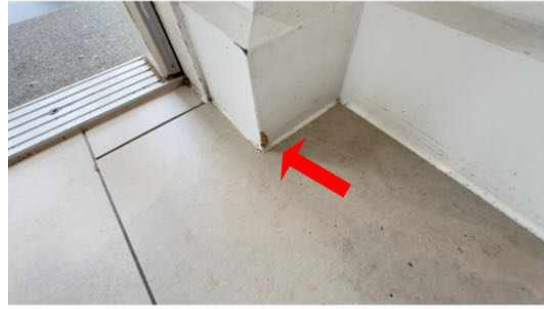
Defects 3.03

Building: Main Building
 Location: Lounge Room, Kitchen >
 Finding: Walls - Scuff Marks
 Information: The walls were inspected for paint condition, and discolouration was observed. While primarily a cosmetic issue, deteriorated paint may indicate poor surface preparation, or

age-related wear.

Possible causes include age-related wear and impact damage.

A qualified painter should be engaged when practical to prepare and repaint affected areas. Addressing paint deterioration improves aesthetics and protects wall materials from further wear.

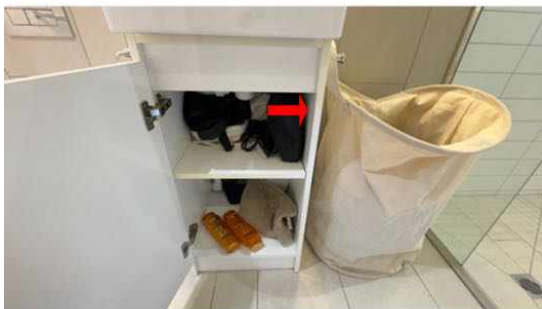
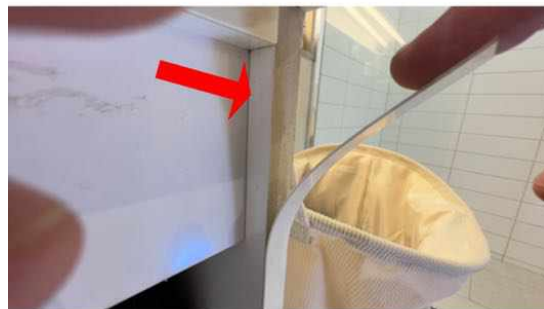
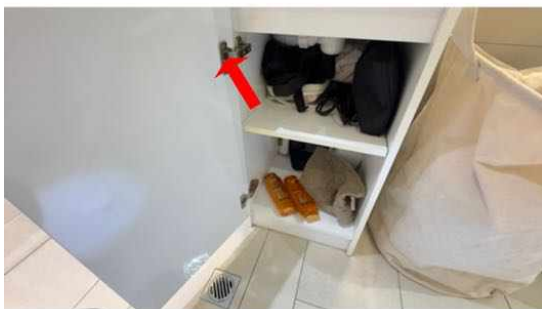
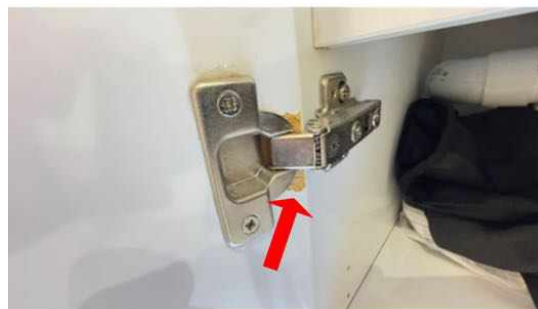
Defects 3.04

Building: Main Building
 Location: Ensuite - Master >
 Finding: Cabinets - Damaged
 Information: Visible damage was noted to cabinet units, affecting both their appearance and functionality. If left unaddressed, the damage may worsen over time.

This damage may result from impact during installation or use, moisture exposure, poor-quality materials or finishes, or inadequate installation and protection during construction. *No elevated moisture levels were detected at the time of inspection.

When practical, a qualified cabinetmaker should be engaged to repair or replace the damaged components to restore proper function and appearance.

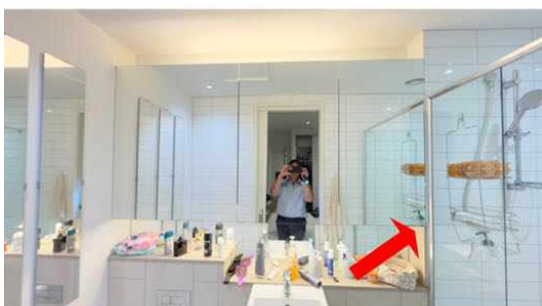
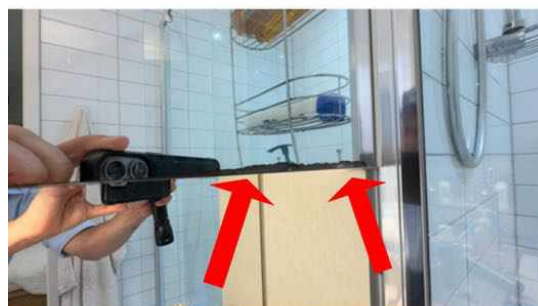
Defects 3.05

Building: Main Building
 Location: Ensuite - Master
 Finding: Bathroom Mirrors - Edge Deterioration
 Information: Mirrors were observed to have edge deterioration in this area. Damaged mirrors can be a safety hazard due to sharp edges, reduce visual appeal, and affect functional use.

This may be due to age-related wear, poor installation, or exposure to moisture causing edge damage.

A qualified glazier or bathroom specialist should be engaged without delay to inspect and repair or replace the damaged mirrors. This may include replacing affected mirrors, securing the mounting, and ensuring edges are properly sealed. Prompt action will help prevent injury, restore functionality, and maintain appearance.

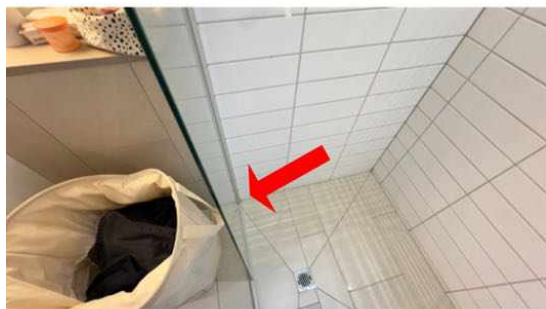
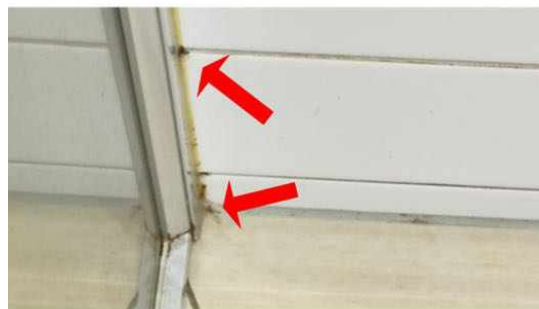
Defects 3.06

Building: Main Building
 Location: Ensuite - Master
 Finding: Shower - Minor Mould
 Information: Mould growth was observed in this area. The affected areas showed visible signs of

surface mould, indicating that moisture has been present for a period of time.

Mould can pose health risks to occupants and may accelerate the deterioration of building materials, including wall linings, paint, and structural elements. Its presence is often a sign of underlying moisture issues that require further investigation.

It is recommended that this area be thoroughly cleaned to prevent further mould growth.

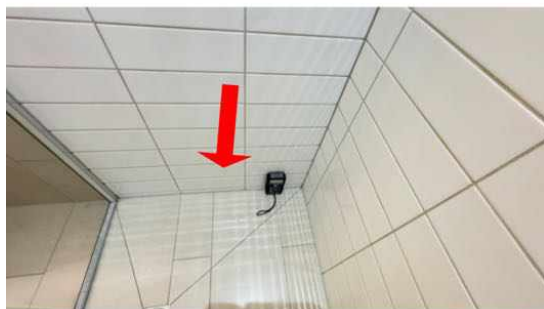
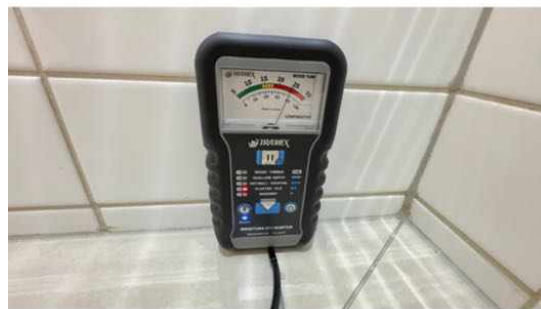
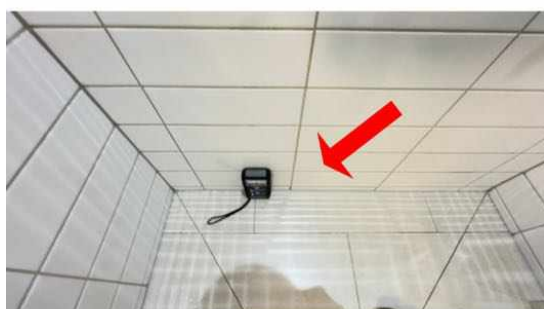
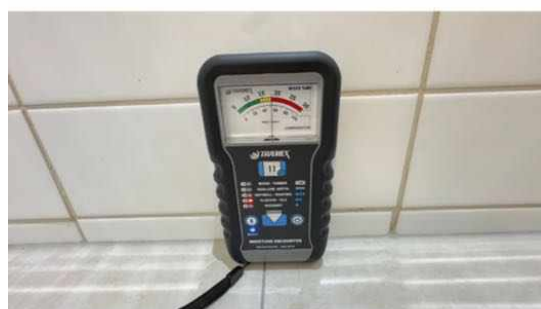
Defects 3.07

Building:	Main Building
Location:	Ensuite - Master >
Finding:	Shower Damp - To Be Monitored & Epoxy Grout
Information:	Damp is evident to the lower wall to the shower alcove and acceptable level moisture readings were found to the reverse side of the shower. Moisture readings were not found to the wall adjacent to the shower.

Damp (or structural damp) refers to the presence of unwanted moisture in the structure of a building, either as the result of intrusion from outside, or condensation from within the structure. In the shower area, internal water leaks or other sources of excessive moisture are generally the cause of damp.

It is advised to engage an epoxy grout specialist to remove and replace the grout with epoxy grout and install epoxy to all floor wall corner joints.

Always ensure that sealant and grout is in good condition to prevent any moisture issues occurring in the future

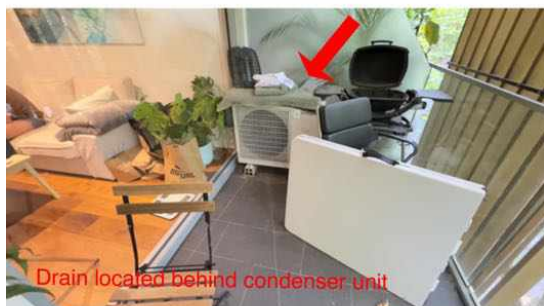
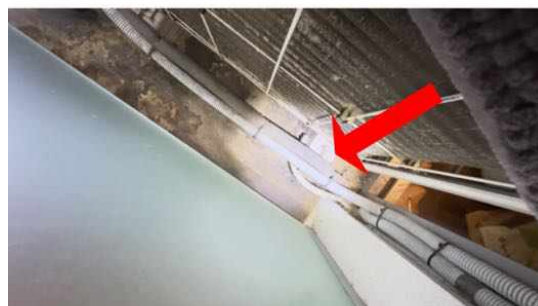
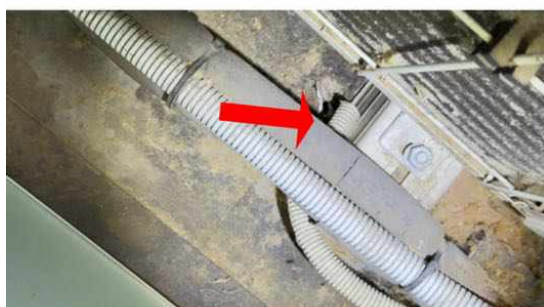
Defects 3.09

Information: The balcony drain was observed to be blocked at the time of inspection. A blocked drain prevents effective surface water runoff, resulting in water ponding which can lead to water ingress into adjoining structures, deterioration of waterproofing membranes, concrete spalling, corrosion of reinforcement, and potential damage to internal finishes.

The blockage is likely caused by debris accumulation and lack of regular maintenance.

A qualified plumber or building maintenance contractor should be engaged immediately to clear the drain, confirm adequate falls, and inspect the waterproofing system for damage. Prompt rectification is required to prevent ongoing water damage and potential structural deterioration.

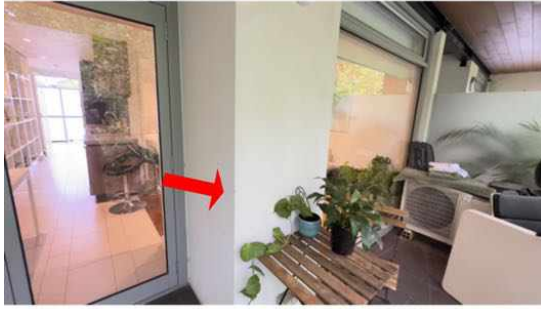
Defects 3.10

Building:	Main Building
Location:	Balcony
Finding:	Walls - Rendered Walls Damaged
Information:	Minor damage to wall surfaces was observed in this area, including small dents, chips, and surface imperfections. This type of damage is commonly associated with general wear and tear, minor impact, or movement over time.

While the damage is not considered structural in nature, it detracts from the overall presentation and finish of the property. Ongoing deterioration may occur if left unattended.

A suitably qualified renderer or competent handyman should be engaged, at the client's discretion, to carry out minor patching, sanding, and repainting as required to restore the affected areas to an acceptable standard.

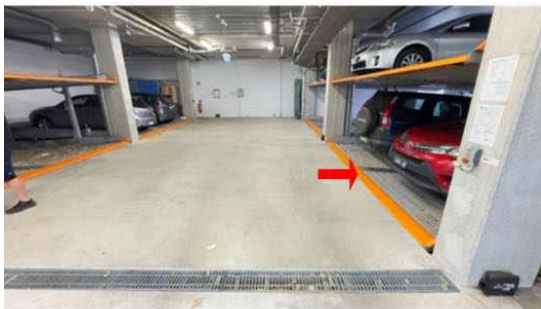
Defects 3.11

Building:	Main Building
Location:	Allocated Car Parking >
Finding:	Allocated Car Parking - Cleanliness & Hygiene
Information:	The allocated car parking space was inspected. At the time of inspection, the area was not in a clean or acceptable condition, likely due to a lack of routine cleaning or post-works housekeeping within the common property.

As this area forms part of the strata-managed common property, responsibility for cleaning and maintenance typically rests with the Owners Corporation, unless otherwise specified in the strata plan or by-laws.

It is recommended that the matter be raised with the strata manager for review and rectification in accordance with the strata maintenance obligations.

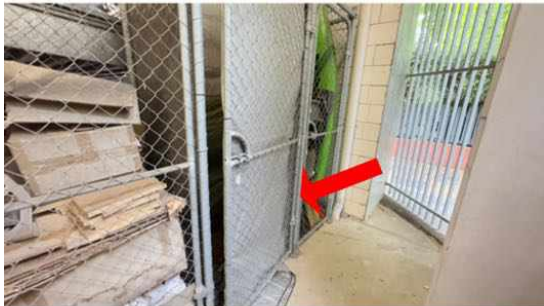
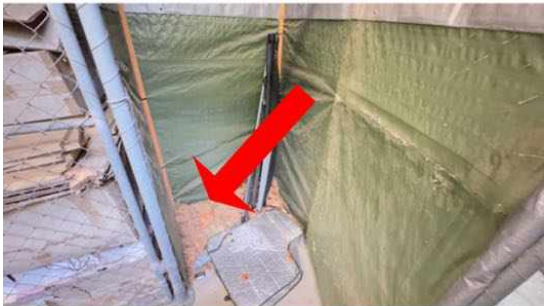
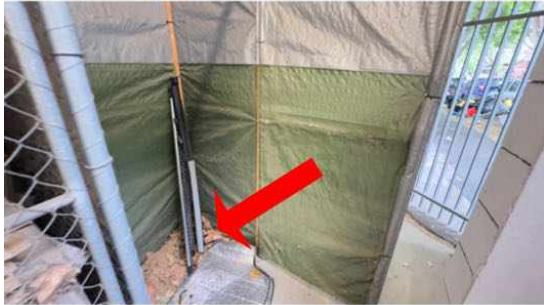
Building: Main Building
Location: Kitchen >
Finding: Allocated Storage Cage - Cleanliness & Hygiene
Information: The allocated storage cage was inspected. At the time of inspection, the area was not in a clean or acceptable condition, likely due to a lack of routine cleaning.

The responsibility for cleaning and maintenance typically rests with the property owners and or tenants, unless otherwise specified in the strata plan or by-laws.

It is recommended that this area be thoroughly cleaned by a competent cleaner and or the matter be raised with the strata manager for review and rectification in accordance with the strata maintenance obligations.

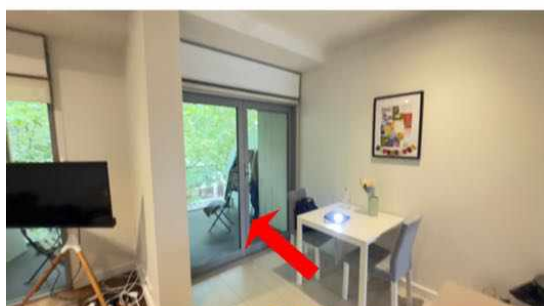
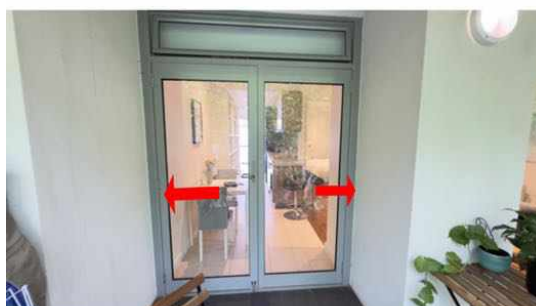
Building: Main Building
 Location: Lounge Room
 Finding: Flyscreens - Missing
 Information: At the time of inspection, flyscreens were observed to be missing from the windows in this area. It could not be determined whether the flyscreens were never installed or were removed after installation.

The absence of this building element detracts from the functional performance of the windows. Missing flyscreens increase the risk of insect and pest ingress into the adjoining rooms and reduce the overall amenity of the property.

It is recommended that all missing flyscreens be installed or replaced to restore the intended function of the windows and improve occupant comfort. A suitably qualified handyman may be engaged to carry out these works at the client's discretion.

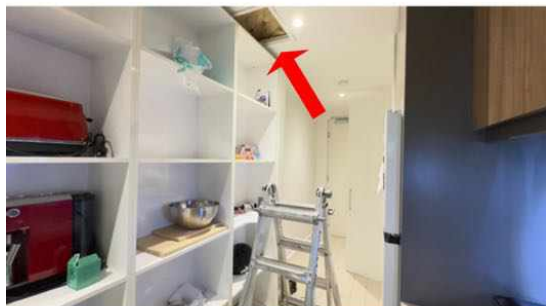
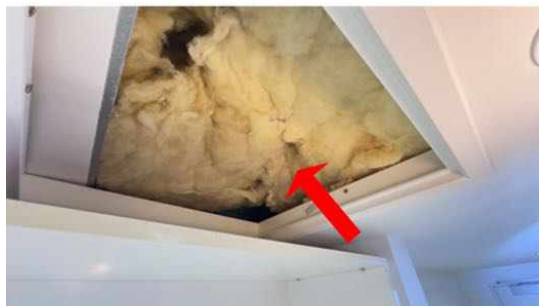
Building: Main Building
 Location: Roof Void
 Finding: Roof Void - Limited Access
 Information: Limited access to the roof void was present due to facts including but not limited to, limited access, insulation, Air condition Unit & ducting, obstructions or placement of insulation and or sarking, for this reason complete access to the roof void was not possible.

A visual inspection was carried out from accessible areas only, recommend installing another access hatch in a more accessible area for a re-inspection.

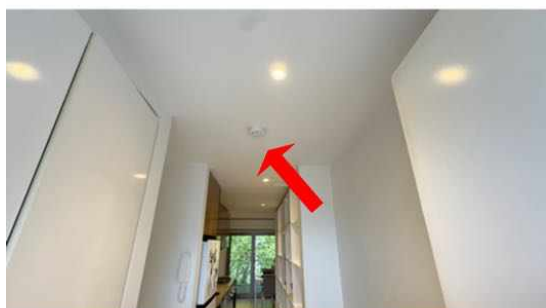
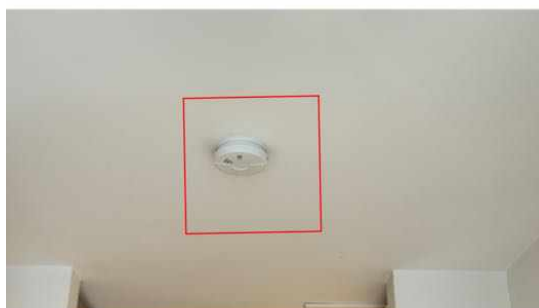
Building: Main Building
 Location: All Internal Areas
 Finding: Smoke Detectors - Advisory
 Information: During the inspection, smoke detectors were noted for advisory purposes only. The operation, age, type, and compliance of smoke detectors could not be fully verified as part of this inspection.

Smoke detectors are critical life-safety devices, and non-compliant, outdated, or non-operational units may not provide adequate warning in the event of a fire.

It is recommended that a licensed electrician be engaged immediately to test, service, and upgrade smoke detectors as required to ensure correct operation and compliance with current safety requirements.

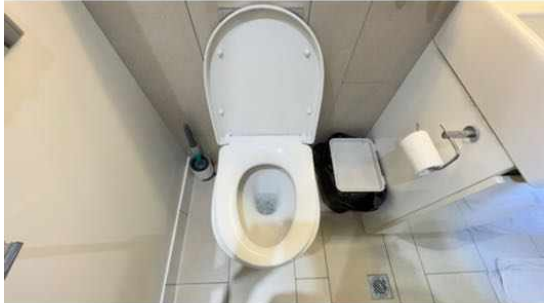
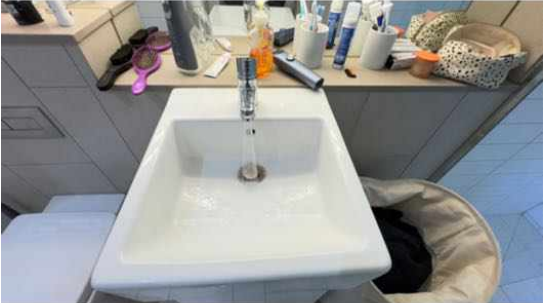
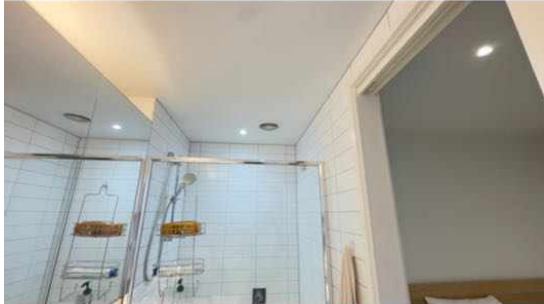
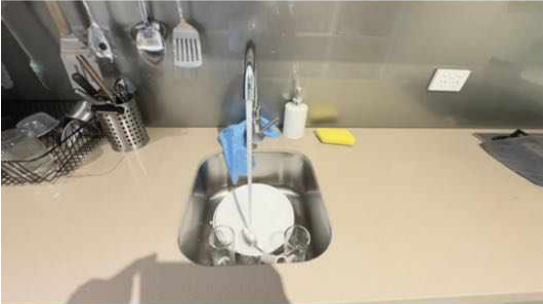
Building: Main Building
Location: All Internal Areas
Finding: Water Supply & Drainage - Shower, Basins, Toilets, & Plumbing Fixtures
Information: The shower recess was tested, and no visible water penetration to surrounding areas was observed at the time of inspection, except where noted as a separate defect elsewhere in this report. Water appeared to flow freely toward the floor waste. Moisture detected to the shower walls is documented separately in the report. The shower floor waste appeared clear during inspection.

Flushing the toilet revealed no visible leaks, and the fixture appeared to operate normally unless otherwise noted as a separate defect. No water damage was observed to the vanity unit unless specifically stated elsewhere in the report. Basins, bathtubs, laundry tubs, vanities, and sinks were tested and inspected with no evidence of leaks, blockages, or drainage issues at the time of inspection unless otherwise noted. All internal taps and shower heads were tested with no leaks observed, unless documented as a separate defect.

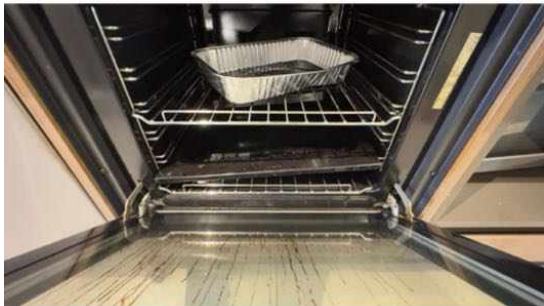
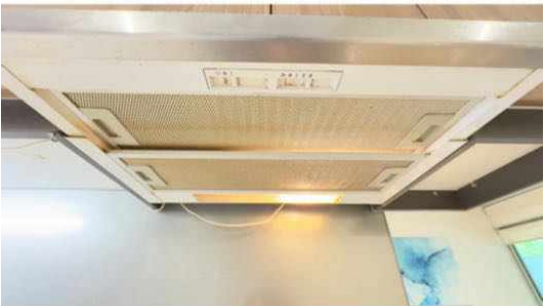
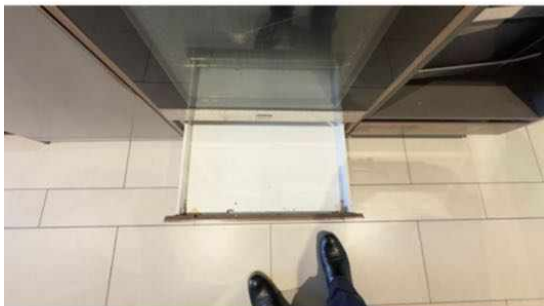
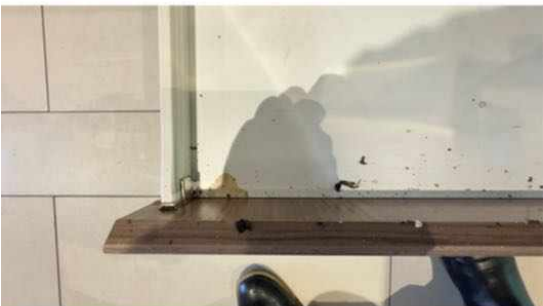
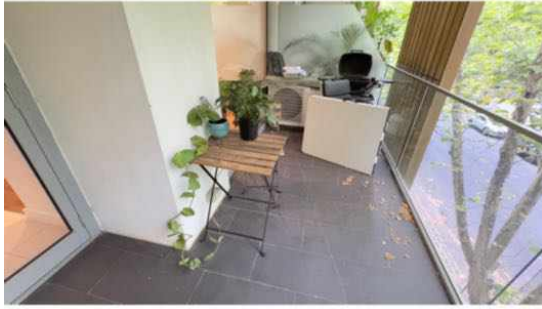
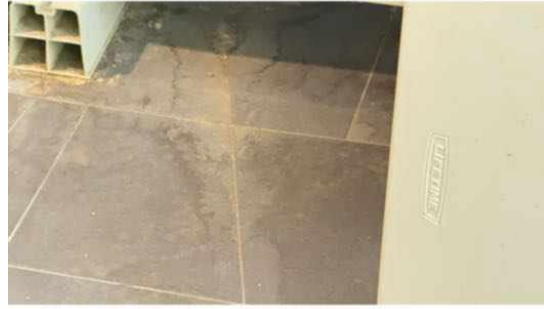
Building: Main Building
Location: All Areas
Finding: Cleanliness & Hygiene - Internal Property Requires Commercial Cleaning
Information: The internal areas of the property, including bedrooms, bathrooms, laundry, floors, carpets, tiles, kitchen surfaces, cupboards, walls, and windows, were observed to require a thorough commercial clean. Accumulated dust, dirt, and general soiling may affect hygiene, indoor air quality, and the overall presentation of the property.

This condition is likely due to routine use, insufficient maintenance, or delayed professional cleaning.

When practical, a professional commercial cleaning service should be engaged to clean all internal surfaces, including bedrooms, bathrooms, laundry, floors, carpets, tiles, kitchen surfaces, cupboards, walls, and windows. Regular cleaning is recommended to maintain hygiene, presentation, and overall amenity of the property.

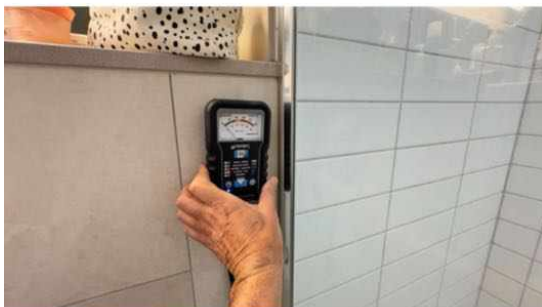
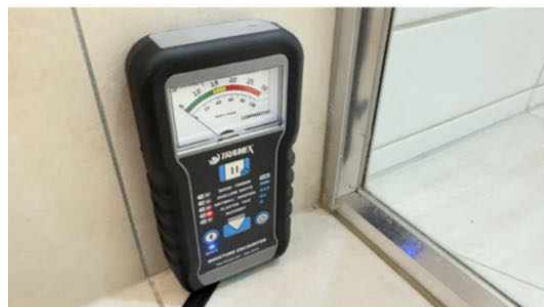
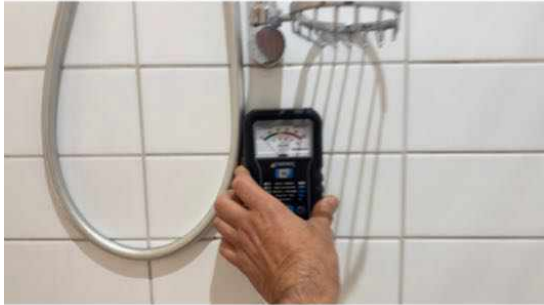
Building: Main Building
 Location: All Areas Interior & Exterior
 Finding: Moisture Levels - Advisory - No Elevated Moisture Levels Present
 Information: At the time of inspection, no elevated moisture levels were detected in these areas. Moisture readings were taken (using a Tramex Moisture Meter) and non-invasive testing methods and reflect conditions present at the time of inspection only. This item is noted for advisory purposes and should not be relied upon as a guarantee that moisture issues are not present elsewhere or may not occur in the future.

It is important to note that moisture levels can fluctuate due to weather conditions, plumbing usage, seasonal changes, or intermittent leaks. Concealed moisture within wall cavities, subfloor areas, or other inaccessible locations may not be detected during a visual or limited moisture assessment.

Ongoing monitoring of the property is recommended, and further investigation by a qualified tradesperson should be considered if signs of water ingress, dampness, staining, mould growth, or material deterioration become apparent.

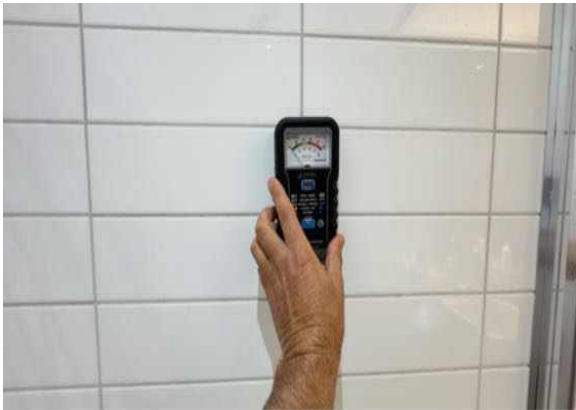
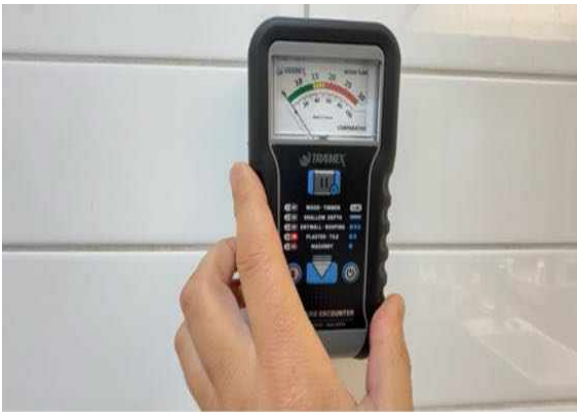
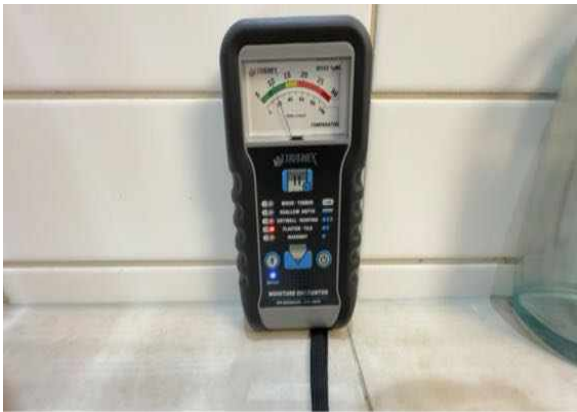
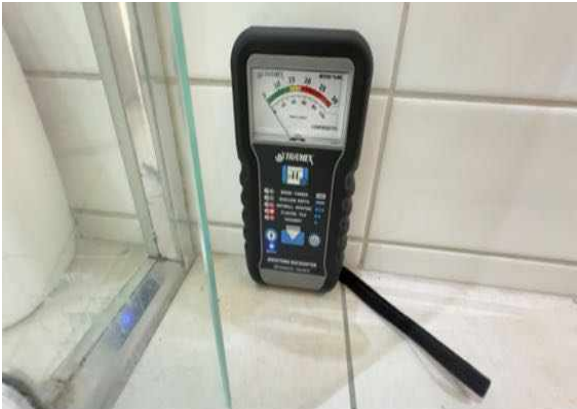
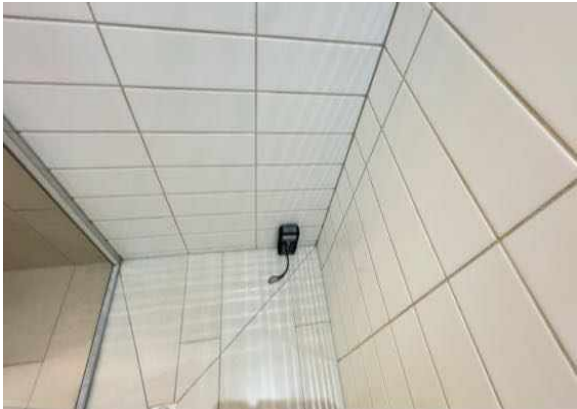
Building: Main Building
 Location: All Areas Interior & Exterior
 Finding: Thermal Scanning & Diagnostic - Advisory - No Elevated Moisture Levels Present
 Information: During the inspection, a thermal imaging camera was utilised as a non-invasive diagnostic tool to assist in identifying potential irregularities associated with moisture ingress, heat loss, insulation deficiencies, or concealed building defects. Thermal imaging detects surface temperature variations that may indicate abnormal conditions within building elements.

Any thermal anomalies identified during the inspection were further assessed where accessible using visual inspection methods and moisture testing. It is noted that thermal imaging is an indicative tool only and does not confirm the presence of defects or moisture without supporting evidence.

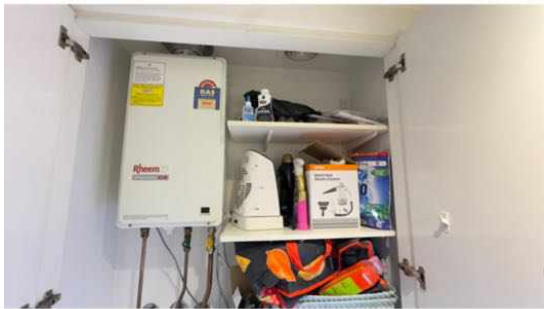
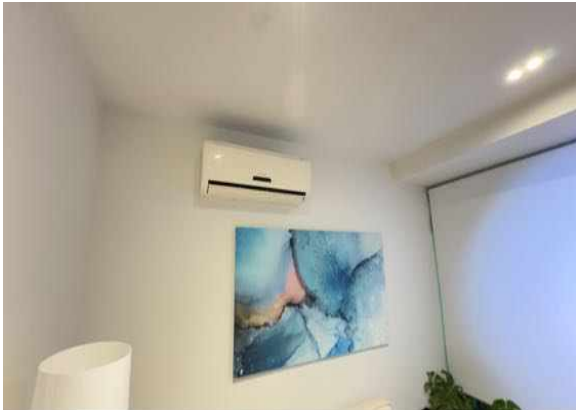
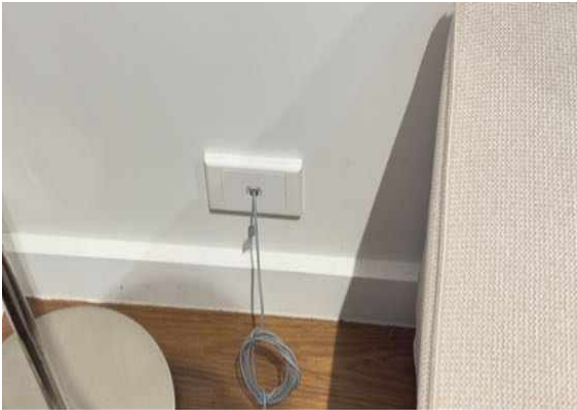
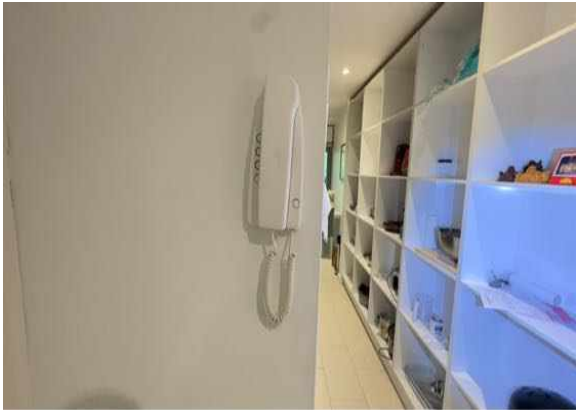
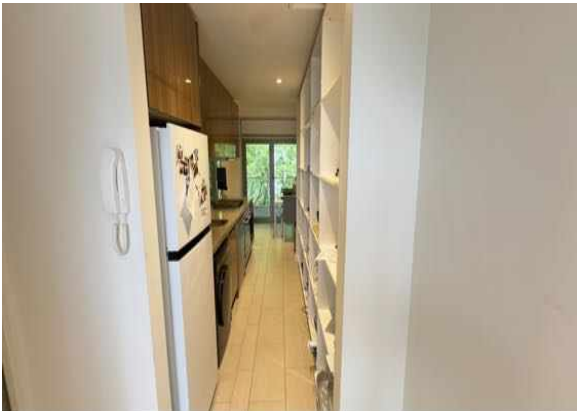
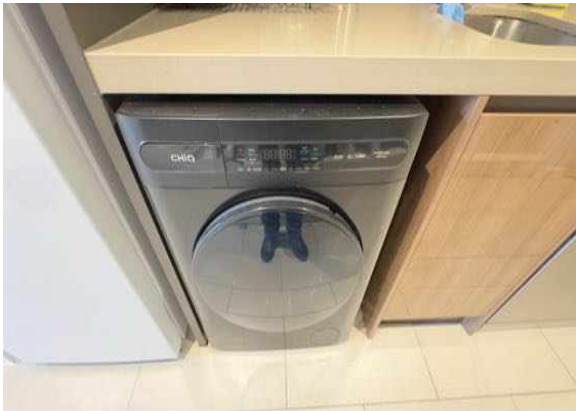
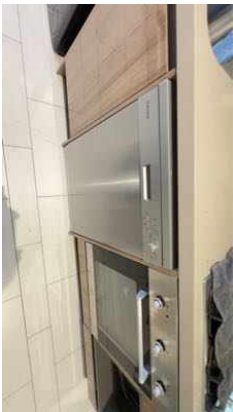
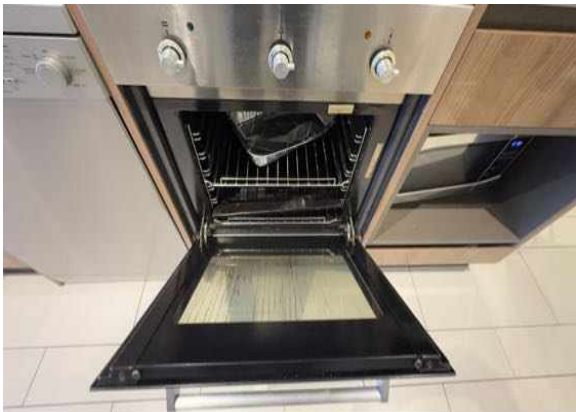
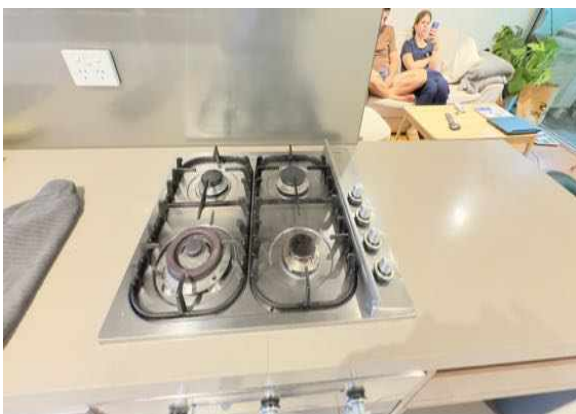
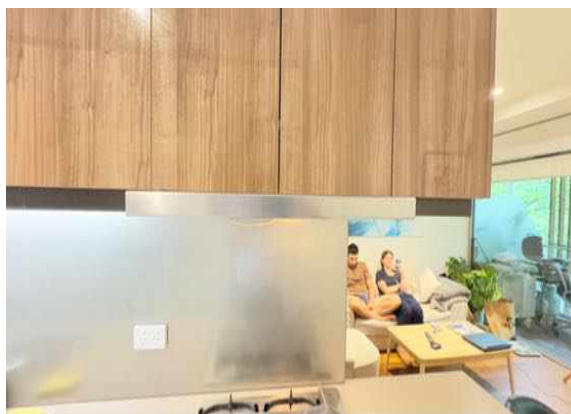
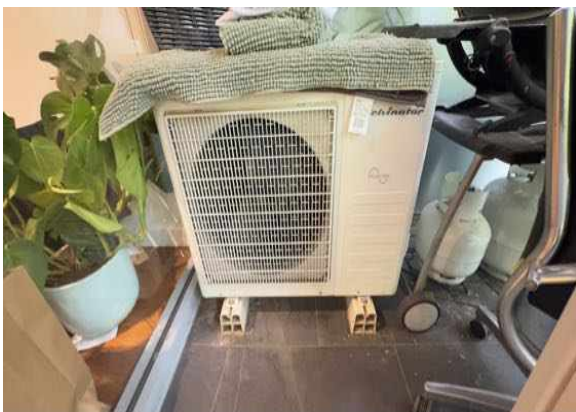
Building:	Main Building
Location:	All Areas, Interior & Exterior
Finding:	Appliances, Heating & Cooling Systems, Mechanical Systems, Plumbing, Electrical, Fireplaces - Advisory
Information:	The inspection did not include testing, operation, safety, or assessment of any installed or portable appliances or mechanical systems. This includes, but is not limited to, ovens, cooktops, microwaves, rangehoods, dishwashers, ducted vacuum systems, air-conditioning units, heating systems, hot water services, ceiling fans, exhaust fans, intercoms, security systems, fireplaces, and solid fuel heaters.

Appliances may be worn, damaged, or malfunctioning. Electrical or gas appliances can pose serious safety hazards if incorrectly installed or maintained.

Service, repair, or replace equipment as necessary, particularly where service history or warranty coverage is unknown.

Inspect any water, gas, or electrical connections associated with appliances to ensure safety and compliance.

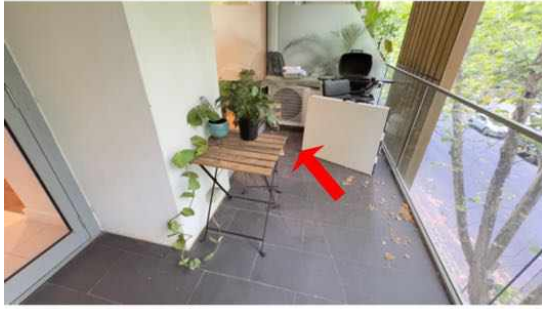
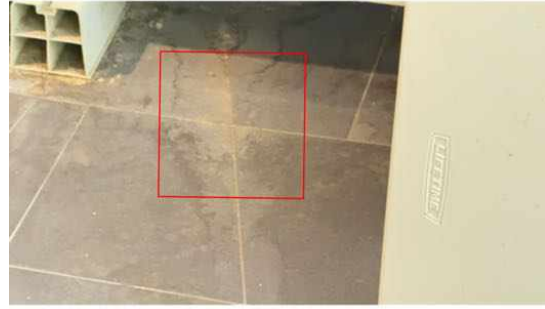
Finding: Site Drainage - Inadequate

Information: The overall site drainage was observed to be inadequate at the time of inspection. Poor drainage can cause water to pond near external walls, increasing the risk of rising damp, foundation movement, timber decay, and deterioration of associated building elements.

Ground levels should slope away from the dwelling to direct water from walls and footings. Downpipes must be properly connected to the stormwater system and should not discharge directly onto walls, paving, or plinths. Stormwater should be directed away from the property through adequately sized and maintained drains. Where ground levels are too high and cover the damp-proof course (DPC), lowering the levels may be necessary to expose the DPC and allow effective drainage.

A licensed plumber should be engaged promptly to investigate and recommend suitable remedial works, which may include the installation of an agricultural (aggie) drain or other site drainage improvements. Immediate action is strongly recommended, as inadequate drainage can lead to progressive water damage and secondary building defects over time.

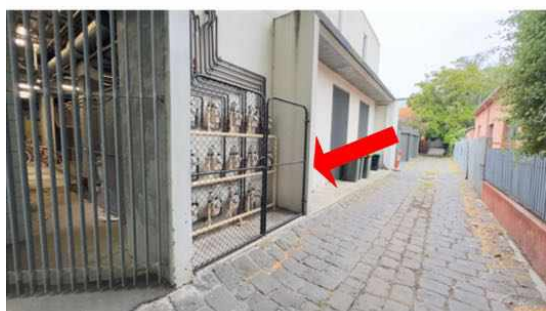
Gas meters can be affected over time by age, environmental exposure, or accidental impact, which may lead to corrosion, physical damage, leakage, or non-compliance with current regulations. Regular checks are recommended to ensure ongoing safe operation.

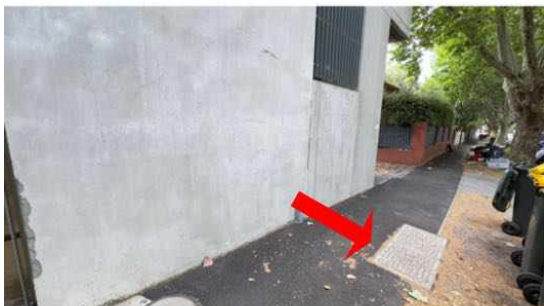
During the inspection, minor cracking, surface wear, or uneven sections were observed on footpaths or crossovers. Some accessible metal components, such as street signage or grates, showed signs of rust or deterioration. Debris accumulation and vegetation encroachment were also noted around council infrastructure. Access or visibility was limited to certain council-owned assets.

These areas should be monitored, and for detailed assessment, maintenance, or compliance verification, the relevant local council authority should be contacted immediately. Regular monitoring of adjacent council assets is recommended to ensure ongoing safety and proper maintenance.

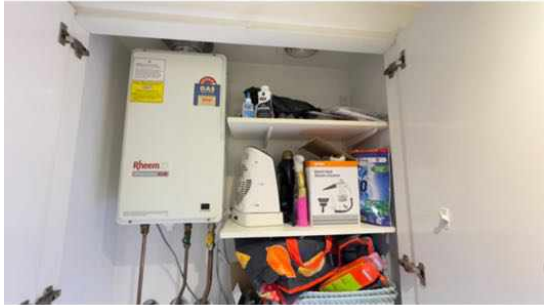
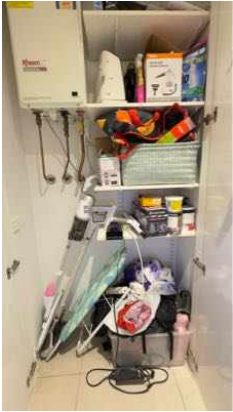
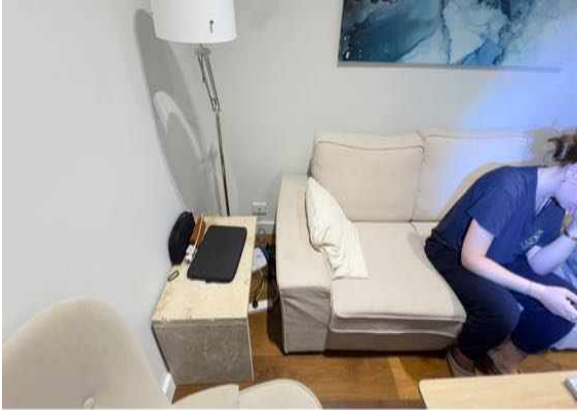
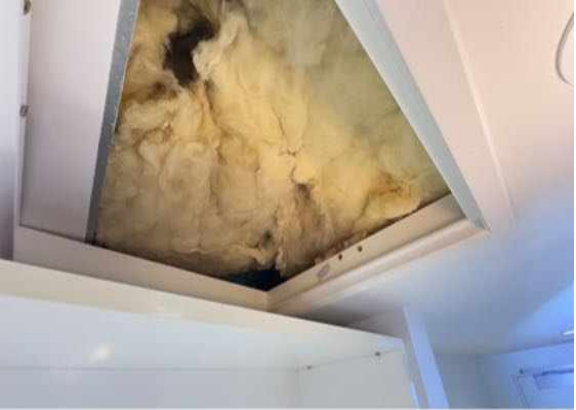
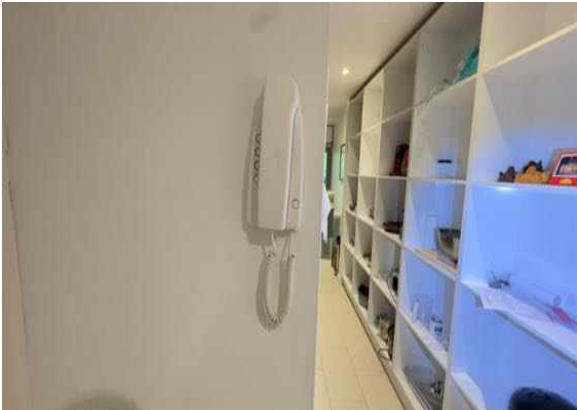
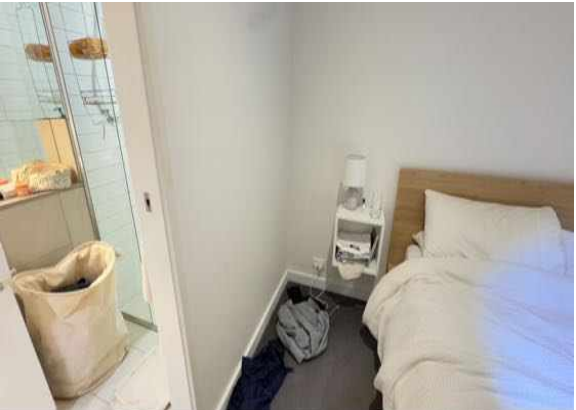
Building: Main Building
 Location: All Areas
 Finding: Additional Photos - Obstructions & Limitations
 Information: These photographs provide evidence of obstructions and restrictions that prevented full access to certain areas of the property at the time of inspection. Such obstructions may include stored goods, furniture, floor coverings, stored building materials, dense vegetation, vehicles, or fixed finishes.

Because these areas could not be visually assessed, no comment can be made on their condition within this report.

It is strongly recommended that obstructions be removed and concealed areas made fully accessible immediately. A re-inspection should then be carried out to allow a complete assessment of the property's condition. This is particularly important prior to purchase, as defects in concealed areas can carry significant rectification costs.
