Building and Timber Pest Inspection Report

Inspection Date: Wed, 25 Mar 2026

Property Address: 1/34 Ayr St, Reservoir VIC 3073, Australia

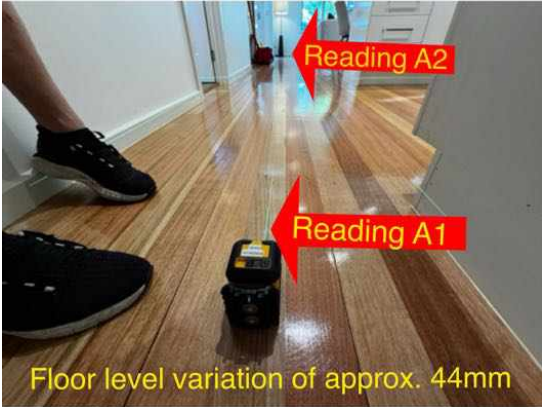
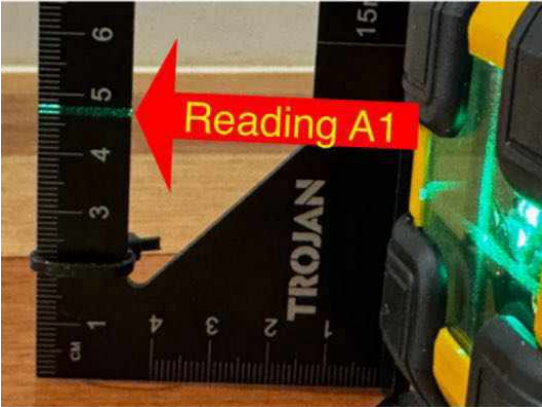
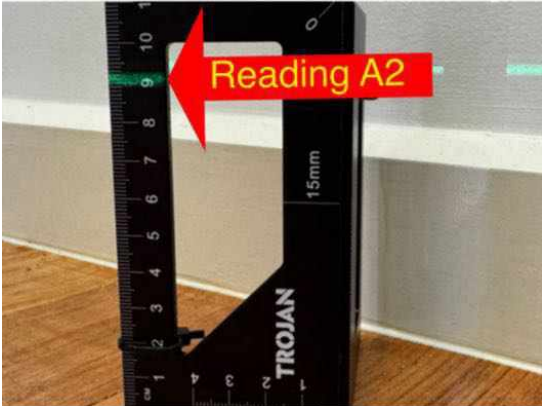
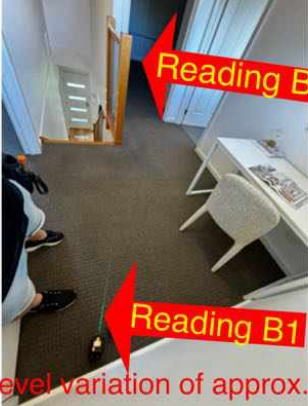
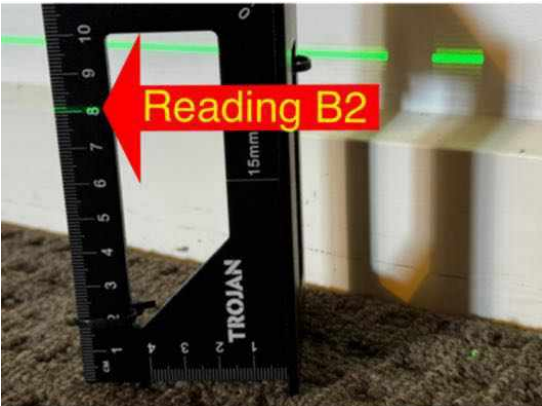
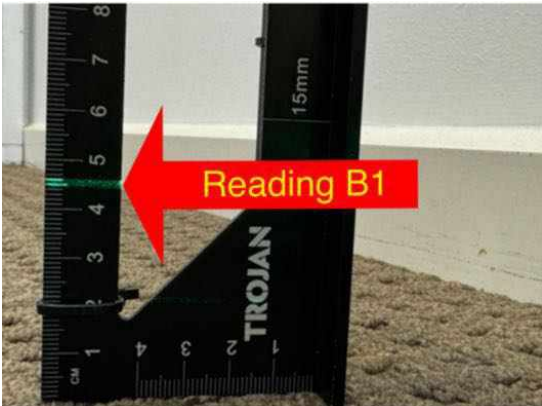
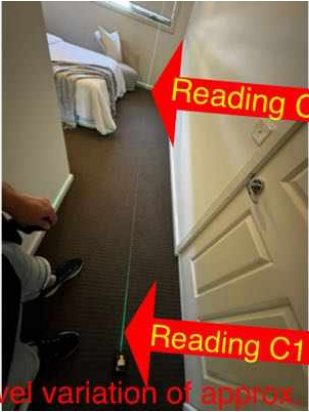
Building: Main Building
Location: All Areas > All Areas
Finding: Excessive Floor Level Deviation and Suspected Movement (Major Defect)
Information: Multiple floor level readings were taken using a laser level, which identified significant deviations across both ground and first floor levels. The ground floor recorded a variation of approximately 44 mm from the entry to the kitchen, while the first floor hallway to front bedroom recorded a variation of approximately 35 mm. A further reading within a first floor bedroom identified a variation of approximately 27 mm over a span of approximately 4 metres.

In addition to the floor level deviations, several doors throughout the dwelling were observed to self-close, including bedroom doors and the entry door, indicating that floors are not level and are sloping. The toilet door was also observed to be binding and scraping on the floor, further supporting evidence of movement or distortion within the structure.

The combination of significant floor level variation across multiple areas, along with functional issues such as door misalignment and binding, indicates that the building is experiencing structural movement or settlement, which may be related to subfloor conditions, footing movement, or differential settlement.

It is also important to note that the subfloor area was only partially accessible due to obstructions such as ductwork and plumbing, limiting the ability to fully assess the condition of stumps, bearers, and other structural elements that may be contributing to the observed movement.

In accordance with AS 4349.1–2007 (Inspection of Buildings), defects involving significant movement or distortion affecting the serviceability of the building are classified as Major Defects.

Floor level variation of approx. 27mm

Immediate – further investigation is required as soon as practicable to determine the cause and prevent further movement.

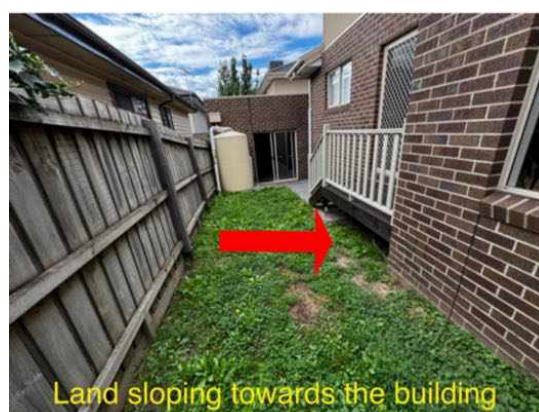
Finding 2.02

Building:	Main Building
Location:	Yard - Front, rear > Front,Rear
Finding:	Poor Site Drainage Around Building Perimeter (Major Defect)
Information:	Poor site drainage was observed to the property, with the front yard visibly sloping towards the building and no visible surface drainage installed along the perimeter. A similar condition was noted to the rear yard, where sections of the ground were also sloping towards the building.

Immediate – rectification is recommended as soon as practicable to prevent moisture-related issues and potential structural impact.

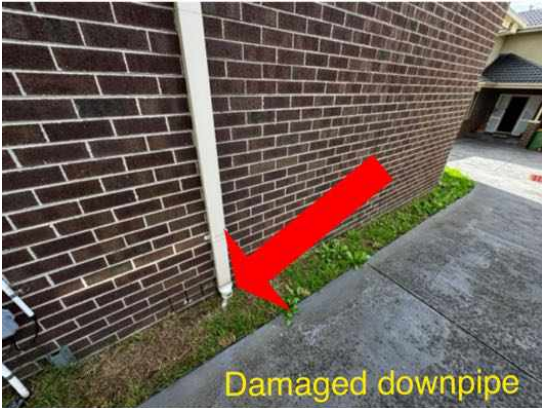
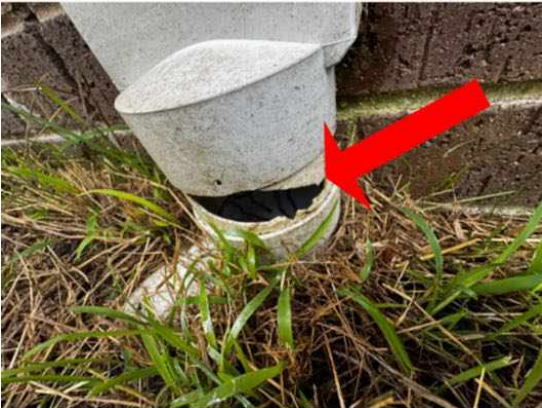
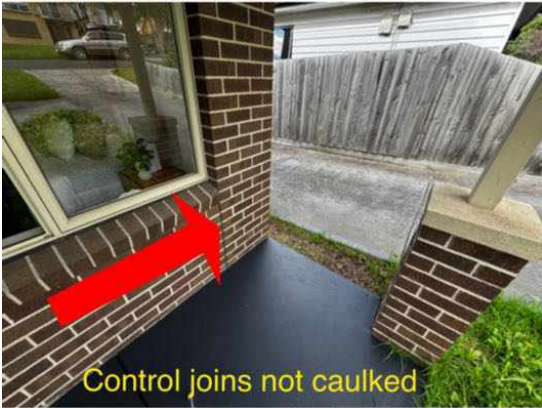
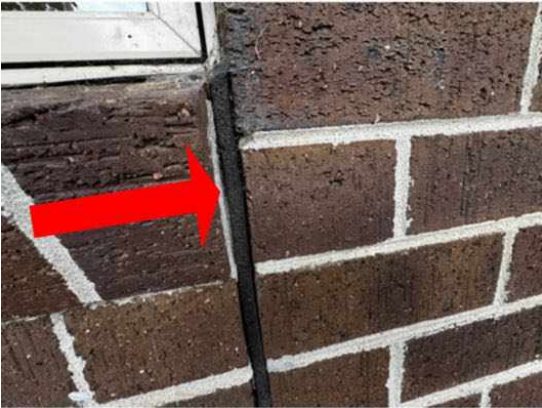
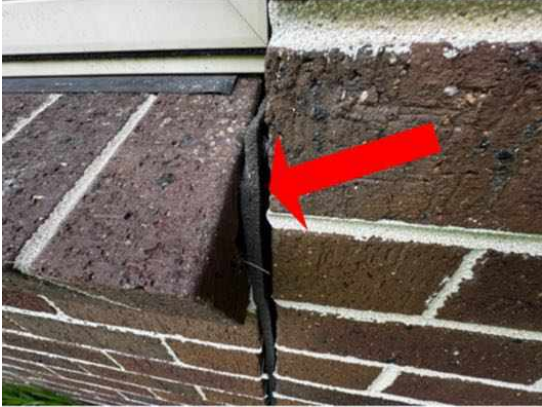
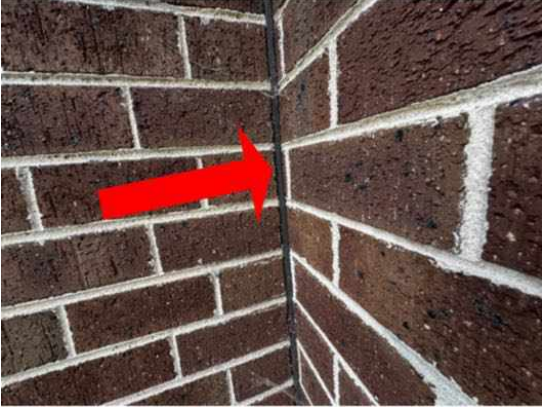
Finding 2.03

Building:	Main Building
Location:	Yard - Front, rear > Front,Rear
Finding:	External Defects Including Drainage, Movement and Maintenance Issues
Information:	The following external defects were observed during the inspection, comprising a combination of major defects and maintenance-related issues.

Immediate – rectification is recommended as soon as practicable to prevent further deterioration and potential structural impact.

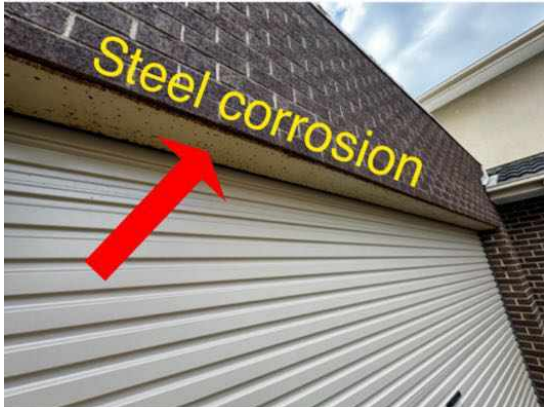
Steel corrosion

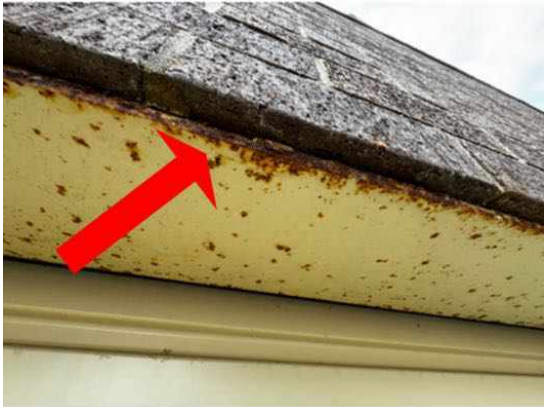
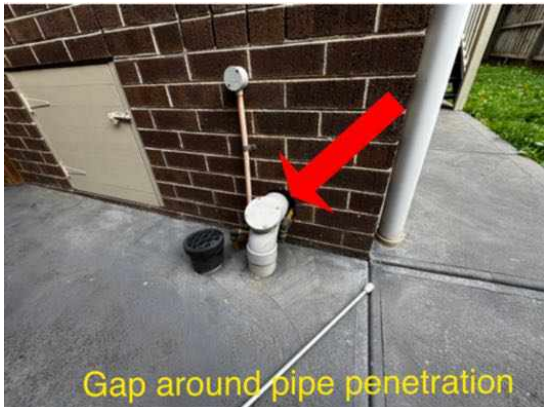
Gap around pipe penetration

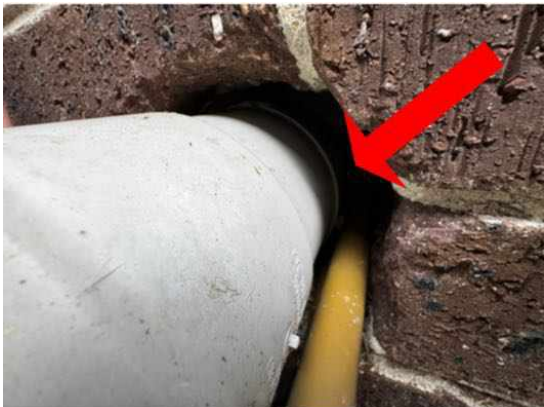
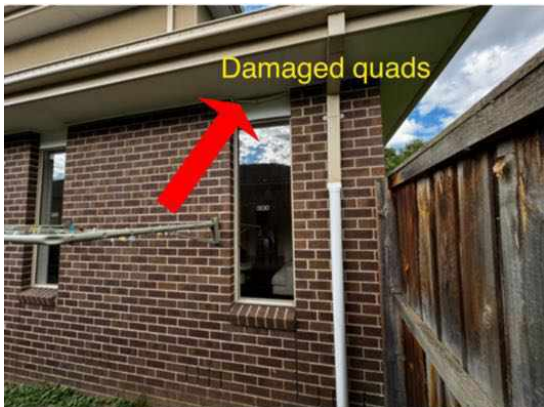
Damaged quads

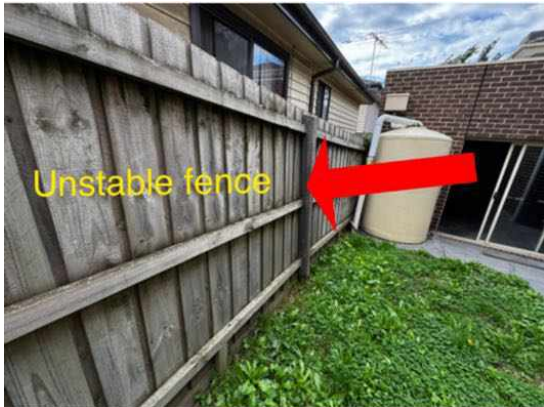
Unstable fence

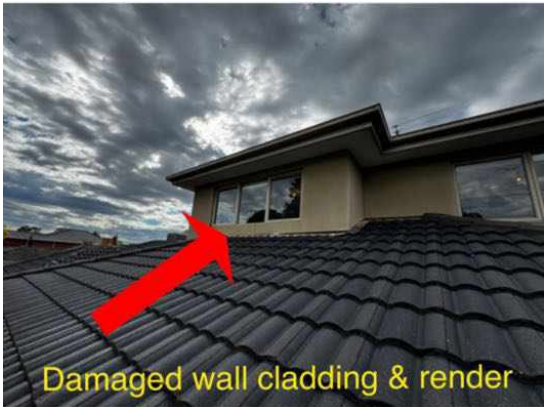
Damaged wall cladding & render

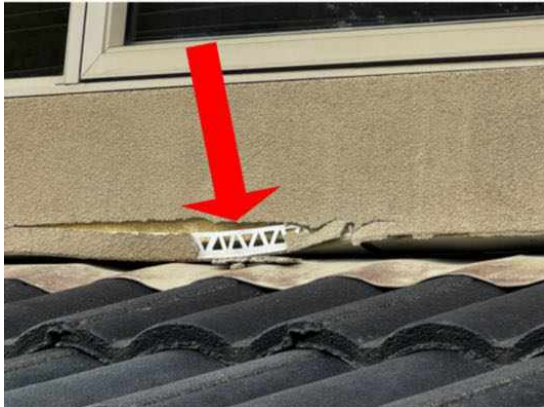
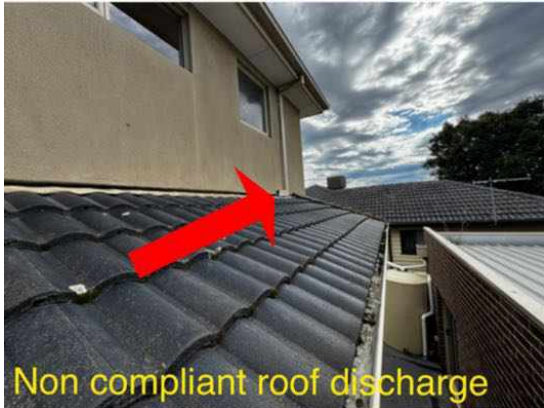
Non compliant roof discharge

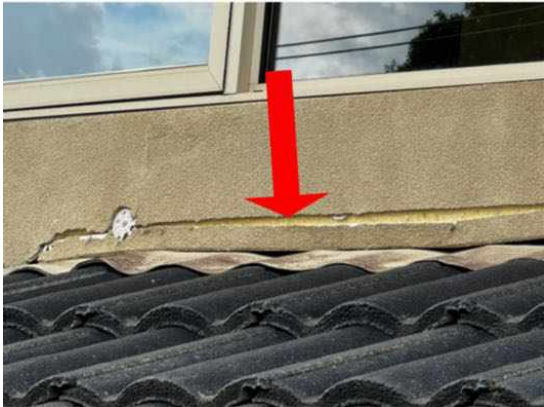
Discharging directly onto roof flashing

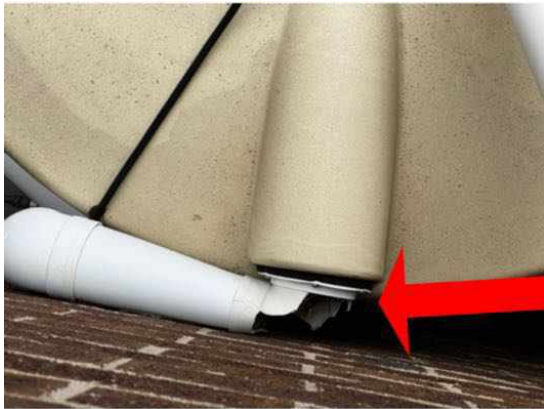
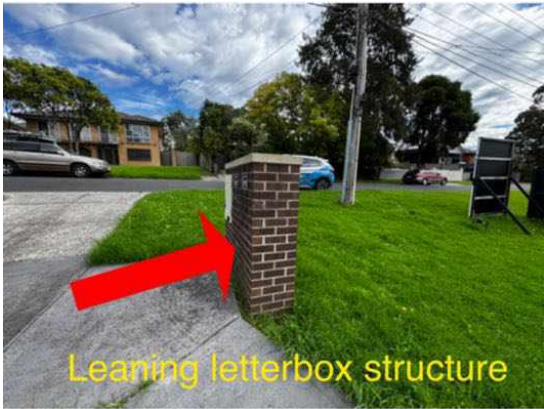
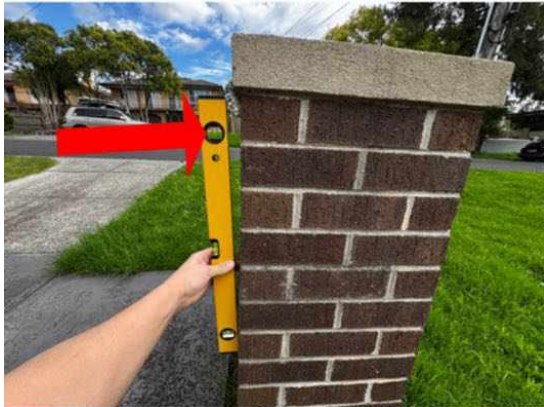
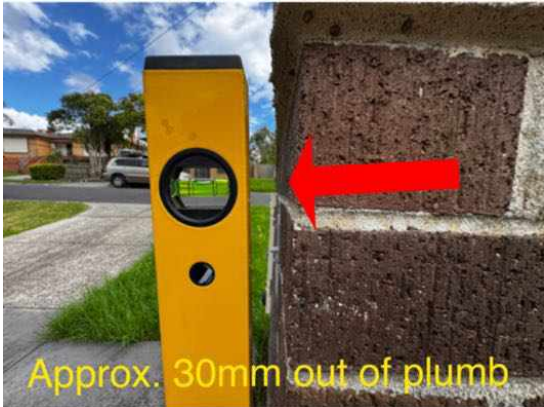
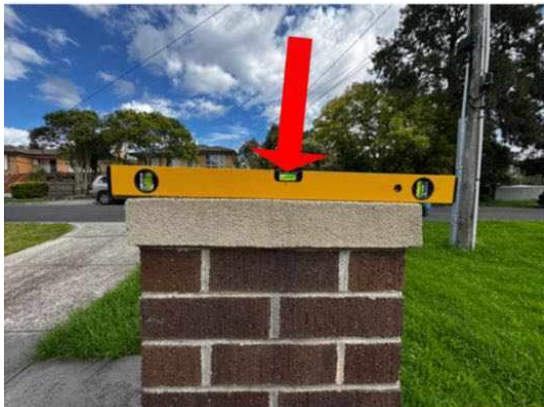
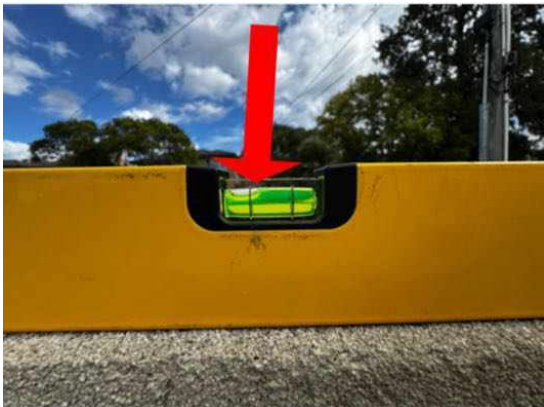
Damaged plumbing pipe

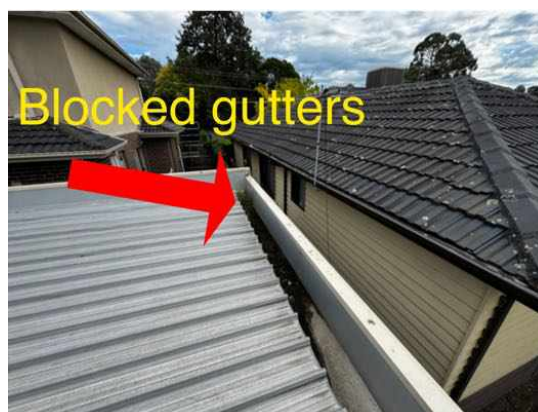
Finding 2.04

Building: Garage
 Location: Roof Exterior > Rear
 Finding: Moisture Damage to Garage Roof Framing from Blocked Box Gutter (Major Defect)
 Information: Moisture staining was observed to the timber members supporting the box gutter within the detached garage, which are visible due to the absence of ceiling linings. The staining indicates that the timbers have been subjected to moisture ingress over time.

Inspection of the roof area above identified that the box gutter was blocked with organic growth and debris, which is the likely cause of the issue. Blocked box gutters can lead to overflow during rainfall events, allowing water to back up and penetrate adjacent structural elements, including the supporting timbers.

Ongoing exposure to moisture may result in timber deterioration, decay, and reduced structural integrity if not addressed.

In accordance with AS 4349.1–2007 (Inspection of Buildings), defects involving moisture ingress affecting structural elements and requiring rectification to prevent further deterioration are classified as Major Defects.

It is recommended that the box gutter be cleaned immediately, and that a licensed roofing contractor inspect the gutter system, including falls, outlets, and waterproofing, to ensure proper function. The affected timbers should be assessed for any signs of decay or damage, and repaired or replaced if required.

Immediate – rectification is required as soon as practicable to prevent further moisture damage and potential structural deterioration.

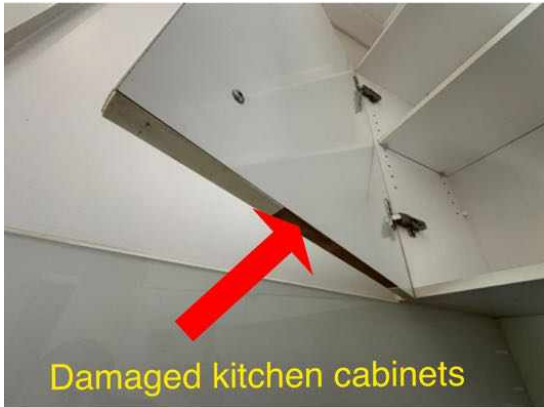
Damaged kitchen cabinets

It is recommended that these items be addressed as part of routine maintenance, including repair or replacement of faulty appliances, resealing of shower screens, and repair or replacement of damaged finishes and fixtures.

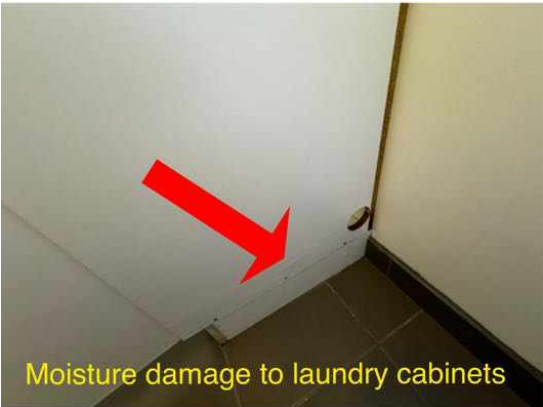
Moisture damage to laundry cabinets

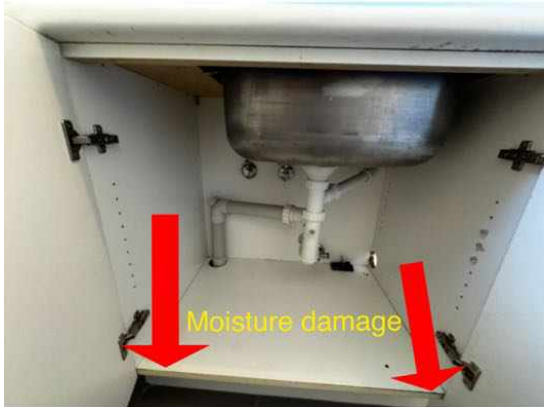
Moisture damage

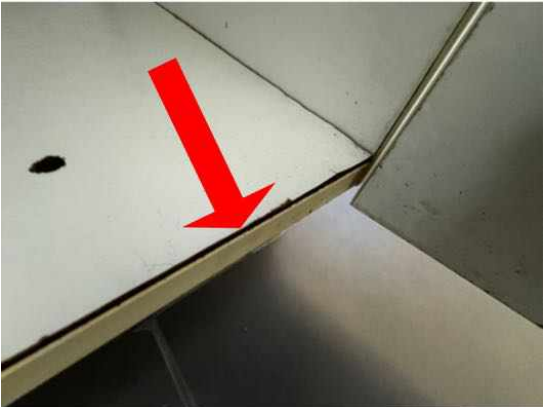
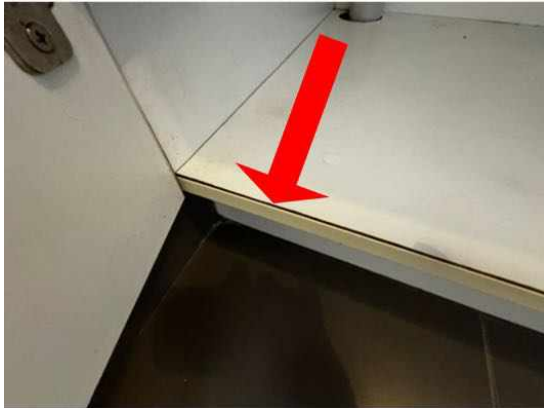
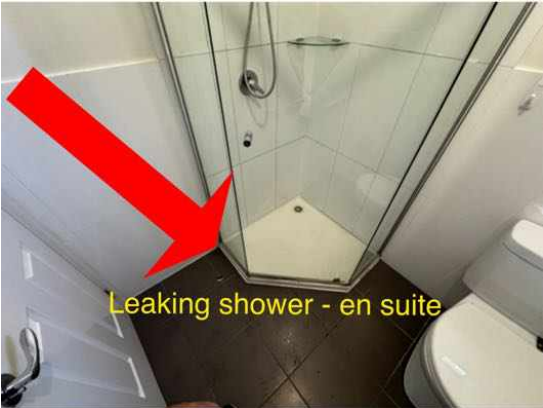
Additional defects included minor damage to kitchen cupboards and moisture damage to laundry cabinets, likely associated with general use and exposure to moisture. A minor leak was observed to the ensuite shower screen following a water test, which is likely due to deteriorated or failed sealant.

Leaking shower - en suite

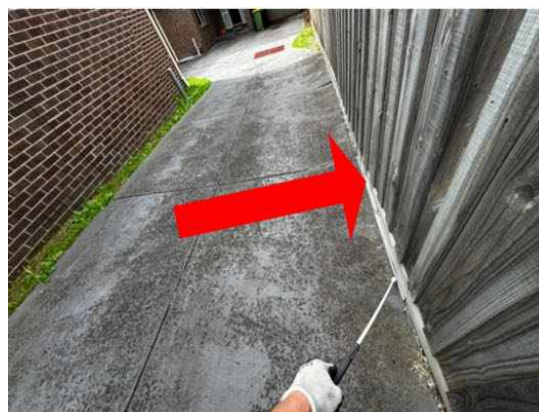
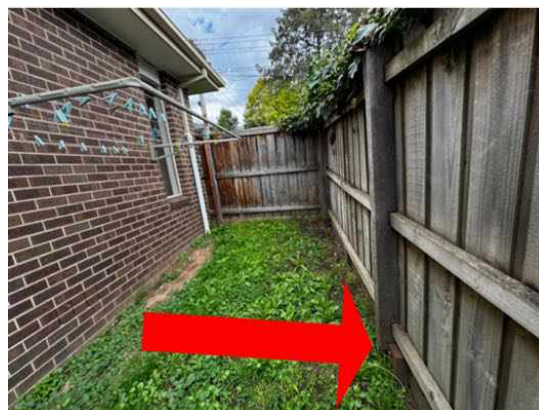
Building:	Main Building
Location:	All Areas > All Areas
Finding:	Inground timber contact (TP)
Information:	At the time of inspection, in-ground timber contact was observed to the front, side and rear yards, all in direct contact with the ground. These timber elements are positioned within the soil zone and in close proximity to the building and associated structures.

In accordance with AS 3660.2, conditions that facilitate termite access or provide a direct food source are recognised as increasing the risk of termite activity to existing

buildings. Timber elements in direct contact with the ground are particularly vulnerable, as they can attract subterranean termites and support concealed foraging activity, potentially allowing termite colonies to establish and migrate toward nearby structures without early detection.

As a result, the presence of in-ground timber elements is considered to increase the risk of termite activity to the property. It is recommended that a licensed termite management or pest control contractor be engaged to assess these conditions and provide advice on appropriate risk mitigation measures, which may include removal or replacement of timber elements with non-susceptible materials, isolation of timber from soil contact, and integration of suitable termite management measures to suit the existing site conditions.

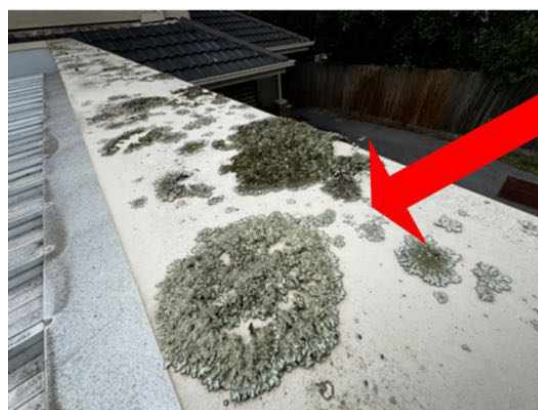
Building:	Main Building
Location:	Roof Exterior > Front,Rear
Finding:	Blocked gutters and organic growth (TP)
Information:	At the time of inspection, organic debris was observed to the roof areas, together with partially blocked gutters and downpipes. These conditions promote prolonged

moisture retention and reduced effectiveness of roof drainage, the issue is suspected to be associated with a lack of routine maintenance.

In accordance with AS 3660.2, conditions that promote ongoing dampness, moisture accumulation, or inadequate drainage are recognised as increasing termite risk to existing buildings, as elevated moisture levels can create environments conducive to termite foraging and concealed activity. Blocked gutters and downpipes may allow water to overflow or discharge against building elements, increasing moisture exposure to adjacent materials and reducing the effectiveness of termite risk management through visual inspection.

As a result, the observed organic debris and drainage issues are considered to increase moisture-related deterioration and elevate the overall risk of termite activity. It is recommended that an appropriately qualified roof plumber be engaged to clean and service the gutters and downpipes and that roof surfaces be maintained to reduce moisture retention, with ongoing monitoring and advice from a licensed termite management or pest control contractor where elevated termite risk is identified.

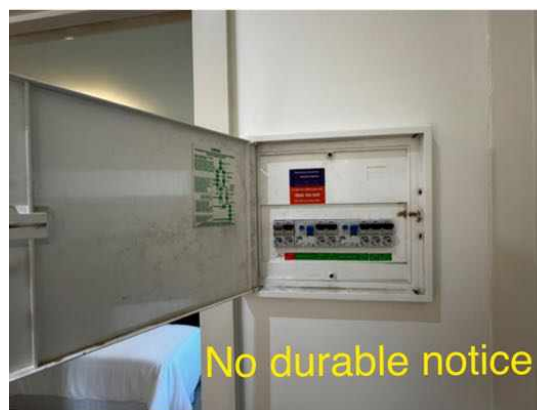
Finding 6.04

Building:	Main Building
Location:	Meter Box > Front
Finding:	Termite management system - no evidence of chemical installation (TP)
Information:	At the time of inspection, there was no visible evidence to suggest that a chemical termite management system has been installed or remains effective. In addition, no durable notice was observed within the electrical switchboard to identify the presence, type, or date of any termite protection measures.

For this reason, the installation of a post-construction chemical termite management system is highly recommended to reduce the risk of termite activity. A durable notice should also be installed within the electrical switchboard to clearly identify the treatment provided and support ongoing inspection and maintenance.

Engagement of a licensed termite management or pest control contractor is recommended as a matter of priority to assess the site conditions, consider local termite risk, and determine the most appropriate treatment method and procedures for this property.

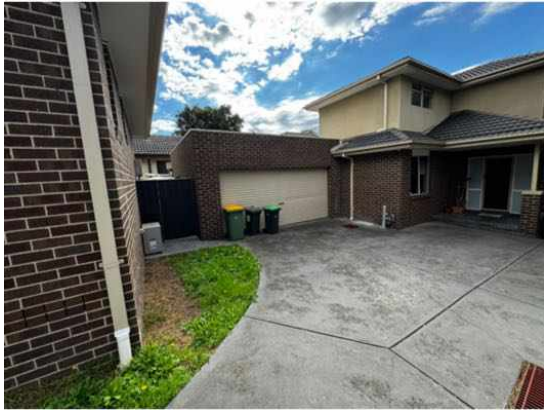
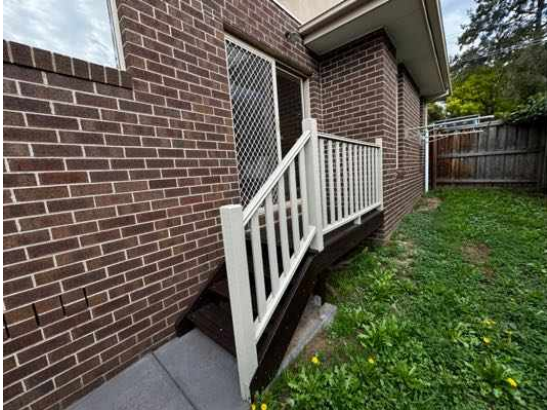
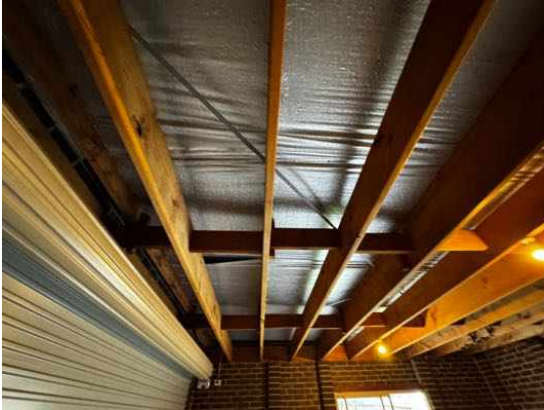
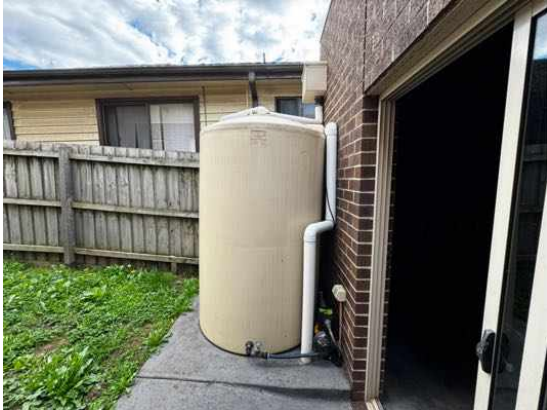
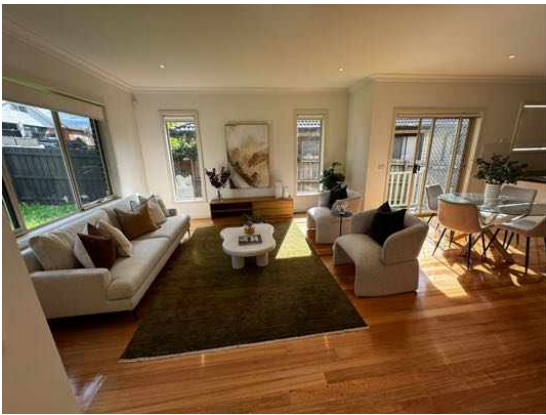
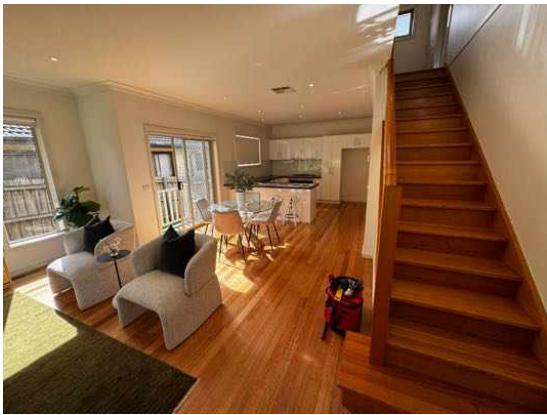
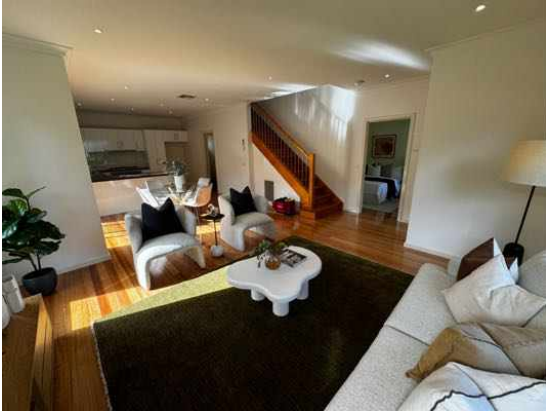
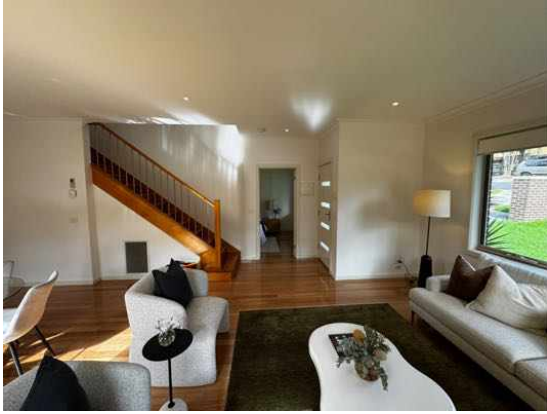
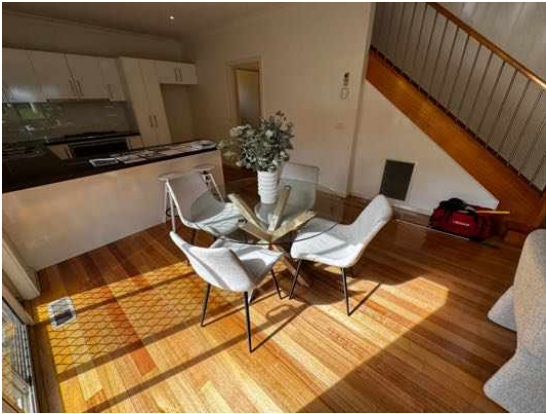
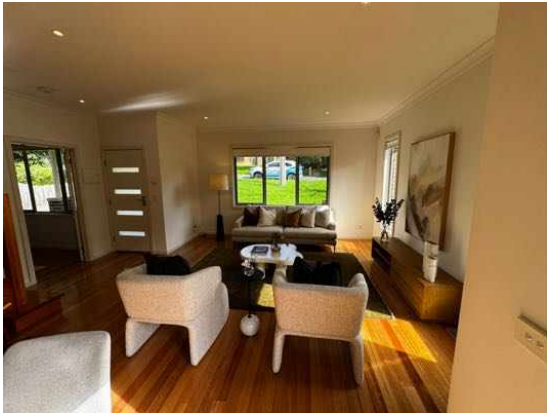
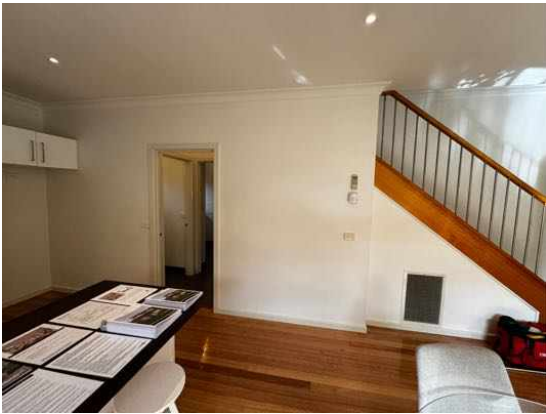
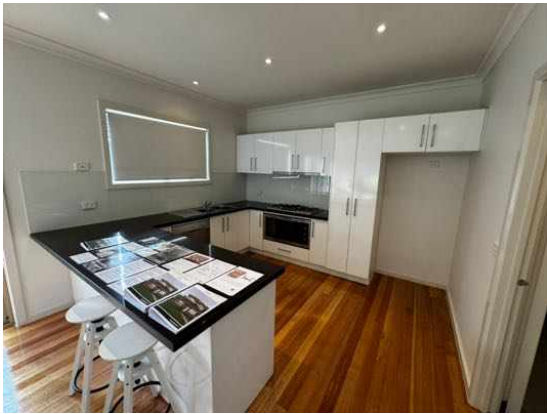
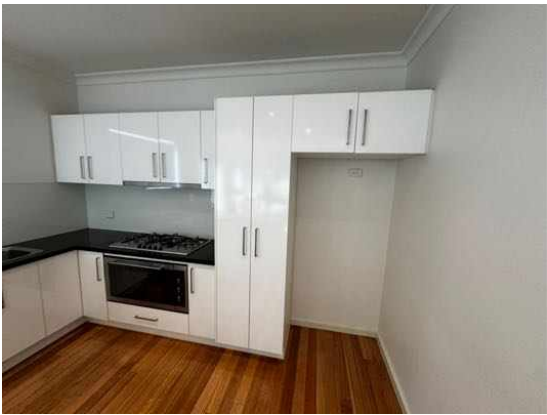
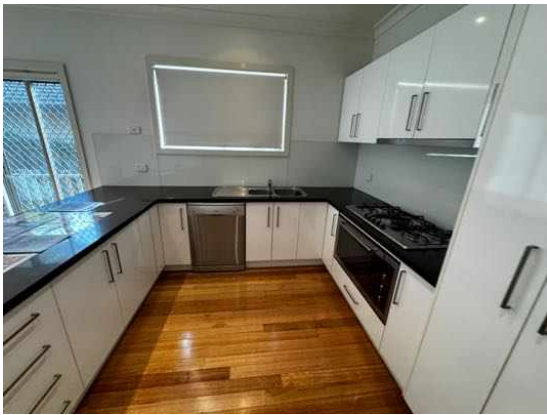
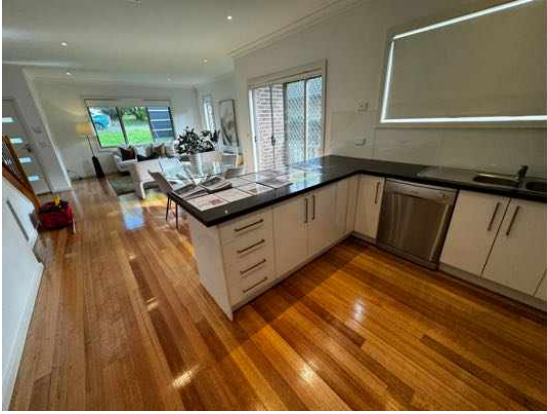
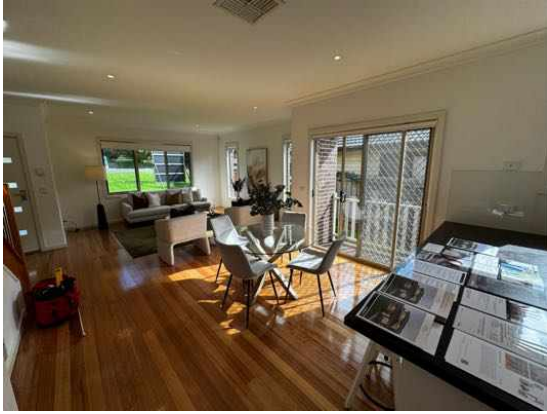
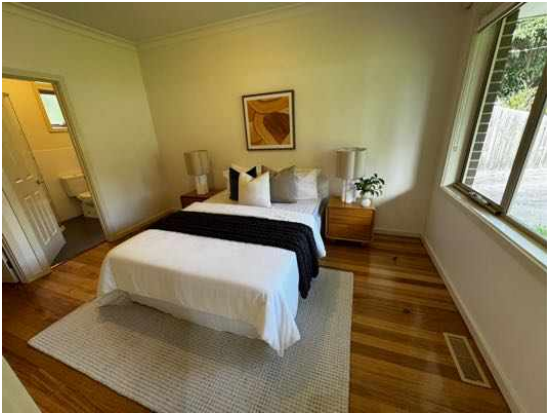
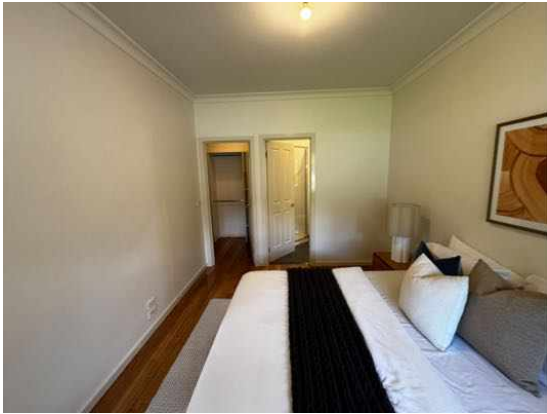
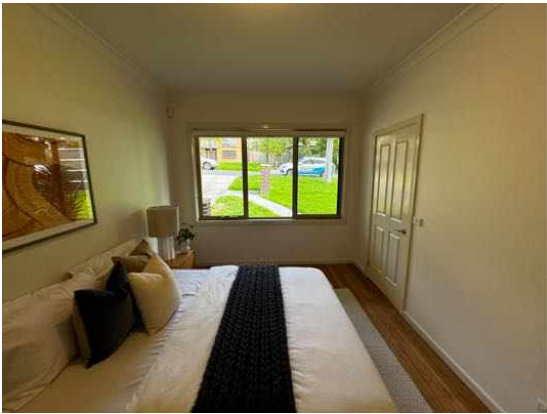
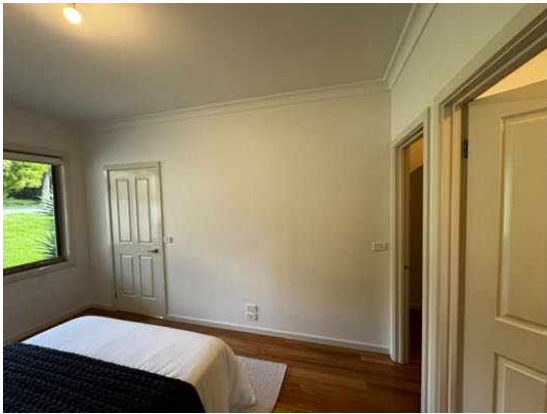
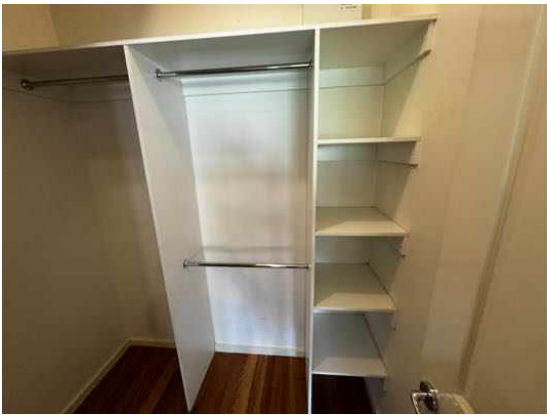
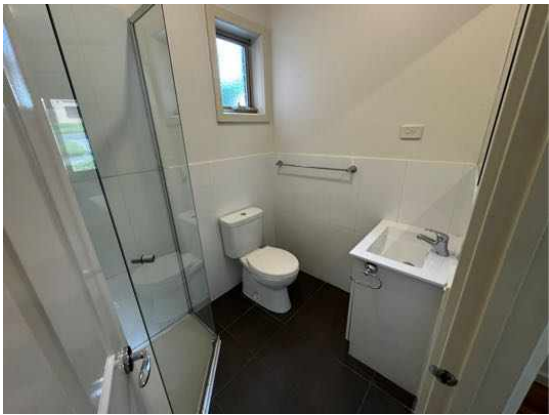
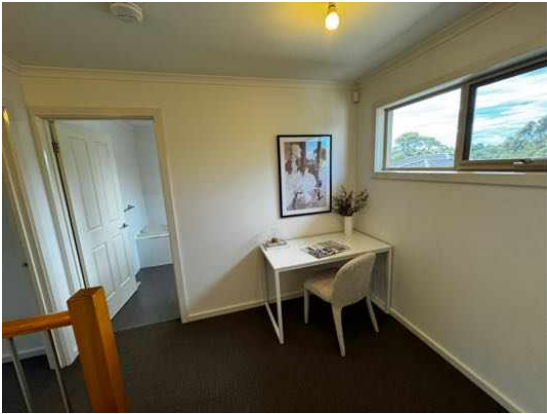
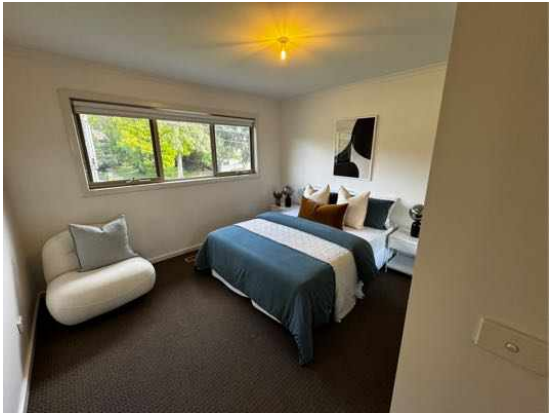
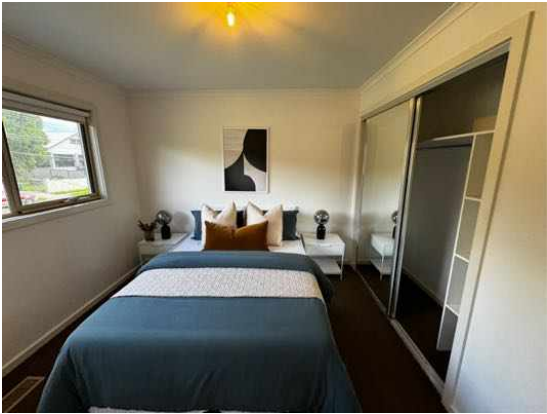
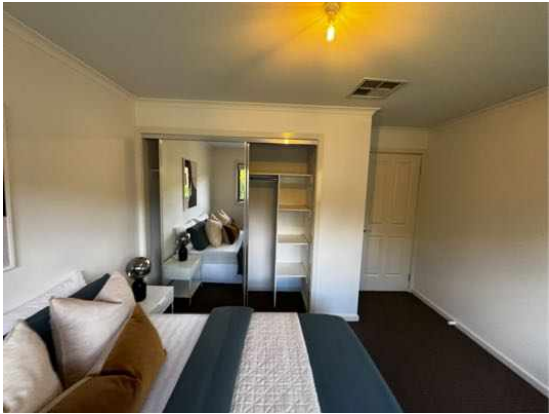
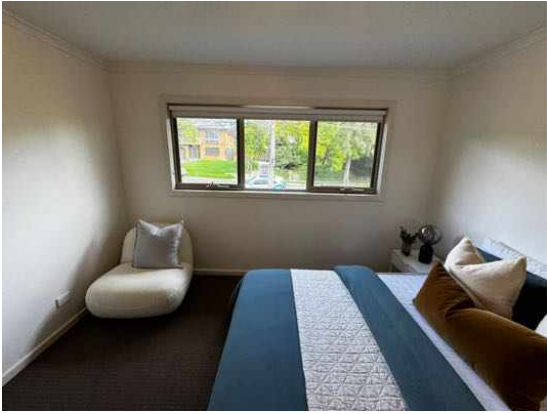
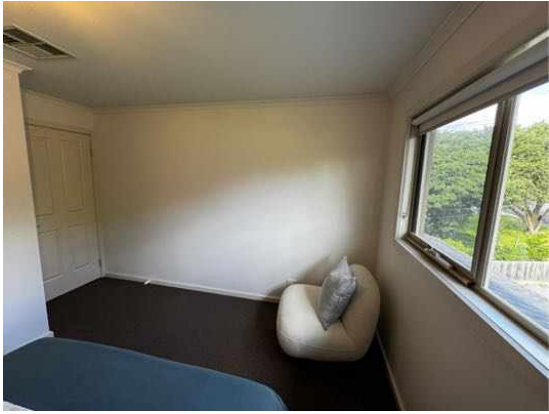
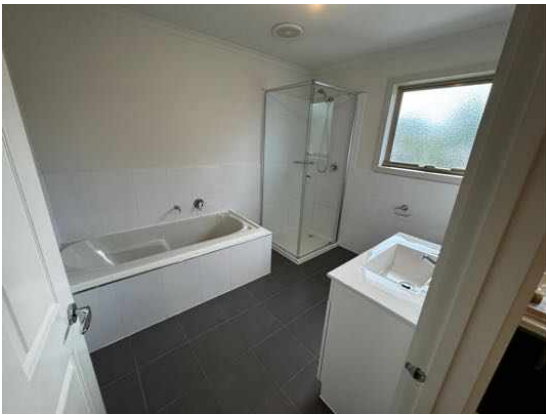
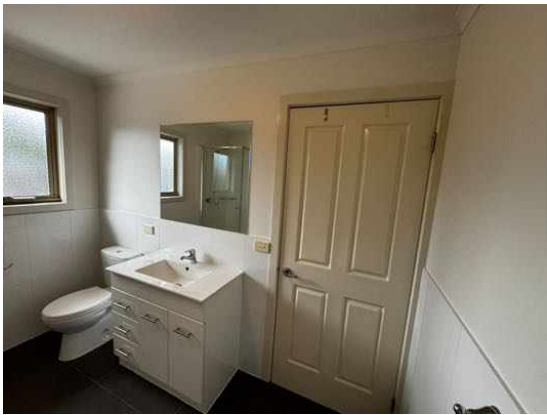
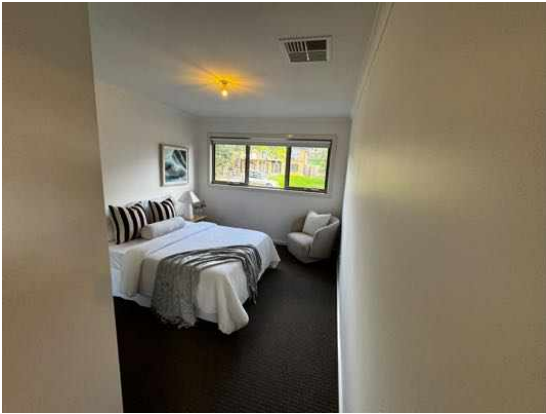
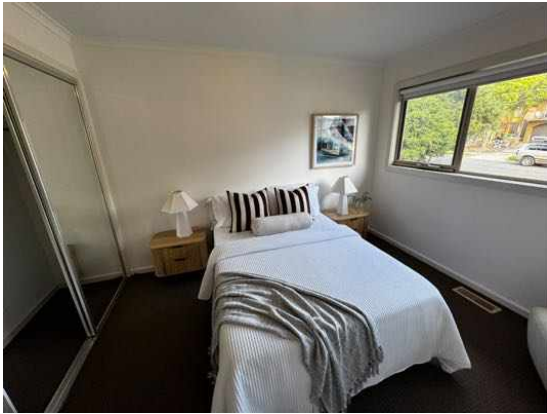
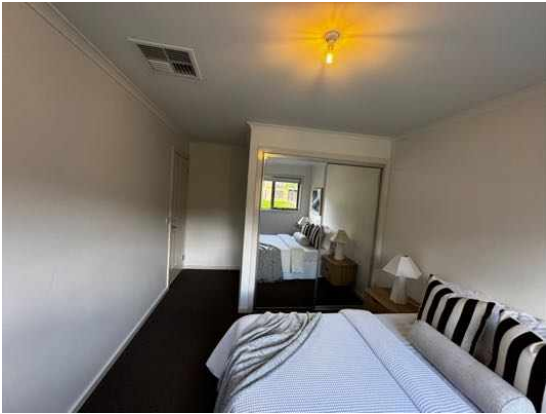
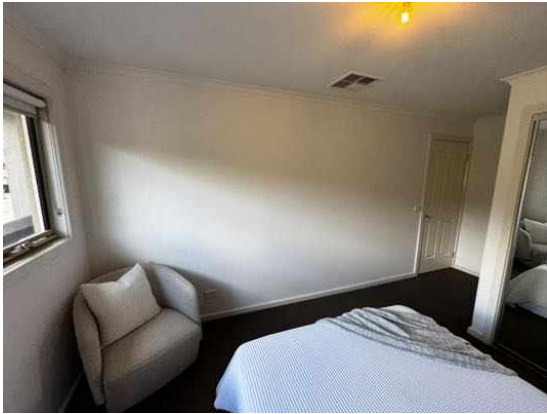
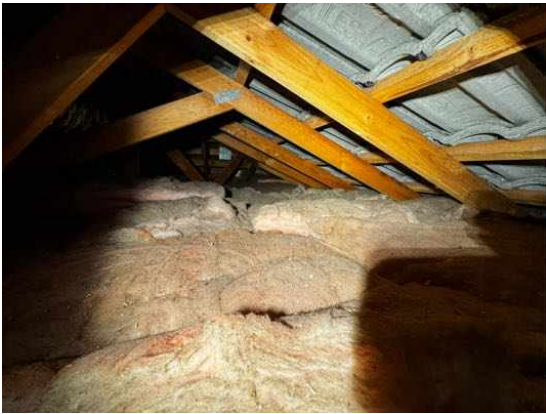
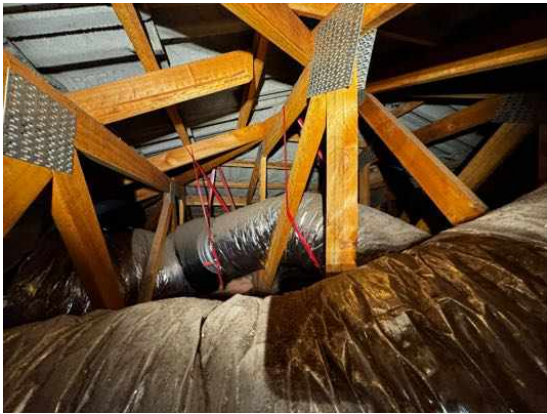
Building: Main Building
Location: All Areas > All Areas
Finding: Additional Photos - Obstructions and Limitations
Information: These photographs are an indication of the obstructions and limitations which impeded full inspection of the property at the time of inspection. These obstructions can hide an array of defects and should be removed to allow full inspection to be carried out. A re-inspection is recommended once the areas are made accessible.
