Building and Timber Pest Inspection Report

Inspection Date: Wed, 25 Mar 2026

Property Address: 1/34 Ayr St, Reservoir VIC 3073, Australia

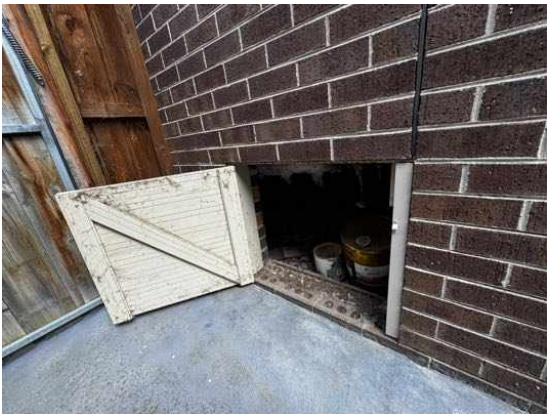
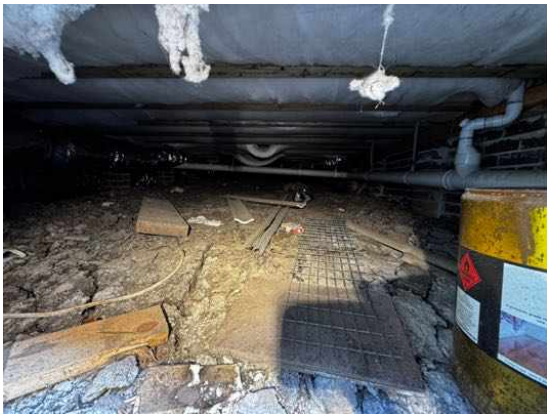
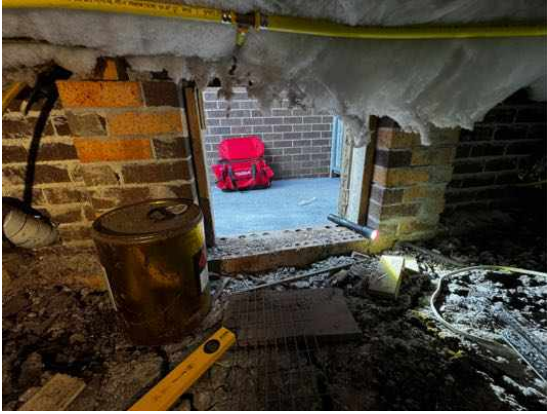
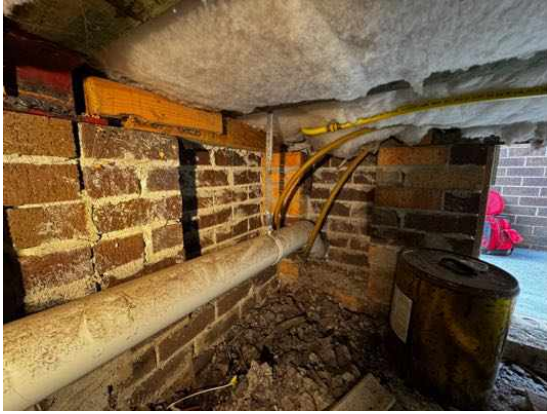
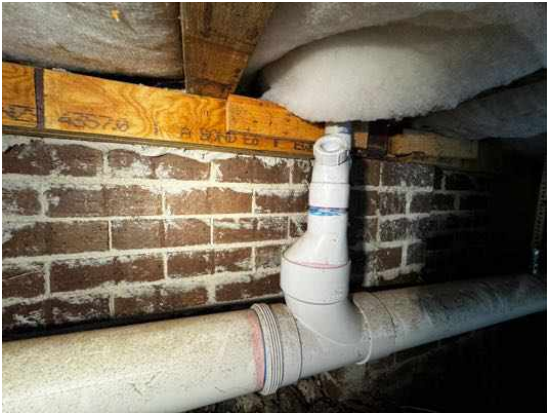
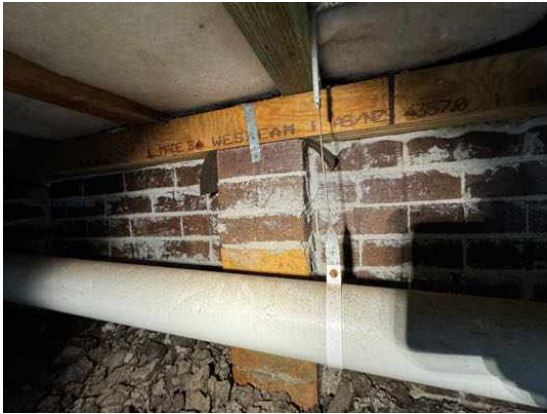
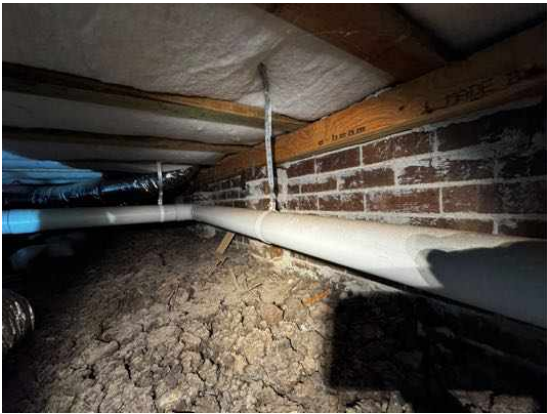
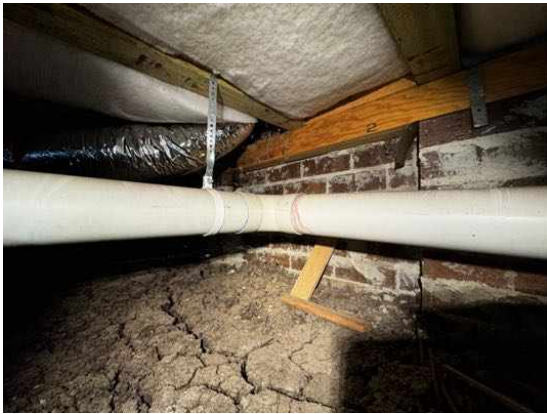
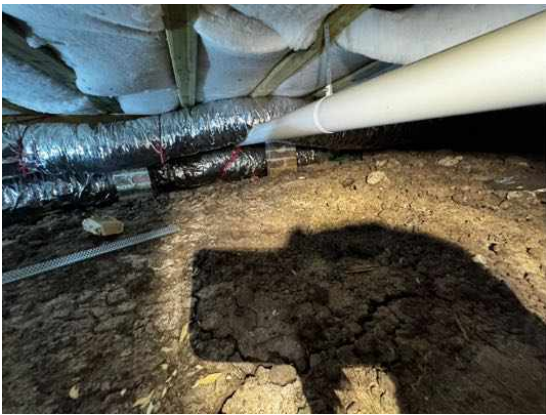
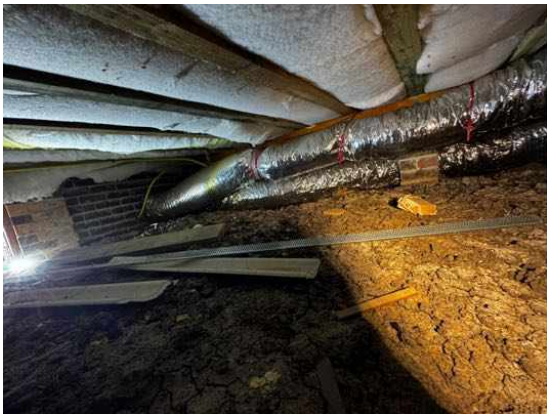
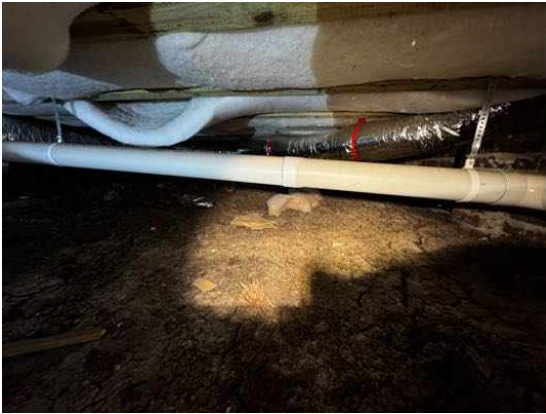
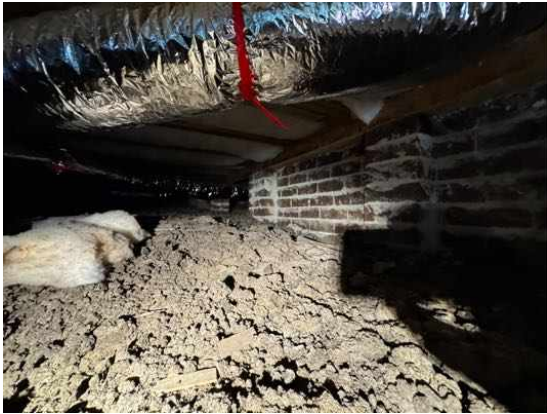
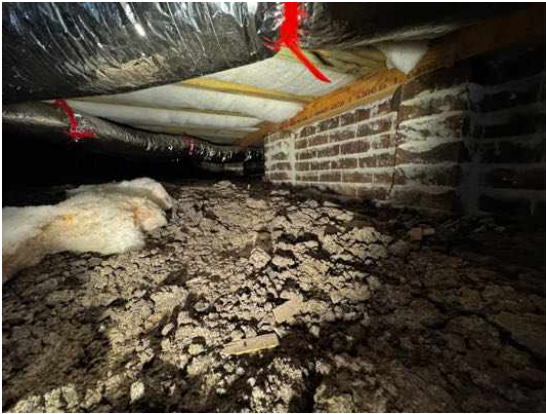
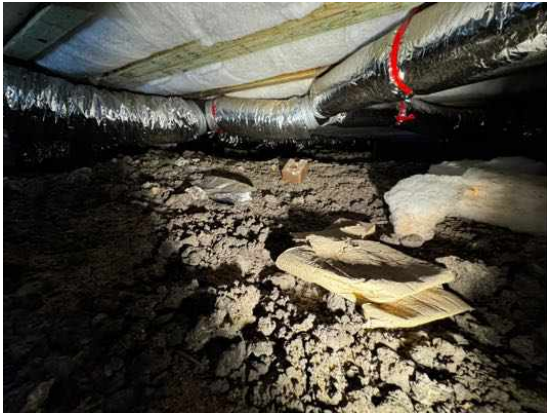
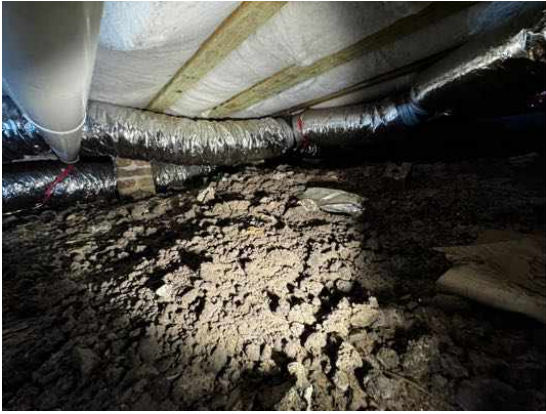
Building: Main Building
Location: All Areas > All Areas
Finding: Additional Photos - Obstructions and Limitations
Information: These photographs are an indication of the obstructions and limitations which impeded full inspection of the property at the time of inspection. These obstructions can hide an array of defects and should be removed to allow full inspection to be carried out. A re-inspection is recommended once the areas are made accessible.

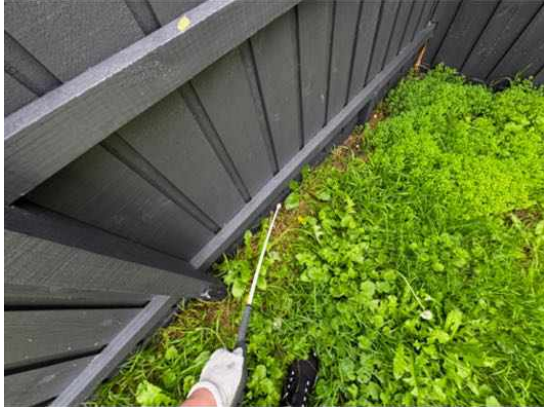
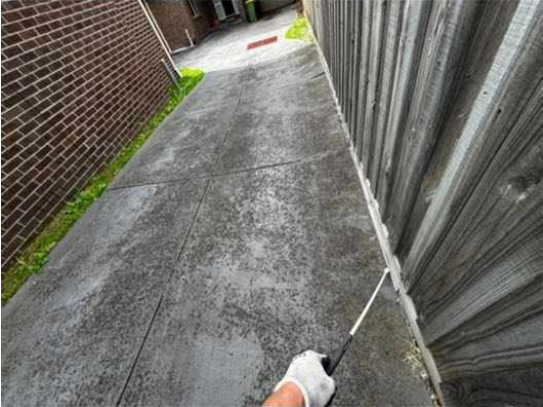
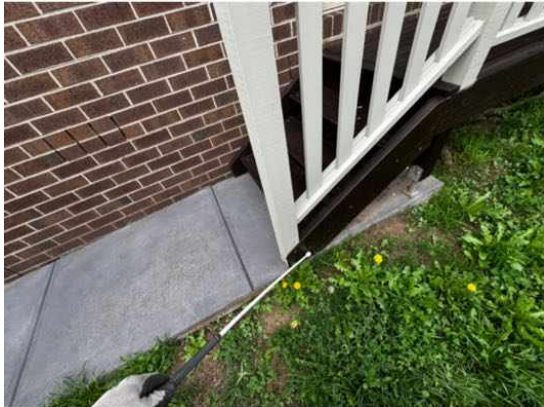
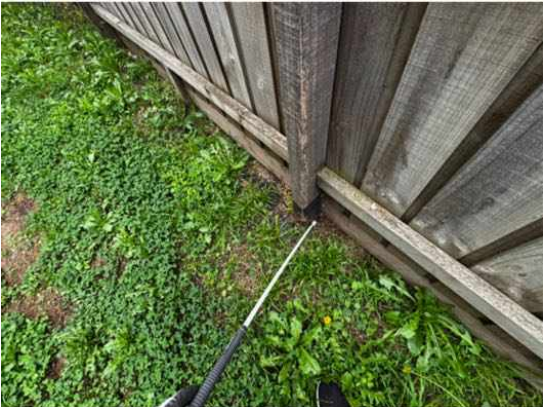
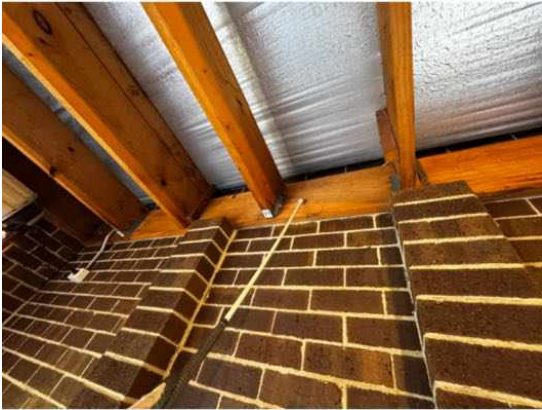
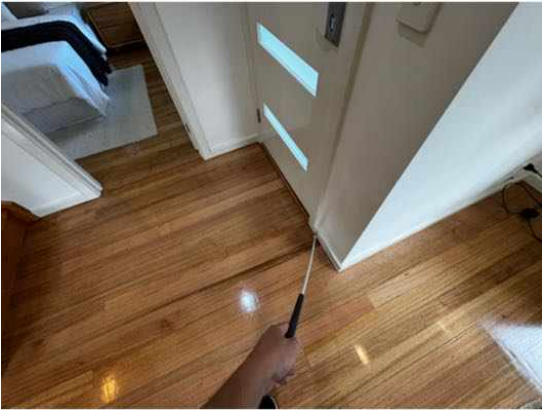
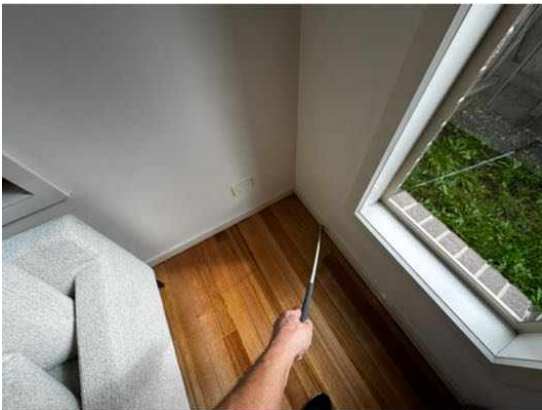
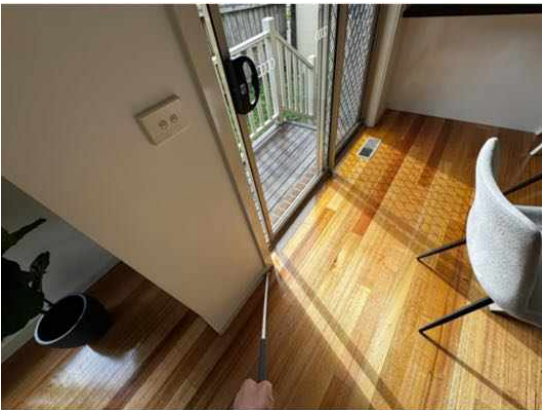
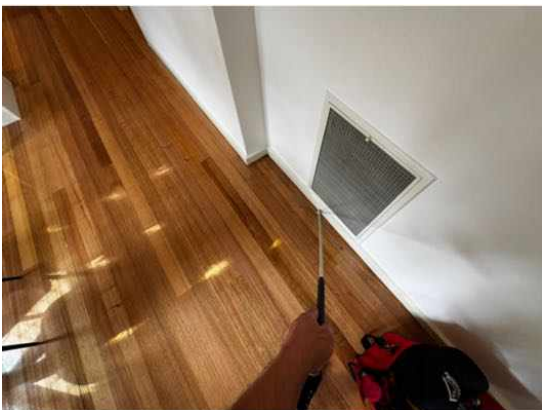
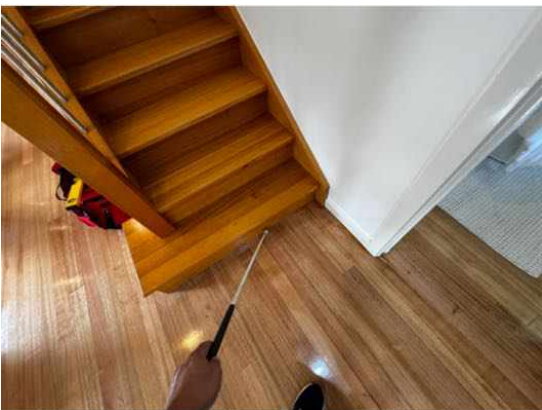
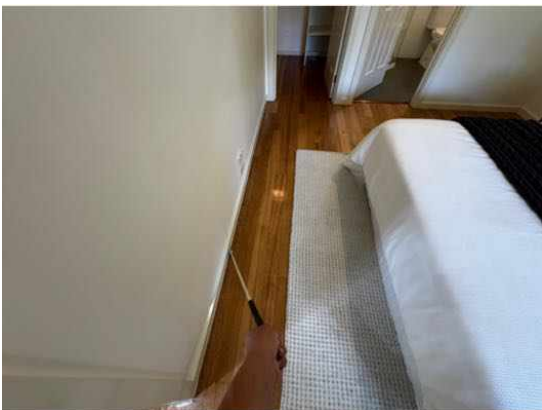
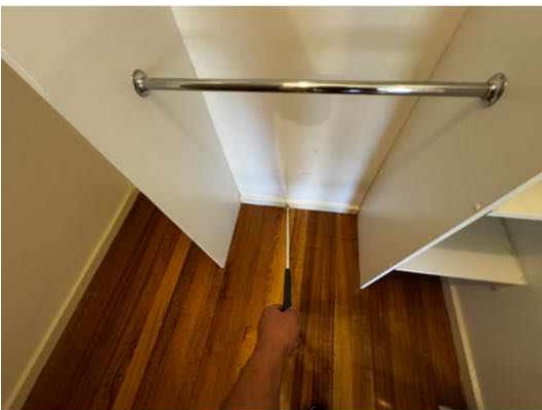
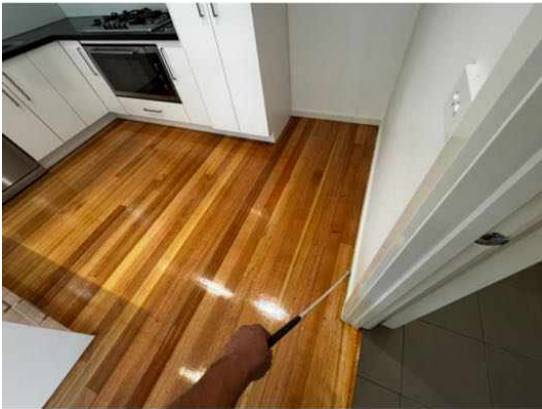
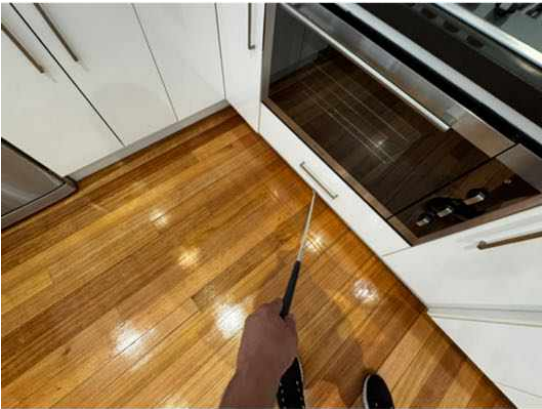
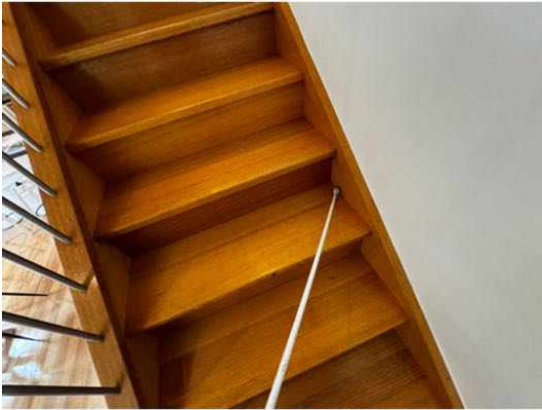
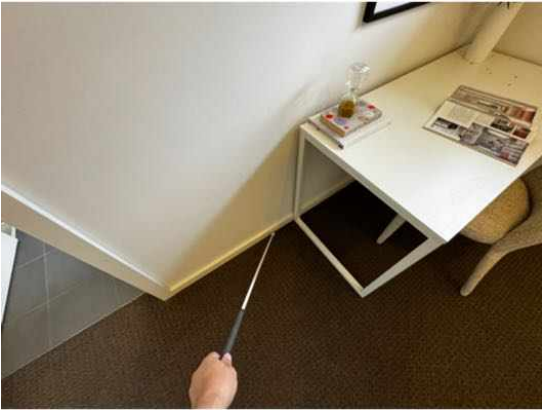
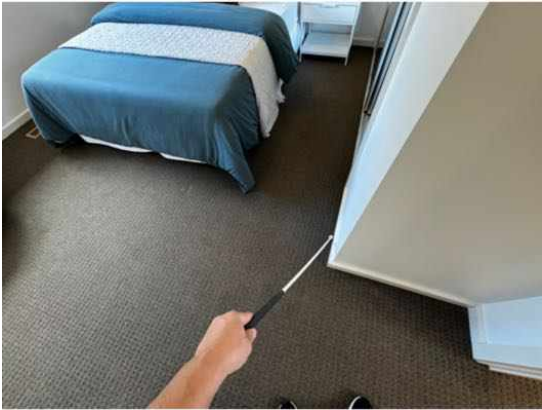
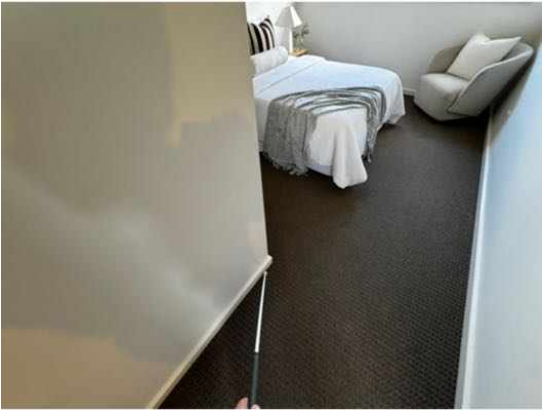
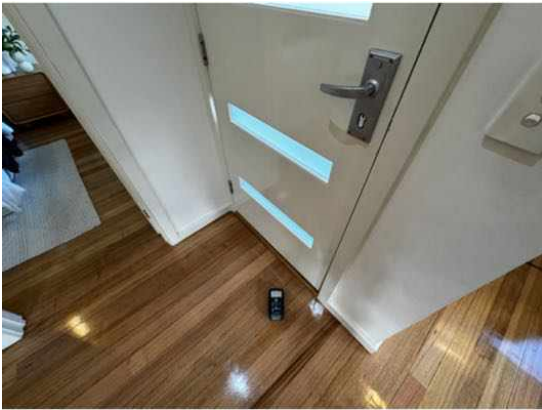
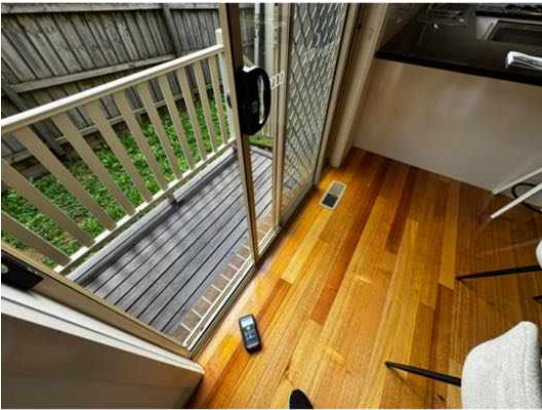
Building: Main Building
Location: All Areas > All Areas
Finding: Termite investigation techniques (TP)
Information: All accessible areas of the dwelling were inspected, with particular attention paid to wet areas, which were closely assessed for elevated moisture levels and temperature anomalies that may indicate conditions conducive to termite activity.

In an attempt to identify concealed or hidden timber pest activity, a range of inspection techniques were adopted. These included the use of a moisture meter to assess susceptible areas, sounding of timber elements using a handheld probing device, and visual assessment of materials for signs commonly associated with termite activity. These signs include moisture-related deterioration, deformation of timber, termite mud leads or bridging, and irregular or regular shaped holes within timber elements that may indicate pest-related damage.

It is noted that termite activity can generate increased moisture and localized temperature variations, and where such irregularities are detected, further investigation may be warranted. However, it is also acknowledged that certain obstructions, including floor coverings, wall linings, wall tiles, and fixed cabinetry such as bathroom fit-offs, can conceal termite activity and limit the effectiveness of visual inspection. As a result, the absence of visible evidence at the time of inspection does not eliminate the possibility of concealed termite activity within inaccessible or obstructed areas of the building.
