Building and Timber Pest Inspection Report

Inspection Date: Wed, 25 Feb 2026

Property Address: 10 Kanowna Ave, Cessnock NSW 2325,
Australia

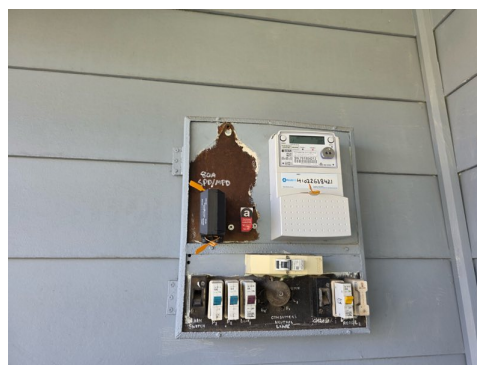
Finding: Electrical Board Condition – Front Verandah

Information: An outdated rewirable fuse board with mixed generations of circuit protection was observed at the external switchboard location. The installation includes older ceramic fuse carriers and does not appear to provide full modern RCD protection to all final subcircuits. The backing board also appears to be asbestos cement sheeting. This type of installation presents an increased risk of electric shock and fire compared to contemporary standards.

A licensed electrician should assess the switchboard, confirm the presence and adequacy of RCD protection, and upgrade the installation as required. If asbestos-containing material is confirmed, appropriate handling procedures will be required. This should be addressed without delay.

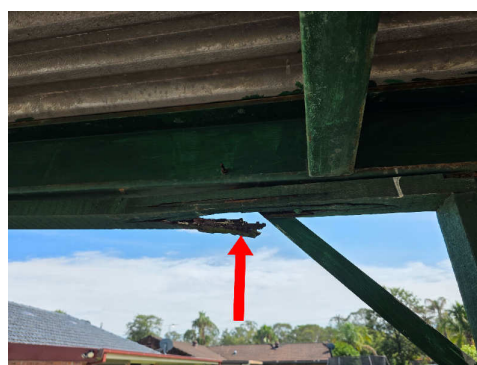
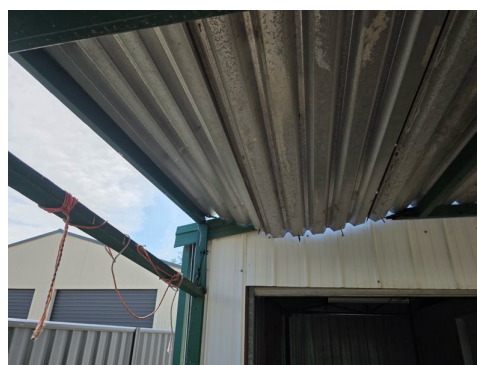
Finding: Carport Timber Decay and Roof Collapse – Carport

Information: Timber elements to the carport are extensively affected by fungal decay, with some sections completely deteriorated. A makeshift roof bridging the carport to the garage is supported by a timber member that has significantly rotted, resulting in the roof being in a state of collapse.

A licensed builder should be engaged to assess the cause and extent and rectify as required. This should be done without delay.

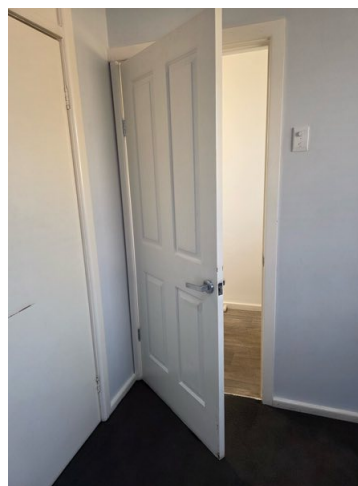
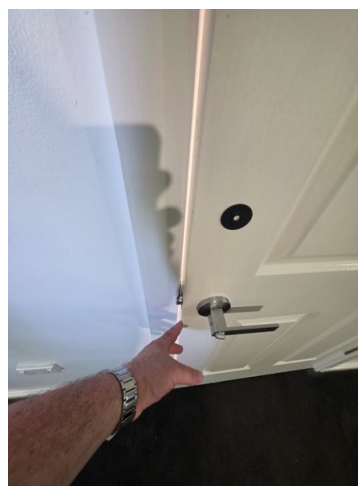
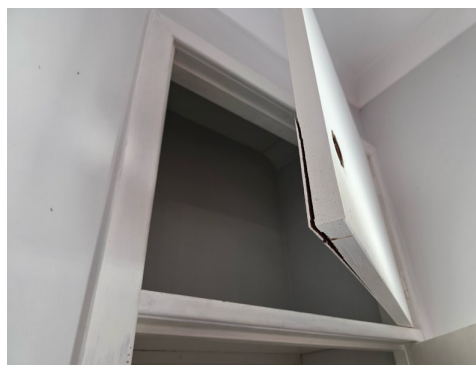
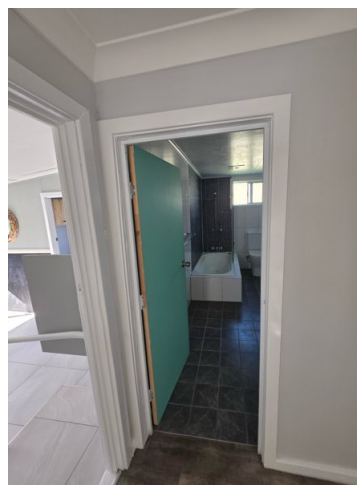
Wardrobe doors in Bedrooms 1 and 3 are binding and require adjustment. In Bedroom 1 the wardrobe doors are rubbing on the carpet and the entry door has minor damage to the lower edge with scratch marks to the internal face. In Bedroom 2 the door does not latch when closed. In Bedroom 3 the top wardrobe doors have sustained minor damage and have no hardware fitted, and the bedroom door has a loose top hinge causing it to bind on the jamb and rub on the carpet, requiring lifting to close. The bathroom door has not been painted or sealed to the top or bottom edges. Unsealed timber in wet areas is susceptible to moisture ingress.

These conditions appear consistent with misalignment, hinge wear or minor movement, and continued use may result in further damage to doors, hardware and adjacent finishes. A qualified carpenter should be engaged to assess and rectify as required. This should be done as soon as practicable.

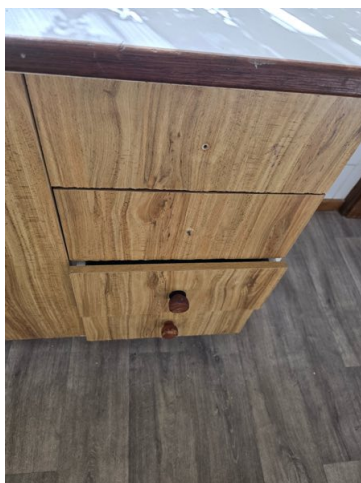
Finding: Deteriorated Kitchen Cabinetry and Moisture-Affected Joinery – Main Kitchen

Information: The kitchen is aged and in deteriorated condition. Overhead cupboards have no doors, drawers are missing handles and are difficult to operate, cabinet doors under the sink are binding, and a corner cupboard shelf has collapsed with fixings pulled through and associated edge damage. Blistering of laminate was also observed to the internal sides of the sink cabinet, which may be due to past moisture exposure; no elevated moisture was recorded at the time of inspection. Continued deterioration may result in further functional failure of cabinetry and progressive material breakdown.

A qualified carpenter should be engaged to assess and rectify as required. This should be done as soon as practicable.

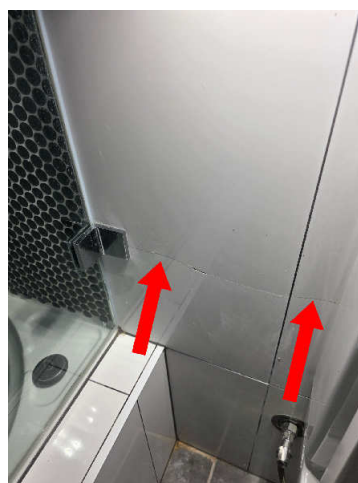
Finding: Cracked Wall Tiles – Main Bathroom

Information: Cracked tiles were observed in the main bathroom extending from a shower screen fixing point through an adjacent tile and continuing behind the toilet cistern. Cracking in wet areas may allow moisture ingress behind finishes, potentially leading to substrate deterioration.

A waterproofing contractor should be engaged to assess the cause and extent and rectify as required.

This should be done as soon as practicable.

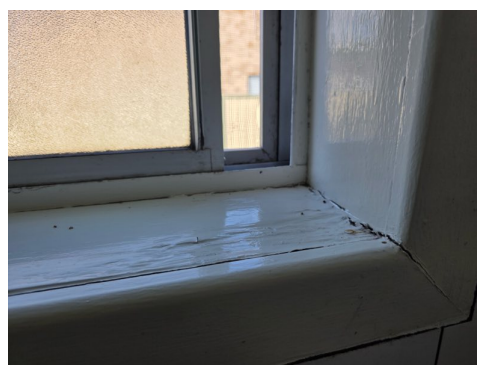
Location:	Bathroom
Finding:	Rotten Window Reveal – Bathroom
Information:	<p>The bathroom window reveal appears to be affected by fungal decay and has been painted over, limiting full assessment during a visual, non-invasive inspection. Timber decay in wet areas may compromise the integrity of the reveal and allow further moisture ingress into adjacent framing.</p> <p>A qualified carpenter should be engaged to assess the cause and extent and rectify as required. This should be done without delay.</p>

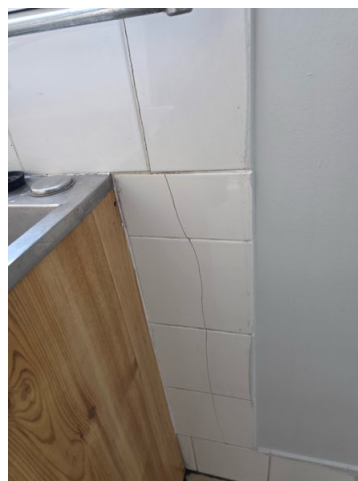
Building:	Main Building
Location:	Laundry
Finding:	Laundry Shower Tiling Defects – Laundry
Information:	<p>In the laundry shower, a vertical crack runs through approximately five tiles in line with the shower curtain, a tile is broken adjacent to the shower hob, and no sealant is present in the internal corner. These defects may allow moisture ingress into wall substrates, potentially resulting in concealed deterioration.</p> <p>A waterproofing contractor should be engaged to assess the cause and extent and rectify as required.</p> <p>This should be done as soon as practicable.</p>

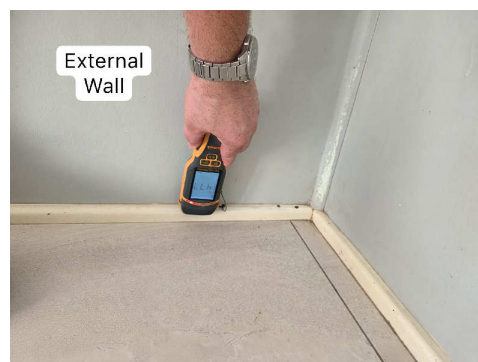
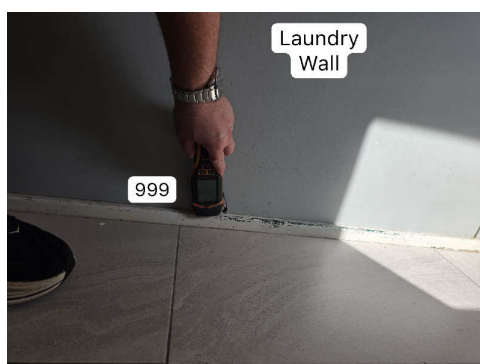
Finding: Elevated Moisture – Rumpus room and Laundry Wall

Information: High moisture readings were recorded to the back wall of the rumpus room, with readings around 500, and to the wall separating the rear of the laundry from the adjacent alcove, where readings reached 999. No visible mould, deterioration or discolouration was observed, and no obvious plumbing fixtures were noted on these walls that would clearly explain the source. The cause is undetermined and cannot be confirmed during a visual, non-invasive inspection. Given the elevated readings, further investigation may be required to rule out concealed moisture issues.

The moisture meter used operates on a scale from 0 to 999. Readings above 200 are considered elevated. Concealed damage could not be ruled out. More invasive inspection is recommended to determine the full extent of damage.

A licensed builder should be engaged to assess the cause and extent and rectify as required. This should be done as soon as practicable.

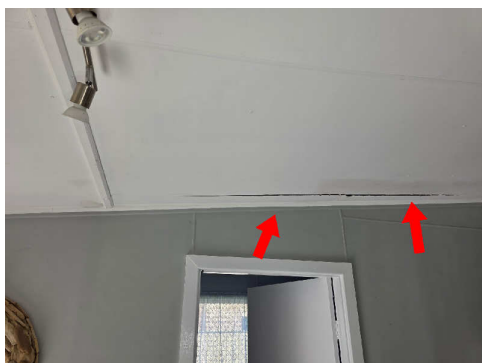
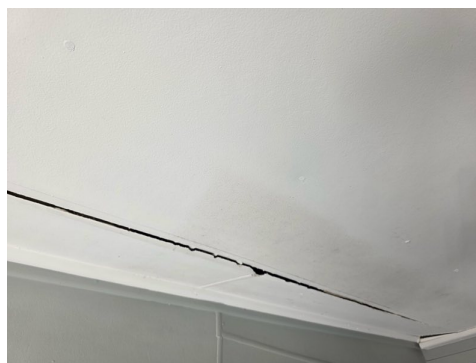
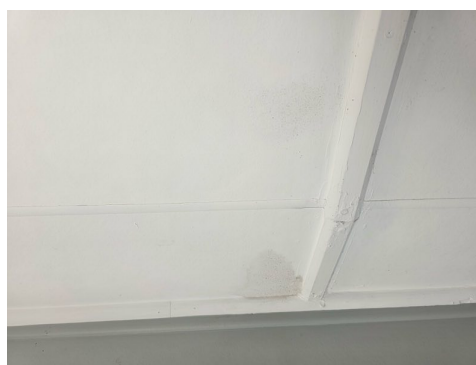
Information: The ceiling in the rear rumpus room has collapsed along one joint, with minor discolouration noted. No elevated moisture was detected at the time of inspection and the cause is unknown. The failure of ceiling linings may indicate underlying structural or fixing issues.

A licensed builder should be engaged to assess the cause and extent and rectify as required. This should be done as soon as practicable.

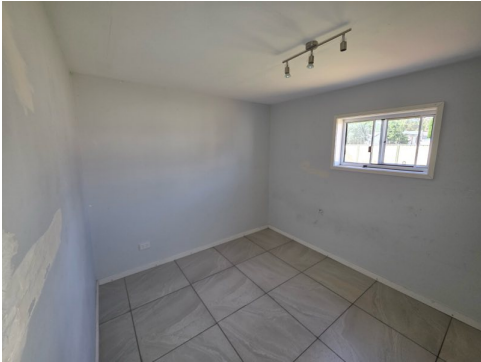
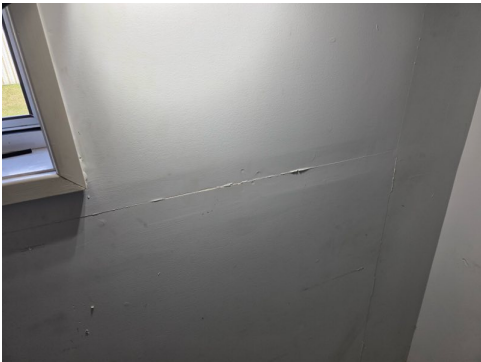
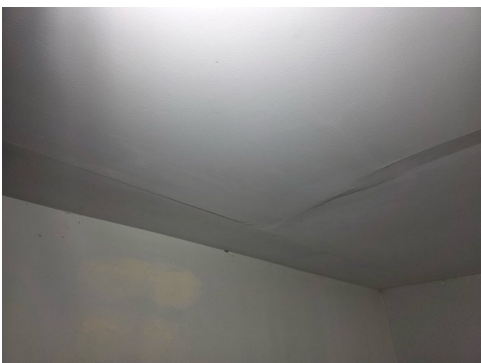
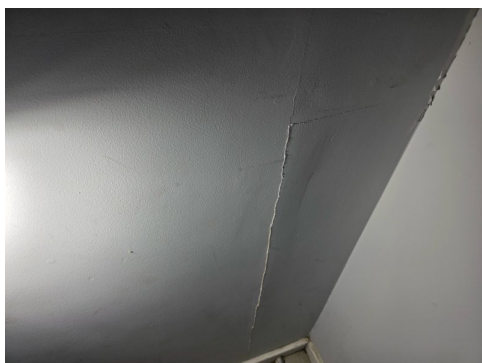
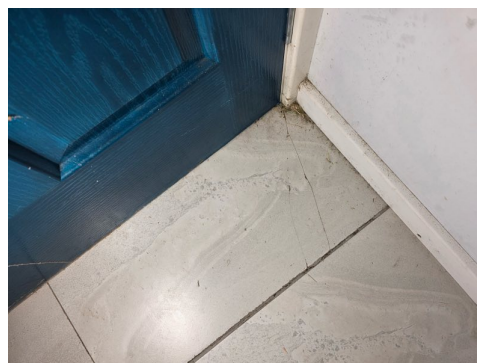
Information: The double garage has been partially converted into two makeshift rooms and a reduced garage space. Multiple cracks are present to ceilings and walls, with wall damage and poor-quality finishing observed. Substandard construction may conceal structural or moisture-related issues and may not perform as intended.

A licensed builder should be engaged to assess the cause and extent and rectify as required.

This should be done as soon as practicable.

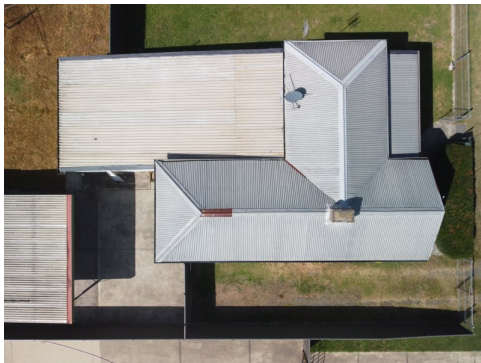
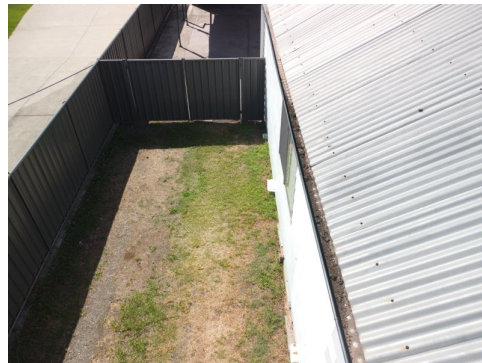
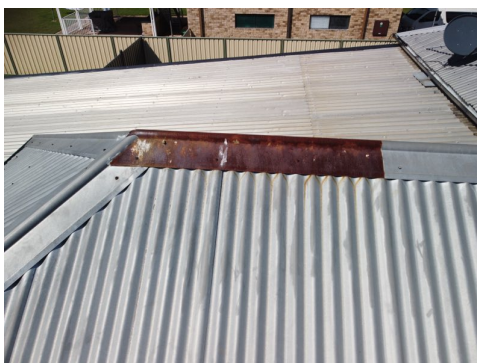
Finding: Roofing Defects – Roof Covering, Flashings and Drainage

Information: One valley pan at the rear of the roof is heavily rusted, numerous roof fixings are rusted with some sealed using silicone, one ridge cap is heavily rusted, and flashings around the chimney appear substandard. Gutters over the rumpus room and garage contain debris, with debris also present on the carport roof. These conditions may allow moisture ingress and reduce the serviceability of the roof covering system. A minor water stain was observed to the ceiling in Bedroom 3 in proximity to the chimney, which may indicate an intermittent leak in this area or may be related to another source; however, no elevated moisture was recorded at the time of inspection and the exact cause cannot be confirmed during a visual, non-invasive inspection.

A roofer should be engaged to assess the overall condition of the roof, including the chimney flashings, and carry out any necessary repairs as required. This should be done as soon as practicable.

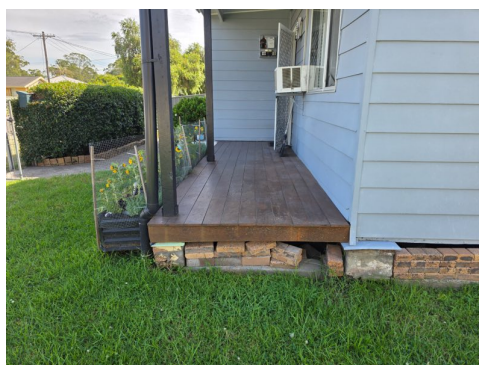
Information: The substructure of the decking in front verandah was not accessible for inspection due to low clearance, ground contact, or cladding. Inaccessible areas such as this prevent a full visual inspection and create conditions conducive to concealed termite entry or timber decay, as any damage or activity may remain undetected until it becomes extensive.

Where practical, the deck should be modified to allow adequate clearance and access for future inspection. Where modification is not possible, the risk of concealed attack remains. In such cases, it is essential that a licensed pest controller establish an ongoing termite management plan and carry out regular timber pest inspections every 6–12 months.

This matter should be addressed without delay to ensure concealed areas are monitored and managed effectively.

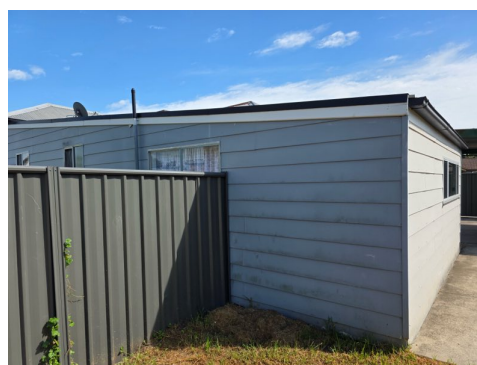
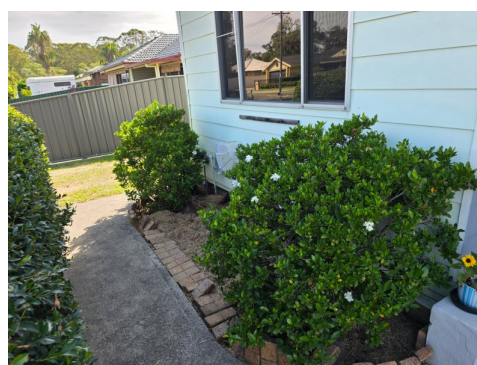
Bridging was observed at various locations around the external perimeter of the dwelling. Bridging occurs where materials or structures create a continuous path over or around the termite management system, allowing termites to bypass barriers and enter the dwelling undetected. Common examples include downpipes, fixed gates, hot water service units, air-conditioning units, garden beds, soil build-up, and paved surfaces installed hard against the slab or footing.

Bridging is a significant risk because it defeats the purpose of a physical or chemical termite barrier. Where practical, bridging elements should be modified or removed so that a clear and uninterrupted inspection zone remains around the entire perimeter.

Where it is not practical to remove or alter the bridging element, the risk of concealed termite entry remains. In these cases, a licensed pest controller should establish an ongoing termite management plan and carry out regular timber pest inspections every 6–12 months. This should be addressed without delay.

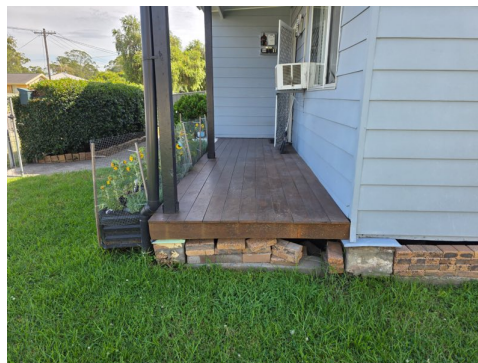
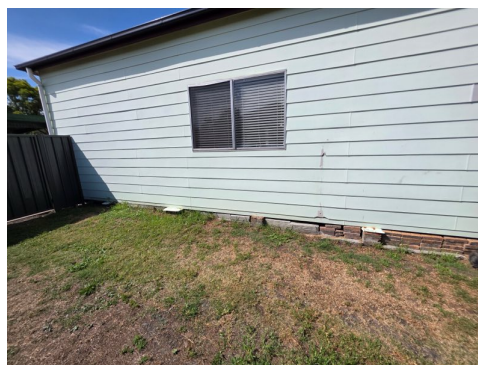
Building:	Main Building
Location:	Subfloor
Finding:	Ventilation - Inadequate subfloor ventilation
Information:	Subfloor ventilation appears to be inadequate in one or more areas beneath the dwelling. Poor airflow can result in elevated moisture levels, which in turn create conditions conducive to fungal decay and termite activity. Signs of dampness or musty odours may also indicate restricted air movement.

Improved cross-ventilation should be established to help manage moisture and reduce the risk of concealed timber pest attack. A licensed builder should assess the subfloor and install additional vents or mechanical ventilation as needed. This should be as soon as practicable.

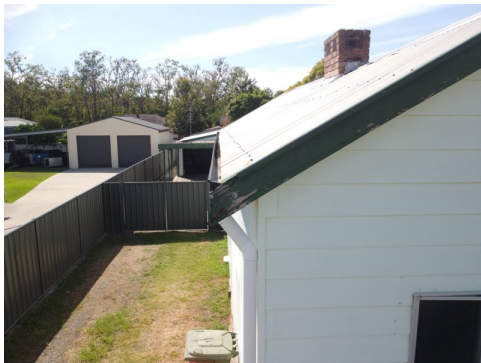
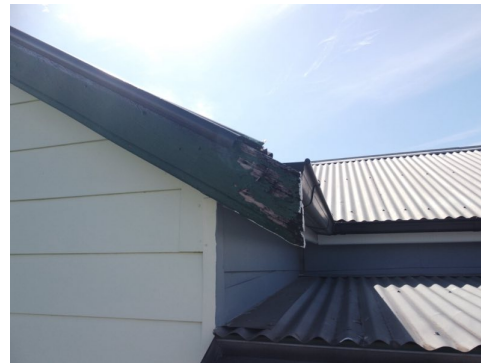
Building: Main Building
Location: Multiple Areas
Finding: Fungal decay observed in timber elements

Recommend a licensed builder assess the extent of deterioration and replace or treat affected timbers as necessary. This should be done as soon as practicable. Regular timber pest inspections should be carried out every 6–12 months.

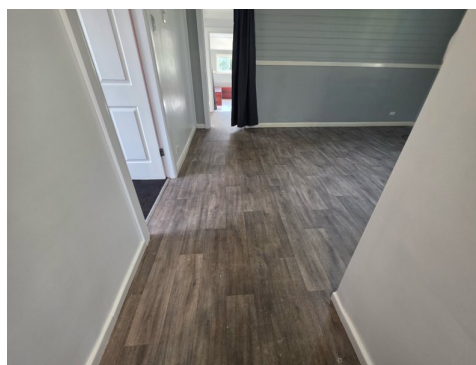
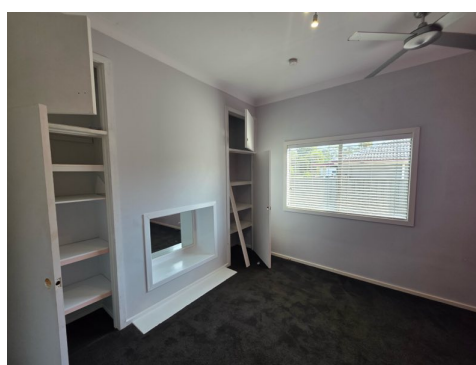
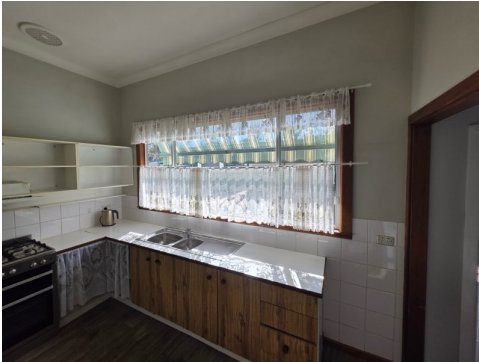
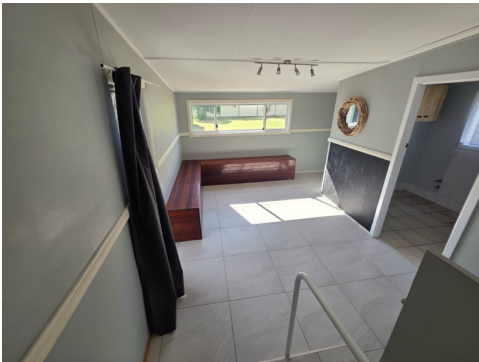
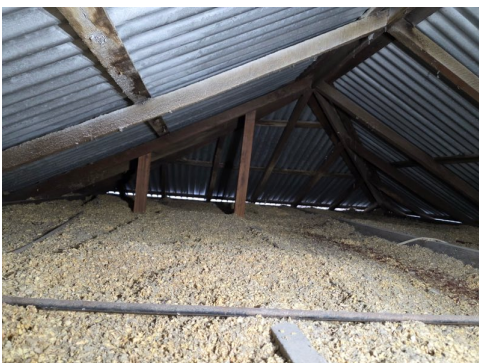
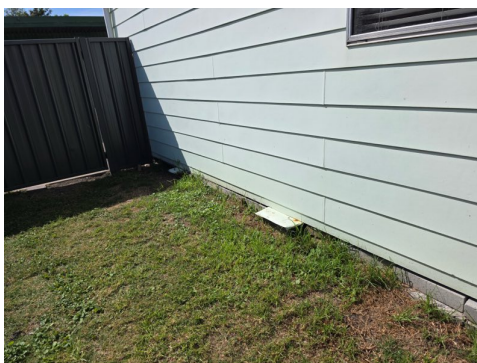
Finding: Additional Photos - Obstructions and Limitations

Information: These photographs are an indication of the obstructions and limitations which impeded full inspection of the property at the time of inspection. These obstructions can hide an array of defects and should be removed to allow full inspection to be carried out. A re-inspection is recommended once the areas are made accessible.

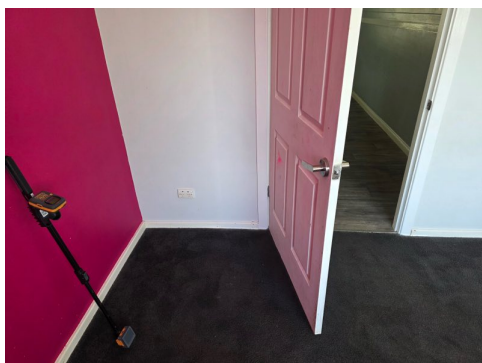
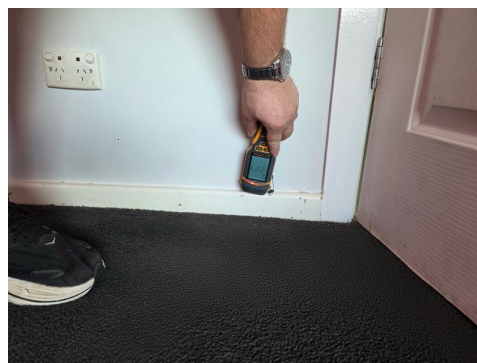
Finding: Low-Level Elevated Moisture

Information: Low-level elevated moisture readings were recorded beneath the window in Bedroom 3 and to the wall separating Bedroom 3 from the living room. No visible mould, deterioration or discolouration was observed at the time of inspection. The readings may not necessarily indicate active moisture ingress and could be influenced by environmental conditions; however, the source cannot be confirmed during a visual, non-invasive inspection. The area should be monitored, and if deterioration, discolouration or mould growth develops, further investigation may be required.

The moisture meter used operates on a scale from 0 to 999. Readings above 200 are considered elevated. Concealed damage could not be ruled out. More invasive inspection is recommended to determine the full extent of damage.

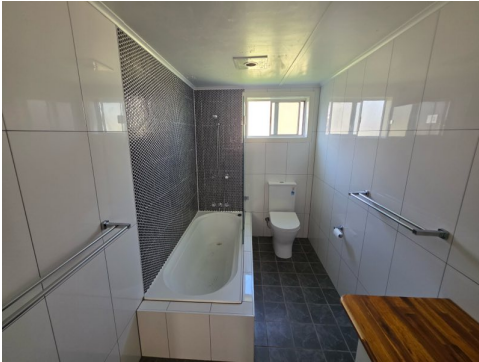
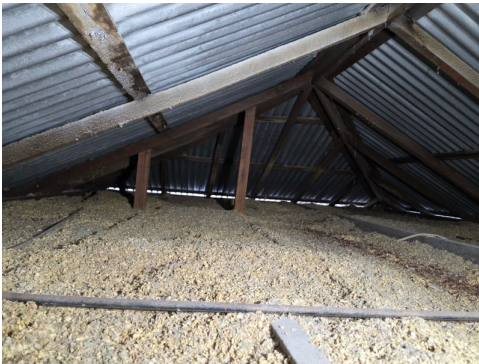
Information: Reporting on asbestos is outside the scope of this inspection. Suspected asbestos-containing material (ACM) was observed in the bathroom ceiling linings, rear rumpus room, external eaves, some wall linings and loose fill insulation within the roof void. Based on our experience in the building industry, there is a higher risk that the identified building elements contain asbestos, particularly given that any home constructed prior to 1990 may contain asbestos in various forms.

No sample testing has been undertaken to confirm the presence of asbestos. We strongly recommend a separate Asbestos Inspection and Condition Audit be carried out by a licensed assessor, which may include laboratory testing for definitive confirmation.

In the meantime, the client is advised to act with caution, especially when considering any disturbance of the material through wear and tear, renovations, extensions, demolition, or maintenance activities.

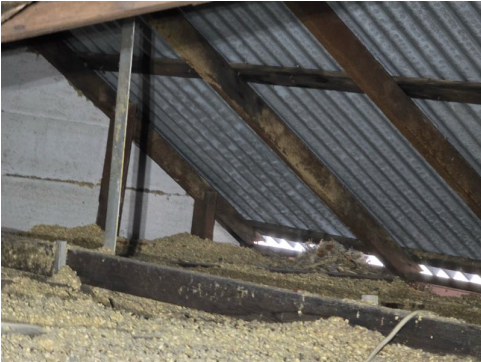
Building:	Main Building
Location:	Roof Void
Finding:	Roof Void Access
Information:	<p>Access to the roof void was not possible due to the presence of loose fill insulation. Loose fill insulation may contain asbestos, and the material cannot be confirmed during a visual, non-invasive inspection. Disturbance of insulation that contains asbestos may present a health risk through airborne fibre release.</p> <p>An asbestos assessor should be engaged to carry out testing and provide recommendations as required.</p> <p>This should be done at the owner's discretion.</p>
