Building and Timber Pest Inspection Report

Inspection Date: Thu, 2 Apr 2026

Property Address: 5/23-25 Fontainebleau St, Sans Souci NSW
2219, Australia

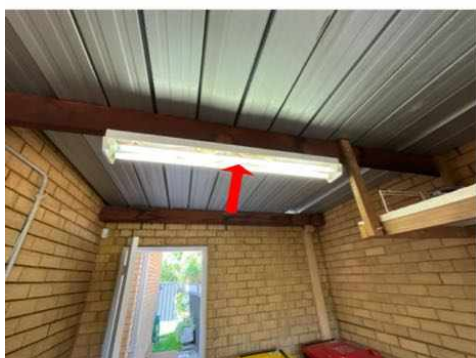
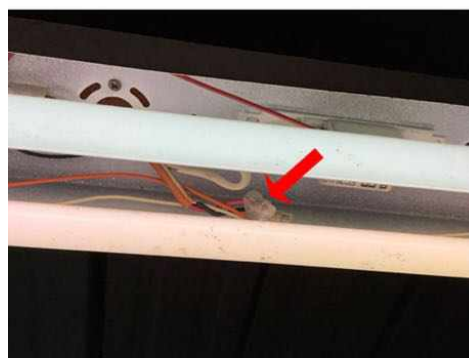
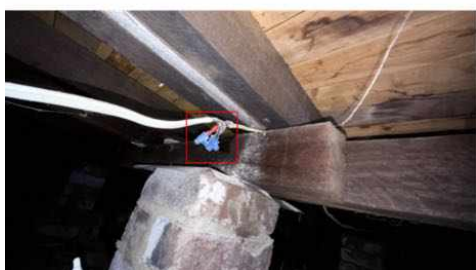
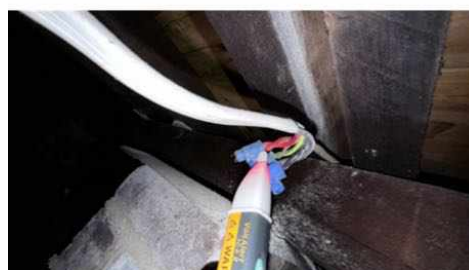
Exposed conductors must be properly insulated or covered to prevent electric shock, and they should always be housed within an enclosure like a junction box.

Exposed electrical wiring represents a potential safety hazard including for fire and personal contact. Contact a licensed electrician urgently for further inspection investigation and rectification.

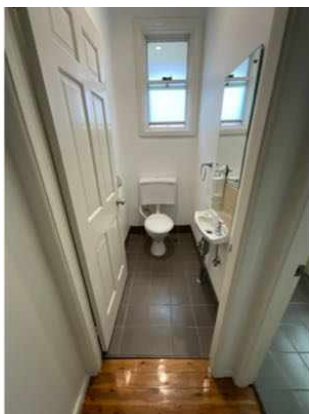
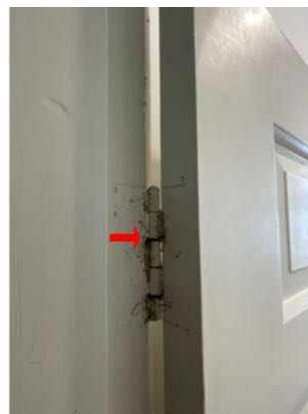
Finding 1.02

Building:	Main Building
Location:	Toilet (WC)
Finding:	SAFETY HAZARD: Door - Safety hinges missing

A suitable door latch allows the door to be lifted upward and away.

Installation of safety hinges to the door should be carried out as soon as possible by a licensed carpenter.

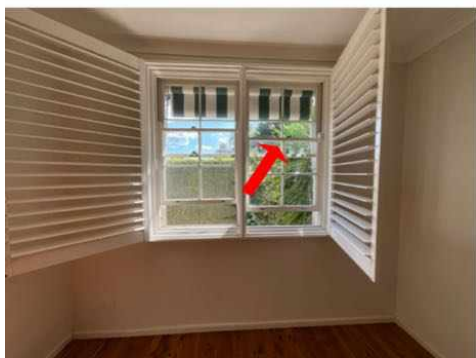
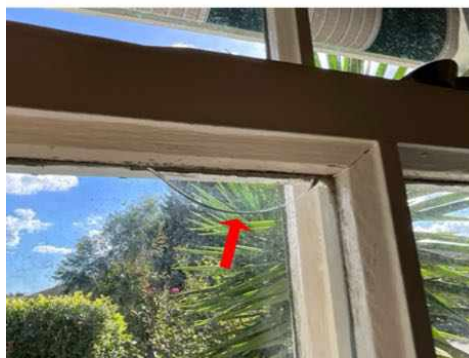
Finding 1.03

Building: Main Building

A qualified glazier is required to repair the window as soon as possible. Depending on the extent of the cracking, replacement of the window may be required. Please be advised that any persons coming into contact with the cracked window should do so

with due caution to avoid any personal injury that may ensue.

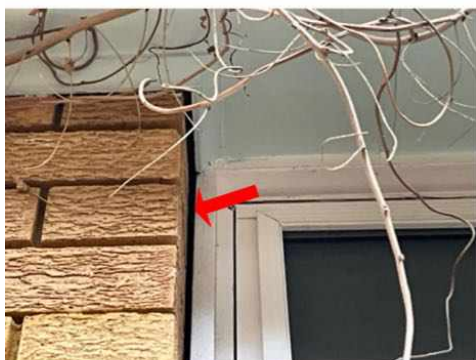
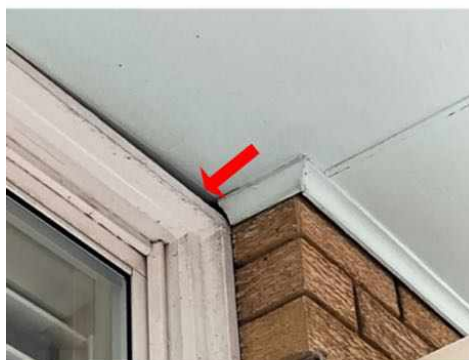
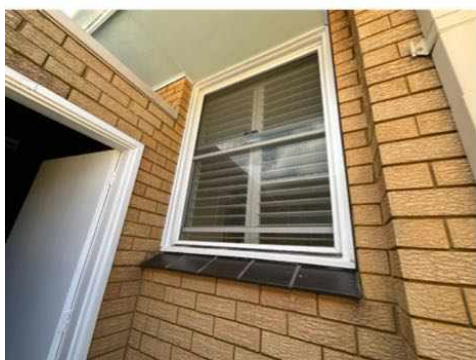
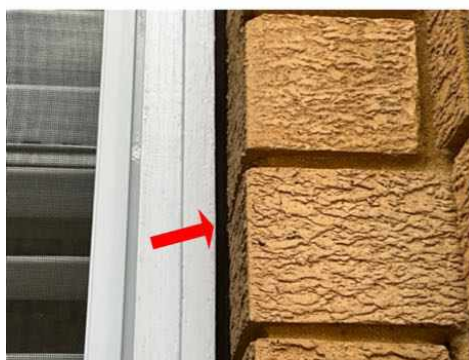
Finding 3.05

Building:	Main Building
Location:	Eaves
Finding:	Eave Beading - movement
Information:	Eave Beading covers the intersection where the eave meets the wall.

Beading works to protect the joints of building materials, which are more susceptible to deterioration and decay.

Repair or replacement of the beading is advised to ensure the protection and longevity of any associated building elements. Such works may be performed by a qualified carpenter. It is advised to monitor this area for further movement and contact a building inspector if further movement occurs.

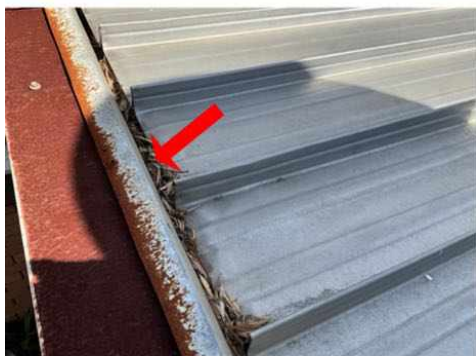
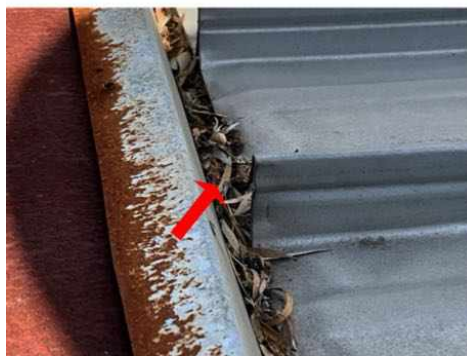
Finding 3.11

Building:	Main Building
Location:	Roof Exterior
Finding:	Rusted -Gutter
Information:	The gutter has areas of rust and corrosion.

A licensed plumber or specialist roofing/gutter company should be appointed to undertake these works.

It is advised that such works be completed as soon as possible to prevent any further damage and deterioration

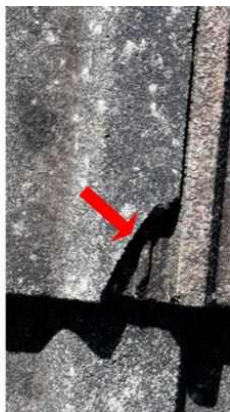
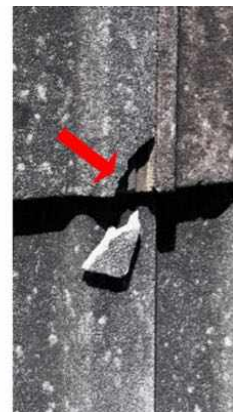
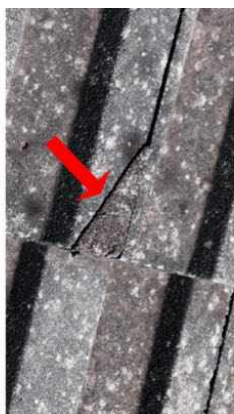
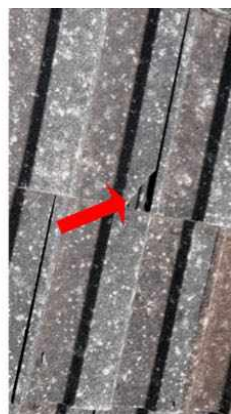
Building:	Main Building
Location:	Roof Exterior
Finding:	Roof tiles - Broken
Information:	Upon inspection of some areas of the exterior roof covering, broken roofing tiles were identified. Broken and friable roof tiles are generally the result of ageing and weathering of what is essentially a porous material.

If left to further deteriorate, broken and brittle roof tiles are likely to lead to water penetration via the roof into the ceiling space, causing secondary damage to ceiling linings, insulation and roof structures. Broken roof tiles are also likely to detract from the effectiveness of the roof drainage system, creating potential for secondary damage to the exterior roof covering and roof plumbing.

Replacement of broken tiles is required and should be performed by a roofing contractor as soon as possible.

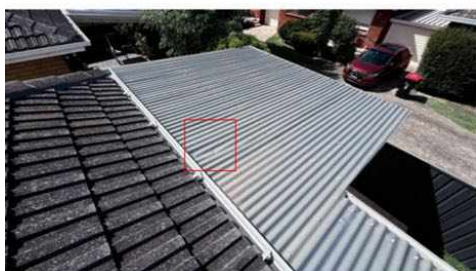
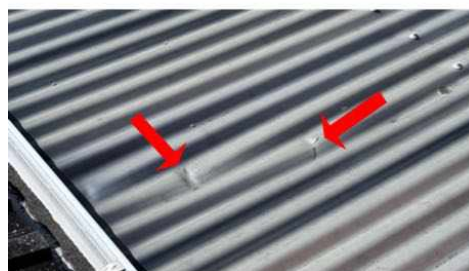
Finding 3.13

Building:	Main Building
Location:	Roof Exterior
Finding:	Roof sheets - damaged
Information:	Upon inspection of the exterior roofing, it was found that the roof sheets were damaged.

This type of damaged is generally associated with persons walking on the roof sheet.

Damaged roof sheets are susceptible to water penetration, exposing the surrounding associated area to internal roof leaks and water damage.

Depending on the extent of the damage, replacement of sections of roof sheets or associated materials may be required. Engagement of a roofing restoration contractor is highly advised to perform remedial works as necessary.

It is highly advised to have the roof inspected by a roofing contractor on a regular basis to prevent water penetration into the building

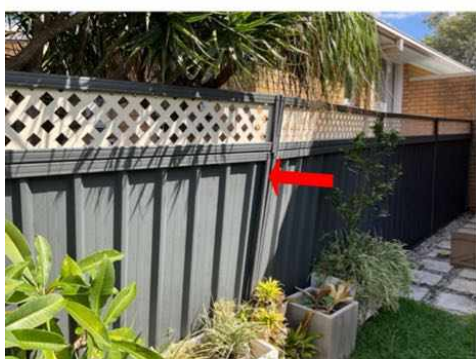
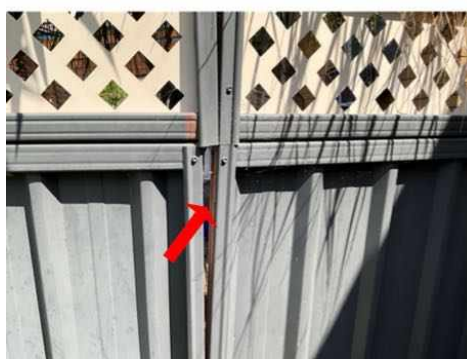
Finding 3.14

Building:	Main Building
Location:	Yard - Back

Finding: Fencing - Deteriorated
 Information: It was noted at the time of inspection that sections of the fencing throughout the property have deteriorated. Typically fencing deteriorates due to age and or wear, rot and or rust which is generally expected for a structure of this age, due to prolonged exposure to weather conditions. Sometimes inadequate installation or maintenance can be to blame.

If left unattended, it is likely that further damage will occur. It is suspected that repair of several elements of the fencing may be required however replacement may be a consideration of the client also.

A licensed fencing contractor should be appointed to provide further advice and perform rectification works as necessary.

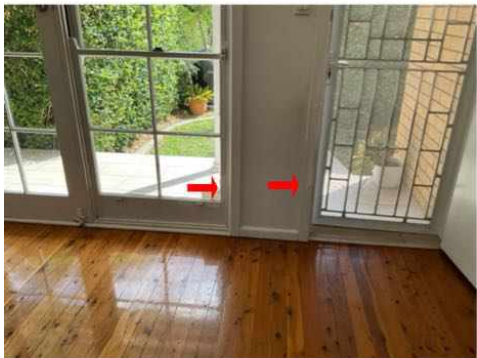
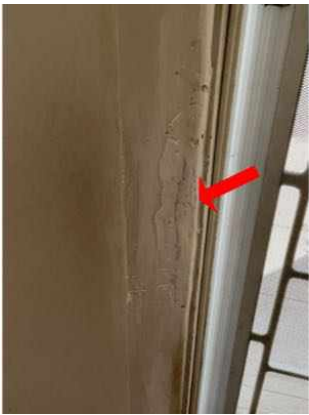
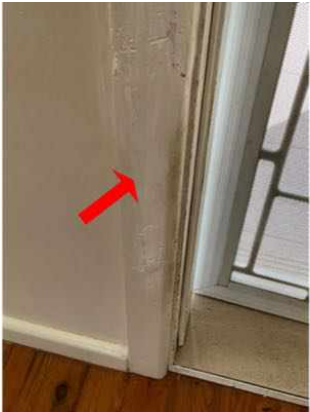
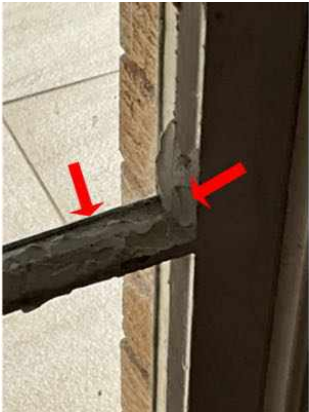
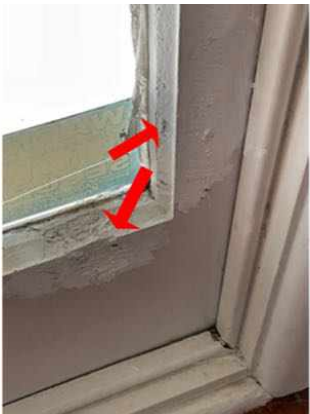
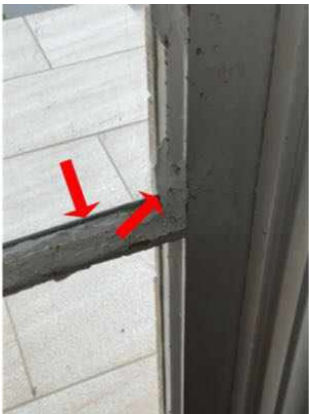
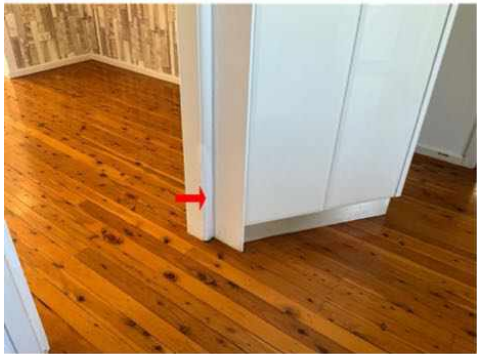
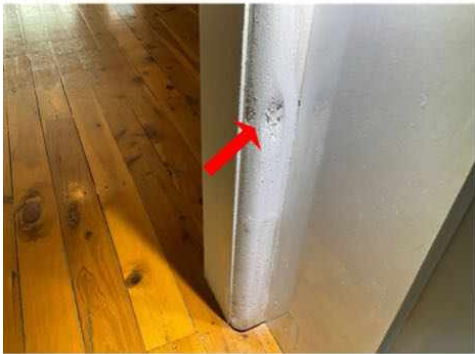
Finding 3.15

Building: Main Building
 Location: All Areas
 Finding: Substandard works identified
 Information: A poor-quality and substandard attempt to repair damaged timber elements to several areas areas has been identified, with visible patching, uneven surfaces, and inadequate finishing evident. This workmanship is not consistent with acceptable building standards and may conceal underlying damage such as moisture ingress or timber deterioration. It is recommended that the affected areas be properly assessed and rectified by a qualified and competent carpenter or builder, which may involve removal of defective materials, appropriate repairs or replacement, and proper preparation and finishing. Failure to address this issue may result in ongoing deterioration, reduced durability, and further cosmetic and potential structural concerns.

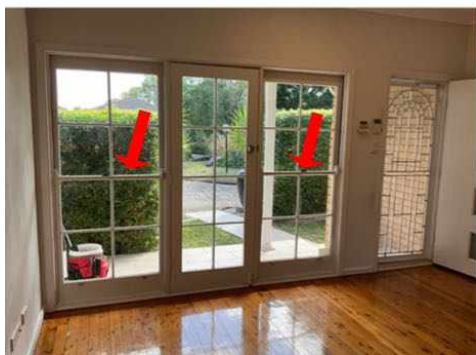
Finding 3.16

Building: Main Building
 Location: All Areas
 Finding: Window - binding or jamming
 Information: Binding and/or jamming of several windows is evident during standard operation.

This defect inhibits the functionality of the affected window as well as creating potential for secondary defects to associated building elements.

A window that binds may have several causes, such as poor installation, sashes painted shut or swelling of timber frames.

A qualified carpenter should be appointed to perform minor rectification works at client discretion.

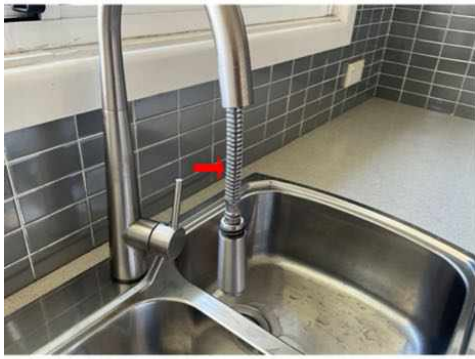
Finding 3.17

Building: Main Building
 Location: Kitchen
 Finding: Tap-not retracting
 Information: The pull out nozzle is not retracting back into the tap housing.

This is generally due to the weight mechanism attached to the flexi hose not operating as intended. This may lead to other associated impairments to the surrounding building elements if not rectified.

Although a relatively minor defect a licensed plumber should be appointed to confirm these findings and restore the tap to its full operational integrity.

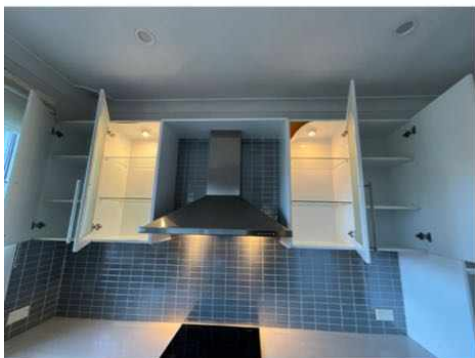
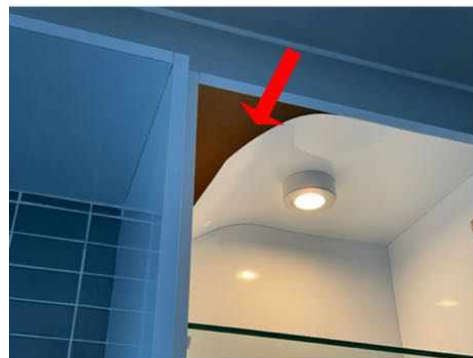
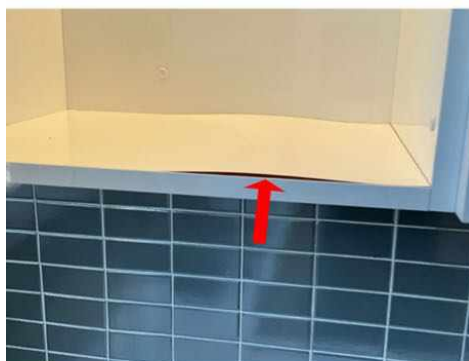
Finding 3.18

Building:	Main Building
Location:	Kitchen
Finding:	Deteriorated-Cabinetry
Information:	The cabinetry in several areas has deteriorated.

This may be the result of general wear and tear due to age which may include but not limited to deteriorated hinges and latches, missing handles, damage to bench tops and shelving.

In some cases the deteriorated cabinetry may be as a direct result of water damage due to leaking pipes or unsealed bench tops allowing water to penetrate the cabinets.

If left unmanaged the cabinetry will deteriorate further which may lead to more costly repairs in the future.

Rectification works may include minor repair work or replacement of the cabinetry depending on the extent of the damage.

It is highly advised to engage a remedial builder to determine and rectify what is causing the deterioration prior to any rectification work to the cabinetry

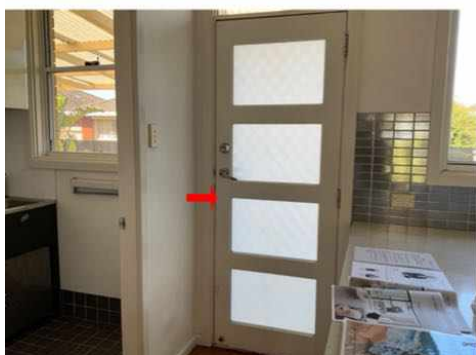
Finding 3.19

Building:	Main Building
Location:	Kitchen
Finding:	Door binding
Information:	Binding of this door is evident during standard operation.

This defect inhibits the functionality of the affected door as well as creating potential for secondary defects to associated building elements, such as the door frame.

A door that binds to the associated door frame may have several causes, ranging from minor defects, such as poor installation of the door, deteriorated hinges or swelling of timber doors due to excessive moisture in the area.

A qualified carpenter should be appointed to advise on suitable rectification works.

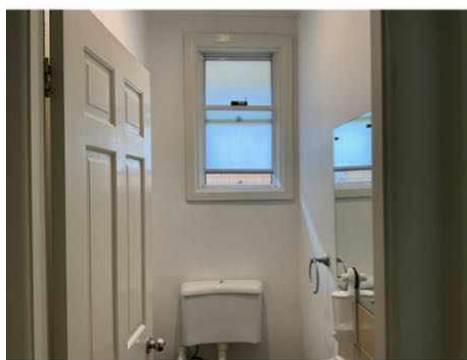
Finding 3.20

Building:	Main Building
Location:	All Areas
Finding:	Windows - difficult to slide.
Information:	Several windows throughout the property were jammed and difficult to operate at the time of the inspection. Windows provide ventilation to the adjoining area and should

be at a fully operational level to ensure user comfort. Restricted function of the window may also pose as a potential safety hazard if required for emergency egress from the building.

Generally, factors such as general age of the building element and a lack of maintenance are the usual causes for this type of defect.

Replacement of window hardware or frame may be required, as well as minor repairs and cleaning. A registered builder or general handy person will be required to repair the affected windows.

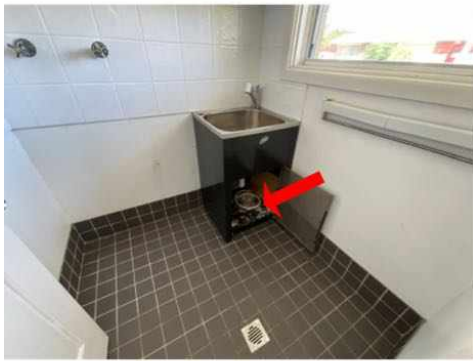
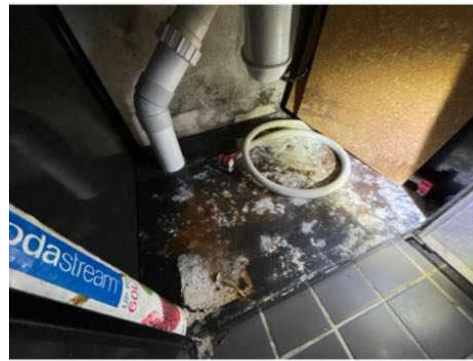
Finding 3.21

Building:	Main Building
Location:	Laundry
Finding:	Laundry tub - Rusted or corroded
Information:	The laundry tub was observed to have visible rusting and surface deterioration. This condition is typically the result of prolonged exposure to moisture and general wear over time and may lead to further corrosion or eventual failure of the fixture if left unaddressed.

It is recommended that the laundry tub be repaired where possible or replaced to prevent further deterioration and potential leakage. Routine maintenance and ensuring the area remains dry when not in use may help prolong the life of the fixture.

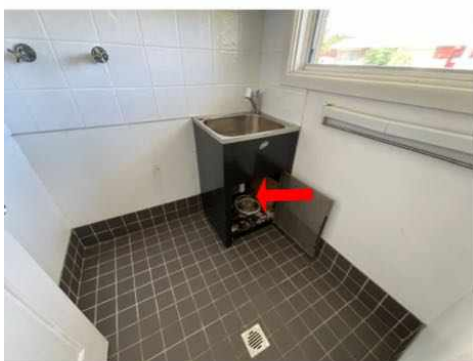
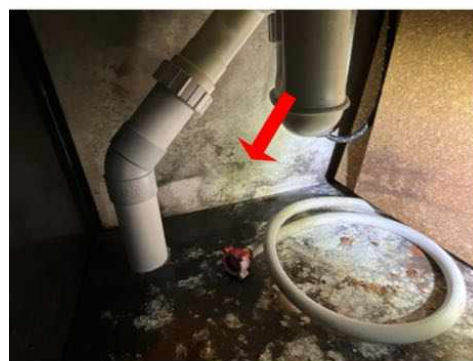
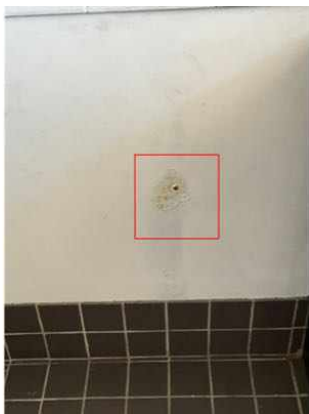
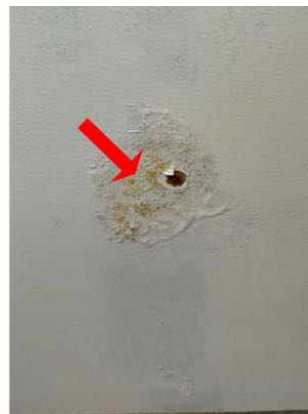
Finding 3.22

Information: Where evidence of mould growth was noted, there may be environmental, biological or health issues associated with the report. A specialist inspection by a suitably qualified environmental health inspector is warranted, where mould is extensive or where any queries regarding air quality spores or other related issues apply.

Generally, the client is advised to ensure that the general environment is free of moisture and humidity to aid in the prevention of mould formation and development. Any mould found during the inspection should be cleaned immediately by a cleaning contractor or the homeowner as applicable.

Please note that severely affected building elements may require replacement by a registered builder or qualified tradesperson.

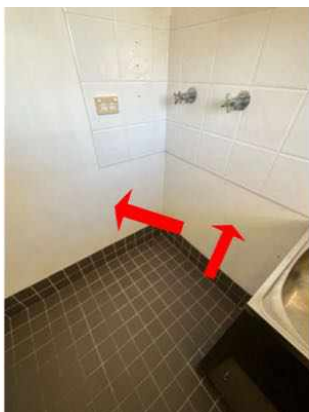
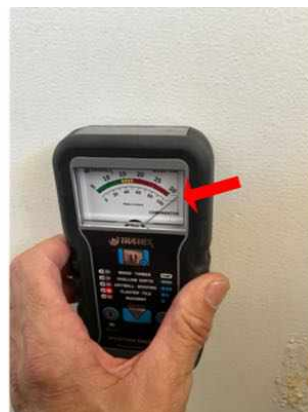
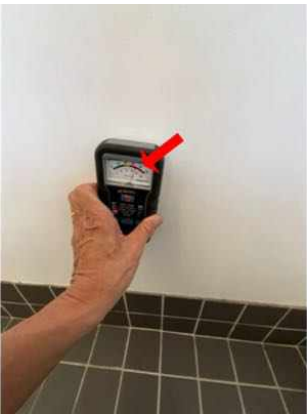
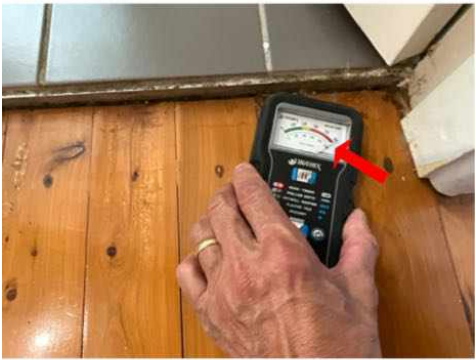
Finding 3.23

Building:	Main Building
Location:	All Areas
Finding:	High Moisture Reading-adjacent to shower
Information:	At the time of inspection, it was noted that there was a high moisture reading to the wall and floor adjacent to the shower.

High moisture readings can have several causes: including live termite activity or different types of building material eg ACM board or an electrical bracket interfering with the moisture readings.

However high moisture readings in walls and timber flooring adjacent to the shower recess are typically a failure of the water proofing membrane to the shower.

Please note: Any moisture penetrating timber frames may result in the structural integrity of the frame being compromised and is conducive to timber pest activity.

An invasive inspection which may include removal of wall linings is recommended to confirm any of these findings.

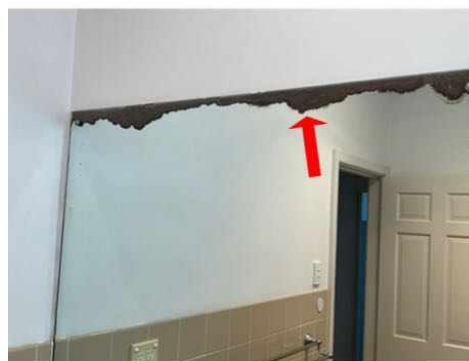
Finding 3.24

Building:	Main Building
Location:	Bathroom
Finding:	Mirror Desilvering
Information:	Mirror desilvering or mirror rot is caused by moisture penetrating between the layer of glass and the layer of backing metal.

Once water vapour has penetrated, the metal that makes your mirror shiny begins to react and oxidize (rusts), turning black.

Once the separation occurs, any moisture — even just steam from showering can begin to cause the black spots to appear.

In some cases rectification is possible but replacement is generally the best option.

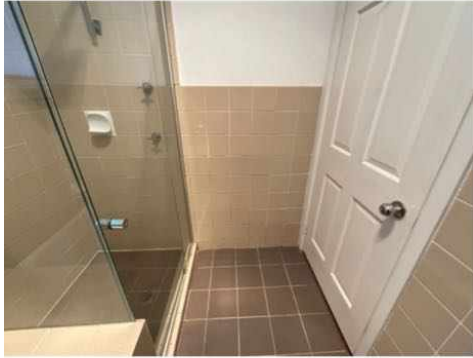
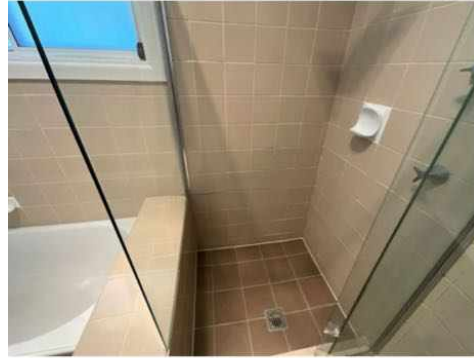
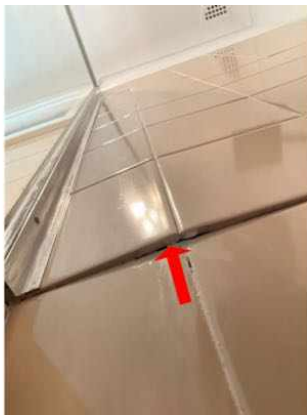
Finding 3.25

Building:	Main Building
Location:	Bathroom
Finding:	Tiles popping
Information:	Several areas of popped tiles were detected. Sometimes known as tile tenting.

A tiling contractor should be contacted to install expansion joints where necessary and perform works such as removing and re-laying affected tiles.

Leaving this unmanaged will lead to further popped tiles and more significant repairs.

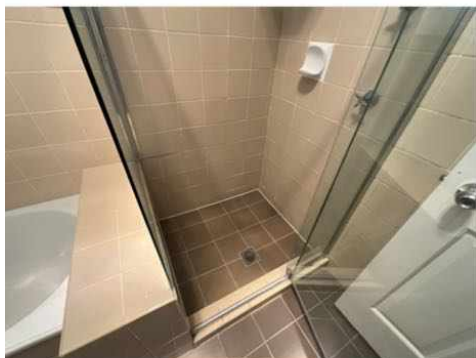
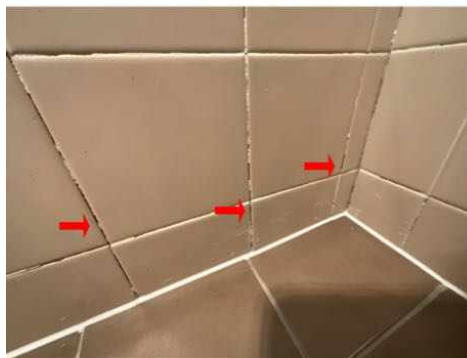
Finding 3.26

Building:	Main Building
Location:	Bathroom
Finding:	Grout - Missing
Information:	Grout is missing in this area.

Failure to do so is likely to lead to water damage to the surrounding area.

Where grout is missing, a tiling contractor should be appointed immediately to apply grout and re-apply any silicone where necessary.

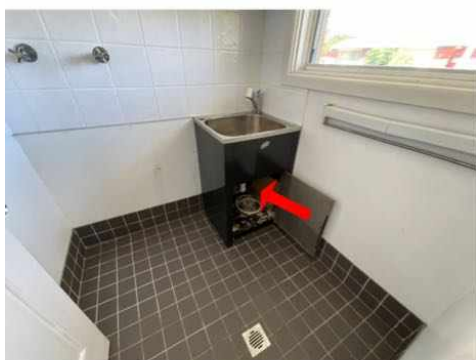
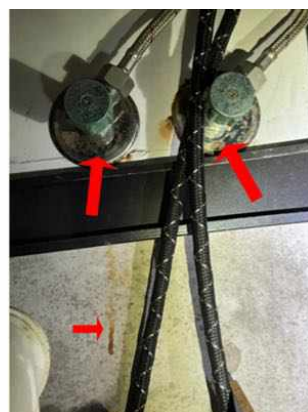
Building:	Main Building
Location:	Laundry
Finding:	Tap connections rust staining
Information:	Rust staining and corrosion are evident around the tap fittings and escutcheon plates, indicating prolonged moisture exposure and possible minor leakage at the connections.

This condition may lead to further deterioration of the fittings and potential damage to surrounding cabinetry or wall linings if left unaddressed.

Failure to address this issue may result in ongoing water damage, increased corrosion, and potential failure of the tap connections.

It is recommended that a licensed plumber inspect the fittings, rectify any leaks, and replace any corroded components as necessary.

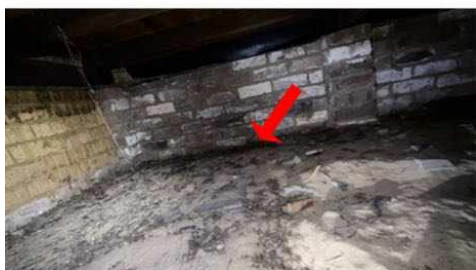
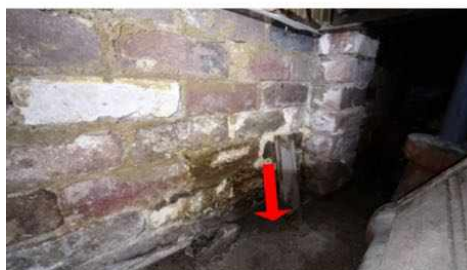
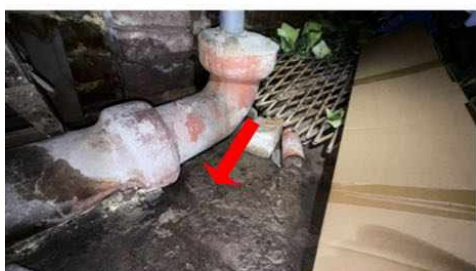
Finding 3.29

Building:	Main Building
Location:	Subfloor
Finding:	Damp subfloor
Information:	Dampness to sections of the subfloor area was identified.

A possible cause of this dampness could be poor site drainage, inadequate subfloor ventilation or leaking pipes, whether on this property or adjoining properties which is allowing water to track through the subfloor.

Dampness in this area is likely to lead to wood rot and general deterioration of structures within the subfloor space.

Excessive moisture also creates an environment which is conducive to termite and pest infestation as well as being conducive to mould growth.

A remedial builder should be appointed immediately to identify the cause of the dampness and rectify the issue. This will ensure a dry subfloor space which in turn will negate other issues that may arise with a damp subfloor.

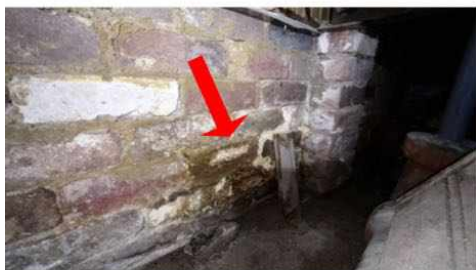
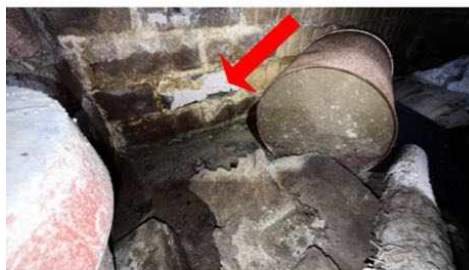
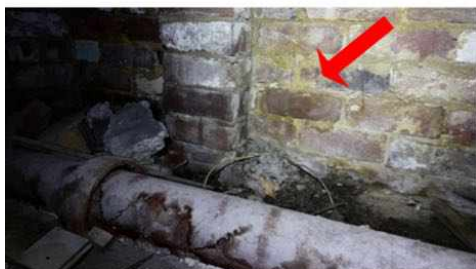
Finding 3.30

Building:	Main Building
Location:	Subfloor
Finding:	Subfloor Mould - Present
Information:	The subfloor of a house is the lowest level of a home or building and commonly refers to the space between the soil and the floor. This area of the house can easily get wet or flooded due to heavy rains, water leaks or other water problems. The combination of a wet subfloor and poor ventilation makes the subfloor a common source of mould

It is important to detect and treat subfloor mould as it can be a major problem in houses. Moulds grow in the form of spores, which can move through the air and land on other wet materials in the house and start growing. They can move from the subfloor area into the walls, floors, and heating/ air-conditioning ducts and continue growing. Moreover, the subfloor mould spores can float through the air, enter the living areas and be inhaled by the occupants. Inhalation of mould spores can lead to many health problems

Where evidence of mould growth was noted, a specialist inspection by a suitably qualified environmental health inspector is warranted, where mould is extensive or where any queries regarding air quality spores or other related issues apply.

Generally, the client is advised to ensure that the general environment is free of moisture and humidity to aid in the prevention of mould formation and development. Any mould found during the inspection should be cleaned immediately.

Please note that severely affected building elements may require replacement by a registered builder or qualified tradesperson.

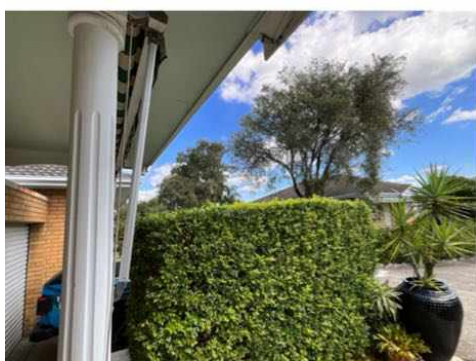
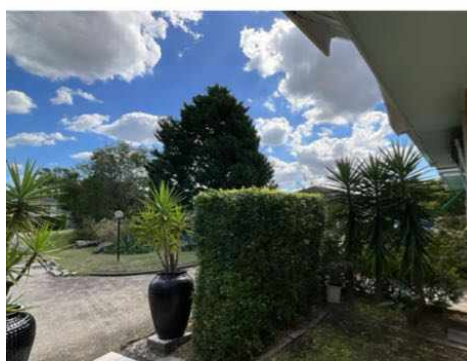
Finding 6.02

Building:	Main Building
Location:	All Areas

Leaving this unmanaged may lead to termites and/or borers infesting the building.

Where trees are close to the building, it is also highly advised to have the trees inspected by an arborist for structural integrity.

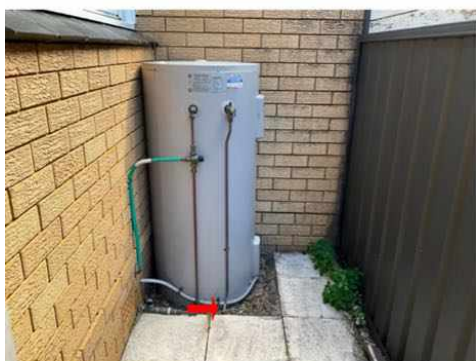
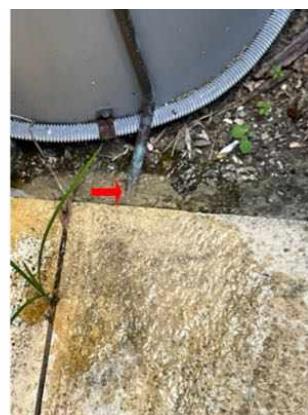
Building:	Main Building
Location:	Yard - Back
Finding:	HWS Overflow - Not Connected
Information:	The Hot Water System (HWS) overflow was found to be disconnected from storm water drainage and is creating excessive moisture in the surrounding area.

These damp conditions can lead to secondary defects such as rot, rust or corrosion of associated building elements, the formation of fungal decay, or even the creation of potential slip hazards. When coupled with poor site drainage, pooling of water may also attract termite activity to this area.

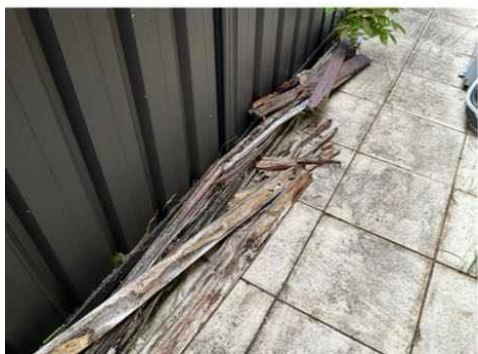
Finding 6.05

Building:	Main Building
Location:	Yard - Back
Finding:	In ground contact
Information:	Any timbers in direct ground contact provide opportunity for concealed termite entry and are likely to be subject to premature rot and decay as the soil retains moisture or damp conditions against the timbers.

Remove untreated timber that is in direct contact with external grounds. Consider

replacement with more durable materials i.e. treated timber or non timber elements. Frequent pest inspections are advised to readily identify any termite activity in these areas.

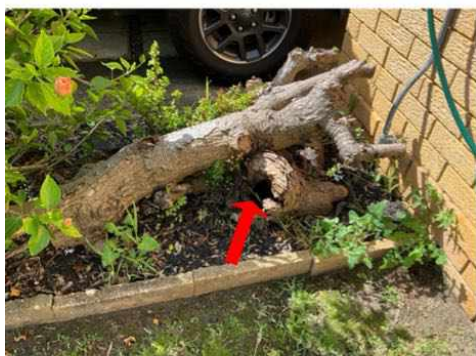
Finding 6.06

Building:	Main Building
Location:	All Areas
Finding:	Tree Stumps on Adjacent Property
Information:	Tree stumps were noted on the neighbouring property in close proximity to the subject dwelling.

Decaying timber, such as tree stumps, can provide an ideal nesting site for subterranean termites, which are capable of travelling significant distances underground to access new food sources.

It is recommended that the neighbouring party be advised of the risk and that regular termite inspections be carried out to monitor for any signs of activity.

A termite specialist should always be contacted for regular inspections and to advise on a termite management system that best suits the property.

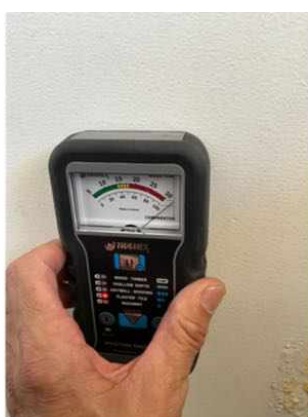
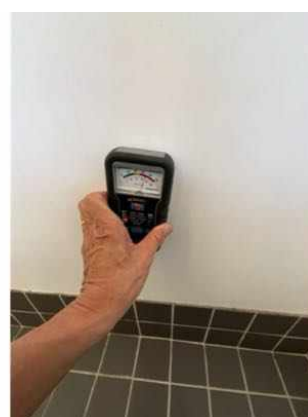
Finding 6.07

Building:	Main Building
Location:	All Areas
Finding:	High moisture reading-conducive conditions to termite activity.
Information:	High moisture readings were detected in the plasterboard during the inspection, which may be conducive to termite activity.

Termites are attracted to damp environments, as moisture softens building materials and facilitates easier access and tunneling.

Elevated moisture levels within or behind plasterboard can indicate potential leaks, poor ventilation, or drainage issues, all of which can create ideal conditions for concealed termite infestation.

Further investigation by a licensed builder or termite specialist is recommended, which may include removal of sections of plasterboard to identify the source of moisture and assess for any signs of active or previous termite presence.

Prompt rectification of moisture issues is essential to reduce the risk of future termite activity.

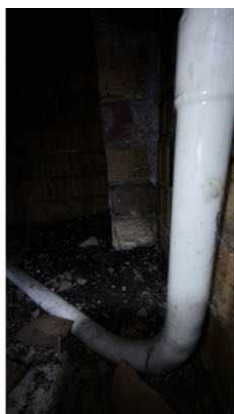
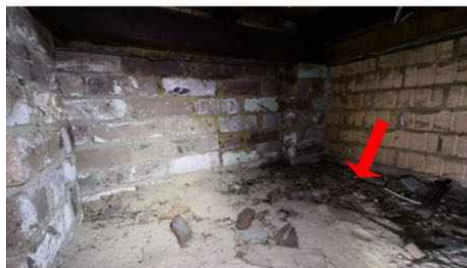
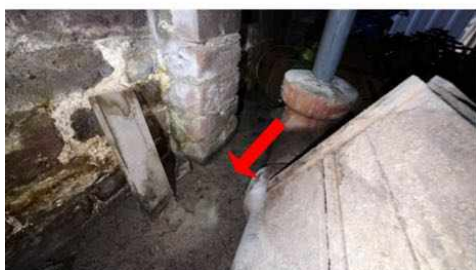
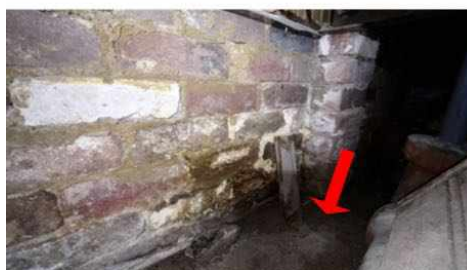
Finding 6.08

Building:	Main Building
Location:	Subfloor
Finding:	Damp subfloor
Information:	Dampness to sections of the subfloor area was identified.

A possible cause of this dampness could be poor site drainage, inadequate subfloor ventilation or leaking pipes, whether on this property or adjoining properties which is allowing water to track through the subfloor.

Dampness in this area is likely to lead to wood rot and general deterioration of structures within the subfloor space.

Excessive moisture also creates an environment which is conducive to termite and pest infestation as well as being conducive to mould growth.

A remedial builder should be appointed immediately to identify the cause of the dampness and rectify the issue. This will ensure a dry subfloor space which in turn will negate other issues that may arise with a damp subfloor.

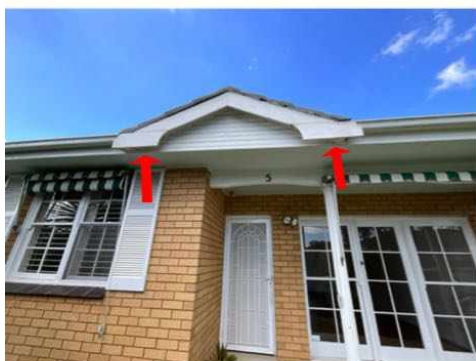
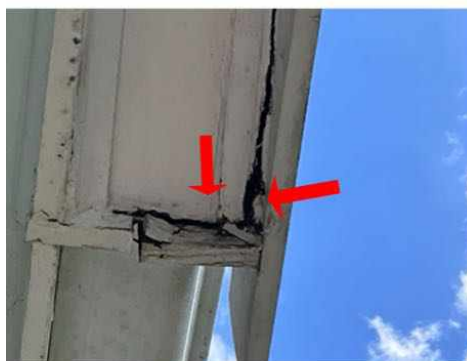
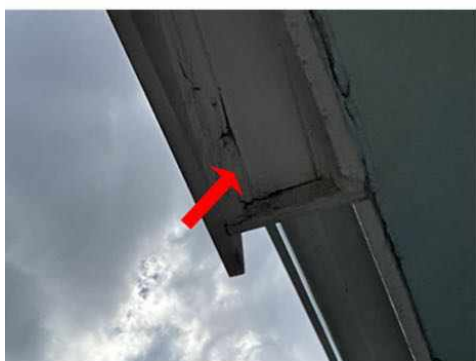
Finding 7.01

Building:	Main Building
Location:	Fascia
Finding:	Fascias - Wood rot
Information:	Wood rot was found to be affecting fascias and barges in this area.

Wood rot, also known as Fungal Decay, occurs when timbers and other cellulose building materials are exposed to damp conditions on an ongoing basis.

It is likely that this wood rot has developed as a result of frequent exposure to rain and other weather conditions also make fascias and barges susceptible to accelerated deterioration.

Early intervention and regular maintenance will prolong the life of these building elements. Prior to any works being performed, the cause of the moisture that has created the visible wood rot should be identified and addressed in a suitable manner.

It is advised that a roof plumber be appointed to inspect all roof plumbing and subsequently identify the cause of the wood rot.

Replacement of affected fascias and barges may then be a necessary step in protecting surrounding building elements from such deterioration.

A qualified carpenter or registered builder may also be required to replace affected building materials.

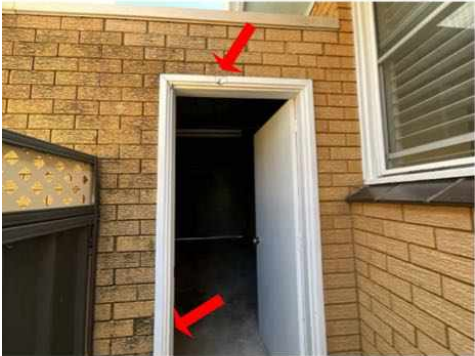
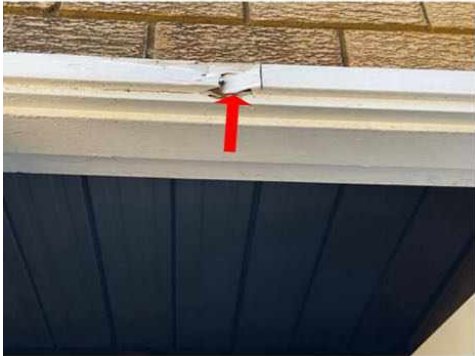
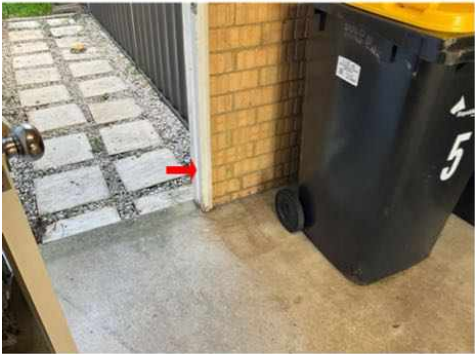
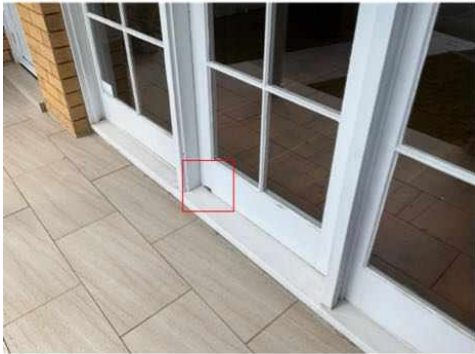
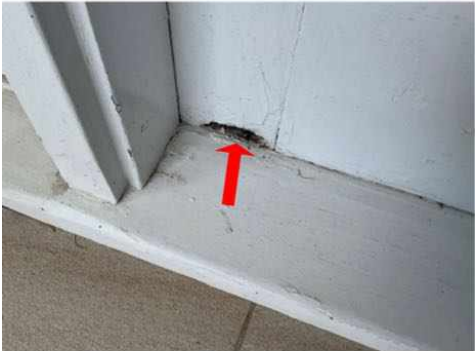
Finding 7.02

Building:	Main Building
Location:	Garage; Porch;
Finding:	Fungal decay - present (localised)
Information:	Fungal decay also known as wood decay or wood rot generally refers to the deterioration of timber elements when in contact with excessive levels of moisture for a prolonged period of time.

The development of fungal decay is accelerated by temperatures in the range of 5degreeC to 40degreeC as well as the presence of oxygen. Generally fungal decay develops on timber elements which are exposed to water penetration.

Although the affected timber element is in a decaying state the extent of any visible damage appears to be localised to a specific area.

Leaving this unmanaged may lead to further fungal decay which may include to structural elements, leading to a more costly repair.

A builder may be engaged to conduct an invasive inspection of the area, with the potential of replacing timbers that have been affected by fungal decay.

Please note that the cause of the fungal decay should be rectified prior to rectification of the affected timber elements.

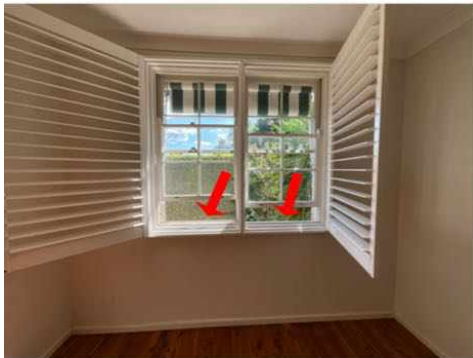
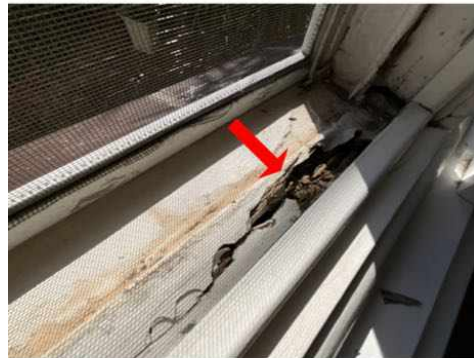
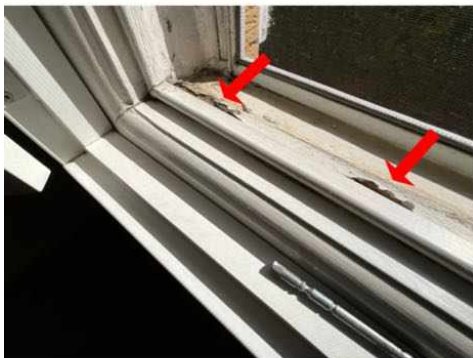
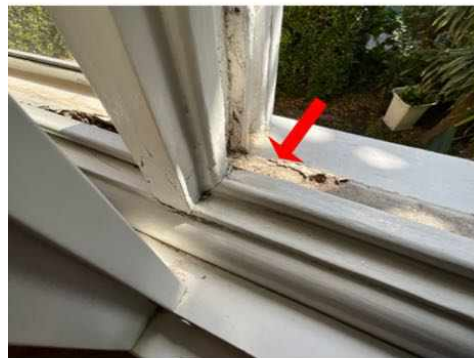
Finding 7.03

Building: Main Building
Location: All Areas
Finding: Windows - Wood rot
Information: Wood rot was found to be affecting external windows. Wood rot, also known as

Fungal Decay, occurs when timbers and other cellulose building materials are exposed to damp conditions on an ongoing basis.

It is likely that this wood rot has developed as a result of frequent exposure to rain and other weather conditions. It is suspected that failure to maintain the window frames over a prolonged period has resulted in them deteriorating at an accelerated rate, increasing their susceptibility to the development of wood rot.

Early intervention and regular maintenance will prolong the useful life of the windows.

Repair and/or replacement of affected window frames may be a necessary step in protecting surrounding building elements from such deterioration. Remedial works should be performed by a qualified carpenter or registered builder as soon as possible to prevent any further damage.

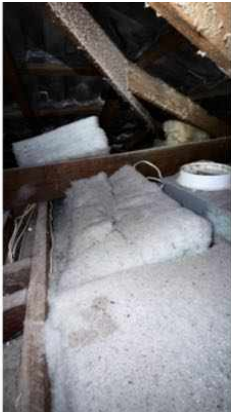
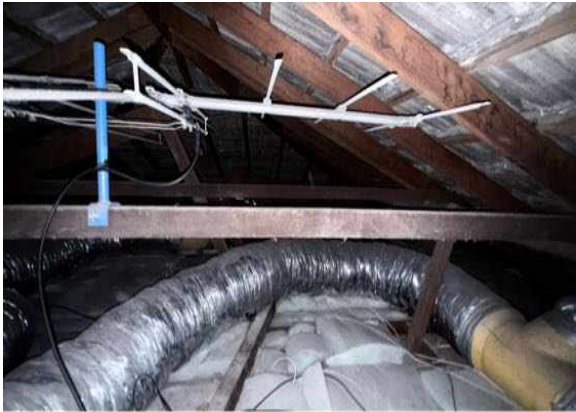
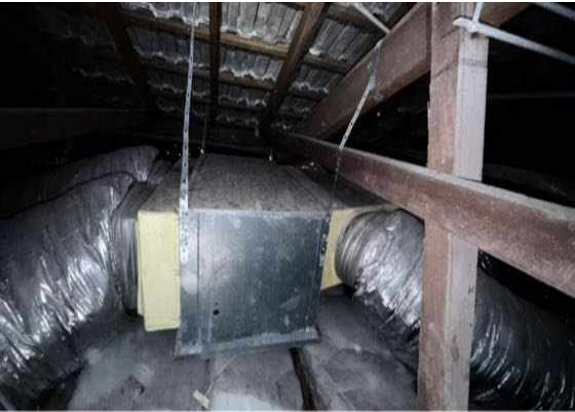
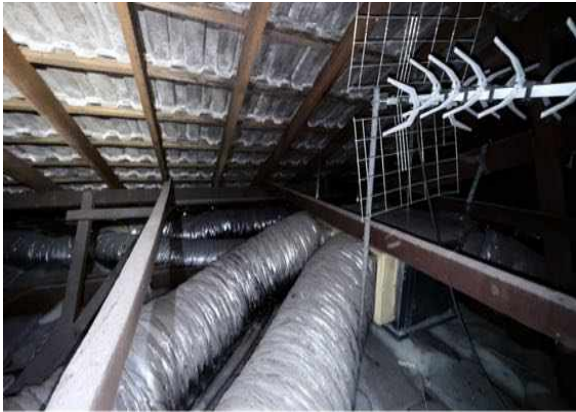
Noted Item

Building: Main Building
Location: All Areas
Finding: Additional Photos - Obstructions and Limitations
Information: These photographs are an indication of the obstructions and limitations which impeded full inspection of the property at the time of inspection. These obstructions can hide an array of defects and should be removed to allow full inspection to be carried out. A re-inspection is recommended once the areas are made accessible.

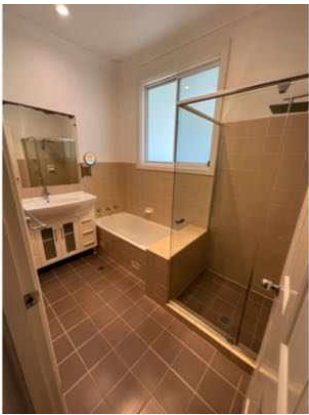
Building:	Main Building
Location:	All Areas
Finding:	Water Proofing Membranes
Information:	Internal Water Proofing Membranes, are crucial in preventing water ingress into the property.

With older property's where this information is unavailable all wet areas should be monitored. If any leaks, water staining, peeling or bubbling of the paint become evident to any adjacent walls or ceilings below a licensed builder or waterproofing specialist is recommended to investigate further.

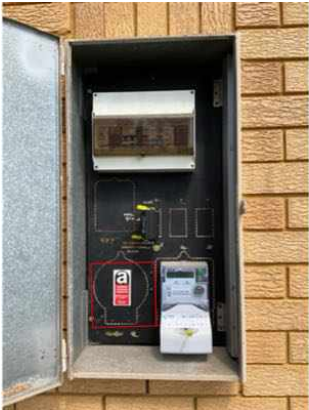
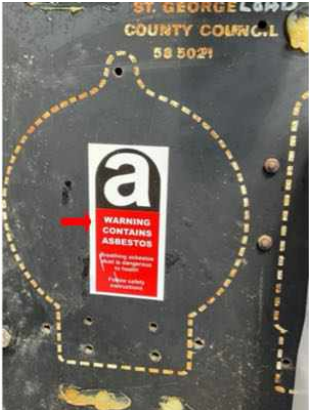
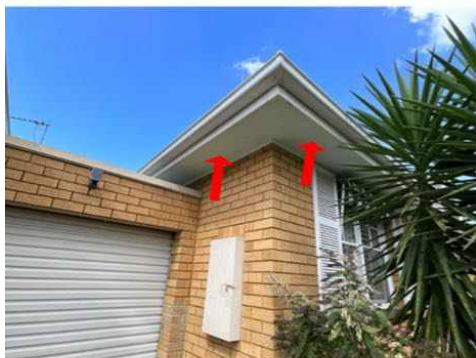
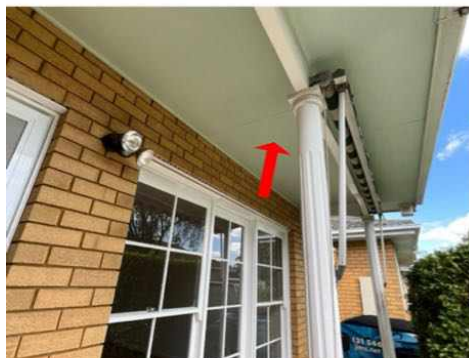
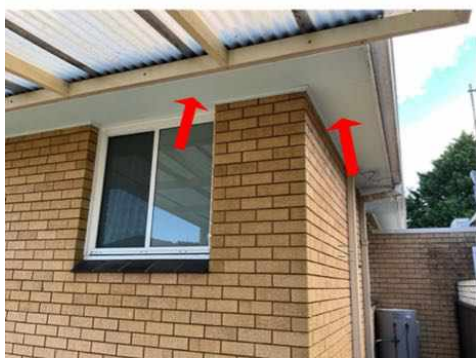
Building: Main Building
Location: All Areas
Finding: Asbestos - Suspected ACM Identified on Site
Information: Reporting on Asbestos is outside the Scope of this Report. This suspected defect is highlighted as a caution only. We suspect, based on our experience in the building industry, that there is a higher risk of the identified building element containing asbestos.

As Asbestos Reporting is outside the scope of this report, we advise that you consider a separate Asbestos Inspection and Condition Audit, which can include the taking of samples for definitive confirmation of the presence of Asbestos.

In the interim, the client is advised to act with caution, especially when considering any damage to building materials general wear and tear renovations extensions demolition and general maintenance activities due to the suspected presence of Asbestos.
