Building and Timber Pest Inspection Report

Inspection Date: Thu, 2 Apr 2026

Property Address: 5/23-25 Fontainebleau St, Sans Souci NSW
2219, Australia

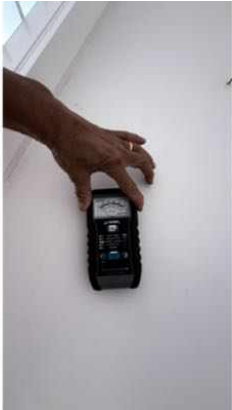
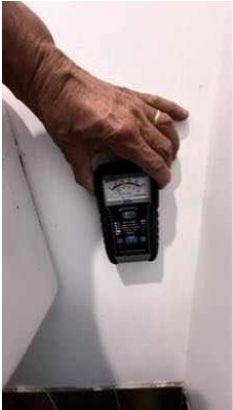
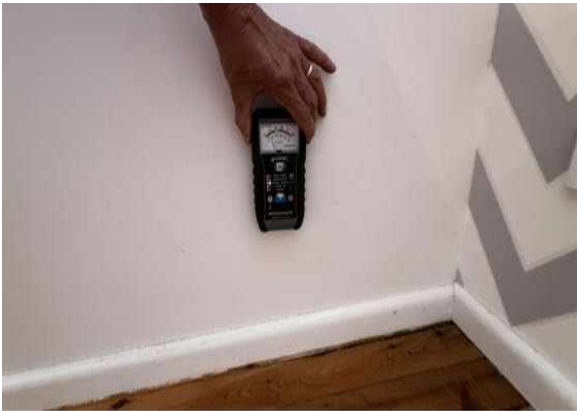
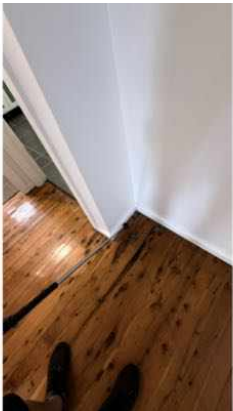
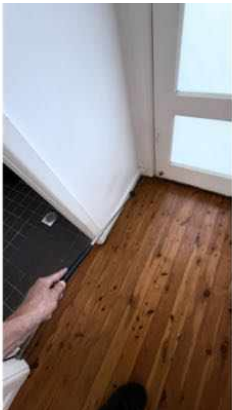
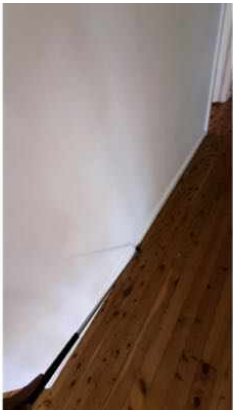
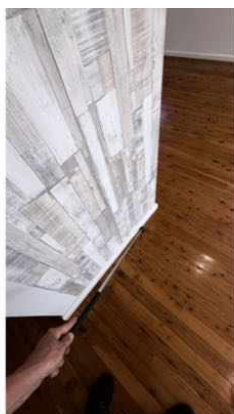
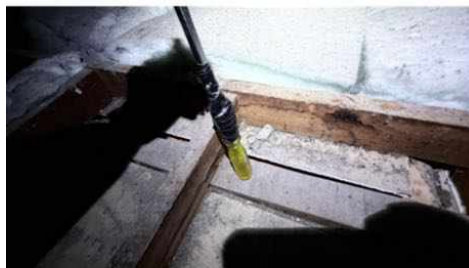
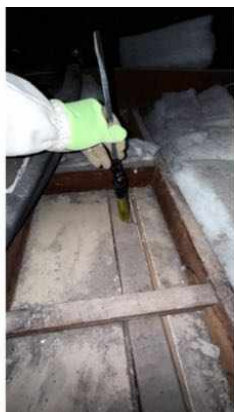
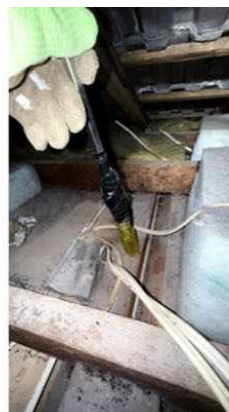
Building:	Main Building
Location:	All Areas
Finding:	Termite Techniques
Information:	All areas of the dwelling are checked with particular attention paid to wet areas which were closely assessed to check for excessive levels of moisture and temperature anomalies.

In an attempt to identify the presence of hidden timber pest activity, a variety of techniques are adopted to identify irregularities including, a moisture meter reading of susceptible areas, sounding of timber elements using a device called a "donga" visual assessment of materials affected by moisture or signs of deformity, trails and bridging constructed by termites, irregular and regular shaped holes in timber elements indicating pest destruction.

Termite activity generates high temperatures and moisture and if this irregularity is found further investigation which may include the removal of wall and ceiling linings is highly recommended.

Please note: Termite management may be the responsibility of strata.

It is highly advised to check with strata about any termite management system in place.

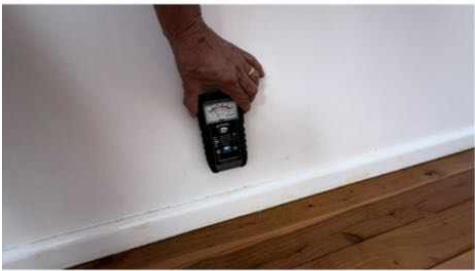
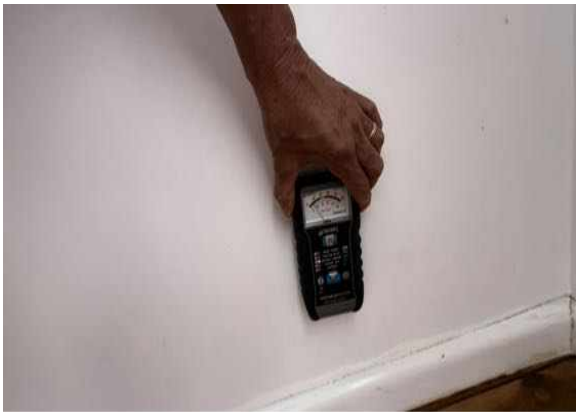
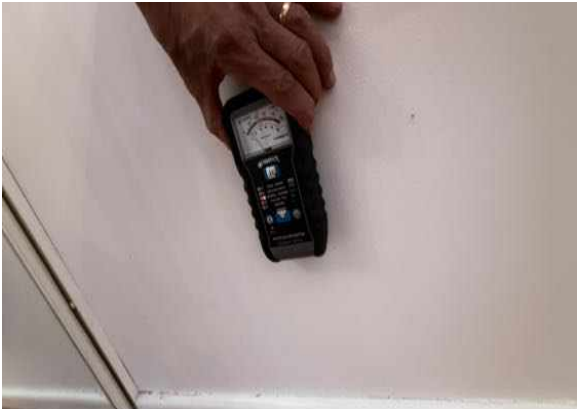
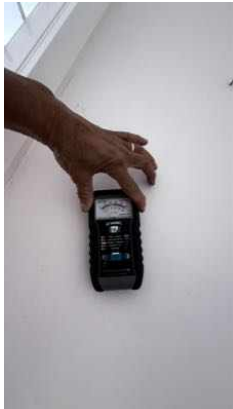
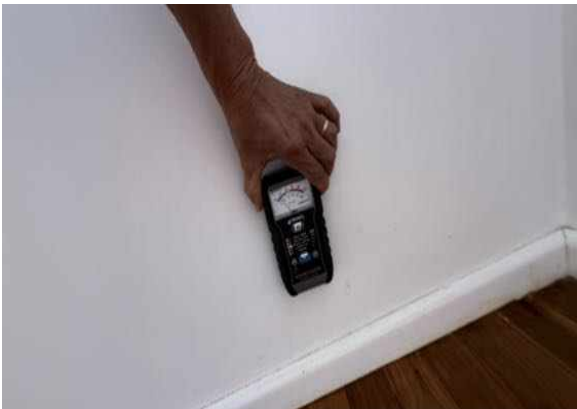
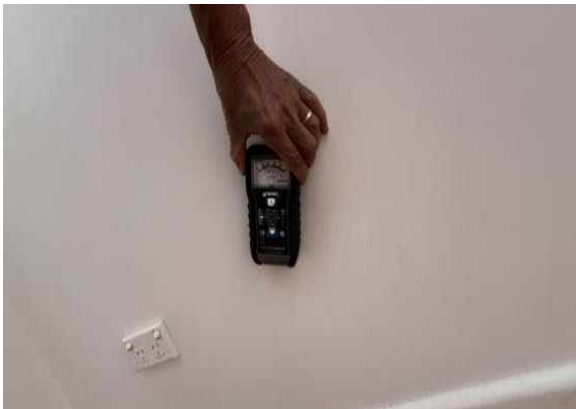
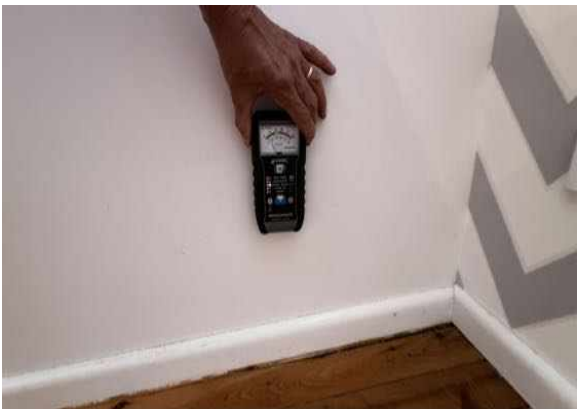
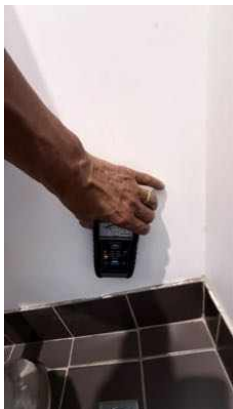
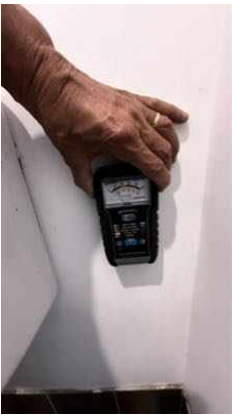
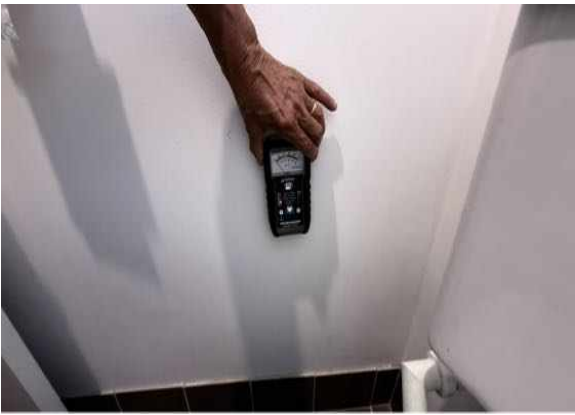
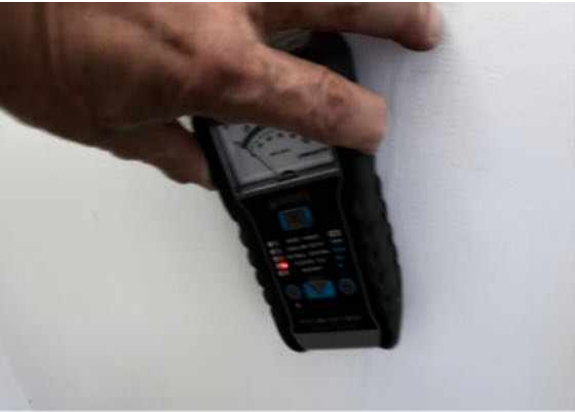
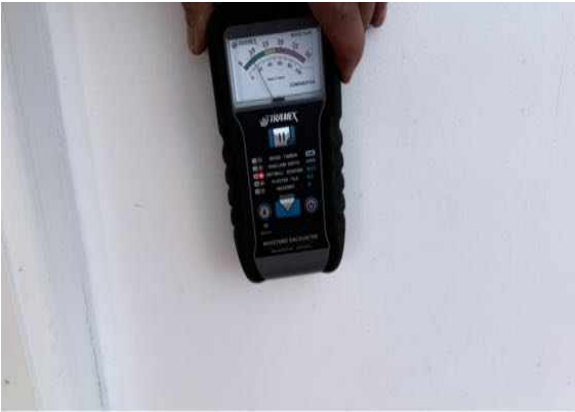
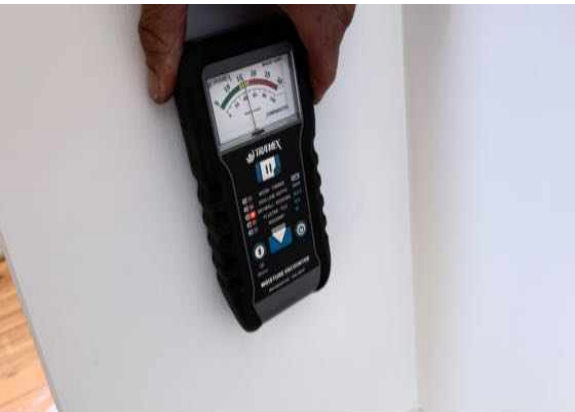
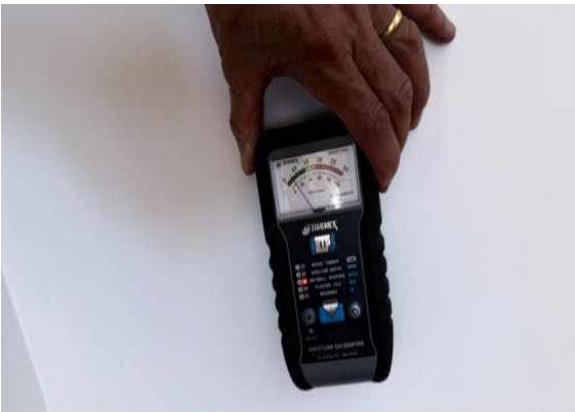
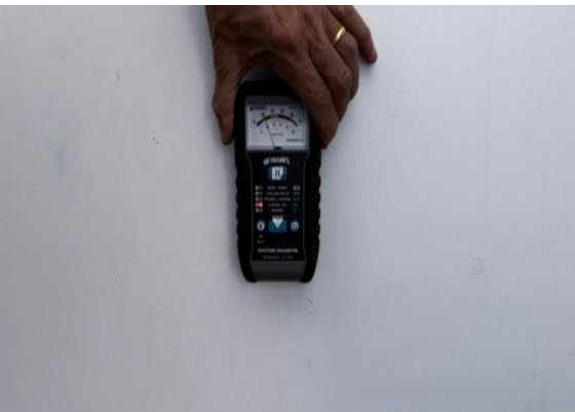
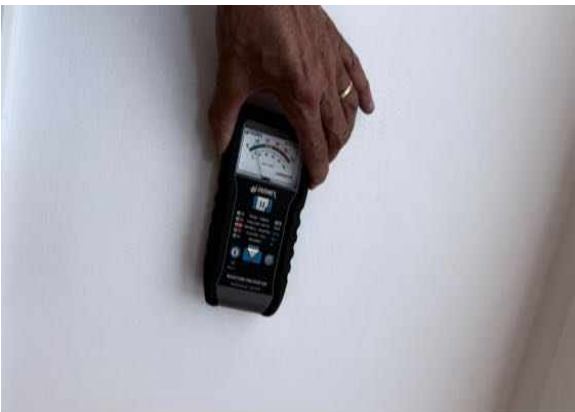
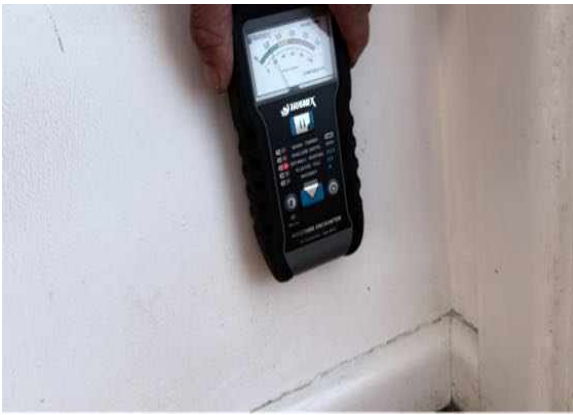
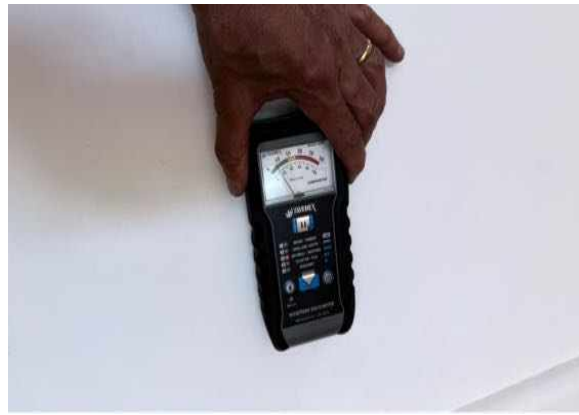
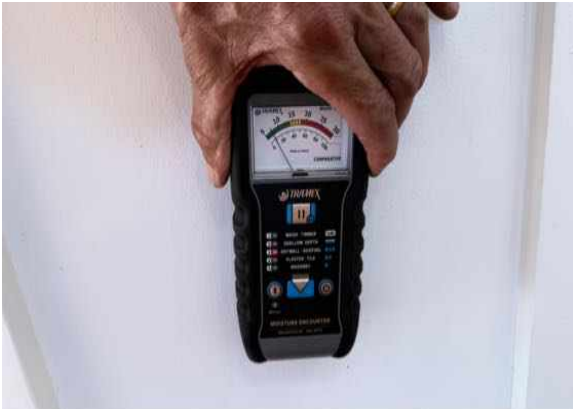
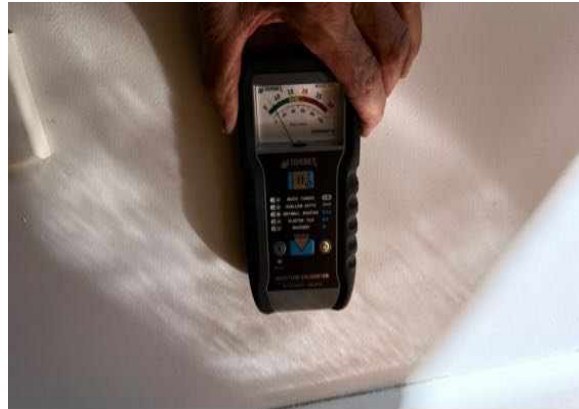
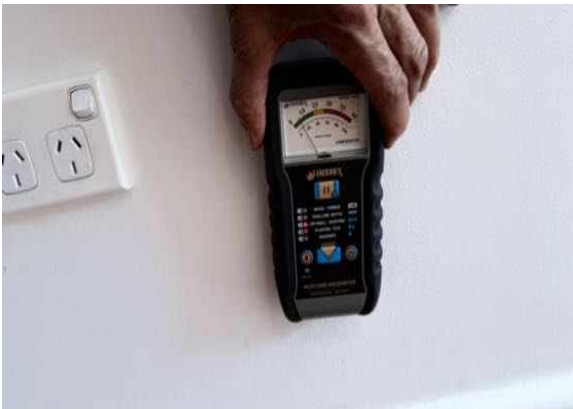
Building:	Main Building
Location:	All Areas
Finding:	Moisture readings
Information:	At the time of inspection, low moisture readings were noted in several accessible areas of the property, including, but not limited to, those shown in the accompanying photographs.

These areas were evaluated for elevated moisture levels and temperature irregularities, which can indicate potential issues such as hidden leaks, failing waterproofing, timber pest activity or poor ventilation.

Identifying such conditions is essential, as prolonged moisture can result in structural deterioration, mould growth, and an increased risk of timber pest activity.

Any anomalies detected during the inspection have been documented in this report and may warrant further invasive investigation to determine their source and extent.

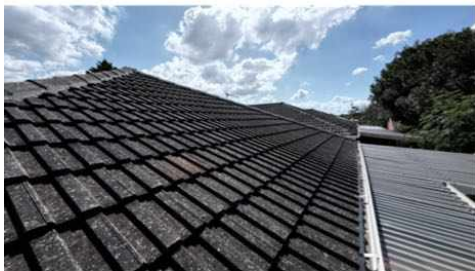
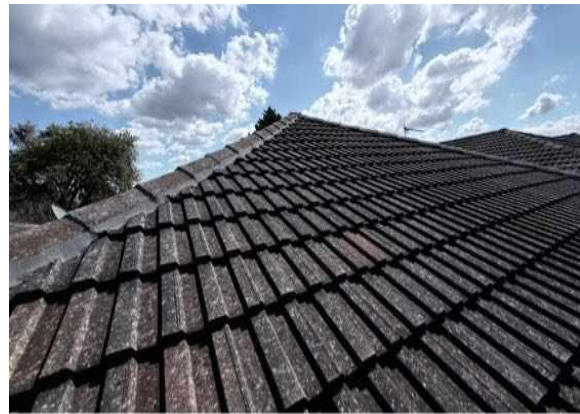
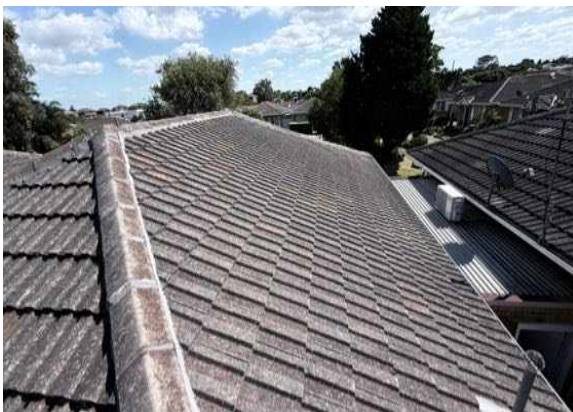
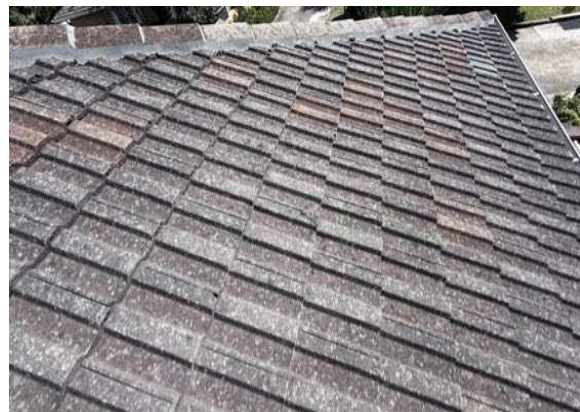
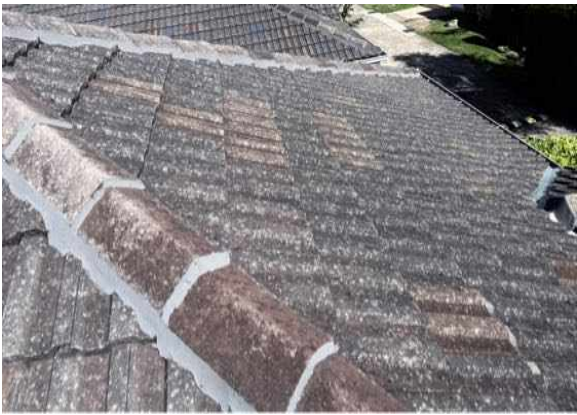
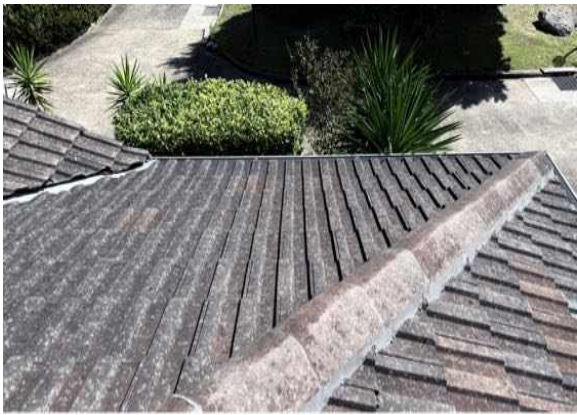
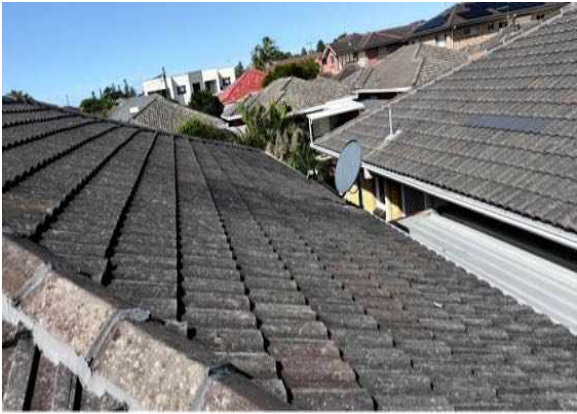
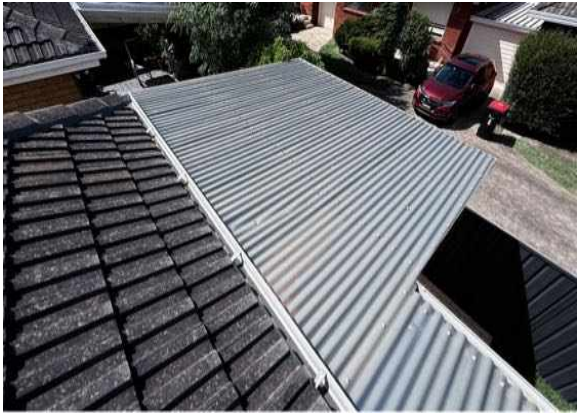
Building: Main Building
 Location: Roof Exterior
 Finding: Roof exterior condition
 Information: The roof exterior, including associated flashings and roof plumbing (gutters and downpipes), wherever safely accessible by a 3.6m ladder and located within a safe viewing position, was inspected and found to be in a serviceable condition unless noted otherwise elsewhere in the report

It should also be noted that if there are any areas of flat or skillion roofing and particularly where box gutters have been used in the design, that the roof gutter in these areas is at a higher than normal risk of leaks into the building interior under extreme weather conditions, due to multiple possible causes which may not be evident during a visual inspection.

Please note: the roof inspection occurred on a dry day with no rain. Roof leaks may only become apparent when a rain event has occurred.

Where a full inspection was not possible, due to height, access and safety restrictions, it is recommended that a roofing contractor be engaged to conduct a further full inspection.

It is highly advised to have the roof inspected on a regular basis to determine the integrity of all roofing elements including tiles, roof sheets, skylights, roof vents, flashing, solar panel fixings, guttering, down pipes etc.
