Building and Timber Pest Inspection Report

Inspection Date: Wed, 11 Mar 2026

Property Address: 43A Welwyn Rd, Hebersham NSW 2770,
Australia

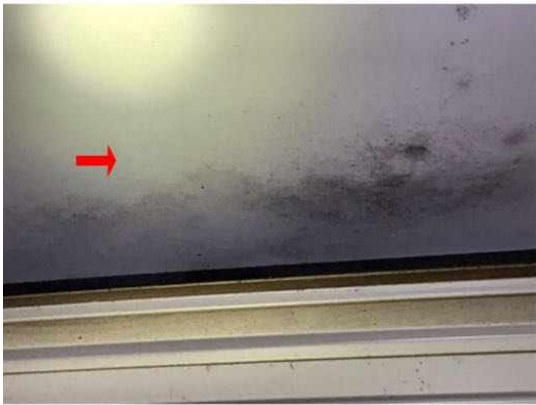
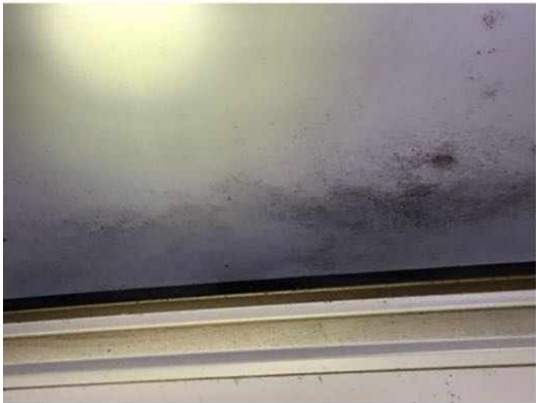
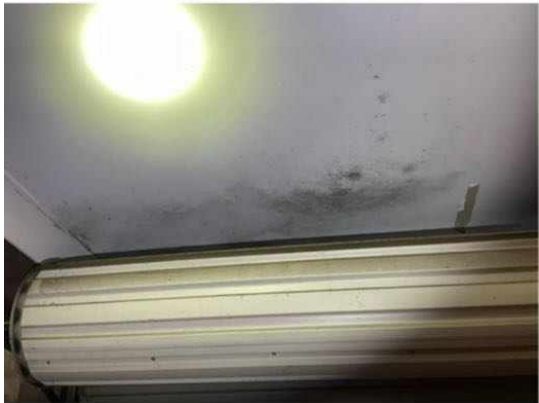
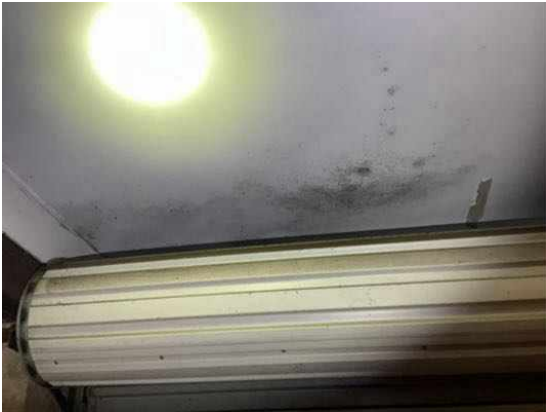
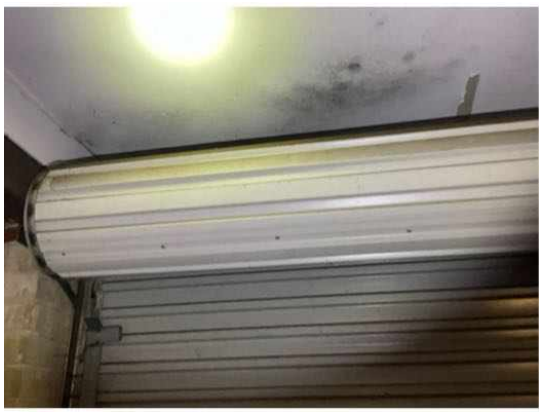
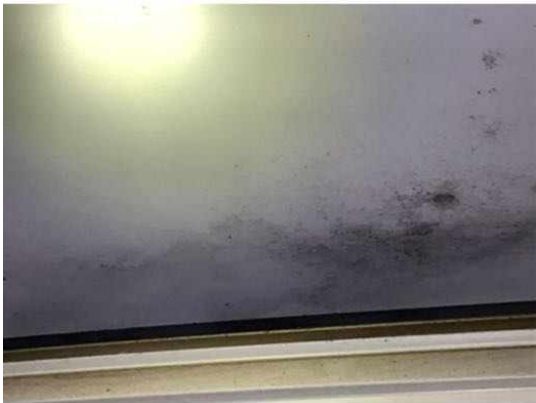
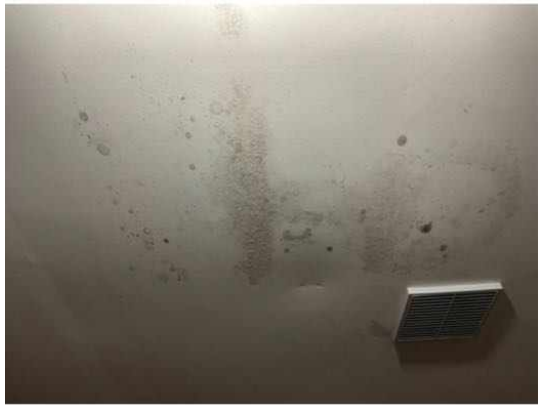
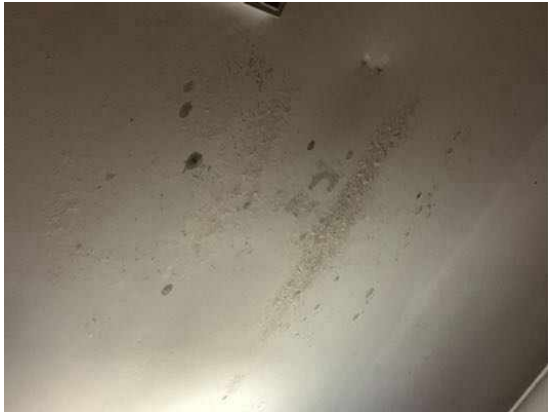
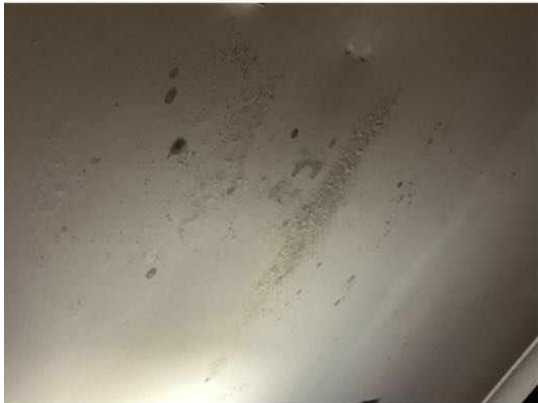
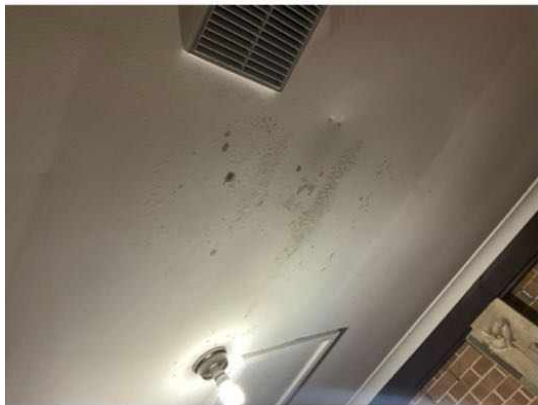
Building: Main Building
Location: Garage
Finding: Mould - Present
Information: Mold growth is present throughout the property, primarily due to inadequate ventilation. Poor airflow and moisture accumulation within the house have created ideal conditions for mold to thrive.

A licensed mold remediation specialist should be engaged to remove the mold and treat affected areas. In addition, a ventilation expert or builder should assess and improve the house's ventilation system, possibly installing exhaust fans, vents, or mechanical ventilation systems to ensure adequate airflow and prevent future mold growth.

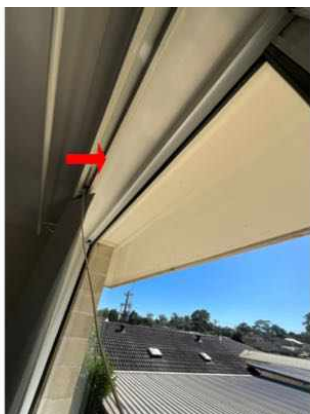
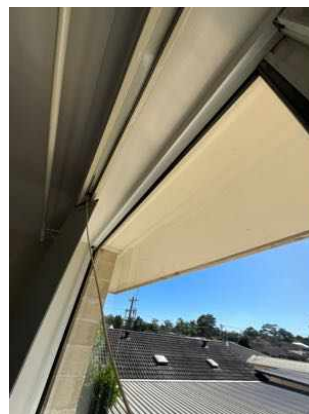
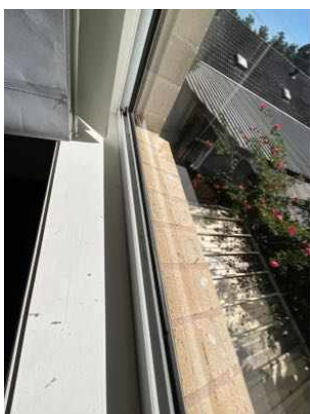
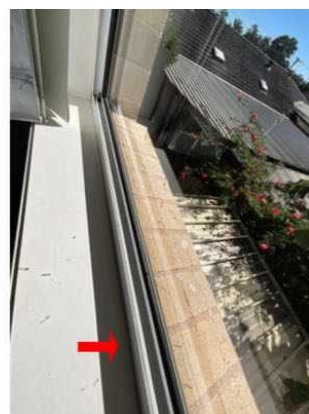
Finding 1.02

Building:	Main Building
Location:	All Areas
Finding:	Window child lock missing
Information:	The window in question lacks a child lock mechanism, which poses a potential safety risk to young occupants in the premises. As per Australian Standards windows accessible to children should be equipped with appropriate child safety locks to prevent accidental opening, reducing the risk of falls and ensuring compliance with safety regulations.

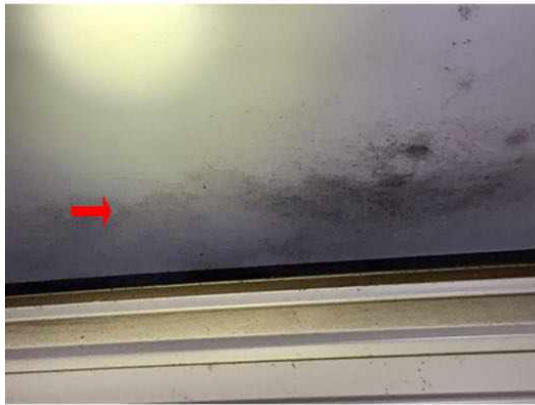
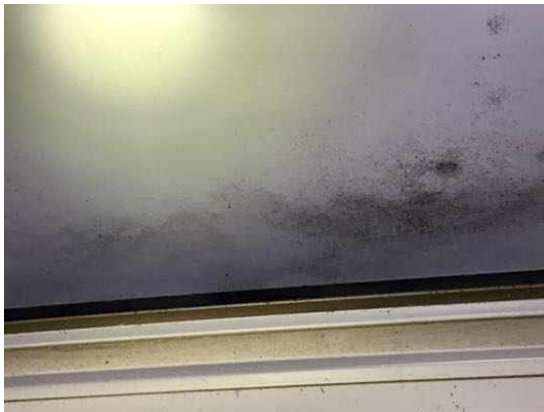
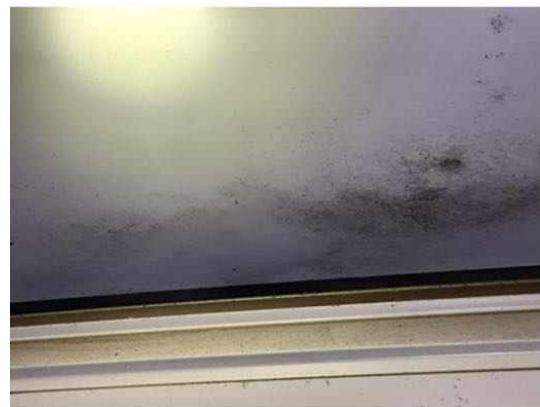
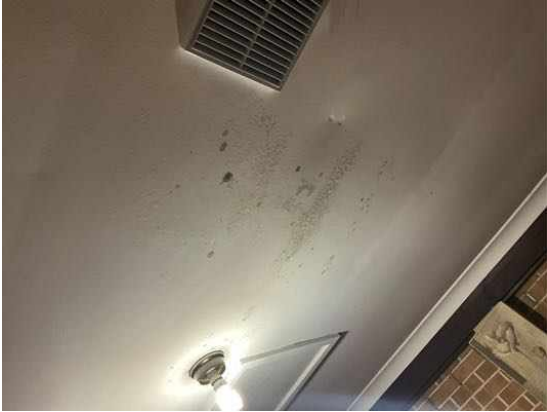
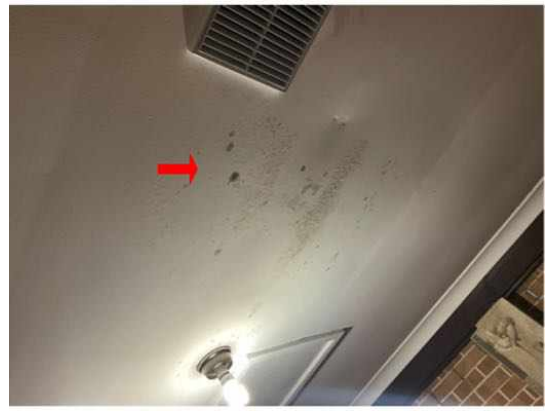
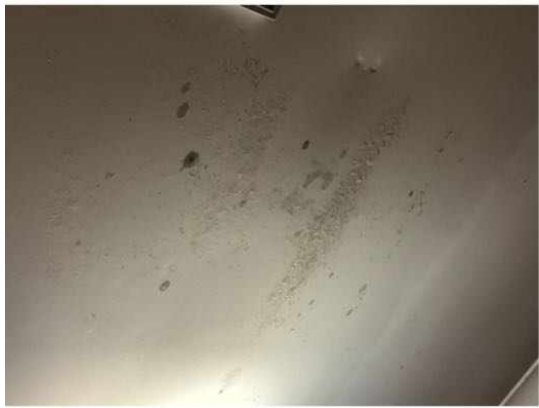
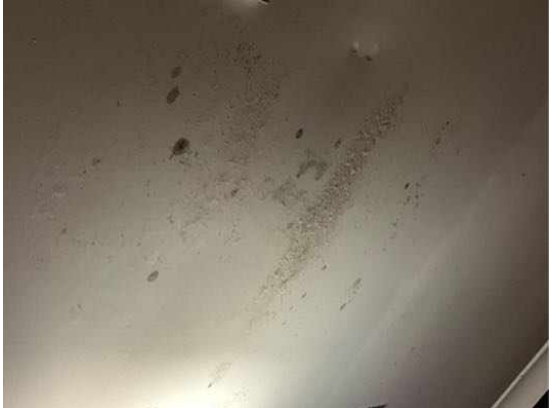
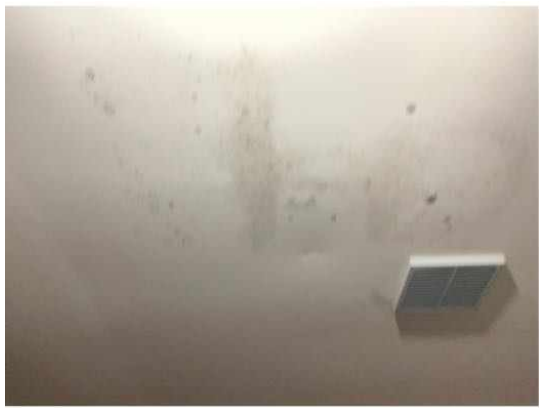
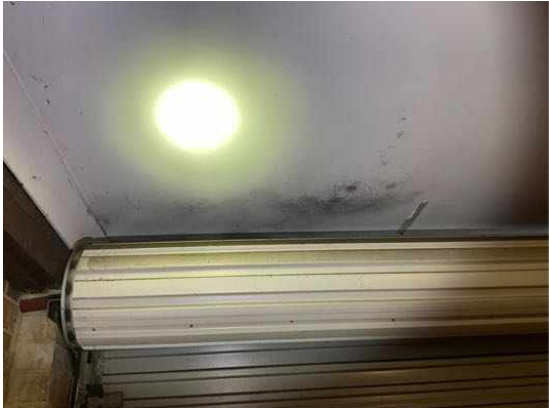
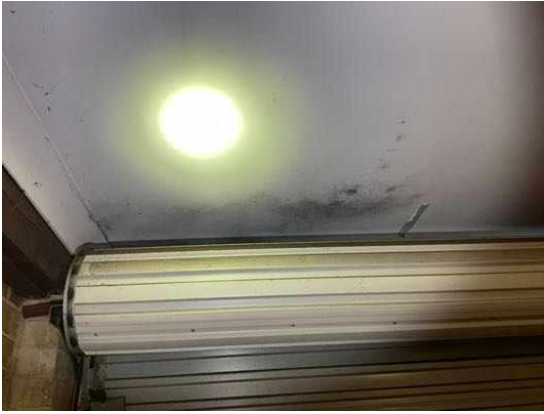
Finding 2.01

Building:	Main Building
Location:	Garage
Finding:	Roof void - Suspected water leak
Information:	Suspected water leak in the roof void, as evidenced by the presence of water stains, indicating potential gaps or holes.

A licensed roofing contractor should be contacted immediately to inspect, diagnose, and repair the source of the leak to prevent further damage.

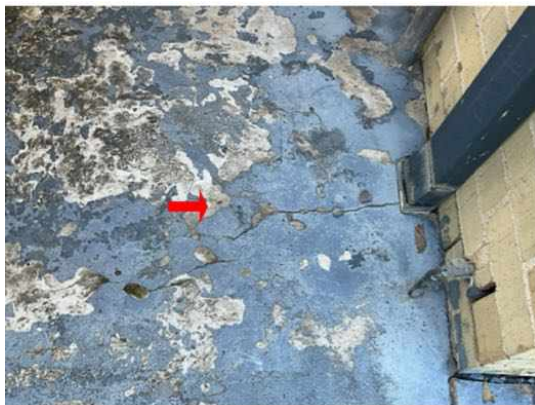
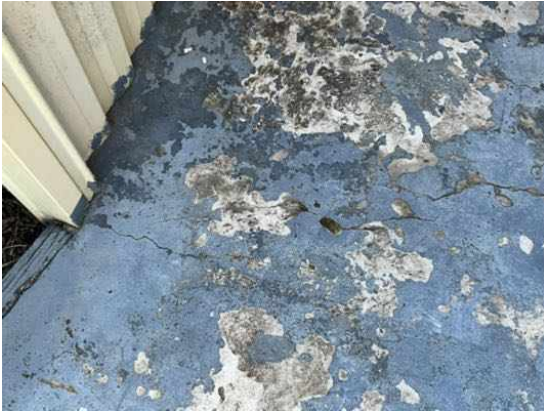
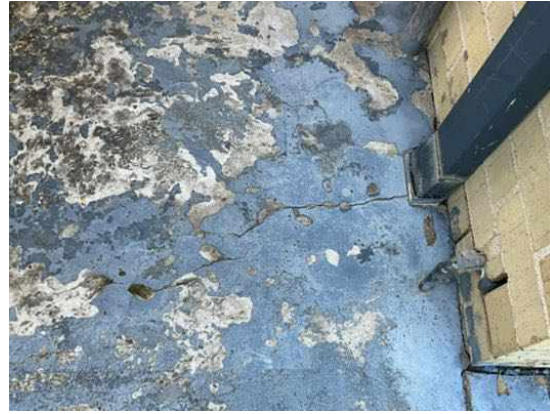
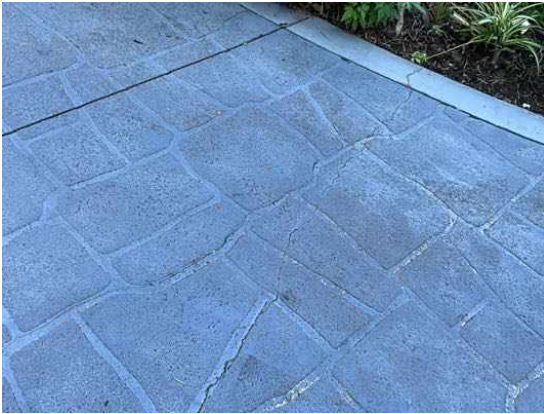
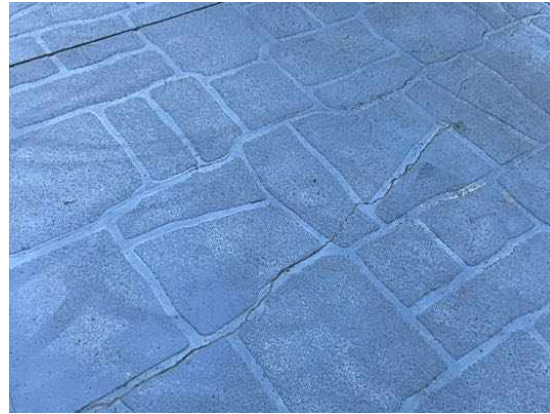
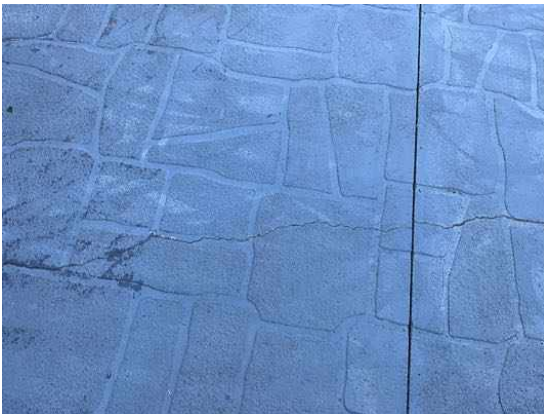
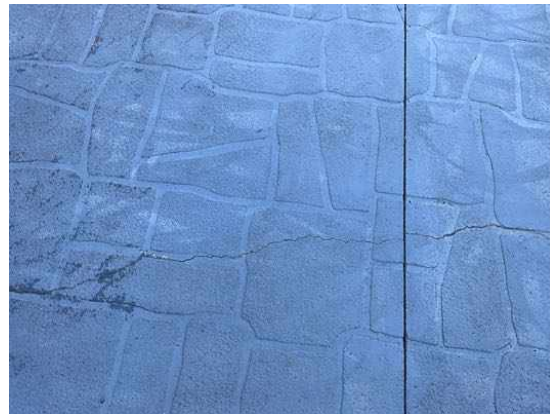
Finding 3.01

Finding: Crack in concrete slab - Category 0

Information: A crack coded as Category 0 was identified in the slab. A Category 0 crack is described as a hairline crack, representing insignificant movement of slab from level.

The approximate width of the crack to be considered Category 0 is 0.3mm, or change in offset of less than 8mm when a 3m straight edge is placed over the defect.

No rectification is required at this time. However, all cracking should be monitored over a 12 month period to identify any further damage in the area.

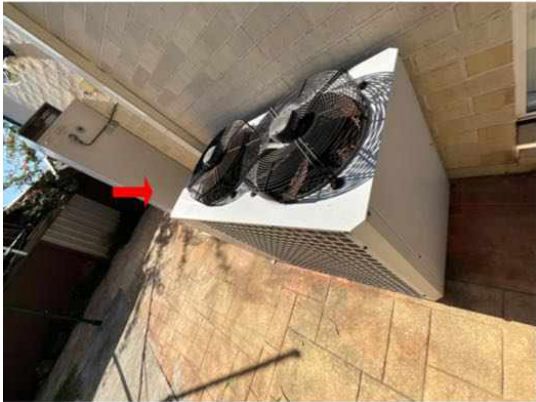
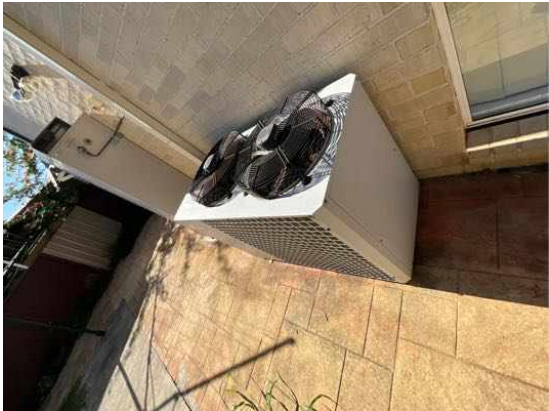
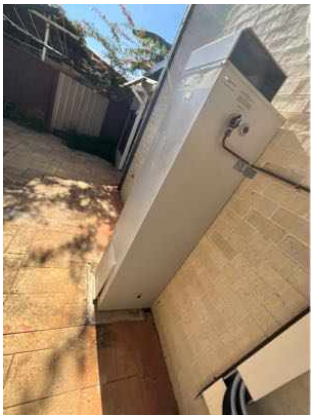
Finding 3.02

Building:	Main Building
Location:	All Areas
Finding:	Bridging or Obstruction Conducive environment for Termites
Information:	Bridging of termite barriers occurs when termites bridge (usually by building a mud tunnel) a termite barrier or inspection inspection zone or where termites have a passage, allowing them to bridge the barrier.

Recommended moving obstructions away from the external walls for further and future inspections.

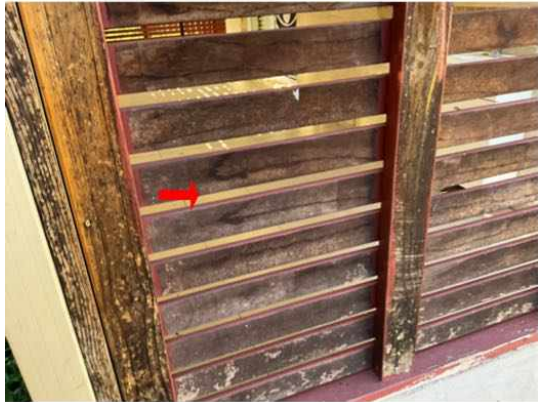
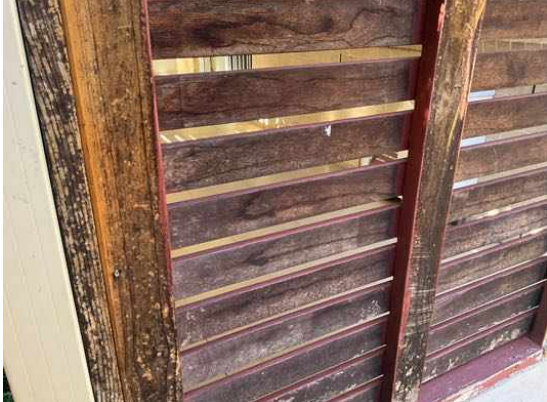
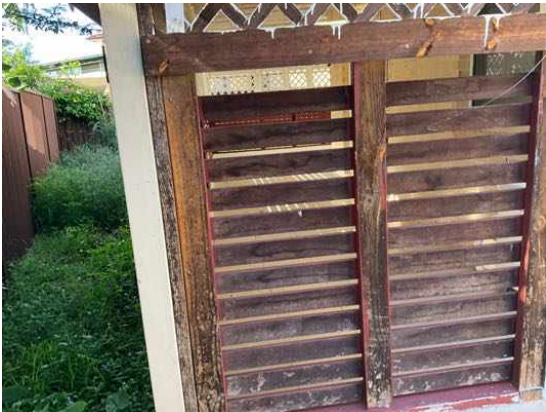
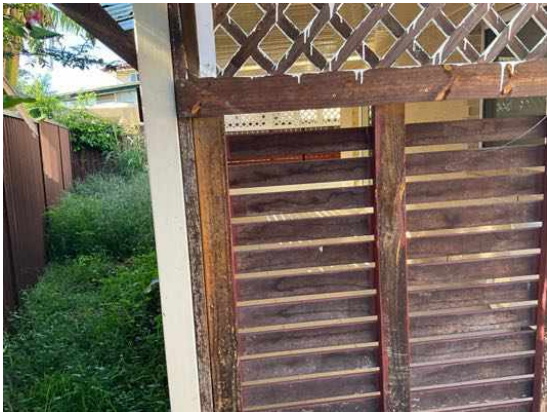
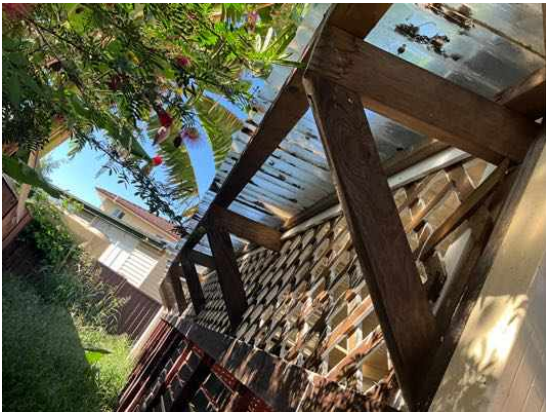
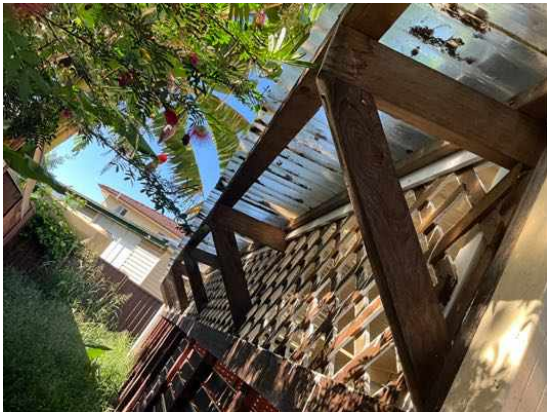
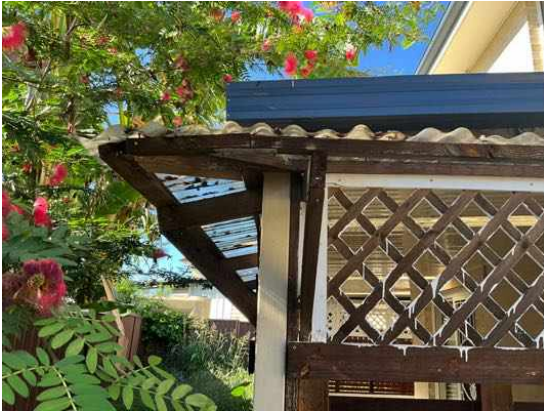
Building: Main Building
Location: Pergola
Finding: Timber - exposed to weather
Information: External timbers that are frequently exposed to harsh weather conditions require adequate protection in order to maintain their condition. Where timbers have not been

painted or treated adequately, general deterioration is likely to occur at an accelerated rate.

If left unattended, replacement of these timbers is likely to be necessary in the short-term future. Adequate treatment of these timbers is required as soon as possible by a painting contractor or general handyman.

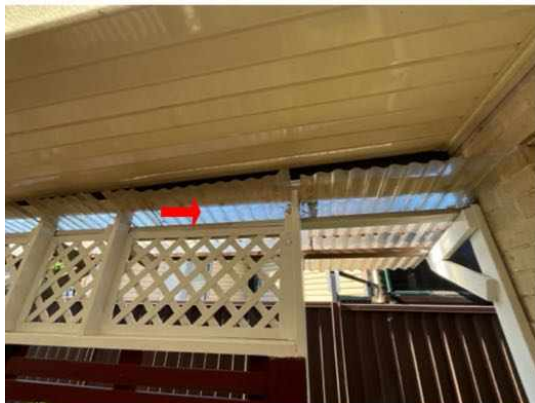
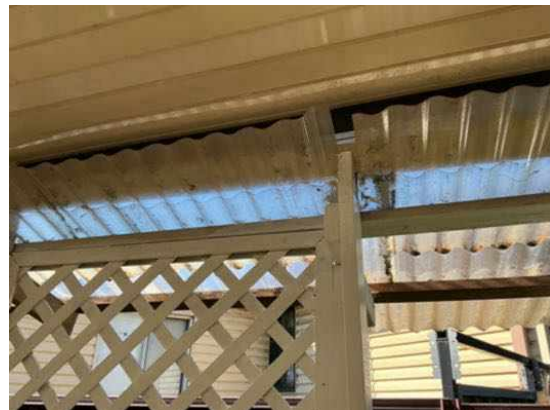
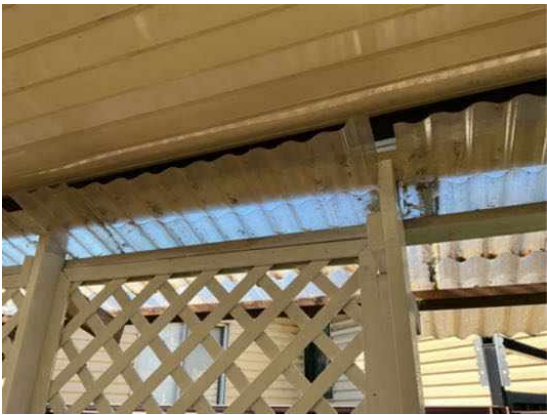
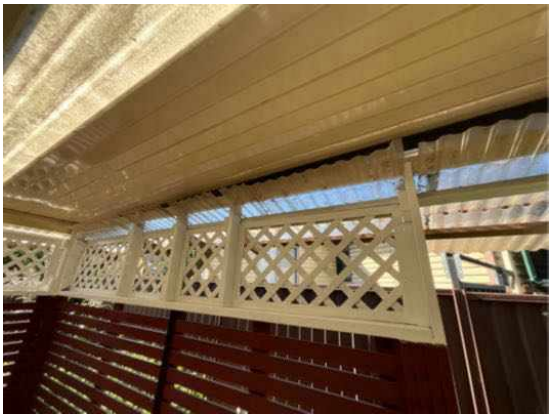
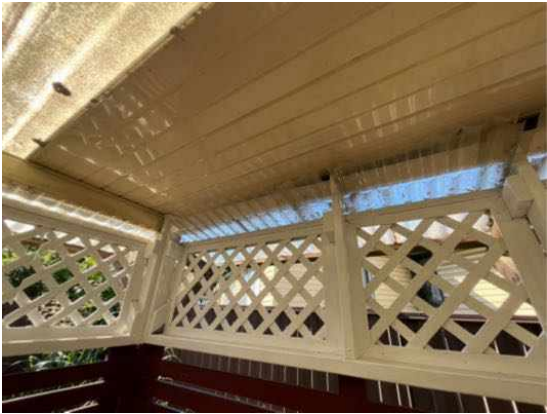
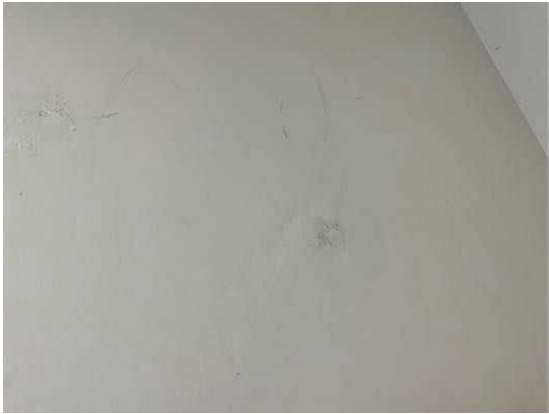
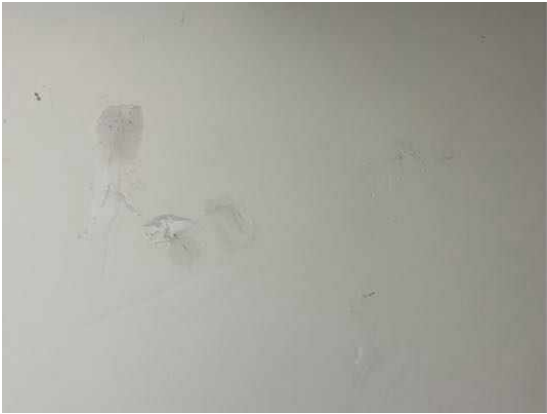
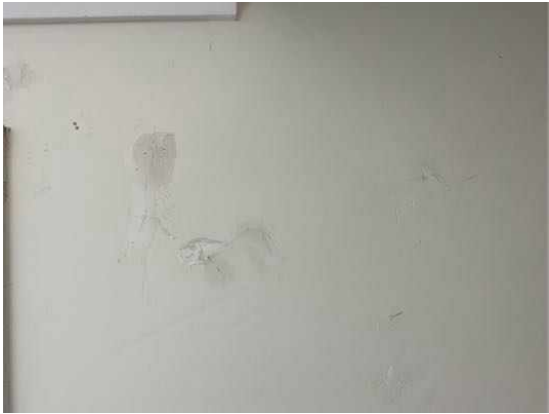
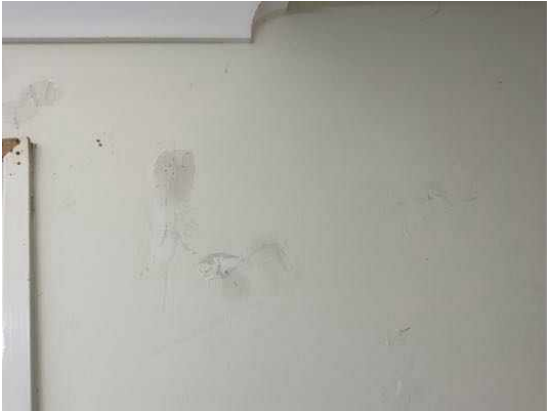
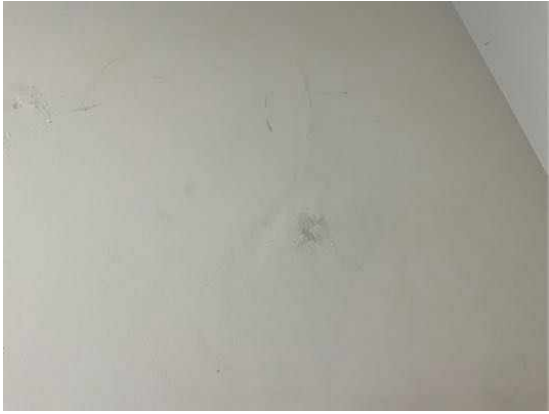
Finding 3.04

Building: Main Building
 Location: All Areas
 Finding: Poor workmanship
 Information: The structure exhibits signs of poor workmanship, evident in various aspects of construction and finishing.

Risk: Poor workmanship poses a range of risks, including compromised structural integrity, potential safety hazards, and a decreased lifespan of the structure. It may also lead to aesthetic and functional issues.

Resolution: A qualified contractor or construction professional should be consulted to assess and address the poor workmanship. They can implement corrective measures to ensure structural soundness, safety, and overall quality of the construction.

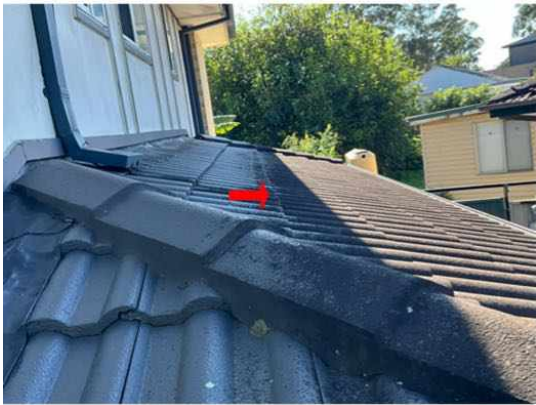
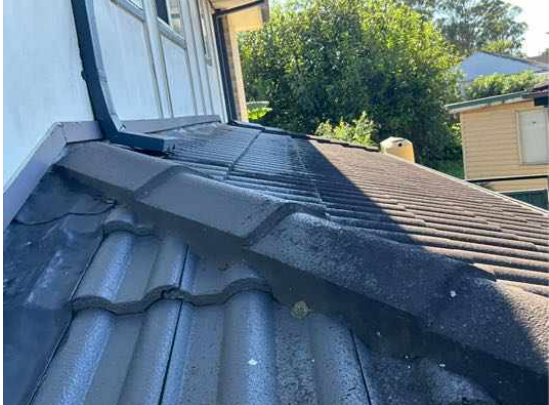
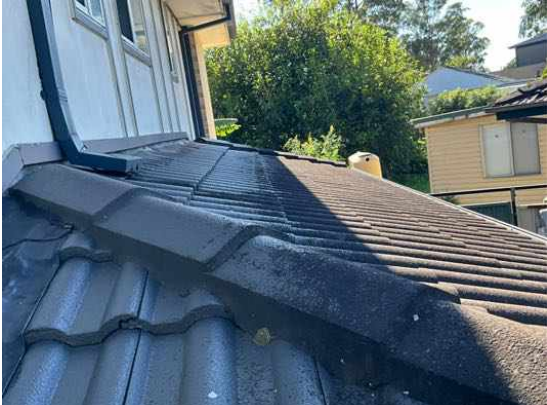
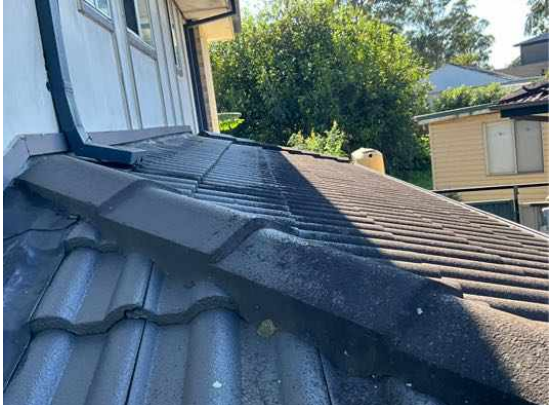
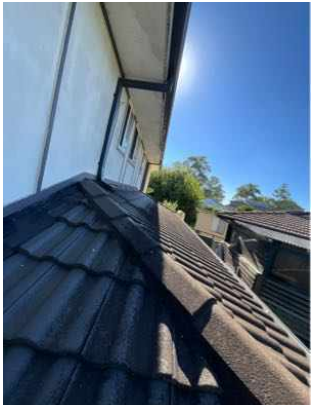
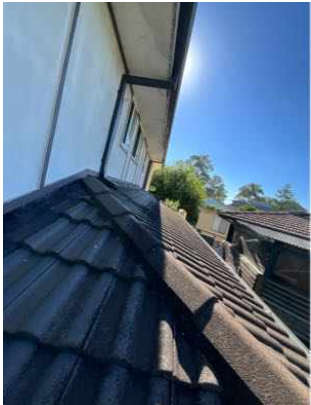
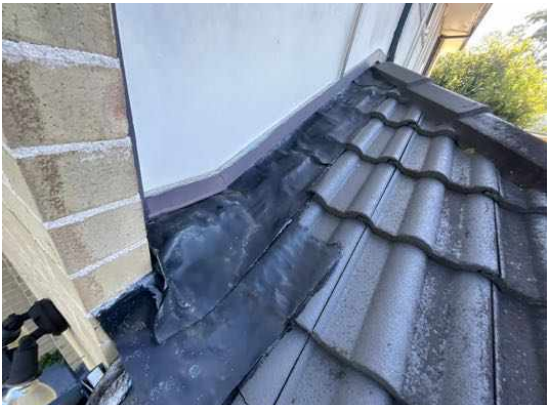
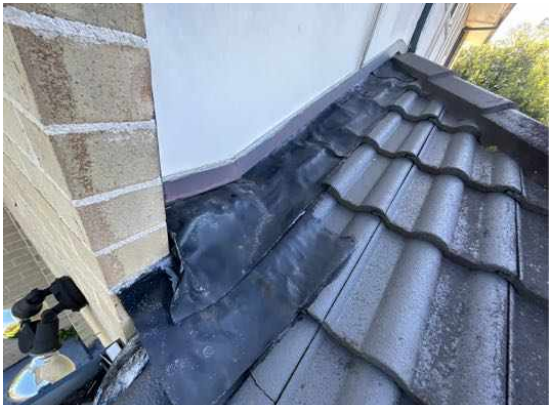
Information: Inspection of the roof revealed widespread weathering to the tiled roof surface. The tiles show loss of surface finish, colour fading, and age-related deterioration typical of older roof coverings. Although no significant cracking was noted, weathering can lead to increased porosity, reduced water-shedding capability, and a higher risk of future cracking or displacement during adverse weather conditions.

A licensed roofer should be engaged to undertake a closer inspection, carry out routine maintenance, and replace any tiles that may be compromised. Ongoing monitoring is recommended due to the age and condition of the roof covering.

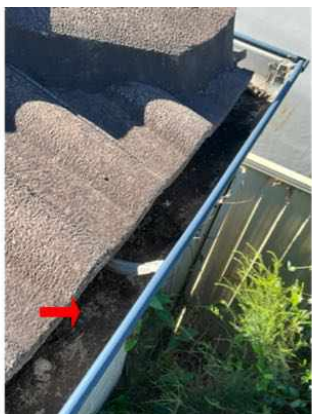
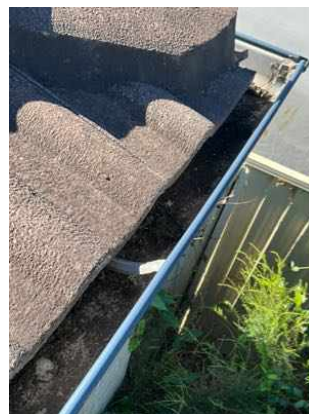
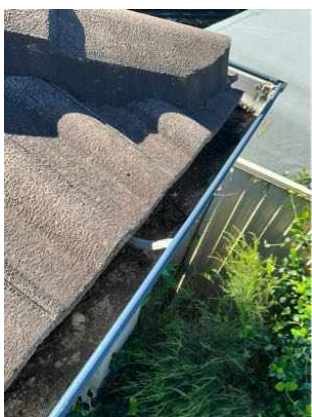
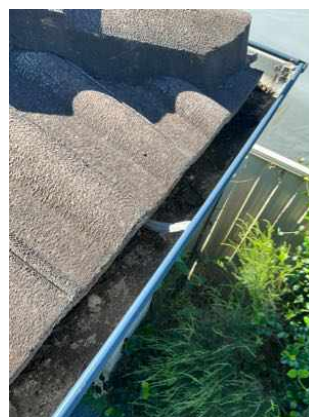
Finding 3.07

Building: Main Building
 Location: Roof Exterior
 Finding: Blocked Gutters
 Information: Blocked gutters , advised gutter to be cleaned.

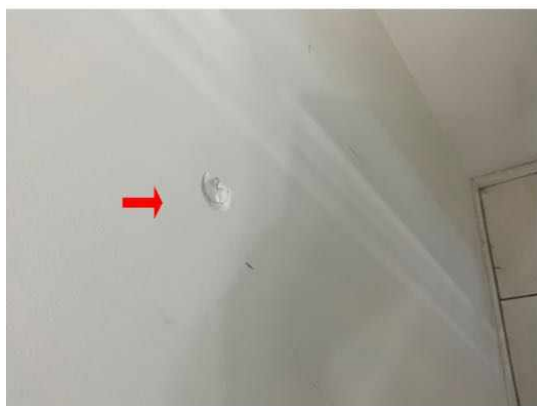
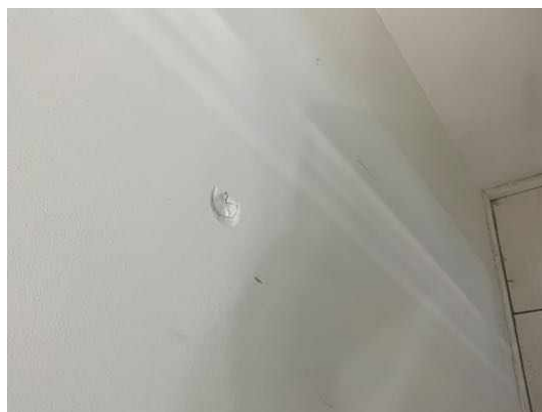
Finding 3.08

Building: Main Building
 Location: Behind Front door
 Finding: Wall Gyprock damaged
 Information: Sections of plaster sheeting in this area appear to be damaged .

The most common causes of plaster failure are physical damage and moisture damage. Moisture causes plaster to swell and shrink as the humidity of the air changes, or as a consequence of leaks.

Plaster generally needs chemical re-adhesion or to be screwed back to the substrate, with minor consequent patching and painting required.

Ensure that the general environment is free from physical damage such as door handles in this instance . Appointment of a qualified plasterer is advised in order to complete remedial works as necessary.

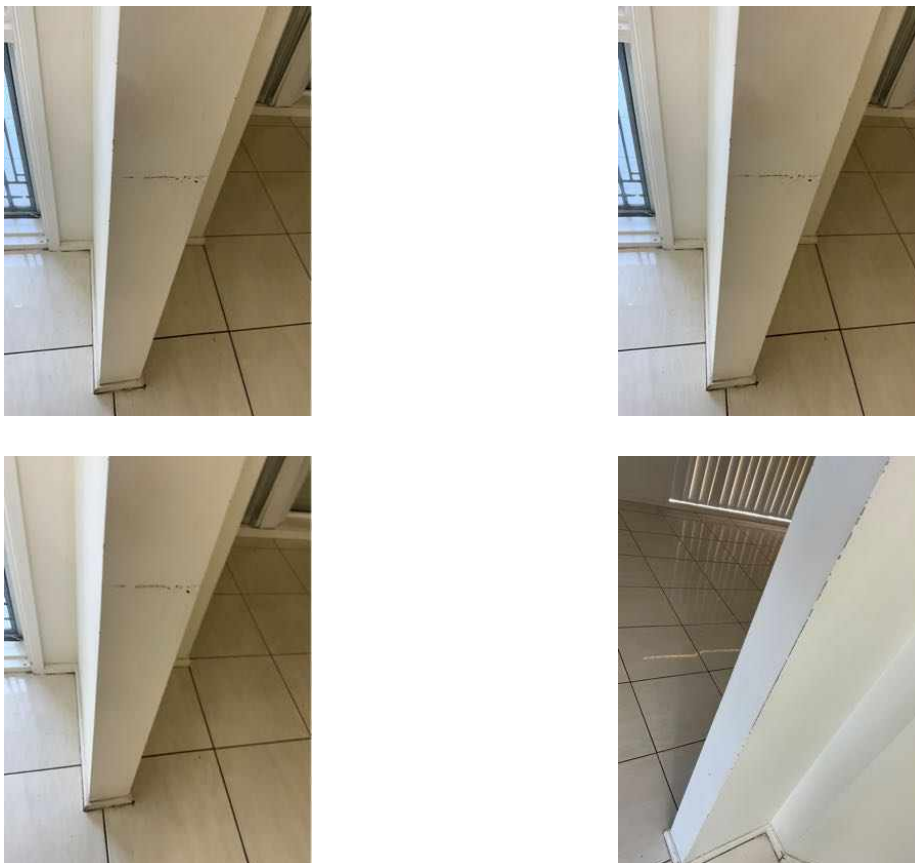
Finding 3.10

Building: Main Building
 Location: All Areas
 Finding: Skirting board: gaps
 Information: Gapping was observed between the skirting board and wall surface. This appears to be caused by poor installation or seasonal expansion/contraction of materials.

- Minor aesthetic concern.
- May allow dust, insects, or moisture ingress if left unsealed.
- If movement continues, it may indicate underlying settlement or moisture-related issues in adjacent flooring or wall structures.

- A qualified carpenter or handyman should be engaged to reseal, reattach, or replace the affected skirting board section.
- If moisture or structural movement is suspected, further inspection by a licensed builder may be warranted.

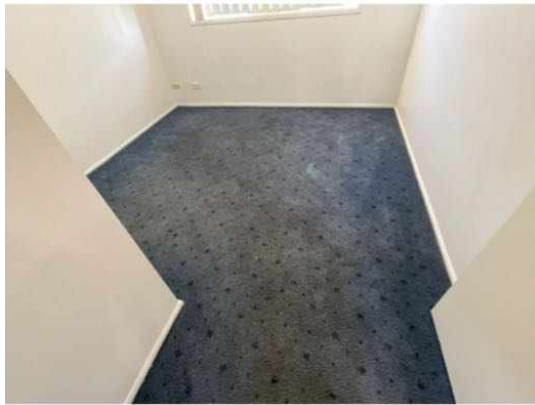
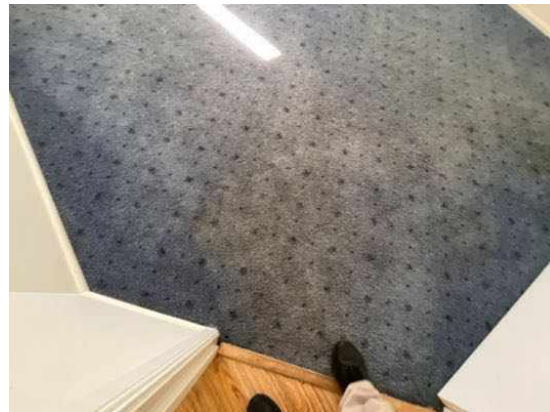
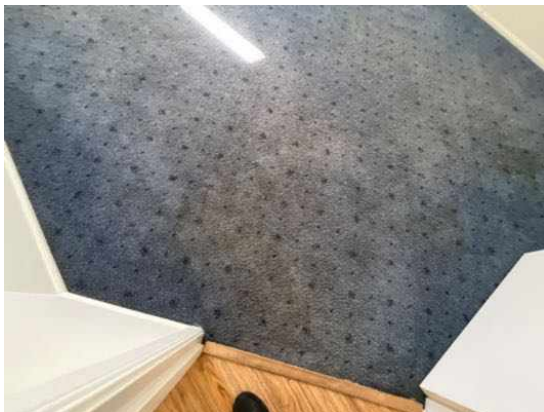
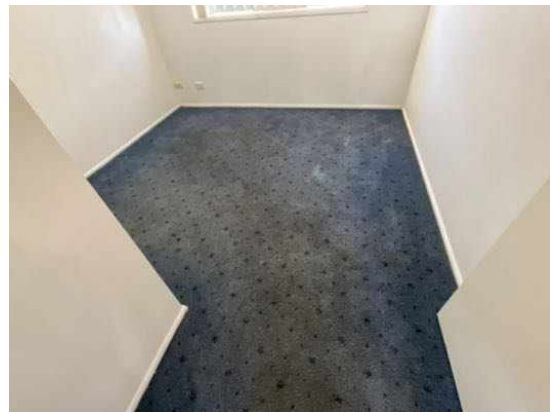
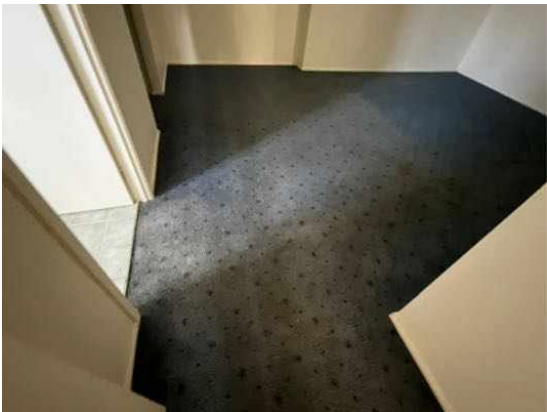
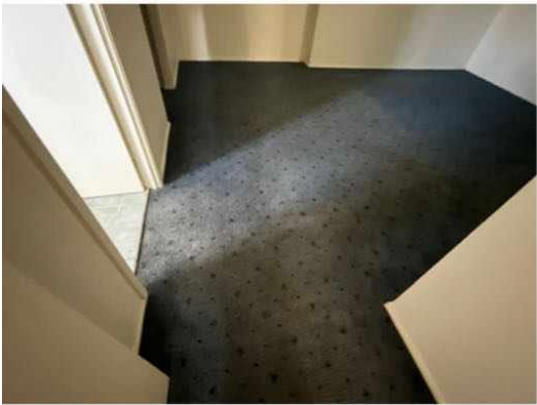
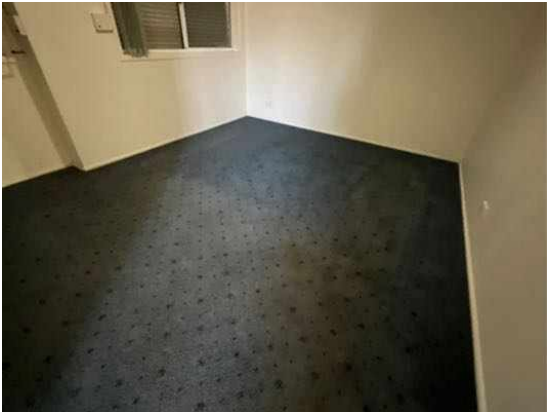
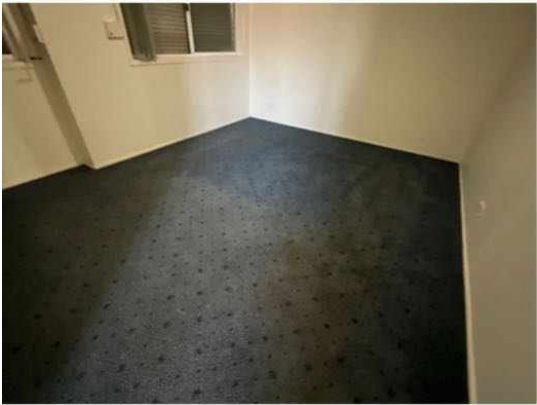
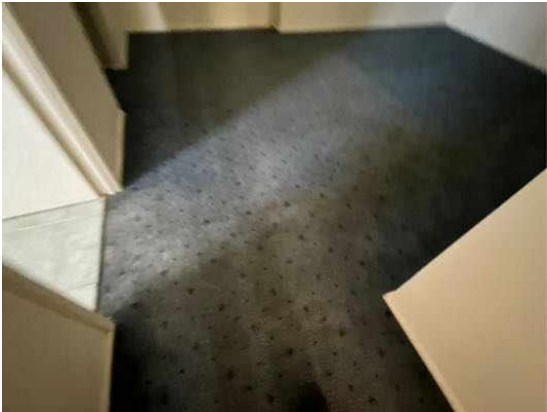
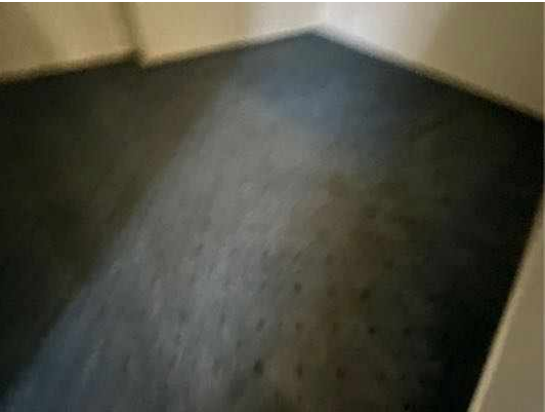
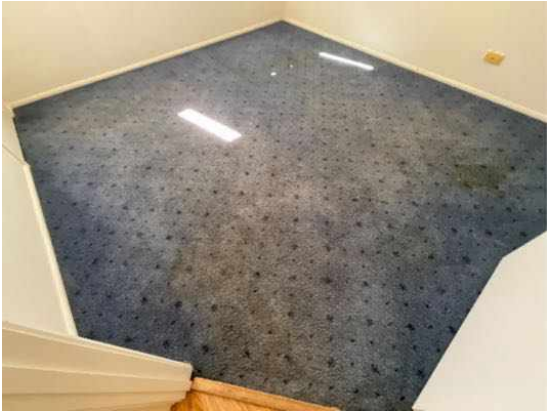
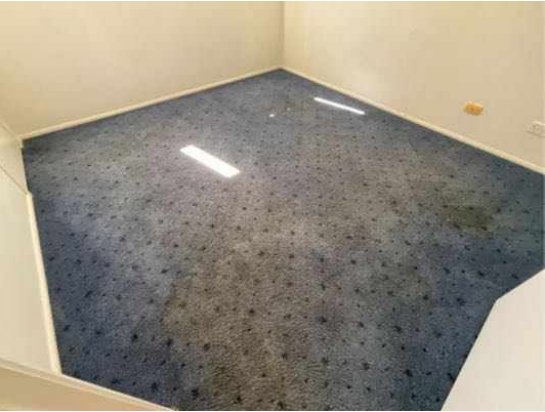
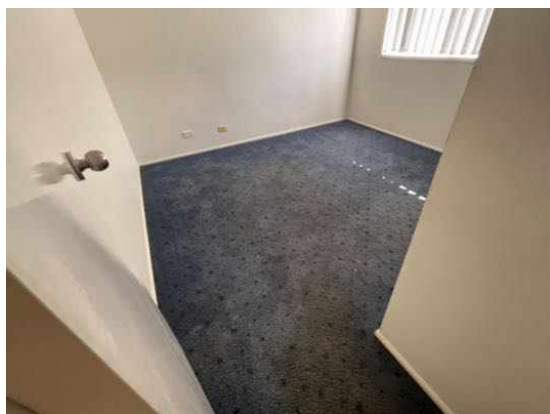
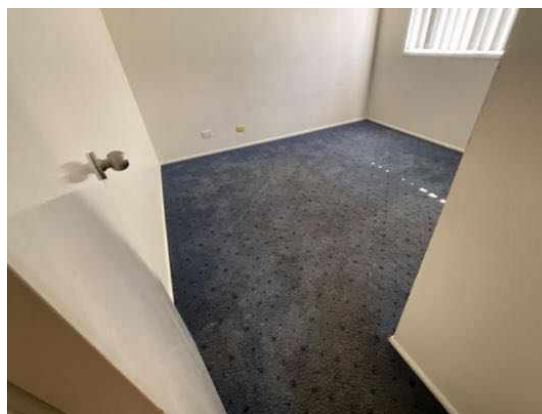
Building:	Main Building
Location:	All Areas
Finding:	carpet exhibits visible staining
Information:	The carpet in the property exhibits visible staining, compromising its overall appearance and cleanliness. This defect poses aesthetic concerns and, if left unaddressed, may lead to permanent damage, affecting the property's visual appeal and potentially contributing to indoor air quality issues.

The risks associated with stained carpet include:

1. Permanent Damage: Some stains, if not treated promptly, can become permanent, diminishing the lifespan and visual appeal of the carpet.
2. Aesthetic Impact: Stained carpet negatively impacts the aesthetics of the space, creating an unclean and unkempt appearance.
3. Potential for Odors: Stains may contribute to unpleasant odors over time, affecting indoor air quality and creating an undesirable living environment.

To address stained carpet, it is recommended to:

- Engage a professional carpet cleaning service to assess and treat the stains using appropriate cleaning methods and solutions.

- Identify the type of stain and use suitable spot treatment products or methods to minimize or eliminate the staining.

- Implement preventive measures, such as regular cleaning and prompt treatment of spills, to maintain the cleanliness of the carpet and prevent future stains.

Timely intervention by a professional carpet cleaning service is essential to restore the carpet's appearance and prevent permanent damage. Regular maintenance practices contribute to the longevity and cleanliness of the carpeted areas in the property.

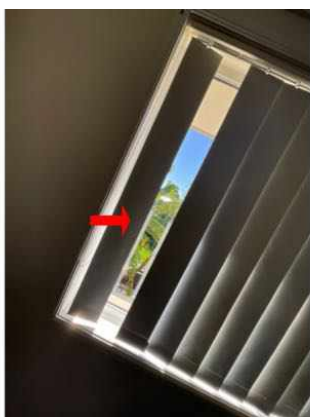
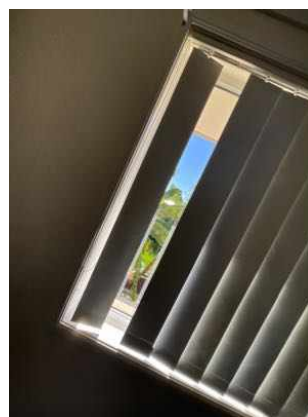
Finding 3.22

Building:	Main Building
Location:	Bedroom 2
Finding:	A non-functional or broken blind
Information:	A non-functional or broken blind is identified within the property, impairing its functionality and diminishing privacy and light control.

The dysfunctional blind poses a privacy concern and hampers the ability to regulate natural light, potentially affecting the occupants' comfort and security.

A qualified blind repair service or a handyman with expertise in window treatments can address and rectify the non-functional or broken blind, restoring its functionality and contributing to the overall functionality of the space.

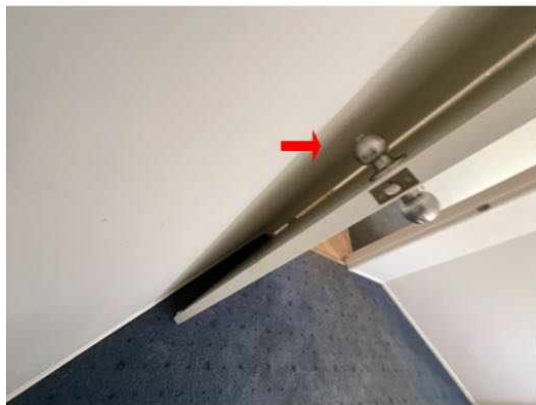
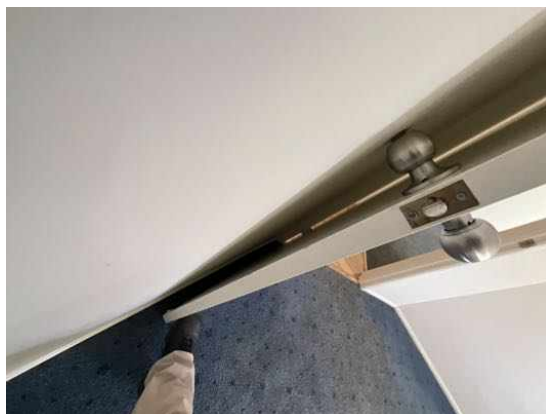
Finding 3.23

Building:	Main Building
Location:	Bedroom 2
Finding:	Missing Door Stopper
Information:	The door lacks a stopper, which is essential to prevent the door from swinging too far and potentially damaging the wall or the door handle. The absence of a door stopper increases the likelihood of impact damage to both the door and surrounding surfaces

- **Damage Risk:** Moderate risk of damage to the door handle, wall, or door itself from repeated impacts when the door is opened forcefully or by a gust of wind.
- **Wear and Tear Risk:** Increased wear on door hardware and hinges due to the potential for abrupt stops without a dedicated stopper.

This issue is a minor defect but should be addressed to prevent potential damage and maintain the integrity of the door and surrounding areas.

Recommendation for Rectification:

- **Engage a Handyperson or Carpenter:** A handyperson or carpenter should install a suitable door stopper to prevent excessive door movement. This could be a floor-mounted or wall-mounted stopper depending on the space and door design.

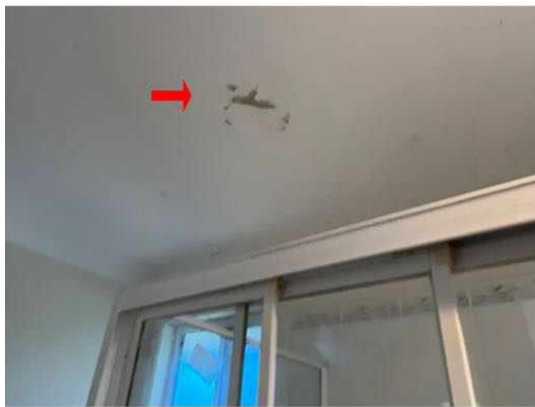
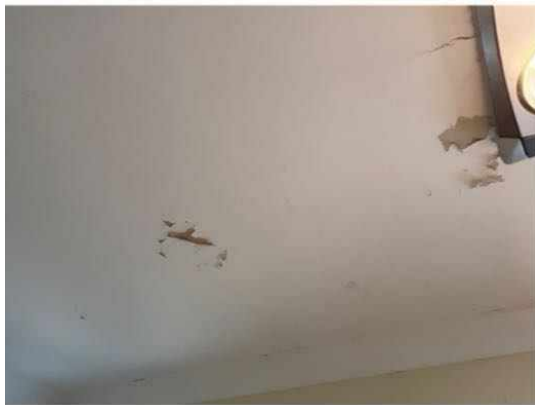
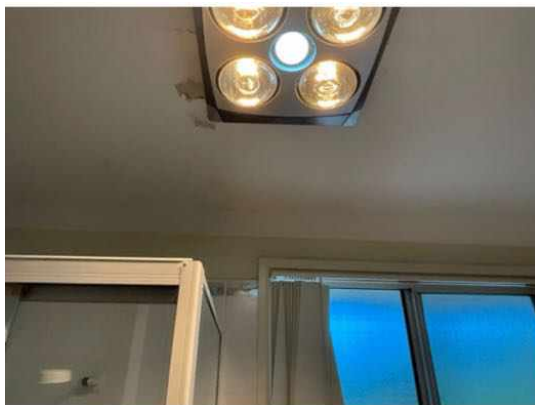
Finding 3.24

Building: Main Building
Location: Bathroom
Finding: Flaky Paint

Sections of the paint in this area was found to have deteriorated. Paint deteriorating is generally an indication of excessive moisture in the area that is currently hidden by the painted surface.

The presence of excessive moisture can have major implications on associated building elements if left unattended. While only seemingly minor at this stage, the damage cannot be determined due to the paint, obstructing any further inspection of the damage.

It is highly advised that the affected paint to be cleaned to allow a further, more invasive inspection by a licensed builder/painter. Failure to act on this defect may necessitate major works in the future.

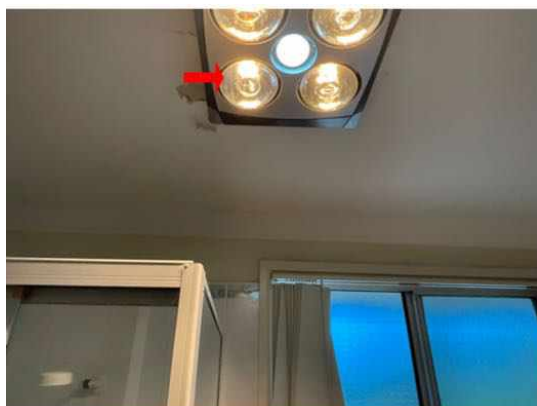
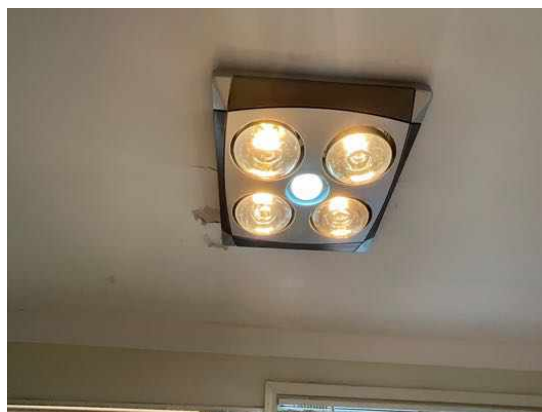
Finding 3.25

Building:	Main Building
Location:	Bathroom
Finding:	Exhaust fan - Not operating
Information:	The exhaust fan in this area appears to be damaged or blocked and is not operating as intended. If left unmanaged, a lack of general maintenance is likely to lead to the development of more significant defects, such as water damage to surrounding building materials from inadequate ventilation. If left unattended for a prolonged period of time, poor ventilation in this area may also be conducive to the development of mould.

Where no secondary damage has developed, the Homeowner may undertake minor cleaning of the area and consider replacement of the exhaust fan. Alternatively, consultation with a Licensed Electrician is required to check for any secondary or concealed damage and consider repair or replacement.

Please be advised that a cabinet maker or qualified carpenter may also be required if water damage has occurred and that an additional specialist mould inspection may be required if severe mould has resulted.
