Building and Timber Pest Inspection Report

Inspection Date: Wed, 11 Mar 2026

Property Address: 43A Welwyn Rd, Hebersham NSW 2770,
Australia

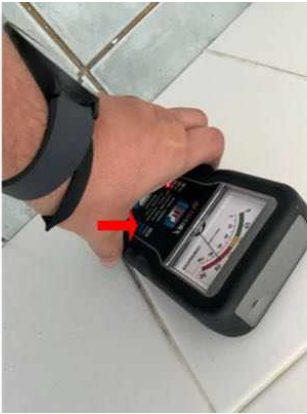
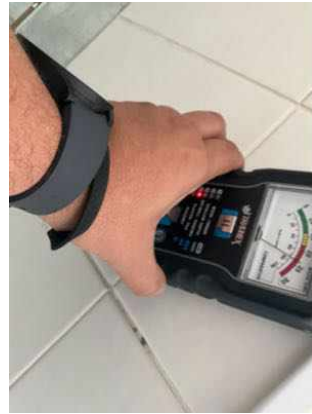
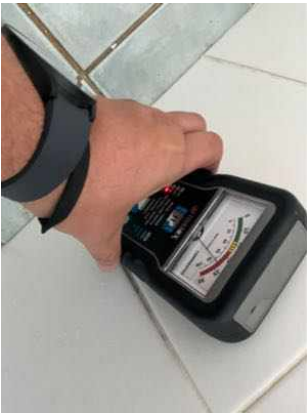
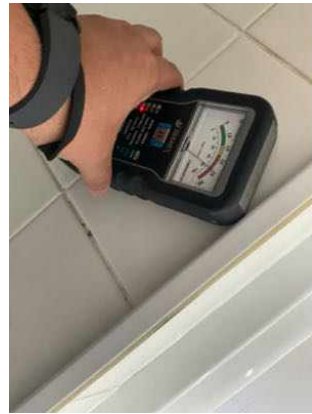
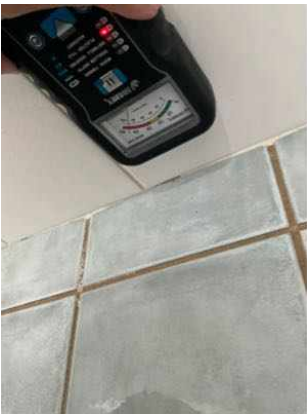
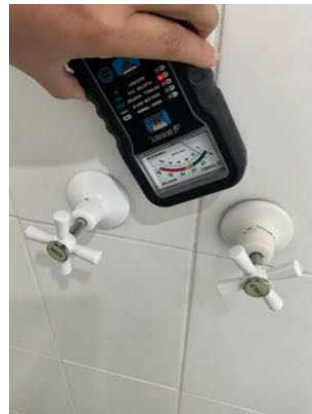
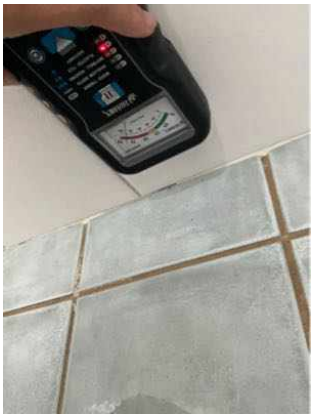
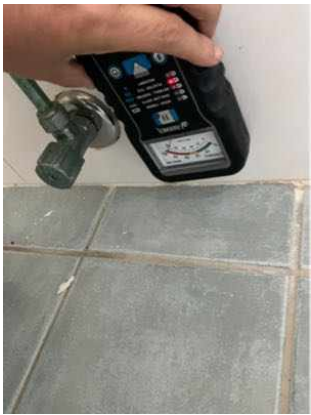
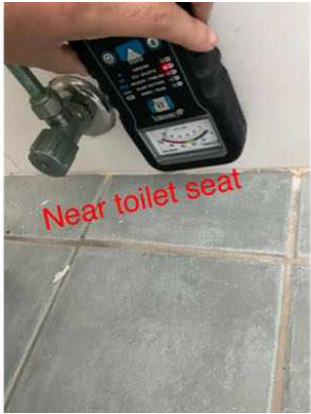
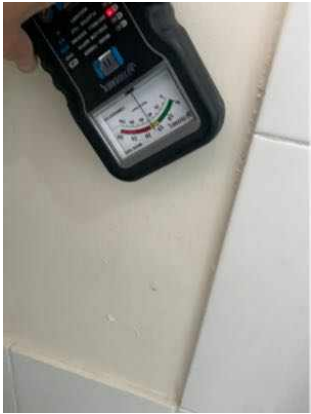
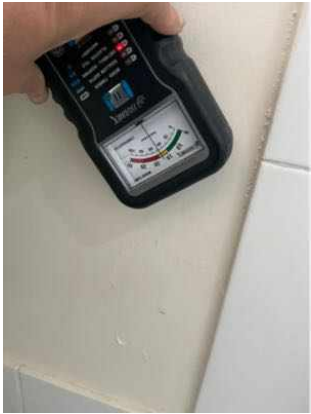
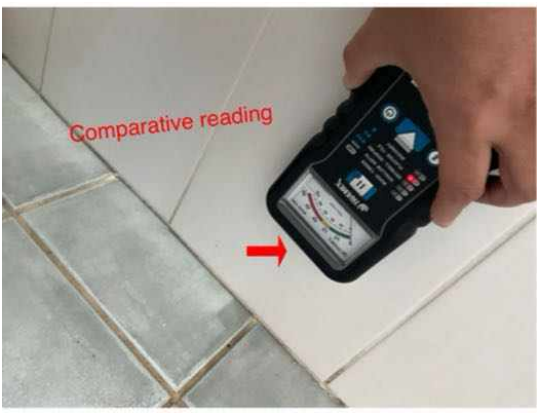
Finding 3.26

Building:	Main Building
Location:	Bathroom
Finding:	Evidence of excessive moisture was present at the time of inspection
Information:	Excessive moisture is present behind the bathroom tiles, indicating a potential water leakage issue within the wall.

The prolonged presence of moisture can lead to mold growth, deteriorate the structure, and create an environment conducive to health hazards. Additionally, it may compromise the adhesive holding the tiles, leading to their detachment.

A licensed plumber or a qualified contractor specializing in water damage remediation

should investigate the source of the moisture, fix any leaks, and address the damage. Additionally, replacing affected tiles and ensuring proper waterproofing are crucial to preventing future issues.

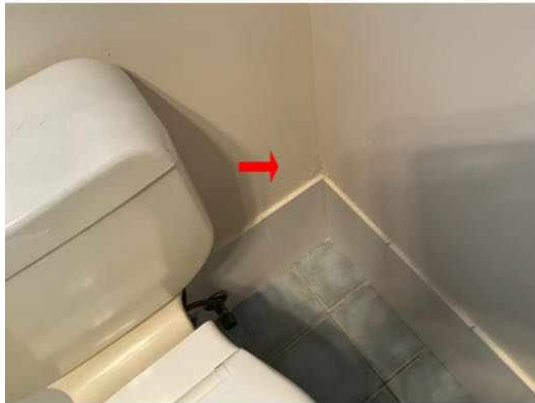
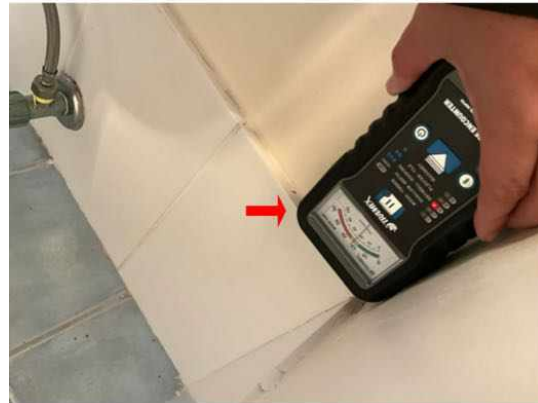
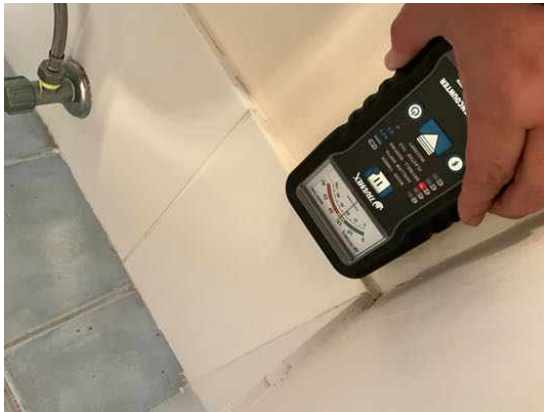
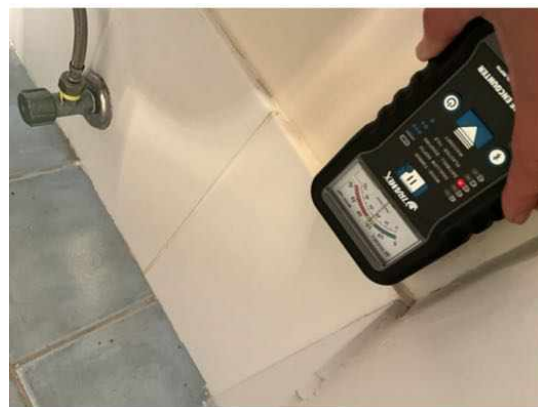
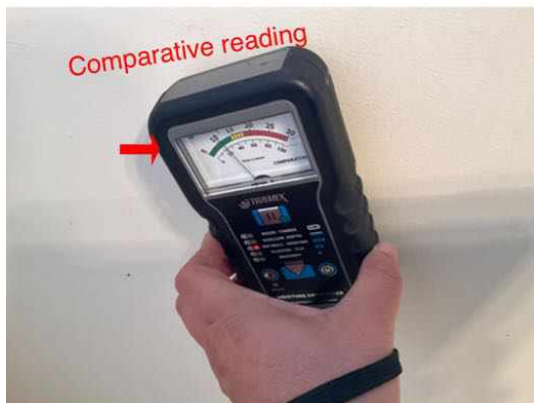
Finding 3.27

Building: Main Building
 Location: Ensuite
 Finding: Evidence of excessive moisture - Drywall
 Information: Excessive moisture is present at the time of , indicating a potential water leakage issue within the wall.

The prolonged presence of moisture can lead to mold growth, deteriorate the structure, and create an environment conducive to health hazards. Additionally, it may compromise the adhesive holding the tiles, leading to their detachment.

A licensed plumber or a qualified contractor specializing in water damage remediation

should investigate the source of the moisture, fix any leaks, and address the damage. Additionally, replacing affected tiles and ensuring proper waterproofing are crucial to preventing future issues.

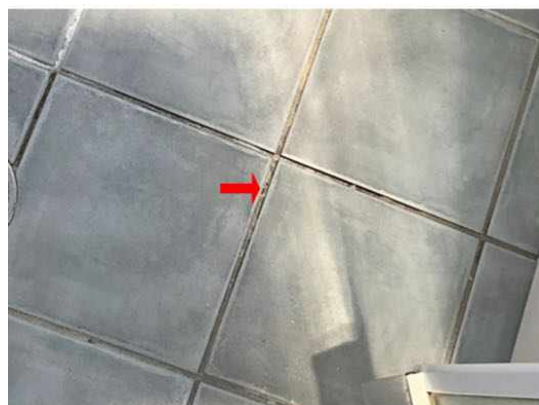
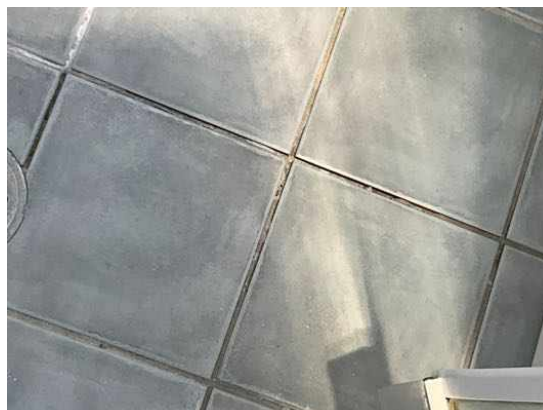
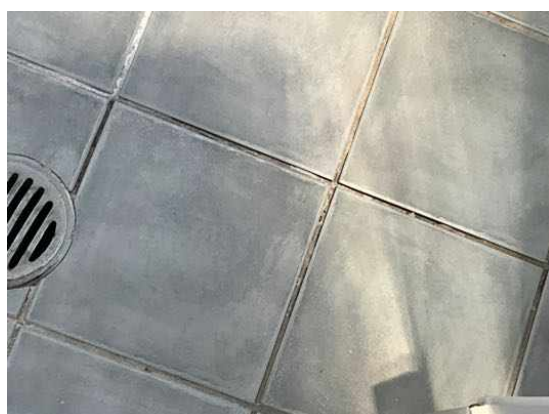
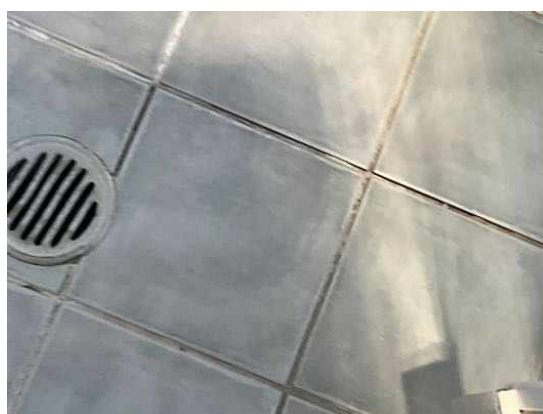
Building:	Main Building
Location:	Ensuite
Finding:	Sealant and grouting - Missing or damaged
Information:	It was noted on inspection that sealant or grout is degraded to the tiled shower alcove and or other areas of the bathroom.

Different materials and floor areas move at different rates, generally causing cracking to grout or sealant at this point. A flexible sealant is required to allow for expected expansion and contraction, while keeping the joint water tight and protective of all associated building materials.

There appears to be excessive mould to the sealant and grout which will likely require scraping out and replacement.

Flexible and mould resistant materials should be applied to affected areas to prevent any subsequent water damage that is likely to occur. Regular maintenance and replacement of damage or missing or damaged sealant and grout is highly recommended to the wet areas, as this is a regular wear and tear defect. Sealant and grouting in areas that come into regular contact with water should be maintained for the long term care of your property.

A sealant specialist or tiling contractor should be appointed to complete these works as soon as possible

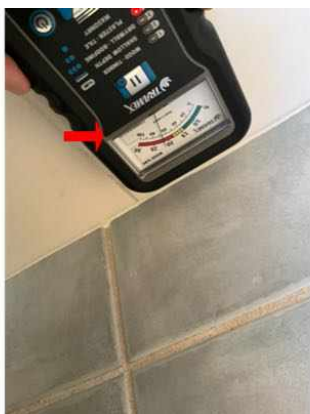
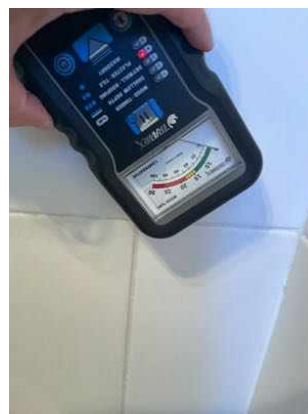
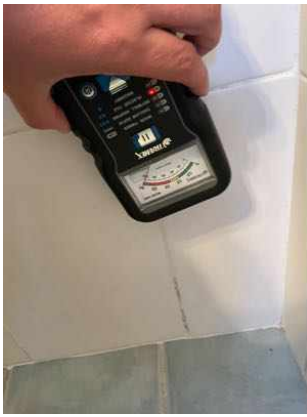
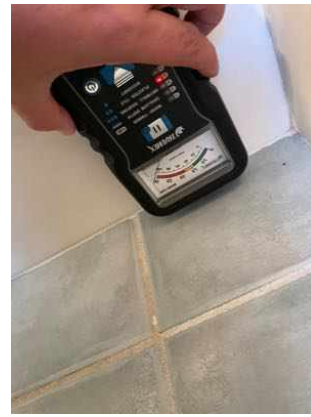
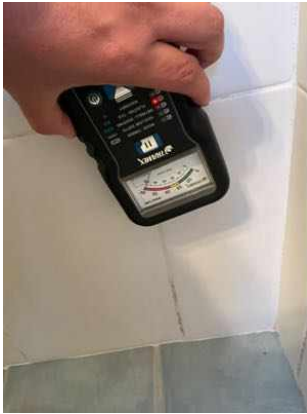
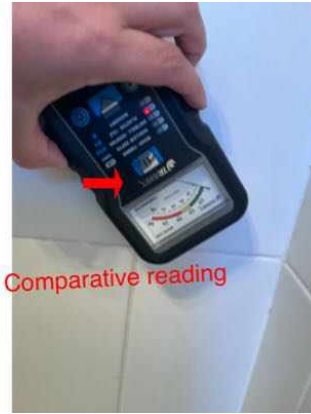
Finding 3.29

Building: Main Building
Location: Ensuite
Finding: Shower - Damp

Information: Damp is evident to the lower 300mm of wall to the shower alcove. This defect is quite common, and is suspected to have been caused by moisture permeating through the grouting in this area, which shows evidence of deterioration. Leaking pipes within the adjoining wall is also a possible cause.

Unmanaged damp in the shower recess is likely to facilitate the formation and development of mould and fungi growth, decaying associated building materials and compromising their structural integrity. It is important to address damp conditions, as the World Health Organisation notes that excess moisture leads - on almost all indoor materials - to growth of microbes such as moulds, fungi and bacteria, which subsequently emit spores and other matter into the indoor air. Exposure to these contaminants is associated with a wide range of respiratory and other health-related problems.

Consultation with a qualified plumber or bathroom specialist is advised immediately to identify the cause of damp and to perform remedial works as required. Where excessive mould growth is present, further inspection by a specialist environmental health inspector should also be considered.

Always ensure that sealant and grout is in good condition to prevent any moisture issues occurring in the future.

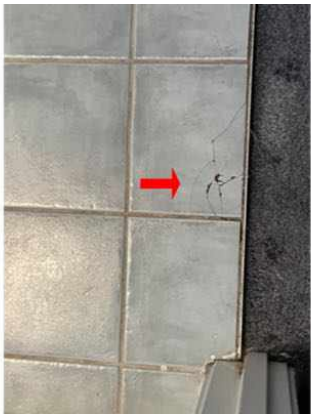
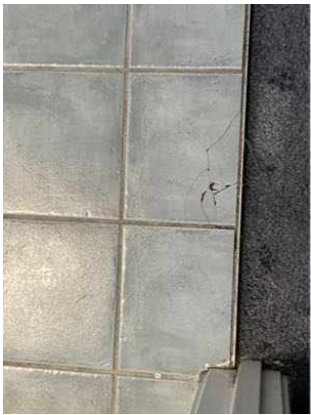
Finding 3.30

Building: Main Building
 Location: Ensuite
 Finding: Tile - Floor Tile Damaged
 Information: A floor tile is visibly damaged, showing a chipped/broken section on the surface.

The damaged tile presents a trip hazard, may lead to cuts if stepped on barefoot, and can allow moisture ingress into the substrate, which may cause further deterioration or loosening of adjacent tiles. It also affects the overall appearance of the floor.

A licensed tiler should be engaged to remove the damaged tile and install a matching replacement. If spare tiles are unavailable, additional remedial work may be required to blend the repair with surrounding finishes.

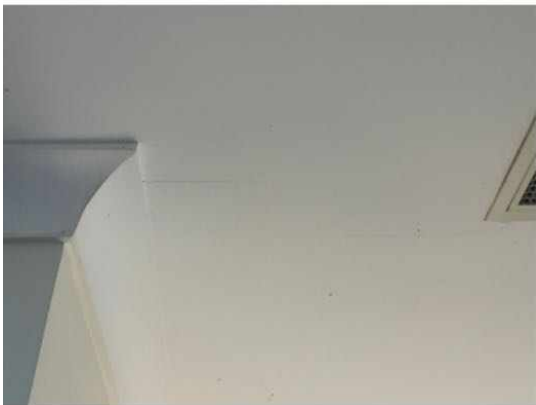
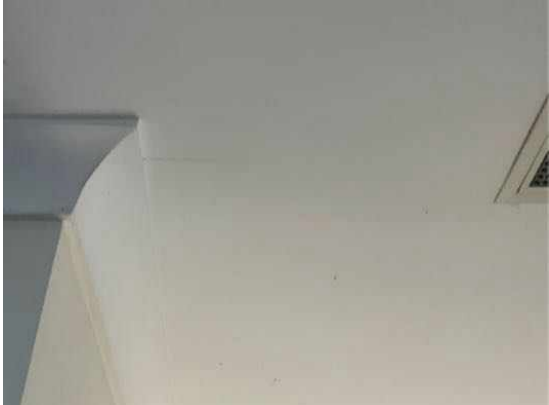
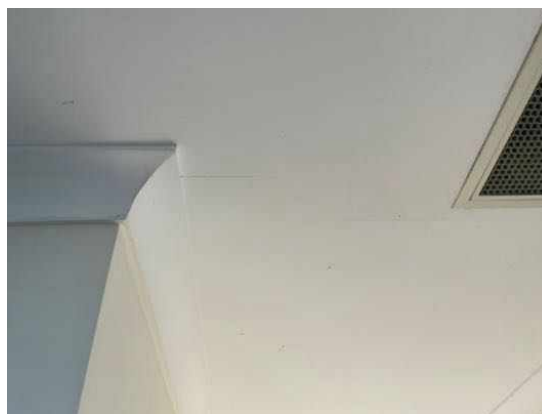
Finding 3.31

Building: Main Building
Location: Foyer
Finding: Ceilings - Crack (Fine)
Information: Fine cracks are observed in the ceiling, suggesting potential structural issues or settling.

The presence of fine cracks in the ceiling poses a risk of further structural damage, compromising the integrity of the building. Additionally, it may indicate underlying issues such as foundation problems or insufficient support.

A structural engineer or a qualified contractor should be consulted to assess the cause of the cracks and recommend appropriate repairs. Addressing the underlying issues is crucial to prevent further damage and maintain the safety and stability of the structure.

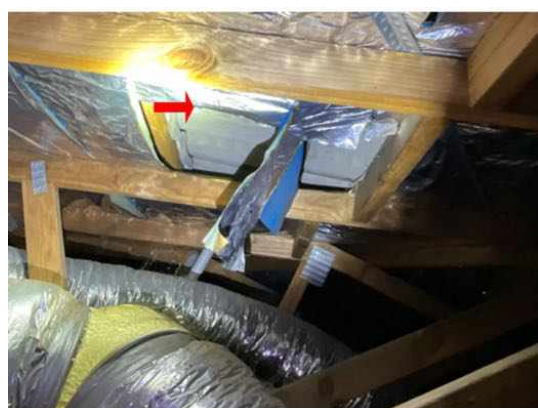
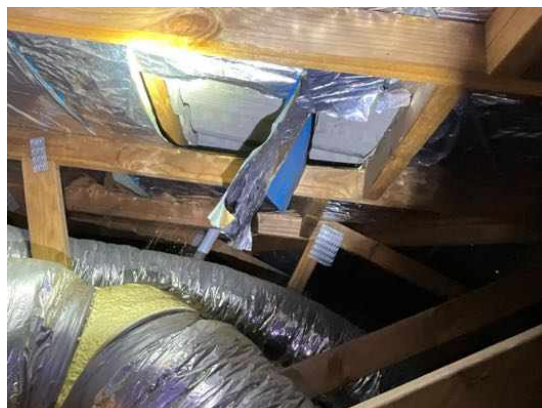
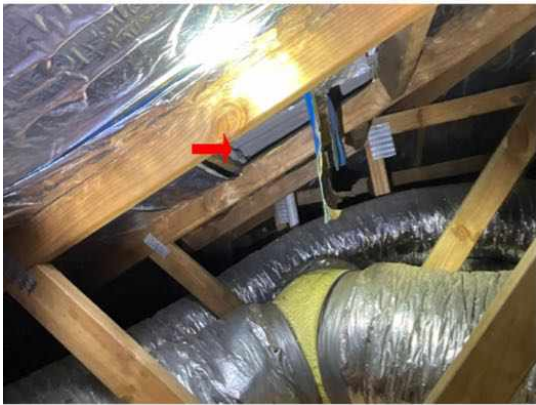
Finding 3.32

Building:	Main Building
Location:	Roof Void
Finding:	Sarking - Damaged
Information:	Sarking, a laminated aluminium foil applied to the interior of the roof covering, assists in insulating the property and acting as a vapour-barrier to the roof void and, subsequently, to the household.

Where sarking is damaged, both insulation and moisture protection of the property are inhibited. This creates a loss of energy and thus negatively impacts the energy efficiency of the property, allowing potential for moisture ingress from condensation or leaking roof tiles.

It is important to repair any holes or damaged sections of sarking to ensure that the building material is fully functional. A registered builder or qualified carpenter should be consulted to provide further advice on this defect and to perform rectification works at client discretion.

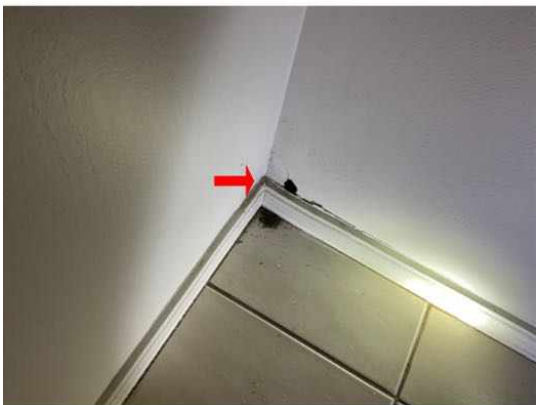
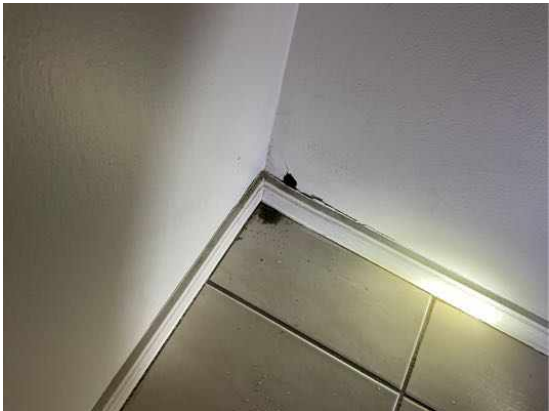
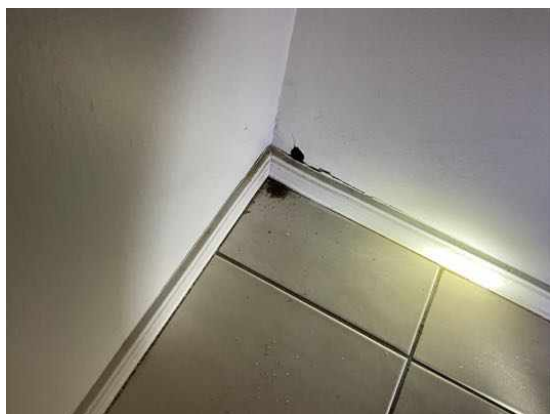
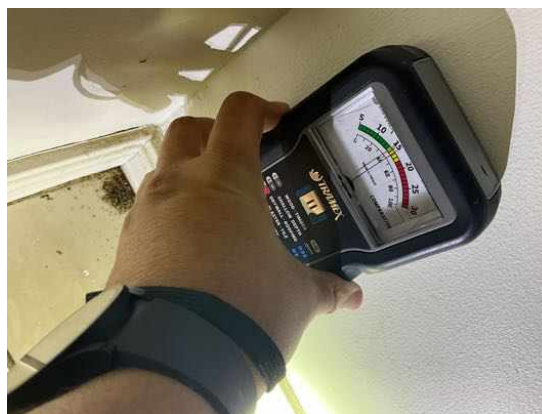
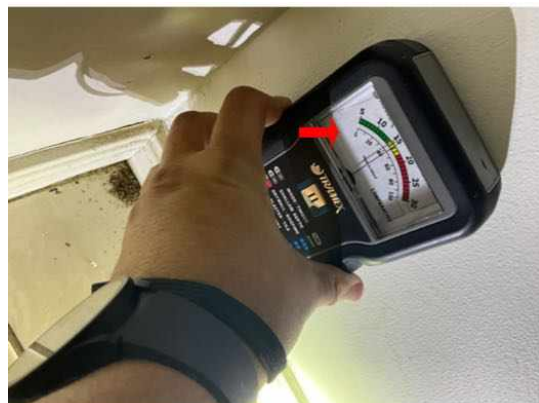
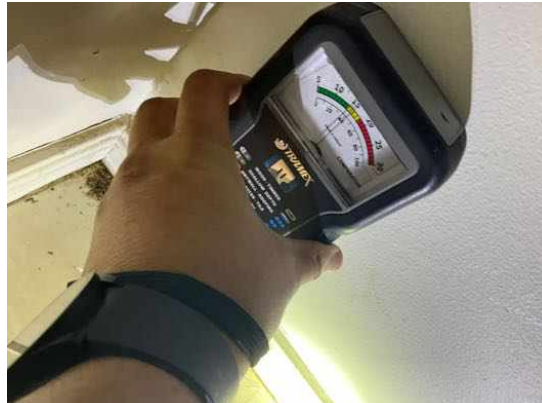
Building: Main Building
Location: Dining Room
Finding: Suspected - Timber pest damage
Information: Despite no live termite or timber pest activity being indicated, suspected previous timber pest damage was found to have affected this area. This damage is considered to be inactive at the time of inspection.

It is advised that the area be visually inspected frequently to ensure that the condition of affected building materials does not worsen.

A licensed pest controller must be appointed to provide a further invasive inspection.

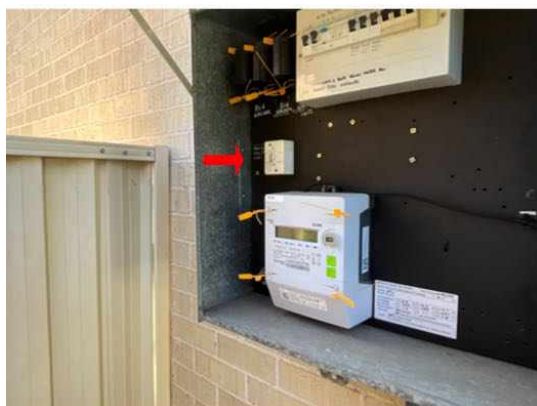
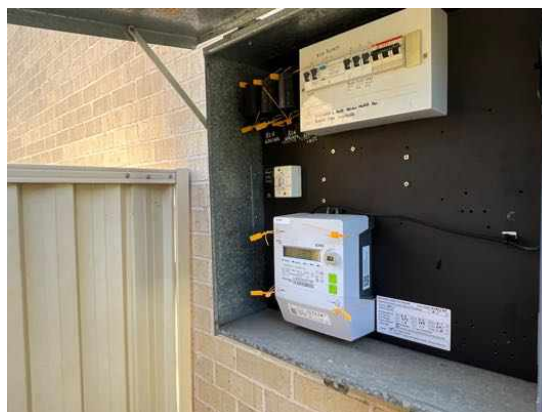
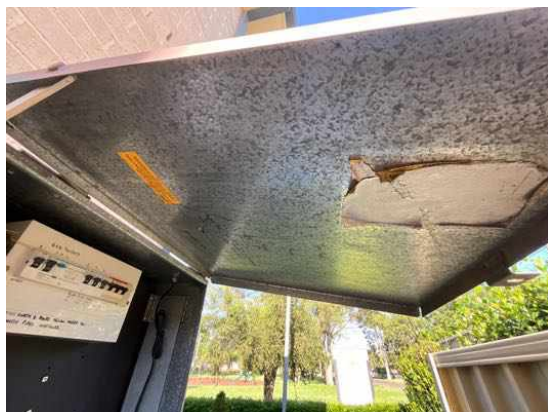
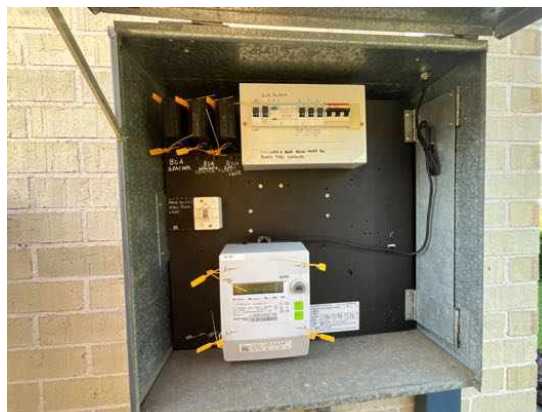
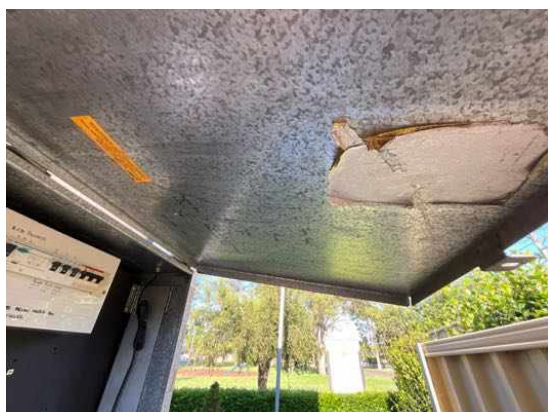
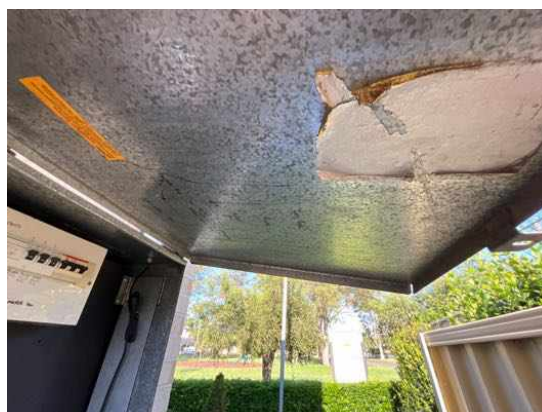
Finding 6.01

Building:	Main Building
Location:	Exterior walls - left side
Finding:	No Evidence of Termite Management System - Durable notice / Legible Sticker
Information:	The application of a pre & post-construction chemical termite barrier is highly recommended for all properties. Such barriers are highly effective in preventing termite attack on any timber building elements throughout the property.

A durable notice was not placed in the switchboard unit to indicate current termite barriers is legible at the time of inspection.

Client must seek further information from the vendor or real estate agent if the conditions of termite management systems were maintained.

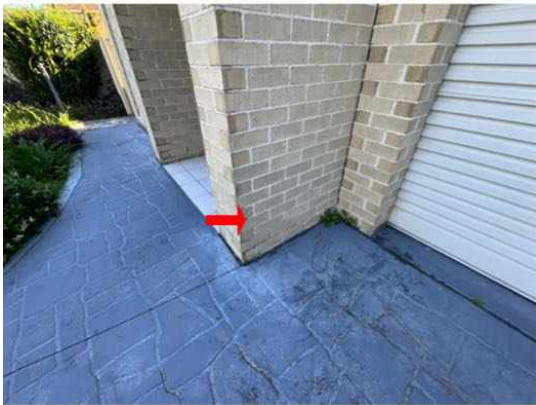
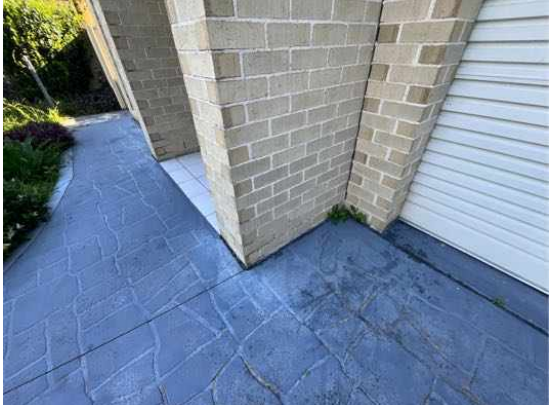
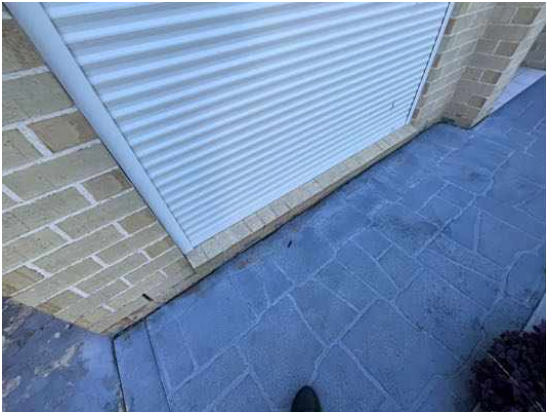
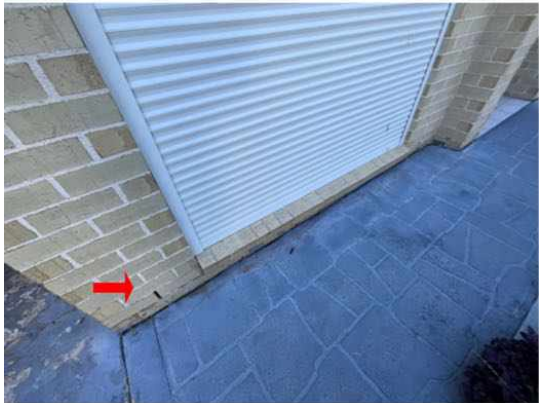
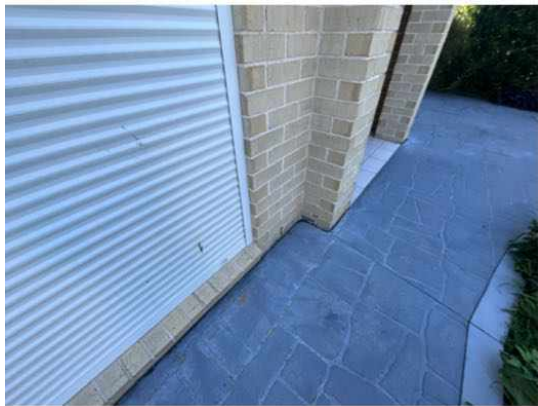
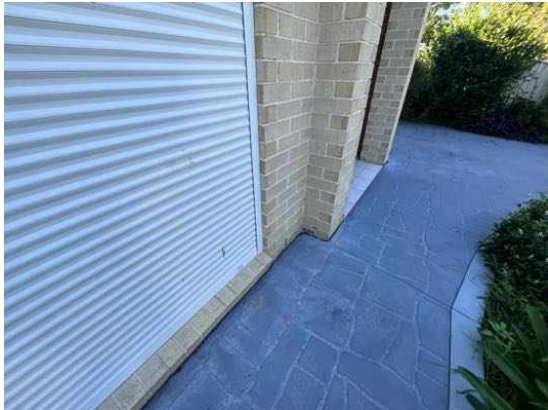
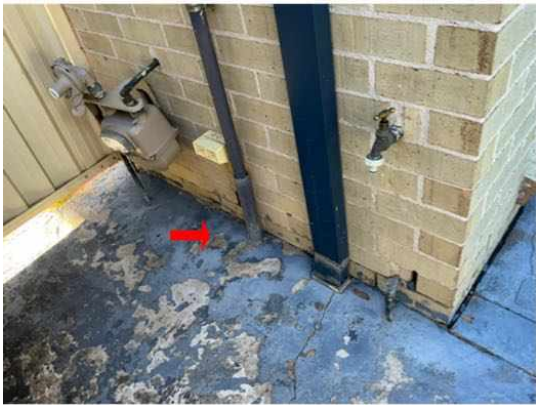
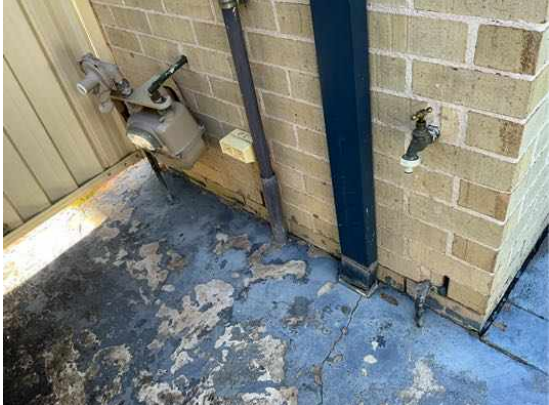
Finding 6.02

Sometimes, in order to determine the type of slab, a suitably qualified person such as an architect or builder may be required to consult the construction plans.

Where the slab edge cannot be properly inspected, it is highly recommended that termite or timber pest inspections be carried out every 6-12 months to aid protection of the property against infestation.

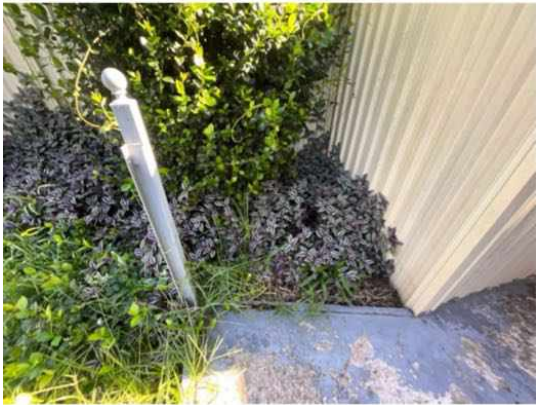
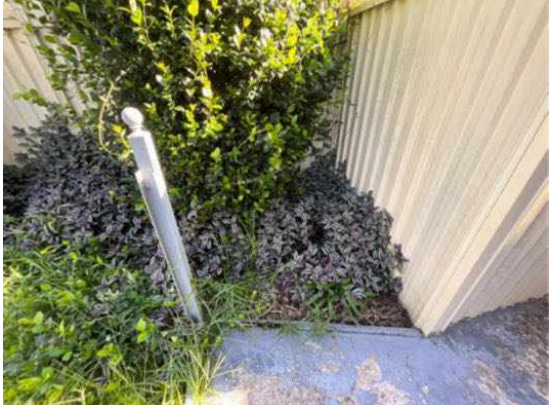
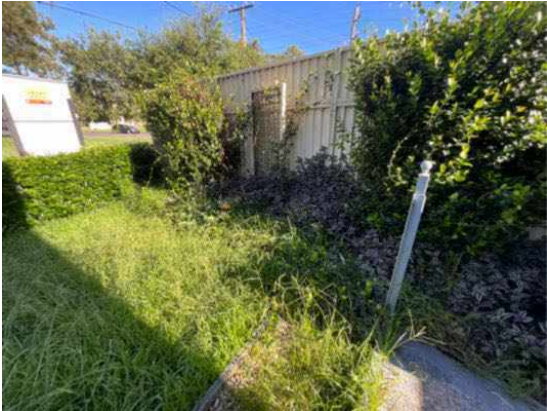
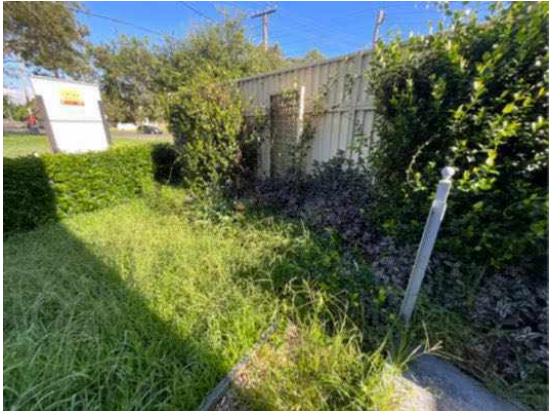
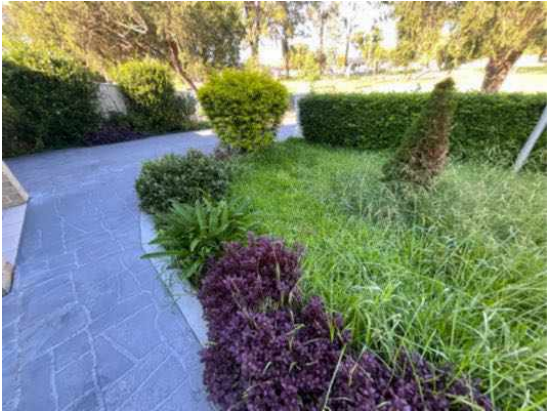
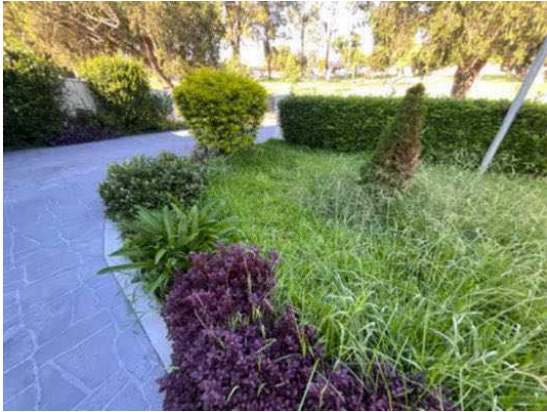
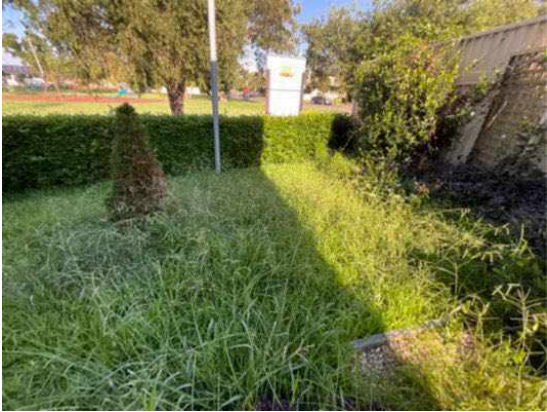
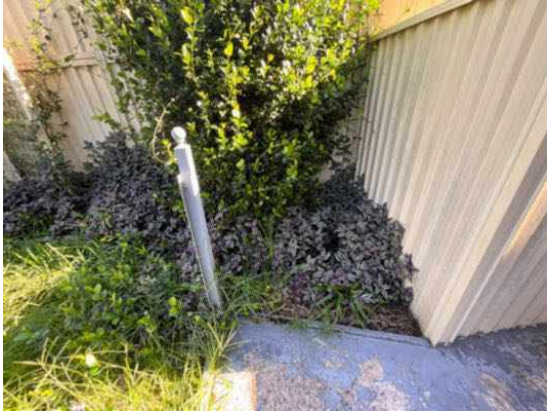
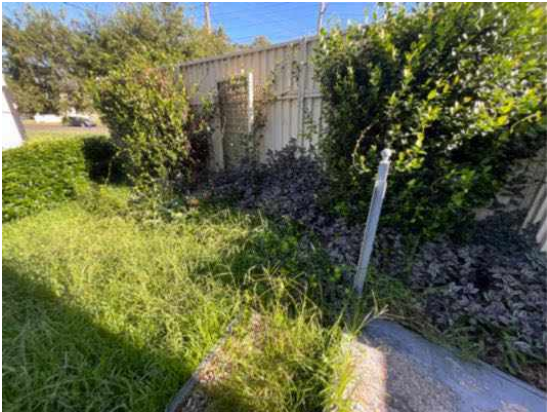
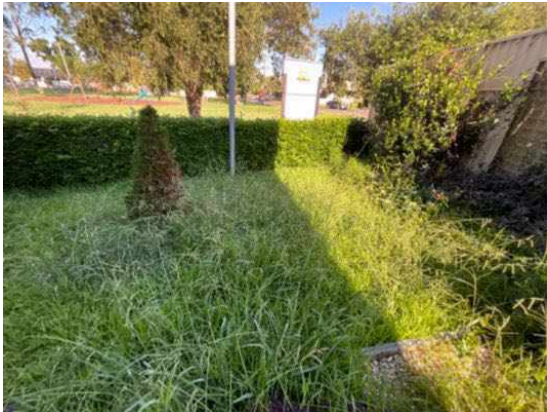
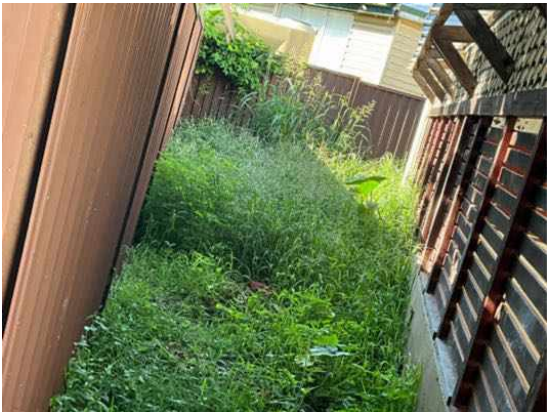
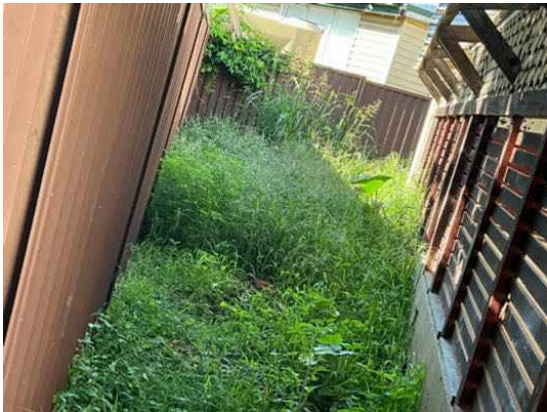
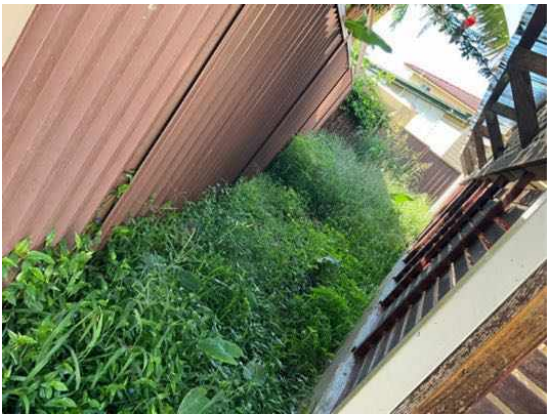
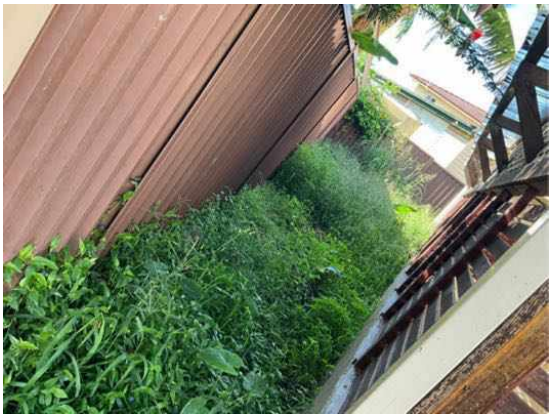
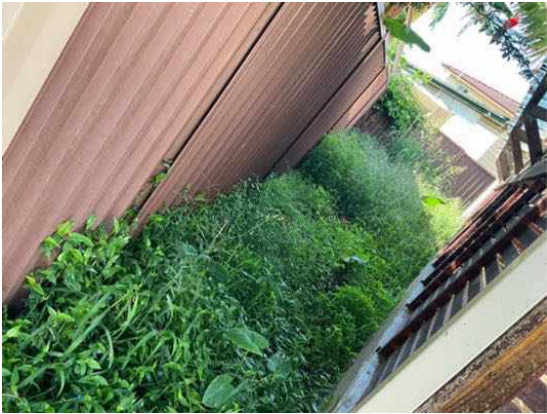
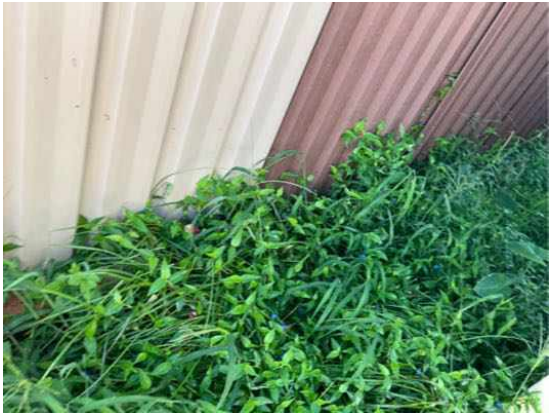
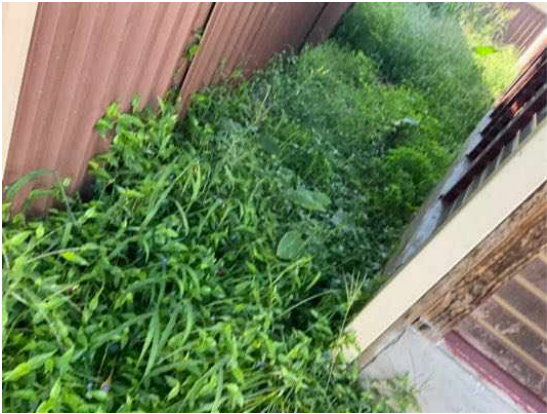
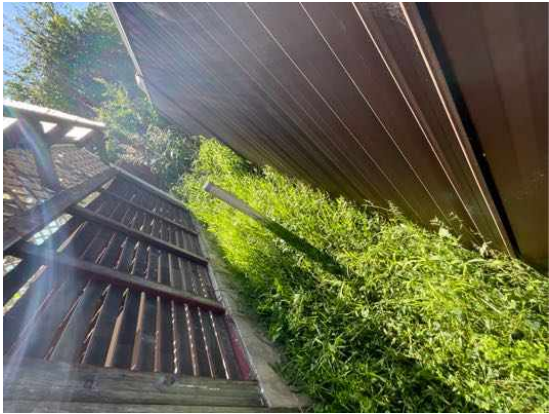
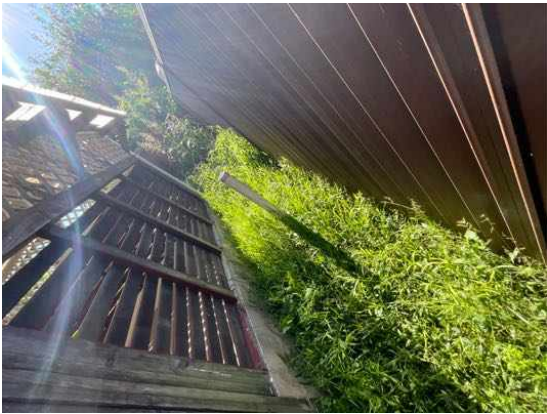
Finding 6.03

Building: Main Building
Location: All Areas
Finding: Dense vegetation around a property can increase the risk of termite infestation
Information: The presence of dense vegetation around a property can increase the risk of termite infestation, as it provides a conducive environment for them. To address this, consider maintaining a clear space between the vegetation and your home. If you suspect a termite issue, it's advisable to consult with a licensed pest control professional for inspection and treatment.

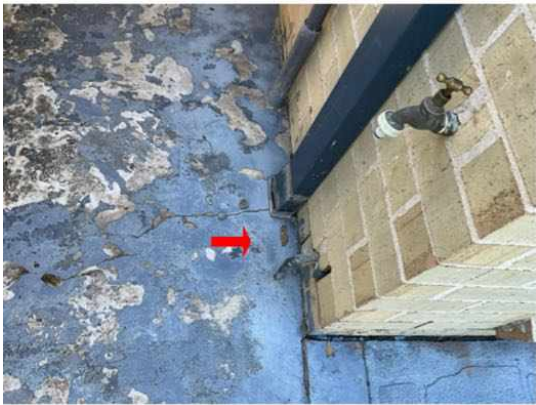
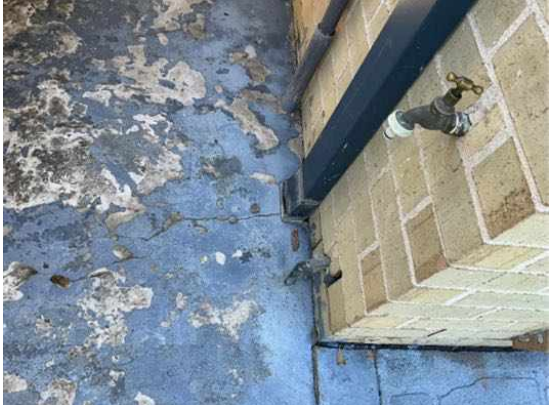
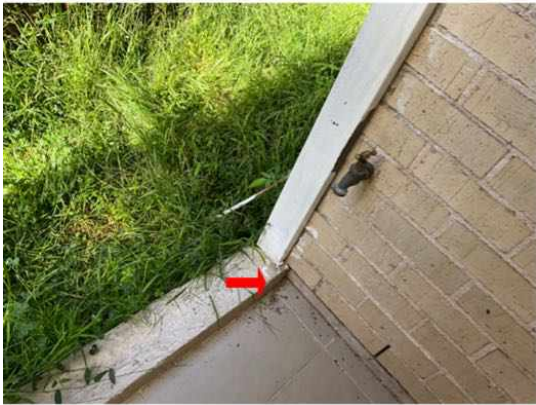
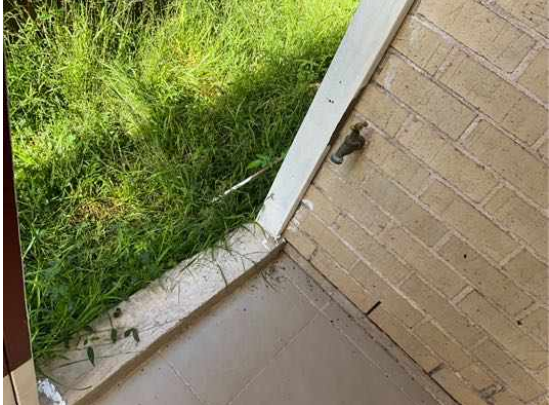
Finding 6.04

Building: Main Building
Location: All Areas
Finding: No Drain under tap
Information: There is no drain installed under the tap, leading to water accumulation and creating conducive conditions for timber pests. This defect needs immediate attention to prevent potential damage and pest infestation.

1. Water Accumulation: Without proper drainage, water can accumulate around the base of the tap, leading to persistent dampness in the surrounding area.
2. Timber Pest Infestation: The damp environment created by standing water is highly conducive to timber pests, such as termites and wood borers, which thrive in moist conditions and can cause significant damage to wooden structures.
3. Structural Damage: Prolonged exposure to moisture can lead to wood rot and deterioration of structural timber, compromising the integrity of the building.
4. Health Hazards: Persistent dampness can also promote mold and mildew growth, posing health risks to occupants.
5. Aesthetic Damage: Water stains and damage to finishes and materials around the tap area can detract from the appearance of the building and lead to costly repairs.

A licensed plumber or a qualified building contractor can address this defect by:

1. Assessment: Evaluating the area to determine the best approach for installing a proper drainage system under the tap.
2. Installation: Installing a drain that effectively channels water away from the base of the tap, preventing water accumulation and dampness.
3. Repair and Prevention: Inspecting and repairing any existing water damage and implementing measures to prevent future water accumulation and pest infestations.

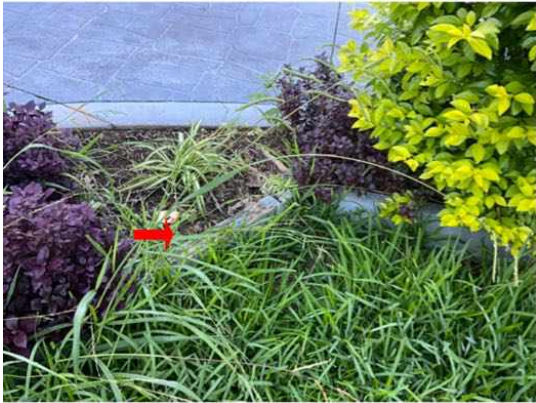
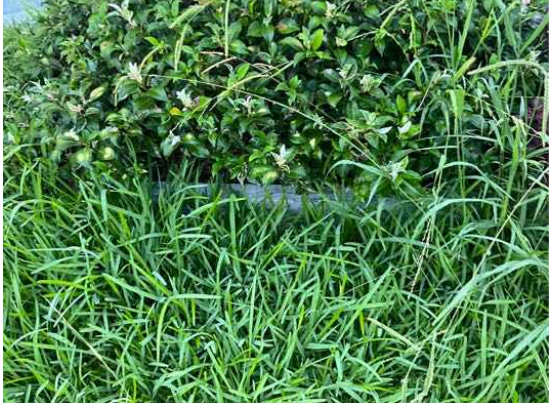
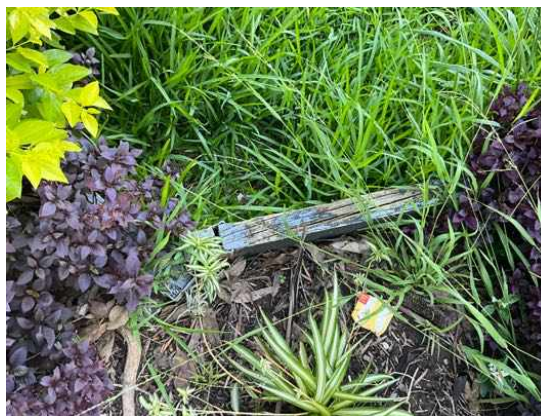
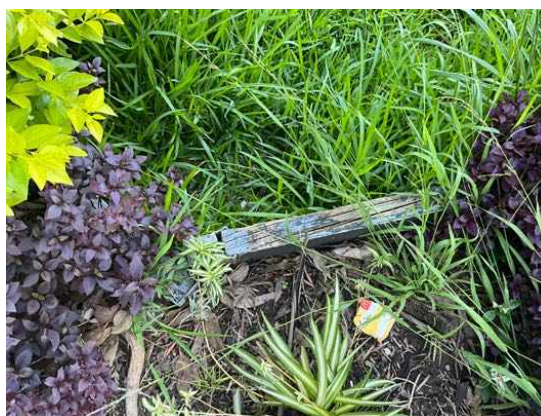
Finding 6.05

Building: Main Building
Location: All Areas
Finding: Timber on ground / conducive conditions to termite damage
Information: Timber on the ground is indeed conducive to termite damage. Termites are known to thrive in moist environments, and wood in contact with soil or moisture is more susceptible to infestation.

To prevent this, it's important to keep timber elevated and away from direct ground contact. Regular inspections and proper termite control measures are also essential to protect your wooden structures from termite damage.

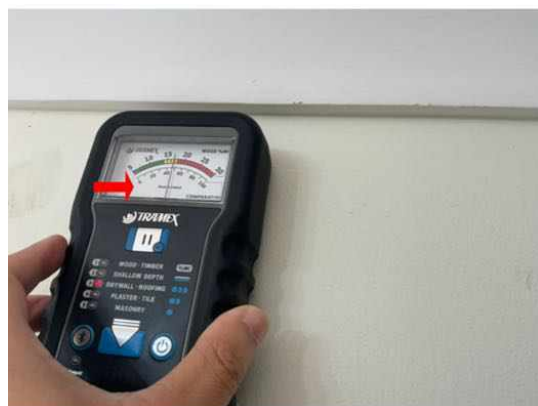
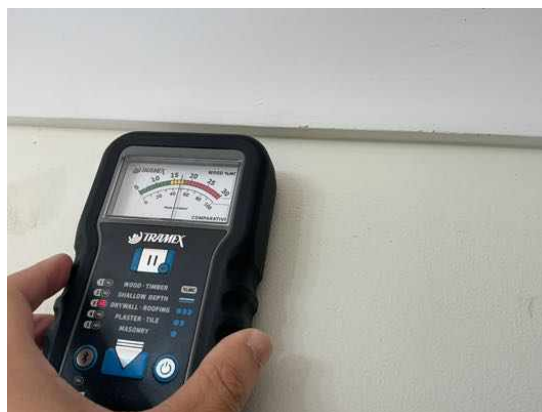
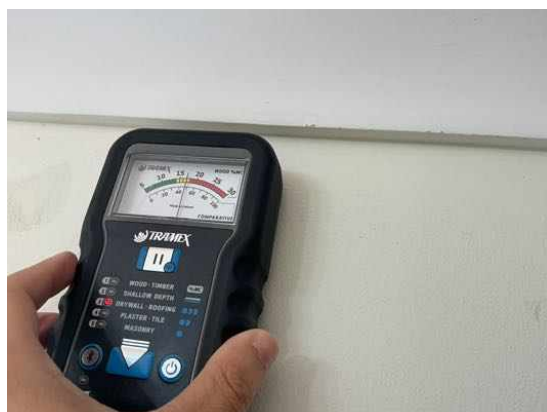
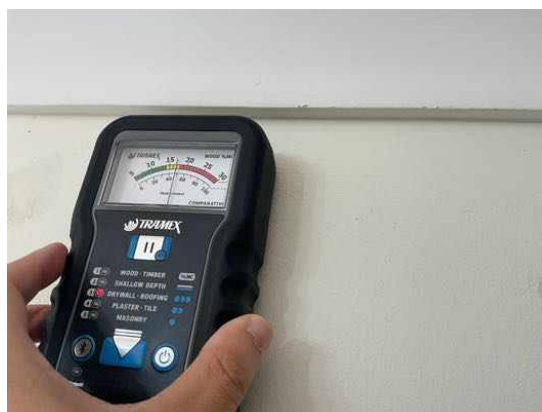
Finding 6.06

Building:	Main Building
Location:	Living Room
Finding:	Excessive moisture - Conducive to Timber pest
Information:	Excessive moisture can attract termites and produce conditions that promote fungal growth and wood decay.

Excessive moisture is generally caused by deteriorated inadequate or missing roof drainage leaking plumbing pipes or fixtures poorly plumbed HWS overflows or condenser units and poor site drainage.

Prior to any remedial works being performed a qualified plumber should be appointed to further inspect the property and to identify the cause of the excessive moisture. Works to remove affected building elements may then be necessary and should be performed by an appropriate tradesperson.

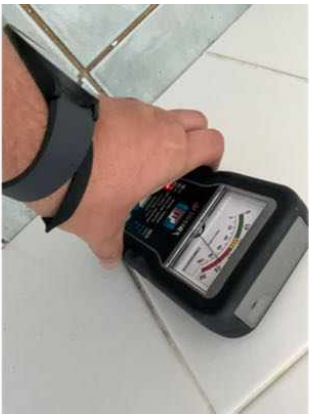
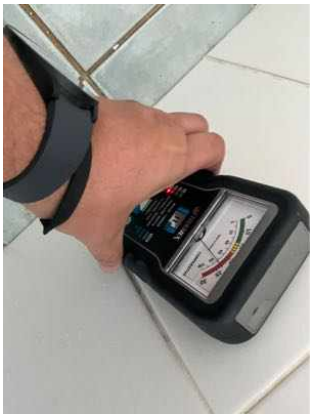
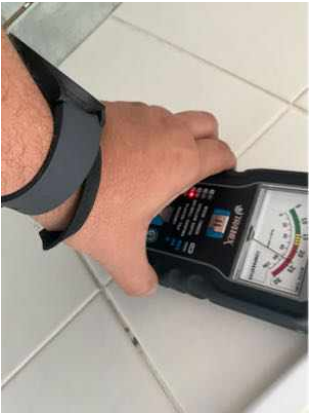
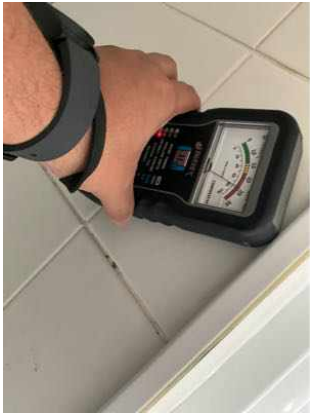
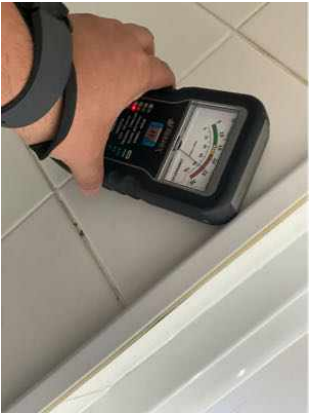
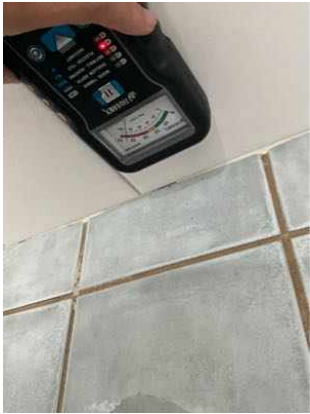
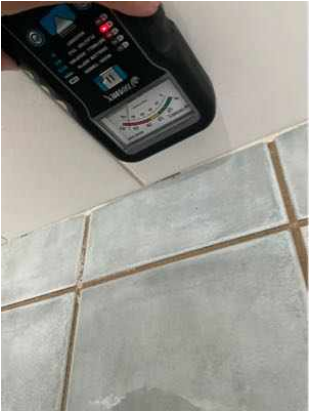
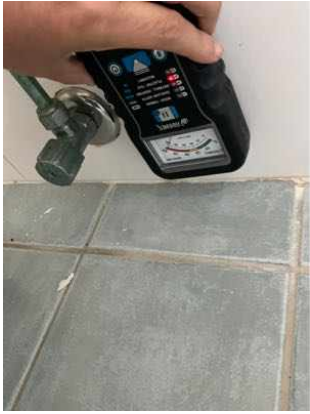
Finding 6.07

Building:	Main Building
Location:	Bathroom
Finding:	Excessive moisture - Conducive to Timber pest
Information:	Excessive moisture can attract termites and produce conditions that promote fungal growth and wood decay.

Excessive moisture is generally caused by deteriorated inadequate or missing roof drainage leaking plumbing pipes or fixtures poorly plumbed HWS overflows or condenser units and poor site drainage.

Prior to any remedial works being performed a qualified plumber should be appointed to further inspect the property and to identify the cause of the excessive moisture. Works to remove affected building elements may then be necessary and should be performed by an appropriate tradesperson.

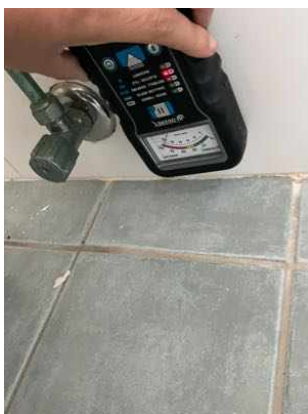
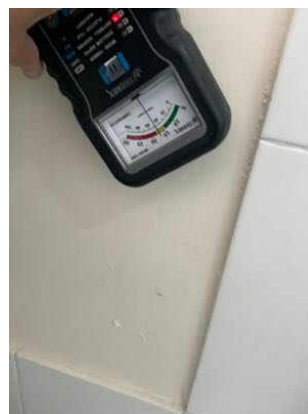
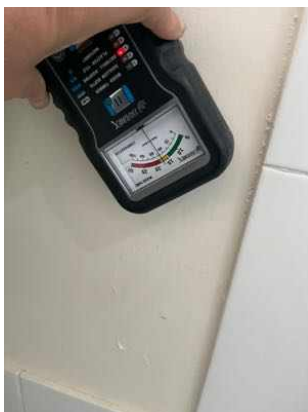
If mould growth has been found there may be environmental biological or health issues involved. In these cases an appropriately qualified inspector should also be contacted.
