Building and Timber Pest Inspection Report

Inspection Date: Wed, 11 Mar 2026

Property Address: 43A Welwyn Rd, Hebersham NSW 2770,
Australia

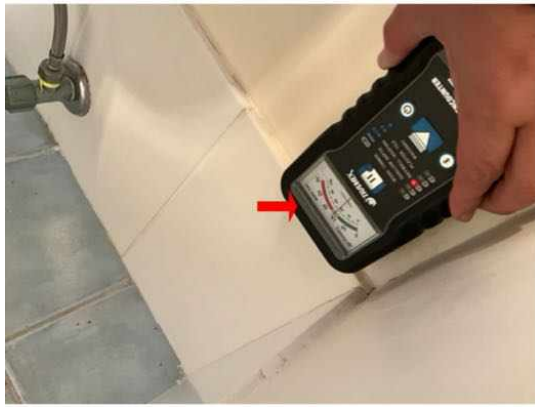
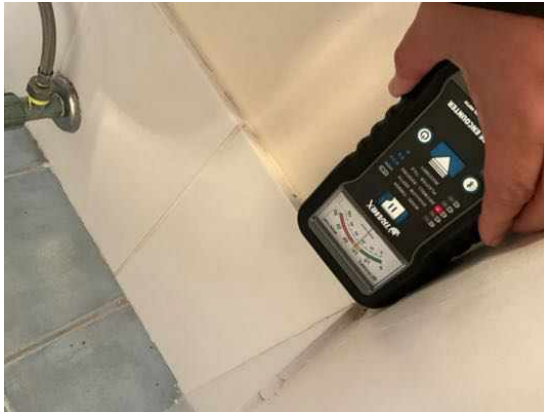
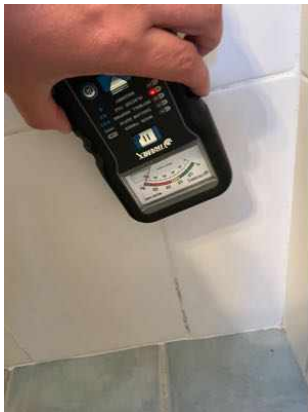
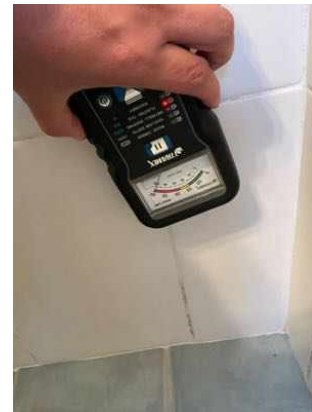
Finding 6.08

Building:	Main Building
Location:	Ensuite
Finding:	Excessive moisture - Conducive to Timber pest
Information:	Excessive moisture can attract termites and produce conditions that promote fungal growth and wood decay.

Excessive moisture is generally caused by deteriorated inadequate or missing roof drainage leaking plumbing pipes or fixtures poorly plumbed HWS overflows or condenser units and poor site drainage.

If mould growth has been found there may be environmental biological or health issues involved. In these cases an appropriately qualified inspector should also be contacted.

Prior to any remedial works being performed a qualified plumber should be appointed to further inspect the property and to identify the cause of the excessive moisture. Works to remove affected building elements may then be necessary and should be performed by an appropriate tradesperson.

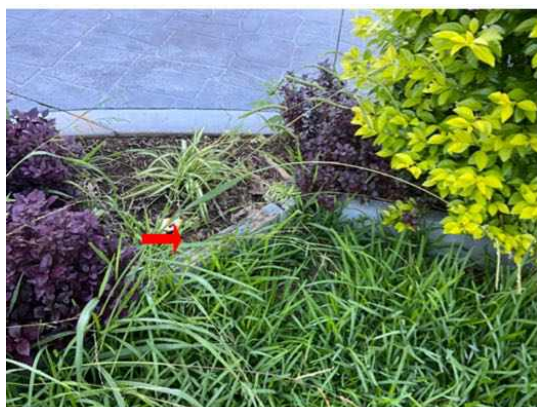
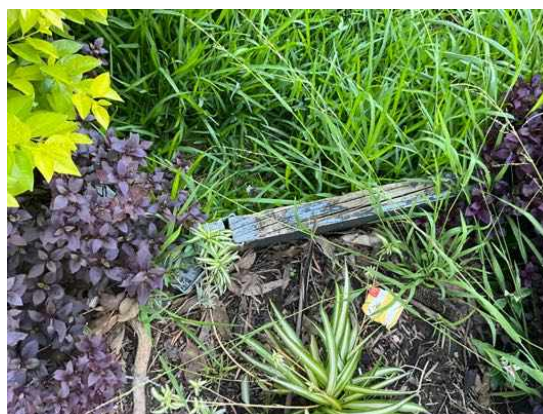
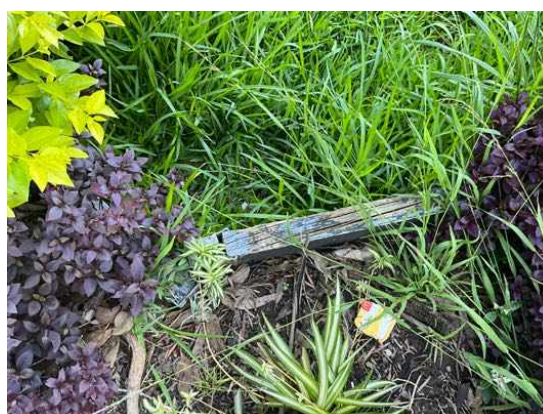
Finding 7.01

Building:	Main Building
Location:	All Areas
Finding:	Wood rot
Information:	This building element shows evidence of wood rot. Wood rot, also known as Fungal Decay, occurs when timbers and other cellulose building materials are exposed to damp conditions on an ongoing basis. This could be the result of exposure to weathering over a prolonged period of time, or the attraction of excessive moisture

Wood rot is often associated with general damp problems and is evidenced by a 'musty' smell or mould and mildew occurring on surfaces. If left unmanaged, damp conditions can lead to further health problems and the decay of timbers will continue.

Early intervention and regular maintenance, particularly of exterior timbers, will prolong the useful life of these building elements. Prior to any works being performed, the cause of the moisture that has created the visible wood rot should be identified and addressed in a suitable manner. Replacement of affected timbers may then be a necessary step in protecting surrounding building elements from such deterioration.

A qualified plumber may be appointed to assess the cause of excessive moisture and to provide advice on any remedial works as required. A qualified carpenter or registered builder may also be required to replace affected building materials.

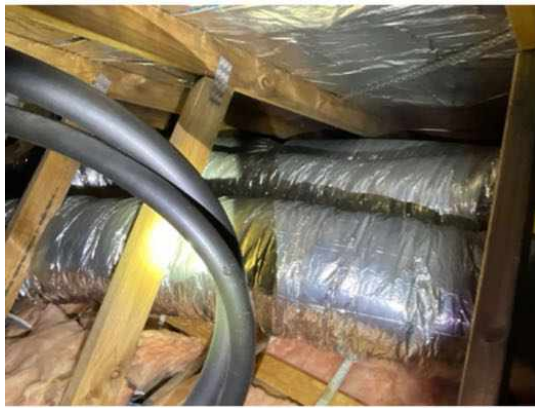
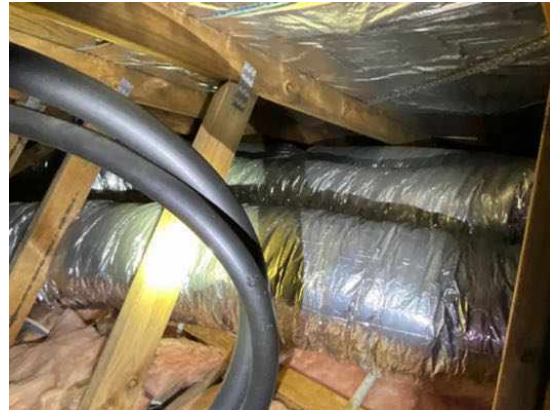
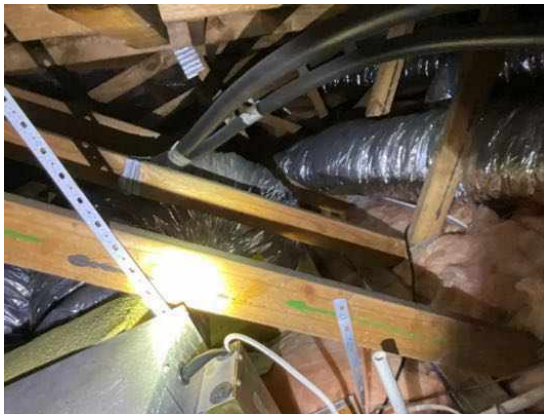
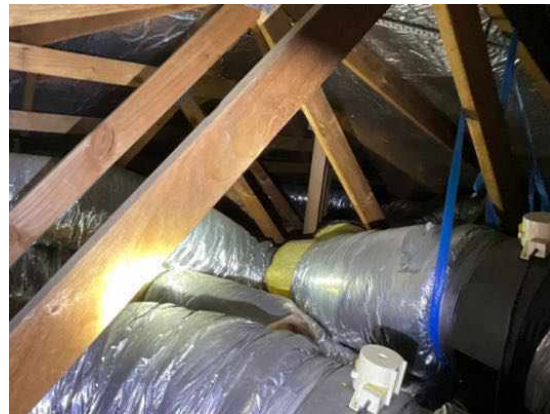
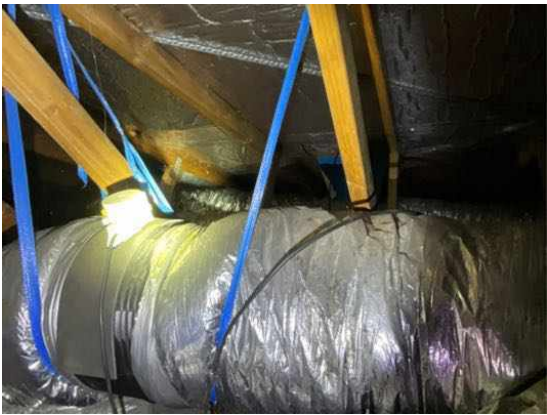
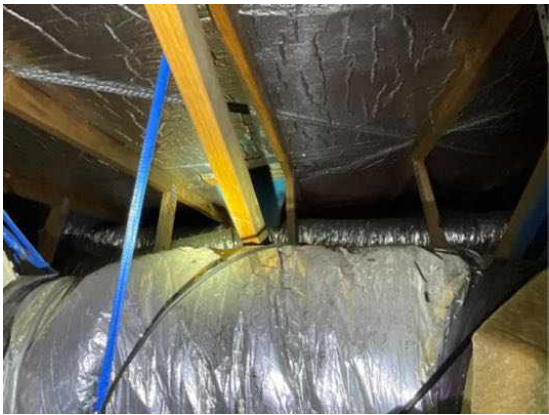
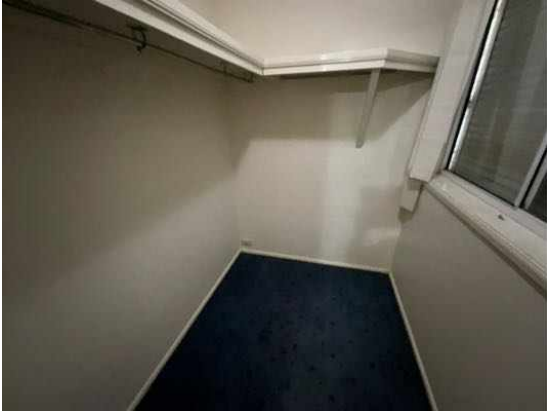
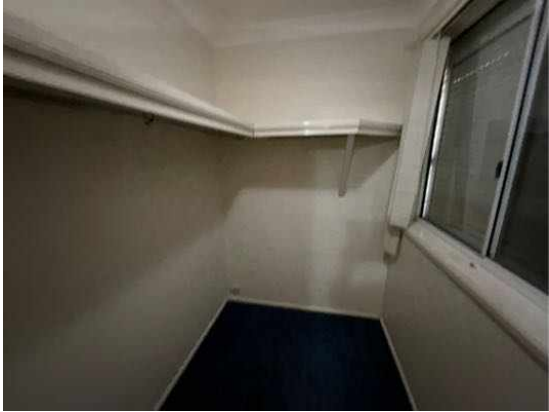
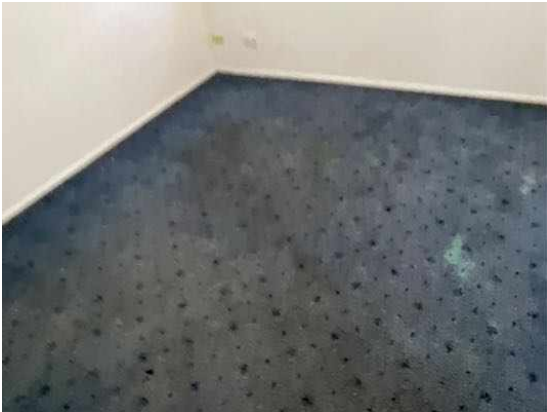
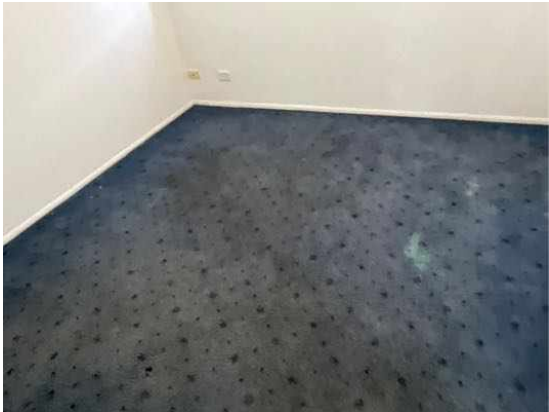
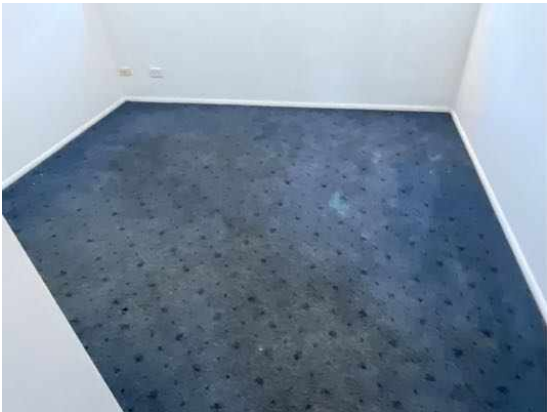
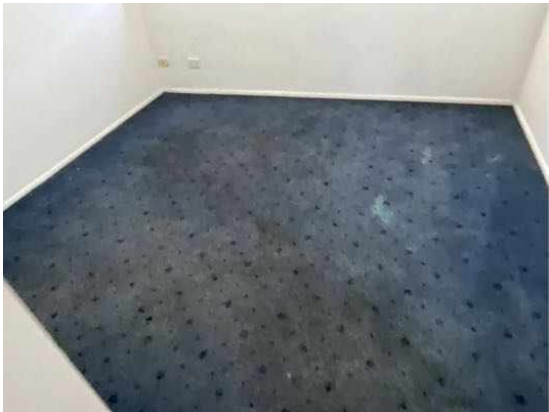
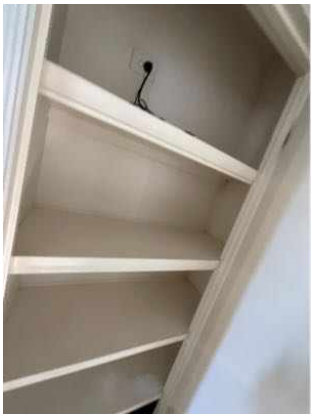
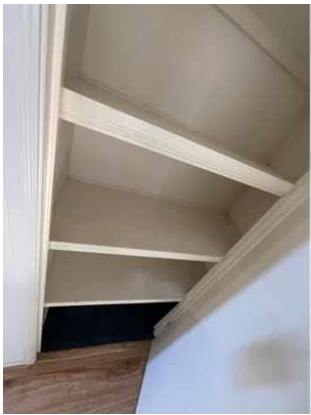
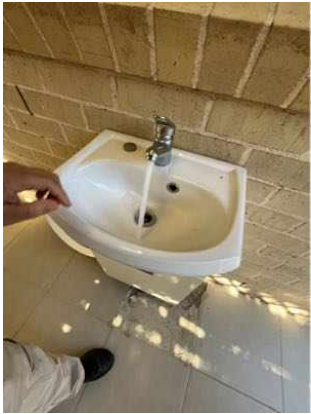
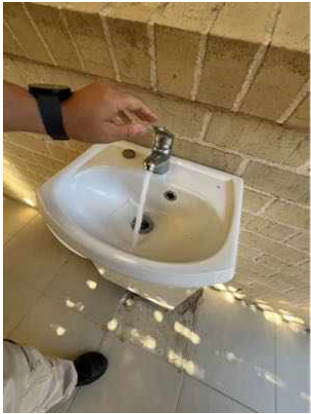
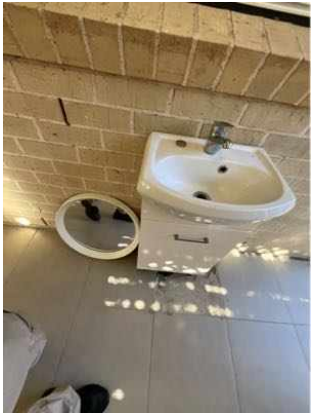
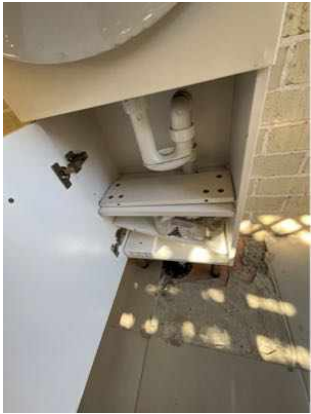
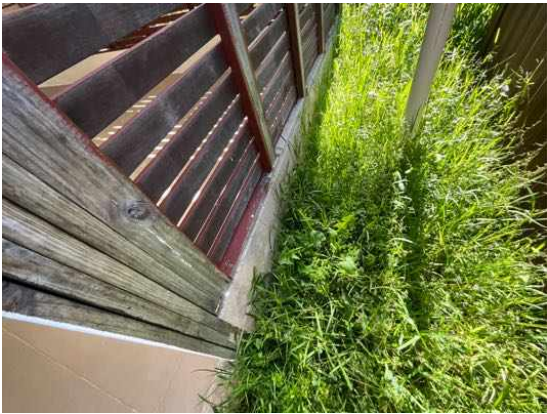
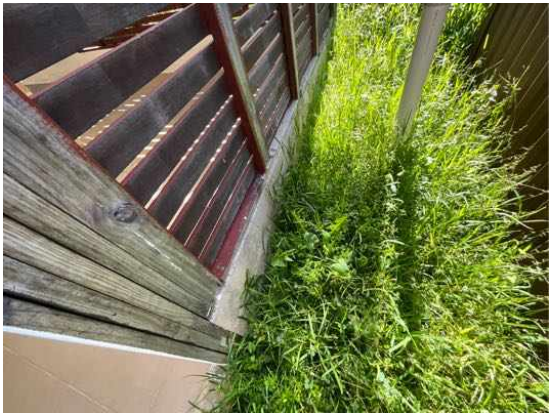
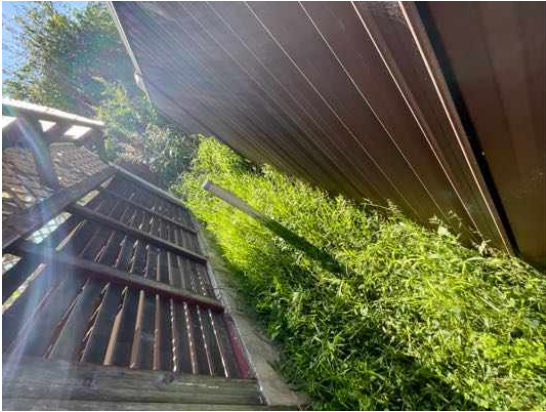
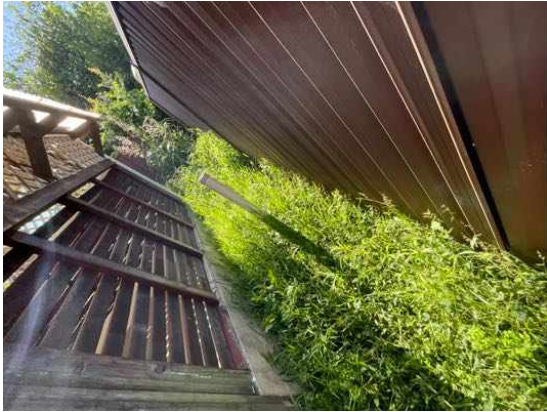
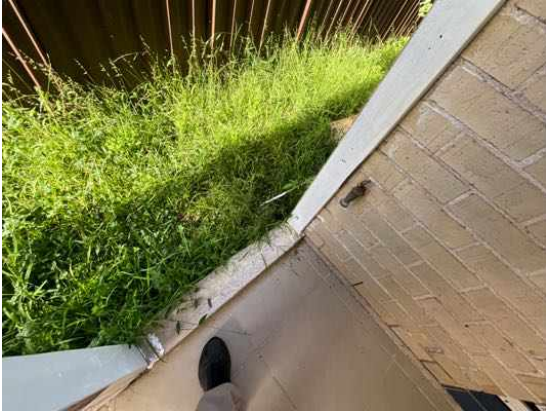
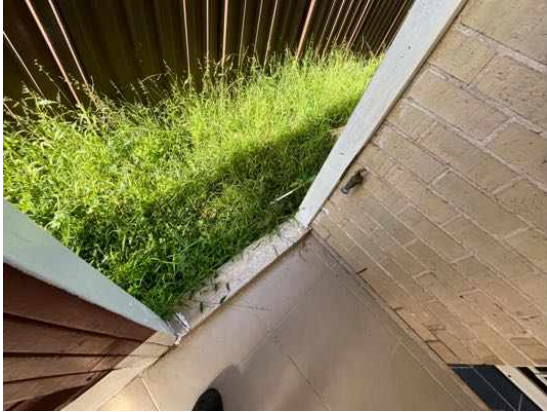
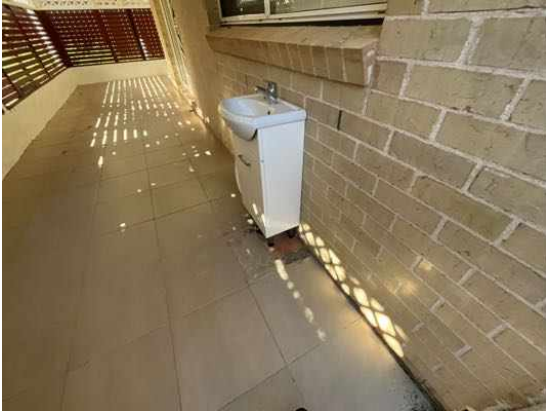
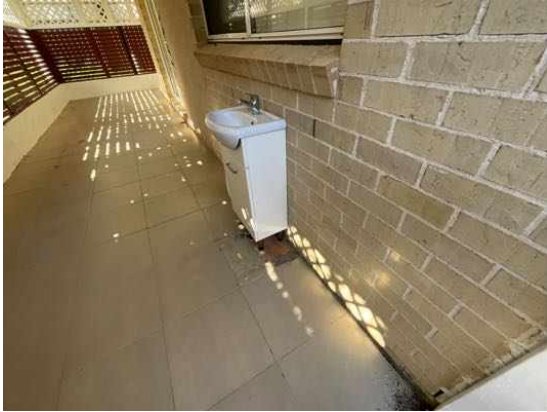
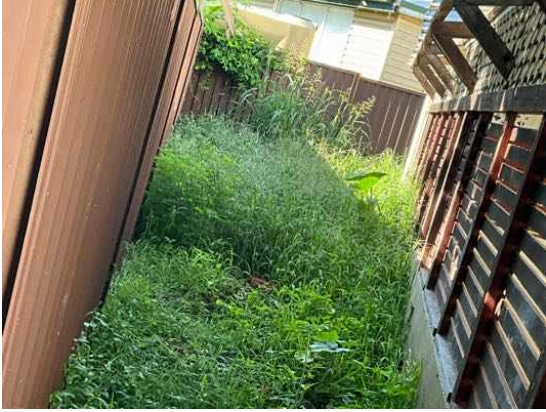
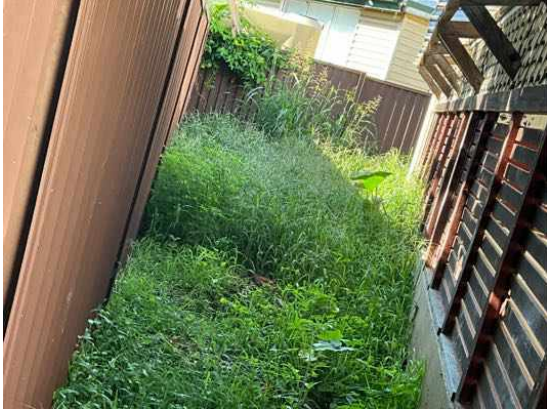
Noted Item

Building: Main Building
Location: All Areas
Finding: Additional Photos - Obstructions and Limitations
Information: These photographs are an indication of the obstructions and limitations which impeded full inspection of the property at the time of inspection. These obstructions can hide an array of defects and should be removed to allow full inspection to be carried out. A re-inspection is recommended once the areas are made accessible.
