## Building Inspection Report

Inspection Date: Tue, 17 Feb 2026

Property Address: 12/21-31 Parman Ave, Pakenham VIC 3810,  
Australia

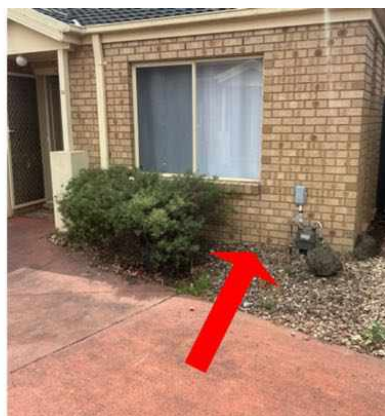
### Defects 3.05

Building: Main Building  
 Location: All External Areas  
 Finding: Site drainage - Inadequate  
 Information:

The site drainage in this area was found to be inadequate at the time of inspection, creating potential for subsequent water damage to associated building elements.

Where site drainage is inadequate, installation of an Agricultural (Aggie) Drain may be required. A qualified plumber should be appointed to further inspect the property and

perform any remedial works as necessary. Water damage and secondary defects are likely to occur if left unmanaged.

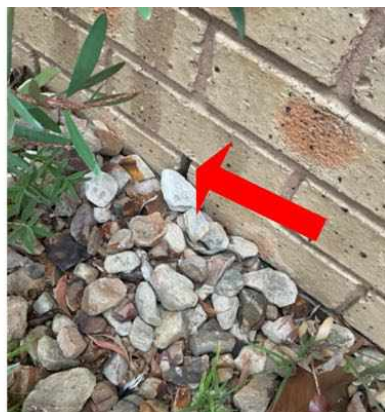
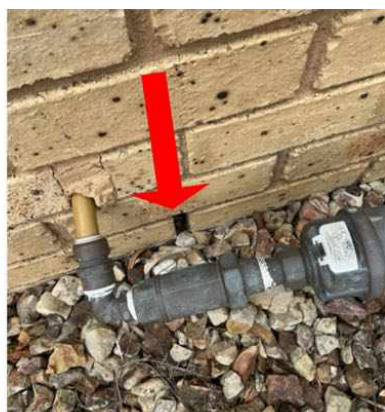
### Defects 3.06

Building:	Main Building
Location:	All External Areas
Finding:	Insufficient Clearance to External Weep Holes
Information:	Inspection revealed that the external weep holes around the base of the external walls have insufficient clearance, with landscaping materials such as soil or stones positioned directly beneath or against them. Weep holes are essential for allowing moisture within the wall cavity to escape and for enabling ventilation of the internal wall

When weep holes are obstructed or have inadequate clearance, their function is compromised. This can result in moisture being trapped within the wall cavity, leading to potential structural deterioration, rising damp, or even termite ingress—especially in timber-framed dwellings.

It is recommended that the landscaping be adjusted to ensure a minimum vertical clearance of at least 75mm below the lowest part of the weephole. This will allow for proper drainage and ventilation and help protect the structural integrity of the property.

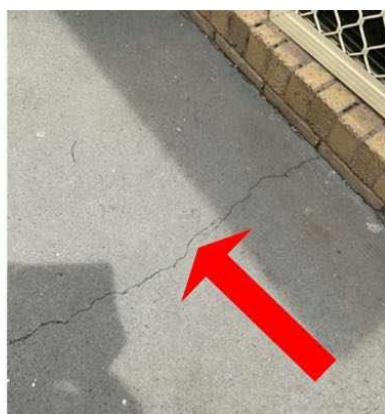
### Defects 3.07

Building:	Main Building
Location:	Yard - Side
Finding:	Cracking - External Concrete Paving Damage Category 1 - Fine (less than 2mm)
Information:	Fine cracks were identified in external concrete paving. Although fine cracks are quite noticeable, they are often only considered to be an appearance defect, and usually do not indicate any structural damage. To be considered a Category 1 or fine crack, the crack is found to be less than 2mm in width.

Generally the cause of a hairline crack in existing concrete paving such as driveways and pathways is indicative of the expansion and contraction of the concrete. Such causes are generally due to environmental factors, such as moisture levels, weather

conditions, root systems of nearby trees or the soil types on which they are laid.

Fine cracks may also be due to poor original installation of the concrete. Factors such as poor compaction of the sub surface and/or inadequate reinforcing of the slab may create cracking and other secondary defects.

Monitoring of all cracking should be conducted frequently. Always contact a building inspector should cracks widen, lengthen, or become more numerous.

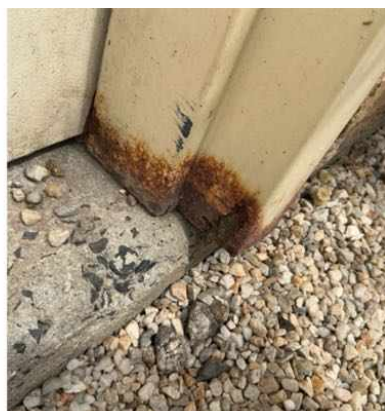
**Defects 3.09**

Building: Main Building  
Location: Garage  
Finding: Minor Rusting to Rear Garage Access Door Frame  
Information:

Minor surface rust was observed at the base of the door frame to the garage rear access door. The corrosion appears to be localised at the lower section, likely due to prolonged moisture exposure at the base of the frame.

If left untreated, surface rust may progressively deteriorate the metal substrate, leading to further corrosion, paint failure, and potential weakening of the door frame over time.

It is recommended that the affected area be mechanically cleaned to remove corrosion, treated with an appropriate rust-inhibiting primer, and repainted with a suitable exterior-grade protective coating to prevent further deterioration.

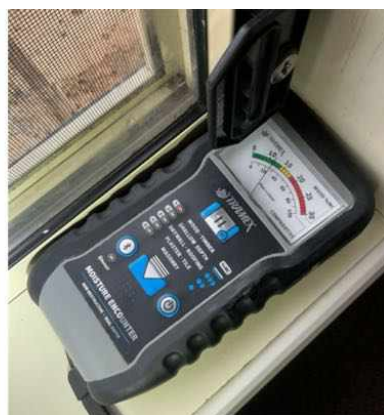
### Defects 3.11

Building:	Main Building
Location:	Lounge Room
Finding:	Minor Historical Water Damage to Lounge Window Sill
Information:	The internal window sill to the lounge room was observed to exhibit signs of previous minor water staining and localised deterioration at the lower section. Non-invasive moisture testing was conducted using a calibrated moisture meter, and readings were within normal parameters at the time of inspection, with no evidence of active moisture ingress detected.

Although no elevated moisture levels were recorded, previous water exposure may have resulted from wind-driven rain penetration or inadequate external sealing. If external junctions are not properly sealed and maintained, future moisture ingress may occur, leading to deterioration of internal finishes and potential timber decay.

It is recommended that the affected sill area be sanded, prepared, and repainted to restore the surface finish. In addition, all external window perimeters and junctions around the dwelling should be inspected and, where required, sealed with an appropriate exterior-grade sealant to prevent wind-driven rain penetration and future moisture-related damage.

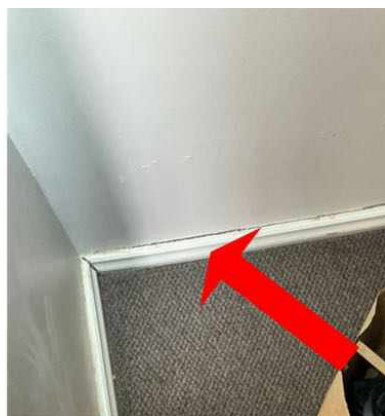
### Defects 3.12

Building: Main Building  
 Location: Lounge Room  
 Finding: Loose Skirting Boards to Lounge Room  
 Information:

The skirting boards in the lounge room were observed to be slightly detached from the wall lining in sections. Non-invasive moisture testing was undertaken to the affected areas, with readings within normal parameters at the time of inspection and no evidence of active moisture ingress detected.

Detached skirting boards are commonly associated with minor shrinkage movement, inadequate fixing, or settlement over time. If left unaddressed, continued movement may result in widening gaps, cosmetic deterioration, and potential damage to adjacent finishes.

It is recommended that the skirting boards be re-secured using appropriate mechanical fixings to ensure firm attachment to the wall framing. Any visible gaps should be filled with a suitable flexible sealant or gap filler, followed by preparation and repainting to achieve a uniform and durable finish.

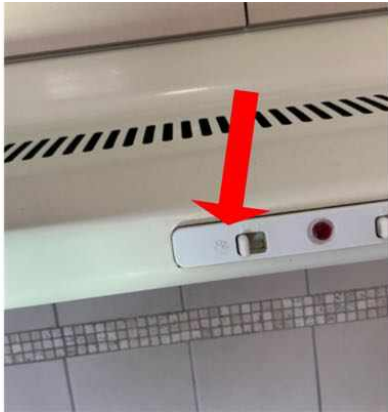
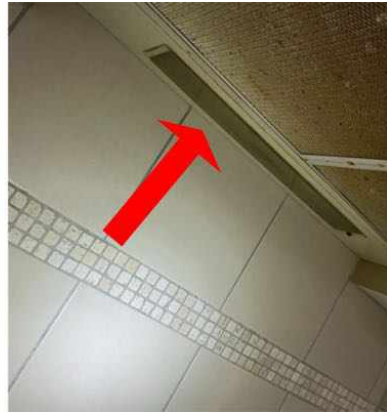
### Defects 3.15

Non-functioning lights may be due to failed globes, electrical connection issues, or internal component failure. Inadequate task lighting above the cooktop may reduce visibility during use and affect functionality.

It is recommended that a licensed electrician inspect the range hood lighting circuit, replace any failed globes as required, and rectify any electrical faults to restore proper operation.

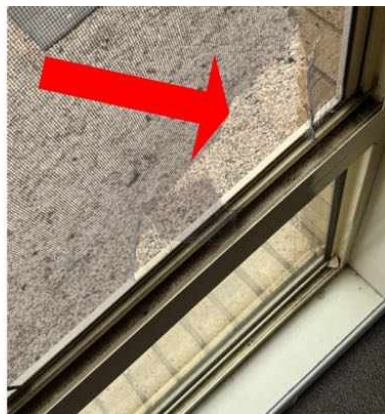
### Defects 3.16

Information: Upon visual inspection, we found that the flyscreen in bedroom 2 and the living room is damaged. This condition could compromise insect protection and allow pests to enter through the open window, potentially affecting indoor comfort and hygiene. We recommend engaging a qualified tradesperson to repair or replace the damaged flyscreen at the earliest convenience to restore its functionality.

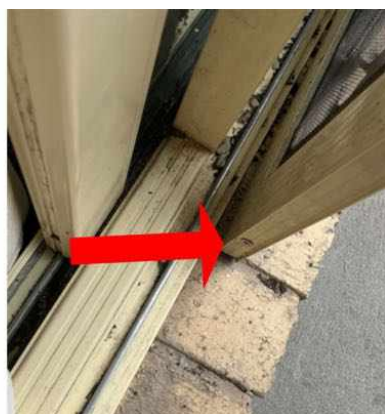
### Defects 3.17

Building: Main Building  
 Location: Living Room  
 Finding: Misaligned Flyscreen Sliding Door  
 Information:

A misaligned or displaced flyscreen door may lead to further damage to the rollers, track system, or frame if forced during operation. Continued improper use may result in permanent distortion of components and reduced serviceability.

It is recommended that the flyscreen door be removed, rollers and tracks inspected, and the door realigned and repositioned correctly within the track system. Any worn or damaged rollers should be replaced to ensure smooth and proper operation.

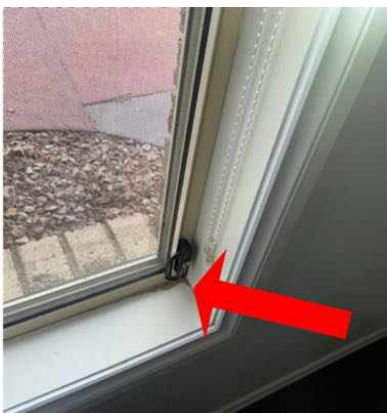
Although no elevated moisture levels were recorded, previous water exposure may have resulted from wind-driven rain penetration or inadequate external sealing. If external junctions are not properly sealed and maintained, future moisture ingress may occur, leading to deterioration of internal finishes and potential timber decay.

It is recommended that the affected sill area be sanded, prepared, and repainted to restore the surface finish. In addition, all external window perimeters and junctions around the dwelling should be inspected and, where required, sealed with an appropriate exterior-grade sealant to prevent wind-driven rain penetration and future moisture-related damage.

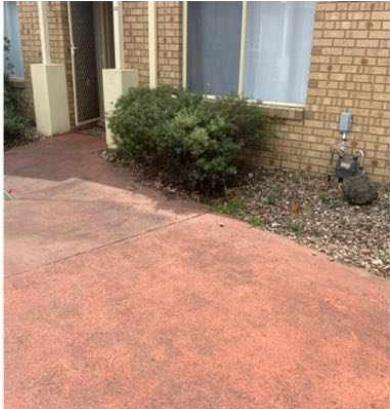
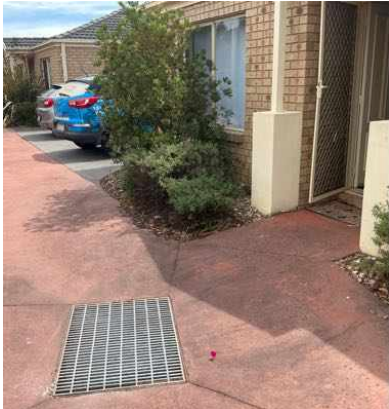
**Noted Item**

Building: Main Building  
Location: All External Areas  
Finding: Obstructions and Limitations - Exterior  
Information: These photographs are an indication of the obstructions and limitations which impeded the inspection of the external areas of the property at the time of inspection. These obstructions can hide an array of defects and should be removed to allow full inspection to be carried out. A re-inspection is recommended once the areas are made accessible.
