Building Inspection Report

Inspection Date: Wed, 28 Jan 2026

Property Address: 14 Delhuntly Rise, Narre Warren South VIC
3805, Australia

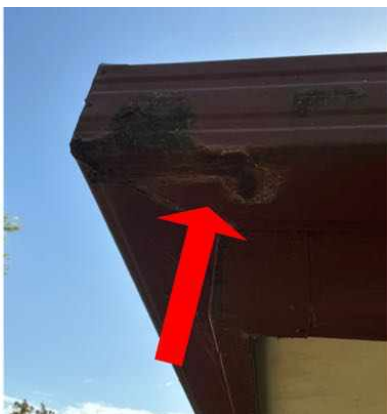
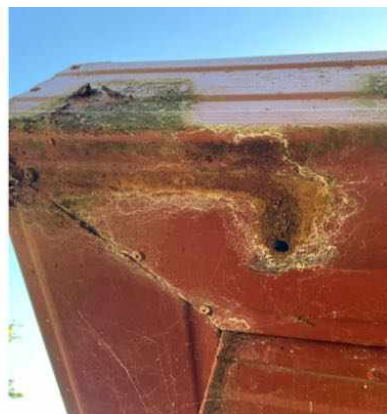
Defects 3.02

Building:	Main Building
Location:	Front Elevation
Finding:	Rust and Corrosion to Gutters
Information:	The gutters at the front elevation exhibit significant rust and corrosion. The metal surfaces are visibly deteriorated, with flaking, pitting, and discoloration present along multiple sections, indicating advanced material degradation.

Corroded gutters can lead to water leakage, blockages, and overflow, which may result in damage to fascia boards, eaves, and external walls. Continued deterioration may also compromise the overall effectiveness of the stormwater drainage system.

It is recommended that all rusted gutter sections be replaced with new, corrosion-resistant materials—such as Colorbond or PVC—by a licensed roofing plumber. The entire roof drainage system should also be inspected to ensure proper installation and functionality.

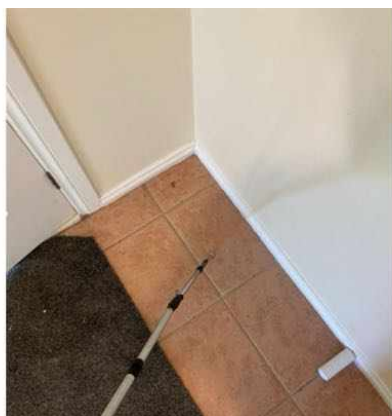
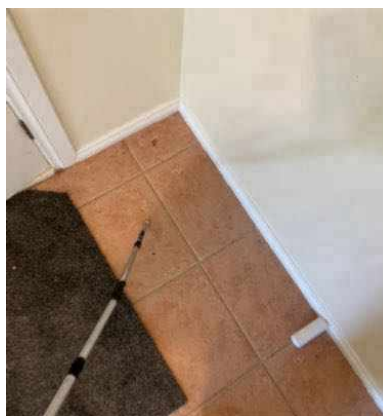
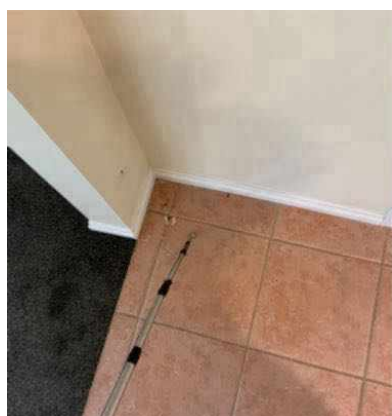
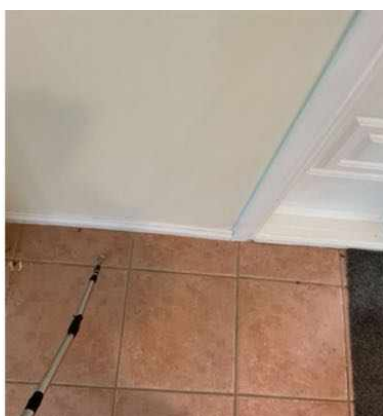
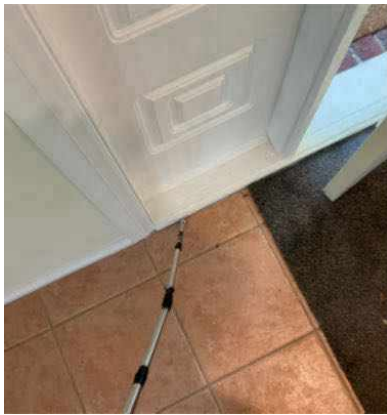
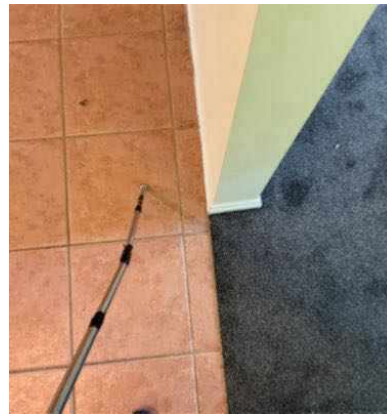
Defects 3.03

Building:	Main Building
Location:	All Internal Areas

Drummy tiled areas were identified at the time of inspection. The term 'drummy' refers to tiles that have become detached from their fixing, despite otherwise being in relatively good condition. Such defects are generally caused by physical or moisture damage to the area. Drummy tiled areas may also be a direct result of poor workmanship during the construction process.

Tiled areas may swell and shrink with changes in air humidity if the area has sustained moisture damage. Any exposure to moisture is capable of causing tiled areas to become drummy and/or cracked over a prolonged period of time. Drummy tiled areas generally require removal and replacement of affected tiles, with adequate sealant and grouting.

Specialist trades are available for these types of services. A registered builder may be required to undertake works if damage is extensive or if secondary building defects have resulted. Otherwise, it is advised that a tiling contractor be appointed to perform works as necessary. Immediate action is recommended to ensure that no further damage is sustained in the affected area.

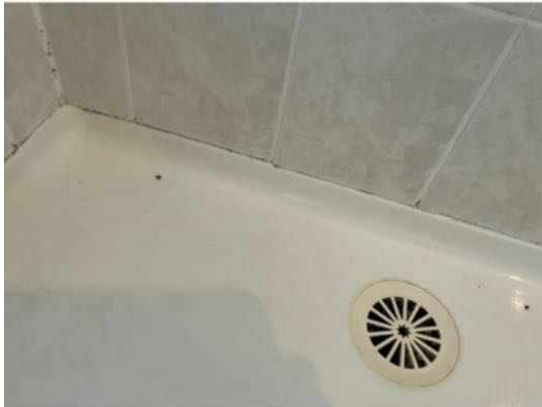
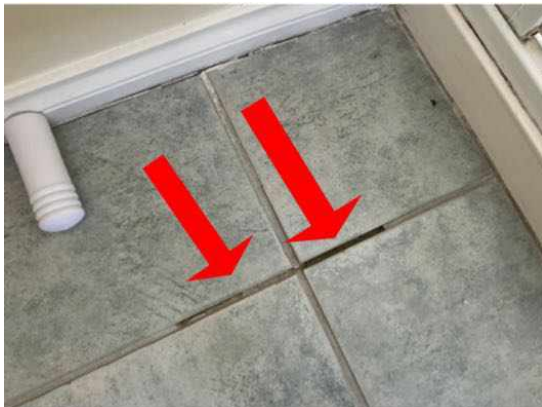
Defects 3.04

Building:	Main Building
Location:	Ensuite - Master
Finding:	Sealant and grouting - Deteriorated
Information:	It was noted on inspection that sealant or grout is degraded to the tiled shower alcove and or other areas of the bathroom.

Different materials and floor areas move at different rates, generally causing cracking to grout or sealant at this point. A flexible sealant is required to allow for expected expansion and contraction, while keeping the joint water tight and protective of all associated building materials.

Flexible and mould resistant materials should be applied to affected areas to prevent any subsequent water damage that is likely to occur. Regular maintenance and replacement of damage or missing or damaged sealant and grout is highly recommended to the wet areas, as this is a regular wear and tear defect. Sealant and grouting in areas that come into regular contact with water should be maintained for the long term care of your property.

A sealant specialist or tiling contractor should be appointed to complete these works as soon as possible

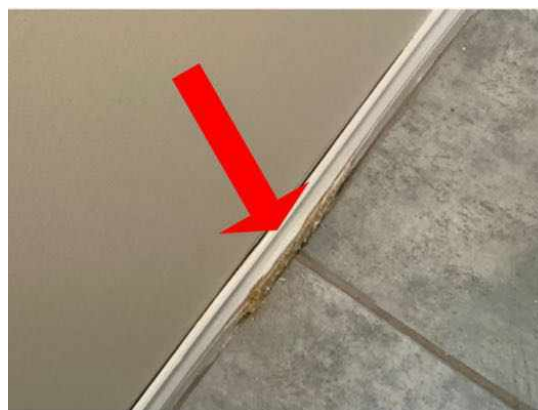
Defects 3.10

Building: Main Building
 Location: WC - Upstairs
 Finding: Water Damage to Skirting Board – Upstairs WC
 Information:

At the time of inspection, the skirting board on the left-hand side inside the upstairs WC was observed to be swollen and distorted, consistent with previous water exposure or moisture contact. The damage appears localised to this section of the skirting and does not indicate any visible structural failure at the time of inspection.

If left unaddressed, the affected skirting may continue to deteriorate, which could impact adjacent finishes and overall appearance.

It is recommended that a qualified painter, handyman, or carpenter assess the damaged section and either replace the affected skirting board or sand, repair, and repaint it as appropriate to restore appearance and durability

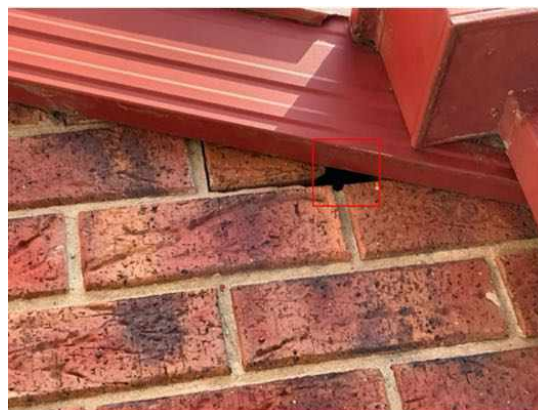
Defects 3.13

This gap allows potential water ingress into the wall cavity and roof junction, which may lead to staining, moisture-related damage, or deterioration of framing and surrounding materials over time if left unsealed.

A suitably qualified tradesperson (bricklayer or qualified caulking specialist) should be engaged to clean, fill, and seal the gap with an appropriate weather-resistant flexible sealant to prevent water entry and protect the surrounding structure.

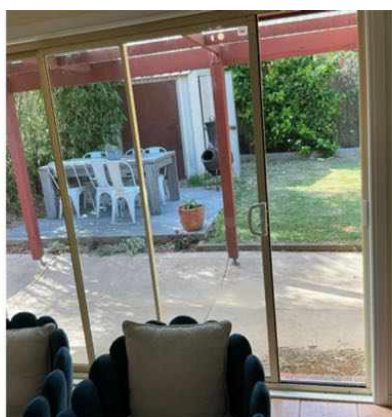
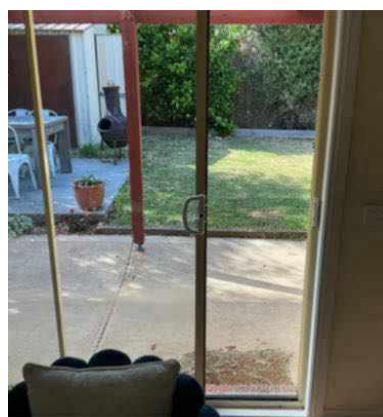
Defects 3.18

Building:	Main Building
Location:	Living Room
Finding:	Door - stiff to slide
Information:	The door to this area was difficult to operate at the time of inspection. This is likely due to damaged wheels which help the door to operate in a smooth fashion.

Generally, factors such as general age of the building element and a lack of maintenance are the usual causes for this type of defect.

Replacement of door running hardware may be required, as well as minor repairs and cleaning. A registered builder or general handy person will be required to repair the sliding door.

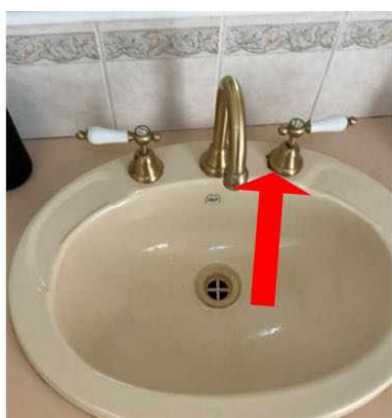
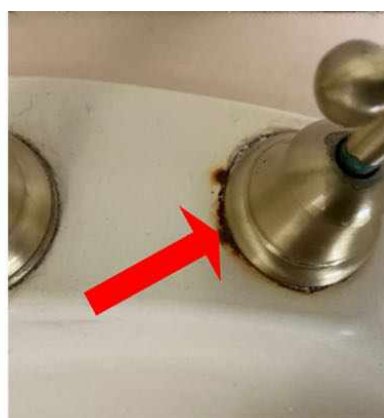
Defects 3.19

Building:	Main Building
Location:	Powder Room

This condition is commonly associated with minor moisture exposure, cleaning products, or gradual ageing of the tap finish, and while currently cosmetic, it may worsen over time if left untreated.

A suitably qualified plumber or handyman should inspect the taps, clean and treat the affected areas, and repair or replace any deteriorated components as required to prevent further corrosion and maintain serviceability.

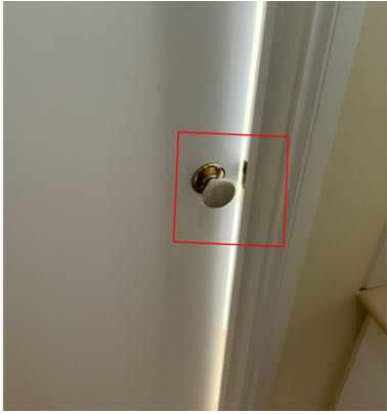
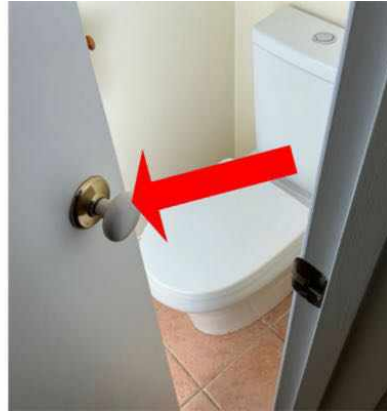
Defects 3.20

Building: Main Building

It is suspected that this defect has occurred due to minor issues with the associated hinges. Such damage is identified as general wear and tear, which is expected for building elements of this age.

A qualified carpenter or general handyperson may be appointed to perform rectification works as necessary, at client discretion. If left unattended, further functional impairment is likely to occur.

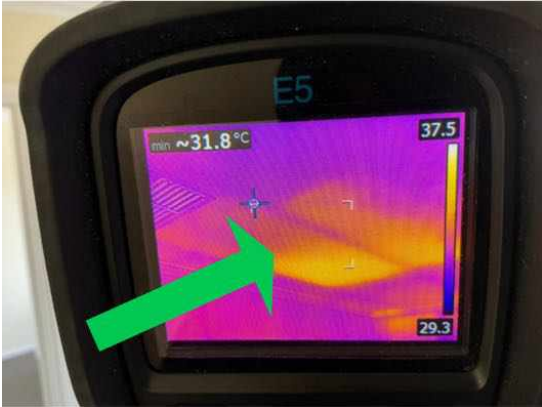
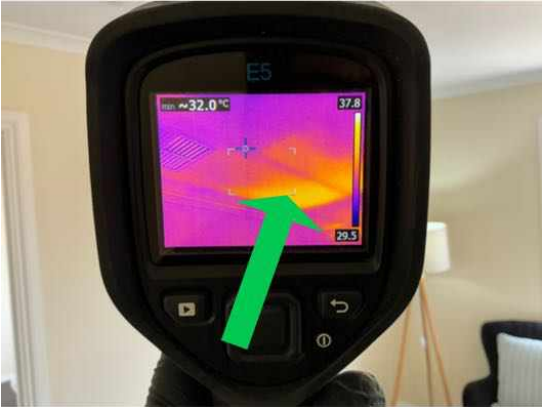
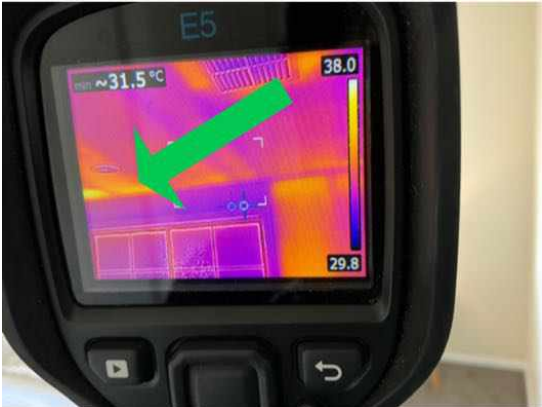
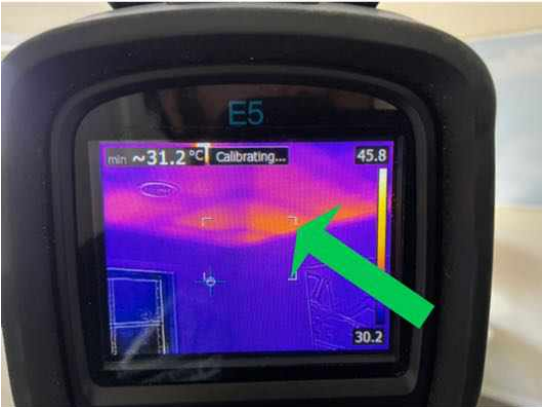
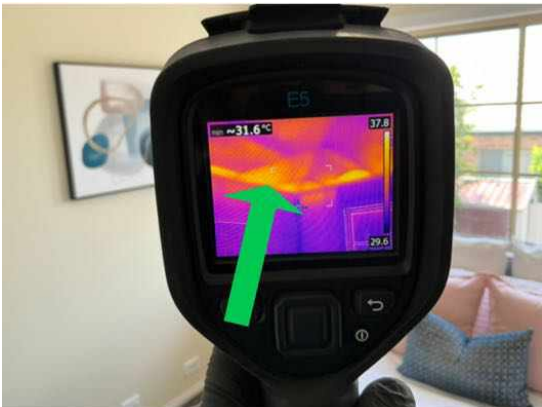
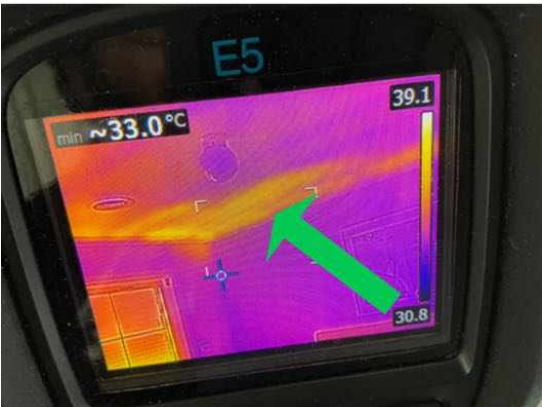
Defects 3.24

Building:	Main Building
Location:	All Internal Areas
Finding:	Inconsistent Thermal Performance to Ceiling Areas – Suspected Insulation Deficiencies
Information:	<p>Thermal imaging conducted to internal ceiling areas at the time of inspection identified inconsistent heat patterns, which are indicative of variations in thermal performance across the roof space. These patterns are commonly associated with areas of missing, displaced, or insufficient insulation above the ceiling linings.</p> <p>Inadequate or uneven insulation coverage can reduce the energy efficiency of the dwelling, contribute to heat loss in cooler periods and heat gain in warmer conditions,</p>

and may result in reduced occupant comfort and increased heating and cooling costs. Due to the non-invasive nature of the inspection, the exact extent and condition of insulation could not be confirmed visually in all affected areas.

It is recommended that a qualified insulation contractor inspect the roof space, assess insulation coverage and condition, and top up or reinstate insulation where required to achieve consistent thermal performance throughout the property.

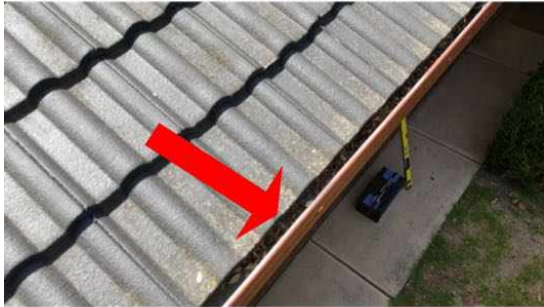
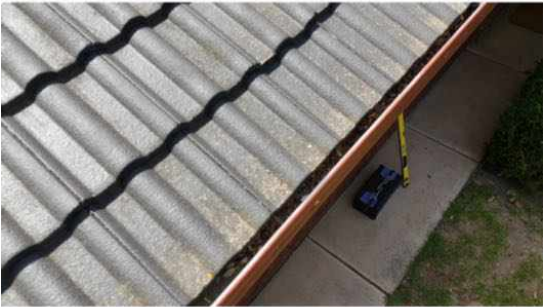
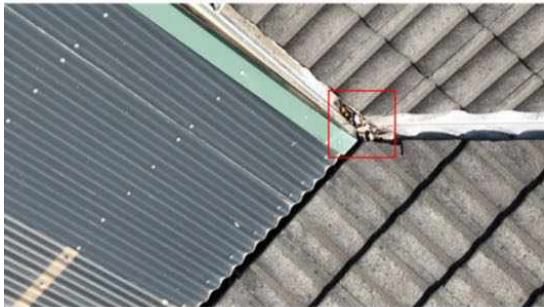
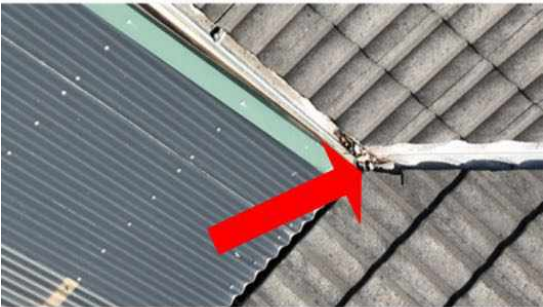
Defects 3.25

Building:	Main Building
Location:	Gutters
Finding:	Gutters - Partially Blocked
Information:	Sections of the external gutters were partially blocked with debris, soil and leaves. Roof plumbing structures, such as guttering and downpipes, should be free of all debris to prevent blockages. Blockages of the guttering and downpipes will lead to pooling and accumulated water overflows, which is likely to subsequently flood eaves and exterior walls.

Blocked gutters are likely to lead to high levels of moisture in the affected areas. Such moisture will not only cause rust and decay of the associated building materials, but can also provide conditions that are conducive to termite and timber pest activity. Blockages in gutters should therefore be removed immediately to ensure dry conditions are maintained.

Consult a Licensed Plumber for further specific advice on remedial works that may be required. In the interim, it is highly advised that blocked gutters be removed by the homeowner or a general handyperson as a matter of urgency.
