## Building and Timber Pest Inspection Report

Inspection Date: Thu, 5 Mar 2026

Property Address: 102/3 Balmoral St, Blacktown NSW 2148,  
Australia

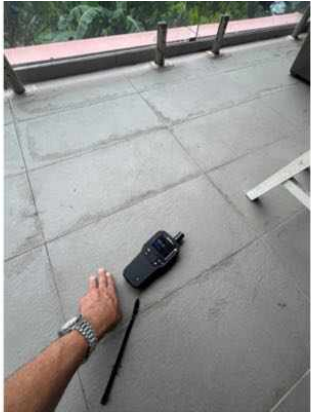
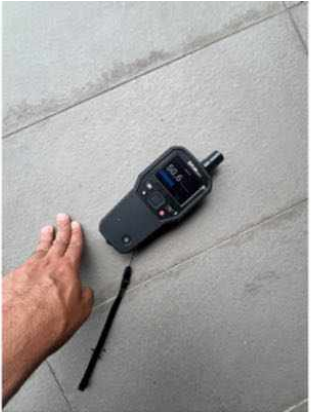
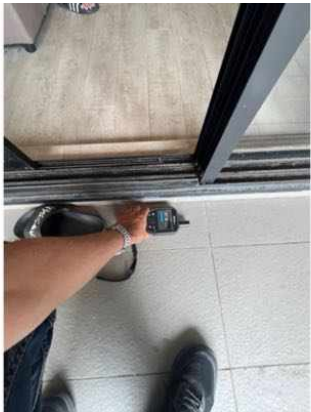
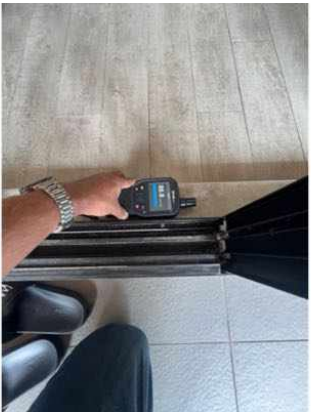
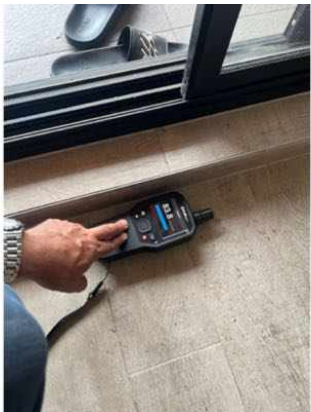
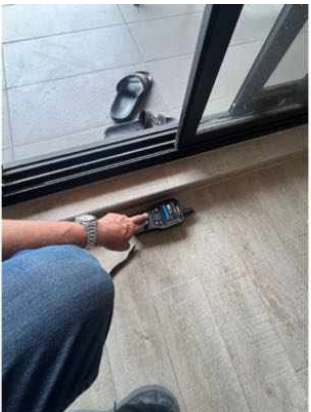
Building:	Main Building
Location:	All Internal Areas
Finding:	Elevated Moisture Detected - Strata (No visible deterioration)
Information:	Elevated moisture was recorded at the base of the balcony tiles and adjacent walls. While no internal damage was visible at the time of inspection, balconies in multi-unit dwellings are high-risk areas for waterproofing failure, which can lead to leaks into adjoining units and significant rectification costs. Further investigation by a licensed waterproofing contractor is recommended.

Depending on the strata plan, this area may form part of the common property, in which case remedial responsibility may rest with the owners corporation (strata). Purchasers should seek clarification from the strata manager and legal adviser prior to purchase.

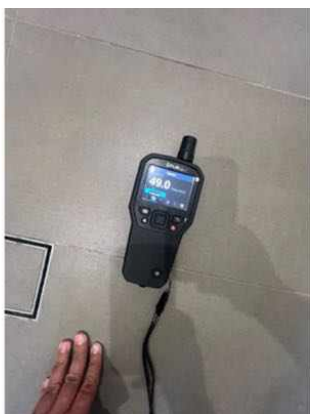
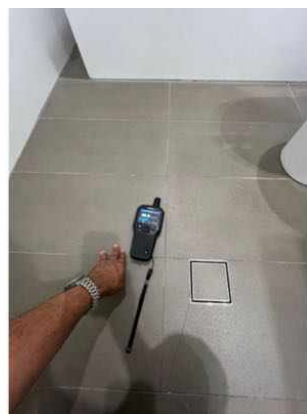
### Finding 3.03

Building:	Main Building
Location:	Bathroom
Finding:	Elevated Moisture Bathroom (No visible deterioration noted)
Information:	Slightly elevated moisture levels were detected to tiled surfaces in bathroom/shower areas. Persistent moisture ingress can lead to concealed damage, including timber rot and mould growth.

Elevated moisture readings in tiled wet areas can occur from normal shower use, age/deterioration of waterproofing membranes, plumbing leaks or moisture absorption through grout lines. While no damage was visible, elevated readings may indicate moisture retention behind tiles, which can be a conducive condition for future deterioration if not monitored.

Monitor the area over time for signs of drumming, efflorescence, tile movement, or grout deterioration. If concerns arise, a licensed waterproofing specialist can perform further investigation (e.g., pressure testing, membrane assessment).

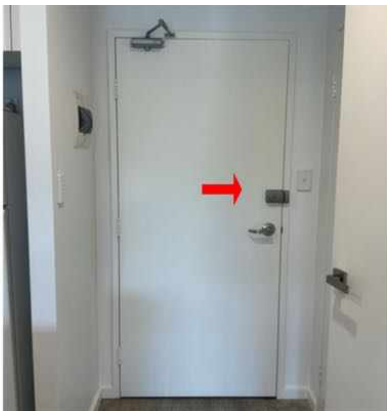
Building:	Main Building
Location:	All Internal Areas
Finding:	Building element - Damaged - main door not closing by itself , mirror desilvering bathrooms , bathtub minor surface scratches , kitchen top minor chips
Information:	Breakage occurs generally when the building materials have either aged and decayed, or as a result of damage (accidental or deliberate).

Repair and/or replacement of broken elements is advised to ensure that additional secondary defects do not arise as a consequence. Such works are necessary, as all building elements play a key role in the operation and function of the overall structure and its performance.

A relevant tradesperson should be appointed to repair or replace the affected building element prior to any subsequent damage being caused.

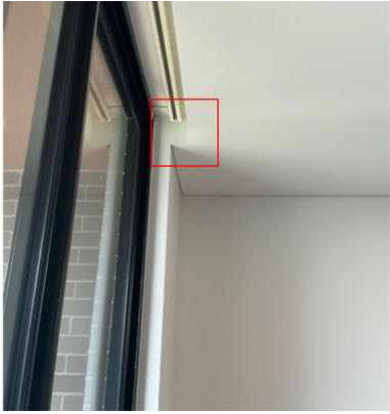
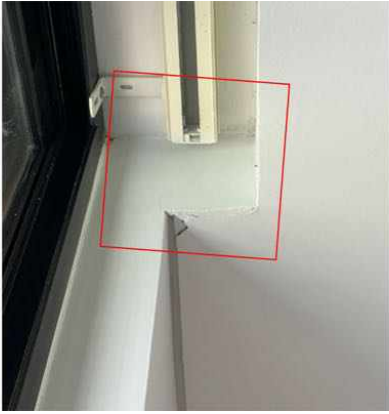
Building:	Main Building
Location:	All Internal Areas
Finding:	Paint finish and hairline cracking
Information:	The paint finish in this area was identified as being incomplete at the time of inspection including some hairline minor cracking.

Whilst incomplete or missing paint finish is generally an appearance defect, it can also lead to the development of secondary building defects over time. Incomplete areas of paint finish expose the area to moisture, potentially accelerating the deterioration of underlying building materials.

Incomplete paint finishes should be sanded back, filled, leveled and painted, as applicable. Where inadequate or missing paint protection has led to the deterioration of the associated building element, repair and/or replacement of this building element may be required.

A painting contractor should be appointed as soon as possible to perform necessary works to aid the appearance of the affected area and to ensure the area is protected against further deterioration. Alternatively, the homeowner following manufacturer instructions may perform these works.

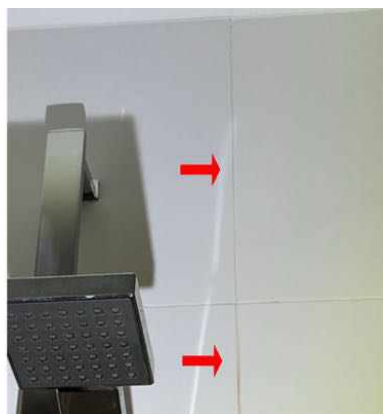
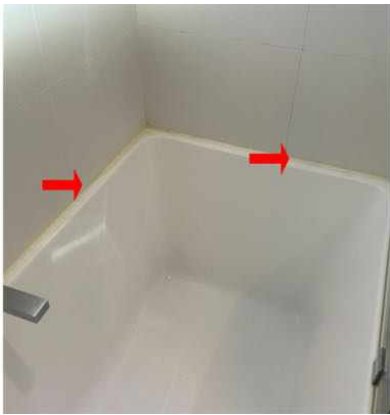
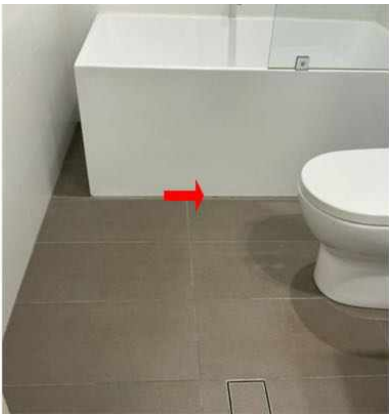
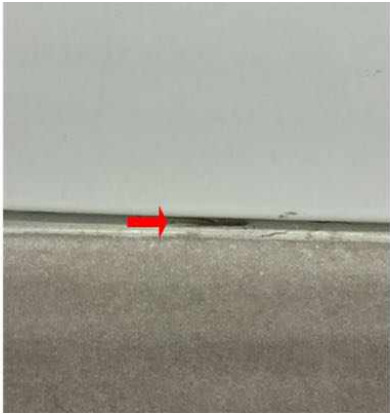
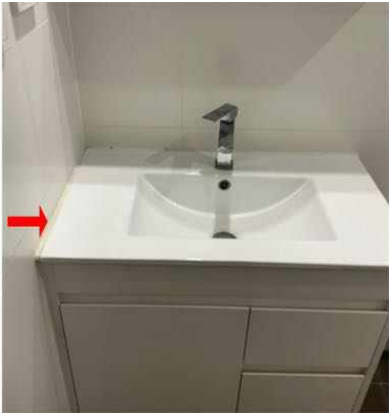
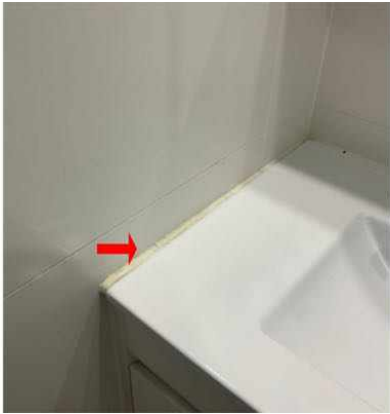
Finding 3.10

Building: Main Building  
Location: All Internal Areas  
Finding: Sealant and grouting - Missing or degraded  
Information: It was noted on inspection that sealant or grout is degraded. There is also evidence of poor workmanship and excessive use of sealant. Silicone should never be used as a first line of defence against waterproofing. Further inspection by a licensed waterproofing contractor is highly recommended.

Different materials and floor areas move at different rates, generally causing cracking to grout or sealant at this point. A flexible sealant is required to allow for expected expansion and contraction, while keeping the joint water tight and protective of all associated building materials.

There appears to be excessive mould to the sealant and grout which will likely require scraping out and replacement.

Flexible and mould resistant materials should be applied to affected areas to prevent any subsequent water damage that is likely to occur. Regular maintenance and replacement of damage or missing or damaged sealant and grout is highly recommended to the wet areas, as this is a regular wear and tear defect. Sealant and grouting in areas that come into regular contact with water should be maintained for the long term care of your property.

A sealant specialist or tiling contractor should be appointed to complete these works as soon as possible.

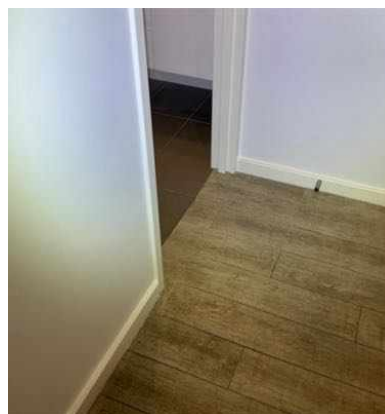
Building: Main Building  
Location: Bathroom, ensuite  
Finding: Bathroom & external floor threshold  
Information: The bathroom floor is at the same level as the adjoining timber flooring. This configuration is typical in modern apartments and is permitted where compliant waterproofing and floor falls are provided. No evidence of moisture damage was observed at the time of inspection; however, waterproofing performance cannot be confirmed without invasive inspection.

Care should be taken to avoid excessive water migration beyond the bathroom during use.

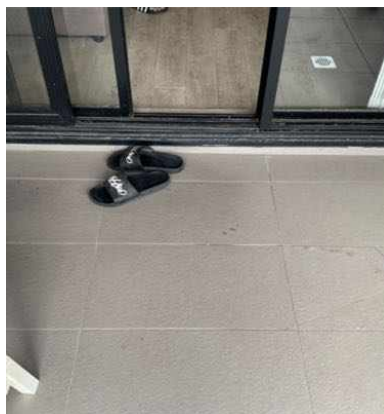
Building: Main Building  
Location: Balcony  
Finding: Balcony Floor Level Differential

Information: The balcony finished surface appears to be close to, or at the same level as, the internal floor. Standard construction practice requires a step-down of approximately 50 mm unless a fully engineered threshold drainage system is provided. No such drainage features were visible during inspection. This configuration increases the risk of water ingress, and confirmation of the balcony waterproofing detail through strata/building management is recommended.

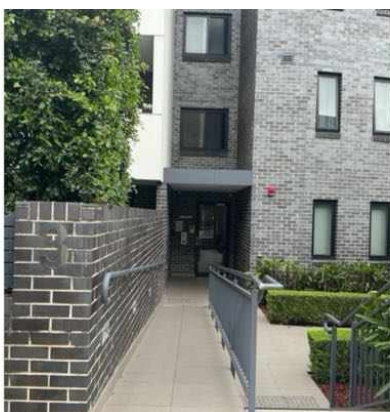
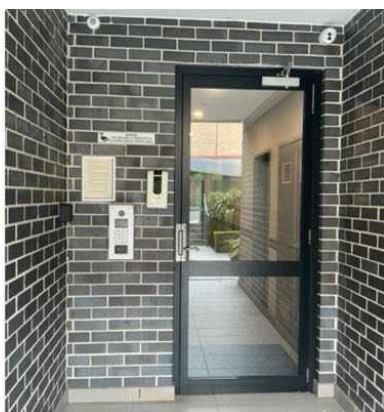
Finding: Additional Photos - Obstructions and Limitations

Information: These photographs are an indication of the obstructions and limitations which impeded full inspection of the property at the time of inspection. These obstructions can hide an array of defects and should be removed to allow full inspection to be carried out. A re-inspection is recommended once the areas are made accessible.

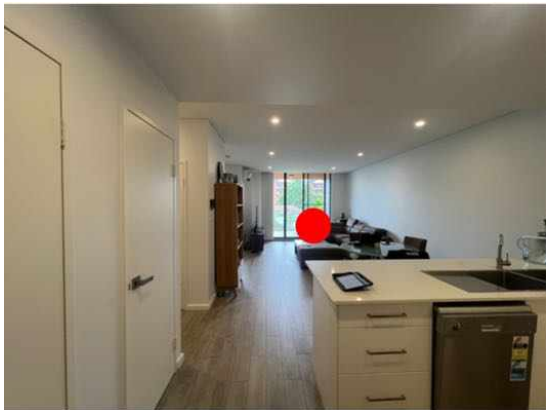
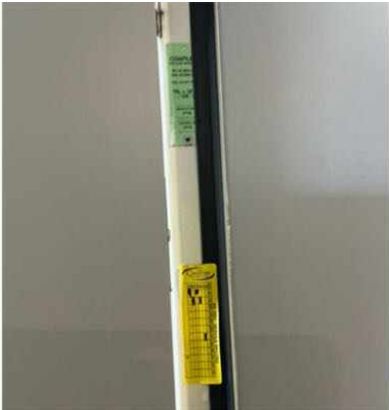
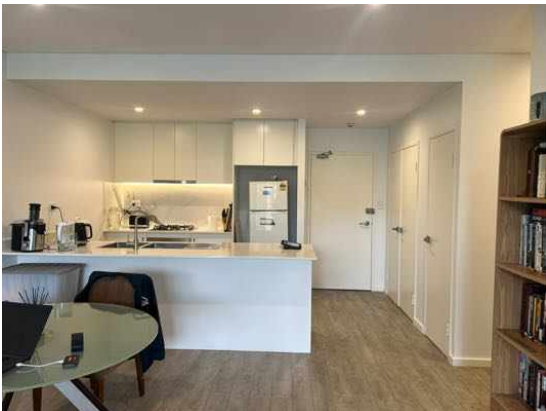
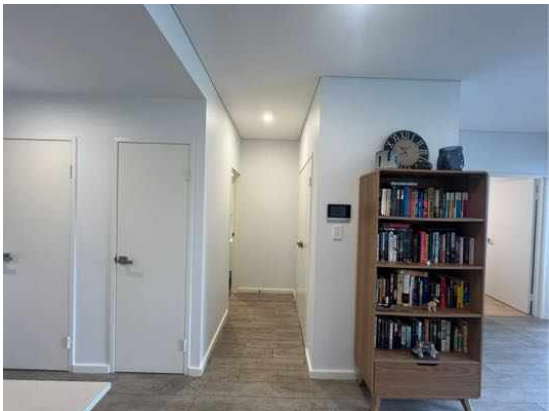
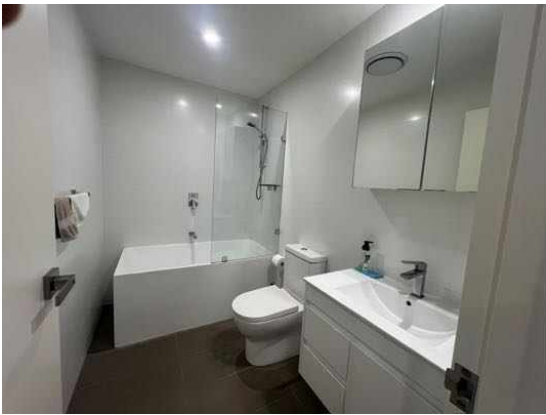
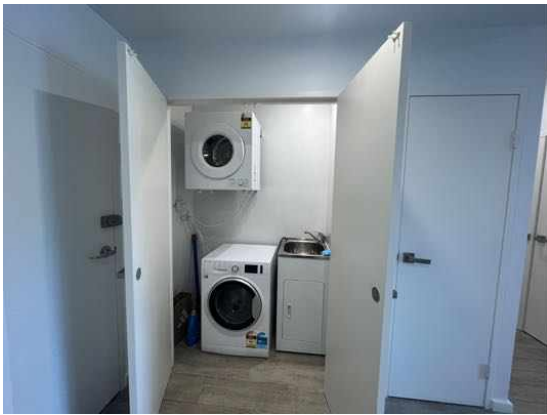
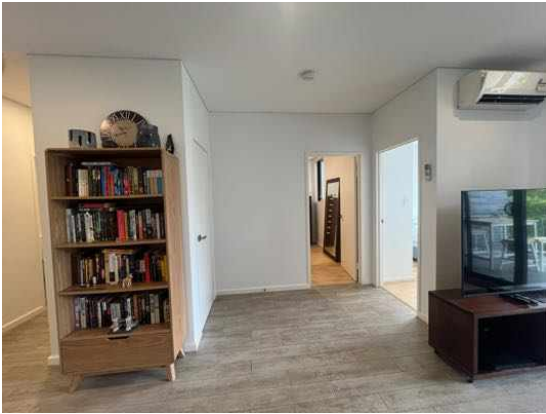
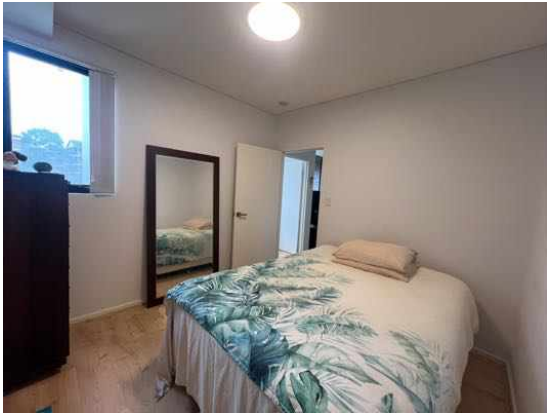
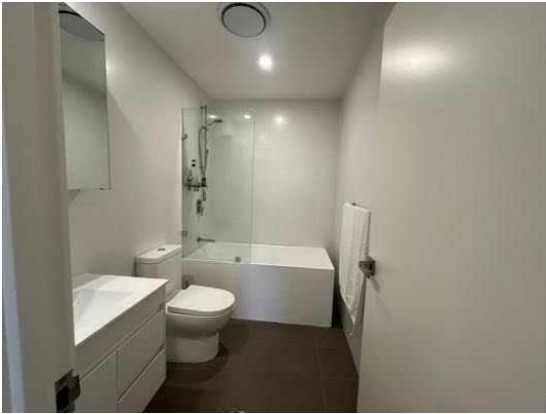
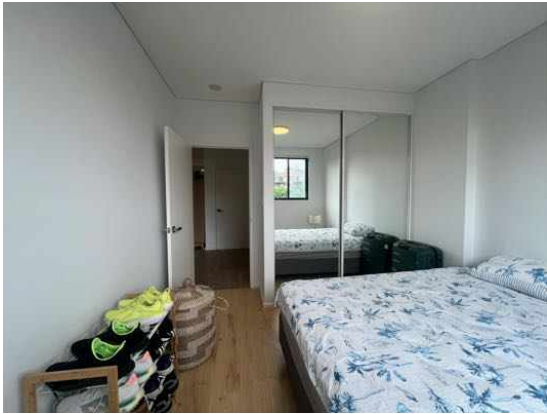
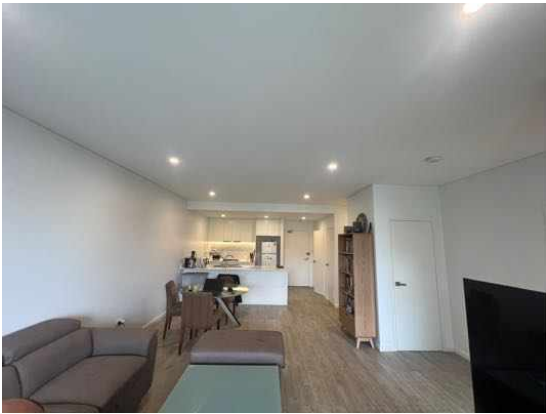
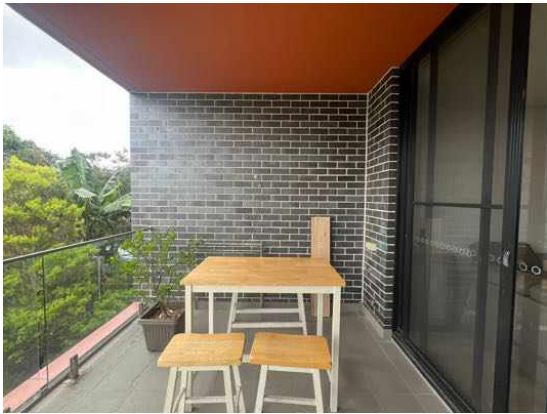
Building: Main Building  
 Location: All Internal Areas  
 Finding: Additional Photos - Obstructions and Limitations  
 Information: These photographs are an indication of the obstructions and limitations which impeded full inspection of the property at the time of inspection. These obstructions can hide an array of defects and should be removed to allow full inspection to be carried out. A re-inspection is recommended once the areas are made accessible.
