Building and Timber Pest Inspection Report

Inspection Date: Thu, 26 Feb 2026

Property Address: 2 Foster Way, Berowra NSW 2081, Australia

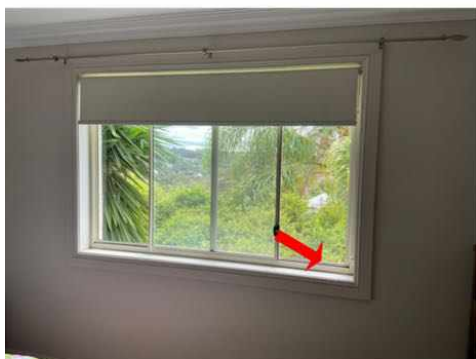
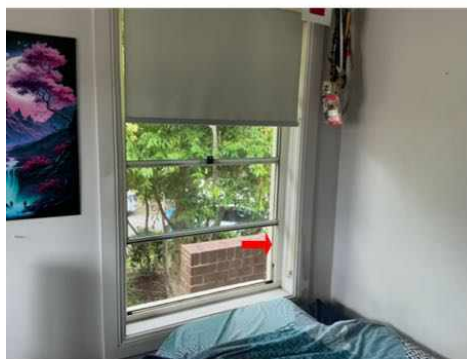
Building:	Main Building
Location:	All Areas Upstairs
Finding:	Window Restrictors - Recommended
Information:	Upstairs windows did not have window restrictors installed. Although not a requirement at the time of construction, it is advisable to install window opening restrictors on all second storey windows with sill heights below 1.7 meter and potential fall of 2 meters or more.

If you live in a strata scheme, window safety devices must be installed on all applicable windows by 13 March 2018. Residents with safety devices installed can still fully open their windows but it's recommended that devices be engaged whenever children are present, to prevent falls.

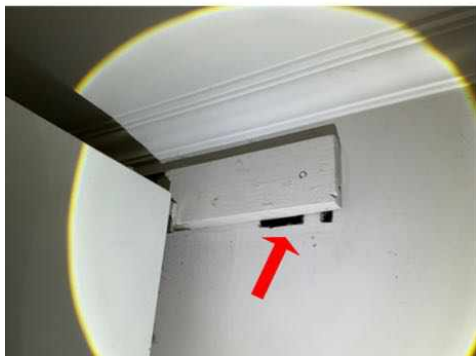
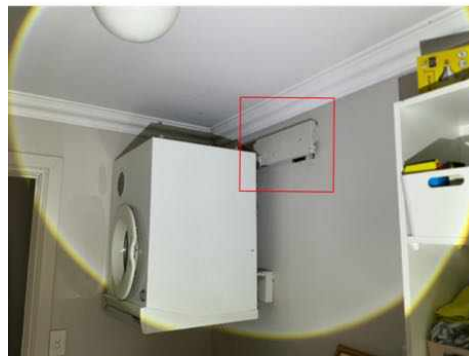
Building:	Main Building
Location:	Laundry
Finding:	Areas - Not Sealed
Information:	At the time of inspection, certain areas were found to be unsealed, which may allow moisture ingress, pest entry, or air leaks. Gaps and unsealed sections can contribute to deterioration over time and reduce the overall integrity of the structure. It is

recommended to seal the affected areas to prevent potential damage and ensure better protection against environmental factors.

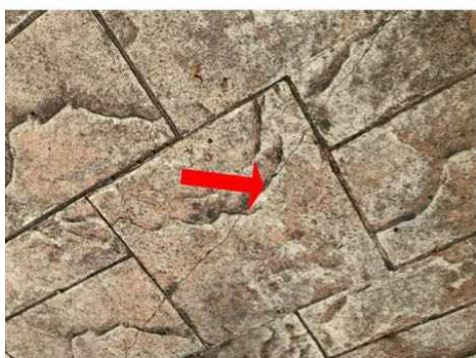
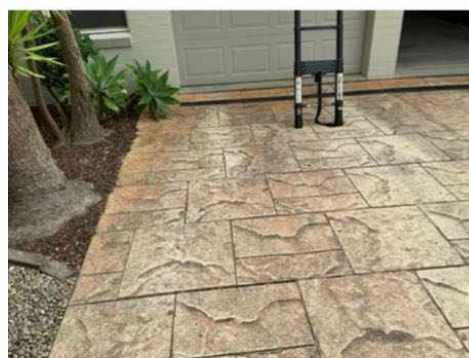
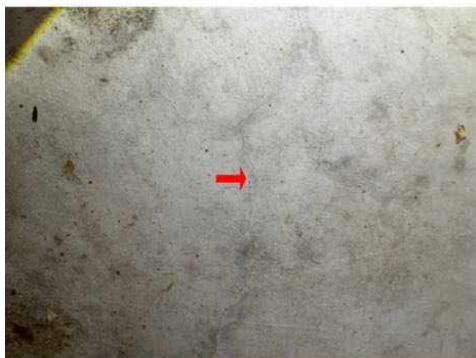
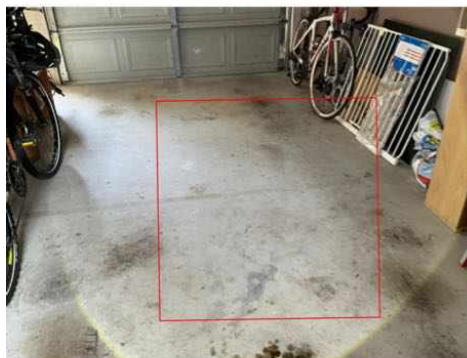
Finding 3.02

Finding: Crack in Pavers/slab - Category 1

Information: A crack coded as Category 1 was identified in the slab. A Category 1 crack is described as a fine but noticeable crack, with the slab at an otherwise reasonable level.

To be considered Category 1, the approximate width of the crack is less than 1.0mm, or a less than 10mm change in offset when a 3m straight edge is placed over the defect.

Category 1 cracks should be monitored for a period of 12 months. At the end of the monitoring period, identified cracks that are rated greater than Category 2 are considered defects, and require rectification.

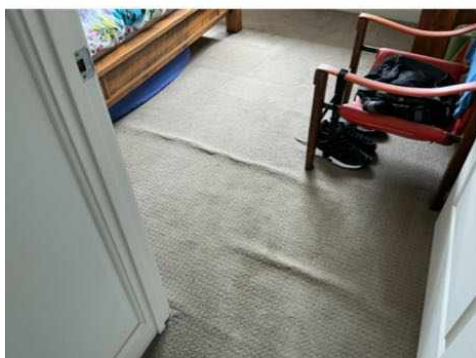
Finding 3.03

Building:	Main Building
Location:	All Areas
Finding:	Carpet - Buckling & Stained
Information:	At the time of inspection, the carpet was noted as stained in several areas and also showing signs of buckling, creating uneven surfaces. These conditions detract from the overall appearance of the flooring and may present a trip hazard if left unaddressed.

It is recommended that a professional carpet cleaner be engaged to treat and clean the stained areas. In addition, a qualified carpet specialist should be engaged to re-stretch or otherwise repair the carpet to eliminate the buckling and restore a safe, even surface.

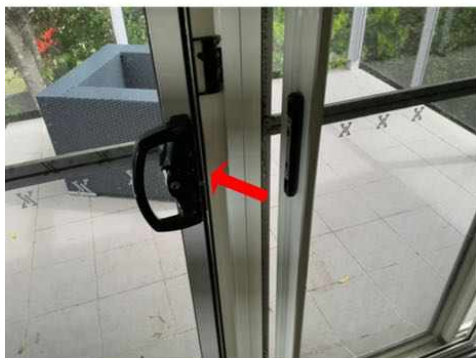
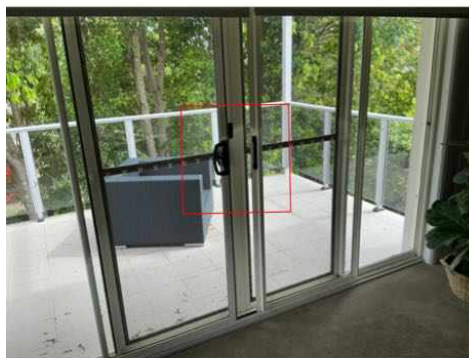
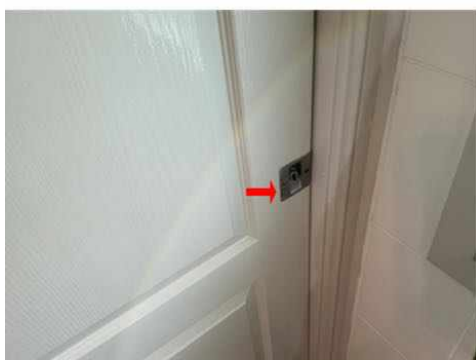
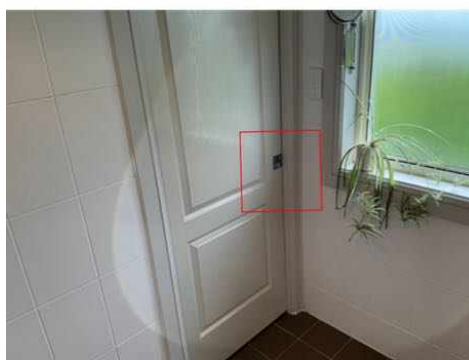
Finding 3.05

Building:	Main Building
Location:	Bedroom - Master, Master En-suite
Finding:	Lock - Not working
Information:	The lock in this area was not operational at the time of inspection. Where locks have deteriorated to a point where they are no longer usable, the security of the property is immediately compromised.

Repair or replacement of the lock is highly recommended. Consultation with a locksmith or general handyman is required to gain further advice on any added security that may be available for the area.

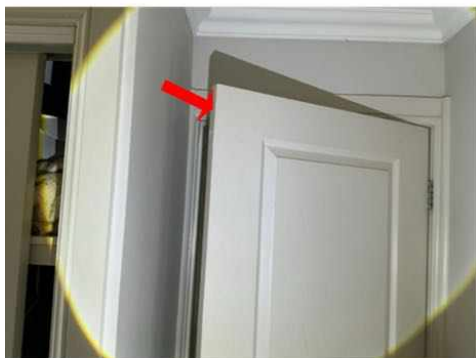
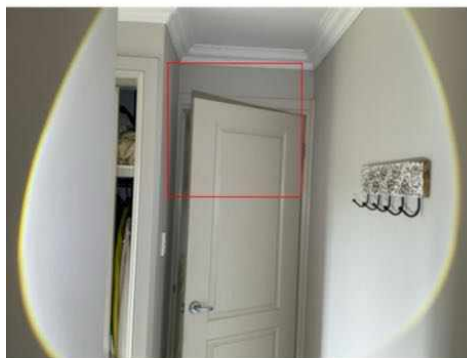
Finding 3.06

Building:	Main Building
Location:	Bedroom - Master
Finding:	Door(s) - Binding/Jamming
Information:	At the time of inspection, it was noted that the door was binding or jamming in this area.

Several factors could contribute to this issue, including swelling due to moisture, which can cause wooden doors to expand and fit tightly in the frame. Misaligned or loose hinges may also result in the door sagging or becoming misaligned, making it difficult to close. Over time, wooden doors may warp due to fluctuations in temperature or humidity, leading to improper closure.

It is recommended that a qualified carpenter or handyman be engaged to carry out the necessary repairs to ensure proper door operation.

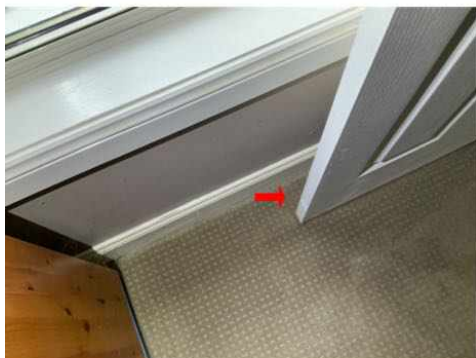
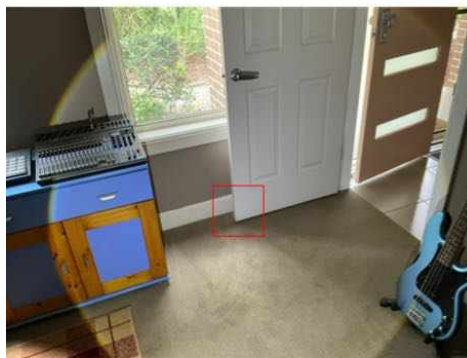
Finding 3.07

Building: Main Building
 Location: Bedroom 5
 Finding: Door Stopper(s) - Missing
 Information: At the time of inspection, it was noted that a door stopper was missing in this area.

The absence of a door stopper can lead to potential damage to the door, wall, or surrounding finishes, as the door may swing open too far and impact the wall or adjacent objects. Over time, this can cause dents, scuffs, or even structural damage to the wall or door. It is recommended that a door stopper be installed to prevent further damage and ensure the protection of both the door and the surrounding area.

The client is advised to engage services of a handyman to install the door stopper.

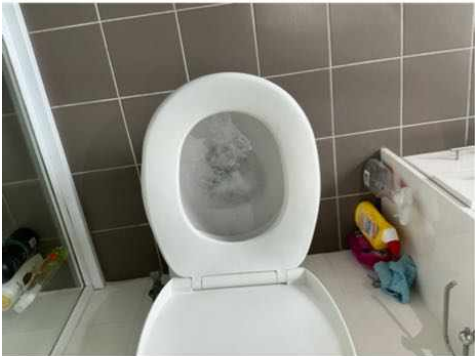
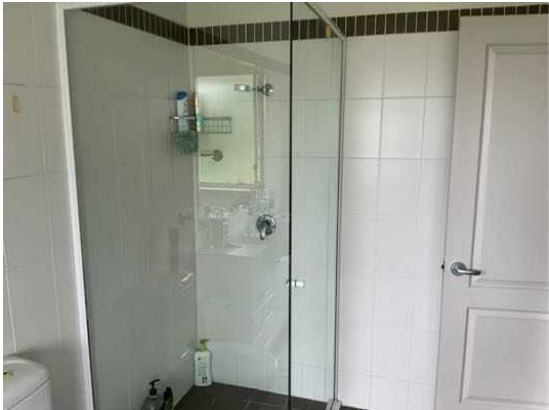
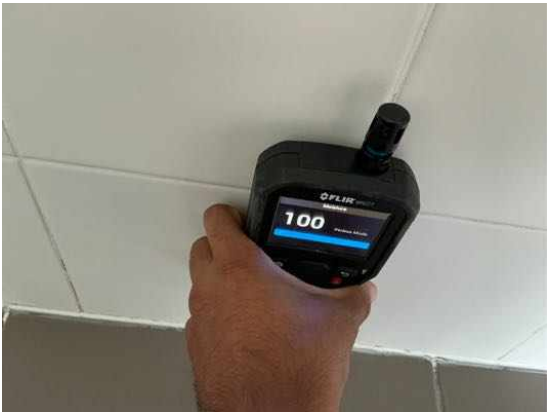
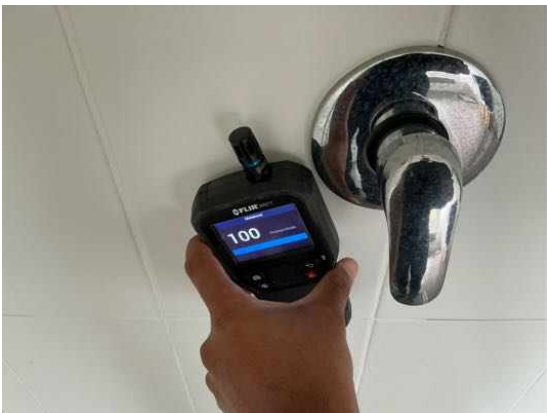
Finding 3.08

Building: Main Building
 Location: Both Bathrooms
 Finding: Excessive Moisture - Shower Damp
 Information: At the time of inspection, excessive moisture was noted within the shower area, which is a common issue in wet areas due to the continual exposure to water. This condition is typically caused by moisture seeping through grout lines and settling behind tiles,

resulting in localised high-moisture zones. Provided there is no evidence of water staining or elevated moisture readings on the opposite side of the wall, this is considered a minor defect.

However, persistently damp conditions may act as conducive conditions for termite activity, as termites are strongly attracted to moisture-rich environments. It is recommended that the client ensures regular use of the exhaust fan and maintains adequate ventilation after shower use to promote drying and reduce long-term moisture build-up, thereby also reducing the risk of attracting termites.

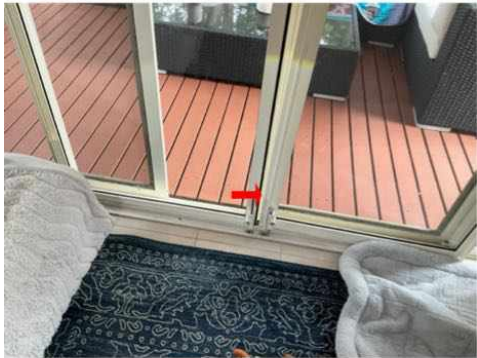
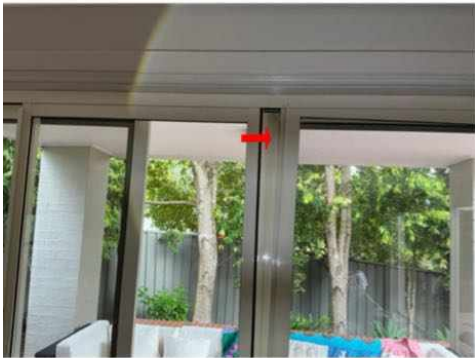
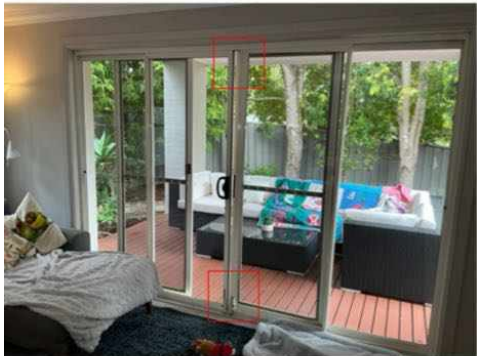
Finding 3.09

During inspection, it was noted that the sliding door is malfunctioning and gets stuck every time it is operated. This issue prevents the door from opening and closing smoothly, which can cause inconvenience and potential safety hazards. Immediate repair or adjustment is required to ensure the door functions properly and to prevent further wear or damage to the door mechanism.

A professional handyman should be appointed to rectify the issue at earliest possible.

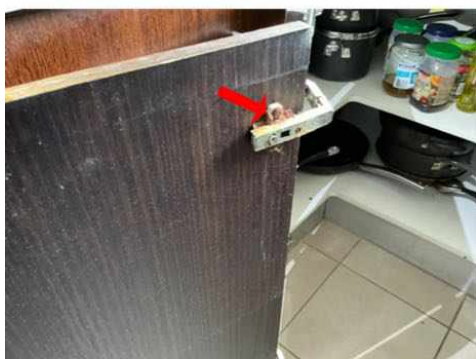
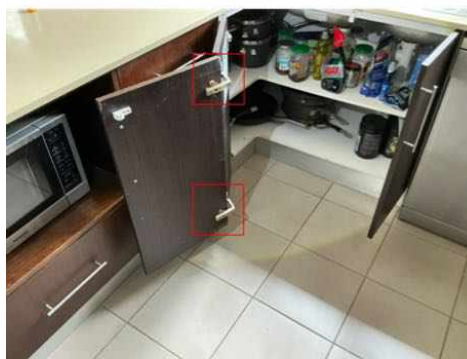
Finding 3.10

Building:	Main Building
Location:	Kitchen
Finding:	Building element - Rusted or corroded
Information:	This building element shows evidence of rusting and corrosion, which is likely to have developed as a result of excessive exposure to moisture and or inadequate coatings.

As surface rust provides no protection to the underlying iron, the deteriorating condition is likely to worsen if not addressed in the short-term future.

Where possible, the use of galvanized (treated) metals or aluminium coated metals aid in rust prevention, as does regular general maintenance. Rust formation can be controlled with coatings, such as paint, that isolate the iron from the environment.

Rusting and corrosion should be managed by ideally removing or limiting the affected surface from exposure to moisture. A registered builder may be appointed to replace any building elements that have been severely affected by rust or water damage.

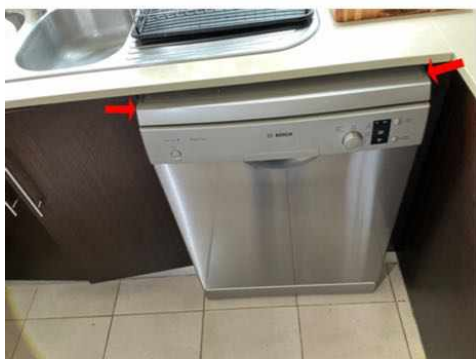
Finding 3.11

Building:	Main Building
Location:	Kitchen
Finding:	Dishwasher Installation - Not Secured
Information:	At the time of the inspection, it was noted that the dishwasher in this area was not securely installed and appeared to be loose. This improper installation requires prompt attention to ensure the appliance is correctly fitted and stable. If left unmanaged, the condition of the fitting may worsen over time, potentially leading to further deterioration and the development of additional minor defects. These secondary issues could affect both the dishwasher itself and the surrounding cabinetry or flooring.

A loose dishwasher may produce excessive noise and vibration during operation, which can be both disruptive and uncomfortable for occupants. The lack of secure

installation may also place strain on the dishwasher's components, potentially reducing the lifespan of the appliance and leading to more significant repairs or maintenance needs in the future.

It is strongly recommended that a qualified plumber be appointed to carry out the necessary rectification work. Ensuring the dishwasher is securely installed will improve its performance, reduce noise and vibration, and prevent further damage to the surrounding area. The client should engage a professional plumber to complete these repairs, ensuring the appliance operates efficiently and safely.

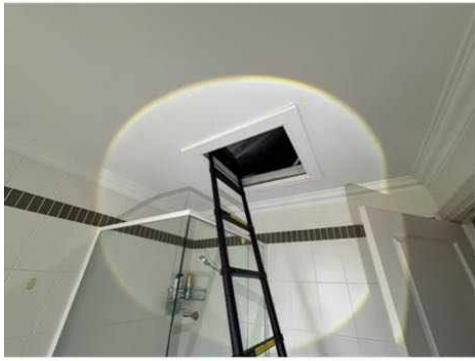
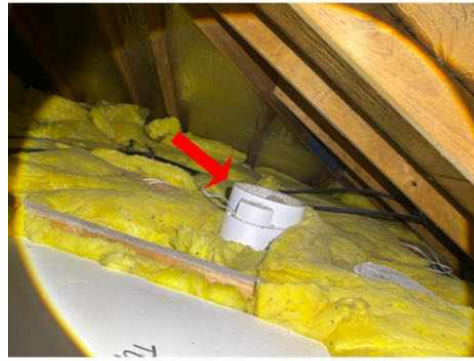
Finding 3.12

Building:	Main Building
Location:	Roof Void
Finding:	Vent - Extracted into Roof Space
Information:	During the inspection, it was noted that the exhaust vent has been improperly terminated into the roof space instead of being ducted to the exterior of the property.

This configuration is a defect as it allows moist air to accumulate within the roof cavity, increasing the risk of condensation, mould growth, and deterioration of insulation or timber framing. Proper ventilation is essential to maintain a healthy indoor environment and protect the structural integrity of the building. It is recommended that the vent be appropriately re-routed to discharge externally in compliance with relevant building standards.

A licensed mechanical ventilation contractor/electrician should be appointed as soon as possible to provide further consultation on the scope of these works and to provide quotations for any necessary works.

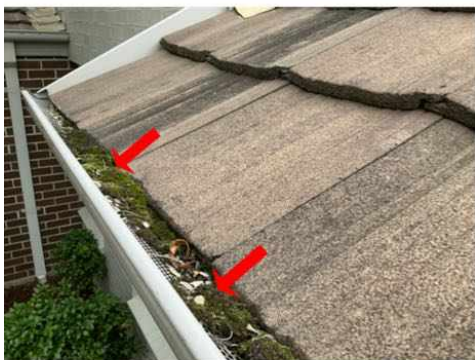
Finding 3.13

Building: Main Building
 Location: Garage
 Finding: Plant Growth - Gutters
 Information: At the time of inspection, plant growth and debris were noted within sections of the guttering system. Vegetation in gutters can restrict the free flow of rainwater.

It is recommended that the gutters be cleaned and cleared of debris. Regular maintenance and periodic cleaning are advised to help ensure proper drainage.

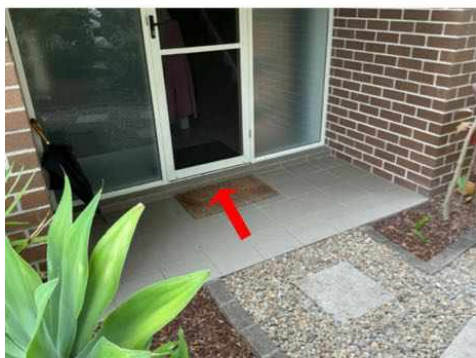
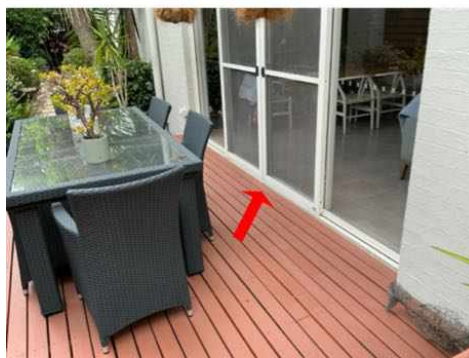
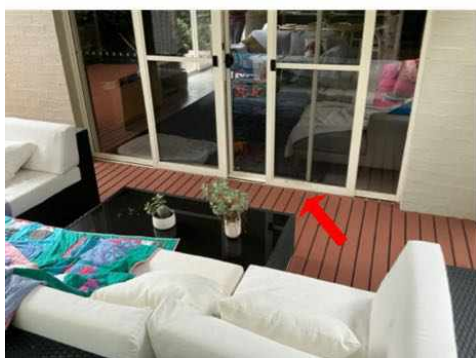
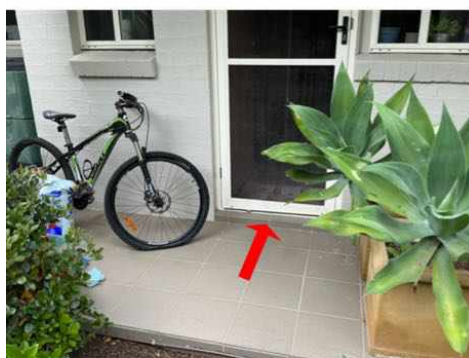
It is important for internal flooring to be raised above adjacent external ground levels. Where external ground levels are above or same level as internal flooring, water pooling and subsequent internal flooding is likely to occur which may attract termite activity to the internal area.

It is highly advised that a landscaper or relevant tradesperson be appointed to lower external grounds that are raised above or same as adjacent internal flooring. Alternatively if external grounds and internal flooring is level installation of a raised door sill may be appropriate in preventing any water pooling in the area. If the client wishes not to make any changes, then a qualified pest controller is recommended for termite treatment around the perimeter of the house and subfloor (if any) as soon as possible.

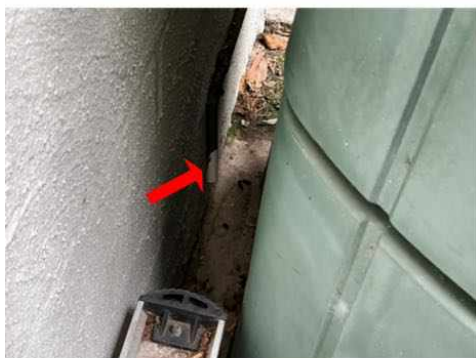
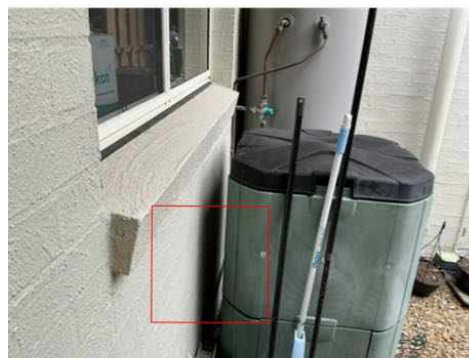
Finding 6.05

Building:	Main Building
Location:	Exterior walls - rear
Finding:	No Stormwater Drain - Under Exterior Tap
Information:	The inspection identified that the exterior tap is not connected to a stormwater drainage system, allowing water to pool around the base. This can lead to moisture-related issues such as deterioration of nearby building materials, mould growth, and increased risk of termite activity—each of which may compromise the property's structural integrity and create health or safety concerns.

To prevent these risks, it is strongly recommended that a licensed plumber be engaged to assess the area and install appropriate drainage, such as a stormwater connection or splash block, to redirect water away from the property. Ongoing maintenance and monitoring of external water sources are also advised to ensure long-term protection.

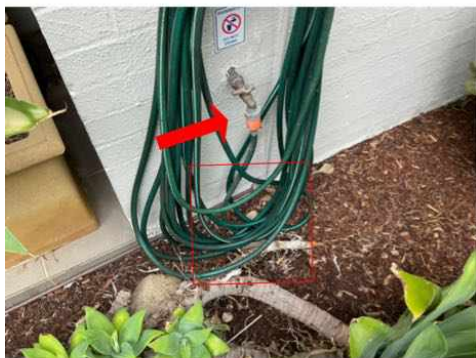
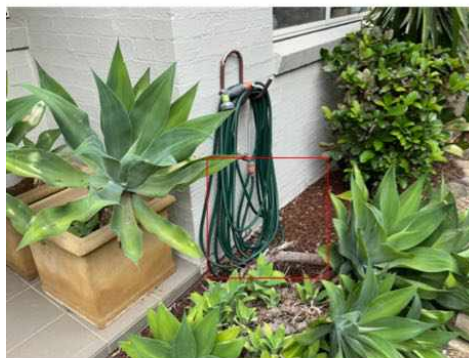
Finding 6.06

Information: At the time of inspection, timber materials were noted to be directly attached to the external wall of the dwelling. This practice is considered a conducive condition for termite activity, as it provides both a potential food source and concealed entry point for termites into the structure.

It is recommended that the timber be removed, isolated, or appropriately treated to reduce the risk of termite infestation. A licensed pest management specialist should be consulted for further assessment and advice in line with AS 3660.2 (Termite Management).

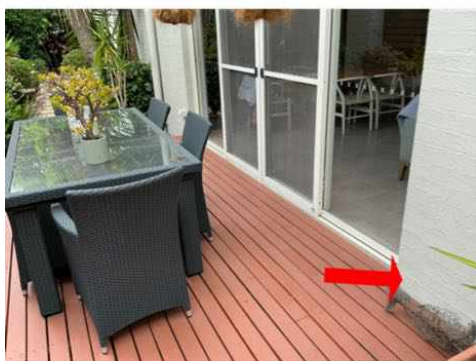
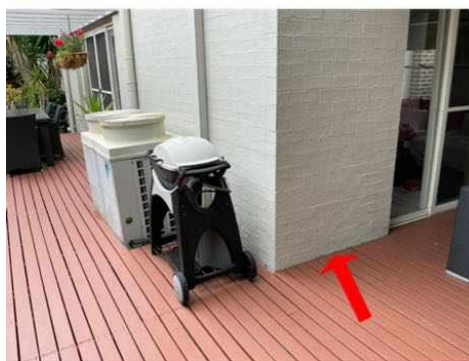
Finding 6.07

Finding: Trees within 2 meters of Property - Conducive Conditions to Termites

Information: Trees were located within 2 meters of the property's foundation at the time of inspection, creating conducive conditions for termite activity. Trees and their root systems can provide shelter and moisture, attracting termites and increasing the risk

of termite ingress into the structure. Additionally, decaying wood, tree stumps, or root systems near the foundation can serve as a direct food source and pathway for termites to access the property.

It is recommended that a qualified arborist or pest management professional assess the trees to determine the level of risk they pose. Consider removing or relocating trees in close proximity to the foundation and implementing regular termite inspections and preventive treatments to mitigate the risk of infestation. Additionally, maintaining a clearance zone between vegetation and the property can help reduce conducive conditions for termites.

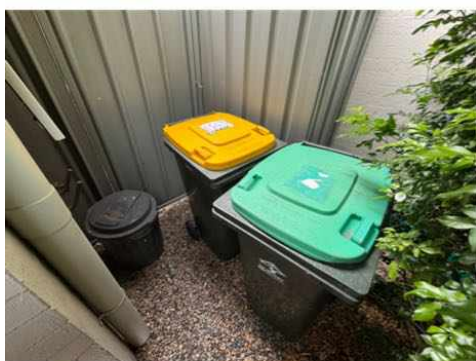
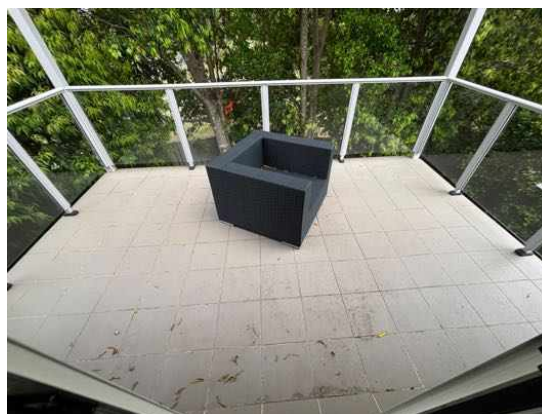
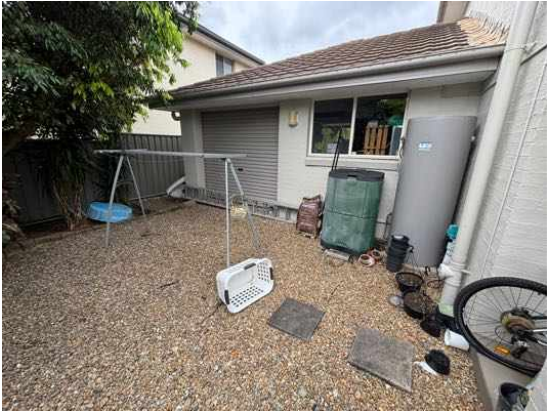
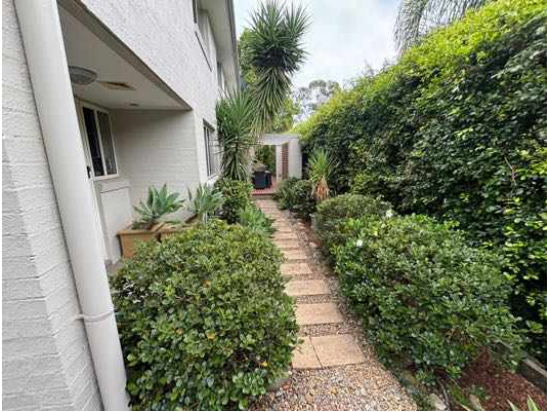
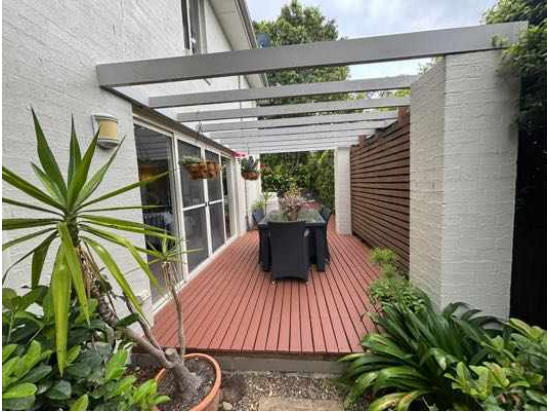
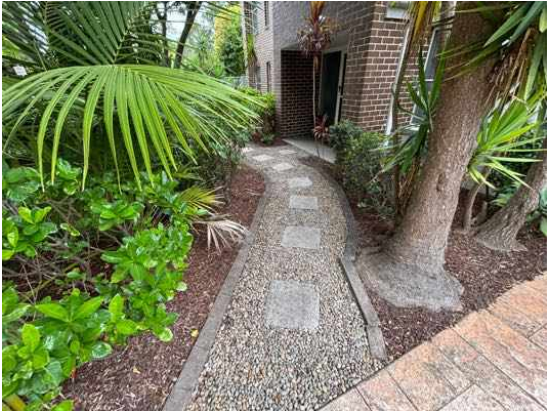
Building: Main Building
Location: All External Areas
Finding: Obstructions and Limitations - External Areas
Information: The attached photographs provide a visual representation of the obstructions and limitations that impeded a full inspection of the external areas of the property at the time of assessment. These obstructions, which may include vegetation, stored items, debris, or other physical barriers, can obscure potential defects and prevent a thorough evaluation of the property's condition. Obstructions of this nature can conceal a wide range of issues, such as structural damage, water ingress, pest infestations, or deteriorating building materials, which may not be visible during the initial inspection.

It is essential that these obstructions be cleared to allow for a comprehensive inspection of the external areas. Removing these barriers will enable a more accurate assessment of the property's condition and allow any hidden defects to be identified and addressed promptly. Failure to do so could result in undetected issues worsening over time, potentially leading to more costly repairs in the future.

Therefore, it is strongly recommended that the obstructions be removed and a re-inspection be scheduled once the affected areas are made fully accessible. This will ensure a complete evaluation of the property's exterior and provide the client with a clear understanding of any potential issues that may have been concealed during the initial inspection.

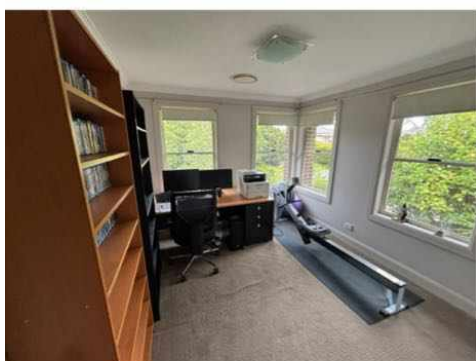
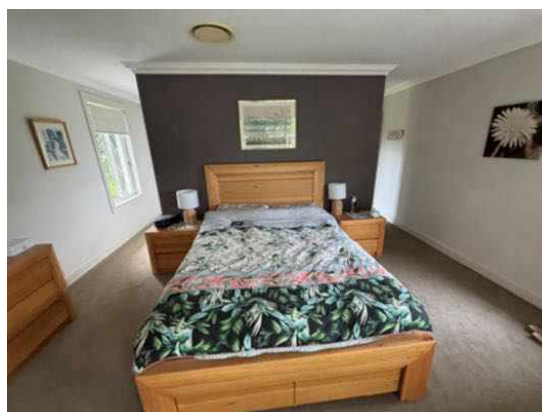
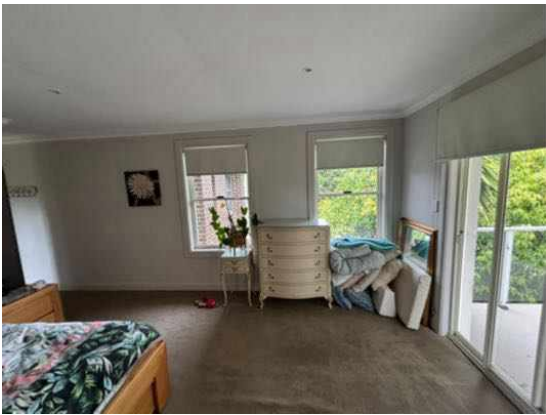
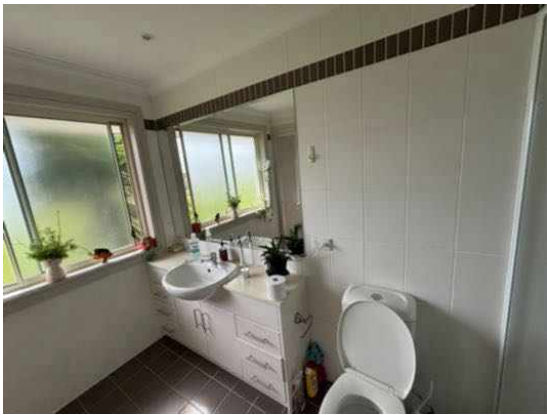
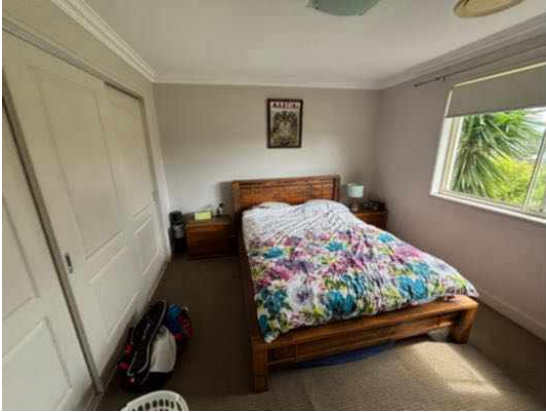
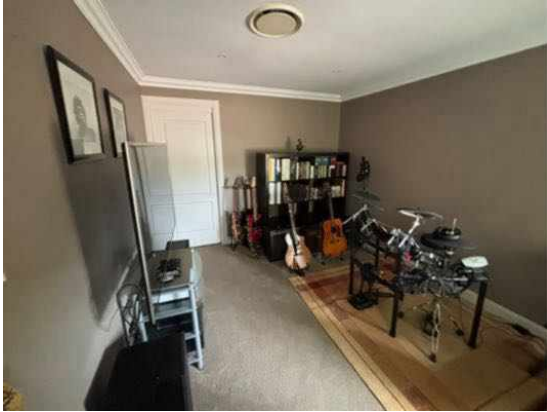
Building: Main Building
Location: All Internal Areas
Finding: Obstructions and Limitations - Internal Areas
Information: The accompanying photographs provide clear evidence of the obstructions and limitations that restricted a comprehensive inspection of the internal areas of the property at the time of assessment. These obstructions, which may include furniture, personal belongings, stored items, or structural elements such as wall coverings and built-ins, significantly hindered the ability to thoroughly evaluate these areas. It is important to note that such obstructions can potentially conceal a wide array of defects, ranging from hidden structural damage, water leaks, pest infestations, or electrical issues, to deteriorating materials that may not be visible during the initial inspection.

The presence of these impediments means that critical areas of the property were not accessible, and therefore, any underlying defects that may affect the integrity and safety of the property could remain undetected. These hidden defects, if left unaddressed, could worsen over time and may result in costly repairs or pose potential safety hazards to the occupants.

It is highly recommended that all obstructions be cleared to facilitate a complete and thorough inspection of the internal areas. Once the obstructions have been removed and full access is available, a re-inspection should be carried out to ensure that any previously concealed issues can be properly identified and rectified. This follow-up inspection will provide a more accurate assessment of the property's internal condition and help the client make informed decisions about any necessary repairs or maintenance.

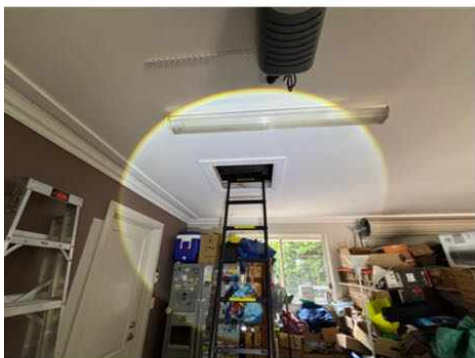
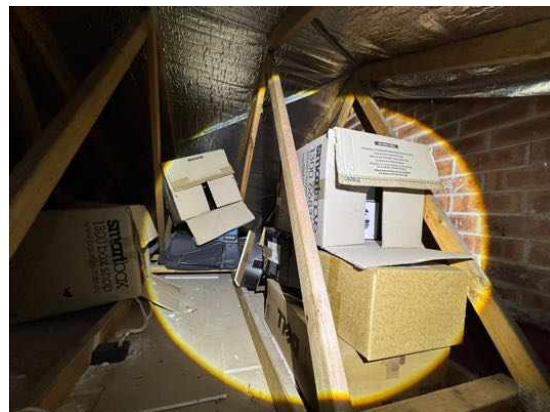
Building: Main Building
 Location: Roof Void
 Finding: Obstructions, Limitations, and General Roof Space Condition
 Information: The photographs provided document both the general condition and the obstructions and limitations that were present in the roof cavity of the main building at the time of inspection. These obstructions—such as insulation materials, stored items, structural elements, or electrical wiring—restricted safe and adequate access to key areas within the roof space. As a result, a comprehensive inspection of all components could not be completed.

Obstructions of this nature may conceal a variety of potential defects, including damaged framing, compromised insulation, evidence of moisture ingress, pest activity, or electrical hazards. While no major issues were observed in the visible areas, the presence of these limitations means that some defects may remain undetected.

It is recommended that these barriers be removed or repositioned to facilitate full and safe access to the roof space. Once clear, a follow-up inspection should be conducted to allow for a thorough assessment of all concealed areas. This will help ensure that the condition of the roof cavity is accurately evaluated and any hidden issues are appropriately identified and addressed.

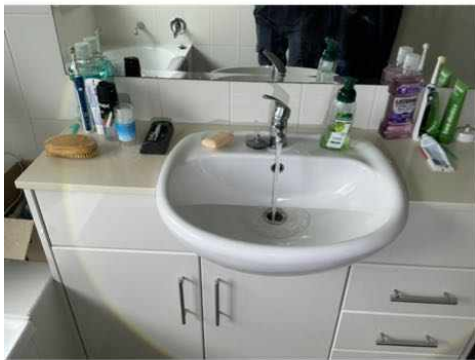
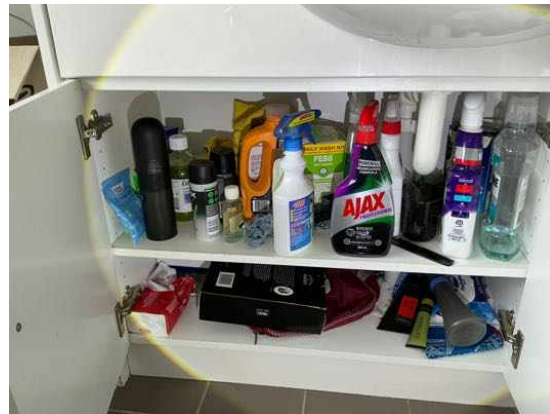
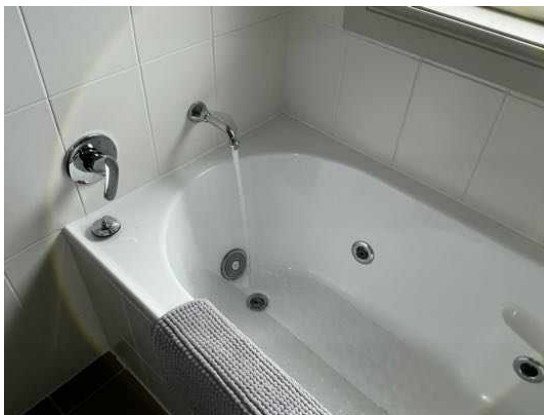
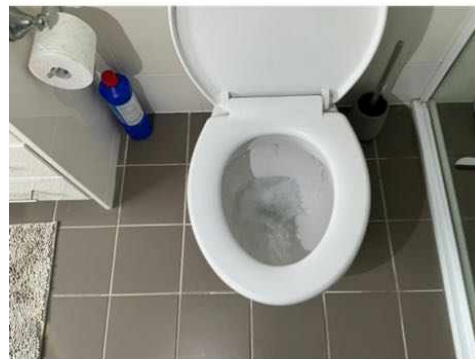
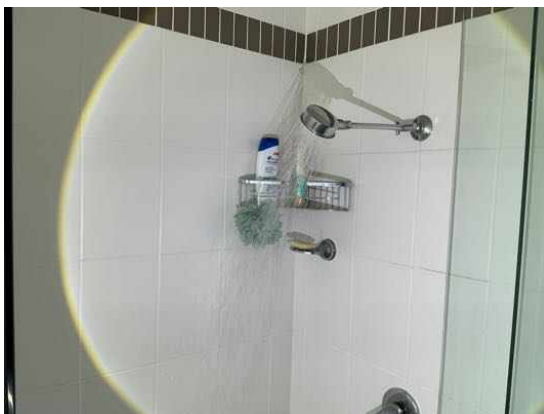
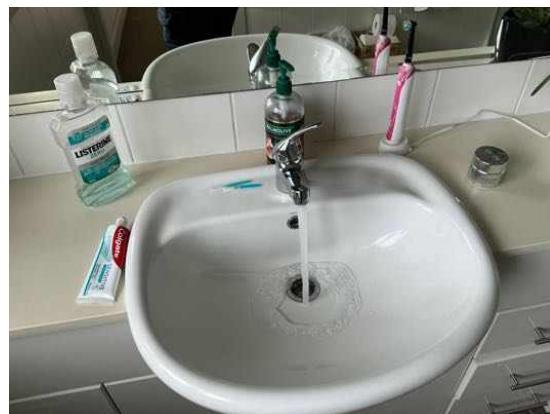
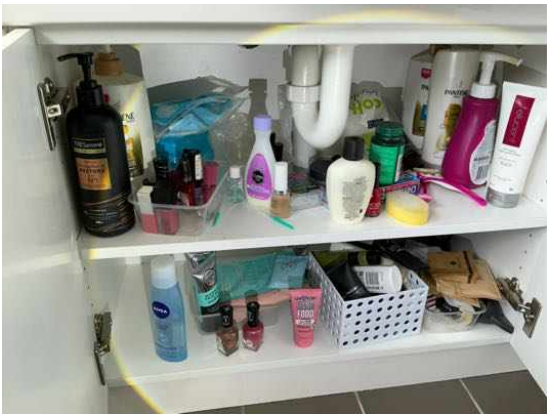
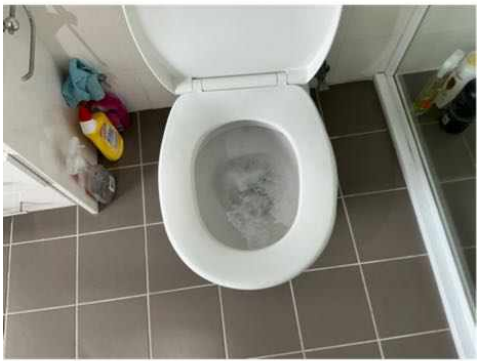
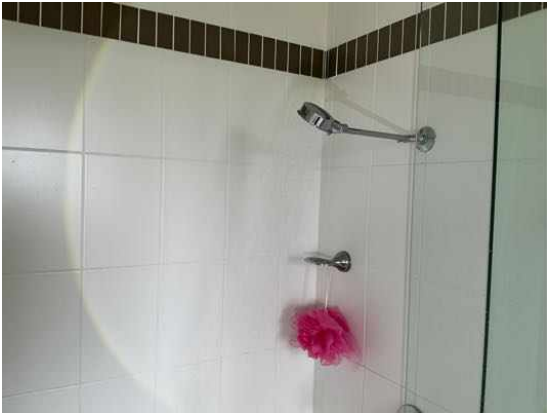
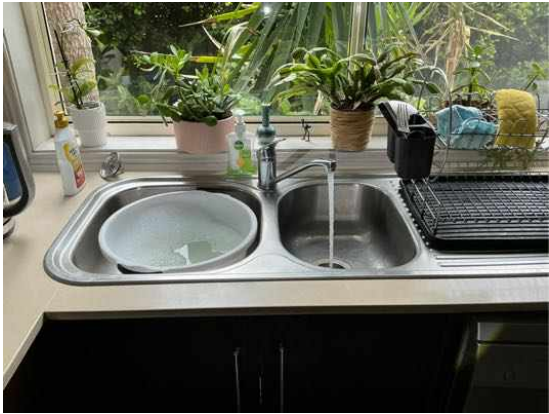
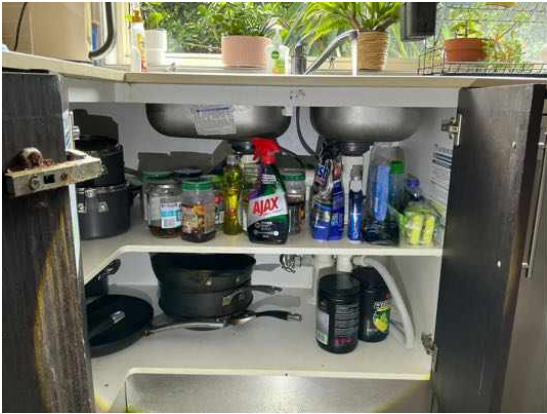
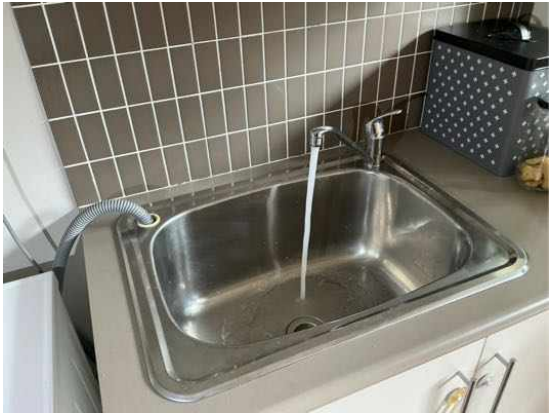
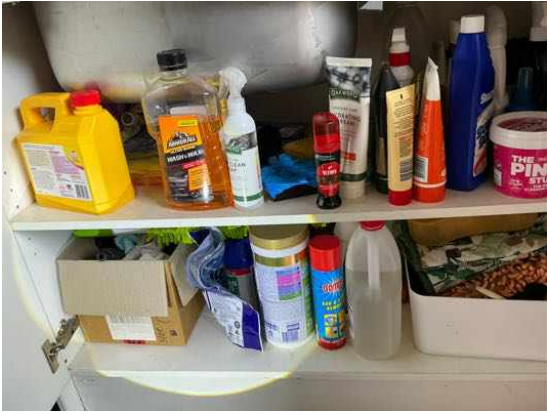
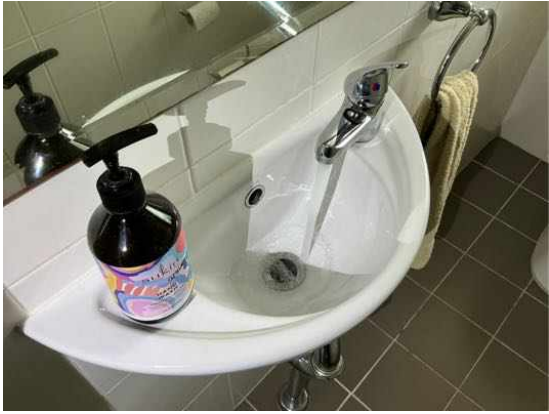
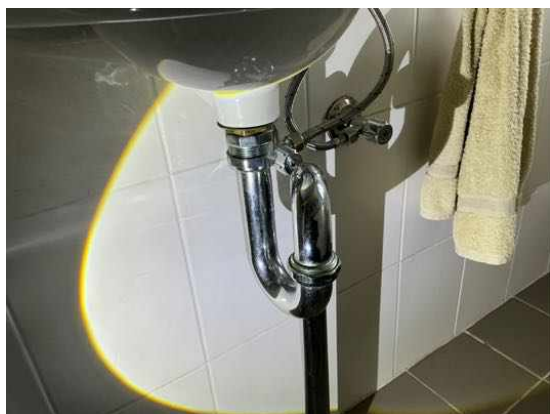
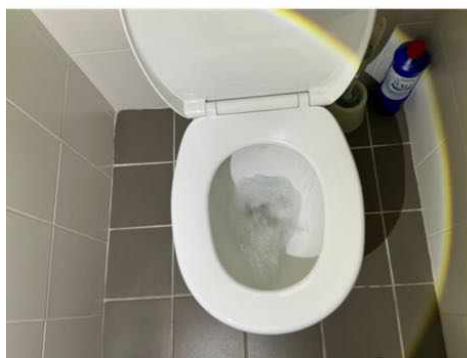
Building: Main Building
Location: All Areas
Finding: FYI - Taps, Drainage & Toilets Tested and Cabinetry Obstructions
Information: During the inspection, all accessible taps, drainage systems, and toilets were tested for water flow and drainage efficiency, and checked for any visible signs of leakage. At the time of the inspection, no issues were noted in these areas. Unless highlighted in a separate defect statement, no immediate remedial work appears necessary. Supporting images may be found in the additional photos section for reference.

beneath sinks and vanities was undertaken, stored personal items and fixtures presented obstructions that limited full visibility of the internal areas. As per standard inspection practices, inspectors are not permitted to move or disturb personal belongings during the inspection process. Therefore, only visible and accessible sections were inspected, and concealed water damage or plumbing defects may not have been detected.

Given this, a re-inspection is recommended after all obstructions have been cleared to allow for a comprehensive assessment of these areas. Regular maintenance and monitoring of plumbing and drainage systems is also advised to ensure ongoing functionality and early detection of potential issues.

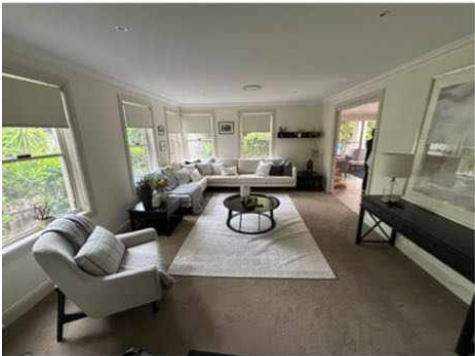
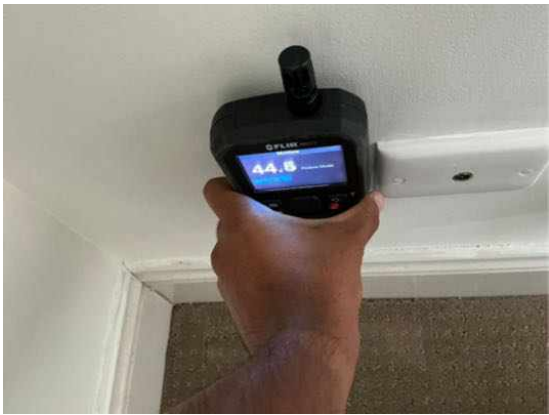
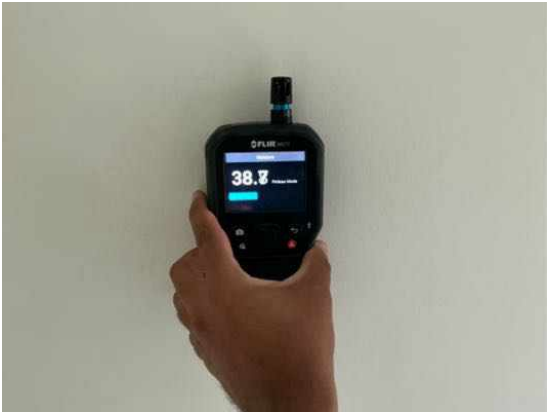
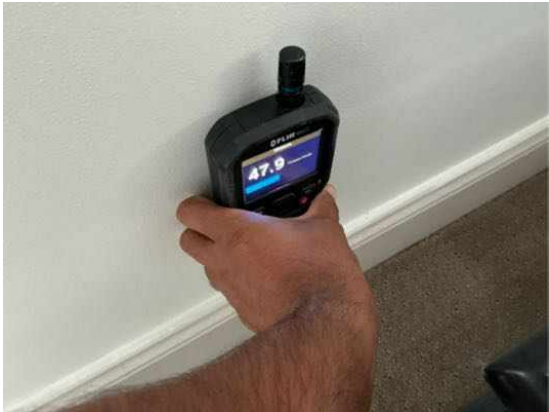
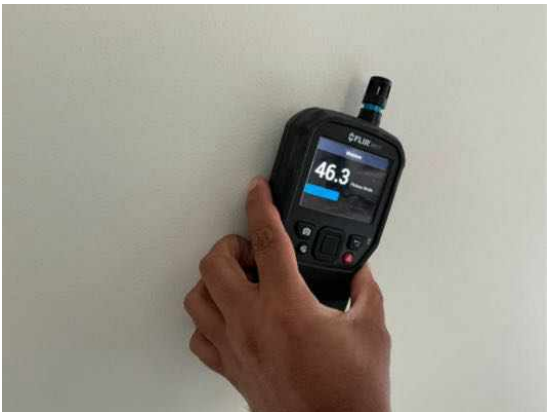
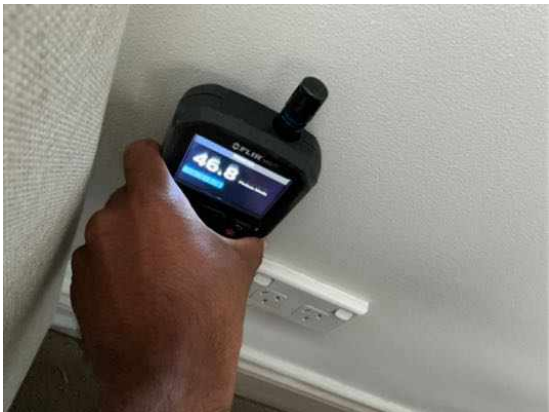
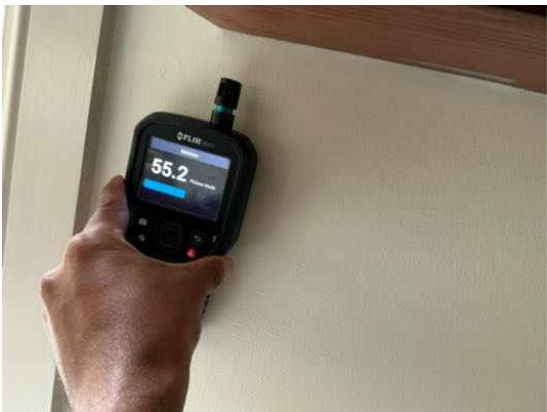
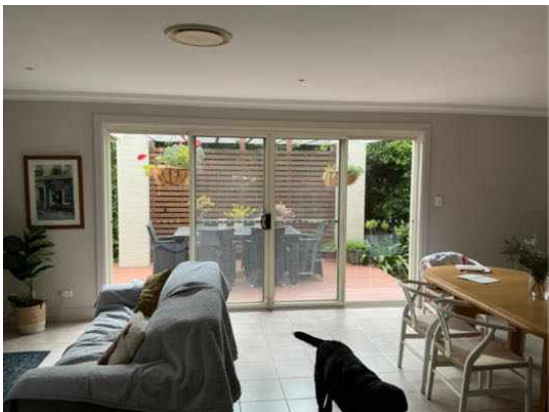
Finding: Additional Photos - Moisture Meter Readings

Information: Additional moisture meter reading photos have been provided for the property to offer further clarity on areas tested during the inspection. These photos are intended to give a visual reference for the specific locations where moisture levels were measured. These readings were taken at the time of the inspection to assess any potential moisture-related issues within the property. Any defects related to moisture that were identified during the inspection have been separately mentioned in the defect statements within the report.

For further clarification or additional information regarding the moisture readings, the client is encouraged to contact the building inspector directly. Regular monitoring of moisture-prone areas is recommended to ensure any emerging concerns are addressed promptly, particularly during wetter seasons or in high-humidity conditions.
