Building and Timber Pest Inspection Report

Inspection Date: Thu, 26 Feb 2026

Property Address: 2 Foster Way, Berowra NSW 2081, Australia

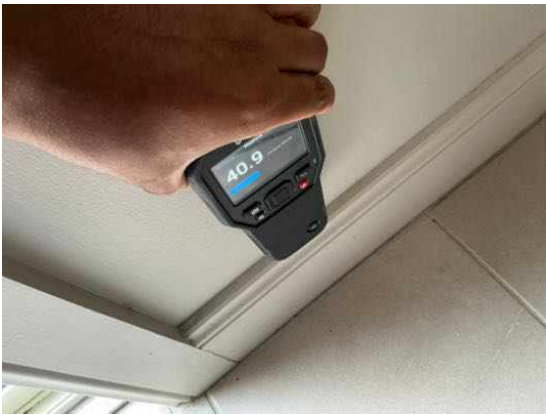
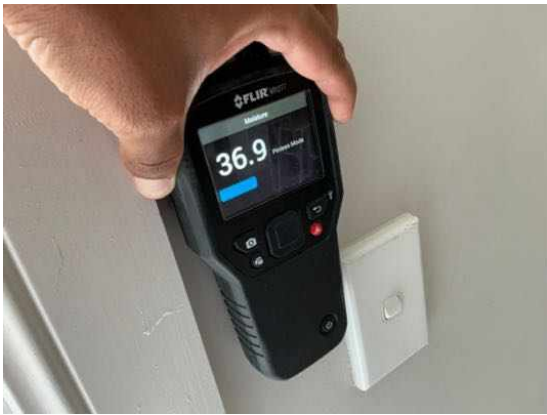
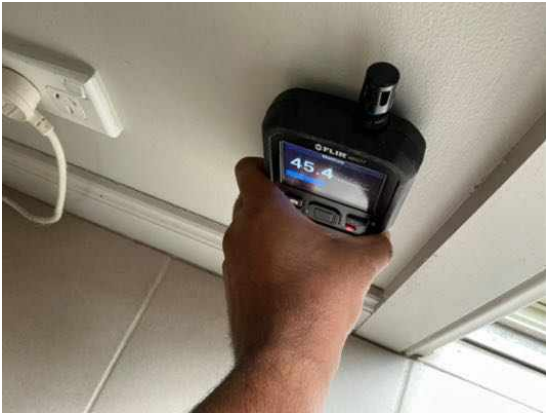
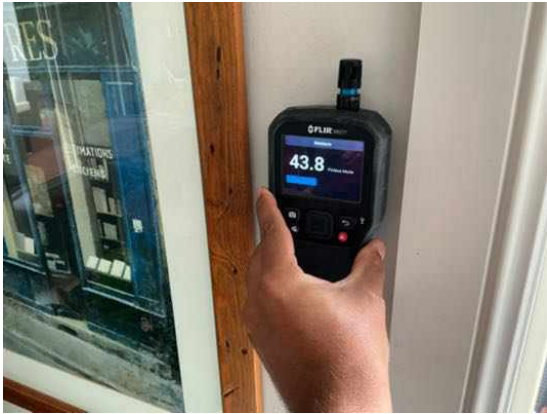
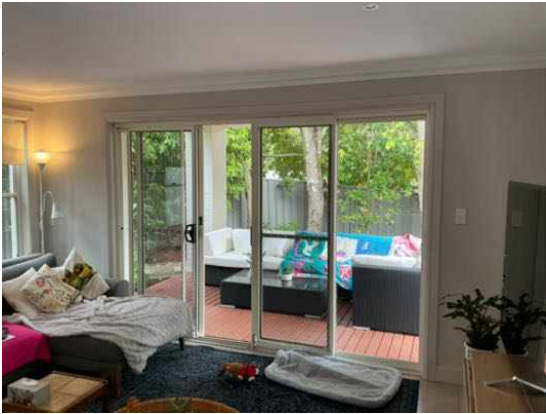
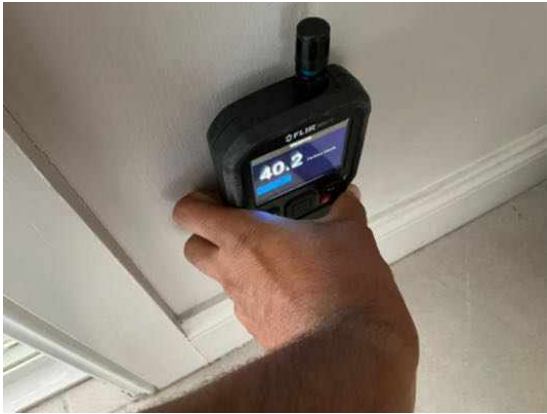
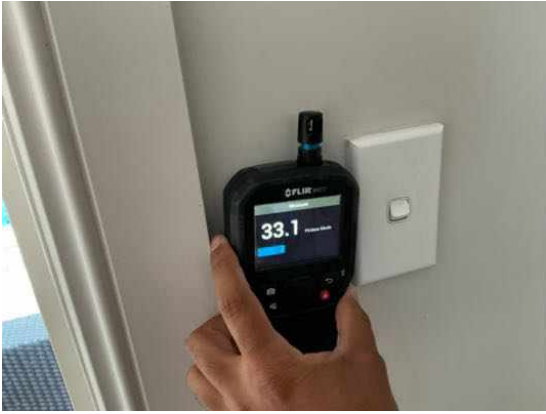
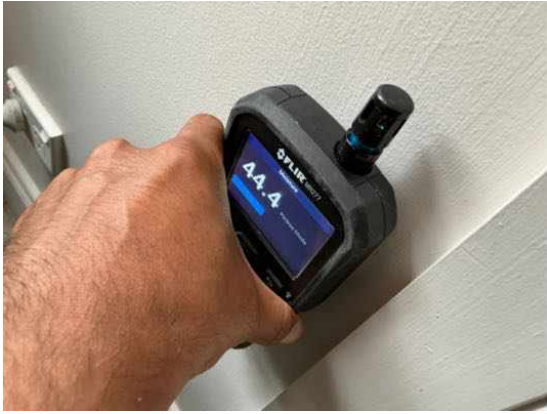
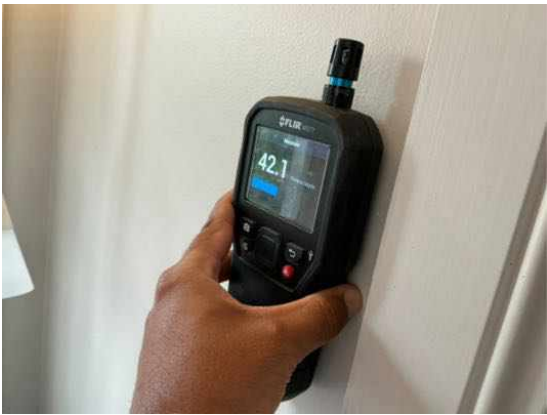
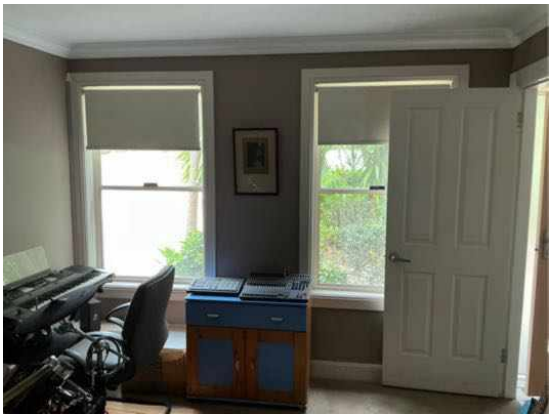
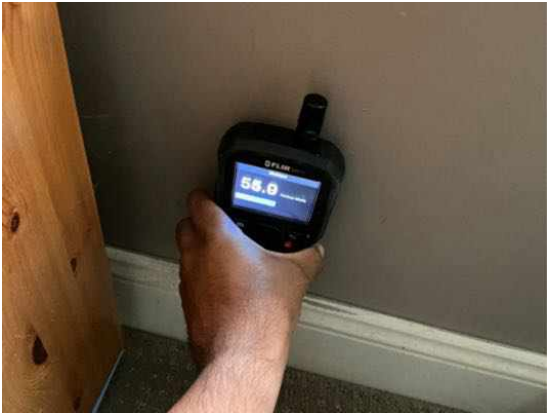
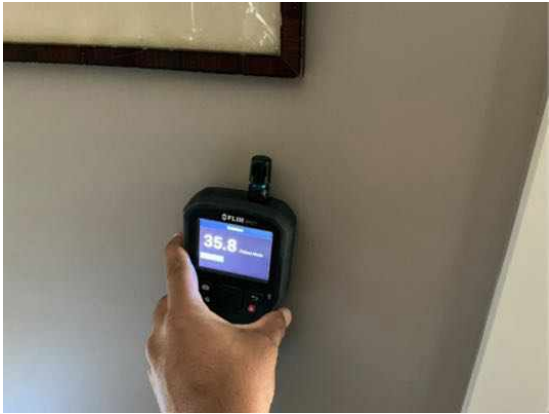
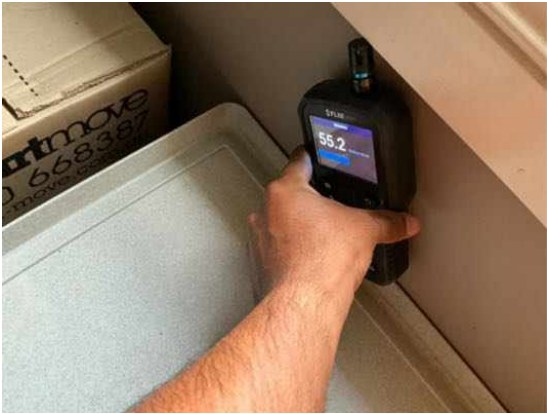
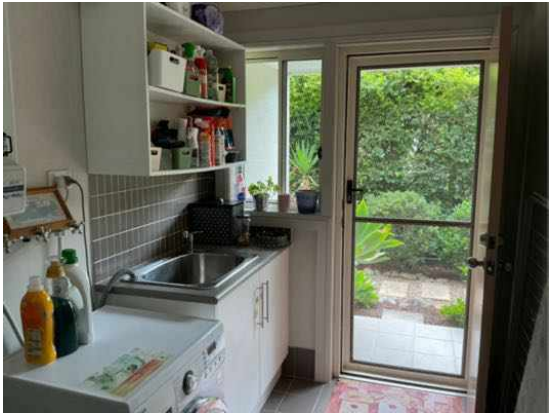
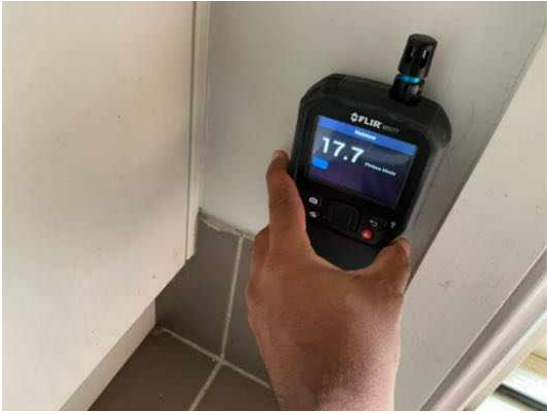
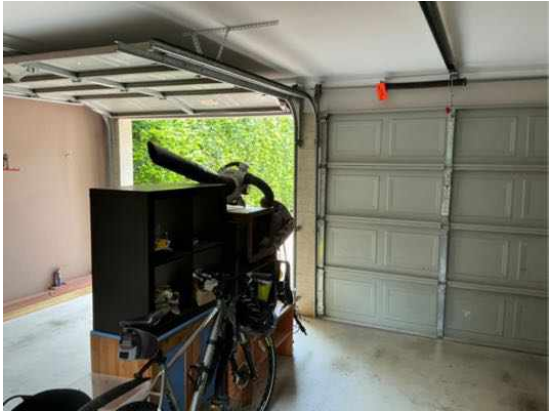
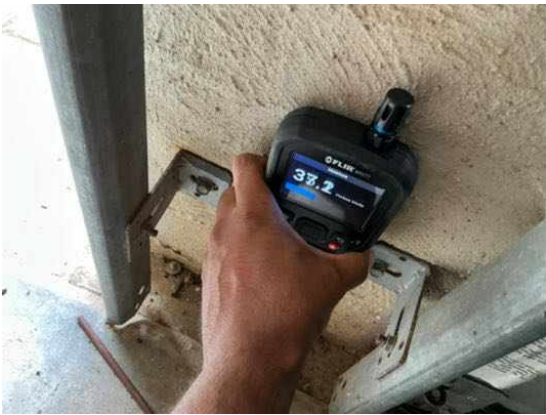
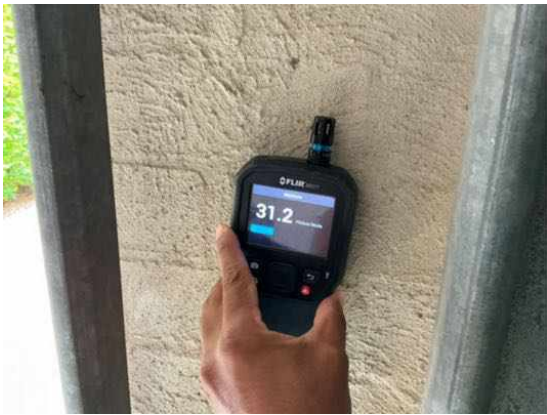
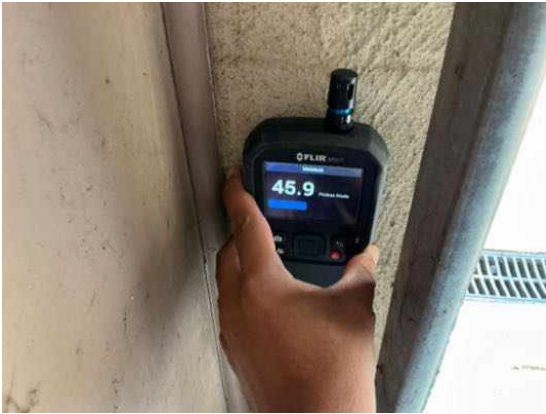
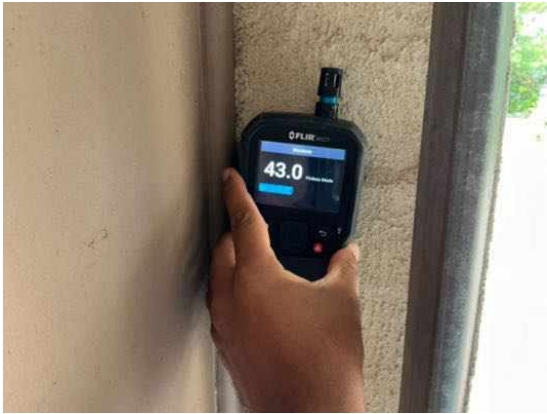
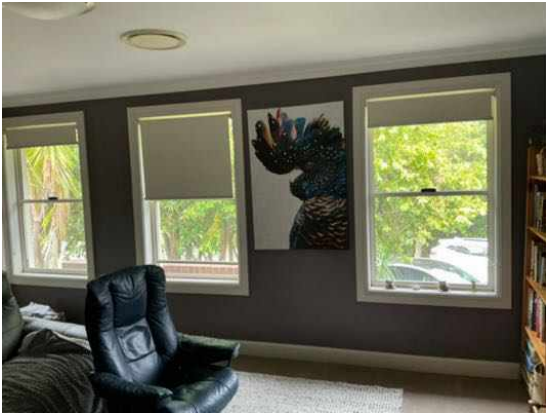
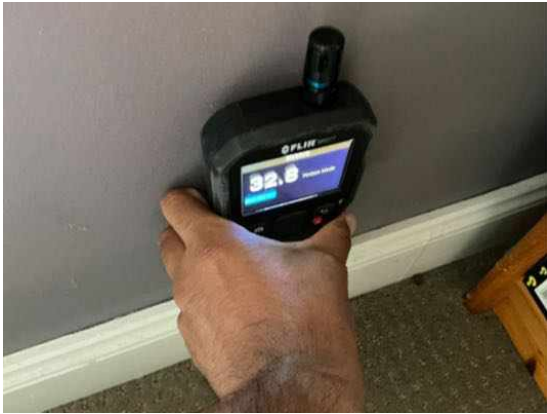
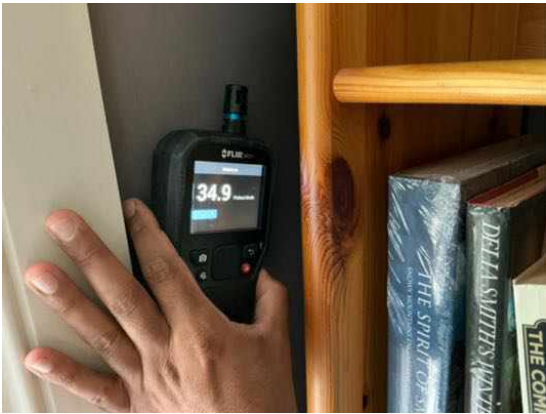
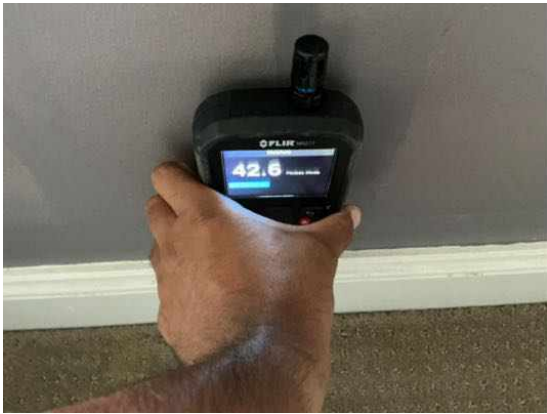
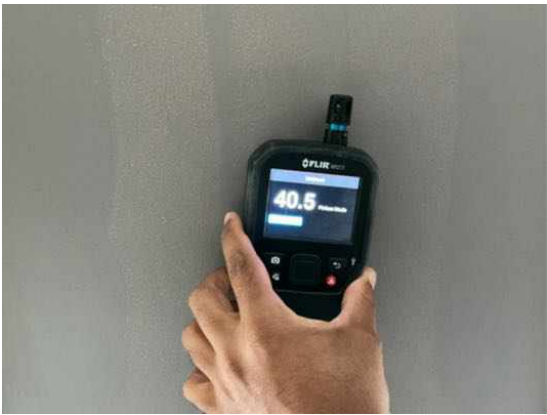
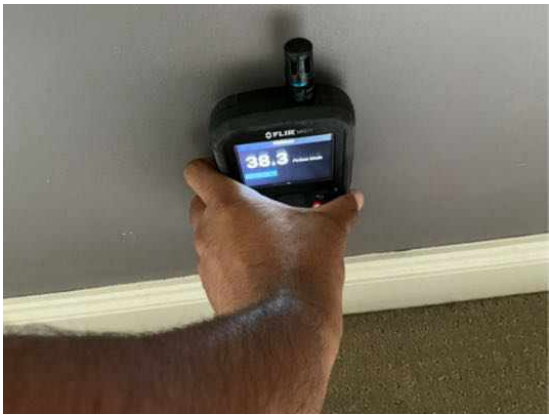
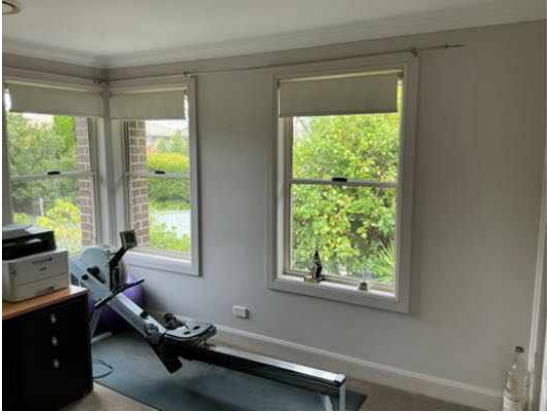
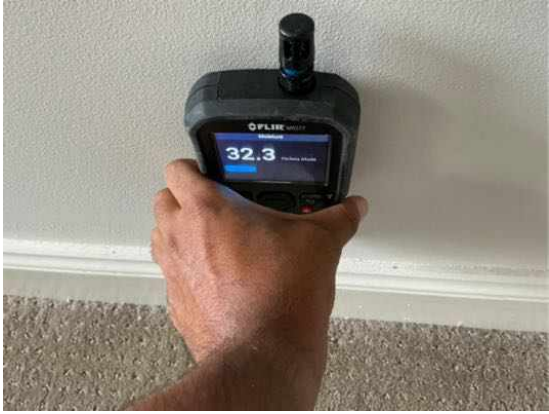
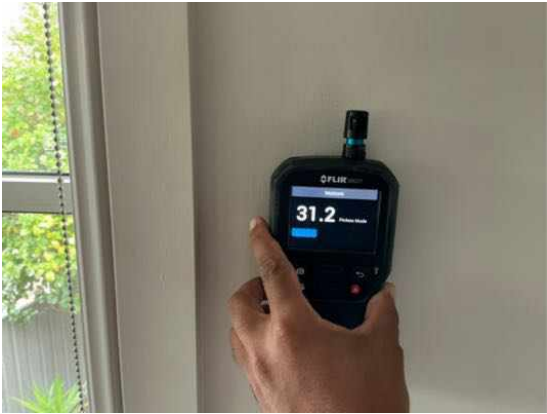
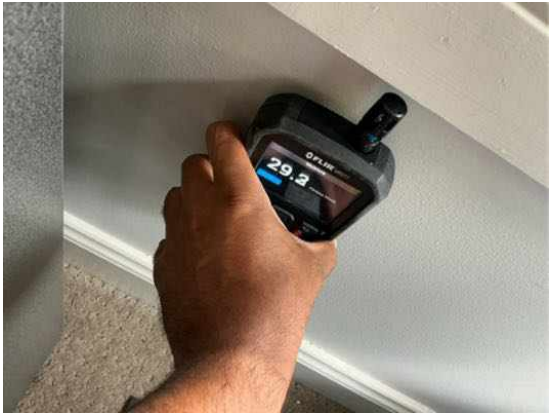
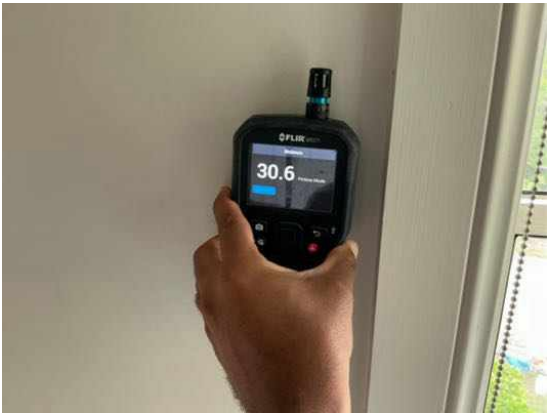
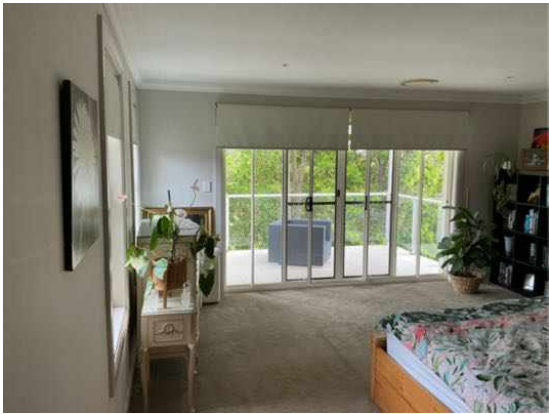
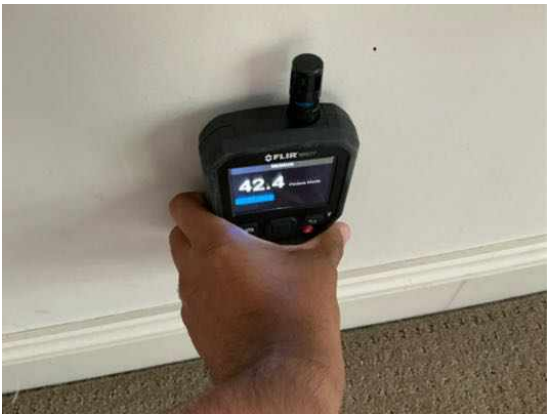
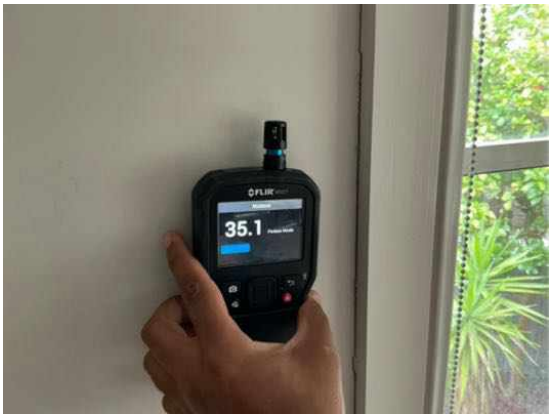
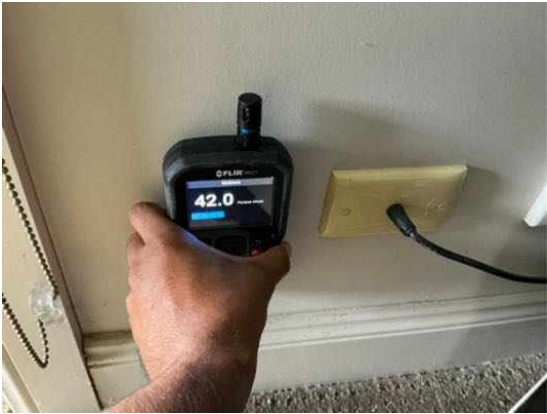
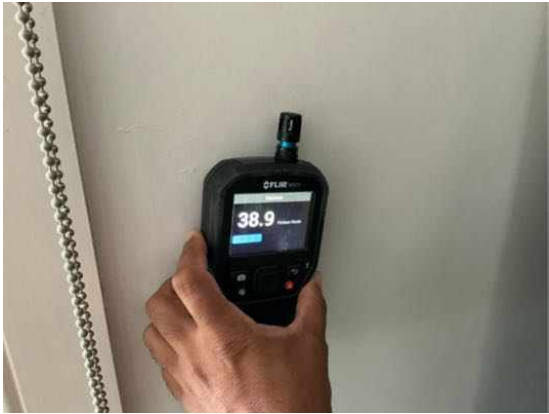
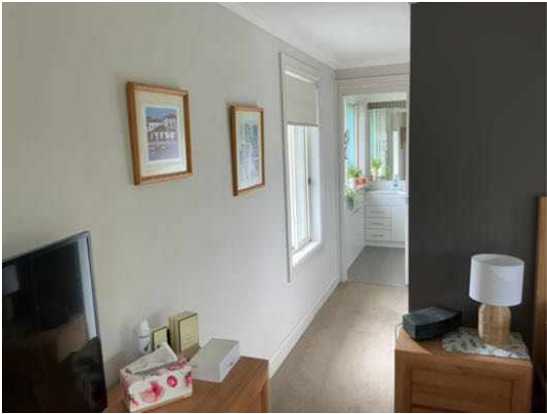
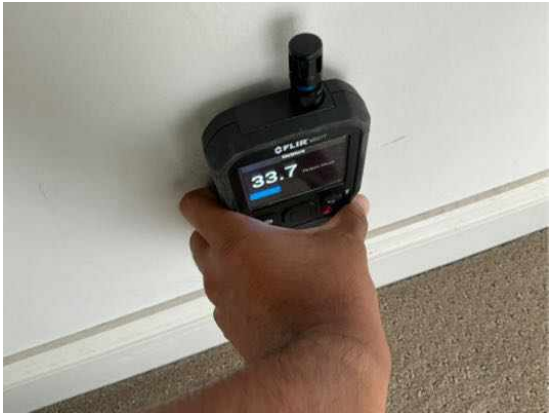
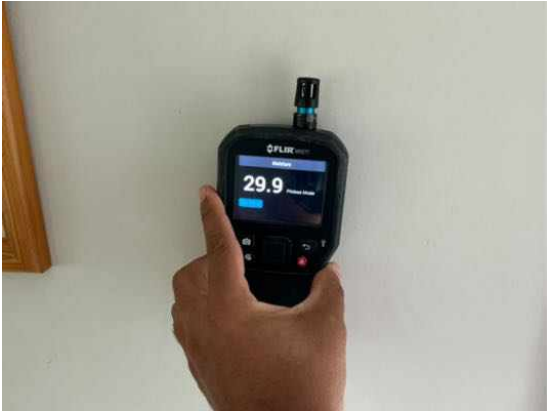
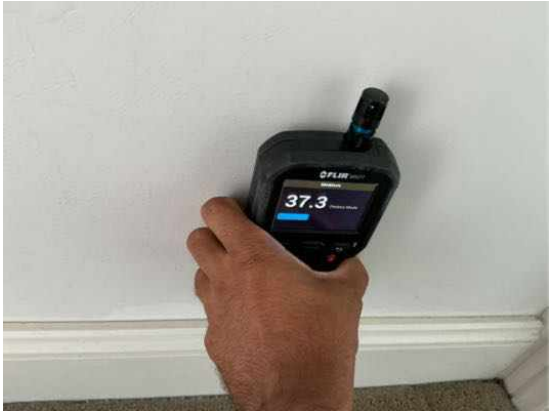
Finding: Additional Photos - Moisture Meter Readings

Information: Additional moisture meter reading photos have been provided for the property to offer further clarity on areas tested during the inspection. These photos are intended to give a visual reference for the specific locations where moisture levels were measured. These readings were taken at the time of the inspection to assess any potential moisture-related issues within the property. Any defects related to moisture that were identified during the inspection have been separately mentioned in the defect statements within the report.

It is important for the client to understand that moisture levels can fluctuate over time due to various factors, including changes in weather, humidity, and environmental conditions. While the readings reflect the property's moisture levels during the inspection, they may not represent future conditions, and increased moisture could lead to issues such as dampness, mould growth, or deterioration of building materials if left unmonitored.

For further clarification or additional information regarding the moisture readings, the client is encouraged to contact the building inspector directly. Regular monitoring of moisture-prone areas is recommended to ensure any emerging concerns are addressed promptly, particularly during wetter seasons or in high-humidity conditions.

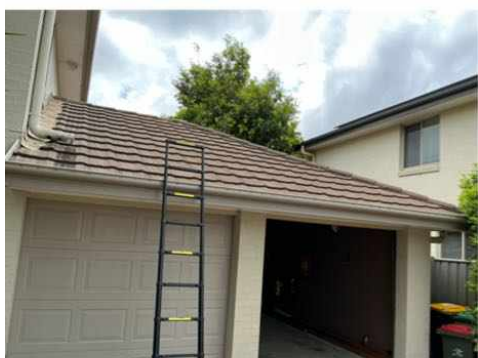
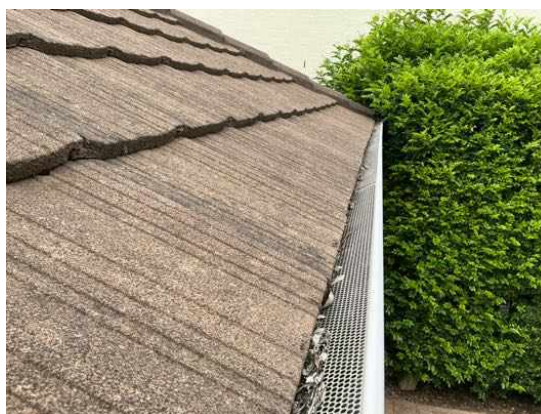
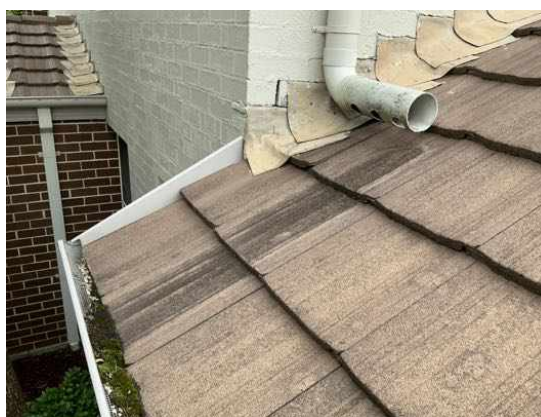
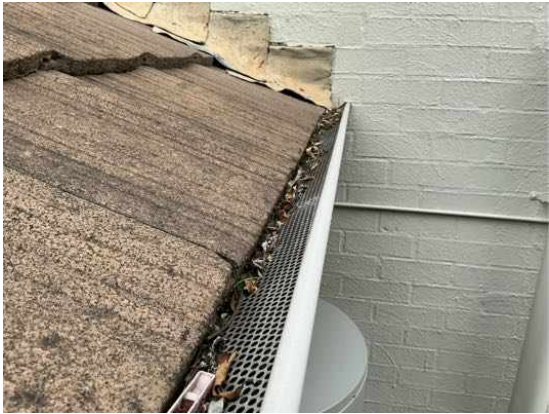
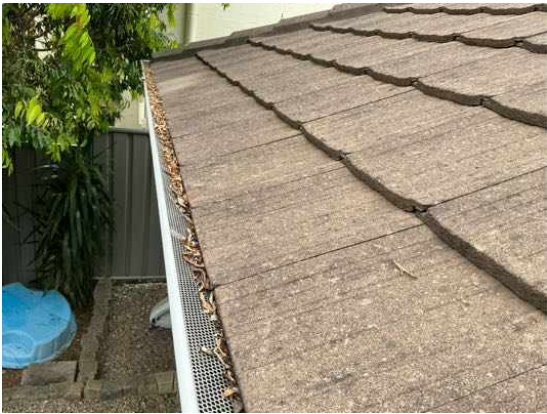
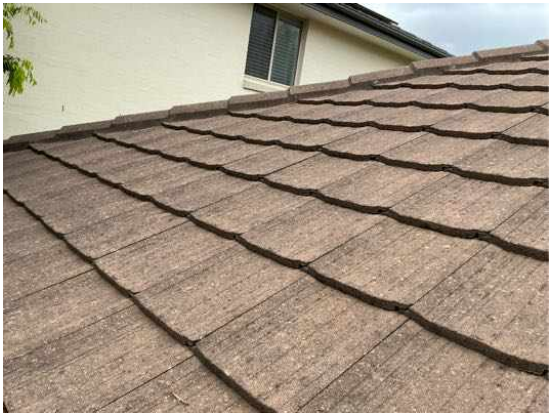
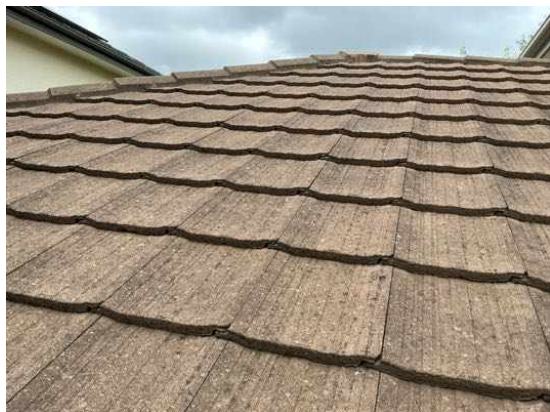
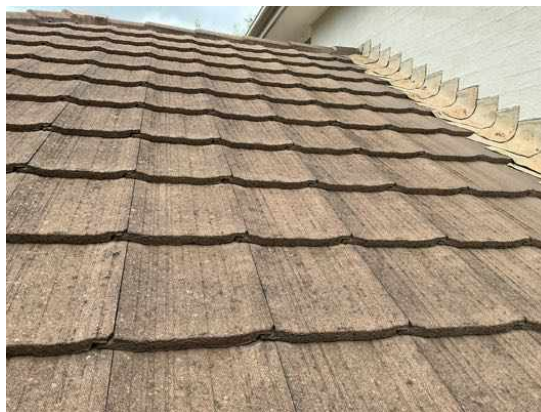
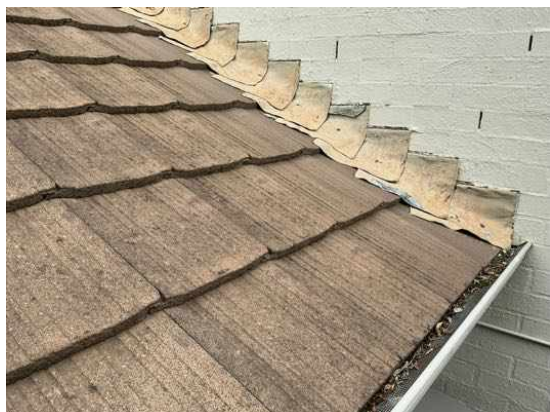
Building: Main Building
Location: Roof Exterior
Finding: Additional Roof Photos

Information: As part of the information provided, please note that the attached roof photos represent the condition of the roof at the time of inspection. These photos are for visual reference only and do not constitute a detailed roofing assessment. Any defects or issues identified with the roof are mentioned separately in the defect statements. It is strongly recommended that the client engage a qualified roofer to conduct a thorough inspection of the roof, ensuring that any potential issues, such as leaks, structural integrity, or wear and tear, are properly identified and addressed.

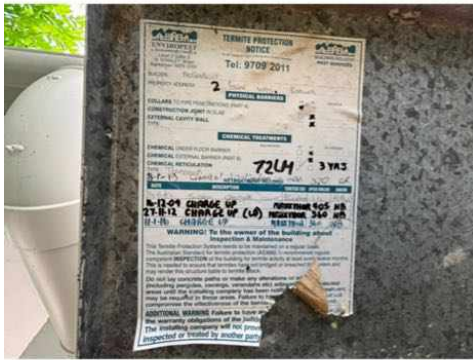
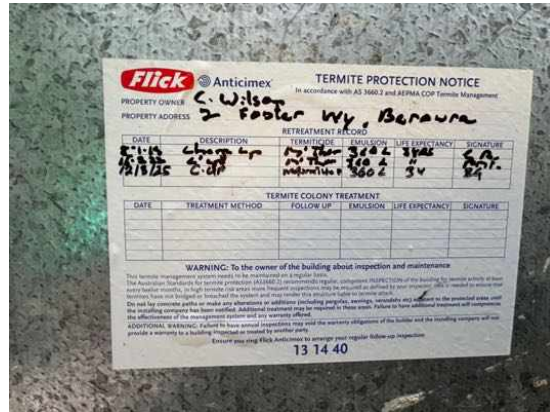
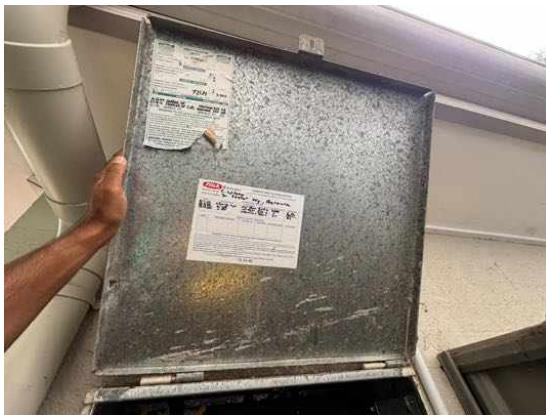
The following items were noted as - Evidence of a previous termite management program

Where a Termite Management System has been identified you should refer to the type of barrier date of installation warranty conditions and any documentation provided by a builder or past owner. Consult the company who installed the barrier to confirm whether the system is still under warranty.

Most chemical termite management systems expire and require replenishment and all physical systems are primarily designed to prevent concealed entry.
