# Building and Timber Pest Inspection Report

Inspection Date: Wed, 28 Jan 2026

Property Address: 30 Carver Cres, Baulkham Hills NSW 2153,  
Australia

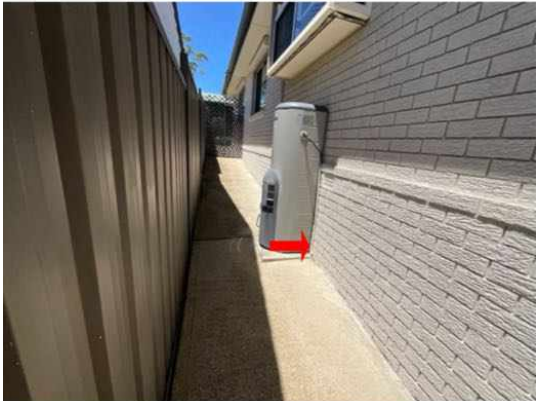
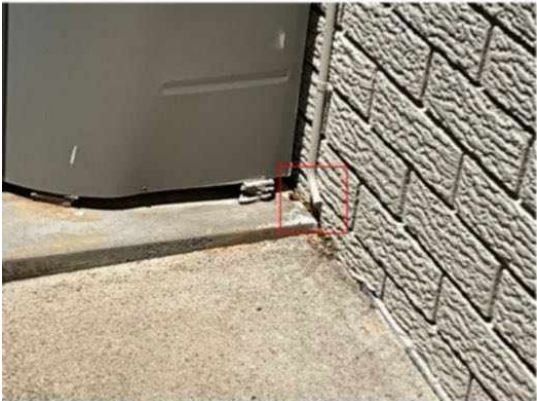
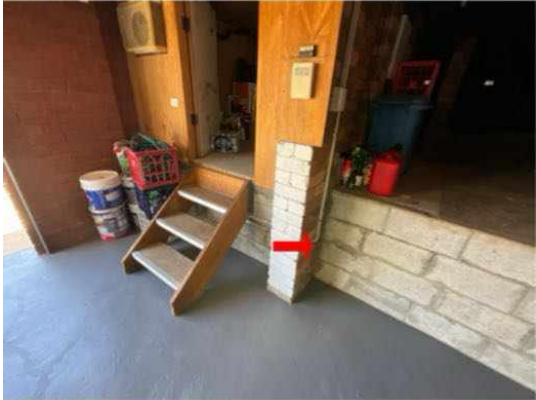
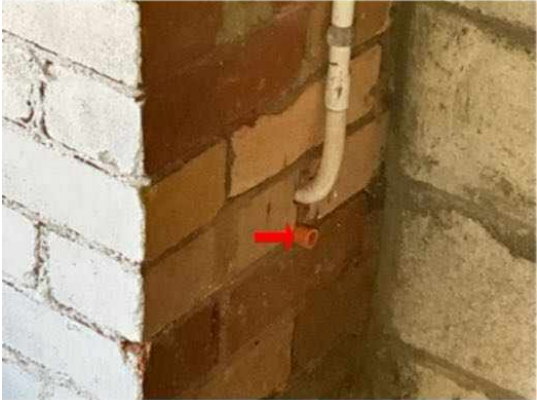
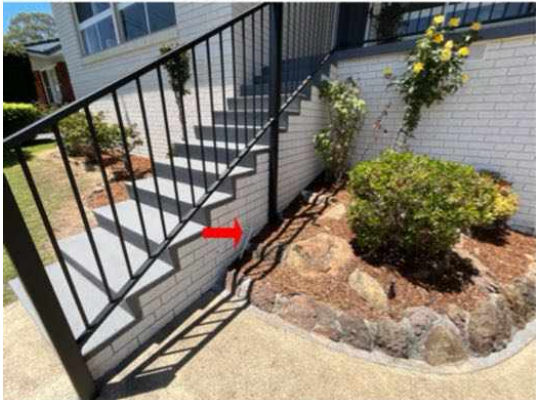
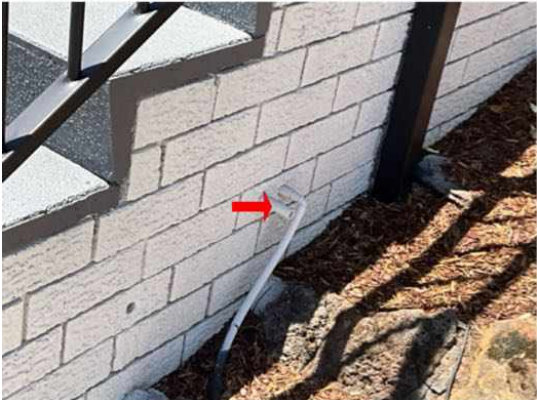
## Finding 6.05

Building:	Main Building
Location:	Fencing & Landscaping
Finding:	Building materials in direct ground contact - conducive to termites
Information:	Where timber elements are in direct contact with the ground and consequently moisture or dampness they become conducive to termite activity. Whether timber is used as a building element part of a fencing structure or stored as an unused item they can provide an environment that is attractive to termite infestation.

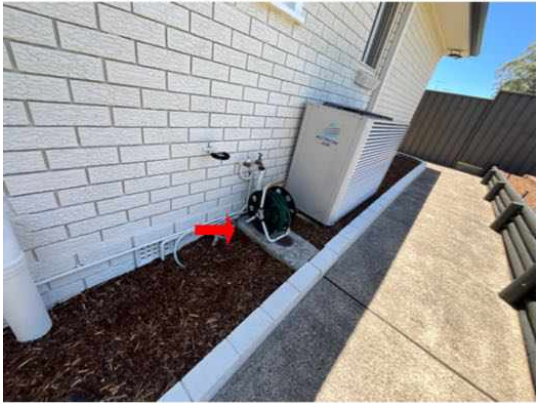
## Finding 6.08

Building: Main Building  
 Location: Multiple areas  
 Finding: Ant caps - Not installed  
 Information: Ant caps have not been installed to this area of the subfloor structure at the time of inspection. Generally, ant caps are installed to the intersection between the top of the stumps (or piers) and the subfloor structures.

Where ant caps have not been installed, frequent monitoring of these areas should be carried out in order to identify any signs of termite or timber pest workings.

A licensed builder must be appointed urgently to replace any missing ant caps.

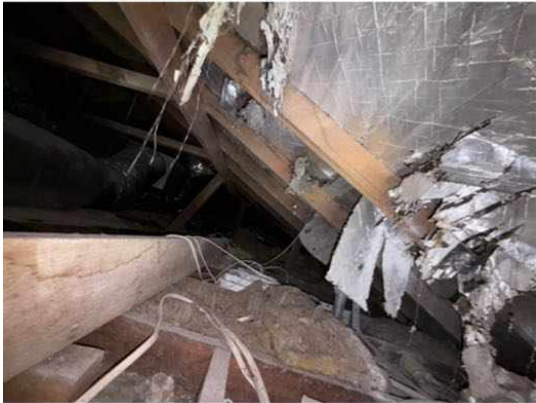
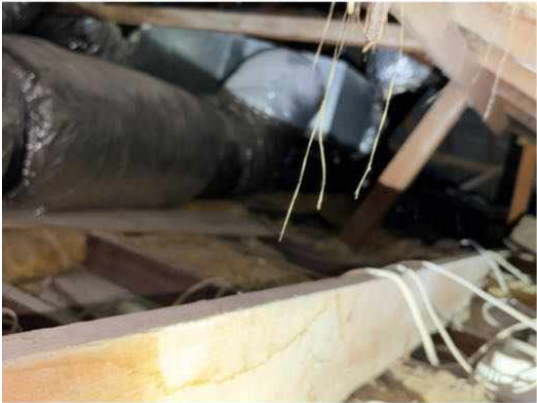
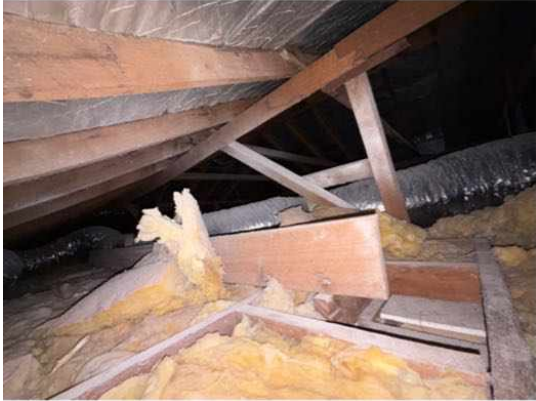
Building: Main Building  
Location: Roof Void  
Finding: Additional Photos  
Information:

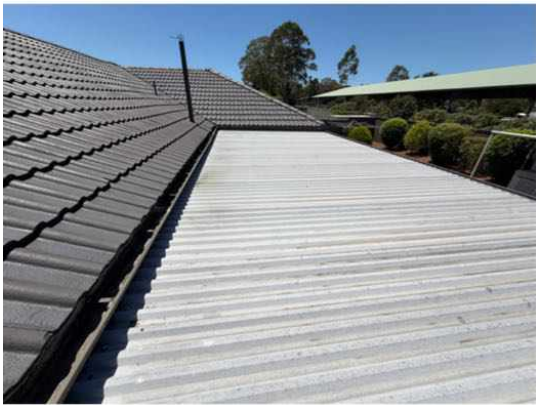
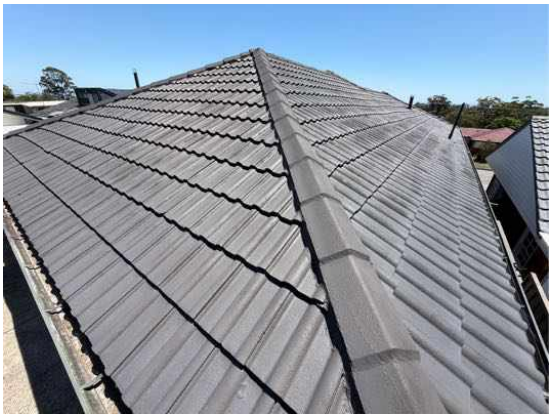
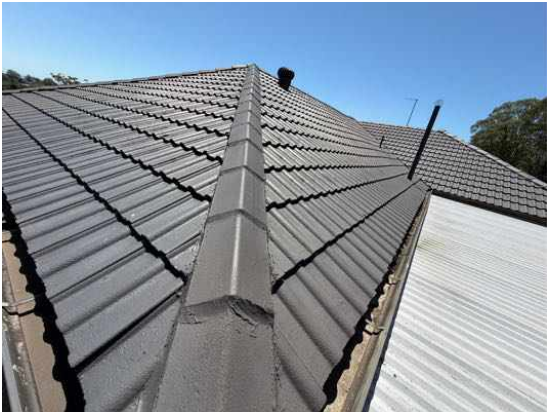
Building: Main Building  
Location: Roof Exterior  
Finding: Additional Photos  
Information:

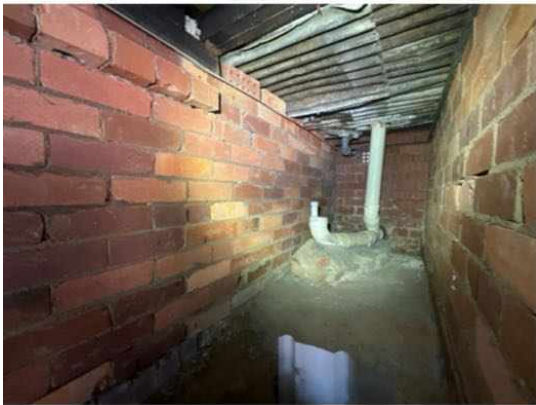
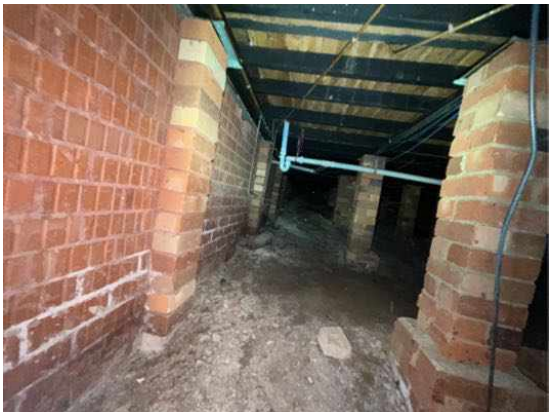
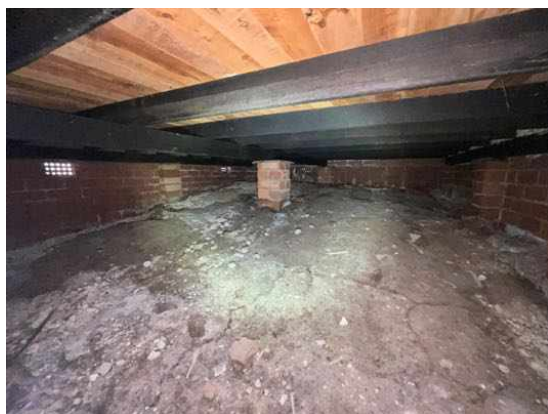
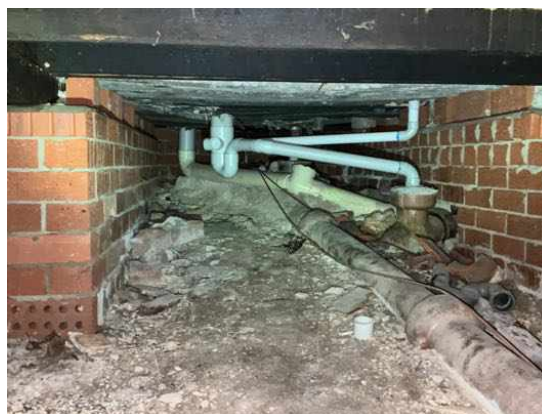
Building: Main Building  
Location: Subfloor  
Finding: Additional Photos  
Information:

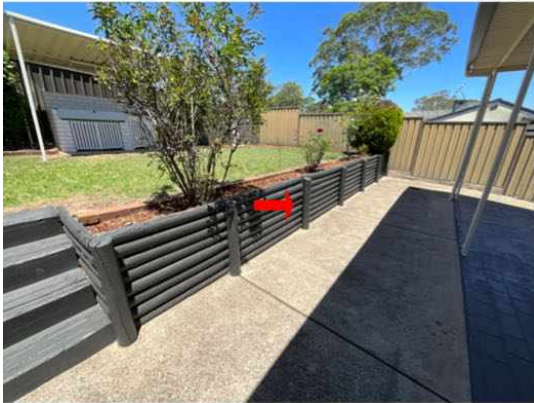
Building: Main Building  
 Location: Retaining walls  
 Finding: Retaining walls  
 Information: At the time of inspection the retaining walls were checked and no defects were observed other than those which May have been mentioned earlier in this report.

AS4349.1-2007 requires all retaining walls in excess of 700mm to be inspected by a licensed and practicing structural engineer.

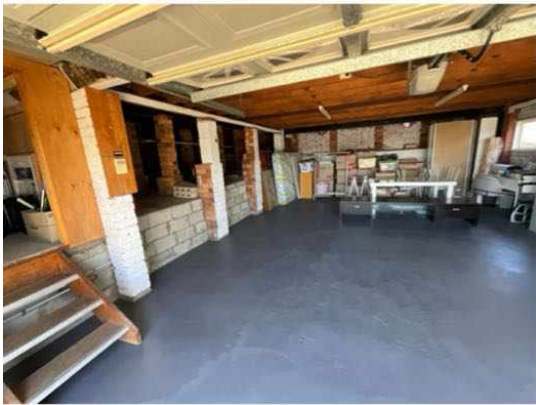
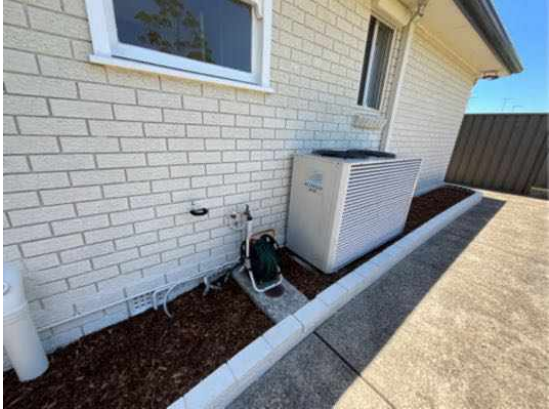
These photographs are an indication of the obstructions and limitations which impeded full inspection of the property at the time of inspection. These obstructions can hide an array of defects and should be removed to allow full inspection to be carried out. A re-inspection is recommended once the areas are made accessible.

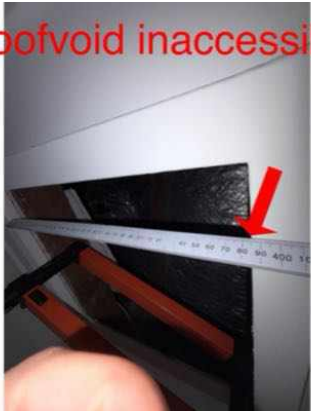
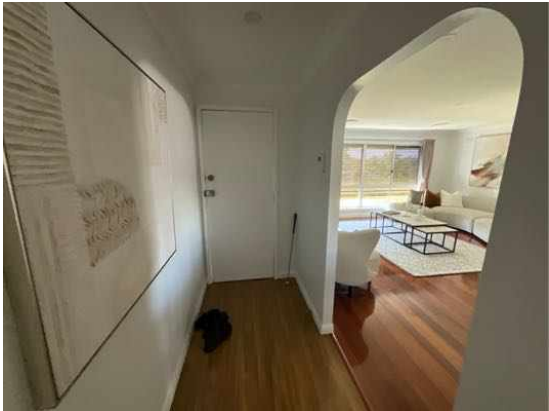
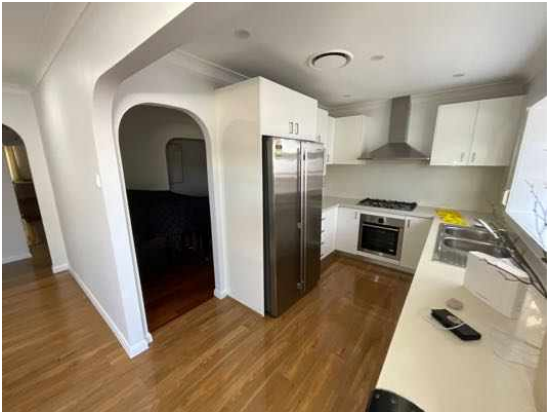
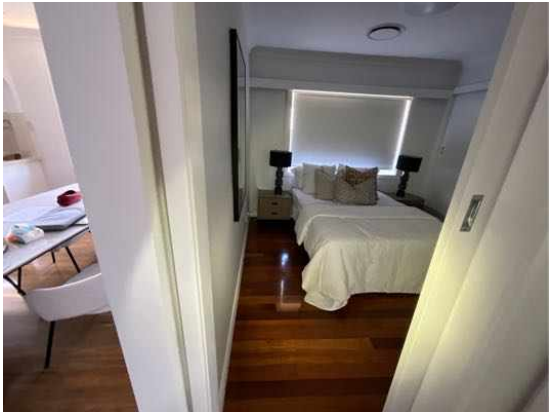
Roofvoid inaccessible
