Building and Timber Pest Inspection Report

Inspection Date: Mon, 12 Jan 2026

Property Address: 105 Eucalyptus Dr, Macquarie Fields NSW
2564, Australia

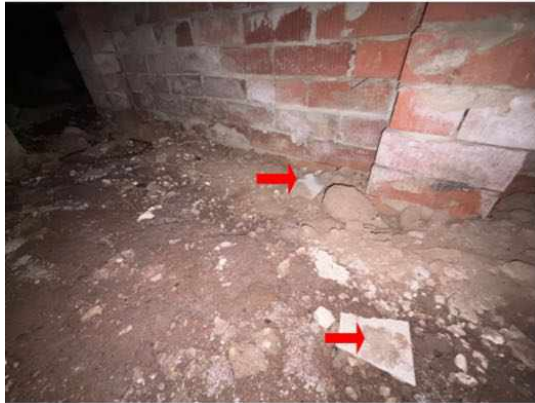
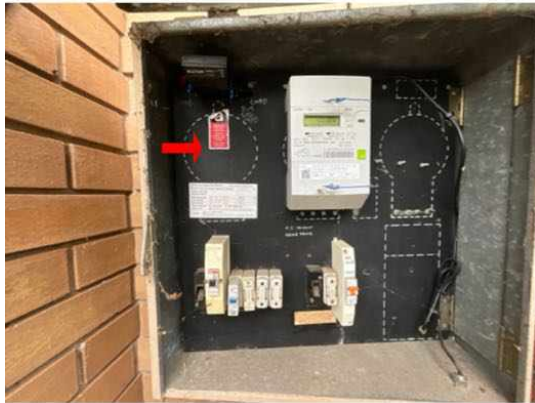
Building:	Main Building
Location:	Multiple areas
Finding:	Asbestos - Suspected ACM Identified on Site
Information:	Reporting on Asbestos is outside the Scope of this Report. This suspected defect is highlighted as a caution only. We suspect, based on our experience in the building industry, that there is a higher risk of the identified building element containing asbestos.

As Asbestos Reporting is outside the scope of this report, we advise that you consider a separate Asbestos Inspection and Condition Audit, which can include the taking of samples for definitive confirmation of the presence of Asbestos.

In the interim, the client is advised to act with caution, especially when considering any damage to building materials general wear and tear renovations extensions demolition and general maintenance activities due to the suspected presence of Asbestos.

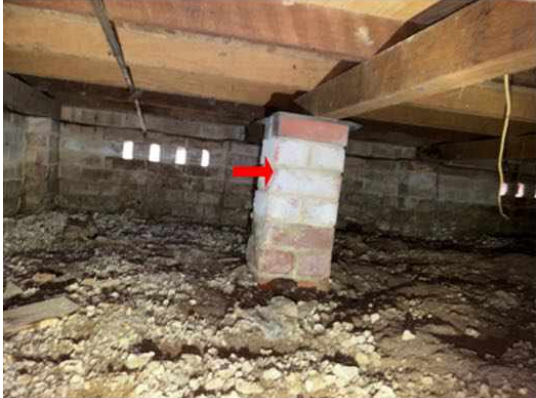
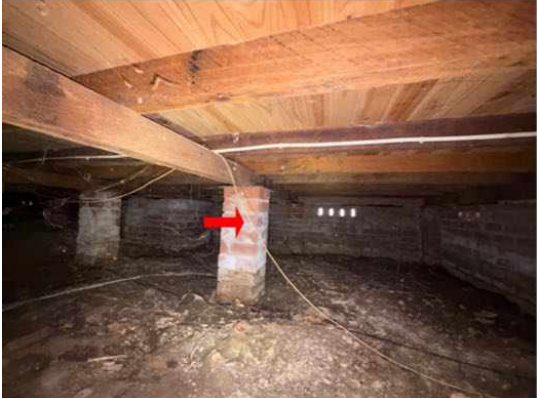
Building: Main Building
 Location: Subfloor
 Finding: Piers - Leaning
 Information: Pier to the subfloor structure is leaning, indicating that its structural integrity may have been affected. The cause of this instability is likely to be caused by movement / minor subsidence of the pier due to moisture.

Although only minor the pier should be monitored to avoid potential structural damage, which is likely to lead to a range of major and minor defects. Improving site drainage is recommended to avoid further movement / subsidence of the affected

pier.

If further movement is evident appointment of a structural engineer is advised to assess the condition of the piers and provide advice on remedial works that may be required.

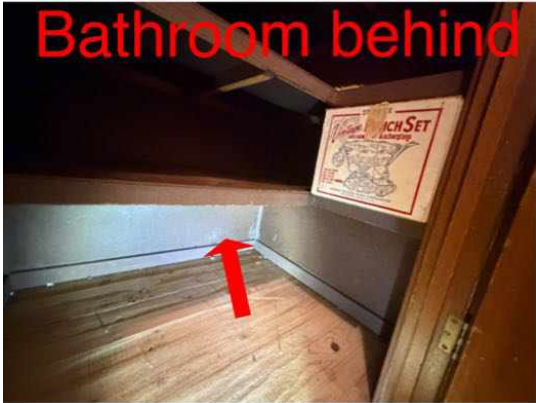
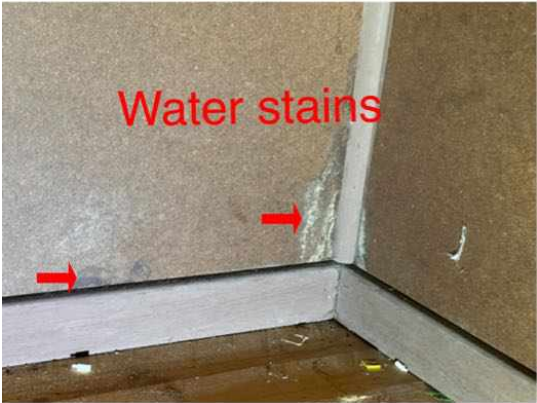
Finding 3.02

Building: Main Building
 Location: Bathroom
 Finding: Water leak - Inactive
 Information: Water leaks generally occur when a particular area of the property is not weather- or water-tight. While the damage in this area appears to be from an old inactive water leak, the area should be monitored frequently for the recurrence of any dampness.

Repair and / or replacement of previously affected building elements is at client discretion. Consider a further invasive inspection: removal of obstructions around the damaged area may reveal further damage which has been concealed. A more significant or major defect may be identified at this time.

Where recurrence of an active water leak is identified, a bathroom specialist should be appointed immediately to rectify the leak and advise on any further preventative works as necessary.

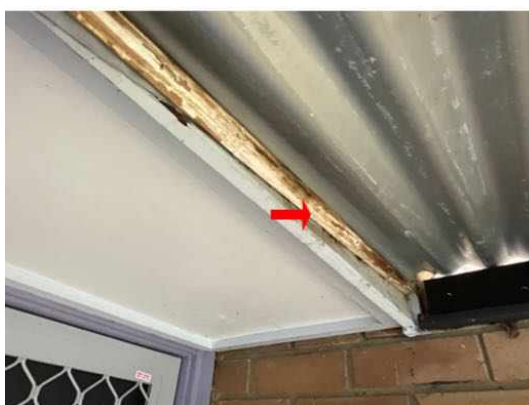
Finding 3.03

Building:	Main Building
Location:	Porch
Finding:	Damp - Rain penetration
Information:	Rain penetration (also known as penetrating damp) is a common form of dampness that can occur through walls, roofs or openings (e.g. windows). In this case rain penetration occurs through the defective roof flashing above.

Trades responsible for such works may include licensed roofing plumber.

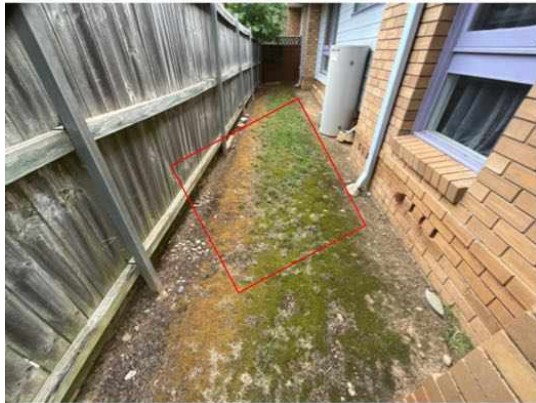
Finding 3.04

Building:	Main Building
Location:	Yard
Finding:	Site drainage— Inadequate
Information:	The site drainage in this area was found to be inadequate at the time of inspection, creating potential for subsequent water damage to associated building elements. This is additionally conducive to termite activity.

by large, regularly cleaned drains. Ground levels may need to be lowered to expose a buried DPC.

Where site drainage is inadequate, installation of an Agricultural (Aggie) Drain may be required. A licensed plumber should be appointed to further inspect the property and perform any remedial works as necessary. Water damage and secondary defects are likely to occur if left unmanaged.

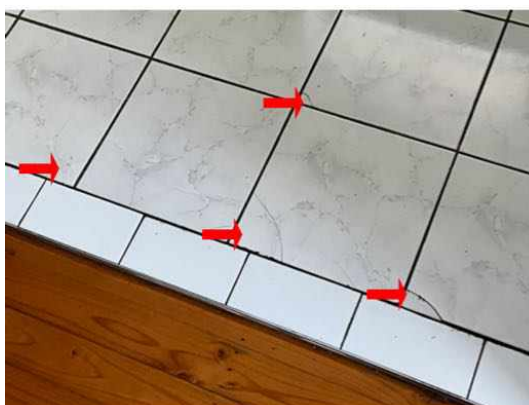
Building: Main Building
 Location: Kitchen
 Finding: Cracked floor tiles
 Information:

Cracking in the floor tiles was evident in this area at the time of inspection. It is suspected that this cracking has occurred as a result of minor settlement or shrinkage.

Cracked tiles throughout the household detract from the overall appearance of the affected areas however it is unlikely to create or lead to any secondary defects.

While not considered a matter of urgency, replacement of cracked floor tiles is recommended at the clients discretion. A licensed tiling contractor may be appointed to perform these works. Where cracks become more numerous, contact a licensed building inspector for further investigation.

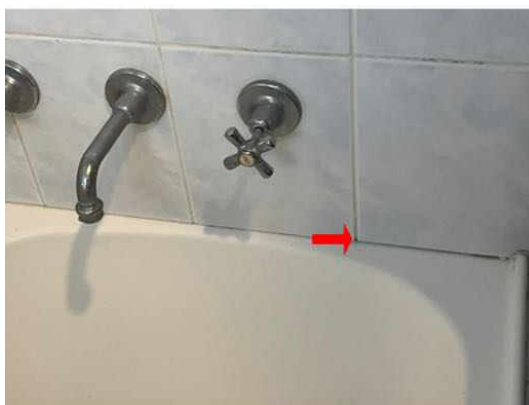
Finding 3.12

Building: Main Building
Location: All Wet Areas
Finding: Sealant and grouting - Missing or damaged
Information:

It was noted on inspection that sealant or grout is degraded to this area.

Different materials and floor areas move at different rates, generally causing cracking to grout or sealant at this point. A flexible sealant is required to allow for expected expansion and contraction, while keeping the joint water tight and protective of all associated building materials.

Flexible and mould resistant materials should be applied to affected areas to prevent any subsequent water damage that is likely to occur. Regular maintenance and replacement of damage or missing or damaged sealant and grout is highly recommended to the wet areas, as this is a regular wear and tear defect. Sealant and grouting in areas that come into regular contact with water should be maintained for the long term care of your property.

A sealant specialist should be appointed to complete these works as soon as possible.

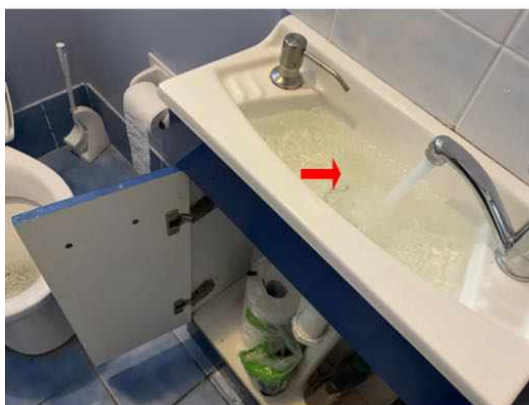
Finding 3.13

The sink/basin drain appeared to be partially blocked at the time of inspection. Blockages here are usually caused by hair and other debris. If left unmanaged, a lack of general maintenance may lead to the development of more significant defects, such as water damage to surrounding building materials.

A licensed plumber should be appointed to remove the blockage at the client discretion.

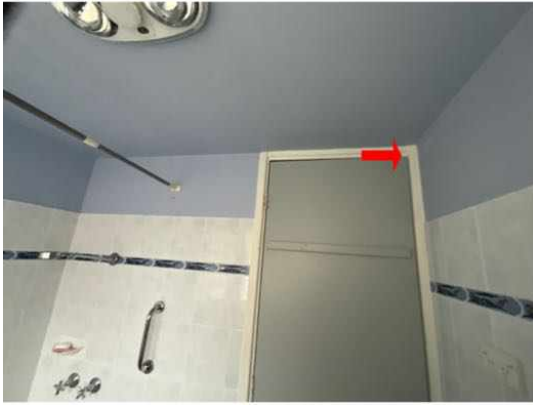
Finding 3.14

Building: Main Building
 Location: Bathroom
 Finding: Door - Binding/jamming
 Information:

Binding and/or jamming of this door is evident during standard operation. This defect inhibits the functionality of the affected door as well as creating potential for secondary defects to associated building elements, such as damage to the floor covering or adjacent frame.

A door that binds to flooring or to the associated door frame may have several causes, ranging from minor defects, such as poor installation of the door or deteriorated hinges.

A licensed carpenter should be appointed to perform minor rectification works at client discretion.

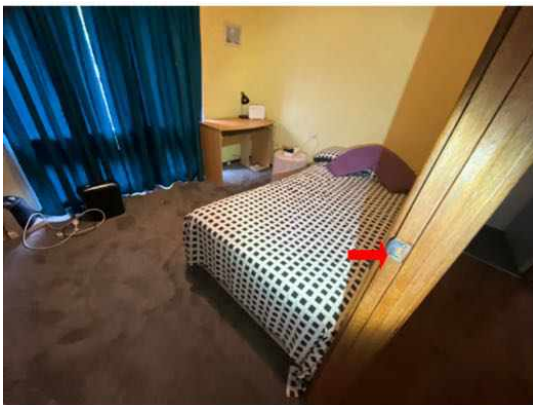
Finding 3.15

Building:	Main Building
Location:	Bedroom 2
Finding:	Door - Striker plate misaligned
Information:	The striker plate to this door appears to have become misaligned and has consequently resulted in the door's operation being compromised.

This is a common defect and is expected in a property of this age, whether being due to substandard installation or general deterioration of the door hardware.

Readjustment of the striker plate is recommended at client discretion. Works such as these can be completed by a general handyman or qualified carpenter.

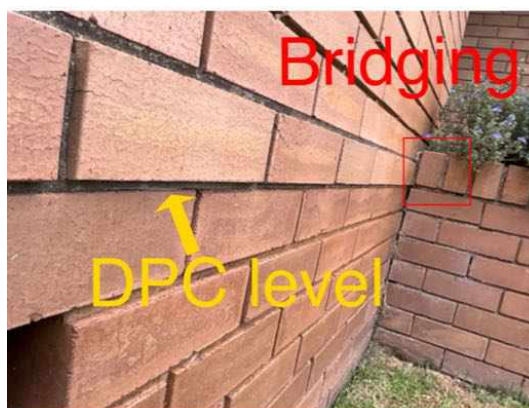
Damp proof course (DPC) is a barrier of impervious material built into a wall or pier to prevent moisture from moving to any part of the building. Where external ground levels are built up over this barrier ingress is provided for moisture from the exterior grounds into the base brickwork or other building material and allowed to rise.

Such conditions attract termites into these damp areas which is likely to lead to infestation if left untreated.

While retrospective fitting of DPC is considered to be impractical works are required in order to prevent the extraction of moisture from the external environment into exterior brickwork or wall materials. Landscaping or re-paving of external grounds may be considered by the client. Regular annual inspections are strongly advised.

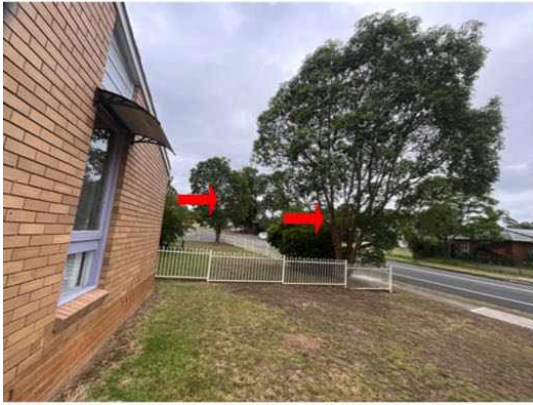
Finding 6.08

Building:	Main Building
Location:	
Finding:	Surrounding bushland - Conducive
Information:	Home and or building is situated in a high risk area for termite activity, due to close proximity to surrounding bushland.

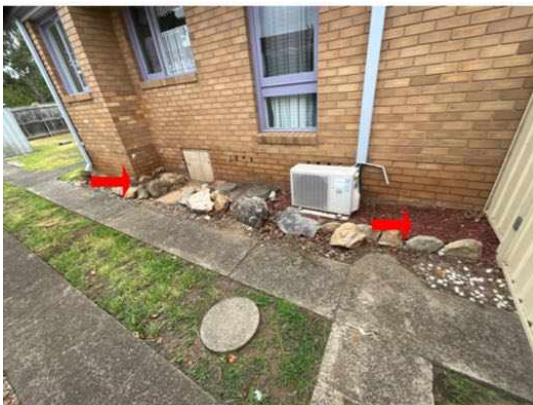
Finding 6.09

Building:	Main Building
Location:	Garden beds
Finding:	Garden Beds
Information:	Garden beds were found to be evident in the garden area. These garden beds can include untreated timber, and with a combination of moisture from watering hosing can make conditions conducive to termite activity and termite ingress.

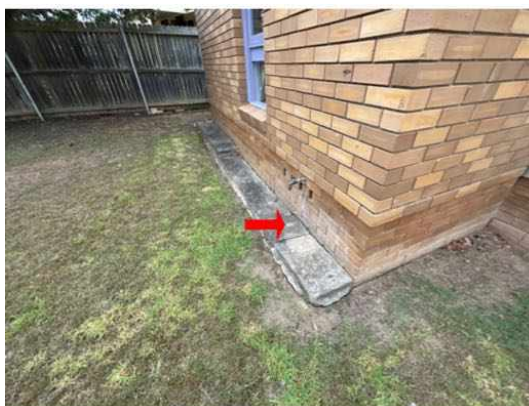
Finding 6.10

Building:	Main Building
Location:	External tap
Finding:	Tap - No drain
Information:	The external tap in this area was noted to have no drain at the time of inspection. This keeps the surrounding surfaces damp while using the tap, which becomes conducive to termite activity. A licensed plumber must be appointed to ensure an appropriate drain is installed.

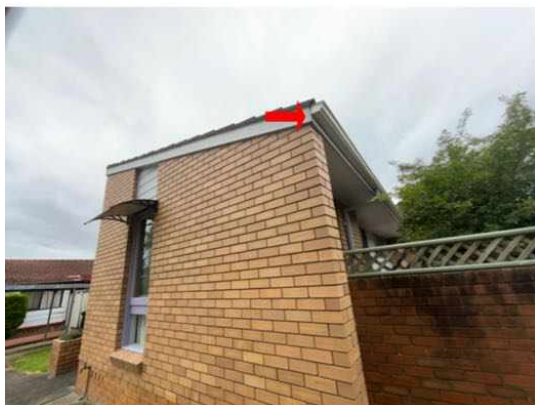
Finding: Fascias - Wood rot/decay

It is advised that a roof plumber be appointed to inspect all roof plumbing and subsequently identify the cause of the wood rot. Replacement of affected fascias and bargeboards may then be a necessary step in protecting surrounding building elements from such deterioration.

A licensed plumber may be appointed to assess the cause of excessive moisture and to provide advice on any remedial works as required. A licensed carpenter may also be required to replace affected building materials.

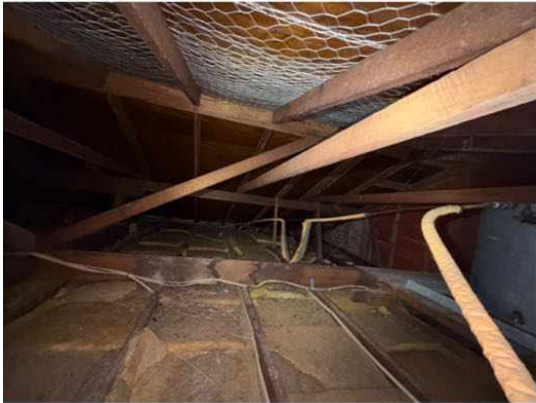
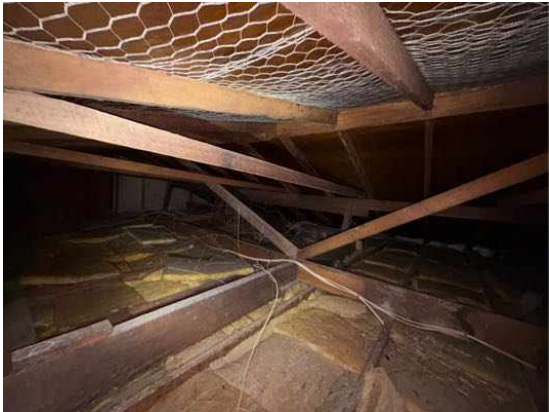
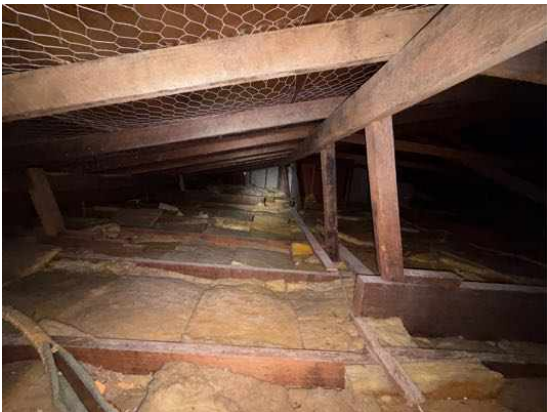
Building: Main Building
Location: Roof Void
Finding: Additional Photos
Information:

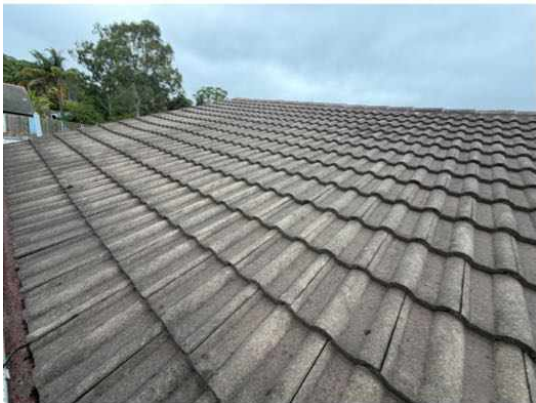
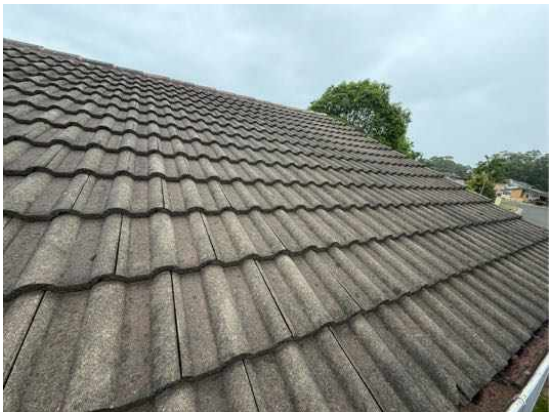
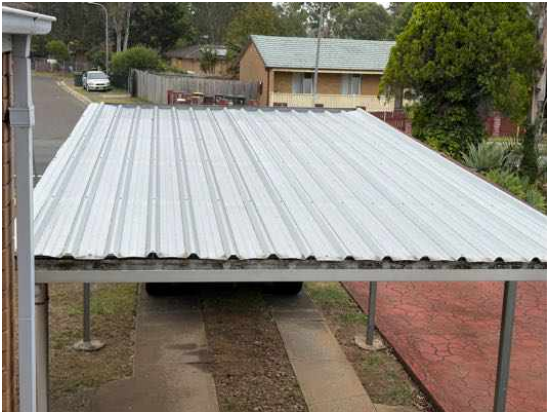
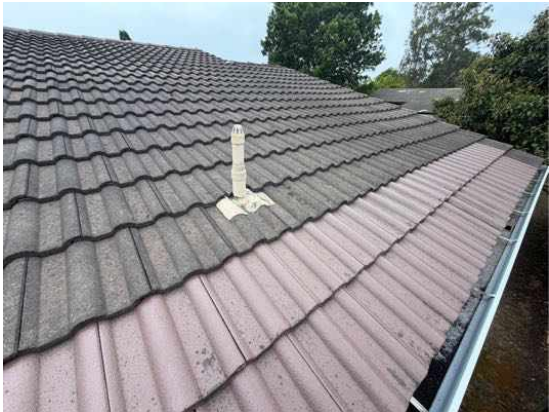
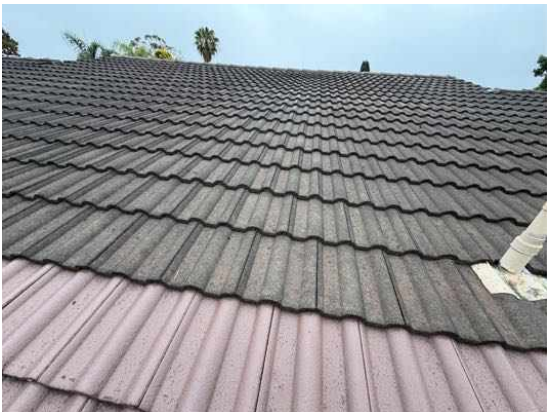
Building: Main Building
Location: Roof Exterior
Finding: Additional Photos
Information:

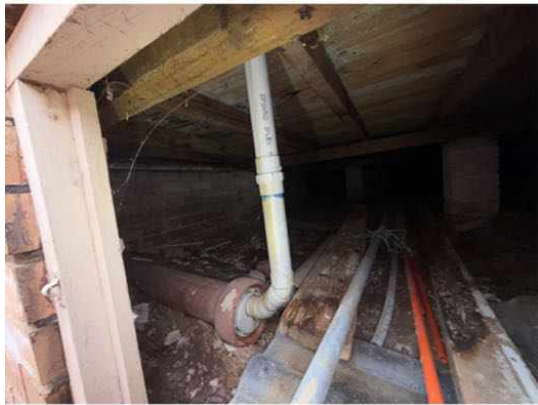
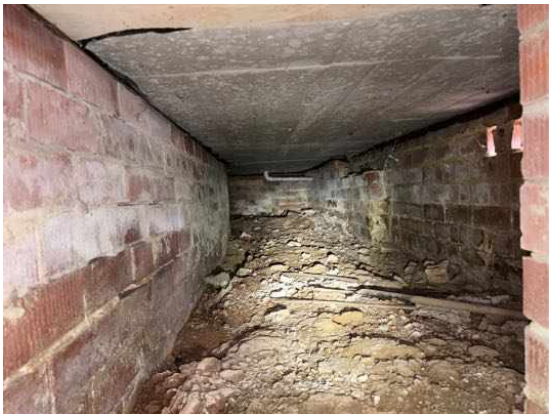
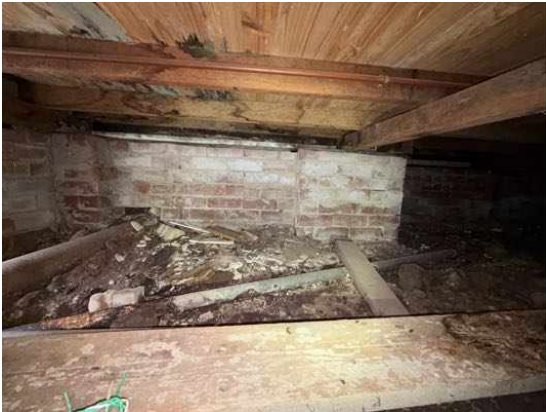
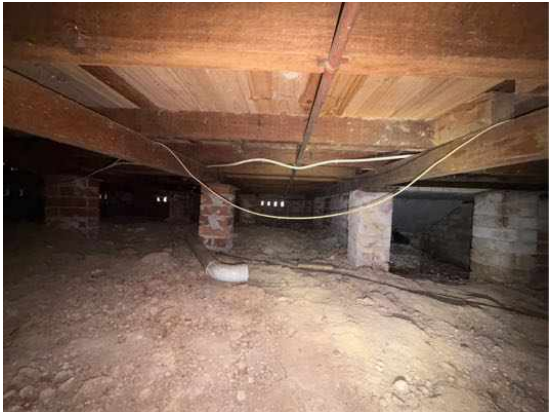
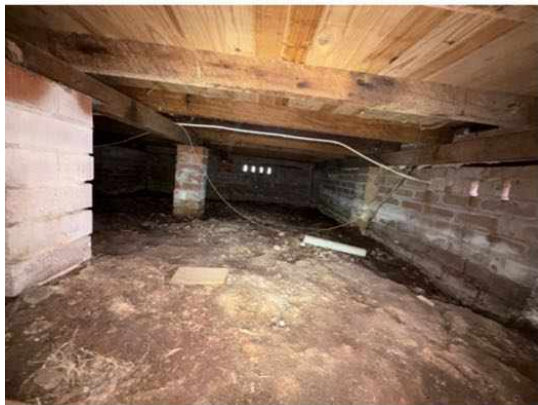
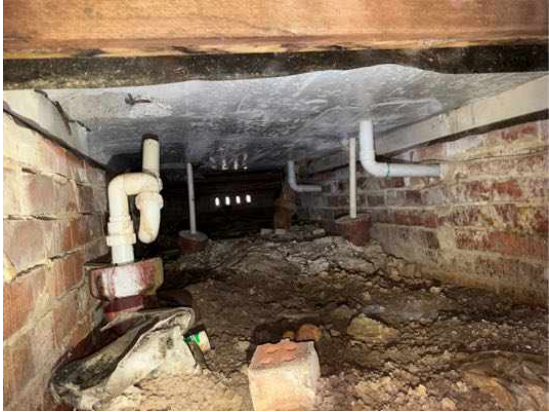
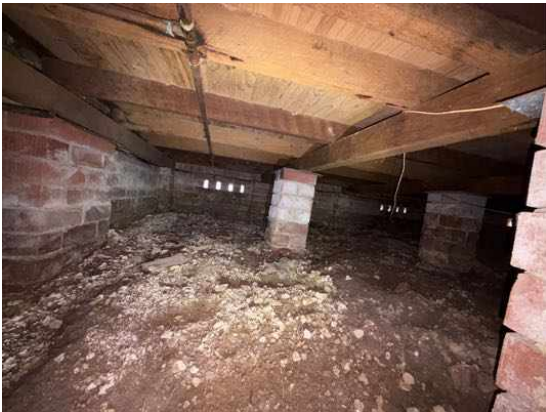
Building: Main Building
Location: Subfloor
Finding: Additional Photos
Information:

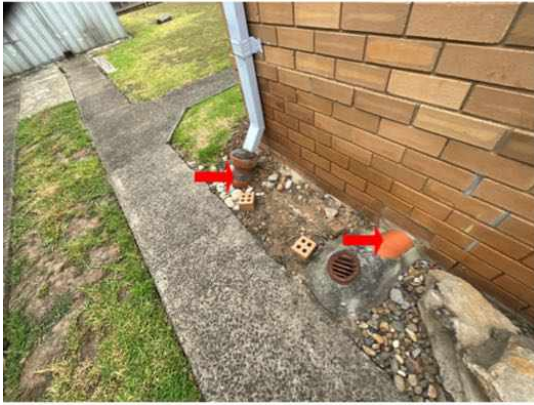
Building: Main Building
 Location:
 Finding: Pipework - Old urban wear pipes
 Information: Old urban wear pipes were identified at the time of inspection.

Consultation with a licensed plumber is advised. CCTV inspection on pipes may be required.

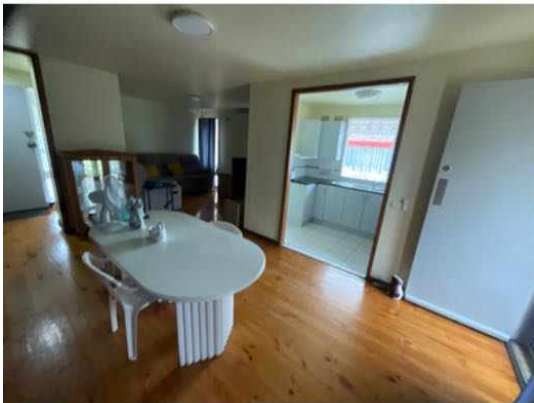
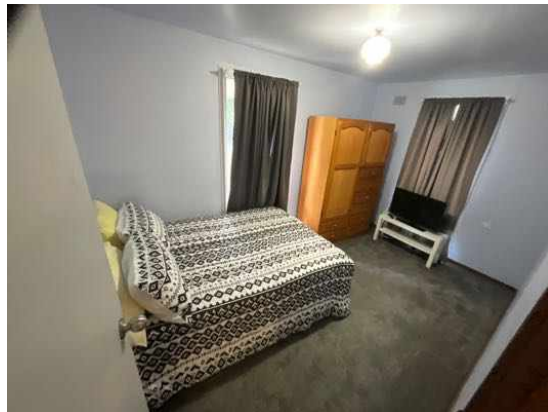
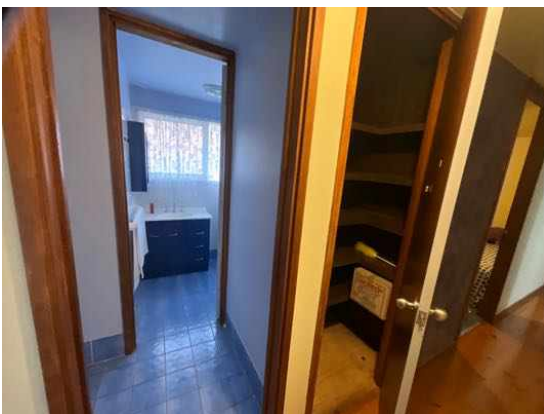
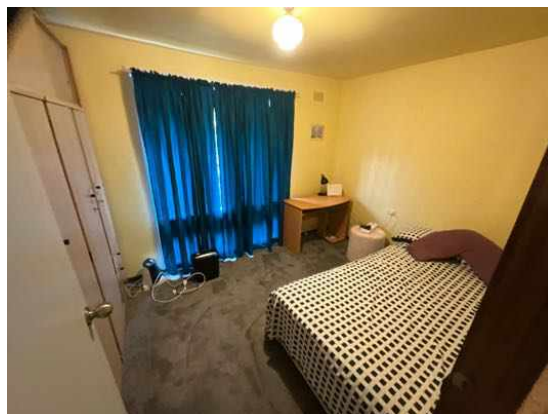
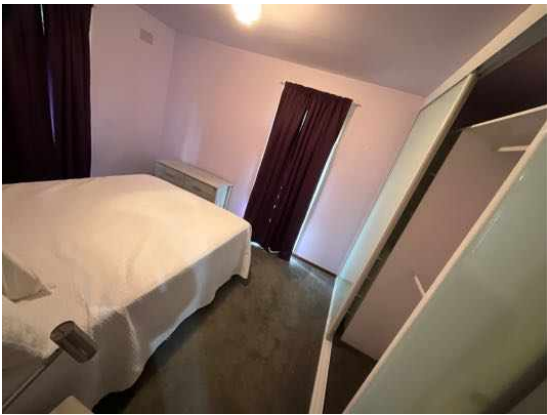
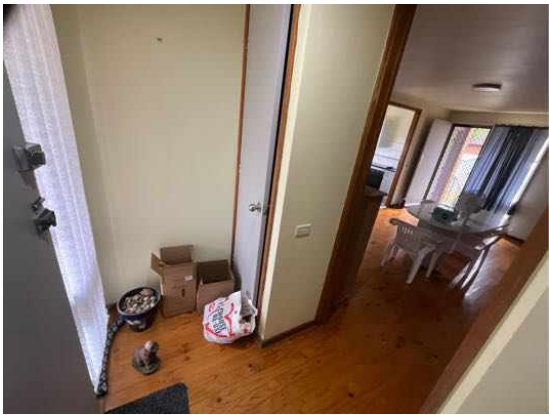
Building: Main Building
 Location: All Areas
 Finding: Additional Photos - Obstructions and Limitations
 Information:

These photographs are an indication of the obstructions and limitations which impeded full inspection of the property at the time of inspection. These obstructions can hide an array of defects and should be removed to allow full inspection to be carried out. A re-inspection is recommended once the areas are made accessible.
