Building and Timber Pest Inspection Report

Inspection Date: Tue, 17 Feb 2026

Property Address: 16 Abernethy St, Shepparton VIC 3630,
Australia

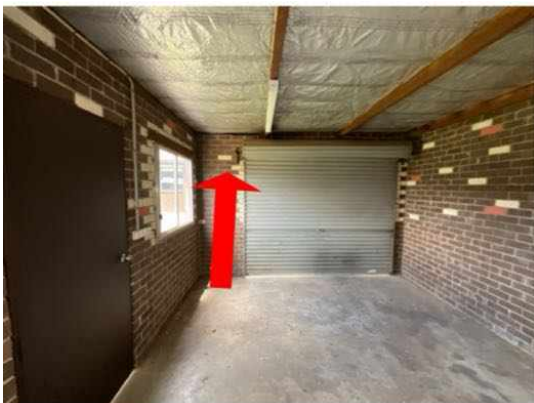
Building: Building 1
Location: Garage
Finding: Brickwork - Cracking noticeable
Information: There were several cracks and or crack repairs evident to external brickwork.

Noticeable cracks are a common occurrence in external brickwork and are a likely result of age expected building movement, general expansion, and/or contraction of building materials in different weather conditions. Noticeable cracks in brickwork may develop if left unattended, with potential for necessitating major remedial works or replacement of the brickwork.

It is highly advised that a qualified bricklayer be appointed to provide necessary works to cracked brickwork to prevent any further damage. Such works should be conducted as soon as possible.

Always monitor these cracks and contact a building inspector should cracks widen, lengthen, or become more numerous.

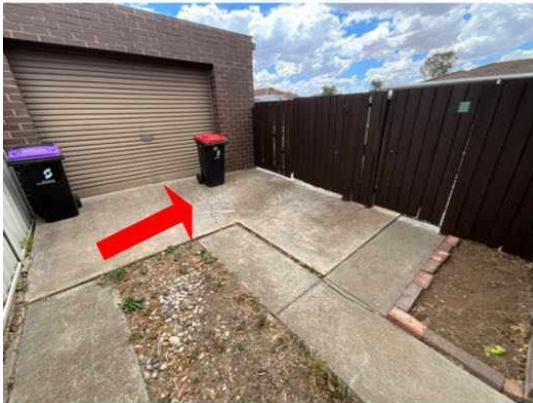
Cracking to this degree may also be due to poor original installation of the concrete. Factors such as poor compaction of the sub surface and/or inadequate reinforcing of the slab may create cracking and other secondary defects. Gaps in the concrete paving may also have a more significant structural cause, such as subsidence of soils.

Where gaps in the concrete paving are adjacent to structural elements of the building, the advice of a Structural Engineer is advisable before undertaking repairs. Significant repair and likely replacement of the concrete paving is probable.
