# Building and Timber Pest Inspection Report

Inspection Date: Fri, 16 Jan 2026

Property Address: 77 Diamond Parade, Skye VIC 3977,  
Australia

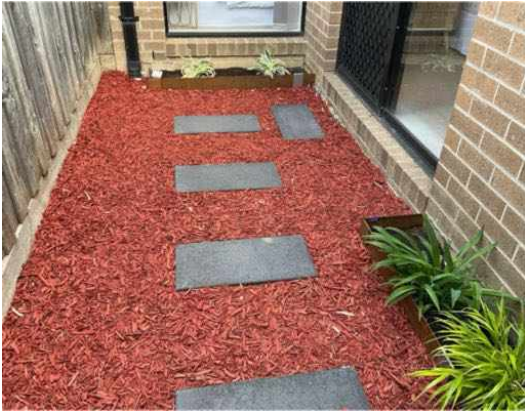
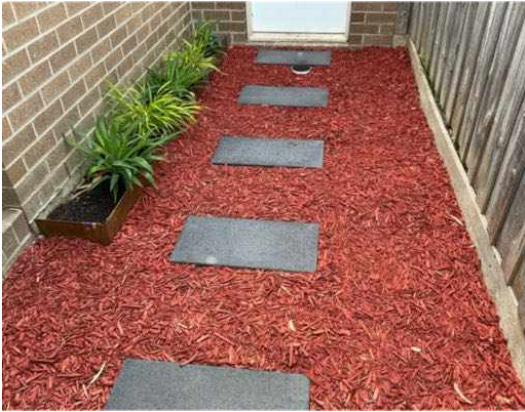
Building: Main Building  
Location: Yards  
Finding: Paving - loose/uneven  
Information: Sections of the external paved area are loose/uneven, creating a potential trip hazard. It appears as though the area has been subject to rough installation.

Where paving creates a trip hazard, personal injury may ensue if due caution is not taken by all persons within this area.

Re-paving of the area is required as soon as possible to remedy this situation. Further consultation with a specialist paver is advised.

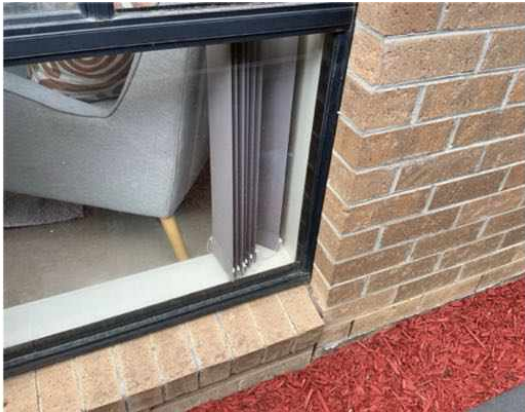
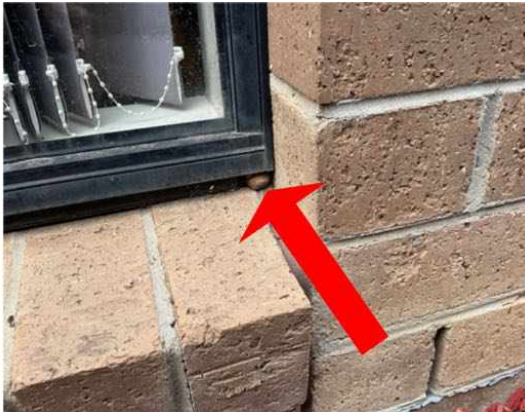
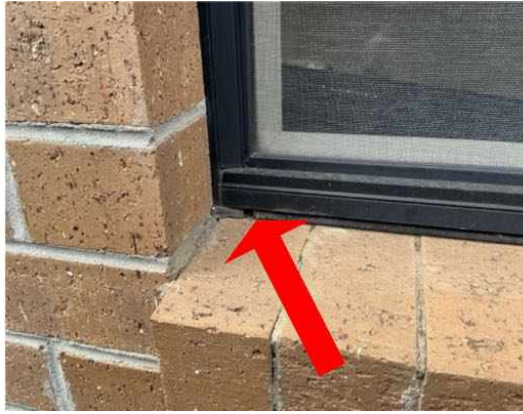
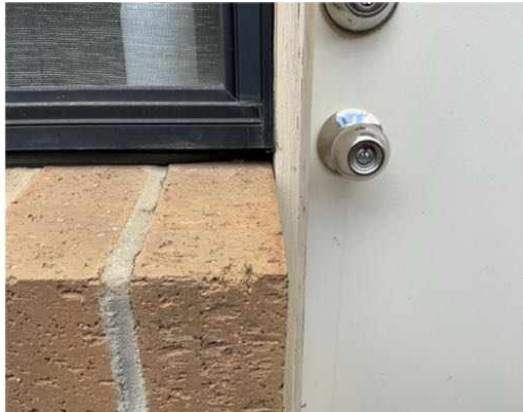
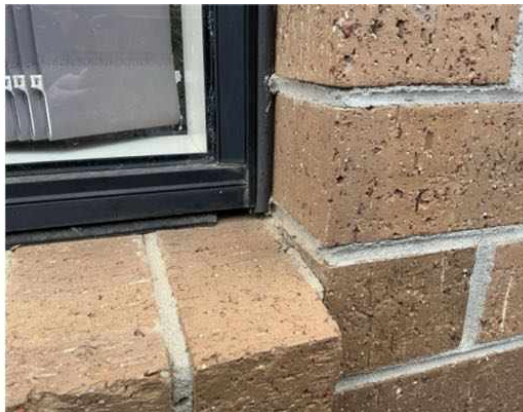
**Finding 3.02**

Building: Main Building  
Location: Various parts of the building  
Finding: A few gaps to the exterior walls/windows  
Information: A few gaps were noticed to some of the exterior walls/windows to the building. These gaps can let in water, drafts, and pests. Overtime moisture ingress may cause damage to internal walls, mould growth, or structural issues. Gaps also reduce the energy efficiency of the property. Recommend engaging a caulker to seal gaps with an exterior grade flexible sealant that is UV and weather resistant to reduce the risk of pest/water penetration to the building as soon as possible.

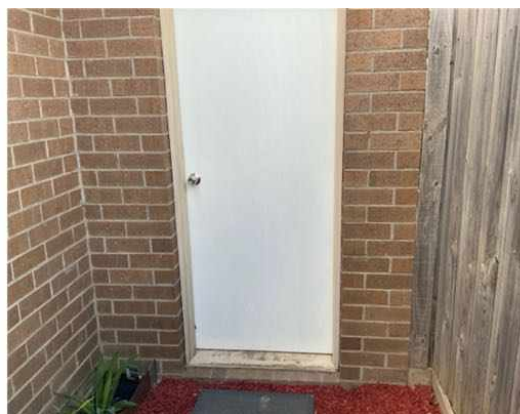
### Finding 3.03

Building:	Main Building
Location:	Laundry and garage
Finding:	External painting deteriorated
Information:	Parts of the external paintwork has been neglected and requires attention to prepare and re-paint.

Whilst incomplete or missing paint finish is generally an appearance defect, it can also lead to the development of secondary building defects over time. Incomplete areas of paint finish expose the area to moisture, potentially accelerating the deterioration of underlying building materials.

Degraded paint finishes should be sanded back, filled, leveled and painted, as applicable. Where inadequate or missing paint protection has led to the deterioration of the associated building element, repair and/or replacement of this building element may be required.

A painting contractor should be appointed as soon as possible to perform necessary works to aid the appearance of the affected area and to ensure the area is protected against further deterioration. Alternatively, the homeowner following manufacturer instructions may perform these works.

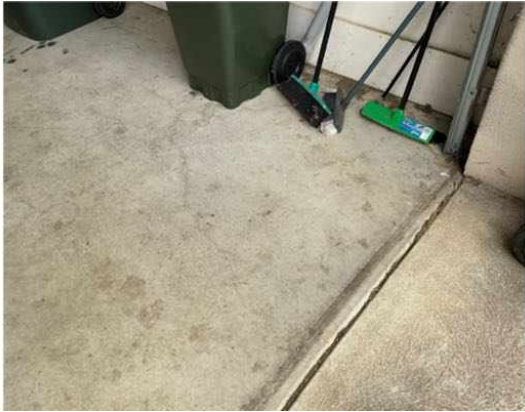
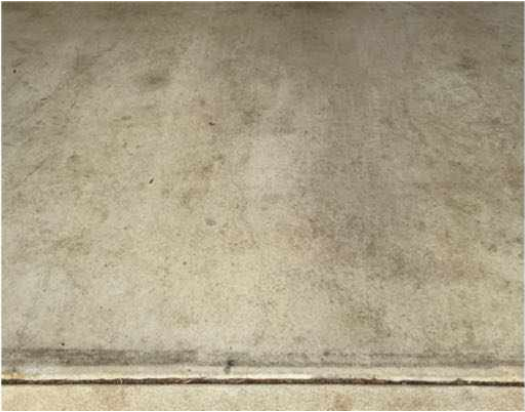
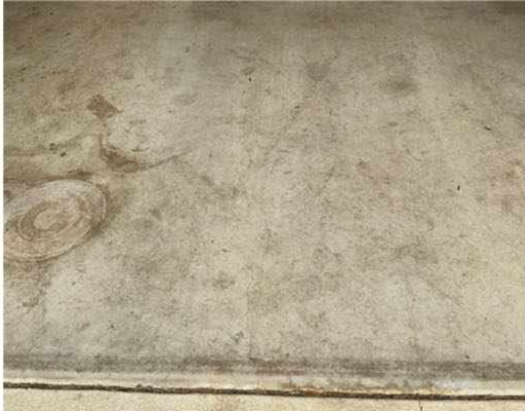
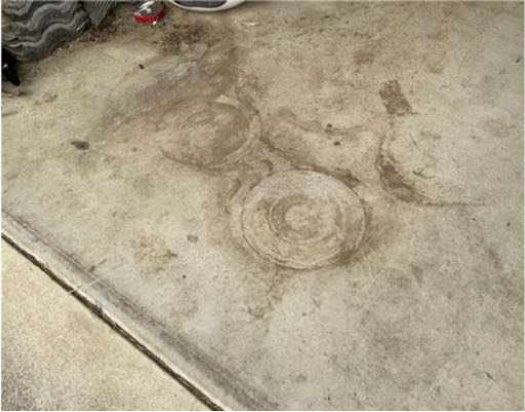
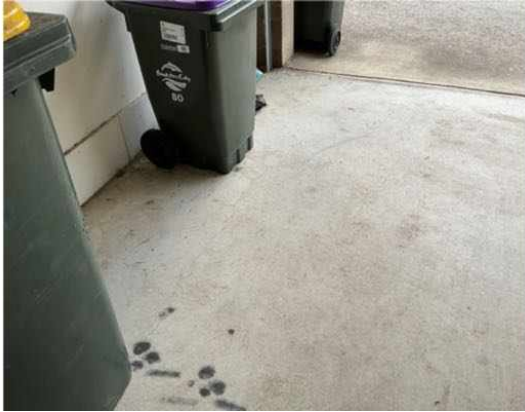
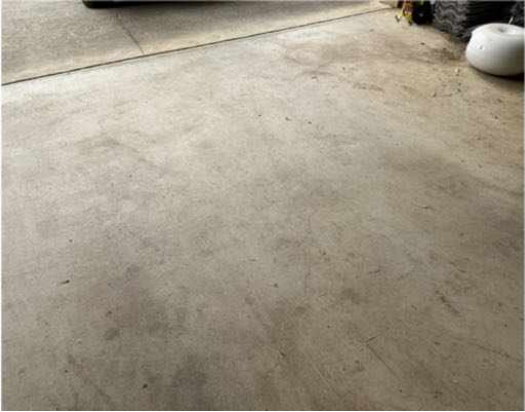
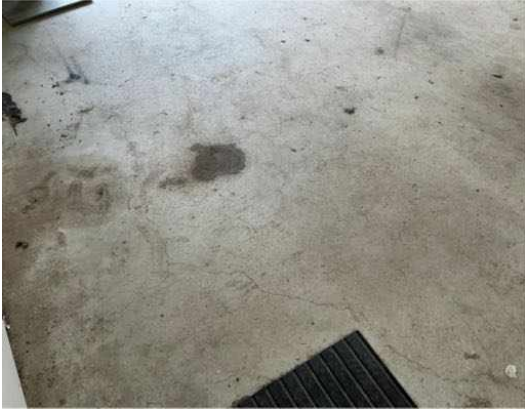
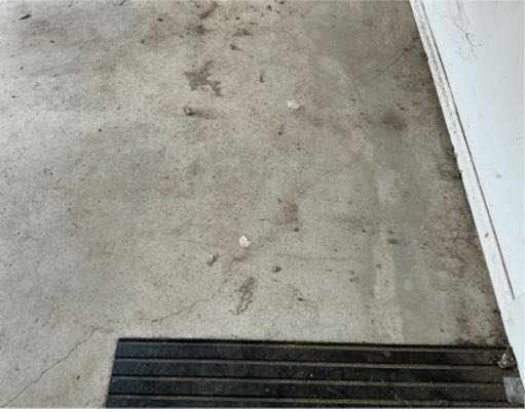
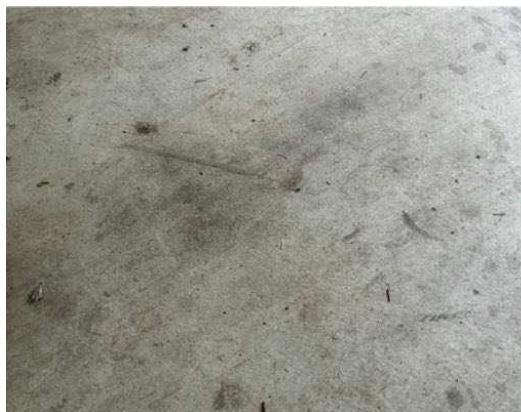
### Finding 3.04

Building:	Main Building
Location:	Garage
Finding:	Garage Cracking - External Concrete Paving Damage Category 1 - Fine (less than 2mm)
Information:	Fine cracks were identified in the garage concrete paving. Although fine cracks are quite noticeable, they are often only considered to be an appearance defect, and usually do not indicate any structural damage. To be considered a Category 1 or fine crack, the crack is found to be less than 2mm in width.

Generally the cause of a hairline crack in existing concrete paving such as driveways and pathways is indicative of the expansion and contraction of the concrete. Such causes are generally due to environmental factors, such as moisture levels, weather conditions, root systems of nearby trees or the soil types on which they are laid.

Fine cracks may also be due to poor original installation of the concrete. Factors such as poor compaction of the sub surface and/or inadequate reinforcing of the slab may create cracking and other secondary defects.

Monitoring of all cracking should be conducted frequently. Always contact a building inspector should cracks widen, lengthen, or become more numerous.

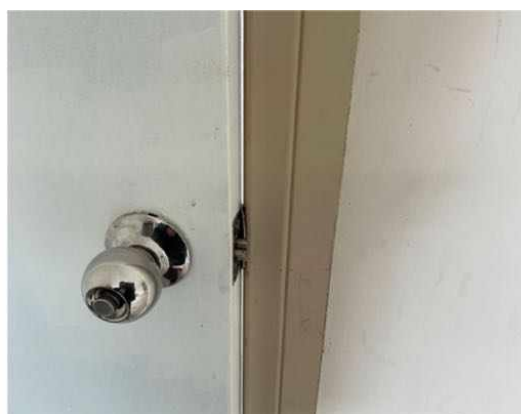
### Finding 3.05

Building: Main Building  
 Location: Garage  
 Finding: Door - Binding/jamming garage  
 Information: Binding and/or jamming of the garage door is evident during standard operation. This defect inhibits the functionality of the affected door as well as creating potential for secondary defects to associated building elements, such as damage to the floor covering.

A door that binds to flooring or to the associated door frame may have several causes, ranging from minor defects, such as poor installation of the door or deteriorated hinges.

For minor causes, a qualified carpenter or general handyperson should be appointed to perform minor rectification works at client discretion.

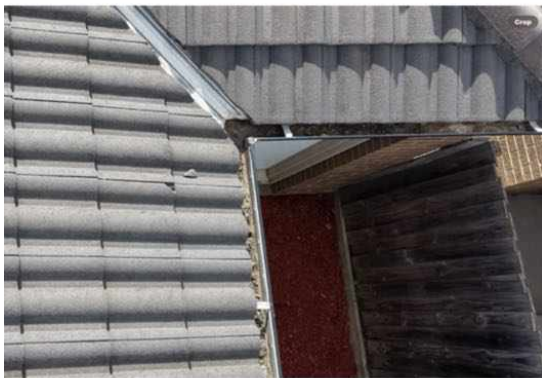
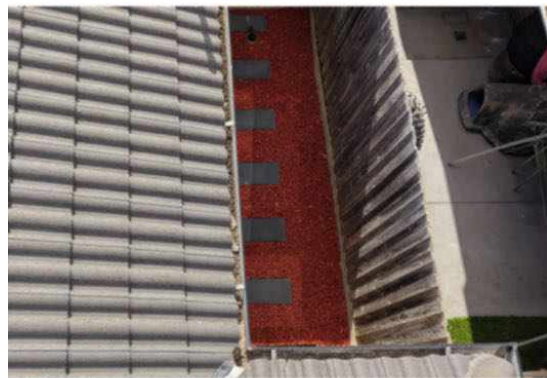
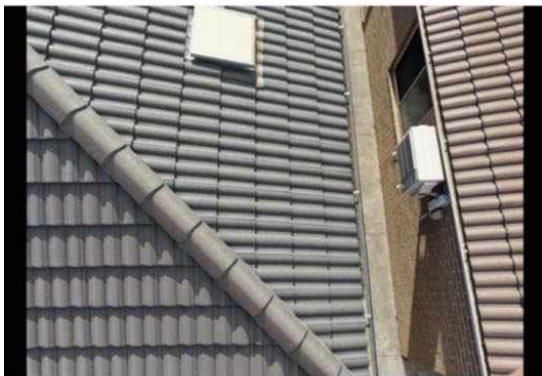
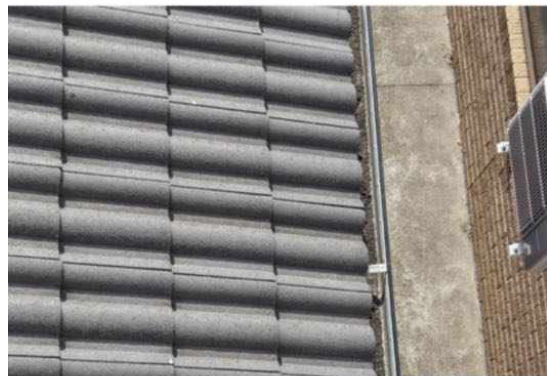
### Finding 3.06

Building: Main Building  
 Location: Roof Exterior  
 Finding: Gutters -Partially Blocked with debris  
 Information: It was noticed on inspection that some of the gutters were partially blocked with

Blocked gutters are likely to lead to high levels of moisture in the affected areas. Such moisture will not only cause rust and decay of the associated building materials, but can also provide conditions that are conducive to termite and timber pest activity. Blockages in gutters should therefore be removed immediately to ensure dry conditions are maintained.

Consult a Licensed Plumber for further specific advice on remedial works that may be required. In the interim, it is highly advised that blocked gutters be removed by the homeowner or a general handyperson as a matter of urgency.

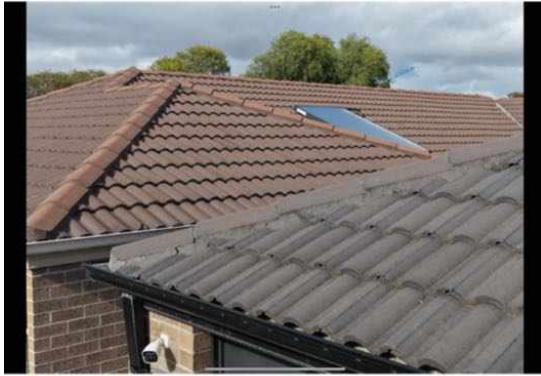
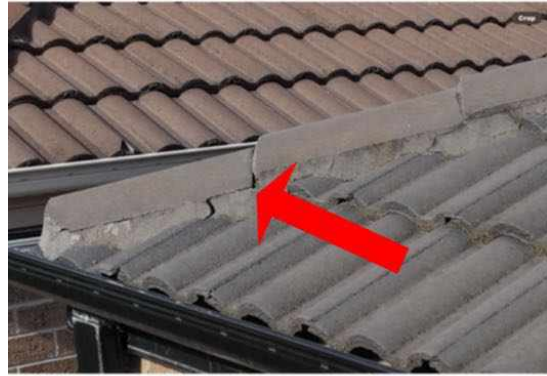
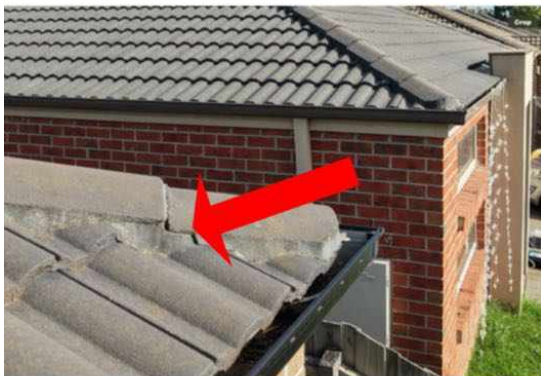
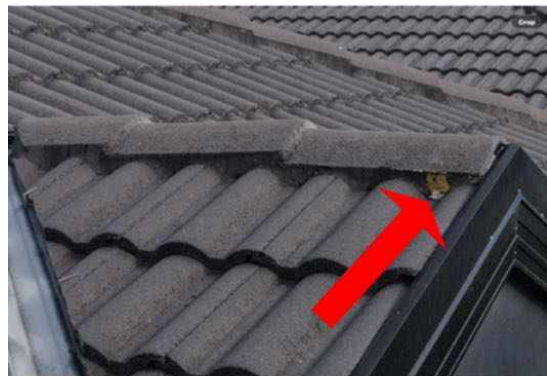
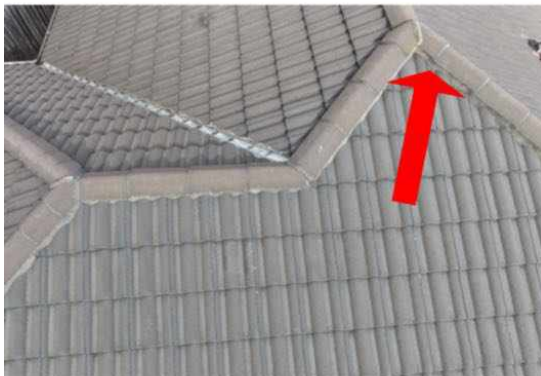
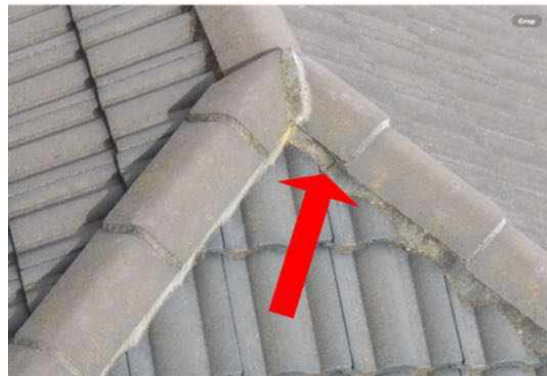
### Finding 3.07

Building:	Main Building
Location:	Roof Exterior
Finding:	Roof tile mortar deterioration and cracking
Information:	Cracking and deterioration was observed in the ridge and hip tile mortar bedding. The mortar has separated in several areas, with visible gaps forming between ridge tiles and the underlying bedding. This condition indicates age-related degradation and exposure to the elements, which has caused the mortar to become brittle and lose its bonding integrity.

Compromised mortar may lead to further deterioration, potentially allowing water ingress and structural damage to the roof structure below.

Recommend engaging a qualified roofing contractor to carry out repointing or full re-bedding of affected ridge and hip tiles as necessary. All deteriorated mortar should be removed and replaced with new flexible roof bedding compound in accordance with current Australian Standards (AS 2050).

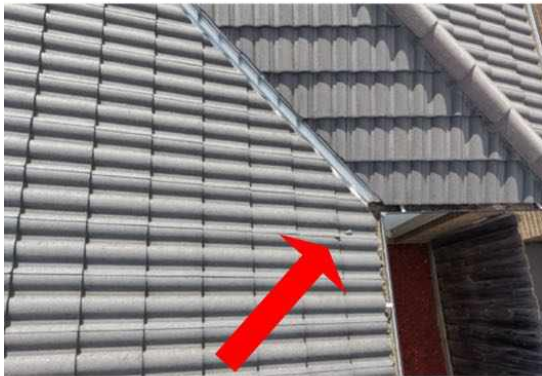
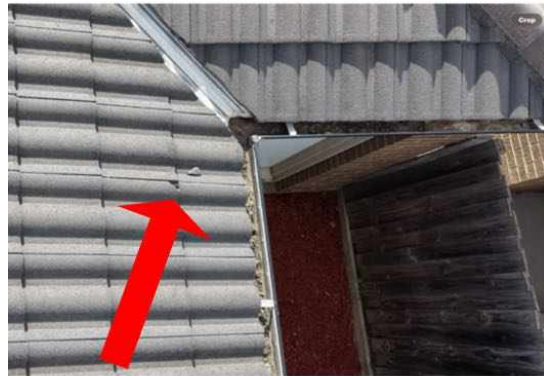
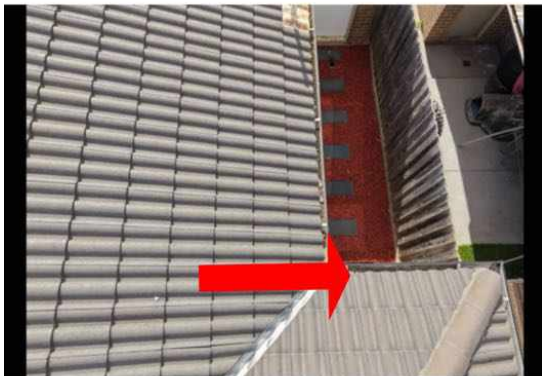
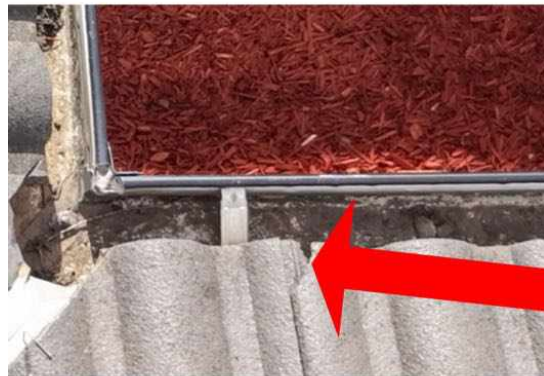
### Finding 3.08

Finding: Roof tiles- Broken

Information: Upon inspection of the exterior roof covering, broken roof tiles were identified. Broken tiles are generally the result of ageing and weathering of what is essentially a porous material.

If left to further deteriorate, broken and brittle roof tiles are likely to lead to water penetration via the roof into the ceiling space, causing excessive moisture and secondary damage to ceiling linings, insulation and roof structures. Broken roof tiles are also likely to detract from the effectiveness of the roof drainage system, creating

potential for secondary damage to the exterior roof covering and roof plumbing. Excessive moisture could attract termites.

Replacement of broken tiles is required and should be performed by a roofing contractor as soon as possible.

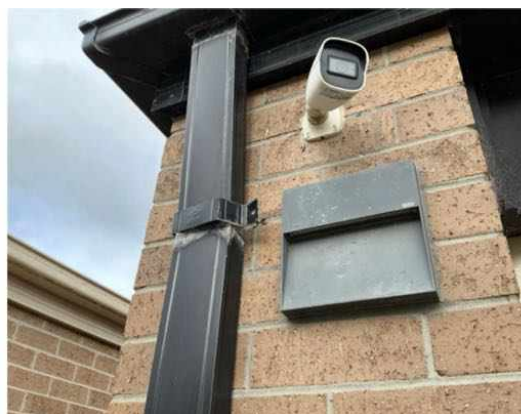
### Finding 3.09

Building:	Main Building
Location:	Exterior walls - front
Finding:	Down pipe clips loose
Information:	The down pipe clips to the front left of the building have come loose due to poor installation.

It is recommended that a plumber be appointed to further inspect the area and to install/repair clips where necessary at the owners discretion.

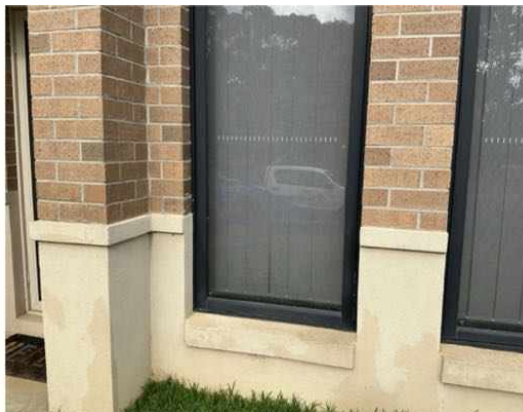
Finding: Flyscreen damaged

Information: The living room flyscreen was found to be damaged at the time of inspection. This can happen overtime with deterioration in harsh weather conditions or accidental impact damage.

Where not replaced, damaged flyscreens allow pest and insect ingress into the adjoining room/s. It is advised that all damaged flyscreens be replaced in order to ensure the full function of all building structures.

A general handyperson may be appointed to replace flyscreens at the discretion of the client.

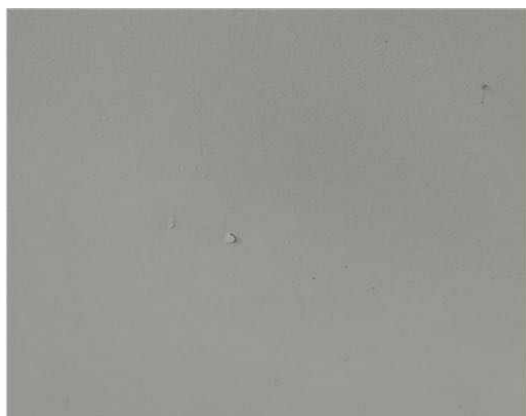
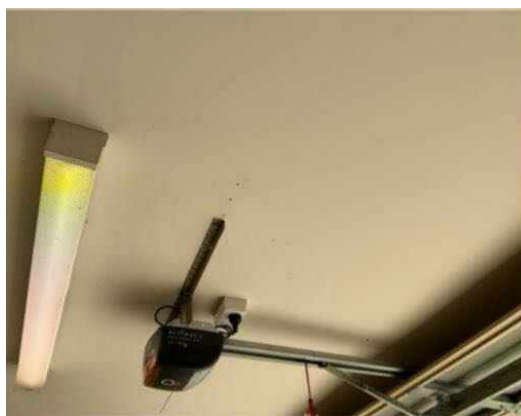
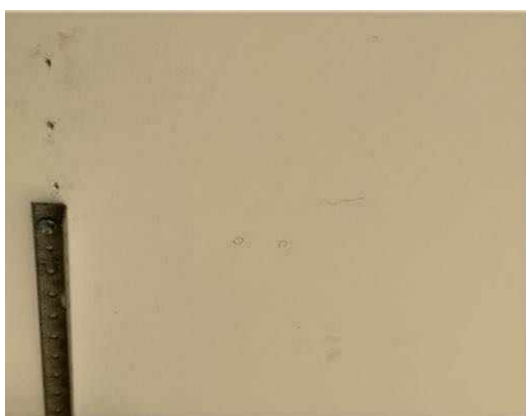
### Finding 3.12

Information: Sections of the garage ceiling were found to be sagging, and some of the nails were popping at the time of inspection. Sagging to the fixed ceiling structure generally

indicates that the building materials/fixings (e.g. nails or glue) have become loose and require reattachment. This is quite a common defect in garages of this age. It is suspected that internal plaster is used where wet board plasterboard should be used and it gets affected by the moisture and condensation in the air. There is normally no insulation in the garage ceiling allowing the moisture to accelerate the deterioration.

Where sagging is evident repairs such as re-gluing or replacing of ceiling sheets, may be required. Such works may be performed by relevant tradespeople, such as plasterers and painters.

The appropriate action should be taken by the client as soon as possible to ensure that any potential further damage is limited.

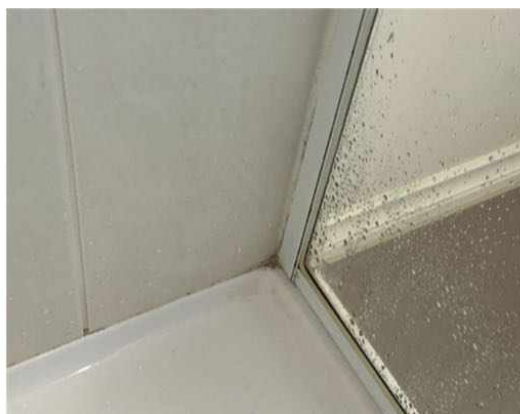
Building:	Main Building
Location:	Ensuite - Master
Finding:	Bathroom Sealant and grouting - Missing or damaged
Information:	It was noted on inspection that sealant or grout is degraded to the tiled shower alcoves and or other areas of the bathrooms.

Different materials and floor areas move at different rates, generally causing cracking to grout or sealant at this point. A flexible sealant is required to allow for expected expansion and contraction, while keeping the joint water tight and protective of all associated building materials.

Flexible and mould resistant materials should be applied to affected areas to prevent any subsequent water damage that is likely to occur. Regular maintenance and replacement of damage or missing or damaged sealant and grout is highly recommended to the wet areas, as this is a regular wear and tear defect. Sealant and grouting in areas that come into regular contact with water should be maintained for the long term care of your property.

A sealant specialist or tiling contractor should be appointed to complete these works as soon as possible

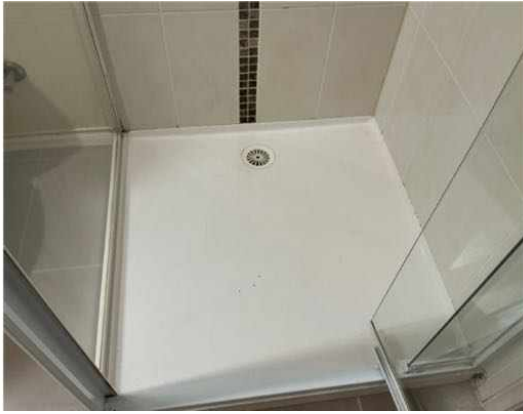
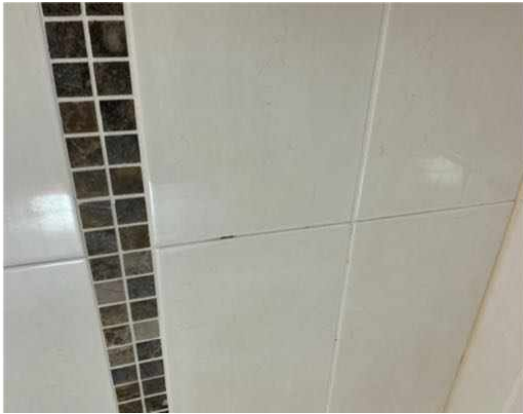
### Finding 3.14

Building:	Main Building
Location:	Bathroom
Finding:	Bathroom Sealant and grouting - Missing or damaged
Information:	It was noted on inspection that sealant or grout is degraded to the tiled shower alcoves and or other areas of the bathrooms.

Different materials and floor areas move at different rates, generally causing cracking to grout or sealant at this point. A flexible sealant is required to allow for expected expansion and contraction, while keeping the joint water tight and protective of all associated building materials.

Flexible and mould resistant materials should be applied to affected areas to prevent any subsequent water damage that is likely to occur. Regular maintenance and replacement of damage or missing or damaged sealant and grout is highly recommended to the wet areas, as this is a regular wear and tear defect. Sealant and grouting in areas that come into regular contact with water should be maintained for the long term care of your property.

A sealant specialist or tiling contractor should be appointed to complete these works as soon as possible

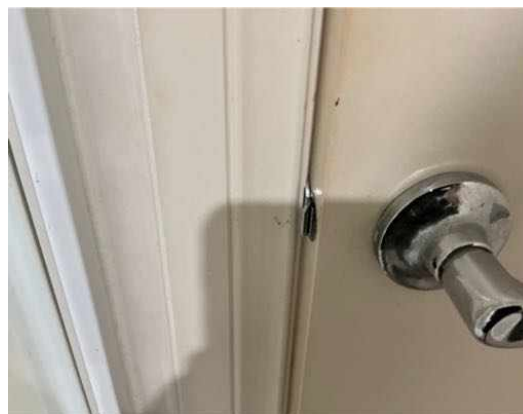
Building: Main Building  
Location: Bathroom  
Finding: Door - Binding/jamming bathroom  
Information: Binding and/or jamming of the bathroom door is evident during standard operation. This defect inhibits the functionality of the affected door as well as creating potential for secondary defects to associated building elements, such as damage to the floor covering.

A door that binds to flooring or to the associated door frame may have several causes, ranging from minor defects, such as poor installation of the door or deteriorated hinges.

For minor causes, a qualified carpenter or general handyperson should be appointed to perform minor rectification works at client discretion.

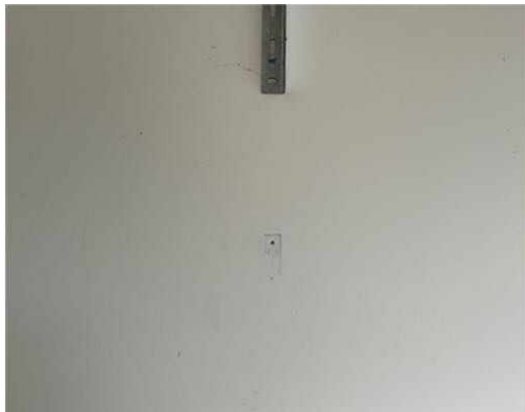
### Finding 3.17

Building: Main Building  
Location: Garage  
Finding: Plaster - Damaged  
Information: Evidence of damage was identified to various parts of the garage plaster by general wear and tear or impact damage. Recommend engaging a plasterer to repair to make more aesthetically pleasing at the owners discretion.

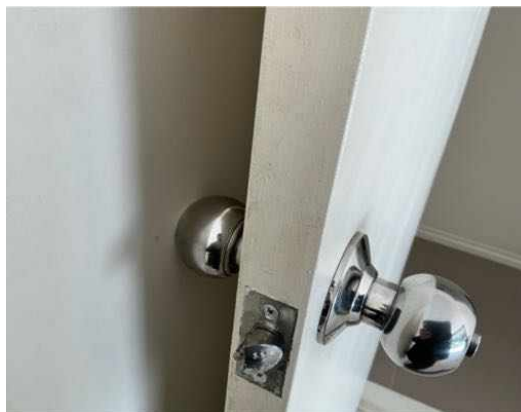
### Finding 3.18

Building:	Main Building
Location:	Garage
Finding:	Garage Door stop missing
Information:	The garage door stop is missing and inadequate to stop the door handle from damaging the wall. Although some building elements may seem irrelevant or unnecessary, all building elements play a key role in the operation and function of the overall structure and its performance.

Re-installation or replacement of the door stop is advised as soon as possible to prevent any subsequent damage to the door or associated structures. A general handyman may be appointed to perform these works at client discretion.

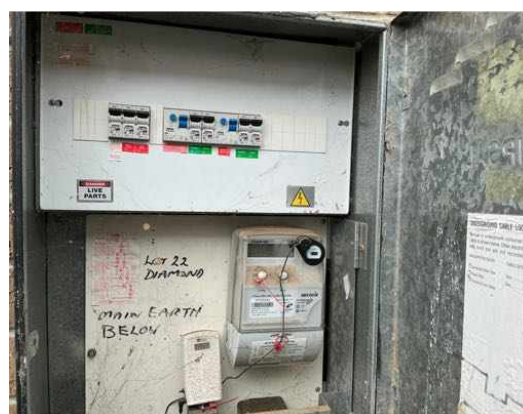
Building:	Main Building
Location:	All External Areas
Finding:	No Termite Management System - no evidence of a chemical installation
Information:	The application of a post-construction chemical termite barrier is highly recommended for all properties, particularly if live termite activity has been found on the site previously. Such barriers are highly effective in preventing termite attack on any timber building elements throughout the property.

A durable notice should be placed in the switchboard unit to indicate current termite barriers. At the time of inspection, it appeared as though no termite management system has been installed, with no evidence to suggest preventative works taking place.

The client may consider gaining further advice from a pest controller as to the costs and procedures involved with this application. It is recommended that obtaining such advice be a short-term priority.

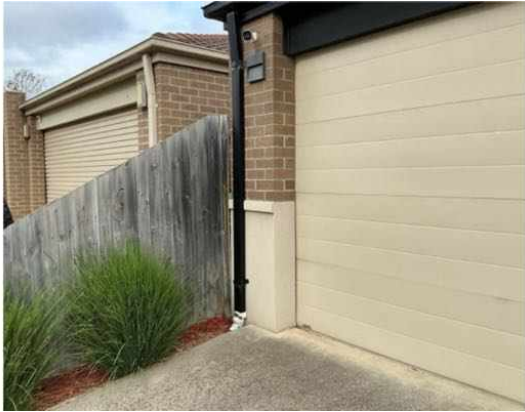
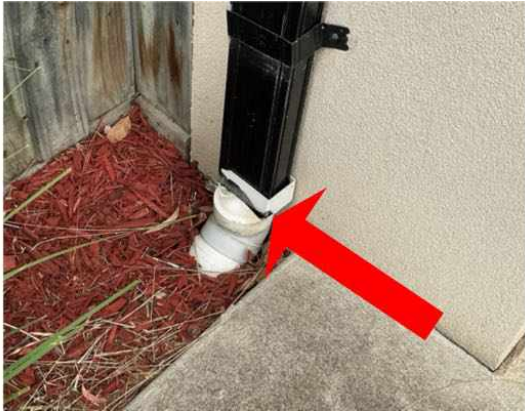
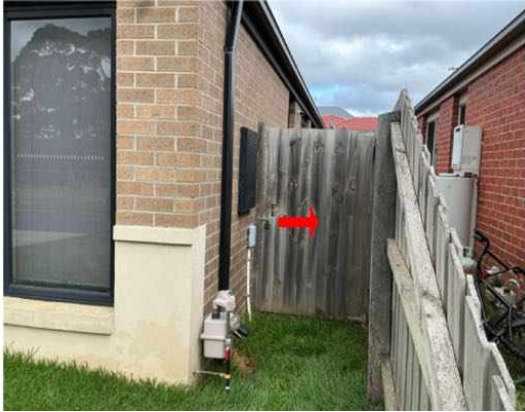
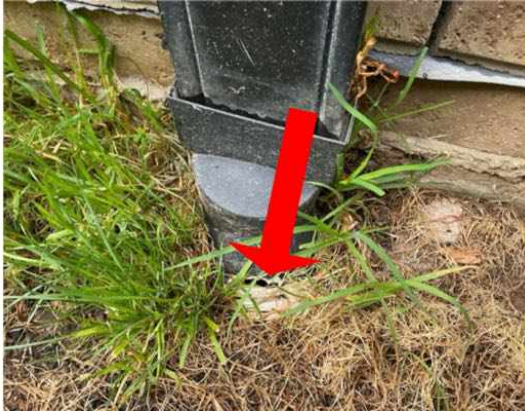
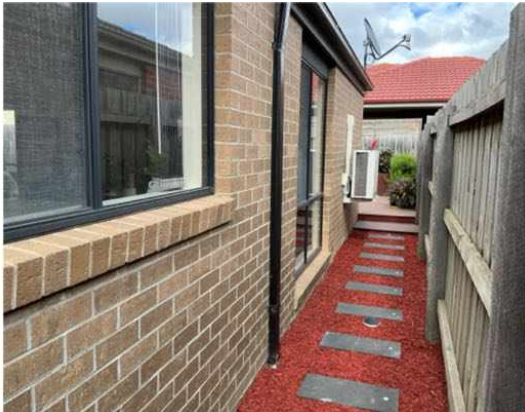
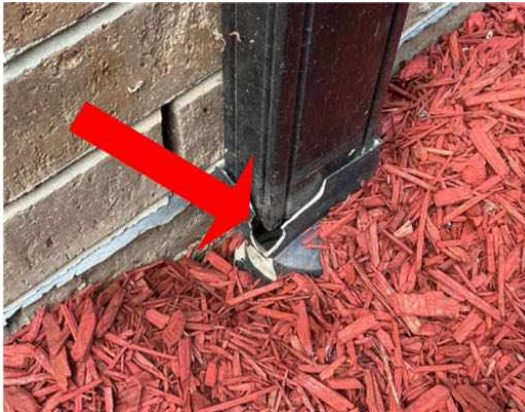
## Finding 6.02

Building:	Main Building
Location:	Exterior walls
Finding:	Damaged down pipes
Information:	Three of the down pipes to the property are damaged due to deterioration overtime or impact damage. This disconnection negatively impacts the functional capacity of the roof plumbing.

Where roof plumbing doesn't drain adequately, the area at the base perimeter can become excessively damp, potentially creating an environment that is susceptible to rust and corrosion of surrounding building elements, as well as attracting termites and other pests.

It is highly recommended that a plumber be appointed to further inspect the area and to install adequate drainage equipment where necessary.

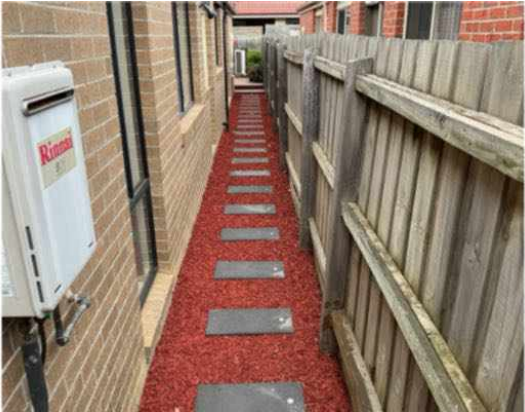
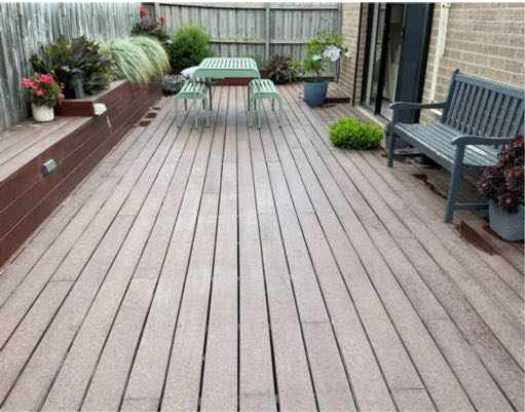
**Finding 6.03**

Building: Main Building  
 Location: Yards  
 Finding: Site drainage - poor/inadequate  
 Information: The site drainage to parts of the yards was found to be inadequate at the time of inspection, creating potential for subsequent water damage to associated building elements. Excessive moisture will attract termites.

Where site drainage is inadequate, installation of an Agricultural (Aggie) Drain may be required. A qualified plumber should be appointed to further inspect the property and perform any remedial works as necessary. Water damage and secondary defects are likely to occur if left unmanaged.

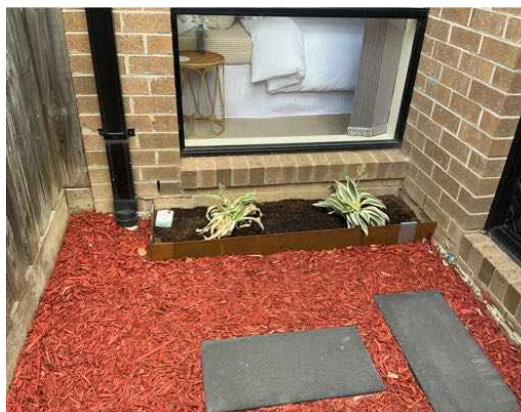
**Finding 6.04**

Building: Main Building  
Location: Yard -Side  
Finding: Garden Beds Conditions Conducive to Termites

Information: Garden beds were found to be evident in close proximity to the building. Garden beds immediately adjacent to the perimeter of the building block the visual inspection of these areas, providing a concealed termite entry point.

These garden beds can include untreated timber, and with a combination of moisture from watering hosing can make conditions conducive to termite activity and termite ingress.

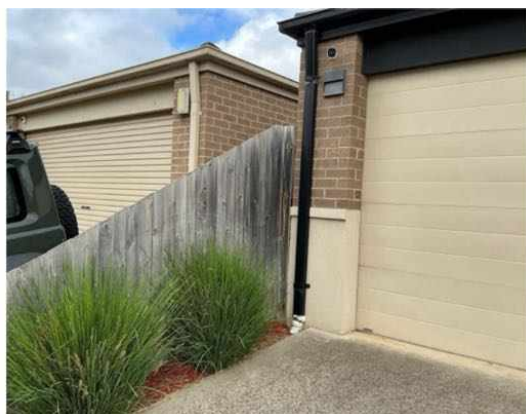
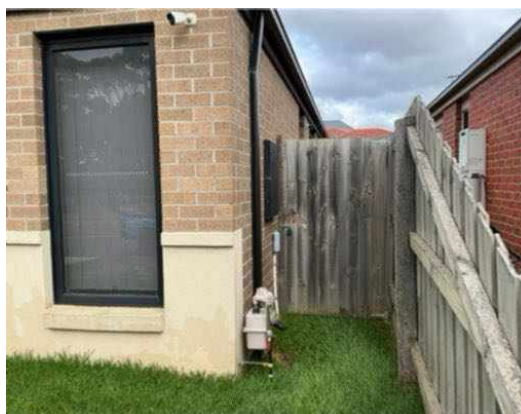
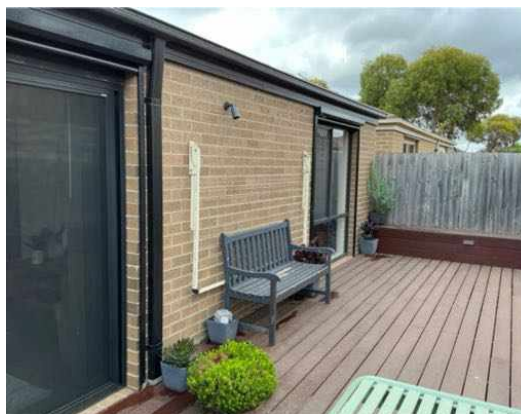
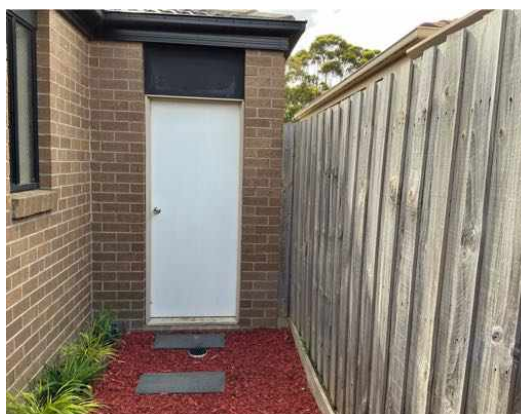
### Finding 6.05

Building: Main Building  
 Location: Various parts of the building  
 Finding: Bridging attachments to buildings  
 Information: Bridging occurs when items against a building provide a concealed entry point for termites into the building or by passing around a termite management system.

Where any part of an attachment to a building is not isolated and is not provided with a clear gap of not less than 25mm from building, bridging occurs. Attachments to buildings such as hot water services, downpipes, verandahs, decks, steps, fences, service conduits and the like provide the opportunity for concealed entry.

Building attachments of this nature need to be frequently inspected for termite activity by a qualified inspector.

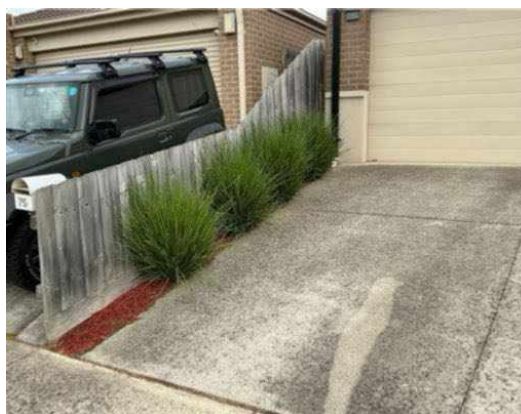
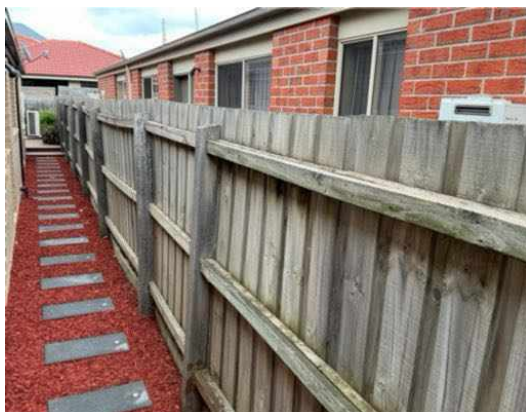
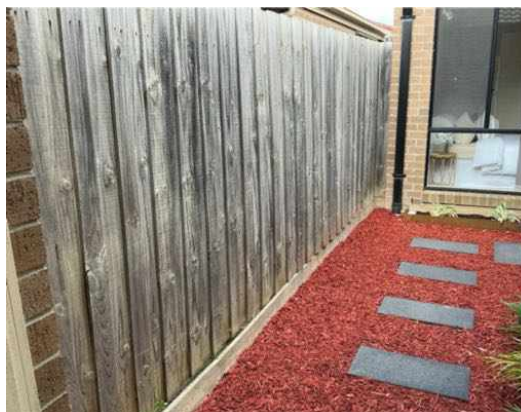
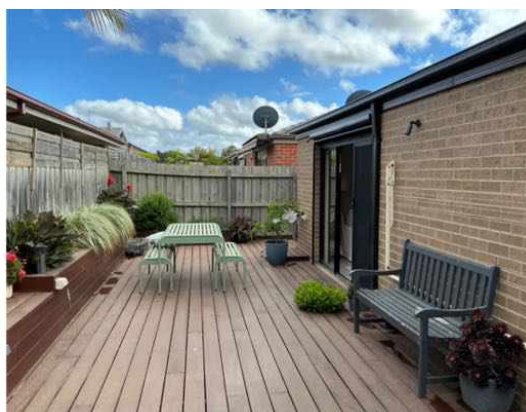
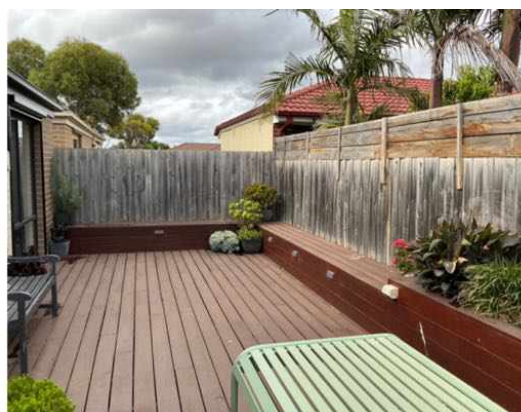
### Finding 6.06

Building:	Main Building
Location:	Various parts of the building
Finding:	In ground contact
Information:	Any timbers in direct ground contact provide opportunity for concealed termite entry and are likely to be subject to premature rot and decay as the soil retains moisture or damp conditions against the timbers.

Remove untreated timber that is in direct contact with external grounds. Consider replacement with more durable materials i.e. treated timber or non timber elements. Frequent pest inspections are advised to readily identify any termite activity in these areas.

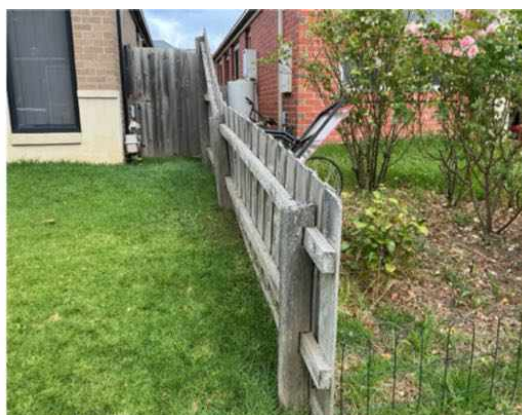
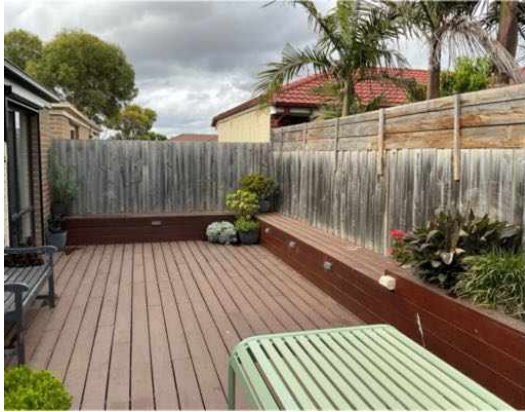
Building: Main Building  
 Location: Yards  
 Finding: Fencing - wood rot-fungal decay  
 Information: It was noted at the time of inspection that sections of the fencing to the property have deteriorated and have fungal decay/wood rot present. Typically fencing deteriorates due to age and or wear, rot and or rust which is generally expected for a structure of this age, due to prolonged exposure to weather conditions. Sometimes inadequate installation or maintenance can be to blame.

If left unattended, it is likely that further damage will occur. It is suspected that repair of several elements of the fencing may be required however replacement may be a consideration of the client also.

A licensed fencing contractor should be appointed to provide further advice and perform rectification works as necessary.

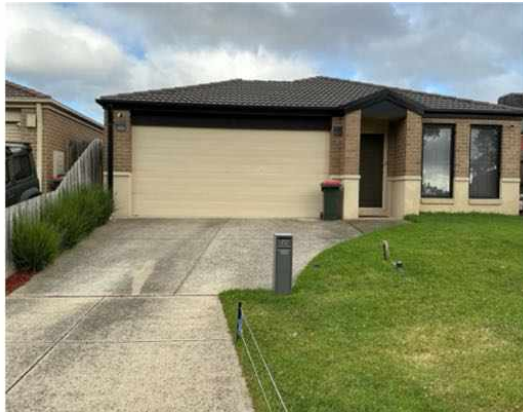
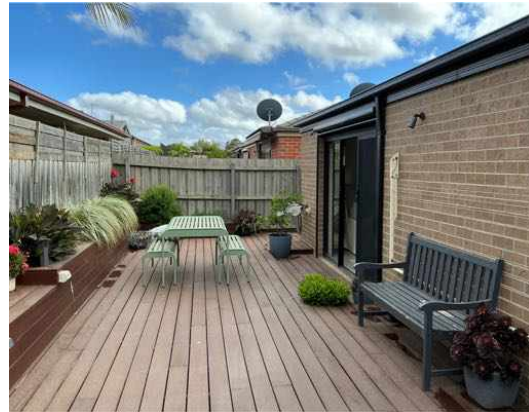
Building: Main Building  
 Location: All External Areas  
 Finding: Additional Photos - Obstructions and Limitations  
 Information: These photographs are an indication of the obstructions and limitations which impeded full inspection of the property at the time of inspection. These obstructions can hide an array of defects and should be removed to allow full inspection to be carried out. A re-inspection is recommended once the areas are made accessible.

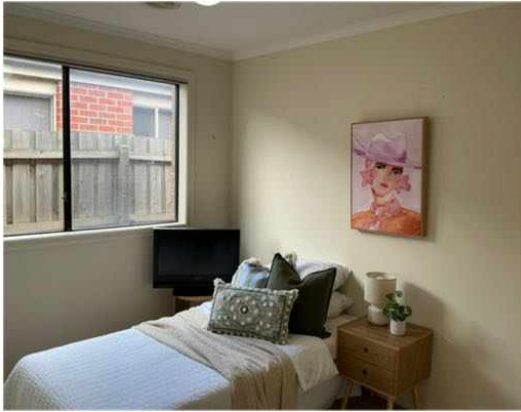
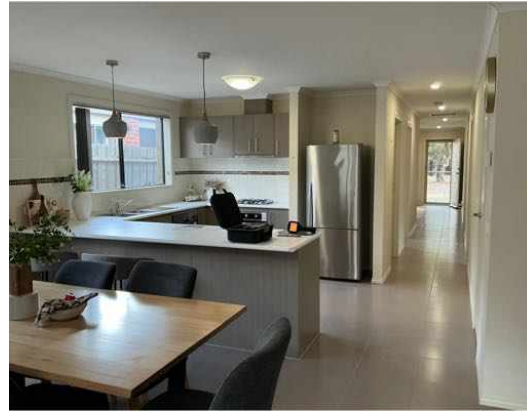
Building: Main Building  
 Location: All Internal Areas  
 Finding: Additional Photos - Obstructions and Limitations  
 Information: These photographs are an indication of the obstructions and limitations which impeded full inspection of the property at the time of inspection. These obstructions can hide an array of defects and should be removed to allow full inspection to be carried out. A re-inspection is recommended once the areas are made accessible.

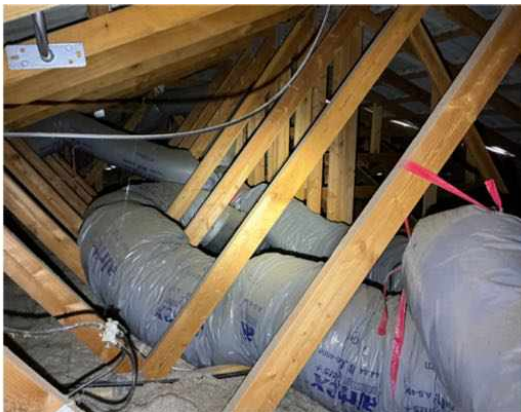
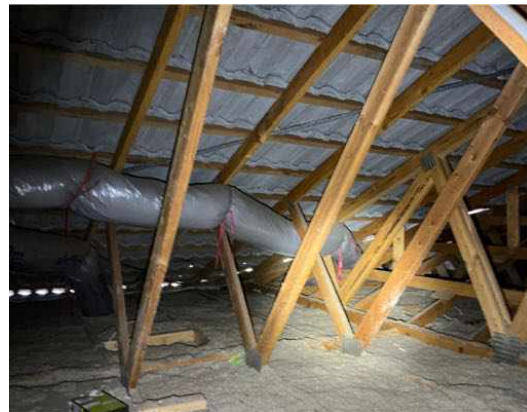
Building: Main Building  
 Location: Roof Void  
 Finding: Obstructions and Limitations -roof cavity  
 Information: These photographs are an indication of the obstructions and limitations which impeded full inspection of the roof cavity at the time of inspection. These obstructions can hide an array of defects and should be removed to allow full inspection to be carried out. A re-inspection is recommended once the areas are made accessible.
