# Building and Timber Pest Inspection Report

Inspection Date: Fri, 16 Jan 2026

Property Address: 77 Diamond Parade, Skye VIC 3977,  
Australia

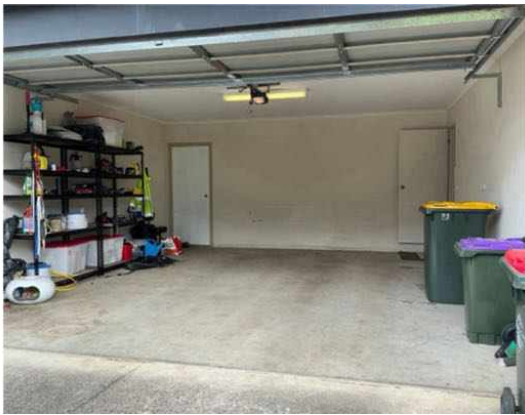
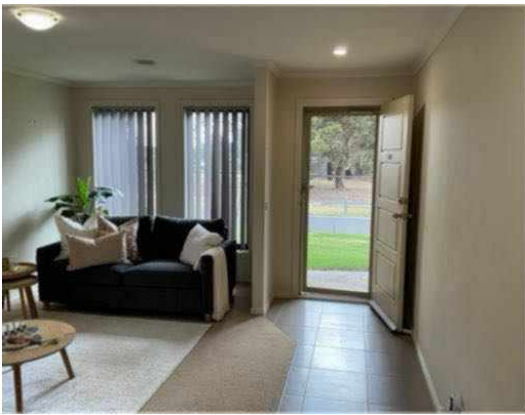
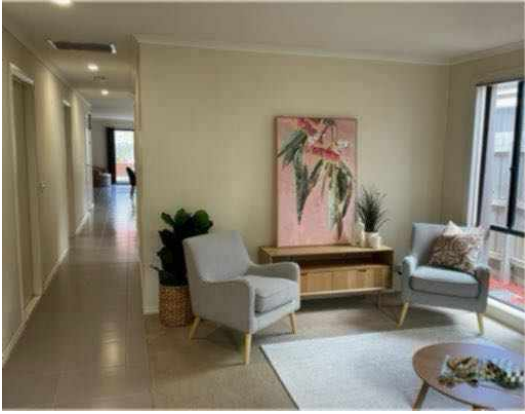
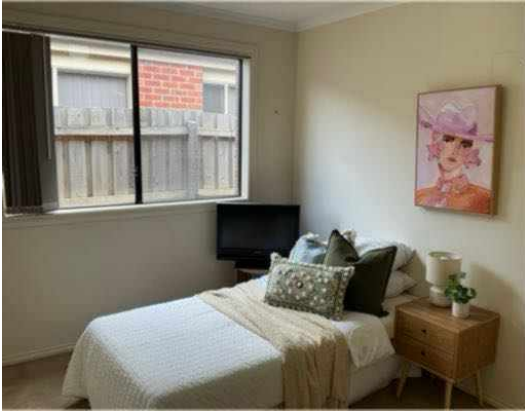
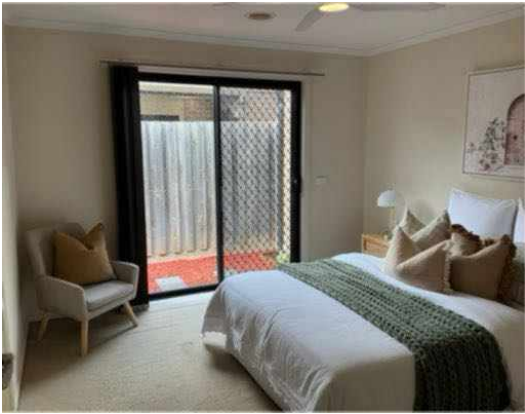
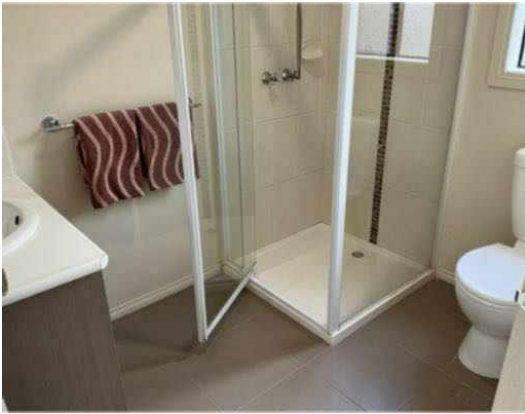
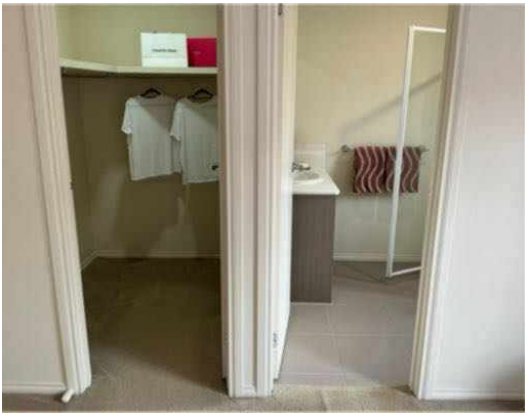
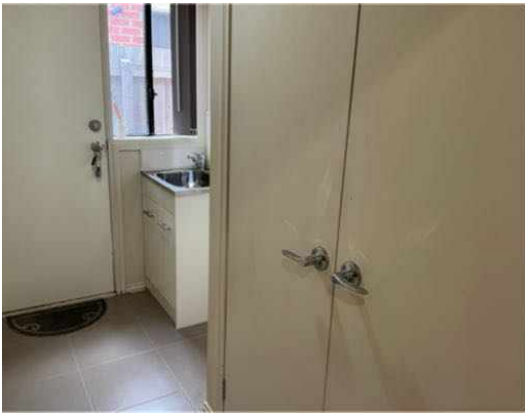
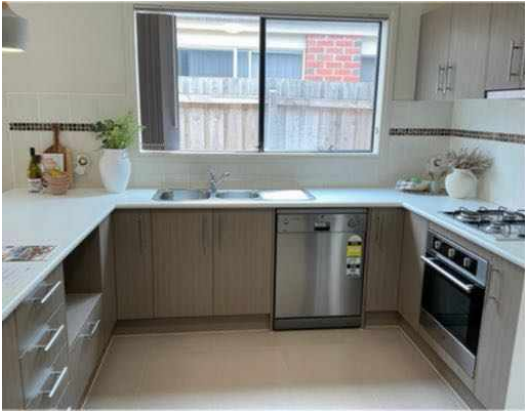
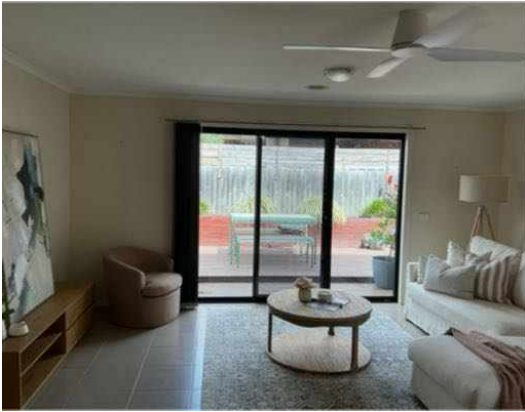
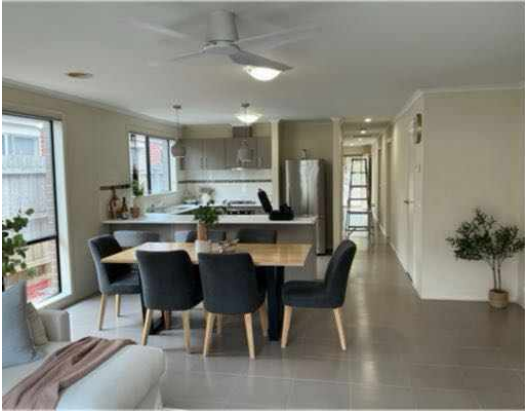
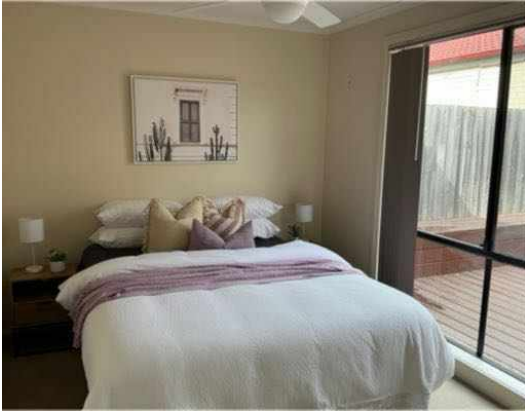
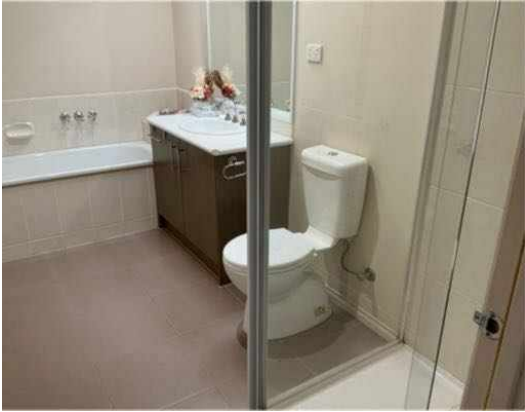
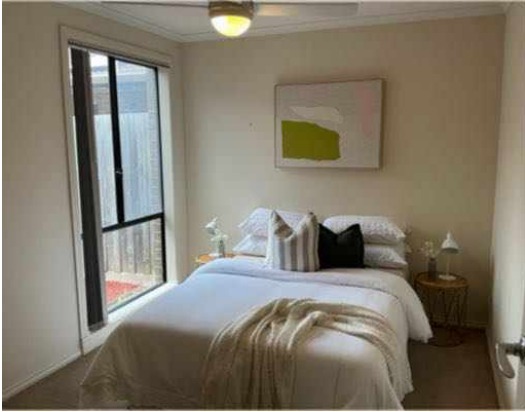
Building: Main Building  
 Location: All Internal Areas  
 Finding: Additional Photos  
 Information: Additional photos are provided for your general reference
