# Building and Timber Pest Inspection Report

Inspection Date: Thu, 9 Apr 2026

Property Address: 1 Collins St, Rushworth VIC 3612,  
Australia

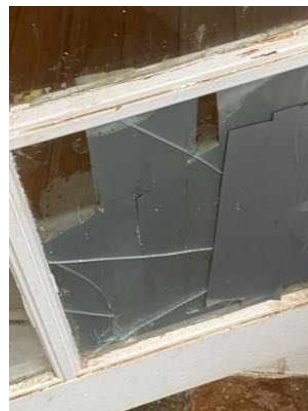
Building:	Building 1
Location:	Entry
Finding:	Window - Cracked
Information:	Cracks were identified in the window in this area. Cracking in windows is generally the result of impact damage, and is likely to develop further when left unmanaged.

The likelihood of this windowpane further cracking and shattering is increased exponentially, providing a safety hazard in the area. The cracked window also impairs the weather tightness of the building, creating potential for minor water leaks.

A qualified glazier is required to repair the window as soon as possible. Depending on

the extent of the cracking, replacement of the window may be required. Please be advised that any persons coming into contact with the cracked window should do so with due caution to avoid any personal injury that may ensue.

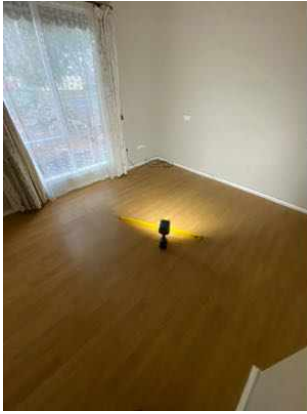
Building: Building 1  
 Location: All Internal Areas  
 Finding: Flooring - Uneven  
 Information: The internal flooring in this area is out of level and uneven. Uneven flooring is likely to indicate minor defects such as expected movement of the foundations of the property, but may also indicate subsidence of the associated subfloor stumps.

It is advised that the flooring be closely monitored to identify any further movement. Where flooring remains relatively unchanged for an extended period of time (i.e. several months), it is likely that this defect has been caused by expected movement of the foundations of the property.

However, where flooring is uneven further, potentially invasive inspection of the subfloor structures and stumps in this area is required. In this case, works to repair are likely to be required, and would be carried out by a registered builder specialising in re-stumping.

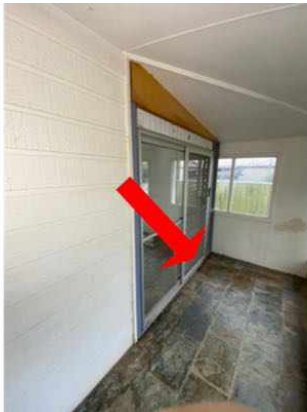
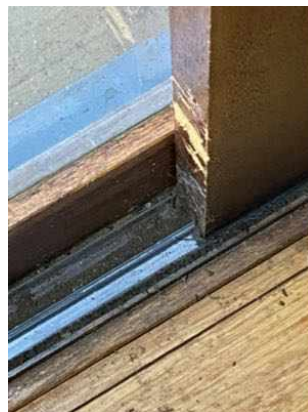
### Finding 3.02

Building: Building 1  
 Location: Living, entry  
 Finding: Door- Stiff to slide  
 Information: The door in this area was jammed and difficult to slide along the associated tracks at the time of the inspection. Restricted function of the affected door may pose as a potential safety hazard if required for emergency egress from the building.

Generally, factors such as general age of the building element and a lack of maintenance are the usual causes for this type of defect.

Replacement of door hardware or tracks may be required, as well as minor repairs and cleaning. A registered builder or general handy person will be required to repair the affected doors.

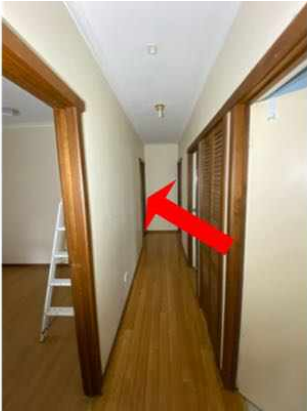
### Finding 3.03

This is a common defect and is expected in a property of this age, whether being due to substandard installation or general deterioration of the door hardware.

Readjustment of the striker plate is recommended at client discretion. Works such as these can be completed by a general handyman or qualified carpenter.

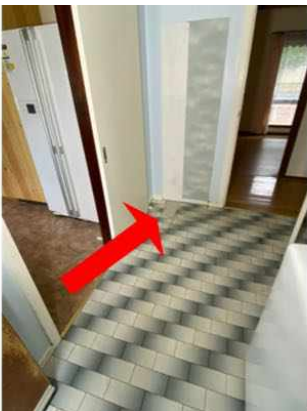
### Finding 3.04

Finding: Cracked floor tiles

Information: Cracking in the floor tiles was evident in this area at the time of inspection. It is suspected that this cracking has occurred as a result of minor settlement or impact damage.

Cracked tiles throughout the household detract from the overall appearance of the affected areas however it is unlikely to create or lead to any secondary defects.

While not considered a matter of urgency, replacement of cracked floor tiles is recommended at the clients discretion. A tiling contractor may be appointed to perform these works. Where cracks become more numerous, contact a licensed building inspector for further investigation.

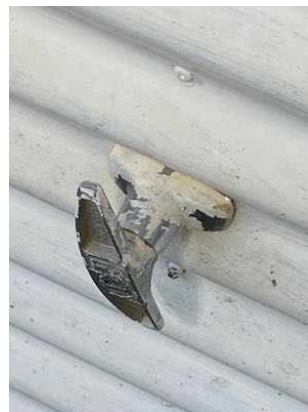
**Finding 3.05**

Building: Building 1  
Location: Garage  
Finding: Garage door  
Information: The garage door locking mechanism shows poor function. A flower pot is used to keep it closed.

A garage specialist or handyman should be contacted soon to improve the area and prevent further deterioration.

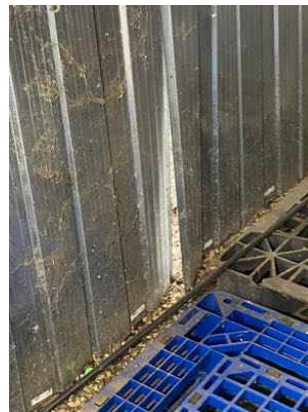
Building: Building 1  
Location: Shed  
Finding: Shed wall- damaged  
Information: The shed wall has been damaged and shows signs of water penetration. Some small amount of rust is evident.

A handy person or shed specialist should be contacted soon to replace or repair the sheeting to prevent further deterioration.

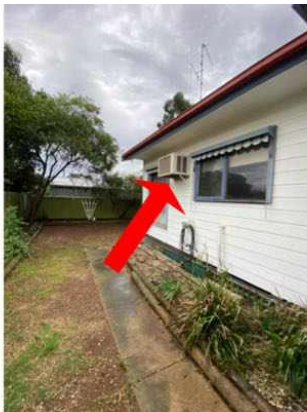
Building: Building 1  
 Location: Yard - Back  
 Finding: Air conditioner - Disconnected overflow  
 Information: The Air Conditioner (A/C) overflow was found to be disconnected from storm water drainage and is creating excessive moisture in the surrounding area.

Such leaking creates an environment which is conducive to an array of defects, including water damage to associated building elements and the attraction of termite or timber pest infestation.

It is highly recommended that a licensed plumber be appointed to connect the A/C

overflow in order to prevent such an environment from being created. These minor works should be carried out as soon as possible.

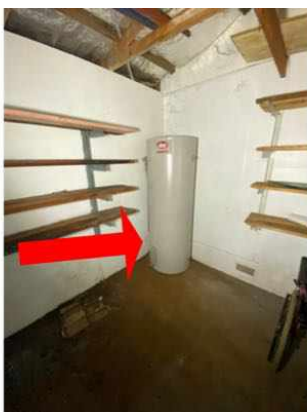
### Finding 6.02

Building: Building 1  
 Location: Garage  
 Finding: HWS Overflow - Not Connected  
 Information: The Hot Water System (HWS) overflow was found to be disconnected from storm water drainage and is creating excessive moisture in the surrounding area.

These damp conditions can lead to secondary defects such as rot, rust or corrosion of associated building elements, the formation of fungal decay, or even the creation of potential slip hazards. When coupled with poor site drainage, pooling of water may also attract termite activity to this area.

It is highly recommended that a licensed plumber be appointed to connect the HWS overflow in order to prevent such an environment from being created. These minor works should be carried out as soon as possible.

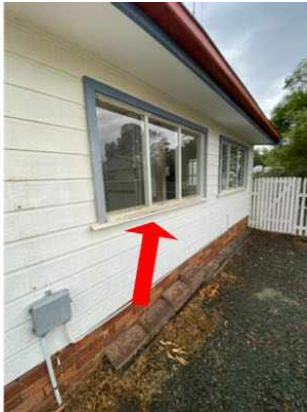
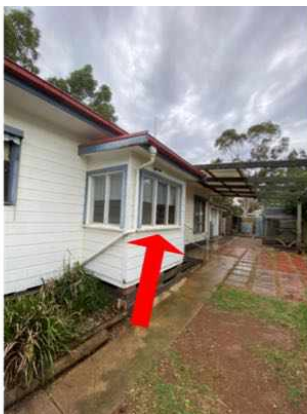
Building:	Building 1
Location:	Timber windows
Finding:	Timber - exposed to weather
Information:	External timbers that are frequently exposed to harsh weather conditions require adequate protection in order to maintain their condition. Where timbers have not been painted or treated adequately, general deterioration is likely to occur at an accelerated rate.

If left unattended, replacement of these timbers is likely to be necessary in the short-

term future. Adequate treatment of these timbers is required as soon as possible by a painting contractor or general handyman.

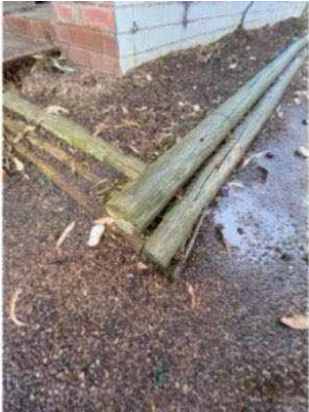
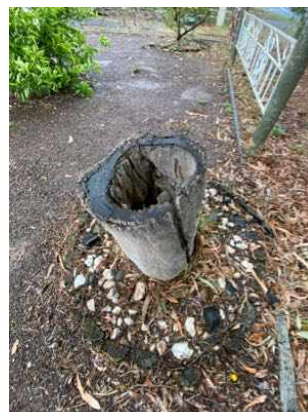
### Finding 6.07

Building:	Building 1
Location:	All External Areas
Finding:	Termite Management System - no evidence of a chemical installation
Information:	The application of a post-construction chemical termite barrier is highly recommended for all properties, particularly if live termite activity has been found on the site previously. Such barriers are highly effective in preventing termite attack on any timber building elements throughout the property.

A durable notice should be placed in the switchboard unit to indicate current termite barriers. At the time of inspection, it appeared as though no termite management system has been installed, with no evidence to suggest preventative works taking place.

The client may consider gaining further advice from a pest controller as to the costs and procedures involved with this application. It is recommended that obtaining such advice be a short-term priority.

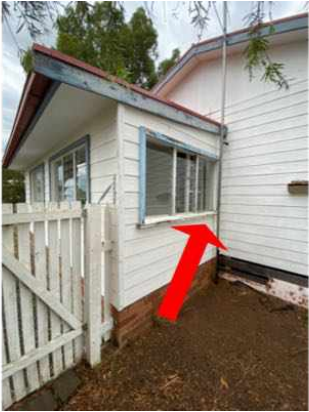
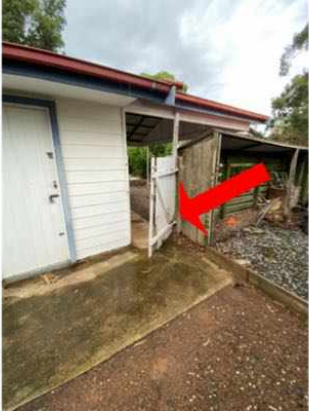
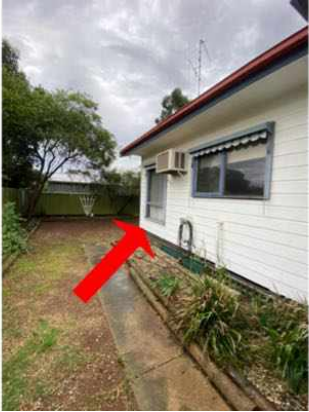
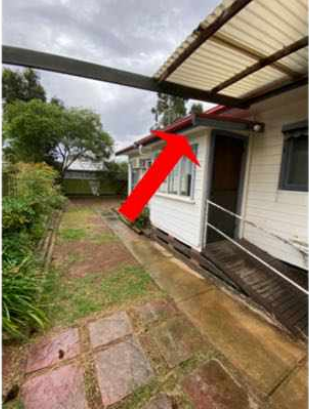
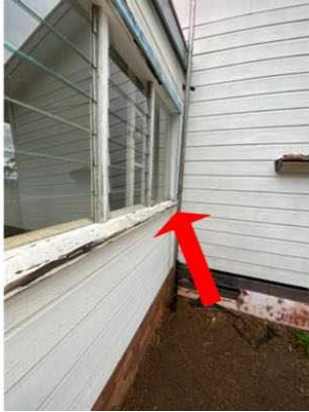
### Finding 7.01

Building:	Building 1
Location:	Several timber areas
Finding:	Fungal decay - present (localised)
Information:	Fungal decay also known as wood decay or wood rot generally refers to the deterioration of timber elements when in contact with excessive levels of moisture for a prolonged period of time.

The development of fungal decay is accelerated by temperatures in the range of 5degreeC to 40degreeC as well as the presence of oxygen. Generally fungal decay develops on timber elements that are in use in an external environment which are exposed to rain penetration.

In this case although the affected timber element is in a decaying state the extent of any visible damage appears to be localised to a specific area and is yet to spread to other parts of the building element or affect adjoining structures. The fungal decay is therefore likely to be of a relatively superficial nature with minimal impact on the structural integrity or tensile strength of the timber element.

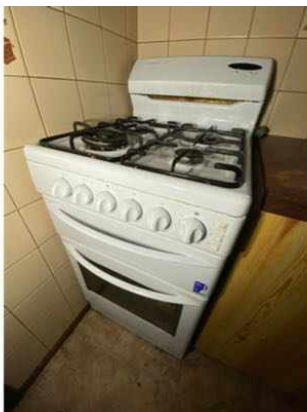
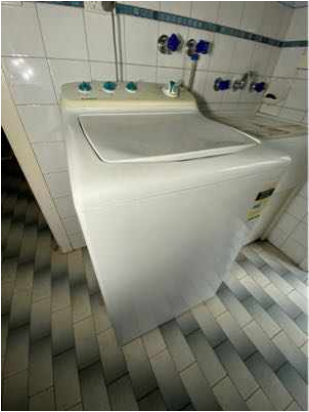
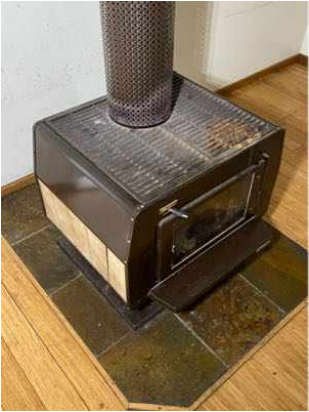
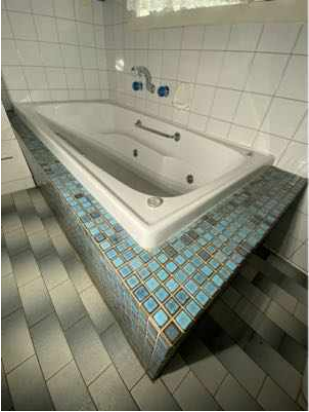
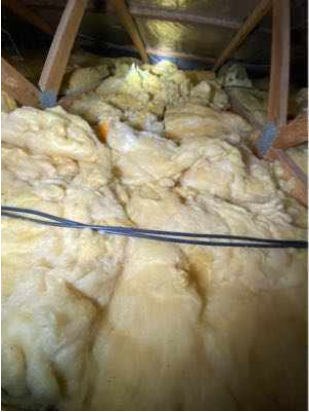
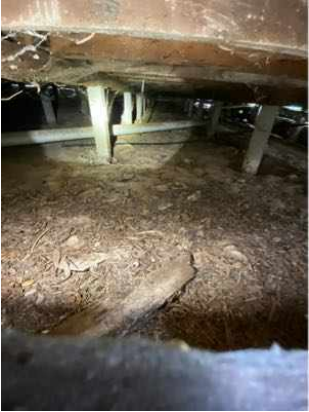
Building:	Building 1
Location:	All Areas
Finding:	Additional Photos - Obstructions and Limitations
Information:	These photographs are an indication of the obstructions and limitations which impeded full inspection of the property at the time of inspection. These obstructions can hide an array of defects and should be removed to allow full inspection to be carried out. A re-inspection is recommended once the areas are made accessible.
