Building and Timber Pest Inspection Report

Inspection Date: Thu, 12 Mar 2026

Property Address: 10 McEwen St, Shepparton VIC 3630,
Australia

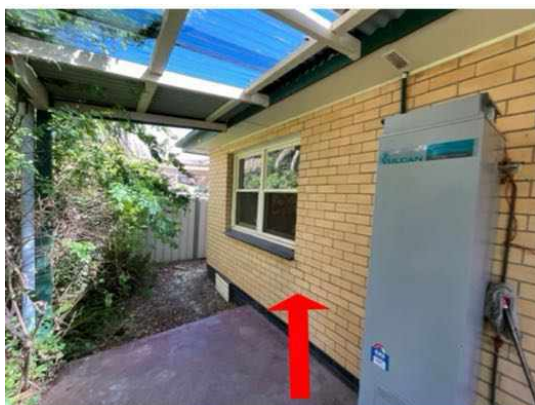
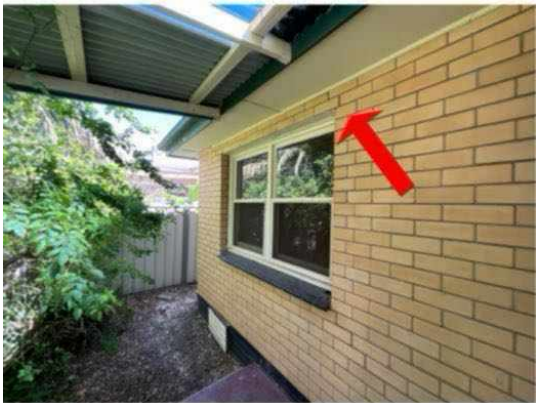
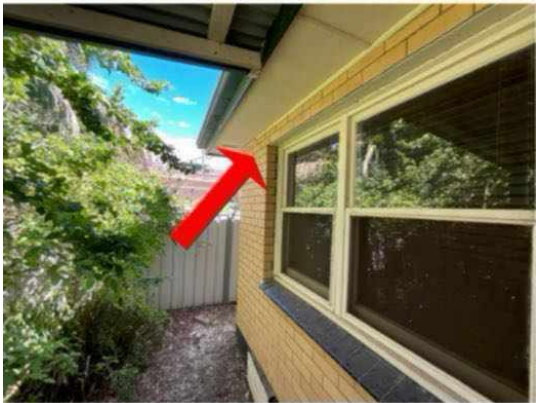
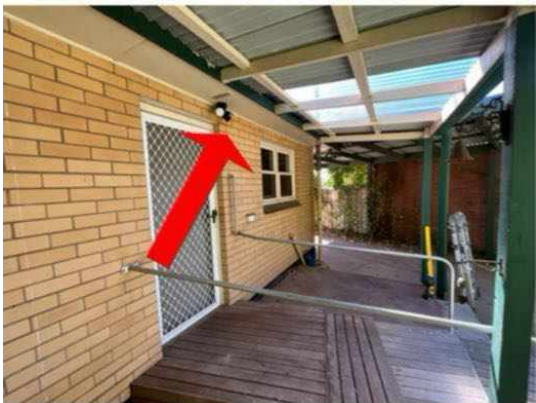
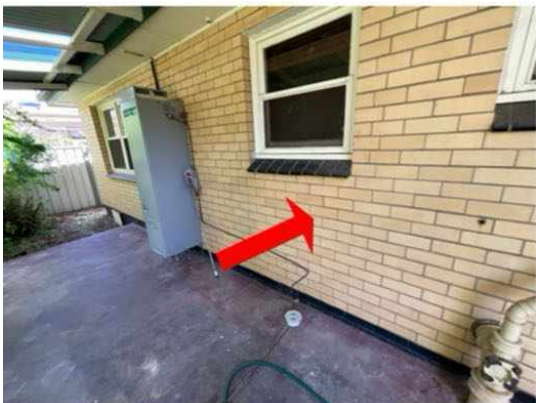
Building: Building 1
Location: Rear, front wall
Finding: Brickwork - Step cracking
Information: Step cracking was identified to the brickwork in this area at the time of inspection. Step cracking, which is similar to other forms of cracking, has a variety of possible causes. However, the most common is the subsidence of adjacent footings.

Step cracking is a relatively common defect, and is most likely to occur adjacent to windows, doors and other openings. Mortar failure in the gaps between affected bricks indicates the stresses and tensions affecting the wall.

Where step cracking is extensive or severe, the client is advised to consult a structural engineer. Minor step cracking can be used as a warning sign to address factors causing stress to the wall, which can include the effect of surrounding trees, water leaks, soil erosion, or even the presence of reactive soils in the surrounding area.

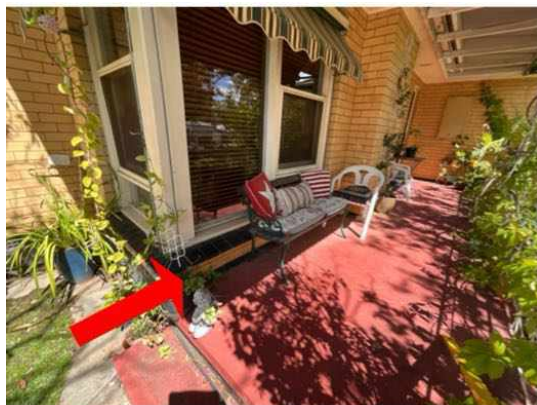
Finding 3.02

Building:	Building 1
Location:	Front wall
Finding:	Brickwork - Cracking [Fine]
Information:	<p>Although fine cracks are quite noticeable, they are often only considered to be an appearance defect and usually do not indicate any structural damage. Generally, the cause of a fine crack is indicative of a separation between brickwork and mortar throughout the structure, but single bricks may also show cracks of this nature.</p> <p>Cracking of this nature can generally be repaired with minor filling and should be conducted by a qualified bricklayer.</p> <p>Always contact a building inspector should cracks widen lengthen or become more numerous.</p>

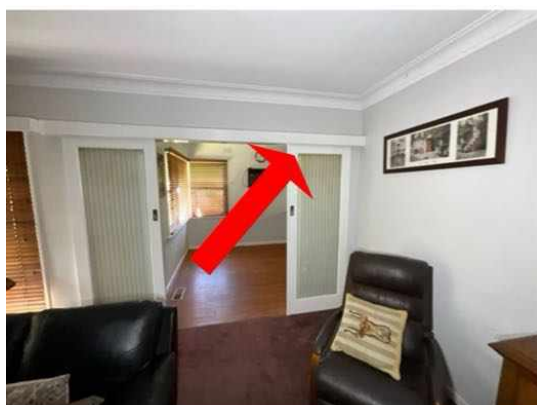
Building: Building 1
 Location: Living Room
 Finding: Door- Stiff to slide
 Information: The door in this area was jammed and difficult to slide along the associated tracks at the time of the inspection. Restricted function of the affected door may pose as a potential safety hazard if required for emergency egress from the building.

Generally, factors such as general age of the building element and a lack of maintenance are the usual causes for this type of defect.

Replacement of door hardware or tracks may be required, as well as minor repairs and cleaning. A registered builder or general handy person will be required to repair the affected doors.

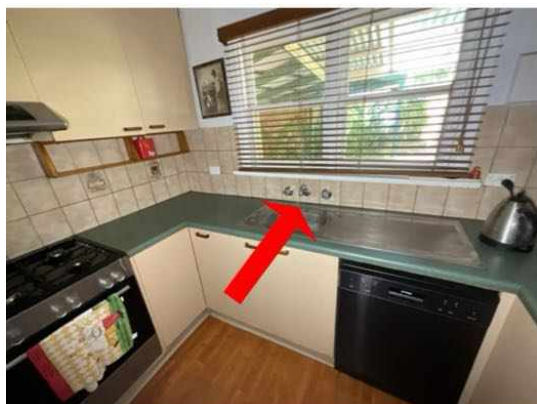
Finding 3.06

Building: Building 1
 Location: Kitchen
 Finding: Inadequate sealant or Grout
 Information: This area has a lack of effective Sealant or Grout. This is allowing the ingress of water to the structure inside the wall.

The presence of water encourages Termite attack, Mould and Fungal Decay.

A Tiler or General Handy person must be contacted as soon as possible to effect repairs and prevent further deterioration.

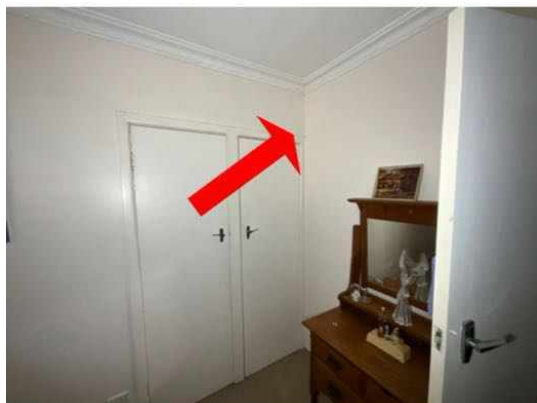
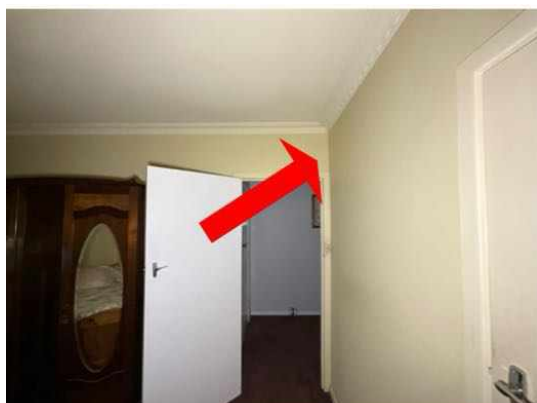
Finding 3.07

Building:	Building 1
Location:	Bed 1,2,3
Finding:	Cracking - Damage Category 1 - Fine (up to 1mm)
Information:	Although fine cracks are quite noticeable, they are often only considered to be an appearance defect, and usually do not indicate any structural damage. Generally, the cause of a fine crack is indicative of a separation between building materials and finishes (e.g. paint, plaster, etc.) along joins.

Cracking of this nature can generally be repaired with minor sanding, filling and/or repainting. Such works should be performed by a qualified painter or a general handyman.

Monitoring of all cracking should be conducted frequently. Always contact a building inspector should cracks widen, lengthen, or become more numerous.

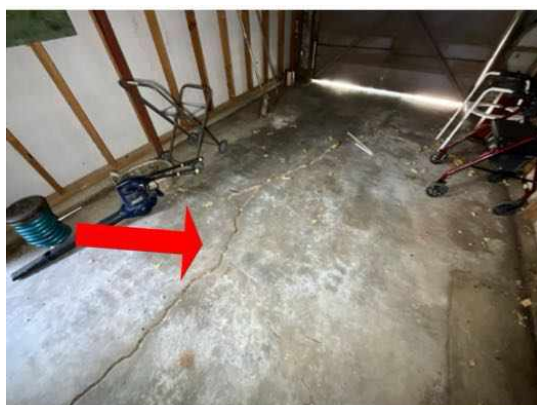
Finding 3.08

Building:	Building 1
Location:	Garage
Finding:	Cracking - External Concrete Paving Damage Category 4 - Gaps in Slab (4mm - 10mm +)
Information:	Gaps in the slab were identified in external concrete paving. Gaps in the slab are significant and are likely to lead to the development of safety hazards and secondary defects if left unmanaged, such as the creation of a trip hazard.

General age and expected deterioration of the paved areas is a common cause of this type of cracking. However, expansion and contraction of the slab may also have occurred due to environmental factors. Such factors include variable moisture and

weather conditions, the presence of trees and their roots having a settling or lifting affect on the soil, or the effect of load bearing, e.g. heavy vehicles over a sustained period of time.

Cracking to this degree may also be due to poor original installation of the concrete. Factors such as poor compaction of the sub surface and/or inadequate reinforcing of the slab may create cracking and other secondary defects. Gaps in the concrete paving may also have a more significant structural cause, such as subsidence of soils.

Where gaps in the concrete paving are adjacent to structural elements of the building, the advice of a Structural Engineer is advisable before undertaking repairs. Significant repair and likely replacement of the concrete paving is probable.

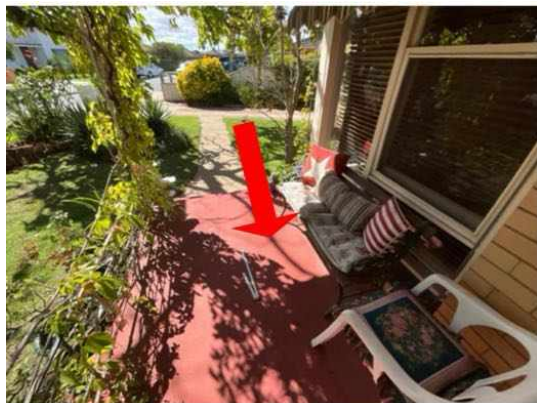
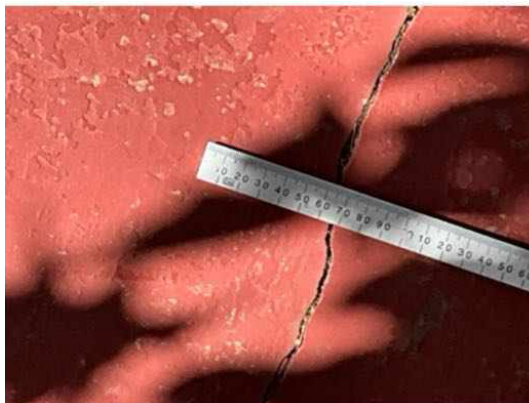
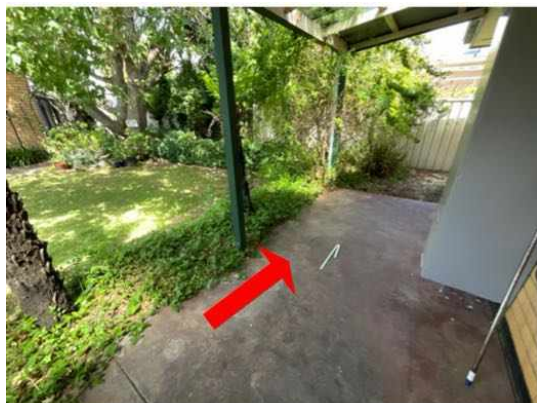
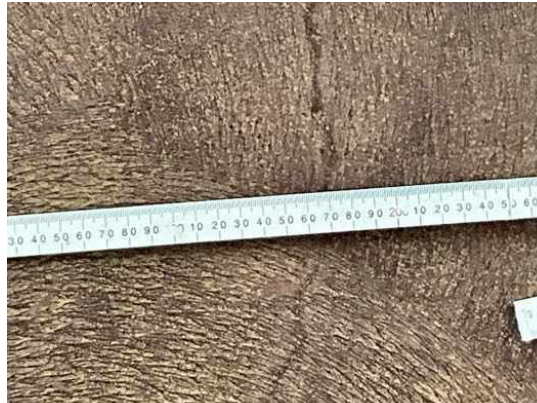
Building:	Building 1
Location:	Verandah
Finding:	Cracking - External Concrete Paving Damage Category 3 - Wide Cracks (2mm - 4mm)
Information:	Wide cracks were identified in external concrete paving. Wide cracks are significant and are likely to lead to the development of safety hazards and secondary defects if left unmanaged.

General age and expected deterioration of the paved areas is a common cause of this type of cracking. However, expansion and contraction of the slab may also have occurred due to environmental factors. Such factors include variable moisture and weather conditions, the presence of trees and their roots having a settling or lifting effect on the soil, or the effect of load bearing, e.g. heavy vehicles over a sustained period of time.

Cracking to this degree may also be due to poor original installation of the concrete. Factors such as poor compaction of the sub surface and/or inadequate reinforcing of the slab may create cracking and other secondary defects. Wide cracks may also have a more significant structural cause, such as subsidence of soils.

Where the crack is located adjacent to structural elements of the building, the advice of a Structural Engineer is advisable before undertaking repairs. Significant repair and likely replacement of the concrete paving is probable.

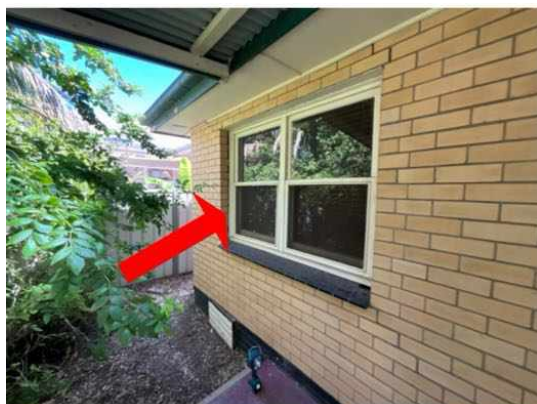
Building:	Building 1
Location:	Bed 3
Finding:	Inadequate sealant/caulking
Information:	This area has a lack of effective Sealant or Grout. This may be allowing the ingress of water to the structure.

The presence of water encourages Termite attack, Mould and Fungal Decay.

A Caulker or General Handy person must be contacted soon to effect repairs and prevent possible deterioration.

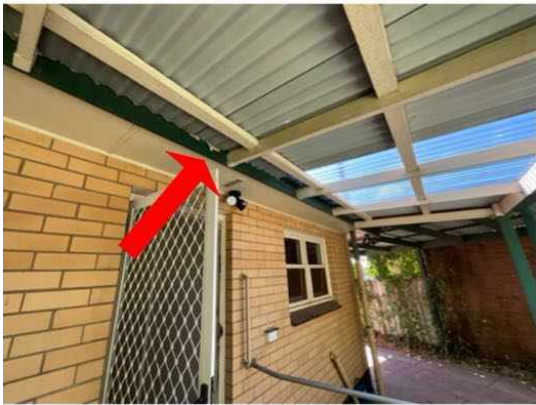
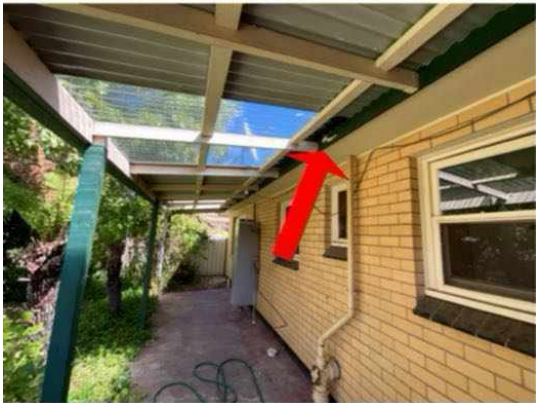
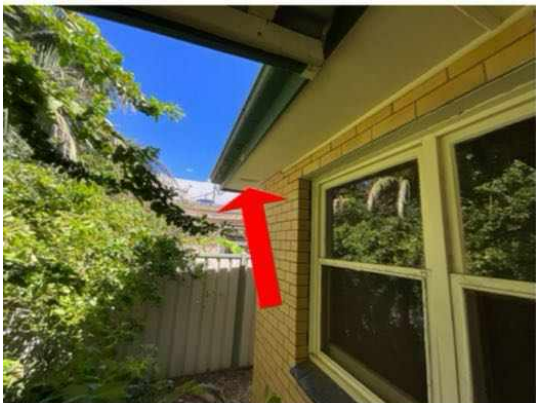
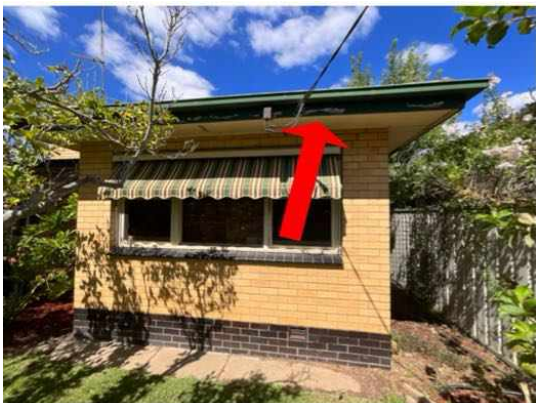
Finding 6.05

Building:	Building 1
Location:	Verandah, eaves >
Finding:	Timber - exposed to weather
Information:	External timbers that are frequently exposed to harsh weather conditions require adequate protection in order to maintain their condition. Where timbers have not been painted or treated adequately, general deterioration is likely to occur at an accelerated rate.

If left unattended, replacement of these timbers is likely to be necessary in the short-term future. Adequate treatment of these timbers is required as soon as possible by a painting contractor or general handyman.

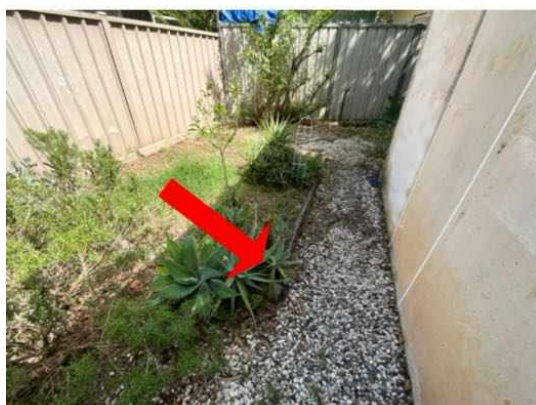
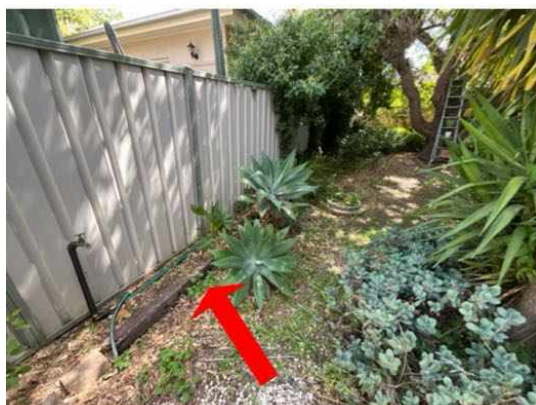
Finding 6.06

Building:	Building 1
Location:	Yard - Back
Finding:	Untreated or non-durable timbers in a hazardous environment
Information:	To reduce the risk of timber pest attack it is essential that timber used in a hazardous environment (e.g. in direct contact with the ground or frequently exposed to damp conditions) is of sufficient durability and/or is adequately preservative treated.

Untreated timbers in direct contact with the ground are likely to develop severe wood rot and/or fungal decay if left unattended creating attraction for subterranean termites to infest the timbers from surrounding areas.

If untreated or non-durable timbers are found to be in a hazardous environment it is highly advised that replacement of these building elements be performed as soon as possible to aid the protection of the property against termite / timber pest attack.

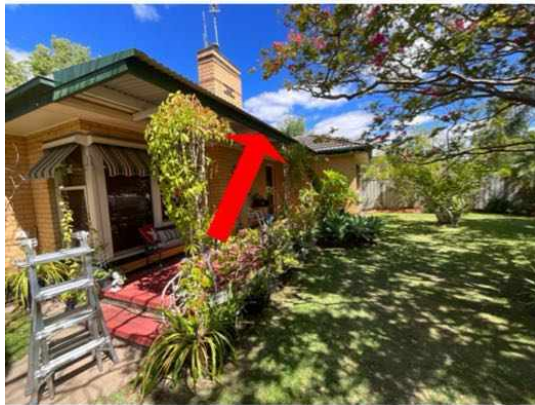
Finding 6.07

Building:	Building 1
Location:	Verandah > Front
Finding:	Guttering Missing
Information:	The Guttering in this area was missing at the time of inspection. Guttering, Downpipes and Stormwater drainage are vital to protect the integrity of the structure and to prevent an environment conducive to Timber Pest attack.

A Plumber should be contacted as soon as possible to replace and connect to drainage the missing Guttering.

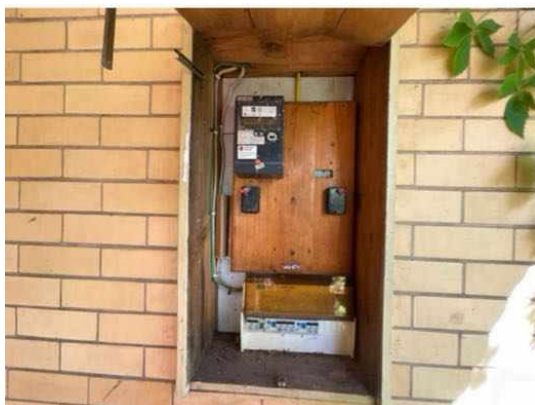
Finding 6.08

Building:	Building 1
Location:	All External Areas
Finding:	Termite Management System - no evidence of a chemical installation
Information:	The application of a post-construction chemical termite barrier is highly recommended for all properties, particularly if live termite activity has been found on the site previously. Such barriers are highly effective in preventing termite attack on any timber building elements throughout the property.

A durable notice should be placed in the switchboard unit to indicate current termite barriers. At the time of inspection, it appeared as though no termite management system has been installed, with no evidence to suggest preventative works taking place.

The client may consider gaining further advice from a pest controller as to the costs and procedures involved with this application. It is recommended that obtaining such advice be a short-term priority.

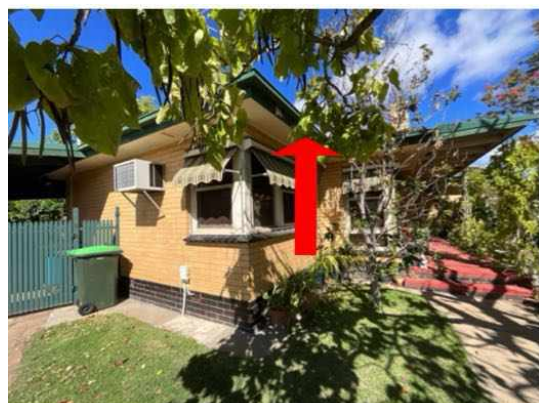
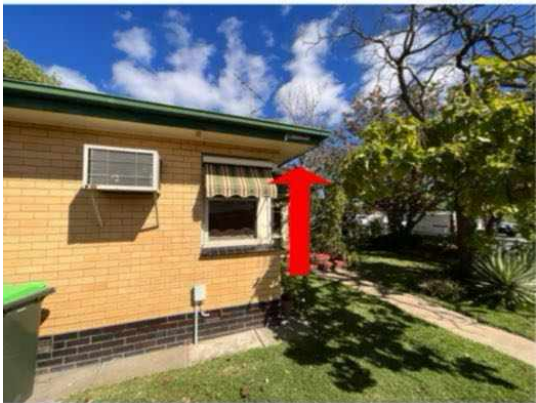
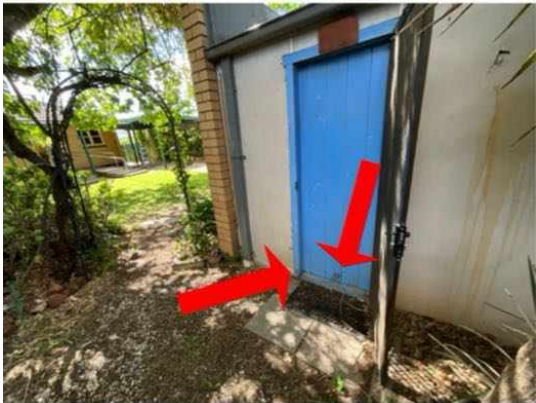
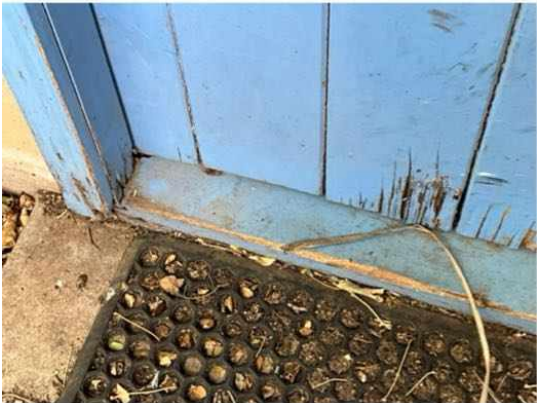
Building:	Building 1
Location:	Eaves, garage
Finding:	Fungal decay - present (localised)
Information:	Fungal decay also known as wood decay or wood rot generally refers to the deterioration of timber elements when in contact with excessive levels of moisture for a prolonged period of time.

The development of fungal decay is accelerated by temperatures in the range of 5degreeC to 40degreeC as well as the presence of oxygen. Generally fungal decay develops on timber elements that are in use in an external environment which are exposed to rain penetration.

In this case although the affected timber element is in a decaying state the extent of any visible damage appears to be localised to a specific area and is yet to spread to other parts of the building element or affect adjoining structures. The fungal decay is therefore likely to be of a relatively superficial nature with minimal impact on the structural integrity or tensile strength of the timber element.

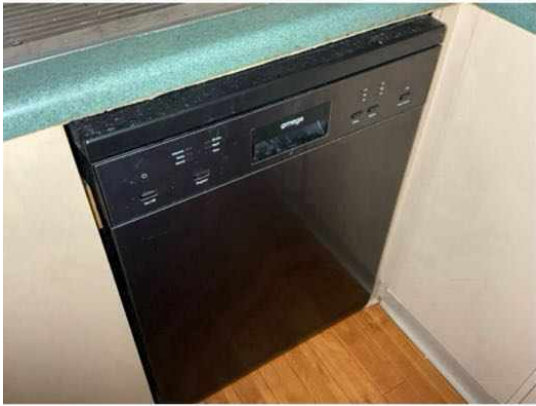
Noted Item

Building: Building 1
Location: All Areas
Finding: Additional Photos - Obstructions and Limitations
Information: These photographs are an indication of the obstructions and limitations which impeded full inspection of the property at the time of inspection. These obstructions can hide an array of defects and should be removed to allow full inspection to be carried out. A re-inspection is recommended once the areas are made accessible.
