# Building and Timber Pest Inspection Report

Inspection Date: Wed, 14 Jan 2026

Property Address: 66B Greenview Dr, Horsley NSW 2530,  
Australia

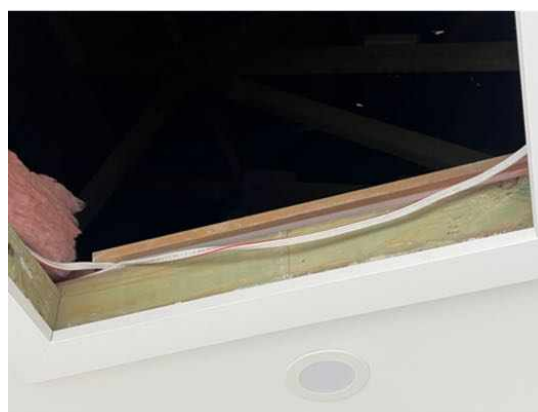
Building:	Main Building
Location:	Hallway
Finding:	Electrical wires exposed - manhole access
Information:	Electrical wiring was observed running directly across the manhole access within the ceiling void. This installation may pose a safety hazard when accessing the roof space, as personal contact or accidental damage to the wiring may occur when using the manhole.

Best practice is for electrical wiring to be routed away from access points to minimise risk. The client should engage a licensed electrician to assess the installation and, if necessary, reposition or protect the wiring in accordance with current electrical standards and safety requirements.

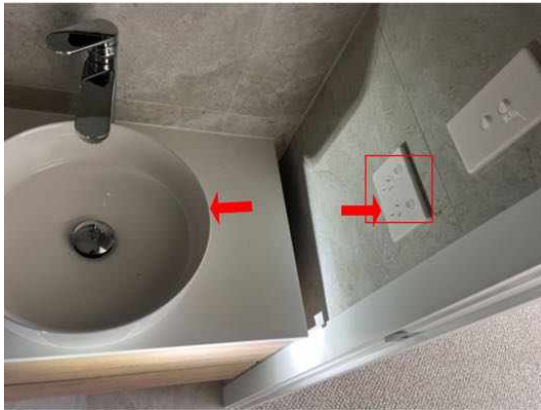
#### Finding 1.02

Building:	Main Building
Location:	Ensuite, Bathroom
Finding:	GPO - Suspected Non-Compliance With Wet-Area Clearances
Information:	A general-purpose outlet was observed installed close to a bathroom basin in a configuration that may not comply with the clearance provisions for basins with a capacity of 45 litres or less. Under AS/NZS 3000 (Wiring Rules), power outlets located near small basins must maintain a minimum 150 mm horizontal clearance from the edge of the water container, a minimum 400 mm clearance above the top of the container, and must be protected by a 30 mA safety switch.

Based on the observed proximity, the installation is suspected to fall short of the required separation distances and should be assessed by a licensed electrician to confirm compliance with AS/NZS 3000 and ensure the outlet is adequately protected

against moisture exposure.

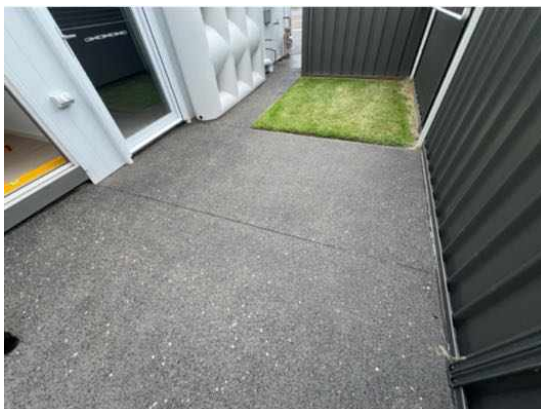
### Finding 2.01

Information: The perimeter paving or ground levels were found to have an inadequate slope away from the adjoining building structure, creating potential for water pooling in this area.

Perimeter paving is required to fall from the building by a minimum of 25mm in the first metre and bare ground should fall away from the house by 50mm in the first meter. This standard ensures that excessive moisture does not pool around the base of building structures, which creates potential for water and structural damage, as well as making the area susceptible to termite and timber pest activity.

Where paving or ground levels do not have adequate fall, a licensed paving contractor should be appointed to install or remove and re-level pavement.

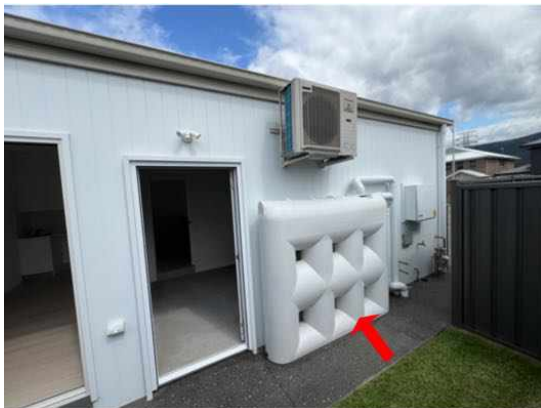
## Finding 2.02

Building: Main Building  
 Location: Yard - Side  
 Finding: Water pooling - against property  
 Information: Water appears to be pooling against the house. It is suspected that this is a result of poor site drainage but may also be due to excessive moisture from an unidentified source.

Where water is pooling against the house water damage to the external wall cladding is imminent.

Such water pooling also increases the risk of termite activity and the development of fungal decay in the area.

Consult a Licensed Plumber regarding the cost of potential site drainage rectification works.

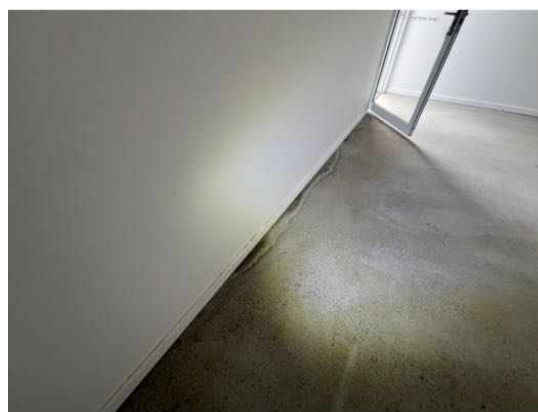
Building:	Main Building
Location:	Garage
Finding:	Water staining
Information:	Water staining was evident in this area at the time of inspection. Water staining indicates that surfaces have been exposed to excessive moisture over time. The minerals and other elements in the water lead to staining, which may graduate to corrosion and deterioration if left unmanaged.

While mostly an appearance defect, water staining can be indicative of more serious defects, which may be currently concealed by other building elements.

Where water staining is active, a licensed plumber must be consulted to identify the cause of the staining and to provide advice on any reparation works that may be required. Replacement of any broken or damaged structures is advised.

Conversely, where water staining is old and inactive, affected building materials may be repaired or replaced at client discretion. A qualified carpenter or registered builder may be appointed to perform these works.

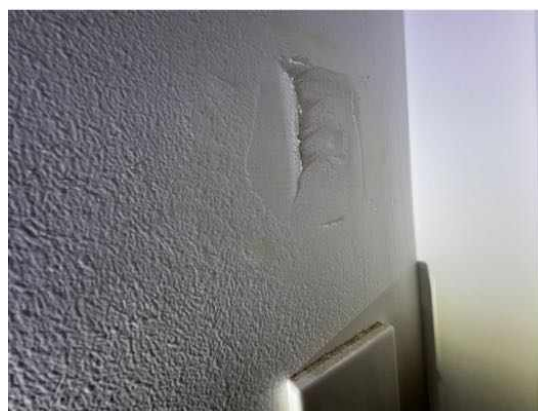
### Finding 3.04

Building:	Main Building
Location:	Garage
Finding:	Plasterboard - damaged
Information:	Sections of plasterboard were observed with visible damage, including dents, gouges, or abrasions. All wall and ceiling linings are required to be presented in an as-new condition at the time of handover, free from visible damage or surface irregularities when viewed from a normal viewing position. The client should consult with the builder to confirm how the damaged areas will be repaired to achieve an acceptable finish prior to handover.

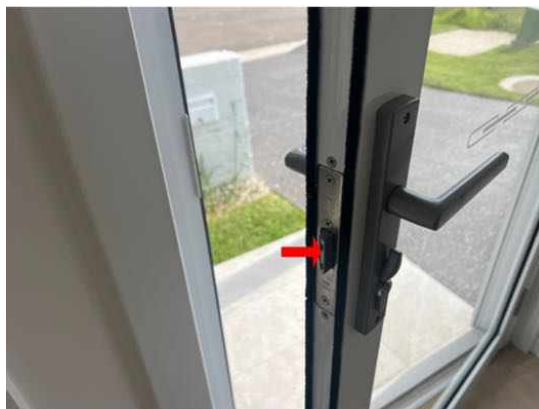
### Finding 3.05

Building:	Main Building
Location:	Entry
Finding:	Lock - Not working
Information:	The lock in this area was not operational at the time of inspection. Where locks have deteriorated to a point where they are no longer usable, the security of the property is immediately compromised.

Repair or replacement of the lock is highly recommended. Consultation with a locksmith or general handyman is required to gain further advice on any added

security that may be available for the area.

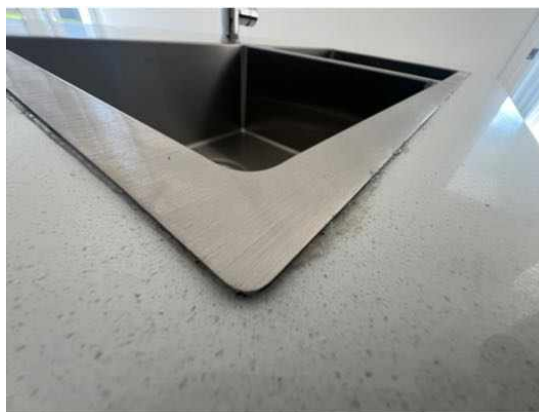
### Finding 3.06

Building:	Main Building
Location:	Kitchen
Finding:	Flexible sealants to junctions - poorly applied (AS 3958.1)
Information:	Sealant was observed to be poorly applied to the kitchen sink, presenting as uneven, smeared, or incomplete.

Flexible sealant is required at junctions to allow for movement while maintaining a watertight finish. As outlined in NSW Standards and Tolerances 12.7, flexible or waterproof sealants are defective if not installed where required by the NCC, AS 3958.1, or the manufacturer's installation requirements.

All affected areas must be properly sealed prior to handover.

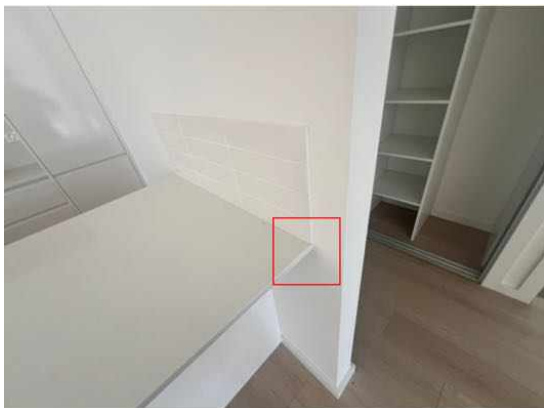
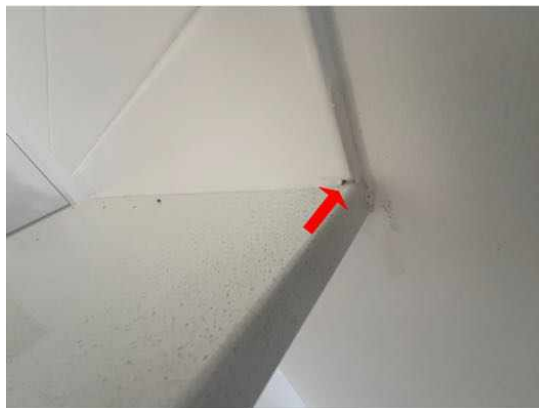
### Finding 3.08

Building:	Main Building
Location:	Kitchen
Finding:	Flexible sealants to junctions - poorly applied (AS 3958.1)
Information:	Sealant was observed to be poorly applied to tiled areas, presenting as uneven, smeared, or incomplete.

Flexible sealant is required at junctions to allow for movement while maintaining a watertight finish. As outlined in NSW Standards and Tolerances 12.7, flexible or waterproof sealants are defective if not installed where required by the NCC, AS 3958.1, or the manufacturer’s installation requirements.

All affected areas must be properly sealed prior to handover.

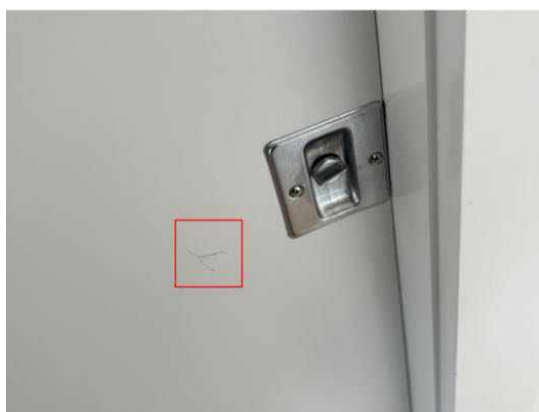
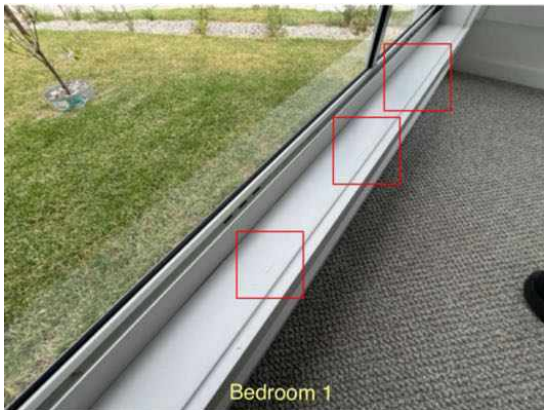
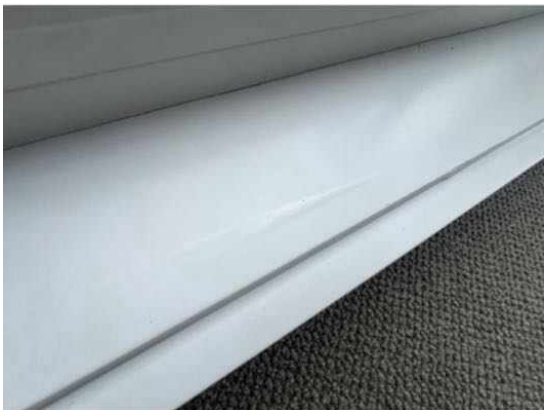
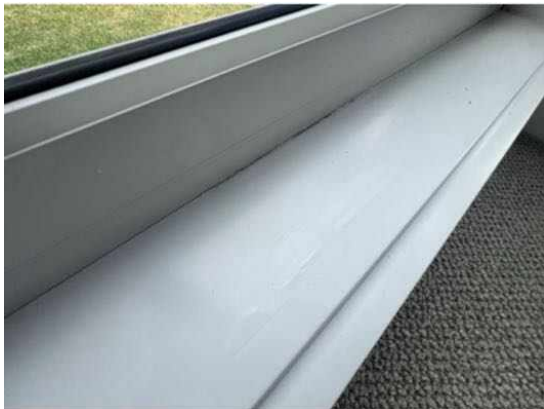
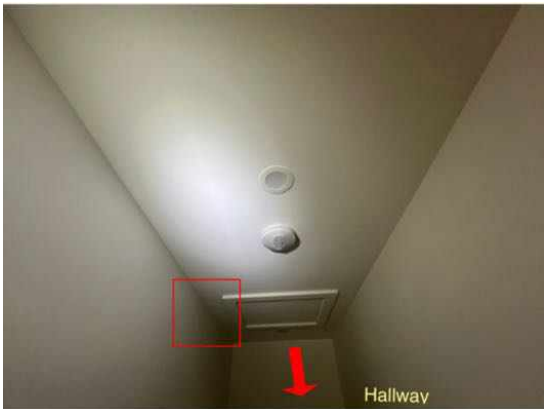
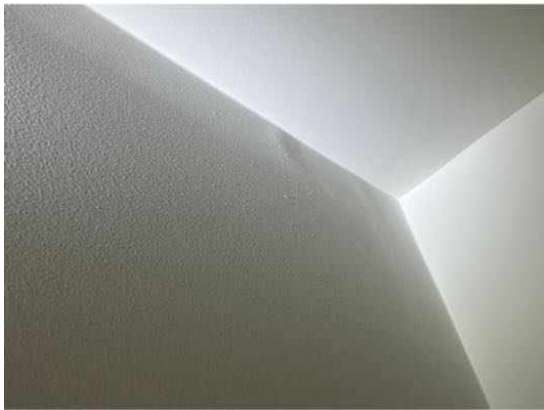
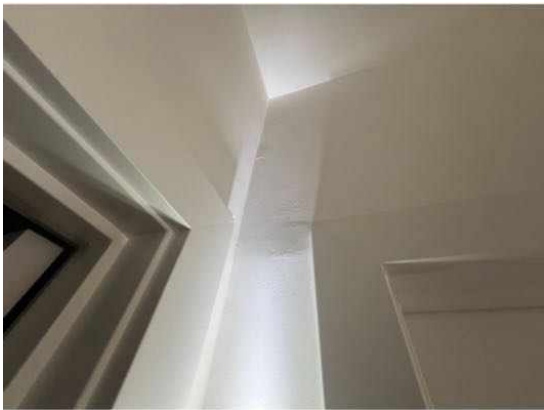
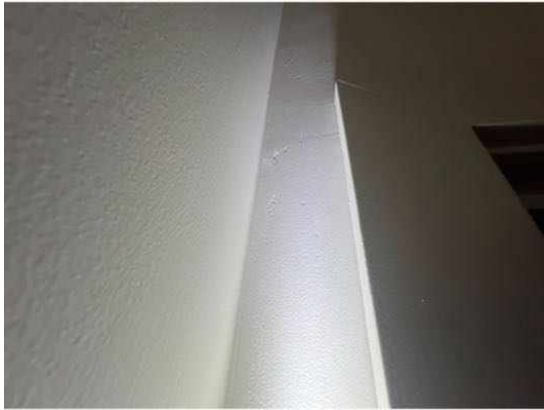
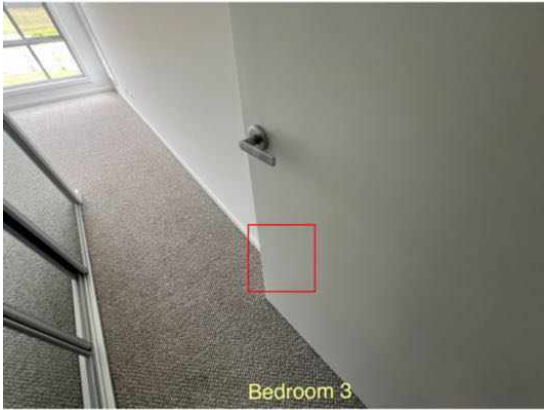
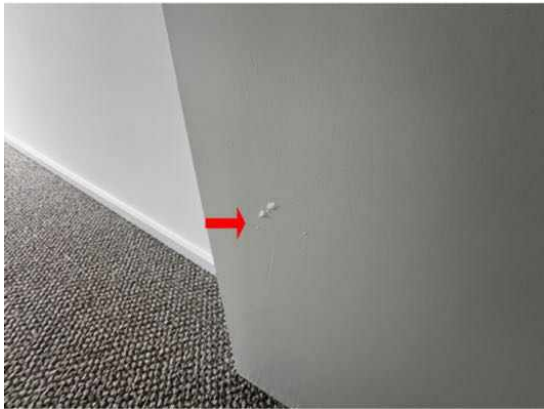
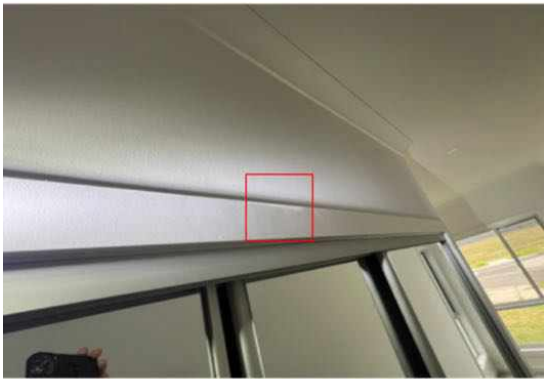
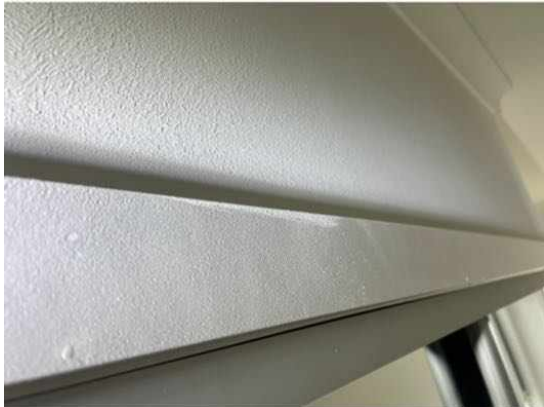
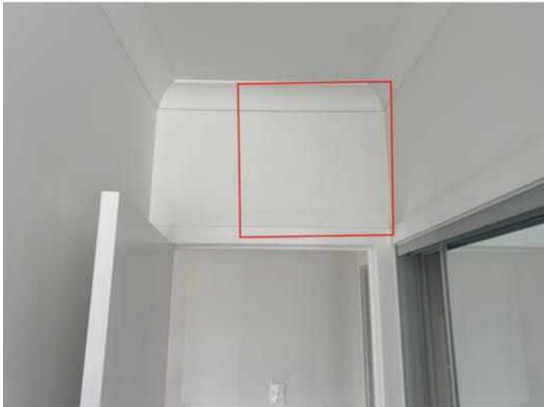
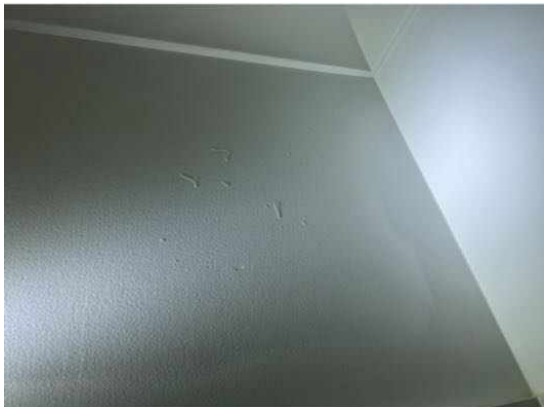
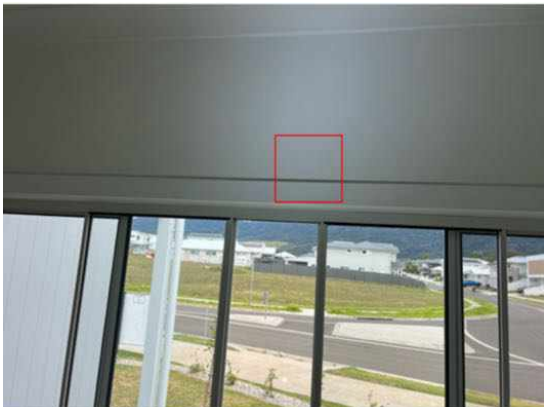
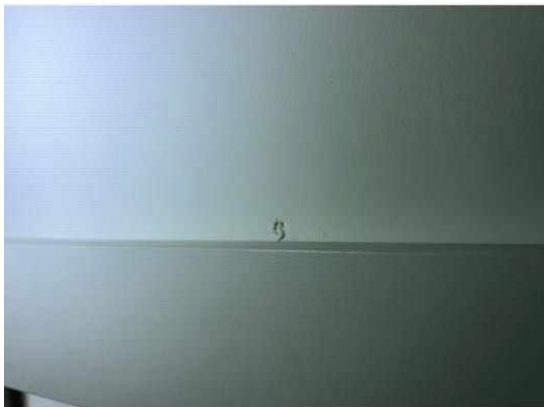
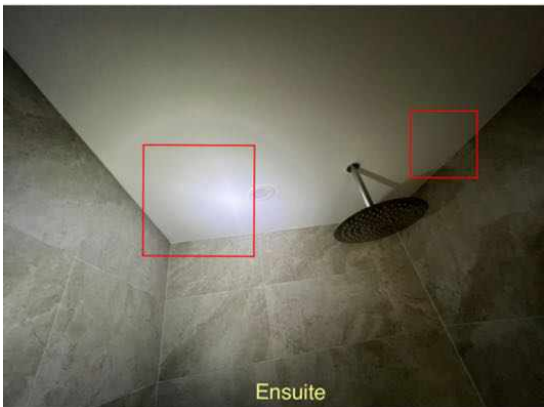
**Finding 3.09**

Building: Main Building  
 Location: Kitchen, Bedroom 1, Hallway, Bedroom 3, Ensuite, Bathroom, Garage, External - Bed 1  
 Finding: Painting - Defective (AS 2311)  
 Information: Areas were identified where the surface finish of the painting was found to be defective. This includes areas of over-painting, paint runs, areas starved of paint, sags and/or wrinkling of paint finish etc.

During New Construction Inspections, any irregularity in the paint finish that is detected from a “normal viewing position” is considered a detraction from the area's overall appearance and is therefore considered to be a defect.

The builder should have the painting contractor perform touch-ups to affected areas prior to final handover to bring the paint finish to an acceptable standard.

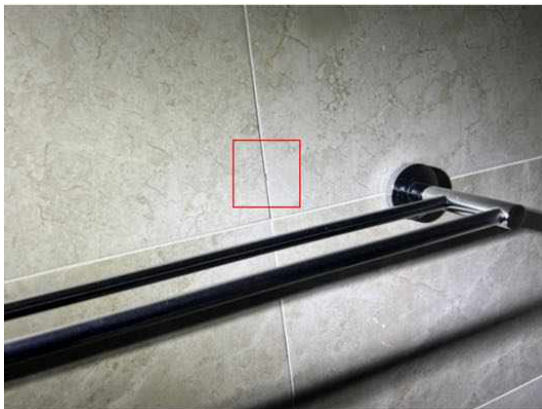
Building: Main Building  
 Location: Bathroom  
 Finding: Grouting and joints - poorly applies (AS 3958.1)  
 Information: Grout was observed with pinholes, voids, and an uneven finish in several areas.

As outlined in NSW Standards and Tolerances 12.6, and in accordance with AS 3958.1 Clause 5.7, finished grout is defective if it is not uniform in colour, smooth, and free from voids, pinholes, or low spots.

All affected grout must be repaired to achieve a consistent and compliant finish prior to handover.

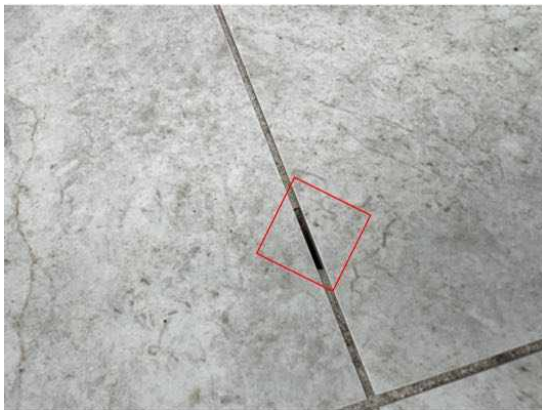
Building:	Main Building
Location:	Porch
Finding:	Grout - Missing (AS 3958.1)
Information:	It was observed that grout is missing in certain areas between tiles.

Guide to the Installation of Ceramic Tiles specifies that grout joints must be fully filled to provide structural integrity, water resistance, and an acceptable finish.

Missing grout may lead to moisture ingress, tile movement, or deterioration of the surrounding finishes. The affected areas should be re-grouted to ensure durability and compliance with AS 3958.1.

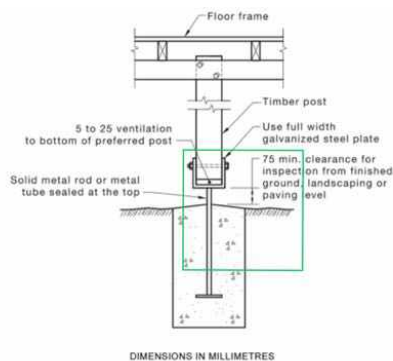
FIGURE 3.1(D) METAL STIRRUP AS ALTERNATIVE TO SHEETING FOR POSTS

zone (metal stirrup) causes a bridging point. Bridging of termite barriers occurs when termites bridge (usually by building a mud tunnel) a termite barrier or inspection zone or where termites have a passage allowing them to bridge the barrier.

Generally this takes the form of finished ground levels external paving or concrete being retrospectively installed above the damp course level the adjacent internal floor level or weep and ventilation holes.

Where bridging has occurred full inspection is prevented and termites may enter a property in a concealed or undetectable manner.

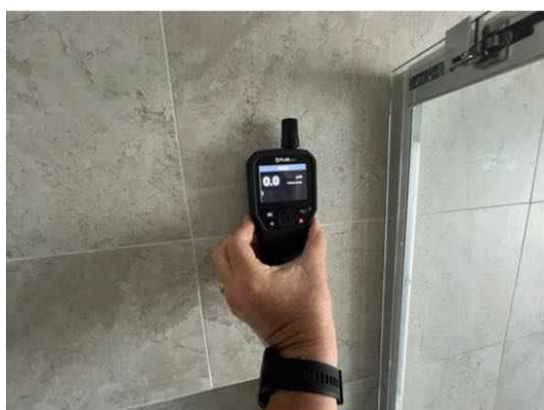
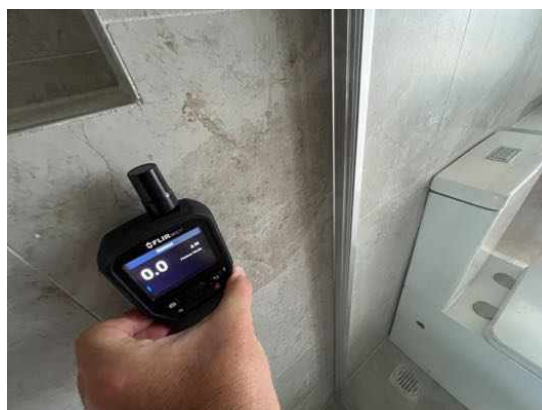
#### Noted Item

Building:	Main Building
Location:	Ensuite
Finding:	Moisture in Shower
Information:	Moisture is evident behind the tiles to the shower alcove. This defect is quite common, and is suspected to have been caused by moisture permeating through the grouting in this area. Leaking pipes within the adjoining wall is also a possible cause.

Damp (or structural damp) refers to the presence of unwanted moisture in the structure of a building, either as the result of intrusion from outside, or condensation from within the structure. In the shower area, internal water leaks or other sources of excessive moisture are generally the cause of damp. Always ensure that sealant and grout is in good condition to prevent any moisture issues occurring in the future.

Consultation with a qualified plumber or bathroom specialist is advised to identify the cause of damp and to perform remedial works as required.

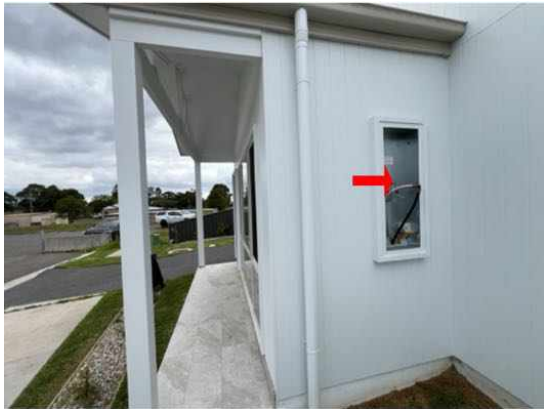
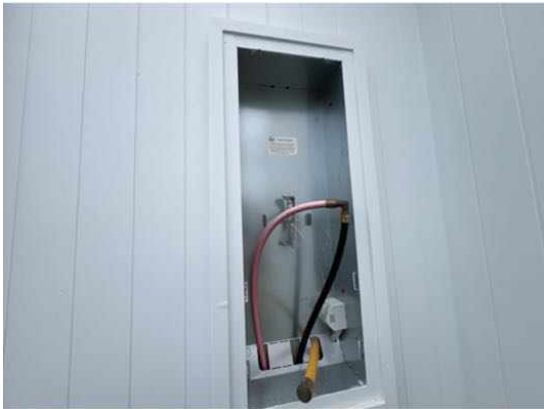
Building:	Main Building
Location:	Exterior walls - front
Finding:	Hot Water Unit - Not Installed / Gas Appliance Not Assessed
Information:	The hot water unit had not been installed at the time of inspection. As a result, the gas appliance and associated gas installation could not be assessed.

This inspection does not include commissioning, testing, or verification of gas appliances, and no gas appliance operation was carried out. Assessment of gas appliance installation, connections, commissioning, and safe operation falls outside the scope of this inspection and requires confirmation by an appropriately licensed gasfitter.

Once the hot water unit is installed, confirmation should be obtained that the appliance and associated gas services have been installed and commissioned in accordance with applicable requirements, prior to handover.

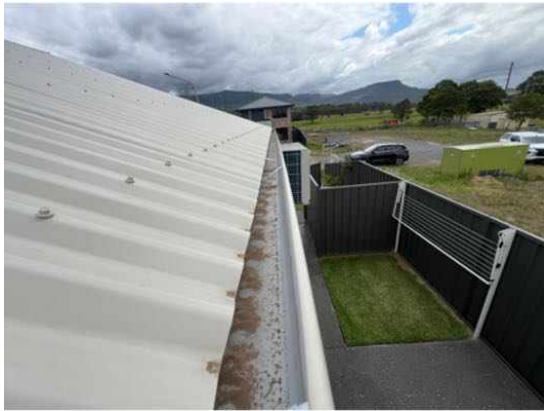
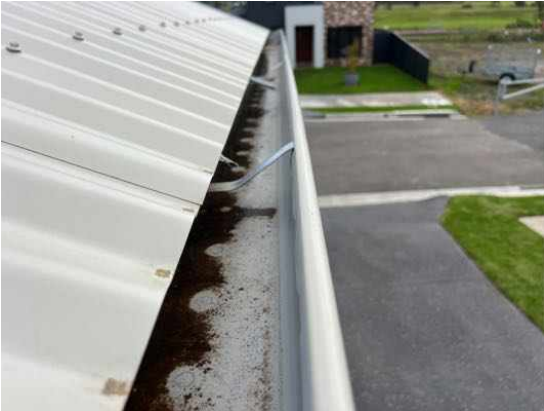
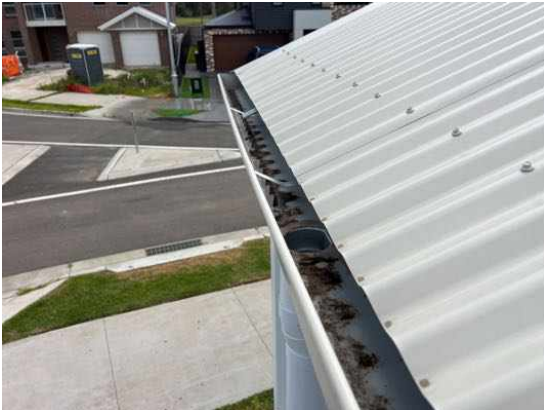
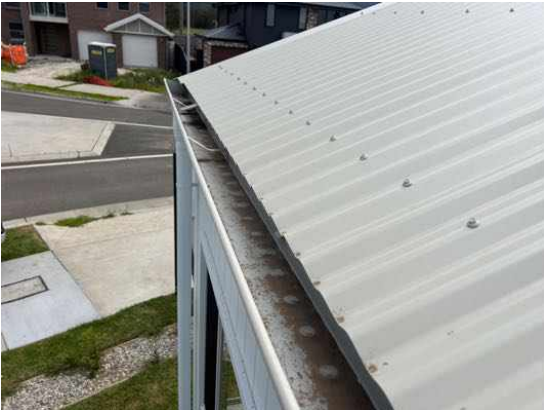
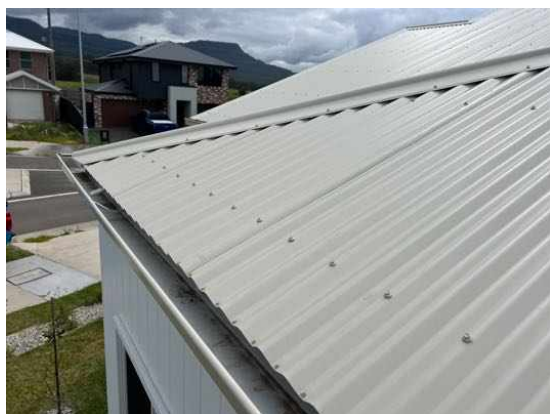
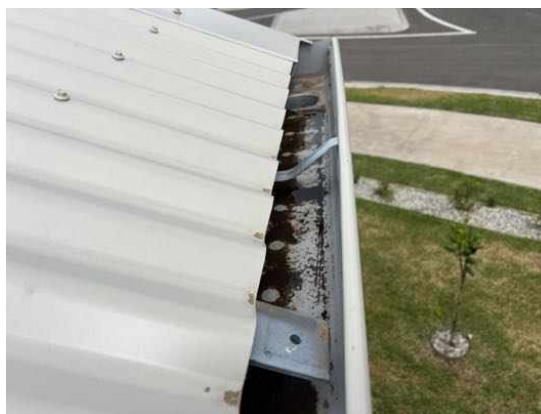
Building: Main Building  
Location: Roof Exterior  
Finding: Gutter - Clear and clean  
Information: At the time of inspection, the gutters were found to be clear of debris and in a clean condition. Blocked gutters are a common cause of water ingress and associated damage to eaves, walls, and internal ceilings. While no concerns were noted at present, it is essential that gutters are routinely maintained and kept free of debris to ensure proper stormwater flow and to avoid potential overflow issues during periods of heavy rainfall.

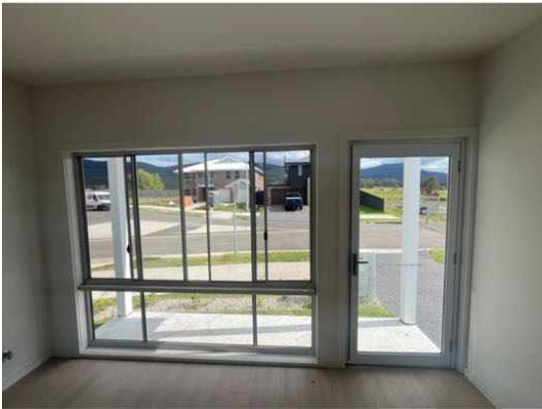
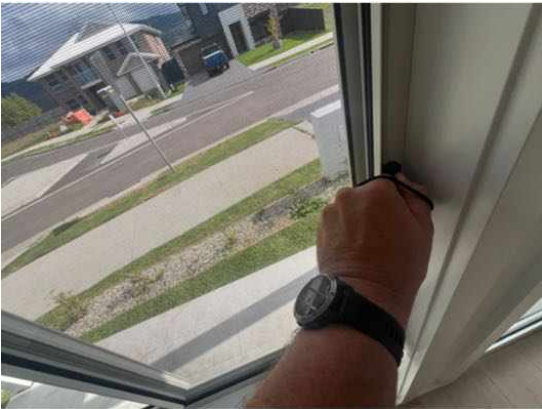
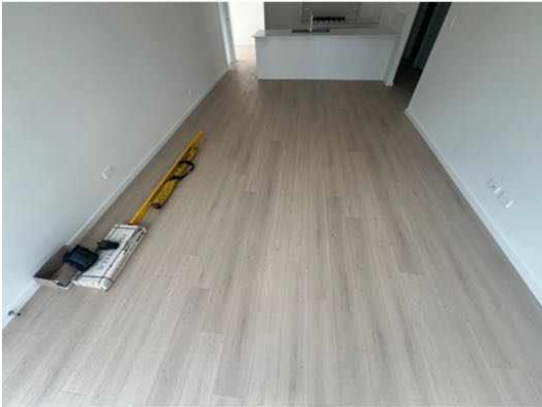
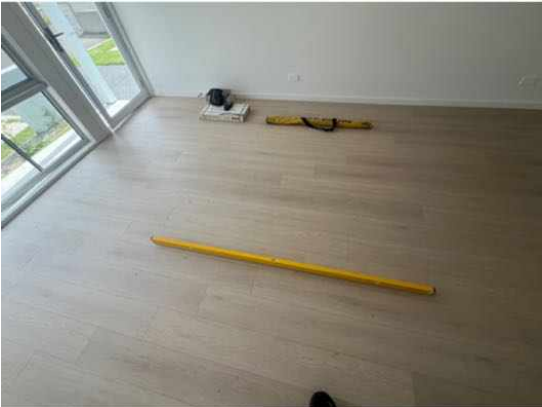
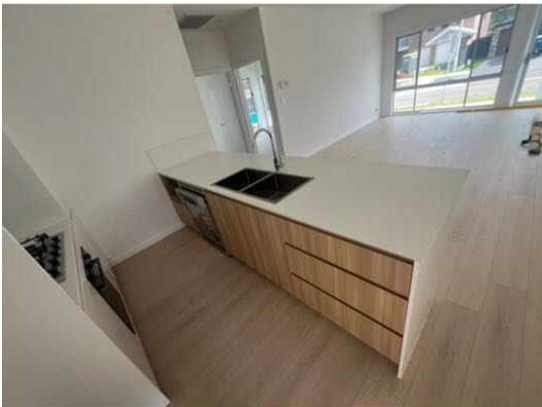
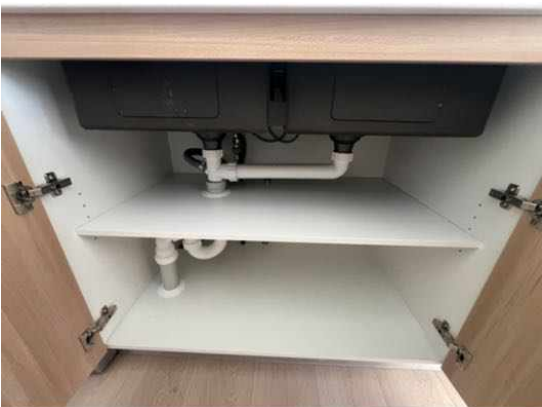
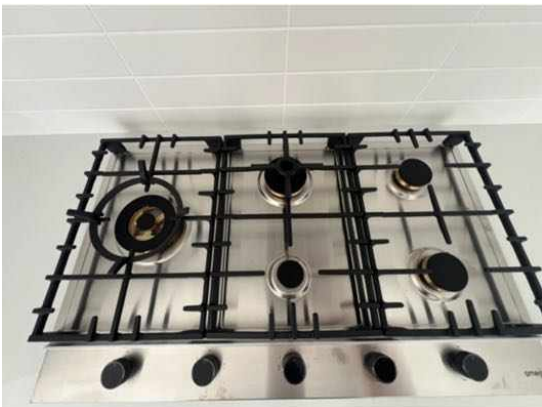
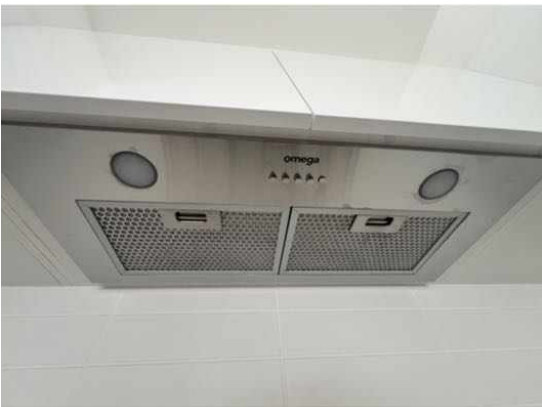
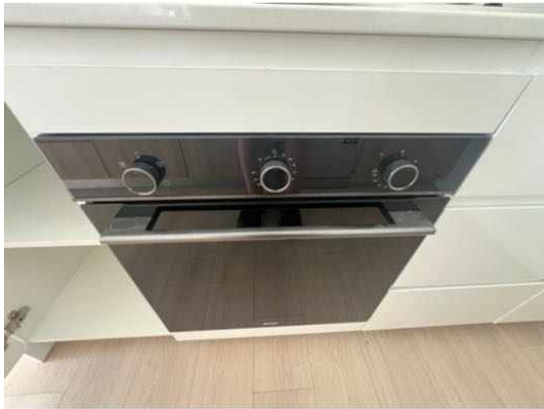
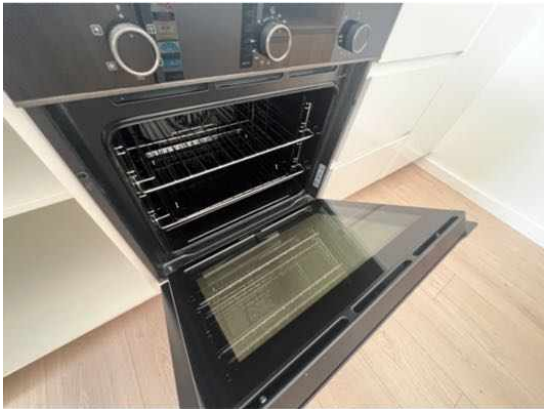
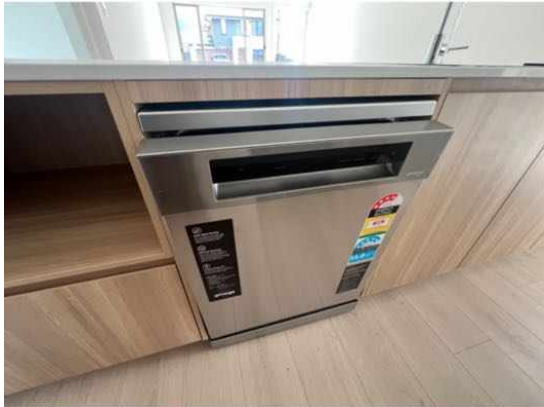
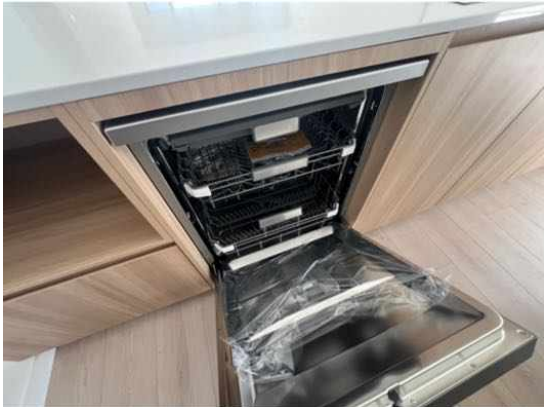
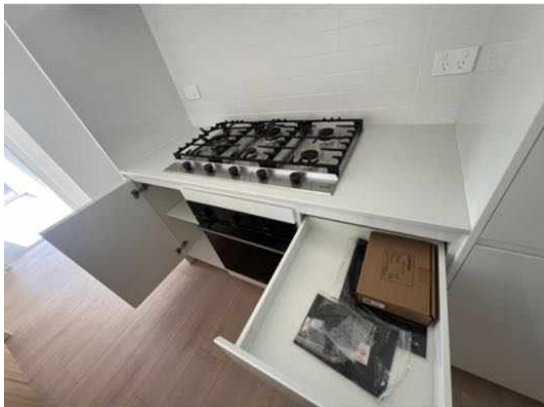
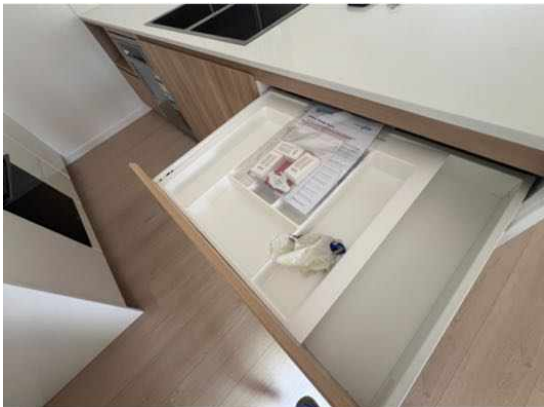
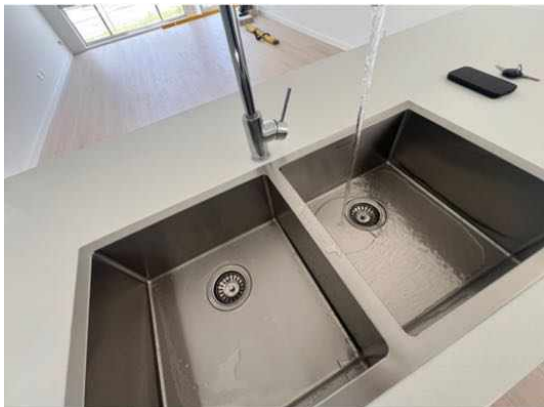
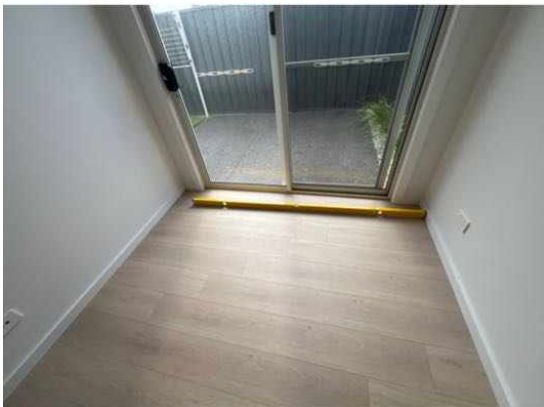
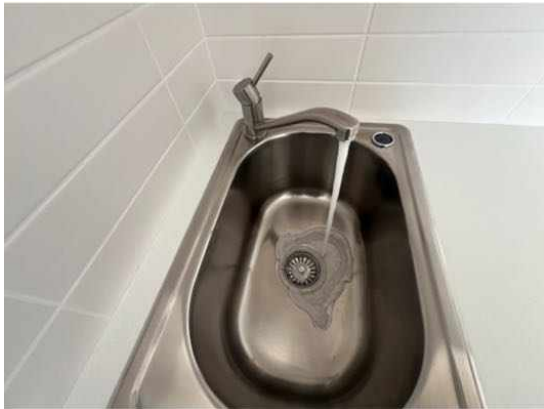
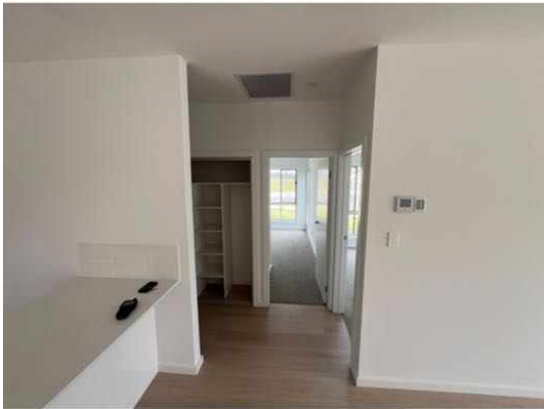
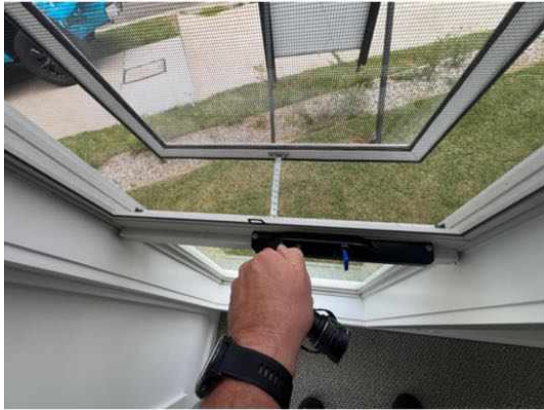
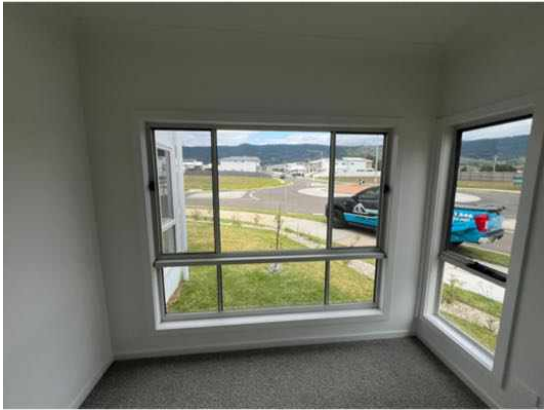
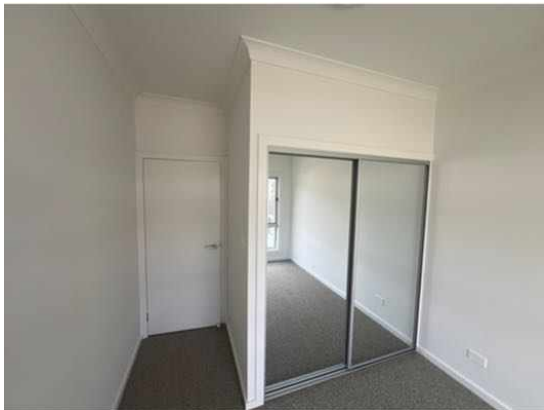
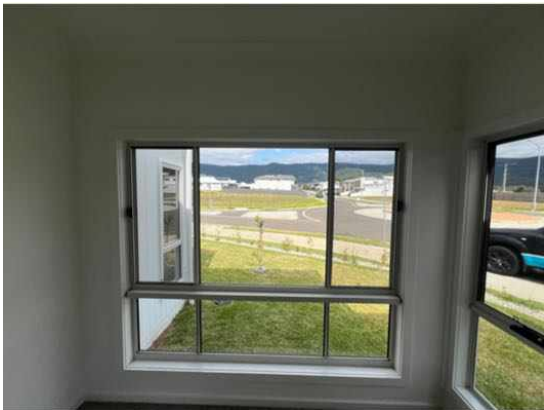
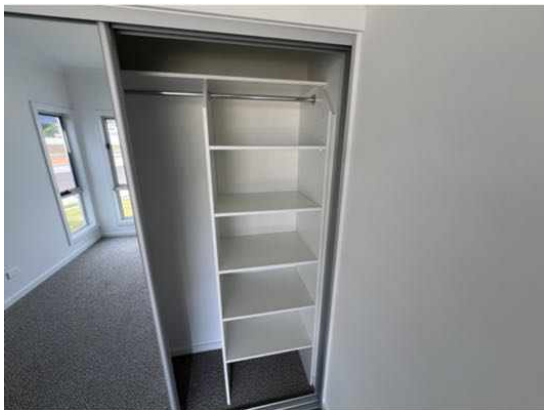
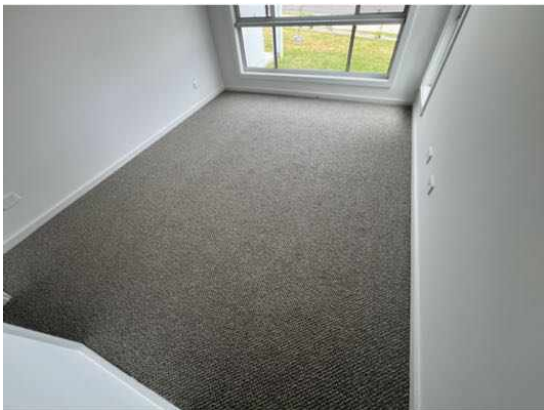
Building: Main Building  
 Location:  
 Finding: FYI - Additional Photos  
 Information: Additional photos are provided for your general reference and may include obstructions, testing of water & windows, moisture readings or minor maintenance items.

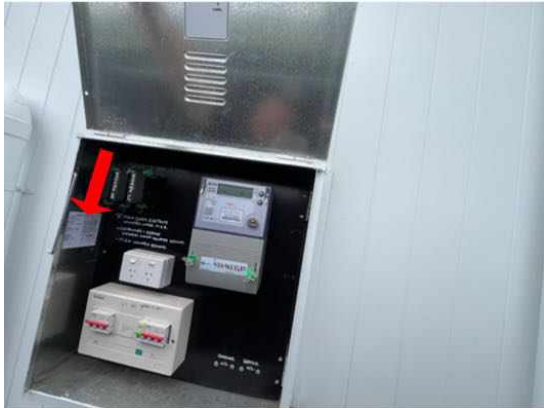
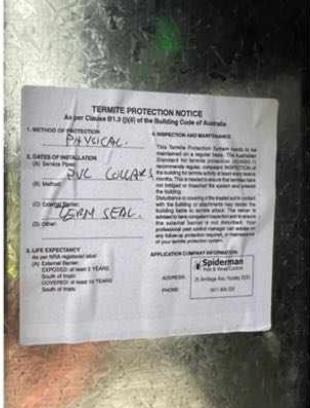
**The following items were noted as - Evidence of a previous termite management program**

Where a Termite Management System has been identified you should refer to the type of barrier date of installation warranty conditions and any documentation provided by a builder or past owner. Consult the company who installed the barrier to confirm whether the system is still under warranty.

Most chemical termite management systems expire and require replenishment and all physical systems are primarily designed to prevent concealed entry.
