Building and Timber Pest Inspection Report

Inspection Date: Mon, 16 Mar 2026

Property Address: 4 Nardu Ct, Currimundi QLD 4551,
Australia

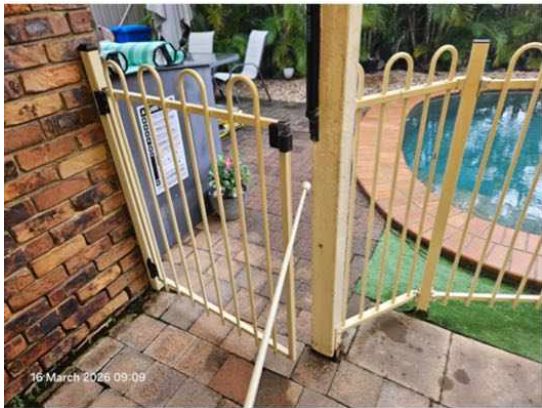
The gate from the rear patio did not operate effectively in the three required positions and at the front colorbond boundary fence intersection, the gap is greater than 100mm.

The recommendation is that these defects be rectified to complete the compliance.

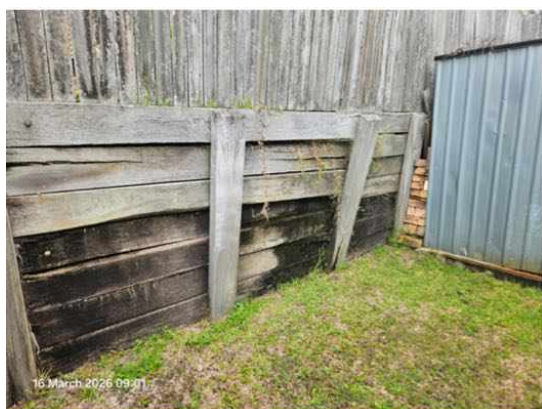
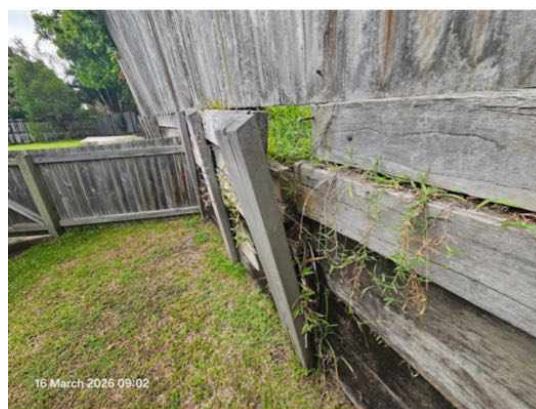
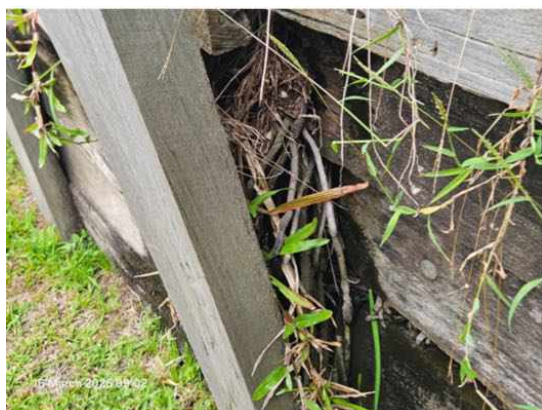
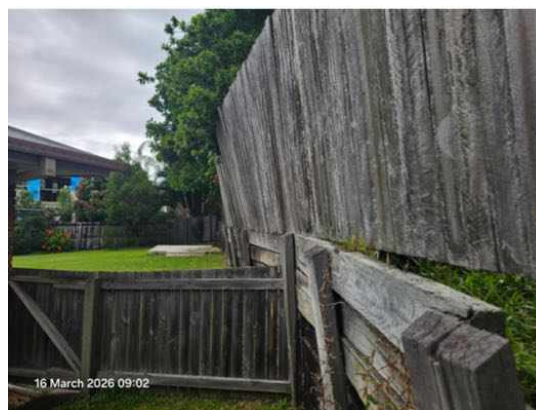
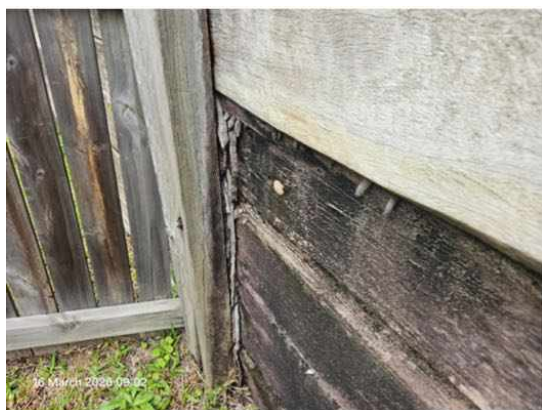
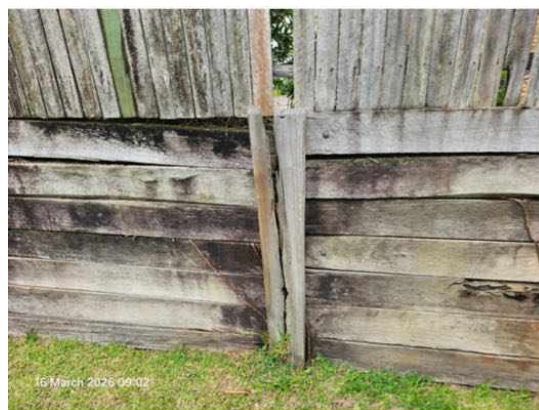
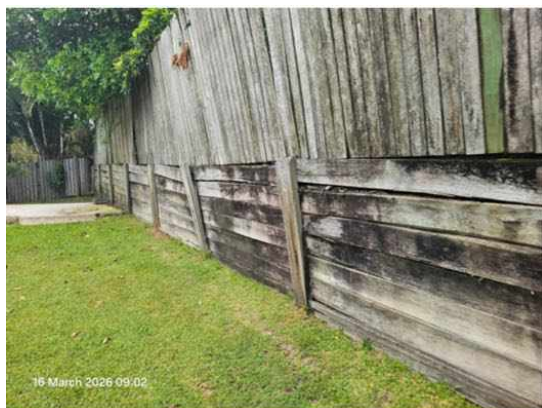
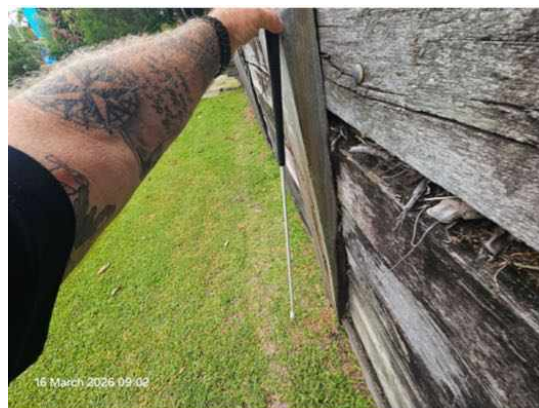
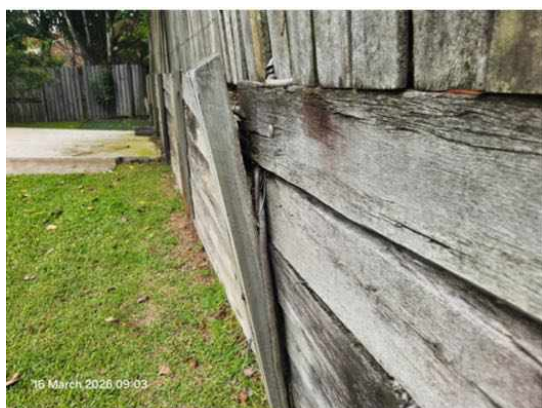
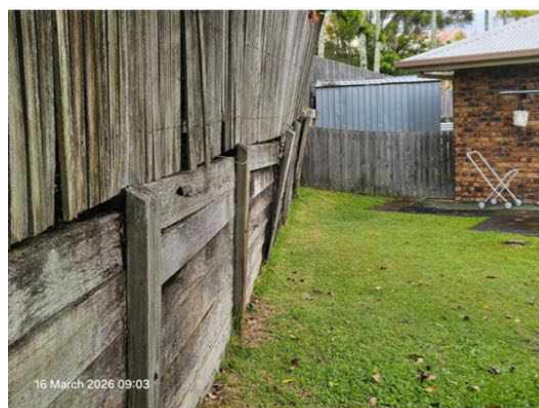
Finding 2.01

Building: Yard
 Location: Right boundary
 Finding: Retaining wall , timber - Defective
 Information: The retaining wall on the right boundary was found to be defective at the time of inspection. Generally, defective retaining walls are caused by poor original design or material use. However, deteriorated retaining walls may also be a result of substandard construction, poor site drainage, unmanaged stormwater flows or interference by trees and plants.

If left unmanaged, the retaining wall may become a safety hazard if it continues to destabilise. Where retaining walls further rot and decay, an environment is created that is conducive to termite and pest infestation.

Significant repair and replacement should be expected. Where retaining walls are considered structural walls, a structural engineer / surveyor should be consulted regarding required remedial works. Otherwise, a landscaper or retaining wall installer may be appointed to repair or replace the wall, at the discretion of the client.

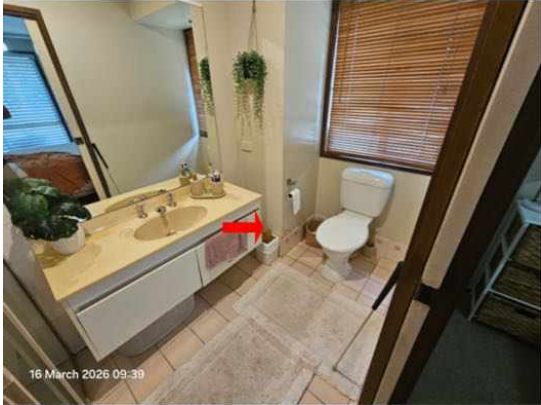
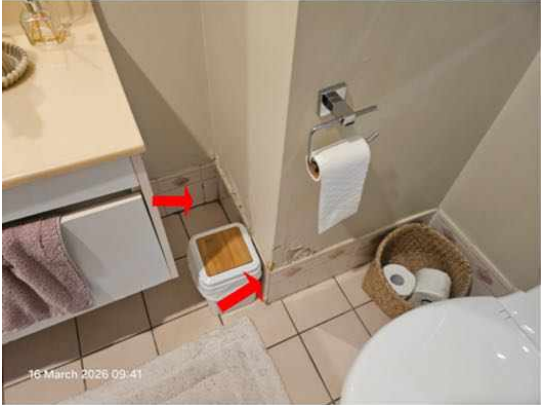
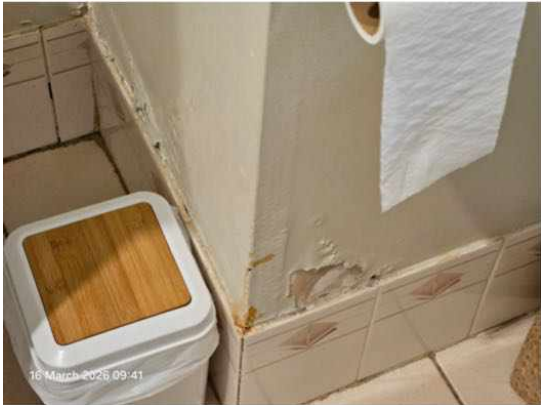
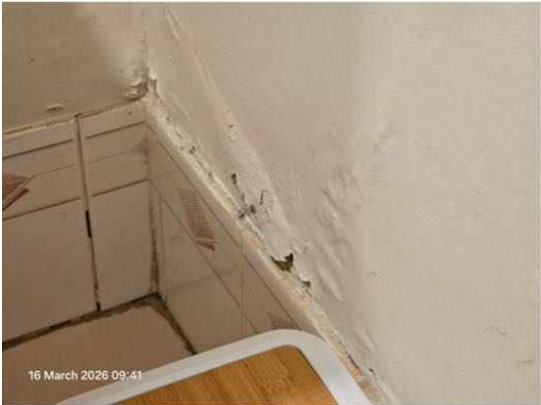
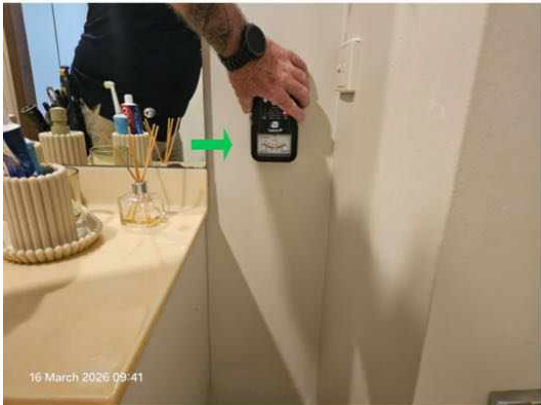
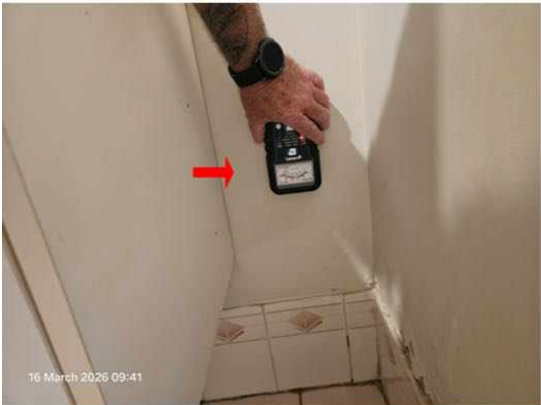
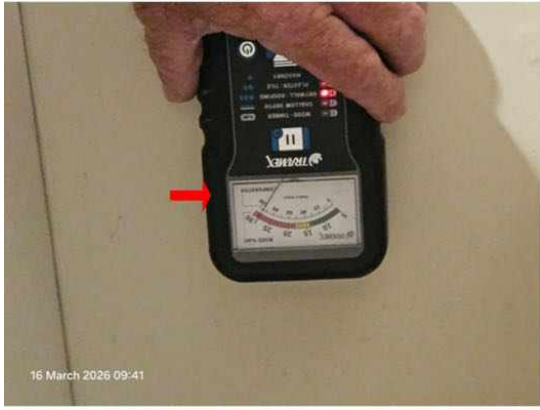
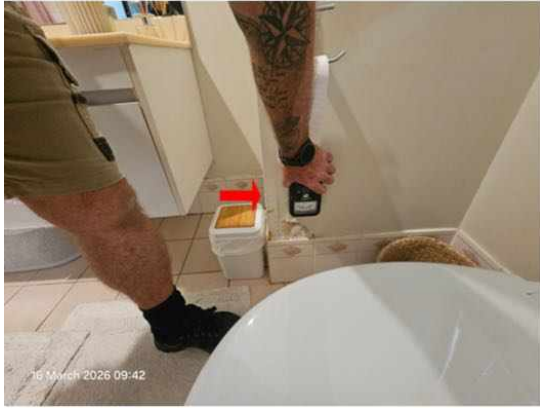
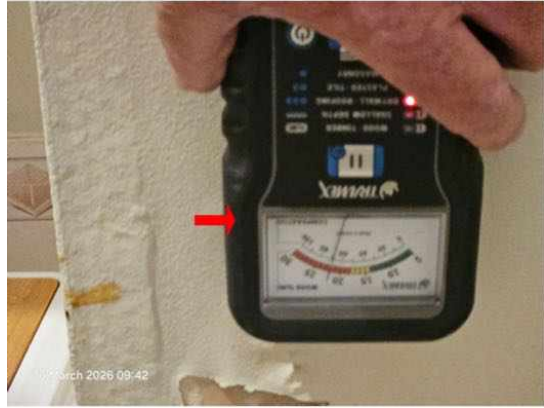
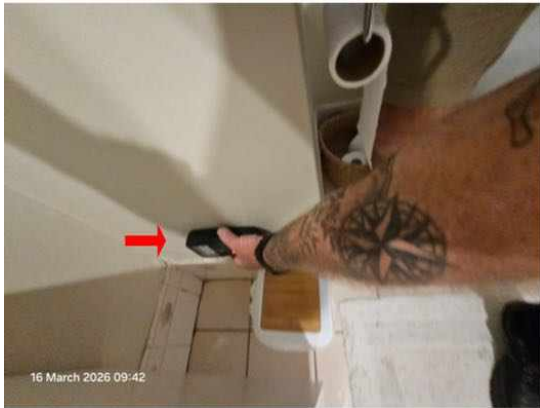
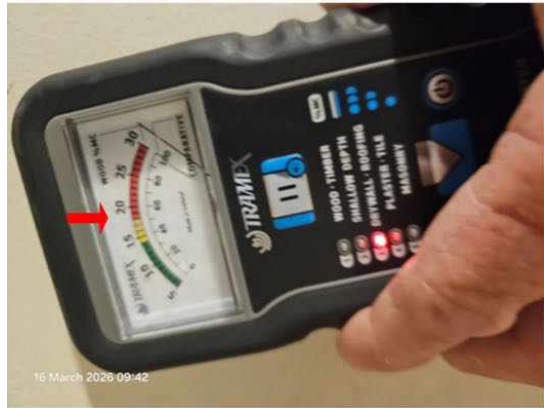
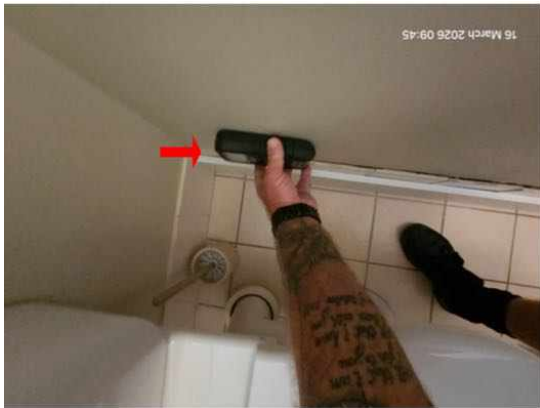
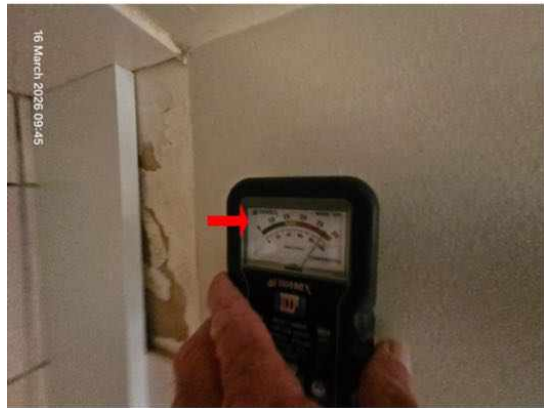
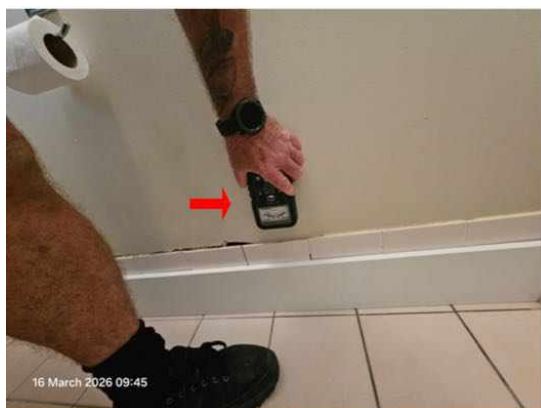
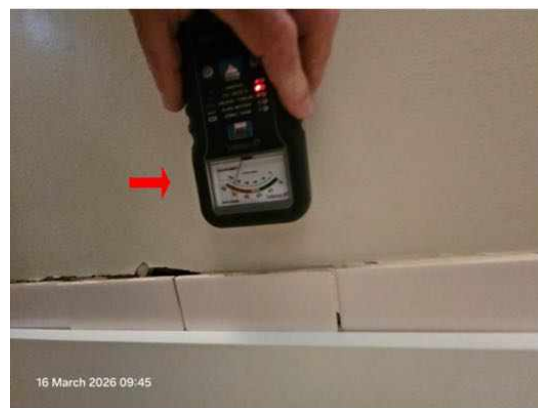
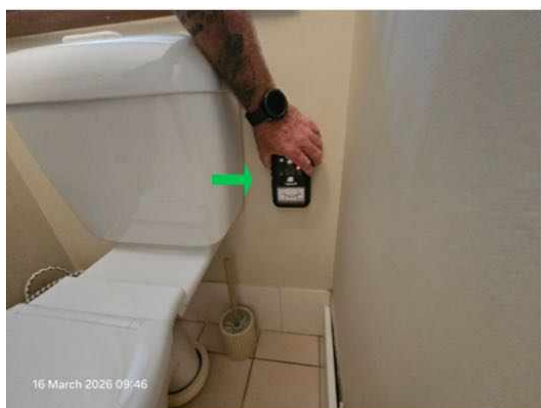
Finding 2.02

Building:	Main Building
Location:	Ensuite - Master
Finding:	High moisture, damage to external wall
Information:	Elevated moisture was noted in the lower wall surface of the internal and external walls of the ensuite. The levels were higher at floor level and declined as readings were taken higher up the wall surface. The elevated readings are also present on the opposing side in the toilet where damage was noted in the skirting tile level of the plasterboard.

This situation has created a high risk of water ingress damage and a high risk level for timber pests. This is the ideal environment for termites to develop an active presence.

This will require further investigation to identify the source of the leak / water ingress and to assess any related damage to framing. This should be done with some urgency.

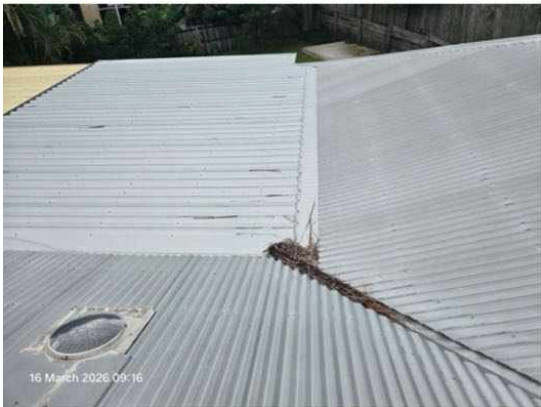
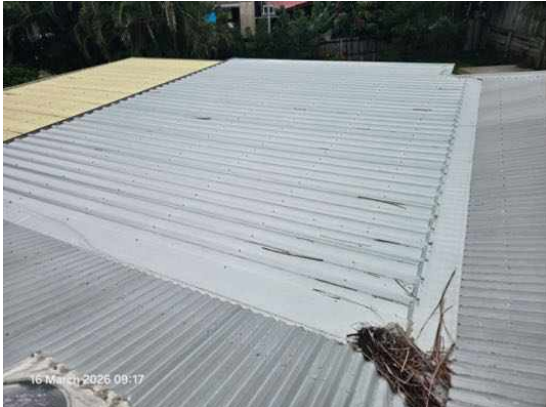
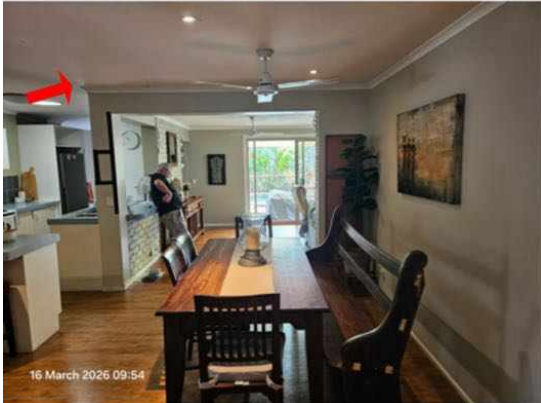
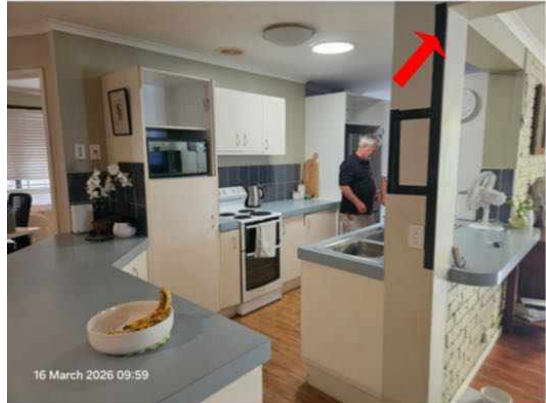
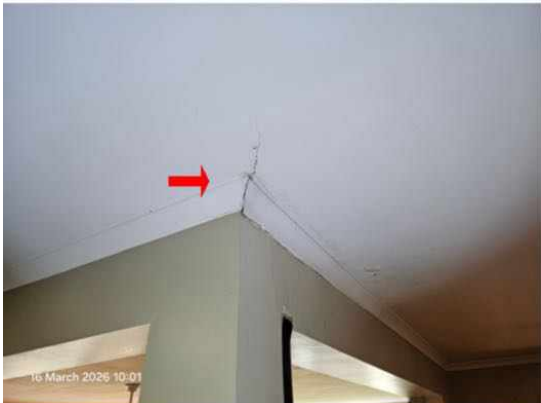
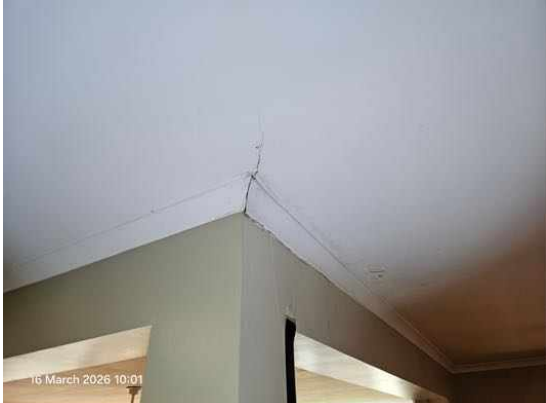
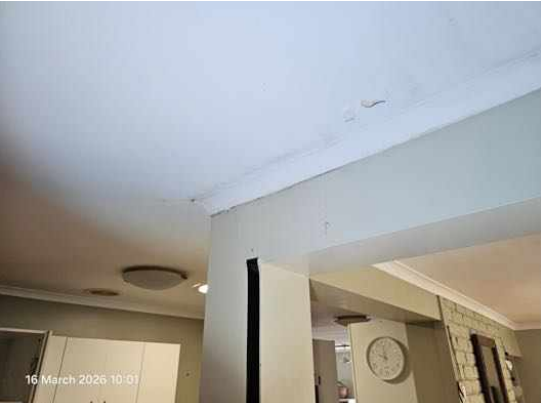
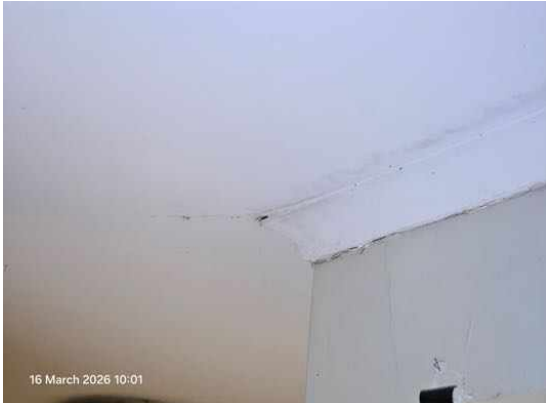
Finding 2.03

Building:	Main Building
Location:	Kitchen
Finding:	Suspected active roof leak
Information:	There is evidence in the kitchen of an active water leak from the roof valley above. As shown in the photos, the valley at the connection of the patio pergola roof to the main house roof is blocked. There is visible damage to the plaster board and paintwork. The roof pitch of the pergola is suspected to be under the required slope of 2 degrees for trimdek sheeting.

It is strongly advised that the cause of the leak be identified and resolved as soon as possible by a licensed roof plumber to prevent any further damage. Depending on the extent of the damage previously sustained, repair and/or replacement of any affected building materials may be required.

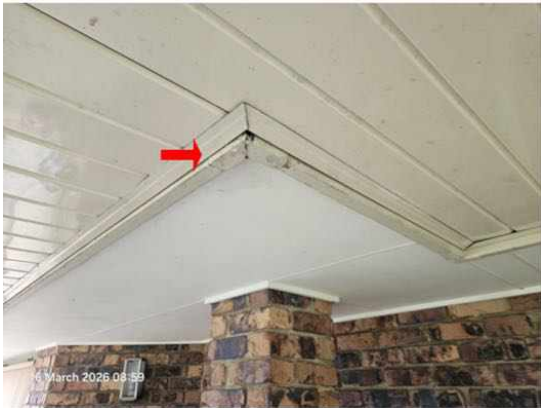
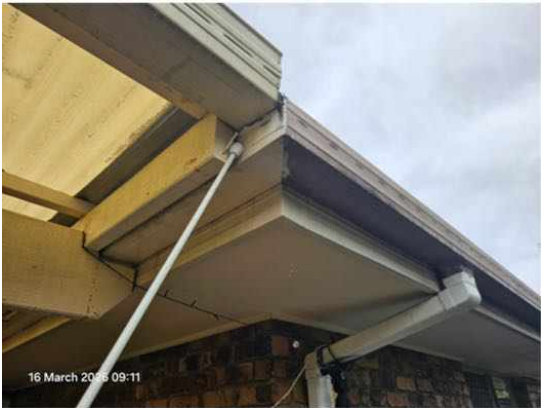
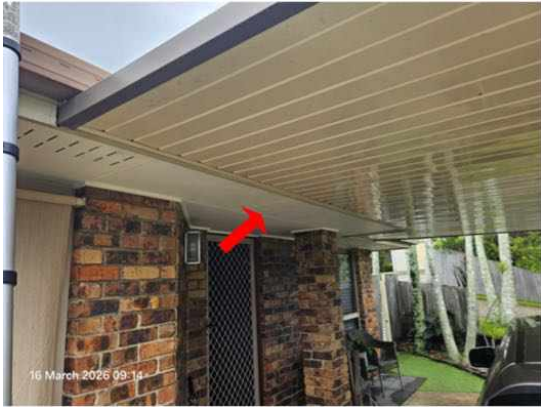
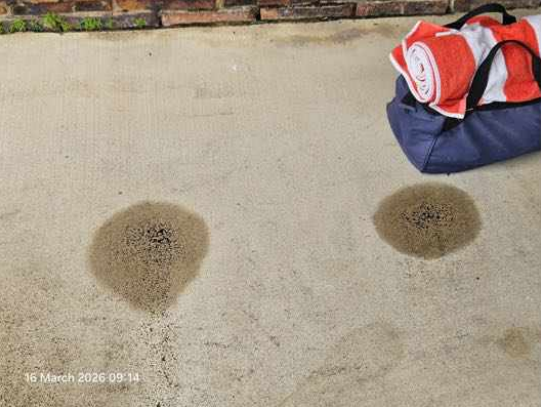
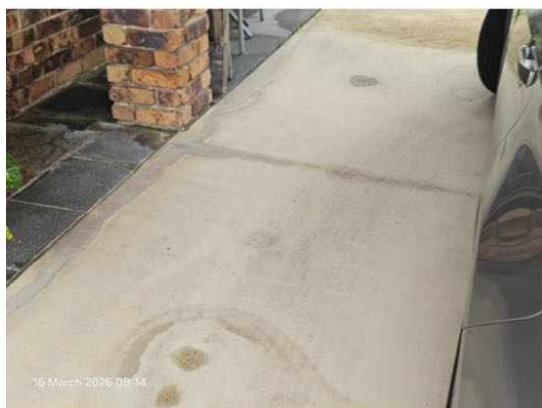
Building: Main Building
Location: As shown
Finding: Gutter leaks
Information: On the day of inspection there was evidence of a water leaks in the selected areas of the roof gutter around the perimeter of the property. Water was observed dripping from some of the joins.

Leaking joints can lead to further defects in the form of rust and holes. Repairing leaks in a timely fashion will help mitigate the risk and add to the longevity of the roof plumbing.

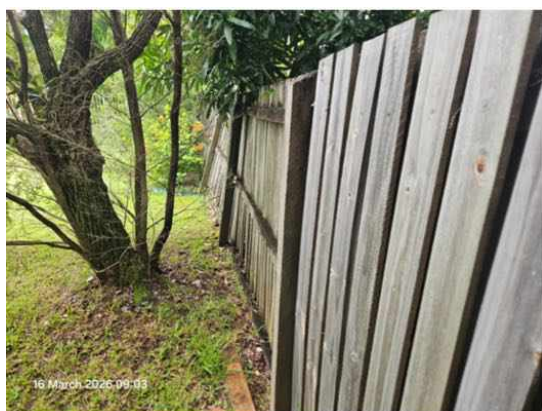
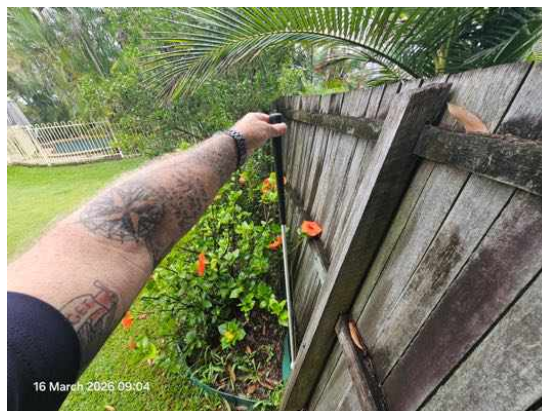
Finding 3.02

Building: Yard
 Location: Rear boundary
 Finding: Boundary fence - poor condition
 Information: On the day of inspection the fence was assessed and sections of the front left timber post and rail fence are in poor condition. As shown in the photos, the fence is leaning badly.

The client should engage a licensed fencer or licensed carpenter to carry out the required repairs.

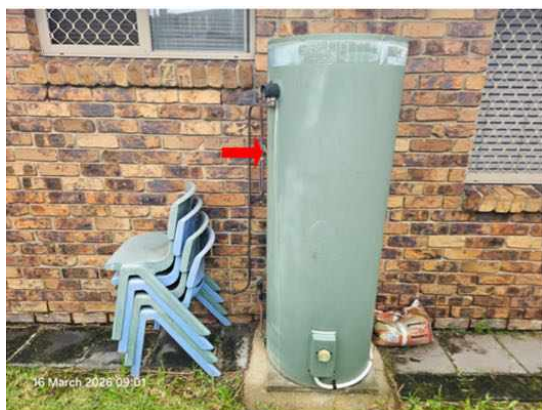
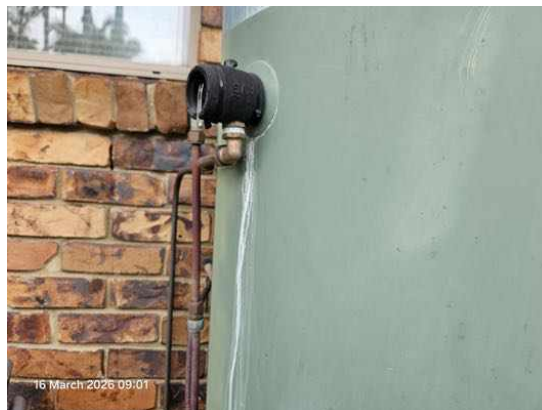
Finding 3.03

Building: Main Building
 Location: Right side
 Finding: Hot water service - service suggested
 Information: It was noted during the inspection that the hot water system outlet appeared to have a leak at the connection.

It is suggested that a plumber be contacted to assess the connection.

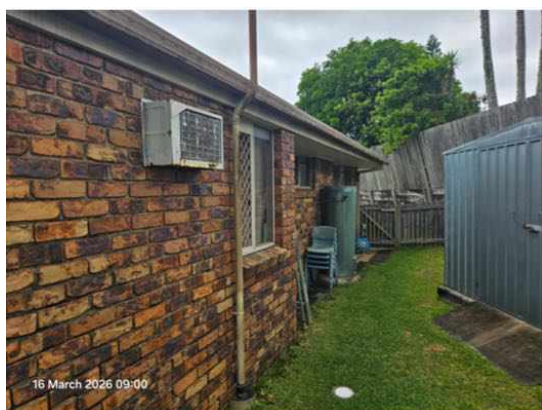
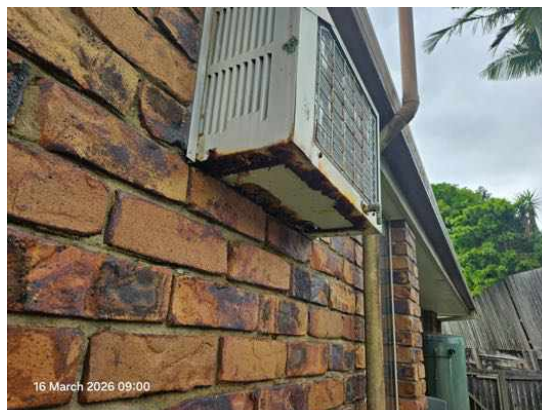
Finding 3.04

Building:	Main Building
Location:	Right side
Finding:	Air conditioner casing - rusted
Information:	The air conditioner casing of the outdoor unit is rusted.

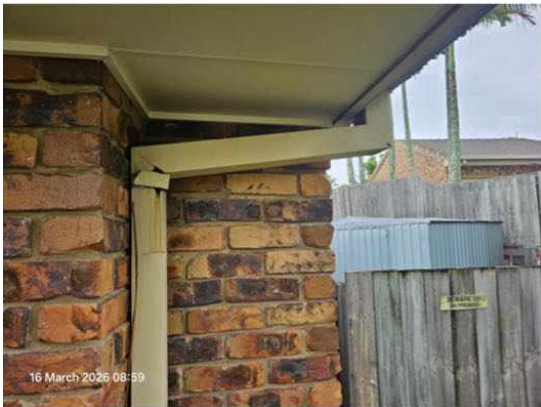
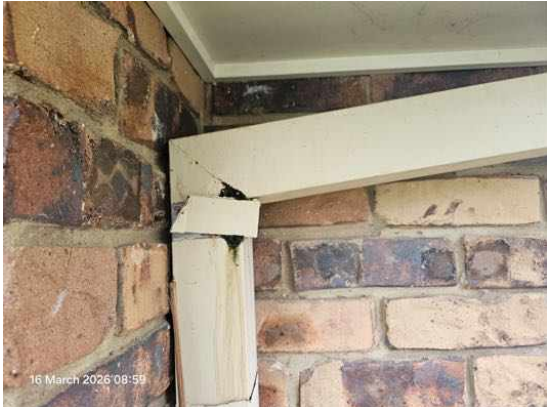
Finding 3.05

Building:	Main Building
Location:	As shown
Finding:	Downpipe leaking
Information:	During the inspection of the perimeter of the building it was noted that there was two downpipes leaking.

Leaking downpipes can create excess moisture at the building perimeter, leading to conditions conducive attractive to timber pests.

The client could engage a plumber to assess and resolve the leak.

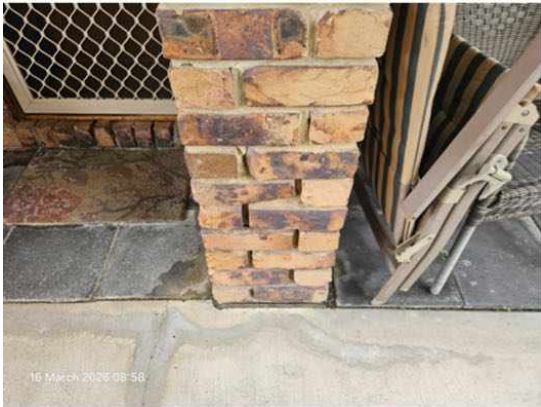
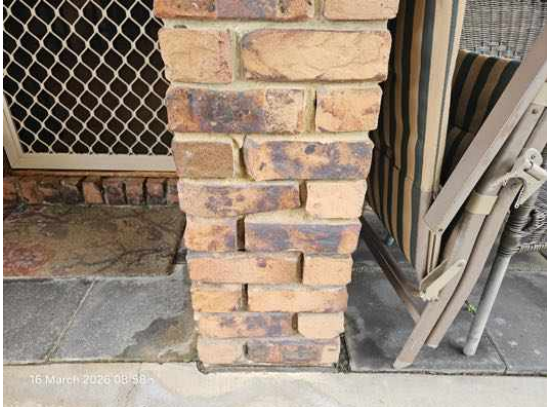
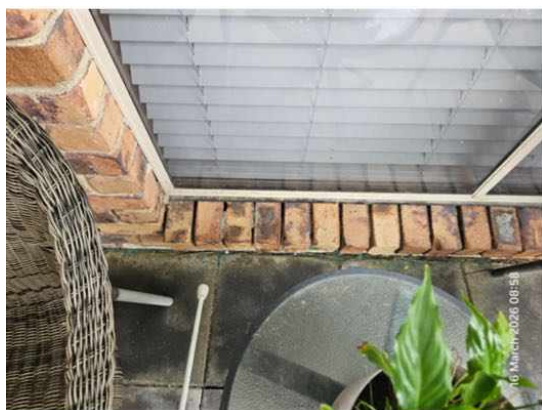
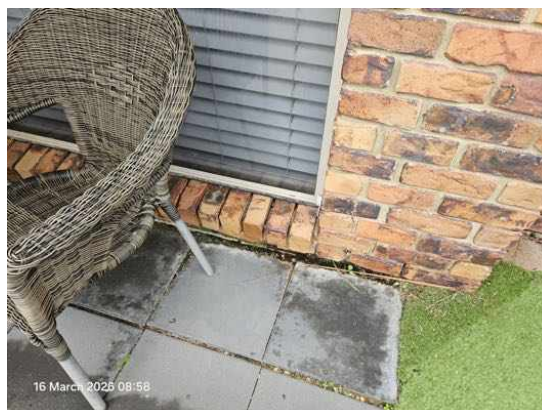
Finding 3.06

Building: Main Building
Location: As shown
Finding: Mortar joints degraded
Information: Areas of defective mortar joints were identified during the inspection. As inspected they appear to be weather worn and may let moisture in via the holes forming.

It would be advisable to have a licensed bricklayer or suitably qualified handy person inspect and carry out the repair as necessary.

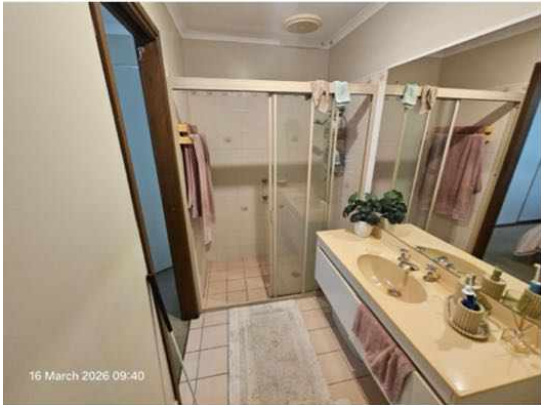
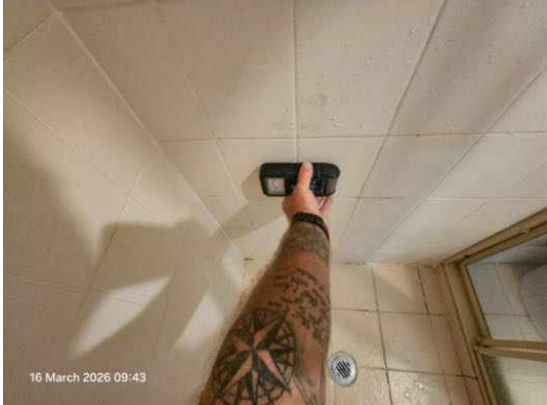
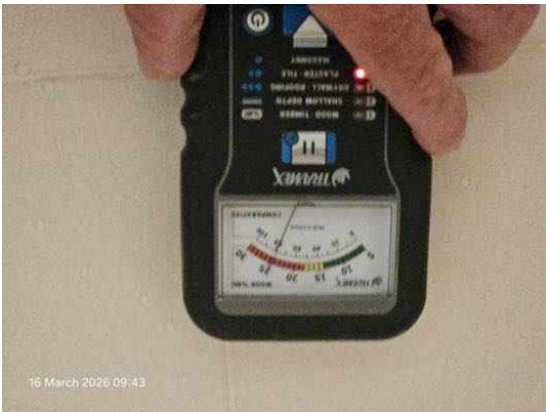
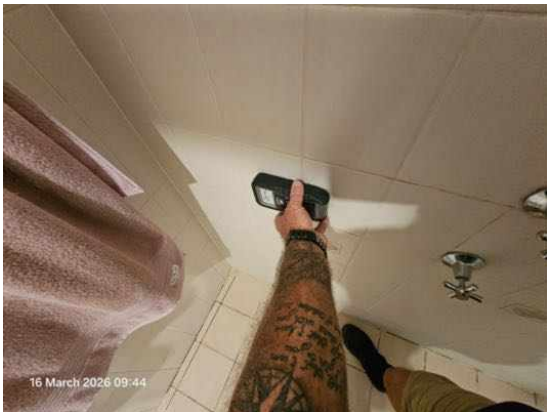
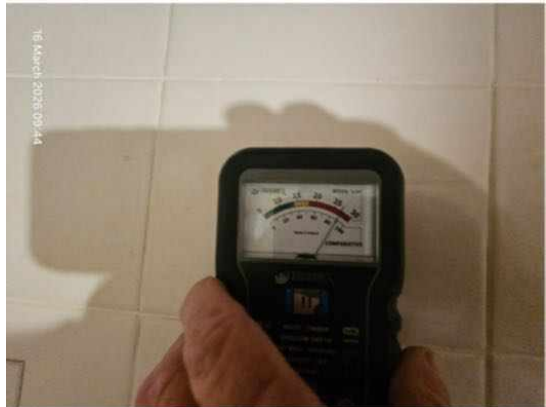
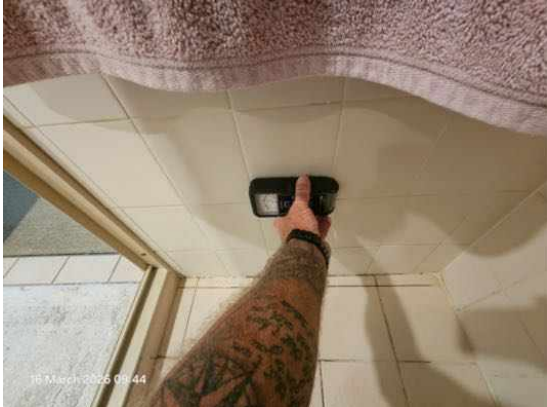
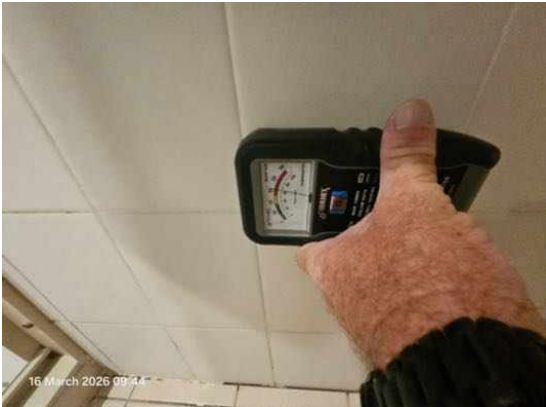
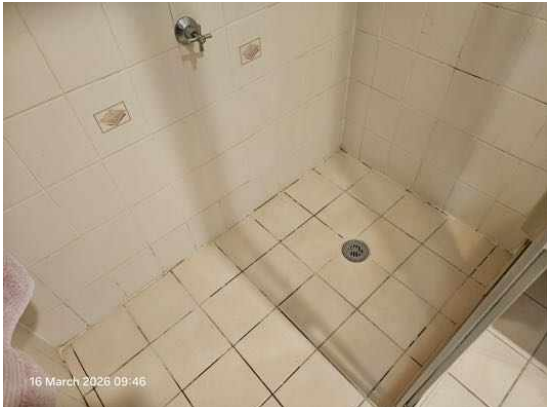
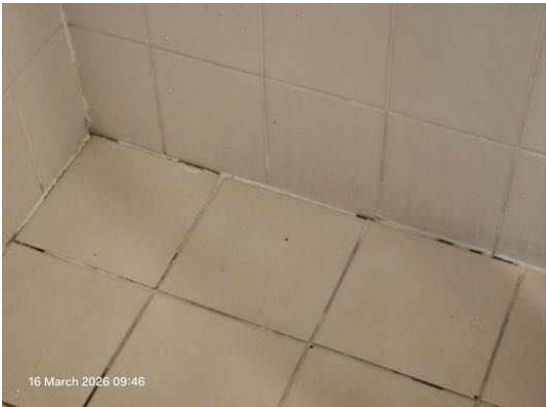
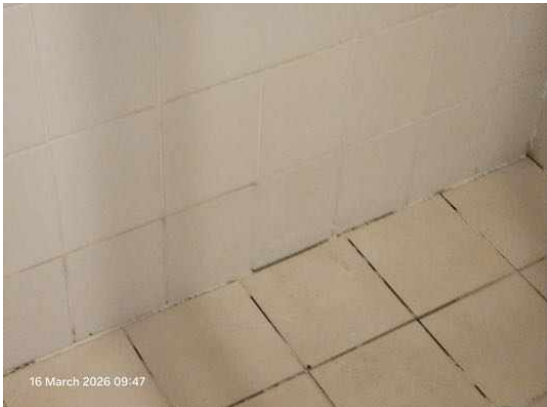
Finding 3.07

Building:	Main Building
Location:	Ensuite - Master
Finding:	Elevated moisture present - ensuite shower
Information:	Elevated moisture was noted in the tiled wall surfaces of the ensuite shower.

The levels varied at differing points throughout the recess. This could possibly be due to deteriorated grout and silicone sealants and / or plumbing fittings and fixtures. The grouts and sealants can break down over time and become porous, allowing moisture to enter the wall sheet surface behind the tiles. Some deterioration of the grout and sealants was noted.

Moisture was not detected the in the wall on the reverse side of the shower in the hallway.

Elevated moisture can attract timber pests and vermin, and produce conditions that promote timber pest attack, fungal growth and wood decay.

It is recommended that the moisture levels in these areas be monitored over time and the grout and silicone be renewed to possibly eliminate any further moisture penetration.

A licensed tiler and / or sealant specialist could be engaged to renew these elements.

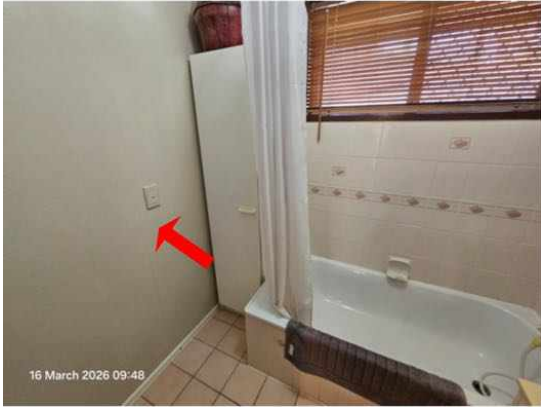
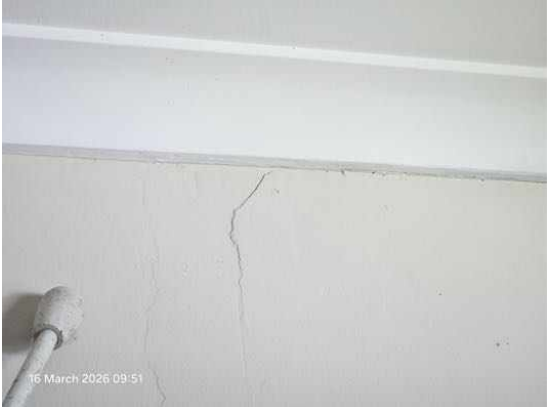
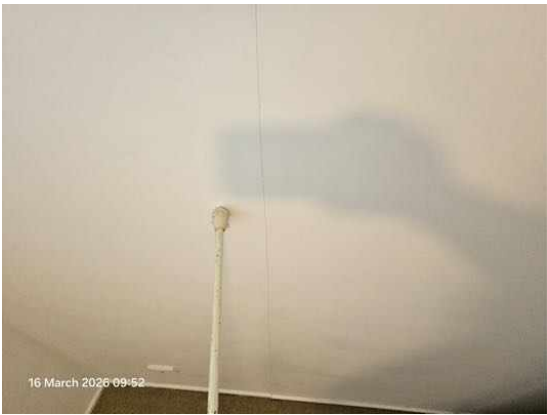
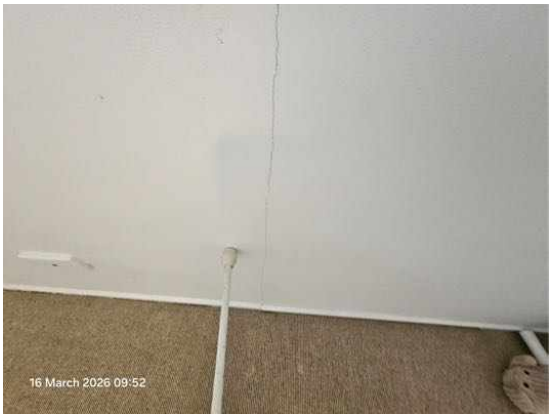
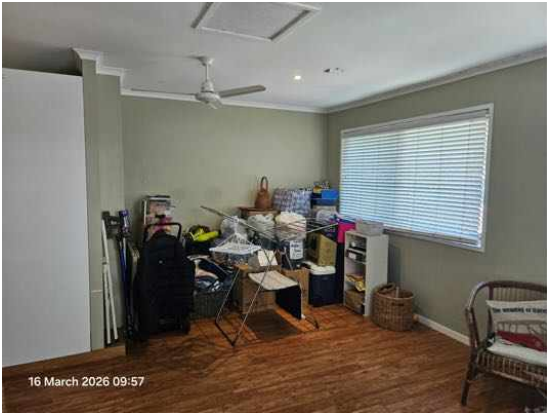
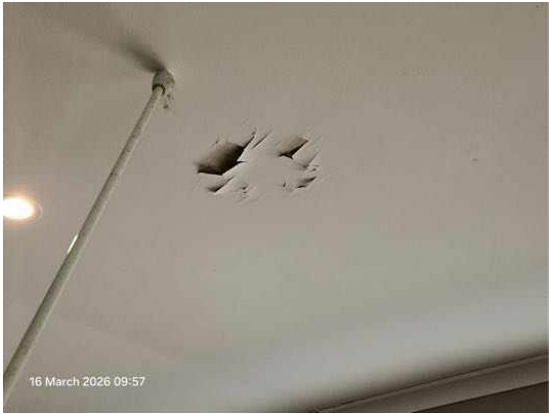
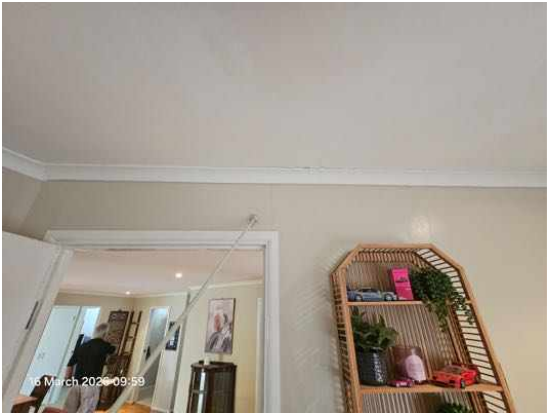
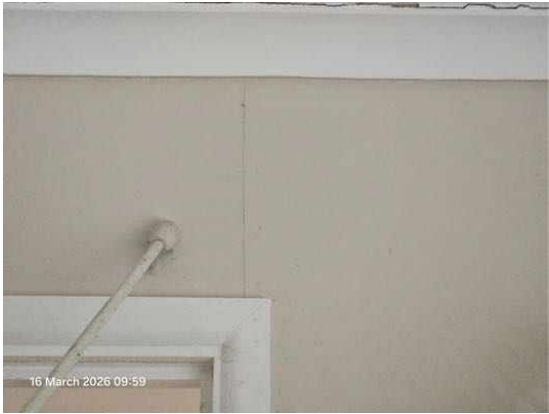
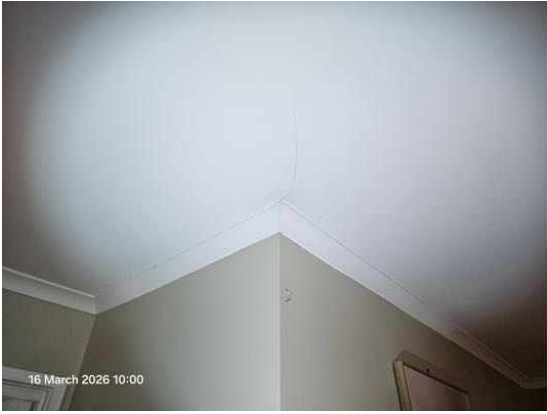
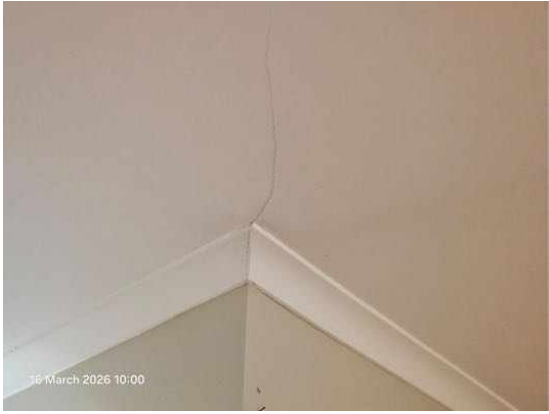
Finding 3.08

Building: Main Building
Location: As shown
Finding: Minor movement cracking
Information: On the day of inspection minor movement cracking and plaster / paint defects were noted.

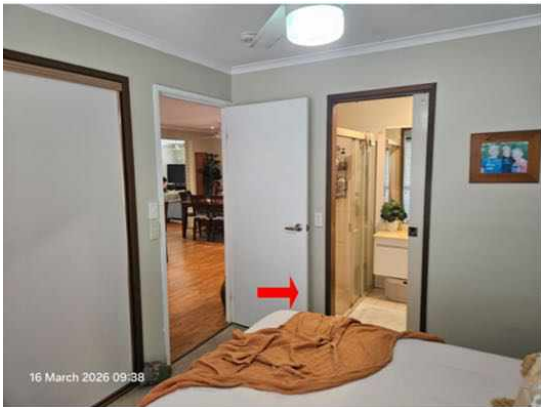
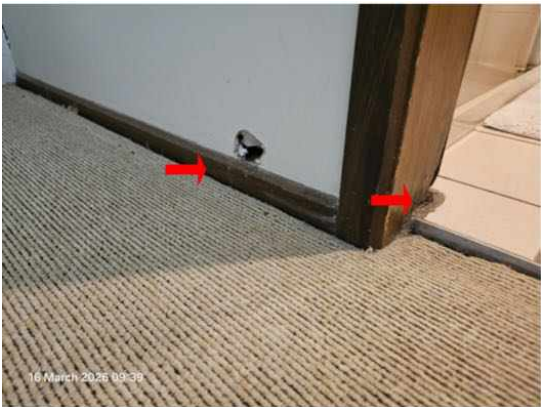
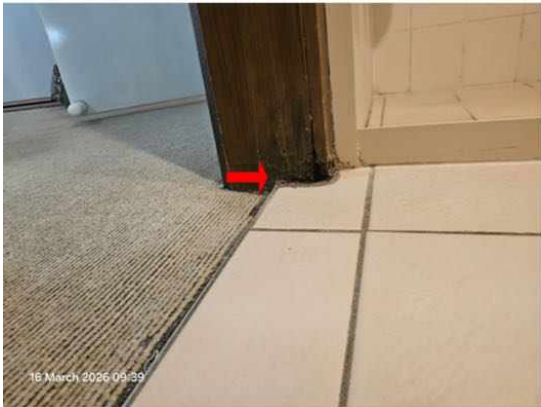
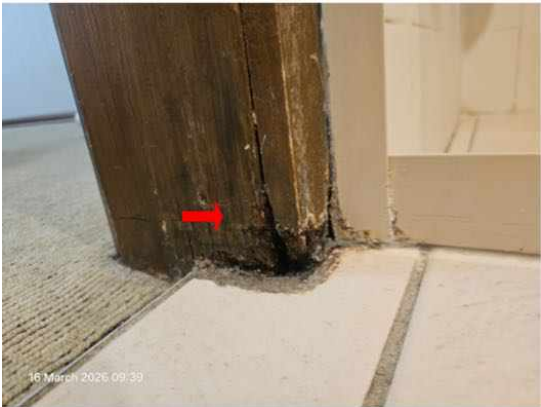
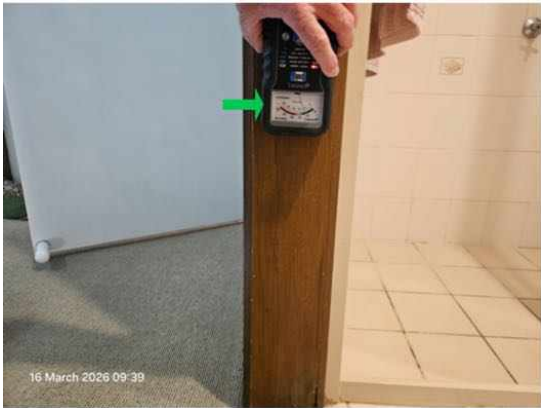
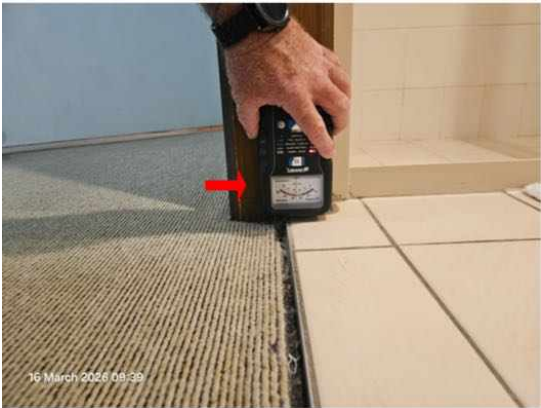
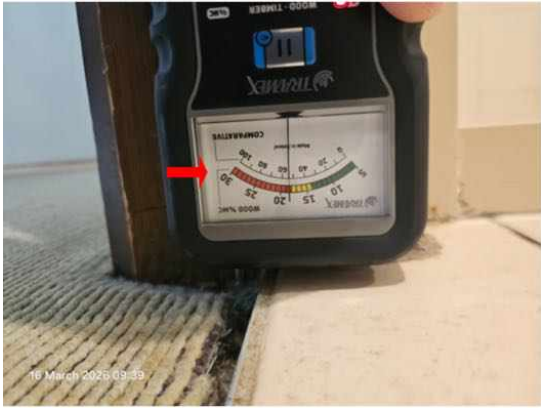
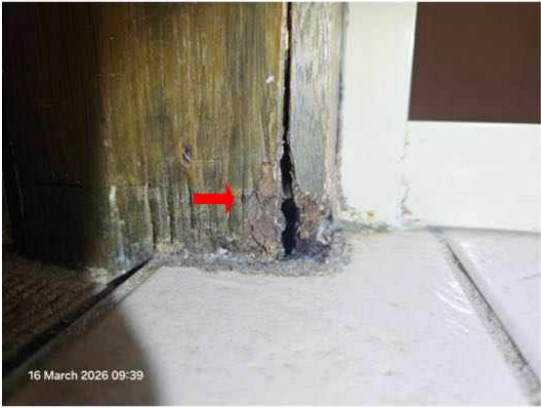
Building:	Main Building
Location:	Ensuite - Master
Finding:	Shower screen - suspected leak
Information:	A suspected leaking was detected in the shower screen at the connection angle at the wall at the time of inspection, showing in the form of minor wood rot in the door jamb. Elevated moisture levels were noted in the lower section of the timber.

While the leak appears to be minor, it may be responsible for the identified water damage to the door jamb and possible damage to the lower part of the frame. Over an extended period of time a minor leak can have a significant effect if left unchecked.

The moisture readings in the ensuite shower recess are limited to the lower courses of tiles, which can usually indicate grout and silicone degradation. An identified possible shower screen leak will require further investigation and rectification.

A qualified glazier or suitably qualified handy person could be engaged at the clients discretion to reseal the screen assembly.

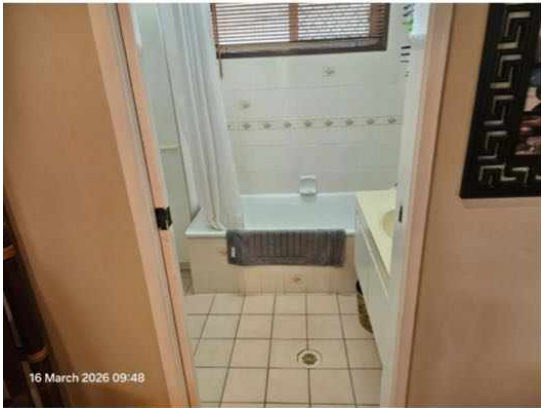
Building: Main Building
Location: Bathroom
Finding: No moisture detected in bathroom
Information: On the day of inspection the shower in the bathroom was measured for moisture using a "Tramex" moisture meter. During this inspection no moisture was detected in these areas and the tiled / sheeted surfaces appear to be in good order.

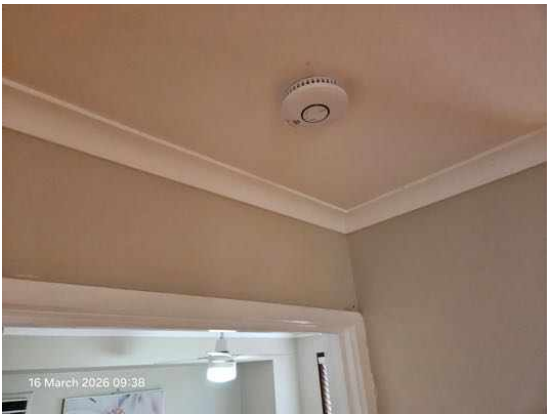
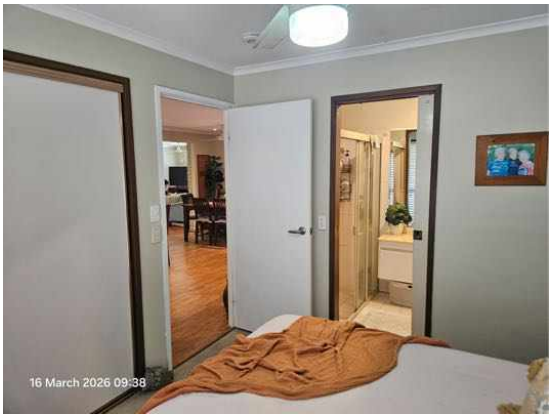
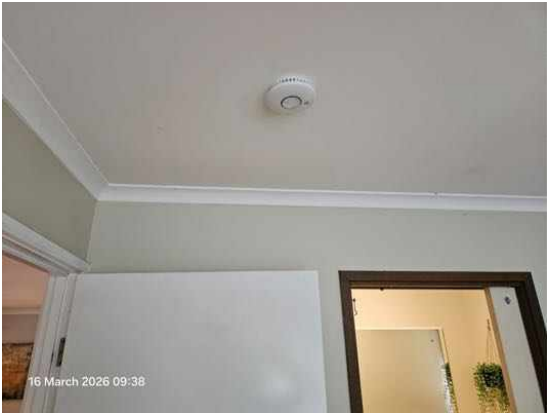
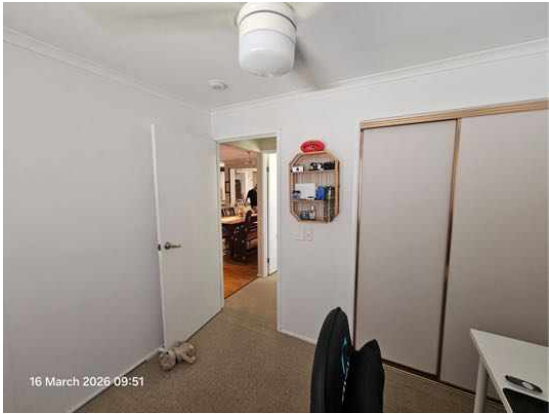
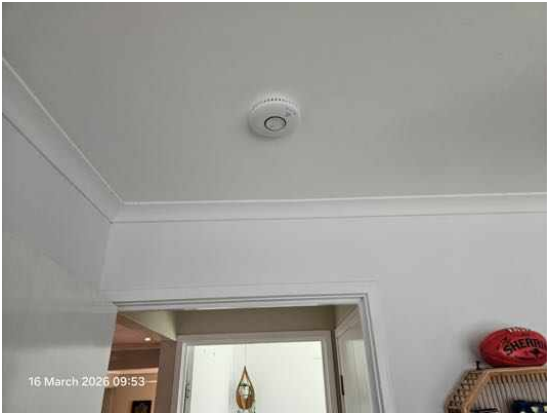
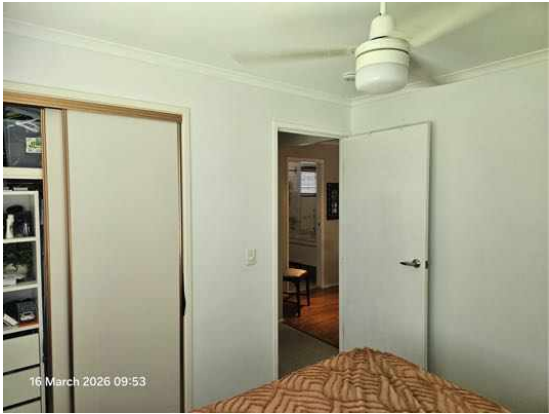
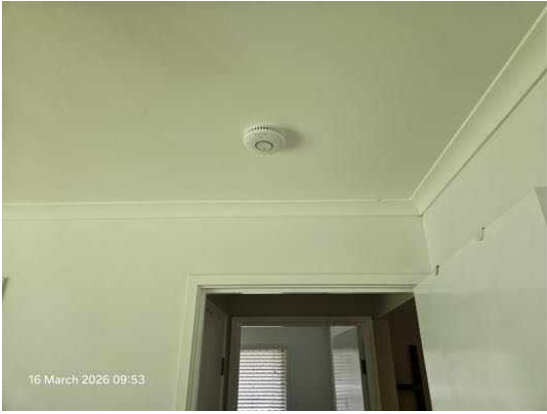
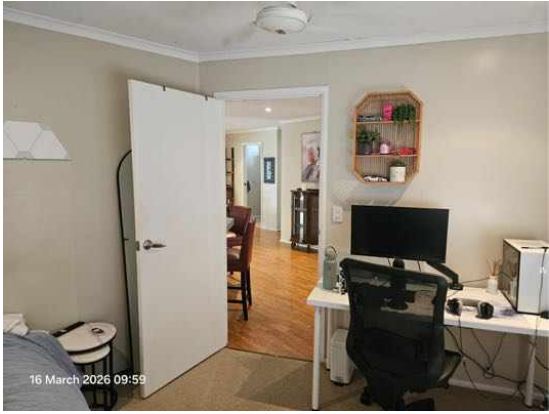
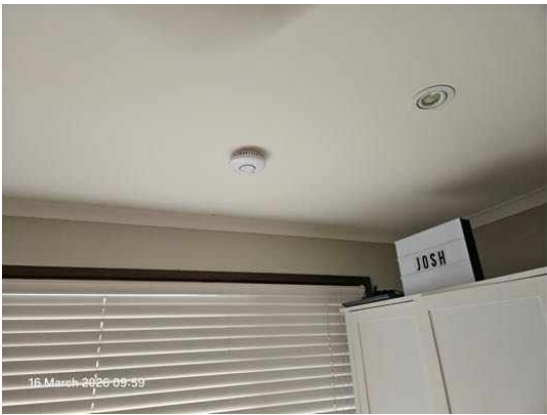
Building: Main Building
Location: All Areas
Finding: Additional Photos - Obstructions and Limitations
Information: These photographs are an indication of the obstructions and limitations which impeded full inspection of the property at the time of inspection. These obstructions can prevent full inspections of the areas shown.
