Building and Timber Pest Inspection Report

Inspection Date: Mon, 16 Mar 2026

Property Address: 4 Nardu Ct, Currimundi QLD 4551,
Australia

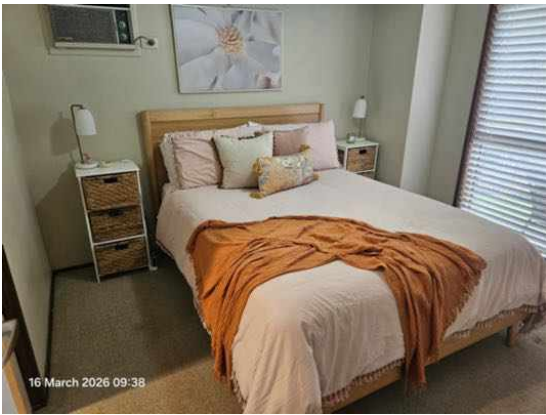
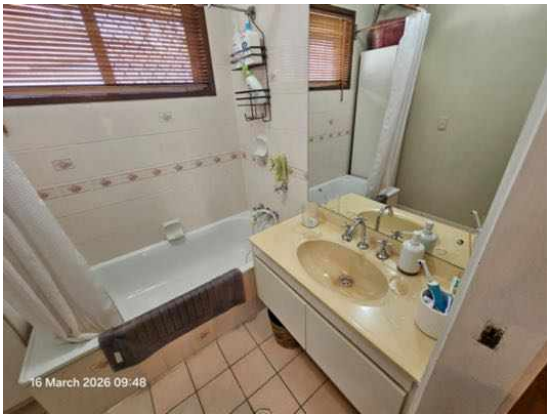
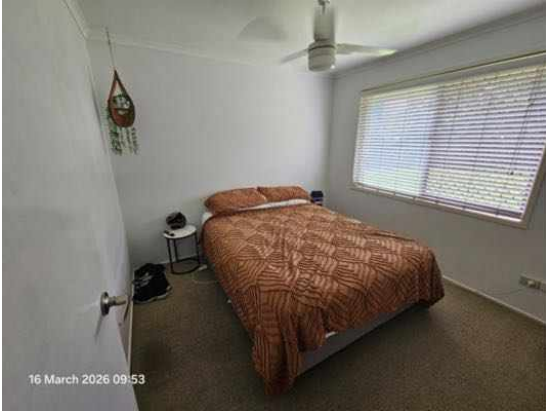
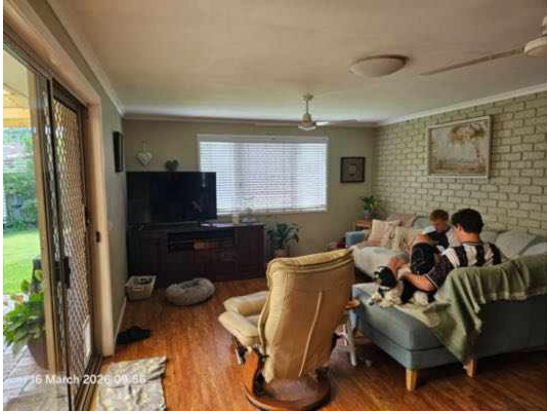
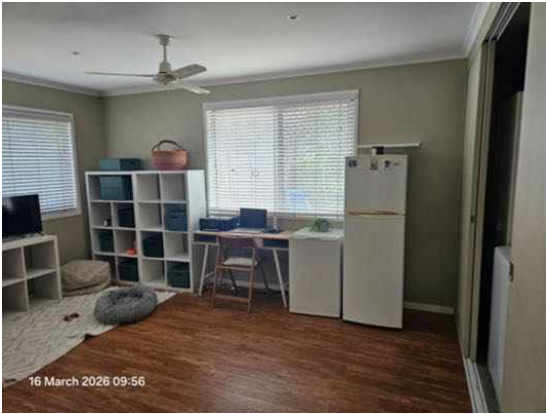
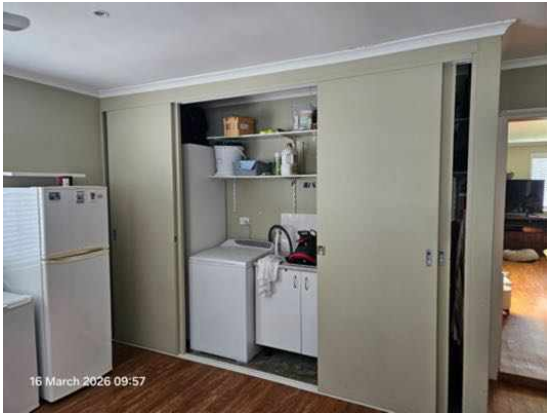
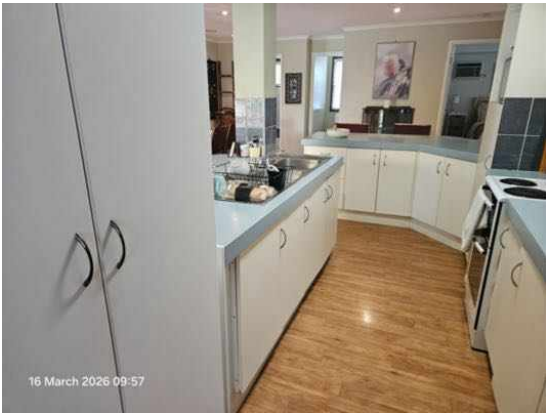
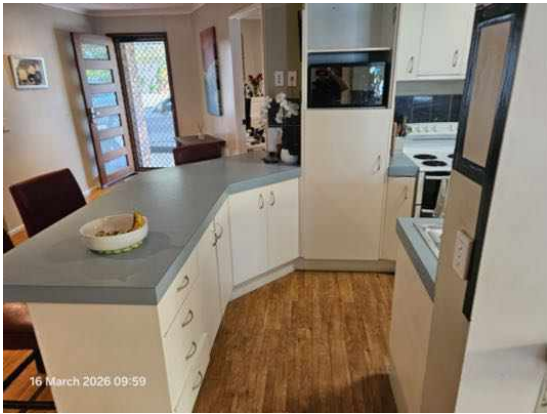
Building: Main Building
Location: All Areas
Finding: Additional Photos - Obstructions and Limitations
Information: These photographs are an indication of the obstructions and limitations which impeded full inspection of the property at the time of inspection. These obstructions can prevent full inspections of the areas shown.
