Building Inspection Report

Inspection Date: Wed, 1 Apr 2026

Property Address: 512/229 Toorak Rd, South Yarra VIC 3141,
Australia

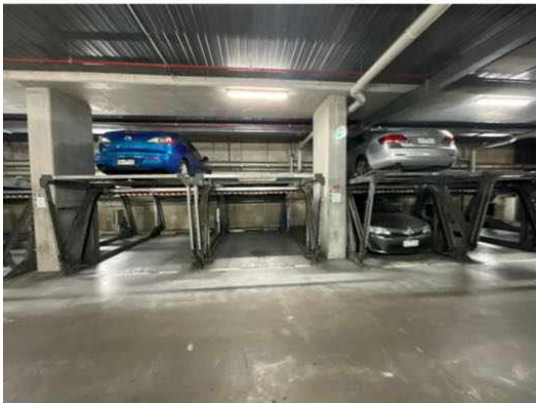
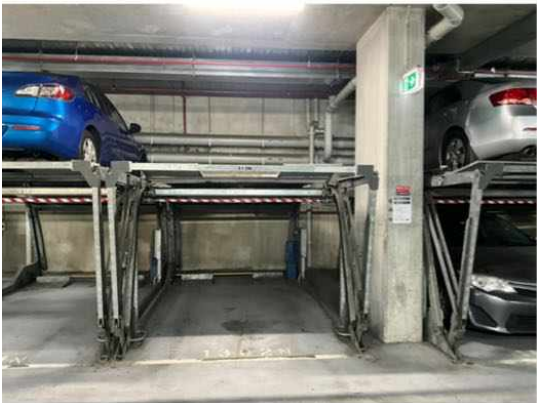
Building:
Location: Common areas
Finding: Additional Photos - for your information (common areas)
Information: Additional photos are provided for your general reference.

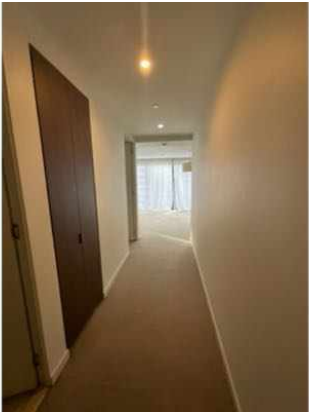
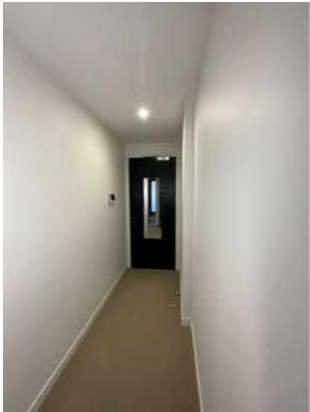
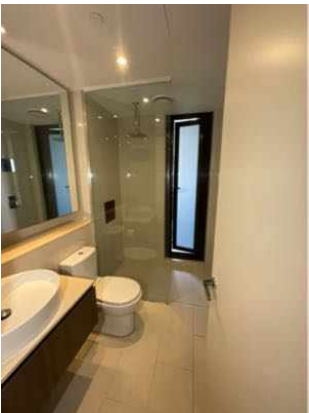
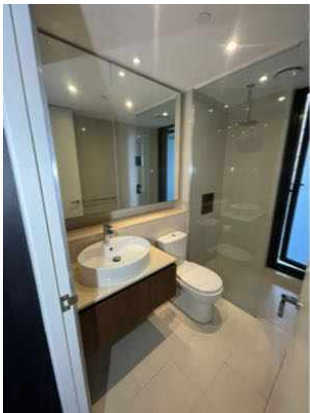
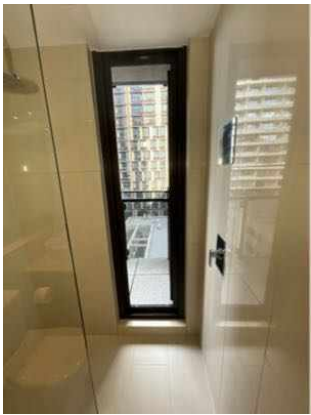
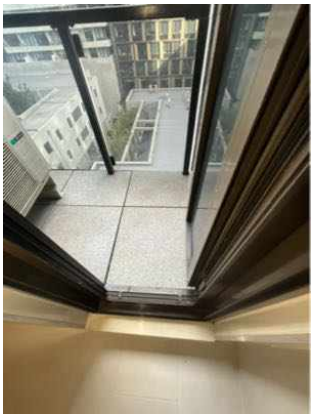
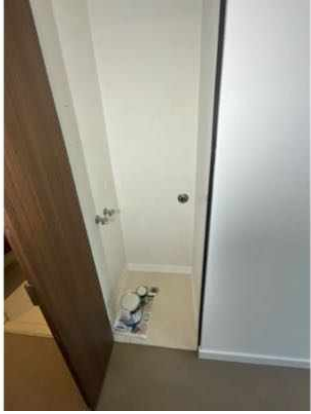
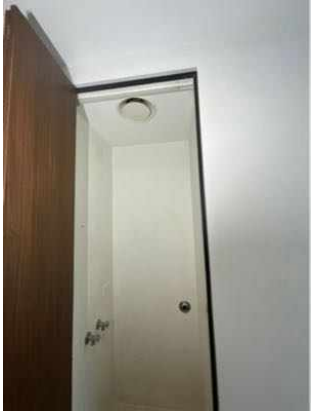
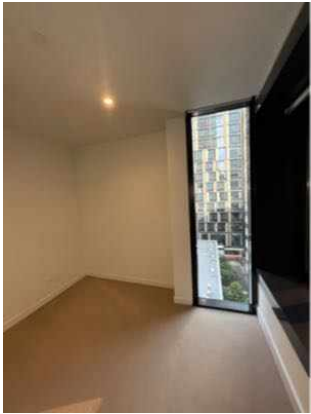
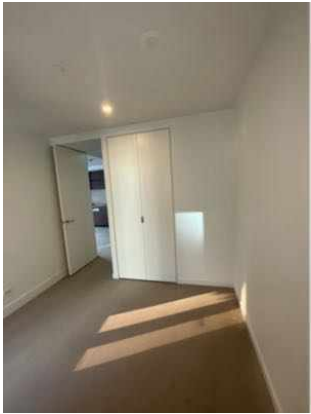
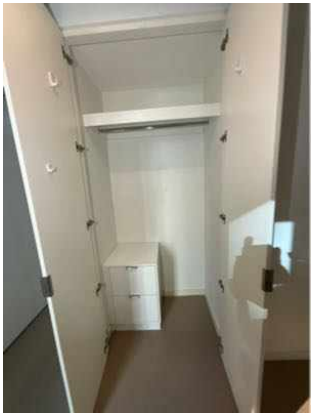
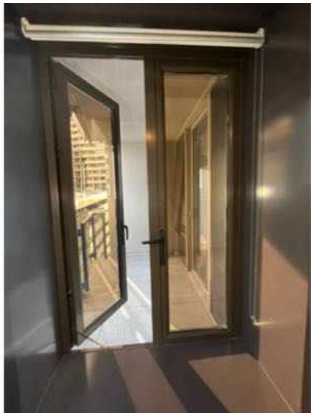
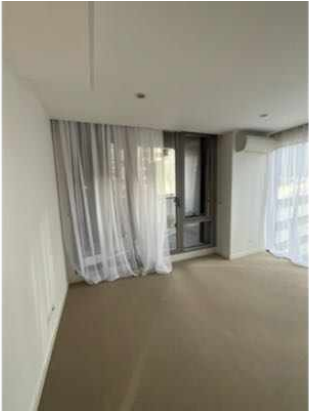
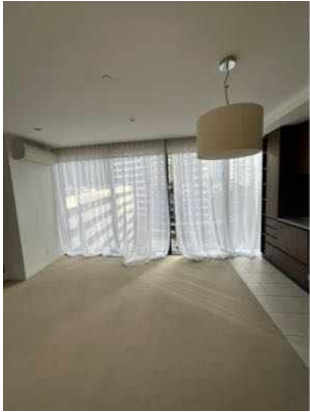
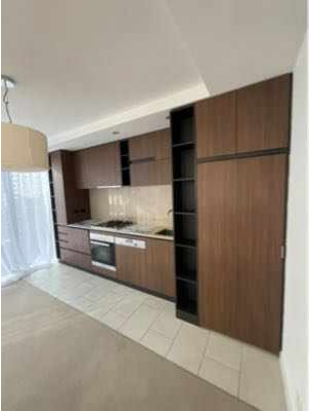
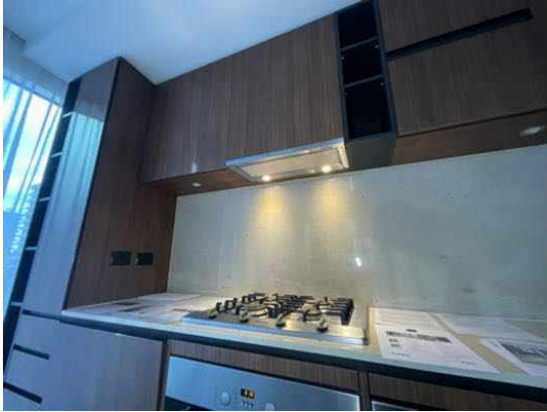
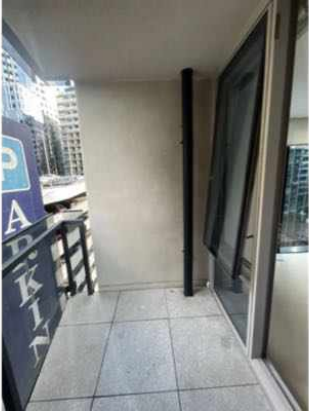
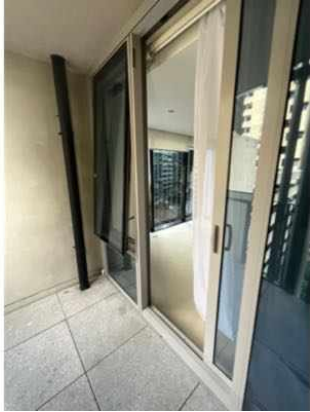
Building:
Location: All Areas
Finding: Area presented in good condition
Information: This area presented in a good condition at the time of inspection.
