Building and Timber Pest Inspection Report

Inspection Date: Wed, 28 Jan 2026

Property Address: 11 Tilgman St, Berry NSW 2535, Australia

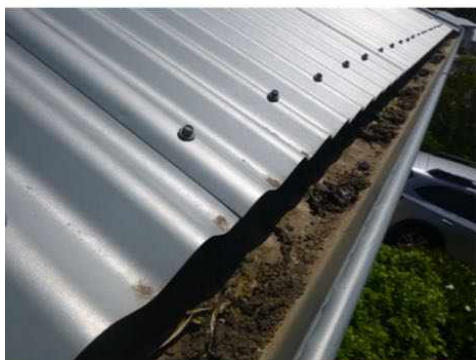
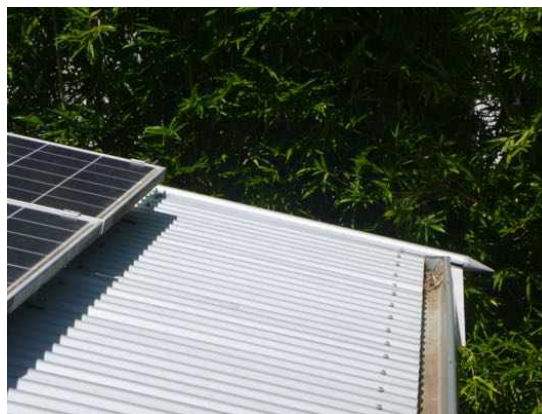
Finding 3.02

Building:	Main Building
Location:	Roof Exterior
Finding:	Gutters - Blocked
Information:	Roof plumbing structures, such as guttering and downpipes, should be free of all debris to prevent blockages. Blockages of the guttering and downpipes will lead to pooling and accumulated water overflows, which is likely to subsequently flood eaves and exterior walls.

Blocked gutters are likely to lead to high levels of moisture in the affected areas. Such moisture will not only cause rust and decay of the associated building materials, but can also provide conditions that are conducive to termite and timber pest activity. Blockages in gutters should therefore be removed immediately to ensure dry conditions are maintained.

Consult a Licensed Plumber for further specific advice on remedial works that may be required. In the interim, it is highly advised that blocked gutters be removed by the homeowner or a general handyperson as a matter of urgency.

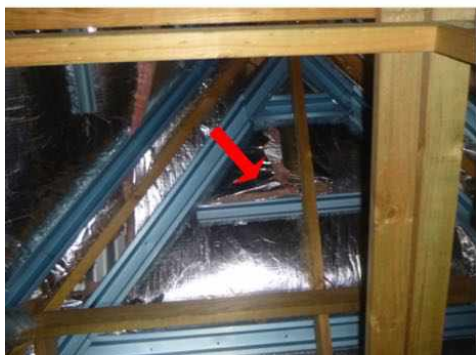
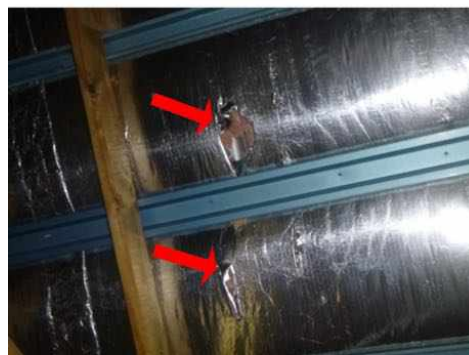
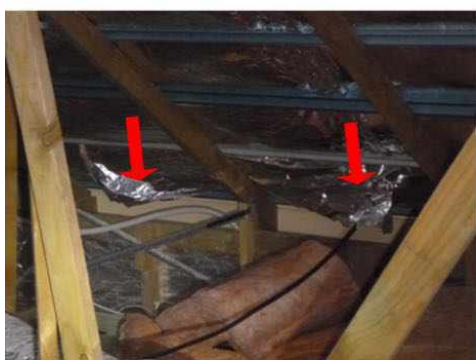
Finding 3.03

Building:	Main Building
Location:	Roof Void
Finding:	Sarking - Damaged or Loose
Information:	Sarking to under the roofing material is damaged, loose or has holes and gaps. Sarking acts as an insulator, helps with noise reduction & is a second barrier against water penetration from broken or slipped tile leaks & condensation.

A Builder, Carpenter or handyman will be able to repair the holes with pieces of sarking and AS4254 tape specific foil tape for this product.

Consult a builder or insulation specialist for further advice.

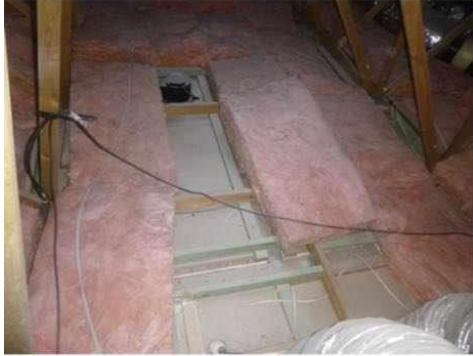
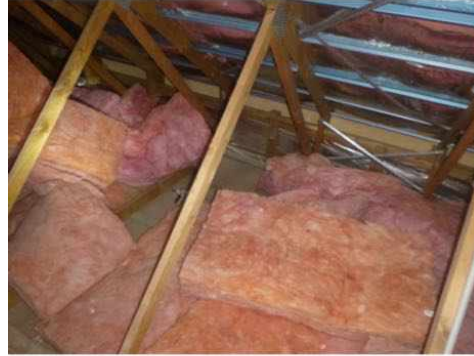
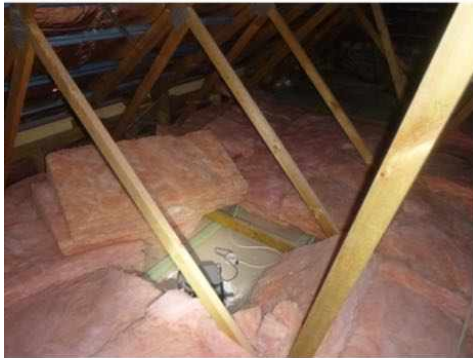
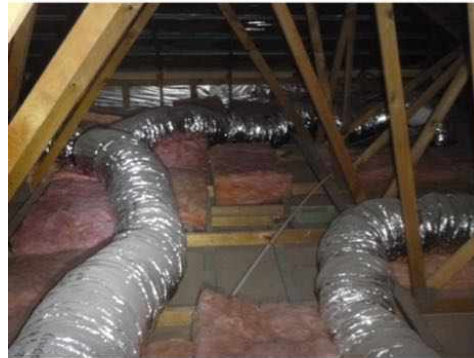
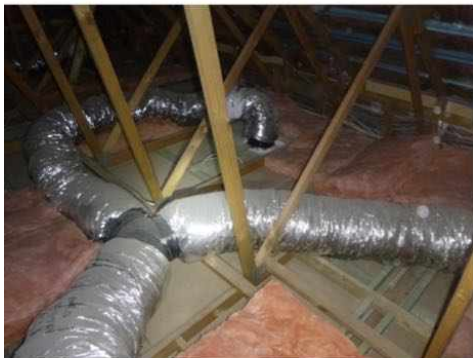
Finding 3.04

Building:	Main Building
Location:	Roof Void
Finding:	Ceiling Insulation - Inadequately installed to some areas
Information:	Upon inspection of the roof void it was noted that the insulation has been pulled back from a few areas and not adequately put back in place.

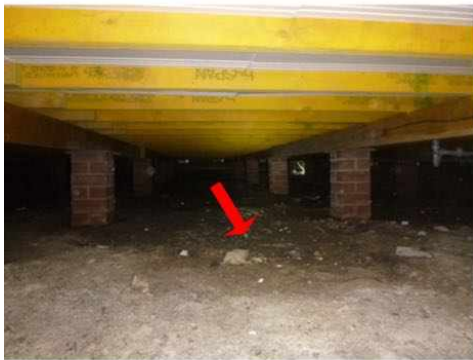
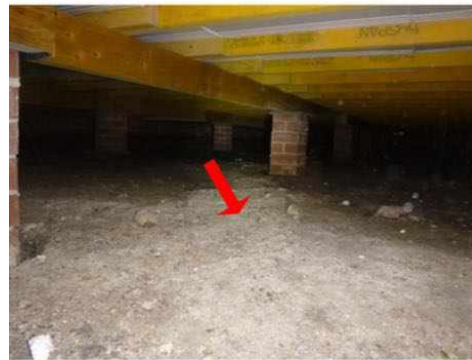
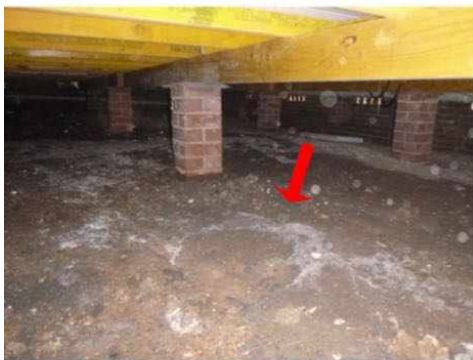
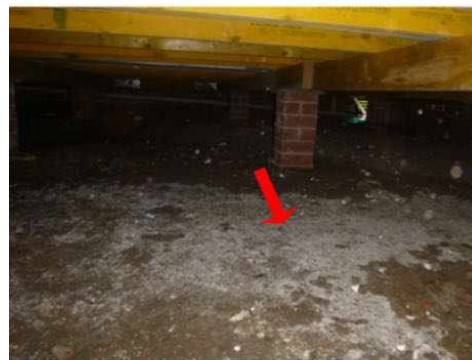
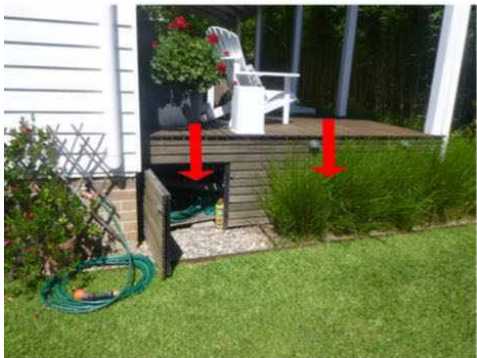
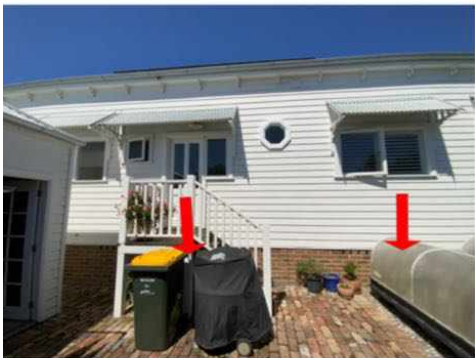
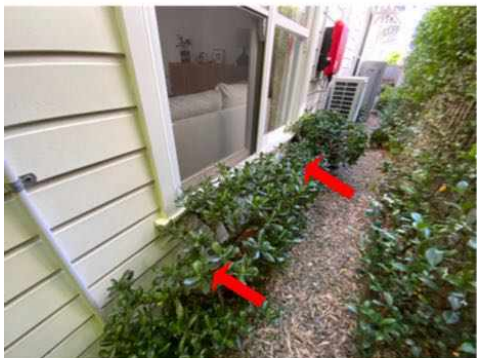
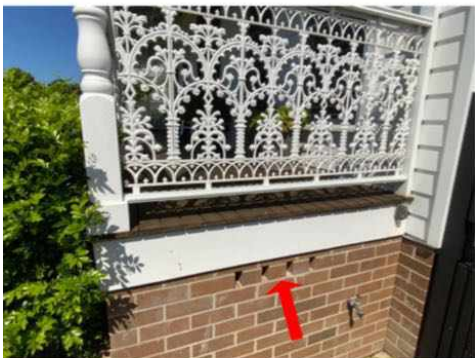
Finding 3.05

Building:	Main Building
Location:	Subfloor
Finding:	Subfloor Ventilation - Inadequate (mouldy subfloor soil to some areas)
Information:	Adequate subfloor ventilation and drainage aids in preventing excessive moisture,

Subfloor ventilation can be improved in most cases by addressing the causes such as exposing subfloor vents, replacing access doors with a gauze or slat door, installing additional new vents (large gauze type is best- 2 bricks high x 2 bricks wide), installing mechanical (forced airflow) ventilation and removing debris & obstructions to air flow from the subfloor.

A registered builder or sub floor ventilation specialist should be appointed as soon as possible to look at improving ventilation & drainage to the perimeter of the building and to perform these works as necessary.

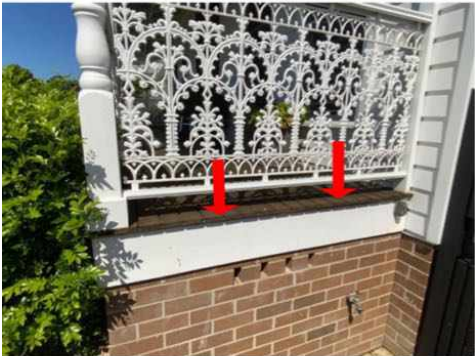
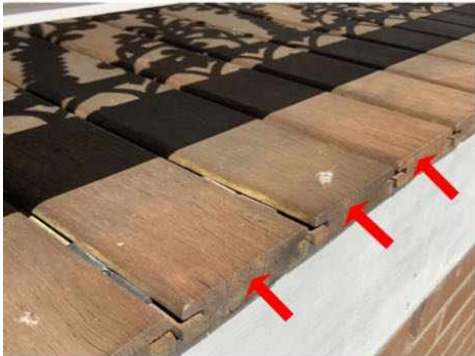
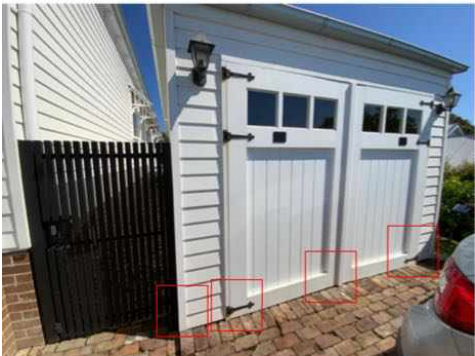
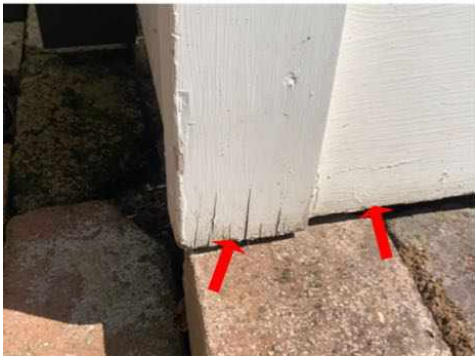
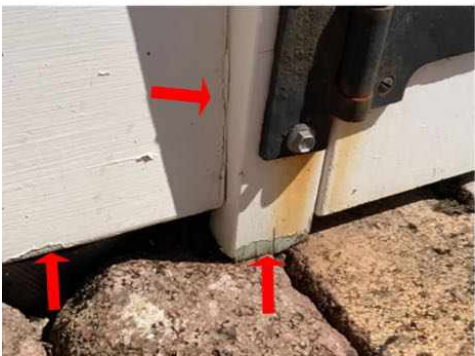
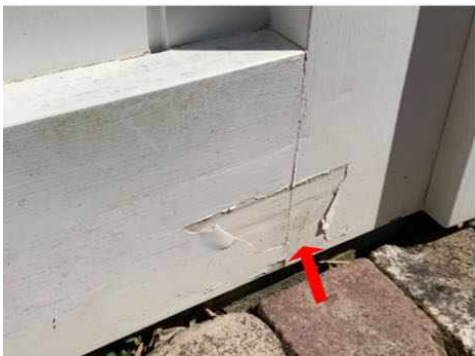
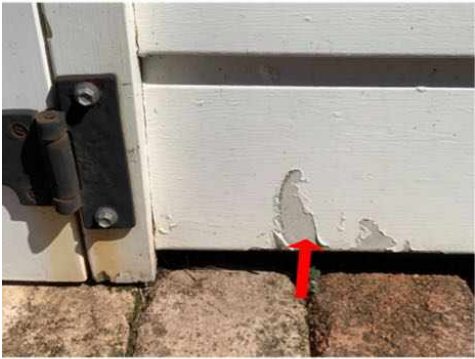
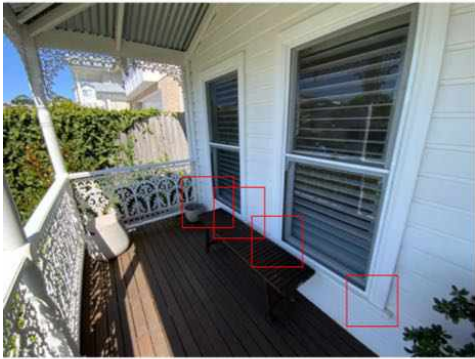
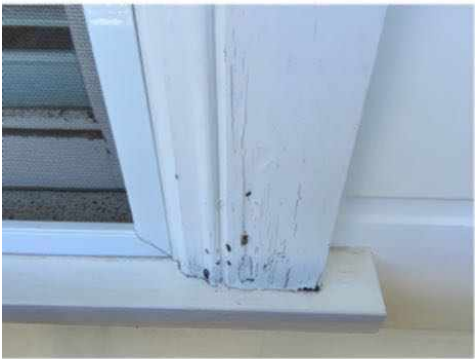
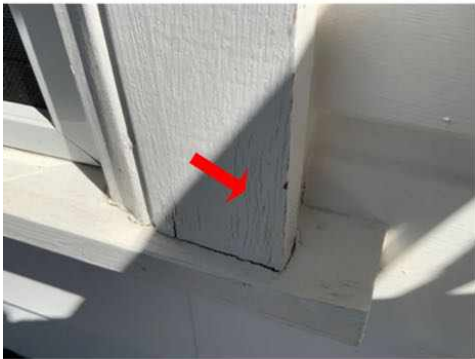
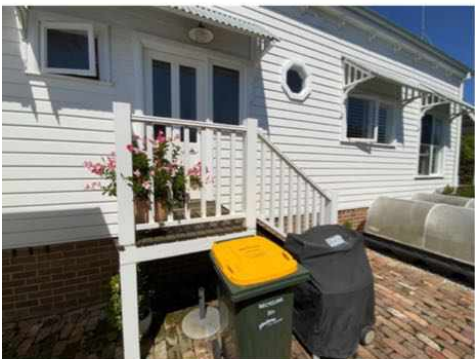
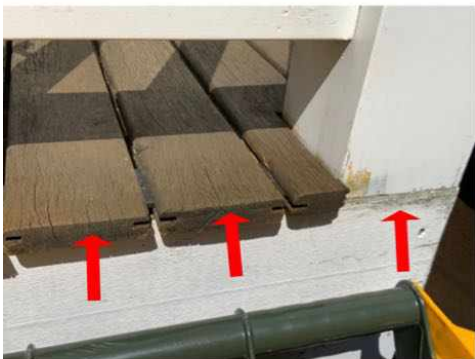
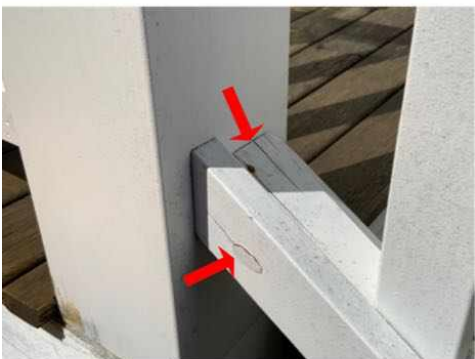
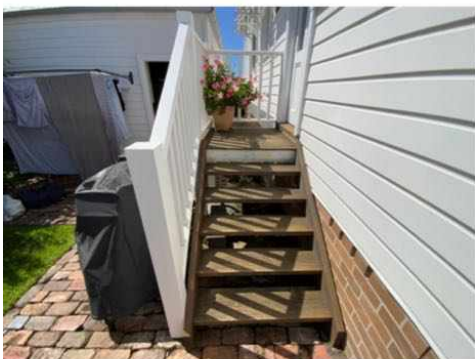
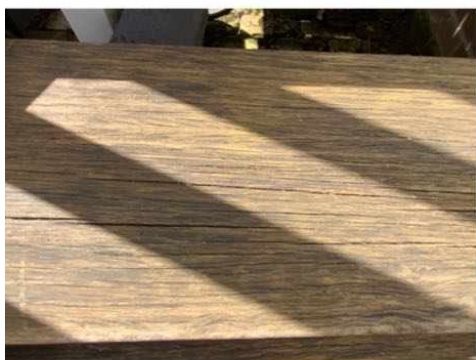
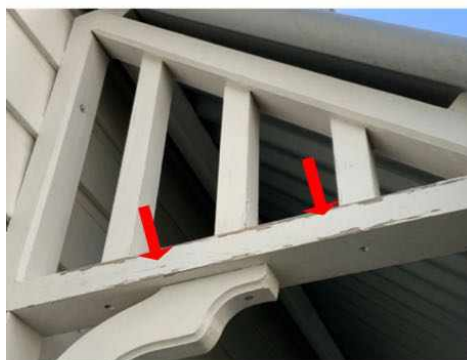
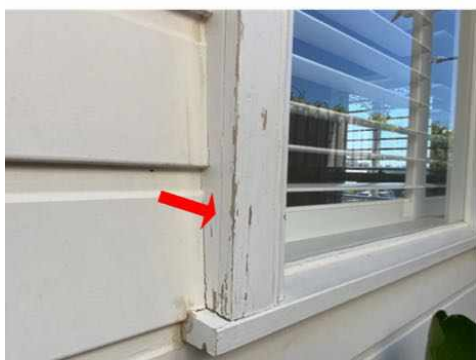
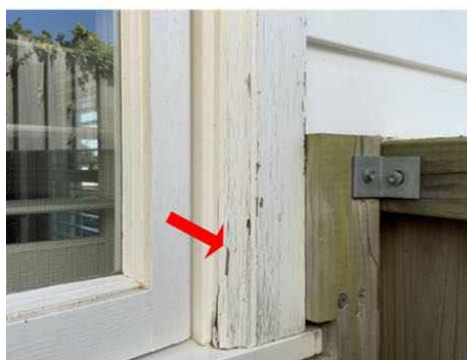
Building:	Main Building
Location:	All Areas
Finding:	External paint to timbers - deteriorated
Information:	Much of the external paintwork including but not limited to external timbers and trims have been neglected and require attention to prepare and re-paint.

Whilst incomplete or missing paint finish is generally an appearance defect, it can also lead to the development of secondary building defects over time. Incomplete areas of paint finish expose the area to moisture, potentially accelerating the deterioration of underlying building materials.

Degraded paint finishes should be sanded back, filled, leveled and painted, as applicable. Where inadequate or missing paint protection has led to the deterioration of the associated building element, repair and/or replacement of this building element may be required.

A painting contractor should be appointed as soon as possible to perform necessary works to aid the appearance of the affected area and to ensure the area is protected against further deterioration. Alternatively, the homeowner following manufacturer instructions may perform these works.

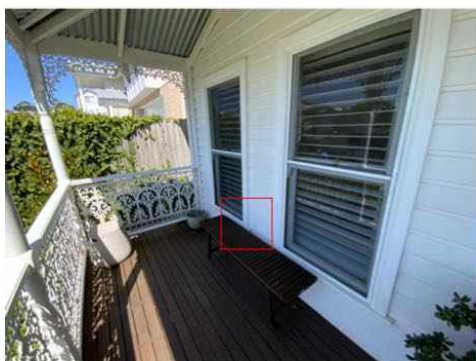
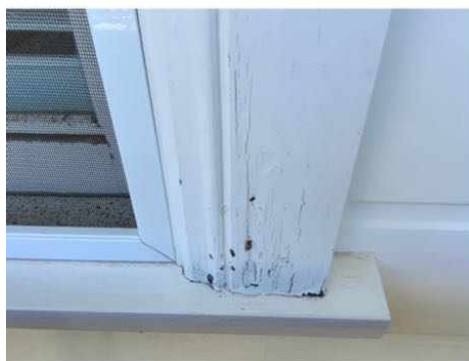
Finding 3.07

Building:	Main Building
Location:	Exterior walls - front
Finding:	Wood rot to bottom of architrave from driving rain
Information:	This building element shows evidence of wood rot. Wood rot, also known as Fungal Decay, occurs when timbers and other cellulose building materials are exposed to damp conditions on an ongoing basis. This could be the result of exposure to weathering over a prolonged period of time, or the attraction of excessive moisture from other abutting building materials. Contributing factors also include poor air ventilation in the area.

Wood rot is often associated with general damp problems and is evidenced by a 'musty' smell or mould and mildew occurring on surfaces. If left unmanaged, damp conditions can lead to further health problems and the decay of timbers will continue.

Early intervention and regular maintenance, particularly of exterior timbers, will prolong the useful life of these building elements. Prior to any works being performed, the cause of the moisture that has created the visible wood rot should be identified and addressed in a suitable manner. Replacement of affected timbers may then be a necessary step in protecting surrounding building elements from such deterioration.

A qualified plumber may be appointed to assess the cause of excessive moisture and to provide advice on any remedial works as required. A qualified carpenter or

registered builder may also be required to replace affected building materials.

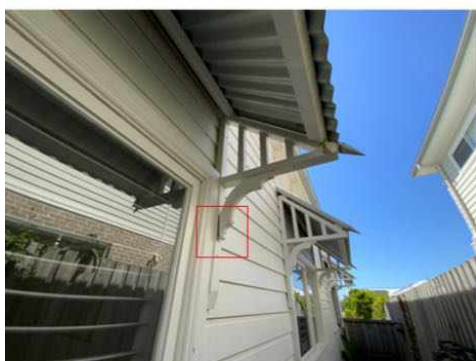
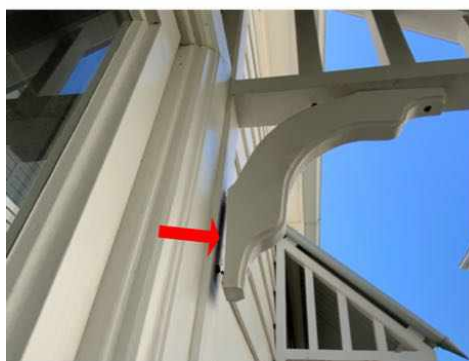
Finding 3.08

Building: Main Building
Location: Exterior walls - left side
Finding: Building element - Damaged (Loose screw)
Information: Breakage occurs generally when the building materials have either aged and decayed, or as a result of damage (accidental or deliberate).

Repair and/or replacement of broken elements is advised to ensure that additional secondary defects do not arise as a consequence. Such works are necessary, as all building elements play a key role in the operation and function of the overall structure and its performance.

A relevant tradesperson should be appointed to repair or replace the affected building element prior to any subsequent damage being caused.

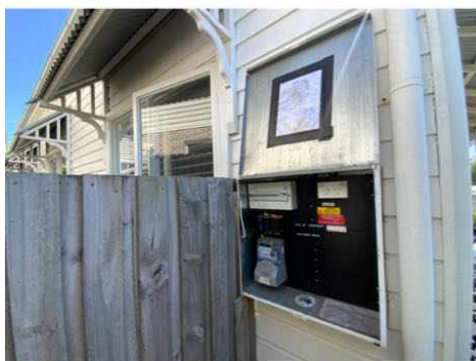
Building: Main Building
 Location: All Areas
 Finding: Termite Management System - no evidence of a chemical installation
 Information: The application of a post-construction chemical termite barrier is highly recommended for all properties, particularly if live termite activity has been found on the site previously. Such barriers are highly effective in preventing termite attack on any timber building elements throughout the property.

A durable notice should be placed in the switchboard unit to indicate current termite barriers. At the time of inspection, it appeared as though no termite management system has been installed, with no evidence to suggest preventative works taking place.

The client may consider gaining further advice from a pest controller as to the costs and procedures involved with this application. It is recommended that obtaining such advice be a short-term priority.

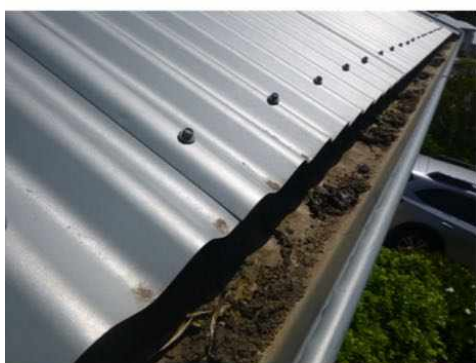
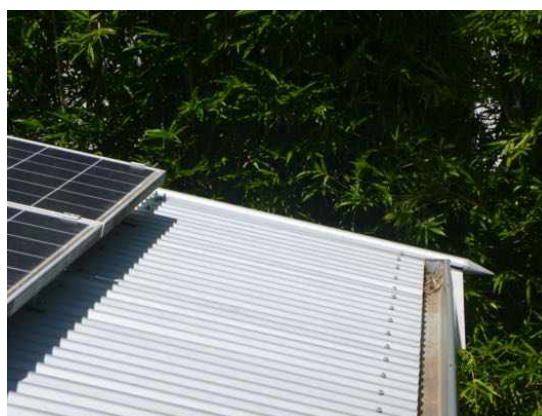
Finding 6.02

Building: Main Building
 Location: Roof Exterior
 Finding: Gutters - Blocked
 Information: Roof plumbing structures, such as guttering and downpipes, should be free of all debris to prevent blockages. Blockages of the guttering and downpipes will lead to pooling and accumulated water overflows, which is likely to subsequently flood eaves and exterior walls.

Blocked gutters are likely to lead to high levels of moisture in the affected areas. Such moisture will not only cause rust and decay of the associated building materials, but can also provide conditions that are conducive to termite and timber pest activity. Blockages in gutters should therefore be removed immediately to ensure dry conditions are maintained.

Consult a Licensed Plumber for further specific advice on remedial works that may be required. In the interim, it is highly advised that blocked gutters be removed by the homeowner or a general handyperson as a matter of urgency.

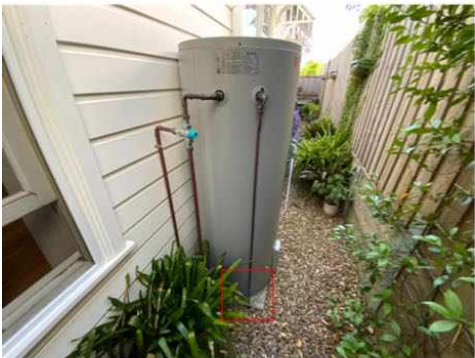
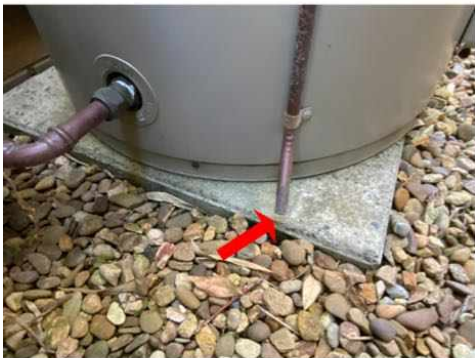
Finding 6.03

Building:	Main Building
Location:	All Areas
Finding:	HWS Overflow - Not Connected
Information:	The Hot Water System (HWS) overflow was found to be disconnected from storm water drainage and is creating excessive moisture in the surrounding area.

These damp conditions can lead to secondary defects such as rot, rust or corrosion of associated building elements, the formation of fungal decay, or even the creation of potential slip hazards. When coupled with poor site drainage, pooling of water may also attract termite activity to this area.

It is highly recommended that a licensed plumber be appointed to connect the HWS overflow in order to prevent such an environment from being created. These minor works should be carried out as soon as possible.

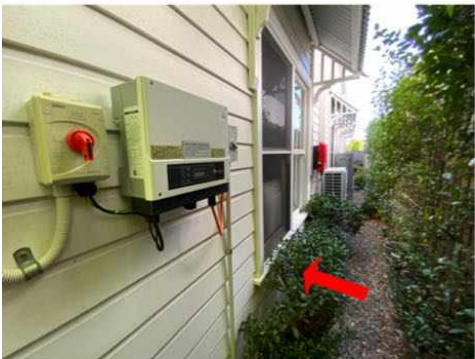
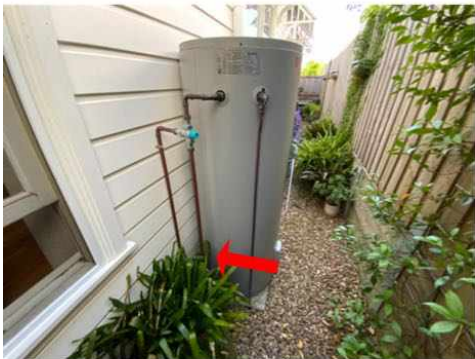
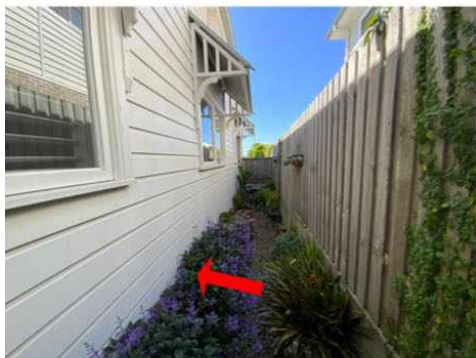
Finding 6.04

Building: Main Building
 Location: Exterior walls
 Finding: Bridging or breaching of termite barriers - damp course level
 Information: Bridging is the spanning of a termite barrier or inspection zone so that subterranean termites are provided with passage over or around that barrier.

Damp proof course (DPC) is a barrier of impervious material built into a wall or pier to prevent moisture from moving to any part of the building. Where external ground levels are built up over this barrier ingress is provided for moisture from the exterior grounds into the base brickwork or other building material and allowed to rise.

Such conditions attract termites into these damp areas which is likely to lead to infestation if left untreated.

While retrospective fitting of DPC is considered to be impractical works are required in order to prevent the extraction of moisture from the external environment into exterior brickwork or wall materials. Landscaping or re-paving of external grounds may be considered by the client. Regular annual inspections are strongly advised.

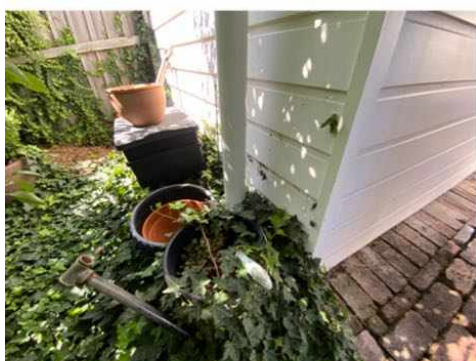
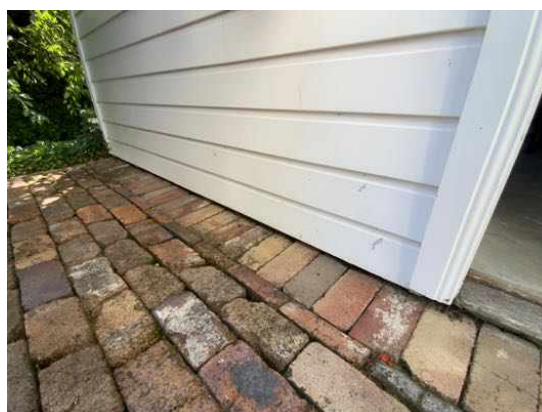
Finding 6.05

If the slab edge is not properly exposed there is a high risk of termite attack. Sometimes, in order to determine the type of slab, a suitably qualified person such as an architect or builder may be required to consult the construction plans.

Where the slab edge cannot be properly inspected, it is highly recommended that termite or timber pest inspections be carried out every 6-12 months to aid protection of the property against infestation.

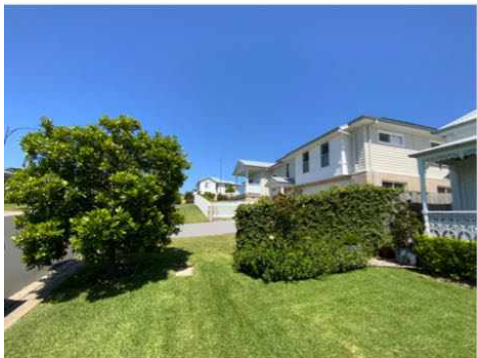
Finding 6.06

Building: Main Building
Location: All Areas
Finding: Trees within 50m of the property
Information: Trees within 50m of the property can be conducive to termite activity. It is recommended an invasive inspection of all trees with 50m to the property be carried out by a qualified pest control expert.

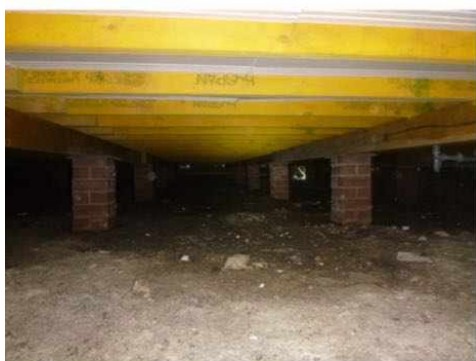
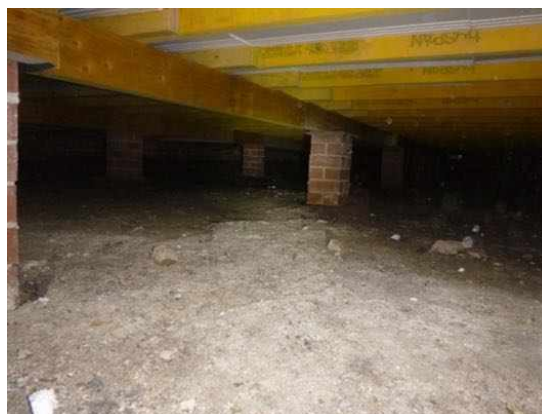
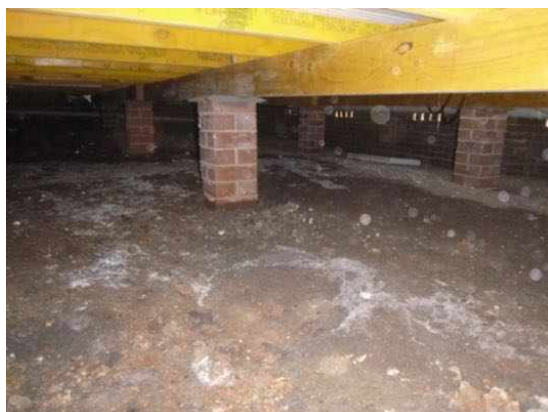
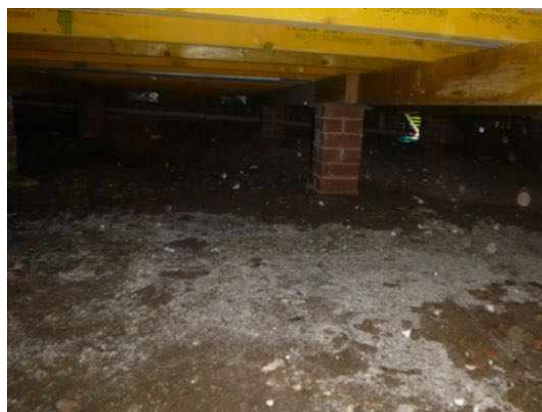
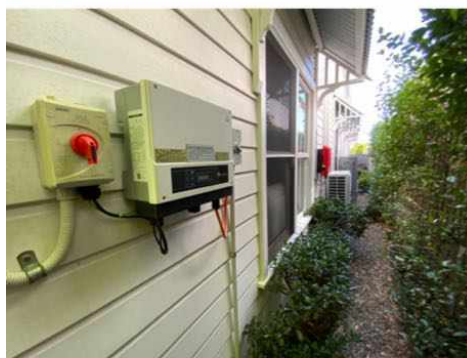
Finding 6.07

Location: Subfloor
Finding: Subfloor - Lack of ventilation
Information: It was noted at the time of inspection that the subfloor area lacks adequate ventilation. Ventilation can be restricted by a variety of minor defects, including obstructions in the subfloor space, a lack of vents or a low clearance.

A well ventilated subfloor aids in maintaining dry conditions, preventing secondary damage such as wood rot and pest activity, as well as preventing the development of mould and mildew (which can lead to respiratory safety hazards for occupants).

The initial step in improving ventilation is to ensure that the subfloor area is free of any debris or stored items. Where ventilation is still inadequate, it is advised to ensure that all vents are clear of blockages, and additional vents may be installed.

The client may also consider mechanical ventilation (powered fans) to improve subfloor airflow. Remedial works should be conducted as a matter of urgency to protect against the development of potentially harmful subfloor conditions.

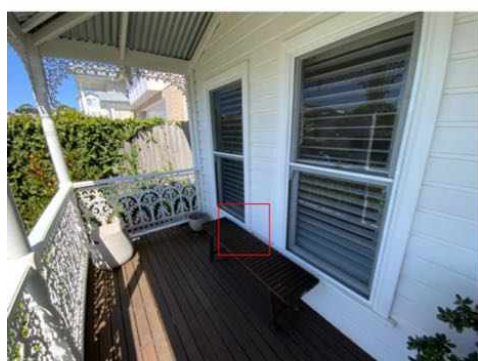
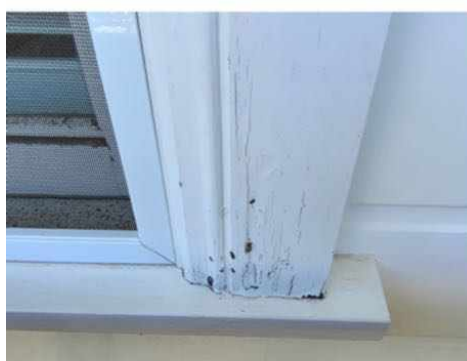
Finding 7.01

Building:	Main Building
Location:	All Areas
Finding:	Fungal decay - present (localised)
Information:	Fungal decay also known as wood decay or wood rot generally refers to the deterioration of timber elements when in contact with excessive levels of moisture for a prolonged period of time.

The development of fungal decay is accelerated by temperatures in the range of 5degreeC to 40degreeC as well as the presence of oxygen. Generally fungal decay develops on timber elements that are in use in an external environment which are exposed to rain penetration.

In this case although the affected timber element is in a decaying state the extent of any visible damage appears to be localised to a specific area and is yet to spread to other parts of the building element or affect adjoining structures. The fungal decay is therefore likely to be of a relatively superficial nature with minimal impact on the structural integrity or tensile strength of the timber element.

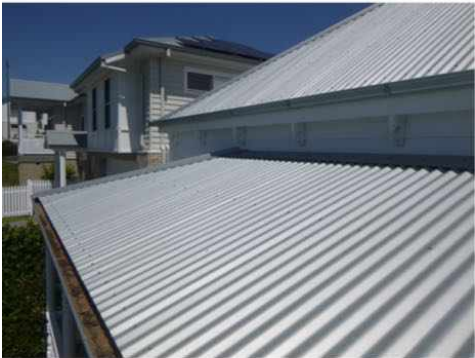
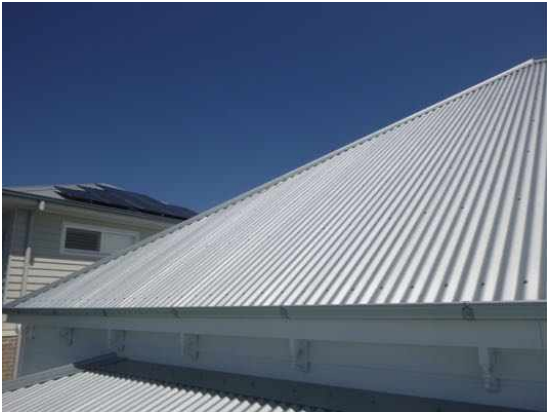
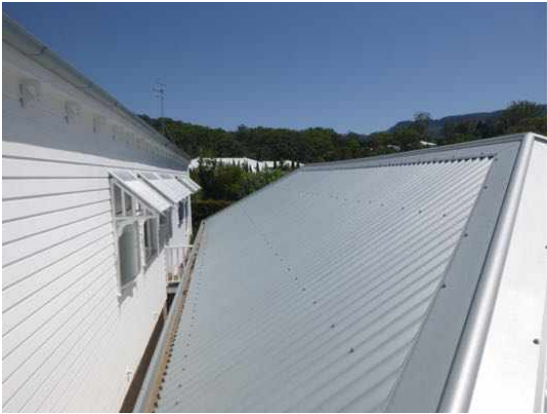
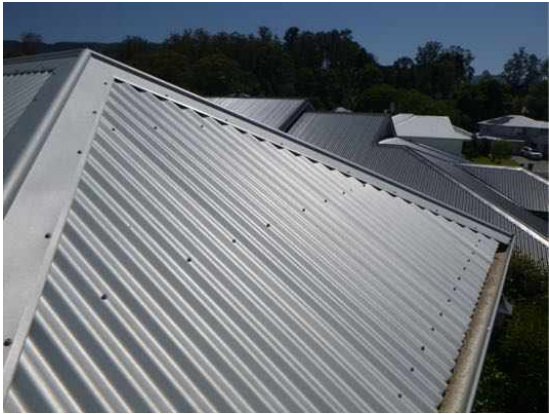
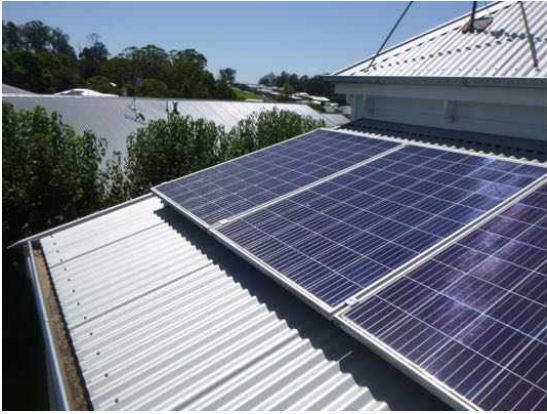
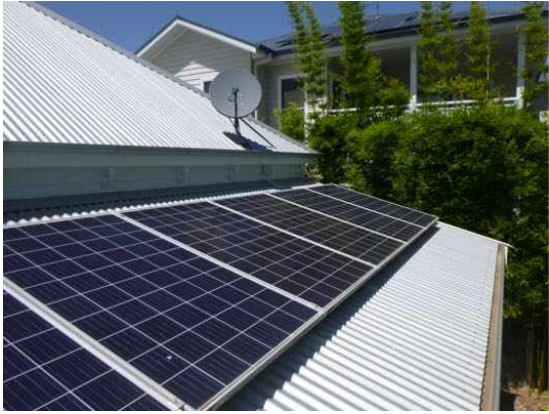
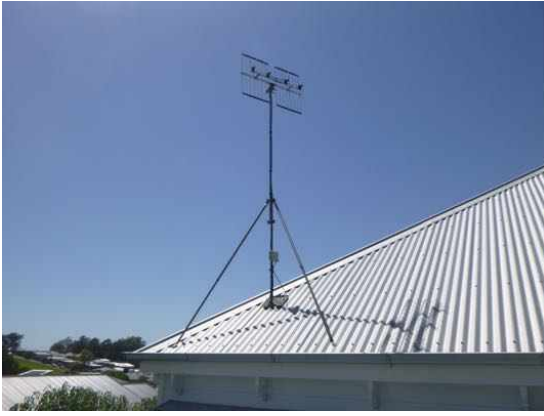
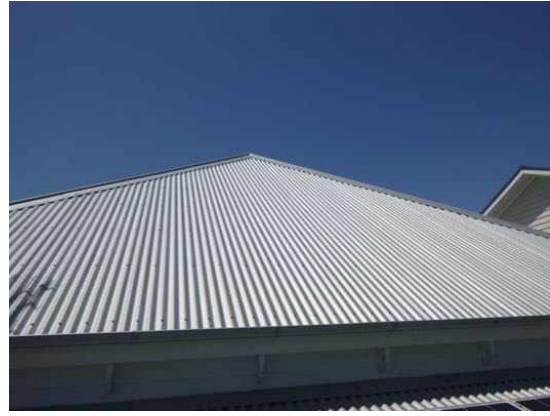
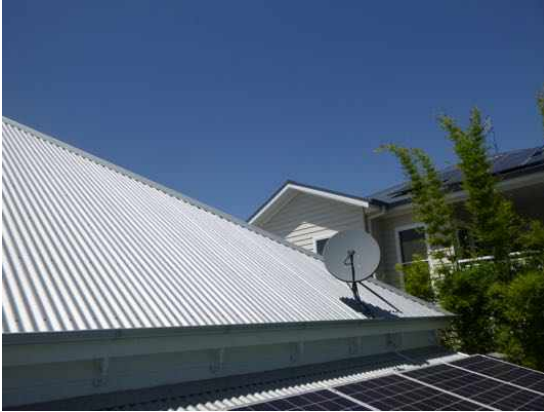
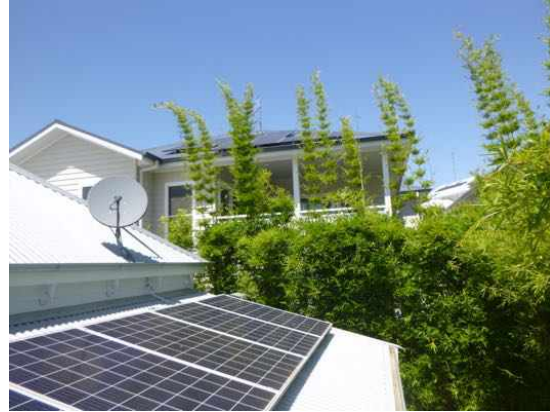
Building: Main Building
Location: Roof Exterior
Finding: Additional Photos - Obstructions and Limitations
Information: These photographs are an indication of the obstructions and limitations which impeded full inspection of the property at the time of inspection. These obstructions can hide an array of defects and should be removed to allow full inspection to be carried out. A re-inspection is recommended once the areas are made accessible.

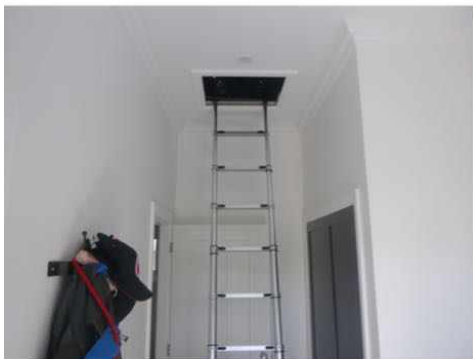
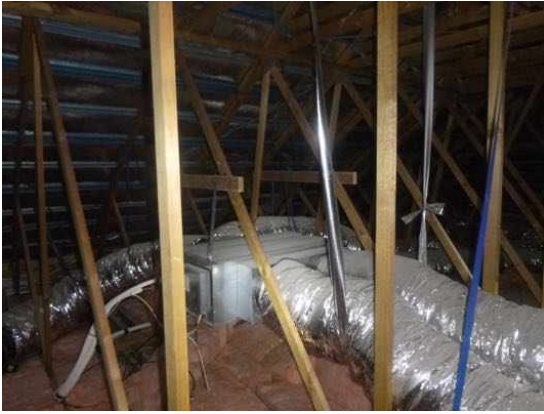
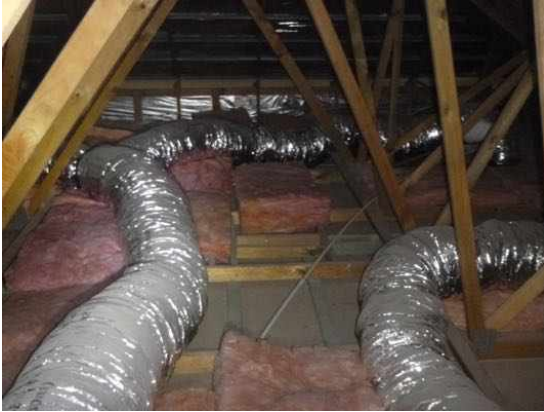
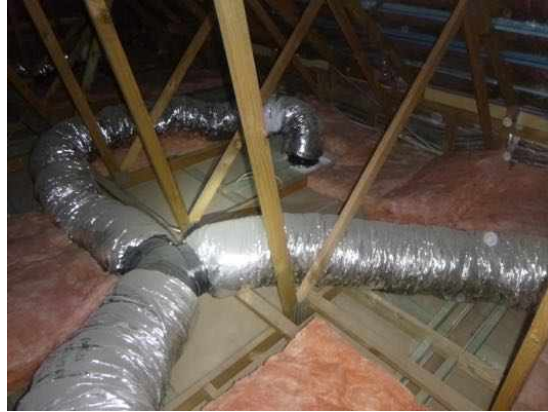
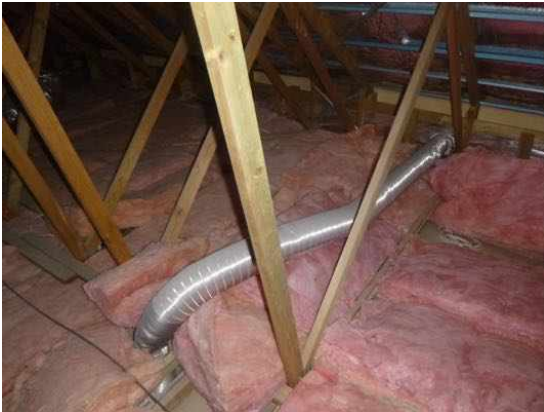
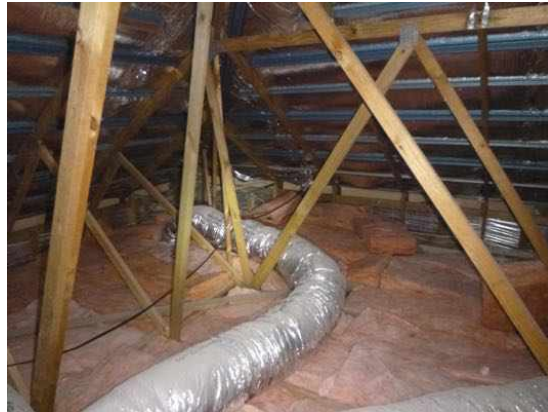
Building: Main Building
 Location: Roof Void
 Finding: Additional Photos - Obstructions and Limitations
 Information: These photographs are an indication of the obstructions and limitations which impeded full inspection of the property at the time of inspection. These obstructions can hide an array of defects and should be removed to allow full inspection to be carried out. A re-inspection is recommended once the areas are made accessible.

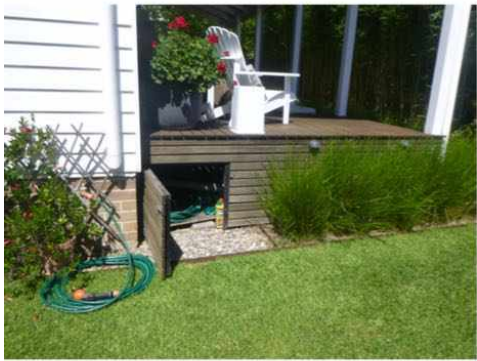
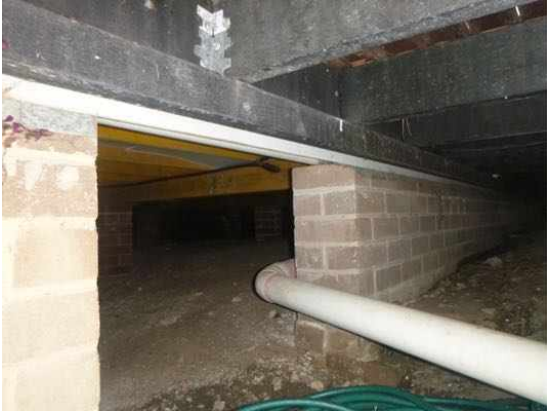
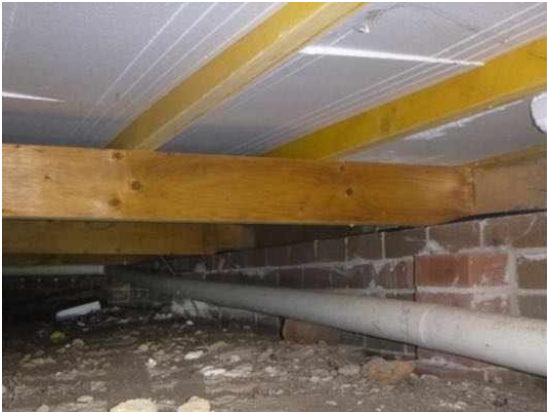
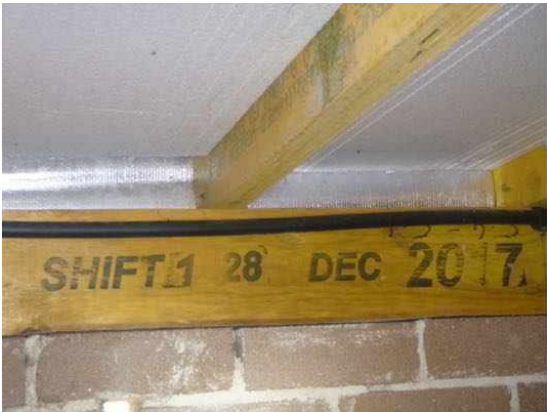
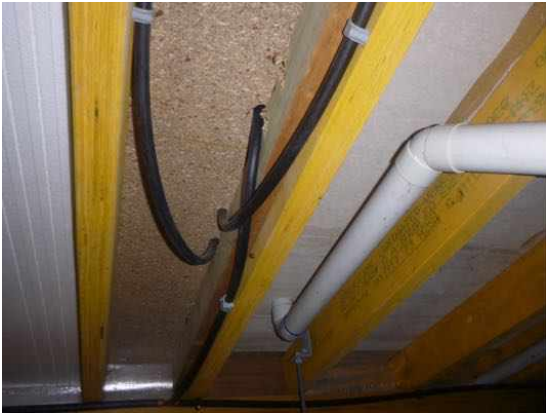
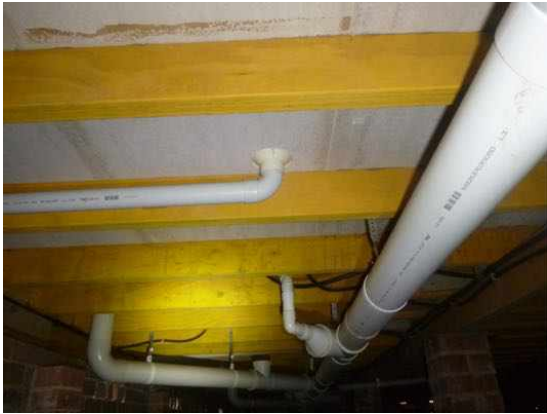
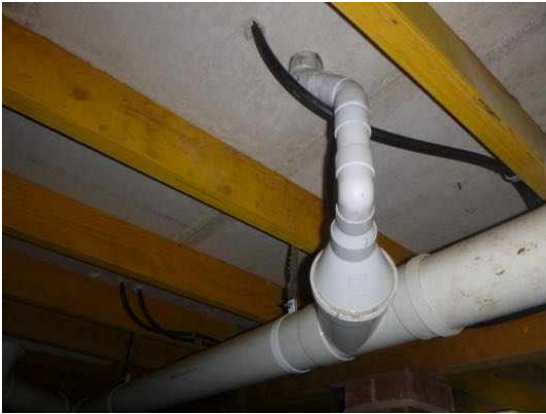
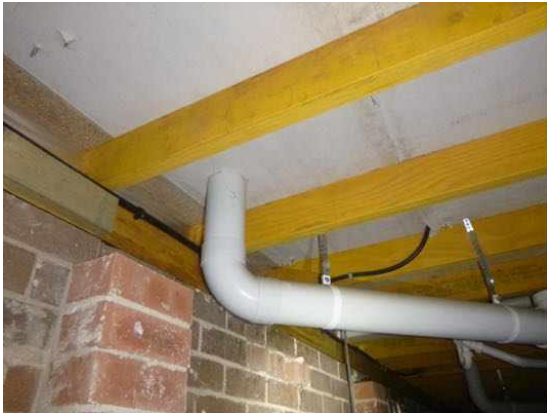
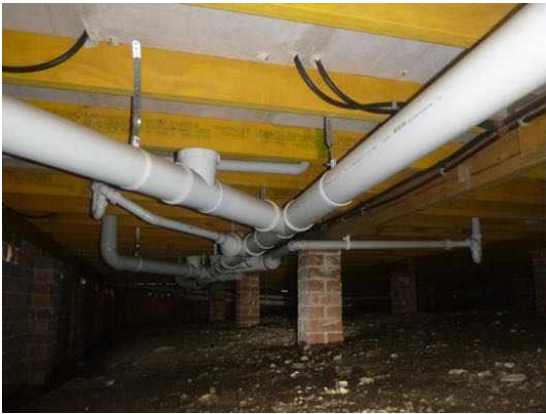
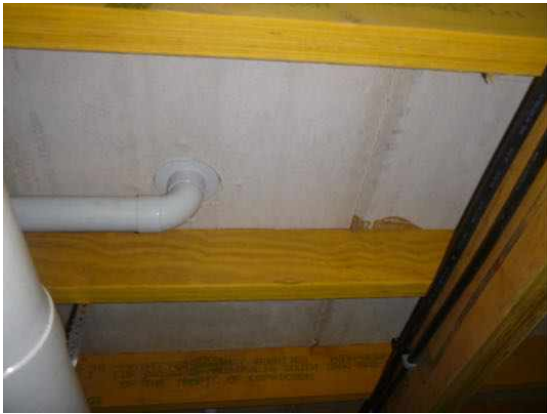
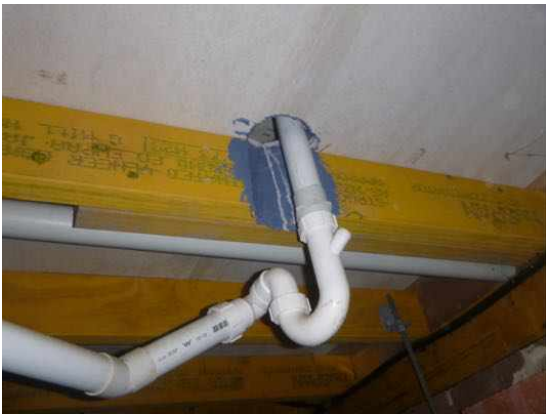
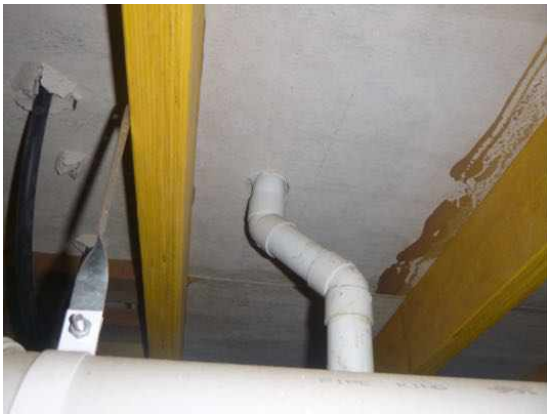
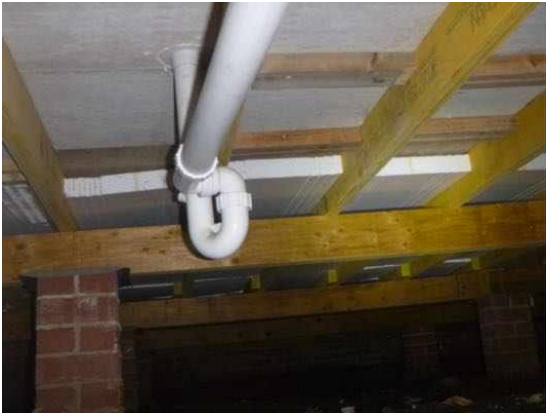
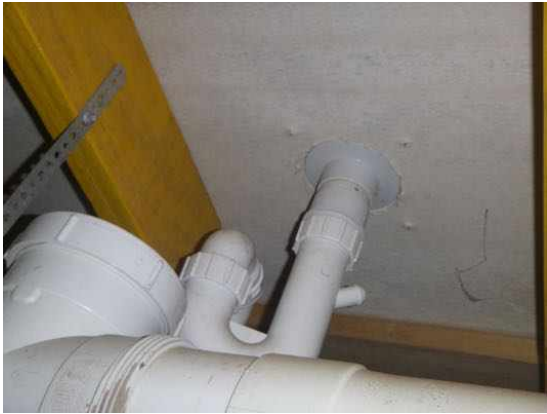
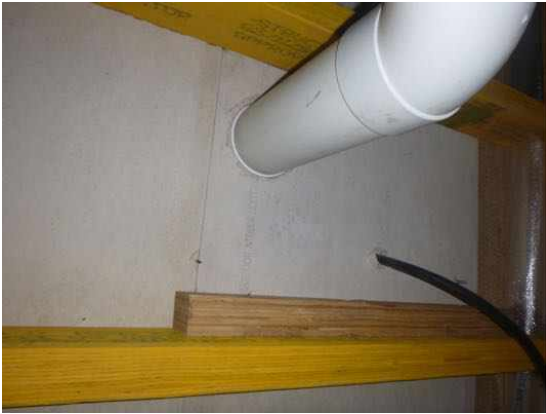
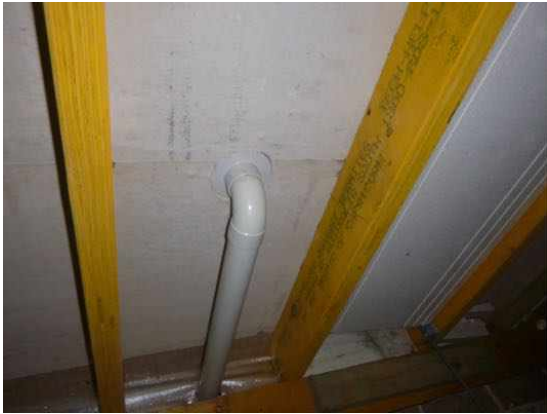
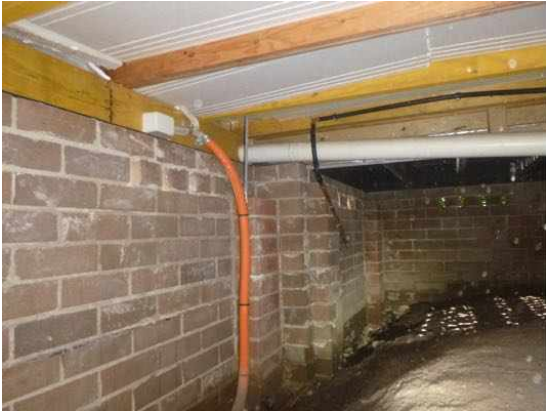
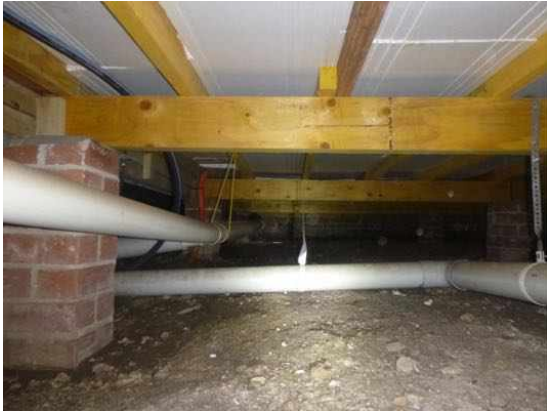
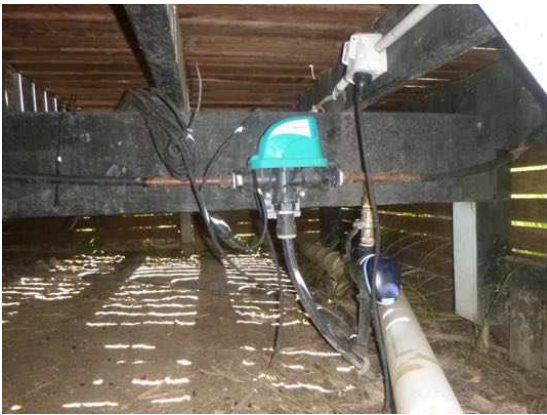
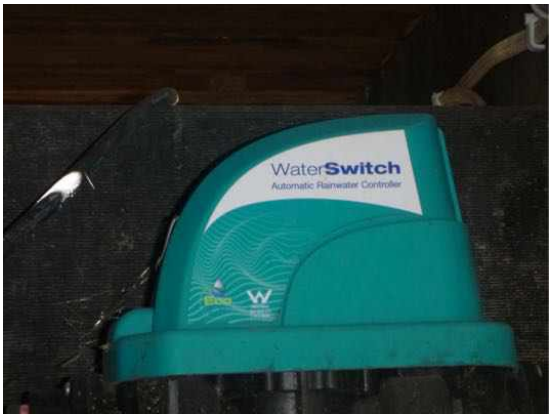
Building:	Main Building
Location:	Subfloor
Finding:	Additional Photos - Obstructions and Limitations
Information:	These photographs are an indication of the obstructions and limitations which impeded full inspection of the property at the time of inspection. These obstructions can hide an array of defects and should be removed to allow full inspection to be carried out. A re-inspection is recommended once the areas are made accessible.

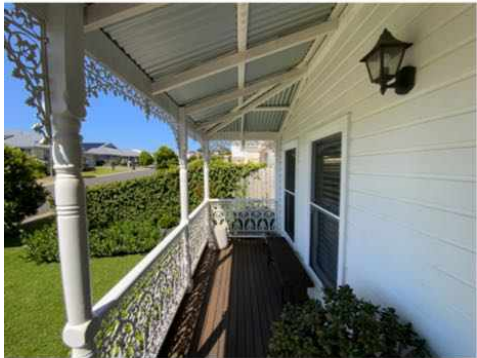
Building: Main Building
Location: All Areas
Finding: Additional Photos - Obstructions and Limitations
Information: These photographs are an indication of the obstructions and limitations which impeded full inspection of the property at the time of inspection. These obstructions can hide an array of defects and should be removed to allow full inspection to be carried out. A re-inspection is recommended once the areas are made accessible.
