Building and Timber Pest Inspection Report

Inspection Date: Wed, 28 Jan 2026

Property Address: 11 Tilgman St, Berry NSW 2535, Australia

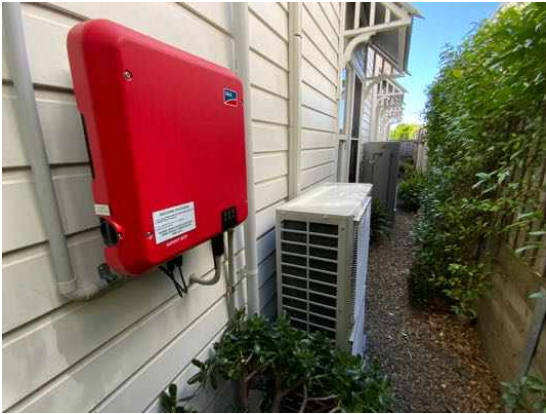
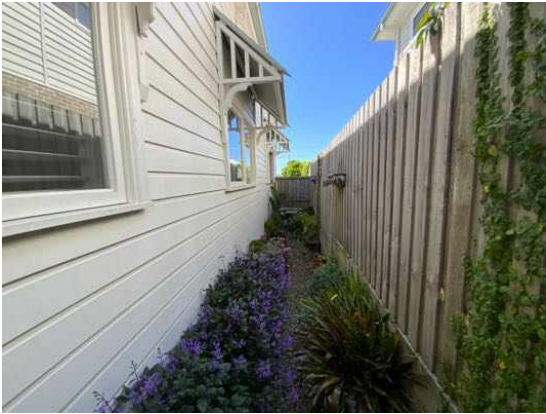
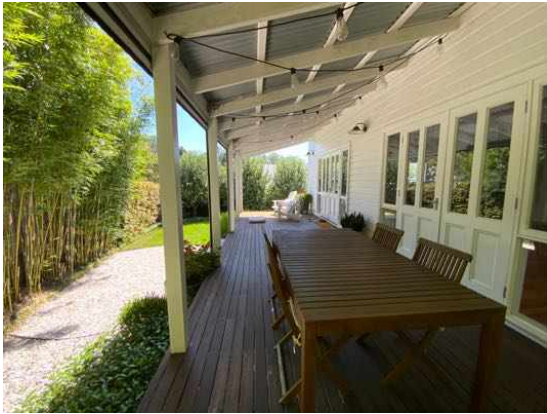
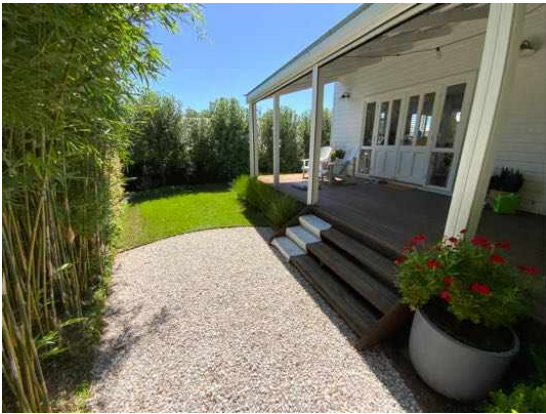
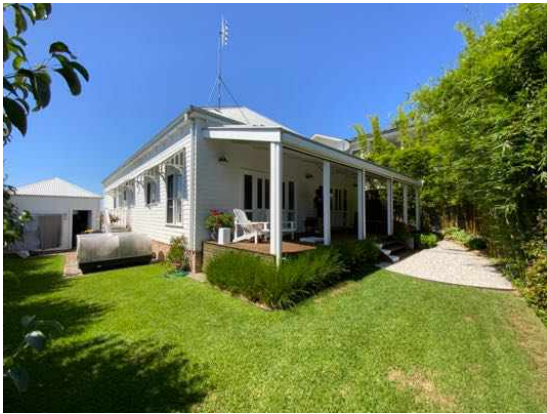
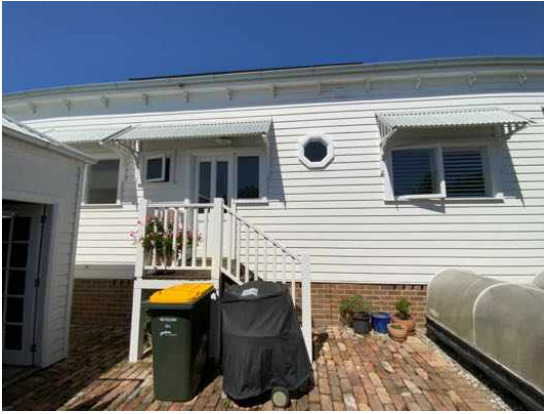
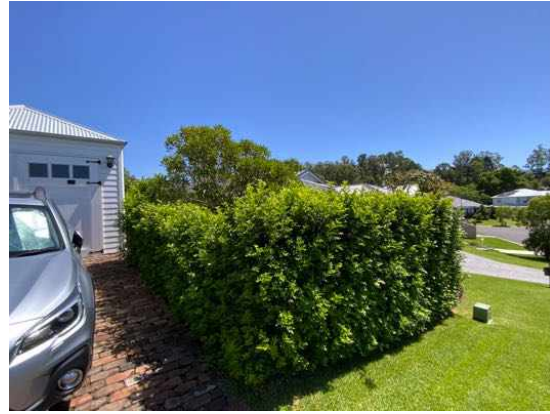
Building: Main Building
Location: All Areas
Finding: Additional Photos - Obstructions and Limitations
Information: These photographs are an indication of the obstructions and limitations which impeded full inspection of the property at the time of inspection. These obstructions can hide an array of defects and should be removed to allow full inspection to be carried out. A re-inspection is recommended once the areas are made accessible.

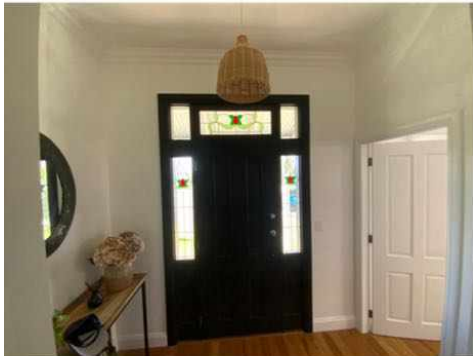
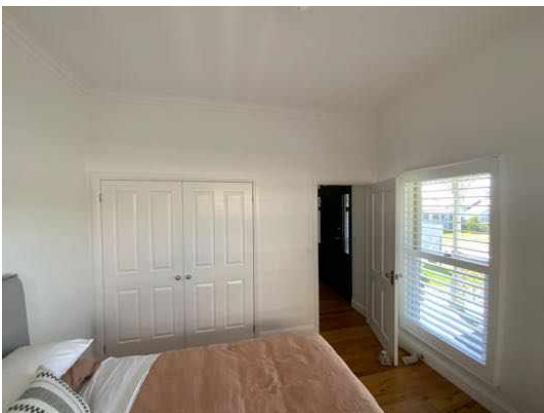
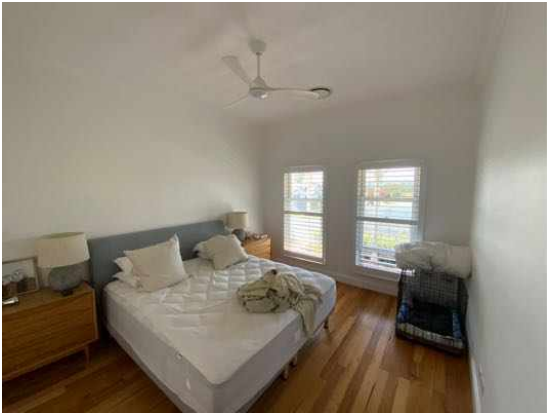
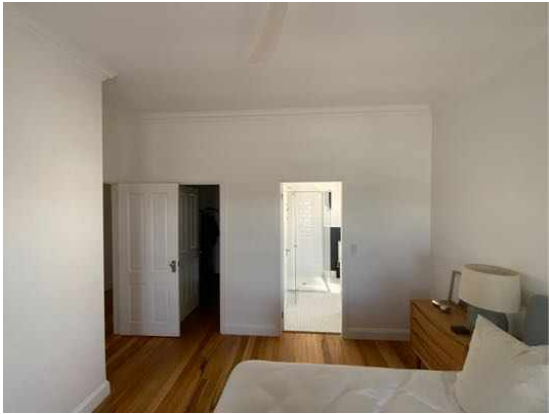
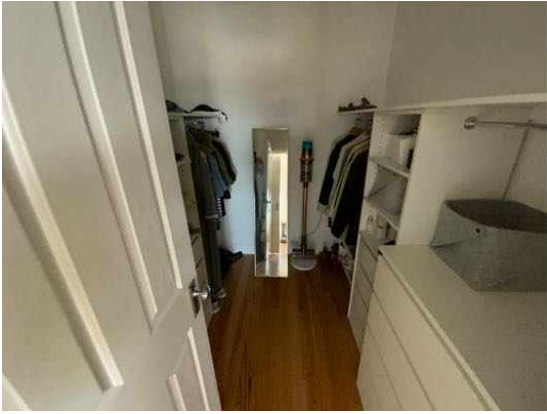
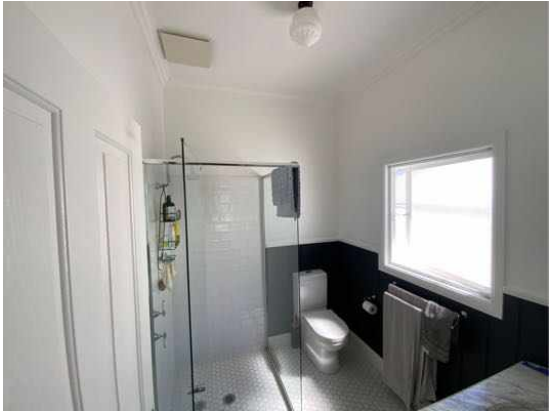
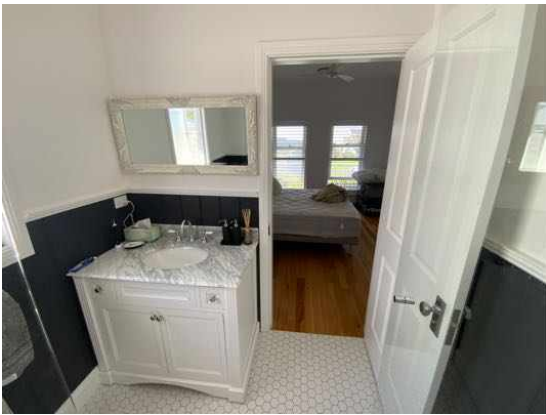
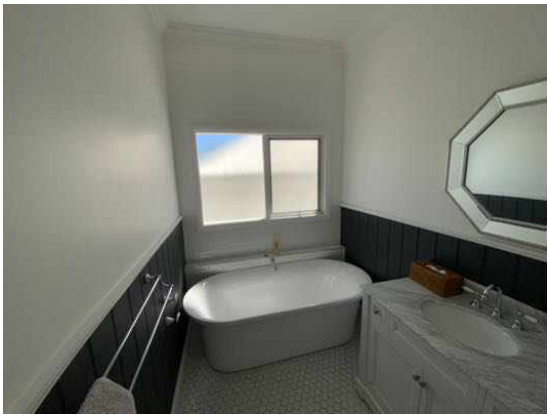
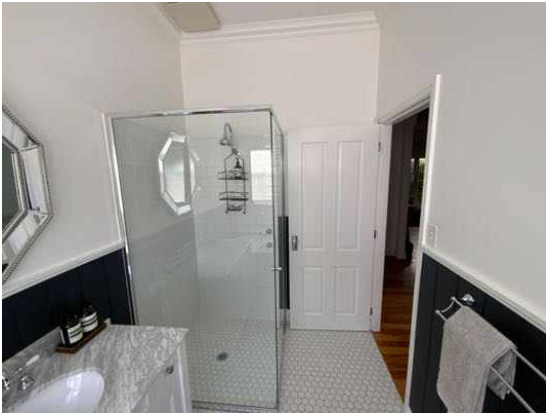
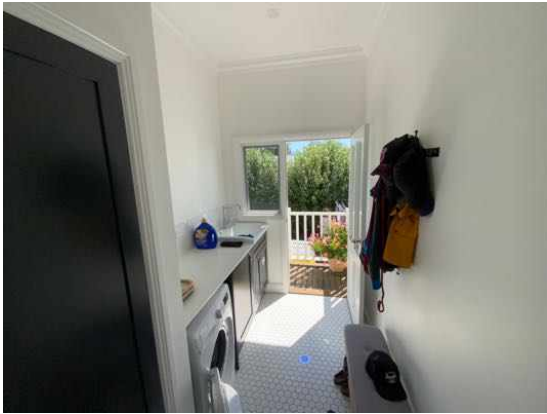
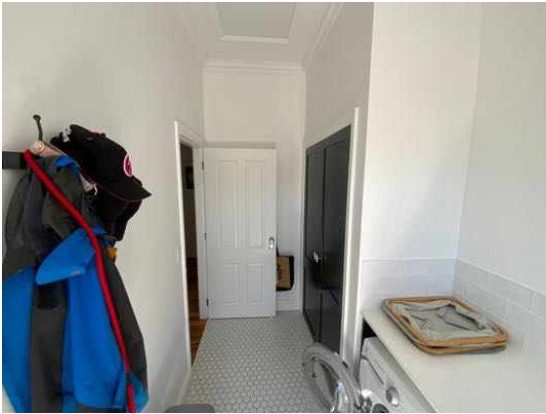
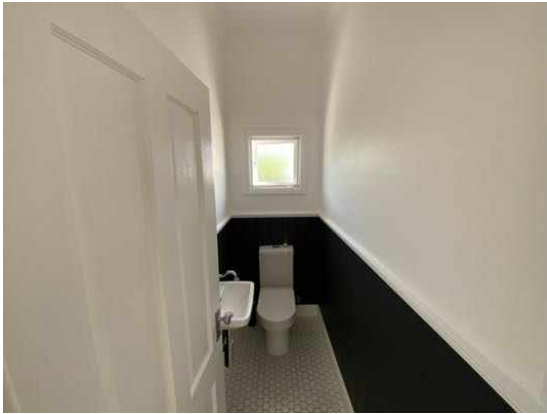
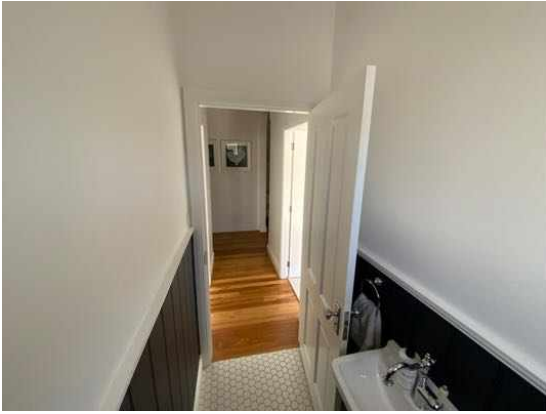
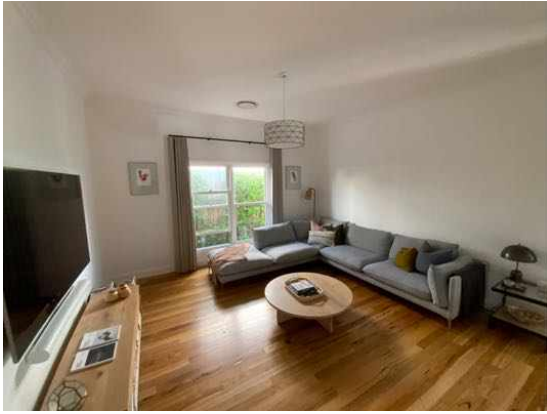
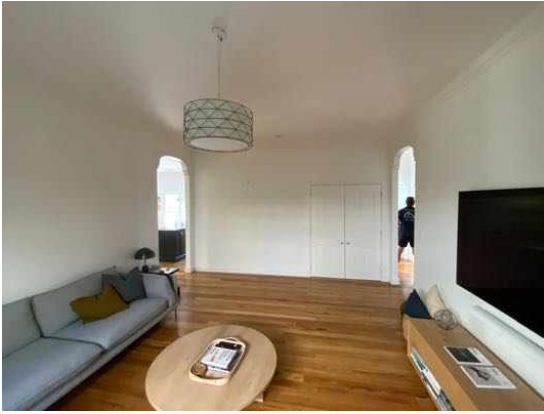
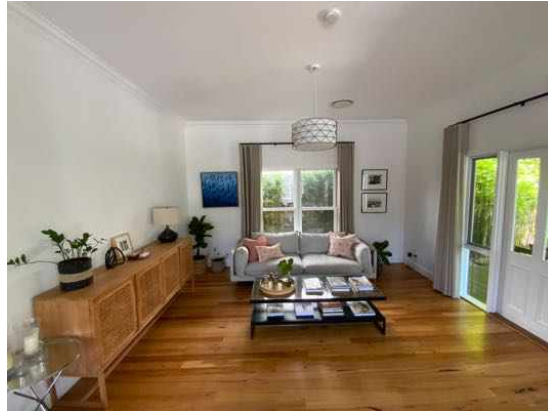
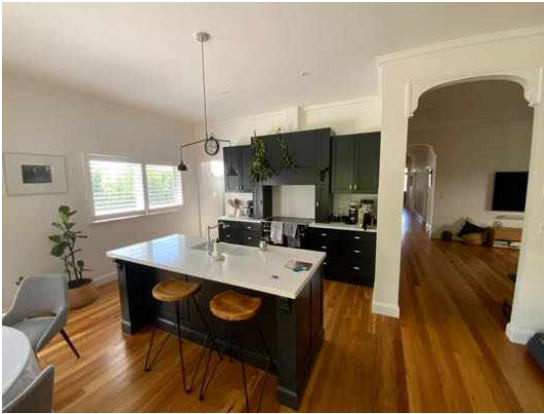
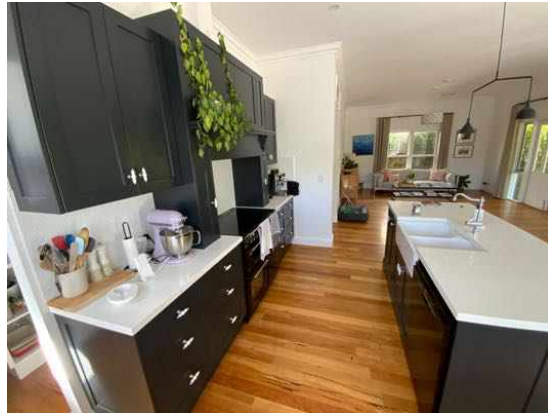
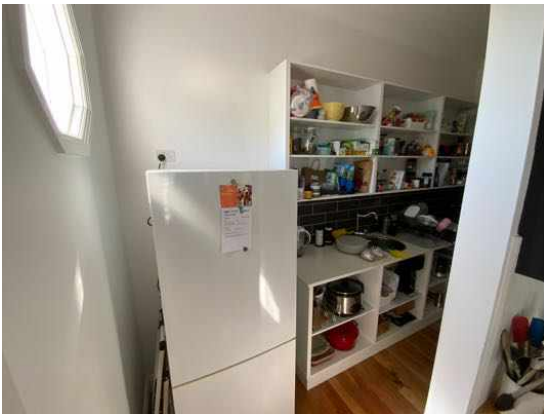
Finding: Additional Photos - Obstructions and Limitations

Information: These photographs are an indication of the obstructions and limitations which impeded full inspection of the property at the time of inspection. These obstructions can hide an array of defects and should be removed to allow full inspection to be carried out. A re-inspection is recommended once the areas are made accessible.

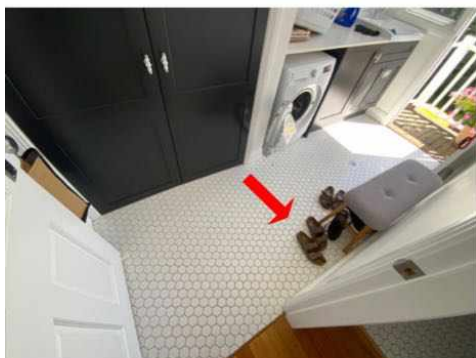
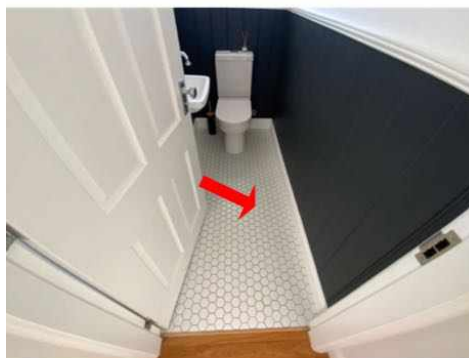
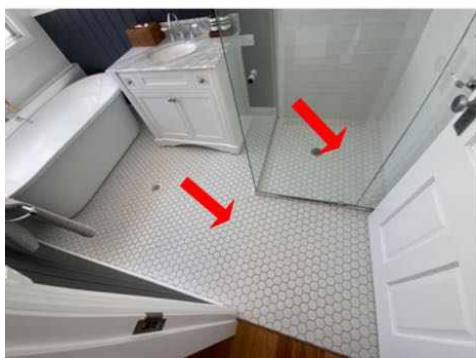
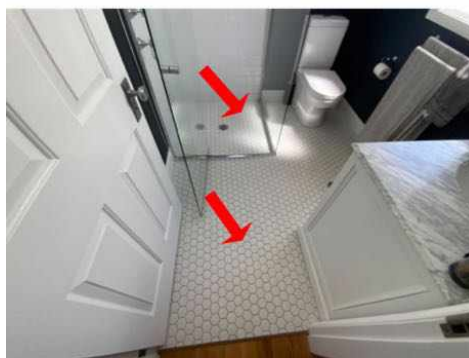
Building: Main Building
 Location: All Wet Areas
 Finding: Water Proofing Membranes - Information Only
 Information: Internal Water Proofing Membranes, are crucial in preventing water ingress into the property is important to know that the Membrane System used is to Australian Standards and has been installed correctly.

With older property's where this information is unavailable all wet areas should be monitored. Generally waterproofing certificates are only valid for approximately 7-8yrs. If any leaks, water staining, peeling or bubbling of the paint become evident to any adjacent walls or ceilings below a licensed builder or waterproofing specialist is recommended to investigate further.

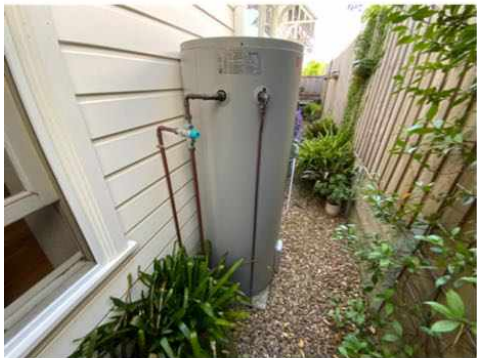
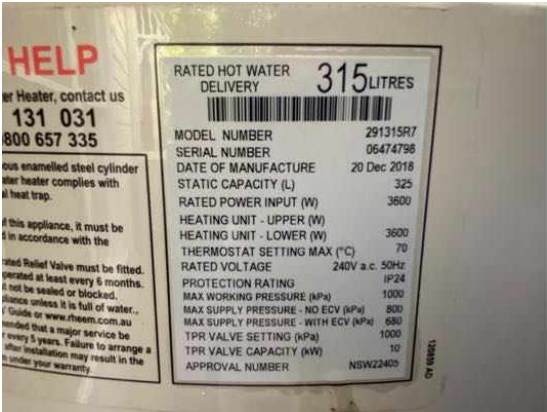
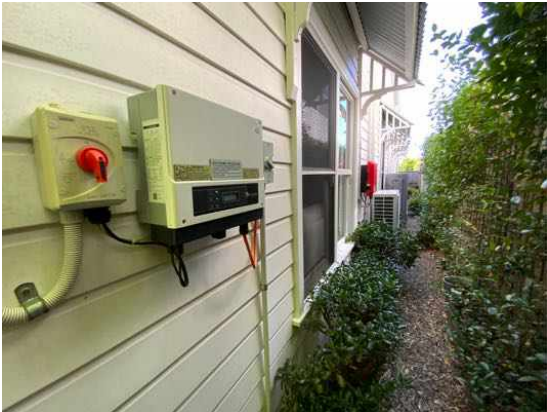
Building: Main Building
 Location: All Areas
 Finding: Additional Photos
 Information:

Additional photos are provided for your general reference. Arrows have been included to highlight areas of importance. Please discuss these photos with your building consultant for clarification.
