Building Inspection Report

Inspection Date: Tue, 17 Mar 2026

Property Address: 15 Hilma St, Sunshine West VIC 3020,
Australia

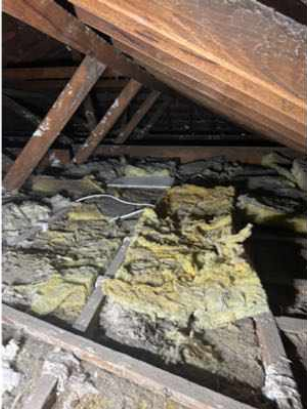
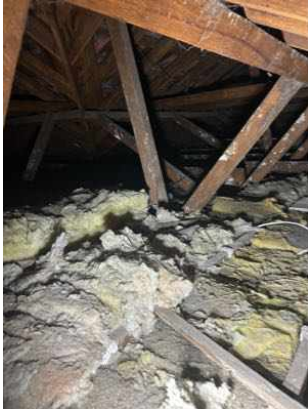
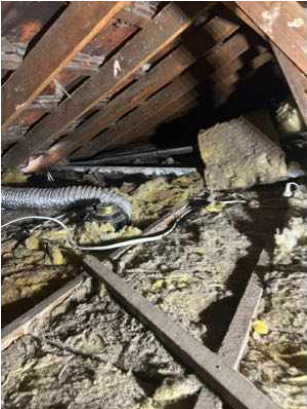
Building: Main Building
Location: All Areas
Finding: Additional Photos
Information: Additional photos are provided for your general reference

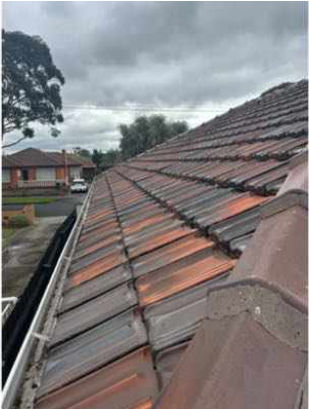
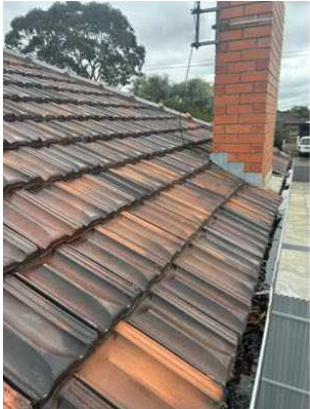
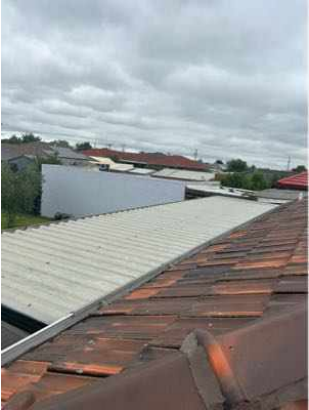
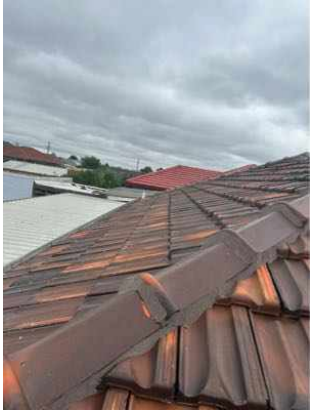
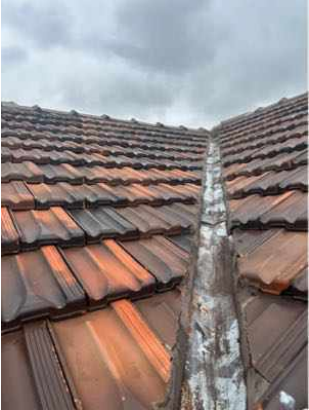
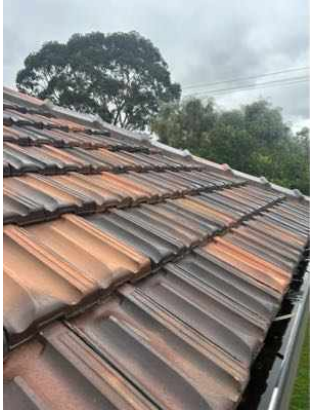
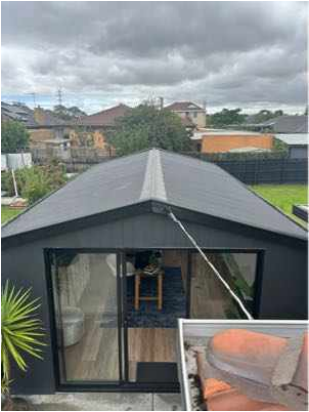
Location: All Areas
Finding: Additional Photos
Information: Additional photos are provided for your general reference
