Building Inspection Report

Inspection Date: Mon, 16 Feb 2026

Property Address: 22/13 Jordan St, Gladesville NSW 2111,
Australia

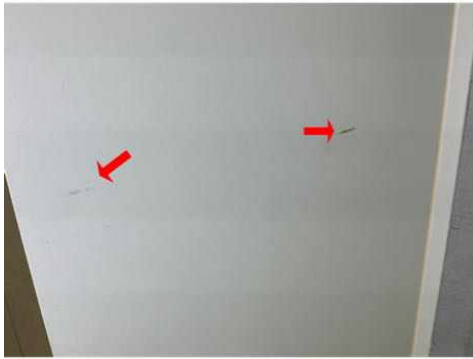
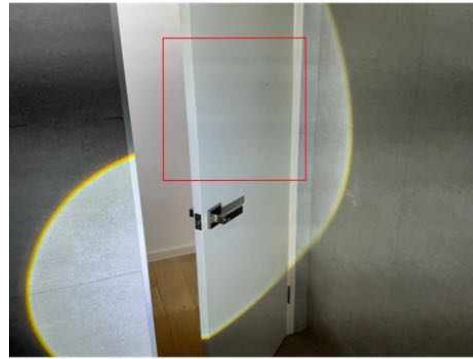
Defects 3.01

Building: Main Building
Location: All Areas
Finding: Maintenance and/or Wear and tear on building elements
Information: It was observed at the time of inspection that some building elements and areas around the property require general maintenance and/or exhibit signs of wear and tear. These typically include minor imperfections such as paint scuff marks, scratches on surfaces, small chips, nails or hooks left in walls from previous picture hanging, and other superficial blemishes.

These are generally considered minor items that are common in established homes. While they may be noticeable on visual inspection, they do not affect the structural integrity or functionality of the property. In most cases, these issues can be easily addressed by a qualified handyman as part of routine maintenance.

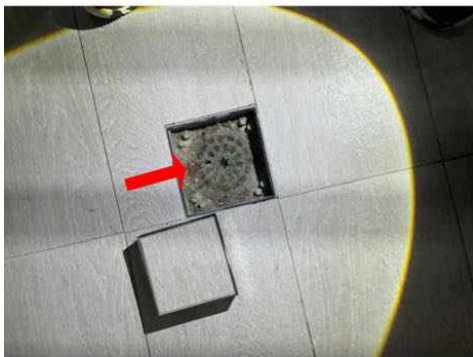
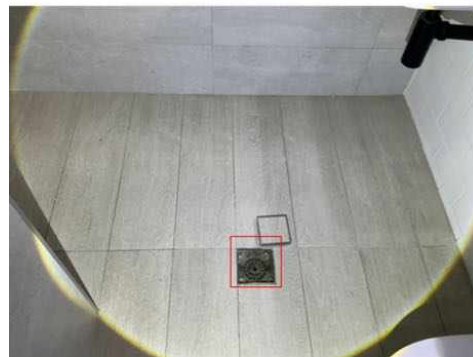
Defects 3.02

Finding: Drain Traps - Debris

Information: During the inspection, it was observed that the drain traps in the area were dirty and had accumulated debris. This condition can impede proper drainage and potentially lead to blockages. Regular maintenance, including cleaning the drain traps and removing any debris, is necessary to ensure efficient drainage and prevent future plumbing issues. It is recommended to address this issue promptly to maintain the functionality and hygiene of the drainage system.

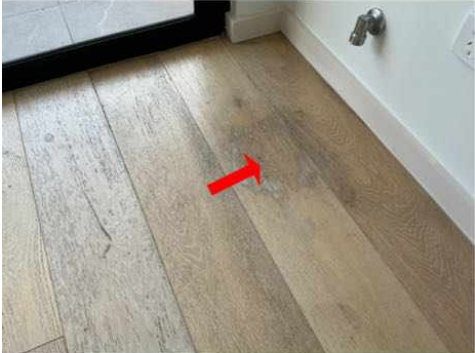
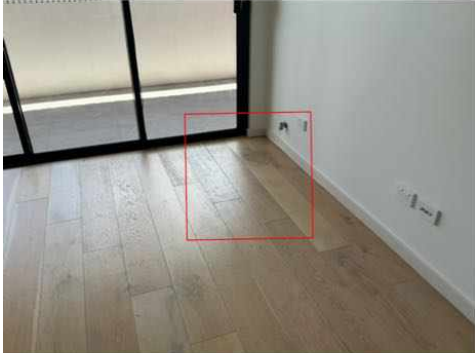
Defects 3.03

Finding: Internal Flooring - Wear & Tear

Information: At the time of inspection, general wear and tear was noted on the flooring, including surface scratches, scuff marks, and areas where the finish has worn away. These signs of deterioration are consistent with age and regular foot traffic and may detract from the overall appearance of the flooring.

It is recommended that a qualified flooring specialist be engaged to assess the condition of the floor and provide advice on appropriate maintenance or refinishing options, such as sanding and re-coating, to restore surface protection and improve presentation.

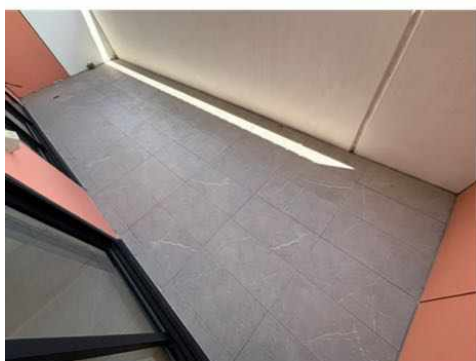
Building:	Main Building
Location:	All External Areas
Finding:	Obstructions and Limitations - External Areas
Information:	The attached photographs provide a visual representation of the obstructions and limitations that impeded a full inspection of the external areas of the property at the time of assessment. These obstructions, which may include vegetation, stored items, debris, or other physical barriers, can obscure potential defects and prevent a thorough evaluation of the property's condition. Obstructions of this nature can conceal a wide range of issues, such as structural damage, water ingress, pest infestations, or deteriorating building materials, which may not be visible during the initial inspection.

It is essential that these obstructions be cleared to allow for a comprehensive inspection of the external areas. Removing these barriers will enable a more accurate assessment of the property's condition and allow any hidden defects to be identified and addressed promptly. Failure to do so could result in undetected issues worsening over time, potentially leading to more costly repairs in the future.

Therefore, it is strongly recommended that the obstructions be removed and a re-inspection be scheduled once the affected areas are made fully accessible. This will ensure a complete evaluation of the property's exterior and provide the client with a clear understanding of any potential issues that may have been concealed during the initial inspection.

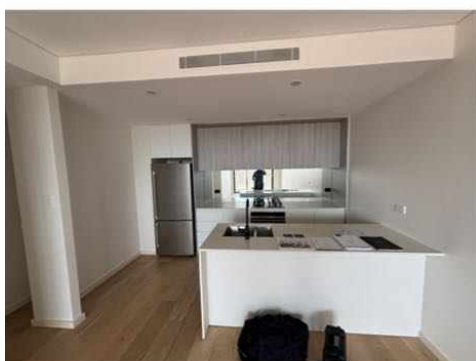
Building:	Main Building
Location:	All Internal Areas

It is highly recommended that all obstructions be cleared to facilitate a complete and thorough inspection of the internal areas. Once the obstructions have been removed and full access is available, a re-inspection should be carried out to ensure that any previously concealed issues can be properly identified and rectified. This follow-up inspection will provide a more accurate assessment of the property's internal condition and help the client make informed decisions about any necessary repairs or maintenance.

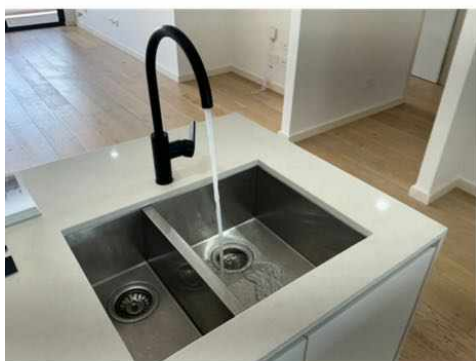
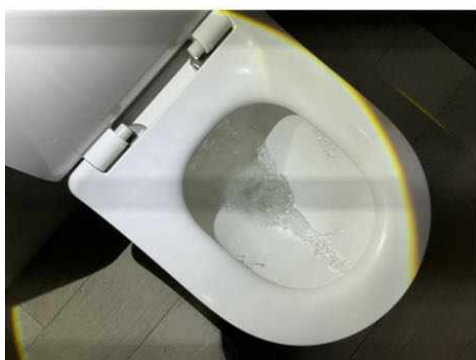
However, it is important to note that while a thorough inspection of cupboards and cabinetry was conducted, the presence of obstructions, such as stored items or fixtures, may have limited full visibility of potential water damage or hidden defects. These obstructions can conceal underlying issues that may not be immediately visible during the initial inspection. Furthermore, conditions can change after the inspection has been carried out, and defects or damage could be revealed once obstructions are removed or as time progresses.

Given this, it is strongly recommended that a re-inspection be conducted after all obstructions have been removed from the cupboards to allow for a full and thorough assessment of these areas. This will ensure that any concealed damage or defects are identified and addressed in a timely manner. Regular maintenance and monitoring of plumbing and drainage systems are also advised to ensure long-term functionality and to prevent future problems from arising.

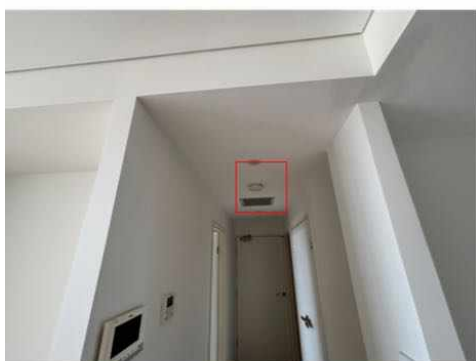
they are working correctly. Furthermore, it is important to consult and adhere to the relevant guidelines, such as Australian Standard AS3786 and state-specific legislation, which outline specific requirements for smoke detectors and fire safety compliance.

By ensuring the proper installation and regular maintenance of smoke detectors, the safety of all occupants is significantly improved, providing critical early warning in the event of a fire.

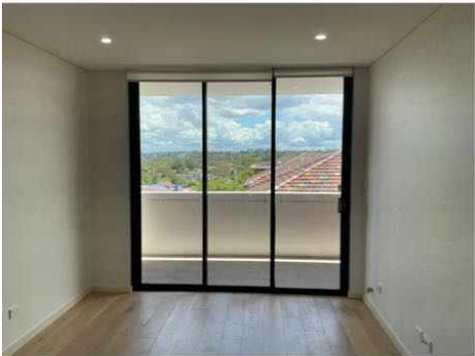
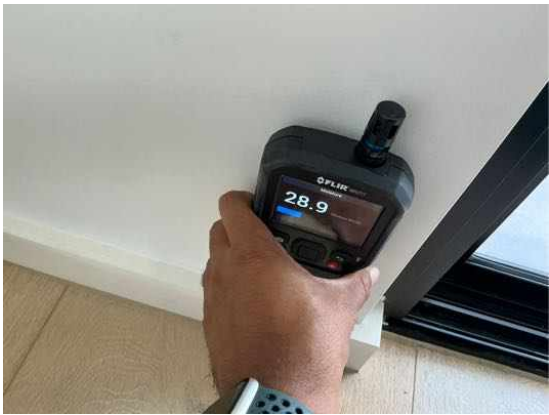
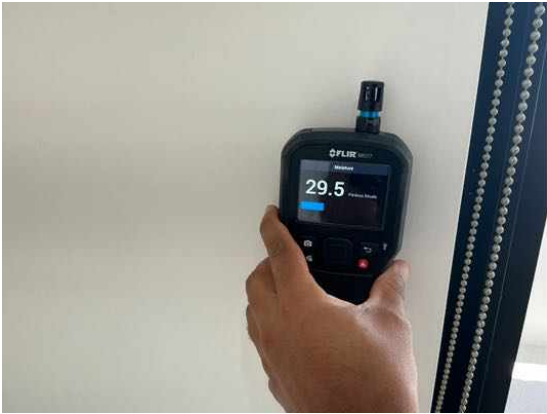
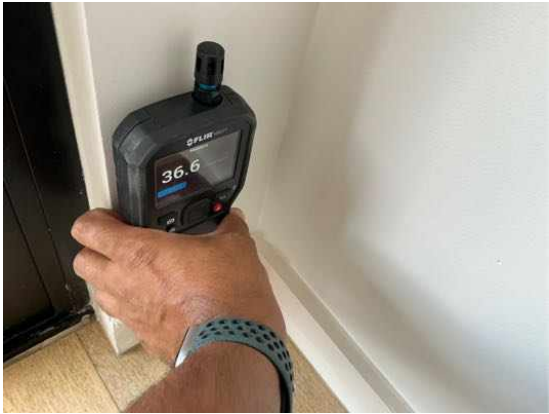
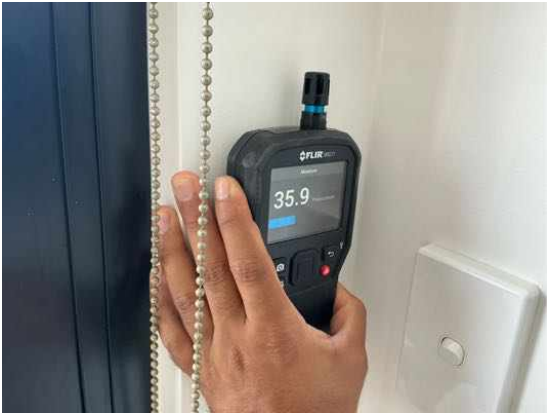
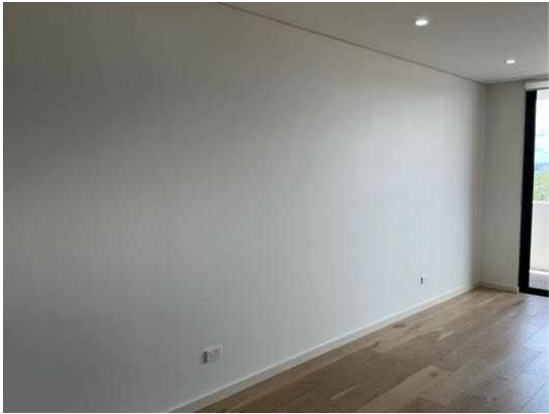
Building:	Main Building
Location:	All Areas
Finding:	Additional Photos - Moisture Meter Readings
Information:	Additional moisture meter reading photos have been provided for the property to offer further clarity on areas tested during the inspection. These photos are intended to give a visual reference for the specific locations where moisture levels were measured, as indicated by the red arrows in the images. These readings were taken at the time of the inspection to assess any potential moisture-related issues within the property. Any defects related to moisture that were identified during the inspection have been separately mentioned in the defect statements within the report.

For further clarification or additional information regarding the moisture readings, the client is encouraged to contact the building inspector directly. Regular monitoring of moisture-prone areas is recommended to ensure any emerging concerns are addressed promptly, particularly during wetter seasons or in high-humidity conditions.

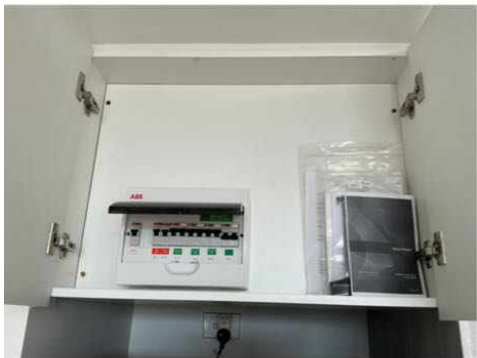
Building: Main Building
Location: Kitchen
Finding: Electrical Meter Box
Information: Electrical meter box is located in kitchen cabinets

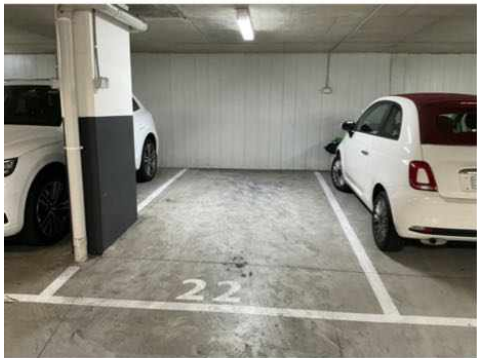
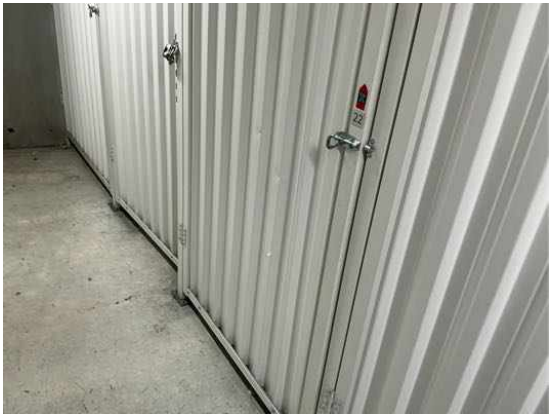
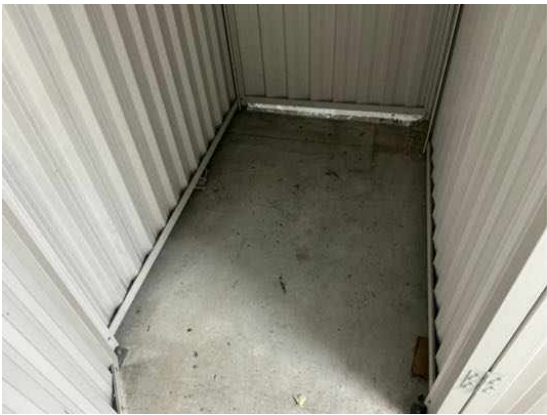
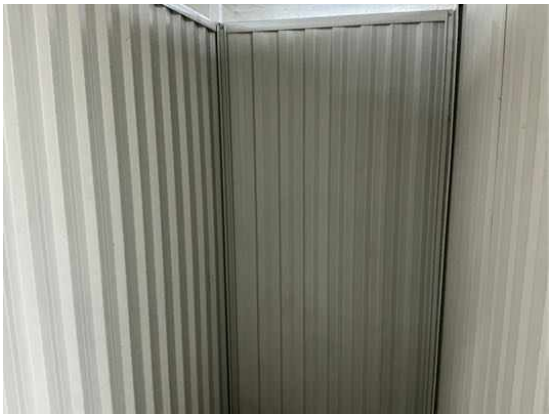
Finding: Allocated Car Spaces & Storage Room

Information: The accompanying photos are provided for your general reference, showcasing the current condition of the car parking spots and storage rooms as observed at the time of inspection. It is important to note that these images are meant to serve as a visual snapshot of the property’s features at the time of the assessment. However, the client is strongly advised to confirm all allocations, such as car parking spots, storage rooms, and any associated rights or access, within the terms of the contract. Verifying these allocations through the contract ensures clarity and avoids potential disputes regarding ownership or usage. The photos included are intended to give an overview of the designated areas, but the final details should always be cross-referenced with the contractual agreements for accuracy and completeness.
