Building and Timber Pest Inspection Report

Inspection Date: Fri, 13 Mar 2026

Property Address: 67 Penrose Rd, Bundanoon NSW 2578,
Australia

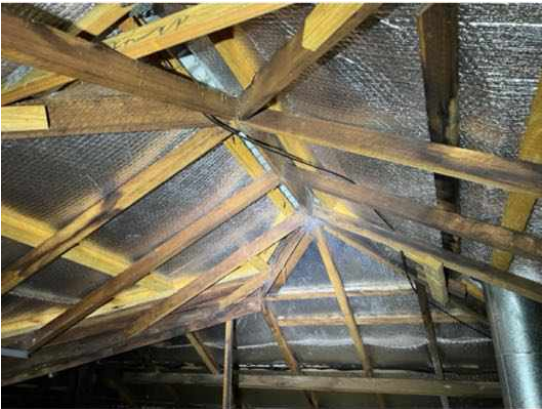
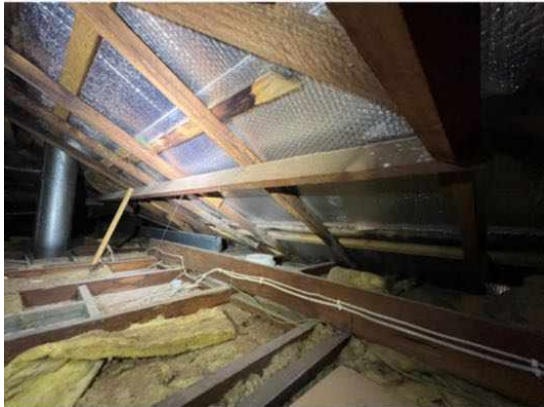
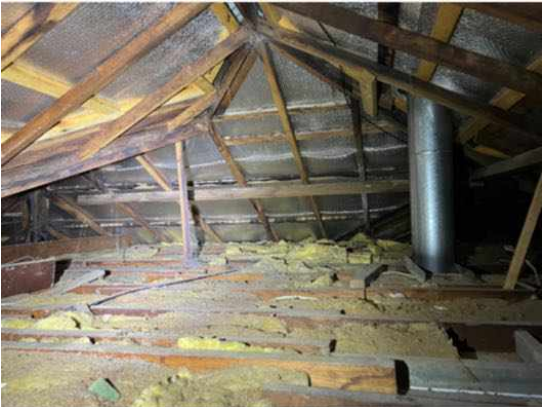
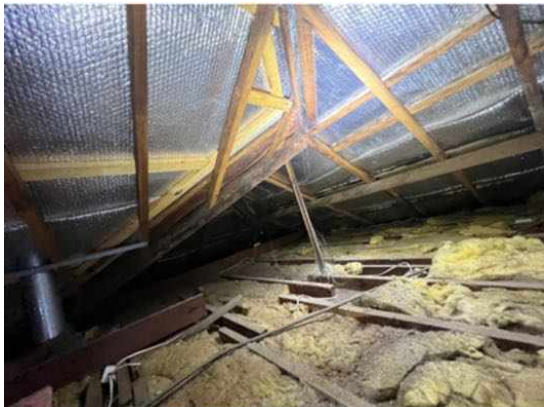
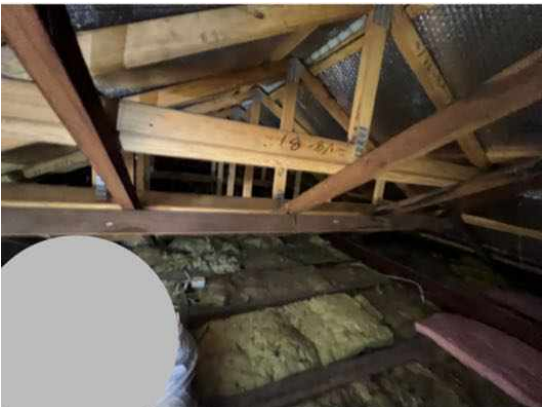
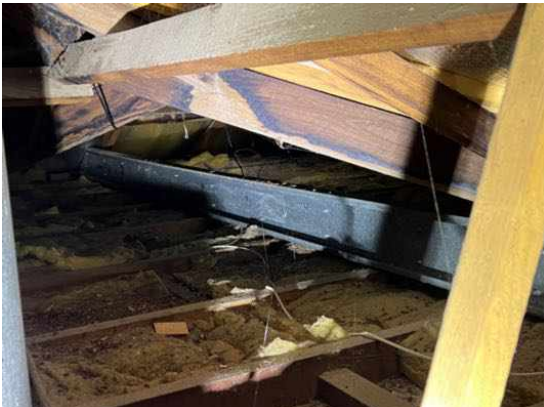
Building: Main Building
Location: Roof Void
Finding: Roof structure - Unconventional support arrangement
Information: Upon inspection of the roofing structure within the ceiling void it was noted that several conventional support elements were not present. Collar ties were not observed and major roof members including the ridge, hips, valley rafter and underpurlins did not appear to be supported by struts. In addition, a large steel channel section has been installed as a hanger spanning across part of the roof structure and connected to the original timber hanger, which is considered an unusual method of support.

Although no significant sagging of the roof structure or distortion to the ceiling linings was observed at the time of inspection, the adequacy of the structural support arrangement cannot be confirmed.

Further assessment is recommended by a structural engineer to confirm the adequacy of the roof structure.

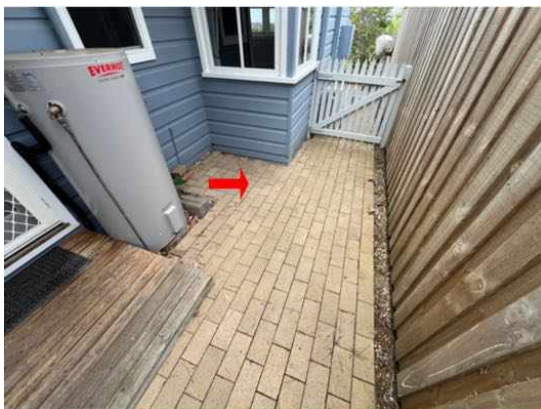
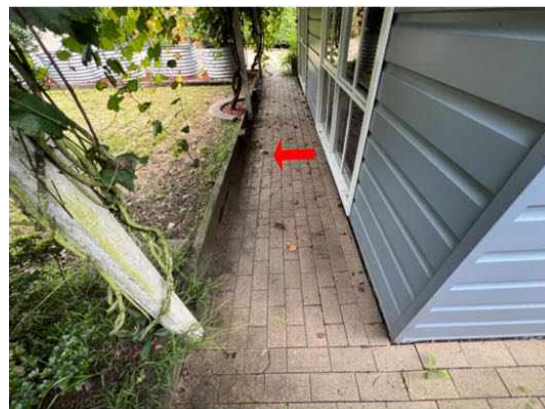
Finding 3.11

Building:	Main Building
Location:	Exterior walls - rear, Pergola, Driveway
Finding:	Paving - Uneven
Information:	Sections of the external paved area are uneven, creating a potential trip hazard. It

appears as though the area has been subject to rough installation, or that paving sections have lifted due to movements in the foundation of the property.

Where paving creates a trip hazard, personal injury may ensue if due caution is not taken by all persons within this area.

Re-paving of the area is required as soon as possible to remedy this situation. Further consultation with a specialist concreter is advised.

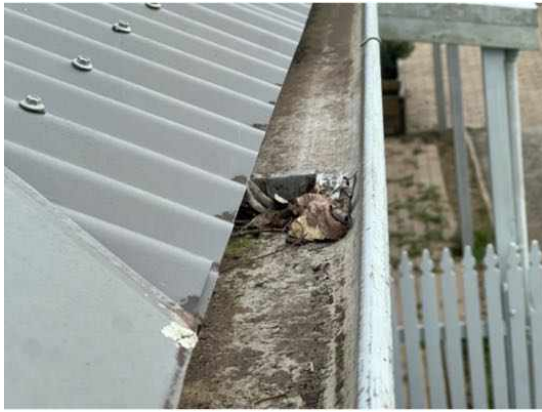
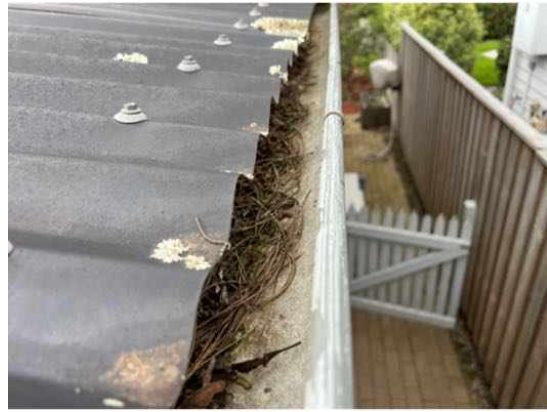
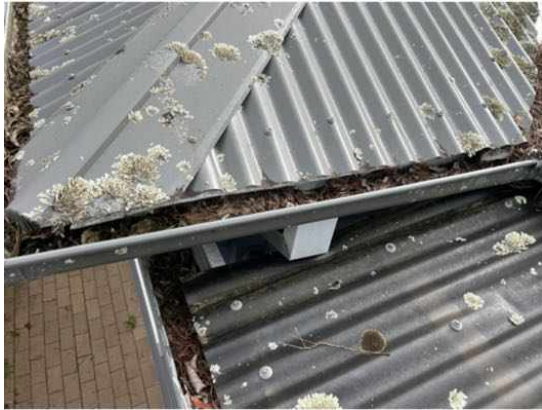
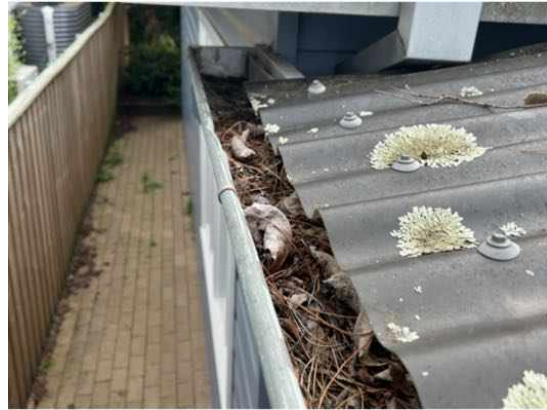
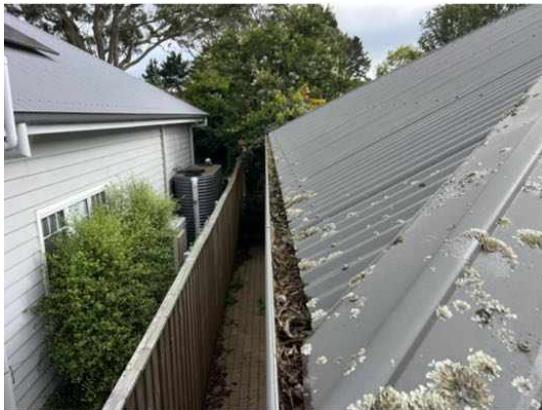
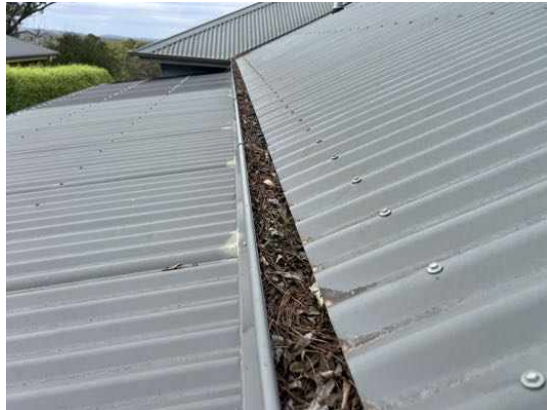
Finding 3.15

Building:	
Location:	Roof Exterior -Main Building, Garage
Finding:	Trees - Overhanging and filling gutters
Information:	Overhanging trees often result in excessive amounts of leaf debris accumulating in gutters.

Gutters are a critical part of the building's management of storm water and rain. It is therefore important that they be kept clear to prevent secondary damage to associated building elements, including exterior and interior walls, ceiling linings and any adjoining building elements. Where gutters are blocked, pooling of rainwater is likely to occur, fast-tracking rust and corrosion of the roof plumbing elements.

It is highly advised that all overhanging tree branches be removed as soon as possible to prevent any further damage. Repair and/or replacement of sections of damaged guttering may also be required where the extent of the damage necessitates.

Such works should be performed by the homeowner; however, appointment of a landscape contractor or an arborist may be required. Consultation with a licensed roof plumber is required where guttering has been damaged.

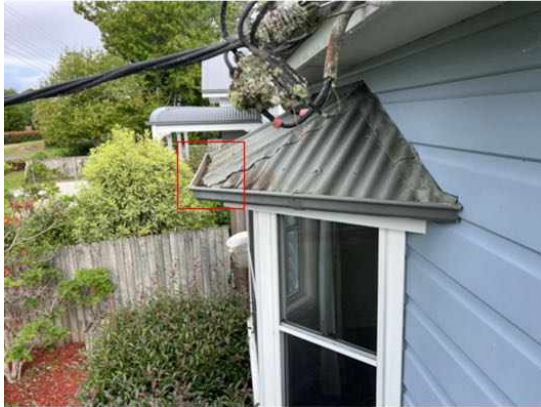
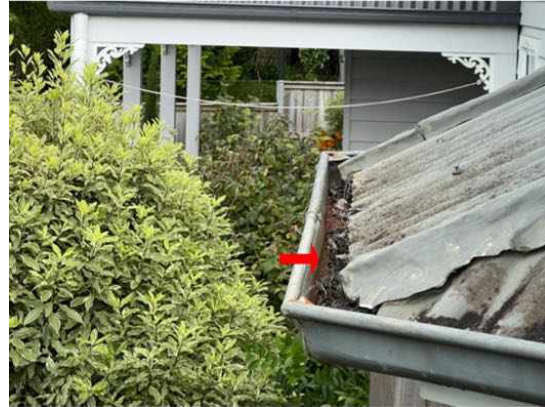
Finding 3.17

Information: The guttering in this area was observed to have a sag at the time of inspection. This is often caused by inadequate fixing, blocked gutters, or excessive water weight from poor drainage.

Sagging gutters can impede proper water flow, potentially leading to water overflow, damage to fascia boards, and moisture ingress into associated structures.

It is recommended that a roofing plumber or general handyman be engaged to assess and secure the guttering to restore proper alignment and functionality.

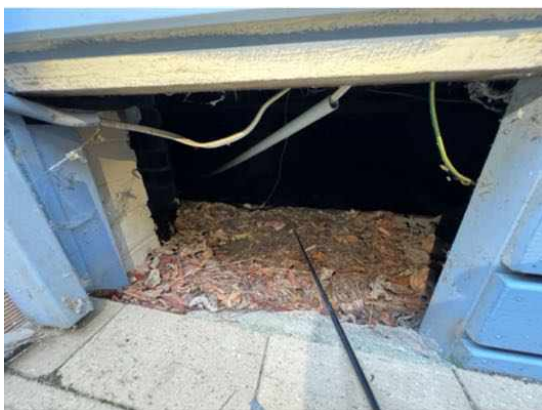
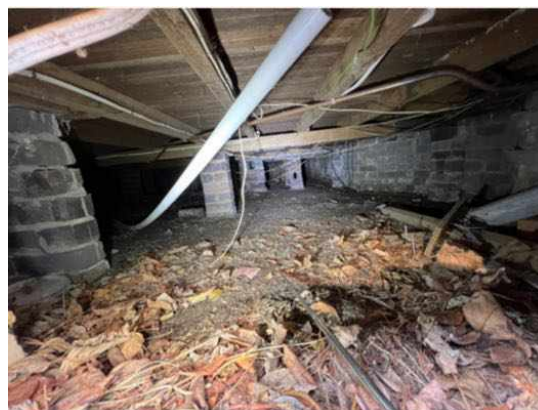
Finding 3.19

Building:	Main Building
Location:	Subfloor
Finding:	Subfloor - Lack of ventilation
Information:	It was noted at the time of inspection that the subfloor area lacks adequate ventilation. Ventilation can be restricted by a variety of minor defects, including obstructions in the subfloor space, a lack of vents or a low clearance.

A well ventilated subfloor aids in maintaining dry conditions, preventing secondary damage such as wood rot and pest activity, as well as preventing the development of mould and mildew (which can lead to respiratory safety hazards for occupants).

The initial step in improving ventilation is to ensure that the subfloor area is free of any debris or stored items. Where ventilation is still inadequate, it is advised to ensure that all vents are clear of blockages, and additional vents may be installed.

The client may also consider mechanical ventilation (powered fans) to improve subfloor airflow. Remedial works should be conducted as a matter of urgency to protect against the development of potentially harmful subfloor conditions.

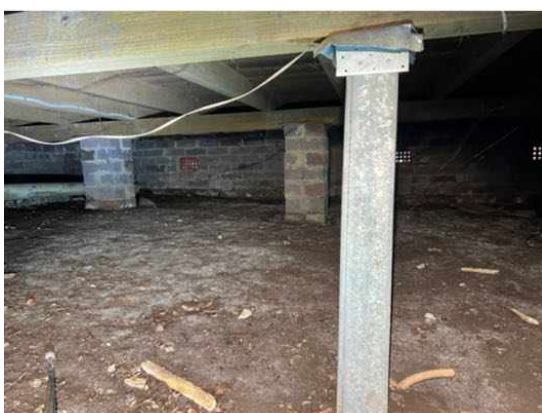
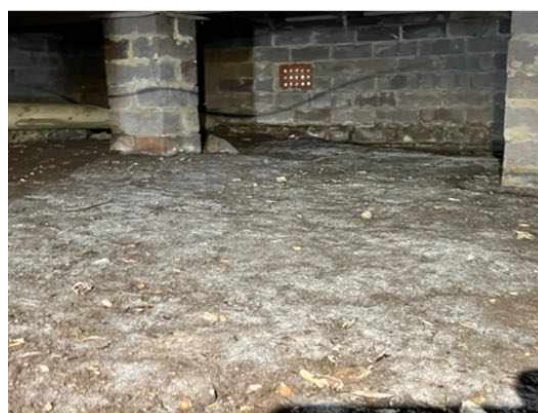
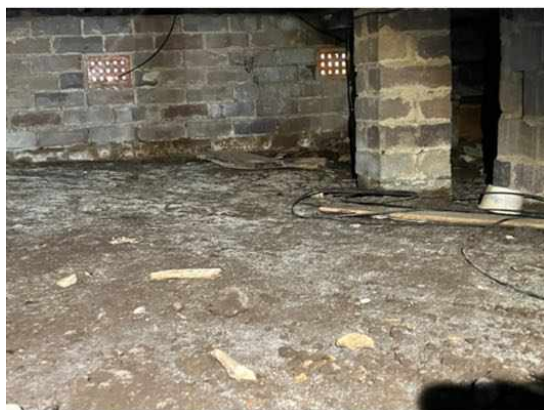
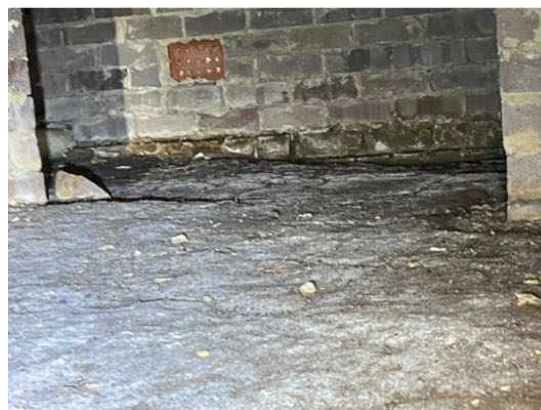
Finding 3.20

Building:	Main Building
Location:	Subfloor
Finding:	Mould observed in Subfloor
Information:	Mould was observed in the subfloor area at time of inspections. This is likely due to poor ventilation and/or water ingress.

Where evidence of mould growth was noted, there may be environmental, biological or health issues associated with the report. A specialist inspection by a suitably qualified environmental health inspector is warranted, where mould is extensive or where any queries regarding air quality spores or other related issues apply.

Generally, the client is advised to ensure that the general environment is free of moisture and humidity to aid in the prevention of mould formation and development. Any mould found during the inspection should be cleaned immediately by a mould remediation contractor. Mechanical ventilation may be required and/or subsoil drain around the perimeter of the property.

A licenced builder or a plumber should be consulted on rectification as soon as possible.

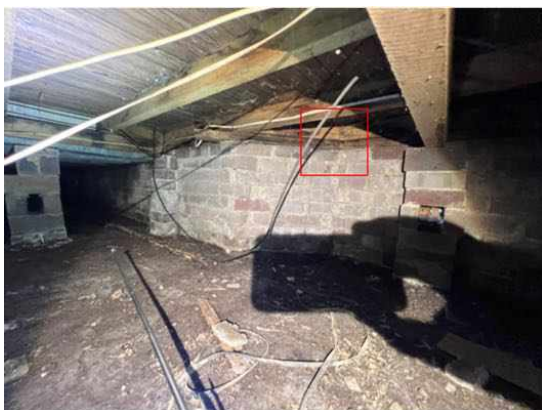
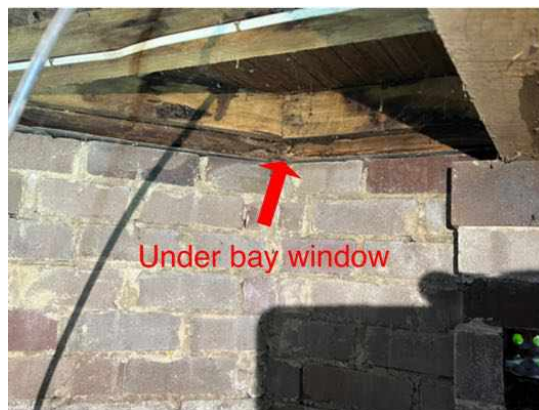
Finding 3.21

Building:	Main Building
Location:	Subfloor
Finding:	Subfloor structure - Wood rot
Information:	The subfloor structures are showing signs of deterioration and wood rot (fungal decay) of the timbers. It is suspected that this defect has developed as a result of damp conditions in the subfloor.

Damp conditions cause the timbers to fail, resulting in the subfloor structures failing to bear the load (or weight) of the building as originally intended. Without repairs and maintenance, including potential replacement of affected elements, it is likely that serious structural faults will result, as well as an array of minor defects.

The presence of wood rot to the subfloor structure is also conducive to termite infestation. As timber stumps are in direct contact with the ground, concealed termite is made possible. Such entry is made easier if the timbers become non-durable due to even slight wood rot.

Where wood rot is present to any structural timber, rectification or replacement of the affected timber building element is required. The adequate timeframe for such works are dependent on the severity of the rot. Where rot has developed to become widespread, replacement of sections of the subfloor structure may be required. Consultation with a structural engineer or registered builder specialising in re-stumping is highly advised as soon as possible.

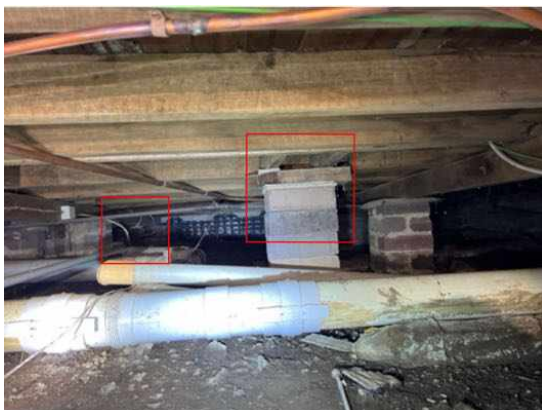
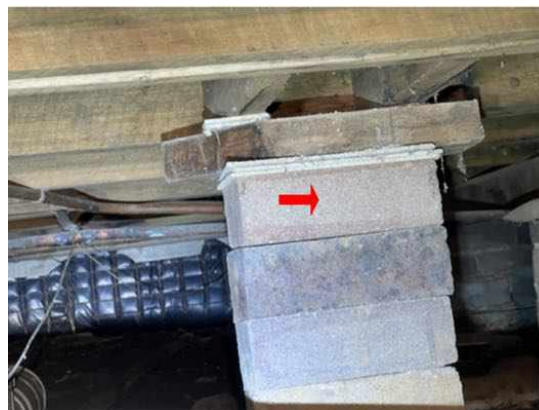
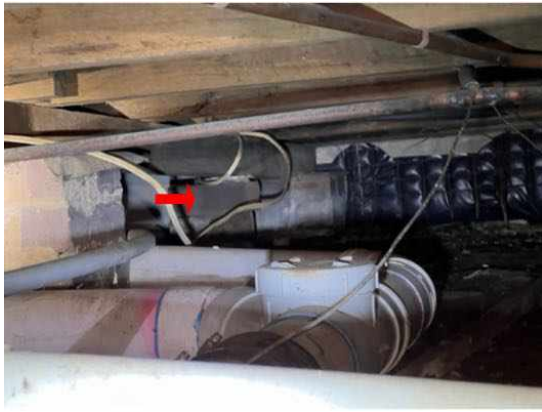
Finding 3.22

Building:	Main Building
Location:	Subfloor
Finding:	Subfloor Support - Improvised
Information:	An improvised support was observed within the subfloor where stacked masonry blocks and packing have been used to support a section of the floor structure. Supports of this nature are generally considered temporary and may not provide a stable or compliant long-term structural support system.

Improvised supports may shift, settle, or deteriorate over time, which can contribute to movement within the floor structure or uneven load distribution.

A licensed builder should be appointed to inspect the support and undertake rectification as required in the short term.

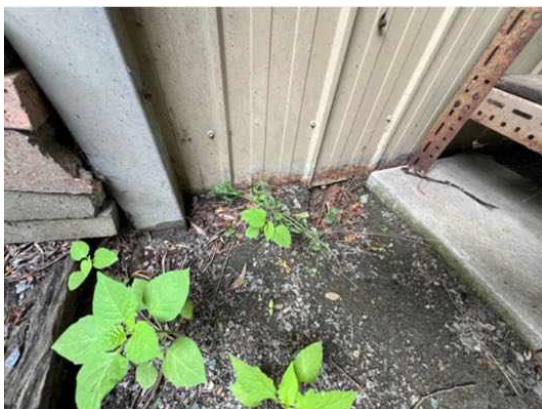
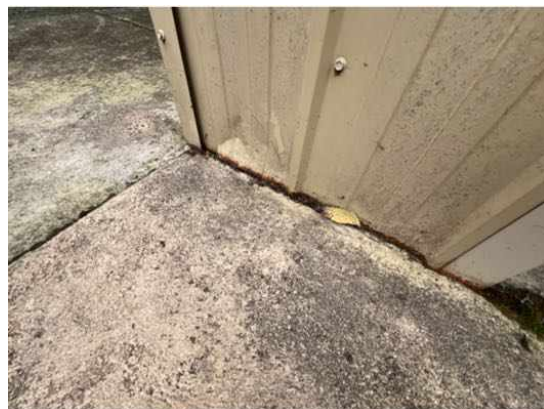
Finding 3.23

Building:	Garage
Location:	Garage
Finding:	Metal Sheets - Rusted (in ground)
Information:	Signs of rust and deterioration were observed on metal sheets in direct contact with the ground at the time of inspection. Prolonged exposure to moisture and soil contact accelerates corrosion, leading to potential weakening and further degradation of the material.

If left unmanaged, continued rusting may compromise the integrity of the metal sheets and associated structures.

Rusting and corrosion should be managed by ideally removing or limiting the affected surface from exposure to moisture. A registered builder may be appointed to replace any building elements that have been severely affected by rust or water damage.

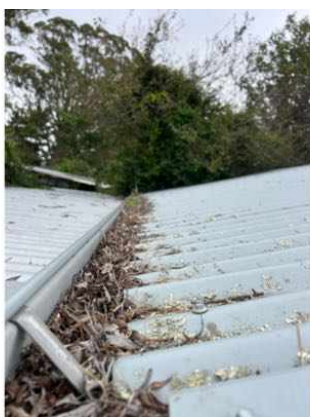
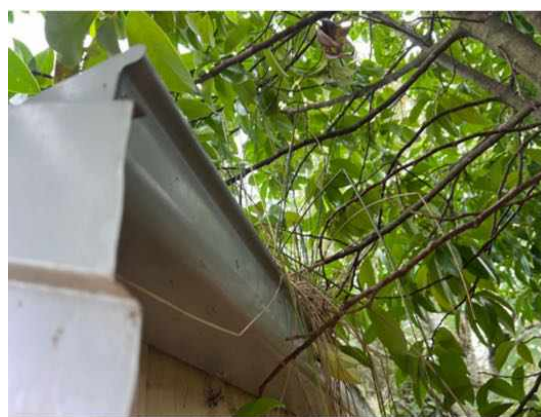
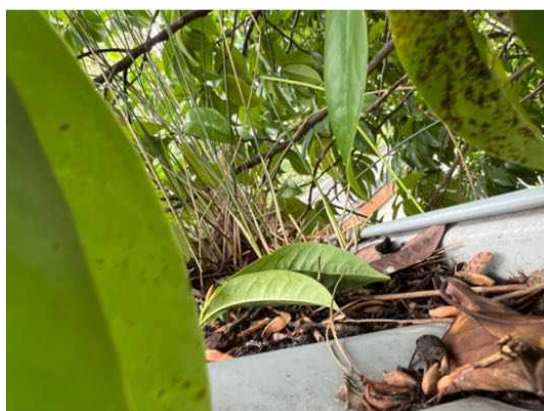
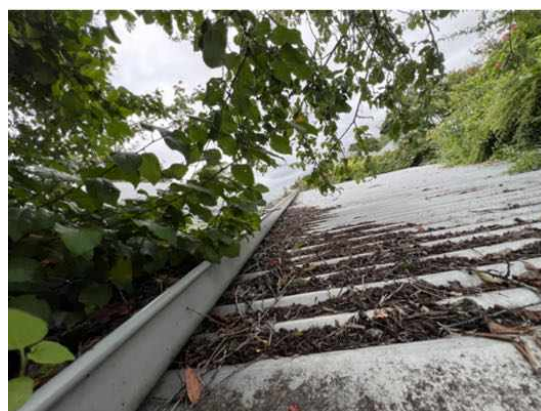
Finding 3.24

Building:	Garage
Location:	Garage
Finding:	Gutters - Blocked
Information:	Roof plumbing structures, such as guttering and downpipes, should be free of all

Blocked gutters are likely to lead to high levels of moisture in the affected areas. Such moisture will not only cause rust and decay of the associated building materials, but can also provide conditions that are conducive to termite and timber pest activity. Blockages in gutters should therefore be removed immediately to ensure dry conditions are maintained.

Consult a Licensed Plumber for further specific advice on remedial works that may be required. In the interim, it is highly advised that blocked gutters be removed by the homeowner or a general handyperson as a matter of urgency.

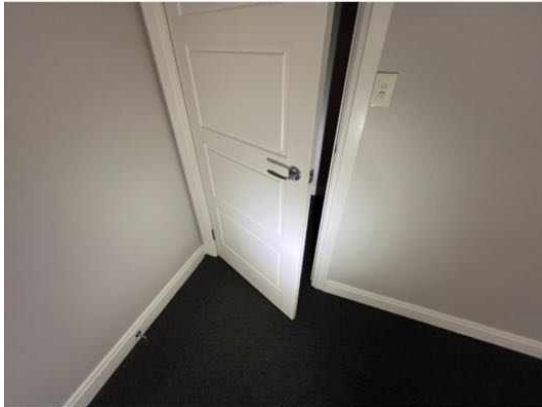
Building:	Main Building
Location:	Entry, Dining room, Bedroom 3
Finding:	Doors - Binding/Jamming
Information:	Binding and/or jamming of several doors throughout the property were evident during standard operation. This defect inhibits the functionality of affected doors as well as creating potential for secondary defects to associated building elements, such as damage to the floor covering.

A door that binds to flooring or to the associated door frame may have several causes, ranging from minor defects, such as poor installation of the door or deteriorated hinges, through to major structural issues, such as damage to subfloor structures.

Where door binding/jamming appears to indicate major structural issues, a registered builder specialising in re-stumping should be appointed to provide an estimate on the cost of rectification.

For minor causes, a qualified carpenter or general handyperson should be appointed to perform minor rectification works at client discretion.

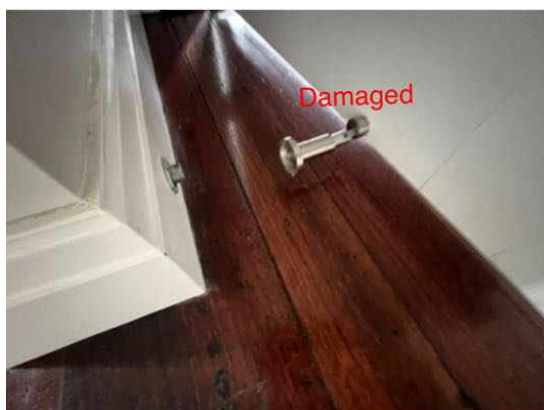
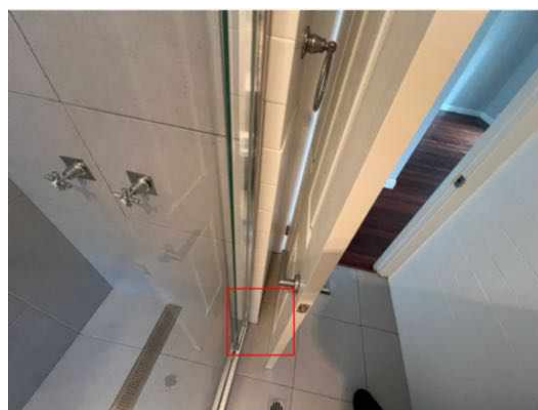
Finding 3.27

Building:	Main Building
Location:	Entry, Bathroom
Finding:	Door stop - Missing
Information:	The door stop is missing or is inadequate to stop the door handle from damaging the wall. Although some building elements may seem irrelevant or unnecessary, all building elements play a key role in the operation and function of the overall structure and its performance.

Re-installation or replacement of the door stop is advised as soon as possible to prevent any subsequent damage to the door or associated structures. A general handyman may be appointed to perform these works at client discretion.

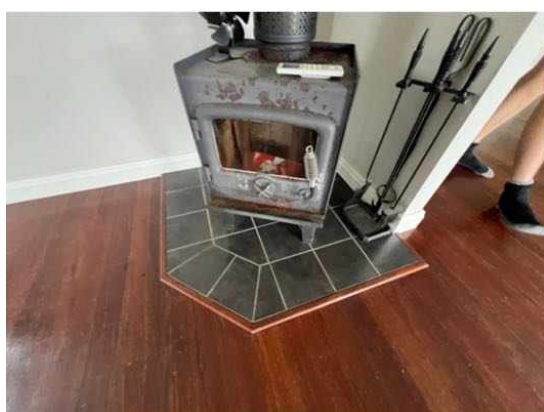
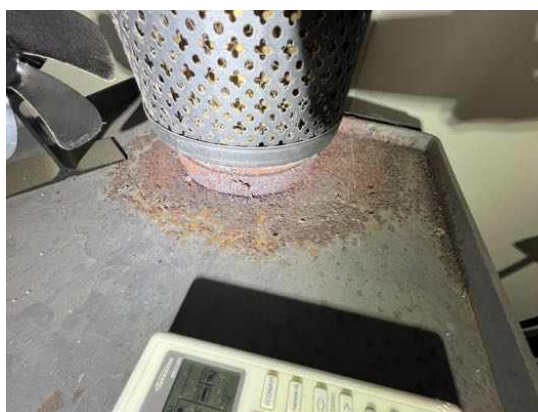
Finding 3.28

Building:	Main Building
Location:	Lounge Room
Finding:	Building element - Rusted or corroded
Information:	This building element shows evidence of rusting and corrosion, which is likely to have developed as a result of excessive exposure to moisture and or inadequate coatings.

As surface rust provides no protection to the underlying iron, the deteriorating condition is likely to worsen if not addressed in the short-term future.

Where possible, the use of galvanized (treated) metals or aluminium coated metals aid in rust prevention, as does regular general maintenance. Rust formation can be controlled with coatings, such as paint, that isolate the iron from the environment.

Rusting and corrosion should be managed by ideally removing or limiting the affected surface from exposure to moisture. A registered builder may be appointed to replace any building elements that have been severely affected by rust or water damage.

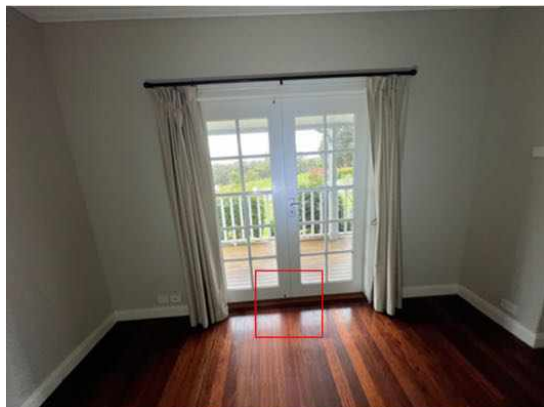
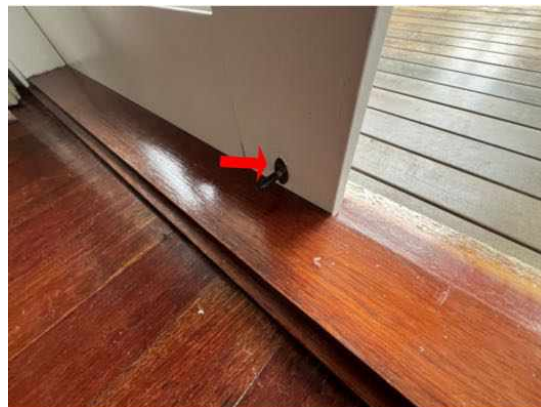
Finding 3.29

Building:	Main Building
Location:	Dining Room
Finding:	Lock - Not working

Information: The lock in this area was not operational at the time of inspection. Where locks have deteriorated to a point where they are no longer usable, the security of the property is immediately compromised.

Repair or replacement of the lock is highly recommended. Consultation with a locksmith or general handyman is required to gain further advice on any added security that may be available for the area.

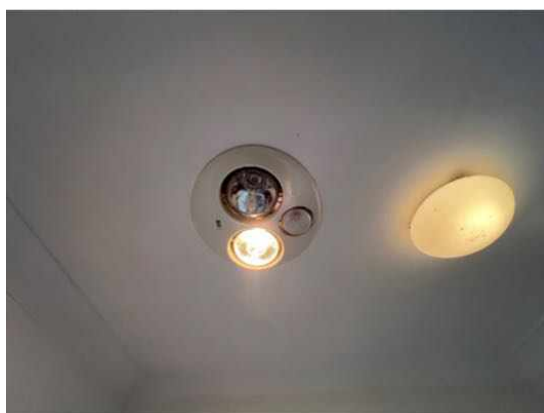
Finding 3.30

Information: During the inspection, it was noted that the light bulbs for the heat light are not working. This could be due to a variety of reasons such as a blown bulb or faulty wiring.

As a remedial action, it is suggested to replace the light bulbs and if the issue persists, further investigation into the wiring and electrical system may be necessary to resolve the problem.

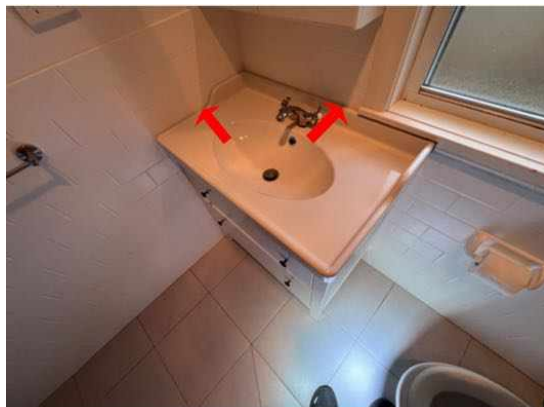
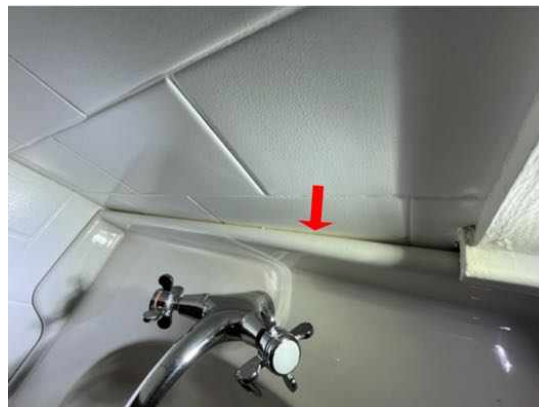
Building:	Main Building
Location:	Bathroom
Finding:	Sealant - missing
Information:	It was noted on inspection that sealant is missing to this area.

Different materials move at different rates, generally causing cracking to grout or sealant at this point. A flexible sealant is required to allow for expected expansion and contraction, while keeping the joint water tight and protective of all associated building materials.

Flexible and mould resistant materials should be applied to affected areas to prevent any subsequent water damage that is likely to occur. Regular maintenance and replacement of damage or missing or damaged sealant and grout is highly recommended to the wet areas, as this is a regular wear and tear defect. Sealant and grouting in areas that come into regular contact with water should be maintained for the long term care of your property.

A sealant specialist or tiling contractor should be appointed to complete these works as soon as possible

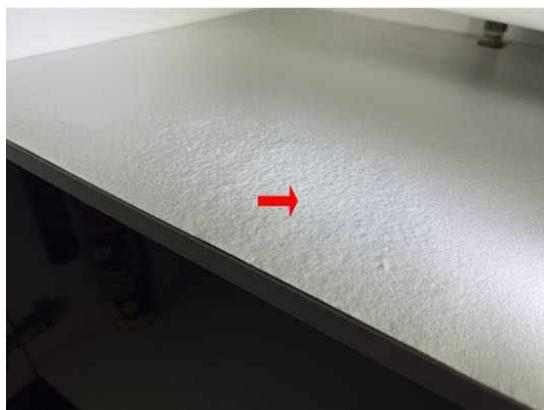
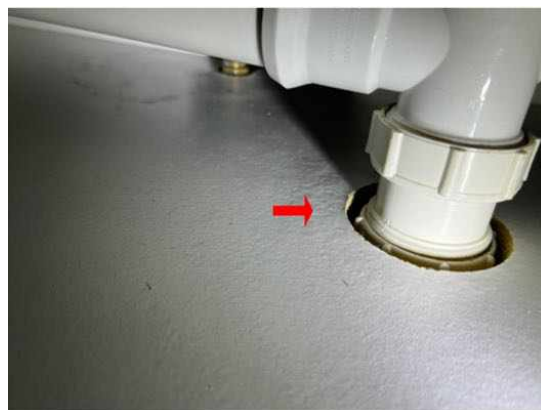
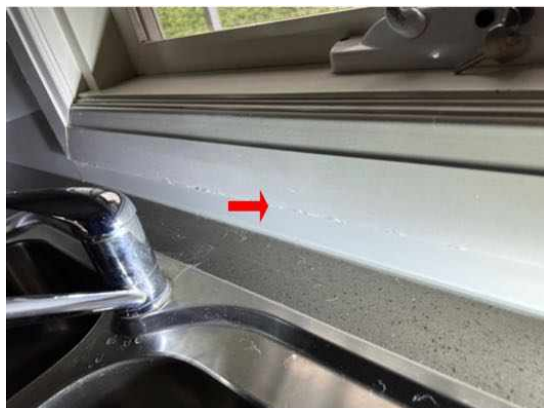
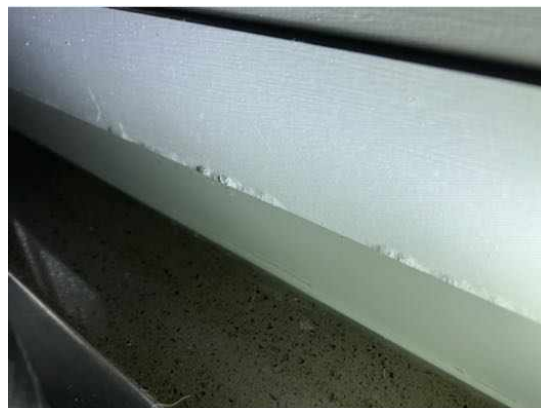
Finding 3.33

Building:	Main Building
Location:	Kitchen
Finding:	Building element - Swollen (very minor)
Information:	Swollen building elements generally indicate that the building materials have been affected by excessive moisture over a prolonged period of time, and have swollen as a result. The formation and development of mould/fungi or mildew is also a likely consequence of excessive moisture, which may pose major respiratory issues for occupants, particularly the elderly, the very young and those with existing illnesses and could be potential health safety hazards. In these cases an appropriately qualified inspector/tester should also be contacted for advice and/or technical assistance.

The structural integrity of swollen building elements can not be guaranteed, and further damage is likely to develop if left unmanaged. Excessive moisture is likely to lead to the development of secondary damage to any associated building elements, which may necessitate major repair works if prolonged.

Rectification of the cause of the water leak should be addressed prior to any remedial works to the swollen building elements. A licensed plumber should be appointed immediately to identify the cause of the leak and provide advice on remedial works as necessary. Repair and/or replacement of swollen building elements should be conducted as a matter of urgency by a registered builder or qualified carpenter.

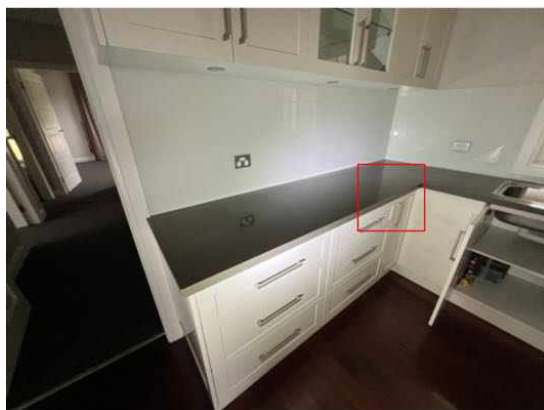
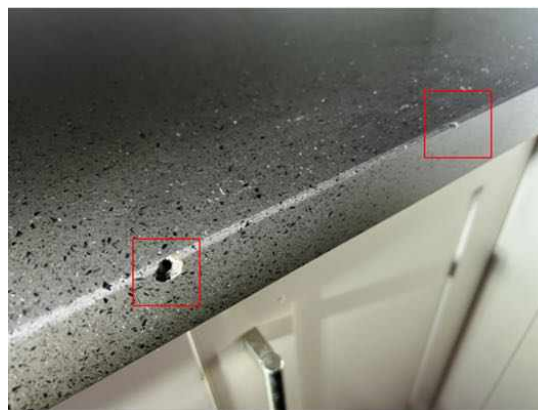
Building:	Main Building
Location:	Kitchen
Finding:	Surface - Chipped
Information:	The surface of this building element appears to have chipped as a result of general wear and tear. While being an appearance defect, such damage is expected of a property of this age and condition.

Chipped surfaces rarely impede on the structure or functionality of the affected building element and generally only create a blemish on its appearance. Chipped surfaces may be left in situ at client discretion, as no repairs or replacement are necessarily required. However, the client may wish to seek quotations for the cost of refurbishment or replacement of the identified building element.

A qualified carpenter or cabinet maker should be appointed to repair chipped surfaces and replace building elements where major damage has occurred.

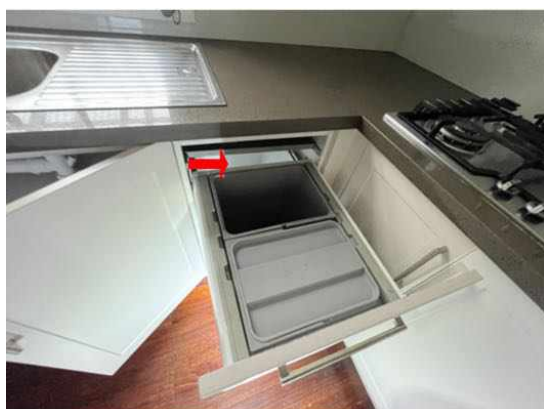
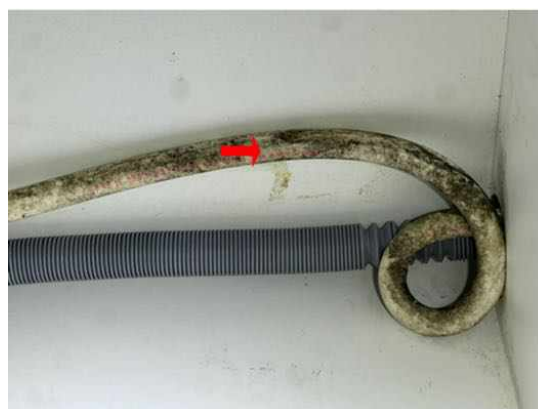
Finding 3.35

Information: Where evidence of mould growth was noted, there may be environmental, biological or health issues associated with the report. A specialist inspection by a suitably qualified environmental health inspector is warranted, where mould is extensive or where any queries regarding air quality spores or other related issues apply.

Generally, the client is advised to ensure that the general environment is free of moisture and humidity to aid in the prevention of mould formation and development. Any mould found during the inspection should be cleaned immediately by a cleaning contractor or the homeowner as applicable.

Please note that severely affected building elements may require replacement by a registered builder or qualified carpenter.

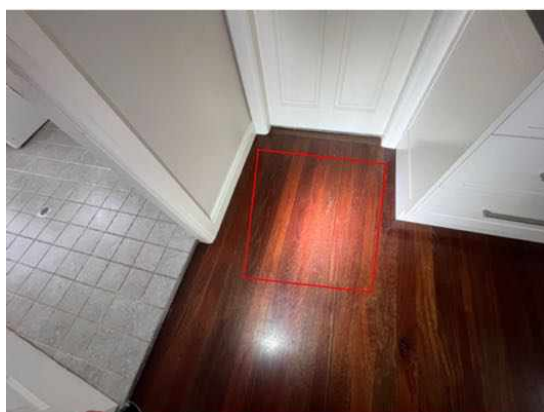
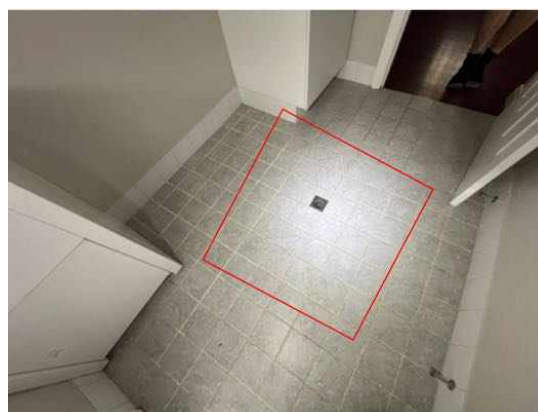
Finding 3.36

Bouncy floors generally indicate that the floorboards or the subfloor structures are coming loose from the joists that they are installed on. Bouncy flooring may also be the result of gaps between flooring and stumps or joist structures, which require packing.

The client is advised to seek quotations for required repairs from a Registered Builder specialising in re-stumping. The potential resolution may range from packing gaps in subfloor structures through to replacement of subfloors stumps and refixing of flooring.

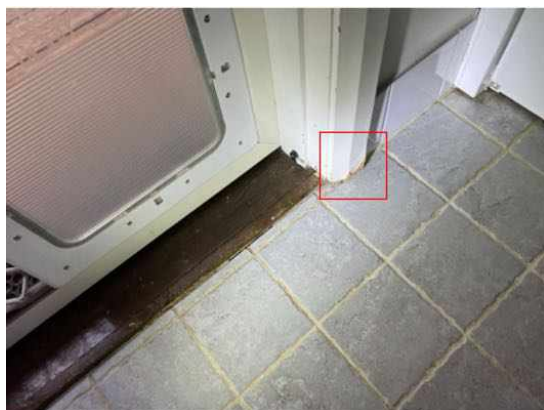
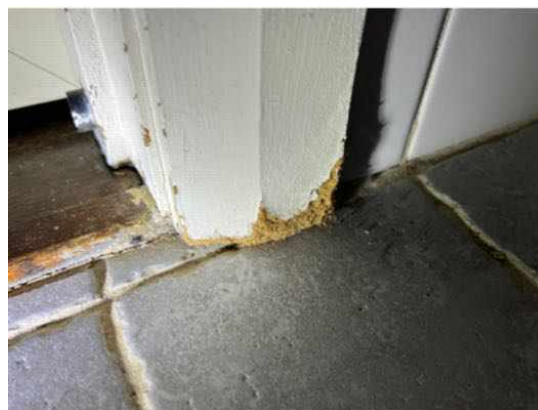
Finding 3.37

Building: Main Building
Location: Laundry
Finding: Door Jamb - Water Damage
Information: Water damage was observed to the base of the door jamb in this area. This type of defect is typically caused by moisture exposure from wet areas, inadequate sealing, or failed waterproofing at adjoining tiled surfaces.

If left unmanaged, water ingress may result in swelling, decay, or deterioration of the timber, potentially affecting the operation of the door and compromising surrounding finishes.

It is recommended that a qualified carpenter or builder assess the extent of damage and carry out repairs or replacement of the affected section as required. Improved sealing or waterproofing should also be considered to minimise recurrence.

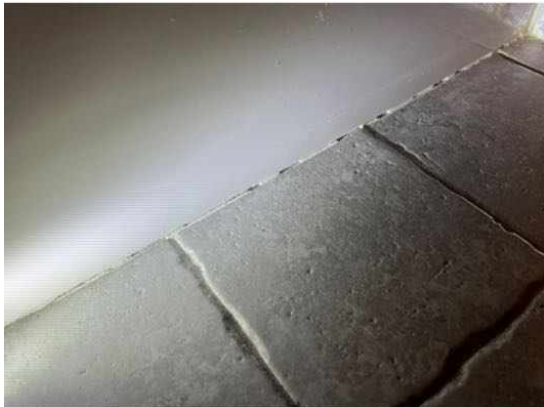
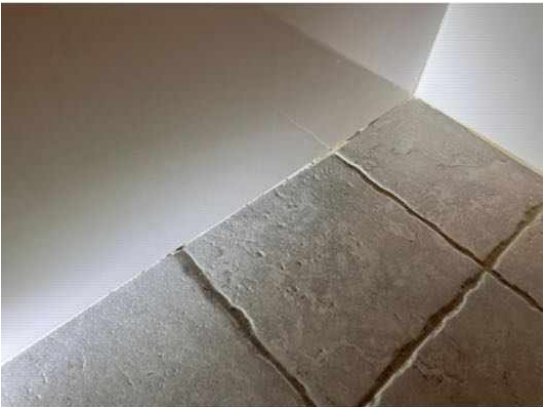
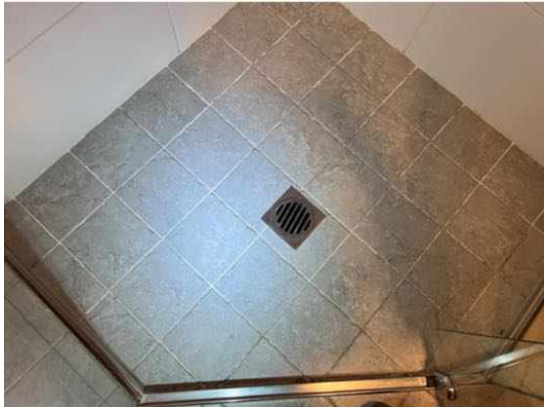
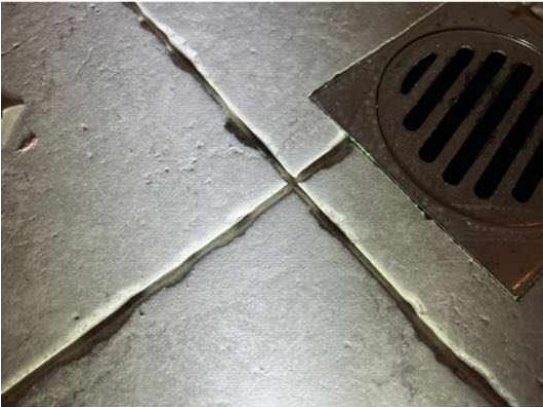
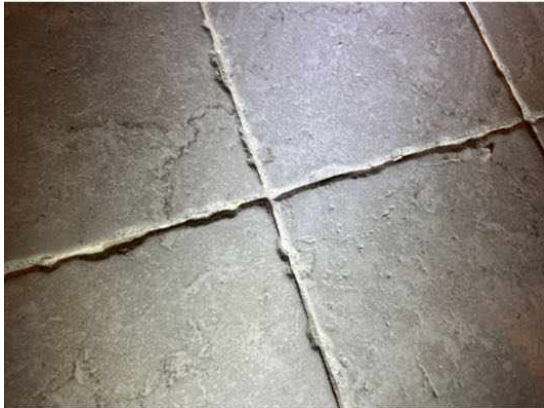
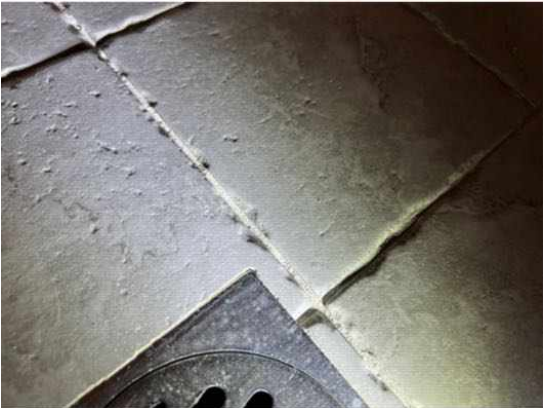
Finding 3.38

Building:	Main Building
Location:	Ensuite
Finding:	Sealant and grouting - Missing or damaged
Information:	It was noted on inspection that sealant or grout is degraded to the tiled shower alcove and or other areas of the bathroom.

Different materials and floor areas move at different rates, generally causing cracking to grout or sealant at this point. A flexible sealant is required to allow for expected expansion and contraction, while keeping the joint water tight and protective of all associated building materials.

There appears to be excessive mould to the sealant and grout which will likely require scraping out and replacement.

Flexible and mould resistant materials should be applied to affected areas to prevent any subsequent water damage that is likely to occur. Regular maintenance and replacement of damage or missing or damaged sealant and grout is highly recommended to the wet areas, as this is a regular wear and tear defect. Sealant and grouting in areas that come into regular contact with water should be maintained for the long term care of your property.

A sealant specialist or tiling contractor should be appointed to complete these works as soon as possible

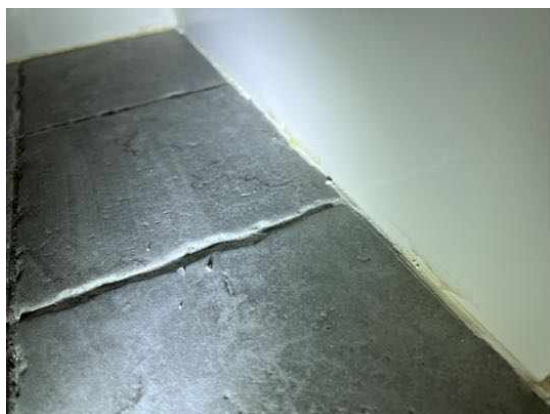
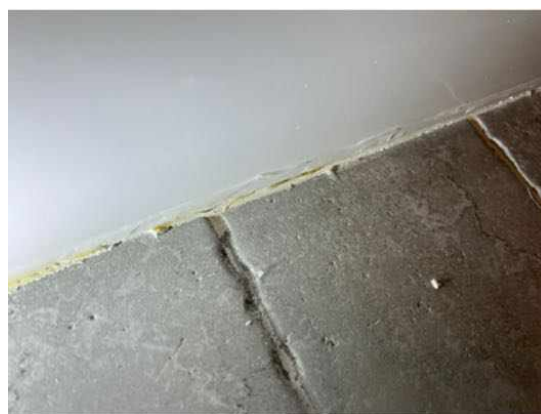
Finding 3.39

Building:	Main Building
Location:	Ensuite
Finding:	Shower base - Water pooling
Information:	Evidence of water pooling around the floor waste in the shower recess was noticed at the time of inspection. It is suspected that this excessive moisture is attributed to insufficient fall in the shower floor tiles.

This pooling is minor overall but is still considered unsatisfactory, as standard tiling practices would not permit this situation to occur. Pooling water around floor wastes can create a slip hazard in extreme cases and create conditions that are conducive to mould growth over time. Where left unmanaged, the degradation of sealant and grouting is also likely to occur, possibly necessitating further repair works.

Remedial works may involve some sections of tiling and flooring repair and replacement. A tiling contractor or bathroom specialist should be appointed to provide further advice on reparation options and to perform works as necessary.

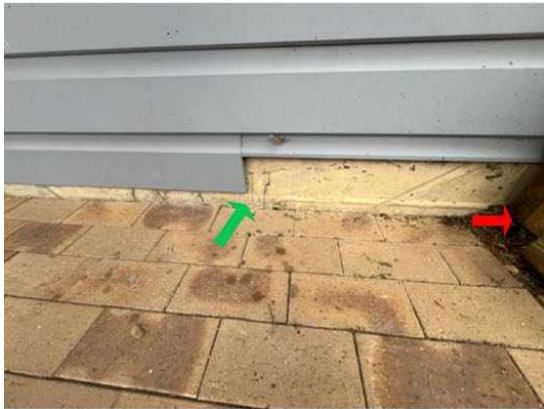
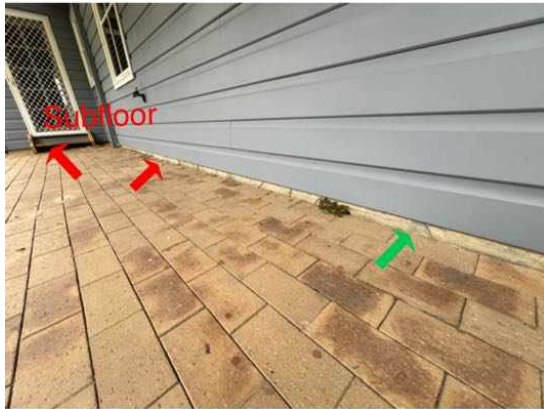
If the slab edge is not properly exposed there is a high risk of termite attack. Sometimes, in order to determine the type of slab, a suitably qualified person such as an architect or builder may be required to consult the construction plans.

Where the slab edge cannot be properly inspected, it is highly recommended that termite or timber pest inspections be carried out every 6-12 months to aid protection of the property against infestation.

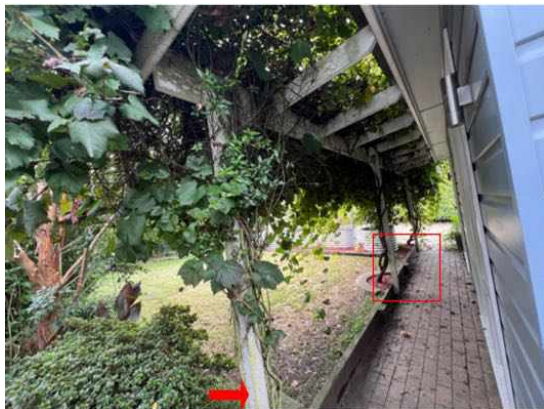
Finding 6.03

Building: Main Building
 Location: Pergola 3, Pergola
 Finding: Bridging of termite barrier - Posts.
 Information: Posts that are attached to home from ground to structure without a 75mm inspection zone (metal stirrup) causes a bridging point. Bridging of termite barriers occurs when termites bridge (usually by building a mud tunnel) a termite barrier or inspection zone or where termites have a passage allowing them to bridge the barrier.

Generally this takes the form of finished ground levels external paving or concrete being retrospectively installed above the damp course level the adjacent internal floor level or weep and ventilation holes.

Where bridging has occurred full inspection is prevented and termites may enter a property in a concealed or undetectable manner.

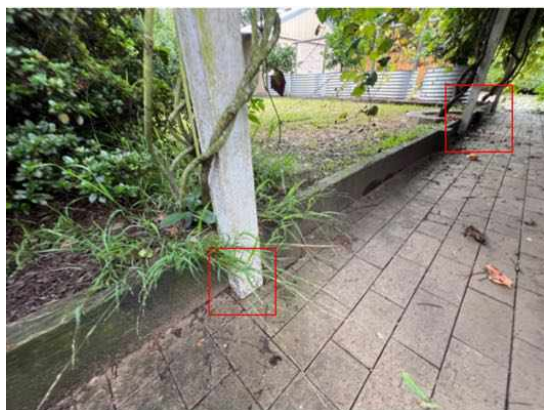
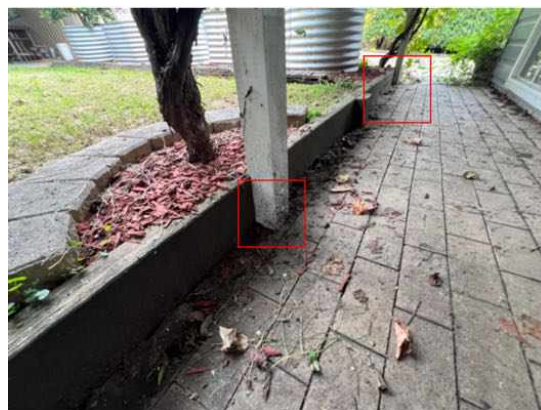
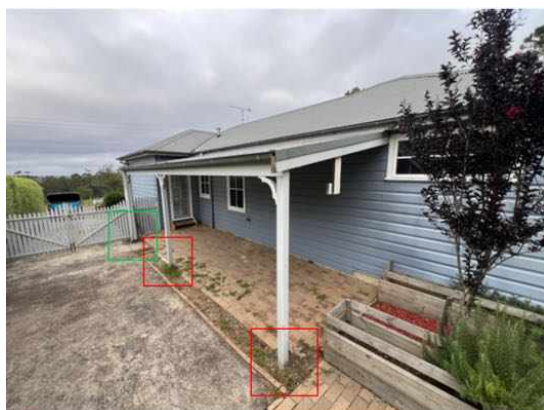
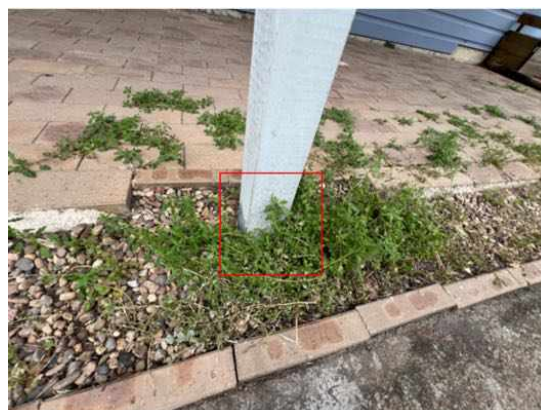
Finding 6.04

Building:	Main Building
Location:	All External Areas
Finding:	Bridging - Attachments to Buildings.
Information:	Bridging occurs when items against a building provide a concealed entry point for termites into the building or by passing around a termite management system.

Where any part of an attachment to a building is not isolated and is not provided with a clear gap of not less than 25mm from the building, bridging occurs. Attachments to buildings such as hot water services, downpipes, verandahs, decks, steps, fences, service conduits and the like provide the opportunity for concealed entry.

Building attachments of this nature need to be frequently inspected for termite activity by a qualified inspector
