Building and Timber Pest Inspection Report

Inspection Date: Fri, 13 Mar 2026

Property Address: 67 Penrose Rd, Bundanoon NSW 2578,
Australia

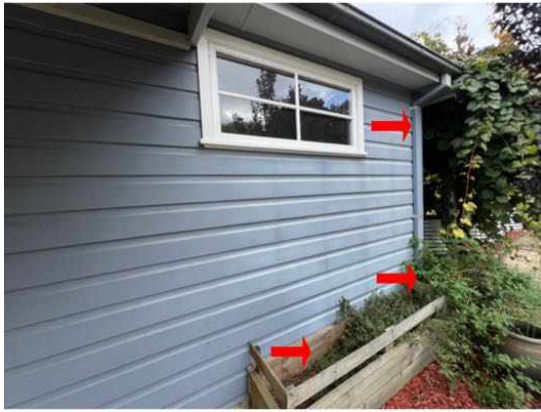
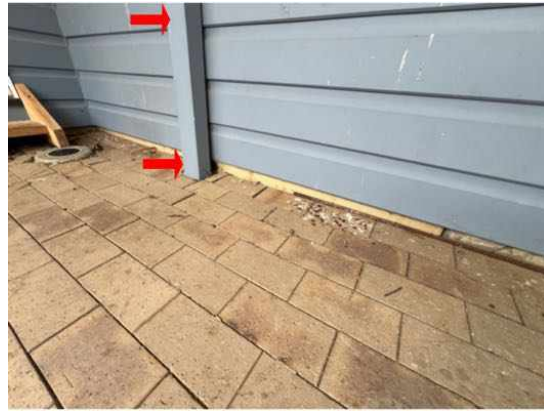
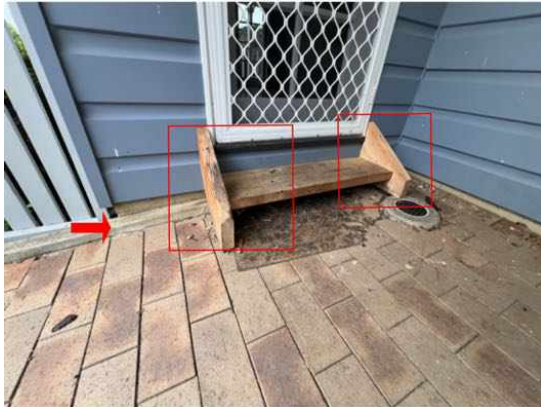
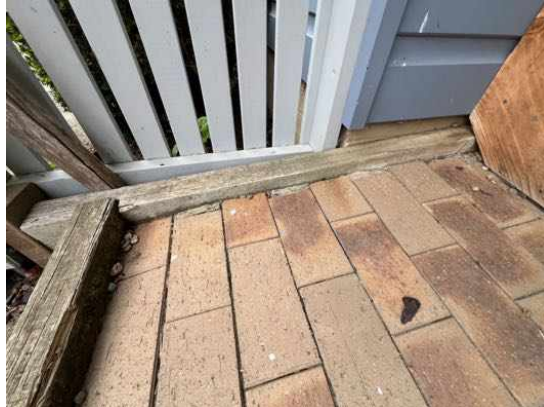
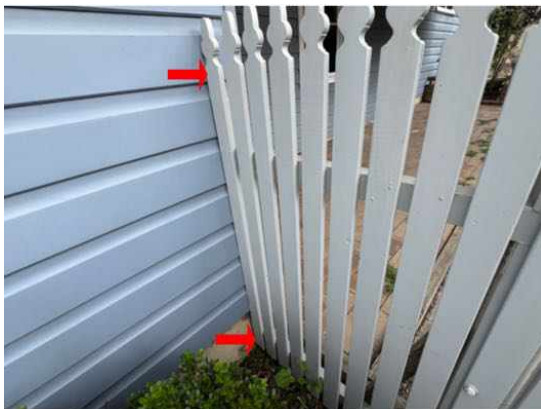
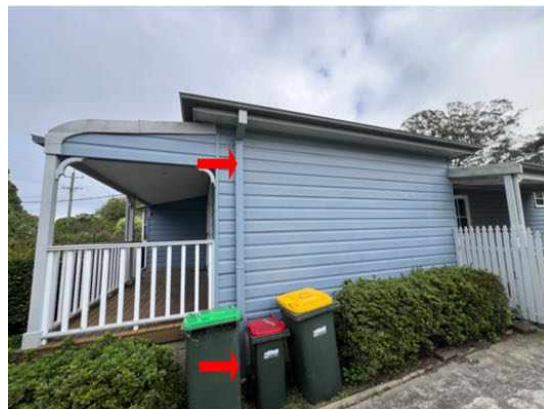
Finding 6.05

Building: Main Building
 Location: Exterior walls - left side
 Finding: Water leak - External (Photos shown in previous defect section)
 Information: Water leaks were found to be present to exterior plumbing work. Leaks are generally caused by deterioration of the plumbing elements over time, due to exposure to weather conditions, but may have also been caused by minor impact damage.

Such leaking creates damp conditions in the affected area, causing potential for water pooling and subsequent water damage if left unattended. These conditions may also attract termite attack, particularly if the area is subject to minimal levels of sun throughout daylight hours.

It is highly advised that a licensed plumber be appointed to rectify any water leaks that may be present. Areas of repair and replacement of plumbing fittings and fixtures may be required and, as such, a quotation should be sought.

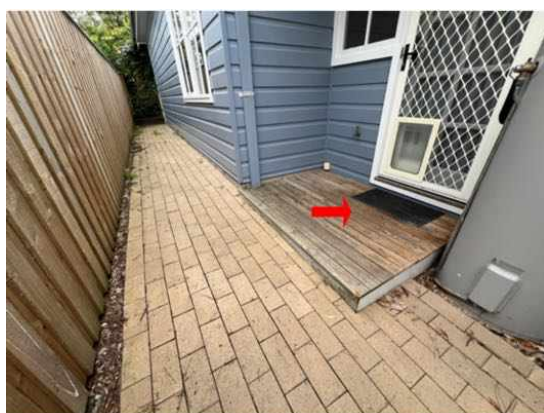
Finding 6.07

Building:	Main Building
Location:	Verandah, Exterior walls - left side
Finding:	Bridging (decking)- Attachments to Buildings.
Information:	Decking to the front porch and side patio abut dwelling causing bridging and concealment. Bridging occurs when items against a building provide a concealed entry point for termites into the building or by passing around a termite management system.

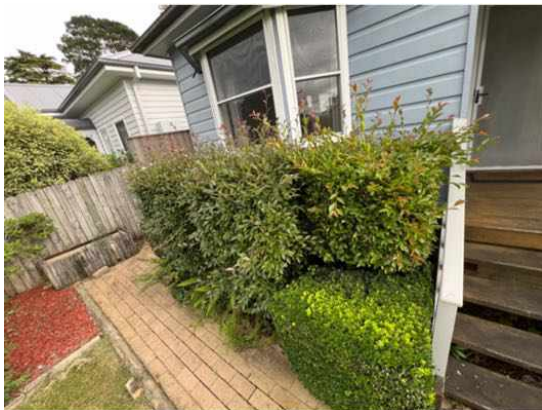
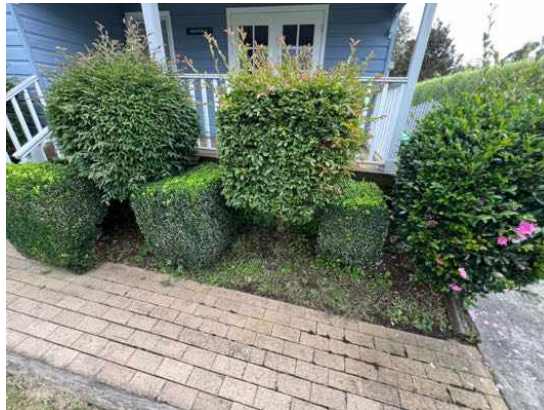
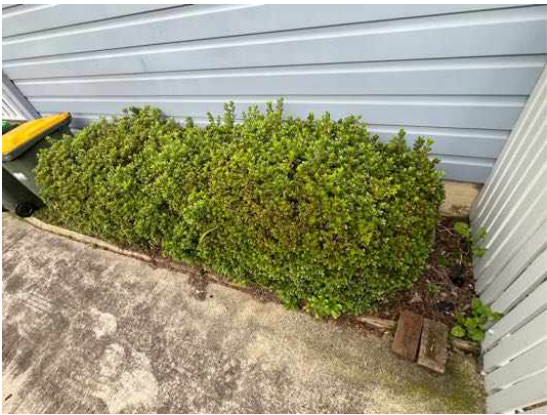
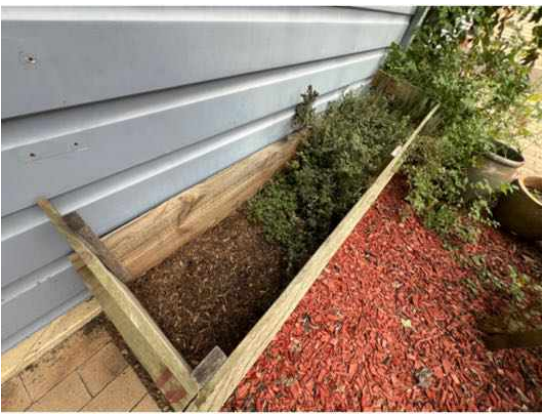
Finding 6.12

Building: Exterior walls - rear, Garage
Location: Exterior walls - rear, Garage
Finding: Vegetation Against Building - Conducive to Termite Activity
Information: Vegetation and trees were observed in direct contact or in close proximity to the building at the time of inspection. This condition creates a conducive environment for termite activity by providing concealed access points, retaining moisture against the structure, and reducing ventilation. Additionally, vegetation can contribute to organic debris buildup, further increasing the risk of pest infestation.

It is recommended that all vegetation be trimmed back to allow adequate clearance from the building. Ongoing maintenance is advised to reduce the risk of termite activity and improve ventilation around the structure. Regular termite inspections should also be conducted to monitor for any signs of infestation.

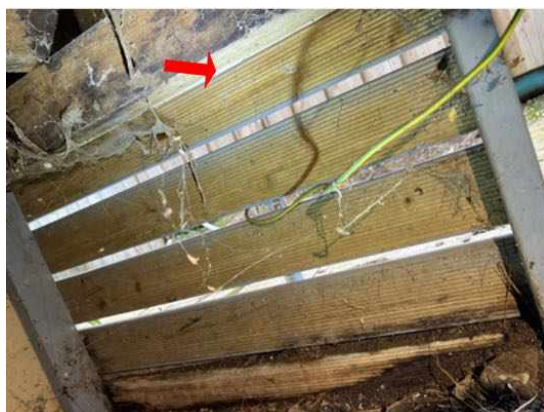
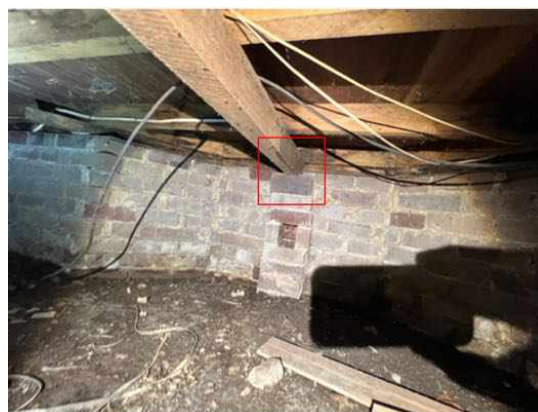
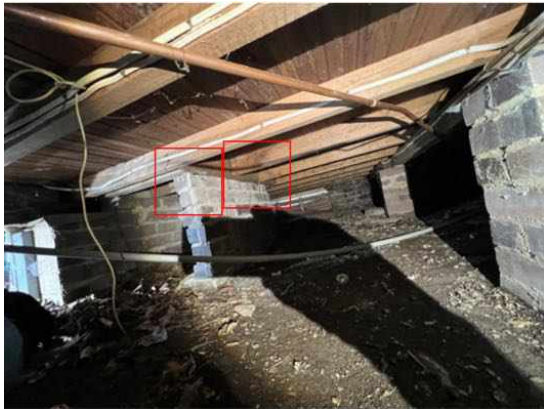
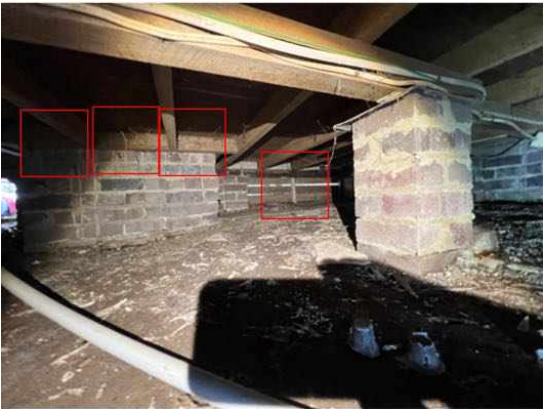
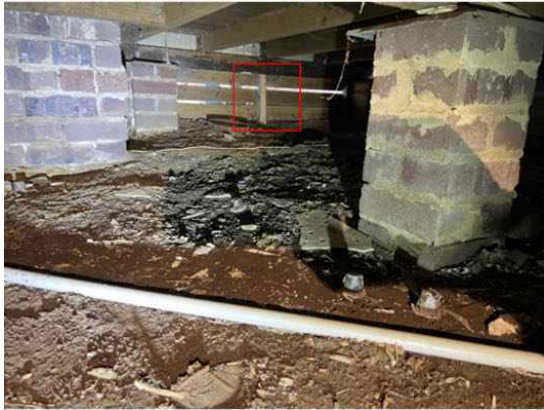
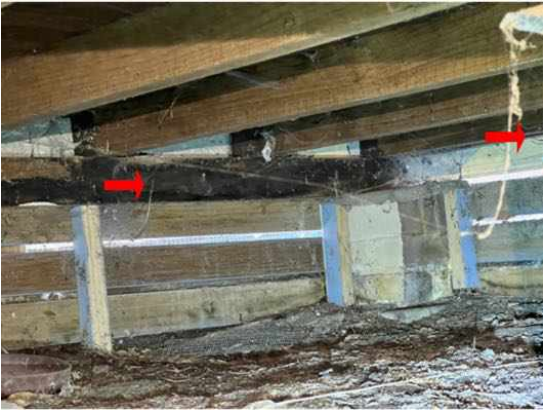
Finding 6.16

Building:	Main Building
Location:	Subfloor
Finding:	Stored timbers - subfloor space or external area
Information:	The storing of timbers in the subfloor space or around the external property increases the risk of termite activity being present. As they are likely to come into contact with weather conditions or excessive moisture wood rot is likely to develop on timbers that are not treated.

It is highly recommended that any stored timbers be immediately removed from areas in which they may attract any termite / timber pest attack. Minimisation of risk / prevention of termite attack is far more adequate than dealing with the presence of termite activity.

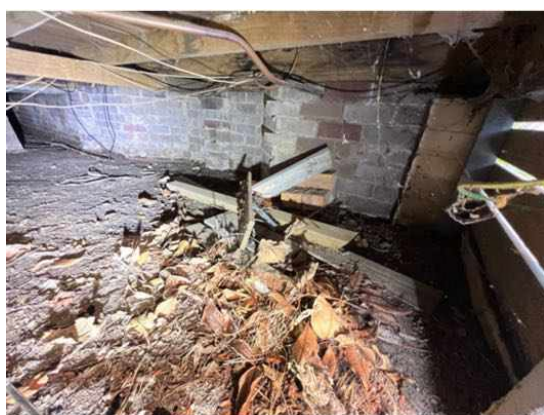
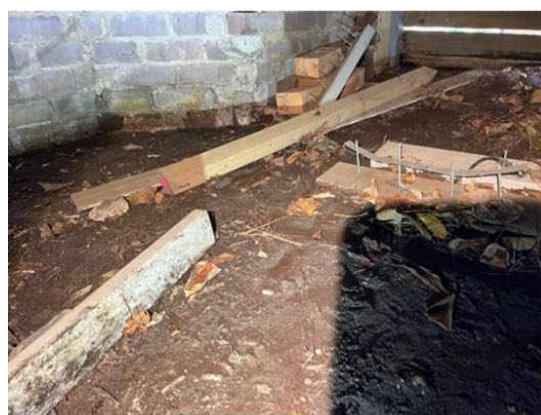
Finding 6.17

Building:	Main Building
Location:	Subfloor
Finding:	Damp or wet - leak
Information:	Damp or wet conditions are generally a direct result of poor drainage an active leak or poor ventilation (or a combination of the three). Dry conditions should be maintained to prevent secondary building defects from developing.

If left unattended damp or wet conditions may have many consequences including the development of fungal decay and/or wood rot as well as providing an environment that may be conducive to termite or timber pest attack.

A qualified plumber should be appointed immediately to identify the cause of the excessive moisture in order to prevent further damage. The water leak should be resolved prior to any repairs of the damaged area which may require localised replacement of building materials and refinishing..

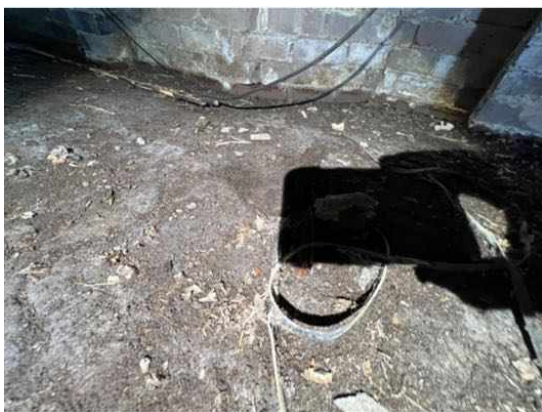
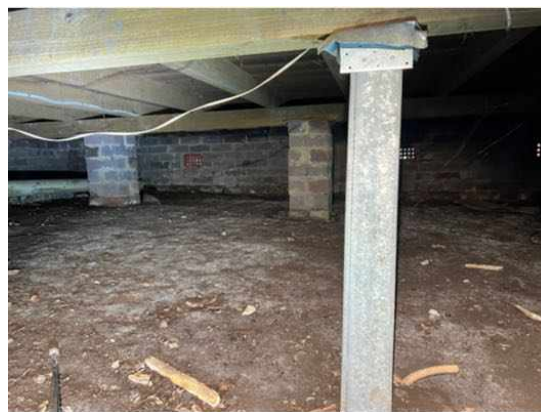
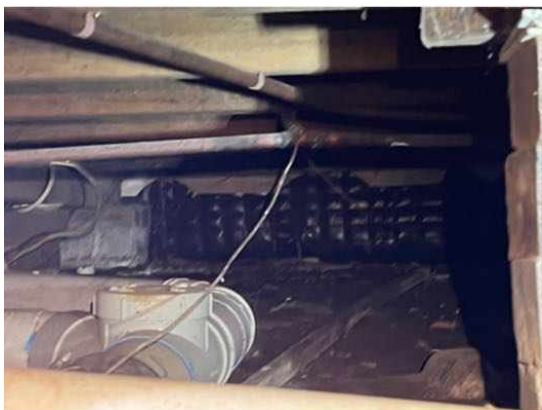
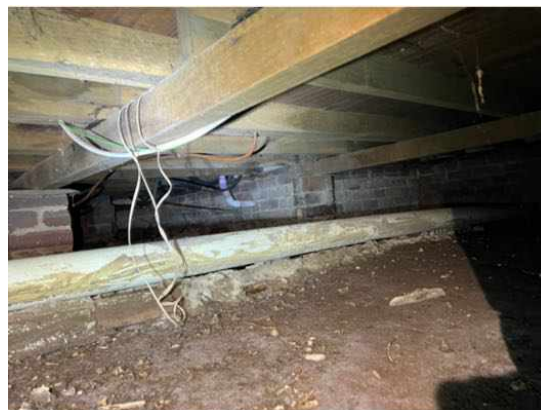
Finding 6.18

Building:	Yard
Location:	All External Areas
Finding:	In ground contact
Information:	Any timbers in direct ground contact provide opportunity for concealed termite entry and are likely to be subject to premature rot and decay as the soil retains moisture or damp conditions against the timbers.

Remove untreated timber that is in direct contact with external grounds. Consider replacement with more durable materials i.e. treated timber or non timber elements. Frequent pest inspections are advised to readily identify any termite activity in these areas.

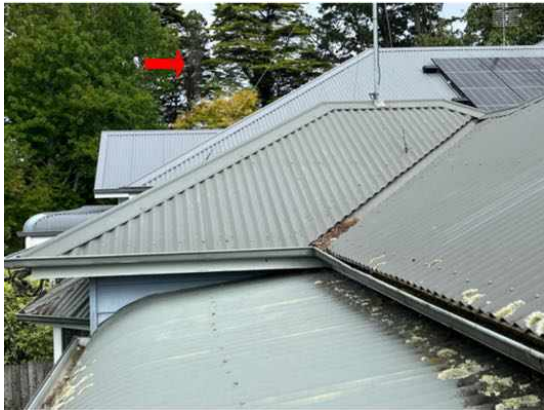
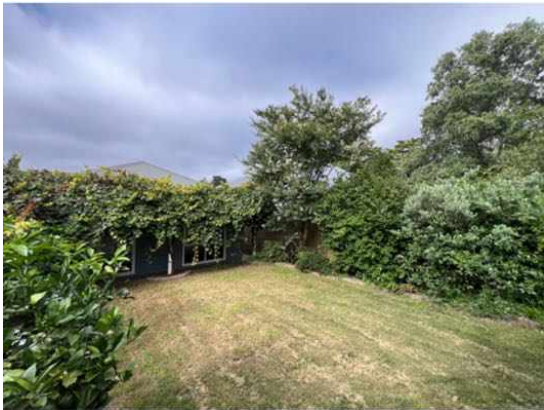
Finding 6.19

Building: Yard
Location: The Site
Finding: Timber Pest Risk – Trees Within 50m of Dwelling
Information: Mature trees were identified within 50 metres of the dwelling. The presence of trees in close proximity to the structure increases the risk of termite activity, as trees provide a natural food source and nesting environment for termites. Tree roots can also contribute to excessive moisture retention in the soil, creating conducive conditions for timber pest activity.

Regular monitoring for signs of termite activity is advised. A licensed pest inspector should be engaged to assess the area and provide further recommendations on risk mitigation and management.

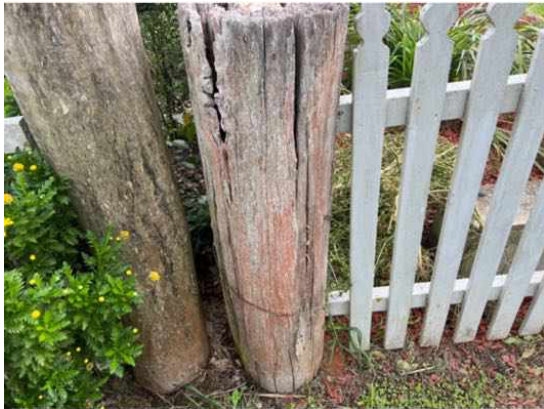
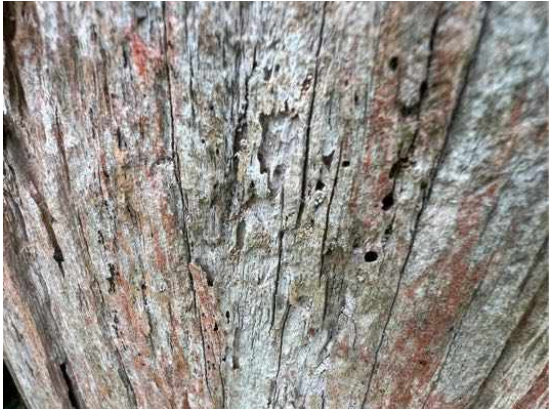
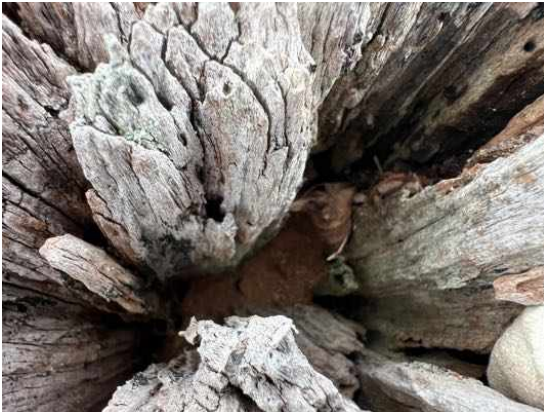
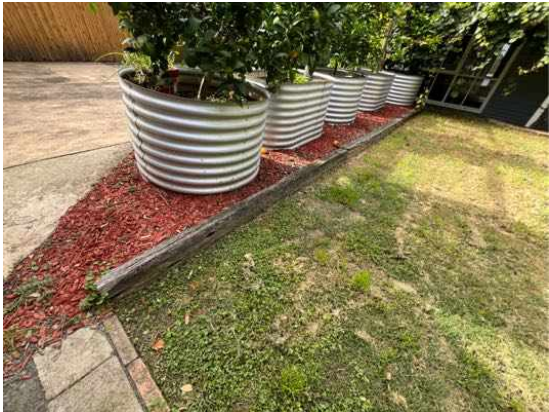
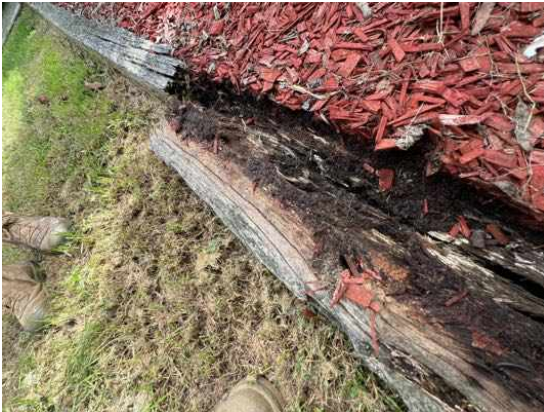
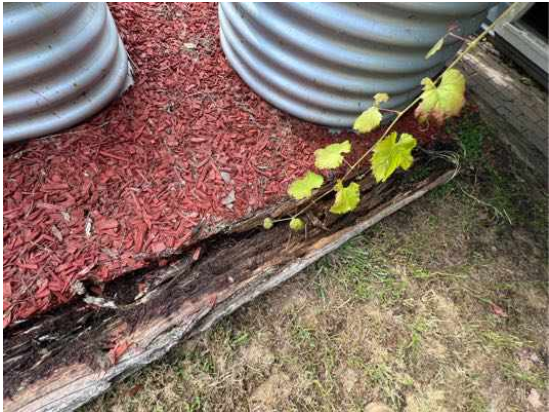
Finding 8.01

Building:	Yard
Location:	The Site
Finding:	Evidence of wood borer activity identified
Information:	<p>Wood borers small beetles that colonise in exposed timber elements are a common timber pest that are regularly mistaken for termites. Although wood borer activity is generally not detrimental to the affected timber they may lead to serious damage and necessitate replacement of certain building elements if left unattended.</p> <p>The Lyctid borer which generally attacks hardwoods such as subfloor and roofing structures is generally identified by fine dust, surrounding the affected timbers.</p> <p>The other commonly known borer the Anobium borer is more likely to attack floorboards and may cause severe structural damage to flooring areas.</p> <p>As no live wood borer activity was identified treatment is not required at this time. Replacement of affected timbers may be considered by the client for superficial reasons.</p>

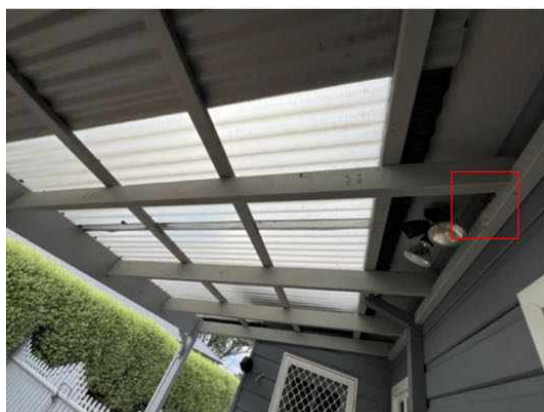
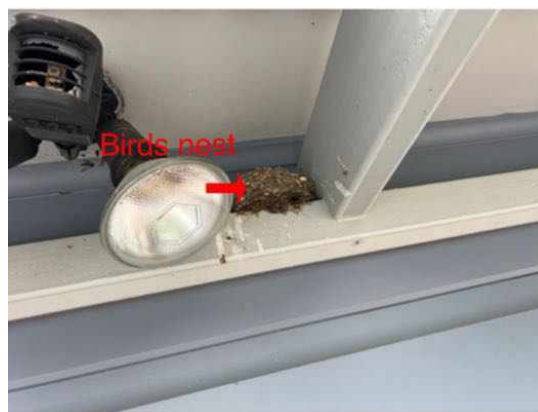
Finding: Bird nest - Additional Photos

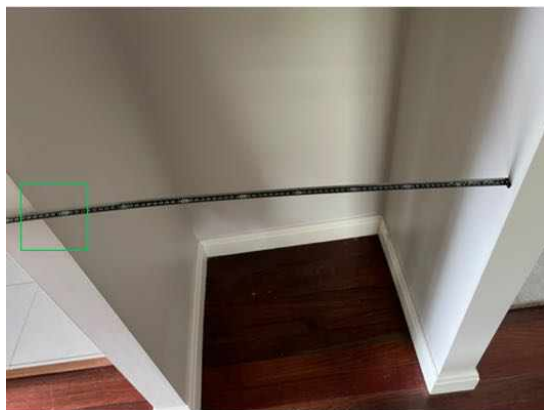
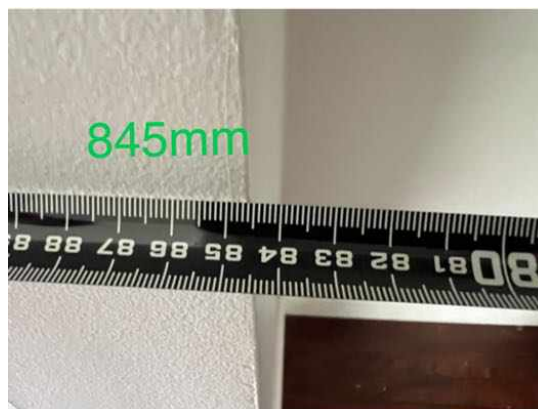
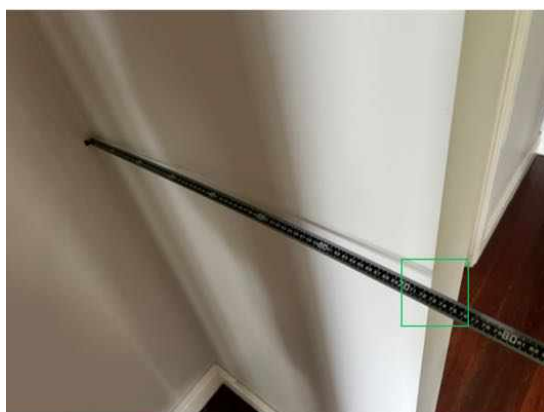
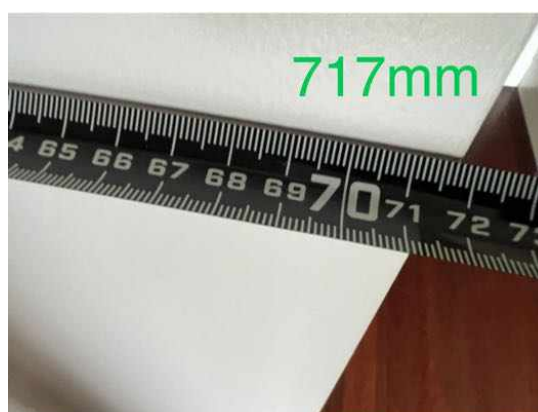
Building:	Main Building
Location:	Bathroom
Finding:	Fridge measurements - Additional Photos
Information:	Additional photos are provided for your general reference

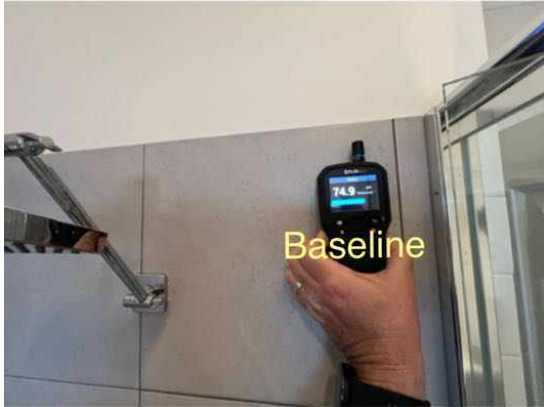
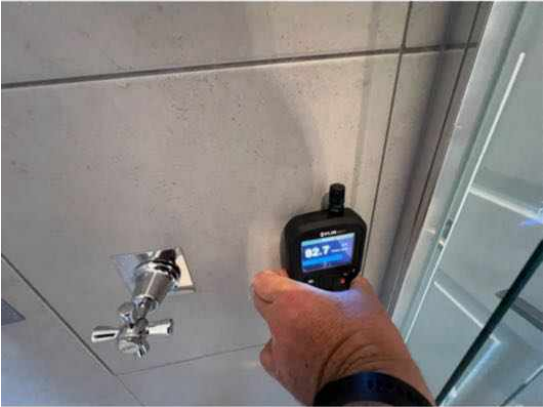
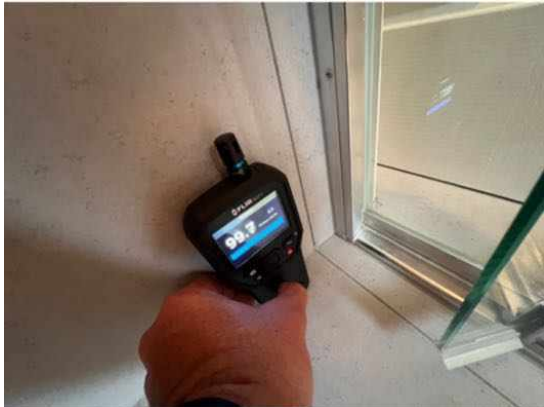
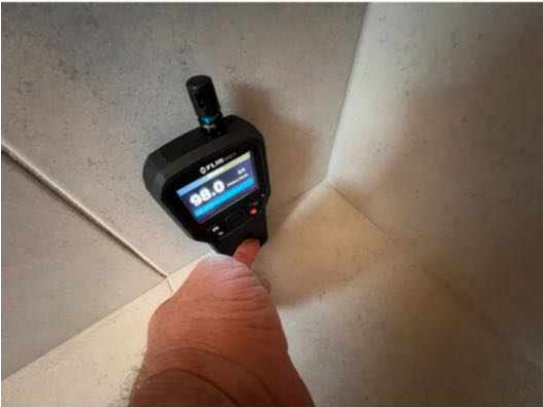
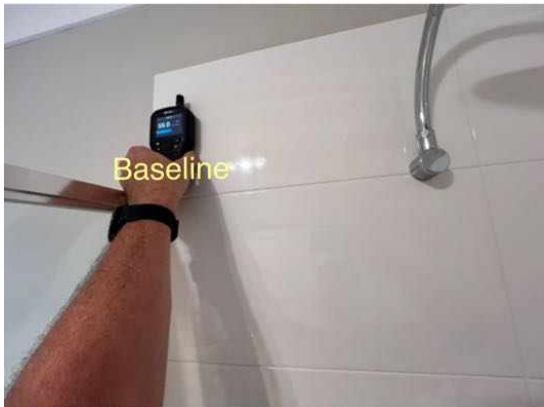
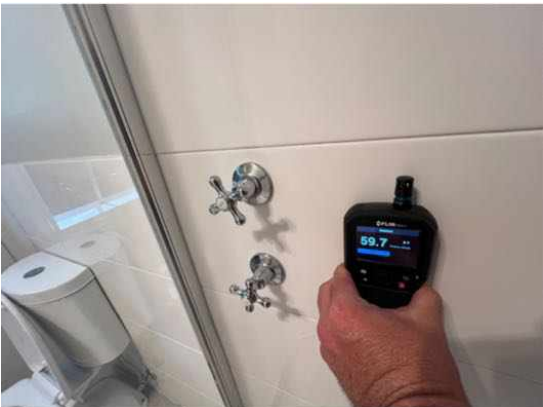
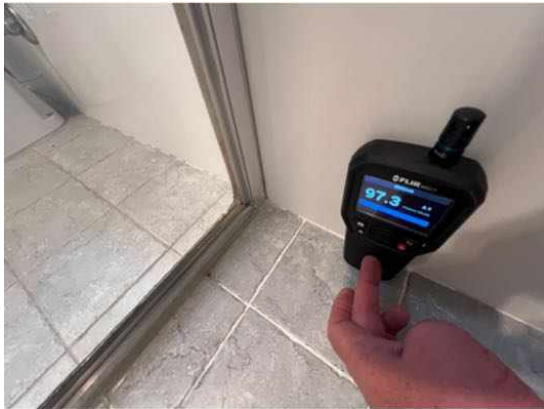
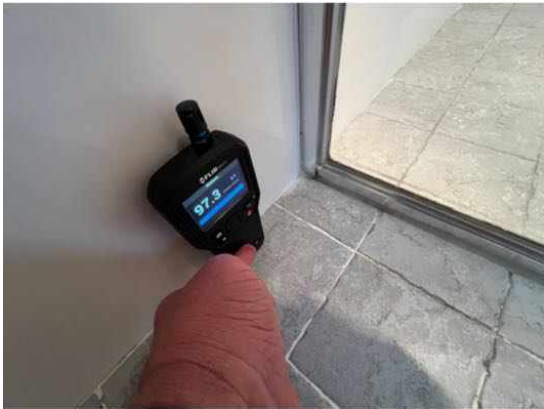
Building:	Main Building
Location:	Bathroom, Ensuite
Finding:	Moisture in shower - No action required
Information:	Moisture is evident behind the tiles to the shower alcove. This defect is quite common, and is suspected to have been caused by moisture permeating through the grouting in this area.

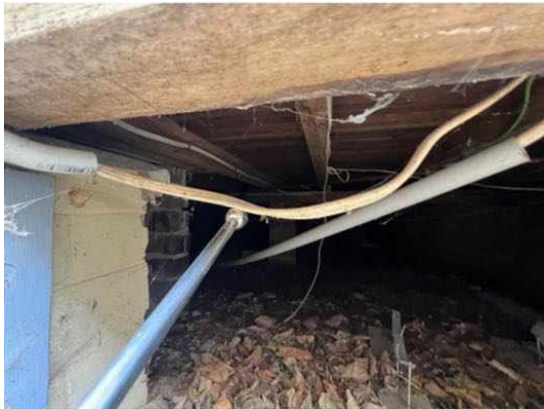
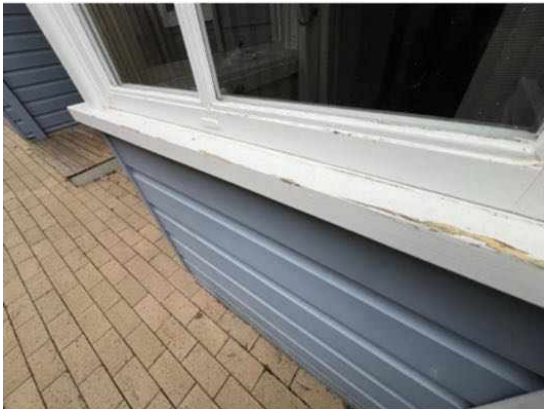
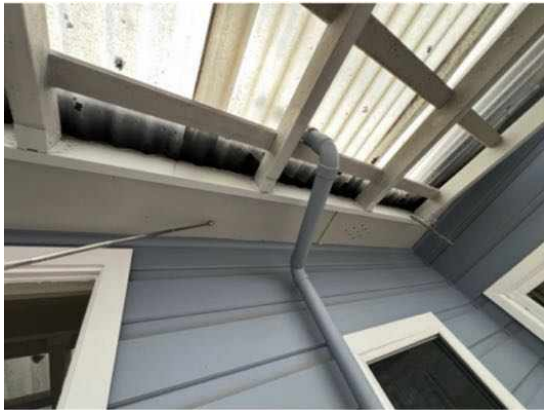
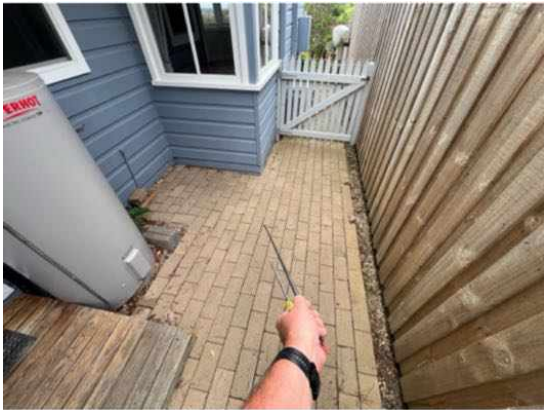
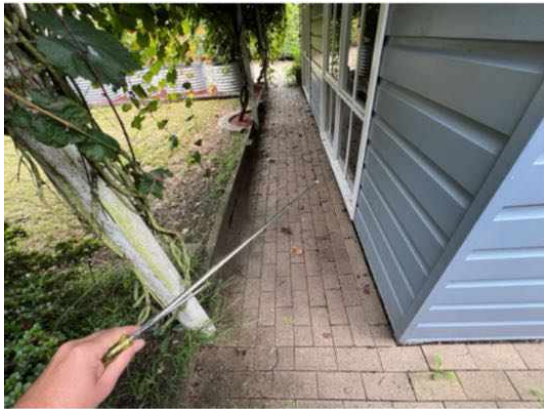
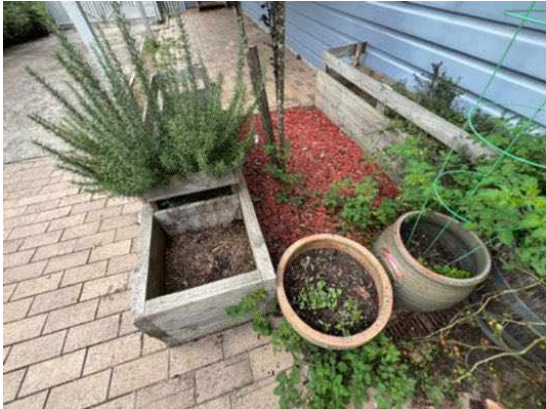
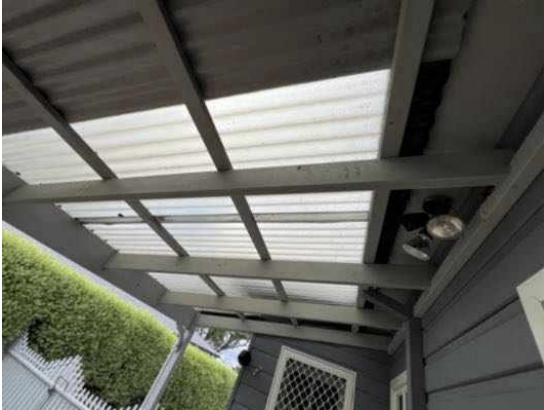
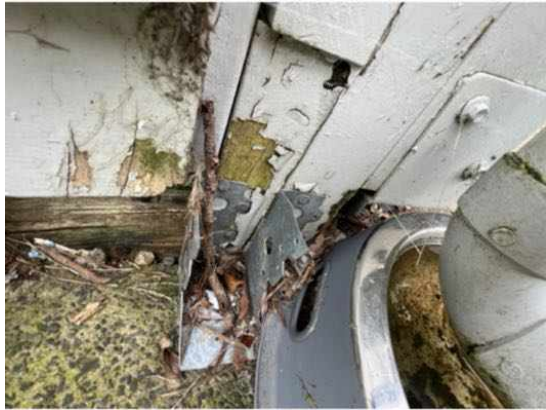
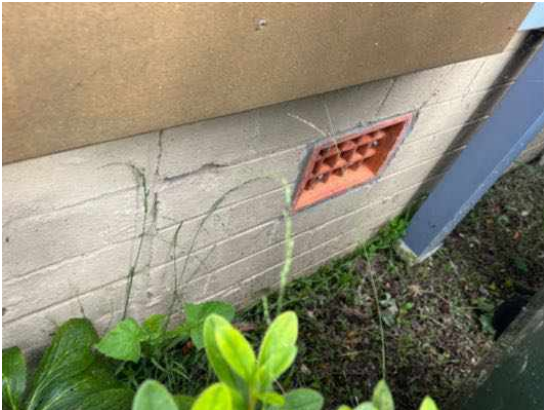
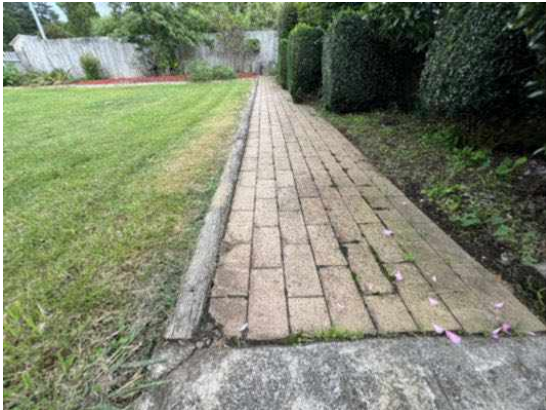
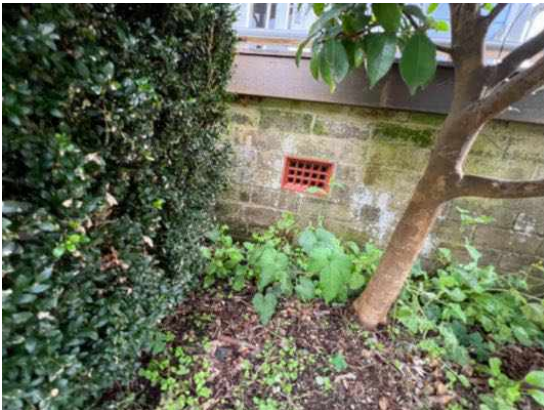
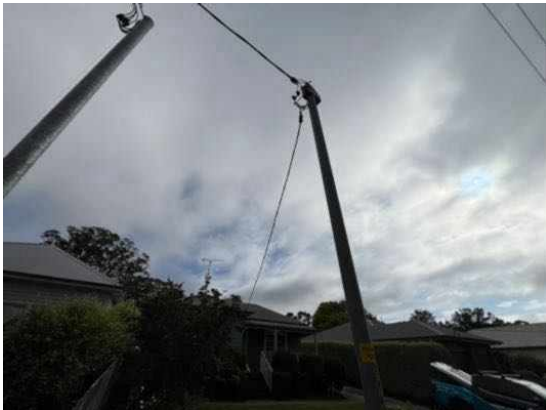
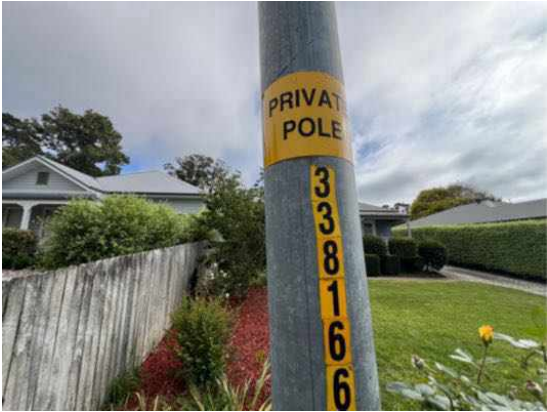
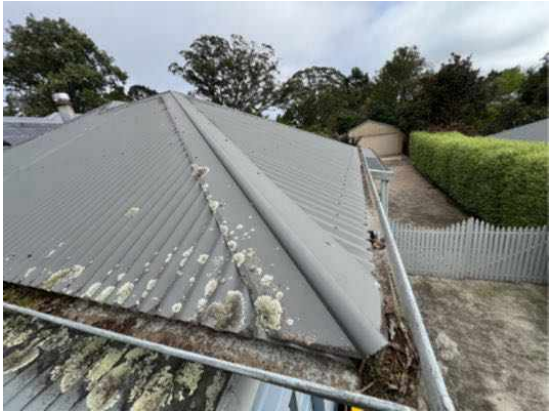
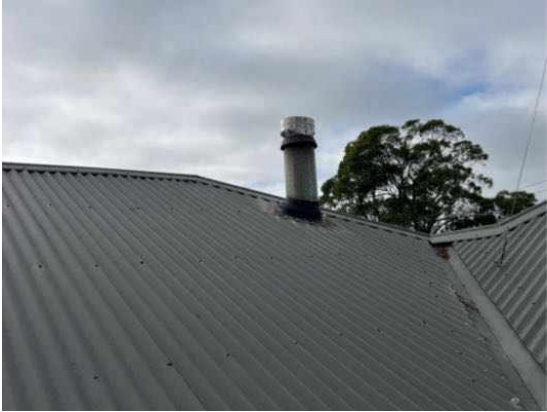
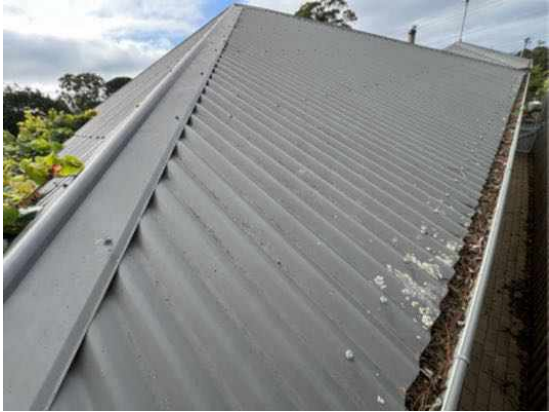
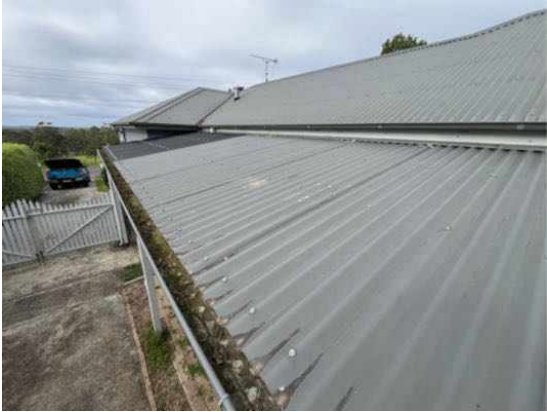
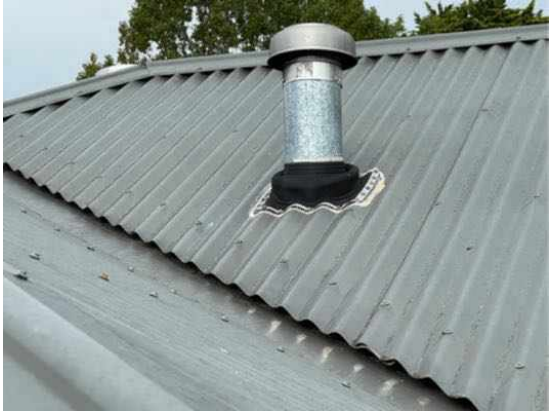
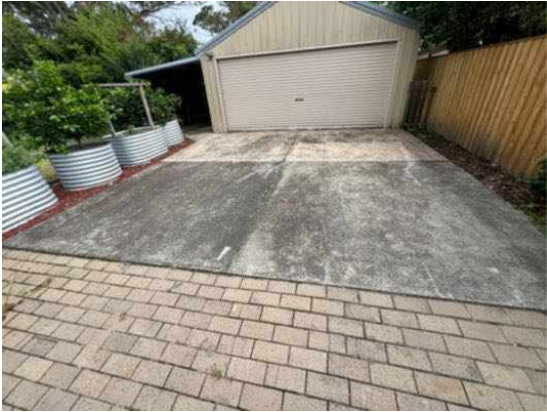
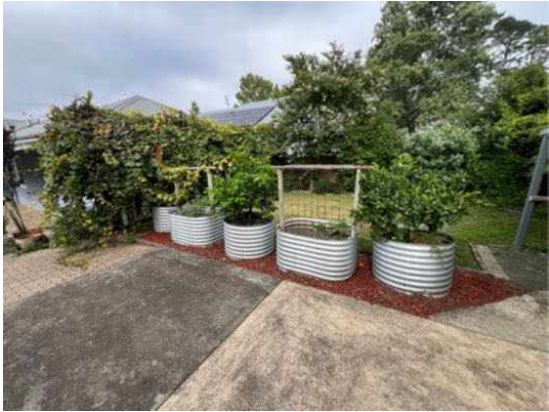
Building: Main Building
Location:
Finding: FYI - Additional Photos
Information: Additional photos are provided for your general reference and may include obstructions, testing of water & windows, moisture readings or minor maintenance items.

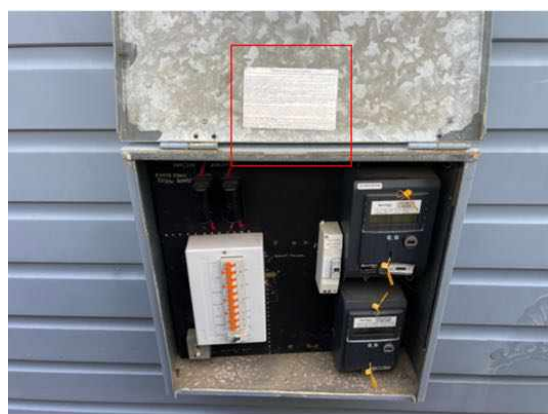
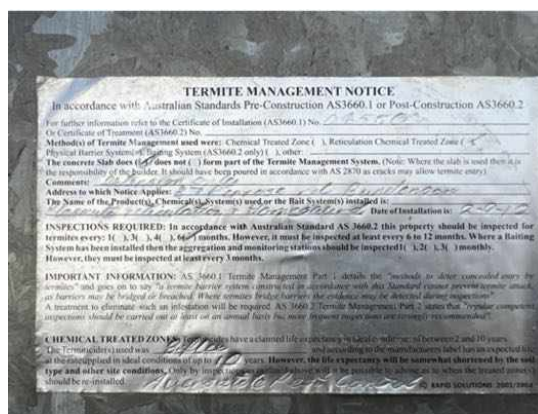
The following items were noted as - Evidence of a previous termite management program

Where a Termite Management System has been identified you should refer to the type of barrier date of installation warranty conditions and any documentation provided by a builder or past owner. Consult the company who installed the barrier to confirm whether the system is still under warranty.

Most chemical termite management systems expire and require replenishment and all physical systems are primarily designed to prevent concealed entry.
