Building and Timber Pest Inspection Report

Inspection Date: Thu, 12 Mar 2026

Property Address: 10 McEwen St, Shepparton VIC 3630,
Australia

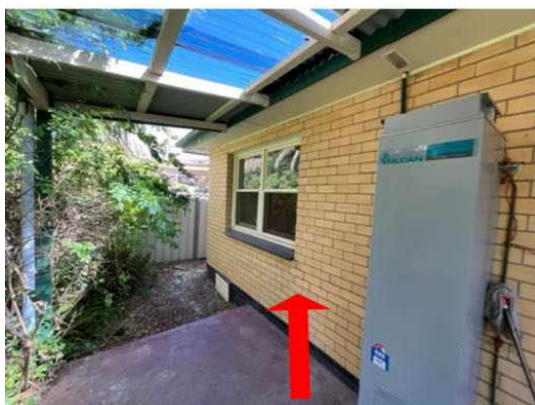
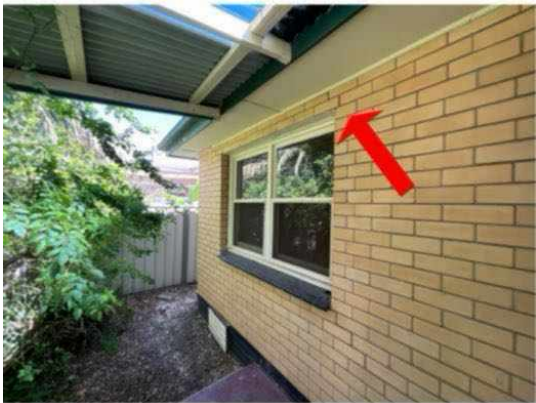
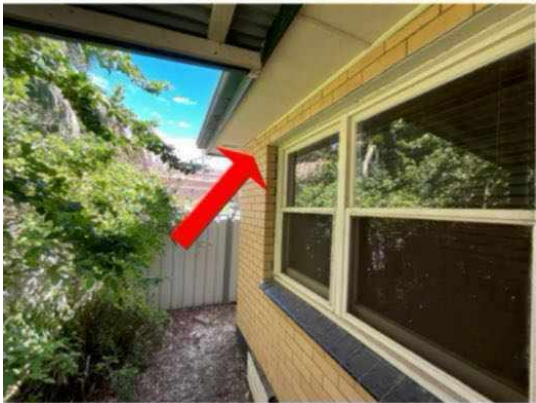
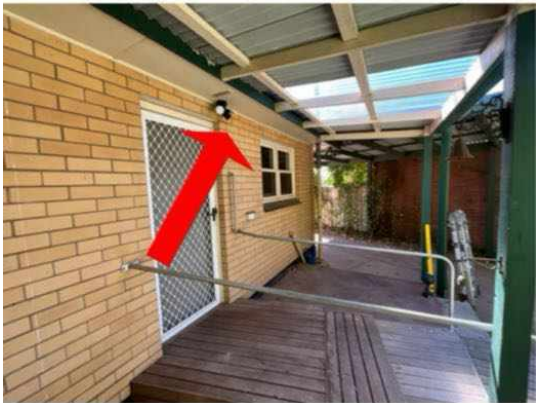
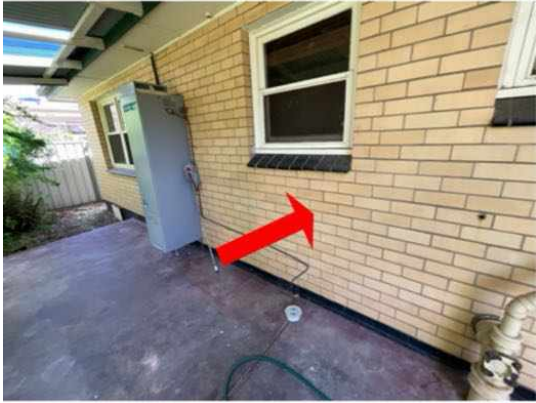
Building: Building 1
Location: Rear, front wall
Finding: Brickwork - Step cracking
Information: Step cracking was identified to the brickwork in this area at the time of inspection. Step cracking, which is similar to other forms of cracking, has a variety of possible causes. However, the most common is the subsidence of adjacent footings.

Step cracking is a relatively common defect, and is most likely to occur adjacent to windows, doors and other openings. Mortar failure in the gaps between affected bricks indicates the stresses and tensions affecting the wall.

Where step cracking is extensive or severe, the client is advised to consult a structural engineer. Minor step cracking can be used as a warning sign to address factors causing stress to the wall, which can include the effect of surrounding trees, water leaks, soil erosion, or even the presence of reactive soils in the surrounding area.

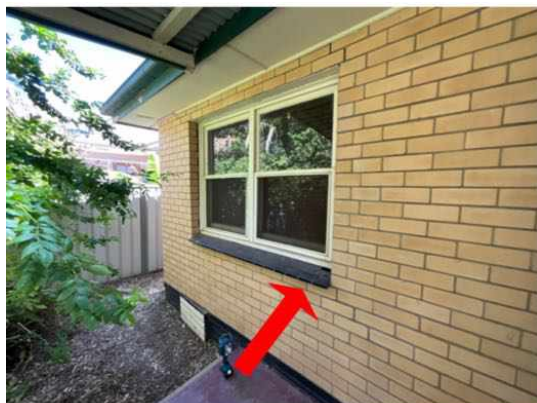
Building:	Building 1
Location:	Rear windows
Finding:	Brickwork - Deteriorated mortar
Information:	Mortar, or 'bedding', is the material which fills joints and intersections between bricks in masonry walls and structures. Sections of mortar in this brickwork were identified as having deteriorated, which is generally expected for a property of this age and condition.

Mortar may deteriorate as a result of age of building materials, minor movement of bricks, or frequent exposure to weathering. Mortar should be replaced to ensure that bricks remain in their intended location and to prevent gaps, which would allow water or moisture ingress and secondary damage as a result.

Mortar deterioration can be addressed by a bricklayer where areas of deterioration are localised and easily accessible. Alternatively, appointment of a registered builder is advised, to repoint large areas of decaying mortar. Where secondary structural defects have become evident, consultation with a structural engineer may be required.

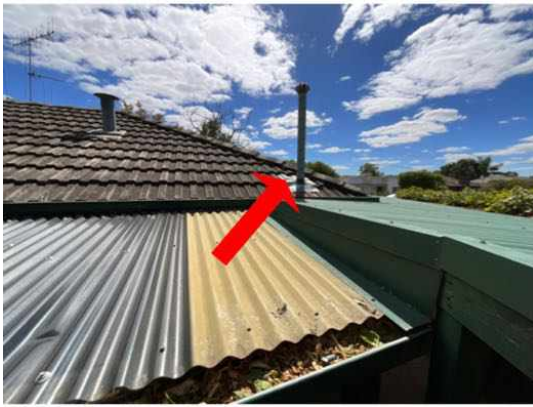
Finding 3.04

Building:	Building 1
Location:	Roof Exterior
Finding:	Mortar - Deterioration
Information:	Mortar, or 'bedding', is the material which fills joints and intersections between tiles and other building elements on the exterior roof covering, such as gable ends, hip capping and valleys. Upon inspection of the exterior roof, it was noted that sections of the mortar show varying levels of deterioration.

Mortar generally deteriorates as a result of frequent exposure to weather conditions over a prolonged period of time. Mortar that is deteriorating may allow water ingress into the roof void, putting associated building elements and roofing structures at risk of water damage. Deteriorated mortar also detracts from the functionality of roof tiles and other roofing elements, potentially decreasing weather tightness and roof drainage.

Mortar deterioration can be attended to by a handyperson where areas of deterioration are localised and easily accessible. Otherwise, consultation with a roofing contractor is advised where greater works are required.

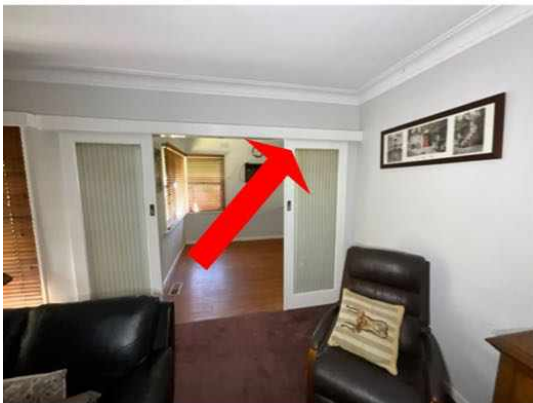
Finding 3.05

Building: Building 1
 Location: Living Room
 Finding: Door- Stiff to slide
 Information: The door in this area was jammed and difficult to slide along the associated tracks at the time of the inspection. Restricted function of the affected door may pose as a potential safety hazard if required for emergency egress from the building.

Generally, factors such as general age of the building element and a lack of maintenance are the usual causes for this type of defect.

Replacement of door hardware or tracks may be required, as well as minor repairs and cleaning. A registered builder or general handy person will be required to repair the affected doors.

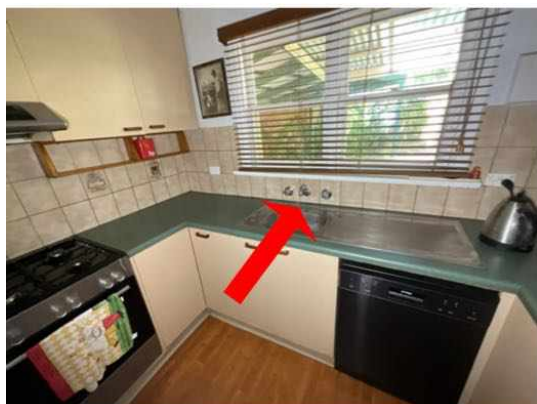
Finding 3.06

Building: Building 1
 Location: Kitchen
 Finding: Inadequate sealant or Grout
 Information: This area has a lack of effective Sealant or Grout. This is allowing the ingress of water to the structure inside the wall.

The presence of water encourages Termite attack, Mould and Fungal Decay.

A Tiler or General Handy person must be contacted as soon as possible to effect repairs and prevent further deterioration.

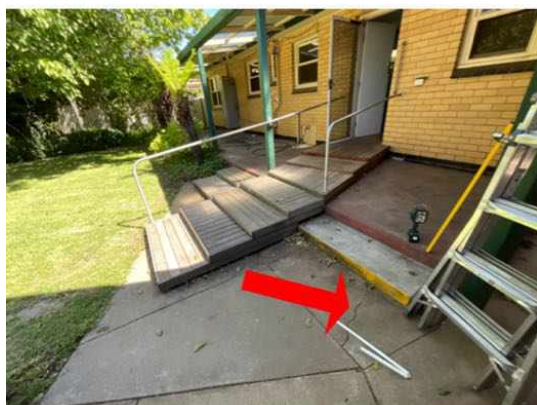
Building:	Building 1
Location:	Yard - Back
Finding:	Cracking - External Concrete Paving Damage Category 4 - Gaps in Slab (4mm - 10mm +)
Information:	Gaps in the slab were identified in external concrete paving. Gaps in the slab are significant and are likely to lead to the development of safety hazards and secondary defects if left unmanaged, such as the creation of a trip hazard.

General age and expected deterioration of the paved areas is a common cause of this type of cracking. However, expansion and contraction of the slab may also have occurred due to environmental factors. Such factors include variable moisture and weather conditions, the presence of trees and their roots having a settling or lifting affect on the soil, or the effect of load bearing, e.g. heavy vehicles over a sustained period of time.

Cracking to this degree may also be due to poor original installation of the concrete. Factors such as poor compaction of the sub surface and/or inadequate reinforcing of the slab may create cracking and other secondary defects. Gaps in the concrete paving may also have a more significant structural cause, such as subsidence of soils.

Where gaps in the concrete paving are adjacent to structural elements of the building, the advice of a Structural Engineer is advisable before undertaking repairs. Significant repair and likely replacement of the concrete paving is probable.

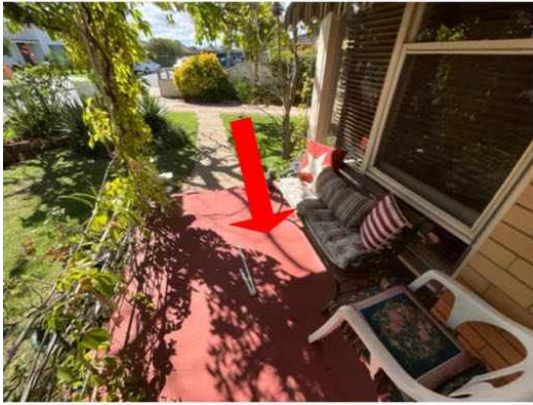
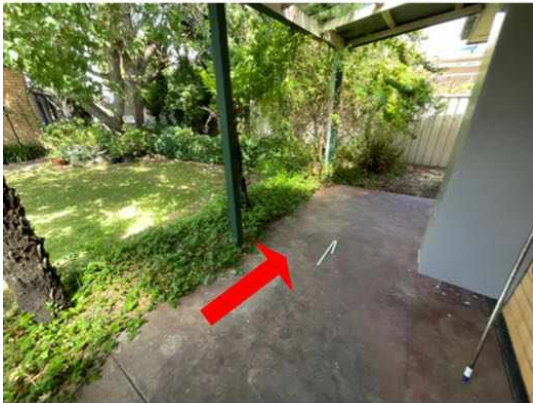
Finding 3.10

Building:	Building 1
Location:	Verandah
Finding:	Cracking - External Concrete Paving Damage Category 3 - Wide Cracks (2mm - 4mm)
Information:	Wide cracks were identified in external concrete paving. Wide cracks are significant and are likely to lead to the development of safety hazards and secondary defects if left unmanaged.

General age and expected deterioration of the paved areas is a common cause of this type of cracking. However, expansion and contraction of the slab may also have occurred due to environmental factors. Such factors include variable moisture and weather conditions, the presence of trees and their roots having a settling or lifting effect on the soil, or the effect of load bearing, e.g. heavy vehicles over a sustained period of time.

Cracking to this degree may also be due to poor original installation of the concrete. Factors such as poor compaction of the sub surface and/or inadequate reinforcing of the slab may create cracking and other secondary defects. Wide cracks may also have a more significant structural cause, such as subsidence of soils.

Where the crack is located adjacent to structural elements of the building, the advice of a Structural Engineer is advisable before undertaking repairs. Significant repair and likely replacement of the concrete paving is probable.

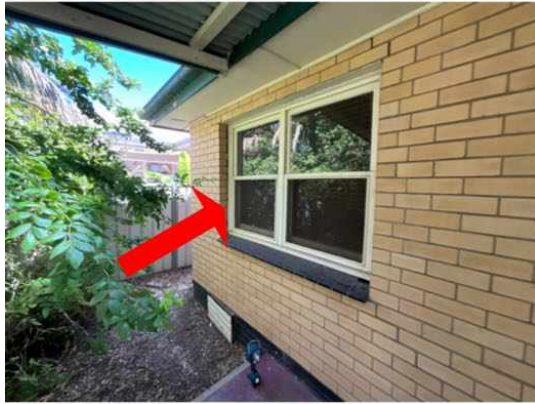
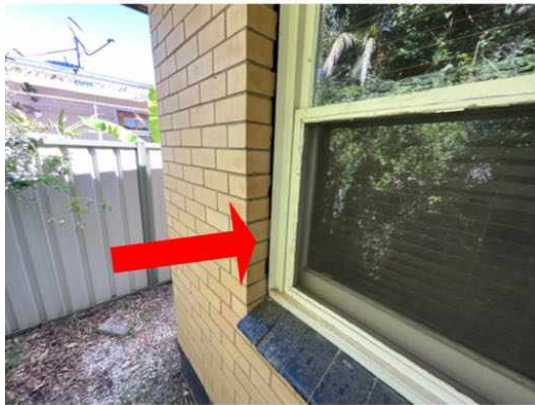
Building: Building 1
Location: Bed 3
Finding: Inadequate sealant/caulking
Information: This area has a lack of effective Sealant or Grout. This may be allowing the ingress of water to the structure.

The presence of water encourages Termite attack, Mould and Fungal Decay.

A Caulker or General Handy person must be contacted soon to effect repairs and prevent possible deterioration.

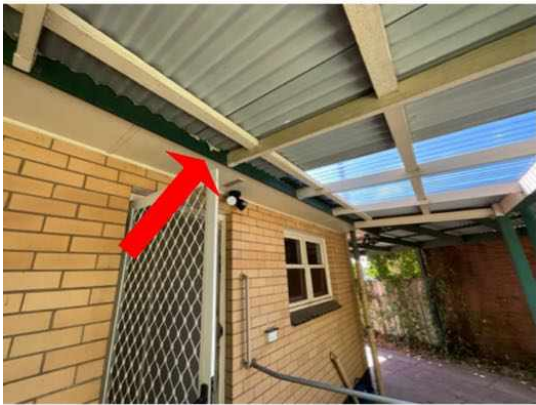
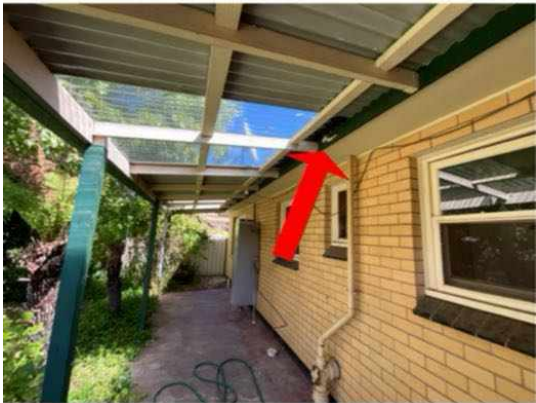
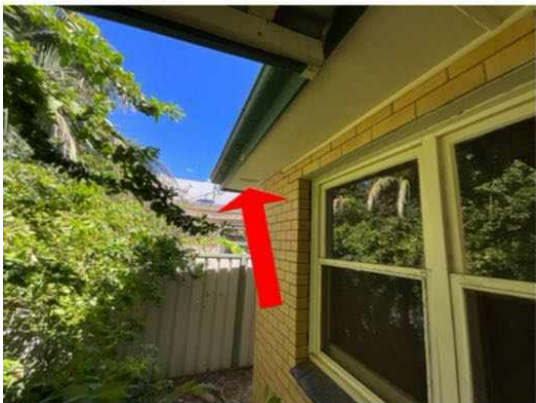
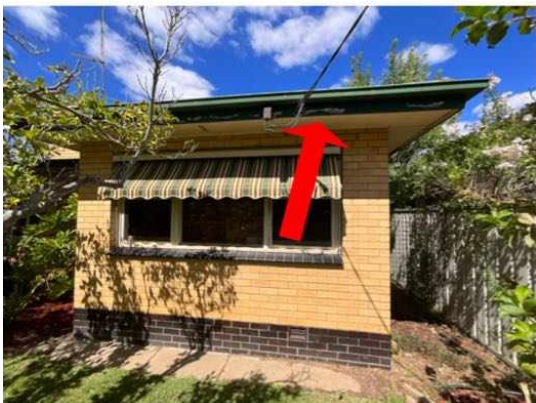
Finding 6.05

Building:	Building 1
Location:	Verandah, eaves >
Finding:	Timber - exposed to weather
Information:	External timbers that are frequently exposed to harsh weather conditions require adequate protection in order to maintain their condition. Where timbers have not been painted or treated adequately, general deterioration is likely to occur at an accelerated rate.

If left unattended, replacement of these timbers is likely to be necessary in the short-term future. Adequate treatment of these timbers is required as soon as possible by a painting contractor or general handyman.

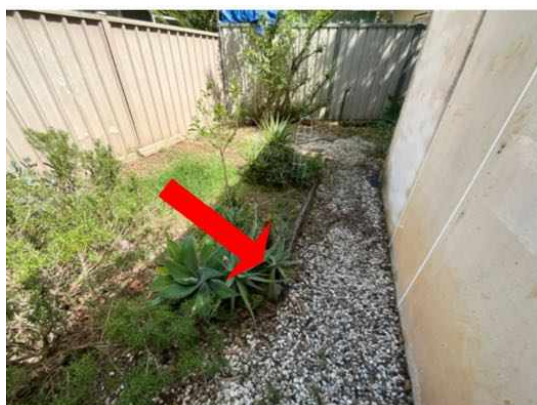
Finding 6.06

Building:	Building 1
Location:	Yard - Back
Finding:	Untreated or non-durable timbers in a hazardous environment
Information:	To reduce the risk of timber pest attack it is essential that timber used in a hazardous environment (e.g. in direct contact with the ground or frequently exposed to damp conditions) is of sufficient durability and/or is adequately preservative treated.

Untreated timbers in direct contact with the ground are likely to develop severe wood rot and/or fungal decay if left unattended creating attraction for subterranean termites to infest the timbers from surrounding areas.

If untreated or non-durable timbers are found to be in a hazardous environment it is highly advised that replacement of these building elements be performed as soon as possible to aid the protection of the property against termite / timber pest attack.

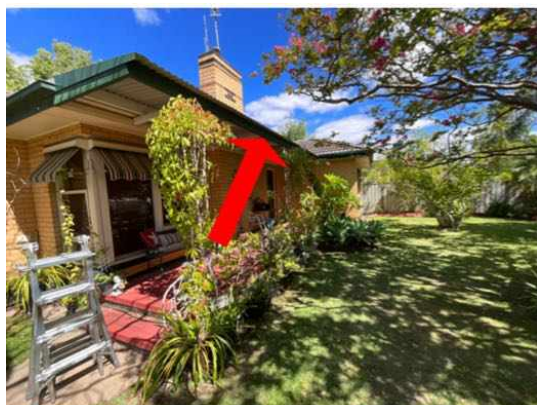
Finding 6.07

Building:	Building 1
Location:	Verandah > Front
Finding:	Guttering Missing
Information:	The Guttering in this area was missing at the time of inspection. Guttering, Downpipes and Stormwater drainage are vital to protect the integrity of the structure and to prevent an environment conducive to Timber Pest attack.

A Plumber should be contacted as soon as possible to replace and connect to drainage the missing Guttering.

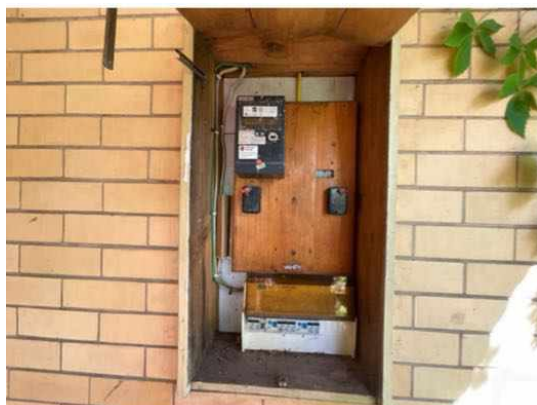
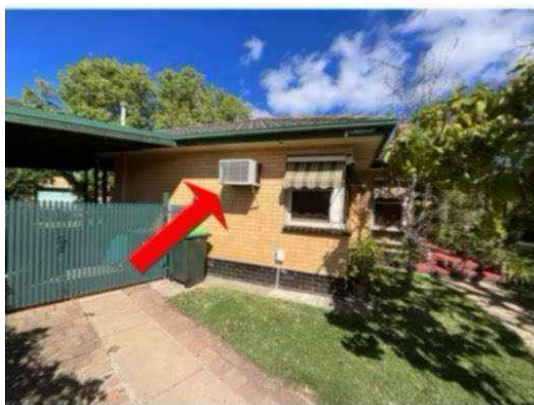
Finding 6.08

Building:	Building 1
Location:	All External Areas
Finding:	Termite Management System - no evidence of a chemical installation
Information:	The application of a post-construction chemical termite barrier is highly recommended for all properties, particularly if live termite activity has been found on the site previously. Such barriers are highly effective in preventing termite attack on any timber building elements throughout the property.

A durable notice should be placed in the switchboard unit to indicate current termite barriers. At the time of inspection, it appeared as though no termite management system has been installed, with no evidence to suggest preventative works taking place.

The client may consider gaining further advice from a pest controller as to the costs and procedures involved with this application. It is recommended that obtaining such advice be a short-term priority.

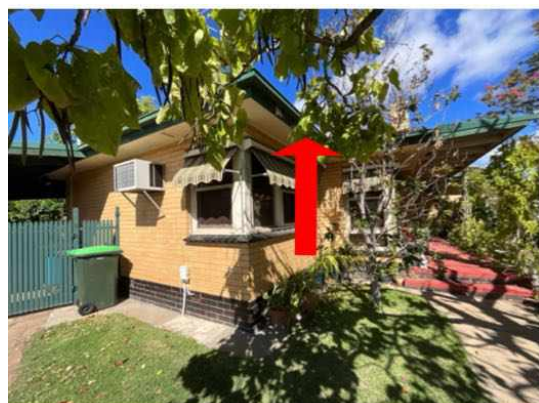
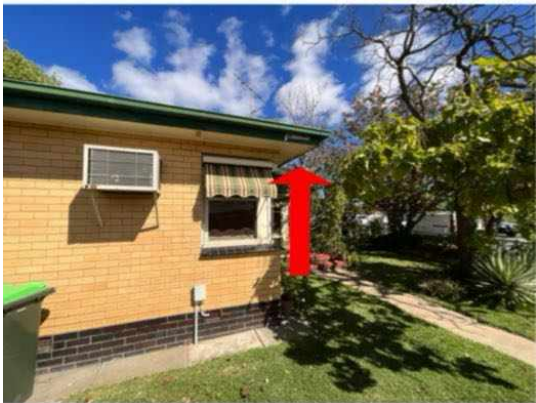
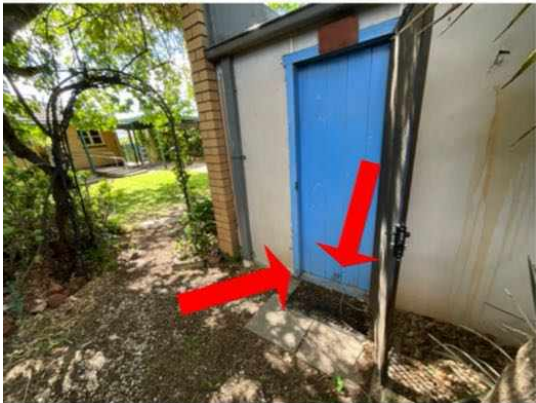
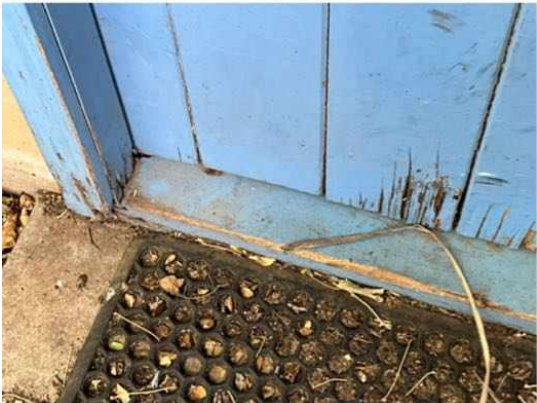
Building:	Building 1
Location:	Eaves, garage
Finding:	Fungal decay - present (localised)
Information:	Fungal decay also known as wood decay or wood rot generally refers to the deterioration of timber elements when in contact with excessive levels of moisture for a prolonged period of time.

The development of fungal decay is accelerated by temperatures in the range of 5degreeC to 40degreeC as well as the presence of oxygen. Generally fungal decay develops on timber elements that are in use in an external environment which are exposed to rain penetration.

In this case although the affected timber element is in a decaying state the extent of any visible damage appears to be localised to a specific area and is yet to spread to other parts of the building element or affect adjoining structures. The fungal decay is therefore likely to be of a relatively superficial nature with minimal impact on the structural integrity or tensile strength of the timber element.

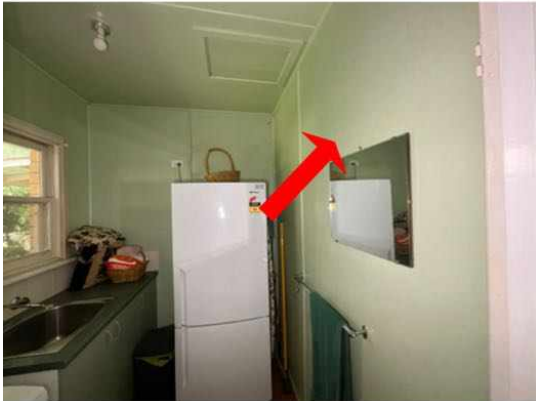
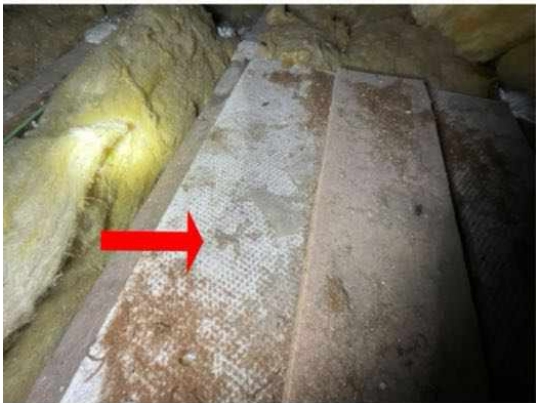
Noted Item

Building: Building 1
Location: All Areas
Finding: Asbestos - Suspected ACM Identified on Site
Information: Reporting on Asbestos is outside the Scope of this Report. This suspected defect is highlighted as a caution only. We suspect, based on our experience in the building industry, that there is a higher risk of the identified building element containing asbestos.

As Asbestos Reporting is outside the scope of this report, we advise that you consider a separate Asbestos Inspection and Condition Audit, which can include the taking of samples for definitive confirmation of the presence of Asbestos.

In the interim, the client is advised to act with caution, especially when considering any damage to building materials general wear and tear renovations extensions demolition and general maintenance activities due to the suspected presence of Asbestos.

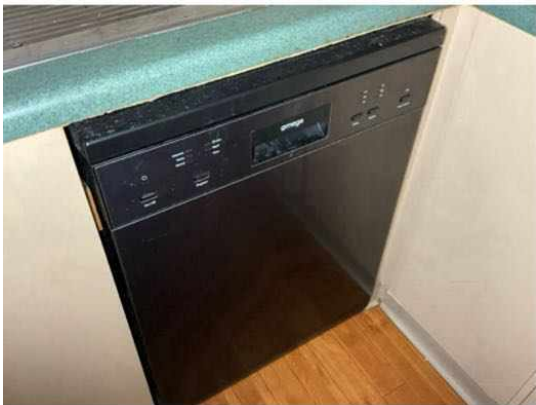
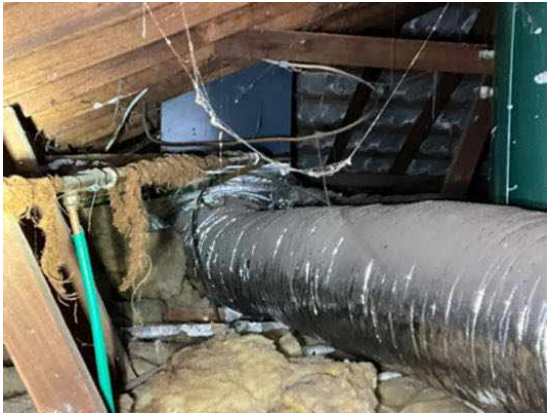
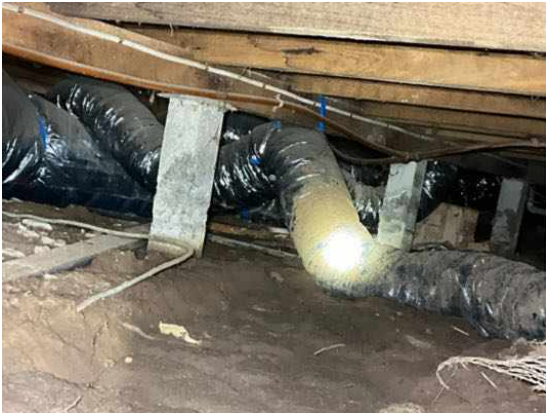
Noted Item

Building: Building 1
Location: All Areas
Finding: Additional Photos - Obstructions and Limitations
Information: These photographs are an indication of the obstructions and limitations which impeded full inspection of the property at the time of inspection. These obstructions can hide an array of defects and should be removed to allow full inspection to be carried out. A re-inspection is recommended once the areas are made accessible.
