Building and Timber Pest Inspection Report

Inspection Date: Thu, 22 Jan 2026

Property Address: 29 Wardell Rd, Lewisham NSW 2049,
Australia

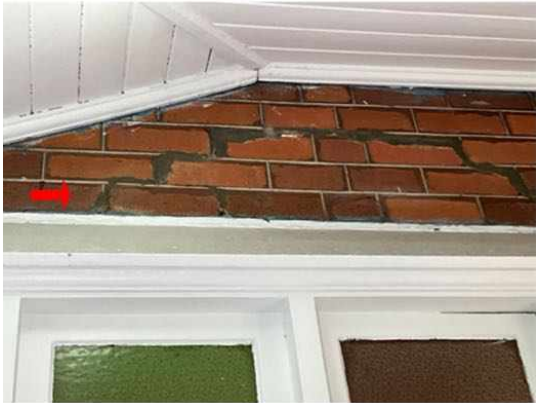
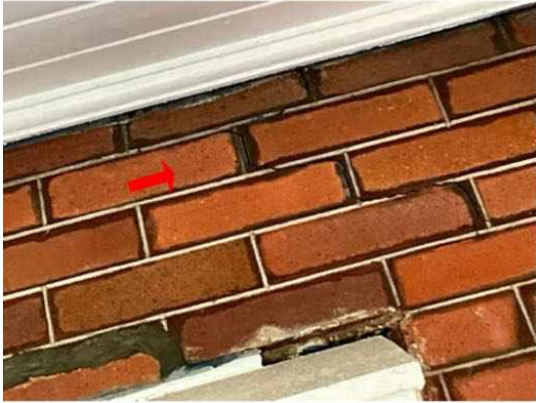
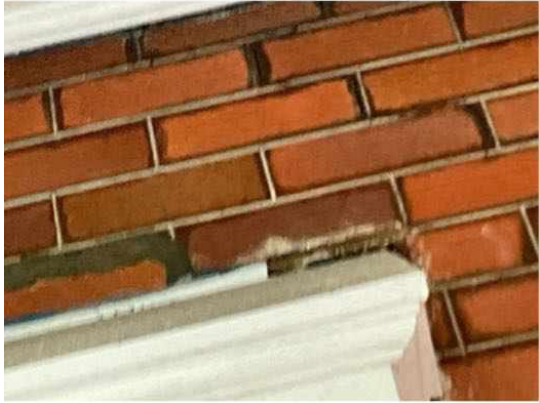
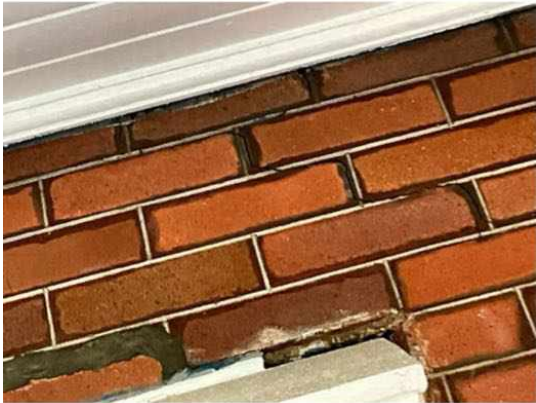
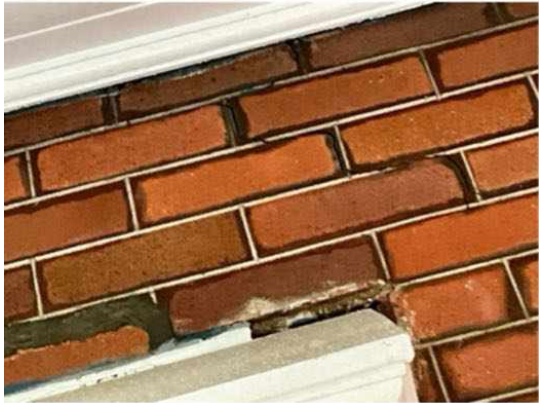
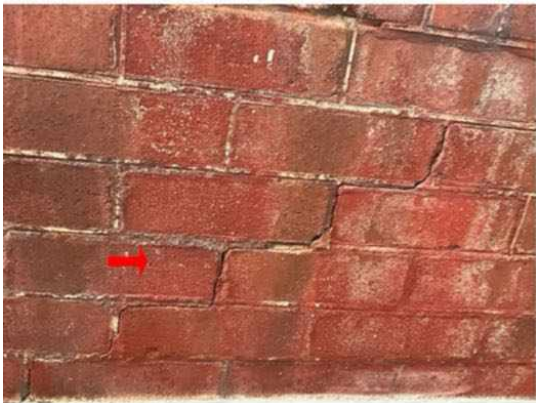
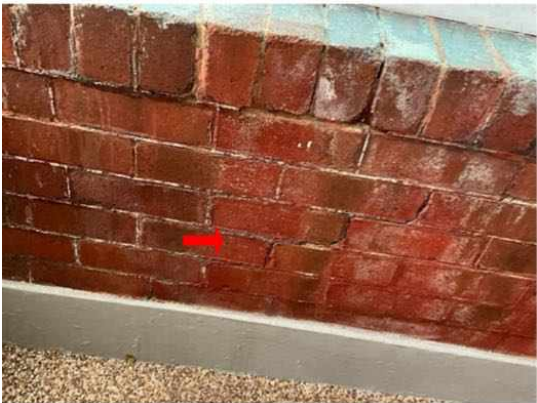
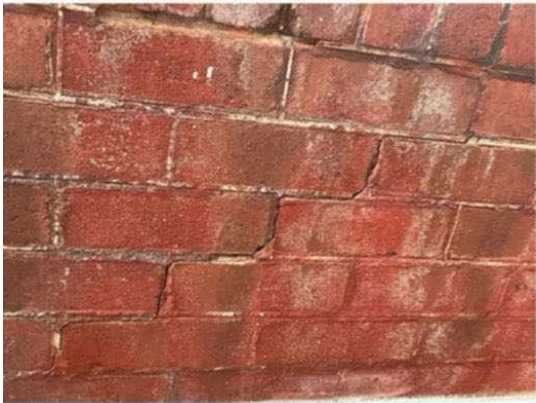
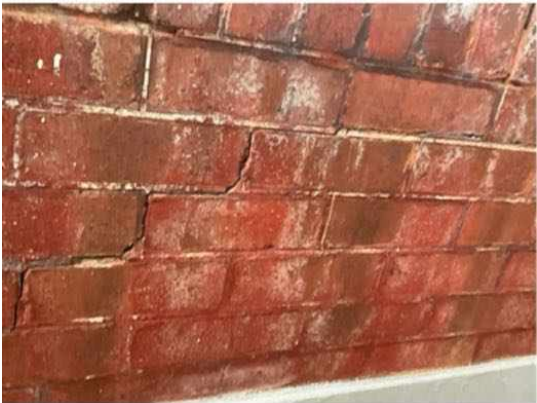
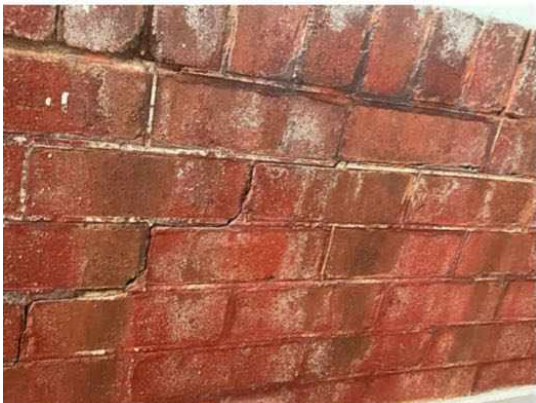
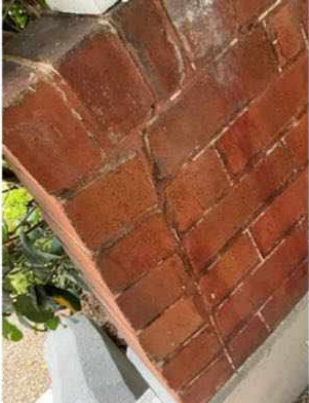
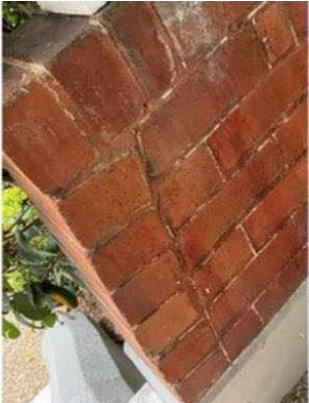
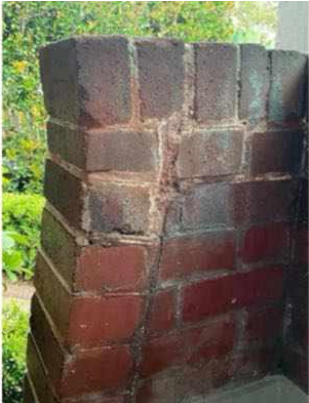
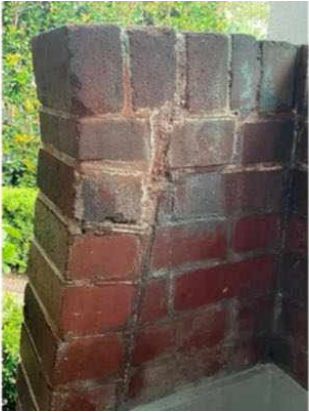
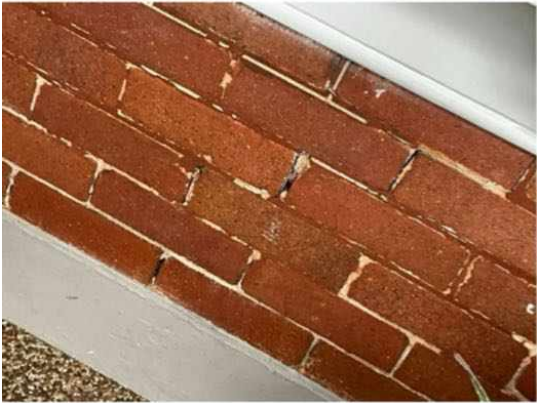
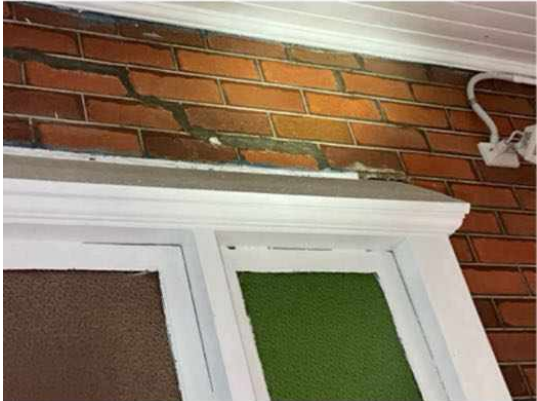
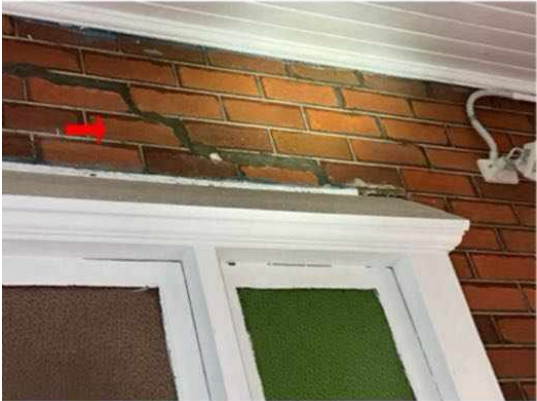
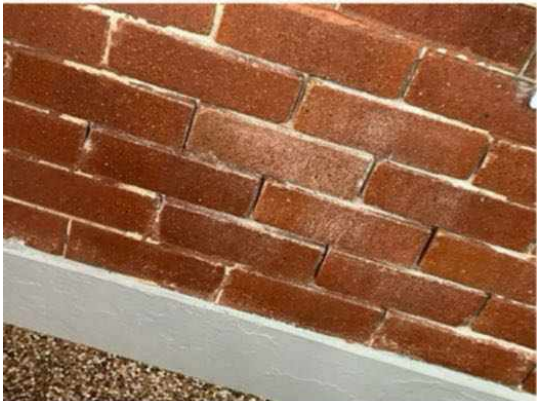
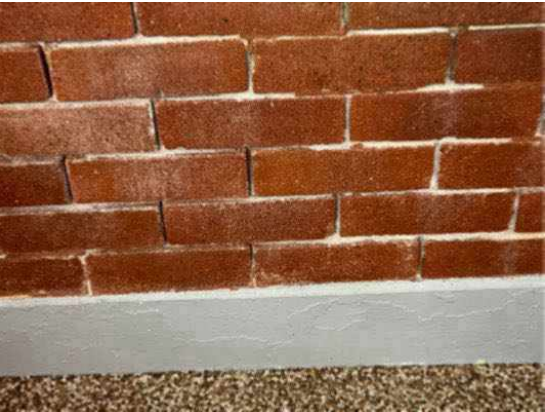
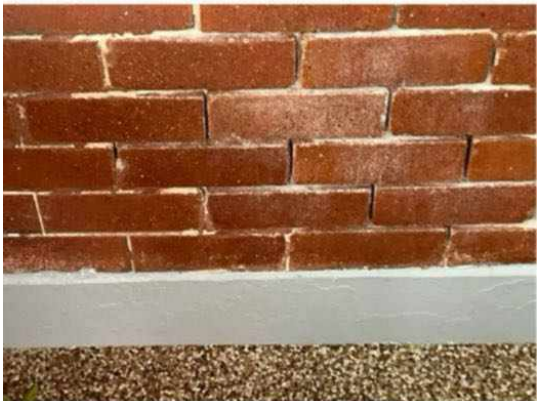
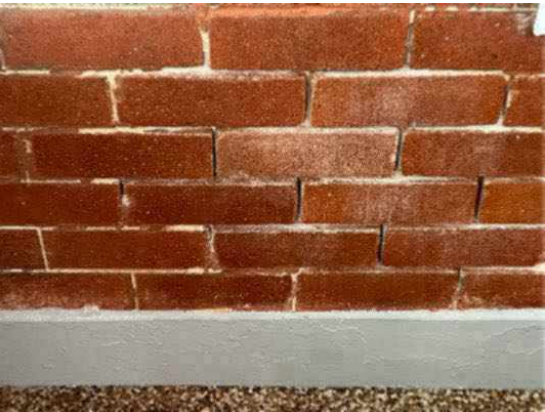
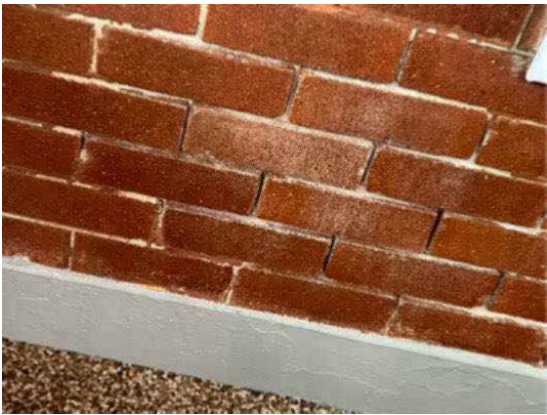
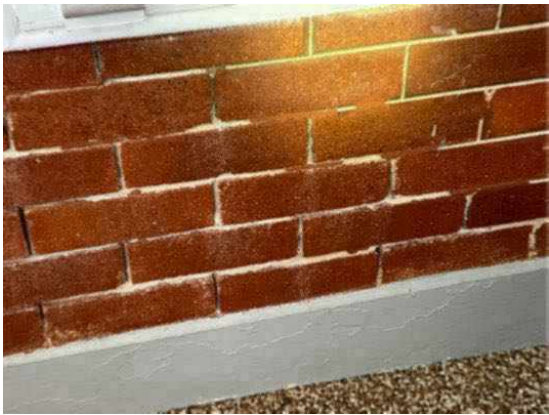
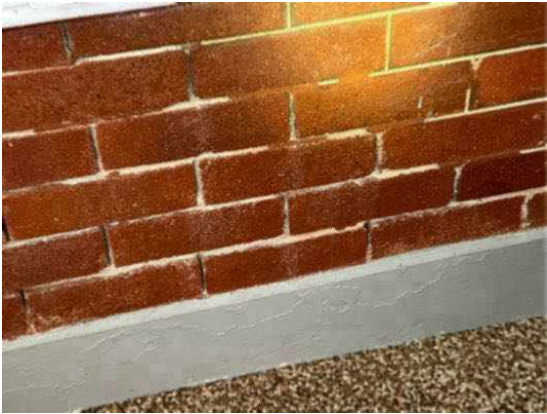
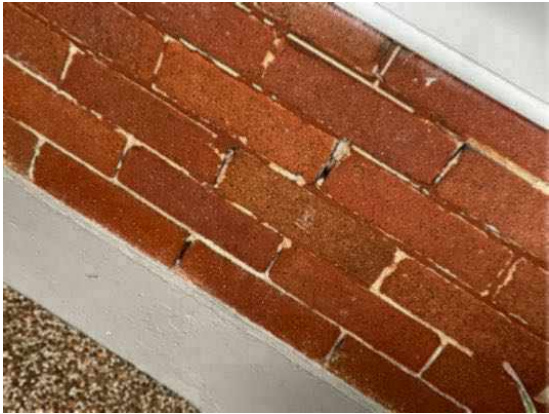
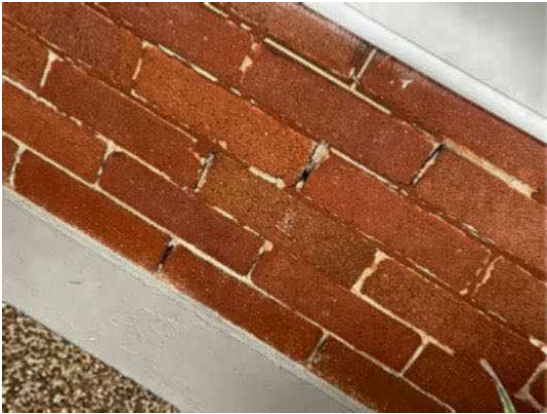
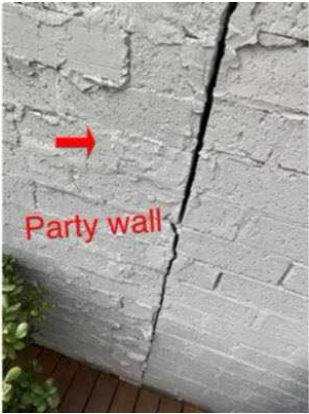
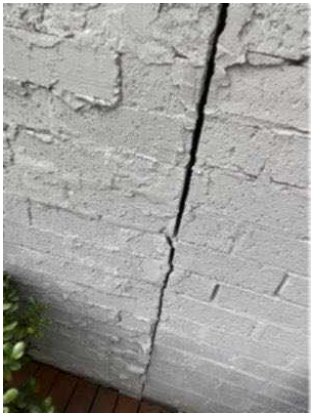
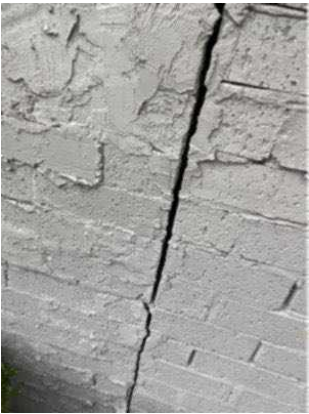
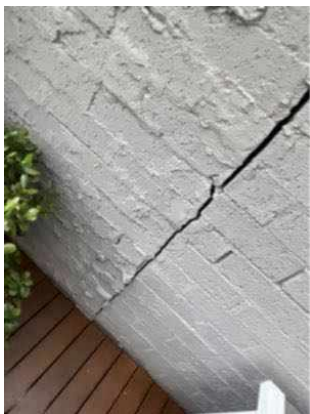
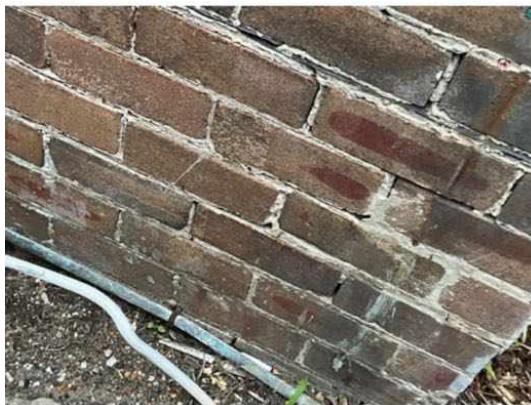
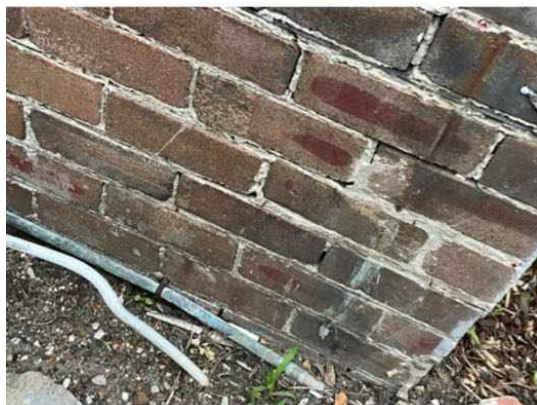
Building: Main Building
Location: All Areas
Finding: Brickwork - Cracking in External Wall
Information: The external wall displays several cracks, some of which follow a stepped pattern, indicative of movement within the structure. The cracks appear to vary in width, and some may be deep enough to compromise the weatherproofing of the wall, potentially allowing water ingress. These cracks suggest either settlement of the foundations, shrinkage, or thermal expansion/contraction of the building materials.

- **Structural Risk:** While the cracks may not indicate immediate danger of structural collapse, they pose a moderate risk by allowing further movement or deterioration over time. If left unattended, these cracks may widen, leading to more severe structural instability.
- **Water Ingress Risk:** There is a high risk of water ingress through the cracks, which could cause internal damage such as mold growth or moisture damage, especially during heavy rainfall.
- **Safety Risk:** If the cracks continue to propagate or are symptomatic of more significant underlying issues (e.g., foundation movement), there could be a moderate to high risk to the structural integrity of the building.

This defect could be classified as a major defect in accordance with Australian Standard AS4349 if the structural movement is confirmed and the cracks are found to be indicative of more severe underlying problems. If the cracks are cosmetic, it may be considered a minor defect but still requires prompt attention.

Recommendation for Rectification:

- **Engage a Structural Engineer:** A structural engineer should be consulted to assess the underlying cause of the cracks, particularly if there is suspicion of foundation movement or structural weakness.
- **Repair by a Licensed Builder:** Once the cause is identified, a licensed builder experienced in masonry work should undertake the necessary repairs. This may involve crack stitching, mortar repair, or even foundation stabilization if required.
- **Monitor for Further Movement:** Ongoing monitoring of the area should be conducted to check for further cracking or movement.

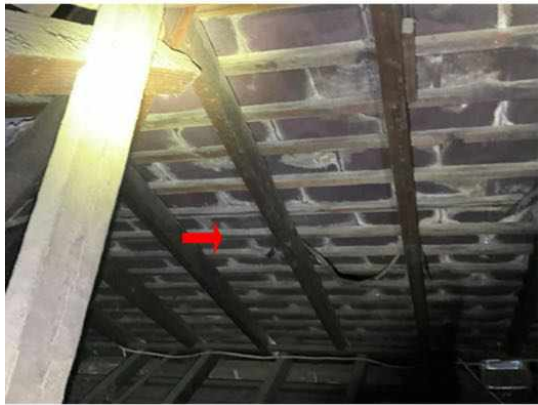
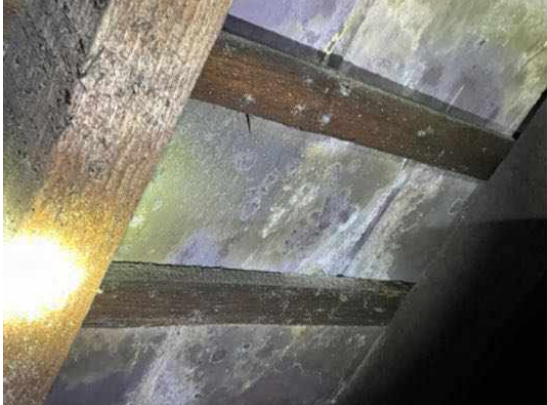
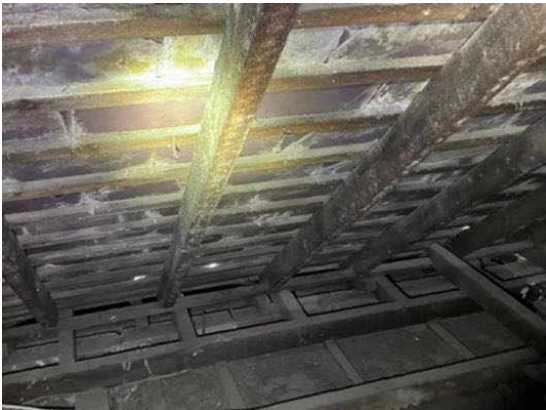
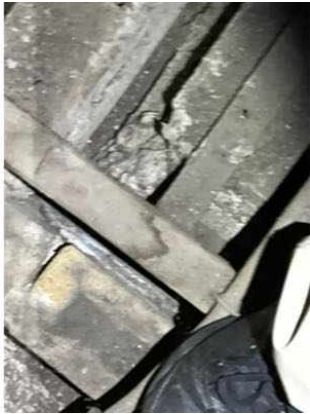
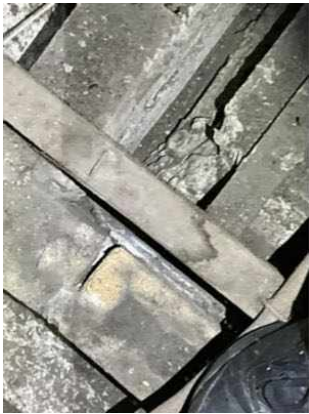
Finding 2.02

| Finding: | Roof void - Suspected water leak with tray |
| Information: | Evidence of a suspected water leak was observed in the roof void, with tray placed beneath the roof structure to collect water. This indicates an ongoing or previous roof leak, likely from damaged roof covering, flashing. |
| Risk: | High. Ongoing moisture intrusion can lead to timber rot, mould growth, insulation damage, and electrical hazards if not addressed promptly. |

| Recommended Action: | It is recommended to engage a licensed roofing contractor to inspect the roof coverings, flashings, and penetrations. Repairs should be carried out as needed to prevent further internal damage. |

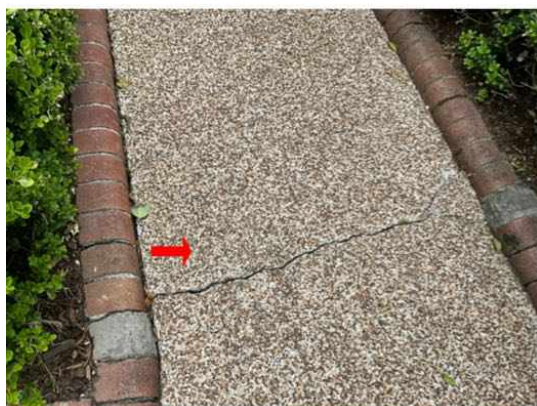
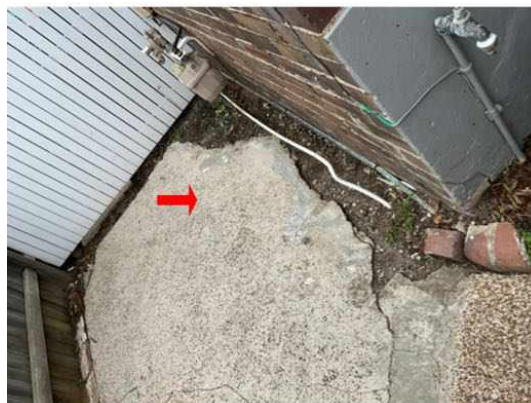
| Finding: | Noticeable Cracking in Concrete Slab |
| Information: | Noticeable cracking has been observed in the concrete slab, failing to meet the required construction and quality standards. |

- Cracks are visible on the surface and may extend through the depth of the slab.
- Evidence of improper curing or inadequate reinforcement leading to cracking.

- Compromised structural integrity of the slab, potentially leading to failure under load.
- Water ingress through cracks, causing corrosion of reinforcement and further weakening the structure.
- Potential trip hazards and aesthetic issues, reducing the overall value and safety of the property.
- Increased maintenance and repair costs due to ongoing deterioration.

- A structural engineer should be engaged to assess the extent of the cracking and recommend appropriate repair methods.
- A licensed contractor or concrete repair specialist should carry out the recommended repairs under the guidance of the structural engineer.

A detailed inspection should be conducted post-repair to confirm compliance with the required standards and to ensure that the structural integrity of the concrete slab has been restored.

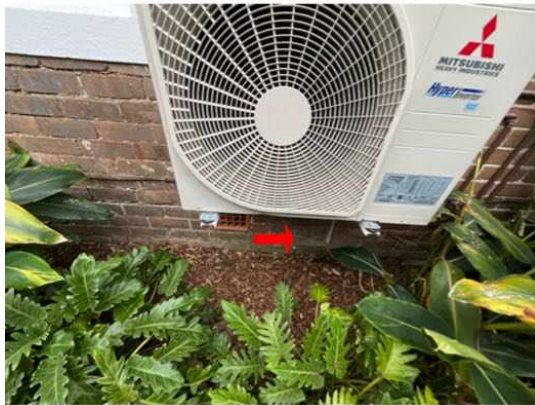
Finding 3.02

Building: Main Building
 Location: Exterior walls - left side
 Finding: Air conditioner - Disconnected overflow
 Information: The Air Conditioner (A/C) overflow was found to be disconnected from storm water drainage and is creating excessive moisture in the surrounding area.

Such leaking creates an environment which is conducive to an array of defects, including water damage to associated building elements and the attraction of termite or timber pest infestation.

It is highly recommended that a licensed plumber be appointed to connect the A/C

overflow in order to prevent such an environment from being created. These minor works should be carried out as soon as possible.

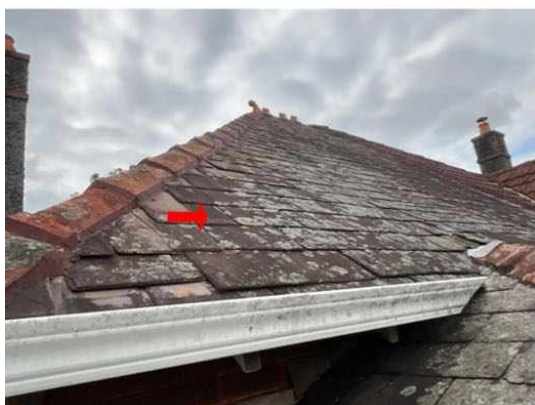
Finding 3.03

| Information: | Upon inspection of the exterior roofing, the majority of roof was not in a fair condition. While weathering of the roof is consistent with the age of the property, maintenance works are required. |

Isolated areas of mortar have come loose in the valleys and minor cracking is also present. Re-pointing and re-sealing the may be considered as an interim solution by the client to help preserve and extend the life span of the tiles.

Where left unmanaged, deteriorating roof are likely to lead to a number of secondary defects, including minor water leaks and weather exposure to internal roofing structures.

Consultation with a roofing contractor is highly advised to gain advice on cost of remedial works that may be required in the short to medium term. Remedial works are likely to increase the longevity of the exterior roofing structure.

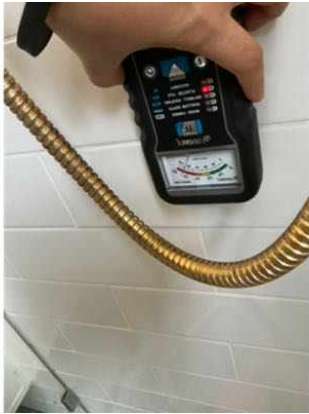
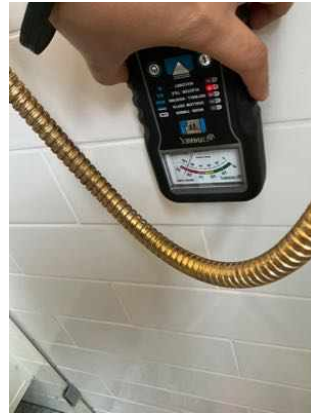
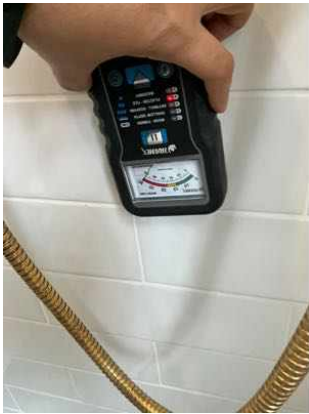
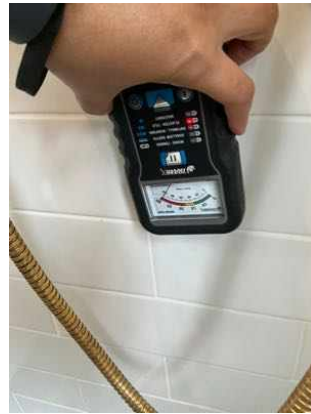
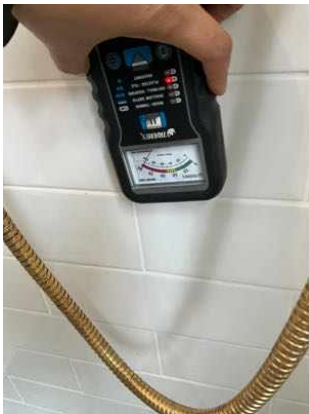
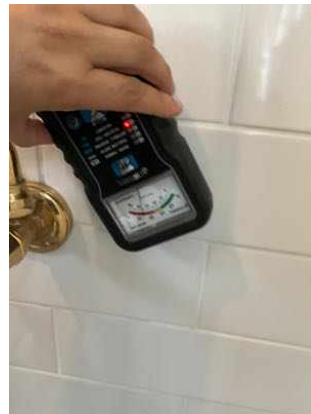
Finding 3.04

Building: Main Building
Location: Bathroom
Finding: Evidence of excessive moisture was present at the time of inspection
Information: Excessive moisture is present behind the bathroom tiles, indicating a potential water leakage issue within the wall.

The prolonged presence of moisture can lead to mold growth, deteriorate the structure, and create an environment conducive to health hazards. Additionally, it may compromise the adhesive holding the tiles, leading to their detachment.

A licensed plumber or a qualified contractor specializing in water damage remediation

should investigate the source of the moisture, fix any leaks, and address the damage. Additionally, replacing affected tiles and ensuring proper waterproofing are crucial to preventing future issues.

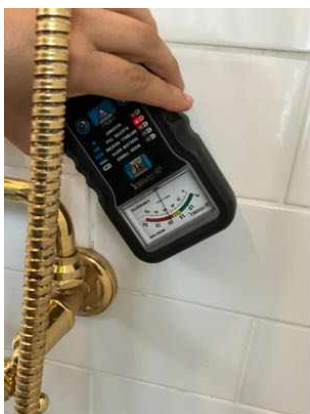
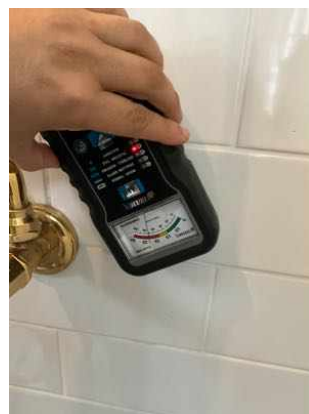
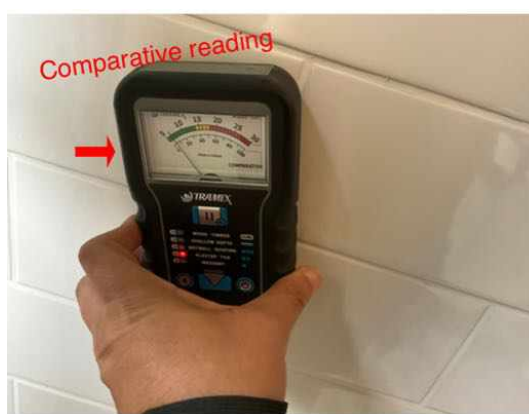
Finding 3.05

| Information: | Evidence of water pooling around the floor waste in the shower recess was noticed at the time of inspection. It is suspected that this excessive moisture is attributed to insufficient fall in the shower floor tiles. |

This pooling is minor overall but is still considered unsatisfactory, as standard tiling practices would not permit this situation to occur. Pooling water around floor wastes can create a slip hazard in extreme cases and create conditions that are conducive to mould growth over time. Where left unmanaged, the degradation of sealant and grouting is also likely to occur, possibly necessitating further repair works.

Remedial works may involve some sections of tiling and flooring repair and replacement. A tiling contractor or bathroom specialist should be appointed to provide further advice on reparation options and to perform works as necessary.

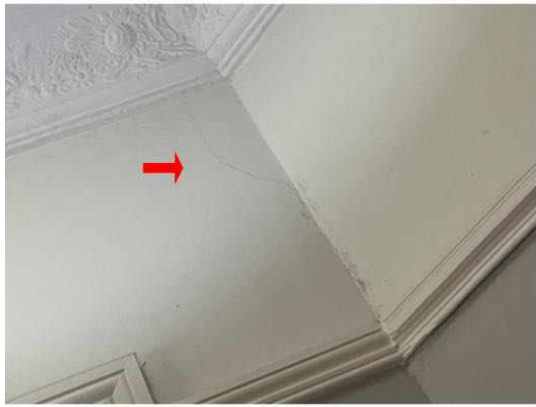
Finding 3.07

Building: Main Building
Location: Kitchen
Finding: Ceiling – Plasterboard Fine Cracking
Information: Fine cracking was observed to the ceiling plasterboard. This is commonly associated with normal building movement, shrinkage, or minor settlement and is generally cosmetic in nature.

However, cracking may worsen over time and affect appearance if left unattended.

Recommendation / Who can fix it: Repair and monitoring by a qualified plasterer or painter is recommended.

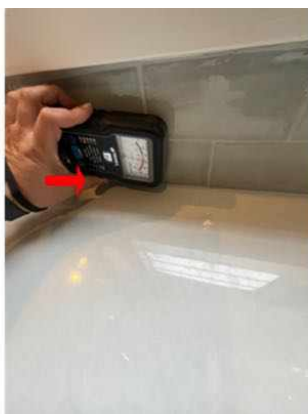
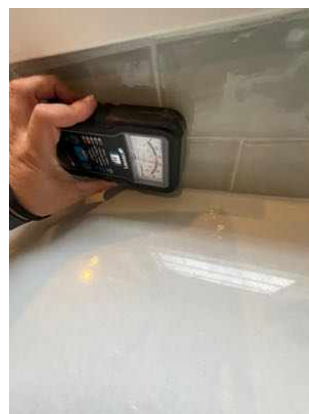
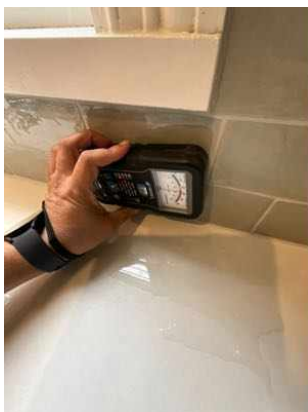
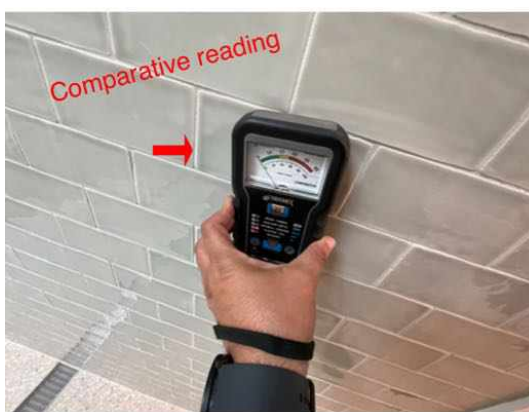
Finding 3.09

Information: Damp is evident to the lower 300mm of wall to the shower alcove. This defect is quite common, and is suspected to have been caused by moisture permeating through the grouting in this area, which shows evidence of deterioration. Leaking pipes within the adjoining wall is also a possible cause.

Damp (or structural damp) refers to the presence of unwanted moisture in the structure of a building, either as the result of intrusion from outside, or condensation from within the structure. In the shower area, internal water leaks or other sources of excessive moisture are generally the cause of damp.

Unmanaged damp in the shower recess is likely to facilitate the formation and development of mould and fungi growth, decaying associated building materials and compromising their structural integrity. It is important to address damp conditions, as the World Health Organisation notes that excess moisture leads - on almost all indoor materials - to growth of microbes such as moulds, fungi and bacteria, which subsequently emit spores and other matter into the indoor air. Exposure to these contaminants is associated with a wide range of respiratory and other health-related problems.

Consultation with a qualified plumber or bathroom specialist is advised immediately to identify the cause of damp and to perform remedial works as required. Where excessive mould growth is present, further inspection by a specialist environmental health inspector should also be considered.

Always ensure that sealant and grout is in good condition to prevent any moisture issues occurring in the future.

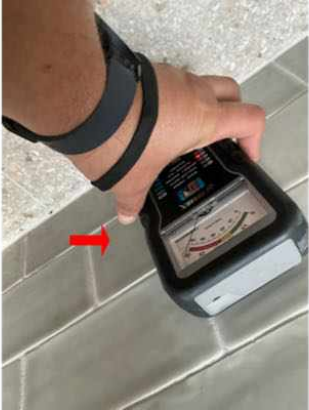
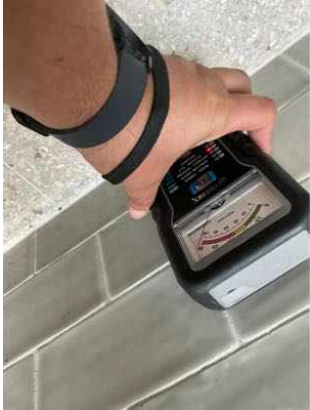
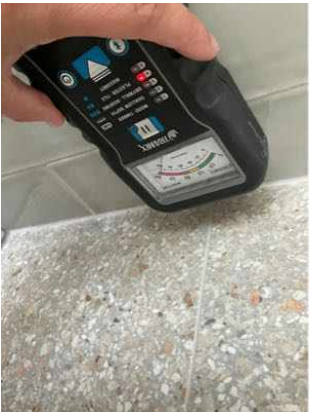
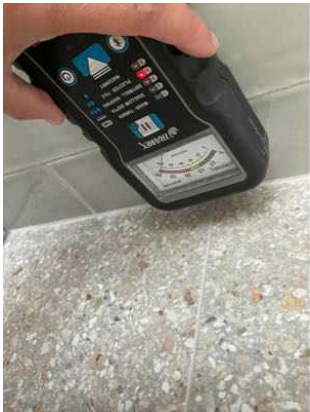
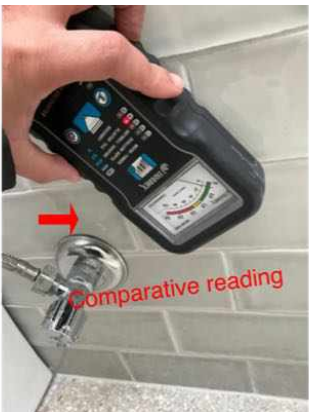
Finding 3.10

Finding: Shower base - Water pooling
Information: Evidence of water pooling around the floor waste in the shower recess was noticed at the time of inspection. It is suspected that this excessive moisture is attributed to insufficient fall in the shower floor tiles.

This pooling is minor overall but is still considered unsatisfactory, as standard tiling practices would not permit this situation to occur. Pooling water around floor wastes can create a slip hazard in extreme cases and create conditions that are conducive to mould growth over time. Where left unmanaged, the degradation of sealant and grouting is also likely to occur, possibly necessitating further repair works.

Remedial works may involve some sections of tiling and flooring repair and replacement. A tiling contractor or bathroom specialist should be appointed to provide further advice on reparation options and to perform works as necessary.

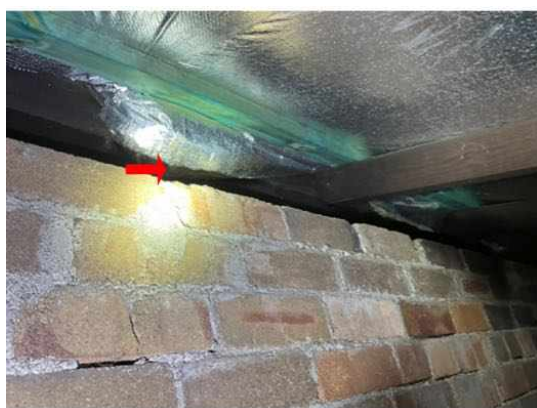
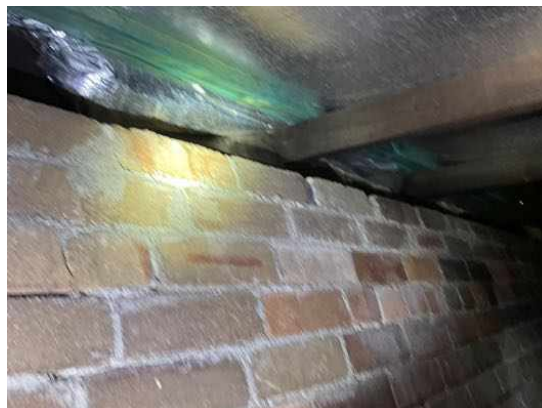
Finding 3.12

Building: Main Building
 Location: Roof Void
 Finding: Insulation - Missing
 Information: Upon inspection of the roof void it was noted that insulation is not present.

Insufficient insulation will result in a comparatively higher cost to heat and cool a property as there is a lack of Insulation (or uneven coverage of insulation) which works as a barrier to heat transfer. This helps to keep out unwanted heat in summer and preserves warmth inside your home in winter. It can also help soundproof your home from unwanted airborne noise transfer.

Where insulation is absent, the area does not meet current Australian Standards. Installation of adequate insulation is required and should be conducted as soon as possible.

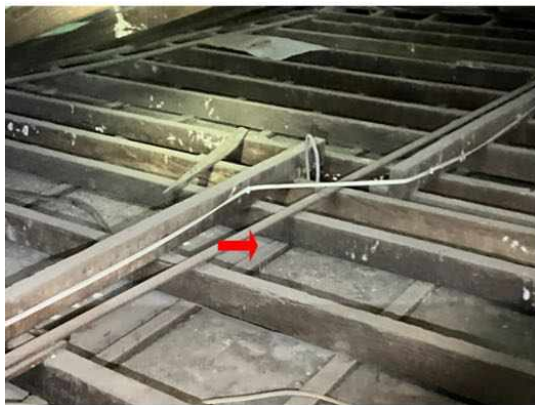
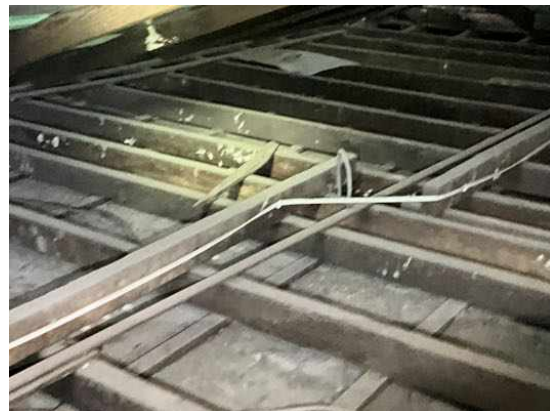
Finding 3.13

| Finding: | Sarking - Missing |
| Information: | Sarking is missing under the roof sheeting. Sarking acts as an insulator that helps with noise reduction and protects against water penetration. Sarking plays a key role in the operation and function of the overall roofing structure and its performance. |

Although not a requirement at the time of construction, replacement of any missing building element is advisable (although this can be quite expensive to do after the time of construction). Where sarking is missing, regular inspections of the roof tiles for cracking and potential moisture penetration is required.

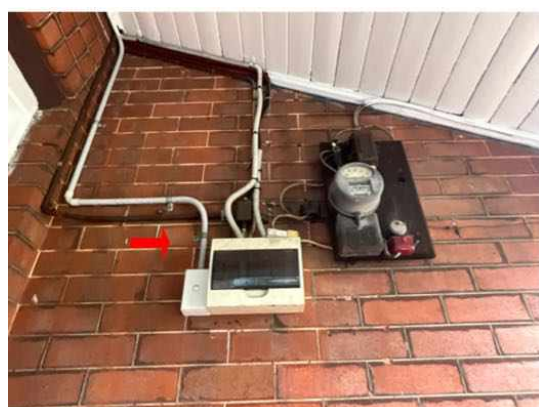
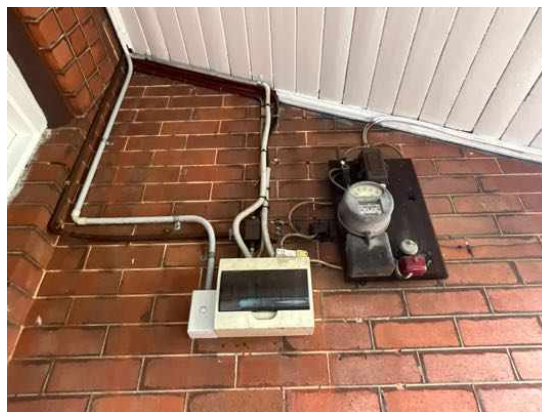
Building: Main Building
 Location: Front porch
 Finding: No Evidence of Termite Management System - Durable notice / Legible Sticker
 Information: The application of a pre & post-construction chemical termite barrier is highly recommended for all properties. Such barriers are highly effective in preventing termite attack on any timber building elements throughout the property.

A durable notice was not placed in the switchboard unit to indicate current termite barriers is legible at the time of inspection.

Client must seek further information from the vendor or real estate agent if the conditions of termite management systems were maintained.

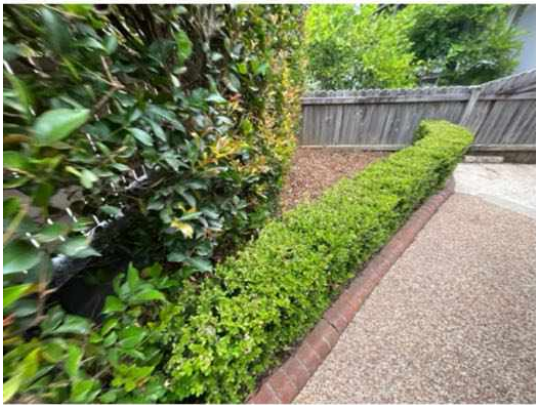
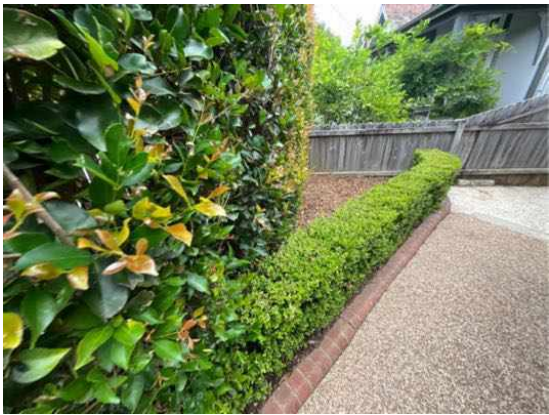
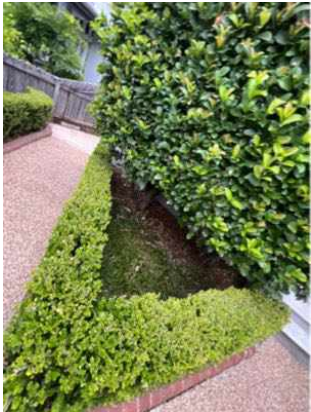
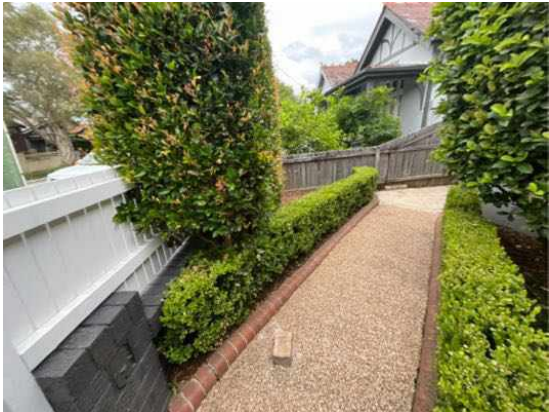
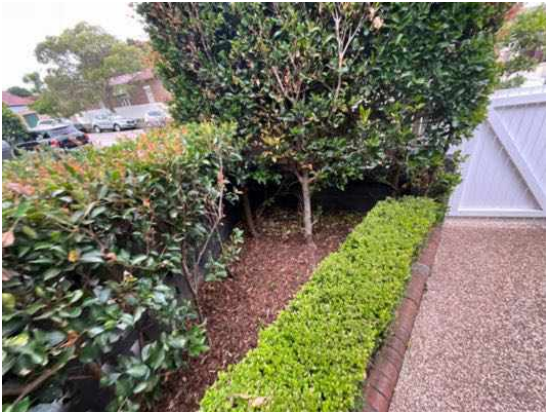
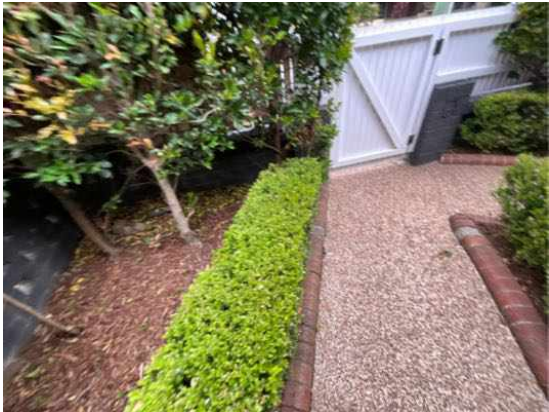
Finding 6.02

Building: Main Building
 Location: All Areas
 Finding: Dense vegetation around a property can increase the risk of termite infestation
 Information: The presence of dense vegetation around a property can increase the risk of termite infestation, as it provides a conducive environment for them. To address this, consider maintaining a clear space between the vegetation and your home. If you suspect a termite issue, it's advisable to consult with a licensed pest control professional for inspection and treatment.

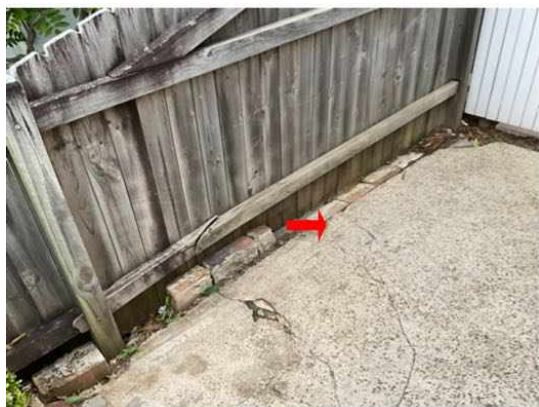
Finding 6.03

| Finding: | Timber on ground / conducive conditions to termite damage |
| Information: | Timber on the ground is indeed conducive to termite damage. Termites are known to thrive in moist environments, and wood in contact with soil or moisture is more susceptible to infestation. |

To prevent this, it's important to keep timber elevated and away from direct ground contact. Regular inspections and proper termite control measures are also essential to protect your wooden structures from termite damage.

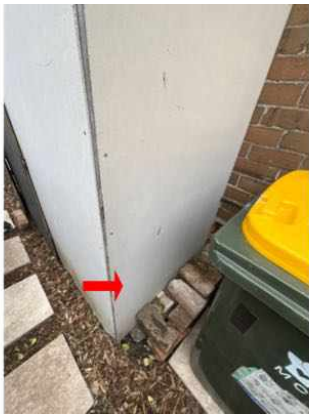
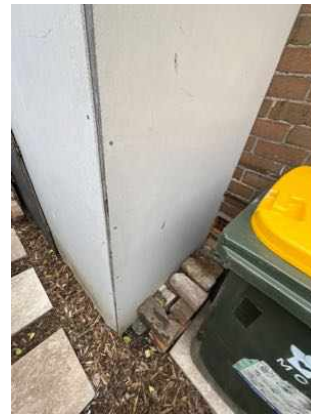
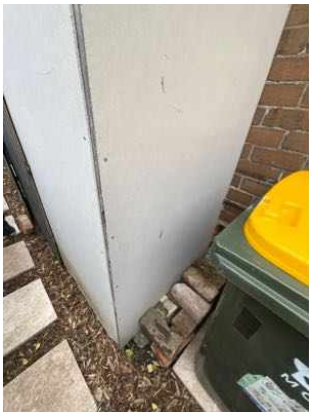
Finding 6.04

Where bridging has occurred full inspection is prevented and termites may enter a property in a concealed or undetected manner.

Recommended moving obstructions away from the external walls for further and future inspections.

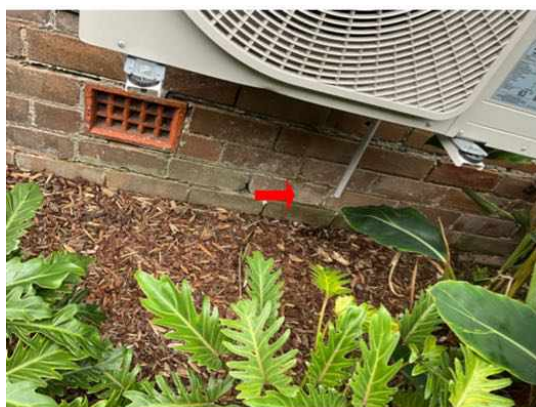
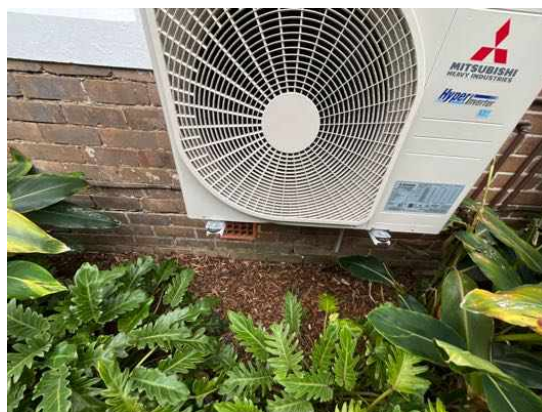
Finding 6.05

| Finding: | Aircon - Excessive moisture conducive condition near Air-conditioner |
| Information: | <p>Excessive moisture near an air conditioner can indeed create conducive conditions for termites. Termites are attracted to damp and decaying wood, which can be found in areas with high moisture levels. To fix this issue:</p> <ol style="list-style-type: none"> 1. Fix Leaks: Check for any leaks or condensation around your air conditioning unit. Repair any damaged pipes, drains, or insulation that may be causing moisture buildup. |

2. Proper Drainage: Ensure that your air conditioner has proper drainage. Make sure the condensate drain line is clear and directed

away from your home's foundation.

3. Ventilation: Improve ventilation around the unit. Ensure that the area is well-ventilated to reduce humidity levels.

4. Regular Maintenance: Schedule regular maintenance for your air conditioning system. This can help prevent leaks and ensure

it's working efficiently, reducing the chance of moisture.

5. Please consult a HVAC Technician: HVAC (Heating, Ventilation, and Air Conditioning) technicians are trained to diagnose and

repair a wide range of air conditioning problems. They can handle issues with the cooling system, refrigerant, electrical components, and more.

6. Consult an appropriate and Qualified Professional: For severe moisture issues or persistent termite problems, consult with a

pest control professional who can provide targeted solutions.

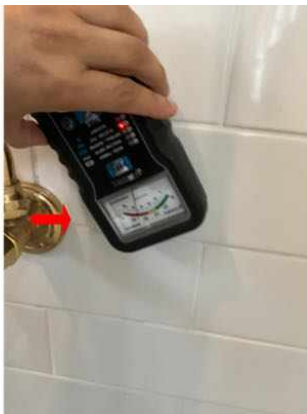
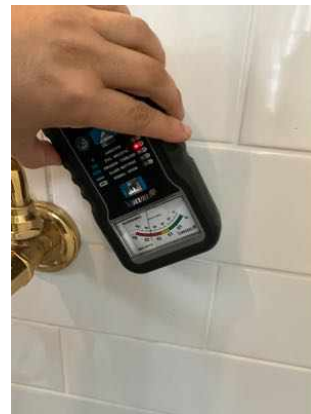
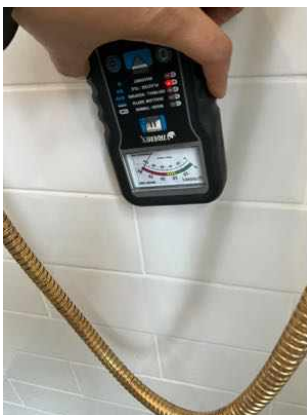
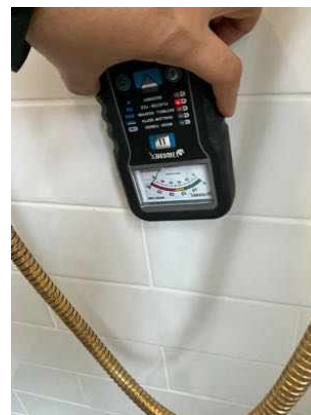
Finding 6.06

| Finding: | Excessive moisture - Conducive to Timber pest |
| Information: | Excessive moisture can attract termites and produce conditions that promote fungal growth and wood decay. |

Excessive moisture is generally caused by deteriorated inadequate or missing roof

Prior to any remedial works being performed a qualified plumber should be appointed to further inspect the property and to identify the cause of the excessive moisture. Works to remove affected building elements may then be necessary and should be performed by an appropriate tradesperson.

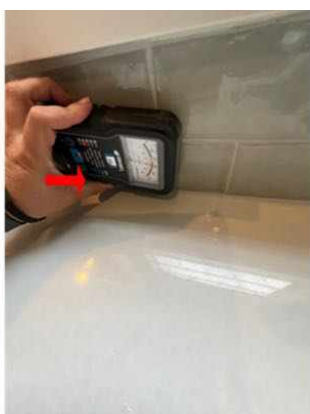
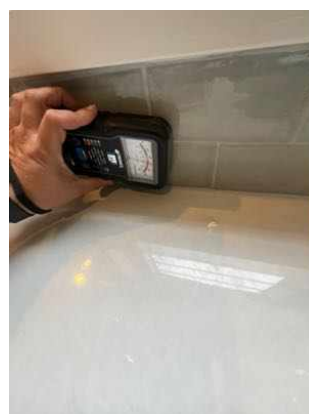
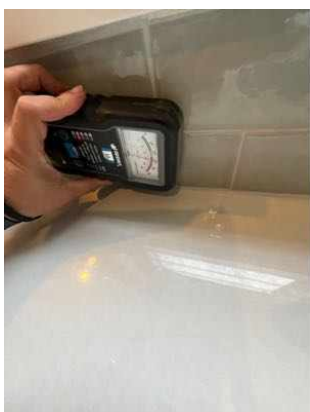
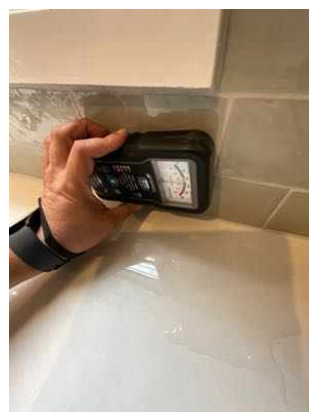
Finding 6.07

| Finding: | Excessive moisture - Conducive to Timber pest |
| Information: | Excessive moisture can attract termites and produce conditions that promote fungal growth and wood decay. |

Excessive moisture is generally caused by deteriorated inadequate or missing roof drainage leaking plumbing pipes or fixtures poorly plumbed HWS overflows or condenser units and poor site drainage.

Prior to any remedial works being performed a qualified plumber should be appointed to further inspect the property and to identify the cause of the excessive moisture. Works to remove affected building elements may then be necessary and should be performed by an appropriate tradesperson.

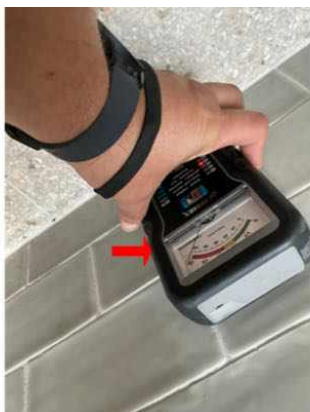
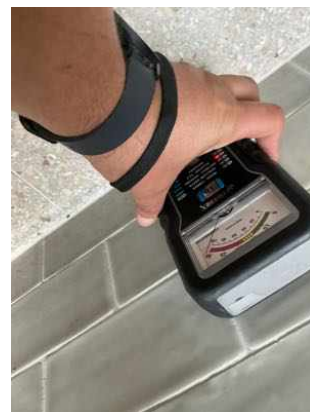
Finding 6.08

| Finding: | Excessive moisture - Conducive to Timber pest |
| Information: | Excessive moisture can attract termites and produce conditions that promote fungal growth and wood decay. |

Excessive moisture is generally caused by deteriorated inadequate or missing roof drainage leaking plumbing pipes or fixtures poorly plumbed HWS overflows or condenser units and poor site drainage.

Prior to any remedial works being performed a qualified plumber should be appointed to further inspect the property and to identify the cause of the excessive moisture. Works to remove affected building elements may then be necessary and should be performed by an appropriate tradesperson.

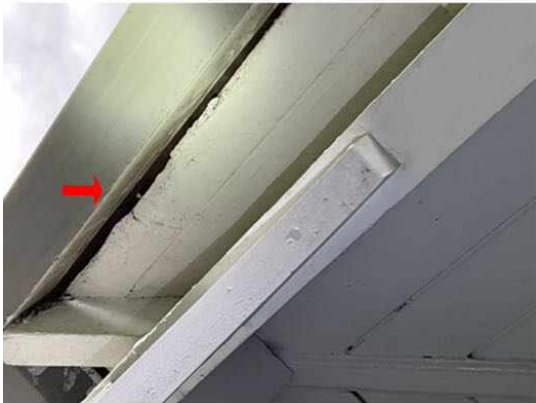
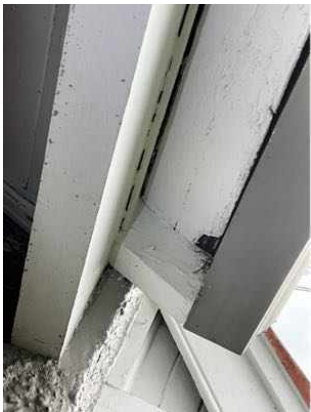
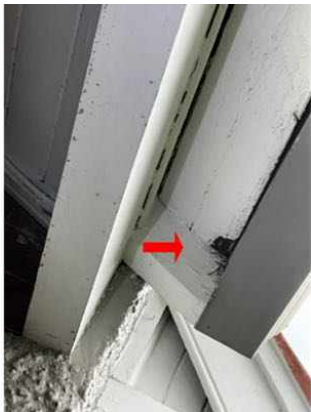
Finding 7.01

| Finding: | Wood rot |
| Information: | This building element shows evidence of wood rot. Wood rot, also known as Fungal Decay, occurs when timbers and other cellulose building materials are exposed to damp conditions on an ongoing basis. This could be the result of exposure to weathering over a prolonged period of time, or the attraction of excessive moisture from other abutting building materials. Contributing factors also include poor air ventilation in the area. |

Wood rot is often associated with general damp problems and is evidenced by a 'musty' smell or mould and mildew occurring on surfaces. If left unmanaged, damp conditions can lead to further health problems and the decay of timbers will continue.

Early intervention and regular maintenance, particularly of exterior timbers, will prolong the useful life of these building elements. Prior to any works being performed, the cause of the moisture that has created the visible wood rot should be identified and addressed in a suitable manner. Replacement of affected timbers may then be a necessary step in protecting surrounding building elements from such deterioration.

A qualified plumber may be appointed to assess the cause of excessive moisture and to provide advice on any remedial works as required. A qualified carpenter or registered builder may also be required to replace affected building materials.
