Building and Timber Pest Inspection Report

Inspection Date: Thu, 22 Jan 2026

Property Address: 29 Wardell Rd, Lewisham NSW 2049,
Australia

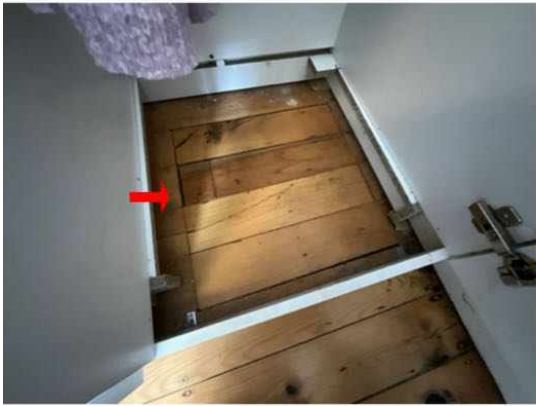
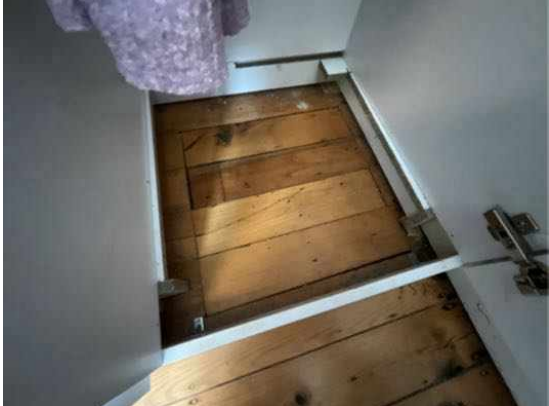
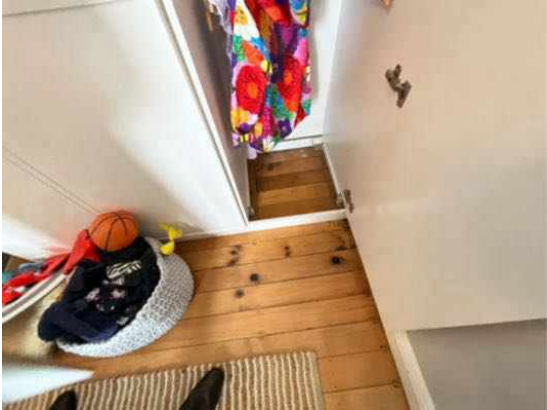
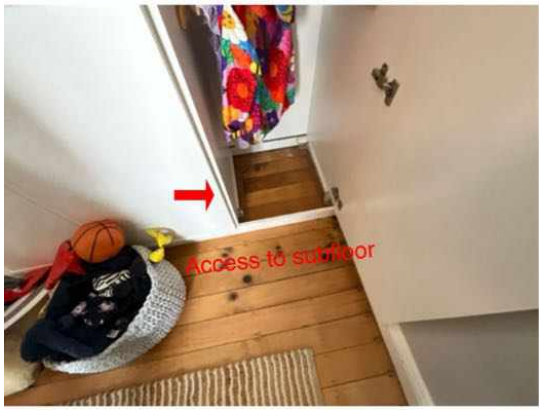
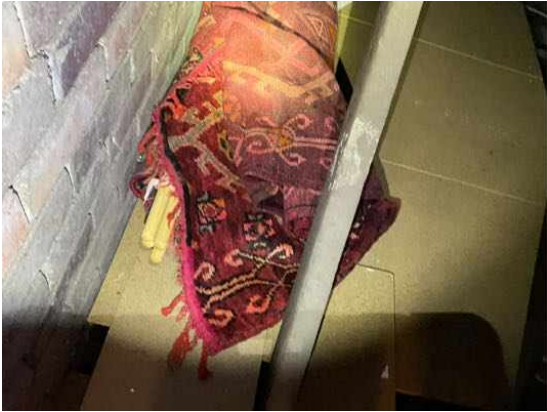
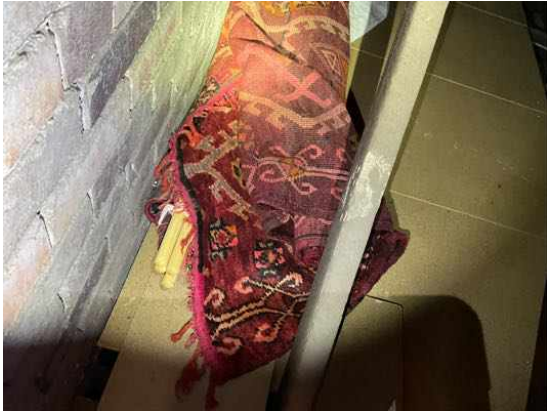
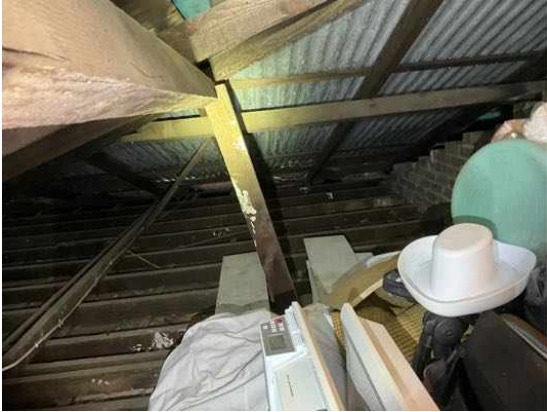
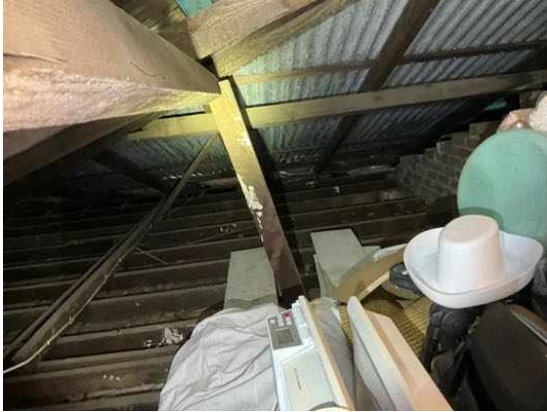
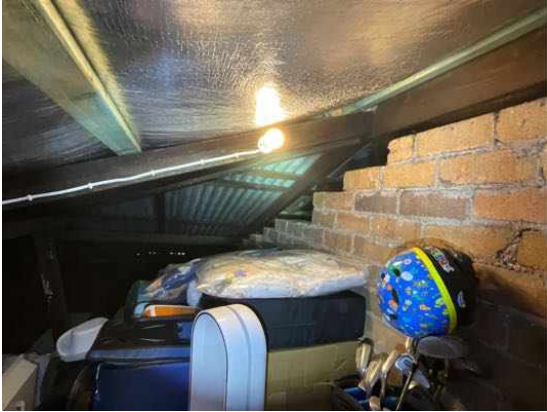
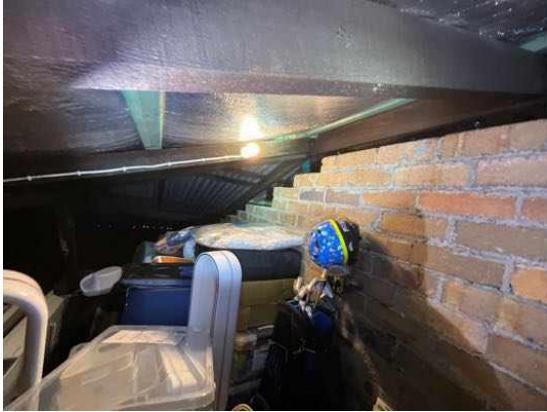
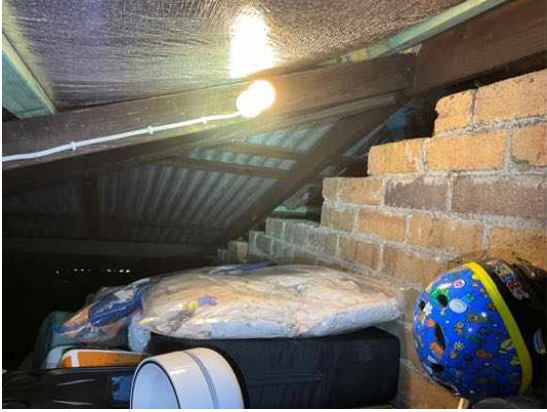
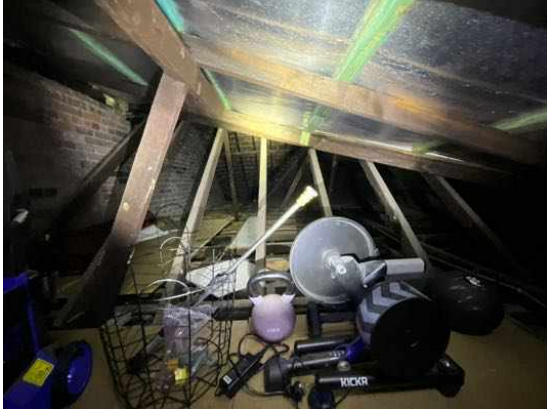
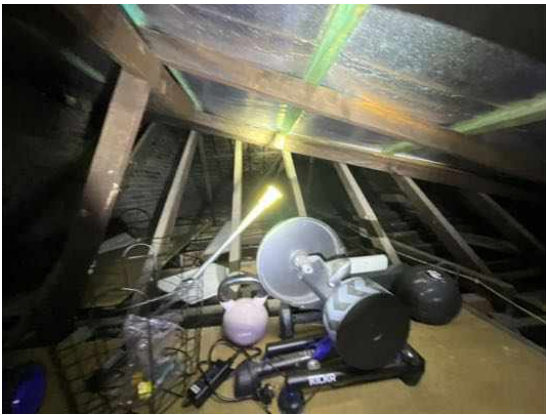
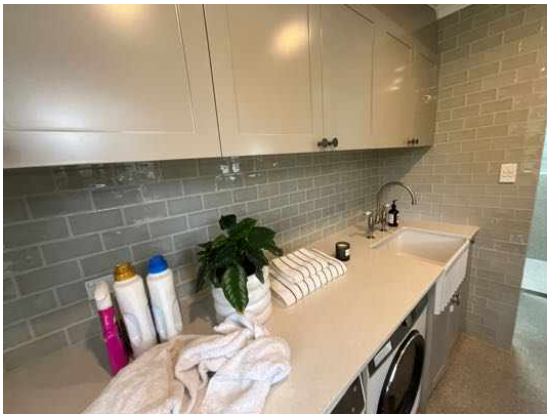
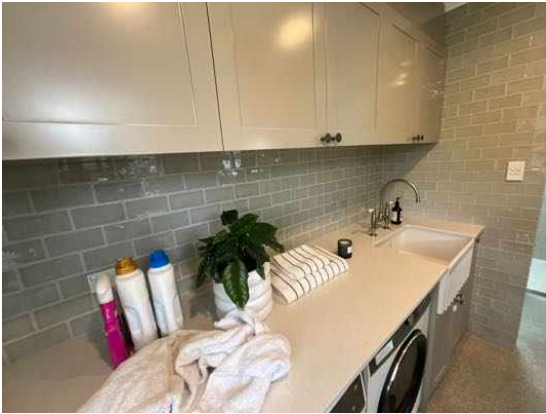
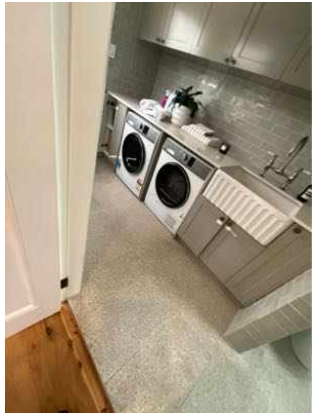
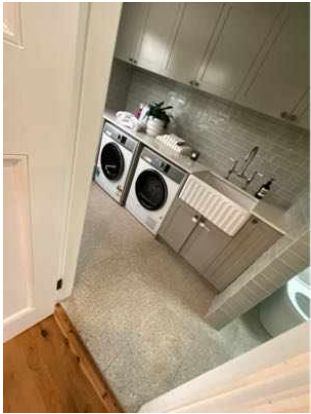
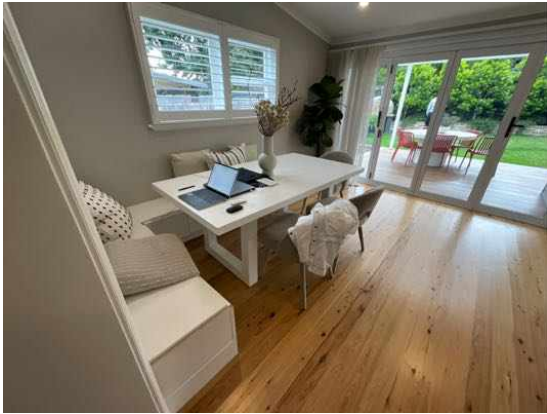
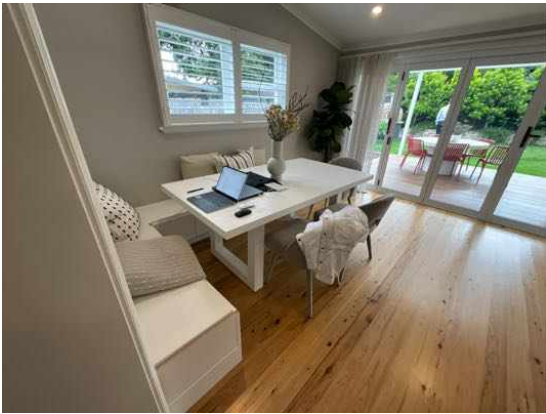
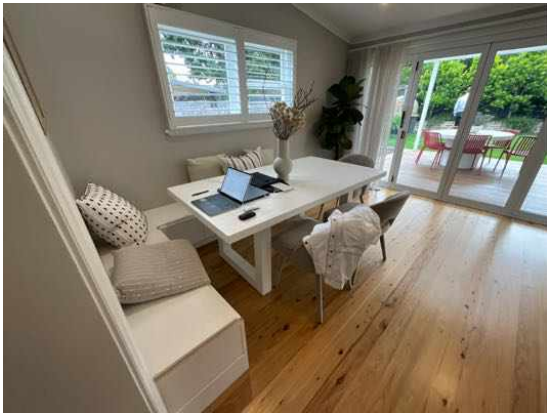
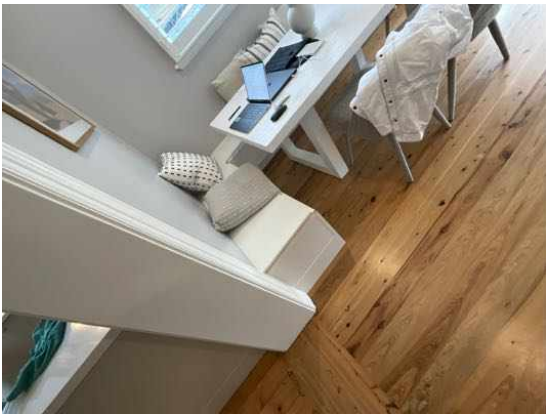
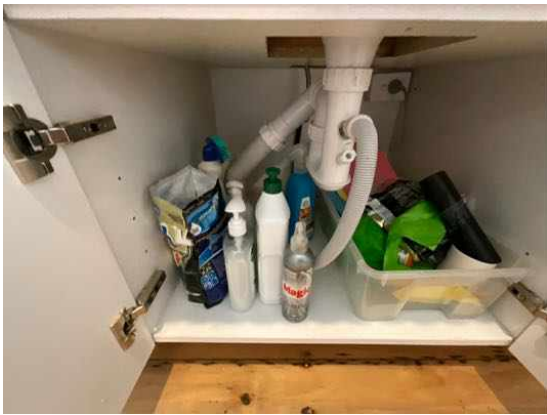
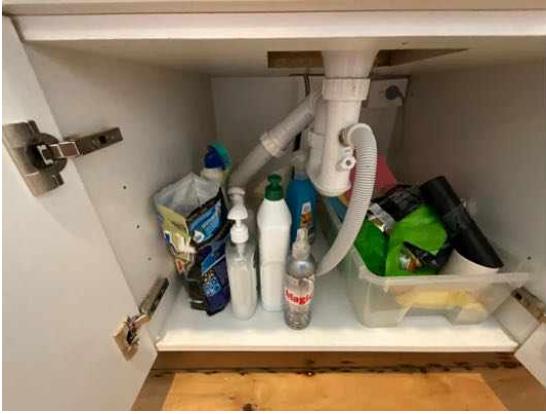
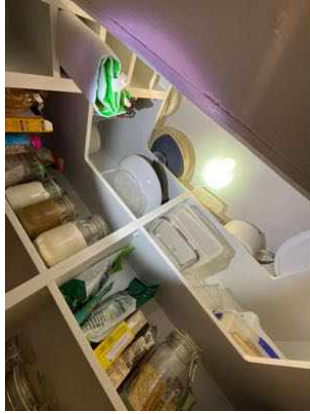
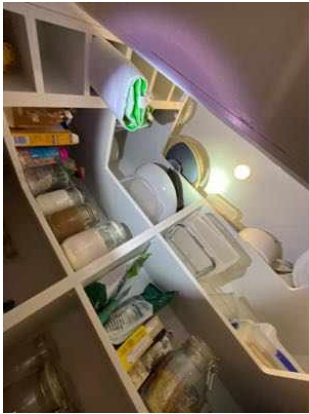
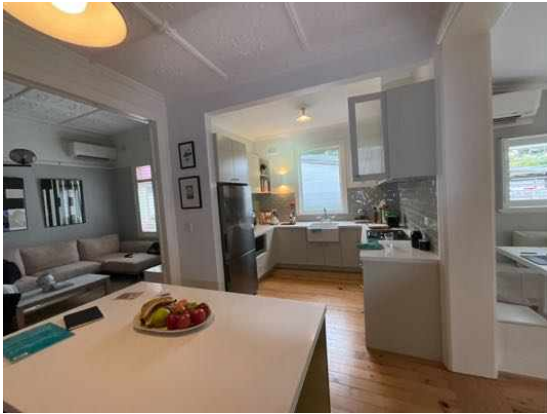
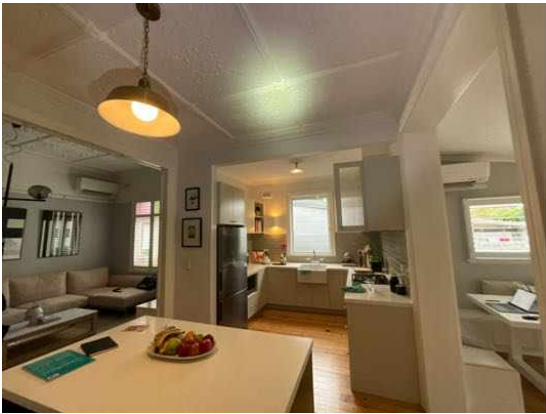
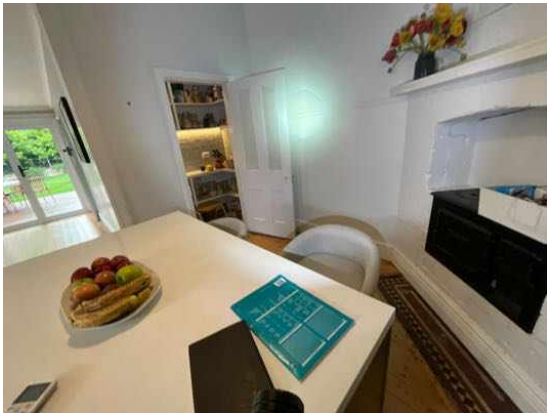
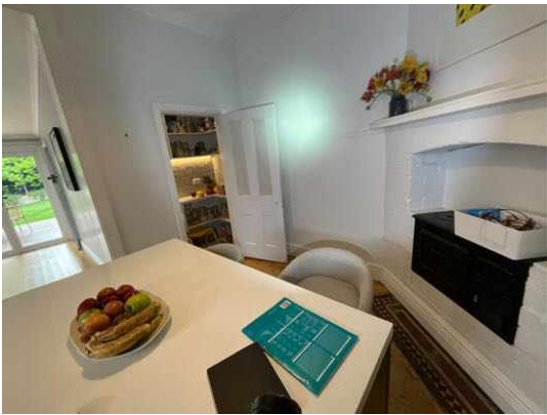
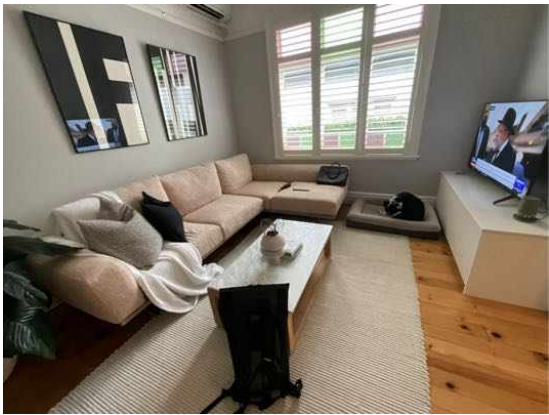
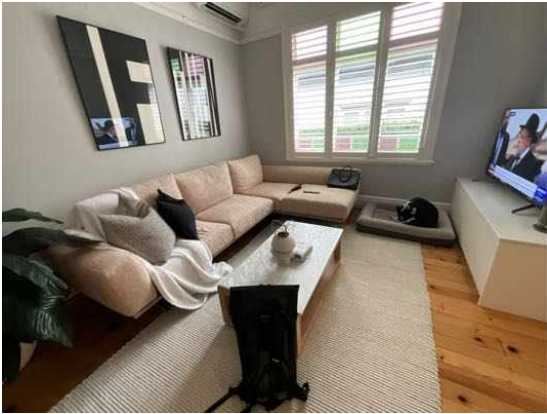
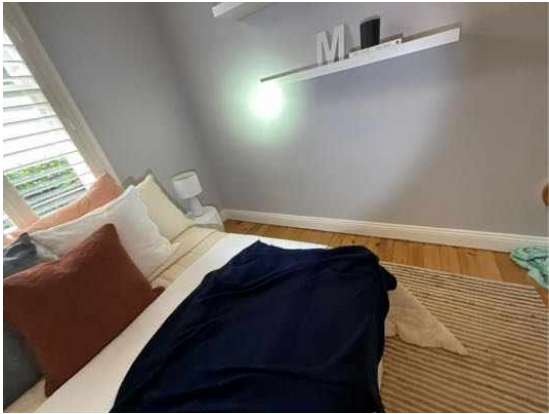
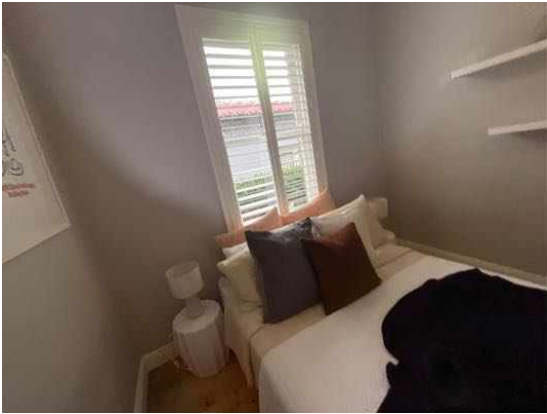
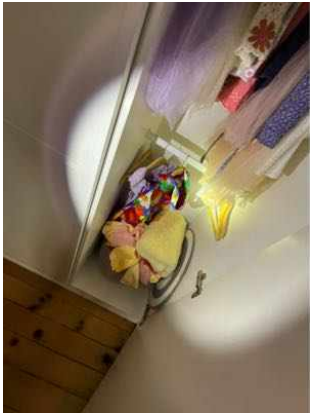
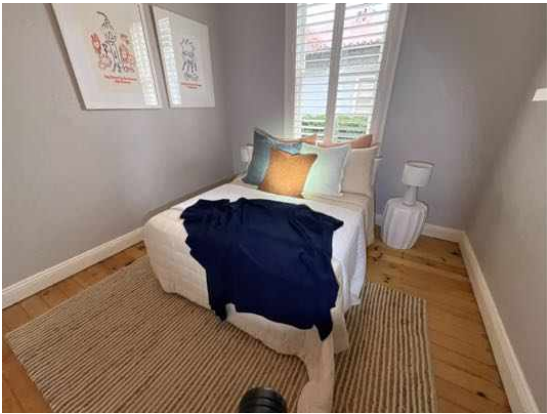
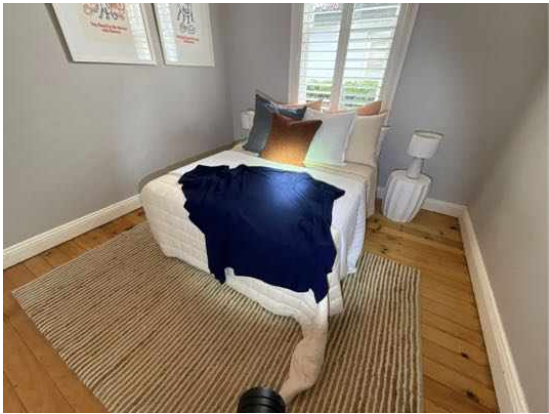
Building: Main Building
Location: All Areas
Finding: Additional Photos - Obstructions and Limitations
Information: These photographs are an indication of the obstructions and limitations which impeded full inspection of the property at the time of inspection. These obstructions can hide an array of defects and should be removed to allow full inspection to be carried out. A re-inspection is recommended once the areas are made accessible.
