Timber Pest Inspection Report

Inspection Date: Fri, 13 Feb 2026

Property Address: 13 Zealandia Rd W, Croydon North VIC
3136, Australia

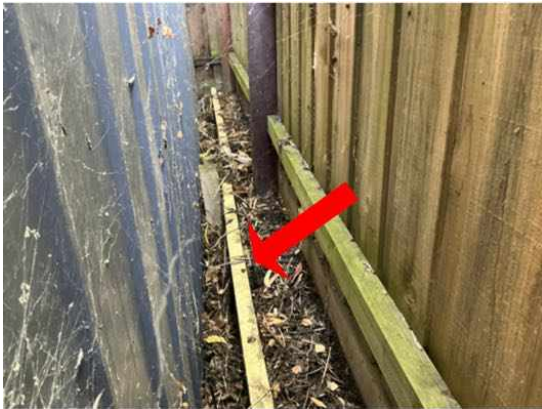
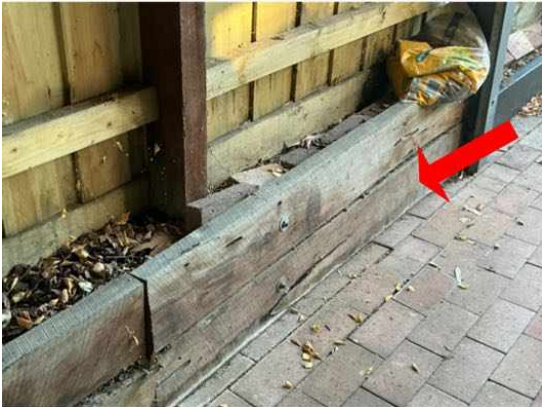
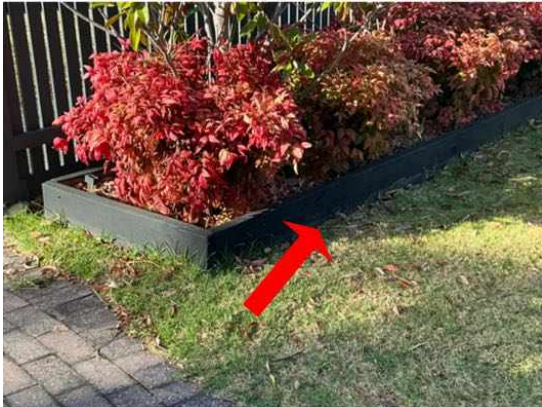
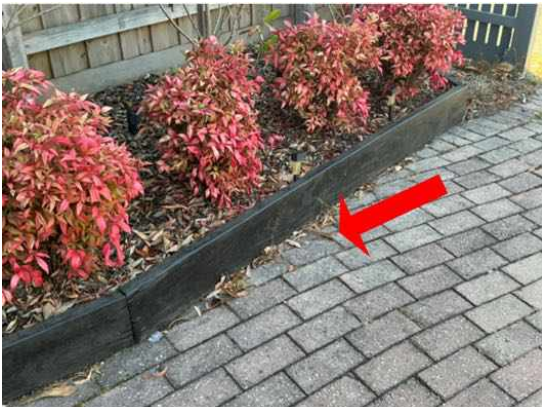
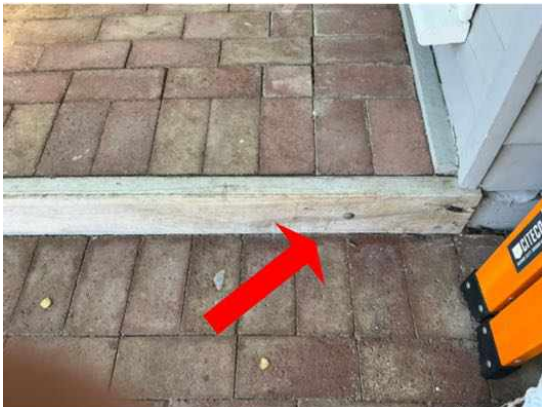
Building: Main Building
Location: All External Areas >
Finding: Untreated or non-durable timbers in a hazardous environment- garden
Information: To reduce the risk of timber pest attack it is essential that timber used in a hazardous environment (e.g. in direct contact with the ground or frequently exposed to damp conditions) is of sufficient durability and/or is adequately preservative treated.

Untreated timbers in direct contact with the ground are likely to develop severe wood rot and/or fungal decay if left unattended creating attraction for subterranean termites to infest the timbers from surrounding areas.

If untreated or non-durable timbers are found to be in a hazardous environment it is highly advised that replacement of these building elements be performed as soon as possible to aid the protection of the property against termite / timber pest attack.

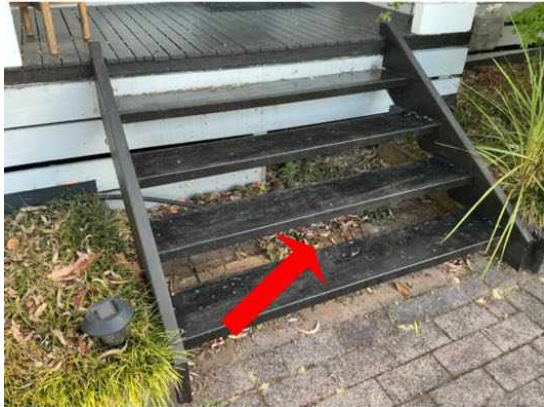
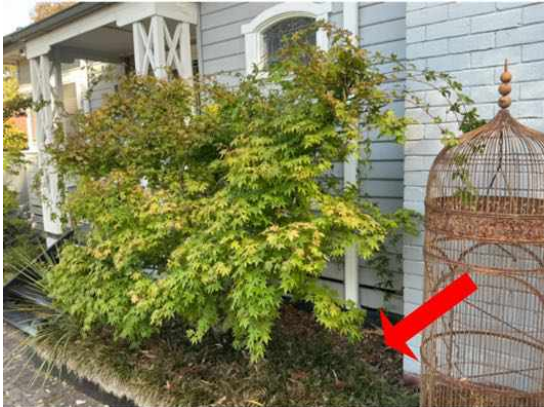
Termite and Timber Pest 4.02

Building: Main Building
Location: All External Areas
Finding: Garden Beds - Conditions Conducive to Termites
Information: Garden beds were found to be evident in the garden area. These garden beds can include untreated timber, and with a combination of moisture from watering hosing can make conditions conducive to termite activity and termite ingress.

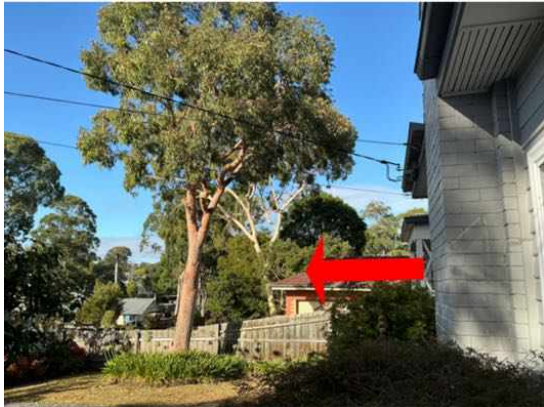
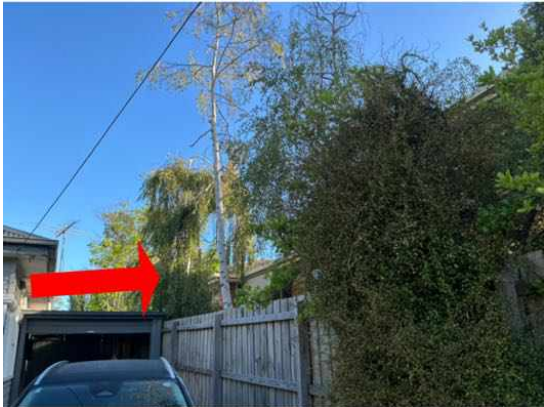
Termite and Timber Pest 4.03

Building: Main Building
 Location: All External Areas
 Finding: Trees/large/termite
 Information: It was observed that there were several large trees next to or nearby the building.

The trees have the potential to provide conducive conditions for termite infestation

It is recommended that periodic 12 monthly inspections by a registered pest control contractor be undertaken and further reinstatement of outdated termite barriers as soon as possible.

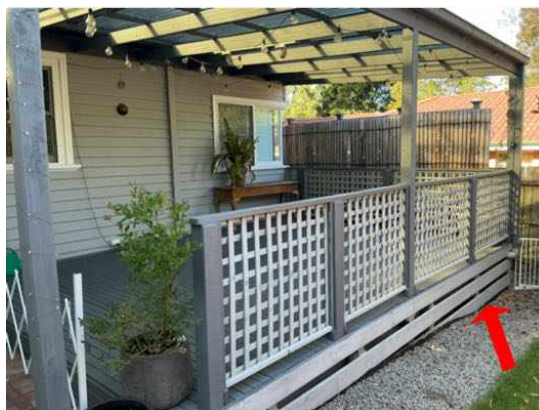
Termite and Timber Pest 4.04

Building:	Main Building
Location:	All Areas
Finding:	Untreated or non-durable timbers in a hazardous environment- building
Information:	To reduce the risk of timber pest attack it is essential that timber used in a hazardous environment (e.g. in direct contact with the ground or frequently exposed to damp conditions) is of sufficient durability and/or is adequately preservative treated.

Untreated timbers in direct contact with the ground are likely to develop severe wood rot and/or fungal decay if left unattended creating attraction for subterranean termites to infest the timbers from surrounding areas.

If untreated or non-durable timbers are found to be in a hazardous environment it is highly advised that replacement of these building elements be performed as soon as possible to aid the protection of the property against termite / timber pest attack.

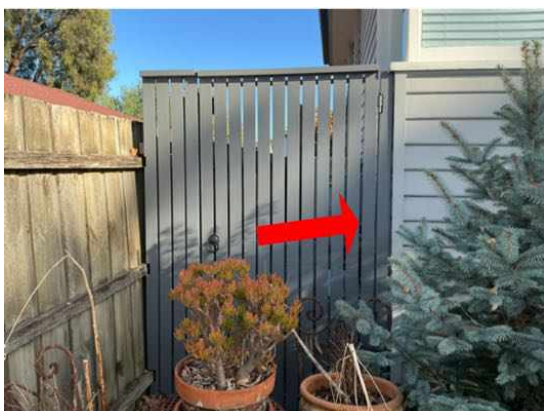
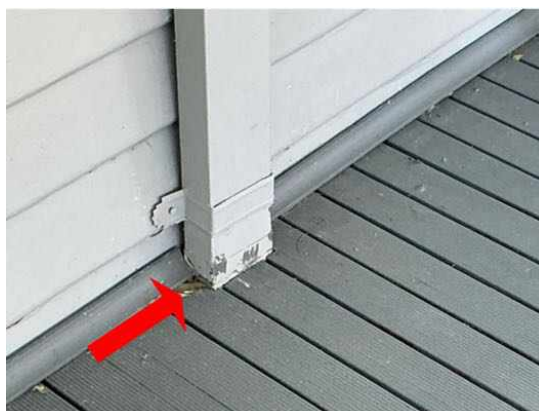
Termite and Timber Pest 4.05

Building: Main Building
Location: All External Areas
Finding: Bridging or breaching of termite barriers - adjacent internal flooring
Information: Bridging is the spanning of a termite barrier or inspection zone so that subterranean termites are provided with passage over or around that barrier.

It is important for internal flooring to be raised above adjacent external ground levels. Where external ground levels are above internal flooring water pooling and subsequent internal flooding is likely to occur which may attract termite activity to the internal area.

It is highly advised that a landscaper or paver be appointed to lower external grounds that are raised above adjacent internal flooring. Alternatively if external grounds and internal flooring is level installation of a raised door sill may be appropriate in preventing any water pooling in the area.

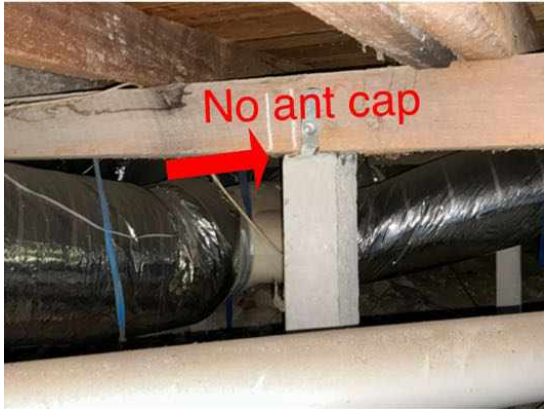
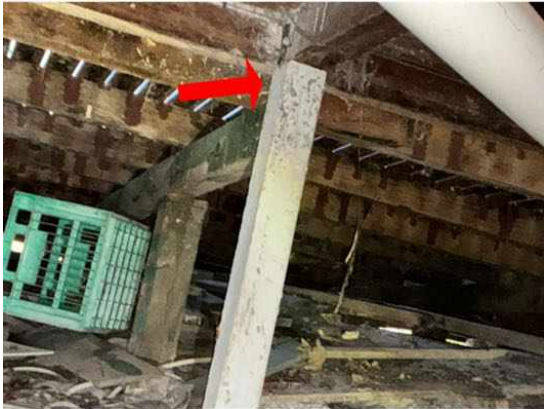
Building: Main Building
Location: Subfloor
Finding: Ant caps -part installed
Information: Ant caps have been part installed to the subfloor structure at the time of inspection. Generally, ant caps are installed to the intersection between the top of the stumps (or piers) and the subfloor structures. It was noted at the time of the inspection that the stumps were concrete and timber some with and someone without ant caps

Installed during the construction process, ant caps are designed to easily identify termite or pest ingress from stumps to the adjoining bearers.

Where ant caps have not been installed, frequent monitoring of these areas should be carried out in order to identify any signs of termite or timber pest workings.

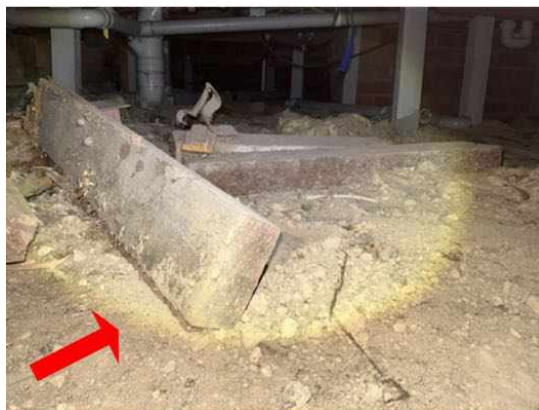
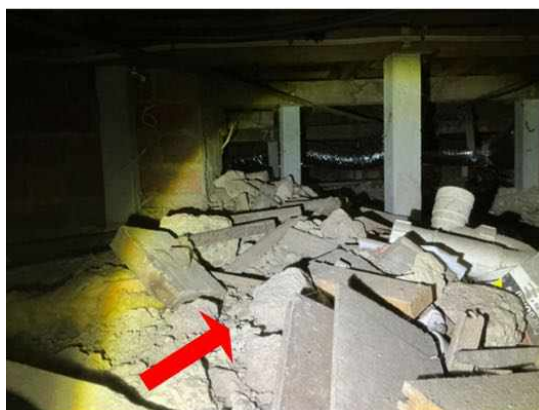
Termite and Timber Pest 4.09

Building:	Main Building
Location:	Subfloor
Finding:	Stored timbers - subfloor space or external area
Information:	The storing of timbers in the subfloor space or around the external property increases the risk of termite activity being present. As they are likely to come into contact with weather conditions or excessive moisture wood rot is likely to develop on timbers that are not treated.

It is highly recommended that any stored timbers be immediately removed from areas in which they may attract any termite / timber pest attack. Minimisation of risk / prevention of termite attack is far more adequate than dealing with the presence of termite activity.

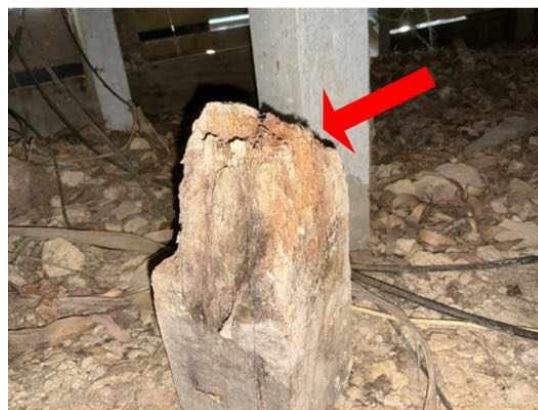
Building:	Main Building
Location:	Subfloor
Finding:	Evidence of termite damage - minor
Information:	Despite no live termite or timber pest activity being indicated, previous termite damage was found to have affected this area. This damage is considered to be inactive and is minor in nature.

It is advised that the area be visually inspected frequently to ensure that the condition of affected building materials does not worsen. At the time of inspection, damage is not structural and is only considered to be superficial.

A building contractor may be appointed to provide a further invasive inspection if further damage is evident.

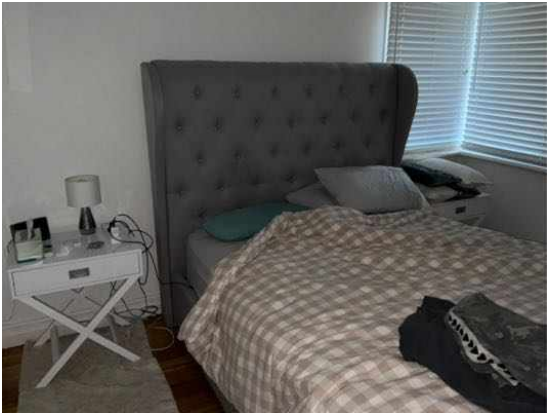
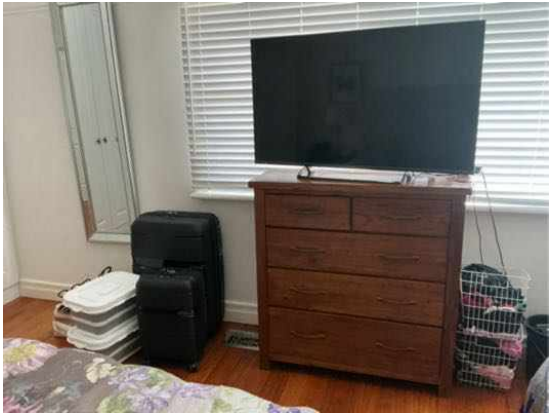
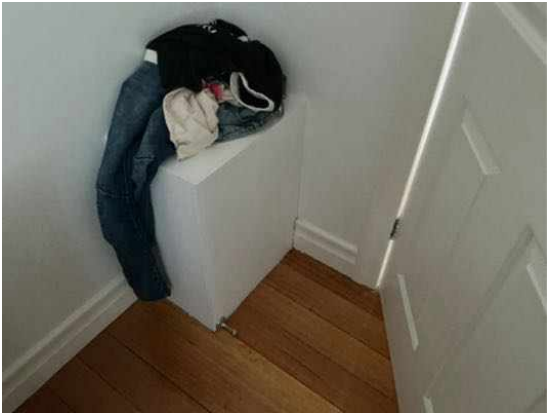
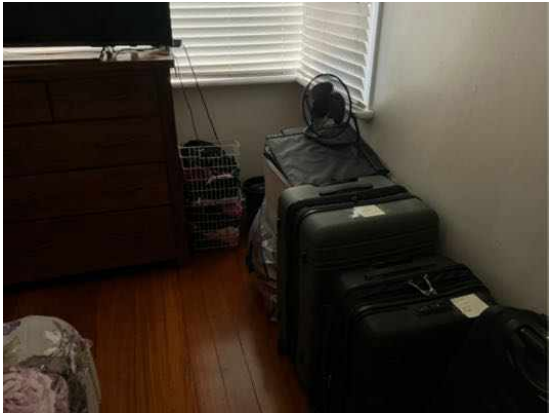
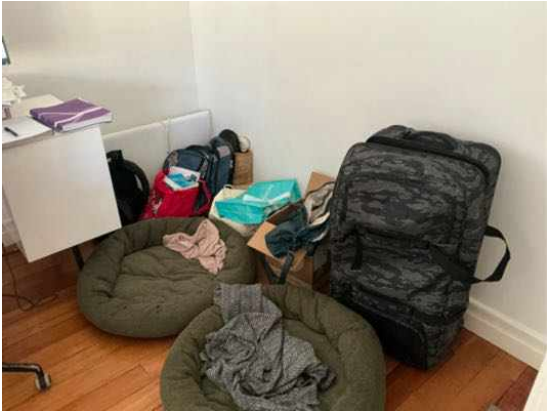
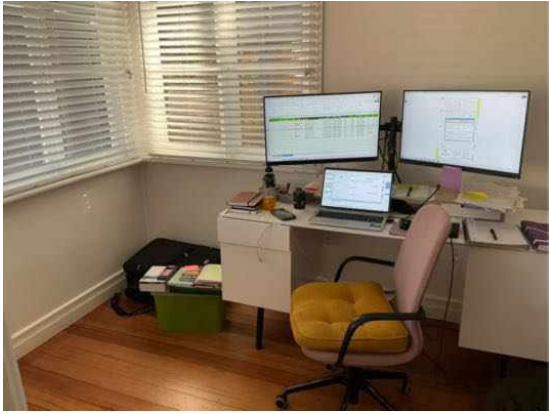
Building: Main Building
Location: All Areas
Finding: Additional Photos - Obstructions and Limitations
Information: These photographs are an indication of the obstructions and limitations which impeded full inspection of the property at the time of inspection. These obstructions can hide an array of defects and should be removed to allow full inspection to be carried out. A re-inspection is recommended once the areas are made accessible.

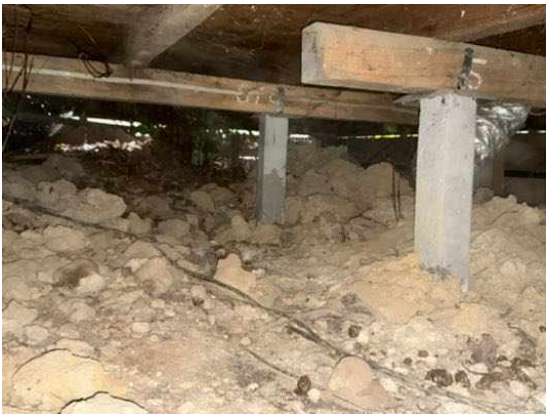
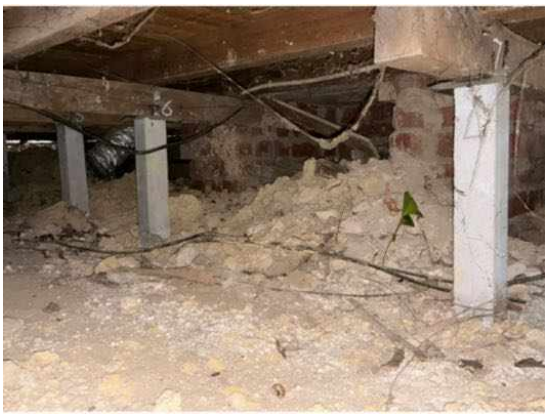
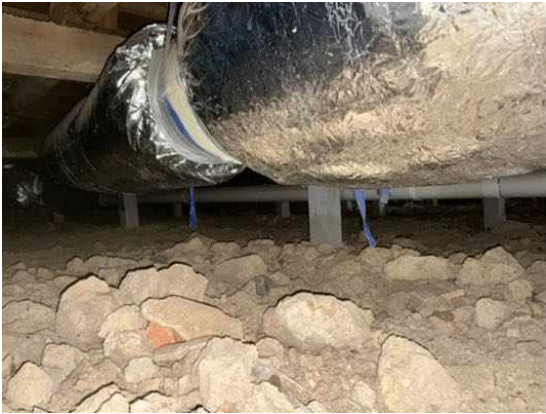
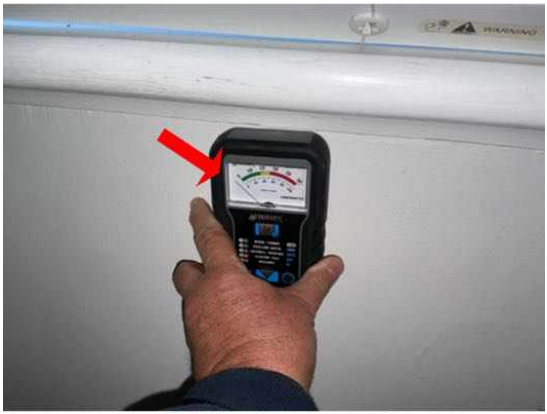
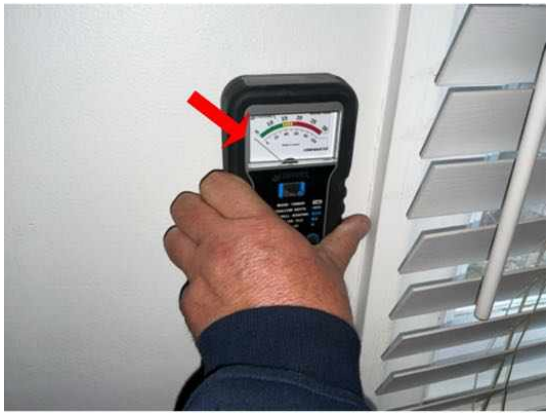
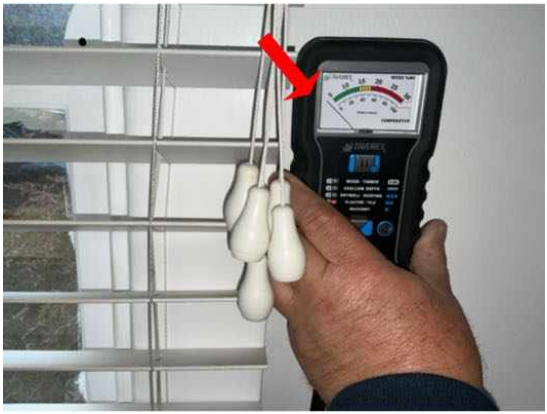
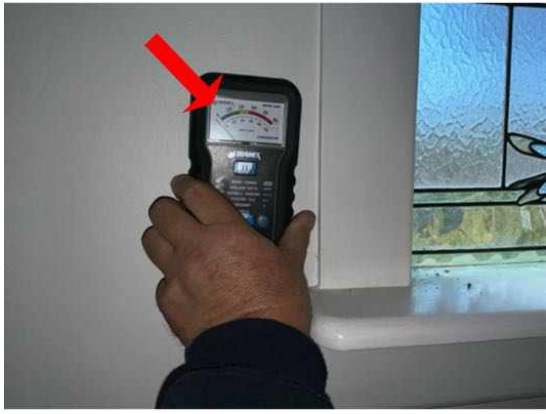
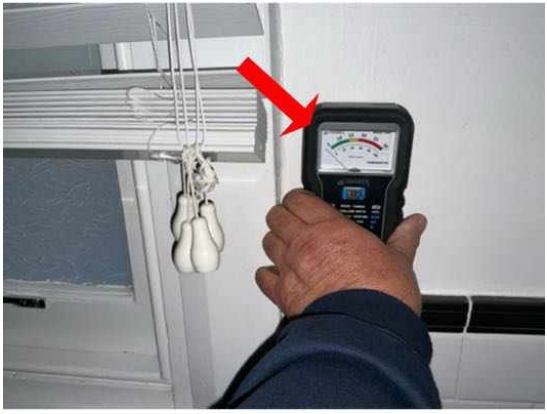
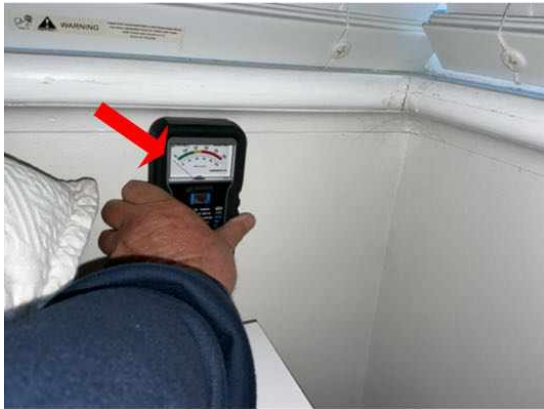
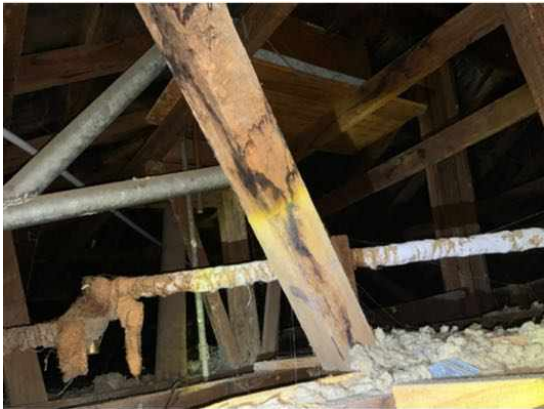
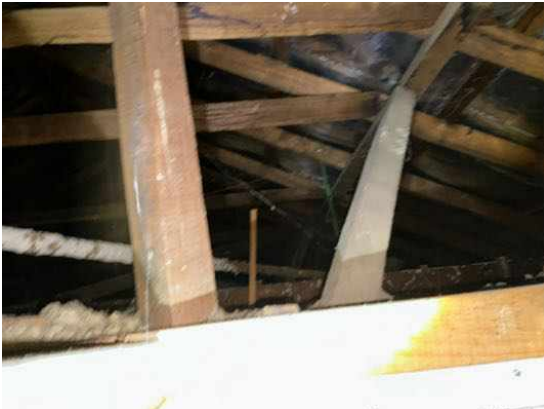
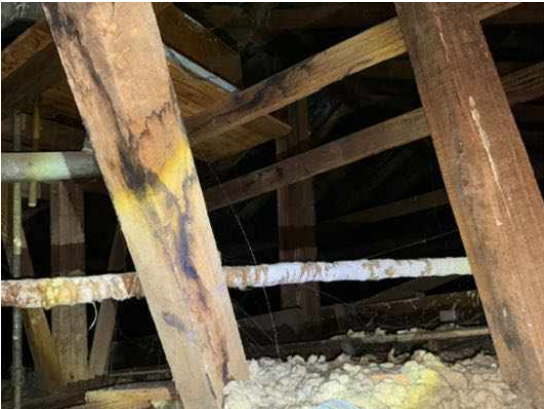
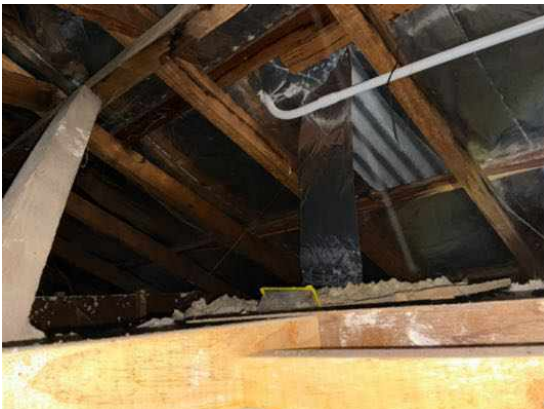
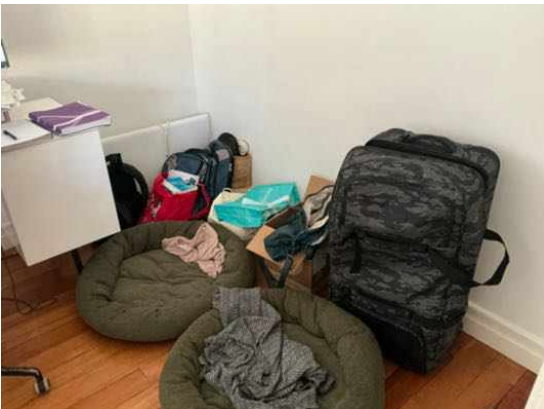
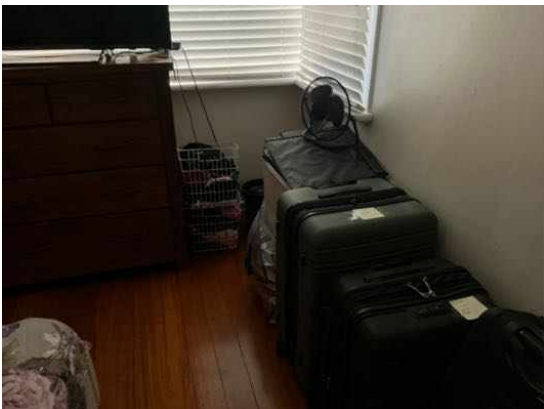
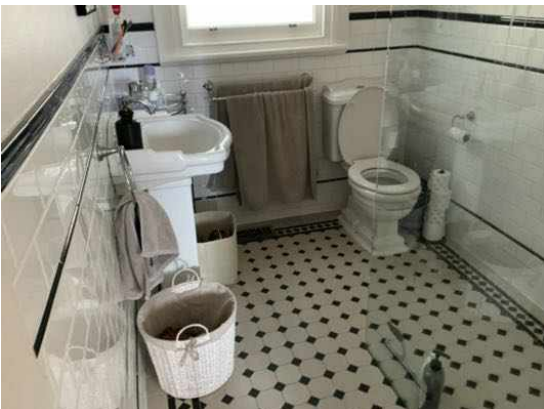
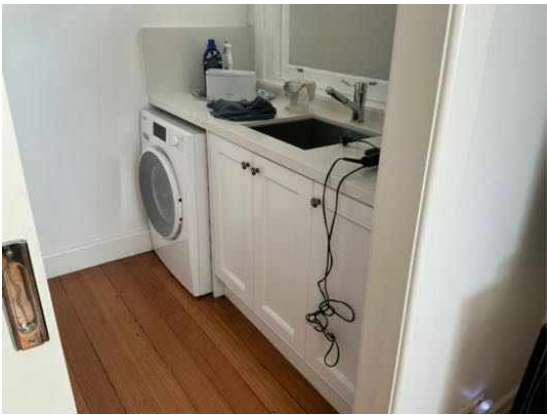
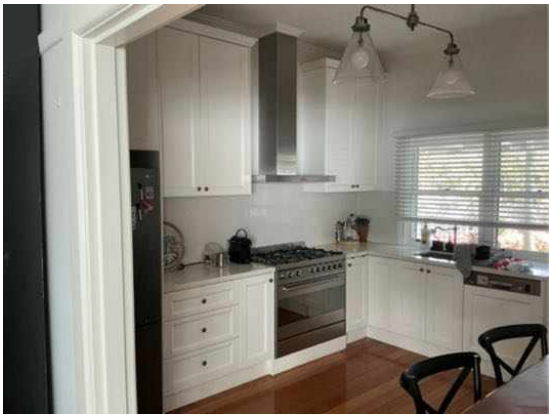
Building: Main Building
Location: All Areas
Finding: Additional Photos
Information: Additional photos are provided for your general reference
