Building and Timber Pest Inspection Report

Inspection Date: Tue, 10 Feb 2026

Property Address: 335 Driftway Dr, Pemulwuy NSW 2145,
Australia

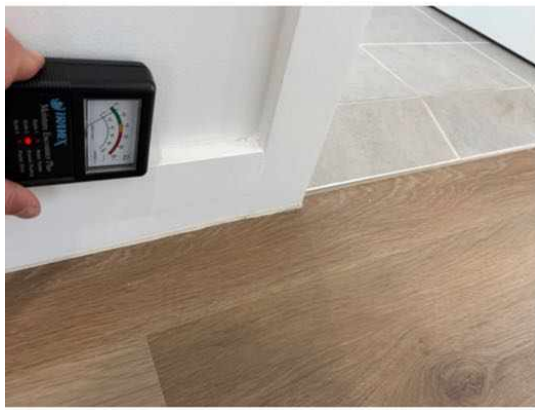
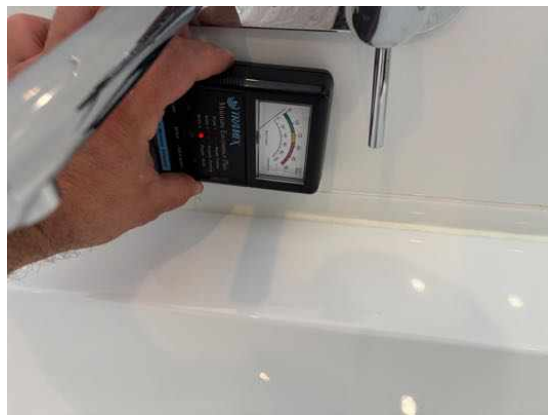
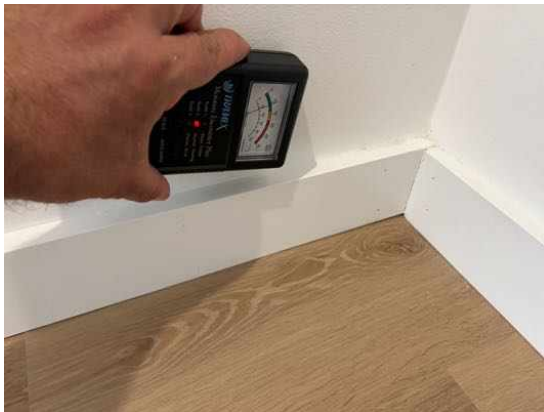
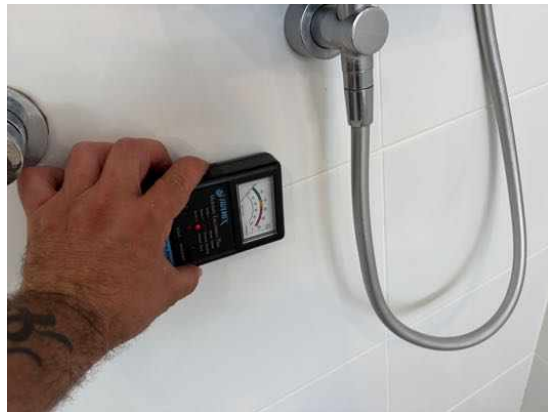
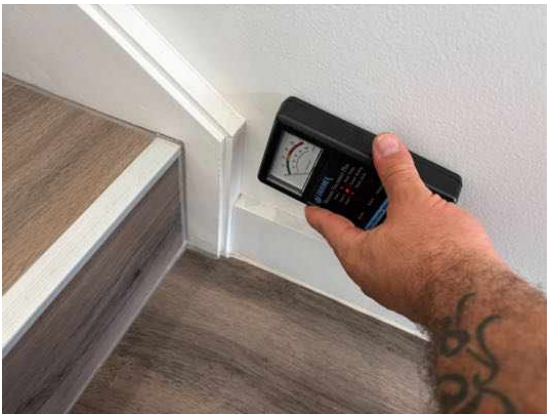
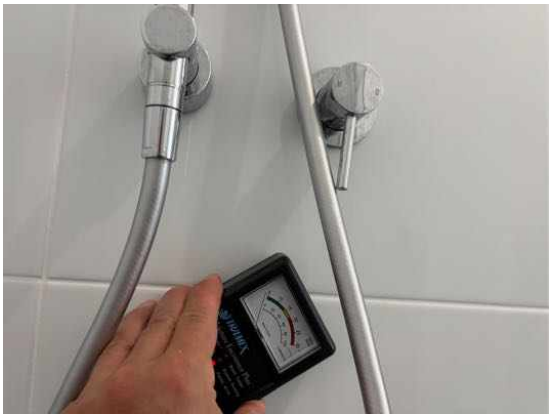
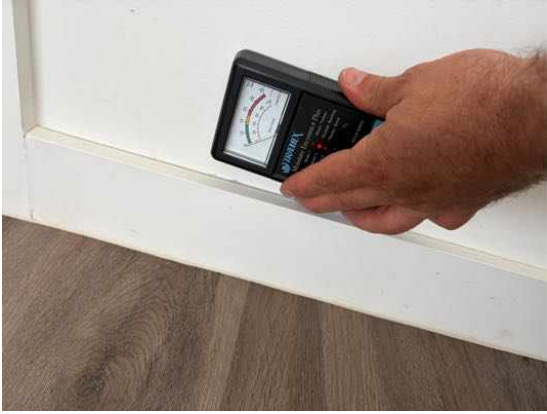
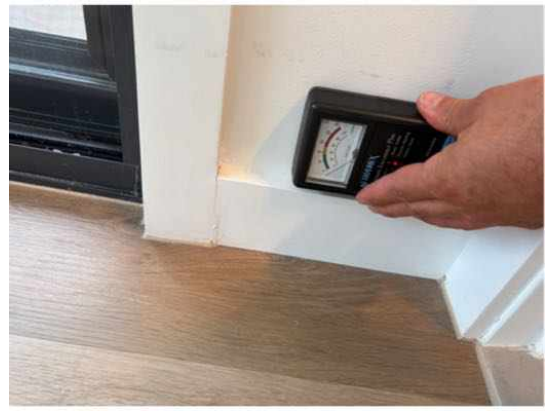
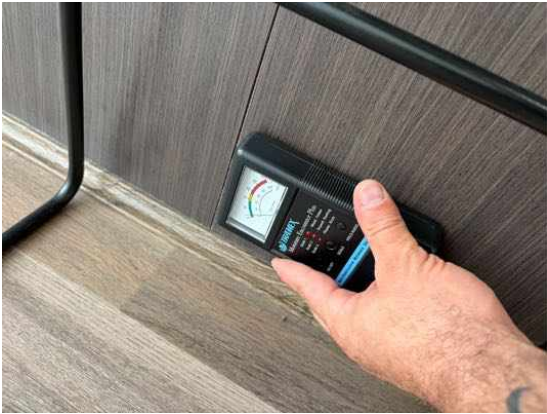
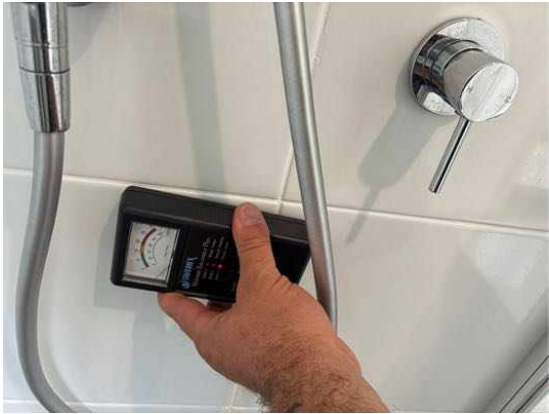
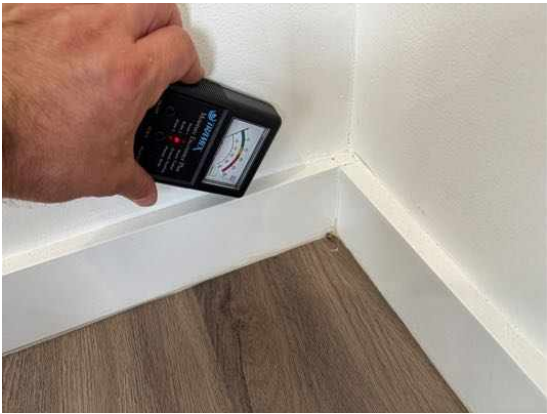
Building: Main Building
Location: All Areas
Finding: Moisture metre
Information: During the inspection the property was checked for moisture using a moisture metre.

This is for information only.

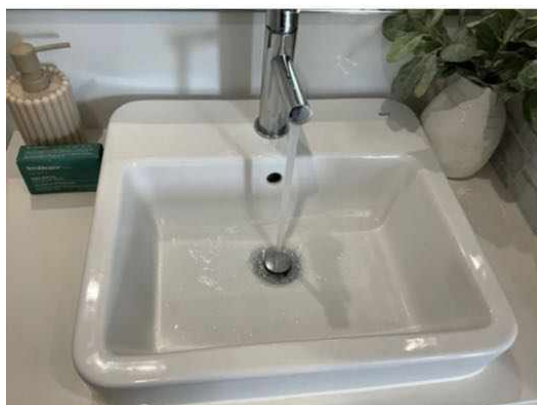
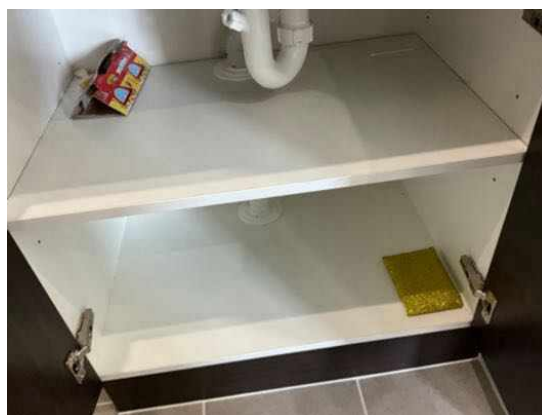
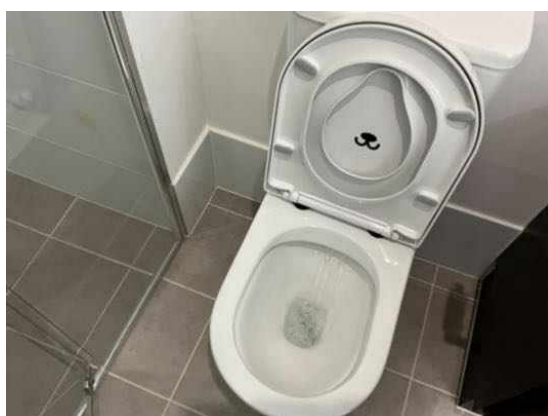
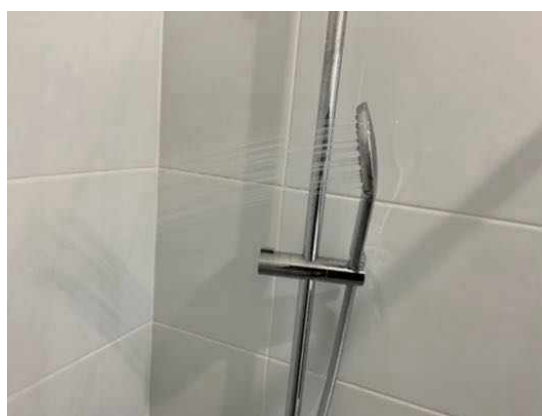
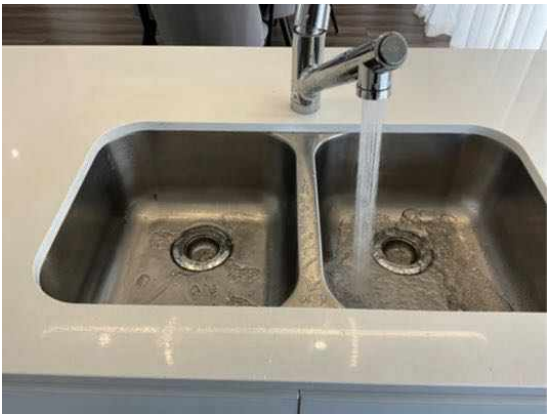
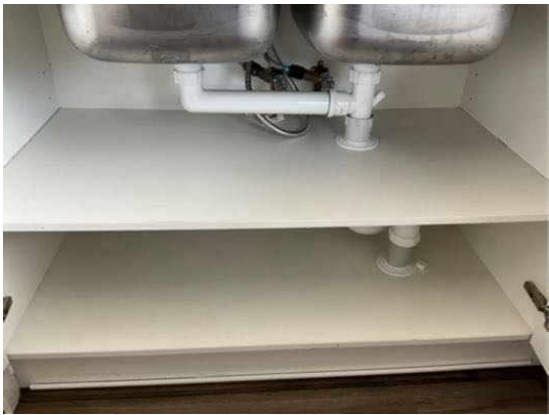
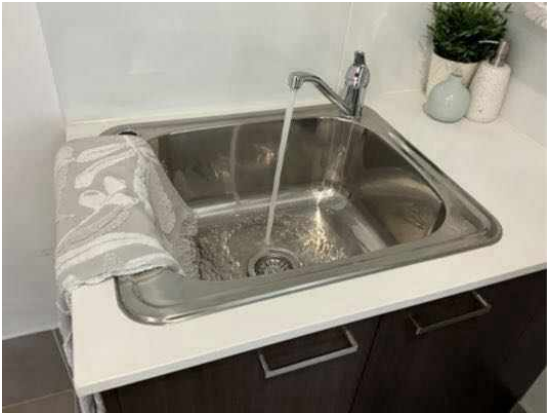
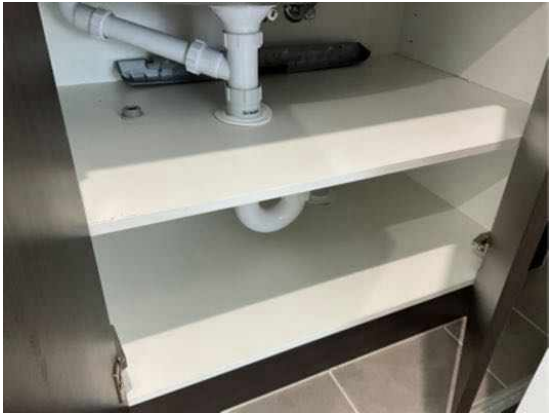
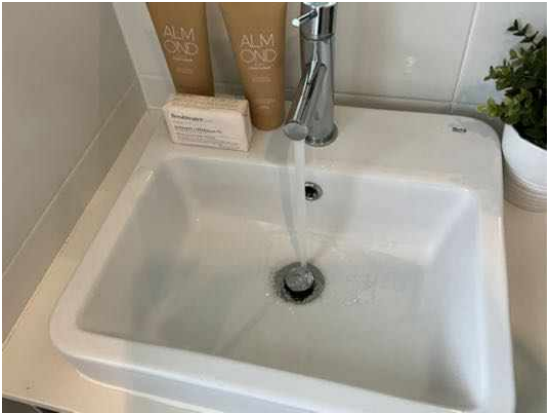
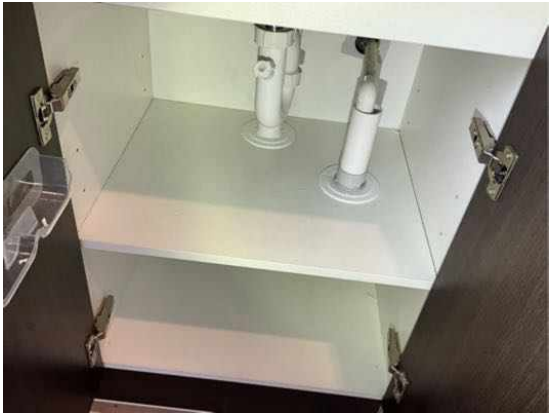
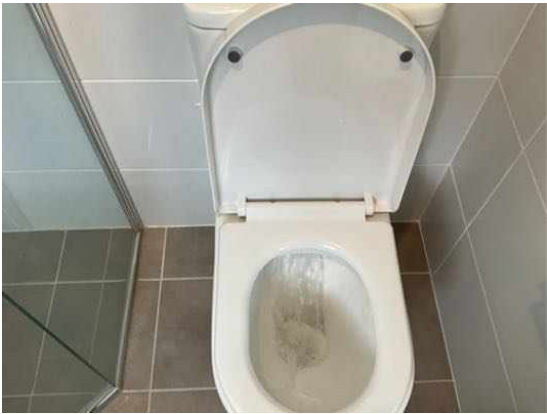
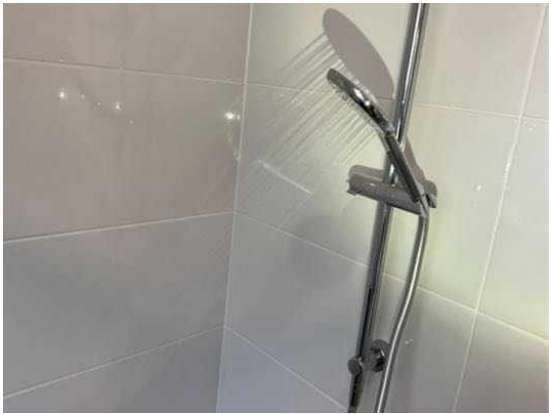
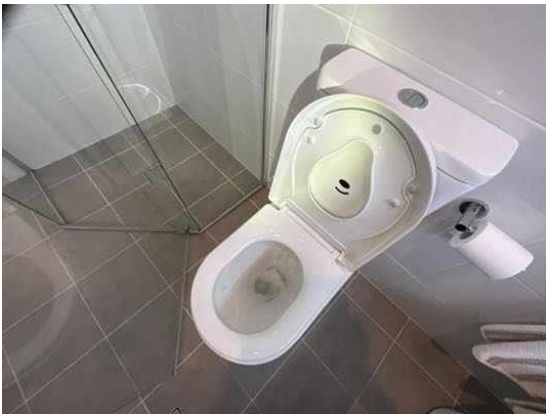
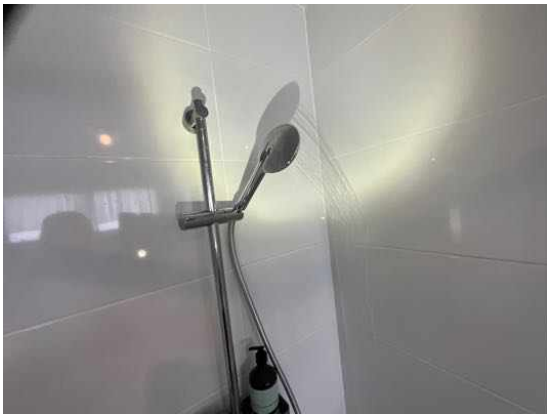
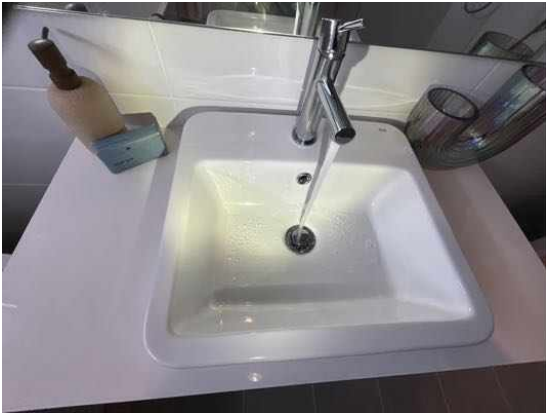
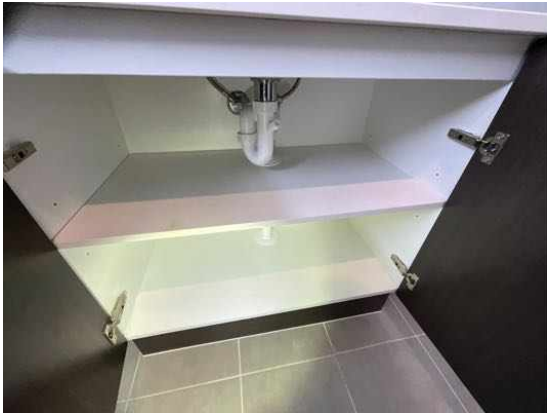
Building: Main Building
Location: All Wet Areas
Finding: Waterproofing
Information:

All taps, mixers and toilets were tested for operation, except for those obstructed. The waterproofing to the shower recess was assessed by checking the walls in and around the shower recess for varying moisture content. There were no significant variations across the tested areas. No sign of recent water damage was evident upon a visual inspection of the surrounding walls, where the visual nature of the inspection was possible.

Consequently, there is no conclusive evidence of any current shower recess leakage other than those which may have already been mentioned earlier in this report. It is reasonable to assume the shower waterproofing is sound. Note that if the shower is not used, or has not been used for some time, moisture readings would not vary significantly and this can lead to erroneous results. It is not possible under the visual inspection criteria (under which a prepurchase inspection is carried out) to categorically determine if there are leaks. If a more accurate assessment is required, a special purpose inspection should be requested. Alternatively, the assumption should be made that the shower may leak.

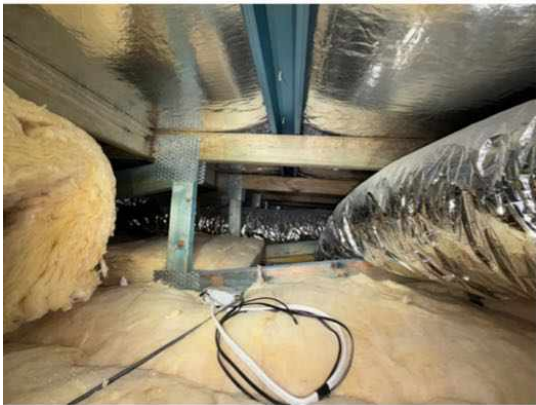
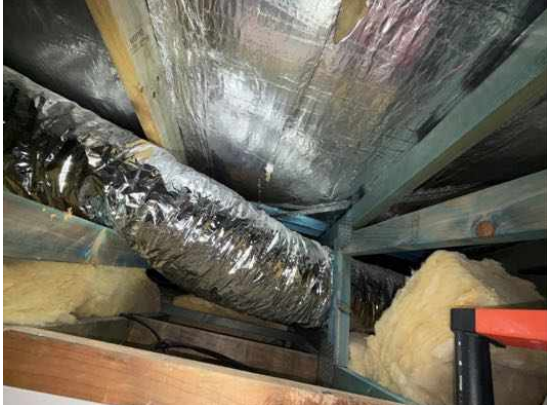
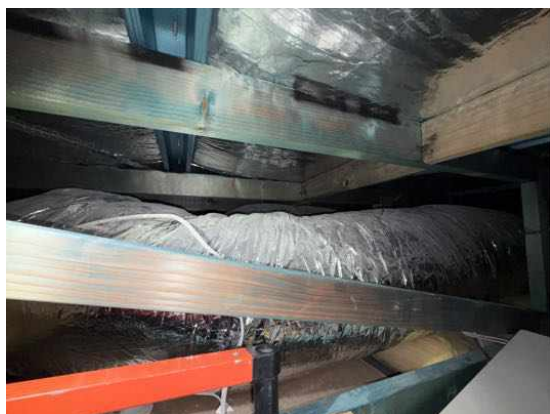
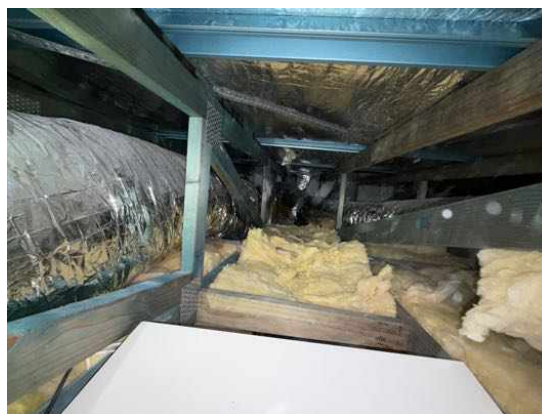
Building: Main Building
Location: Roof Void
Finding: Additional Photos
Information:

Additional photos are provided for your general reference.

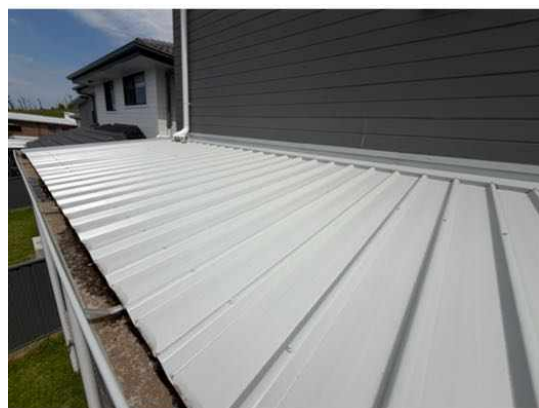
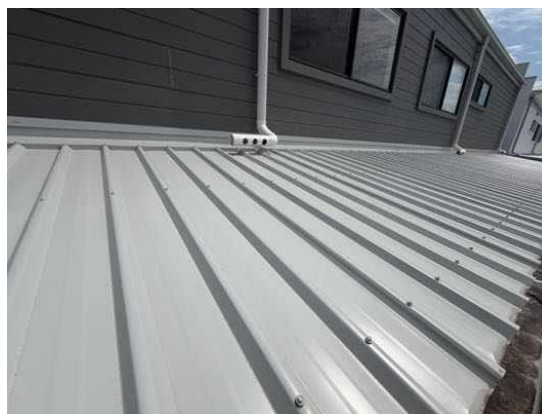
Building: Main Building
 Location: Roof Exterior
 Finding: Additional Photos
 Information:

Additional photos are provided for your general reference.

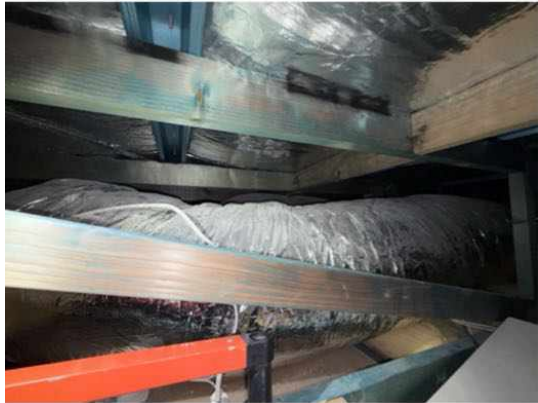
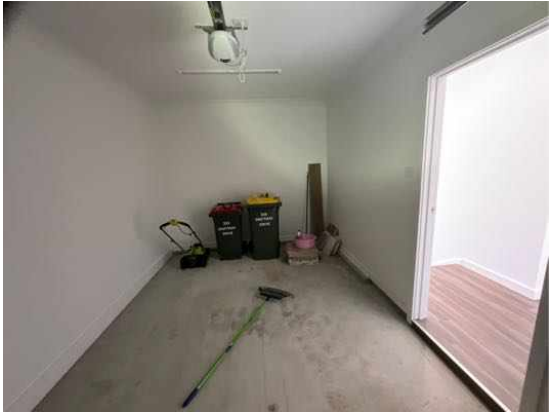
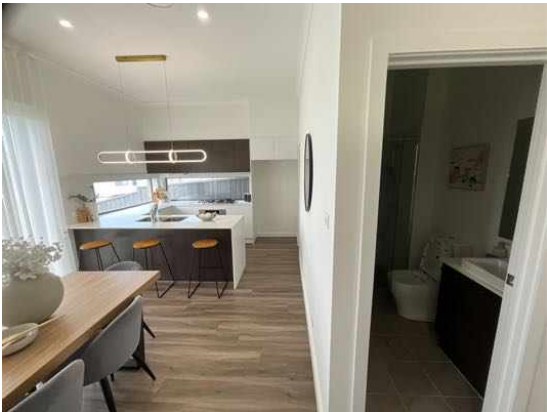
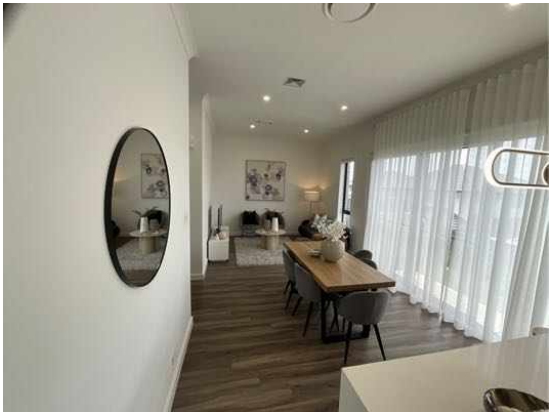
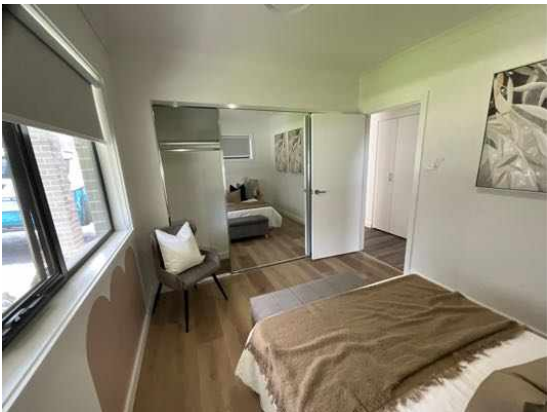
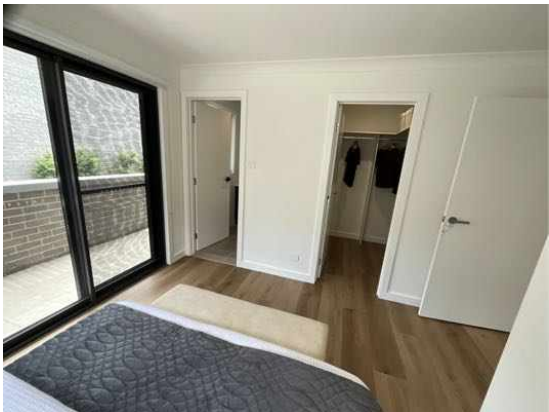
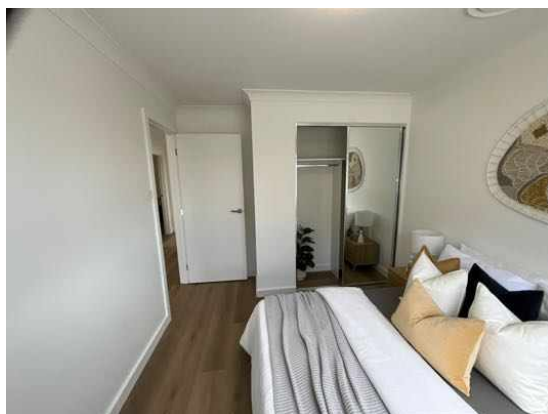
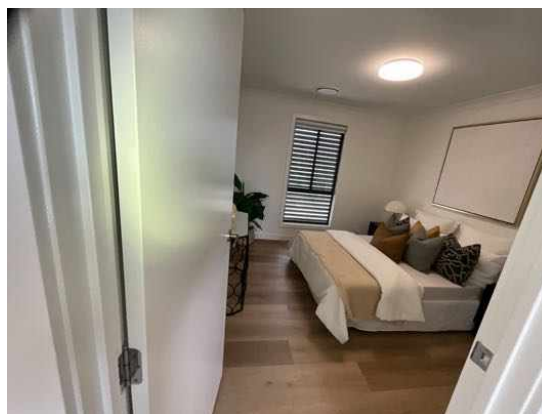
Building:	Main Building
Location:	All Areas
Finding:	Additional Photos - Obstructions and Limitations

Information: These photographs are an indication of the obstructions and limitations which impeded full inspection of the property at the time of inspection. These obstructions can hide an array of defects and should be removed to allow full inspection to be carried out. A re-inspection is recommended once the areas are made accessible.
