Building and Timber Pest Inspection Report

Inspection Date: Wed, 11 Mar 2026

Property Address: 27 Sanctuary Point Rd, Sanctuary Point
NSW 2540, Australia

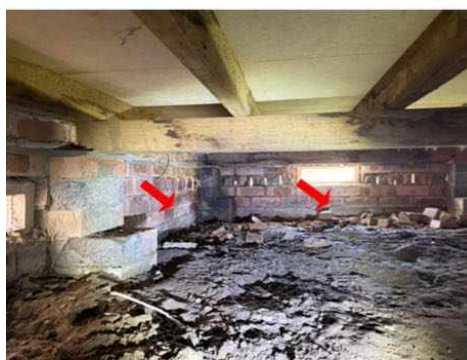
Rising damp is generally managed by the installation of a damp proof course during construction. A Damp Proof Course (DPC) is an impermeable barrier at the base of the wall above ground level. However, many 19th Century buildings have no damp course installed, or the materials have failed. The DPC may have been omitted as a

consequence of poor workmanship, or it may have been bridged where materials built up against the side of the house allow moisture ingress above the DPC level.

The first step in addressing rising damp is to diagnose the cause. The identified cause should be addressed first before addressing the appearance and other defects which have resulted from the rising damp. If the original cause is not resolved, further cases of damp are likely to ensue, resulting in secondary defects.

Consultation with a qualified plumber is advised immediately to identify the cause of the damp and perform remedial works as required. Installation of front drainage should assist in reducing the rising damp in the subfloor.

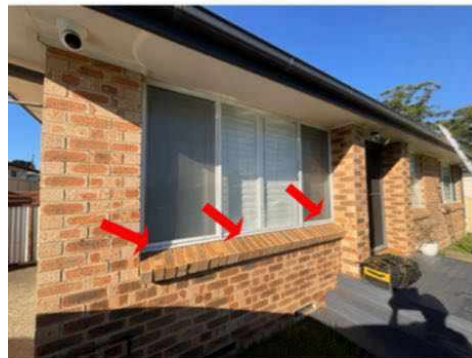
Building: Building 1
Location: Some wall areas
Finding: Sealant (external) - Missing.
Information: It was noted on inspection that areas of external sealant was missing to small areas of the external walls.

Flexible sealants should be applied to these affected areas to prevent any subsequent water damage that is likely to occur.

A sealant specialist or skilled handy person should be appointed to complete these works as soon as possible

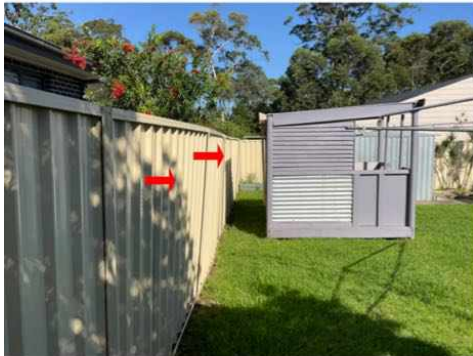
Location: Pictured fences
 Finding: Fences damaged - leaning
 Information: Evidence of damage to the pictured fences was identified at the time of the inspection. The likely cause of this fence leaning is not enough concrete used in the post footings.

If left unmanaged this fence may deteriorate further. It is suggest a fencing contractor be engaged for rectification when convenient.

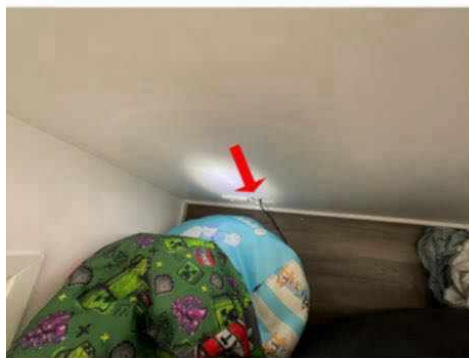
Finding 3.09

Building: Building 1
 Location: Pictured external areas
 Finding: Building elements - Damaged
 Information: Evidence of minor missing or damaged areas was identified at the time of the inspection. These include -

1. There is a small hole in the lounge wall from a removed power point.
2. The right gate is screwed shut and not operational, the left gate is damaged.
3. Some small areas of brickwork are damaged.

A carpenter and bricklayer would be the trade responsible for rectification of these areas when convenient.

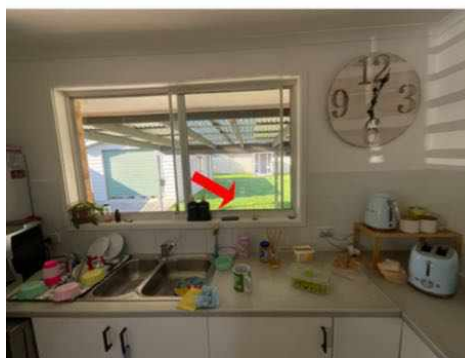
Finding 3.10

Building: Building 1
 Location: Bathroom and kitchen
 Finding: Windows - Stiff to slide
 Information:

The windows in these areas was difficult to operate at the time of the inspection. Windows provide ventilation to the adjoining area and should be at a fully operational level to ensure user comfort. Restricted function of the window may also pose as a potential safety hazard if required for emergency egress from the building.

Generally, factors such as general age of the building element and a lack of maintenance are the usual causes for this type of defect.

A general handy person will be required to repair the window.

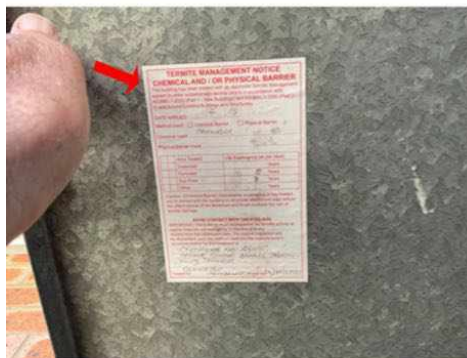
A durable notice should be placed in the switchboard unit to indicate current termite barriers. At the time of inspection, the durable notice was evident from condition. Additional durable notice stickers regarding the chemical termite management system has been installed should also be here.

The client may consider gaining further advice from the owner and/ or the pest controller that installed the last barrier. This 'chemical' application should be recharged immediately. It is recommended that obtaining such advice be a short-term high priority.

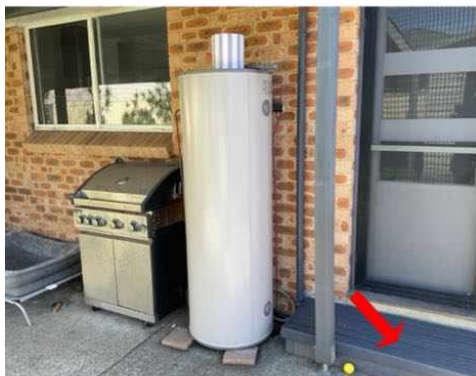
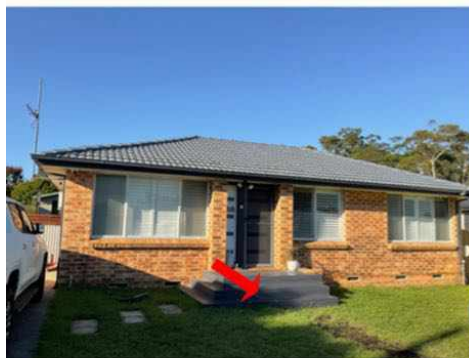
Finding 6.02

Building:	Building 1
Location:	Yard - front
Finding:	Bridging - decking
Information:	Where decking obstructs inspection of building elements, also known as bridging as it provides a bridging point for the access of termites, full inspection can not be achieved. Consequently moisture or dampness may be present and the areas becomes conducive to termite activity. Decks against or very close to buildings provide cover, shade and can provide an environment that is attractive to termite infestation.

Leaving a small gap between decking and the building walls will assist greatly in preventing Bridging from occurring.

The removal of any such stored building materials that may be conducive to termite activity should be carried out as soon as possible and arrange re inspection to minimize the risk of termite attack.

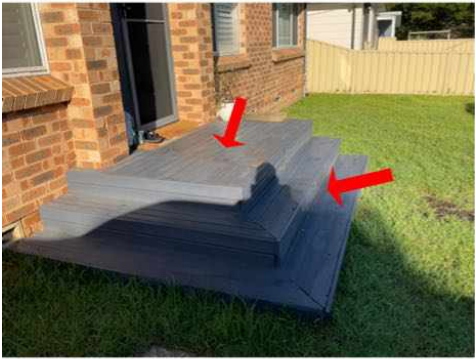
Building: Building 1
 Location: All External Areas
 Finding: Additional Photos - Obstructions and Limitations of EXTERNAL AREAS
 Information: These photographs are an indication of the obstructions and limitations which impeded full inspection of external areas at the time of inspection. These obstructions can hide an array of defects and should be removed to allow full inspection to be carried out. A re-inspection is recommended once the areas are made accessible.

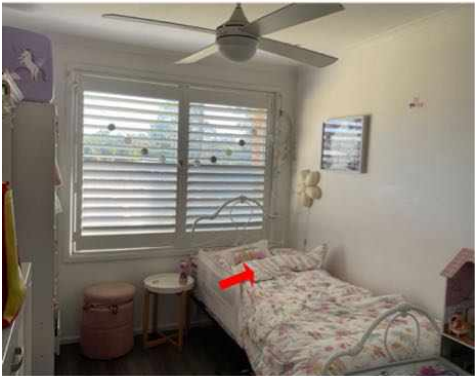
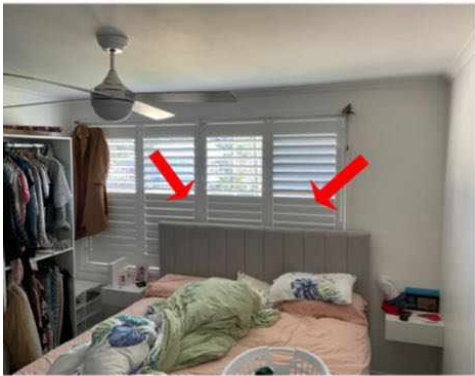
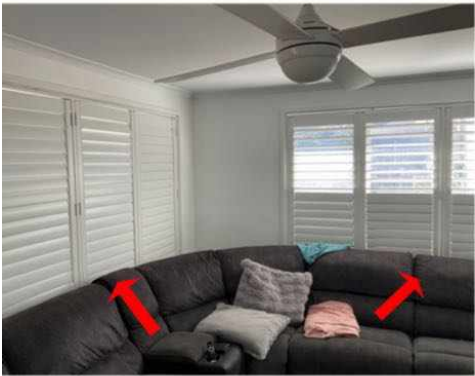
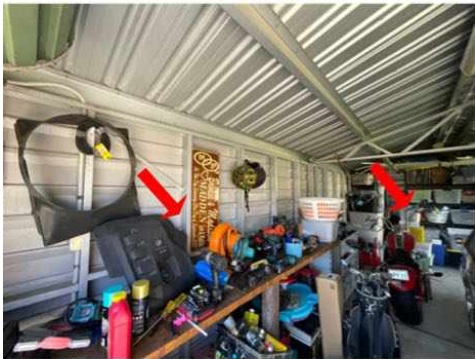
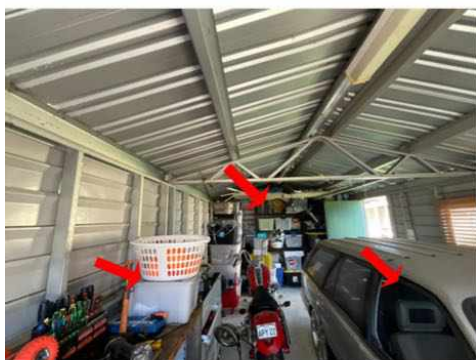
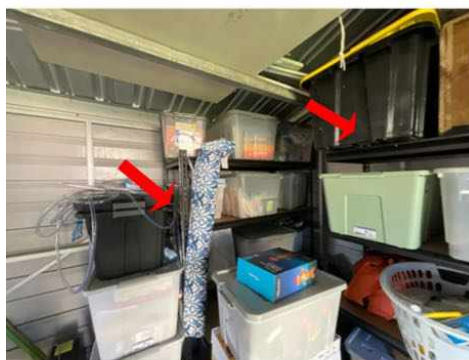
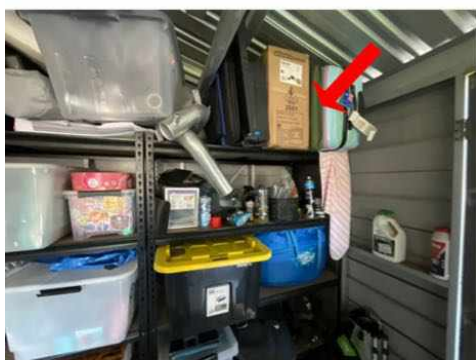
Building: Building 1
Location: All Internal Areas
Finding: Additional Photos - Obstructions and Limitations of INTERNAL AREAS
Information: These photographs are an indication of the obstructions and limitations which impeded full inspection of Internal areas at the time of inspection. These obstructions can hide an array of defects and should be removed to allow full inspection to be carried out. A re-inspection is recommended once the areas are made accessible.

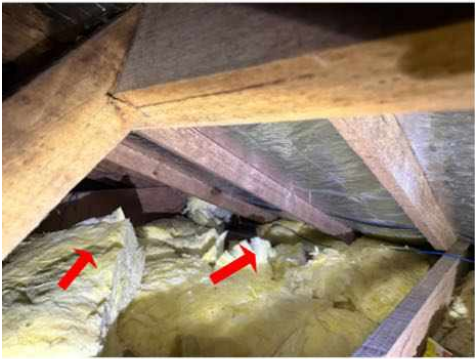
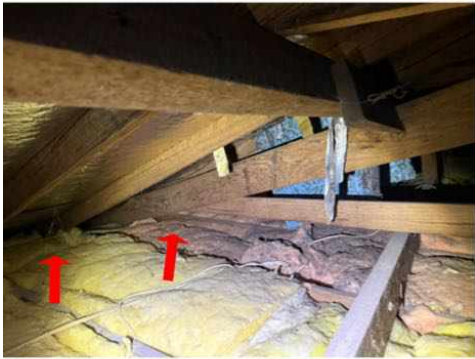
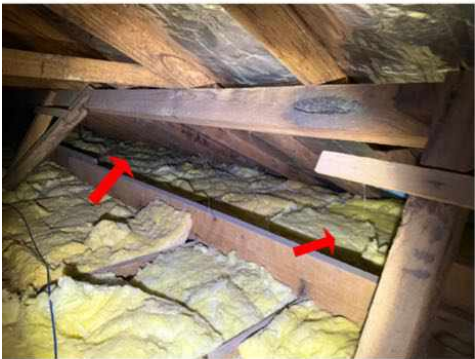
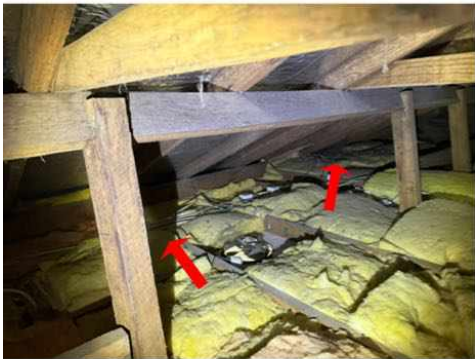
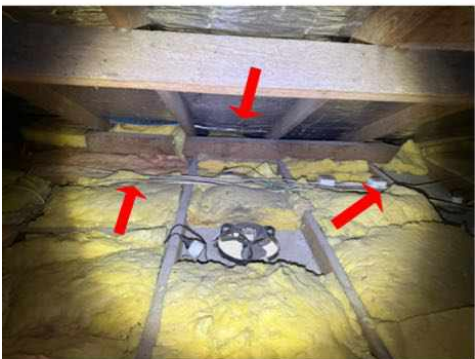
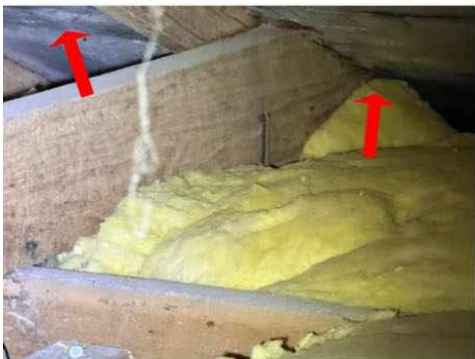
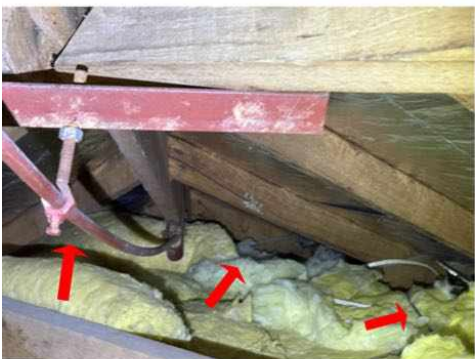
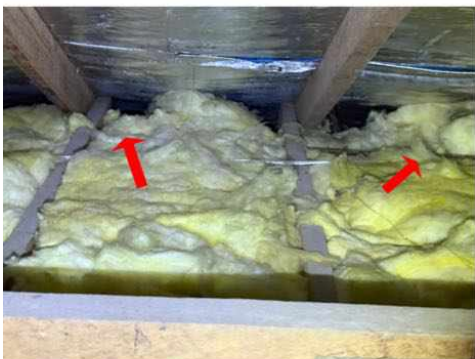
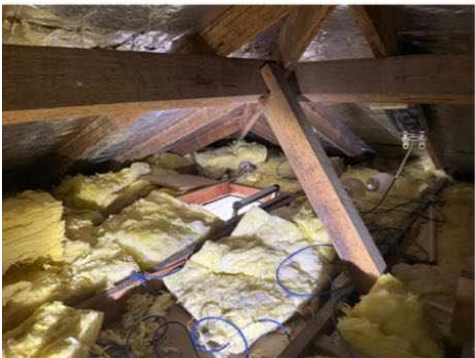
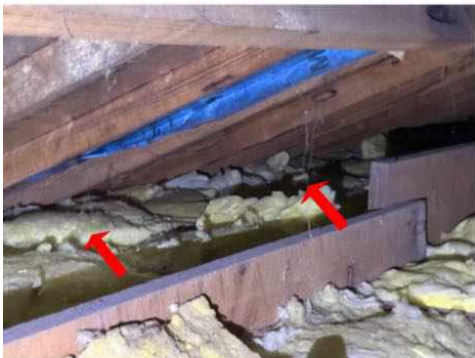
See the 10 photos of “Obstructions and Limitations of the ROOF CAVITY” at the end of this report. This damage is considered to be inactive and is minor in nature.

Building:	Building 1
Location:	All Roof cavity areas
Finding:	Additional Photos - Obstructions and Limitations of the ROOF CAVITY
Information:	<p>These photographs are an indication of the obstructions and limitations which impeded full inspection of roof cavity areas at the time of inspection. These obstructions can hide an array of defects and should be removed to allow full inspection to be carried out if applicable. A re-inspection is recommended once the areas are made accessible.</p> <p>The inspection was also limited to areas with an allowable crawl space of 600mm x 600mm, in particular towards the external walls where the roof line diminishes, these areas were not accessible.</p>

It is advised that the area be visually inspected frequently to ensure that the condition of affected building materials does not worsen. At the time of inspection, damage is not structural and is only considered to be superficial.

A building contractor may be appointed to provide a further invasive inspection if further damage is evident.

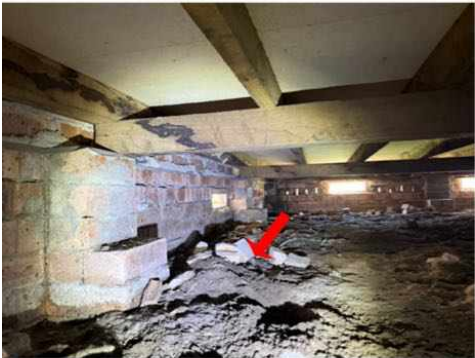
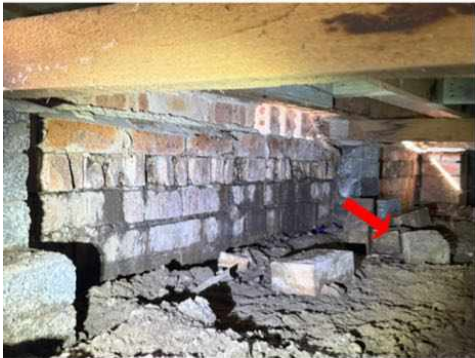
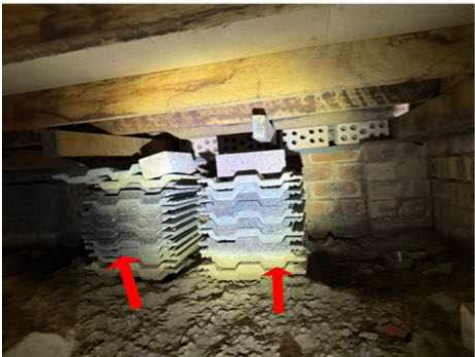
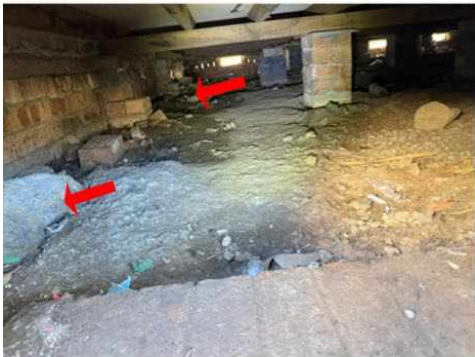
Building: Building 1
 Location: All Subfloor Areas
 Finding: Additional Photos - Obstructions and Limitations of SUBFLOOR AREAS
 Information: These photographs are an indication of the obstructions and limitations which impeded full inspection of subfloor areas at the time of inspection. These obstructions can hide an array of defects and should be removed to allow full inspection to be carried out. A re-inspection is recommended once the areas are made accessible.

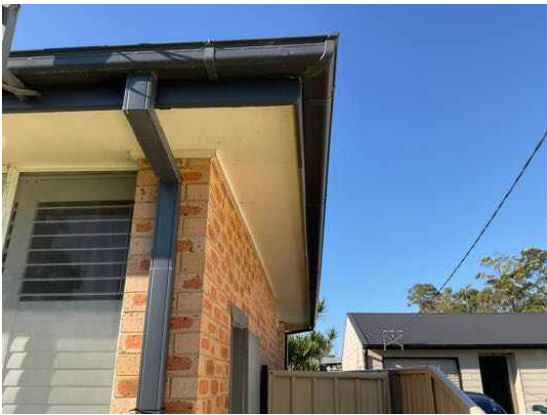
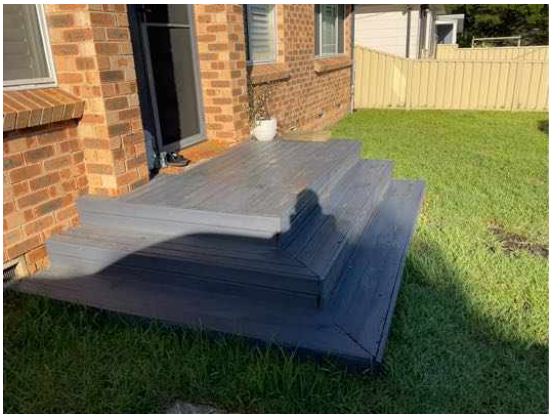
Building: Building 1
Location: All External Areas
Finding: Additional Photos
Information: Additional photos are provided for your general reference

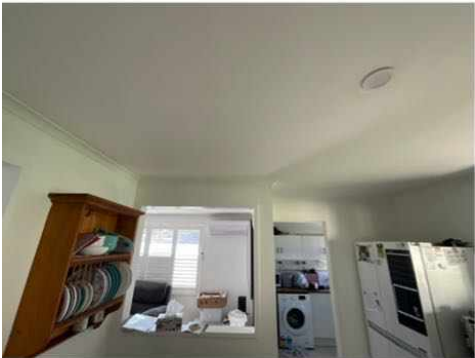
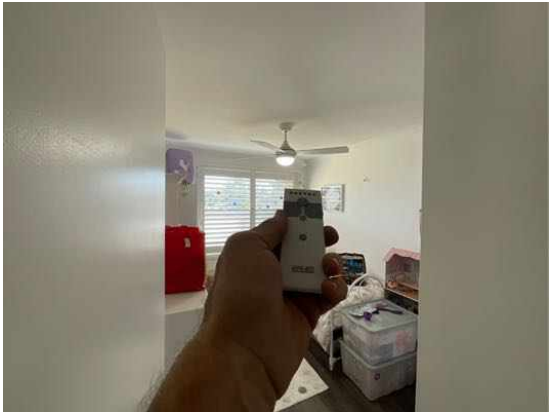
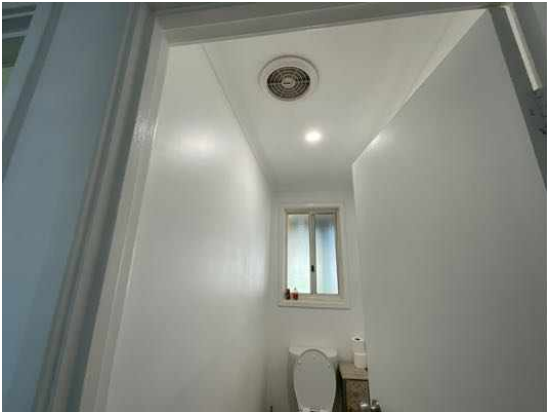
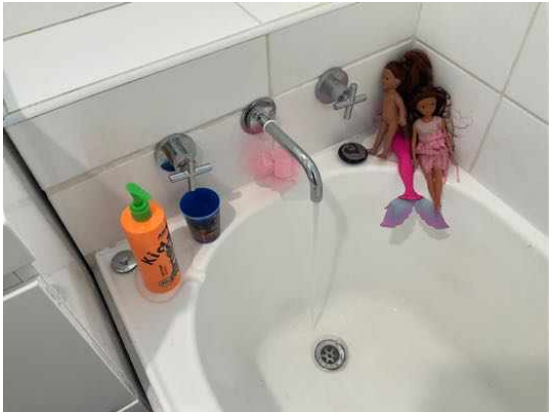
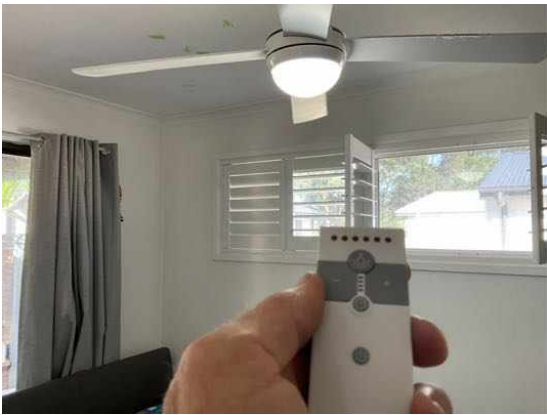
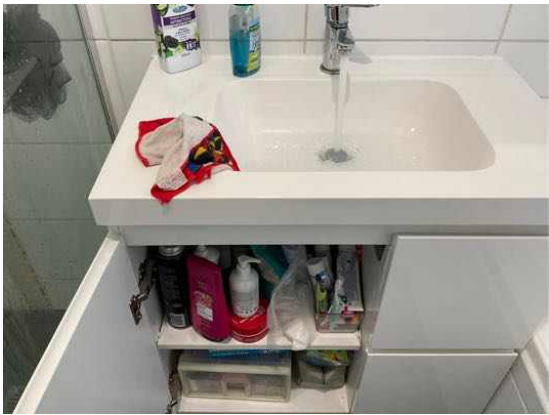
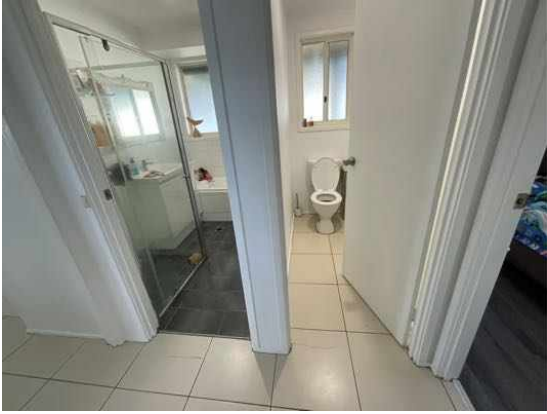
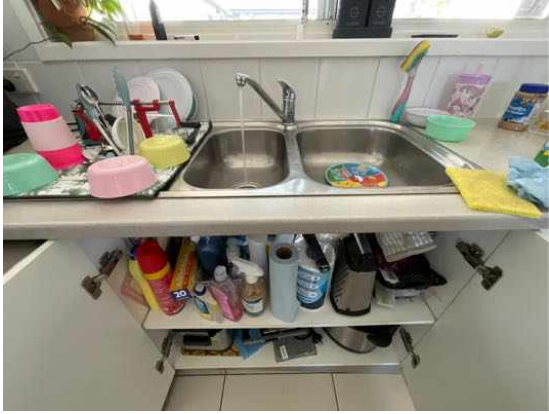
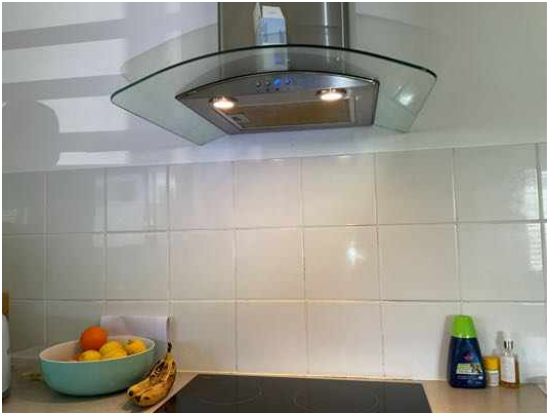
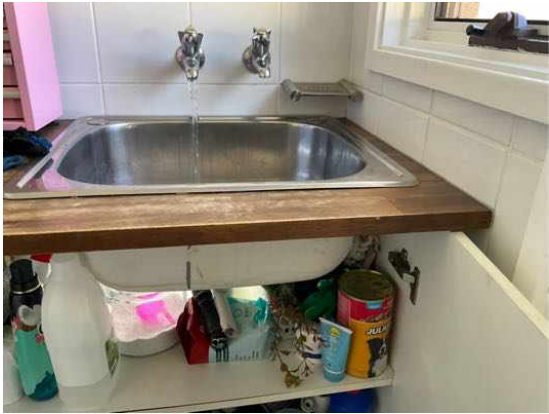
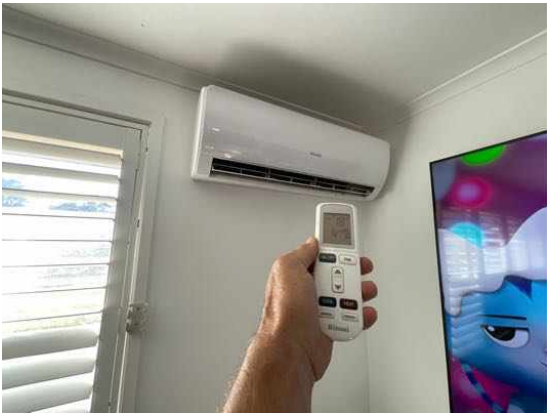
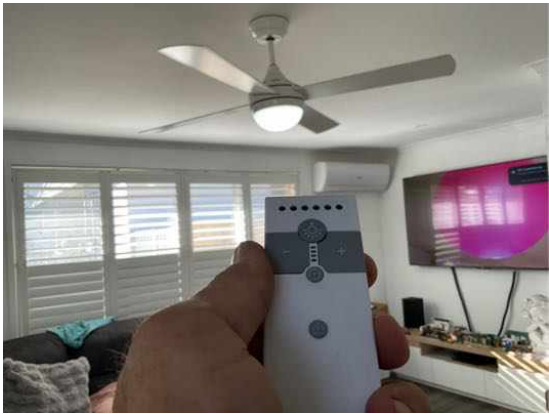
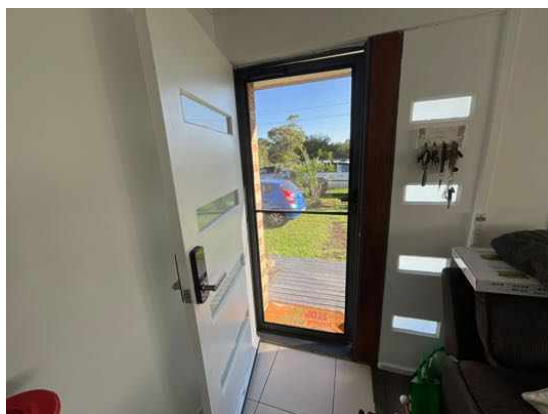
Building: Building 1
Location: All Internal Areas
Finding: Additional Photos
Information: Additional photos are provided for your general reference

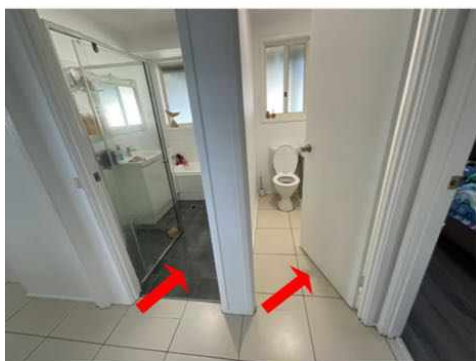
Building: Building 1
 Location: Bathrooms and laundry
 Finding: Waterproofing membranes - Information Only
 Information: Internal Water Proofing Membranes, are crucial in preventing water ingress into the property is important to know that the Membrane System used is to Australian Standards and has been installed correctly.

With older property's where this information is unavailable all wet areas should be monitored. If any leaks, water staining, peeling or bubbling of the paint become evident to any adjacent walls or ceilings below a licensed builder or waterproofing specialist is recommended to investigate further.
