# Building and Timber Pest Inspection Report

Inspection Date: Fri, 20 Mar 2026

Property Address: 605/3 Jean Wailes Ave, Rhodes NSW 2138,  
Australia

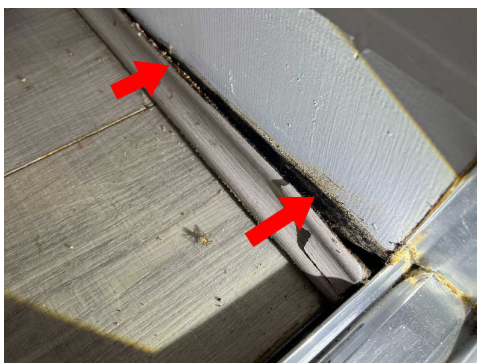
Finding: Moisture Ingress, Material Deterioration and Associated Insect Activity – Built-in Wardrobe Adjacent to Terrace

Information: Deterioration was observed to the base of the built-in wardrobe beneath the sliding door track, located adjacent to the external terrace area. The underlying board material appears moisture affected, with visible swelling, breakdown and friable condition consistent with prolonged moisture exposure. Associated with this condition, insect activity consistent with ants was noted within the damaged material. While no definitive evidence of termite activity was identified at the time of inspection, the presence of moisture-affected materials and concealed voids may provide conditions conducive to timber pest activity. The exact extent of damage could not be fully determined due to concealed construction.

Given the proximity to the terrace and the apparent waterproofing concerns externally, it is considered likely that moisture ingress from the adjoining external area has contributed to the deterioration observed. This condition is of concern as ongoing moisture ingress can result in further material degradation and may attract timber pests or other insects. It is recommended that the source of moisture ingress, including any waterproofing defects, be identified and rectified as a priority. Damaged materials should be repaired or replaced as required. An invasive inspection by a licensed timber pest controller is recommended to further assess concealed areas and confirm the absence of termite activity.

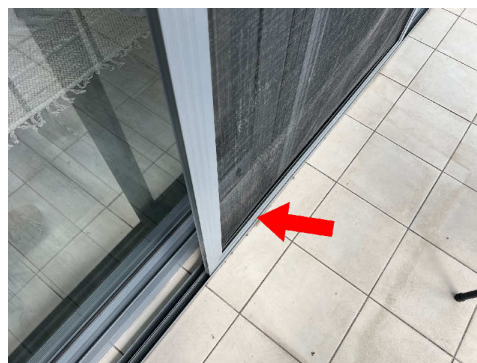
Information: The sliding screen door was found to be stiff and difficult to operate at the time of inspection. The door does not slide freely along its track, requiring increased force to open and close. This condition was observed at the balcony access point and appears likely due to debris build-up within the track, worn or misaligned rollers, or general lack of maintenance.

If left unaddressed, continued use may result in further wear to the rollers or track components, and may eventually lead to failure of the sliding mechanism. In some cases, excessive force can also cause damage to the door frame or track assembly. It is recommended that a suitably qualified handyman or door specialist assess the door, clean the track, and adjust or replace rollers as required to restore smooth operation.

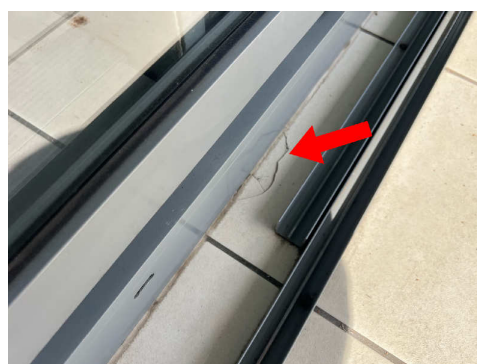
### Finding 3.02

Finding: Cracked Floor Tile – Balcony Sliding Door Threshold

Information: A floor tile adjacent to the sliding door threshold at the balcony was observed to be cracked. The cracking appears localised to a single tile and is likely due to impact damage, substrate movement, or stress at the doorway transition point where foot traffic is concentrated.

Cracked tiles can allow moisture ingress beneath the tiled surface, potentially leading to deterioration of the substrate or loosening of surrounding tiles over time. Additionally, the uneven surface may present a minor trip hazard if the damage worsens. It is recommended that a suitably qualified tiler assess and replace the affected tile and check surrounding tiles for any signs of movement or loss of adhesion.

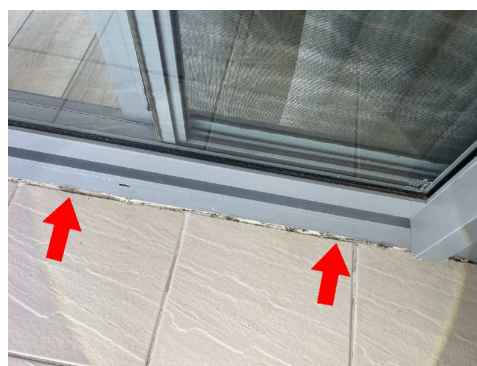
### Finding 3.03

Finding: Deteriorated Grout and Sealant – Balcony Tiling and Door Junction

Information: Grout between the balcony floor tiles and sealant along the junction of the sliding door frame were observed to be deteriorated and worn in sections. Localised gaps, cracking, and breakdown of sealant were noted, particularly along the door threshold and perimeter edges of the tiled surface.

Deterioration of grout and sealant can allow water to penetrate beneath the tiles and into adjoining building elements, potentially leading to moisture-related damage, tile loosening, or deterioration of the substrate over time. The door threshold area is particularly vulnerable due to exposure to weather and foot traffic. It is recommended that a suitably qualified tiler or sealant specialist remove and replace the affected grout and reapply appropriate flexible sealant to all junctions to maintain water resistance.

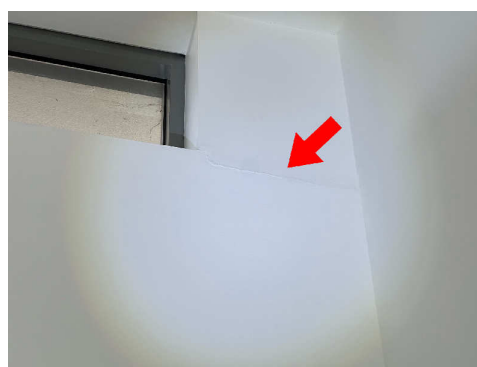
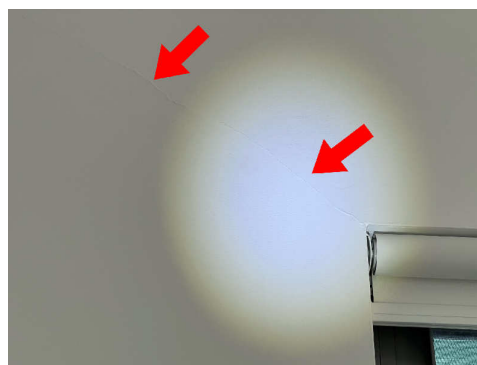
#### Finding 3.04

Finding: Minor Cracking to Internal Wall – Adjacent to Fixed Window Panels

Information: Minor cracking was observed to internal wall surfaces adjacent to fixed window panels, including above and beside the glazing. The cracks are fine and linear in nature and appear consistent with typical movement at junctions between the wall substrate and fixed window framing.

Cracking in these areas commonly occurs due to minor building movement, thermal expansion and contraction, or differential movement between dissimilar materials (e.g. plaster and aluminium window framing). While the cracks appear cosmetic at the time of inspection, they may worsen over time or allow minor moisture ingress if left unsealed. It is recommended that a suitably qualified painter or plasterer carry out patching and repainting as required, with ongoing monitoring to ensure the cracks do not increase in size.

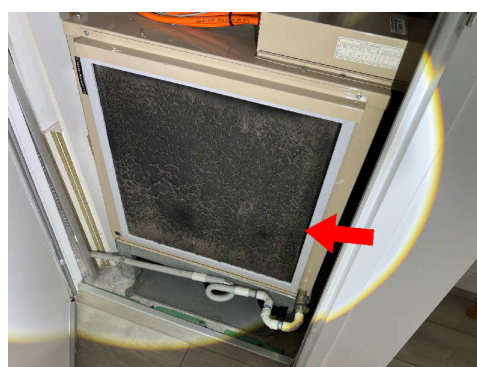
### Finding 3.05

Finding: Air Conditioning Unit – Dirty Filter and Internal Components

Information: The internal air conditioning unit located within the cupboard was observed to have a significant build-up of dust and debris on the return air filter and internal components. The level of contamination indicates the unit has not been cleaned or serviced for some time.

A dirty air conditioning system can restrict airflow, reduce efficiency, and place additional strain on the unit, potentially leading to premature wear or failure. It may also impact indoor air quality by circulating dust and contaminants throughout the dwelling. It is recommended that a suitably qualified HVAC technician carry out a full service, including cleaning or replacement of filters and inspection of internal components to ensure proper operation.

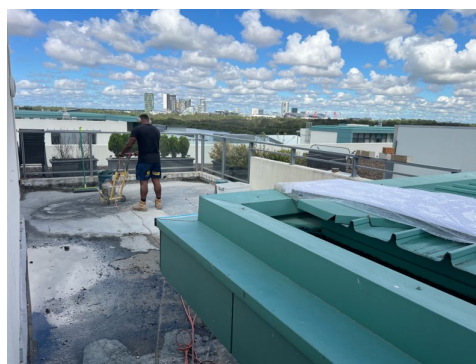
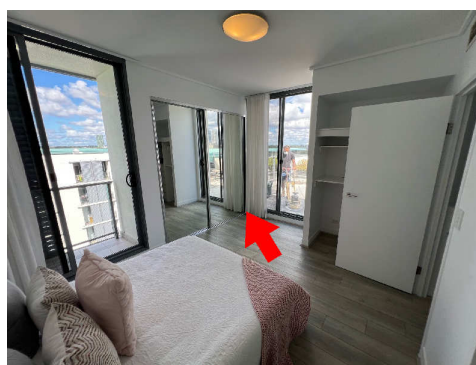
Finding: Conducive Conditions to Timber Pest Activity – Inaccessible Terrace Area

Information: The external terrace area adjacent to the bedroom was not accessible at the time of inspection due to the presence of workers. As a result, the condition of the terrace surface, drainage and waterproofing systems could not be assessed. Notwithstanding this limitation, the internal moisture-related deterioration and insect activity observed to the adjoining built-in wardrobe indicates that moisture ingress may be occurring from this external area.

Inaccessible external areas with potential waterproofing or drainage issues are considered conducive to timber pest activity, particularly where moisture may accumulate and affect adjacent building elements. It is recommended that the terrace area be inspected once access is available, with particular attention to waterproofing, drainage and any defects that may allow moisture ingress. Any identified issues should be rectified as required to reduce the risk of ongoing damage and potential timber pest activity.

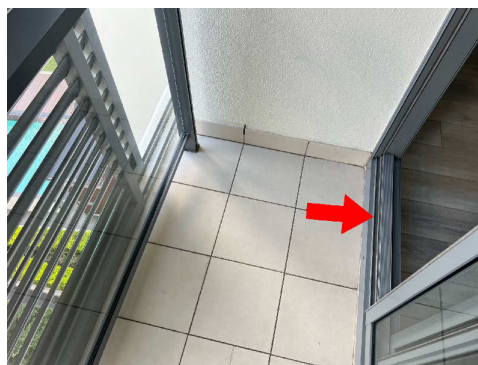
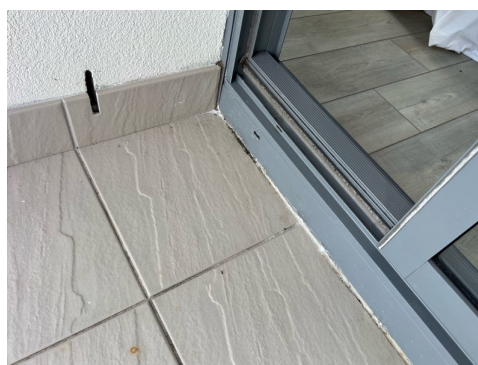
### Finding 6.02

It is important for internal flooring to be raised above adjacent external ground levels. Where external ground levels are above internal flooring water pooling and subsequent internal flooding is likely to occur which may attract termite activity to the internal area.

It is highly advised that a landscaper or paver be appointed to lower external grounds that are raised above adjacent internal flooring. Alternatively if external grounds and internal flooring is level installation of a raised door sill may be appropriate in preventing any water pooling in the area.

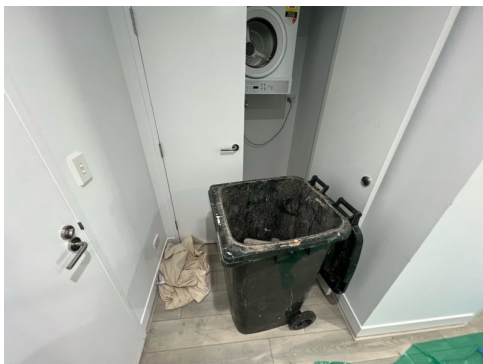
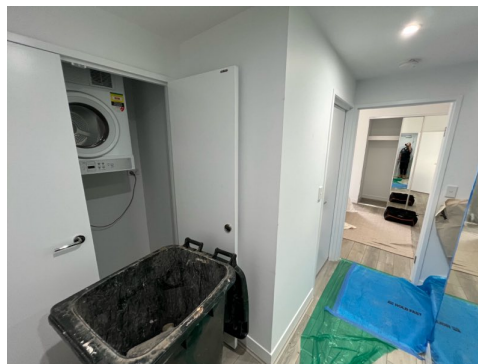
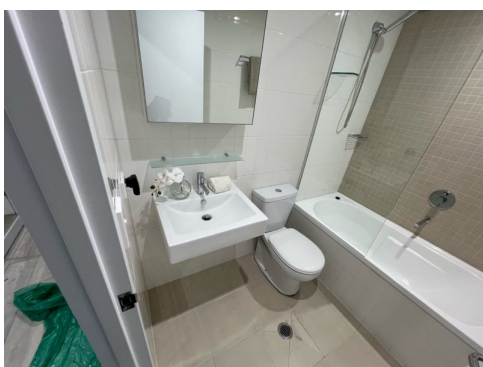
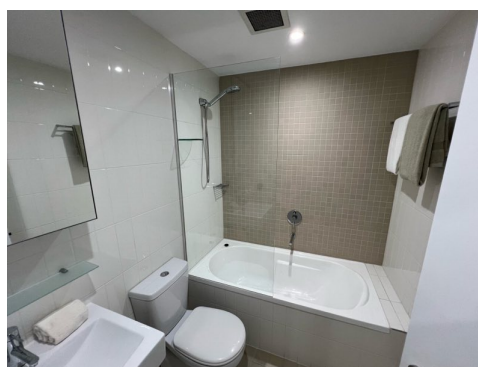
Finding: Additional Photos - Obstructions and Limitations

Information: These photographs are an indication of the obstructions and limitations which impeded full inspection of the property at the time of inspection. These obstructions can hide an array of defects and should be removed to allow full inspection to be carried out. A re-inspection is recommended once the areas are made accessible.

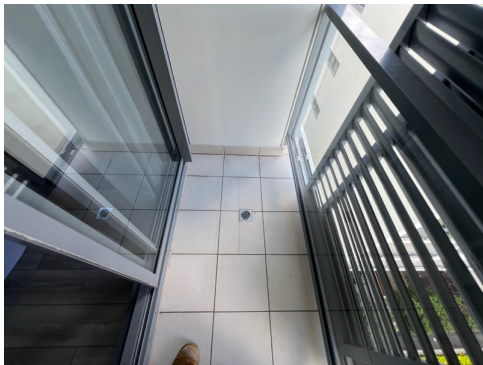
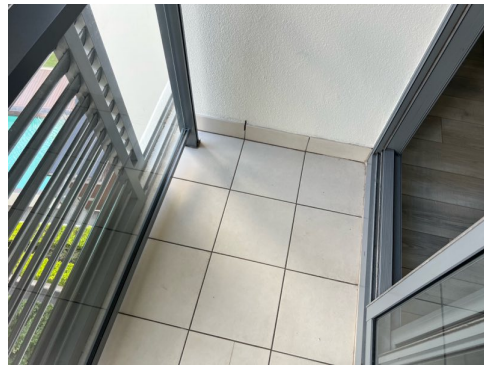
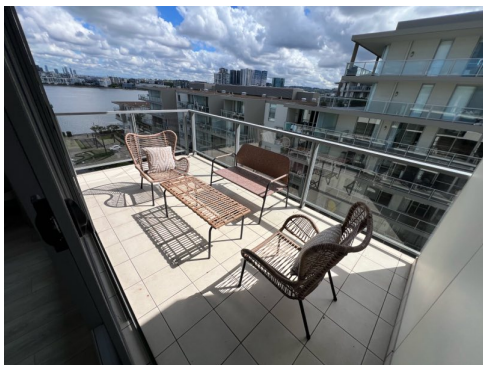
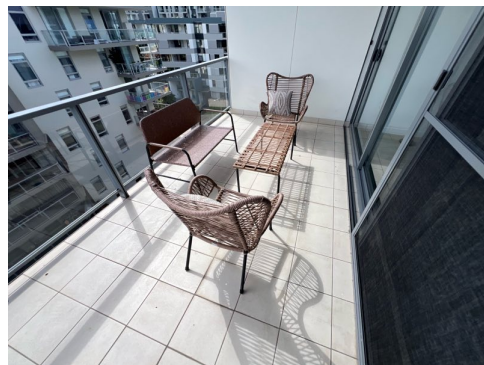
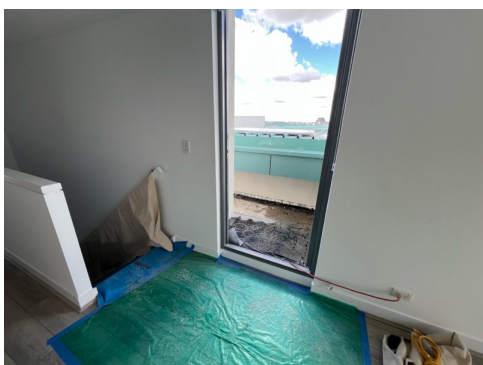
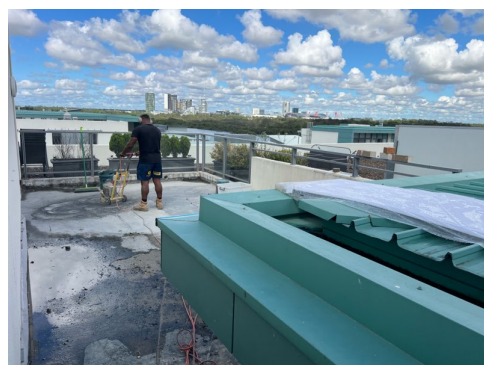
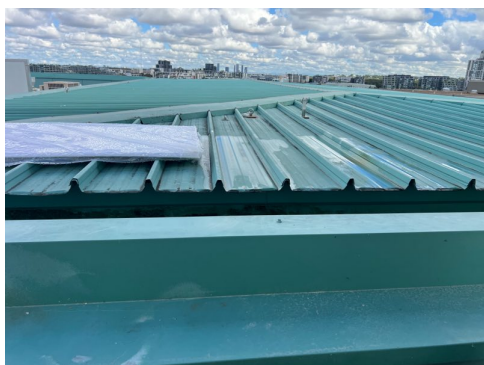
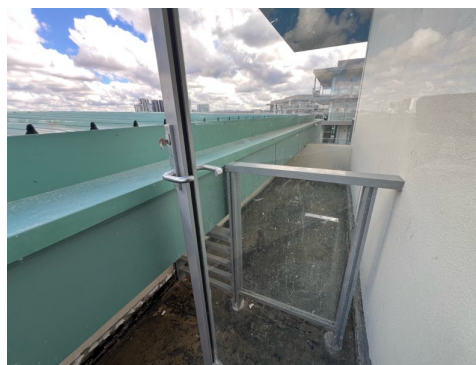
Finding: Additional Photos - Obstructions and Limitations

Information: These photographs are an indication of the obstructions and limitations which impeded full inspection of the property at the time of inspection. These obstructions can hide an array of defects and should be removed to allow full inspection to be carried out. A re-inspection is recommended once the areas are made accessible.

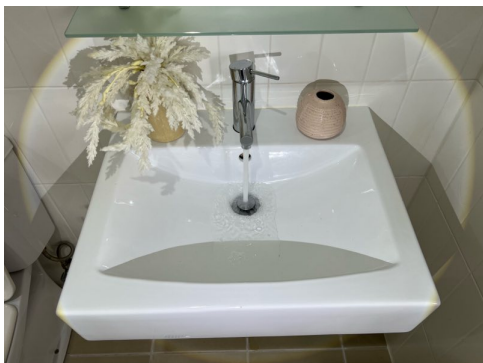
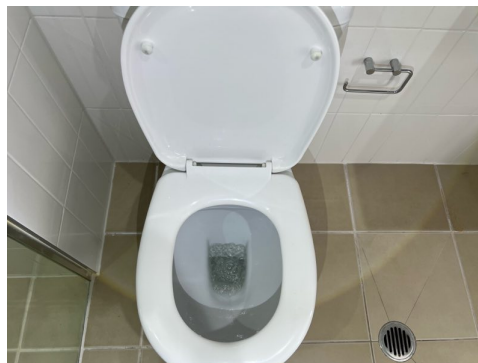
Information: All taps, mixers, and toilets were tested for correct operation, except where access was restricted. The shower recess waterproofing was assessed by conducting noninvasive moisture readings to the walls in and around the shower recess. No abnormal or significant moisture variations were detected within the areas tested. In addition, a visual inspection of the surrounding wall surfaces did not reveal any visible signs of recent or ongoing water damage where inspection was possible.

Based on the above observations, there is no conclusive evidence to suggest the presence of an active shower recess leak at the time of inspection, other than any issues already identified elsewhere in this report. It is therefore reasonable to assume that the shower waterproofing is currently performing as intended. However, it should be noted that if the shower has not been used for an extended period prior to the inspection, moisture readings may not accurately reflect underlying conditions and may result in misleading outcomes. As this inspection is limited to visual and noninvasive methods in accordance with pre-purchase inspection standards, it is not possible to definitively confirm the absence of leaks. If a higher level of certainty is required, a specialist invasive inspection is recommended.

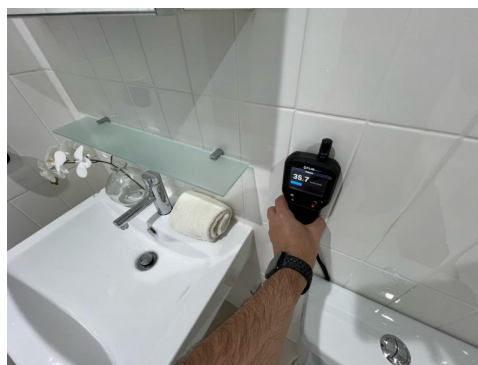
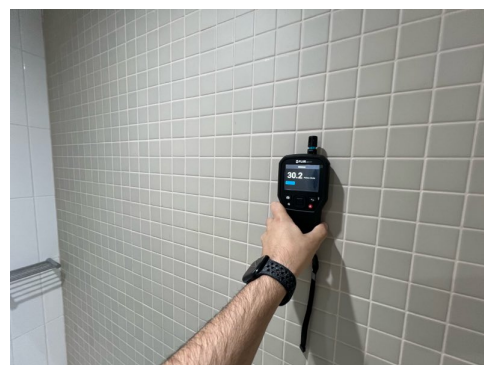
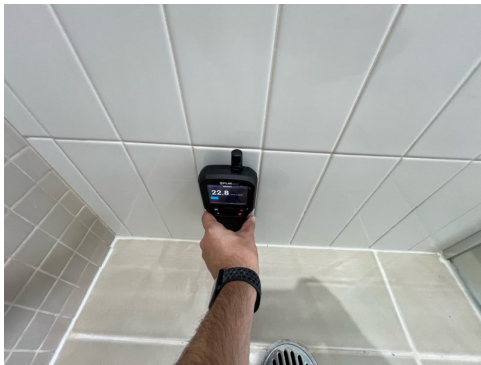
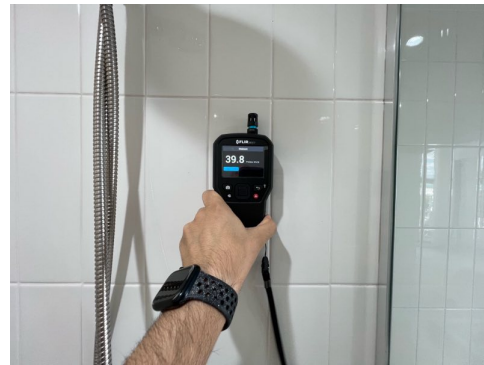
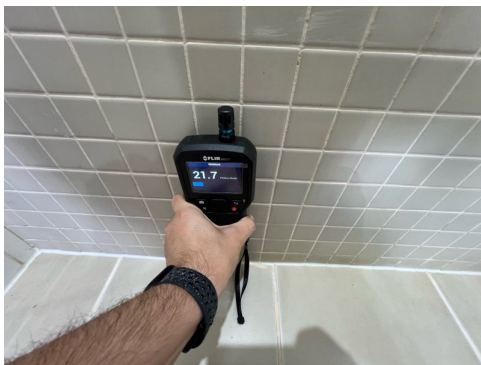
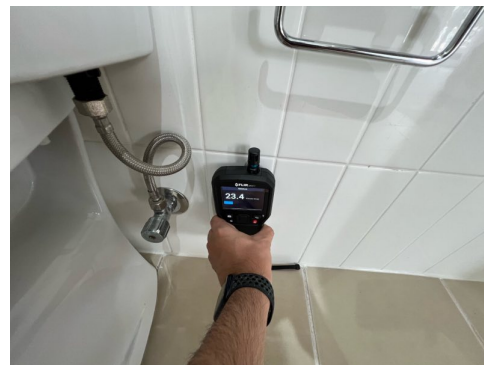
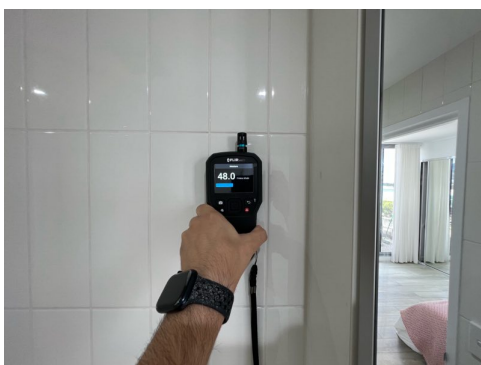
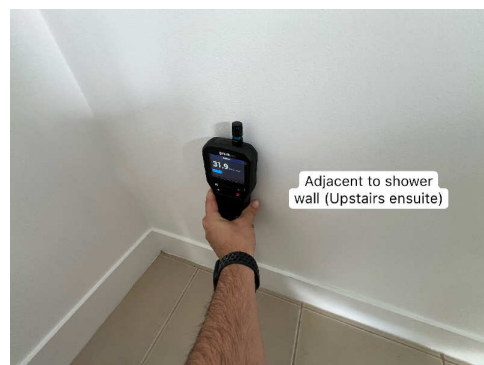
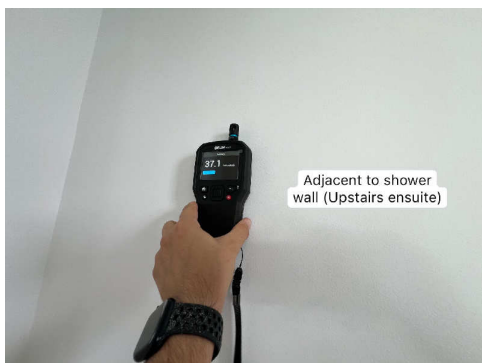
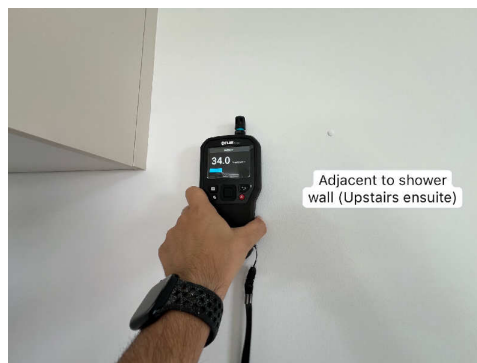
Finding: Moisture Meter Readings - For Information Only

Information: Moisture testing was undertaken to selected accessible internal surfaces using a noninvasive moisture meter at the time of inspection. Readings obtained provide an indicative assessment only and are intended as a guide to assist in identifying areas that may warrant further investigation.

No invasive testing was carried out, and moisture readings can be influenced by a range of factors including material type, surface finishes, environmental conditions, and recent use of wet areas. As such, the results are provided for information purposes only and do not constitute a definitive assessment of concealed moisture conditions. Concealed defects may exist that were not evident at the time of inspection.

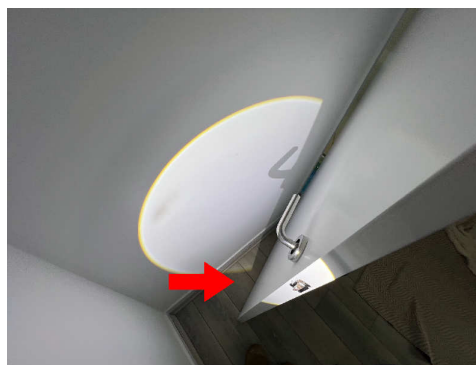
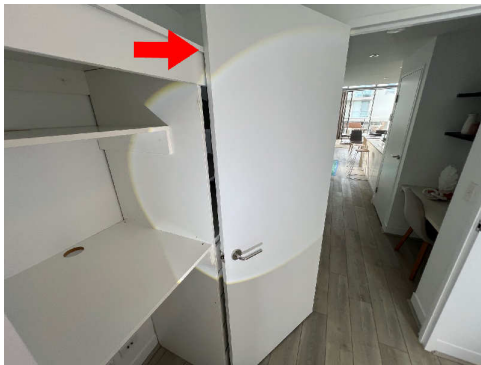
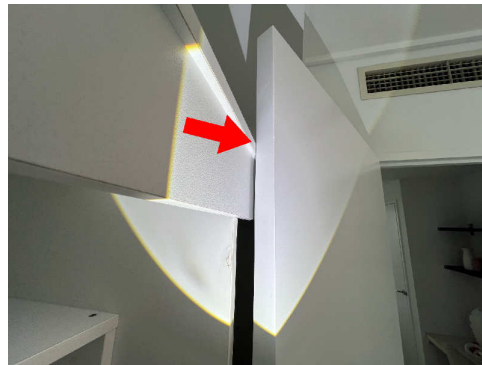
Finding: Door stop - Missing

Information: The door stop is missing stop the door handle from damaging the wall. Although some building elements may seem irrelevant or unnecessary, all building elements play a key role in the operation and function of the overall structure and its performance.

Re-installation or replacement of the door stop is advised as soon as possible to prevent any subsequent damage to the door or associated structures. A general handyman may be appointed to perform these works at client discretion.
